Sunshine Bridge Emergency Repair

ALABAMA TRANSPORTATION CONFERENCE

Chris B. Guidry, P.E.

LADOTD Asst. Bridge Design Administrator

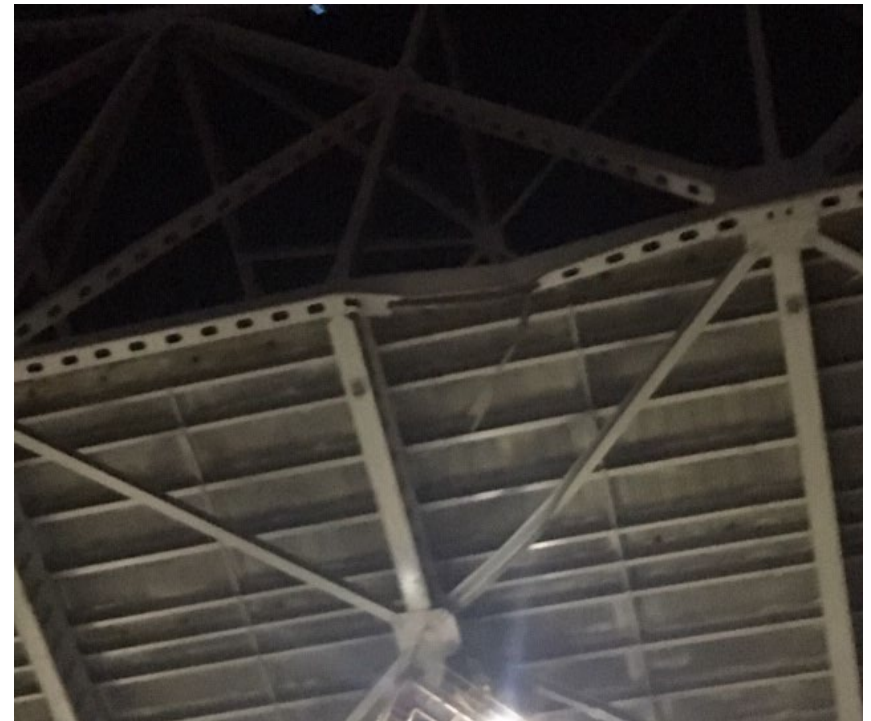
Barge Crane– owned by Marquette Transportation Company Gulf-Inland, LLC strikes lower chord of truss

Probable Cause – inadequate voyage planning; vertical clearance information used by the pilot didn't reflect the actual clearance. (NTSB)

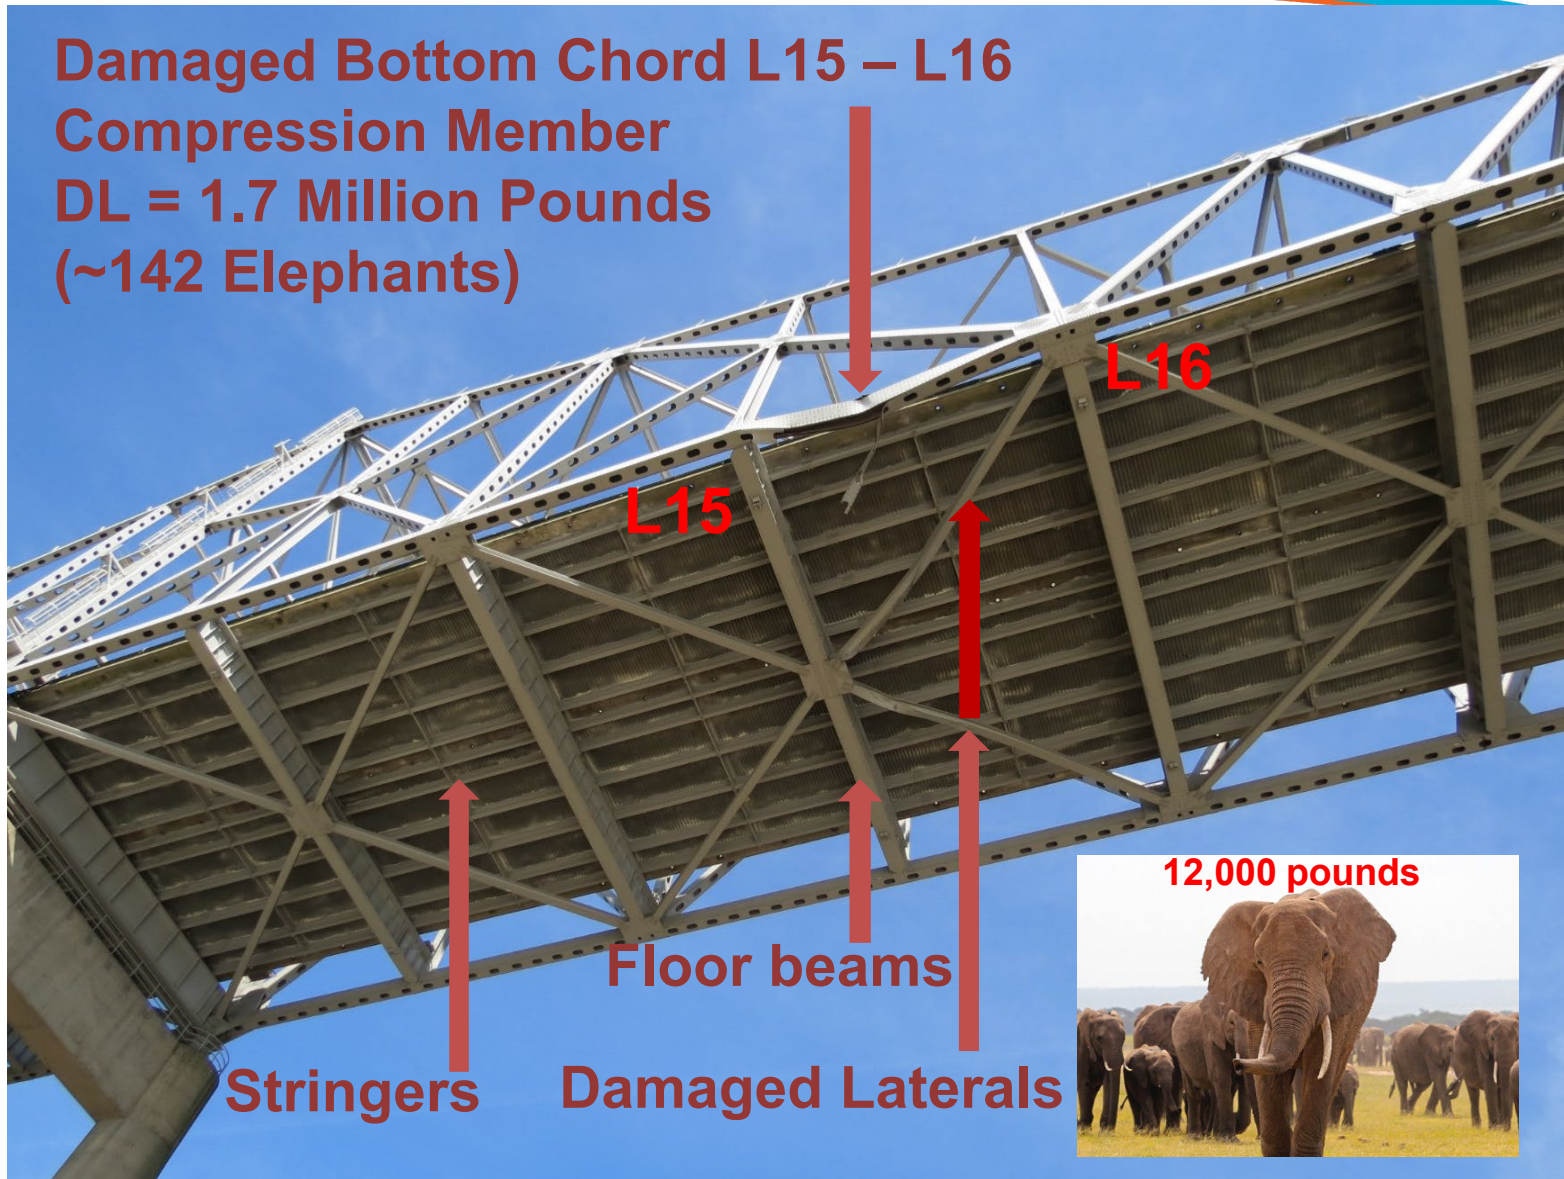
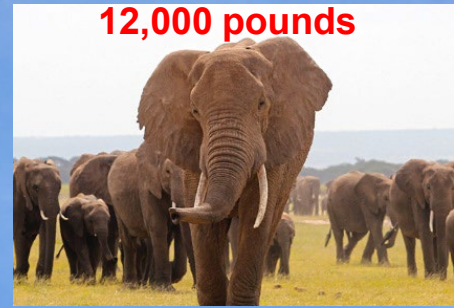
Damaged Bottom Chord L15 – L16
Compression Member
DL = 1.7 Million Pounds
(~142 Elephants)

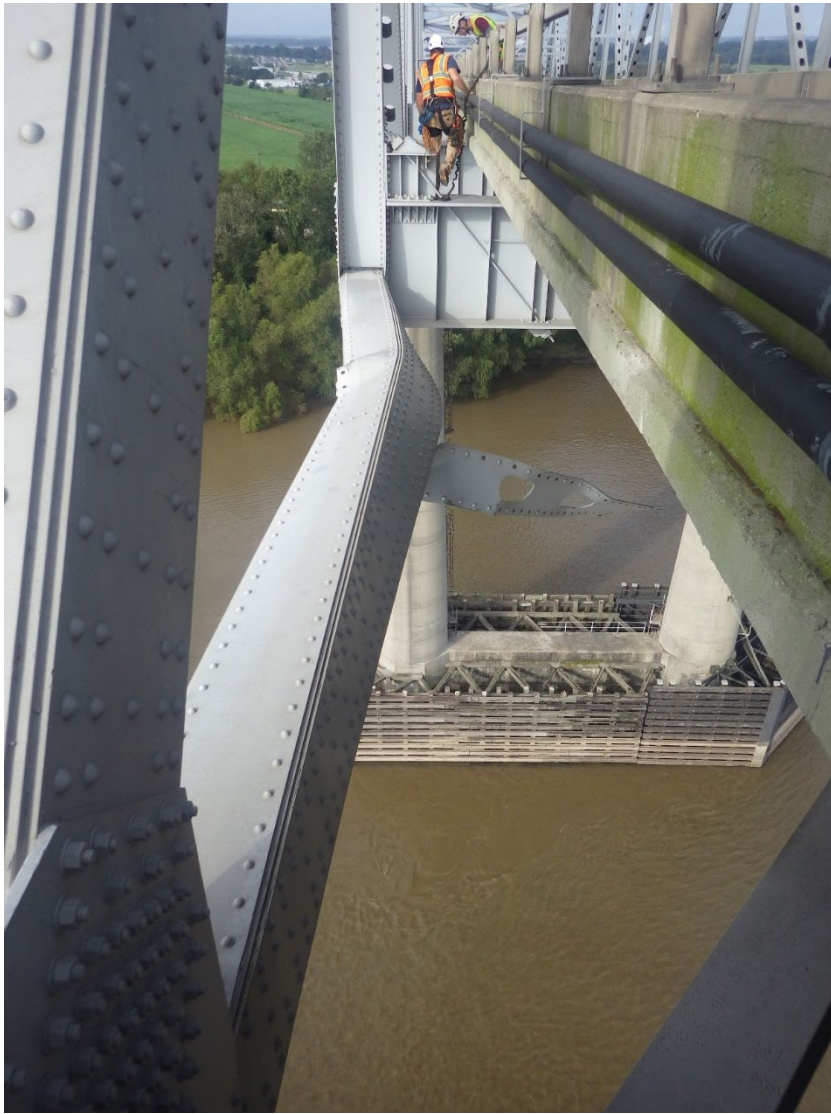
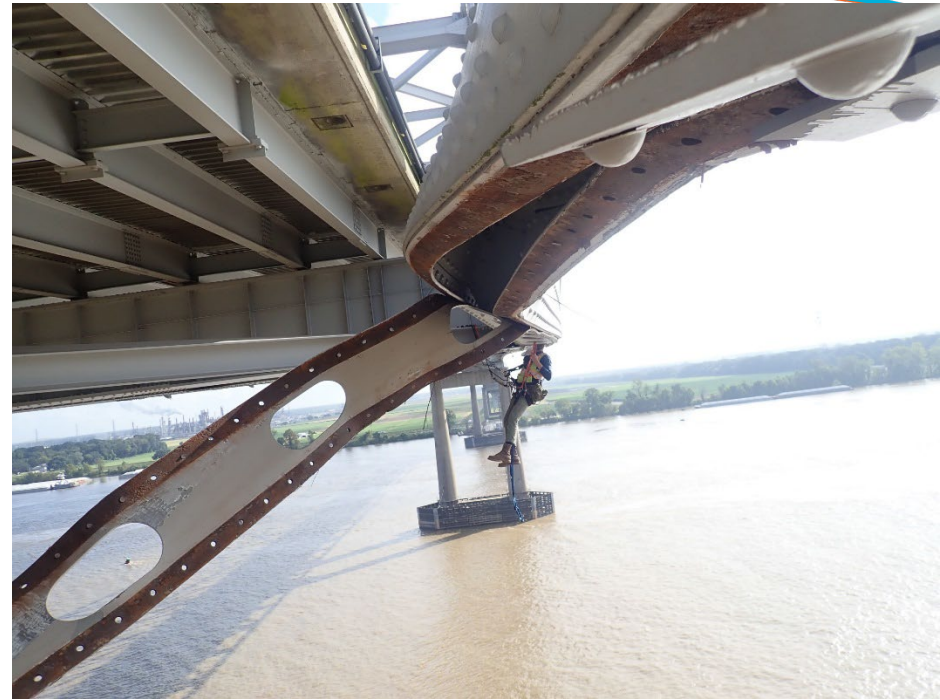
APPROXIMATELY 16"
LATERAL DEFLECTION

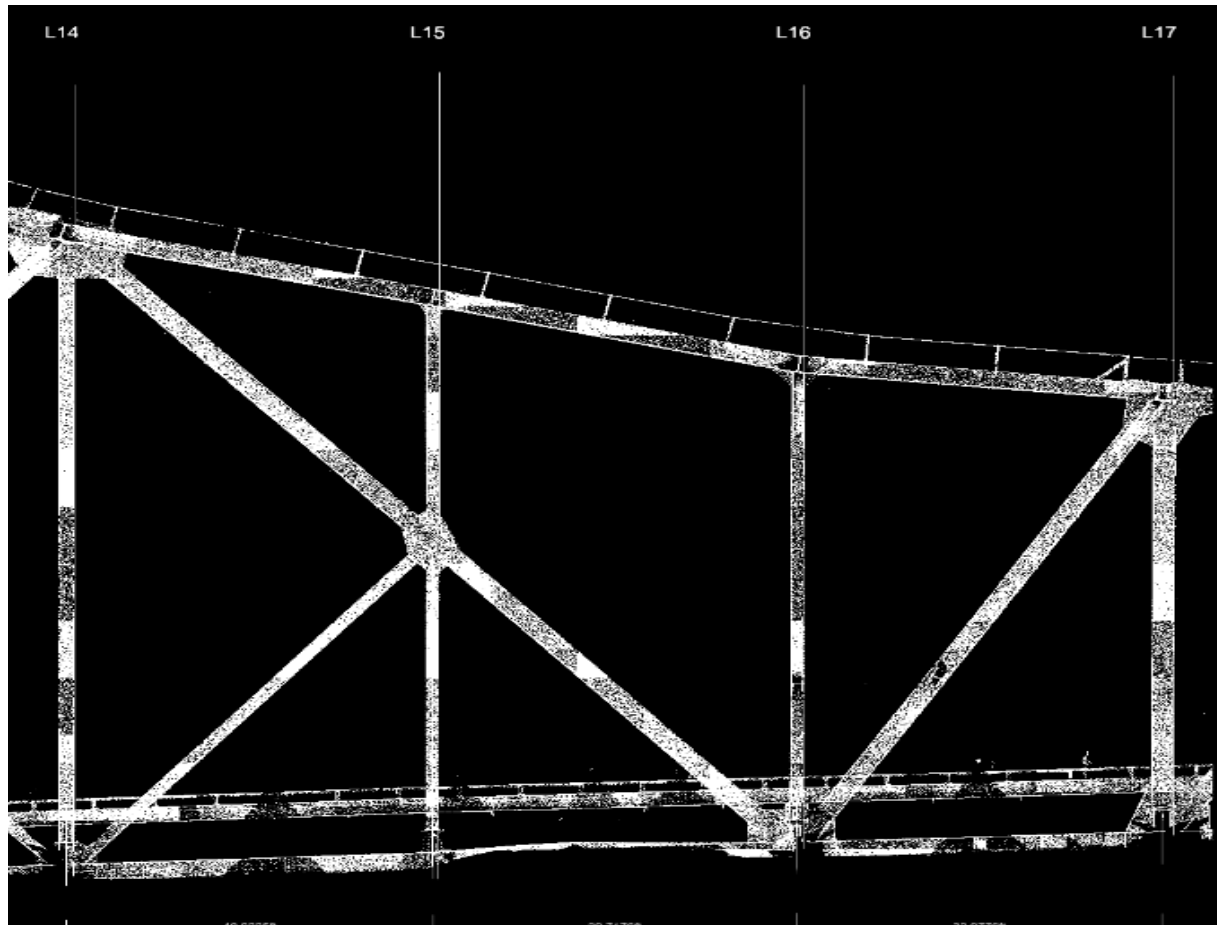
L15 (39.72') L16 (40') L17

Panel between L15 – L16 Shorten by ~ 3 3/8”

Two Repair Goals

- Restore Original Geometry
- Restore Load – 1700 k or 142

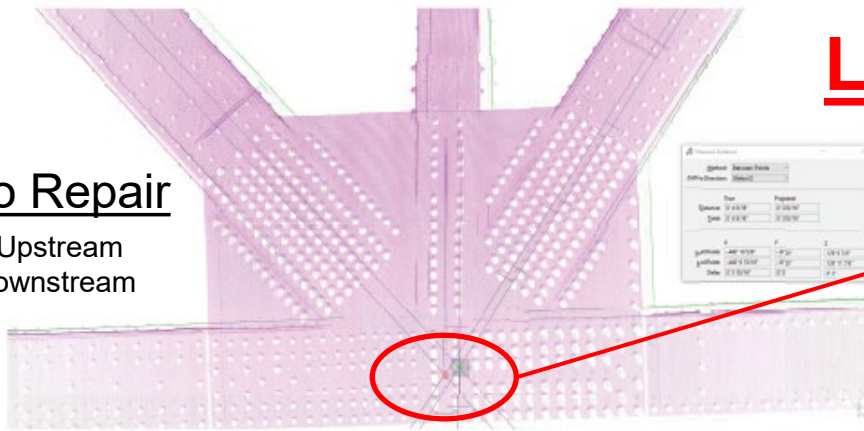
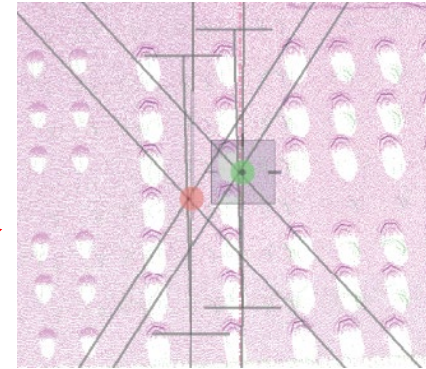
Prior to Repair

X	Y	Z
Start Point:	-440' 10 5/8"	-31' 0"	129' 9 7/8"
End Point:	-440' 6 13/16"	-31' 0"	129' 11 7/8"
Delta:	0' 3 13/16"	0' 0"	0' 2"

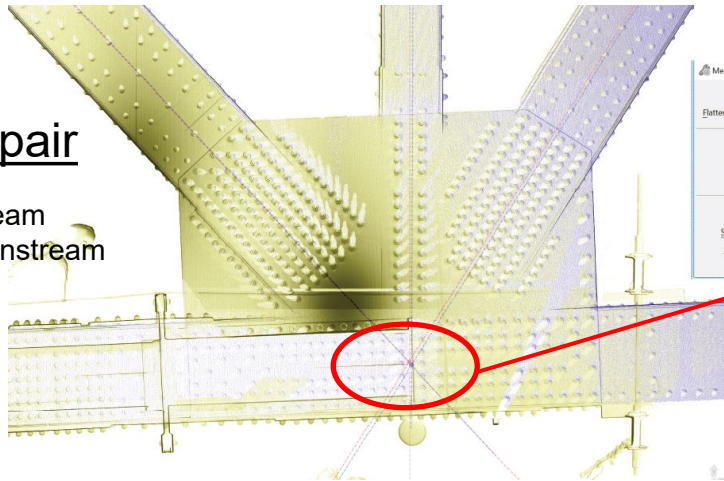
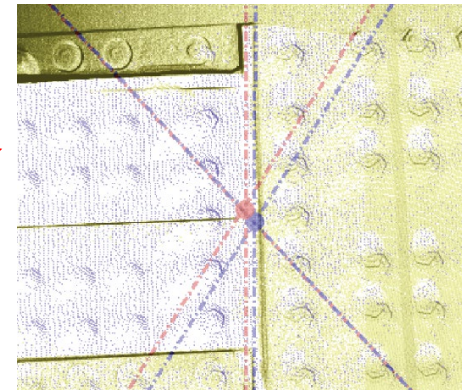
After Repair

X	Y	Z
Start Point:	104' 2 3/4"	144' 10 7/8"	-4' 8"
End Point:	104' 2 1/16"	144' 10 7/8"	-4' 7 3/16"
Delta:	0' 0 5/8"	0' 0"	0' 0 13/16"

Geometry Restored

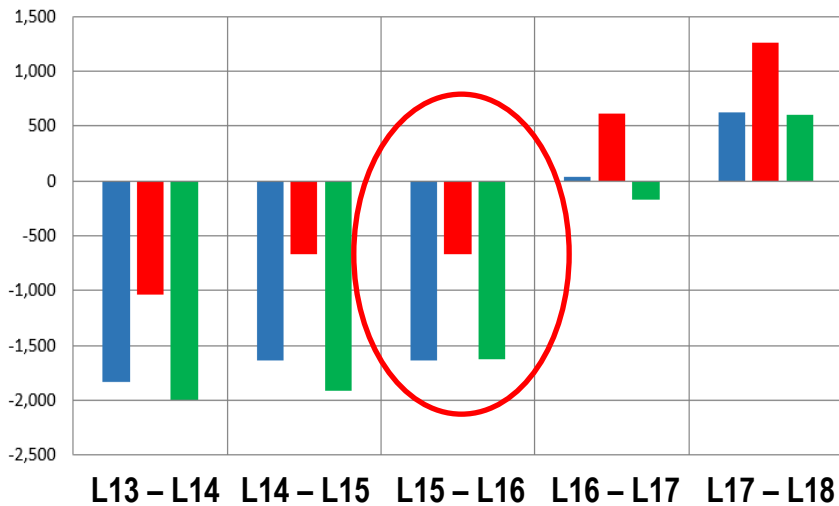
Downstream Bottom Chord Load Changes in Kips

Load Restored
