PAINT MARKING DURABILITY

Project Number ST-2019-5

Final Report

Highway Research Center

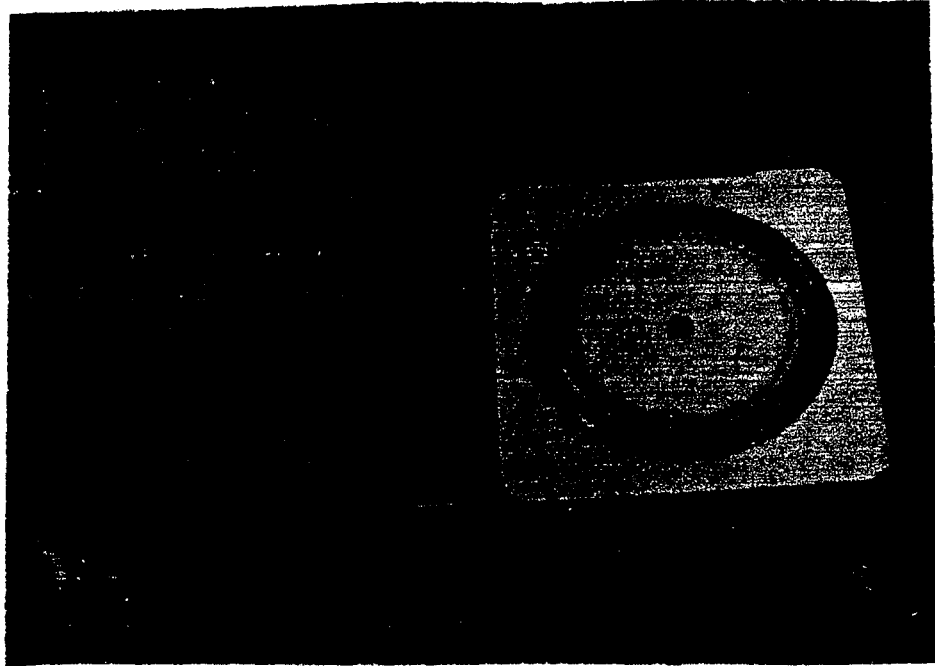
Figure 3.6 shows two specimens after the abrasion test. The specimen on the left shows slight wear, while the specimen on the right wore completely through to the steel plate. The latter condition was undesirable since the actual wear index would be higher than that indicated. However, some samples did wear completely through and this is noted in the results.

Figure 3.6 Two Abrasion Specimens After Test

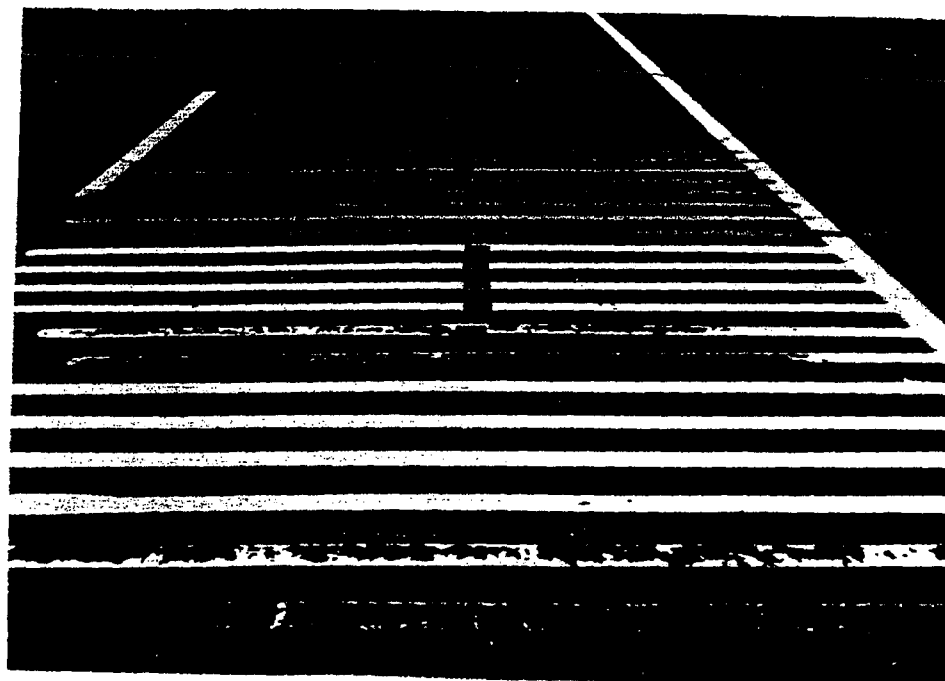
- 1) The house paint [HP-1-W] did not adhere to either asphalt surface and the stripes were obliterated after only 2 to 3 days, as shown in Figure 6.4.
- 2) Water base paint [WB-1-W] experienced excessive premature chipping.
- 3) No abrasion failure distinctions could be made on any of the paints after 42 weeks.
- 4) The test stripes on the old and new asphalt surfaces have performed similarly after 42 weeks.
- 5) Replicate samples for all paints performed similarly.

Figure 6.4. Paint [WB-1-W] is second and eighth from the bottom and paint [WB-2-W] is third and ninth from the bottom in this figure. It should also be noted that paint [WB-2-W] was applied heated as in normal practice, and paint [WB-1-W] was not.

Figure 6.4 Test Stripes on Old Asphalt at Two Weeks

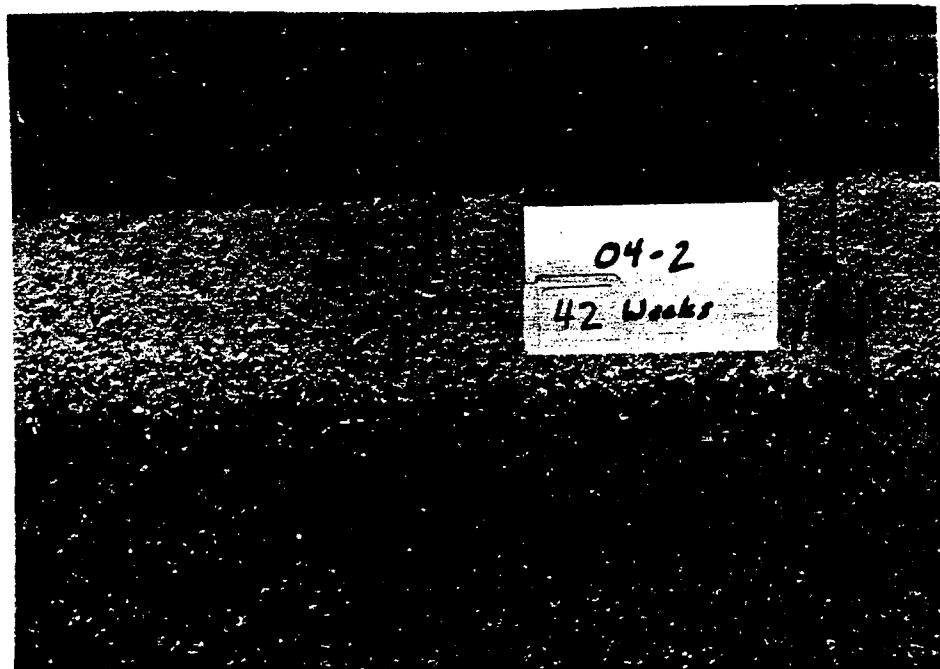
Figures 6.6-6.9 show the same characteristics of the rest of the brittle paints - transverse cracking in the paint and asphalt and asphalt cracking outlining the stripe. Aside from this cracking, the stripes showed no signs of failure due to abrasion or chipping.

Figure 6.7 Paint [CR-1-W] After 42 Weeks

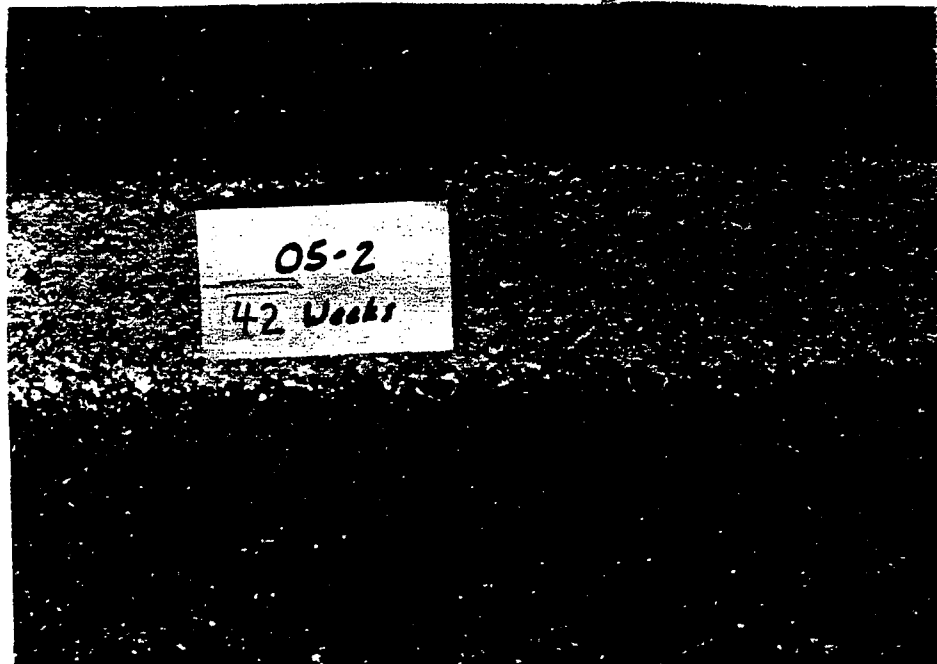
Not counting the house paint, whose formulation was not compatible with the asphalt surface, the average ductility paints exhibited the best wear characteristics to date. No cracking has appeared and no other wear has been observed. Paints [WB-3-Y] and [MAR-1-W] at 42 weeks are shown in Figures 6.10 and 6.11, respectively.

Figure 6.11 Paint [MAR-1-W] After 42 Weeks

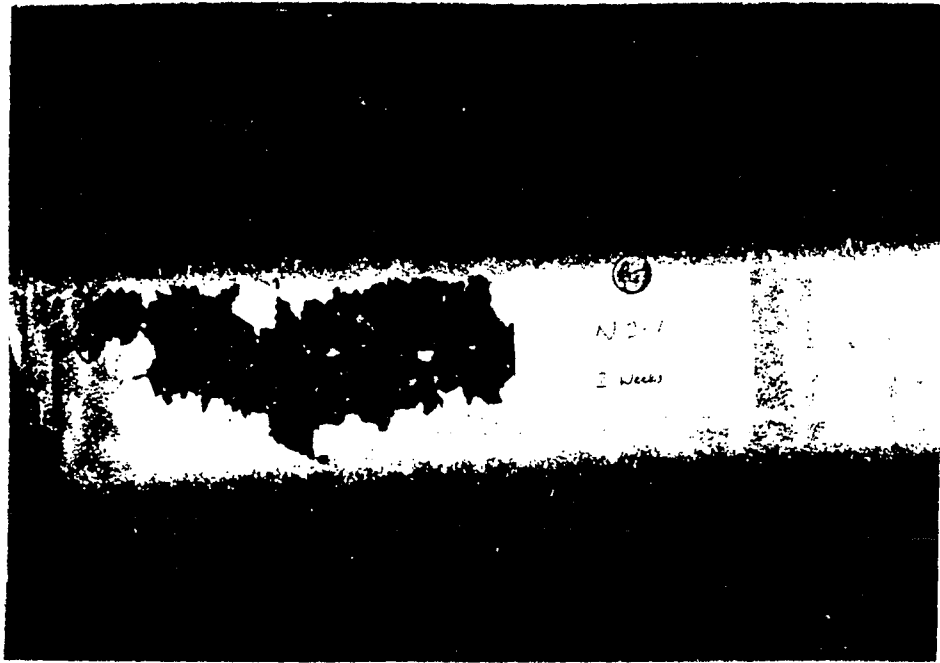
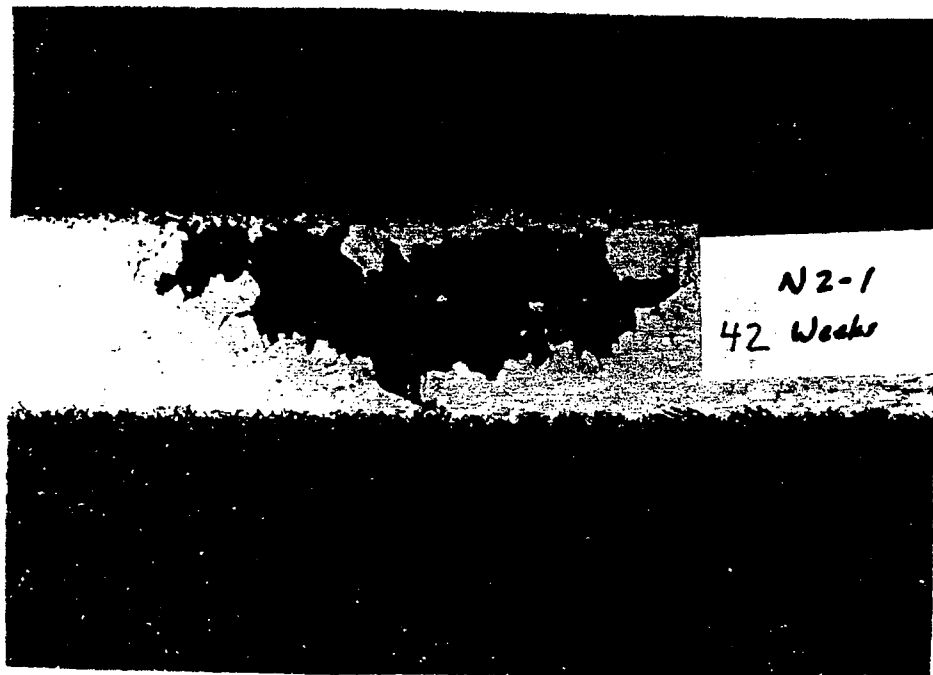
(a) 2 weeks

(b) 42 weeks

Figure 6.12 Paint [WB-1-W] Chipping Evolution

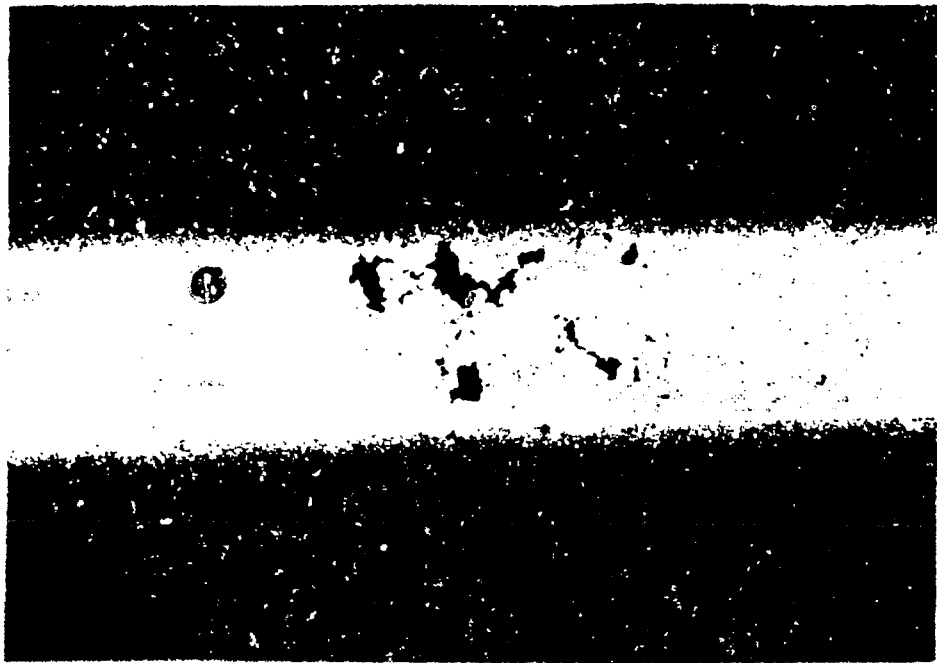
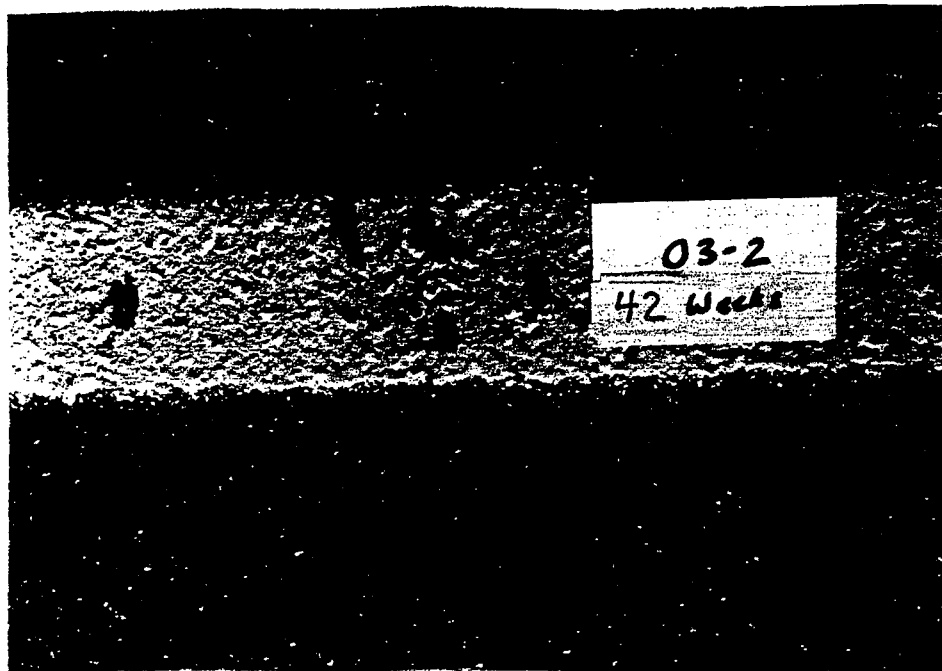
(a) 2 weeks

(b) 42 weeks

Figure 6.13 Paint [WB-2-W] Chipping Evolution
