Executive Summary
RP 930-307

FATIGUE OF DIAPHRAGM-GIRDER CONNECTIONS

**The Alabama Department of Transportation
Montgomery, Alabama**

April 1996

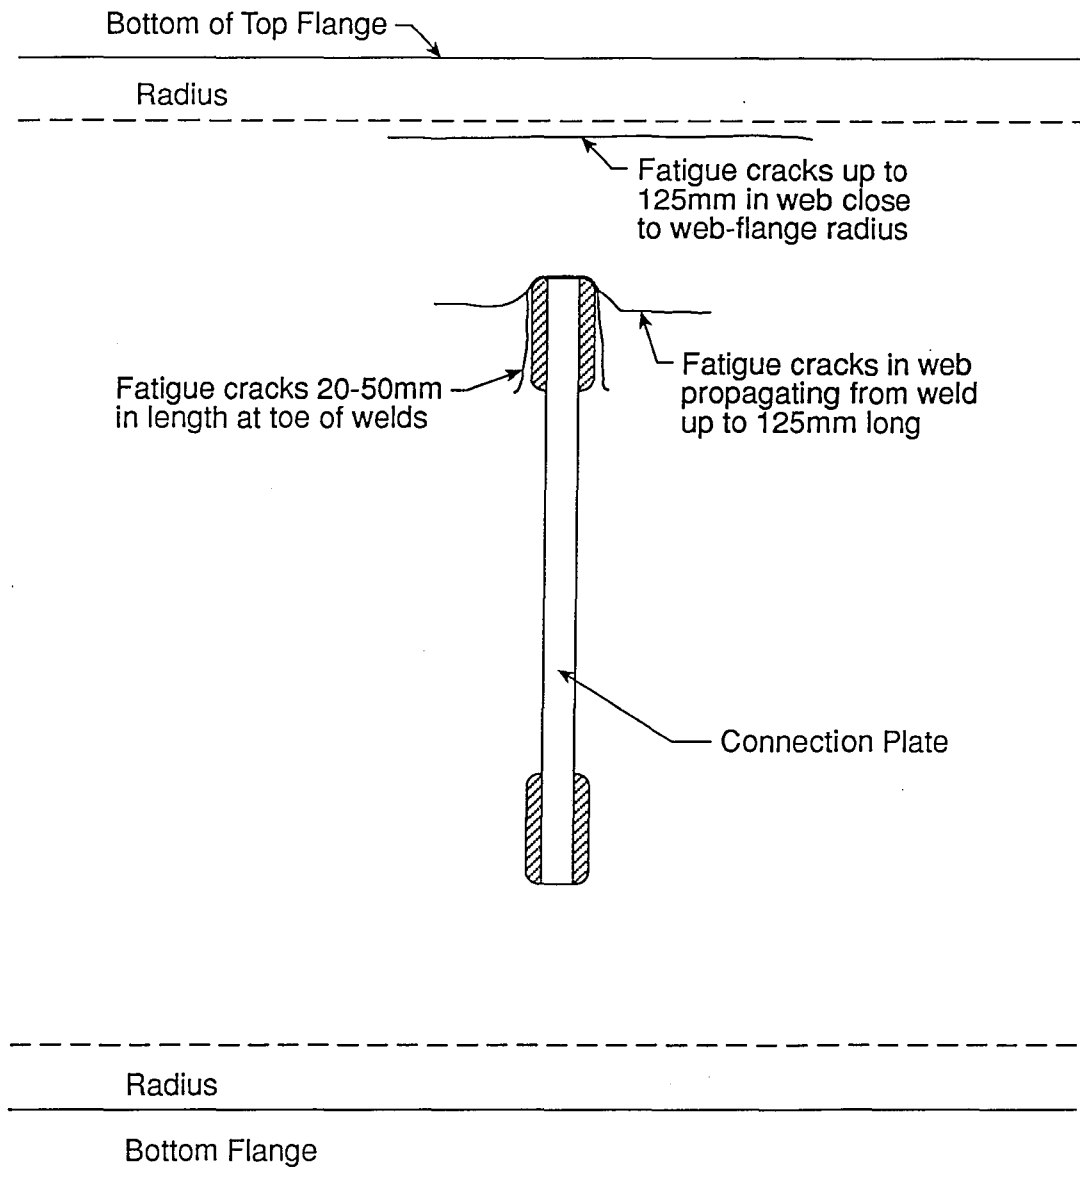
Figure 1.3. Typical Web Gap Cracks

in the welds connecting the connection plate to the girder web and in the girder web. Cracking in the girder web, as illustrated in Figure 1.3, poses the greatest threat to the longevity of the bridges. Fatigue cracks develop at diaphragm-girder connections due to secondary live load forces created by differential deflections between the girders. These secondary live load forces cause out-of-plane distortion of the girder web which leads to distortion-induced stresses in the web and in the welds of the connection.

The fatigue cracks in the girder web should be repaired by drilling a hole at the crack tips as in previous repairs.

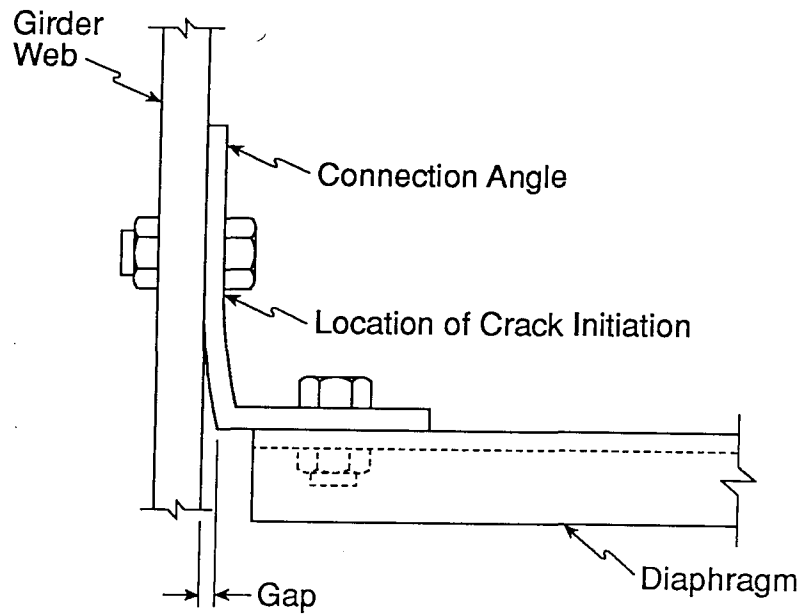
Figure 1.9. Gap Between Connection Angle and Girder Web

A truck crossing a bridge can cause the diaphragm to push or pull on the bottom of a connection angle based on where the connection is relative to the loaded traffic lane. Generally, all connections undergo some pushing and pulling from truck traffic distributed among the traffic lanes. Field measurements of stresses in angles of the original design show that very heavy trucks pull (or pry) on the bottom of the angle sufficiently to cause yielding in front of the bottom bolt. This yielding results in a permanent increase in the width of the gap between the angle leg and the girder web which accelerates fatigue crack initiation.

Fatigue cracking of bolted connection angles used to replace original welded connections was found to be strongly influenced by the gap between the leg of the connection angle and the girder web. The gap results from fit-up error, the installation procedure, and yielding of the angle due heavy trucks. A new angle design and installation procedure was proposed and tested in the laboratory and in the field. The new design performed better in the laboratory and field tests than the angle design most commonly used by ALDOT in previous repairs. The test results indicate that the likelihood of fatigue cracking of the new angle design is reduced but not eliminated. The new installation procedure was used to install four lines of diaphragms in an existing bridge, and the procedure appears practical.

Fatigue damaged connections at necessary lines of interior diaphragms should be replaced with a bolted connection of the new design proposed here. The connection angles should be installed by bolting to the girder web first then to the diaphragm to avoid creation of a gap between the connection angle and girder web. Connection angles should be installed with approximately a 90 mm gap between the top of the connection angle and the bottom of the top girder flange. This will allow existing holes from previous connection replacements to be utilized. Connections at both ends of an individual diaphragm should be replaced at the same time to avoid misalignment of the diaphragm. Fatigue cracks in the girder webs should be repaired by drilling a hole at the crack tips (as performed in previous repairs) before installing the new connections.
