Research Report No. 2F for ALDOT Project 930-601

**REPAIR OF CRACKED PRESTRESSED
CONCRETE GIRDERS, I-565,
HUNTSVILLE, ALABAMA**

The Alabama Department of Transportation

JULY 2011

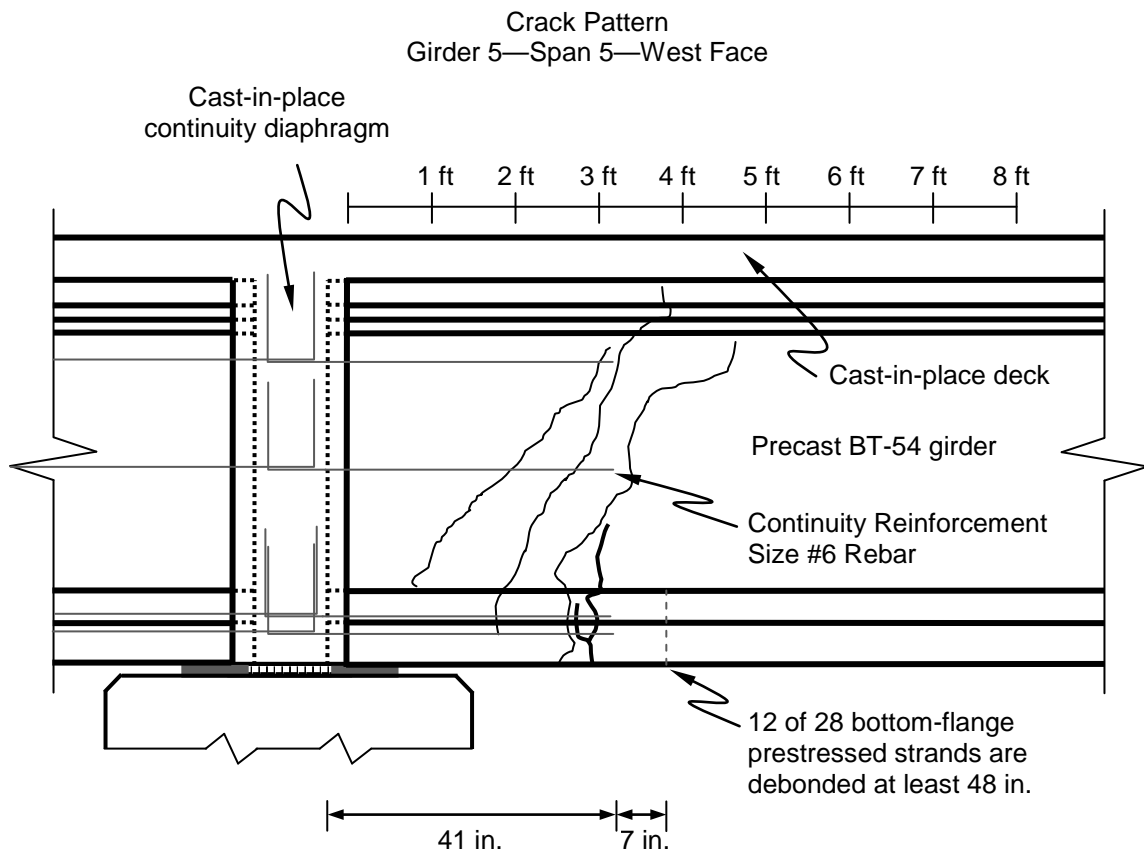
Figure 2.24: Cracked girder with continuity reinforcement details (Barnes et al. 2006)

Prestressing strand debonding and continuity reinforcement details discussed in Sections 2.3.3 and 2.3.5 have an effect on the positive bending moment capacity near the continuity diaphragm. The continuity reinforcement length of 41 in. and the debonded length of 48 in. for more than one-third of the strands have been superimposed with the crack pattern observed at Girder 5 of Span 5, as shown in Figure 2.24.

During a critical thermal event, bottom-flange tensile stresses could be induced near the continuity diaphragm along the girder. The debonded strands result in cross sections with a relatively weak positive moment bending capacity compared to the midspan cross sections. Due to relatively weak cross sections for a distance of 48 in. and local stress concentrations that can occur near the continuity reinforcement termination point at 41 in., cross sections near the continuity reinforcement termination location are likely points of origin for flexural cracking in response to positive moment bending.

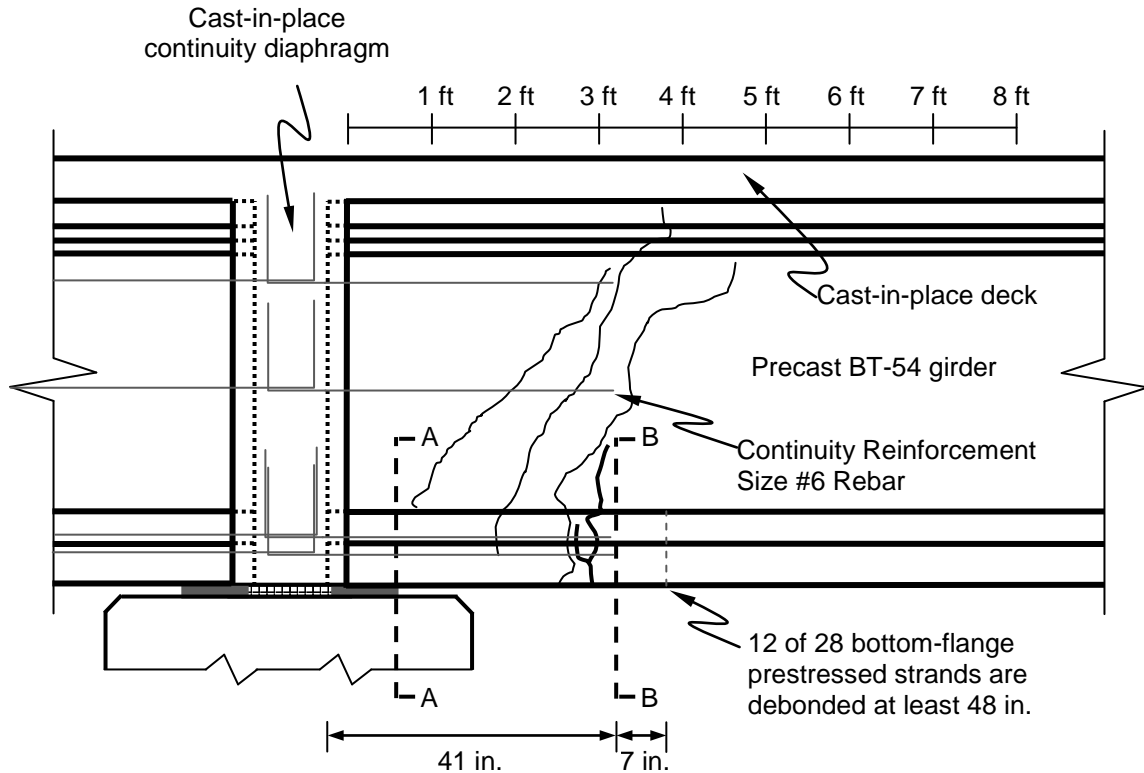
Figure N.1: Cracked girder with continuity reinforcement details (Barnes et al. 2006)

Shear cracks within the web were observed near the interior face of the bearing pad, and flexural cracking was observed near the termination of the continuity reinforcement, as shown in Figure N.1. These critical cross sections have also been noted for a girder with an overlaying illustration of an example FRP reinforcement system with unknown number of layers and length of FRP reinforcement, as shown in Figure N.2.
