# PREMATURE FAILURE OF ASPHALT OVERLAYS FROM STRIPPING: CASE HISTORIES

**Prithvi S. Kandhal**  
**Ian J. Rickards**

NCAT Report 01-01

April 2001

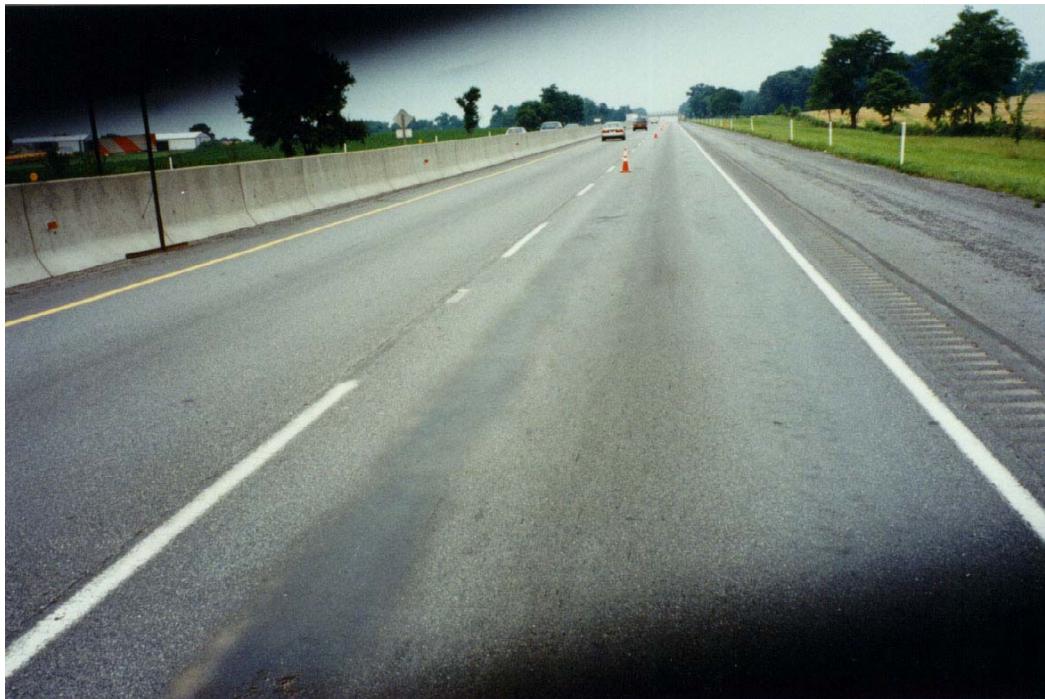
Typical telltale signs of moisture-induced stripping: fines brought up to the surface by water (mud stains), flushing of the surface, and potholing, were clearly visible on the W.B. slow lane from MP 215.5 to 218.0 (Figure 1). Potholes had developed in both wheel tracks of the W.B. slow lane between MP 215.5 and 218.0. There were more potholes in the inside wheel track compared to the outside wheel track (Figure 2). Rutting of the pavement had also started to develop in many areas (Figure 3). A similar investigation of an adjacent section of the Pennsylvania Turnpike between MP 218 and 226 was conducted by the first author in 1978 (1). On that project, the potholing was primarily occurring in the inside wheel track of the slow lane and rutting associated with stripping was not a significant problem. Therefore, this project was exhibiting more severe distressed condition than the 1978 project.

**Figure 1. General View of the Distressed Westbound Lane Near MP 217.65  
Showing Mud Stains, Flushing, and Potholes**

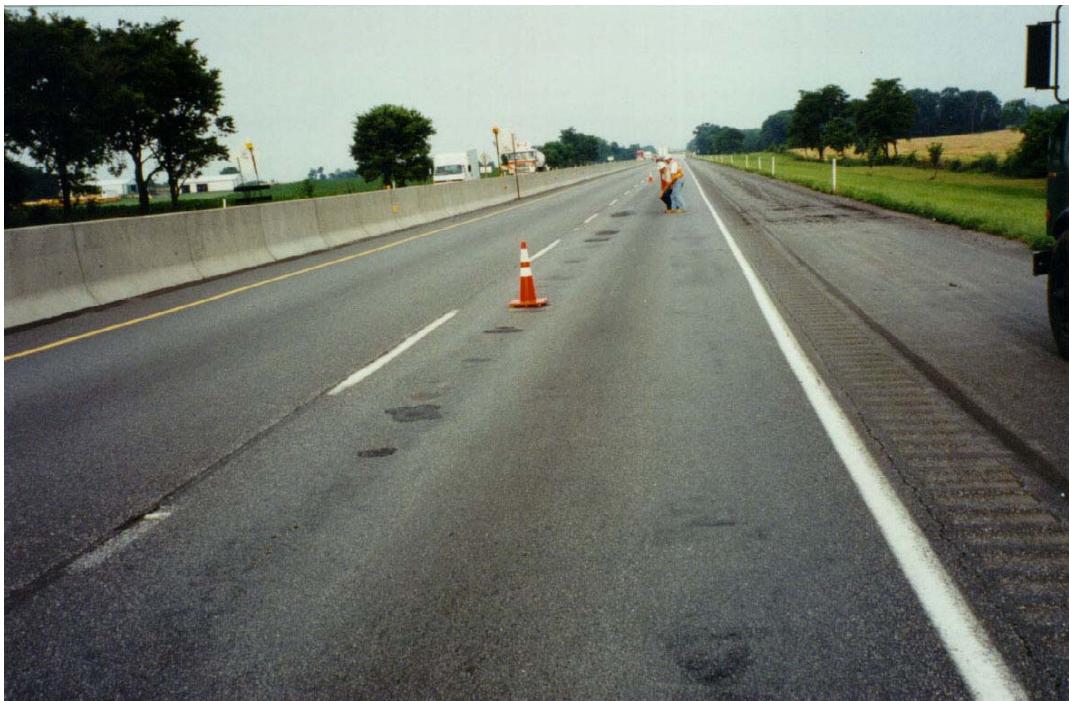
**Figure 2. Potholes in Both Wheel Tracks of the Distressed Westbound Slow  
lane Near MP 217.65 (Most Potholes in the Inside Wheel Track)**

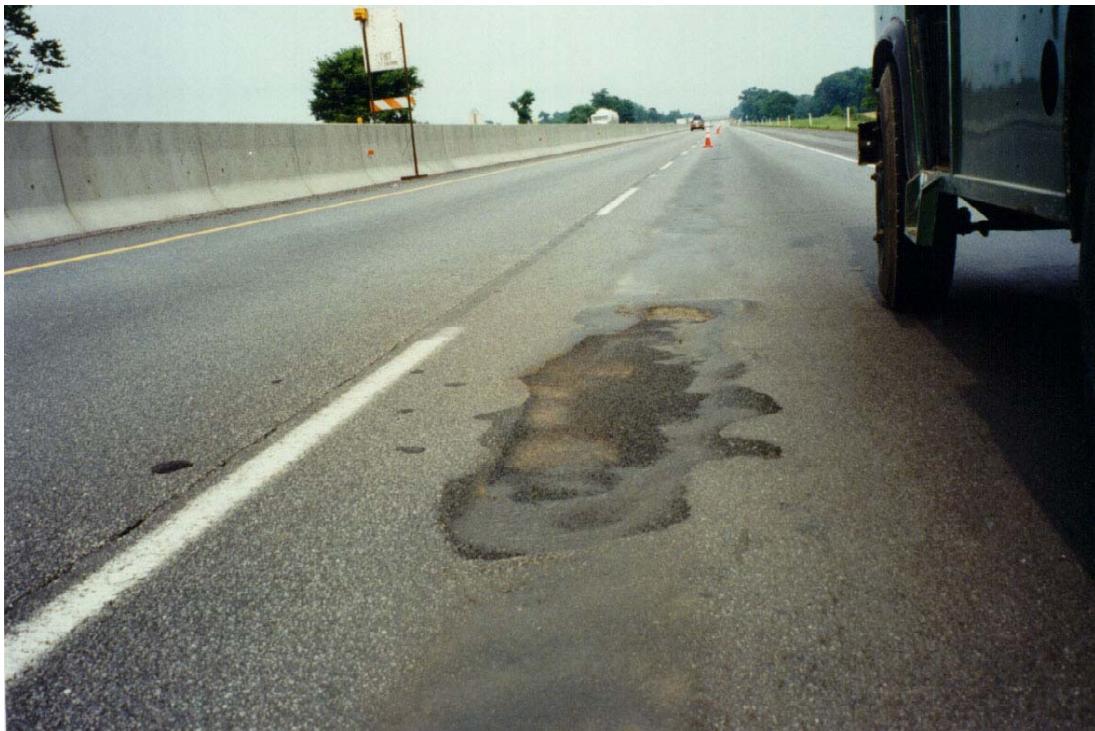
**Figure 3. Potholes and Rutting in the Westbound Slow Lane Near MP 217.65**

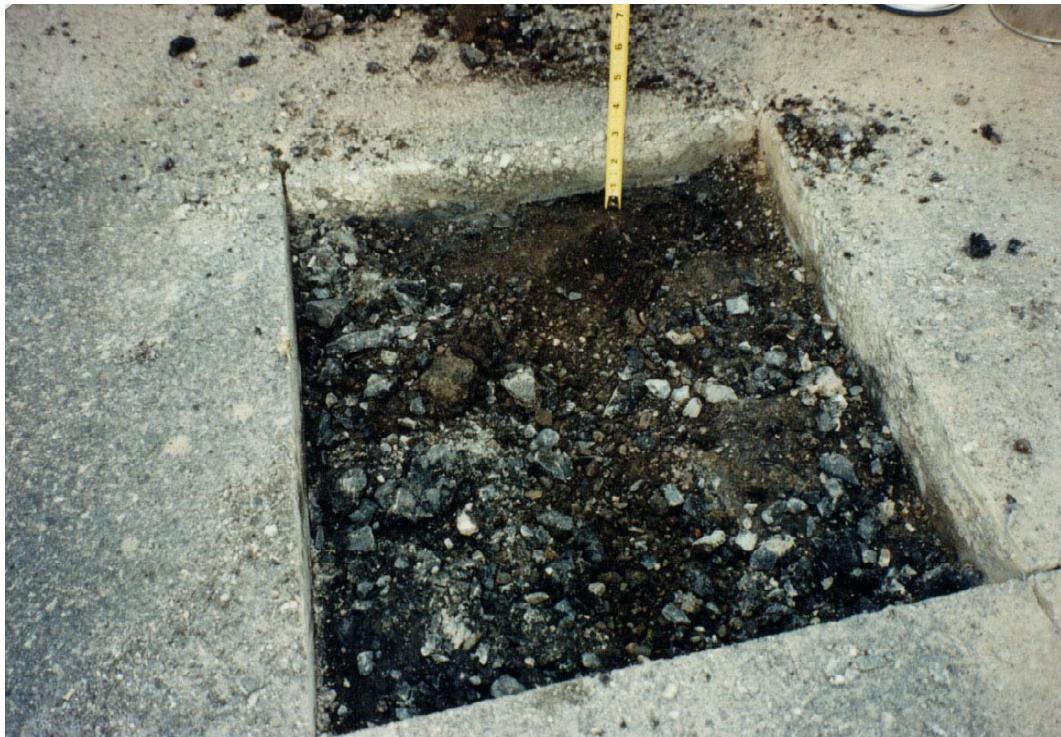
Figure 5 shows the two top layers of the pavement: the new gravel wearing course and the old limestone binder course. The old limestone binder course was about 80% stripped with bare rock particles and hardly any cohesion. This course had a lot of cavities and free moisture (Figure 5). The new gravel wearing course had started to strip from the bottom upwards (about 50% stripping) and one could see the migrated asphalt binder at the top of this layer. It was evident that the excessive moisture or water in the old limestone binder course was causing the stripping in the new gravel wearing course because of the excessive pore pressure buildup under traffic in the slow lane.

**Figure 5. Hole Exposing New Gravel Wearing Course and Underlying Old Limestone Binder Course at MP 217.65**

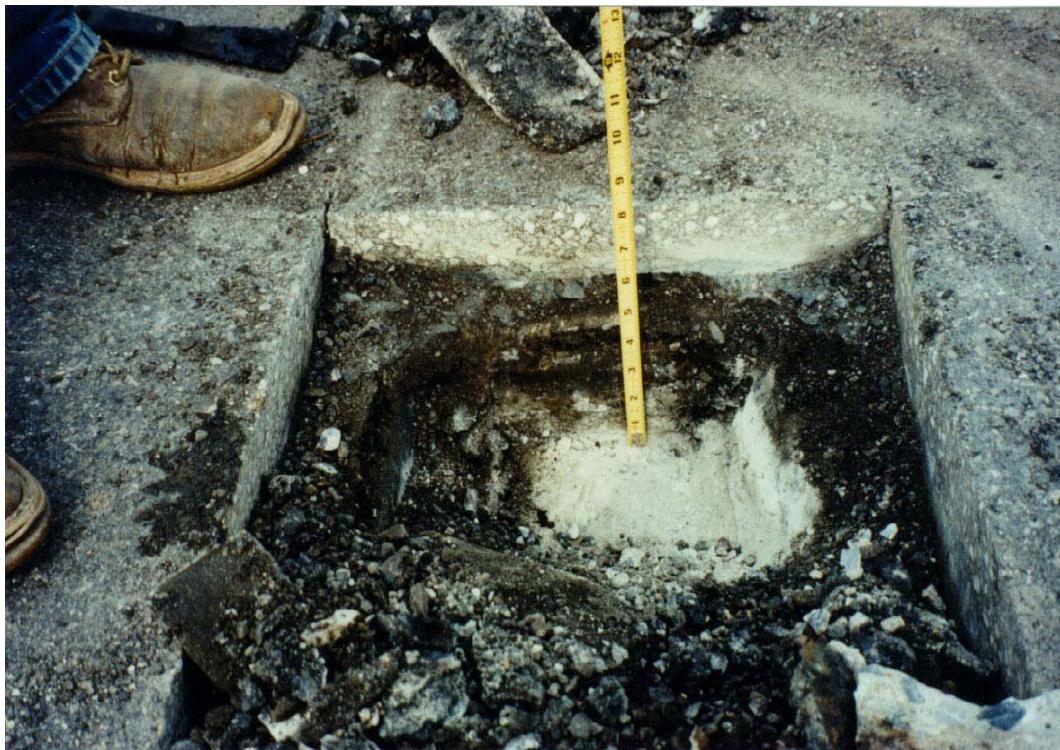
Figure 6 shows the hole cut out full depth about 200 mm to the existing PCC pavement. It was observed that the old gravel wearing course underlying the old limestone binder course was also saturated with water, about 50% stripped, and very friable. It was hard to imagine that such a friable mix (with almost no cohesion) was existing at a depth of about 75 mm only from the road surface. Figure 6 clearly shows wetness in the old limestone binder course as well as in the old gravel wearing course.

**Figure 6. Hole Exposing All Asphalt Concrete Layers and PCC Surface at MP 217.65**

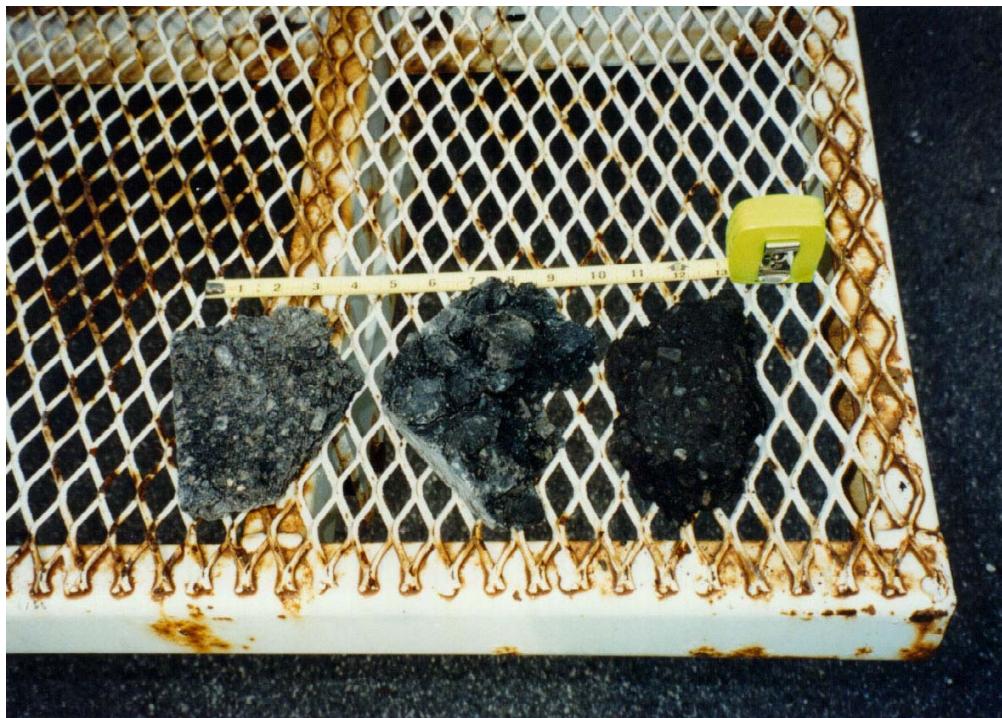
new gravel wearing course from bottom upwards immediately after its placement. Figure 7 shows from left to right: new gravel wearing course with stripping at the bottom; old limestone binder course, wet and very badly stripped; and the old gravel wearing course, wet and very friable.

**Figure 7. From Left to Right: New Gravel Wearing Course, Old Limestone Binder Course, and Old Gravel Wearing Course, From a Hole at MP 217.65**

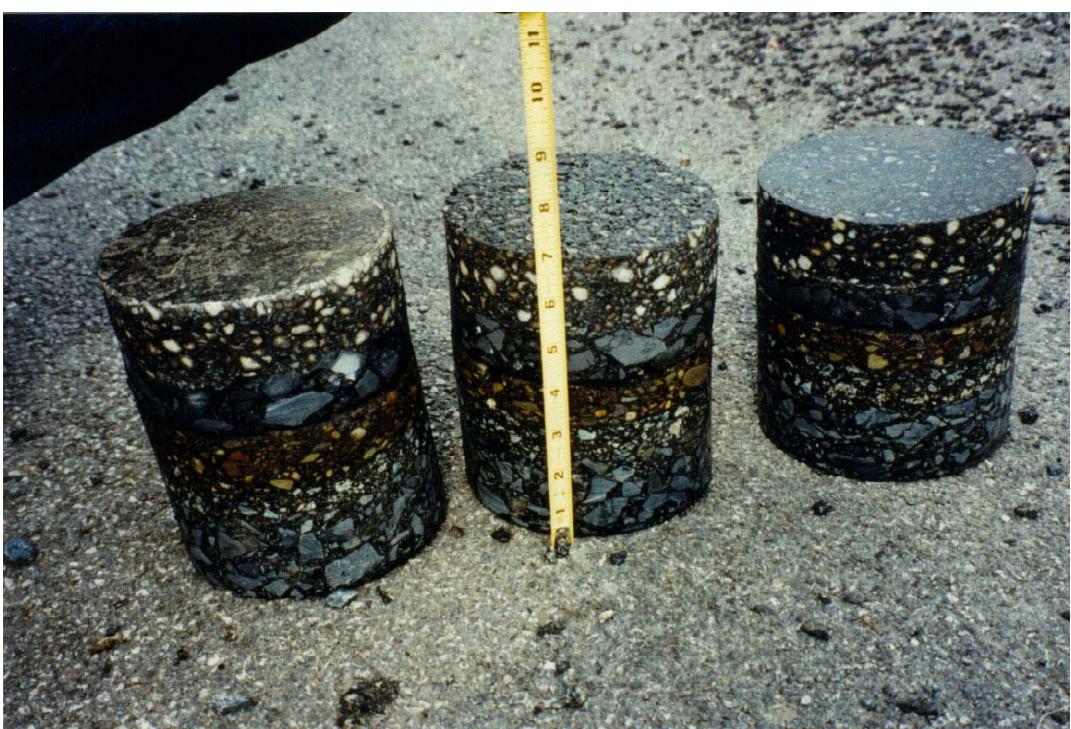
Figure 9 shows the full-depth cores taken (from left to right): inside wheel track, between the wheel tracks, and outside wheel track. All cores showed the following five asphalt pavement layers from top down: new gravel wearing course, old limestone binder course, old gravel wearing course, old slag wearing course, and old limestone binder course. The old limestone binder course underlying the new gravel wearing course had more cavities in the core taken from the inside wheel track compared to the other two cores (Figure 9). Evidently, the inside wheel track was showing more distress compared to the outside wheel track at the time of inspection. More severe stripping was taking place in the inside (left) wheel track of the slow lane probably due to (a) close proximity to the longitudinal center line joint of the PCC pavement where ingress of water from the subgrade is usually high, and (b) increased distance from the pavement base drain at the edge compared to the outside (right) wheel track.

**Figure 9. Cores Taken at MP 217.65 (From Left to Right): Inside Wheel Track, Between the Wheel Tracks, and Outside Wheel Track**

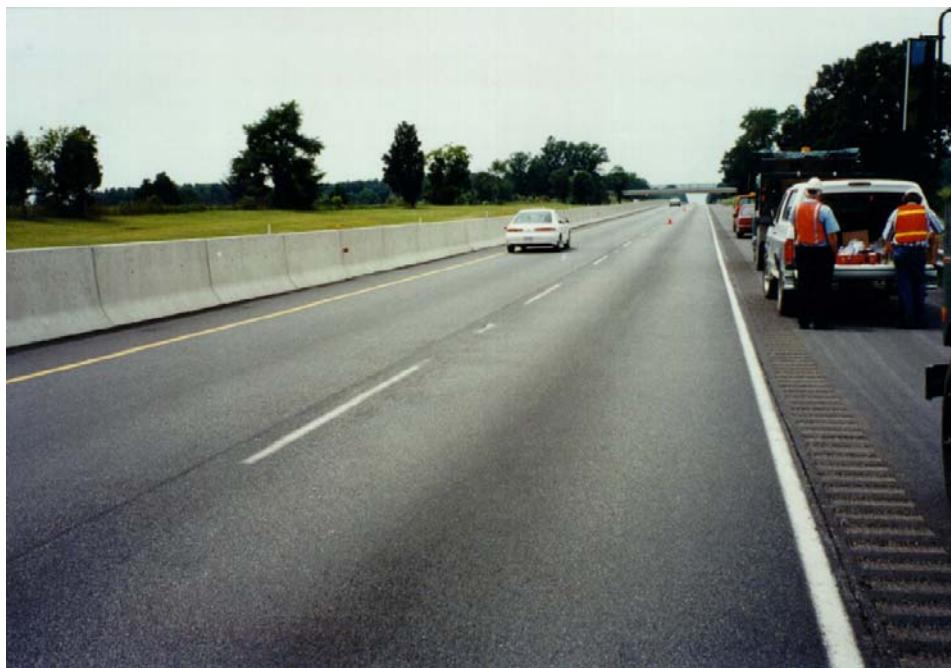
As mentioned earlier, pavement investigation was also conducted in a relatively good area of this project at MP 212.9. Figure 10 shows the westbound lanes which do not exhibit any distress at this time (July 1996). Three holes were cut at MP. 212.9 similar to MP 217.65. Stripping had already initiated in the new gravel wearing course at the bottom. Although the old limestone binder course was wet to a lesser extent compared to that at MP 217.65, it was stripped badly. The old gravel wearing course was also wet and very friable. It appeared a matter of time before

**Figure 10. General View of the Relatively Good Area of the westbound Lanes Near MP 212.9**

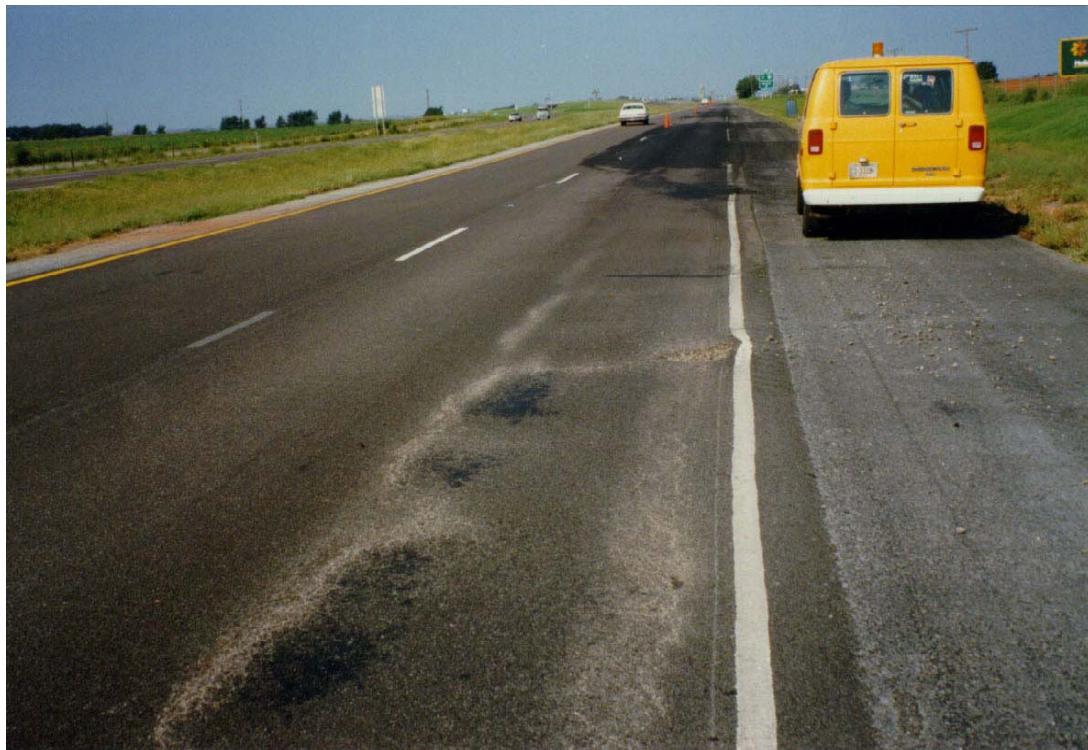
**Figure 11. Development of Potholes Primarily in the Outside Wheel Track of I-40 in Oklahoma**

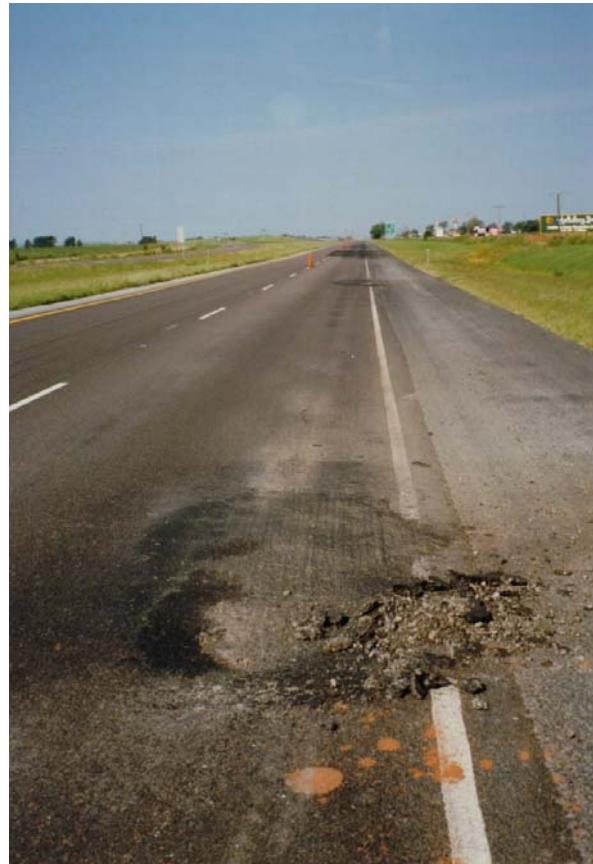
**Figure 12. Potholing on I-40, Oklahoma**

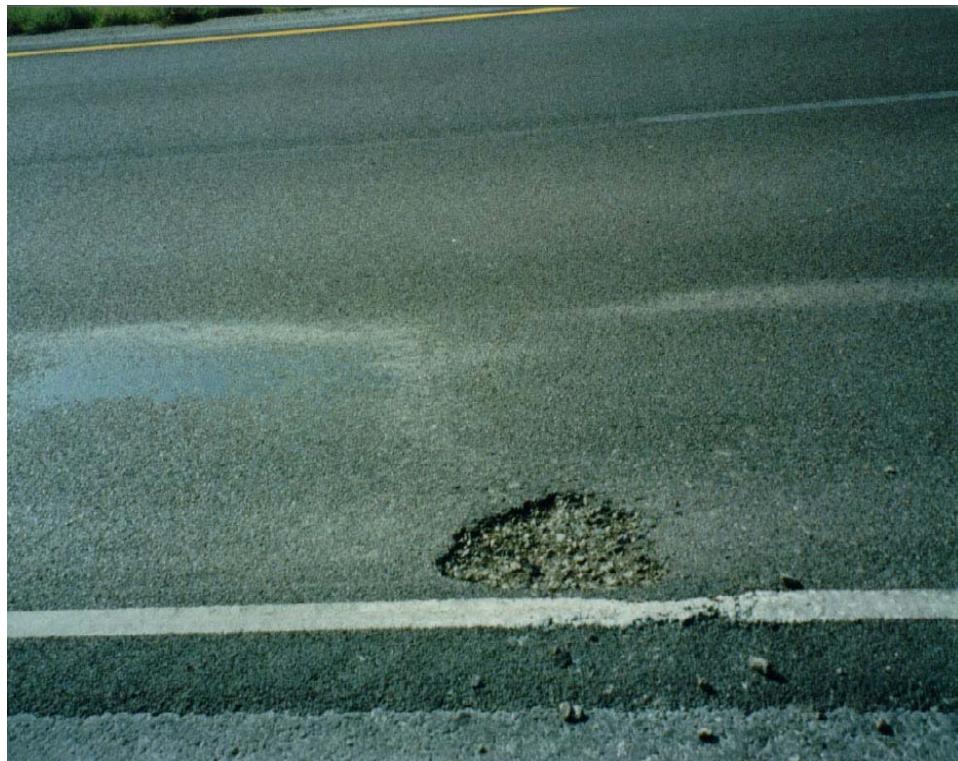
**Figure 13. Three Stages of Stripping: White Stains, Flushing, and Pothole (I-40)**

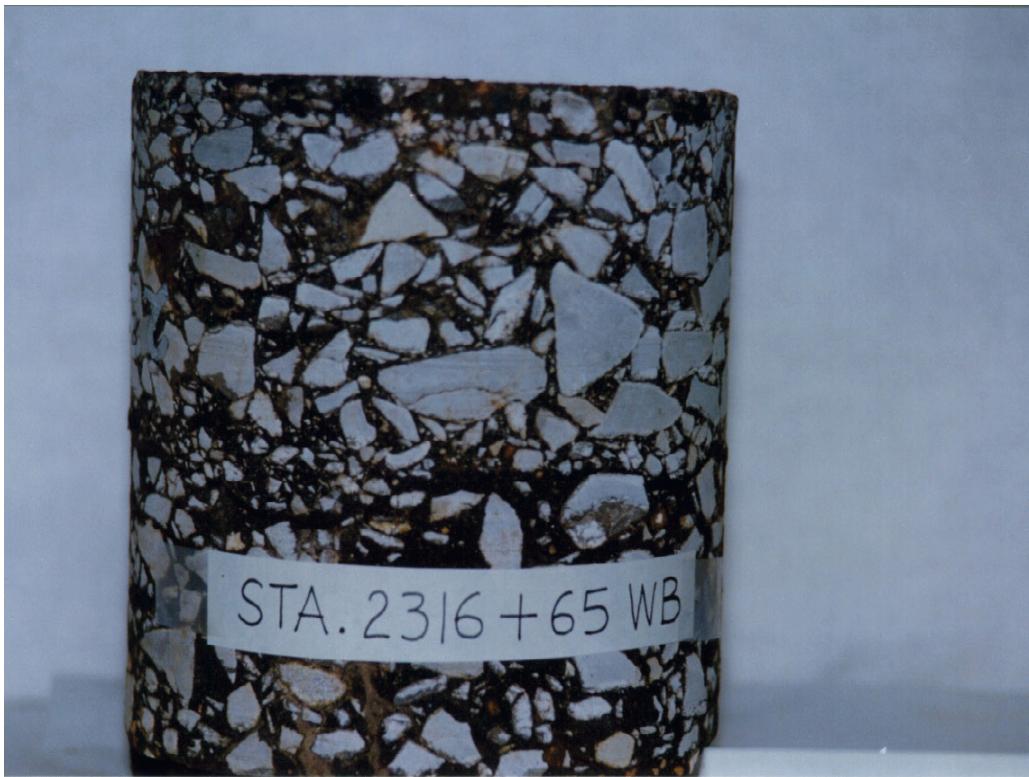
The roadway was sampled with a jack hammer as well as a coring device. No moisture content determinations were made on this project. Figure 14 shows a very open F binder mix underneath the OGFC. In many cases, F mix crumbled and OGFC stayed intact (Figure 15). Therefore, the primary cause of the stripping problem being experienced on this project was the selection of a coarse-

**Figure 14. Pavement Core Showing an Open, Coarse-Graded F Binder Mix Underlying the OGFC (I-40)**

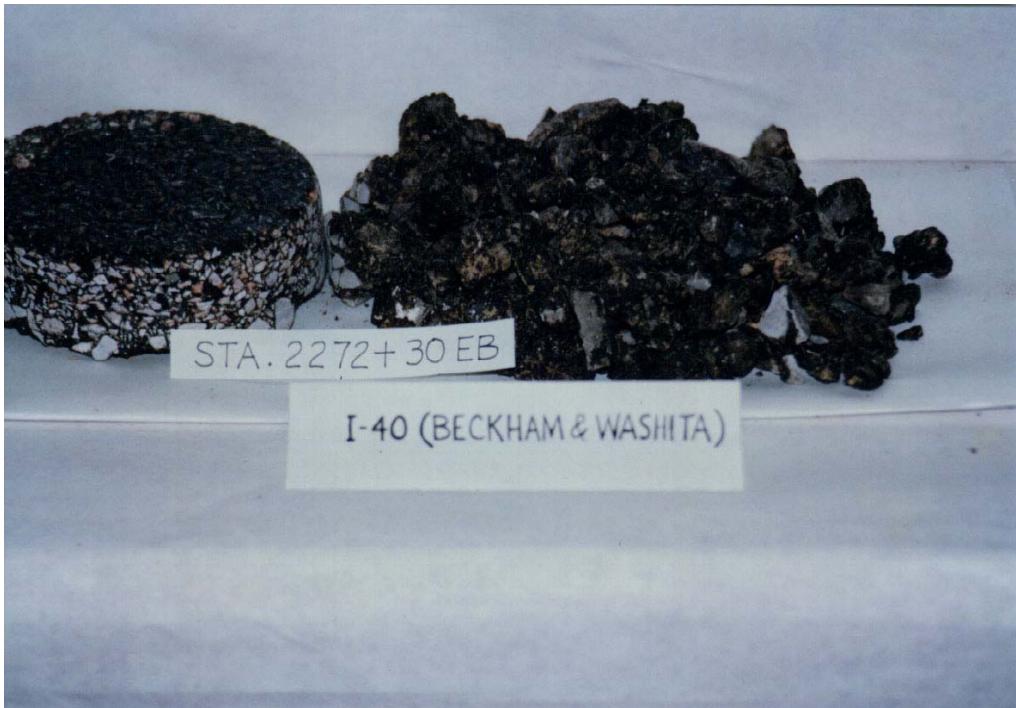
**Figure 15. Stripped F Binder Mix (Right) Which Crumbled on Coring With an Intact OGFC Layer (I-40)**

graded, pervious F binder mix underneath OGFC in a pavement which did not have any edge drain. The “bath tub” effect created by this situation caused the F mix to strip badly due to pore pressure created by the traffic. It was recommended to use a relatively impervious surface course underneath the OGFC.

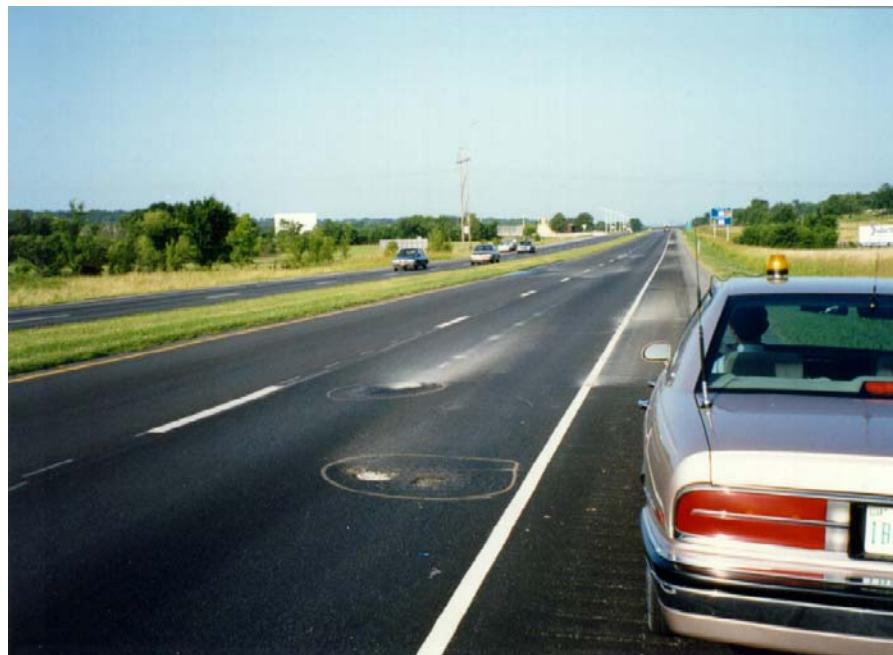
**Figure 16. Potholing in the Inside Wheel Track of Slow Lane**

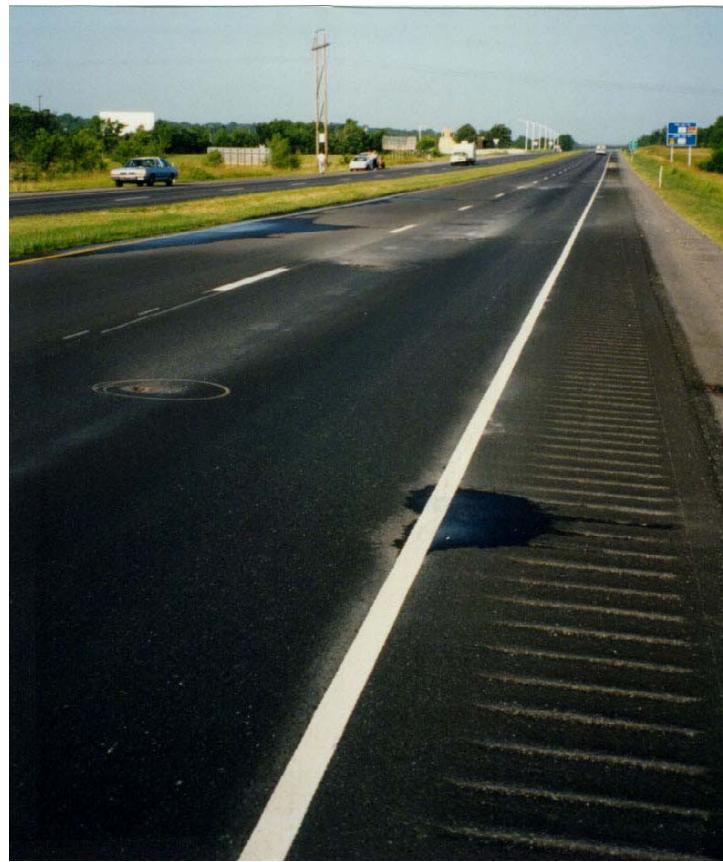
**Figure 17. Potholes in the Inside Wheel Track of slow Lane (Another Location)**

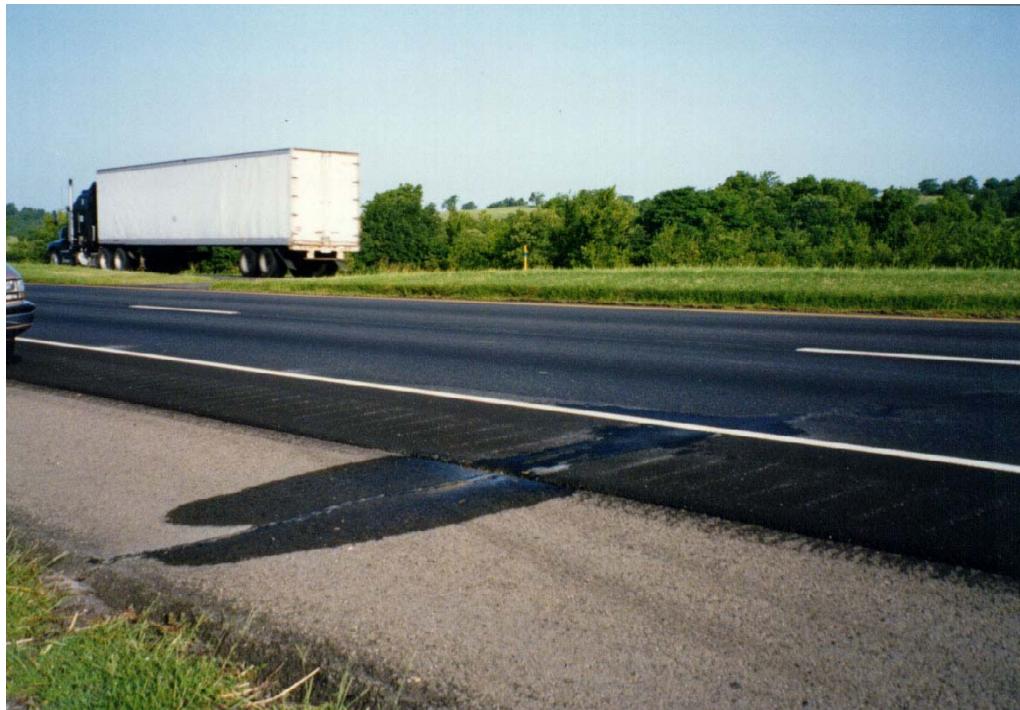
3. Although it had not rained for more than two days prior to this inspection, free water was observed to be coming out of thermal cracks in the shoulder area (Figure 18), from the edge of the raised grassy median (Figure 19), and from the pavement/shoulder joint (Figure 17). This pavement did not have any edge drain to intercept subsurface water.

**Figure 18. Water Coming out of Thermal Cracks**

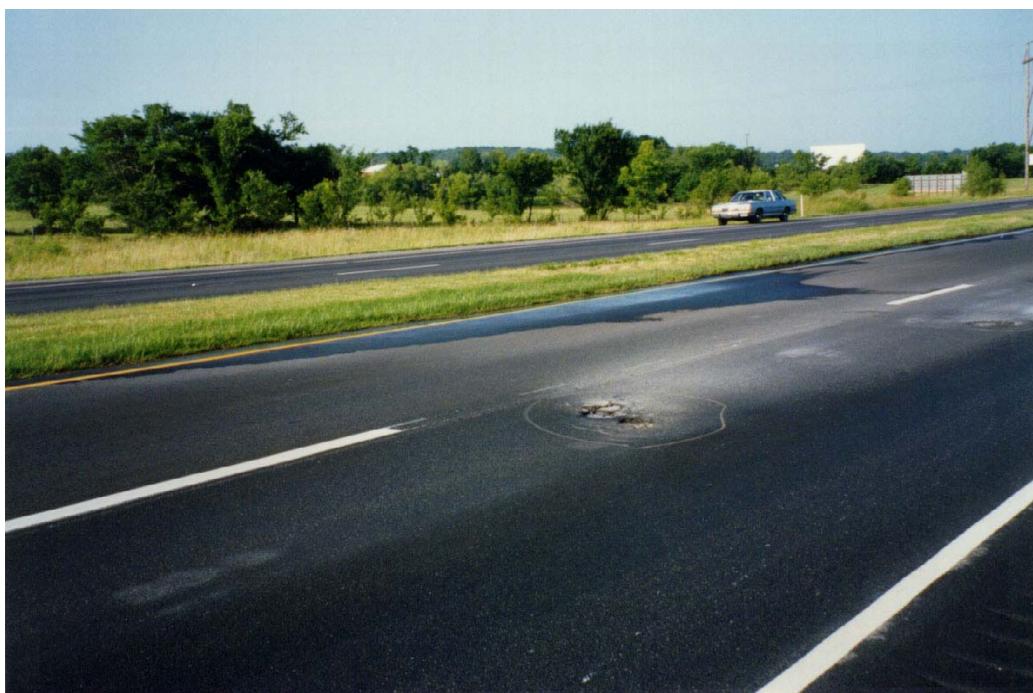
**Figure 19. Water From the Raised Grassy Median**

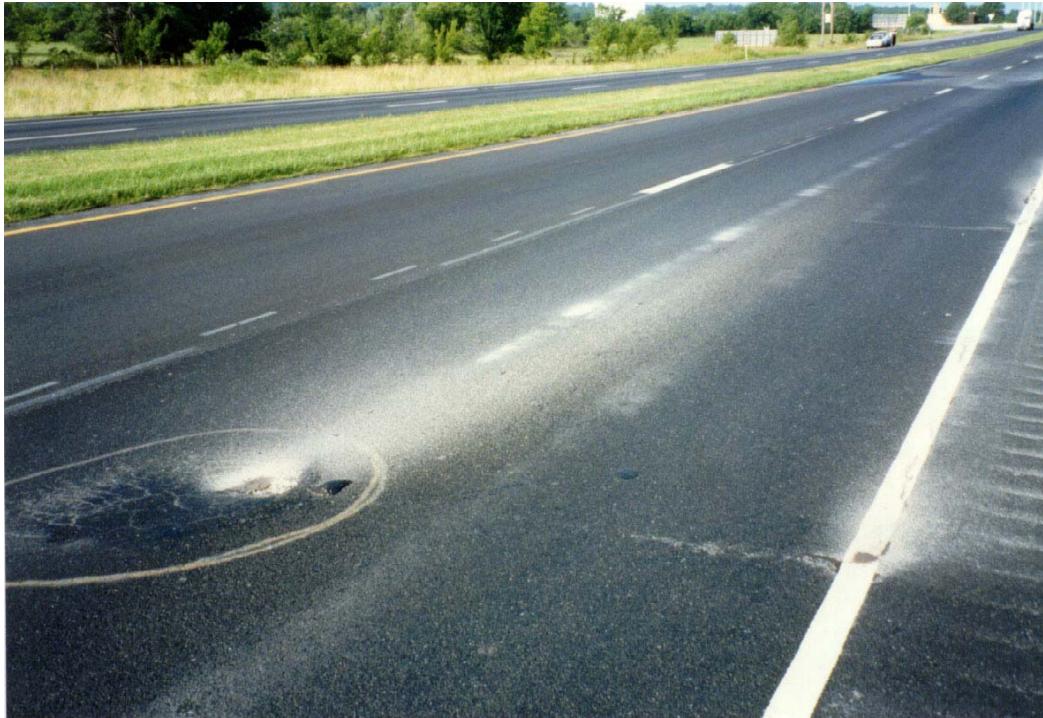
5. Big white-stained patches (Figure 20) could be seen near the potholed areas. No flushing of the pavement was observed. Typically, when the stripping is initiated in the underlying layer(s), white stains appear first (due to migration of fines from the stripped aggregate upwards with water), flushing or bleeding appear next (due to migration of stripped asphalt binder upwards), and the potholing occurs last in the flushed area (this sequence was observed in the first two case histories). Since no flushing was observed in this case, it indicated that the underlying B mix had already stripped substantially and had lost most of the binder prior to the placement of E mix.

**Figure 20. Big White-Stained Patches Near Potholed Areas**

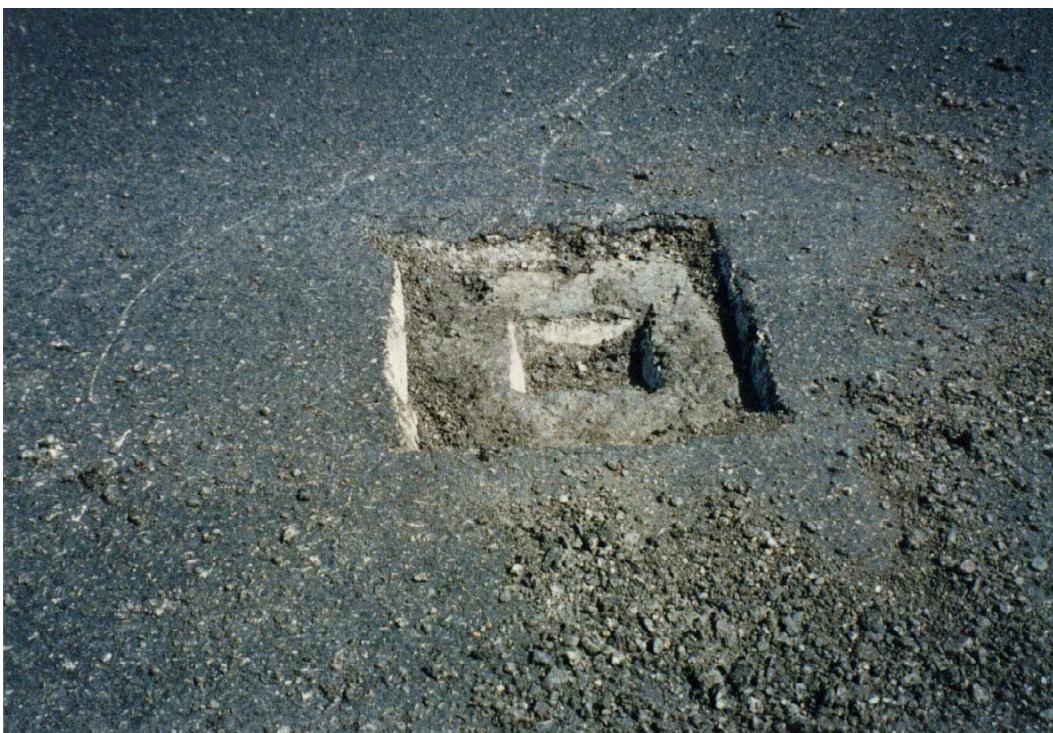
7. A jack hammer was used during the inspection to remove the HMA pavement layers for observation without adding any water (Figure 21). First the E mix was removed. It appeared satisfactory. Then the B mix layer was removed. The top half of the B mix layer was stripped severely (Figure 22). The mix was very friable (no cohesion due to lack of asphalt binder) and it contained excessive visible moisture. The concrete pavement underneath was also wet. Average moisture (water) content in the B mix was determined to be 2.76% when the samples taken by jack hammer were sealed and

**Figure 21. E Mix and B Mix Layers Removed by Jack Hammer**

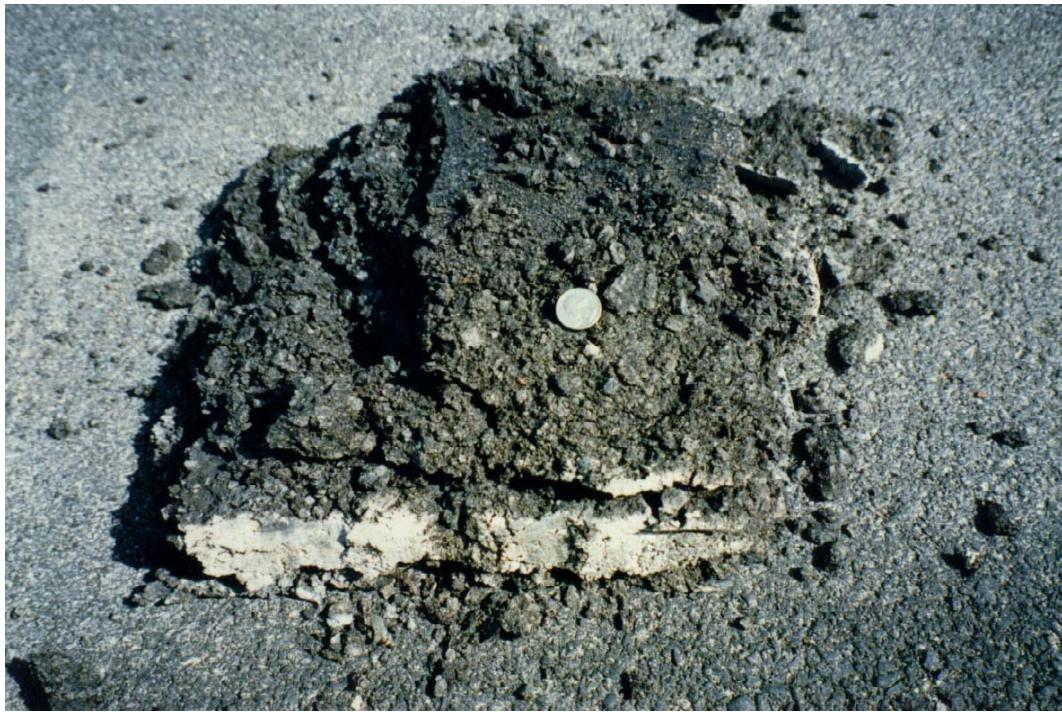
**Figure 22. Bottom of Stripped B Mix Layer**

The lower half of the B mix was stripped to a lesser extent. It appears that the stripping in the B mix layer was initiated at its top and progressed downwards. This downward type of stripping pattern is associated with the presence of an OGFC at the top as observed in several southeastern states. It has been hypothesized that the OGFC retains moisture for a longer time and does not dry out after rain as fast as a conventional dense graded HMA surface. The water in OGFC is also pressed into the underlying course by the truck tires initiating the stripping which progresses downwards.

4. Patch repairs were more likely to be successful if the deteriorated (stripped) B mix was also removed and replaced with a dense-graded B mix, and a positive subsurface drainage system was installed.

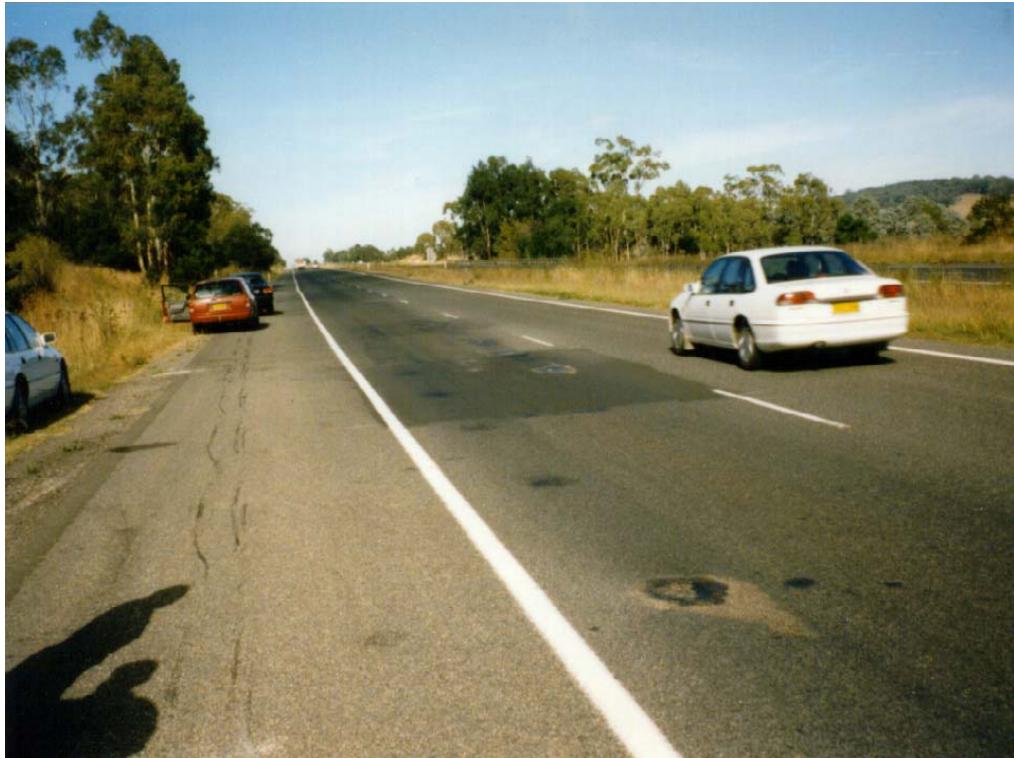
required frequent patching) can be seen in Figures 24 and 25. First a white stain would appear on the surface of the OGFC, followed by a circular pattern of alligator type fatigue cracking (as shown in Figure 26), and then a pothole.

**Figure 24. Pattern of Potholes and Patch Repairs in the Southbound Slow Lane of Hume Highway**

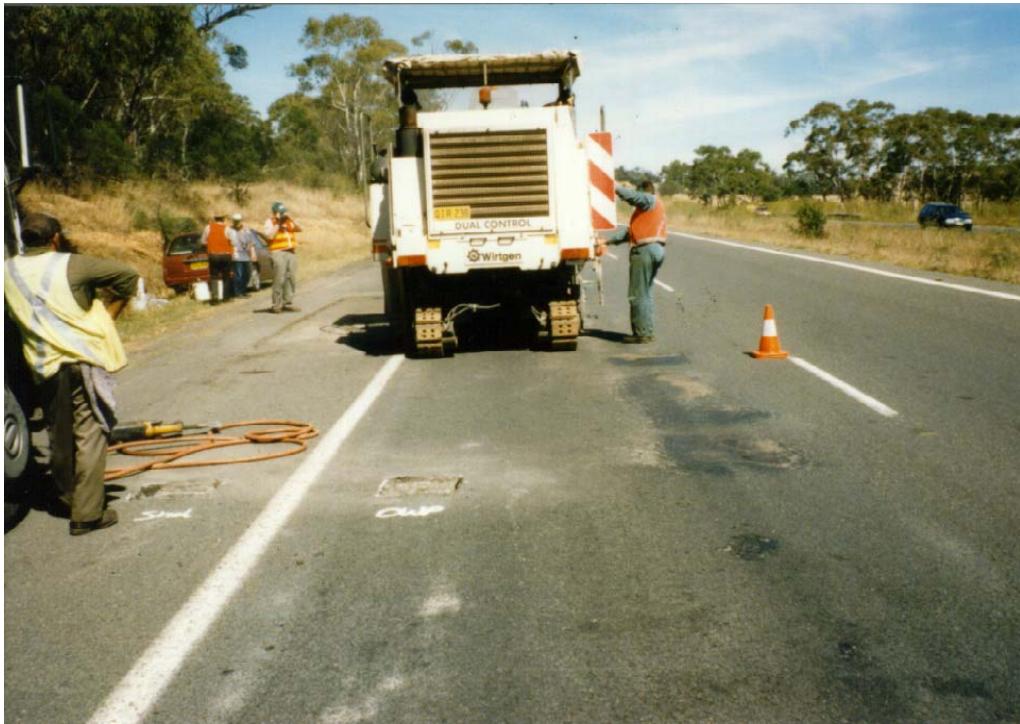
**Figure 25. Potholes in the Southbound Slow Lane of Hume Highway (Another Location)**

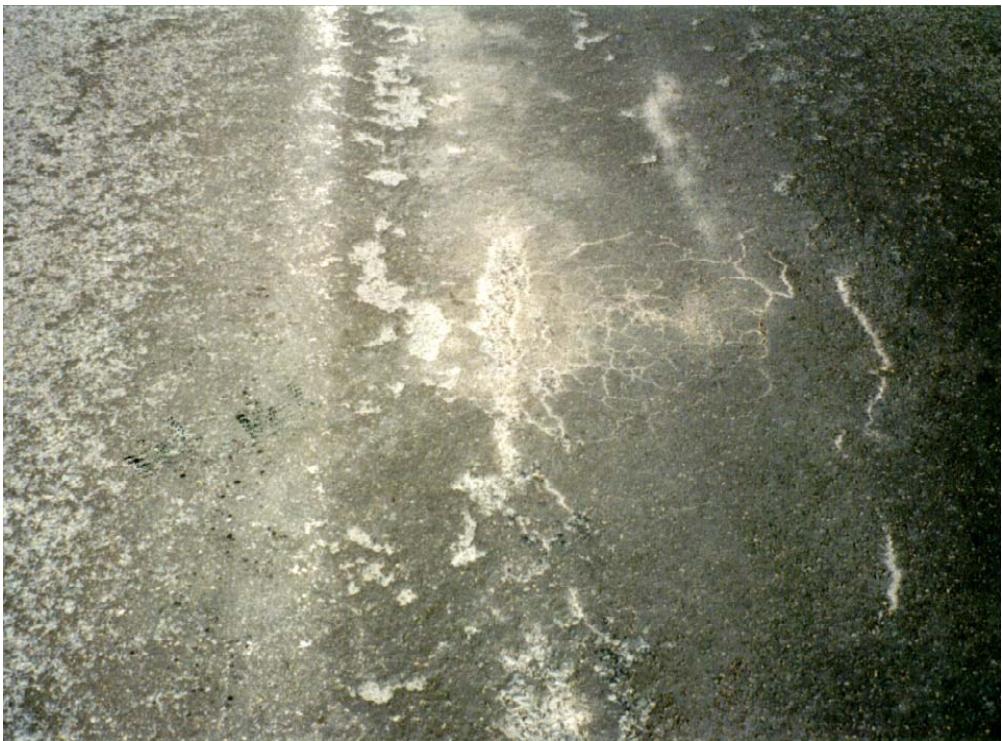
**Figure 26. Stages of Pavement Distress: White Stains, Alligator Cracks, and Pothole**

- Alligator type fatigue cracking in the OGFC surface most likely resulted from the loss of support from stripped AC 14 and AC 28 courses, and this led to the development of potholes.

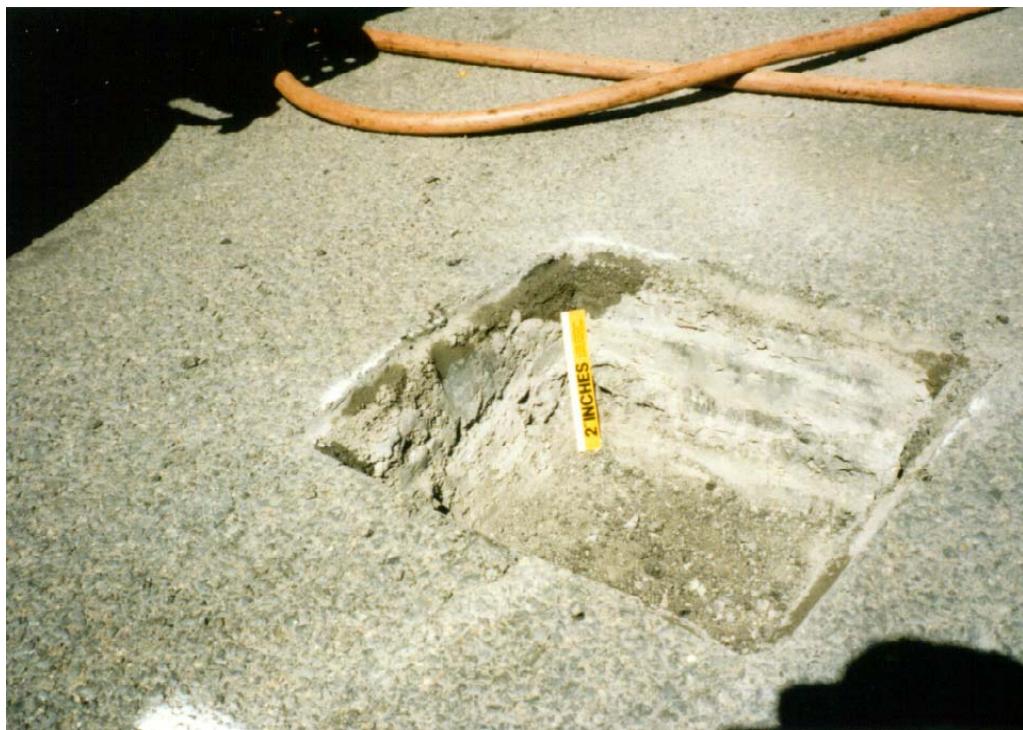
1. Generally, AC 14 which underlays the OGFC has higher moisture content than AC 28. Figure 30 clearly shows a very wet AC 14 course just below the OGFC in the test hole.
2. Moisture contents are slightly higher at locations between the wheel path compared to the locations on the wheel path. This probably resulted from relatively lower air voids in the wheel path resulting from densification by traffic.

**Figure 30. Test Hole Showing a Very Wet AC 14 Course Just Below the OGFC**

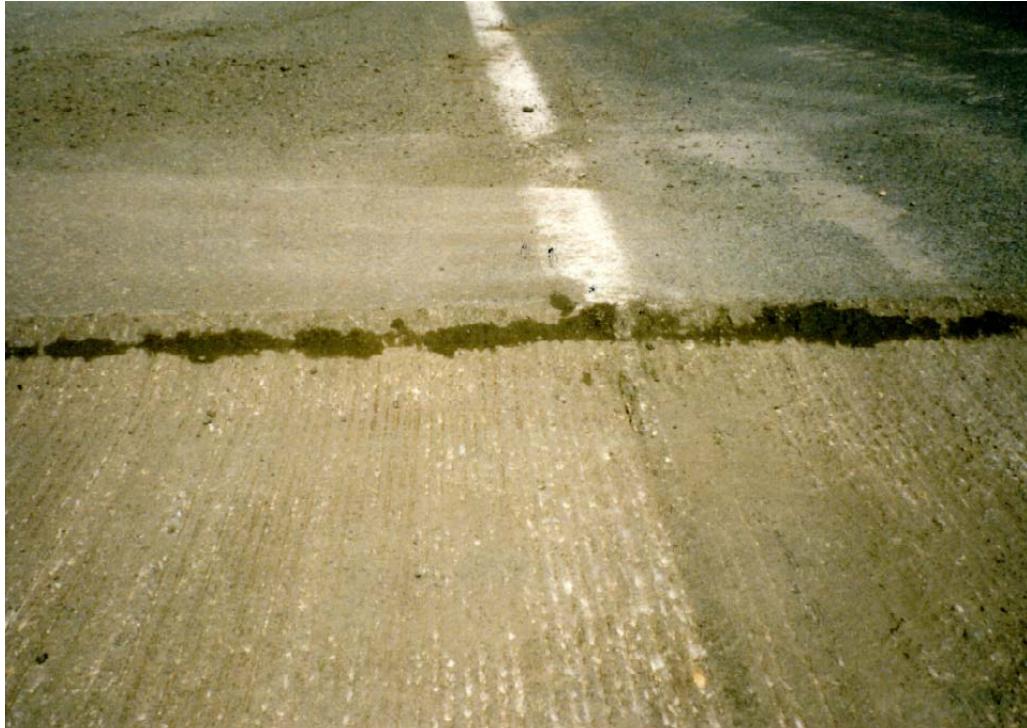
**Figure 32. Wet AC 14 Course Just Below OGFC at the Edge of the Milled Trench**

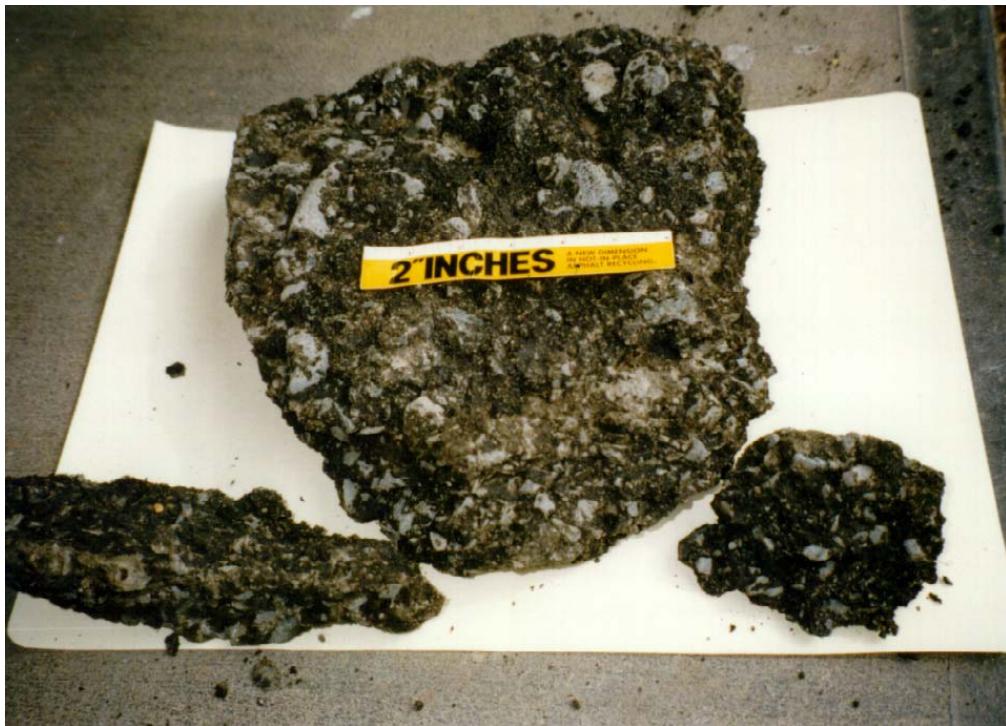
**Figure 33. Badly Stripped AC 28 and AC 14 Courses**
