# **CASE STUDIES OF THE TENDER ZONE IN COARSE-GRADED SUPERPAVE MIXTURES**

## **DRAFT FINAL REPORT**

NCAT Report 02-01

January 2002

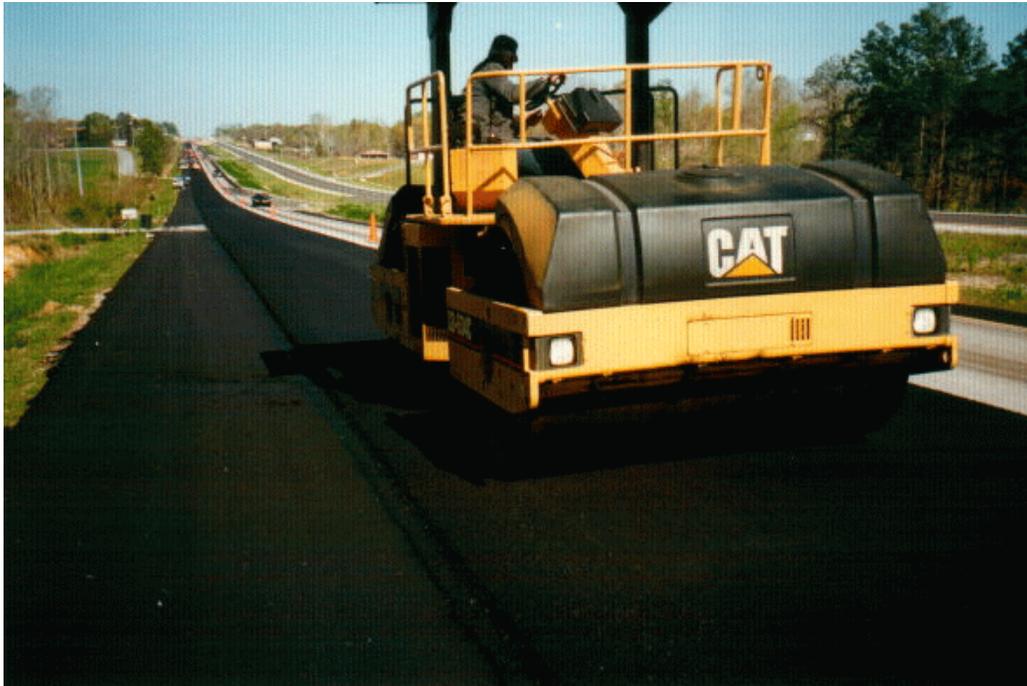
**Figure 3. Alabama Hwy 157 Construction**

Tandem trucks fed the mix to a Roadtec RP30 paver. Breakdown rolling was conducted using a Caterpillar CB643C roller, shown in Figure 3, which started compaction immediately behind the paver at a surface temperature ranging from 285 to 290°F. Maximum amplitude and frequency were used during breakdown rolling with the roller making two passes.

During the field observation only a small amount of tenderness was observed at approximately 235°F which corresponded to the latter part of the breakdown rolling. A small amount of lateral movement and pushing was observed, although not to a large degree, but did increase as the surface temperature decreased. The contractor stated that the degree of the tenderness seemed to change from day to day. This observation tends to suggest the possibility of a temperature gradient within the mix. During the hotter part of the day, the temperature gradient would not be as great as during the early morning.

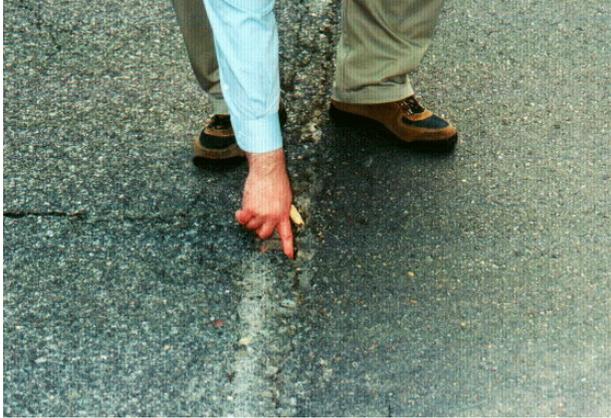
**Figure 4. Close Up of Hwy 78 Cracking**

The underlying pavement was severely cracked with full depth cracks, shown in Figure 4, down to the cement treated base material some 10 inches below the existing surface. It appeared that water had seeped from the cracks onto the surface. As evidenced by water stains, on the existing pavement adjacent to cracks (Figure 5).

Portions of the most severely cracked existing pavement had been patched to a depth of 4 to 6 inches prior to overlaying. The apparent volume increase and measured decompaction were not observed in these patched areas. This along with the water stains on the surface, indicated that the volume increase was likely caused by water in the underlying pavement structure being brought to the surface during construction. When the water reached the bottom of the new asphalt mix layer, the water was trapped and then turned to steam.

The second probable reason occurred during the Alabama Highway 78 project. This project was an overlay of a severely cracked asphalt pavement. The cracks were full depth down to a cement treated base material approximately 10 inches below. Because of the cracking, water had infiltrated the pavement. When the new mix was placed, the heat caused the water within the underlying pavement to move upward in the form of steam. This movement of the water upward resulted in some bulking of the placed mix during construction. Recall, that portions of the pavement were patched prior to placing the new mix. In the area of the patches, no bulking of the mix was noticed. For this project, tenderness within the mix was first noticed at around 245°F which is a common temperature for the tender zone. However, the field observations suggested that decompaction of the mix occurred after the breakdown rolling had been completed and prior to the intermediate roller. This was verified with nuclear density gauge measurements. When the water reached the bottom of the new asphalt mix layer, the water turned to steam resulting in the increase in volume of the mix.

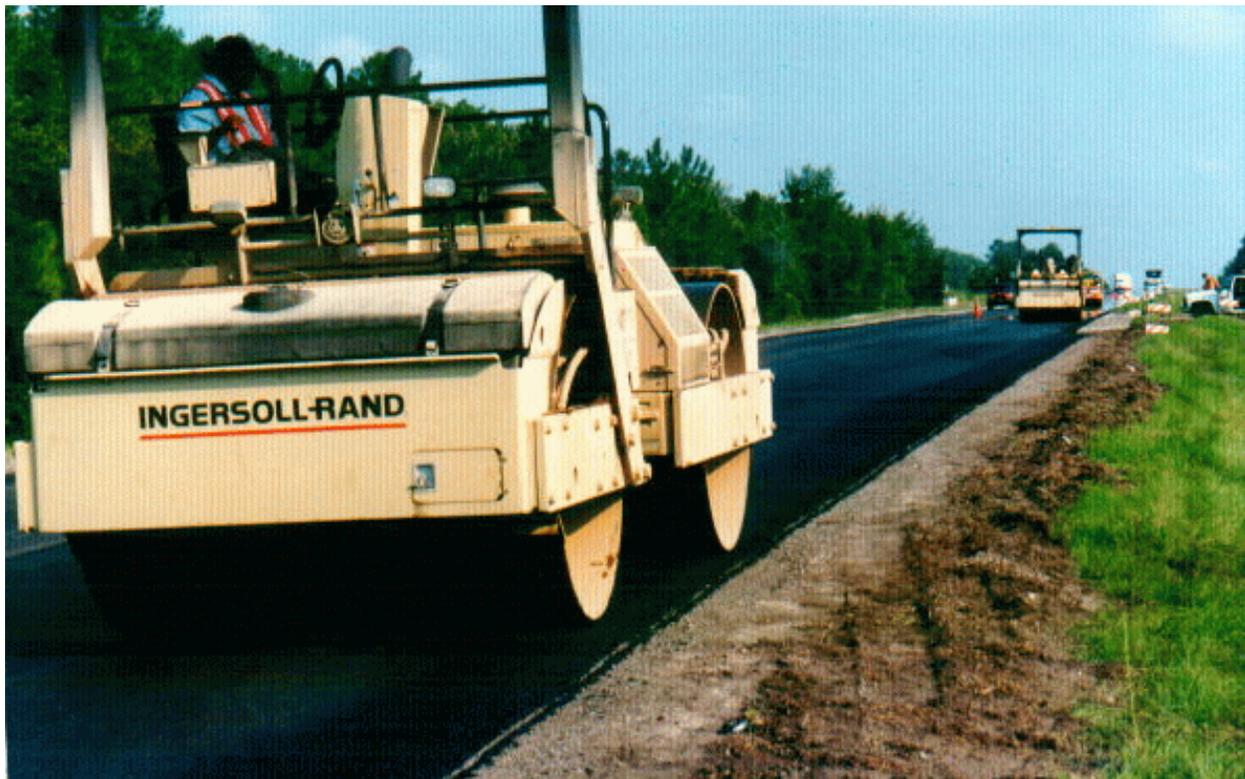
**Figure 6. Florida Hwy 301 Construction**

Horizontal flow trailers delivered the mix to a Blaw Knox PF3200 paver. The average mix surface temperature behind the paver ranged from 285 to 295°F. An Ingersoll Rand DD110 was used for breakdown rolling and followed closely behind the paver. All the breakdown rolling was completed using maximum amplitude and frequency settings, with the rolling pattern consisting of one pass up the right edge and then back along the same line (resulting in two passes). The pattern was duplicated along the left edge with a final pass made up the middle of the lane. Average surface temperature after breakdown rolling was 225 to 235°F. At this point the intermediate roller, another Ingersoll Rand DD110, used the same rolling pattern and settings as the breakdown roller. Intermediate rolling continued down to approximately 190°F surface temperature, where the mix began to exhibit the tenderness. Breakdown and intermediate rollers are shown in Figure 6.

As mentioned, the mix began to show tenderness at about 190°F surface temperature. From this temperature down to 140°F surface temperature, the mix would show a lateral movement (1 inch) and pushing in front of the roller. No tenderness was seen at surface temperatures outside the 140 to 190°F range. The contractor did not try to use a rubber tired roller for compaction in the tender zone.

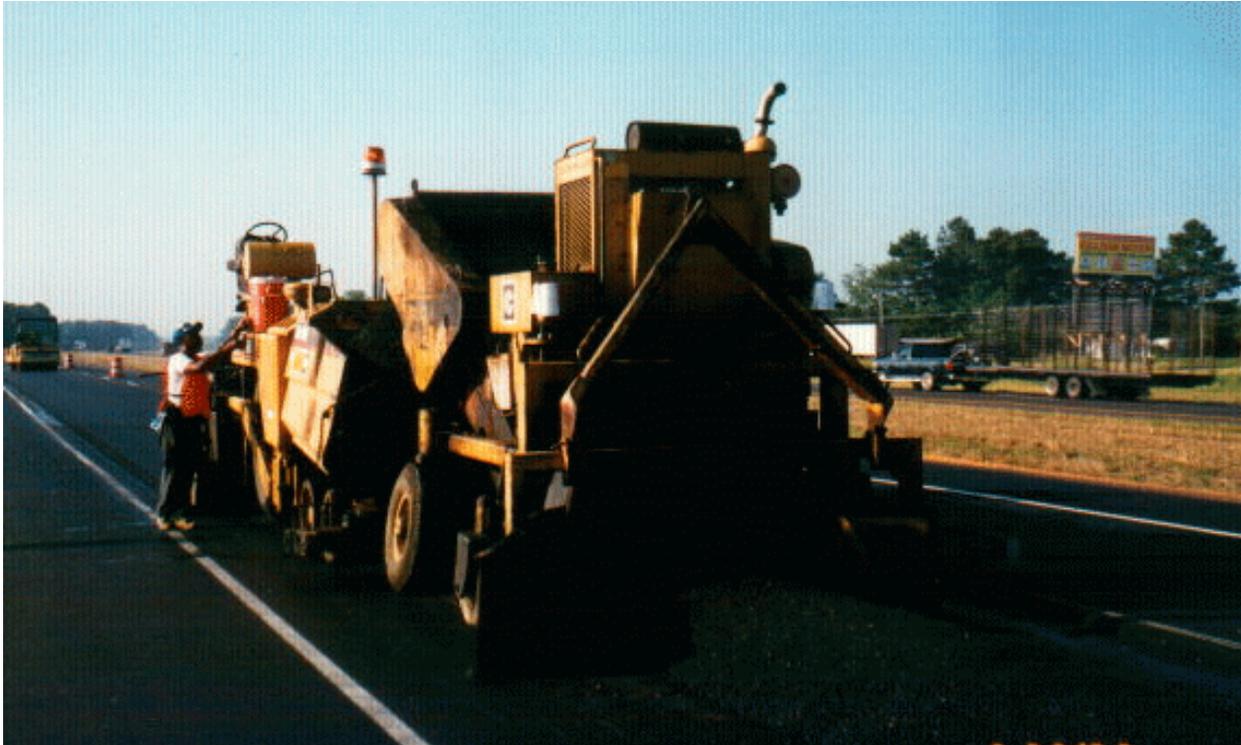
**Figure 7. Mississippi Hwy 49 Construction**

The mix was produced approximately 3 miles from the project site. Mix storage at the drum plant was minimal during the project. The contractor utilized windrow paving techniques, shown in Figure 7, with horizontal flow trailers and end dump trucks used in conjunction with a Crafco Accupave windrow device to construct the windrow. A Caterpillar WE601B windrow elevator fed a Caterpillar AP1000 paver. An emulsified asphalt was used as the tack coat. The average mix surface temperature behind the paver was 295°F. The breakdown roller, an Ingersoll Rand DD130, followed immediately behind the paver. The contractor had varied the amplitude and frequency of the roller throughout the project to optimize compaction, but reported that a medium amplitude and a high frequency yielded the best results. The typical rolling pattern used during breakdown rolling was to make one pass up on the outside edge, then back along the outside edge, make another pass up along the opposite edge, and then back along the same line. All passes were in vibratory mode. Because of the occurrence of mix tenderness, no intermediate roller was used on the project. A Hypac C778B roller was used for finish rolling with no set pattern. Two to three passes were typically made in static mode at a mat temperature of approximately 150°F to take out the roller marks. If there was trouble achieving density, the contractor reported that vibration by the finish roller was used at the same temperature. An increase in density was observed when vibrating at surface temperatures above 150°F, but below 140°F the contractor reported a decrease in density. Some noticeable breakdown of material was observed when vibration was used with the finish roller.

During the beginning of breakdown rolling at approximately 295°F surface temperature down to approximately 245°F, there appeared to be no tenderness in the mix. However, below approximately 245°F, the mix began to push laterally and in front of the roller. The degree of movement increased as the temperature decreased. The contractor reported that the same scenario had been seen throughout construction. At approximately 150 to 160°F, the tenderness in the mix decreased and the contractor was able to conduct finish rolling. No attempts were made to use a rubber-tired roller in the tender zone, due primarily to the contractor's past experience with material pick up.
