NCAT Report 89-01

WATER DAMAGE TO ASPHALT OVERLAYS: CASE HISTORIES

This paper presents three case histories of water damage to asphalt overlays over portland cement concrete (PCC) pavements during the last ten years in Pennsylvania. The most recent case of water damage was observed in the summer of 1986 on Interstate 80. Since similar damage had been observed (and documented) on Pennsylvania Turnpike (both East-West and North-East Sections) in the summer of 1978 it was considered prudent to include those unreported ten year old case histories in this paper as well. Data on existing moisture contents in the wearing, binder and leveling courses which is generally not found in the literature, has also been presented. It should be noted that stripping has not been identified as a major problem in Pennsylvania. It has occurred in very few cases such as, these three case histories where excessive water and/or moisture vapor was apparently present in the pavement system. Unfortunately, the subgrade or subbase underneath the PCC pavements constructed in the past are generally highly impermeable to water. These pavements when overlaid with asphalt overlays present a persistent problem due

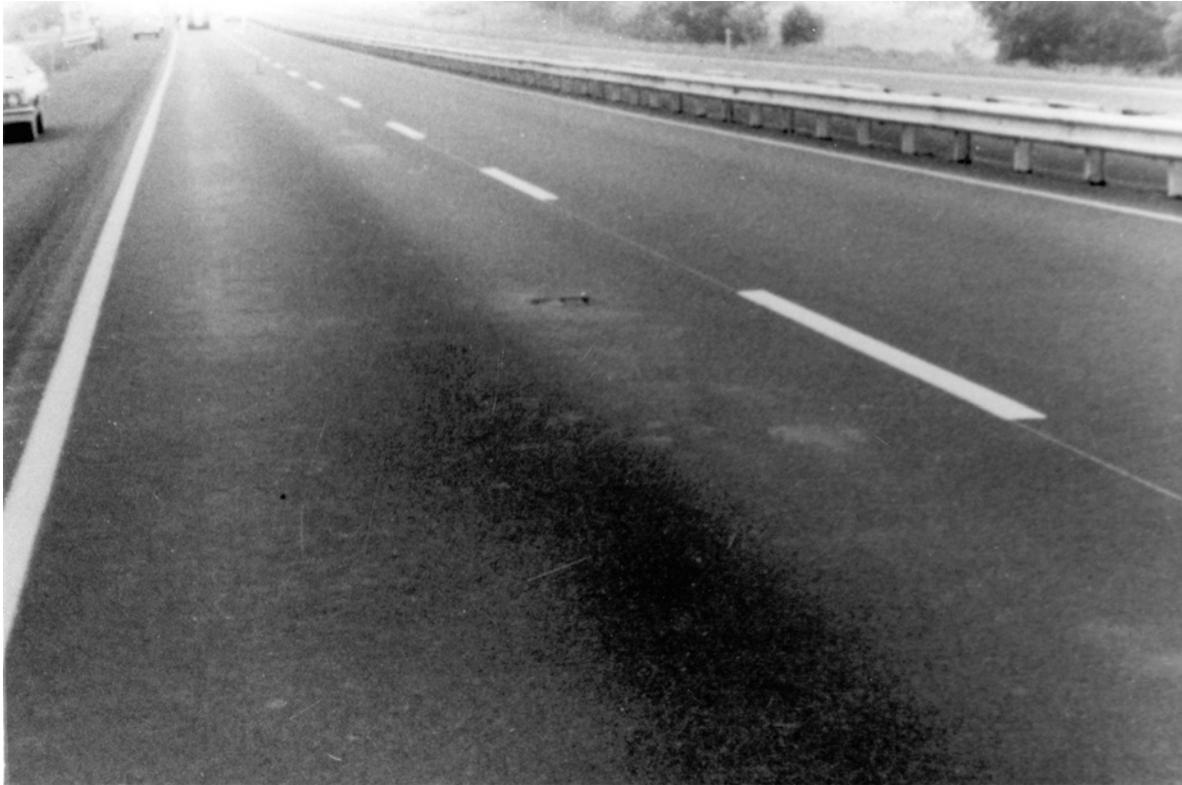
Figures 3 and 4 show typical potholes in the inside wheel track of the slow lane. The fatty areas (resulting from asphalt stripping and migrating to the surface) seen in the pictures usually preceded the formation of potholes. Small blisters or asphalt bubbles were also observed similar to one shown in Figure 5 (framed by the jaw of an adjustable wrench). A big blister (about 9 inches in diameter) was seen in the eastbound slow lane. When it was burst a thick slurry was

Figure 3. East-West Turnpike (General View Showing a Typical Pothole)

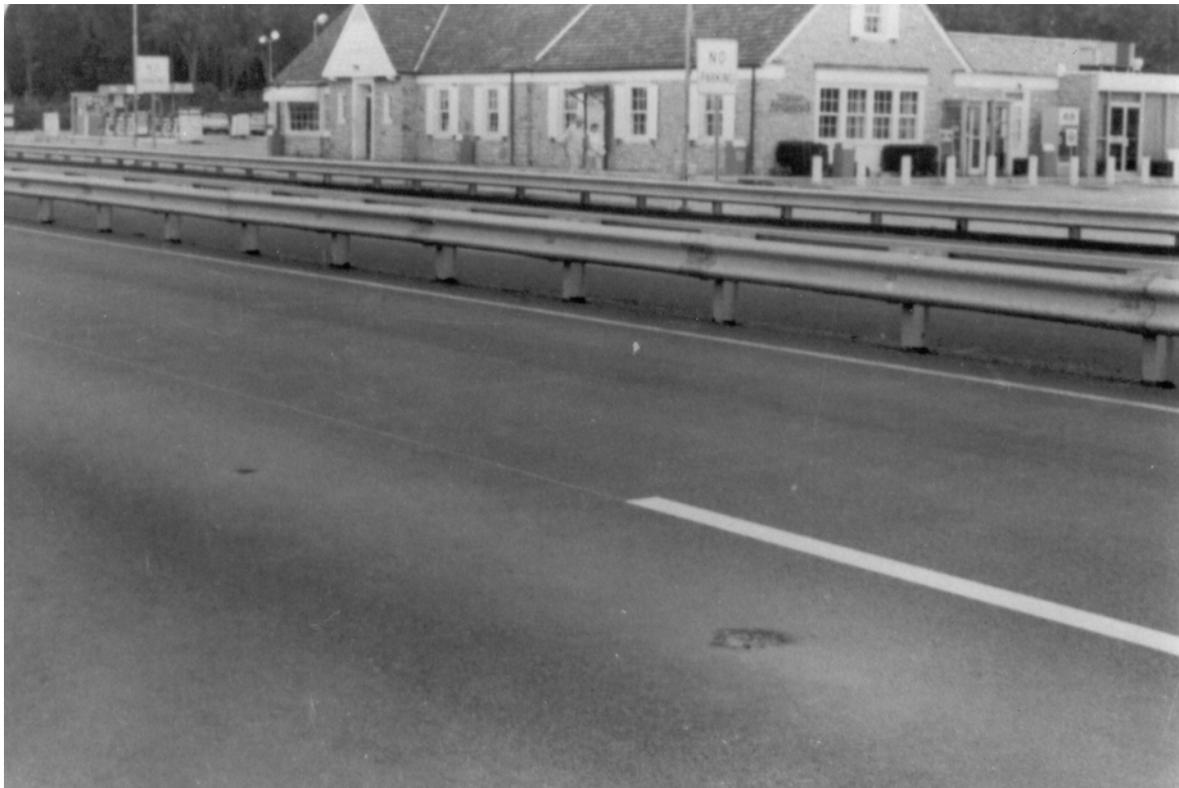
Figure 4. East-West Turnpike (Closeup of Potholes in Inside Wheel Track)

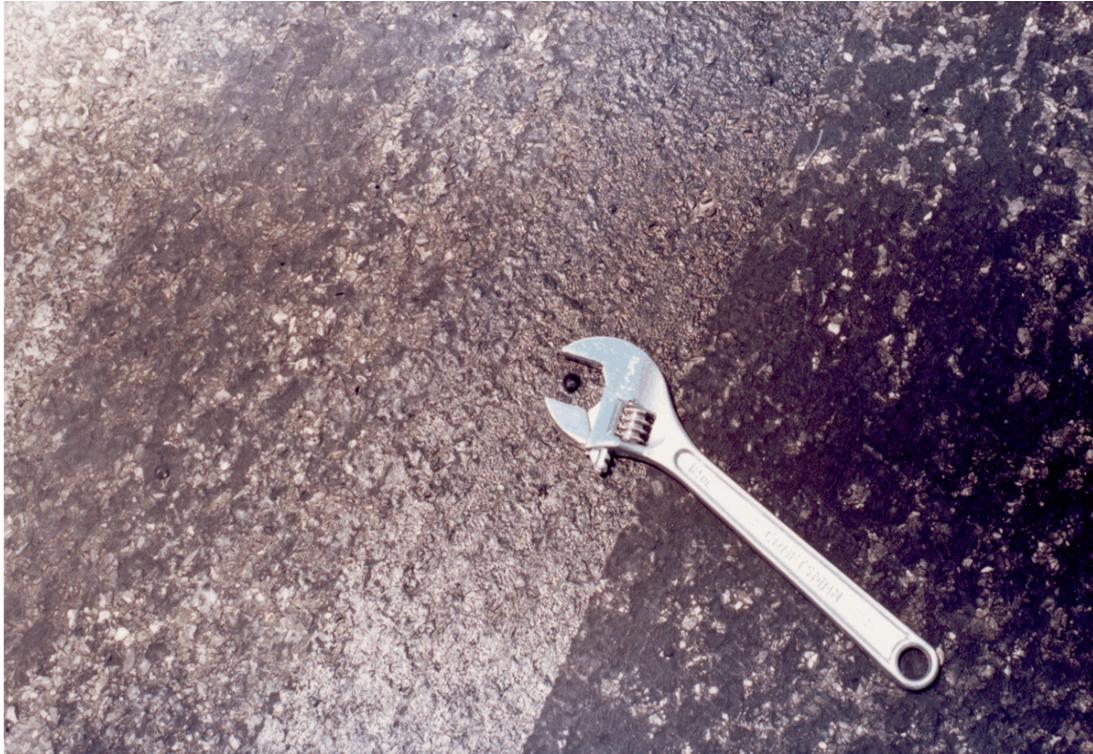
Figure 5. East-West Turnpike (Asphalt Bubbles - One Framed by Wrench)

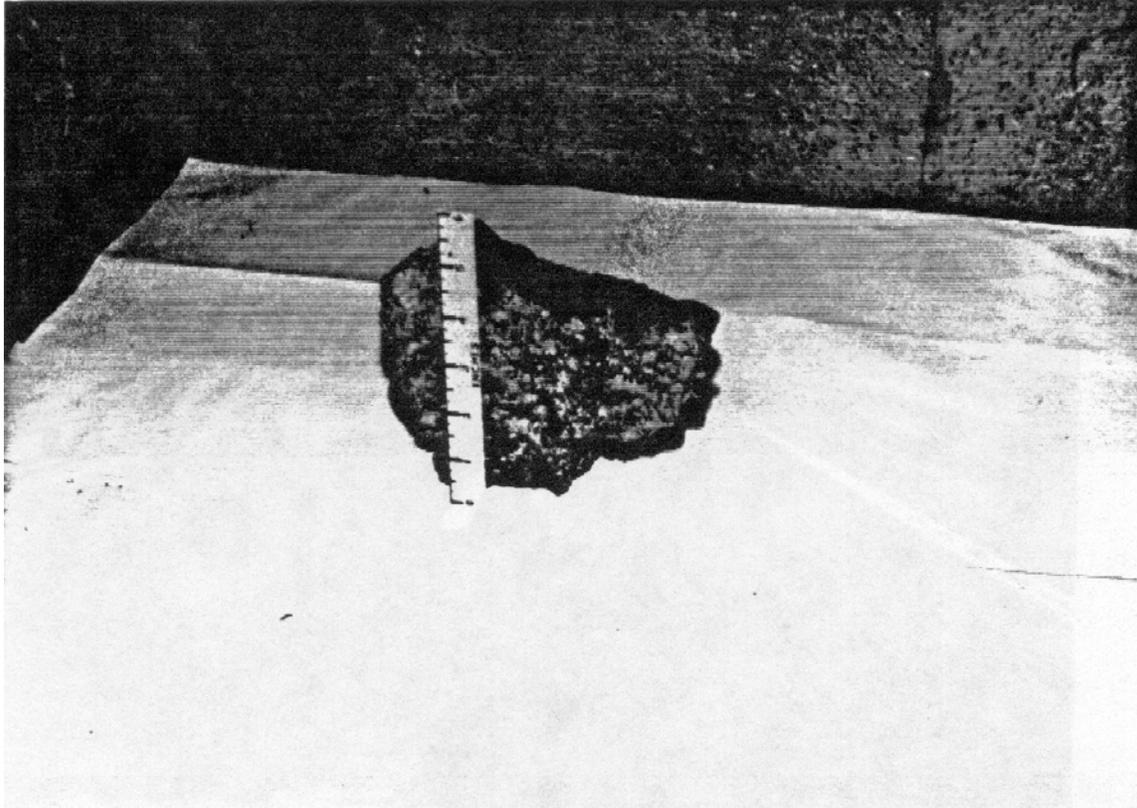
observed at the bottom of the wearing course (Figure 6). Chemical analysis of this slurry confirmed that the suspended fines came from the coarse aggregate in the wearing course and apparently resulted from the grinding of stripped aggregate under traffic.

Figure 6. East-West Turnpike (Bottom of Wearing Course Coated with Slurry)

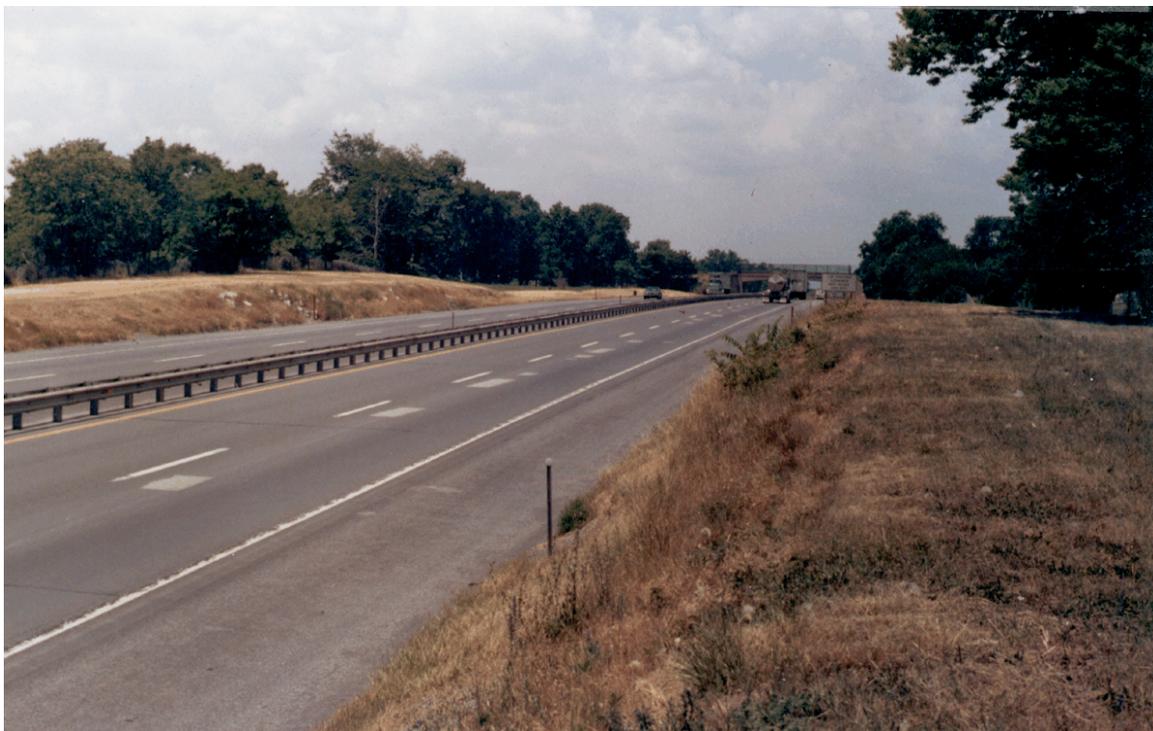
Figures 7 through 10 show the general pattern of the potholes which have been patched over the years. These pictures were taken in June 1988. Figure 10 shows three adjacent patches placed at different times. It should be noted that most of the pothole patching was done during the first two years (1978 and 1979).

Figure 7. East-West Turnpike (General View Showing a Series of Patched potholes on Inside Wheel Track of Slow Lane)

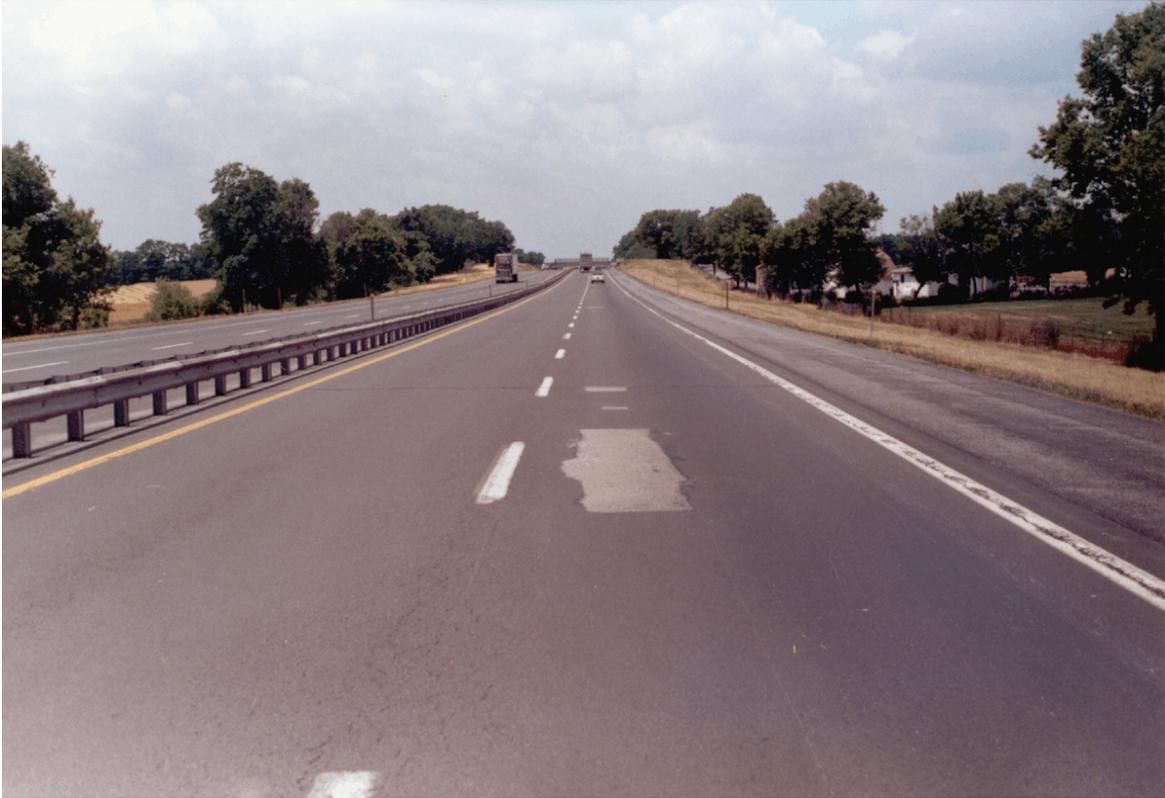
Figure 8. East-West Turnpike (Closeup of Patched Potholes)

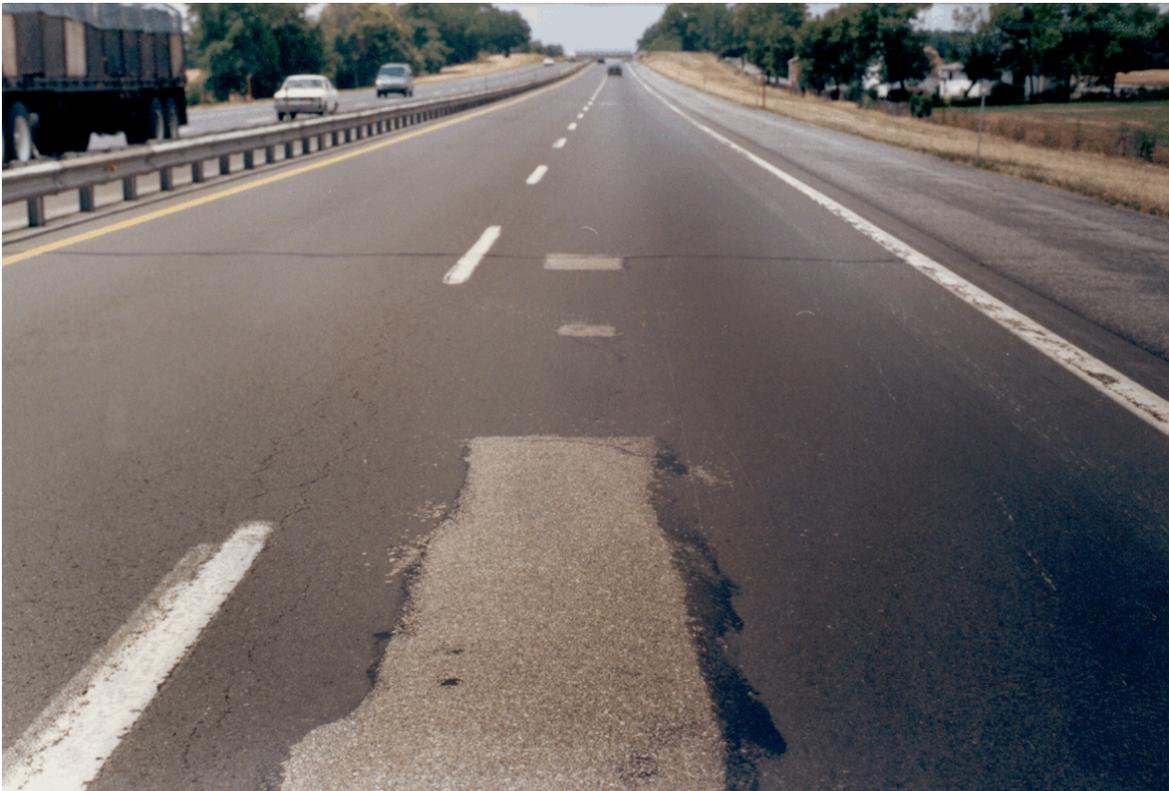
Figure 9. East-West Turnpike (Closeup of Long Patched Pothole)

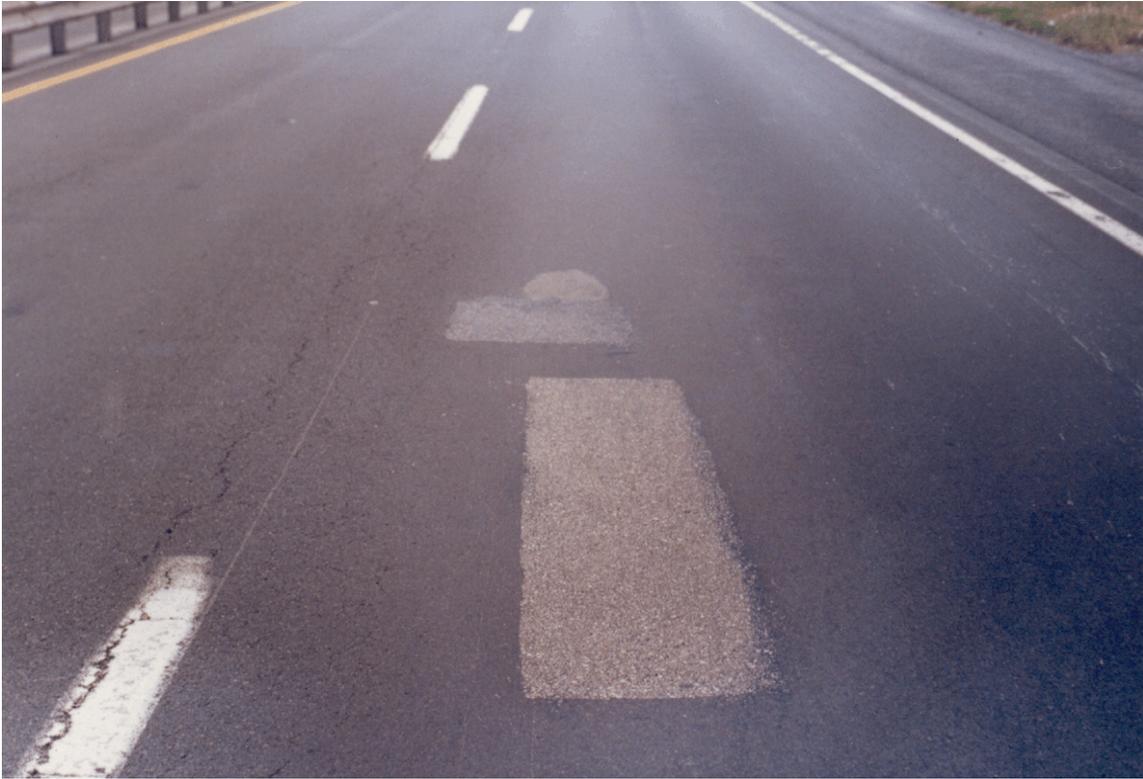
Figure 10. East-West Turnpike (Potholes Patched at Different Times)

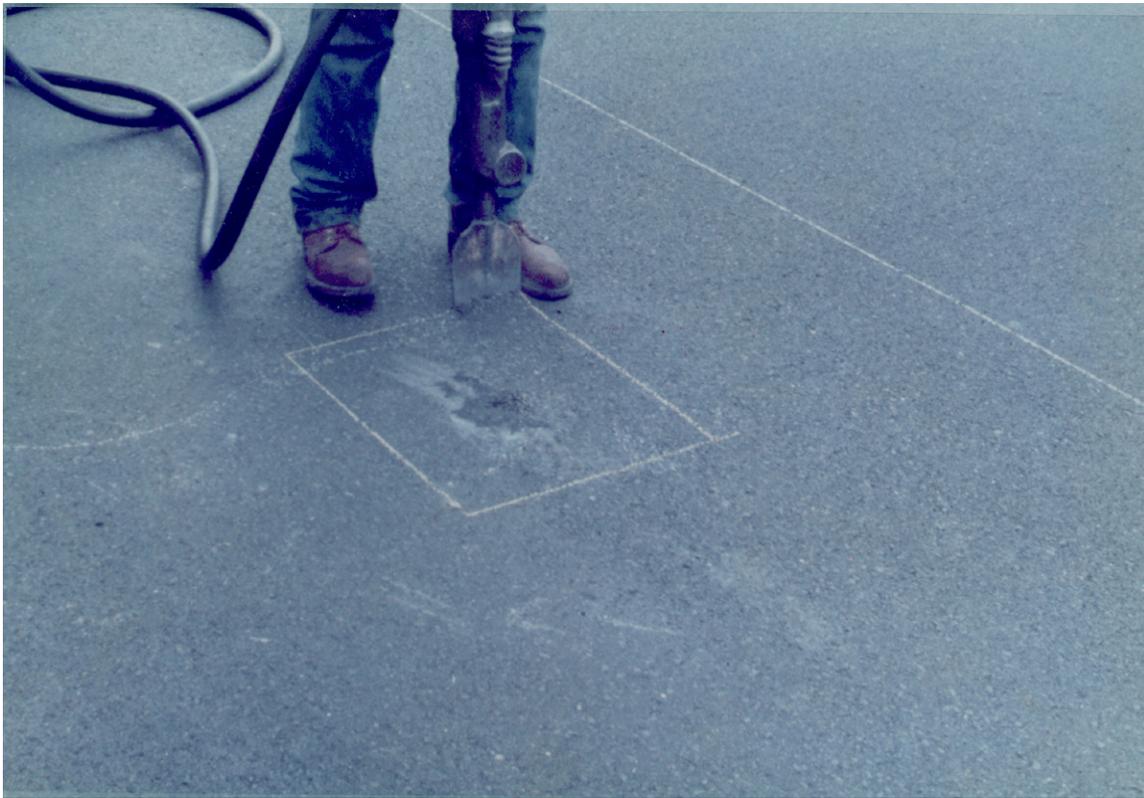
Figure 11 shows the outline around a pothole before jack hammering, Figure 12 shows the rectangular trench after the new wearing course was removed, and Figure 13 shows the trench after the entire new overlay (wearing, binder and leveling) was removed. Figure 14 clearly shows the wetness in pavement layers especially the new binder course. Figure 15 shows the removed slabs of binder and wearing courses which exhibited severe stripping.

Figure 11. East-West Turnpike (Pothole with Rectangular Outline for Jack Hammering)

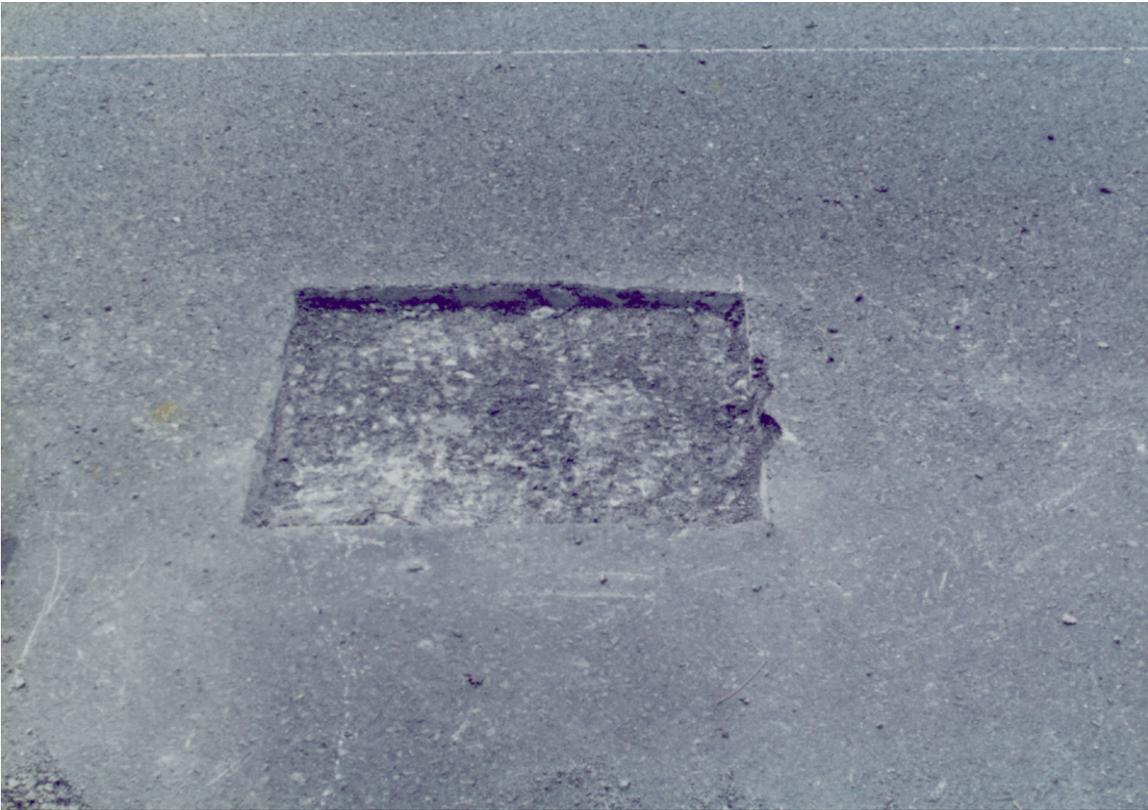
Figure 12. East-West Turnpike (Pothole After Removal of Wearing Course)

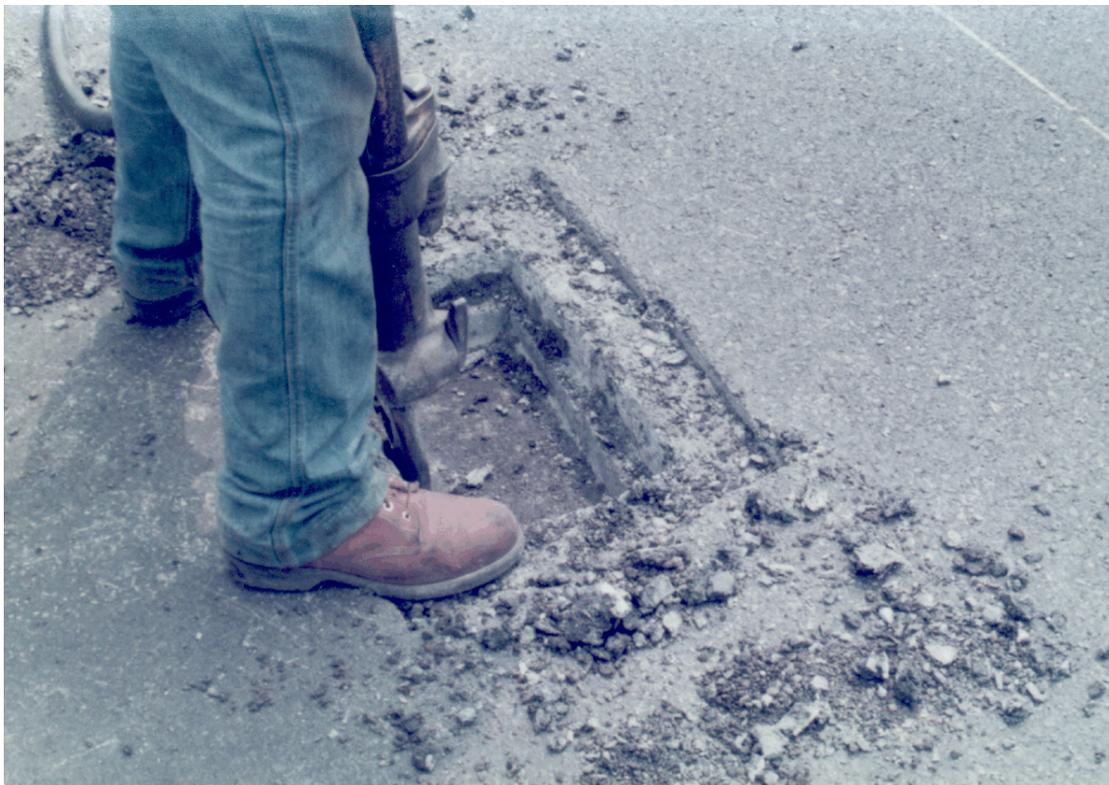
Figure 13. East-West Turnpike (Wearing, Binder, and Leveling Courses Removed)

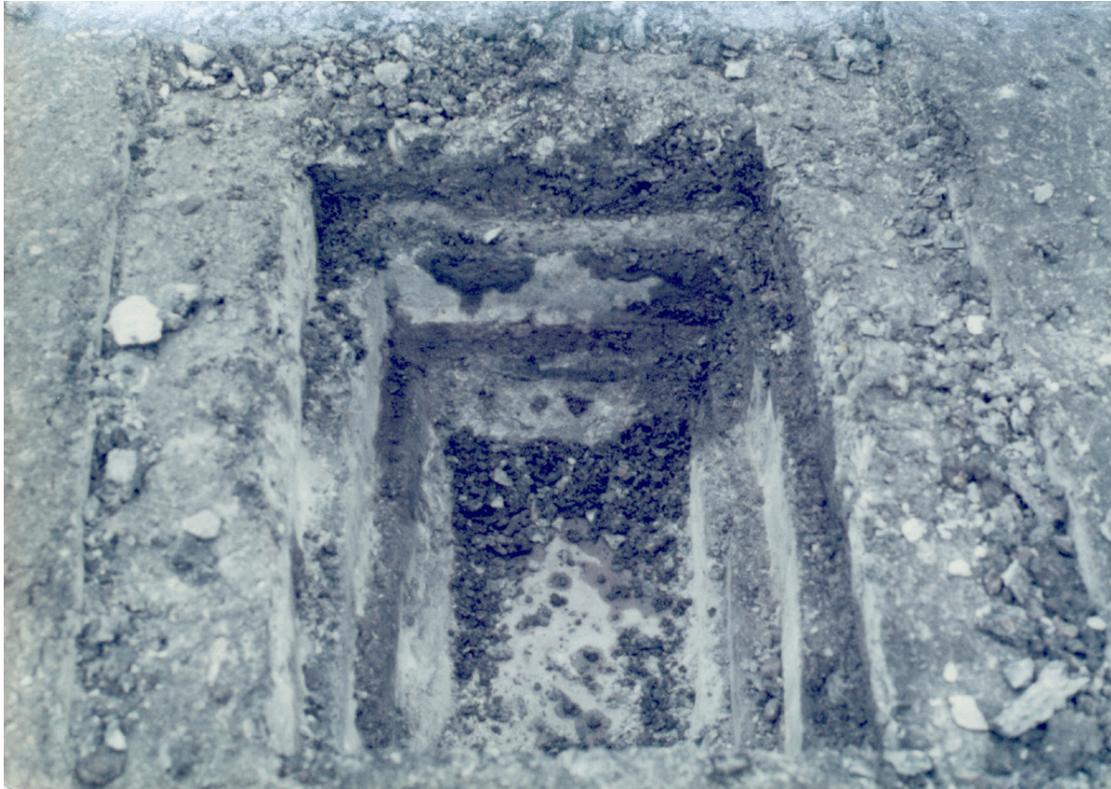
Figure 14. East-West Turnpike (Older Overlays Removed)

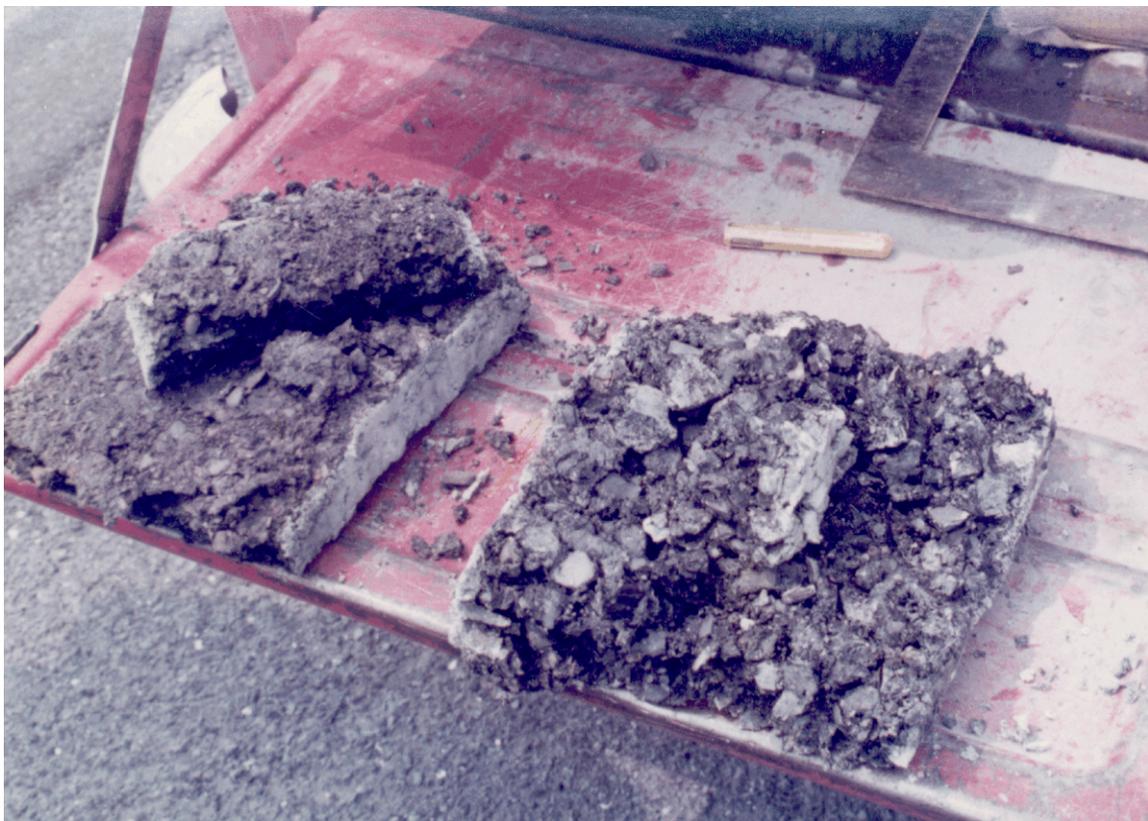
Figure 15. East-West Turnpike (Removed Slabs Placed Upside-Down to Show Stripping)

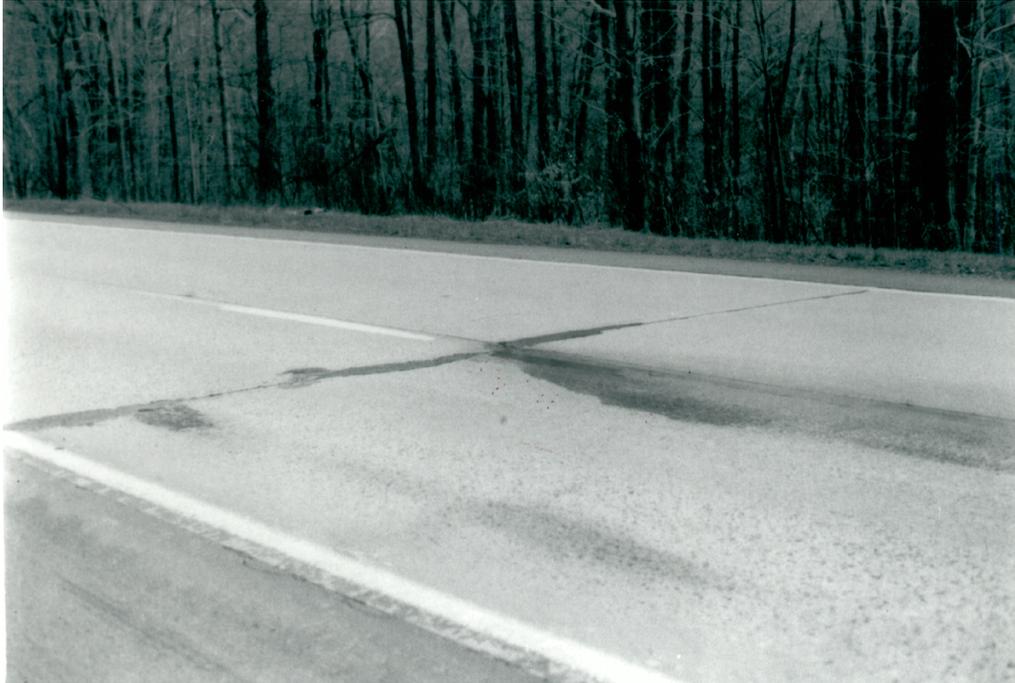
Figure 20. PCC Pavement (Water Pumping from Transverse Joint)

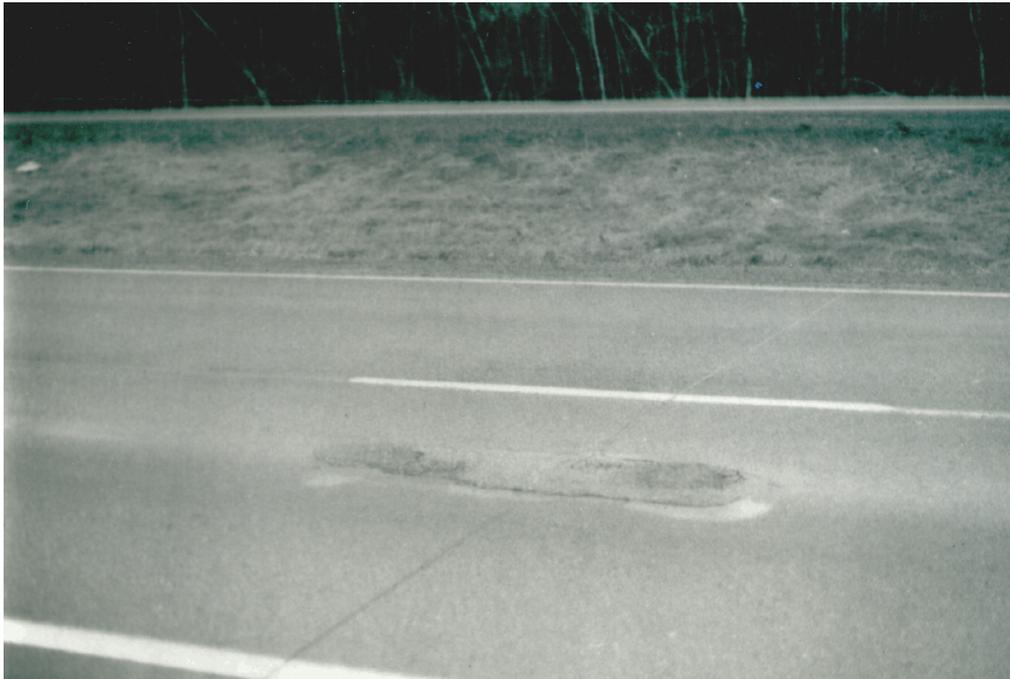
Figure 21. Patched Pothole in Asphalt Overlay on Either Side of Transverse Joint of Underlying PCC Pavement
