NCAT Report 91-07

EVALUATION OF PAVEMENT BLEEDING PROBLEM ON I-55 IN ILLINOIS

January 1991

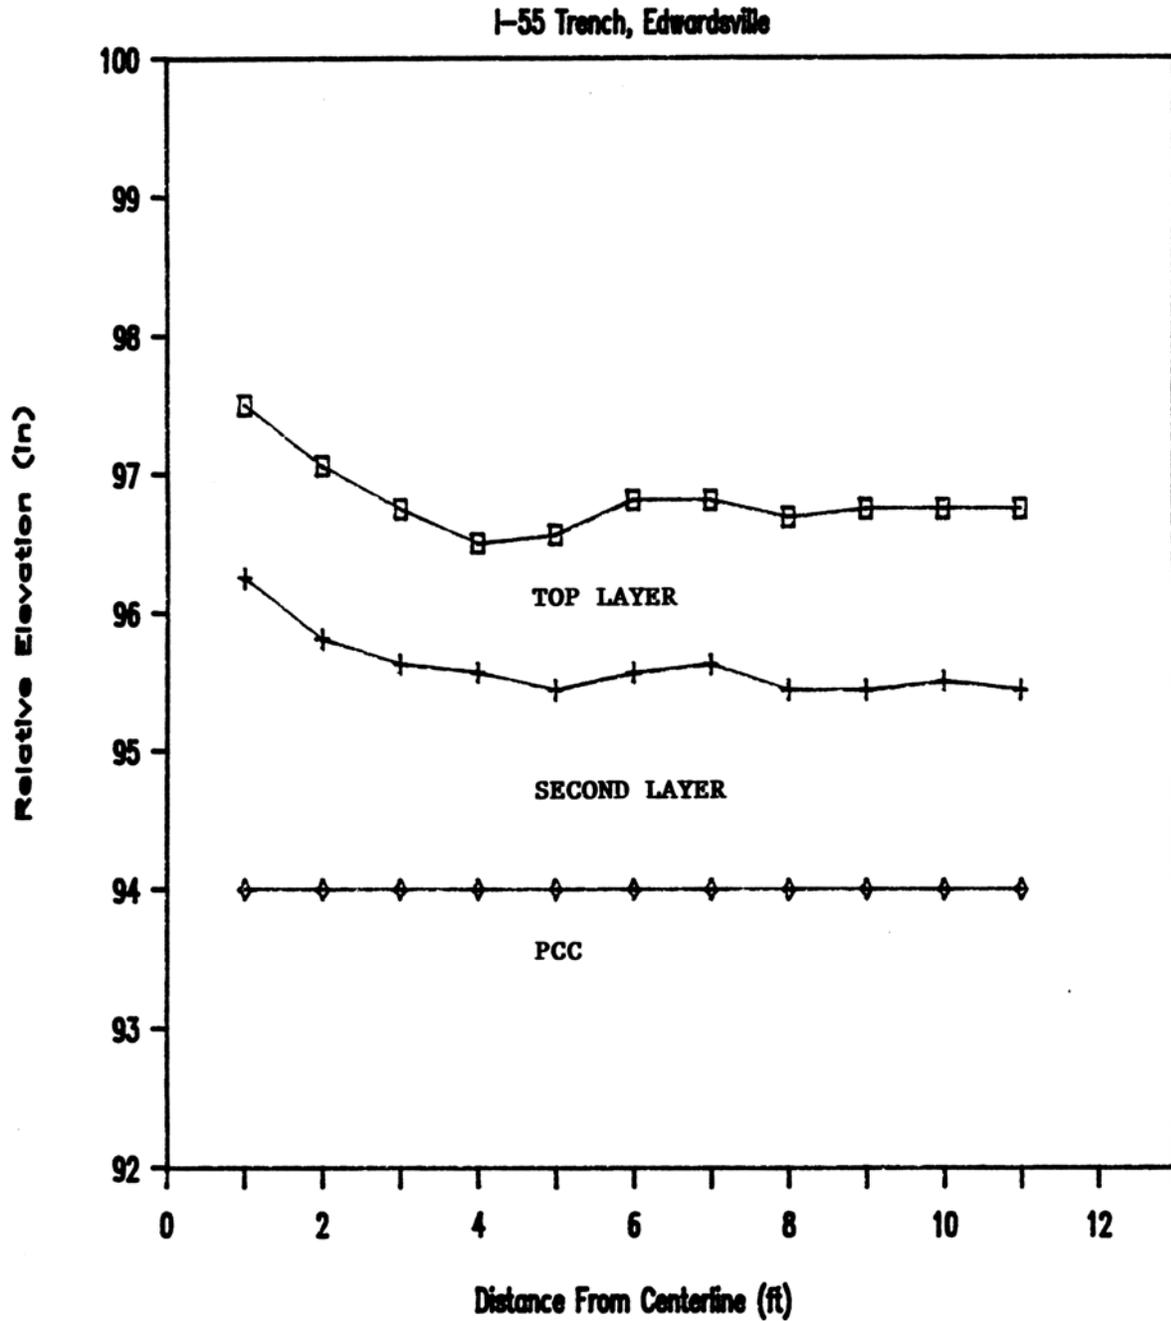
Figure 2. Trench Cut at Sta. 934+70, North Bound Lane, I-55, Near Collinsville, IL

Rut measurements were taken at the trench and the results plotted in Figure 2. The rut depth at this location was approximately 0.6 inches. Atypical localized bleeding area is shown in Figure 3.

The pavement section (Figure 2) shows that there were 2 layers of asphalt mixture placed over an existing layer of concrete. The total thickness of asphalt mixture was approximately 3 inches. Figure 2 shows that rutting had occurred in the surface and binder course. The rutting was more severe at the locations that had localized bleeding than in the other areas. The major concerns at the time of inspection was the rutting problem in general and the ravening and potholes being developed at the localized fat spots.

An inspection of the pavement adjacent to the trench cut through a bleeding spot did not indicate causes of the problem. This inspection did show that the problem was confined to the top layer of asphalt mixture and that the lower half of the layer had less asphalt cement than the top half.
