NO-TACK INLAY ON MILED SURFACE: PROJECT REPORT

NCAT Report 99-02

JUNE 23, 1998

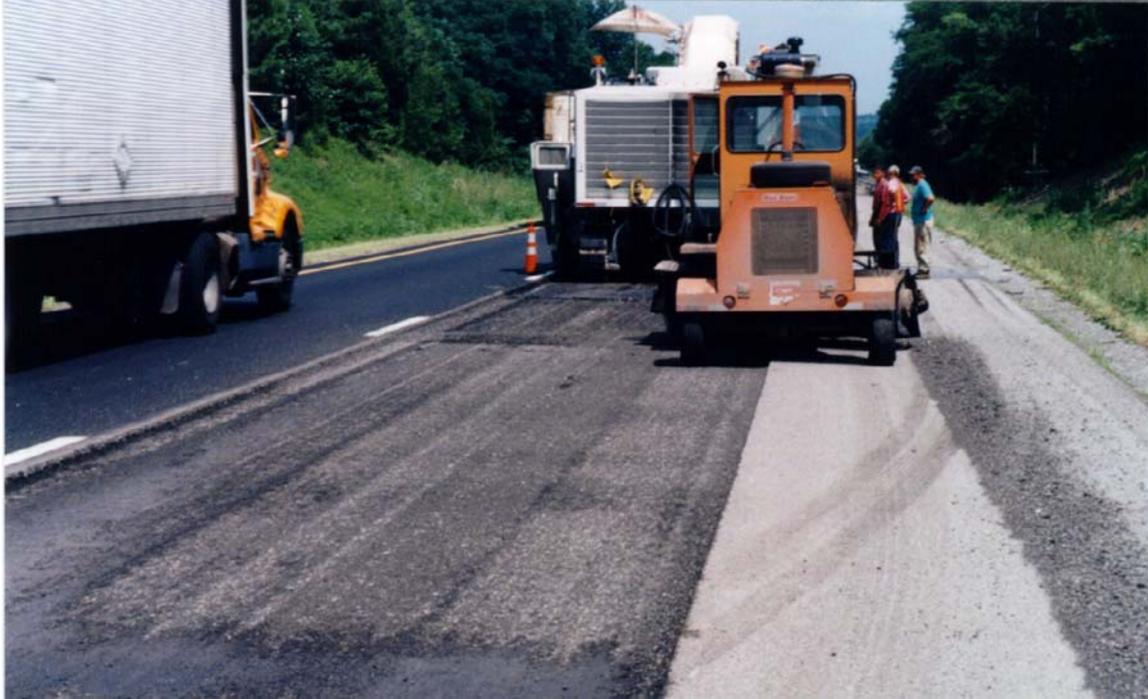
The paving train consisted of a milling machine capable of milling 3.7 m (12 ft) of existing roadway. Next, a sweeper (Figure 1) was used to remove some of the millings from the roadway. Some millings were left in the grooves. About one hour behind the milling machine, the contractor was utilizing a material transfer vehicle (MTV) into which the mixture was unloaded from trucks (Figure 2). Figure 3 shows the surface of the pavement prior to the HMA mixture being placed. The MTV then fed material into the hopper on the paver. Mixture leaving the paver had a temperature of approximately 152°C (305°F). Following the paver, the contractor was using three rollers to achieve compaction. The breakdown roller was a steel-wheel vibratory roller (Figure 4). The intermediate roller was a combination steel-wheel and pneumatic tire roller. The finish roller was a steel-wheel roller used in the static mode.

Figure 1. Milling Machine and Sweeper

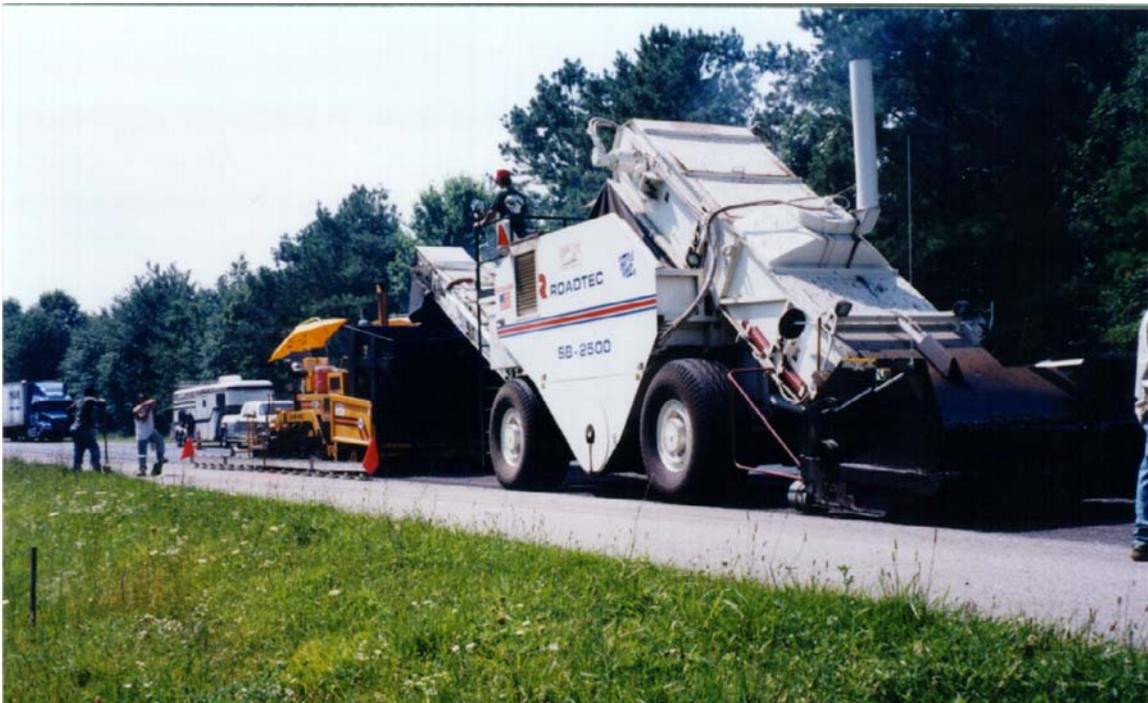
Figure 2. MTV Used on Project

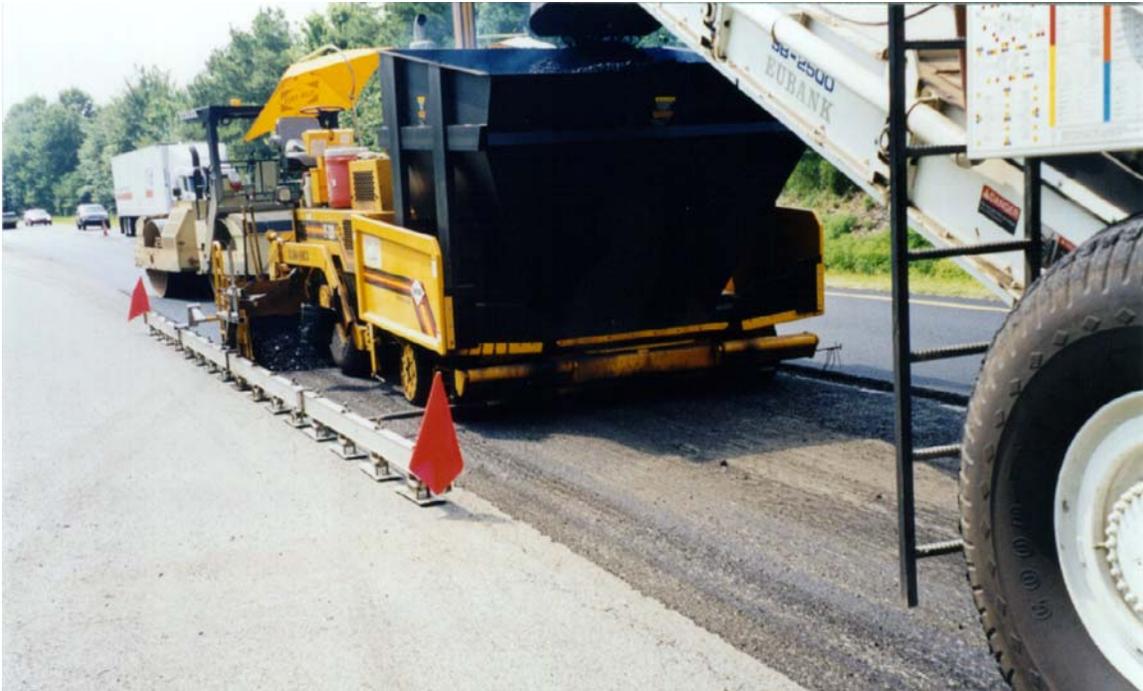
Figure 3. Pavement With No Tack Coat Prior to Placement of Mixture

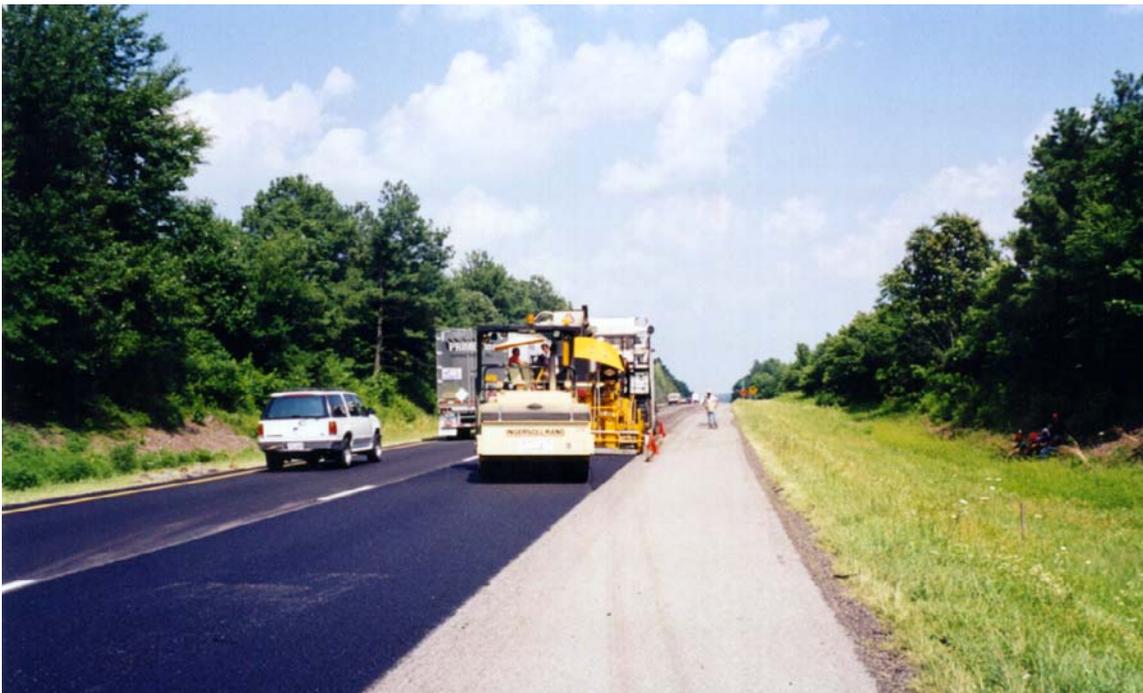
Figure 4. Breakdown Roller

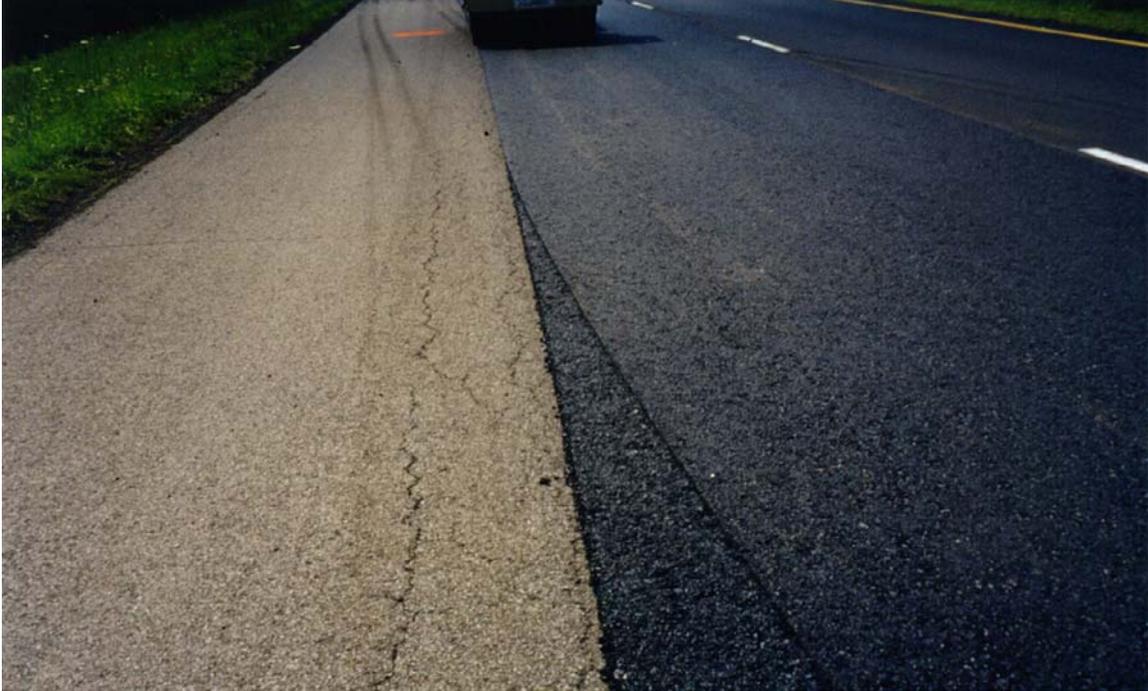
While observing the paving operation, the mixture seemed stable under the rollers. No lateral movement was noticed. Once the breakdown roller had made two to three passes, no appreciable roller marks were observed in the pavement. Figure 5 shows the pavement after one pass of the breakdown roller. The contractor and a TDOT inspector said that the pavement was being compacted to 94-95 percent of theoretical maximum density.

Figure 5. Pavement Surface After One Pass of Breakdown Roller (Roller Mark)

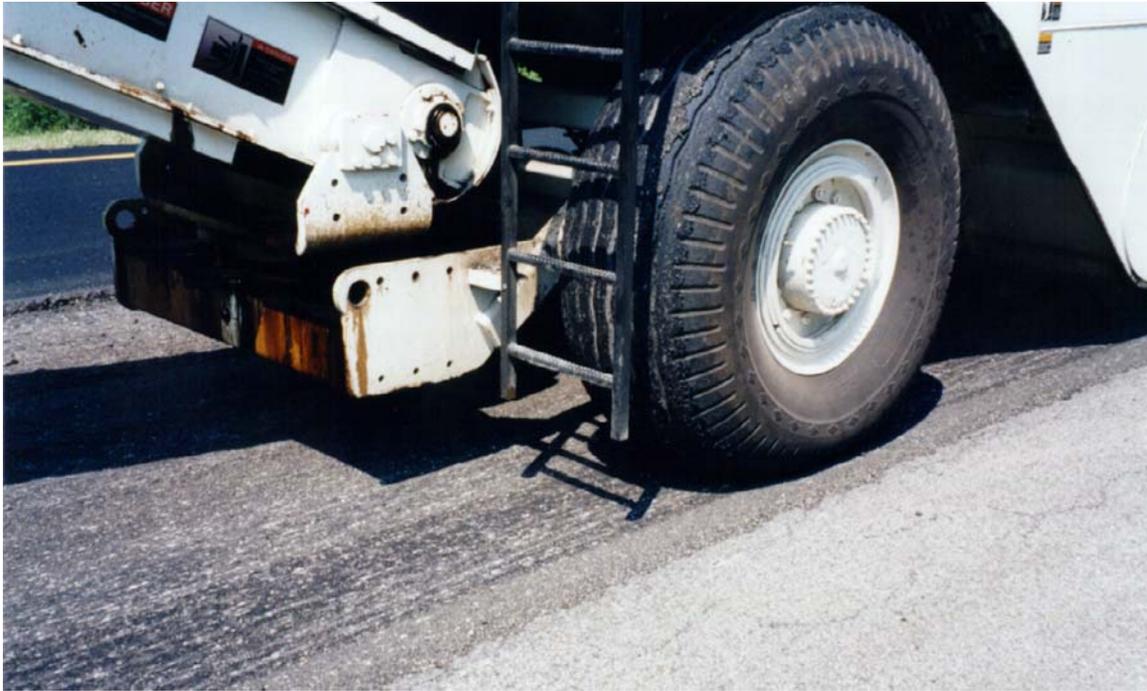
The contractor was pleased with the operation since pick-up prior to placing the HMA was not a problem. The tires on the MTV were clean since no tack coat was used (Figure 6).

Figure 6. Tire From Material Transfer Vehicle

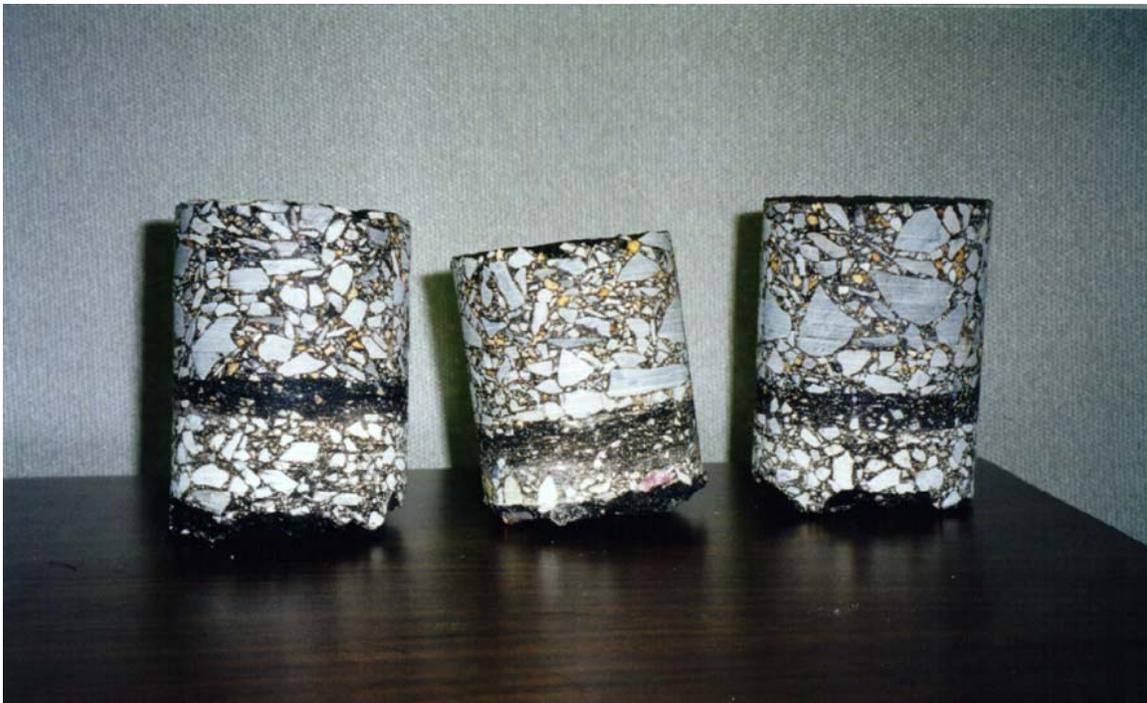
The bond between the placed mixture and underlying pavement seemed strong. The contractor had cut cores to show the strength of the bond (Figure 7). When cutting and removing the cores from the roadway, they actually broke in the underlying pavement and not at the interface below the overlay.

Figure 7. Cores Obtained From Project

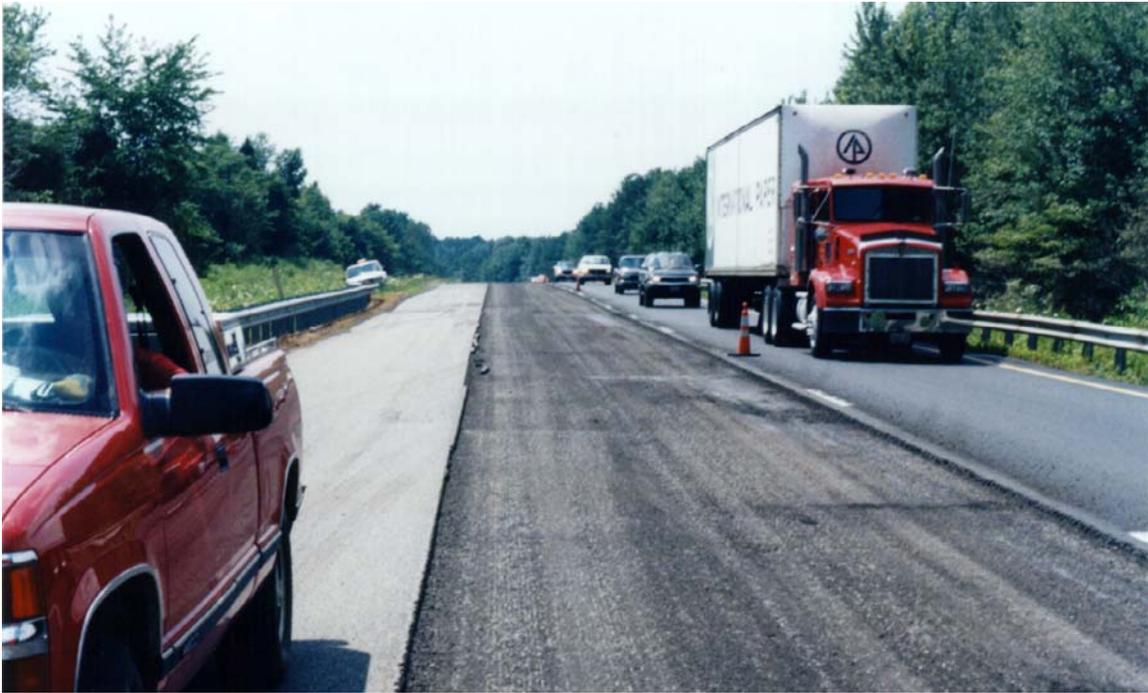
Because of the milling operation, the joints on either side of the roadway were vertical (Figure 8). After the placement and compaction of the mixture, the joints seemed to be tight (Figure 9).

Figure 8. Milled Roadway Showing Vertical Sides

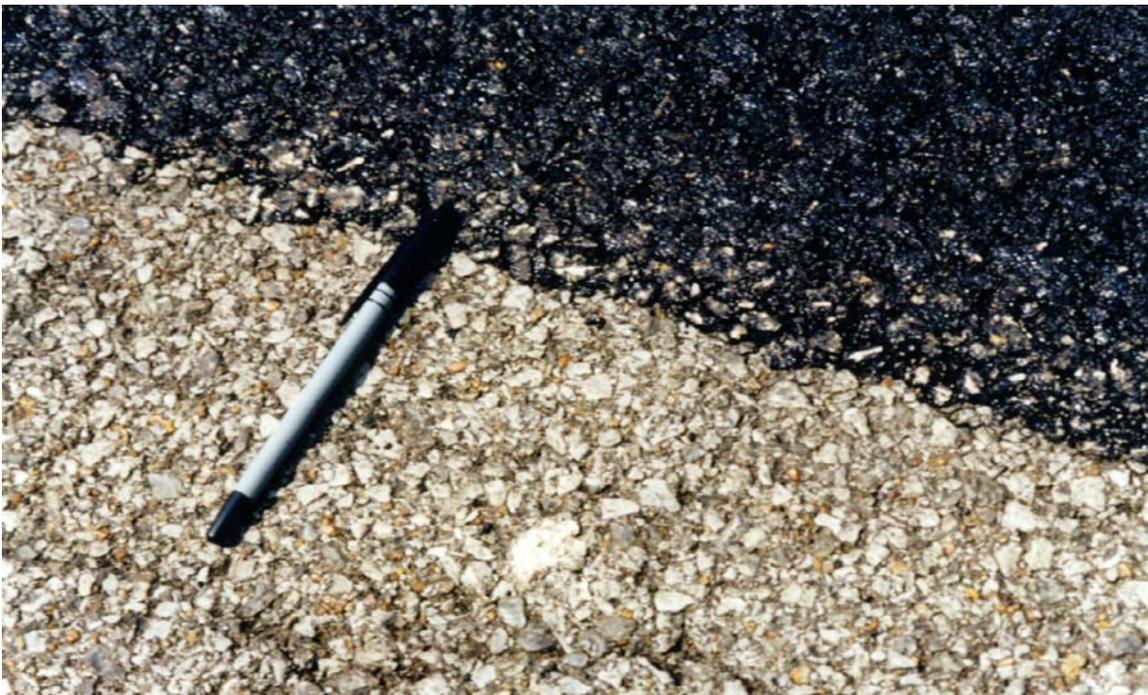
Figure 9. Finished Joint
