PERFORMANCE OF RUBBLIZED PAVEMENT SECTIONS IN ALABAMA

Final Report

Highway Research Center

Auburn University

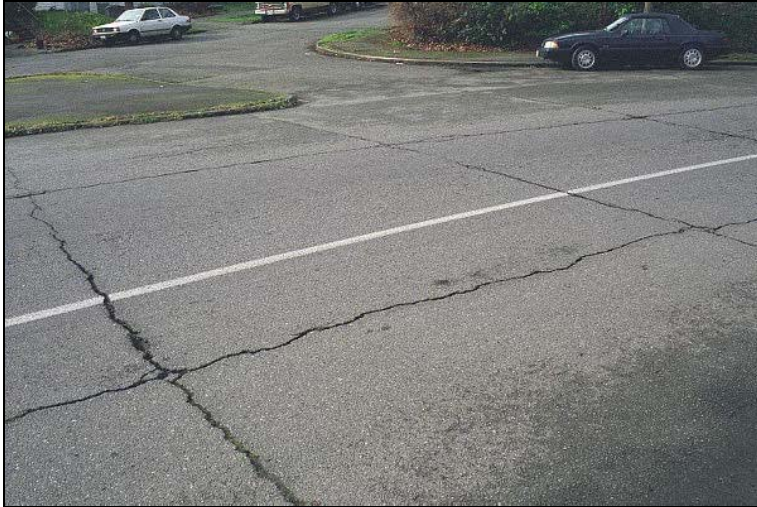
Figure 2.1 Reflective Cracking.

When rehabilitating PCC pavements, a common practice is to place an HMA overlay on top of the existing pavement structure (Freeman, 2002). However, a problem that has presented itself when utilizing an overlay is the development of reflective cracking through the depth of the newly placed overlay. This problem, known as joint reflective cracking, is a distress unique only to materials that have been laid over PCC pavements (Shahin, 1994). This type cracking is illustrated in Figure 2.1. The main concern with reflective cracking in HMA overlays is that reflective cracks accelerate the deterioration of the pavement structure. This deterioration is caused by water and incompressible solids filling the cracks that over time degrade the HMA (Yoder and Witczak, 1975).

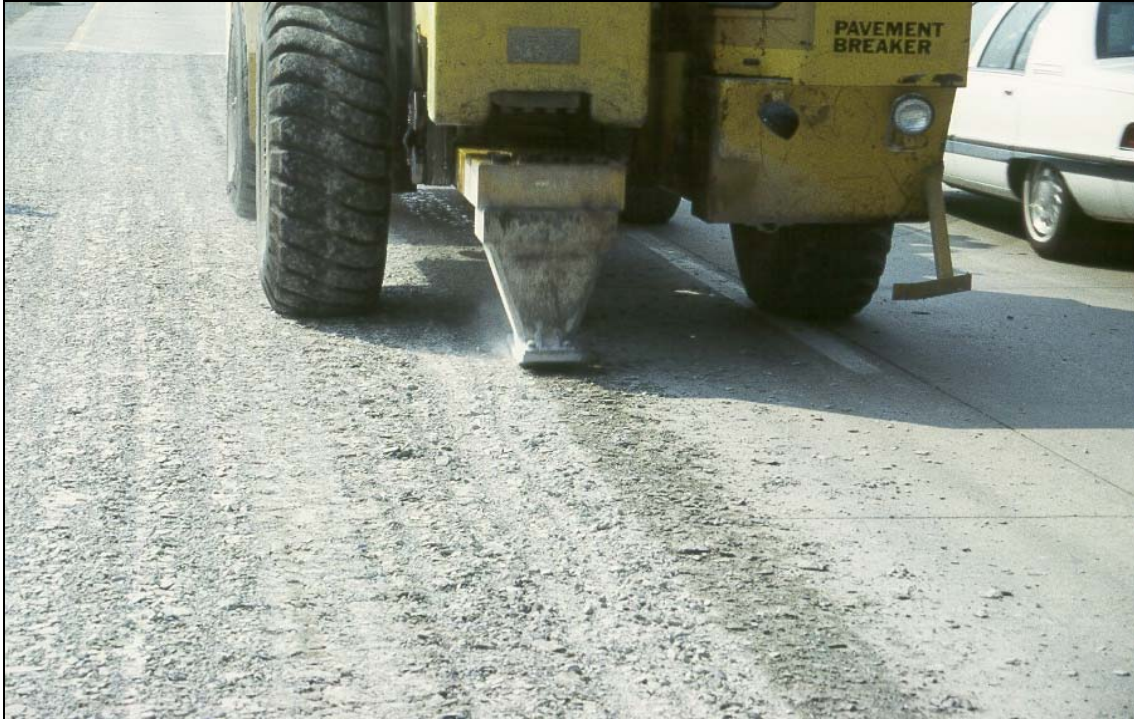
Figure 2.4 Resonance Frequency Breaker (Photo courtesy of Dr. Kevin Hall, University of Arkansas).

In 1986 John Brizzell, a New York Department of Transportation materials engineer, observed the resonance breaker and thought that it might eliminate reflective cracking. He recommended that the process be called rubblization (Kirk, 2001). The resonance frequency breaker uses a 15 cm (6 in) shoe located on the end of a pedestal that is connected to a beam with 5443 kg (12,000 lbs) counter weight located at the opposite end of the beam to break up the PCC pavement. This machine uses a low

amplitude (<12.5 mm) high frequency (44 Hz) shoe to deliver energy to the slab that is near the harmonic frequency of PCC. Figure 2.4 shows an illustration of the shoe that is used to rubblize PCC. This results in an area of high tension at the top of the PCC and causes the slab to fracture on a shear plane approximately 35 degrees from the pavement surface (Fitts, 2001).

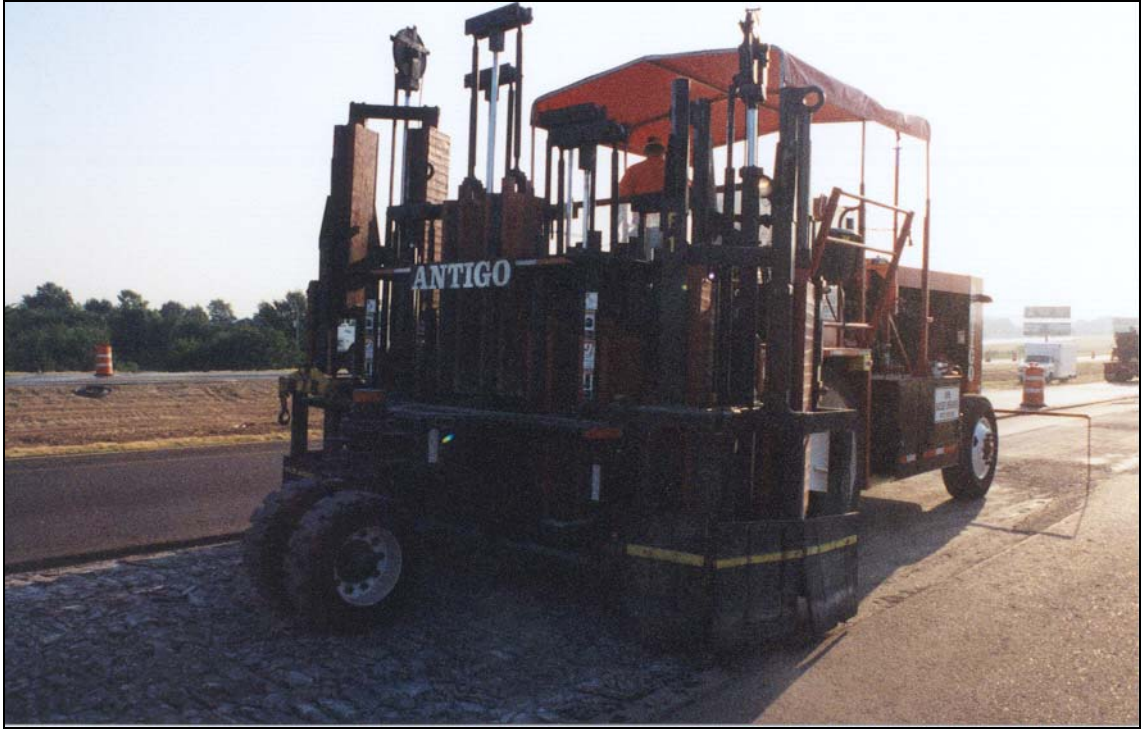
Figure 2.5 Multi-Head Breaker (photo courtesy of Dr. Kevin Hall, University of Arkansas).

The MHB (Figure 2.5) operates by dropping a series of twelve to sixteen 102 to 123 lbs. (454 to 545 N) hammers on the PCC slab generating between 2,000 ft-lbs and 12,000 ft-lbs. (2,700 and 16,000 J). This crushes the pavement into a granular base and is capable of pulverizing pavements widths ranging from 2 ft to 12.5 ft (.61 to 4.0 m) (Fitts, 2001). The MHB allows a one-pass rubblization process and eliminates the subgrade stability issues. The one pass approach of the MHB eliminates the shoving or punch through of fractured PCC pieces which damages the subgrade. It can effectively rubblize 0.75 to 1.0 lane-mile/day (1.2 to 1.7 lane-kilometers/day) (Thompson, 1997). It is interesting to note that although the MHB has a one-pass capability, the rate of rubblization per day is less than the rate of the resonance frequency breaker.

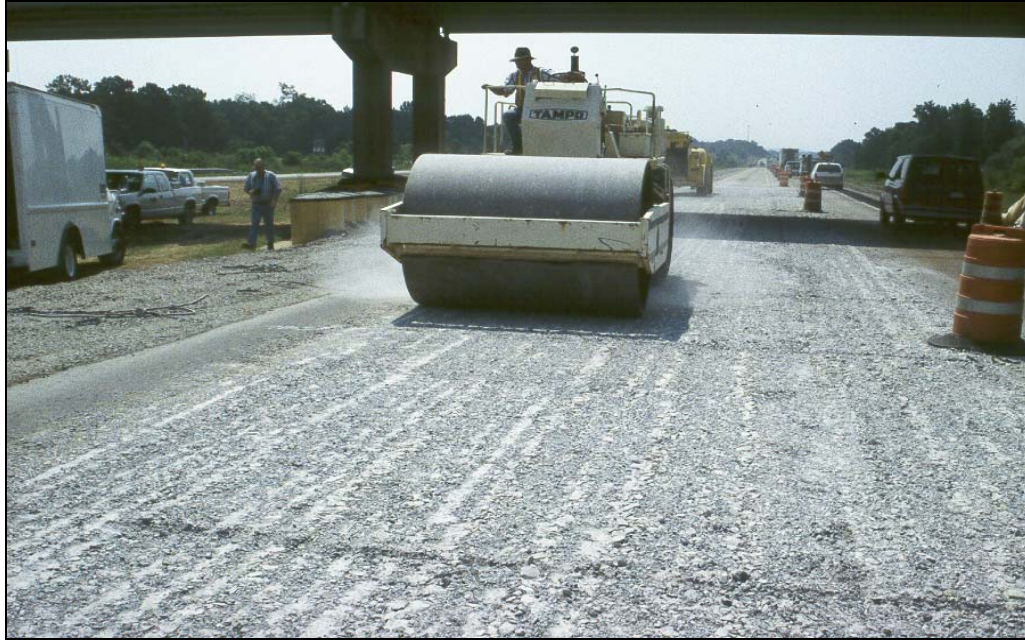
Figure 2.7 Seating the Pavement (photo by Kevin D. Hall, University of Arkansas).

Before the HMA can be placed, the proper seating of the rubblized material must be achieved. The compaction is obtained using no less than one pass of a vibratory steel wheel roller having a nominal gross weight of at least 20 tons (ALDOT, 2001). Figure 2.7 demonstrates the use of the steel roller to seat the rubblized pavement. In the next step of the compaction process, the steel wheel roller will be followed by at least one pass of a self-propelled pneumatic roller. The pneumatic roller should have a gross weight of at least 25 tons. This roller is to be followed by two additional passes of the steel wheel roller. When rubblizing reinforced concrete, the reinforcing steel is to be left in place, unless it is exposed at the surface. In the event the reinforcing steel is exposed during the rubblization or compaction process, it is to be cut below the surface and removed from the job site (ALDOT, 2001).

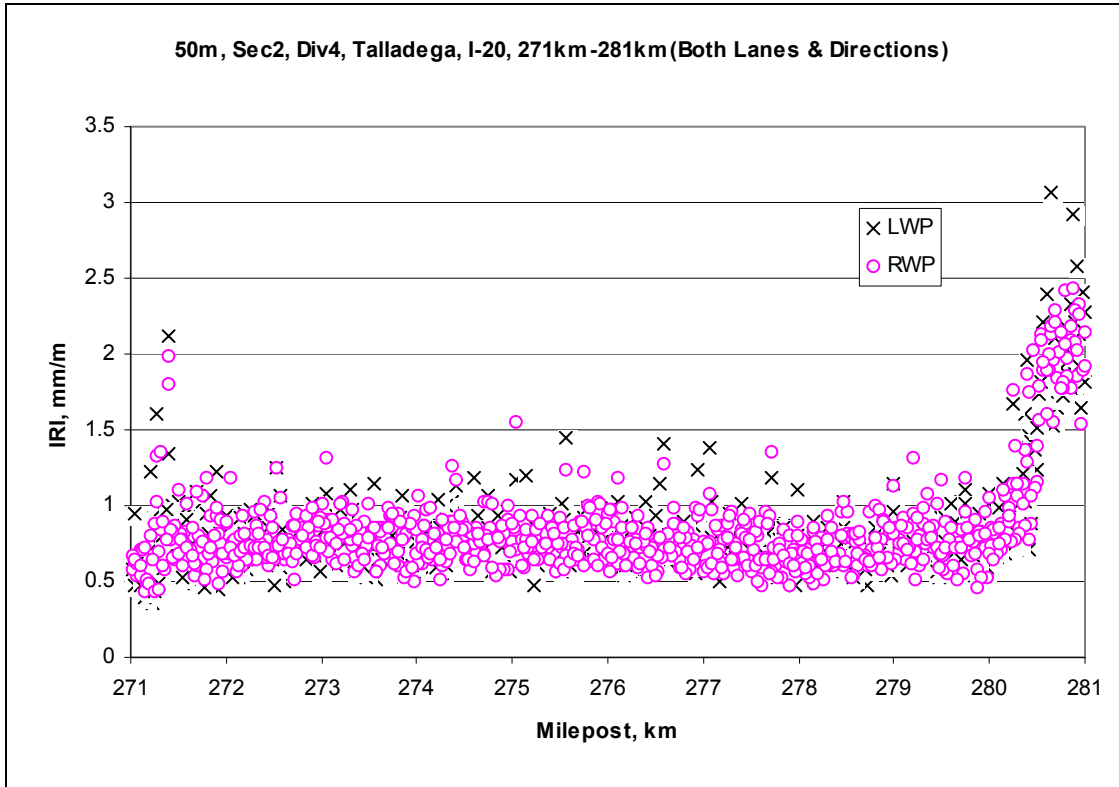
Figure 4.1 2001 IRI vs. Distance for Section 2.

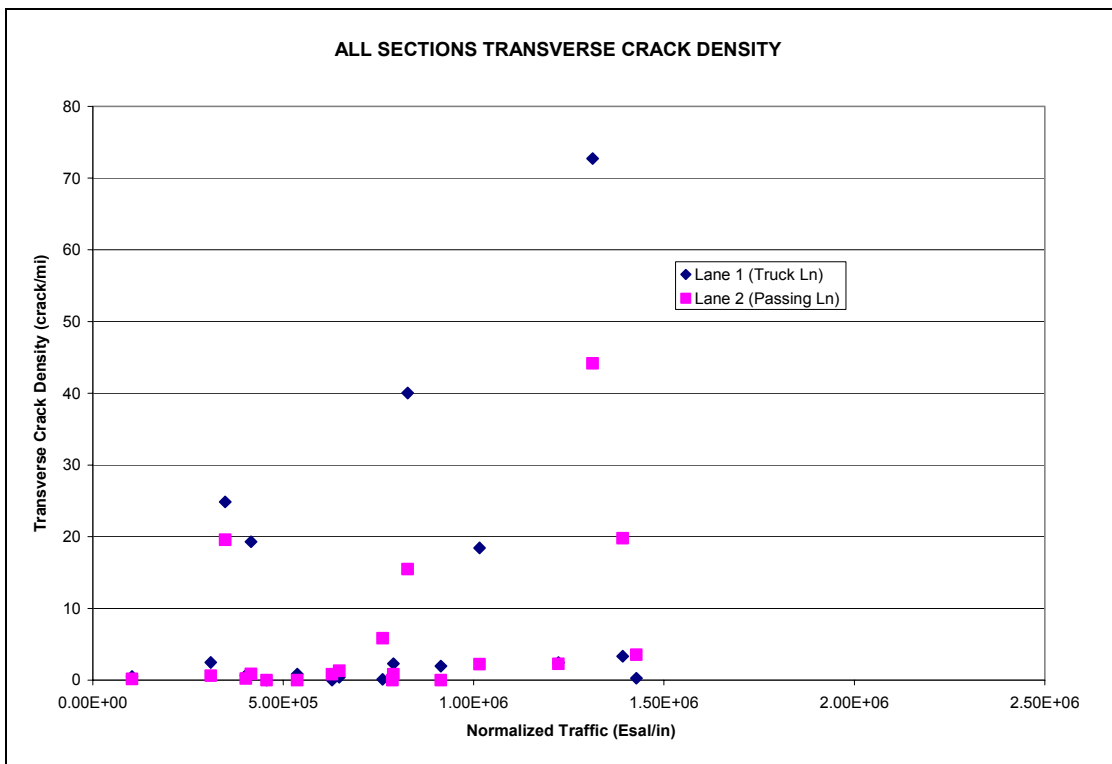
Figure 5.1 Transverse Crack Densities vs. Normalized Traffic.

The data from all of the sections were combined and analyzed with no distinction between the individual rubblized sections. The distresses were plotted for the combined data to better understand how the rubblized pavements were performing in general (See Figures 5.1 – 5.5). The first distress that was evaluated against the three standards is the transverse crack density presented in Figure 5.1.

When studying Figure 5.1, it is important to note that lane one has the highest levels of transverse crack density. This observation is logical because the heaviest vehicles tend to travel in lane one or what is commonly referred to as the truck lane. Another important observation is the magnitude of the data also seems to increase as the pavement age increases.

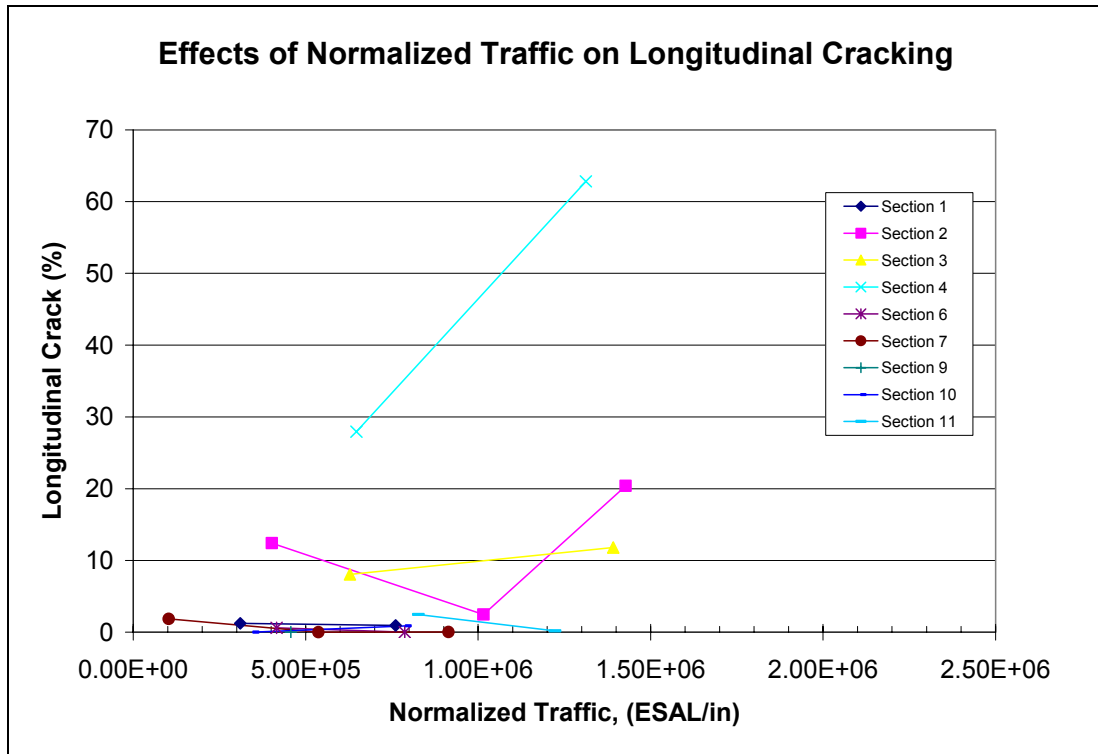
Figure 5.8 Percent Longitudinal Cracking vs. Normalized Traffic.

Next, percent longitudinal cracking and average alligator cracking were explored by pavement section in Figures 5.8 and 5.9. These two distresses will be discussed at the same time because they both have similar trends and are consistent throughout the data. Both distresses are present in low amounts throughout the Alabama rubblized pavements. As noted above, sections three and four are again among the sections that have the largest amounts of distresses present. Reviewing the distresses on section-by-section bases,

provided an important perspective into the performance of the rubblized sections. Observing that sections three and four consistently had the highest levels of distress, raises questions about the possible causes for their elevated levels.

When reviewing the construction information, sections three and four were the only sections that that were originally CRCP pavement. The fact that the reinforced pavements exhibited higher levels of distresses has been documented in the past by Witzack and Rada (1992). The elevated distress levels were credited to PCC pavement not fully debonding from the reinforcing steel in the pavement. Another unique element to sections three and four is that they both are constructed with a stabilized base. Though the issue of the PCC not debonding from the reinforcing steel and the fact that the sections have a stabilized base are not fully investigated in this research, it certainly could have been a contributing factor in the higher distress levels observed in these sections.
