**Airfield Asphalt Pavement
Technology Program Project 05-03:
Effect of Deicing Chemicals on HMA
Airfield Pavements**

REVISED FINAL REPORT

September 15, 2009

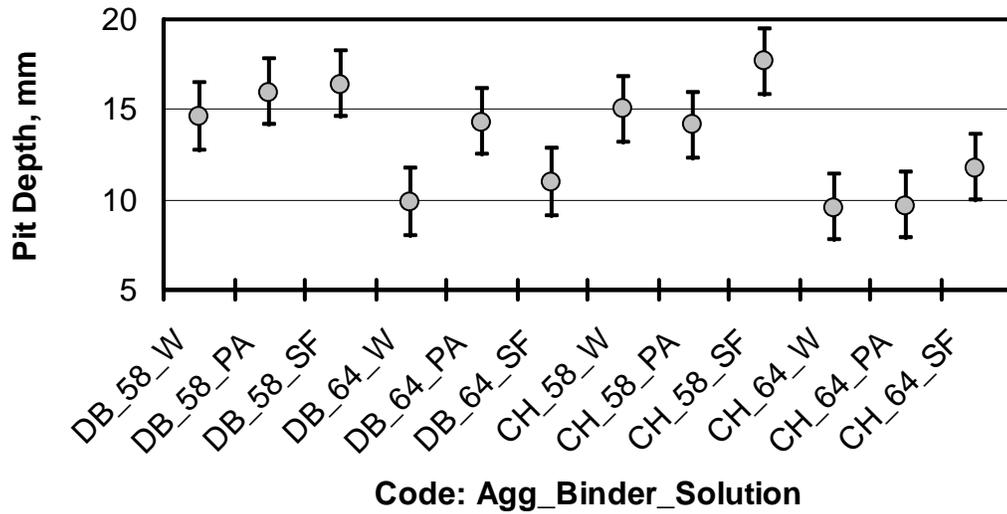
Figure 2. Results of Ultrasonic Horn Test for DIAIC-Induced Damage. Error bars represent D2S precision calculated using a pooled estimate of the standard deviation.

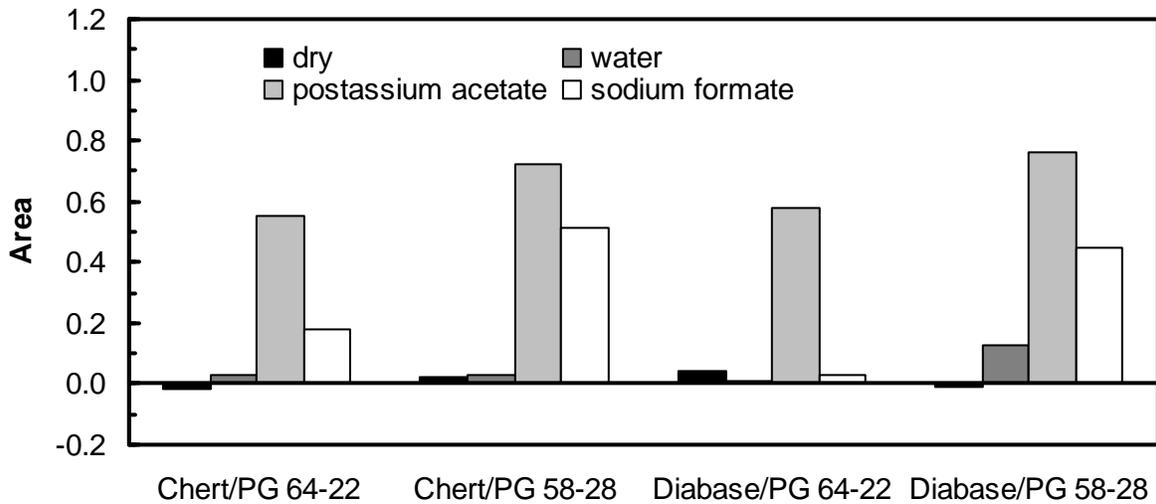
Figure 3. Results of FTIR Testing, Showing Relative Concentration of Carboxylate Salts.

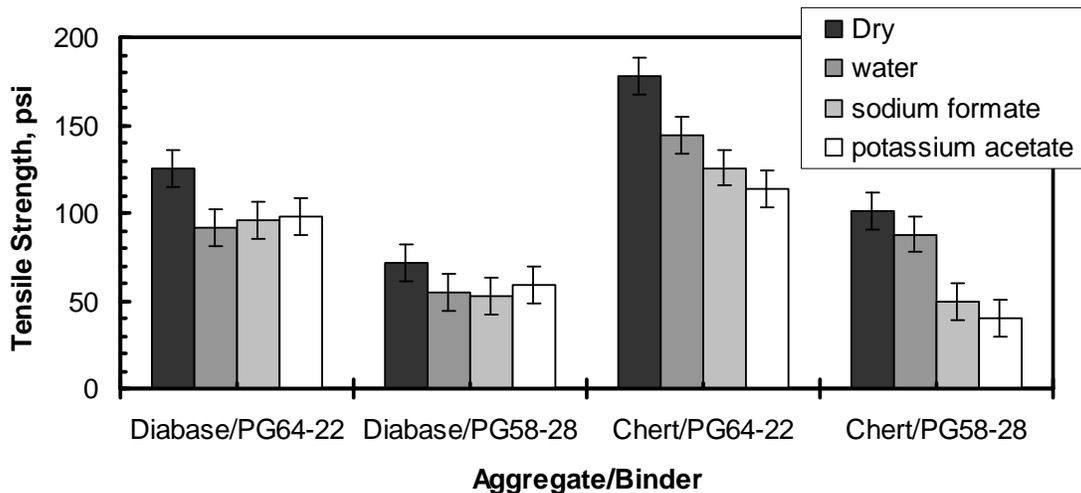
Figure 4. Results of T-283-Based Deicer-Resistance Test. *Error bars represent D2S precision calculated using a pooled estimate of standard deviation.*

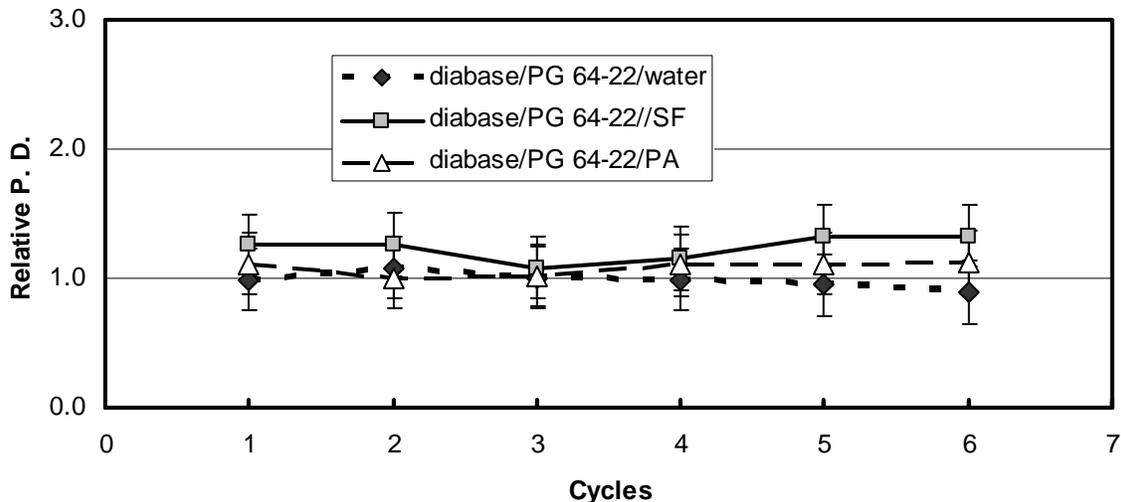
Figure 5. Permanent Deformation Measured During Long-Term Durability Test, Diabase/PG 64-22 Mixture. Error bars represent $D2S$ precision calculated using a pooled estimate of standard deviation.

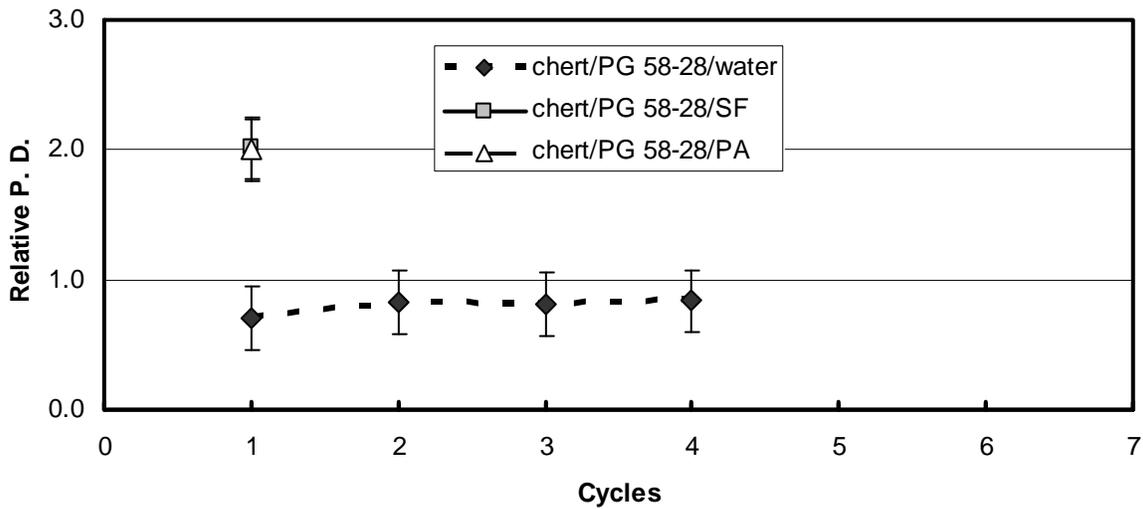
Figure 6. Permanent Deformation Measured During Long-Term Durability Test, Chert/PG 58-28 Mixture. Error bars represent *D2S* precision calculated using a pooled estimate of standard deviation.

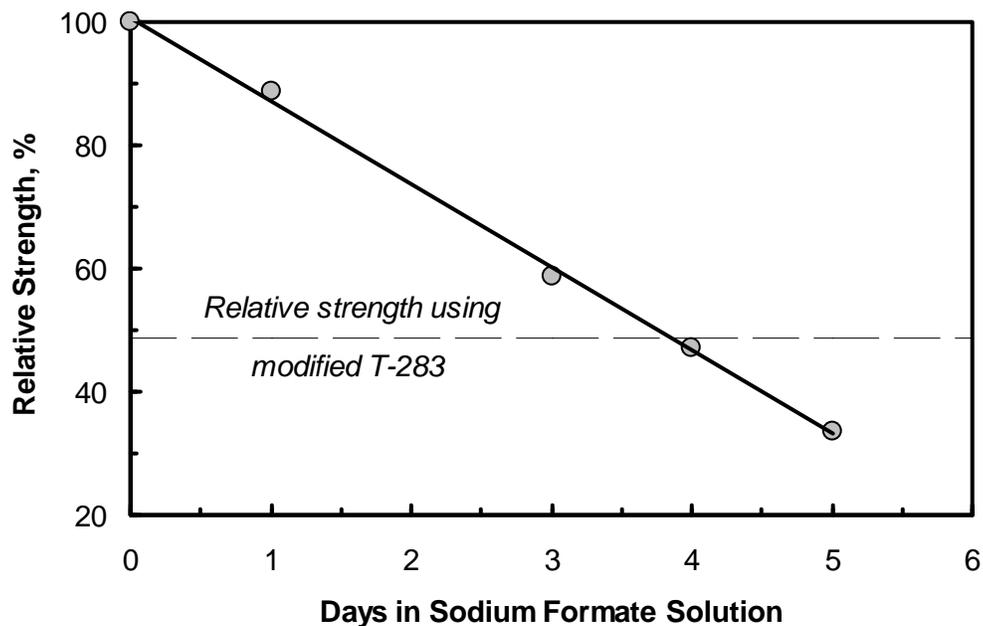
Figure 7. Relative Strength of HMA Immersed in 2 % Sodium Formate Solution (Immersion Tension Procedure).

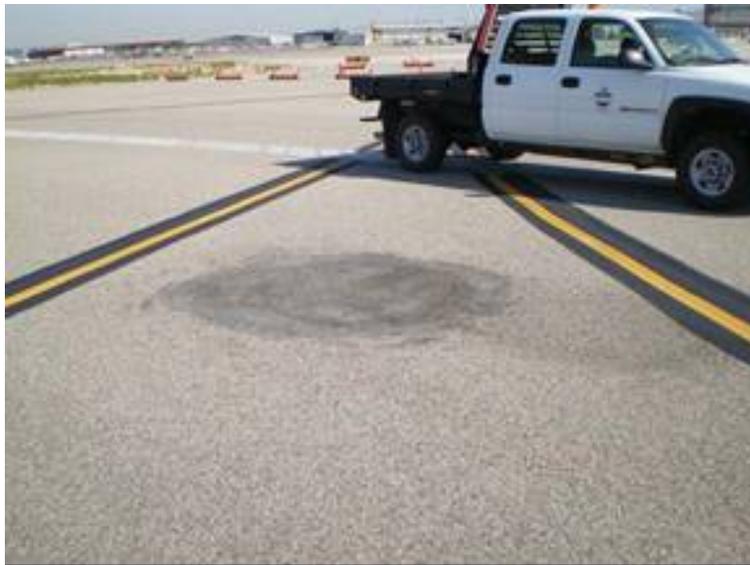
Figure 8. Boise Runway 10L/28R looking toward the intersection of Taxiway E. *This shows a patched area and an initial depression and shoving noticed in 2006. Aircraft landing on Runway 10 used this taxiway for relatively high speed exits to the terminal area. This resulted in some fairly high braking forces. No additional distress has been observed.*

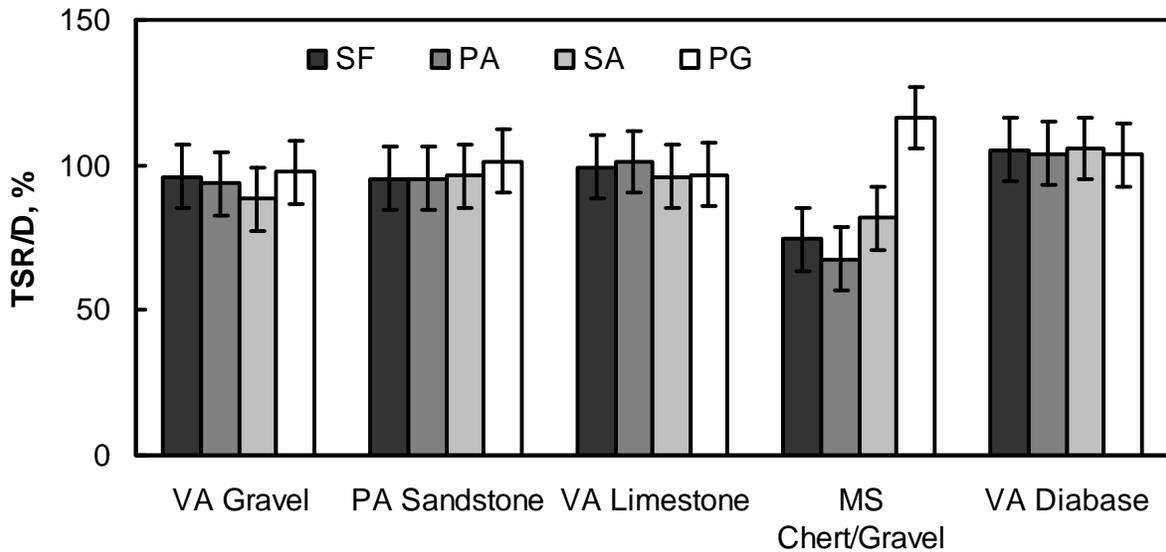
Figure 9. Results of Immersion Tension Testing on Five HMA Mixtures with PG 64-22 Binder, in Solutions of Water and Four Deicing/Anti-icing Chemicals. Error bars show $\pm 2s$ confidence intervals for TSR/D.

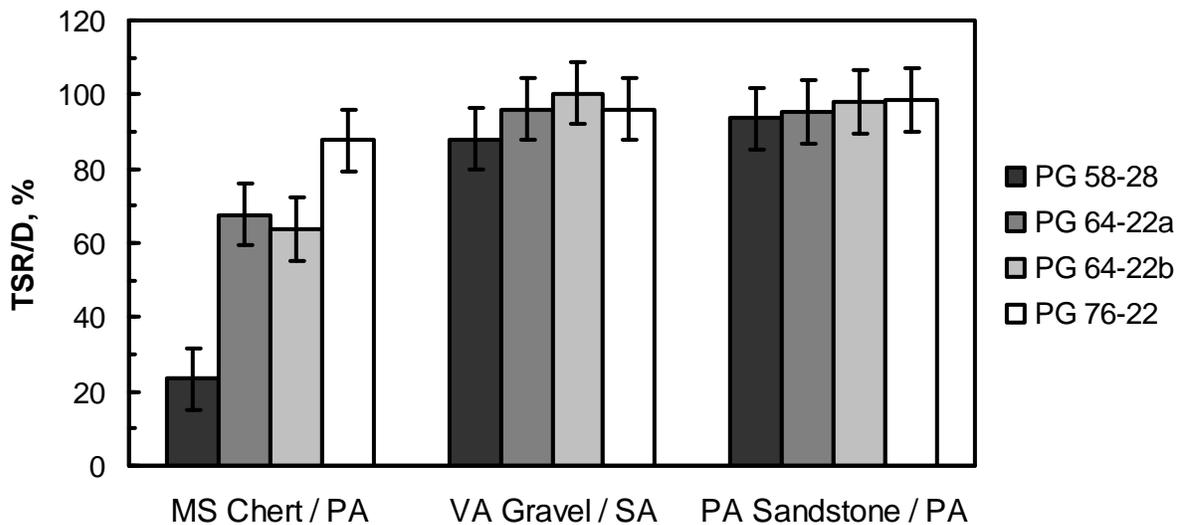
Figure 10. Results of Experiment 2 (Binders). *PA = potassium acetate; SA = sodium acetate.* Error bars show $\pm 2s$ confidence intervals for TSR/D.

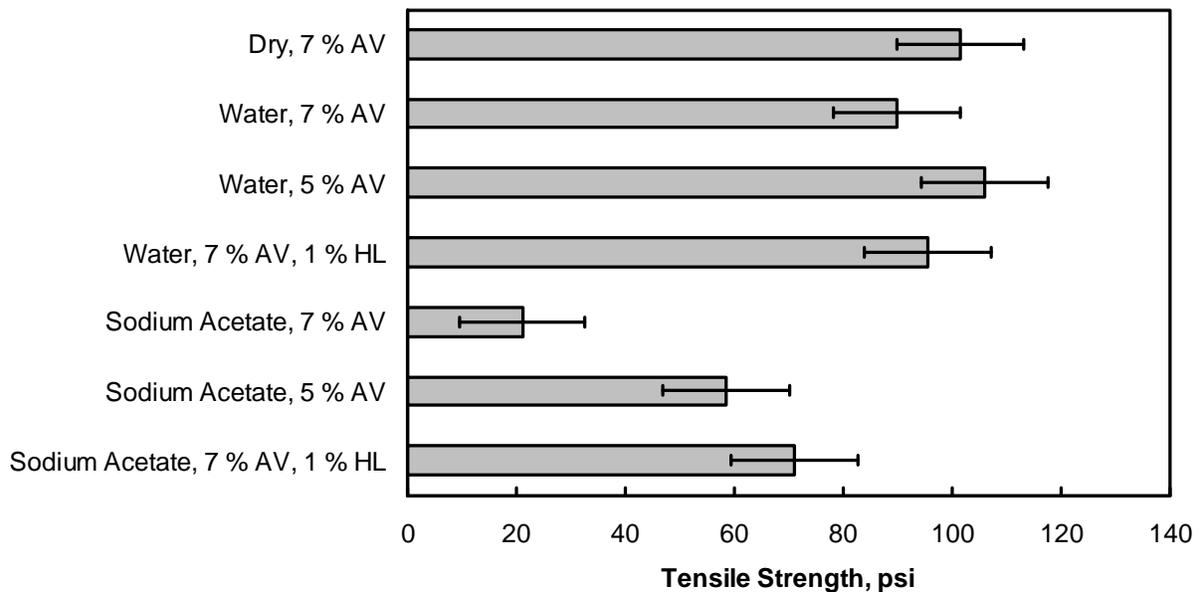
Figure 11. Indirect Tensile Strength Values for Mixture with Mississippi Chert/Gravel and PG 58-28 Binder, Subjected to Different Treatments. *Error bars show $\pm 2s$ confidence intervals for tensile strength.*

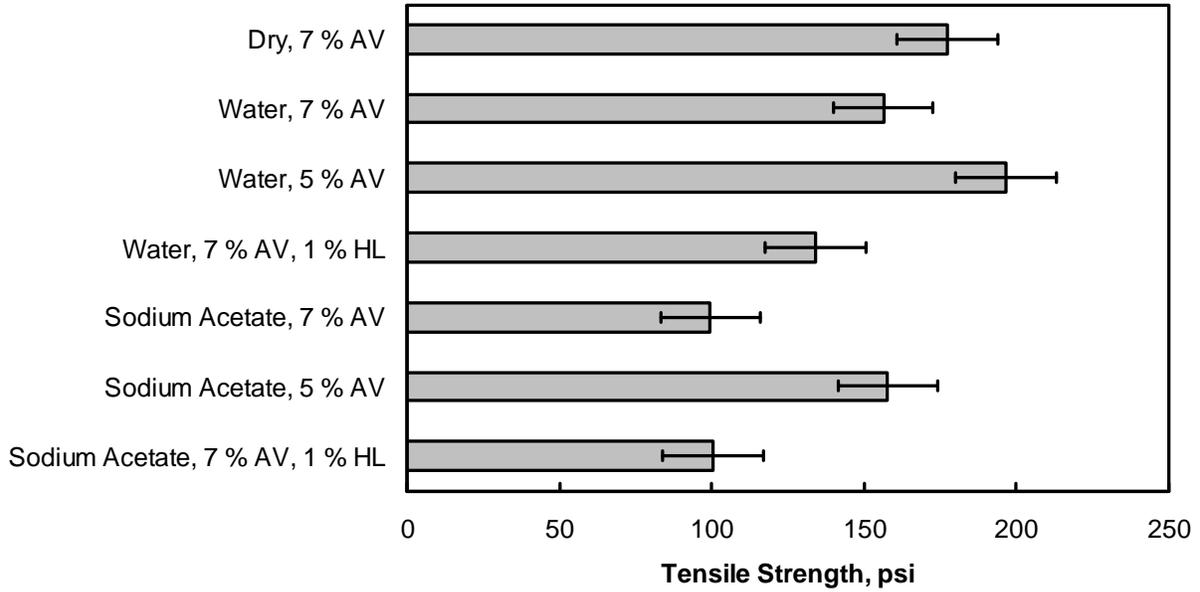
Figure 12. Indirect Tensile Strength Values for Mixtures Made with Mississippi Chert/Gravel and PG 64-22(2) Binder, Subjected to Different Treatments. *Error bars show $\pm 2s$ confidence intervals for tensile strength.*

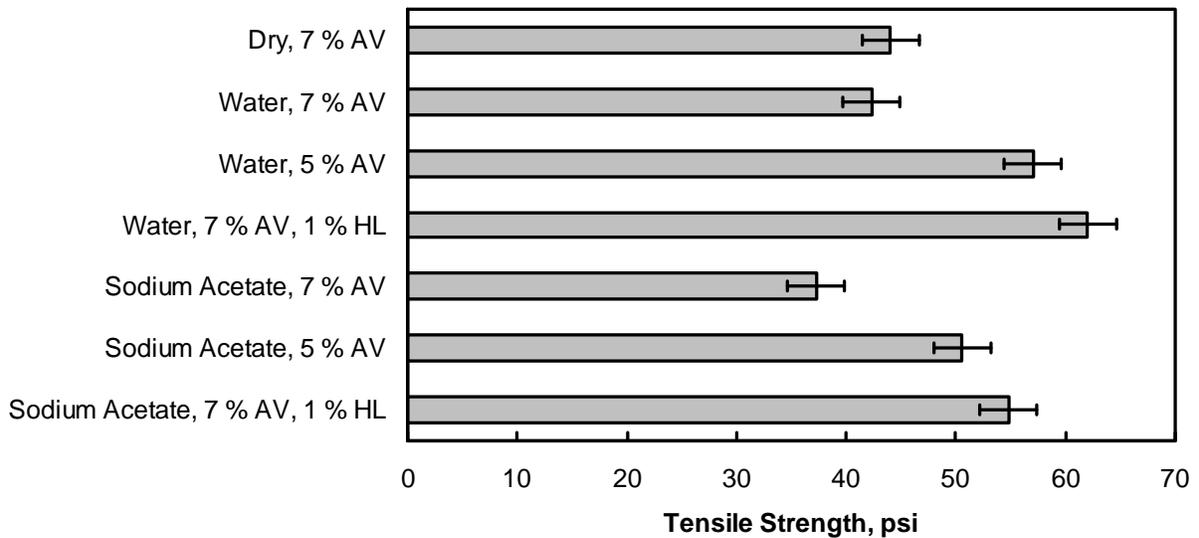
Figure 13. Indirect Tensile Strength Values for Mixture Made with Virginia Gravel and PG 58-28 Binder, Subjected to Different Treatments. *Error bars show $\pm 2s$ confidence intervals for tensile strength.*

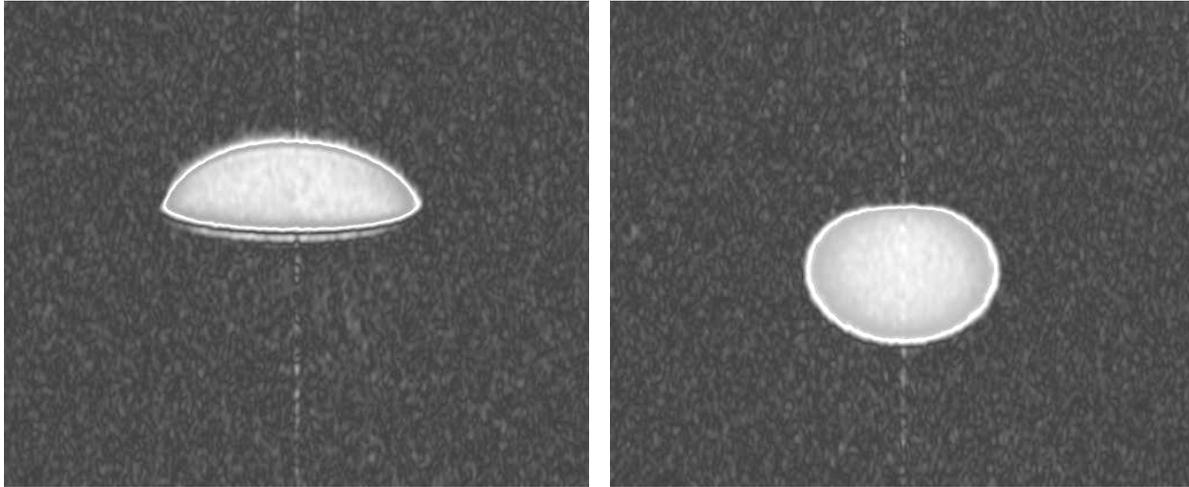
Figure 14. NMR images of the PG 58-28 binder in 35 % potassium acetate at 0h and 22h illustrating contrast enhancement.

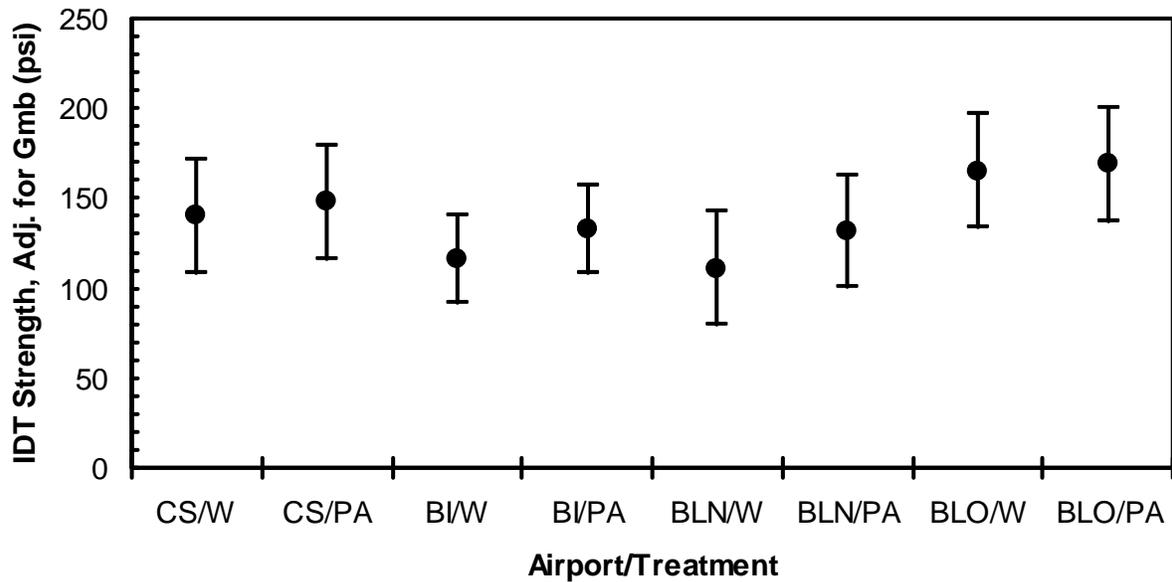
Figure 15. Results of IT Test for HMA Cores Taken at Four Airfields: Colorado Springs (CS); Boise, Idaho (BI); Boston Logan/New (BLN); and Boston Logan/Old (BLO). *W* = water, *PA* = potassium acetate solution. Error bars represent two standard-deviation confidence limits for the average strength.

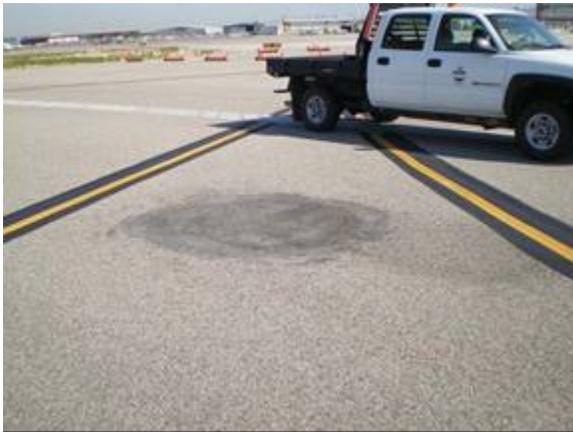
Figure B-1. Boise Runway 10L/28R looking toward the intersection of Taxiway E. *This shows a patched area and an initial depression and shoving noticed in 2006. Aircraft landing on Runway 10 used this taxiway for relatively high speed exits to the terminal area. This resulted in some fairly high braking forces. No additional distress has been observed.*

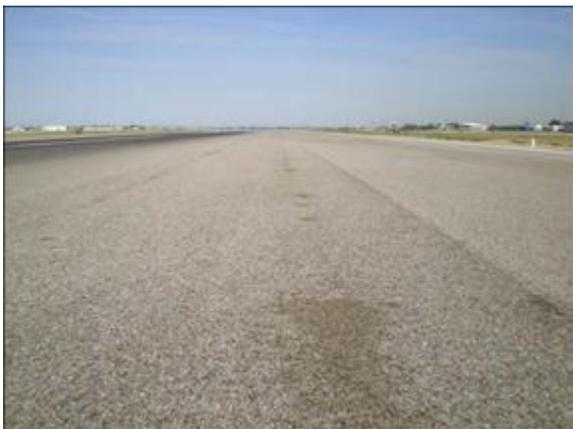
Figure B-2. Boise Runway 10L/28R looking east. *The stained area is offset from the paving joint in the permeable friction course. Airport staff indicate that the staining may be pumping from a joint in the underlying base asphalt concrete.*

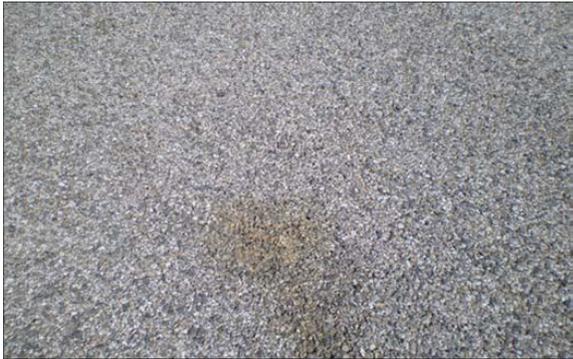
Figure B-3. Close-up of the staining on the surface of the pavement at Boise, Idaho Airport.

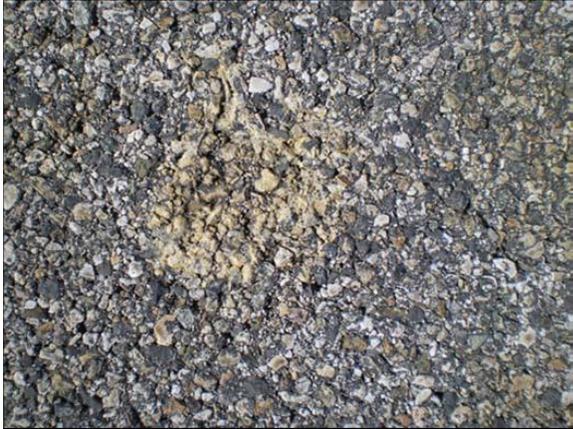
Figure B-4. Close-up of the staining on the surface of the pavement at Boise, Idaho Airport.

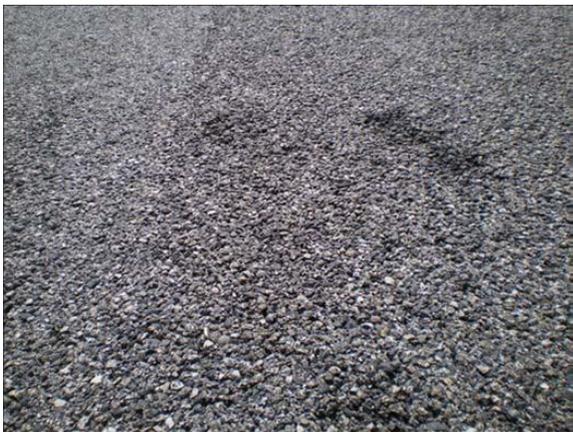
Figure B-5. Boise Runway 10L/28R near Taxiway B. *Area to the right has older permeable surface course showing some signs of raveling. Pavement in the left of the photograph was paved in 2000.*

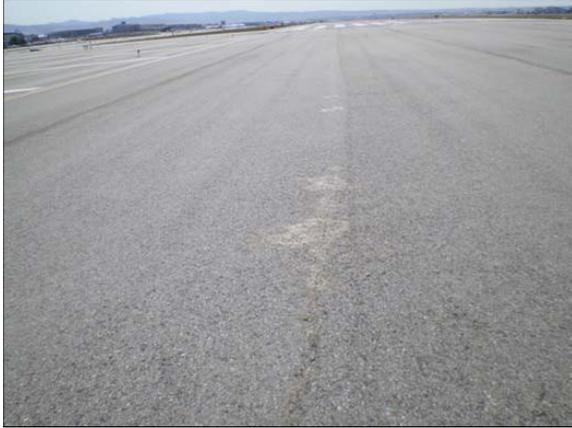
Figure B-6. Boise Runway 10L/28R north of Taxiway M. *Note the staining along the longitudinal joint and low severity cracking in the foreground.*

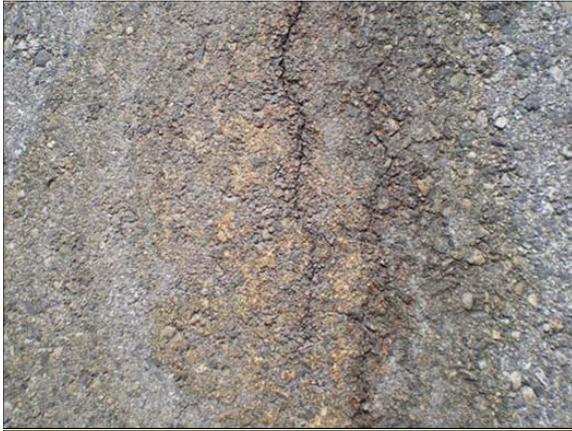
Figure B-7. Runout area north of Boise Runway 28R near the south edge of the pavement. *Severe staining, cracking and some raveling of the asphalt concrete. The surface in this area is P-401 asphalt concrete.*

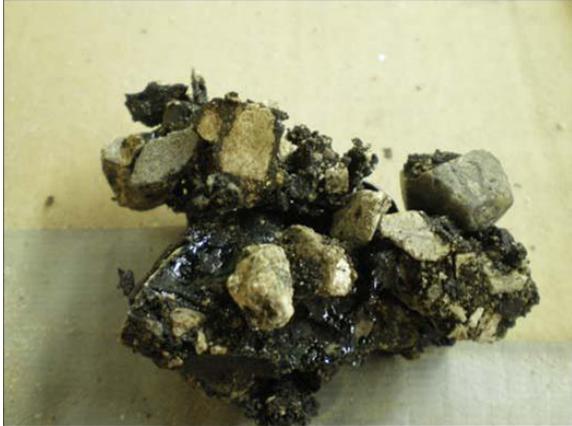
Figure B-8. Close-up of an asphalt sample taken from a core of the runway at Boise Airport. *Note the complete stripping of the asphalt cement from the aggregate.*

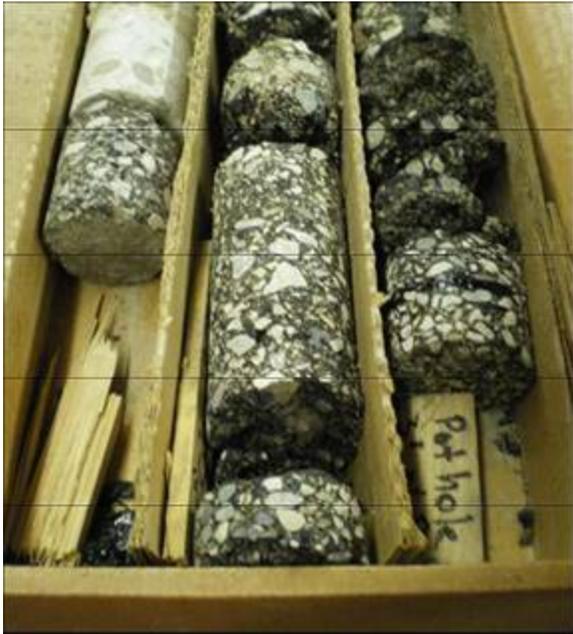
Figure B-9. Typical core taken from Boise Runway 10L/28R. *The permeable surface course is on the right side of the photograph and is intact. Directly below the surface the asphalt concrete is stripped and deteriorated. The asphalt in the center of the box is the old surface below the asphalt concrete placed in 2000.*

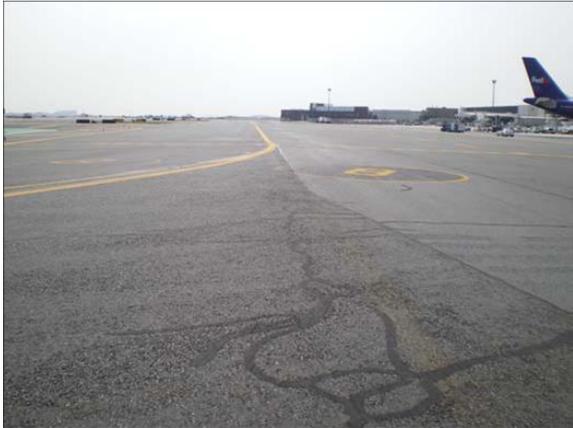
Figure B-10. US Airways Cargo area apron and south outer Taxiway K, Boston Logan Airport. Milled and overlaid with P-401 asphalt concrete in 2000. Note the coarse appears and cracking of the asphalt concrete.

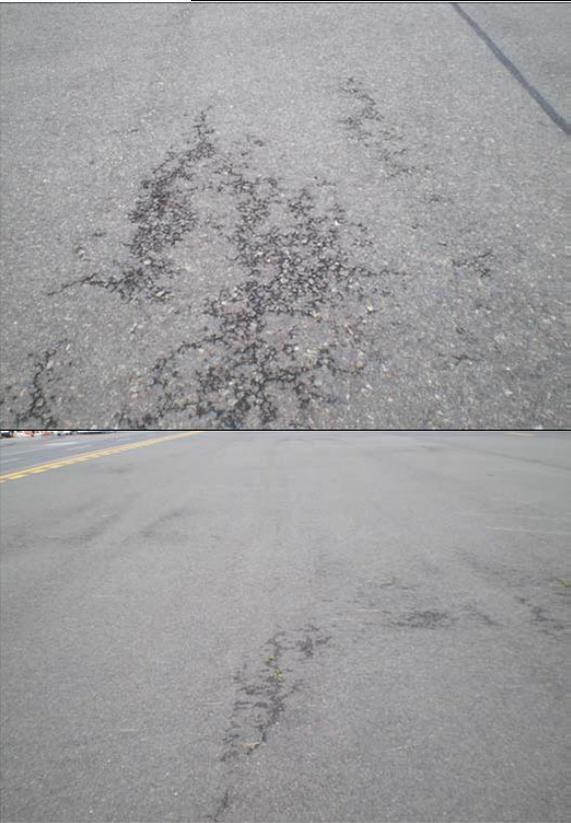
Figure B-11. US Airways Cargo area apron and south outer Taxiway K, Boston Logan Airport. Milled and overlaid with P-401 asphalt concrete in 2000. Note the cracked, segregated and raveled surface.

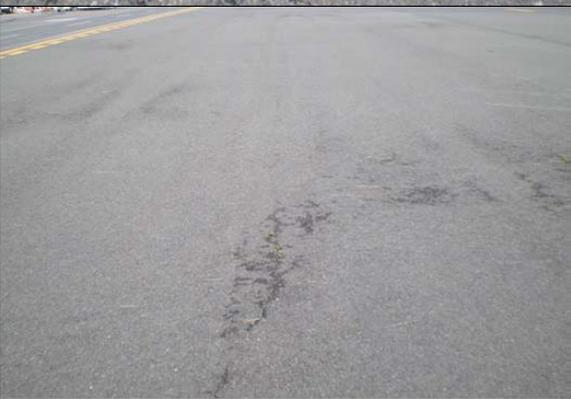
Figure B-12. FedEx Cargo area apron and south outer Taxiway K, Boston Logan Airport. Milled and overlaid with P-401 asphalt concrete in 2000. Asphalt concrete shows low severity cracking and raveling.

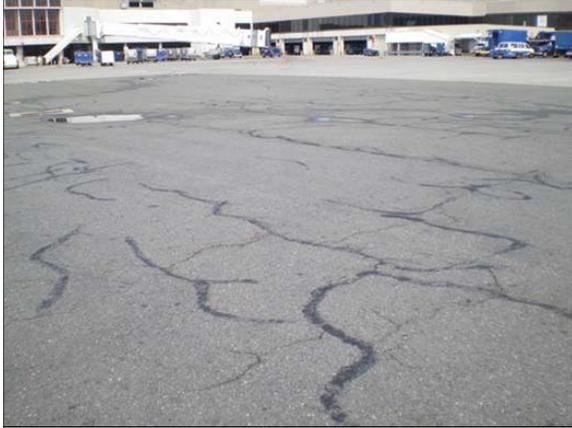
Figure B-13. Apron area in front of Boston Logan B Concourse near Gate B-28. *This pavement was rehabilitated in 1981 consisting of a mill and overlay of 4 inches of P-401 asphalt concrete. Some of the cracking has been sealed but there are also many unsealed cracks. Aircraft anti-icing chemicals run onto this area of asphalt from the adjacent concrete apron pavement.*

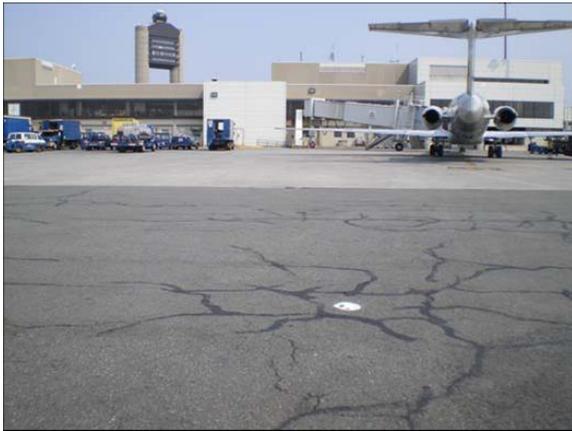
Figure B-14. Apron area in front of Boston Logan B Concourse near Gate B-28. *Random pavement surface cracking. Photograph taken in a low area of the pavement. Deicing fluid from the gate deicing operation flows onto the asphalt concrete at this location. White dot indicates core location.*

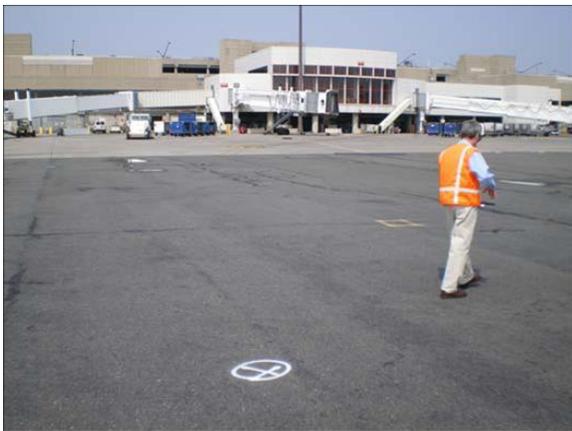
Figure B-15. Apron area in front of Boston Logan B Concourse near Gate B-28. *Photograph taken in a high area of the pavement. Deicing fluid from the gate dicing operation likely flows onto this area but not as much as the location shown in Photograph 2. White dot indicates core location.*

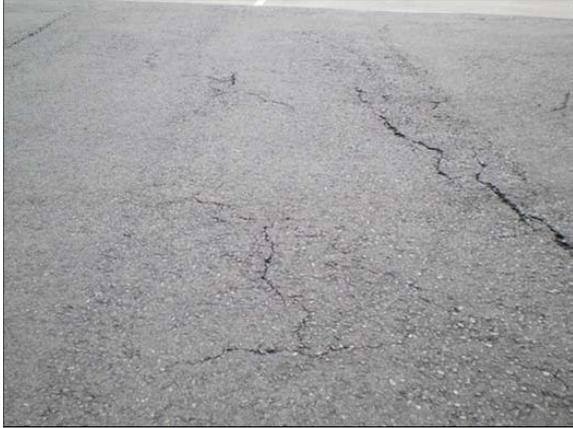
Figure B-16. Inner Taxiway area in front of Boston Logan B Concourse near Air Canada Gate 3. *This area was milled and overlaid with 3 inches of P-401 asphalt concrete in 2000. Note the significant cracking, raveling and exposed aggregate.*

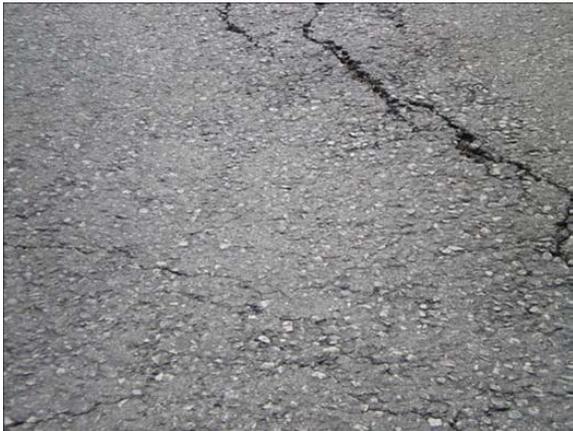
Figure B-17. Inner Taxiway area in front of Boston Logan B Concourse near Air Canada Gate 3. *Close-up of location shown in Figure B-16.*

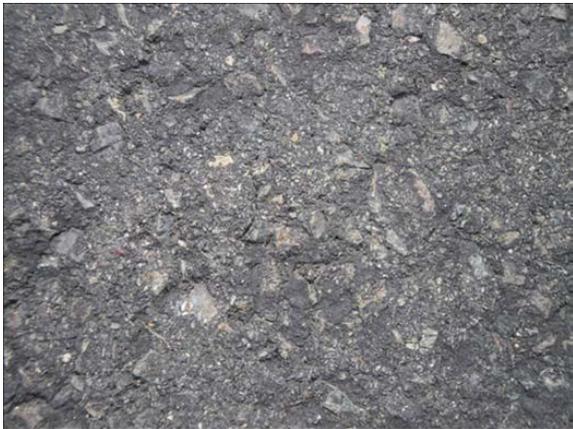
Figure B-18. Inner Taxiway area in front of Boston Logan B Concourse near Air Canada Gate 3. *Further close-up of location shown in B-16.*

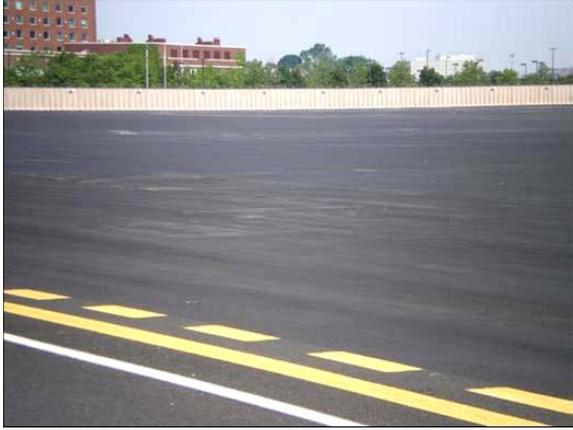
Figure B-19. Taxiway J and asphalt overrun at the end of Runway 14, Boston Logan Airport. *Asphalt concrete pavement constructed in 2006. No evidence of any raveling or stripping.*

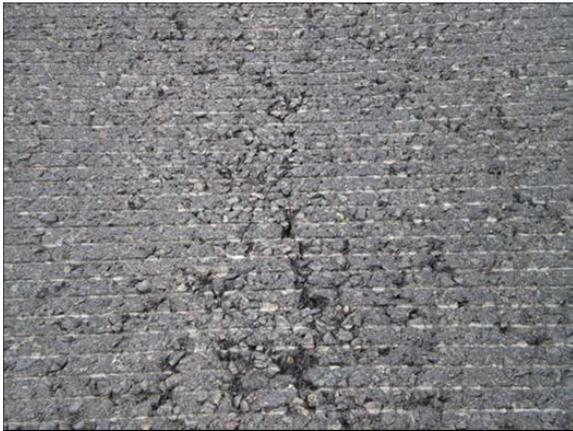
Figure B-20. Boston Logan Runway 06/27 near Taxiway C. *Moderate severity raveling of the transverse grooved asphalt concrete surface.*

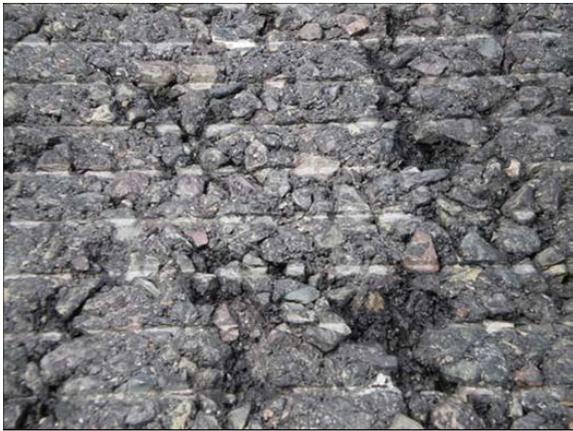
Figure B-21. Boston Logan Runway 06/27 near Taxiway C. *Close-up of location shown in Photograph B-20. Note the missing fine aggregate particles and stripping of the asphalt cement from the coarse aggregates.*

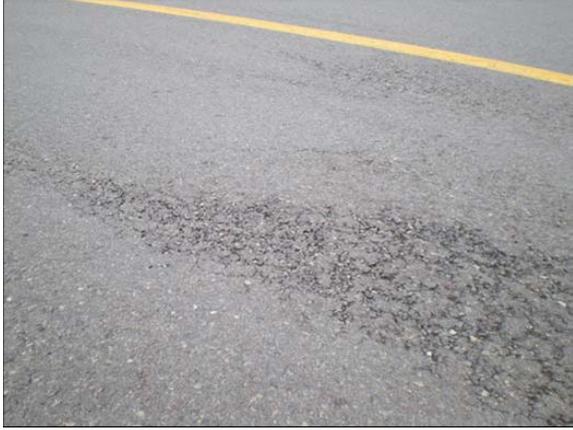
Figure B-22. Boston Logan Taxiway K near Taxiway L. Mill and overlay of 2.5 inches of P-401 asphalt concrete in 2001. This asphalt concrete includes the Bitumar AC-20 and liquid antistripping additive. Note the raveling and stripping of the asphalt cement from the coarse aggregate.

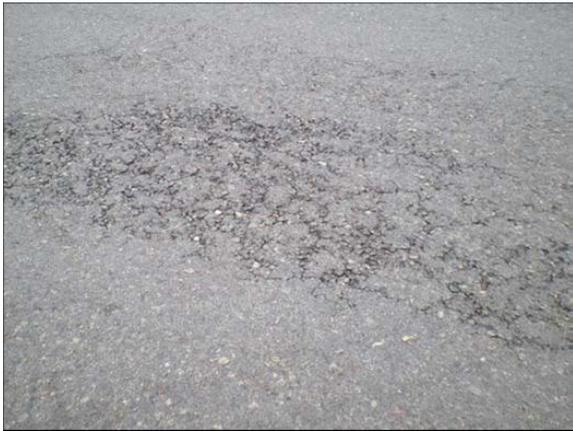
Figure B-23. Boston Logan Taxiway K near Taxiway L. Closeup of area shown in Photograph B-22.

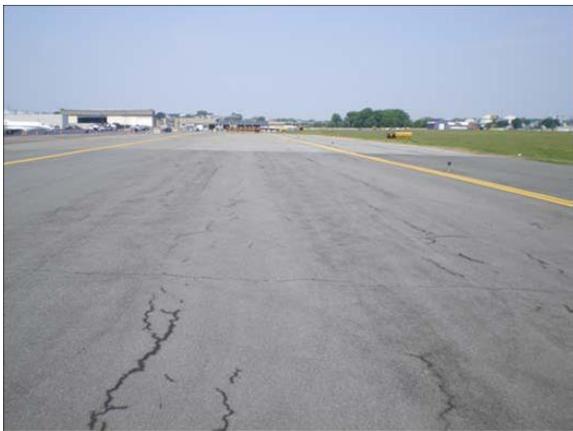
Figure B-24. Boston Logan Taxiway K between Taxiway N and Taxiway Z. Microsurfacing was placed over the raveled and stripped asphalt concrete.

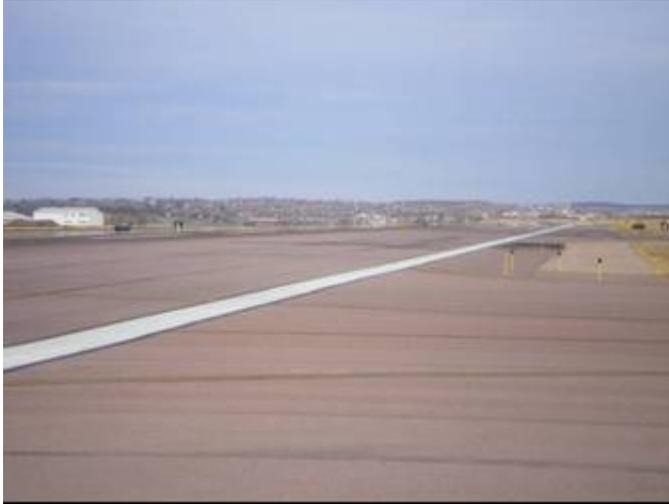
Figure B-26. Colorado Springs Runway 17L/35R looking north from Taxiway Hotel.

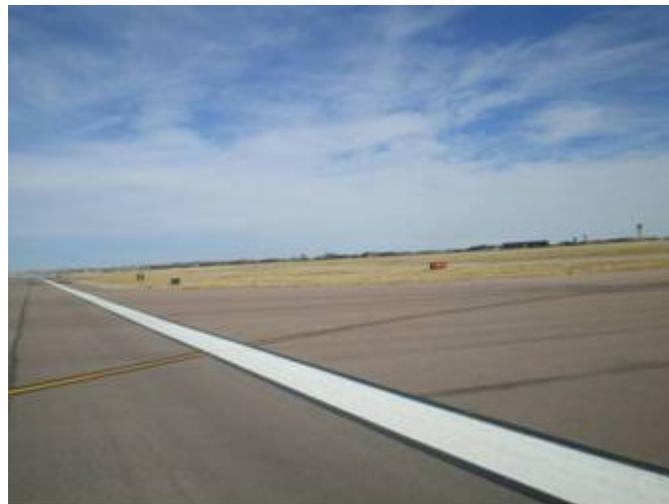
Figure B-27. Colorado Springs Runway 17L/35R looking east at intersection with Taxiway Hotel. *The pavement is new and the only distresses present at this location are low severity longitudinal construction joint cracks.*

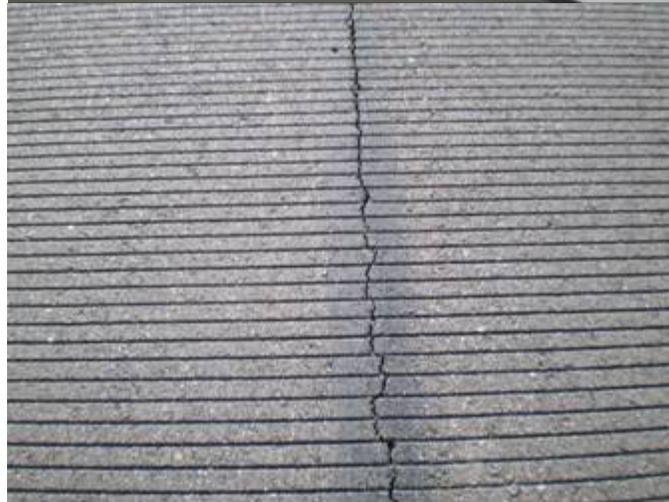
Figure B-28. Close-up of low severity longitudinal construction joint crack on Colorado Springs Runway 17L/35R.

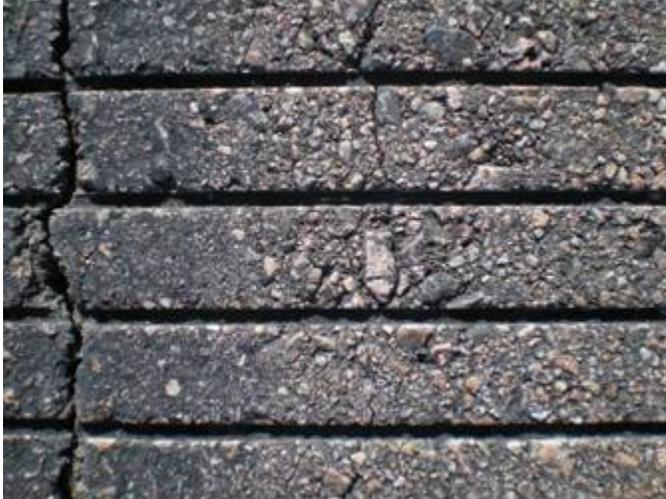
Figure B-29. Close-up of slight segregation and secondary cracking near the low severity longitudinal construction joint crack on Runway 17L/35R, Colorado Springs Airport.

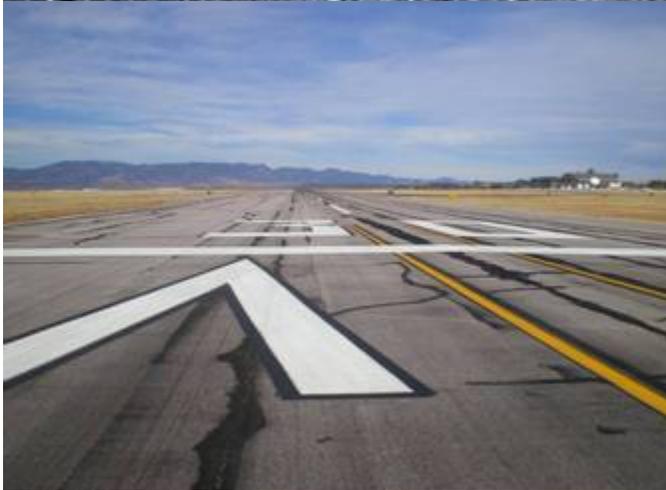
Figure B-30. Colorado Springs Runway 12/30 Looking north from the Runway 30 End. Most cracks including the primary longitudinal construction joint cracking has been sealed with hot-poured rubberized asphalt using an over-banding technique.

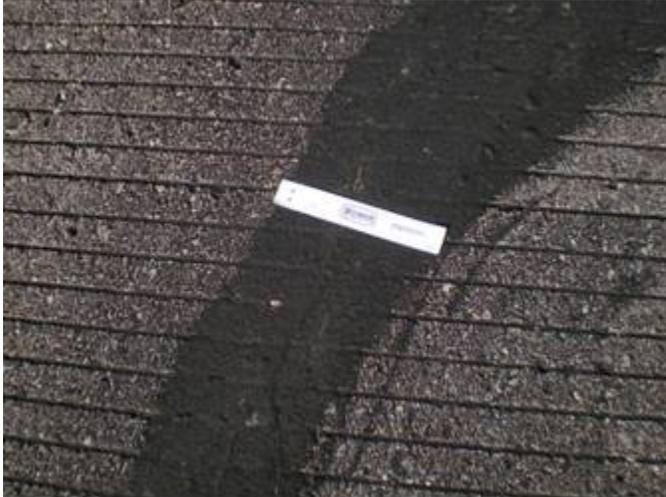
Figure B-31. Large over-band of crack on Colorado Springs Runway 12/30.

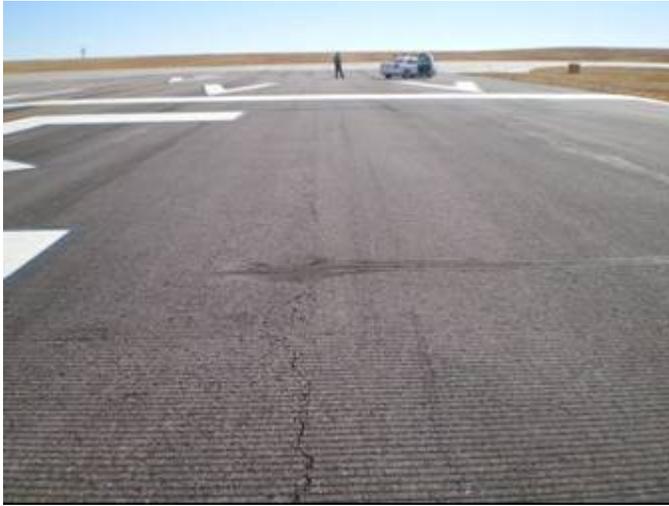
Figure B-32. Mid-mat longitudinal cracking and moderate severity transverse crack near the south end of Runway 30, Colorado Springs Airport.

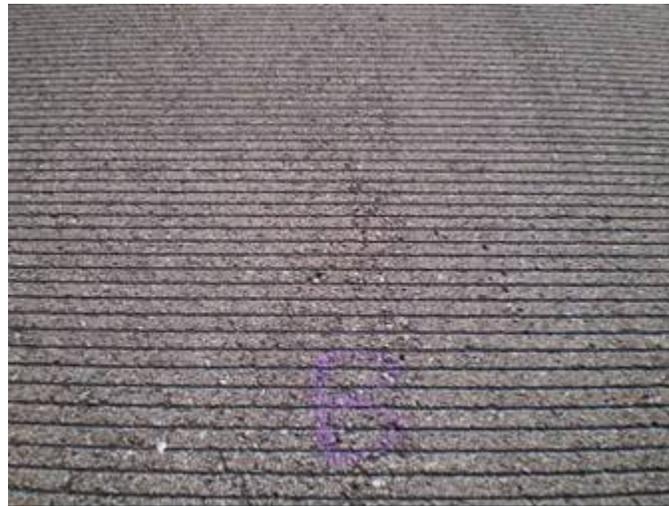
Figure B-33. Close-up of raveling and cracking about 10 feet west of the Runway 30 centerline, Colorado Springs Airport. *Location selected for coring.*

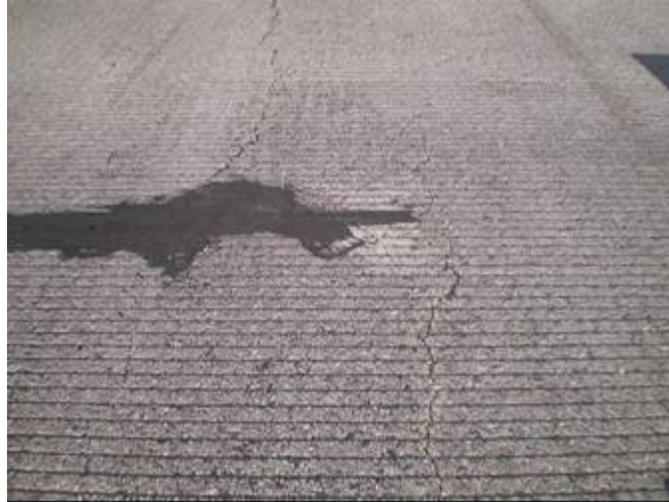
Figure B-34. Cracking, raveling and patching on Runway 30 near Taxiway Foxtrot, Colorado Springs Airport.

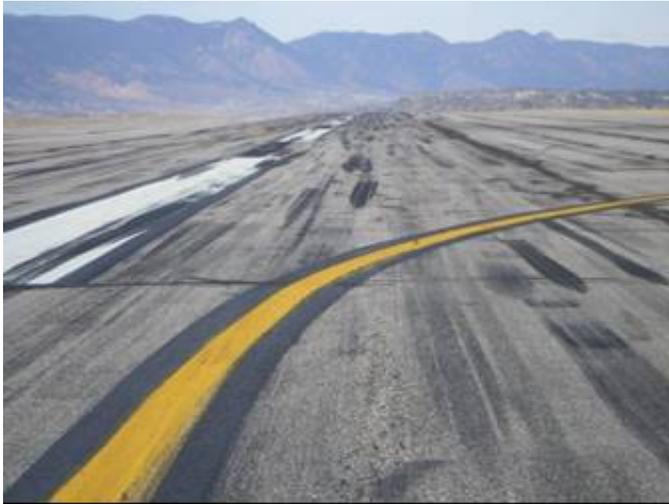
Figure B-35. Runway 12/30 looking north at Taxiway MIL, Colorado Springs Airport.

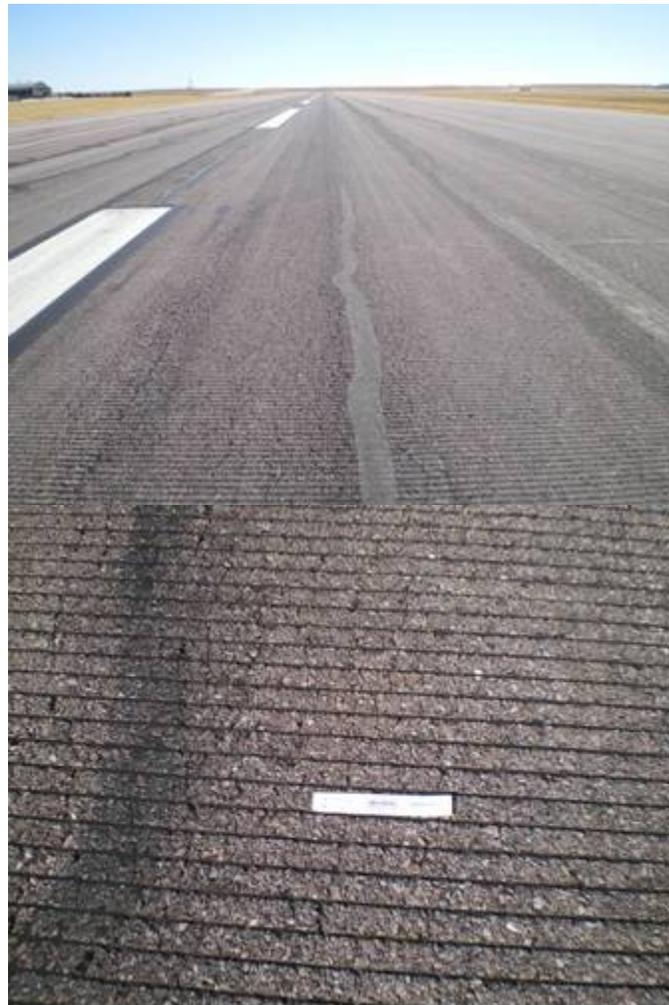
Figure B-36. Runway 12/30 looking south at Taxiway MIL, Colorado Springs Airport. *Note the over-band crack sealing approximately 10 feet west of the runway centerline in the primary wheel path area. Low severity fatigue type cracking on either side of the sealed crack.*

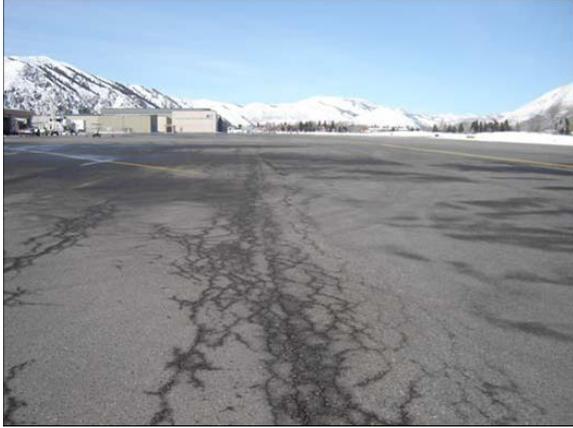
Figure B-38. Apron pavement looking north, Friedman Memorial Airport. Alligator cracking at a longitudinal construction joint.

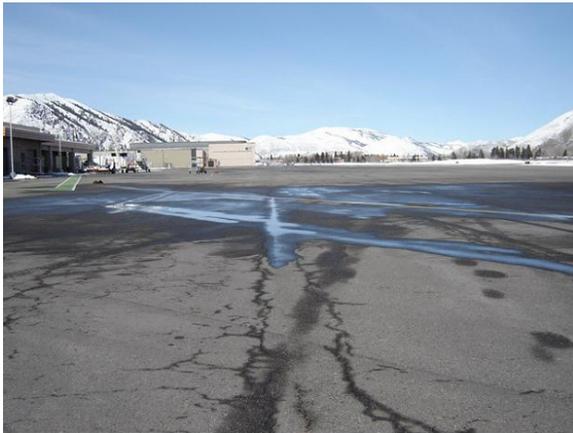
Figure B-39. Apron pavement looking north, Friedman Memorial Airport. Alligator cracking and rutting (transverse to the photograph) on the apron in front of the terminal building.

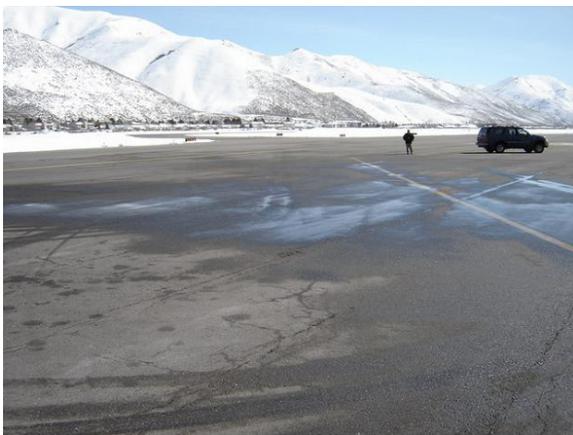
Figure B-40. Apron pavement looking east, Friedman Memorial Airport. Rutting and depressions in the apron pavement in front of the terminal building.

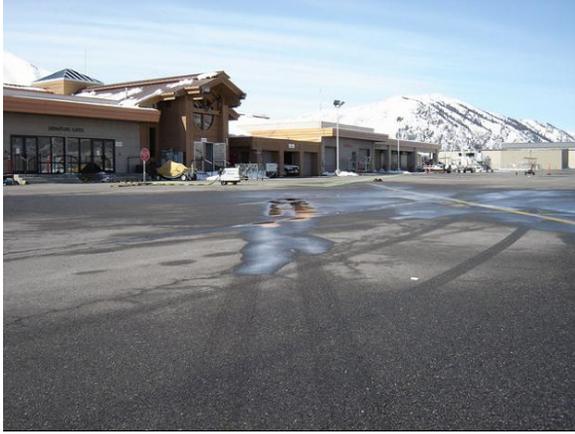
Figure B-41. Apron pavement looking west towards the terminal building, Friedman Memorial Airport. Rutting due to aircraft gear loading in front of the terminal building.

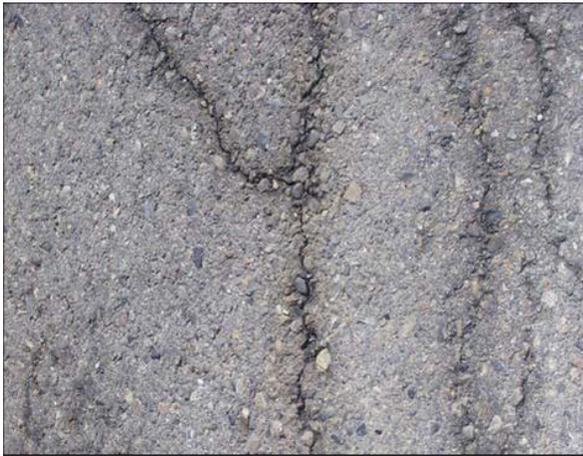
Figure B-42. Close-up of cracking and raveling of the pavement surface.

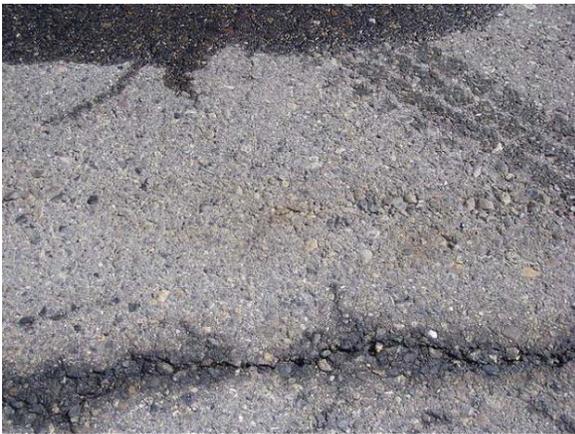
Figure B-43. Close-up of cracking and raveling of the asphalt concrete at the cracks.
