**Airfield Asphalt Pavement
Technology Program Project 05-03:
Effect of Deicing Chemicals on HMA
Airfield Pavements**

REVISED FINAL REPORT

September 15, 2009

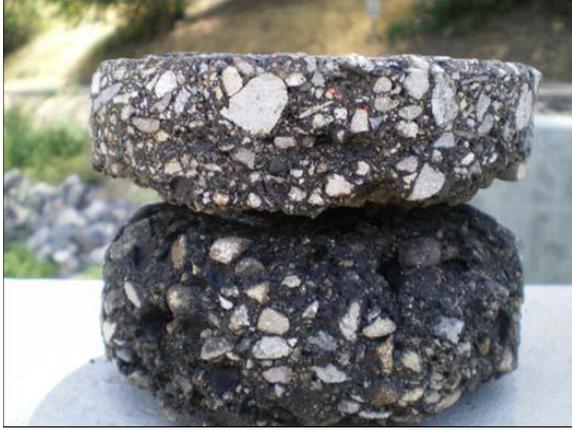
Figure B-44. Core #1 from Friedman Memorial Airport. *Note deterioration of the asphalt concrete between the surface and binder course lifts.*

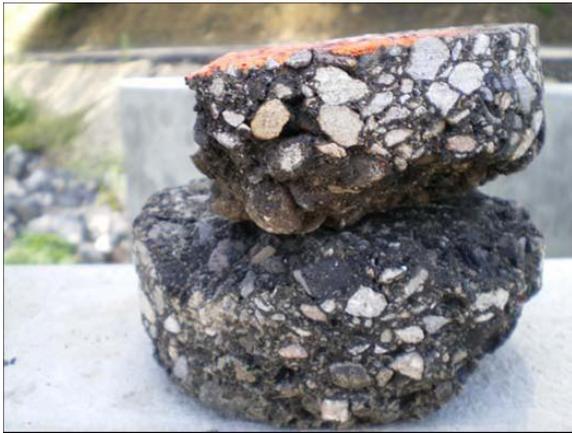
Figure B-45. Core #2 from Friedman Memorial Airport. *Note deterioration of the asphalt concrete between the surface and binder course lifts. Note the stripping of the asphalt cement from the aggregate at the surface of the binder course lift.*

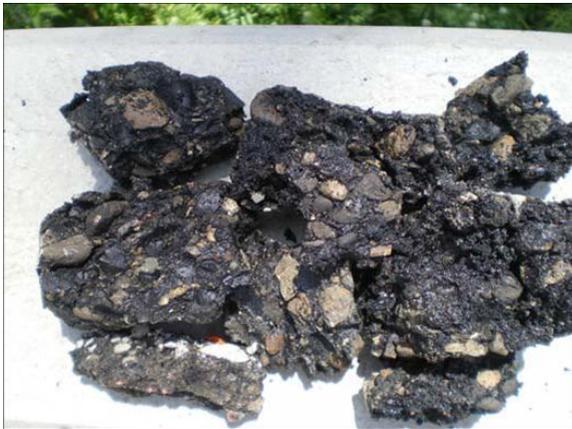
Figure B-46. Core #3 from Friedman Memorial Airport. *The core was not able to be extracted in a solid piece. Note the stripping of the asphalt cement from the aggregate.*

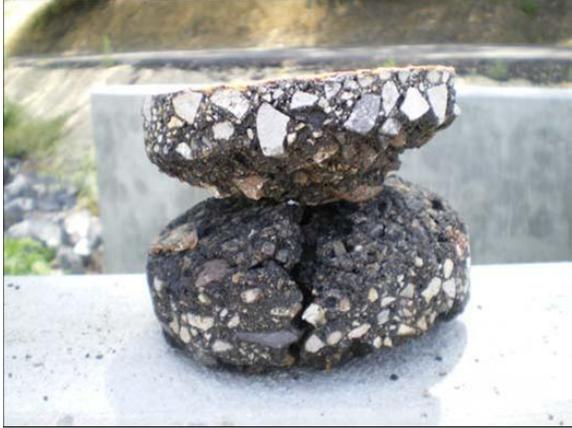
Figure B-47. Core #4 from Friedman Memorial Airport. *Surface and binder course has lost some of the aggregate.*

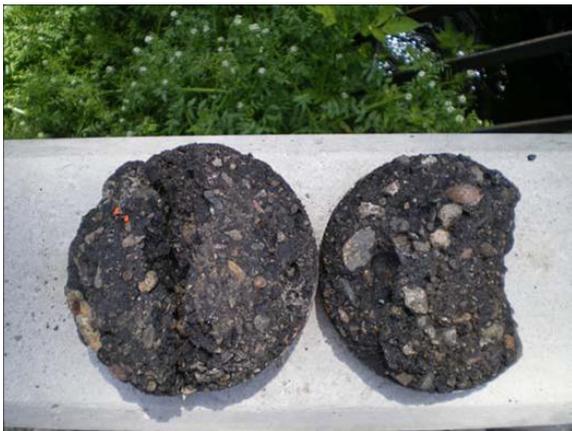
Figure B-48. Core #4 from Friedman Memorial Airport. *Close-up of the bottom of the surface course life (left side of photograph) and top of the binder course life (right side of the photograph). Note the stripping of the asphalt cement from the coarse aggregate.*

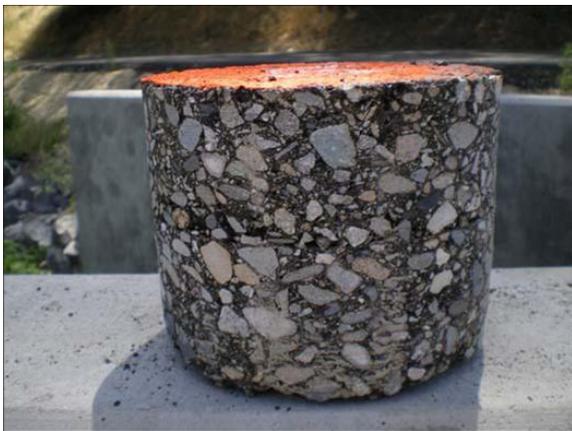
Figure B-49. Core #5 from Friedman Memorial Airport. *Intact surface and binder course. Some deterioration between the lifts is evident on the left side of the photograph.*

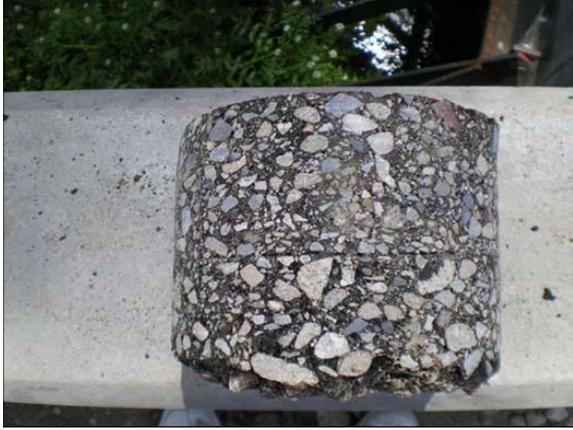
Figure B-50. Core #6 from Friedman Memorial Airport. *Surface and binder course intact. Some open structure is evident at the bottom of the core but may be due to poor compaction of the lower lift.*

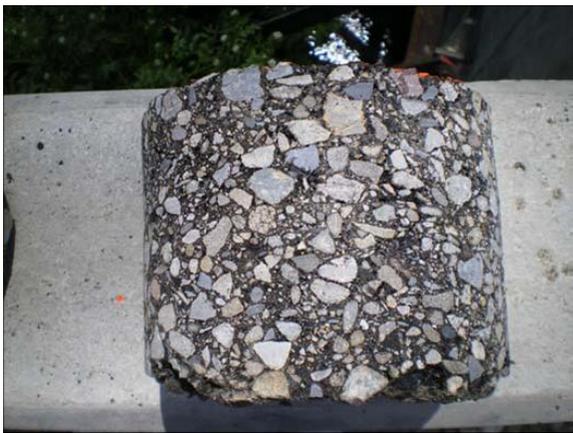
Figure B-51. Core #7 from Friedman Memorial Airport. *Surface and binder course intact. Both the surface and binder course have fairly large aggregate.*

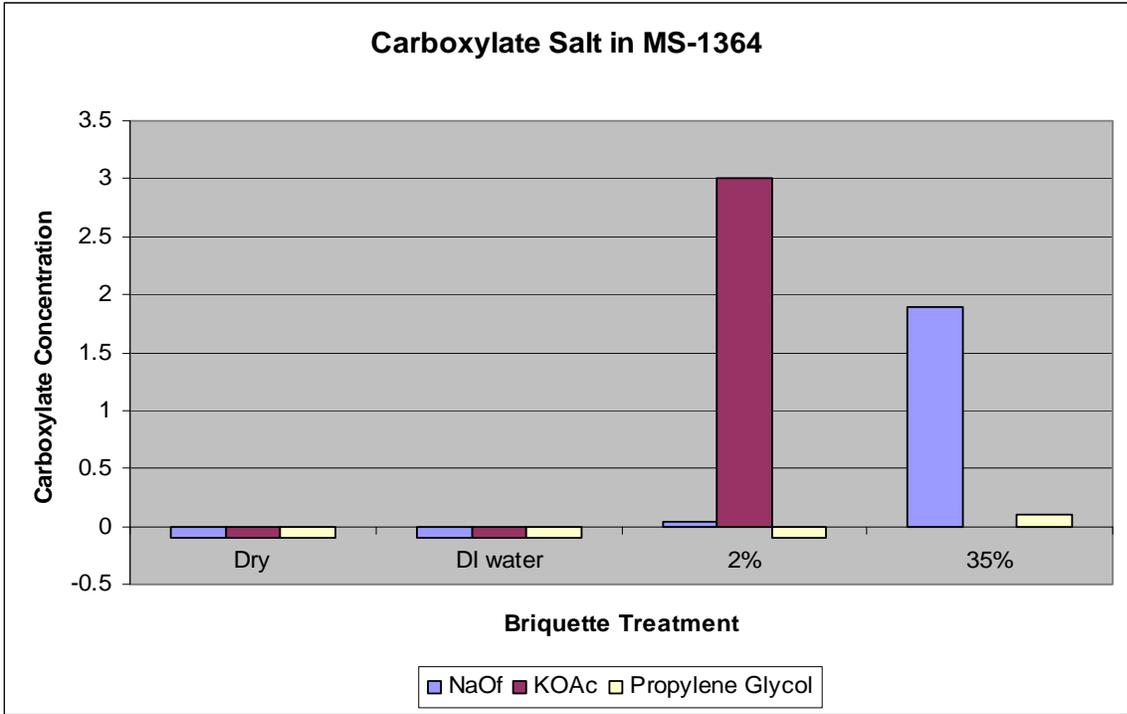
Figure B-1. Carboxylate salt concentration found in sample MS-1364.

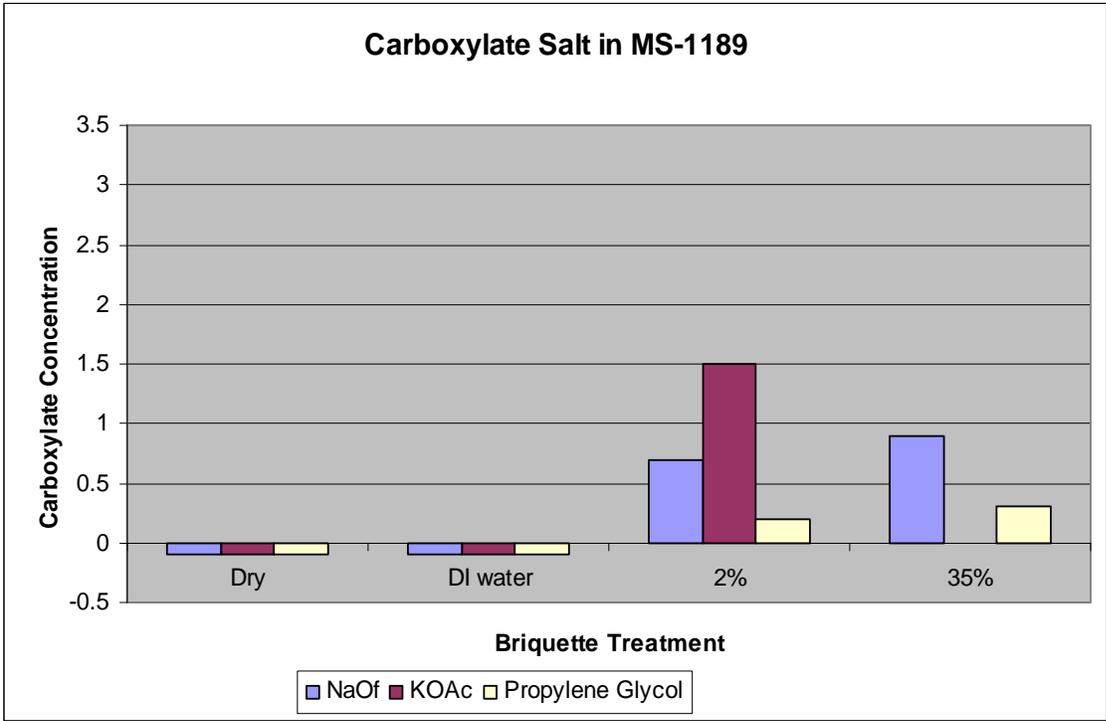
Figure B-2. Carboxylate salt concentration found in sample MS-1189.

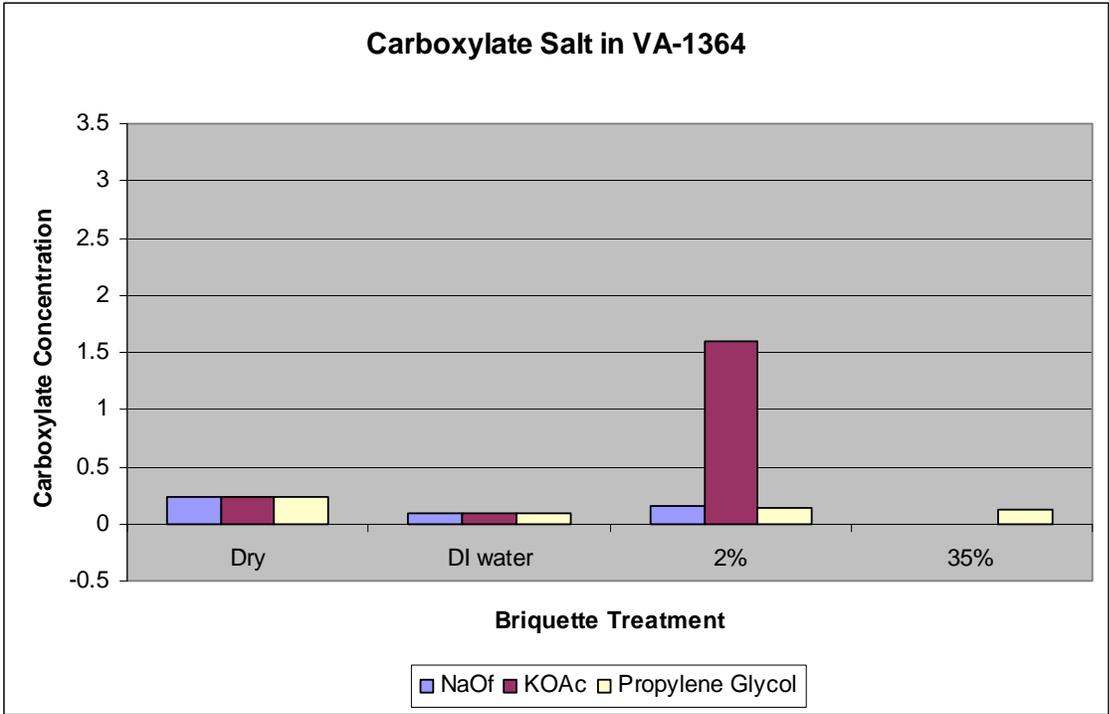
Figure B-3. Carboxylate salt concentration found in sample VA-1364.

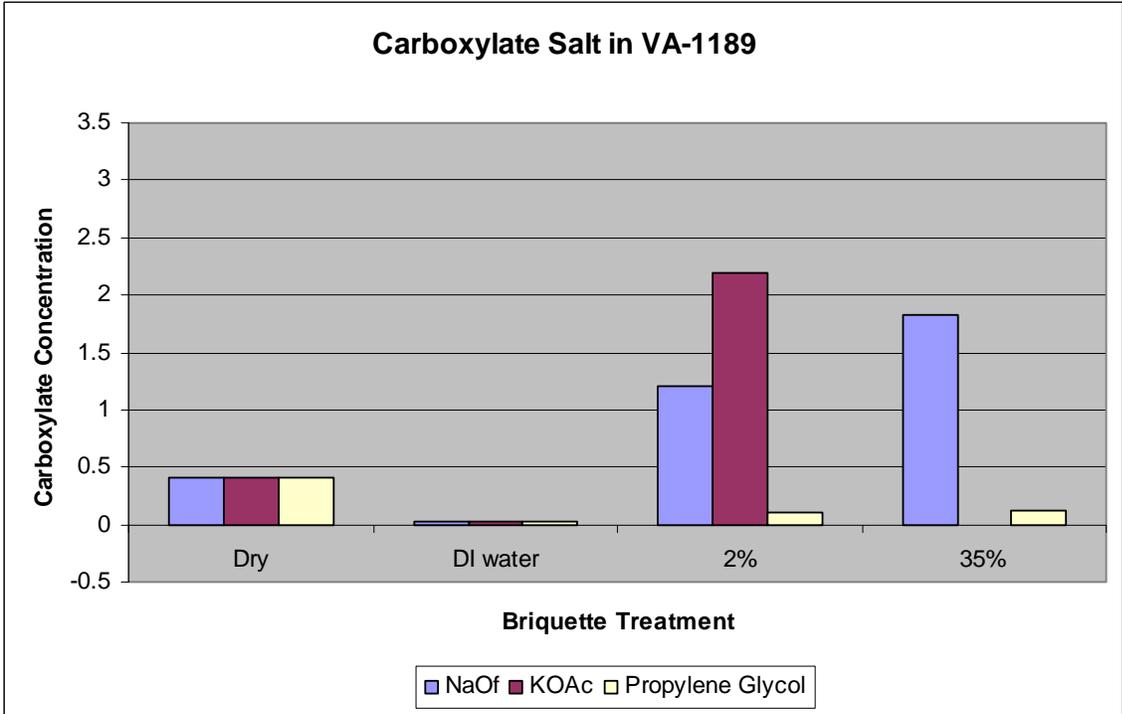
Figure B-4. Carboxylate salt concentration found in sample VA-1189.

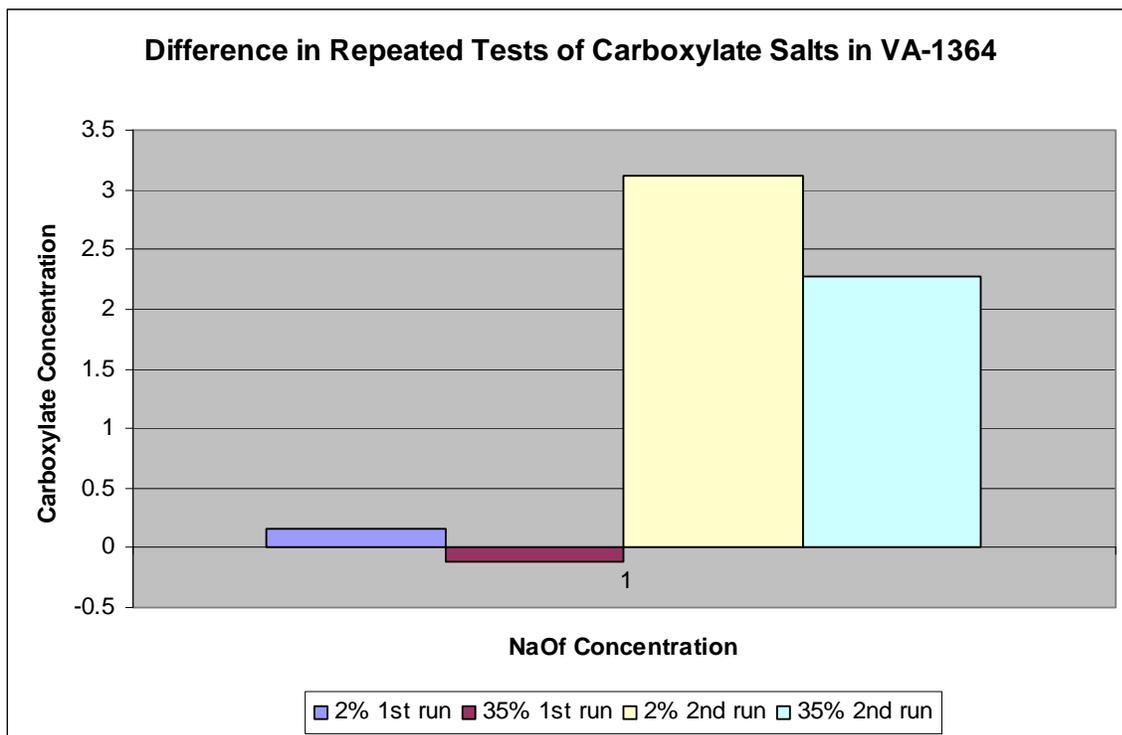
Figure B-5. Carboxylate salt concentration found from repeat analysis of VA-1364.

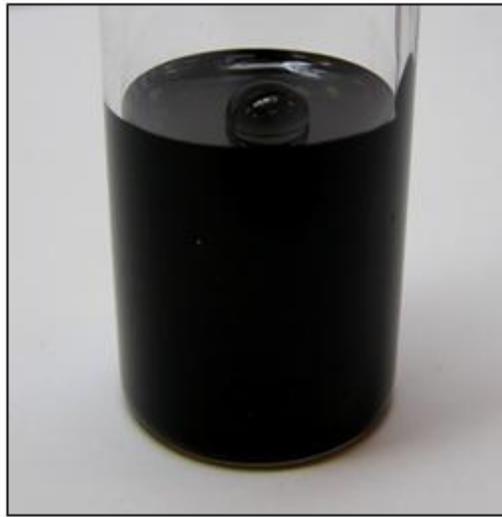
Figure C-1. Photograph of a water drop on asphalt surface.

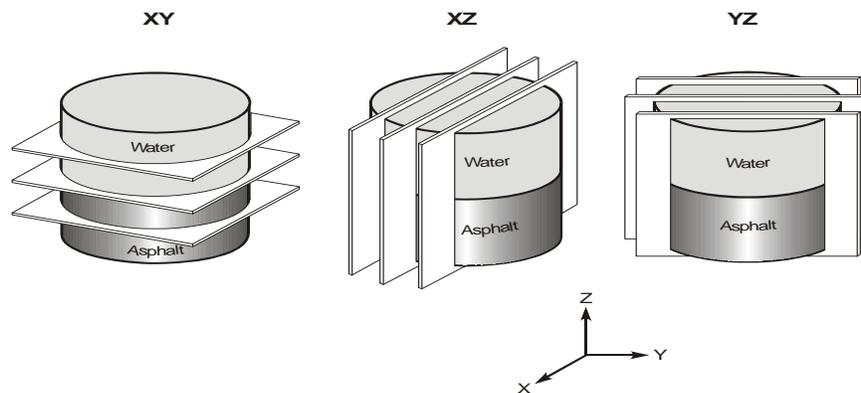
Figure C-2. Illustration of slice geometry used in magnetic resonance imaging.

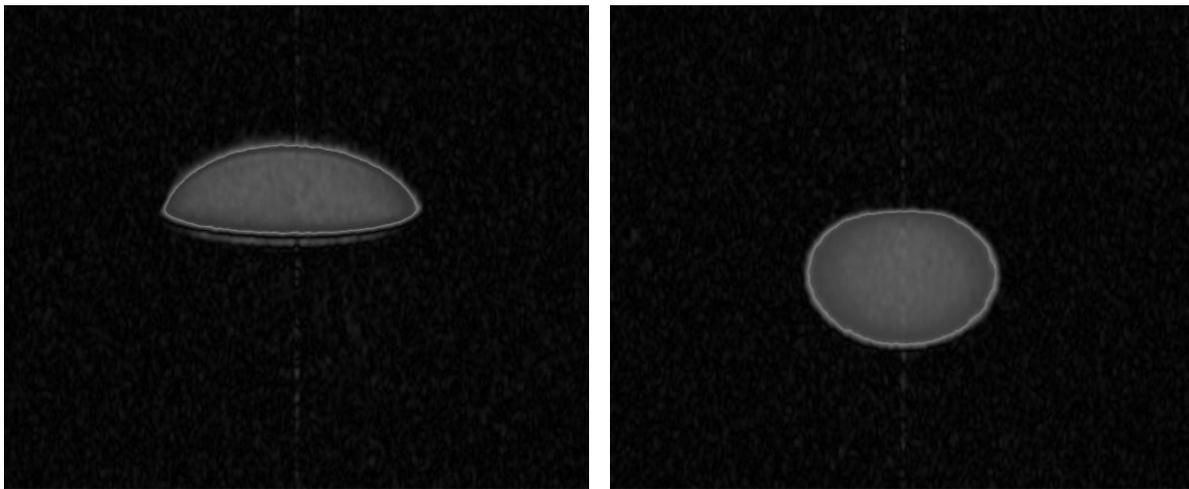
Figure C-3. NMR images of sample 35 % potassium acetate solution in PG 58-28 asphalt binder at 0h and 22h illustrating contrast enhancement.

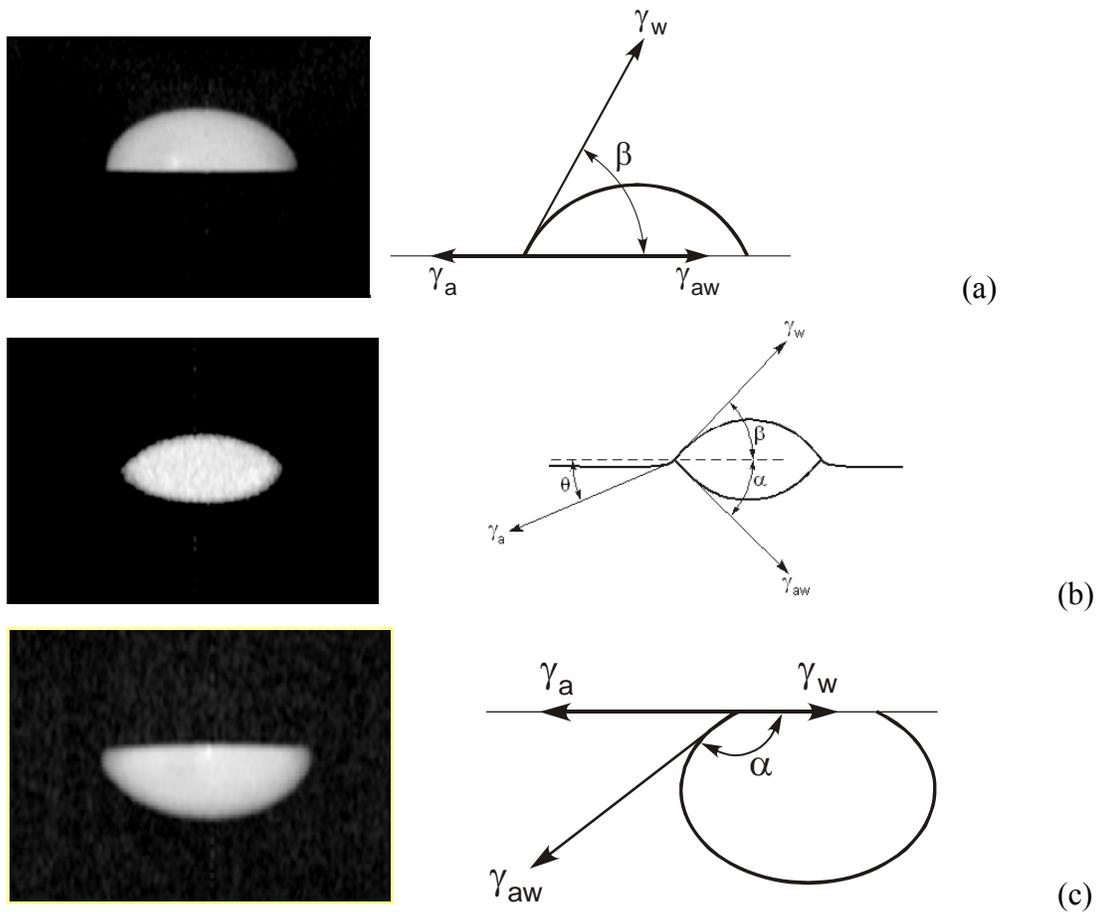
Figure C-4. NMR images of water drops at various stages of sinking and schematic diagrams illustrating surface tension forces.

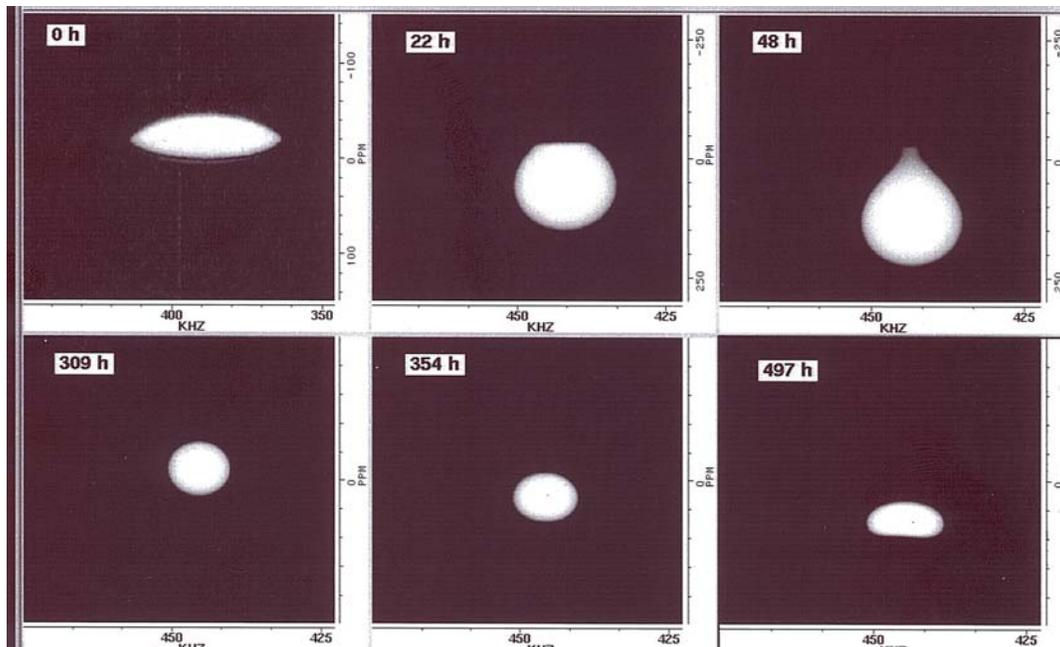
Figure C-5. YZ planar NMR images of a drop of 35 % potassium acetate solution falling through the PG 58-28 asphalt binder.
