NCAT Report 16-04

**PHASE V (2012-2014)
NCAT TEST TRACK FINDINGS**

**National Center for
Asphalt Technology**
NCAT
at AUBURN UNIVERSITY

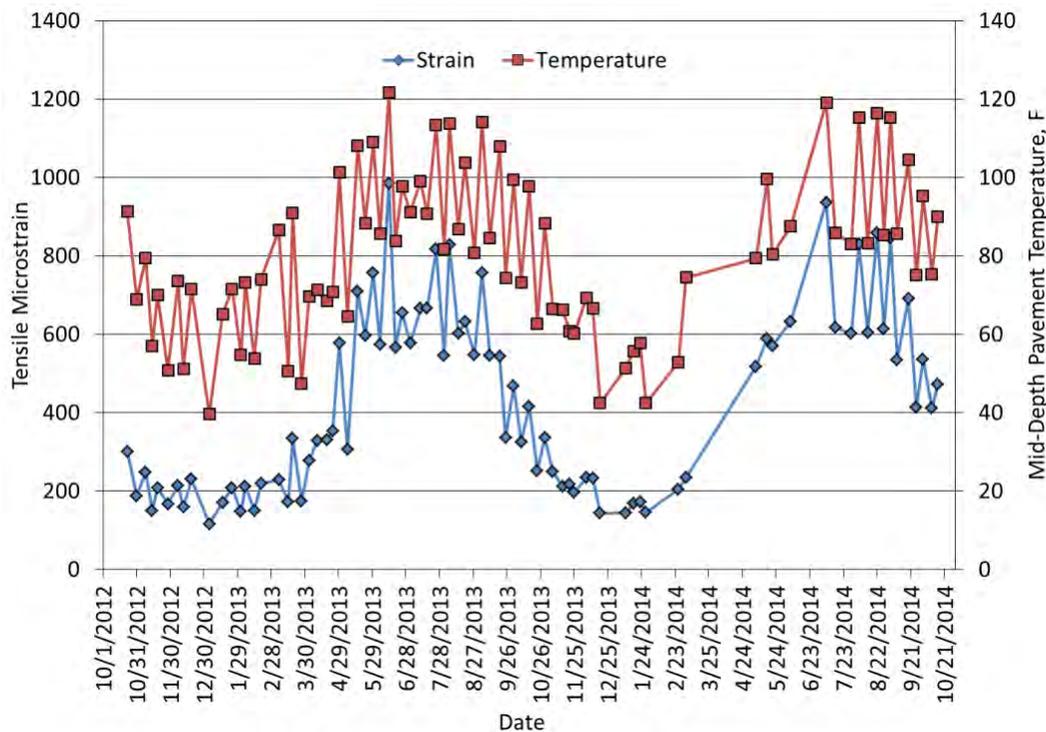
Response vs. Time. As mentioned, strain and pressure data were collected on a weekly basis over the two-year cycle. Figure 3 shows an example data set from Section N3 (sponsored by VDOT) that includes horizontal tensile strain and mid-depth pavement temperature at the time of testing. As expected, the seasonal trends are clearly evident with strain closely following pavement temperature. The more frequent oscillations in both the temperature and strain data sets resulted from alternating between morning and afternoon data collection on a weekly basis.

Figure 3 Strain and Pressure vs. Time

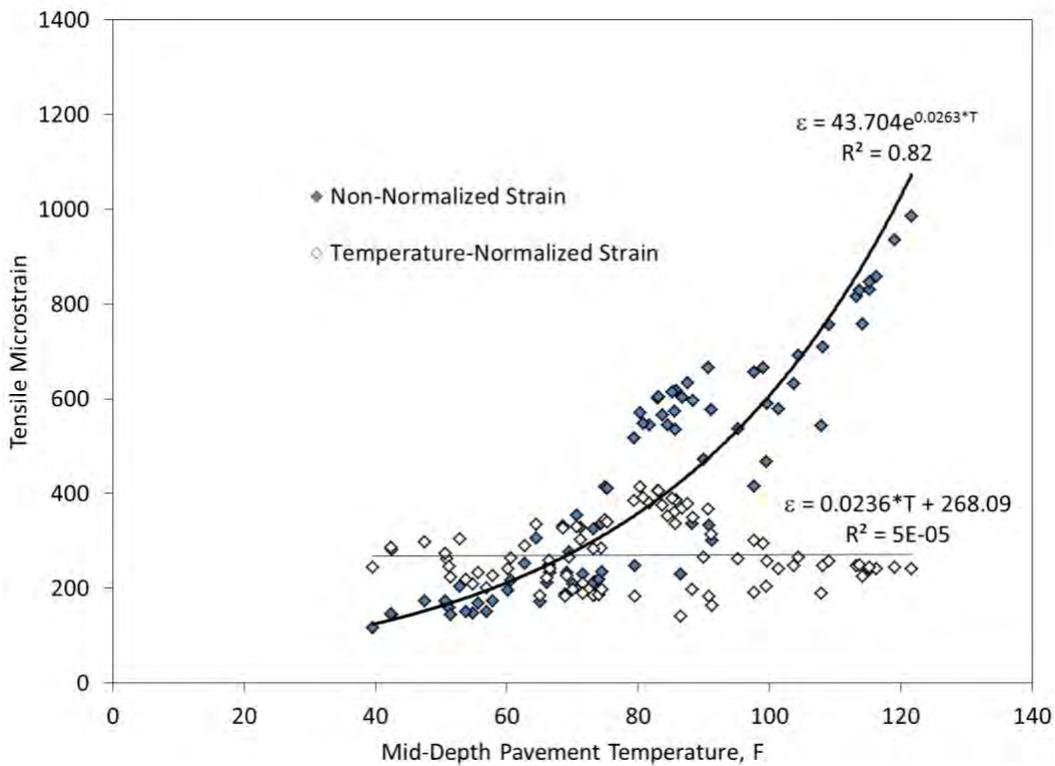
between sections since the temperatures may differ. Therefore, it was important to develop response-temperature relationships to normalize the data to a reference temperature. For example, Figure 4 illustrates this process whereby the strain and temperature from Figure 3 are plotted against each other. The exponential function fit to the non-normalized strain data in Figure 5 indicates a strong relationship between strain and temperature (i.e., high R^2). The exponential regression equation was then used to normalize all the data to a reference temperature of 68°F and is shown by the temperature-normalized strain series. A linear trendline was fit to this series and clearly shows that the strong reliance on temperature was effectively eliminated (i.e., nearly zero slope and extremely low R^2). The normalized data set can be plotted against time or compared against other sections' data at the same reference temperature. Full details of the temperature normalization process have been previously documented (3, 4, 5).

Figure 4 Strain vs. Temperature

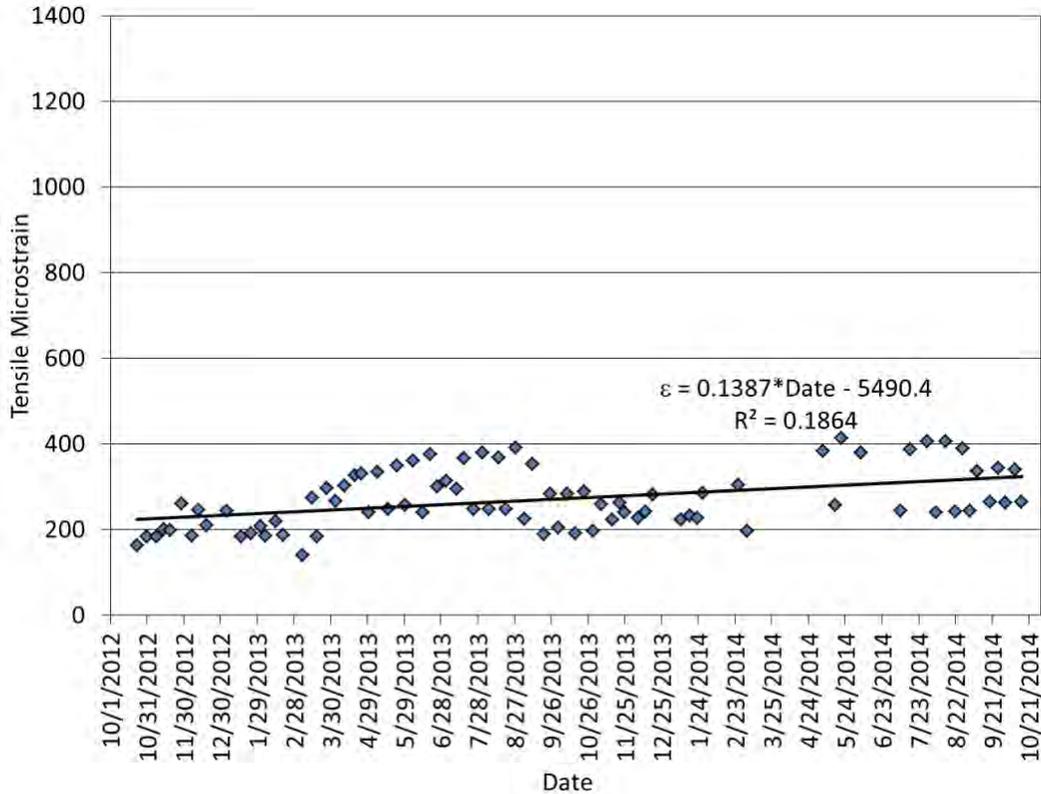
Normalized Response vs. Time. Tracking pavement response over time to identify damage or aging of the pavement sections relied on heavily temperature-normalized data. Figure 5 illustrates the strain data set from Figure 3, which was normalized in Figure 4, plotted against date. In this case, a very slight upward trend was noted (relatively small slope and low R^2). Full analysis of this data set in the context of the VDOT experiment is provided in the VDOT section of this report.

Figure 5 Temperature-Normalized Strain vs. Time

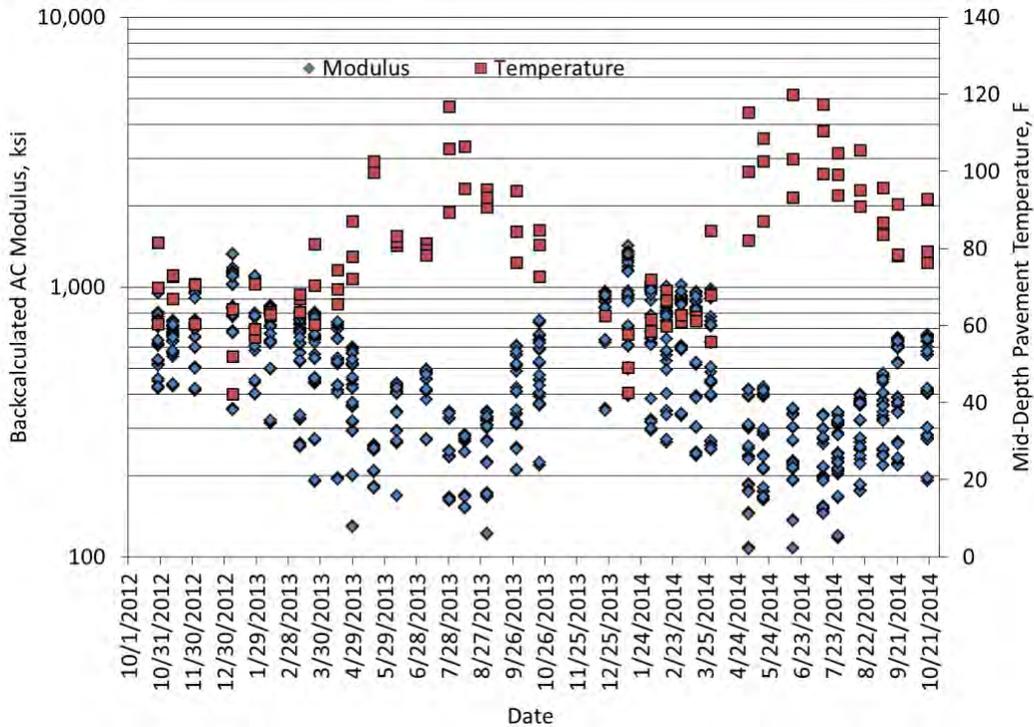
Modulus vs. Time. Deflection data collected through FWD testing were used to determine the in situ layer properties. Figure 8 shows measured temperature and backcalculated AC moduli versus time for one of the VDOT sections (N3). As expected, the inverse relationship between temperature and modulus is clearly evident. The scatter of the data on any given testing date represents the nature of the FWD testing. There are three temperatures on each test date corresponding to each offset tested (IWP, BWP, and OWP) as previously described. Testing was also conducted at four RL's in the section, so the scatter amongst the AC moduli on a given date represents both RL spatial variability and offset temperature effects.

Figure 8 AC Modulus and Temperature vs. Time

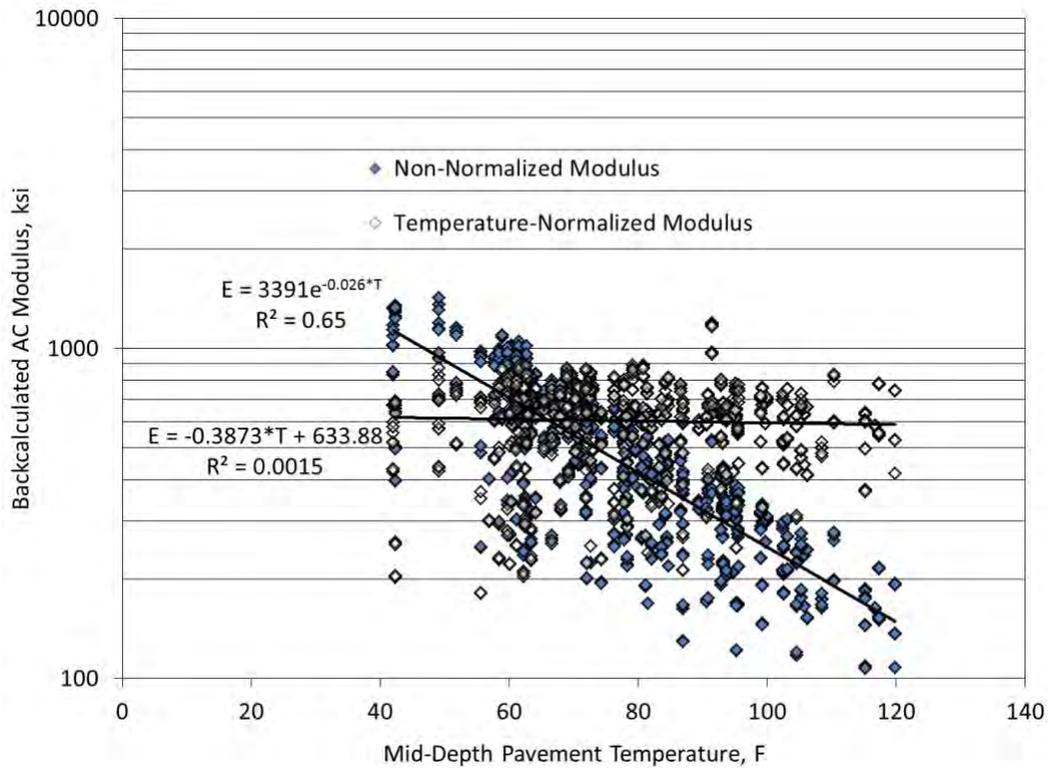
Modulus vs. Temperature. As was done with the strain/temperature data presented above, the moduli and temperature data in Figure 8 were plotted in Figure 9 from which exponential and linear trendlines were fit to the data. The exponential function shown in Figure 9 was used to normalize the AC moduli to a reference temperature of 68°F. The trendline on the normalized data demonstrates that the normalization process was effective at eliminating temperature as a factor. Again, eliminating temperature allows for plotting the data over time to detect changes due to damage or aging and also allows for direct comparisons between test sections evaluated at different temperatures.

Figure 9 AC Modulus vs. Temperature

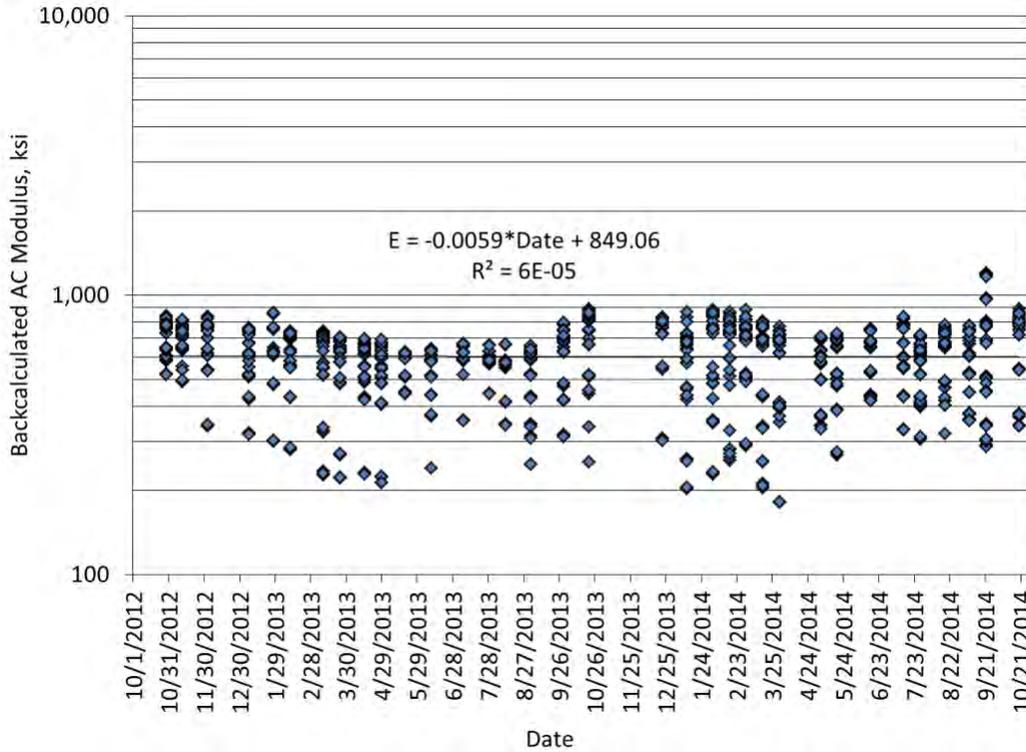
Normalized Modulus vs. Time. Tracking temperature-normalized modulus over time provides an independent data set to further evaluate the possible impact of damage or aging on the pavement structure. Figure 10 illustrates this idea by plotting temperature-normalized AC moduli against corresponding test dates. The linear trendline shows a very slight negative slope with extremely low R^2 , which is consistent with the strain data presented in Figure 5. Full analyses of these data sets are presented in the VDOT section of this report.

Figure 10 Temperature-Normalized AC Modulus vs. Time

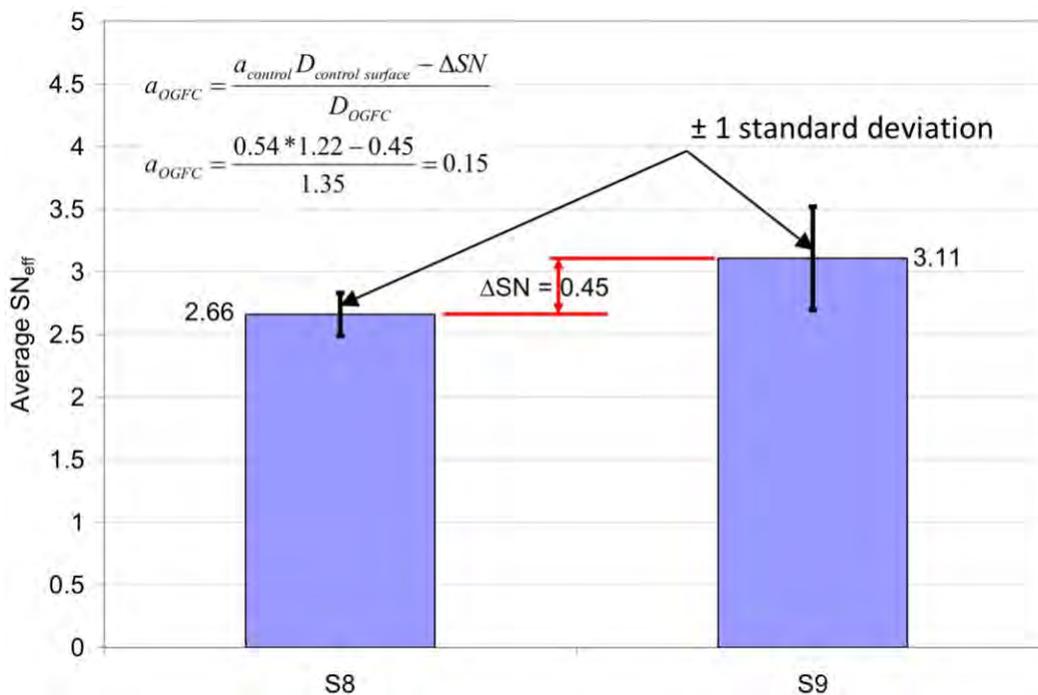
Using 0.15 to represent the OGFC and 0.54 to represent the other asphalt materials, an equivalent thickness was determined to achieve the same total structural number. Assuming a 7-inch control section, a section with OGFC would require 6.6 inches of control material topped with 1.25 inches of OGFC to have an equivalent structural number. This assumes the pavement designer would select 1.25 inches for the depth of OGFC, which was used at the test track. Increases or decreases in selected OGFC thickness would alter the final cross section. In the context of this example, however, an OGFC section would require 7.85 inches total AC depth to equal a 7-inch cross section consisting of dense-graded mixes. This is a 12% increase in thickness, which was in the 10-20% range found through mechanistic analysis (8). Note that this total thickness is 0.4 inches thinner than what would be recommended in a state where no structural value is currently attributed to OGFC. In such a state, if the structural design called for 7 inches, there would be 7 inches of dense-graded material topped with the OGFC surface.

Figure 2 Computed SN_{eff} and Computed OGFC Structural Coefficient

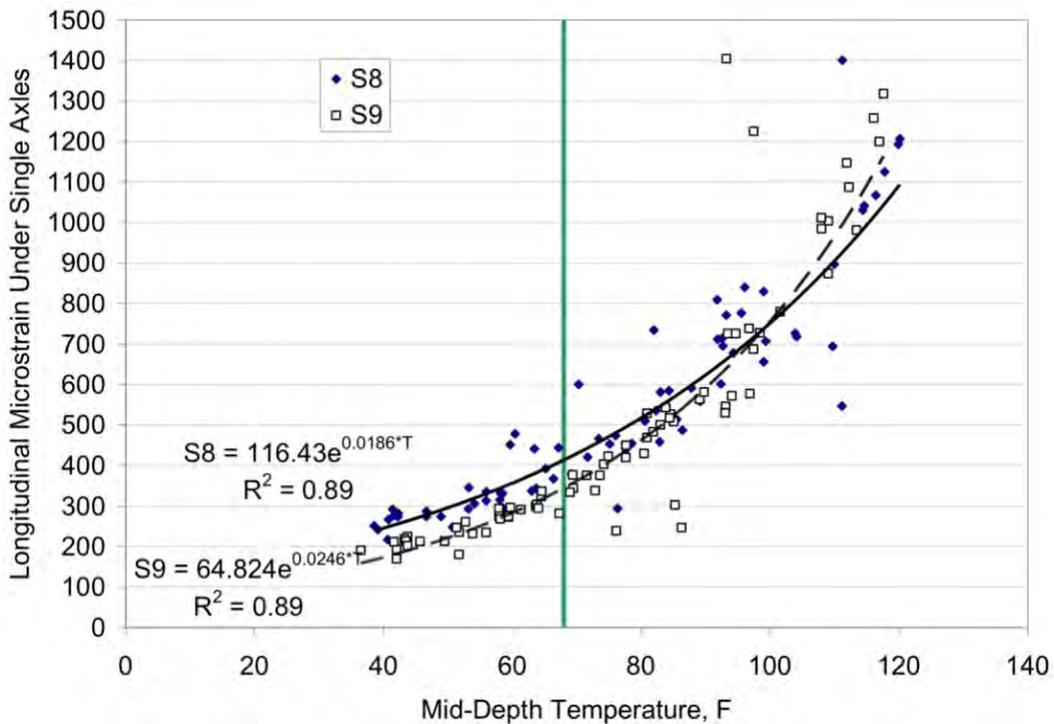
Figure 3 Strain Response of S8 (OGFC) and S9 (Control) Sections

clear, it also appeared in backcalculated AC modulus from FWD testing. Figure 4 shows the backcalculated AC modulus for each section versus temperature. At cooler temperatures, S9 had higher modulus, but became softer at higher temps (above 105°F). Though this doesn't correspond directly with the temperature from the strain data, it is in a similar range. In both the strain and backcalculated data sets, the regression coefficients of the exponent were higher for the control section. This indicates a greater sensitivity to the temperature of this section. Further investigation of this behavior in the context of mechanistic-empirical pavement design is warranted. For the purposes of this investigation related to the structural coefficient, however, the main interest is in the behavior at the AASHTO reference temperature of 68°F, marked by the vertical line in both Figures 3 and 4.

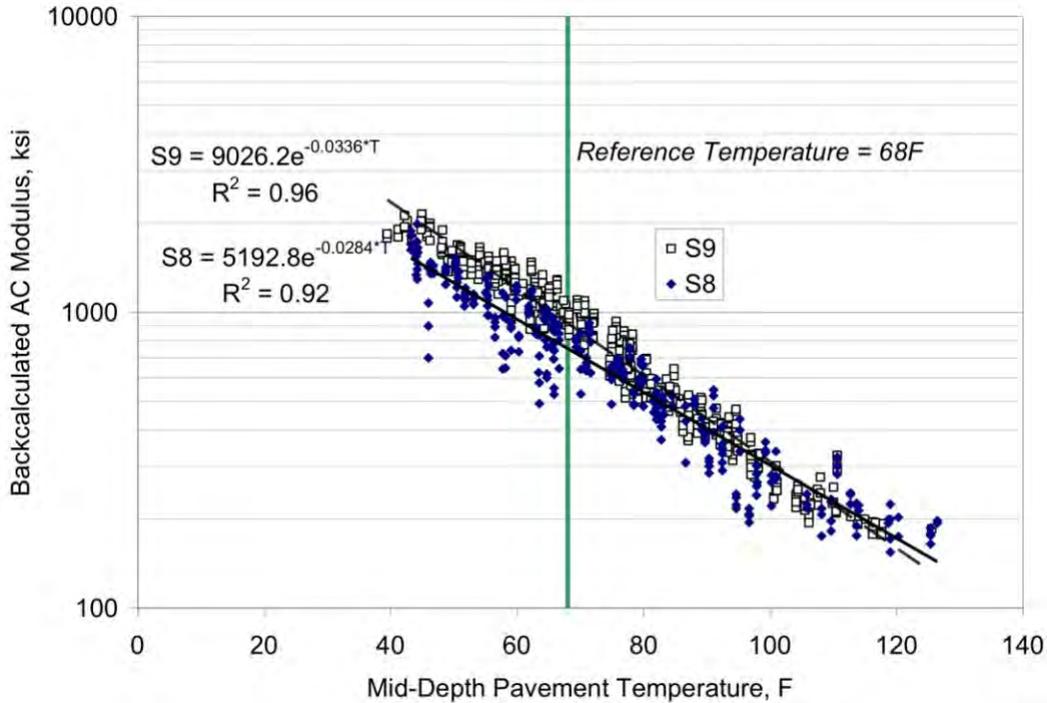
Figure 4 Backcalculated AC Modulus of S8 (OGFC) and S9 (Control)

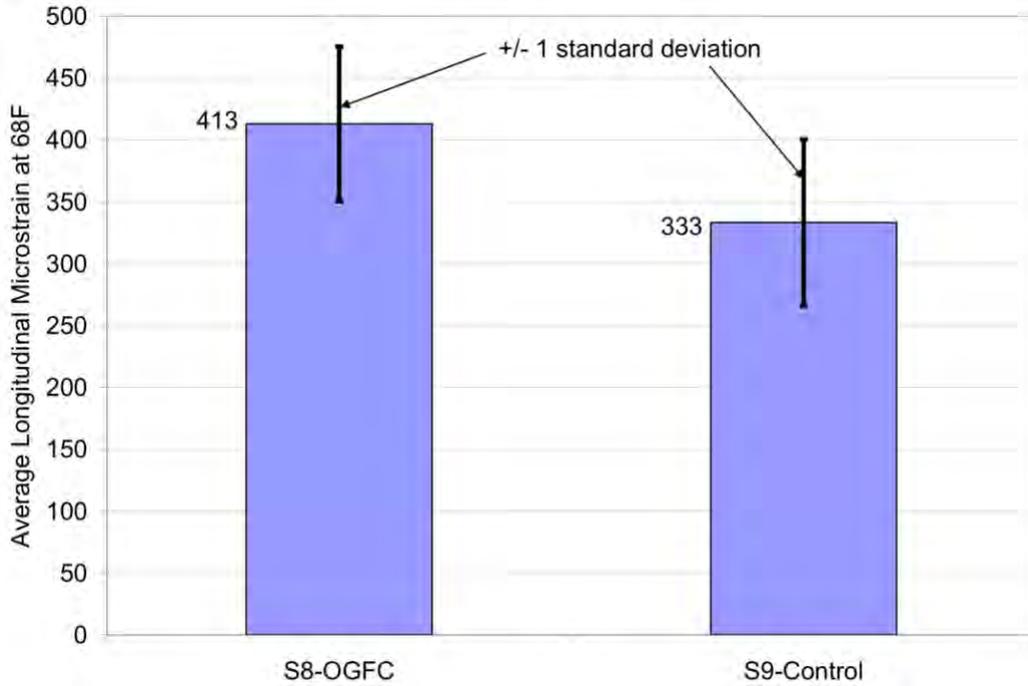
Figure 5 Strain Response Normalized to 68°F

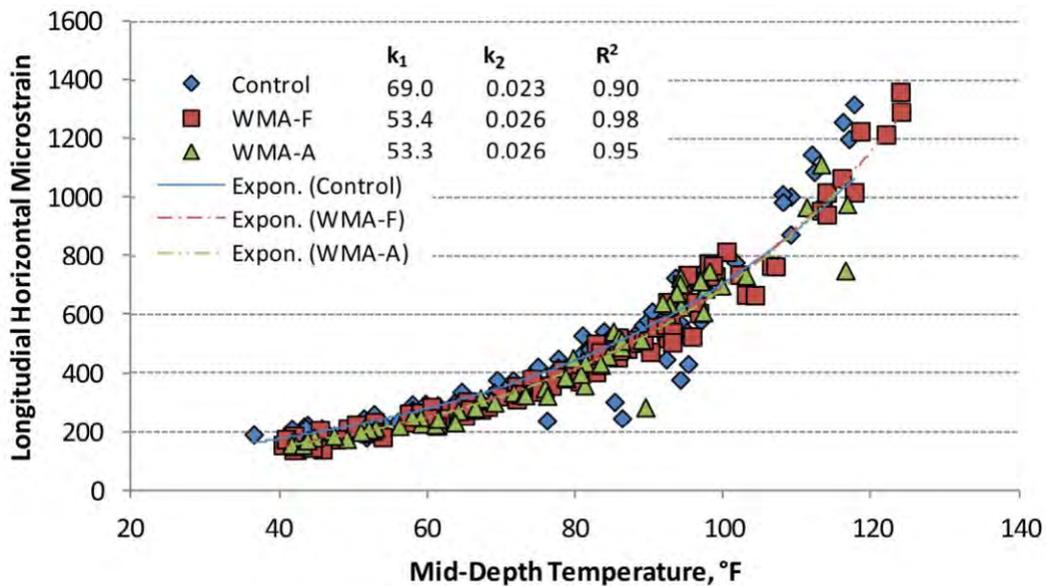
Figures 7 and 8 show the longitudinal strain and vertical subgrade pressure versus mid-depth temperature for the WMA sections and the control sections. Figures 9 and 10 show the same kind of plots for the 50% RAP test sections and the control section. For the plots showing the measured stress and strain responses of the WMA sections compared to the control section it does not appear that either WMA technology appeared to be different than the Control section. However, the strain and pressure data for the 50% RAP-WMA and 50% RAP-HMA sections shown in Figures 9 and 10 appear to indicate that the high RAP content sections were less influenced by temperature presumably due to increased stiffness of the high RAP content mixes.

Figure 7 Longitudinal Strain Versus Temperature for WMA Sections and Control Section

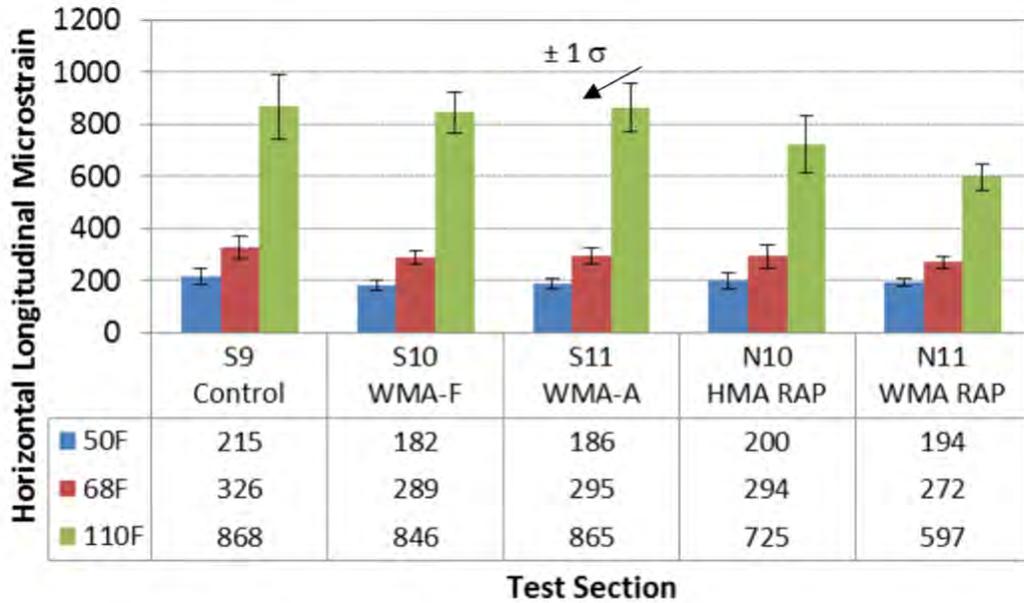
responses of the high RAP sections were significantly lower than those of the control. Strains ranged from 7 to 31% lower, while pressures were between 14 and 55% lower than the control, with the largest differences observed at the highest reference temperature.

Figure 11 Average Longitudinal Strains at Reference Temperatures

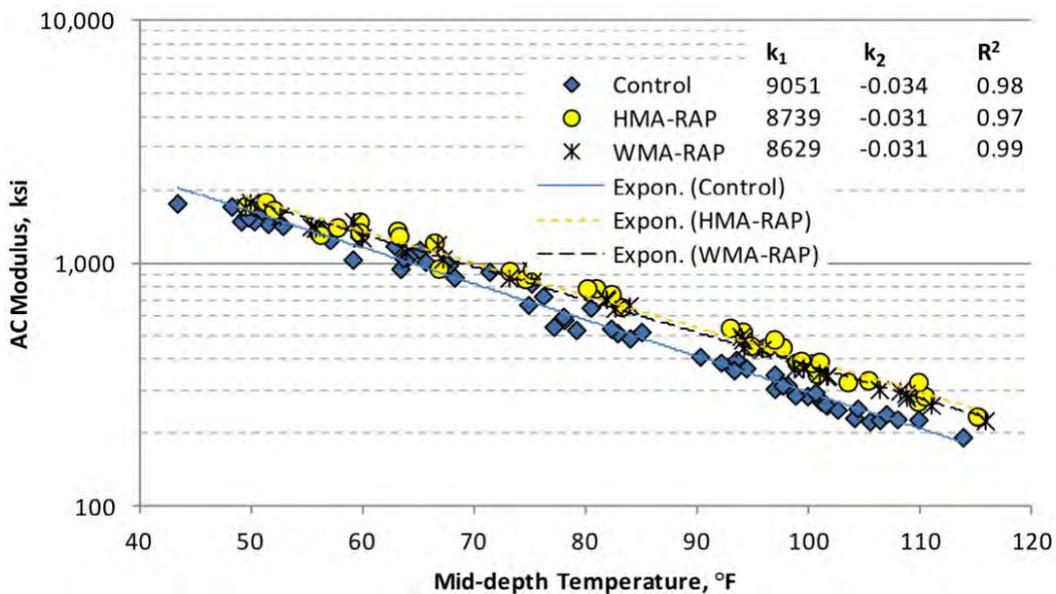
Figure 14 Backcalculated AC Modulus Versus Temperature

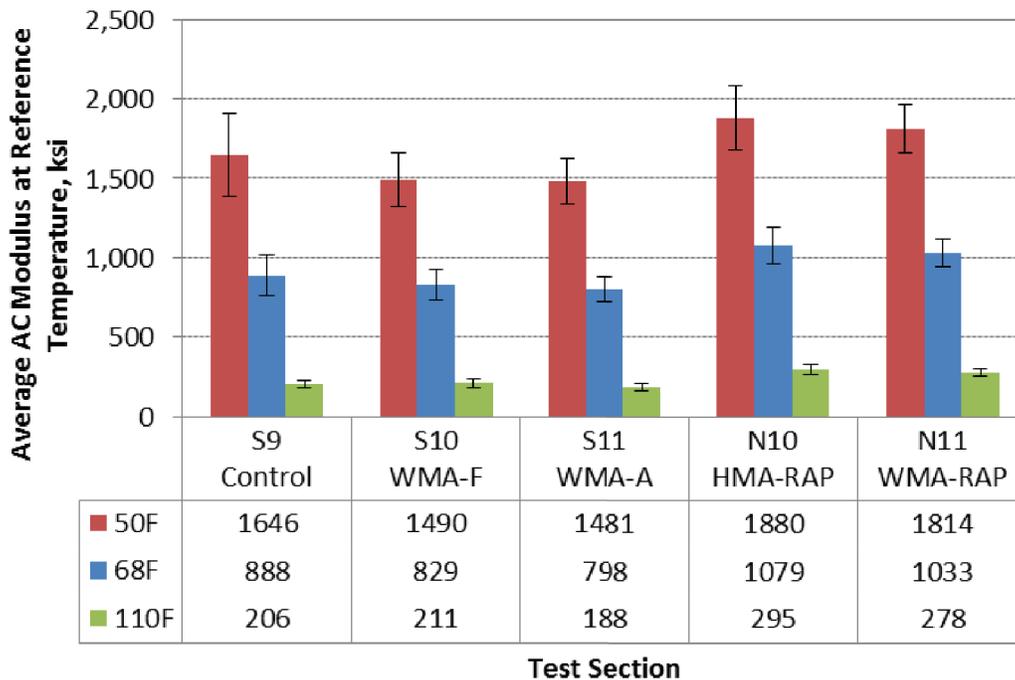
Figure 15 shows the average temperature-normalized moduli. Results were normalized to three reference temperatures using the same procedure applied for strain and pressure. Statistical testing indicated that there were significant differences between the WMA sections and the Control section. Overall, WMA sections had lower moduli than the control; however, these differences were only 7 to 10% lower and may not have practical significance. However, both of the 50% RAP sections had higher moduli than the Control (between 16 and 43% higher), with the largest differences observed at the higher reference temperatures.

Figure 15 Average AC Modulus at Reference Temperature

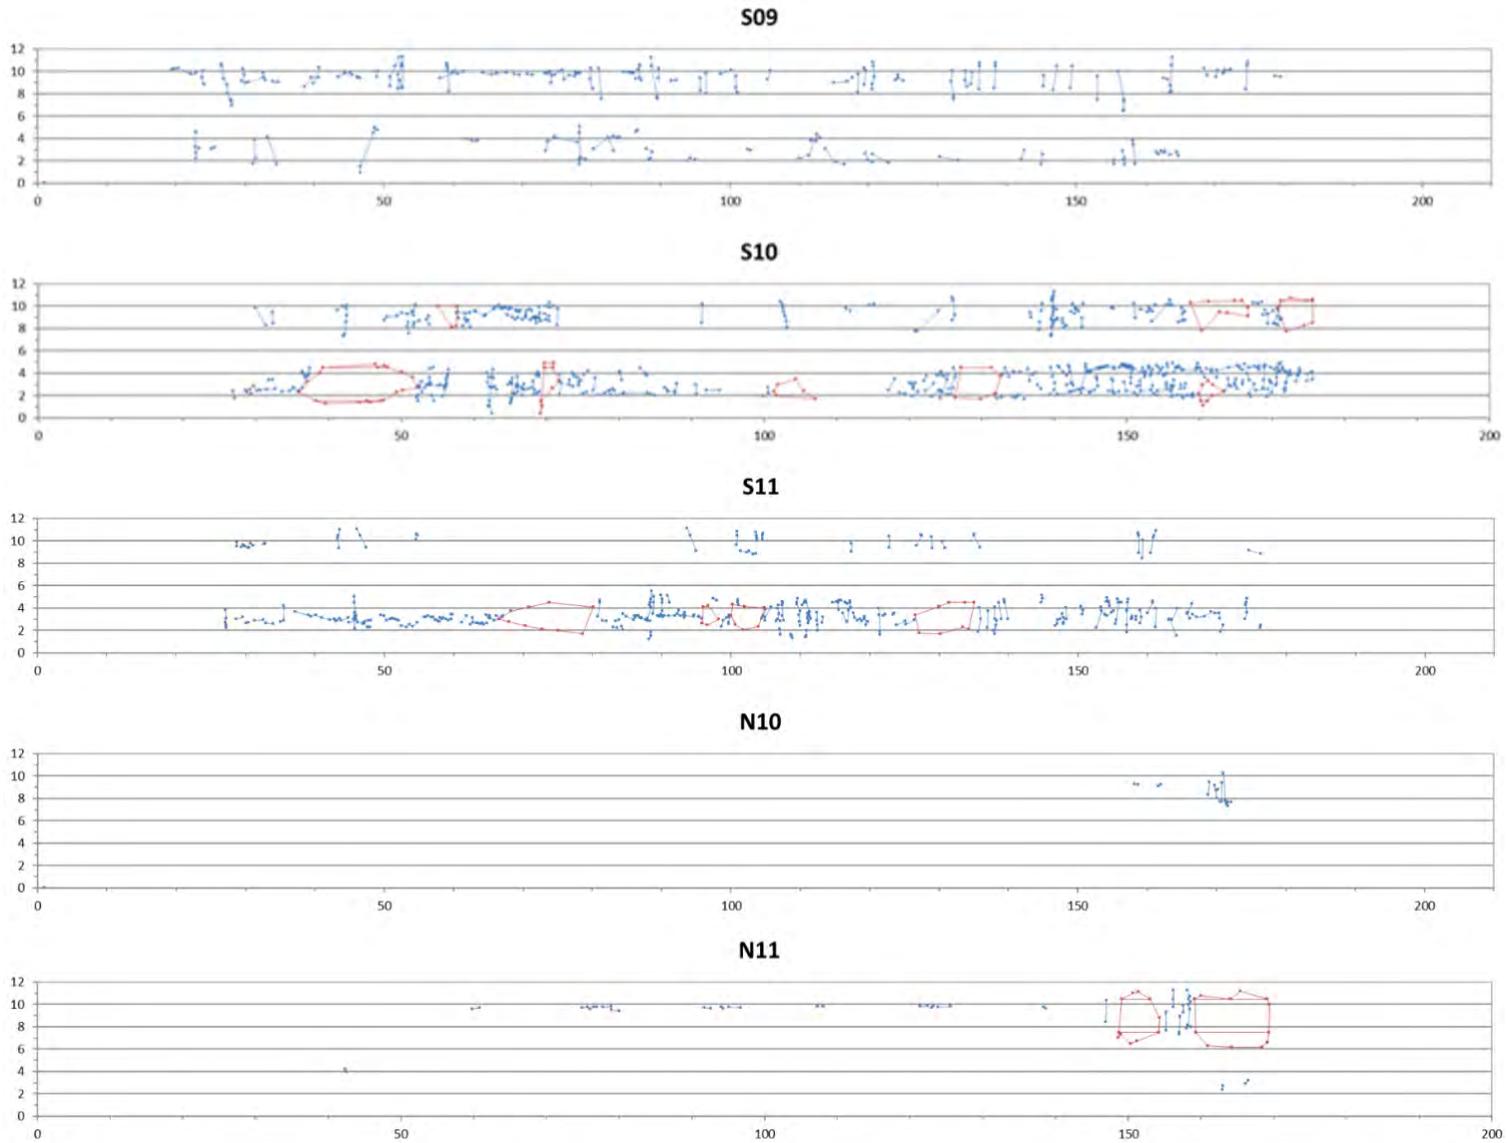
A series of cores were cut in each of the GE test sections in December 2013 to determine if the observed cracking was full-depth fatigue cracking, near surface (i.e. top-down) cracking, or if there were other issues in the pavement structure that contributed to the distresses. Figure 19 shows a photograph of the Control section where a transverse and a longitudinal crack were cored. Figure 20 shows those cores. It can be seen that the crack on the core from the transverse crack extended the full depth of the core, whereas the crack on the core from the longitudinal crack only extended through the surface layer. This link was confirmed with all of the cores taken in the investigation. Therefore, the research team concluded that all of the transverse cracks and cracked areas enclosed by the polygons in the crack maps were bottom-up fatigue cracks and that all longitudinal cracks were only top-down cracks. No weakly bonded or debonded cores were obtained in this preliminary forensic work.

Figure 18 Crack Maps for GE Sections as of December 16, 2013

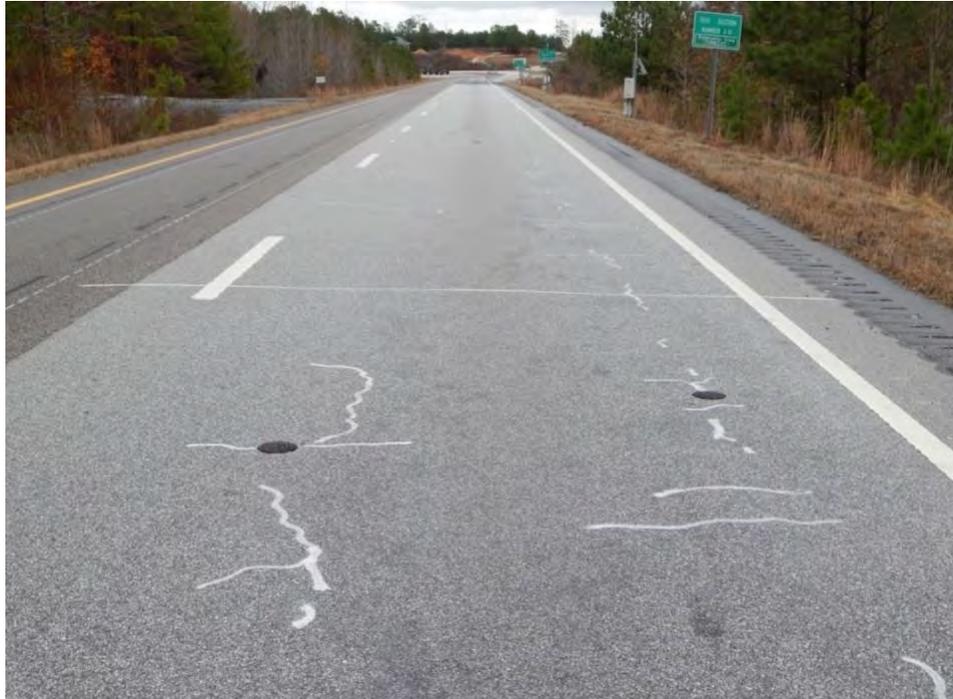
Figure 19 Photo of Typical Cracking Observed in GE Section on December 9, 2013

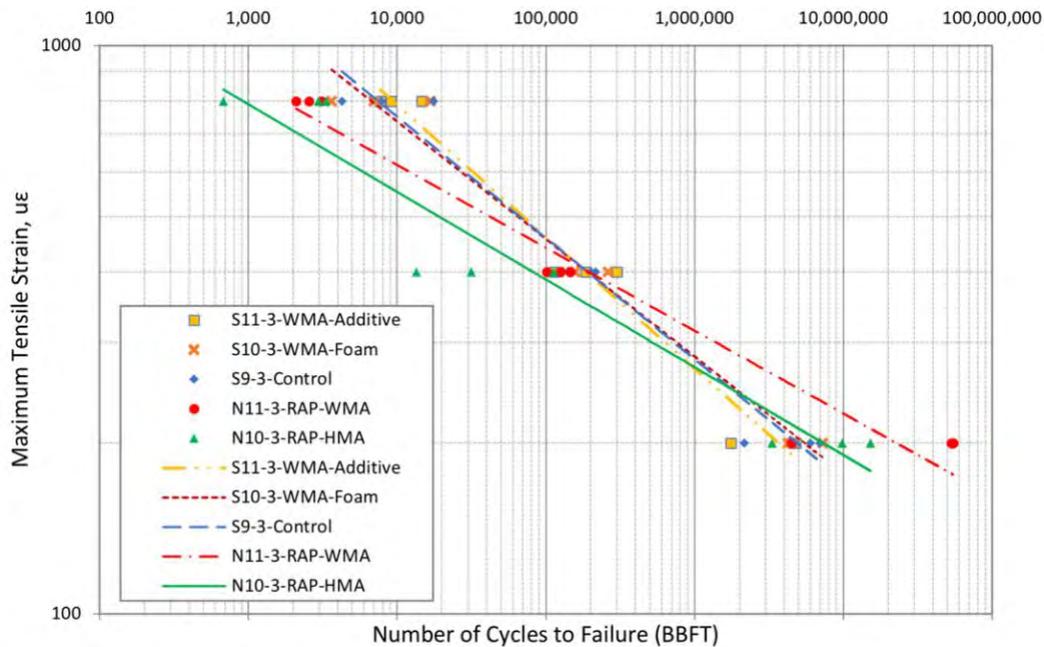
Figure 22 Bending Beam Fatigue Results for GE Base Layer Mixes

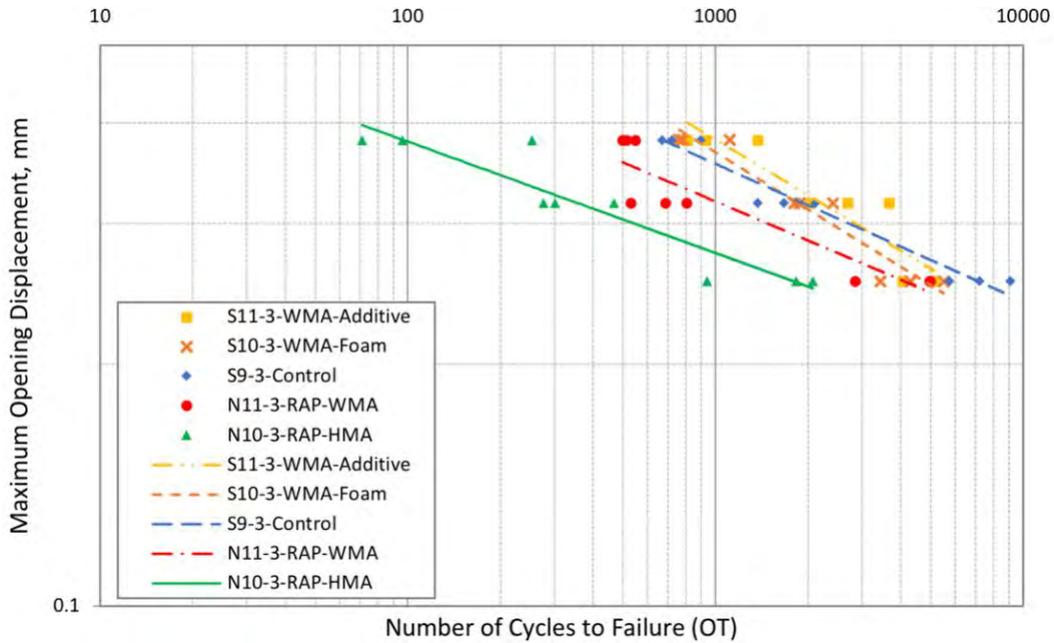
Figure 25 OT Results at Three MOD Levels for GE Base Layer Mixes

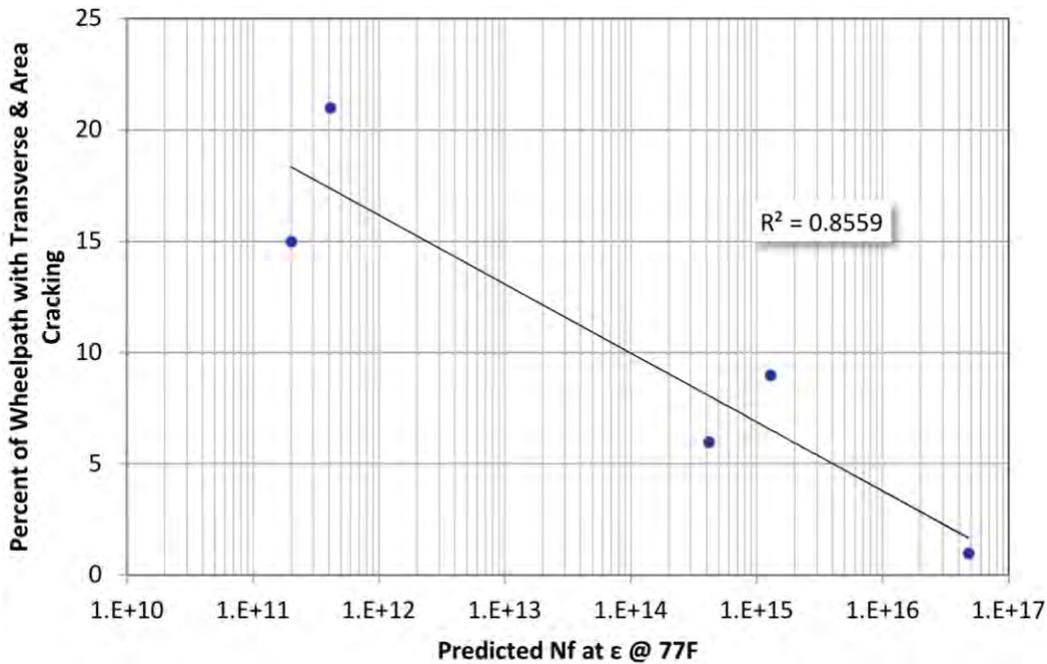
Figure 26 Relationship Between Predicted OT N_f at ϵ_{77} and Percent of Wheelpath with Transverse and Area Cracking for GE

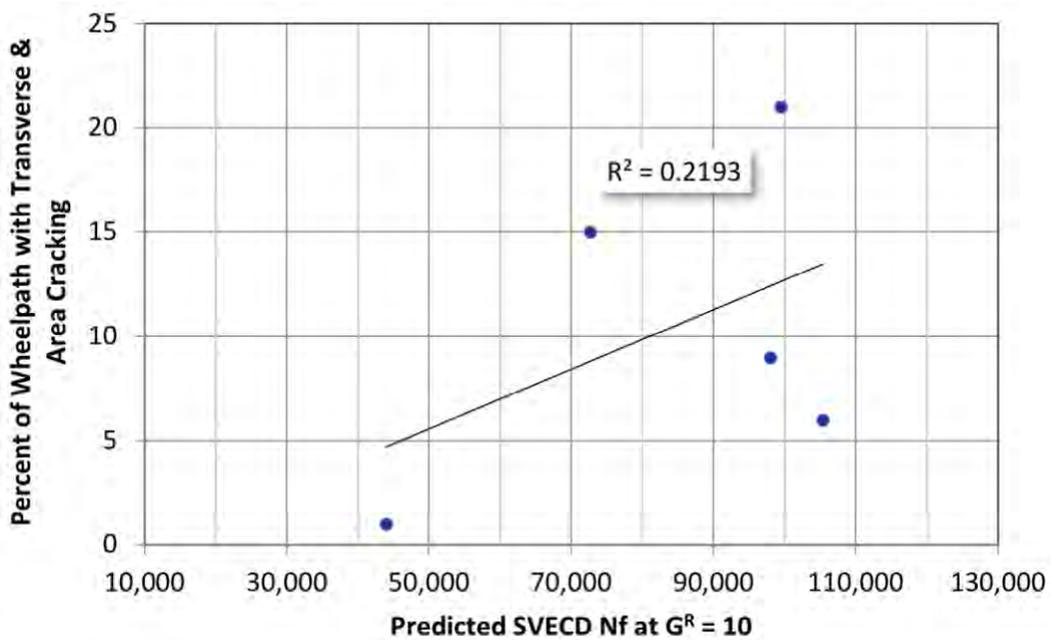
Figure 28 Relationship Between Predicted SVECD at $G^R=10$ and Percent of Wheelpaths with Transverse and Area Cracking for GE

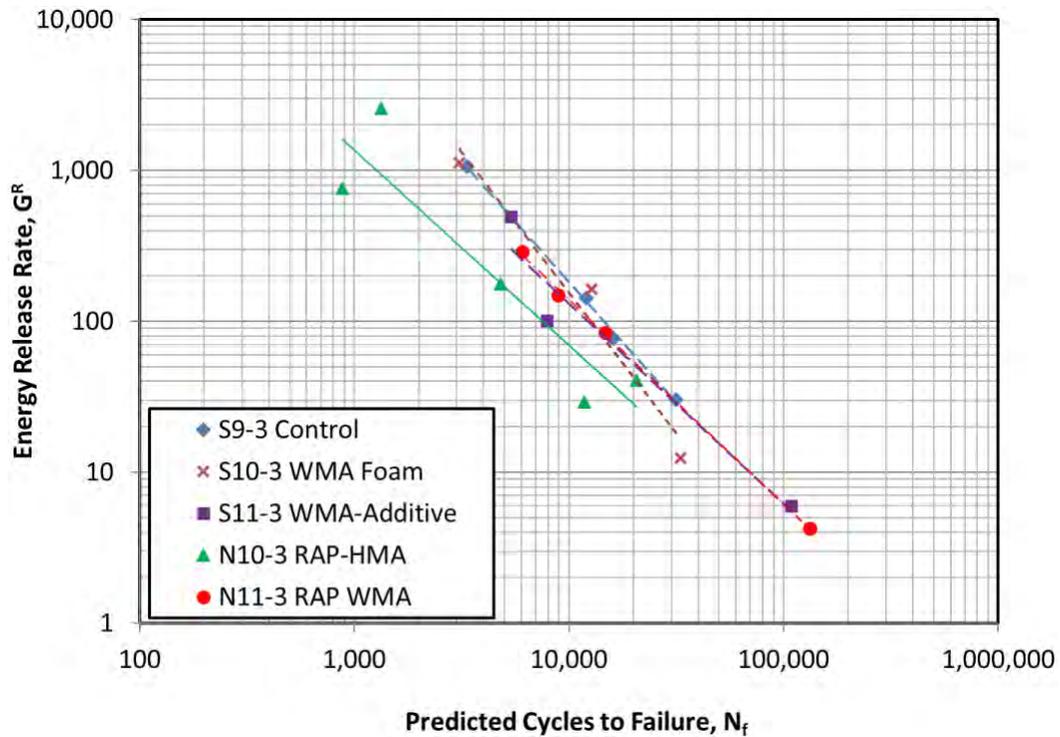
Figure 29 Predicted SVECD Cycles to Failure for Retested GE Base Layer Mixes

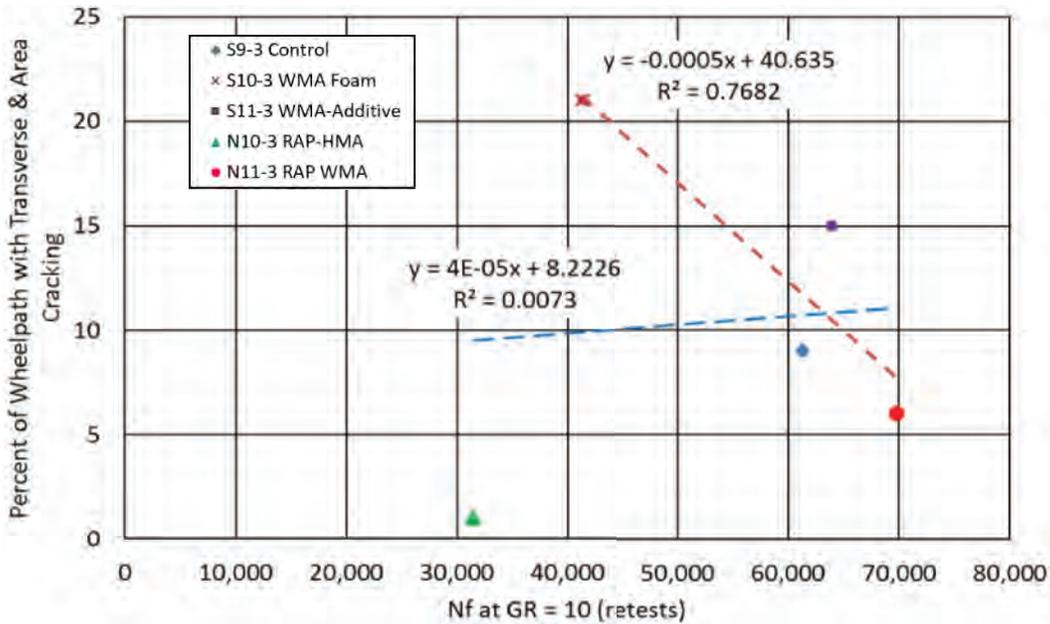
Figure 30 shows the retested SVECD results plotted versus the actual fatigue cracking. The blue dashed line is the correlation trend line including results for all mixes. This poor correlation is strongly influenced by the point for the 50% RAP HMA, which performed the best in the field but had the lowest cycles to failure in the SVECD test. If that mix is excluded from the data, the correlation improves considerably and follows the expected trend for the lab to field correlation.

Figure 30 Relationship between Retested SVECD N_f at $G^R=10$ and Percent of Wheelpaths with Transverse and Area Cracking

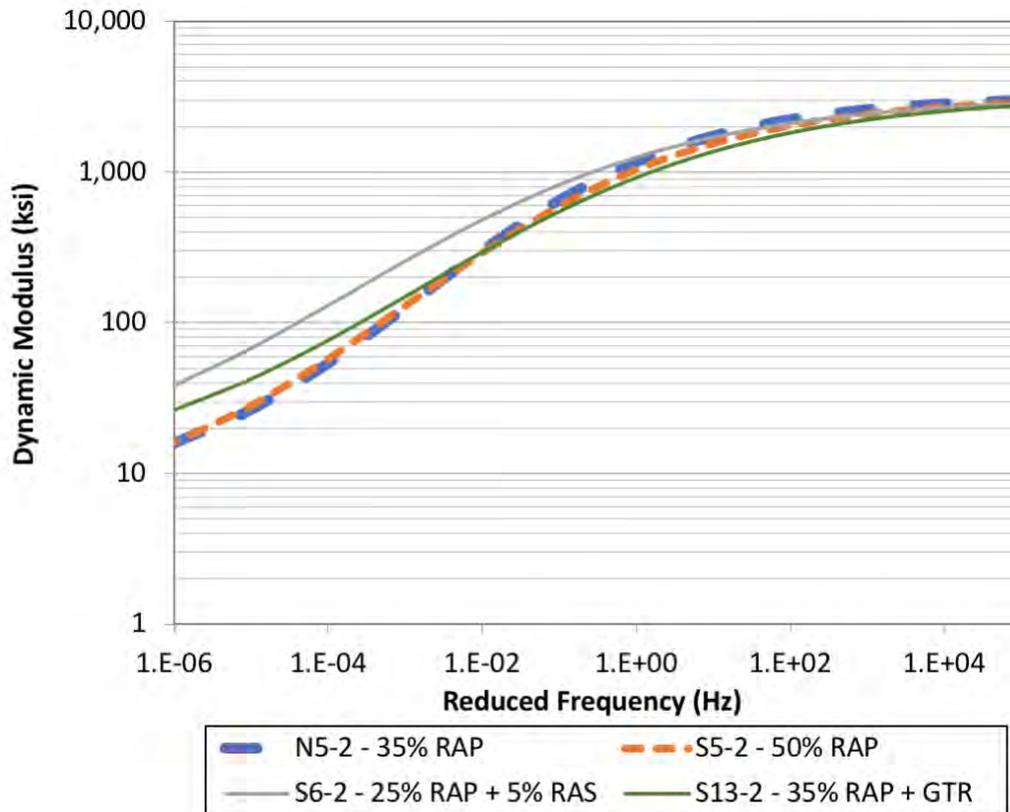
The full E* master curves for the intermediate layers are plotted in Figure 6. This plot shows that the mix from S6 containing RAP and RAS was much stiffer than the other mixes at the higher temperatures and lower frequencies. The GTR modified intermediate layer from S13 had a lower stiffness at lower and intermediate temperatures but was stiffer than the conventional mix from N5 and the 50% RAP mix from S5 at high temperatures and low frequencies.

Figure 6 Dynamic Modulus Master Curves for Intermediate Layers

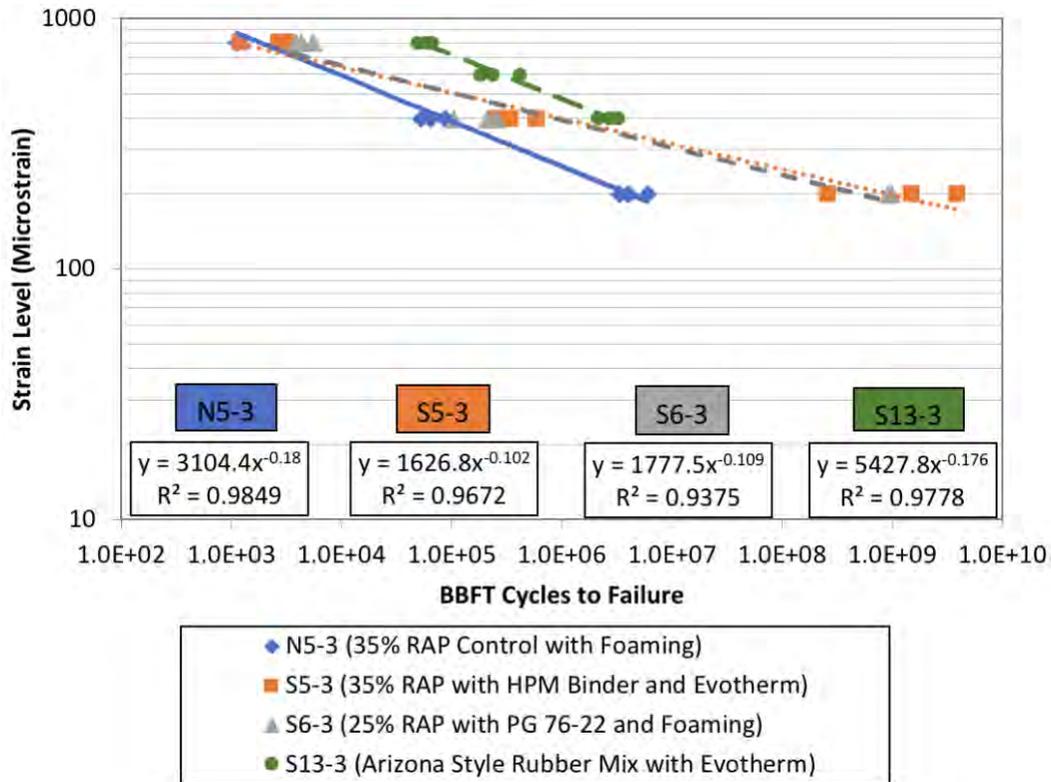
Bottom Asphalt Layers. The highest load-related tensile stresses in any well-bonded pavement cross-section occur at the bottom of the pavement’s lowest asphalt layer. Therefore, for this experiment, the bottom asphalt layers in sections S5, S6, and S13 were designed to have greater resistance to fatigue compared to the conventional asphalt base mix used in N5. Two laboratory tests were used to evaluate the fatigue resistance of these mixtures: the bending beam fatigue test and the simplified viscoelastic continuum damage (SVECD) test. Results of the bending beam fatigue tests on the bottom layers is shown in Figure 7. These results indicate that the bottom layers for S5 and S6 are very similar. These mixes have similar fatigue lives to the conventional mix in N5 at high strain levels (e.g. 800 microstrain) but have fatigue lives that are at least two orders of magnitude higher at relatively low strain levels (e.g. 200 microstrain). The Arizona-style gap-graded asphalt-rubber mix in S13 has a higher fatigue life at high and intermediate strain levels compared to the other bottom layer mixes. This mix was not tested at 200 microstrain, but it would appear that if the results were extrapolated that the mix in S13 would have a lower fatigue life than the corresponding mixes in S5 and S6 at that low strain level.

Figure 7 Bending Beam Fatigue Results for Bottom Layers

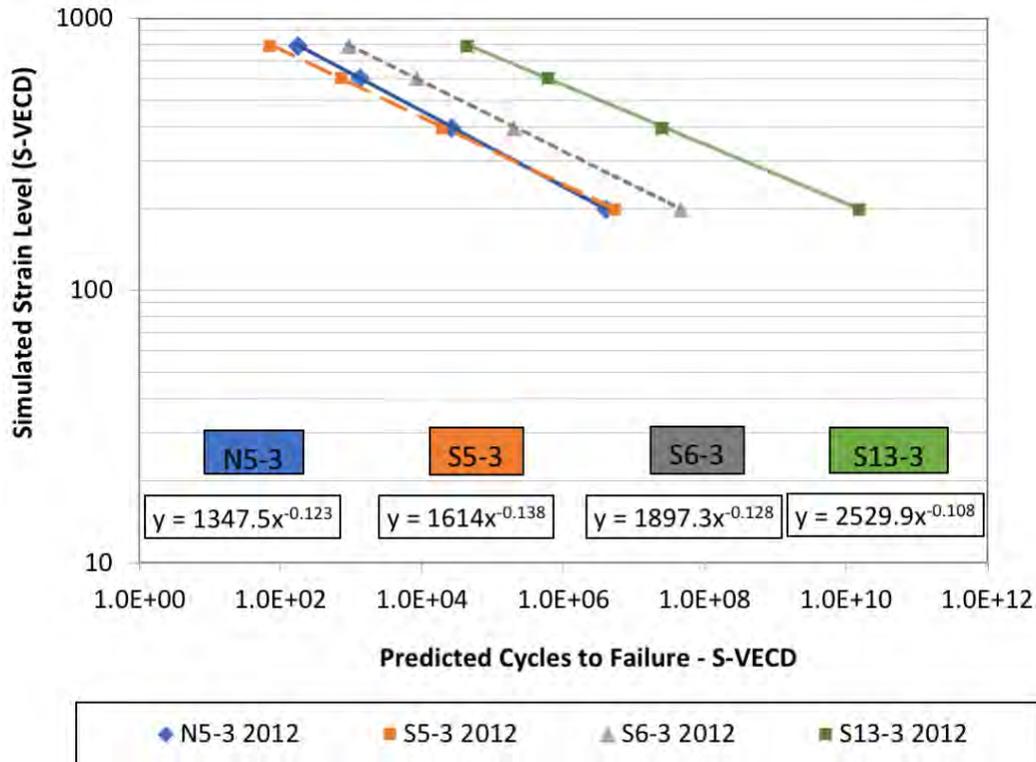
SVECD testing was performed on the bottom layer mixes following the draft procedure developed at North Carolina State University. In this method, at least four fatigue tests (two tests at a relatively high strain input level and two at a relatively low strain input level) were performed at 19°C and at a frequency of 10 Hz. Pseudo stiffness and damage characteristic curves were generated according to the SVECD model. The damage curves combined with the mixture's modulus were used in the ALPHA-F v3.1.3 analysis software to predict the fatigue behavior at other conditions. Results of the SVECD testing and analysis are illustrated in Figure 8. The SVECD results differ from the BBF results in several ways. For this method, the high polymer modified mix from S5 has essentially the same fatigue life as the conventional mix from N5 across all of the simulated strain levels. The SVECD results also indicate that the rich bottom mix from S6 is substantially better than the conventional mix, but the Arizona-style gap-graded asphalt-rubber mix is far superior.

Figure 8 Fatigue Lives of Bottom Layer Mixes from SVECD Testing and Analysis
