NCAT Report 16-04

**PHASE V (2012-2014)
NCAT TEST TRACK FINDINGS**

**National Center for
Asphalt Technology**
NCAT
at AUBURN UNIVERSITY

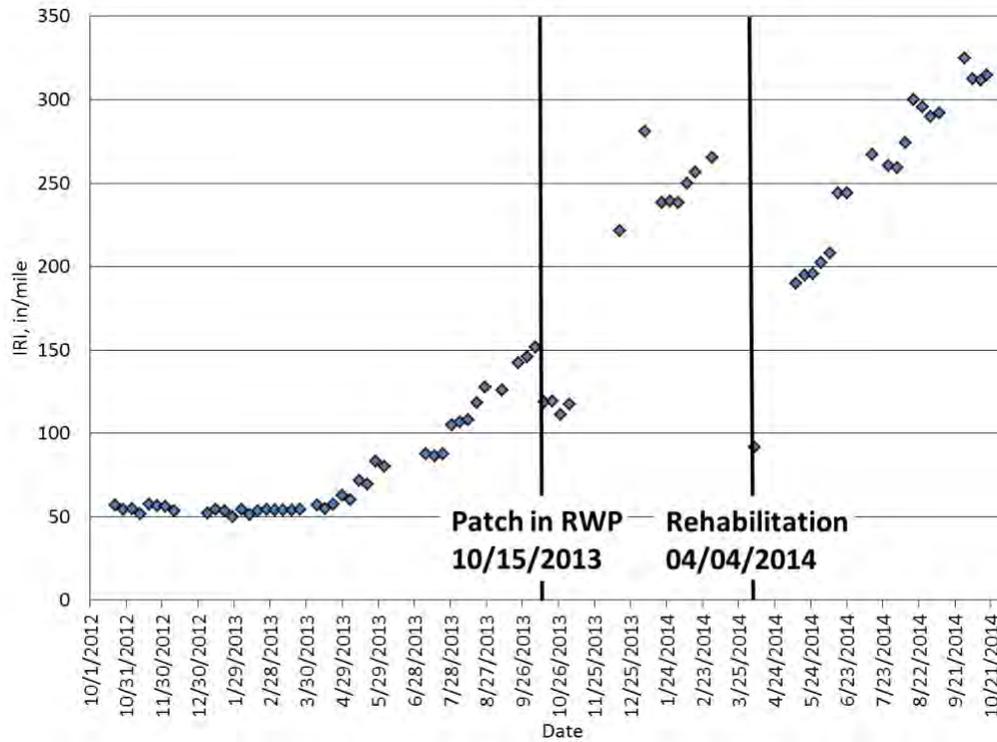
Figure 11 Section N5 (Standard RAP) Surface Performance

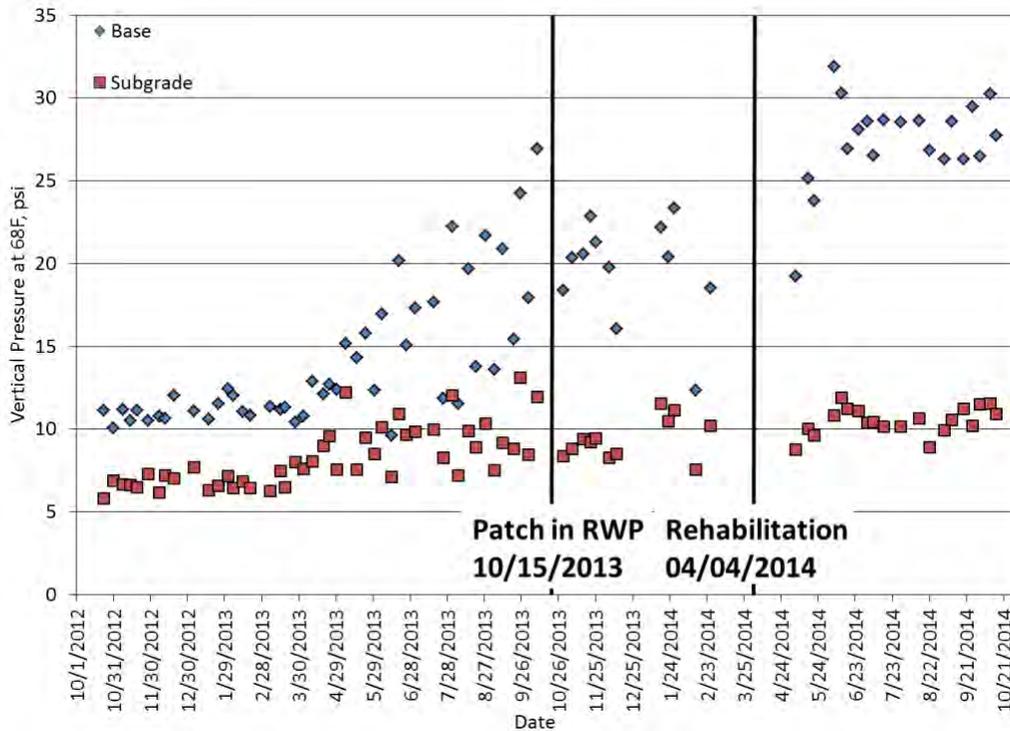
Strain/Pressure Measurements. The temperature-corrected vertical pressures at the top of the base and subgrade are shown in Figure 12. As expected, since the base pressure plate was higher in the pavement structure, it was therefore subjected to greater stress levels. It can be seen that the pressures were fairly consistent before the first crack appeared on April 23, 2013. After the first crack was observed, the base pressure doubled over the next year. There was also a greater amount of scatter in both data sets after the first crack appeared. After rehabilitation on April 4, 2014, the scatter reduced and the pressures were more stable. However, there was a larger difference between the base and subgrade pressures after rehabilitation indicating that despite the temporary rehabilitation restoring the pavement’s surface functionality, the pavement structure was still damaged.

Figure 12 Section N5 (Standard RAP) Vertical Pressure

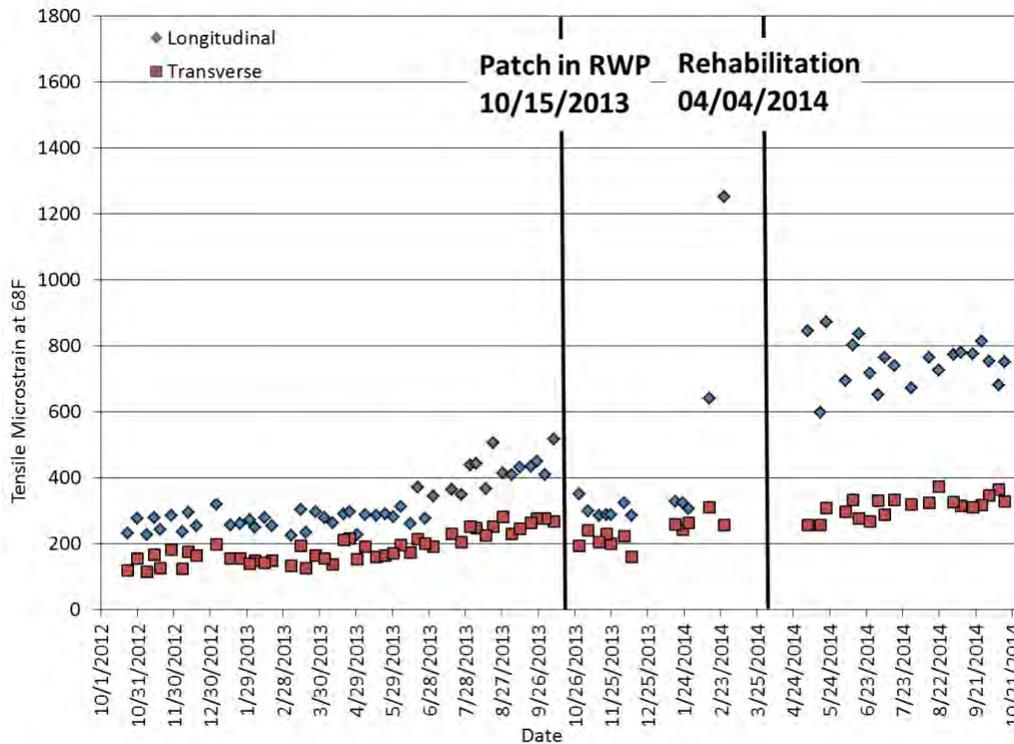
The horizontal strain corrected to a reference temperature of 68°F is presented in Figure 13. As observed in previous Test Track research, the longitudinal strain is greater than the transverse strain throughout the research cycle (6). Longitudinal strain results from bending in the direction of travel while transverse strains are perpendicular to the direction of travel. Both are measured in tension in the horizontal plane at the bottom of the asphalt concrete. It can be seen that the longitudinal strain level steadily increased from October 2012 through September 2013. The longitudinal strain was reduced after the patch was applied in October 2013. In February 2014, strain levels sharply increased until the rehabilitation on April 4, 2014. After rehabilitation, the strain levels became more consistent.

Figure 13 Section N5 (Standard RAP) Horizontal Strain

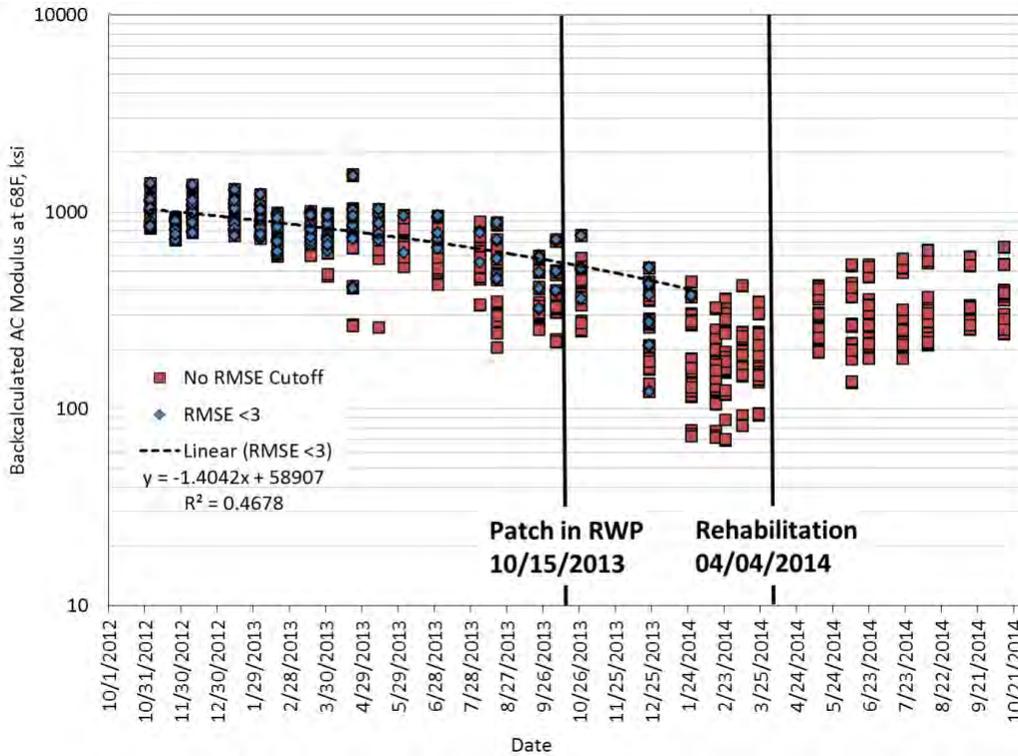
The backcalculated composite AC modulus (at a reference temperature of 68°F) versus time is presented in Figure 14. Modulus values are presented with and without the 3% RMSE cutoff to show when the section was no longer behaving like a homogenous, linear-elastic material. It can be seen that from October 2012 through February 2013 the modulus was fairly stable and there were no moduli values that had an RMSE above 3%. Beginning in March 2013, there were backcalculated moduli values with an RMSE above 3% (shown as red boxes without a blue diamond marker on top). As traffic continued and the pavement accrued damage, there were fewer and fewer data points with an RMSE less than 3% until February 2014 when there were no data points below 3%. Even after rehabilitation, there were no data points with an RMSE below 3%, indicating that although the surface functionality had been temporarily restored, the pavement structure was still damaged. The variation on a given testing date is also worth noting. In the beginning of the cycle the moduli values had a relatively tight distribution on a given date. As the section became more damaged the variation on a given testing date also increased. Prior to the first crack appearing in April 2013, the modulus was only slightly decreasing with time and traffic. After that point in time, the effect of cracking on modulus degradation was much more pronounced.

Figure 14 Section N5 (Standard RAP) Backcalculated FWD Results

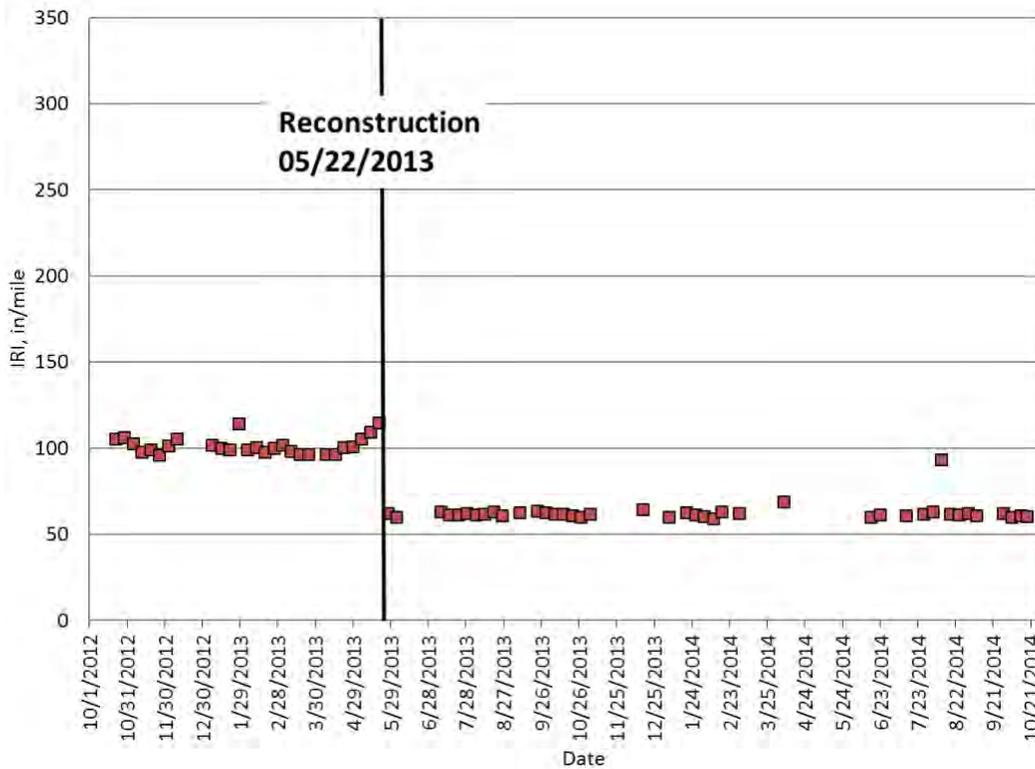
Figure 18 Section S5 (High RAP) Surface Performance

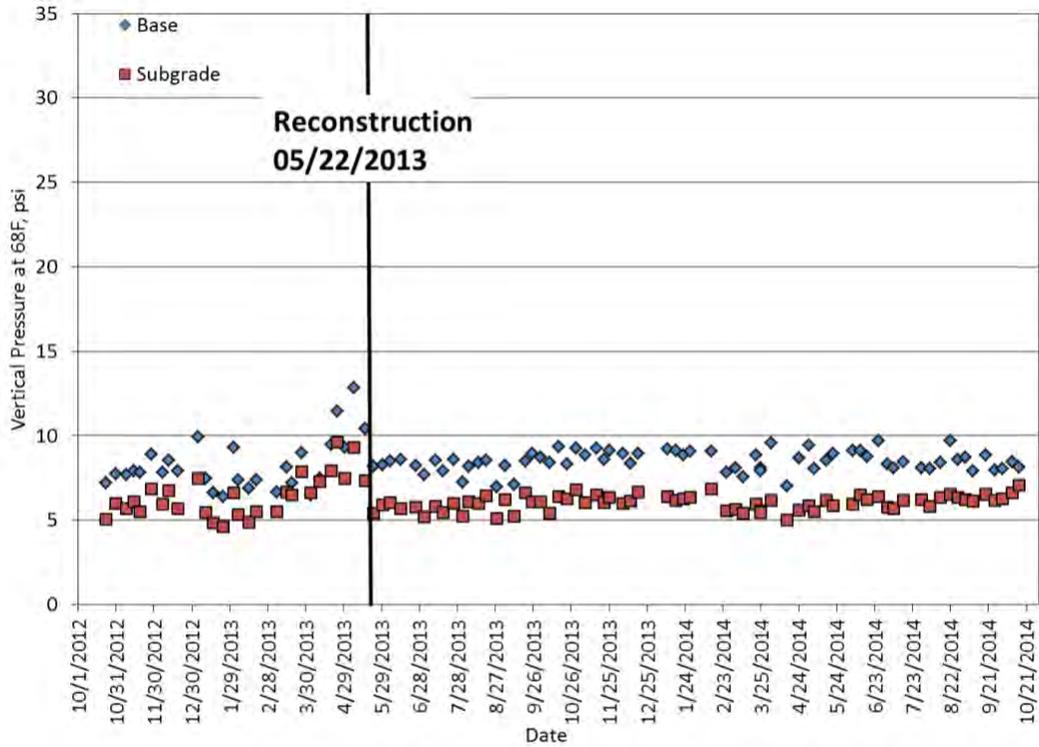
Figure 19 Section S5 (High RAP) Vertical Pressure

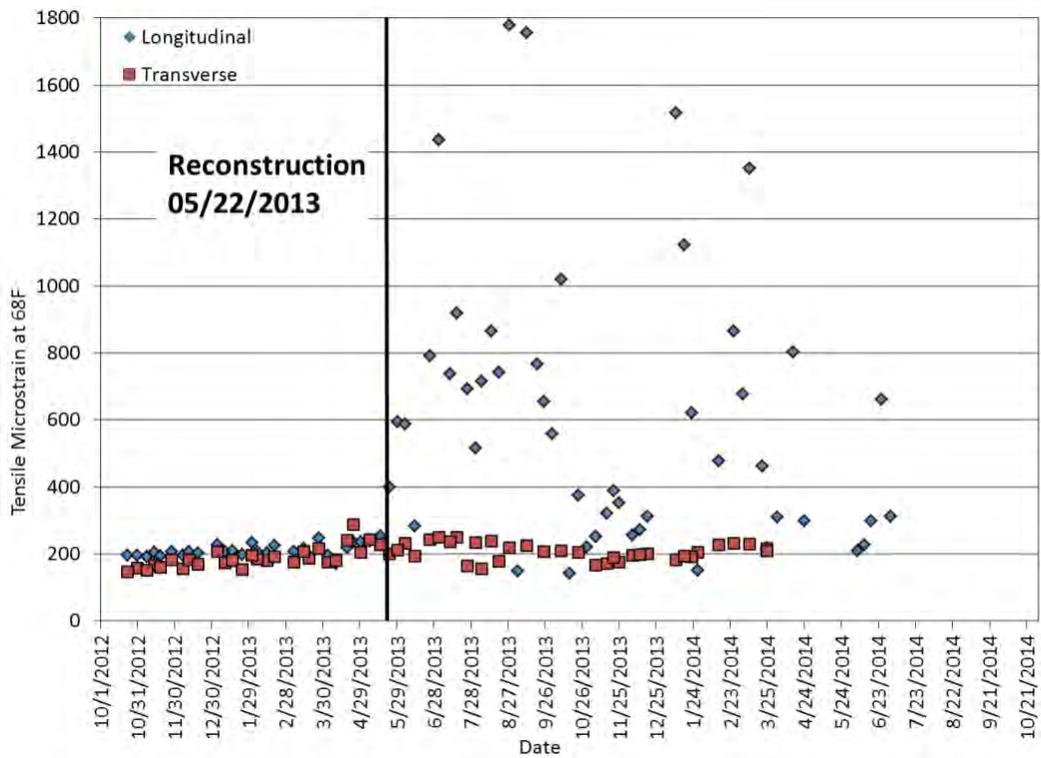
The horizontal strain, at a reference temperature of 68°F, at the bottom of the AC is shown in Figure 20. Prior to April 2013, the strain levels were drifting up slightly. After reconstruction, the transverse strain level stayed fairly constant over time. The longitudinal strain data were erratic after reconstruction indicating gauge damage during reconstruction. It should also be noted that there were no working transverse gauges past March 25, 2014 and no working longitudinal gauges past July 2014.

Figure 20 Section S5 (High RAP) Horizontal Strain

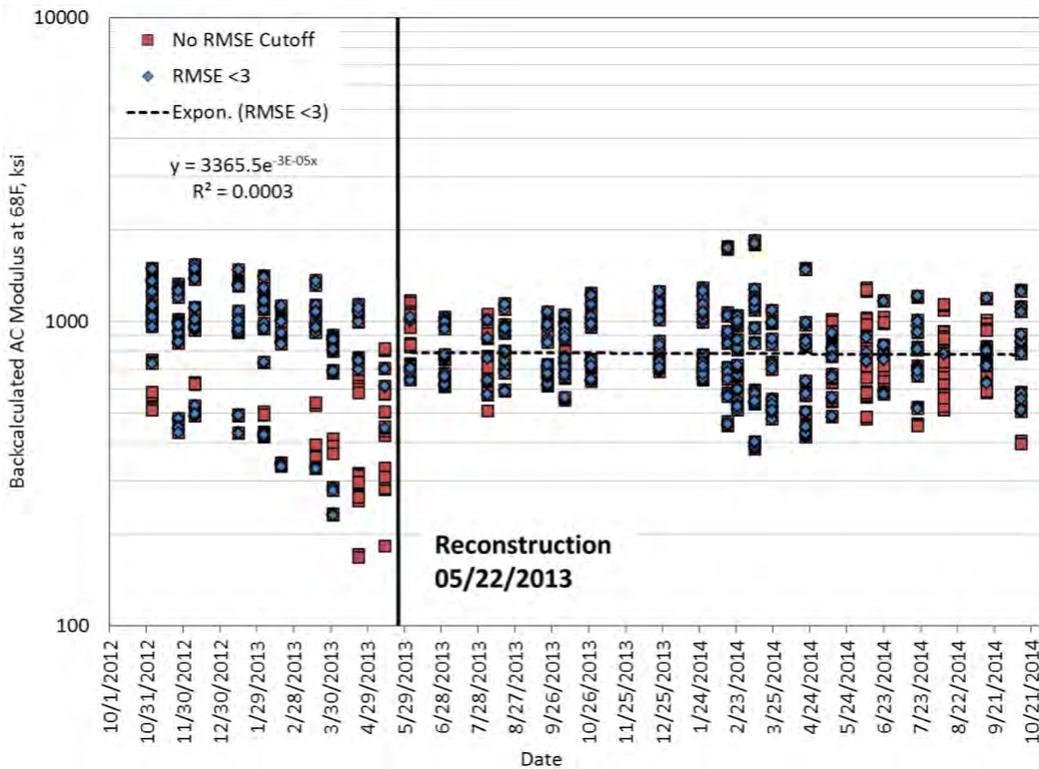
Backcalculated Moduli. It can be seen in the temperature-corrected backcalculated asphalt moduli versus time plot, presented in Figure 21, that the asphalt pavement stiffness was decreasing with traffic from the beginning of traffic until reconstruction, indicating accumulated damage to the pavement structure. The backcalculated moduli also had greater variability prior to reconstruction. After reconstruction, the modulus stayed relatively constant as shown by the low R^2 .

Figure 21 Section S5 (High RAP) Backcalculated FWD Results

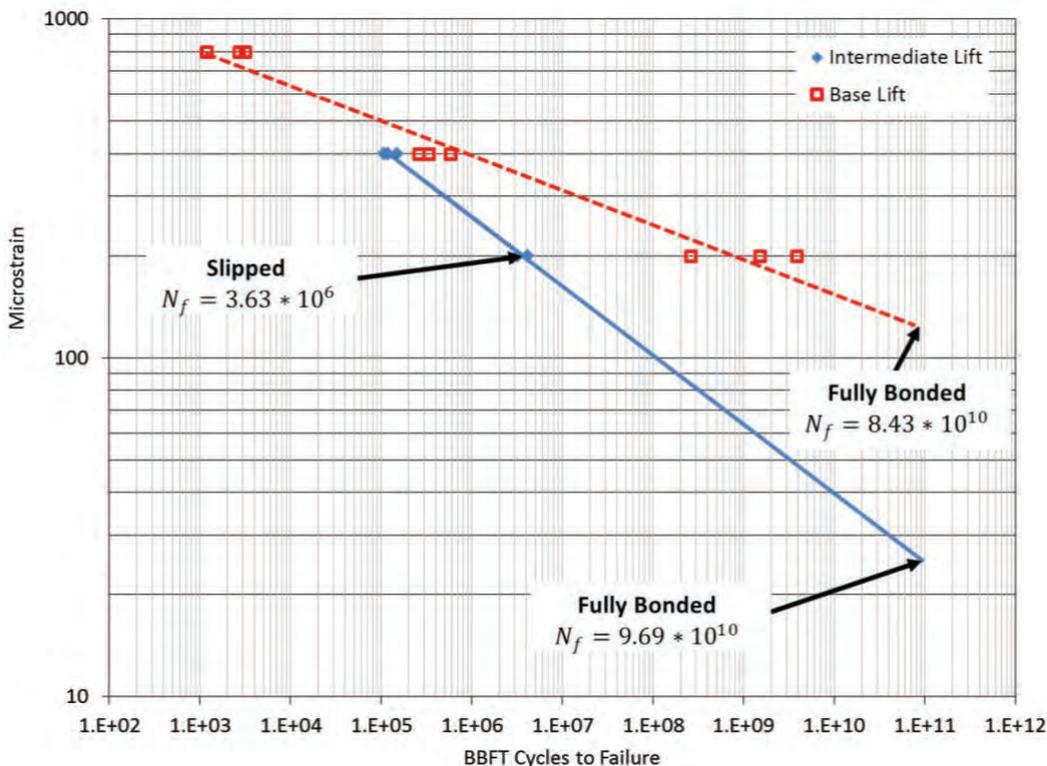
Figure 24 BBFT Results for Section S5 (High RAP) (1)

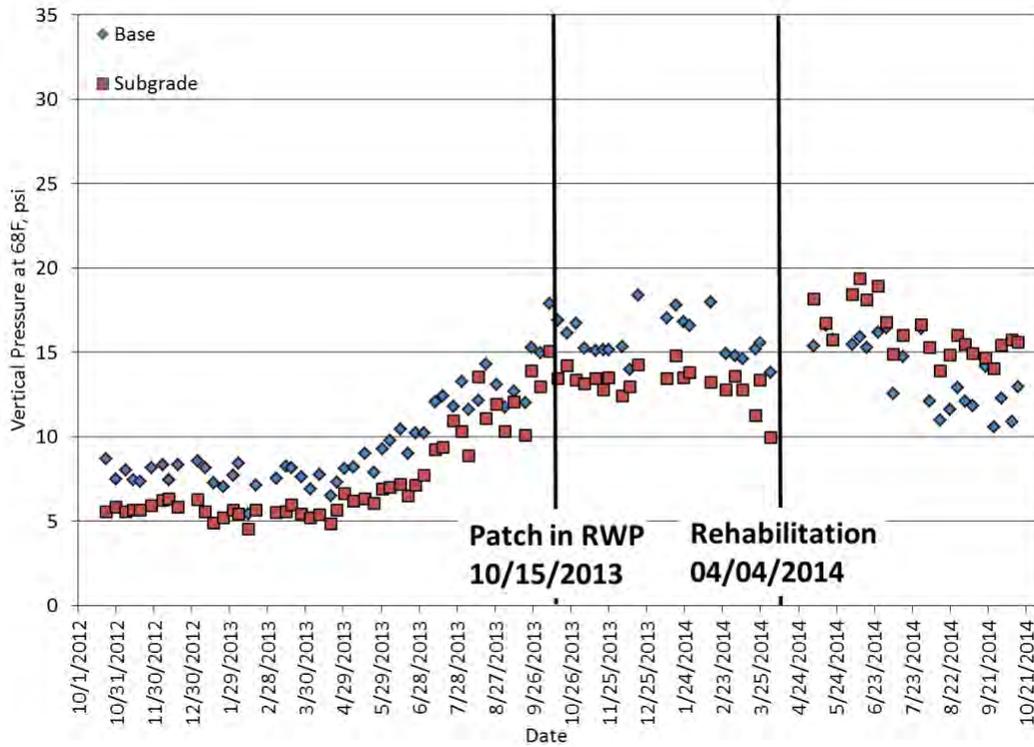
Figure 28 Section S6 (RAP/RAS) Vertical Pressure

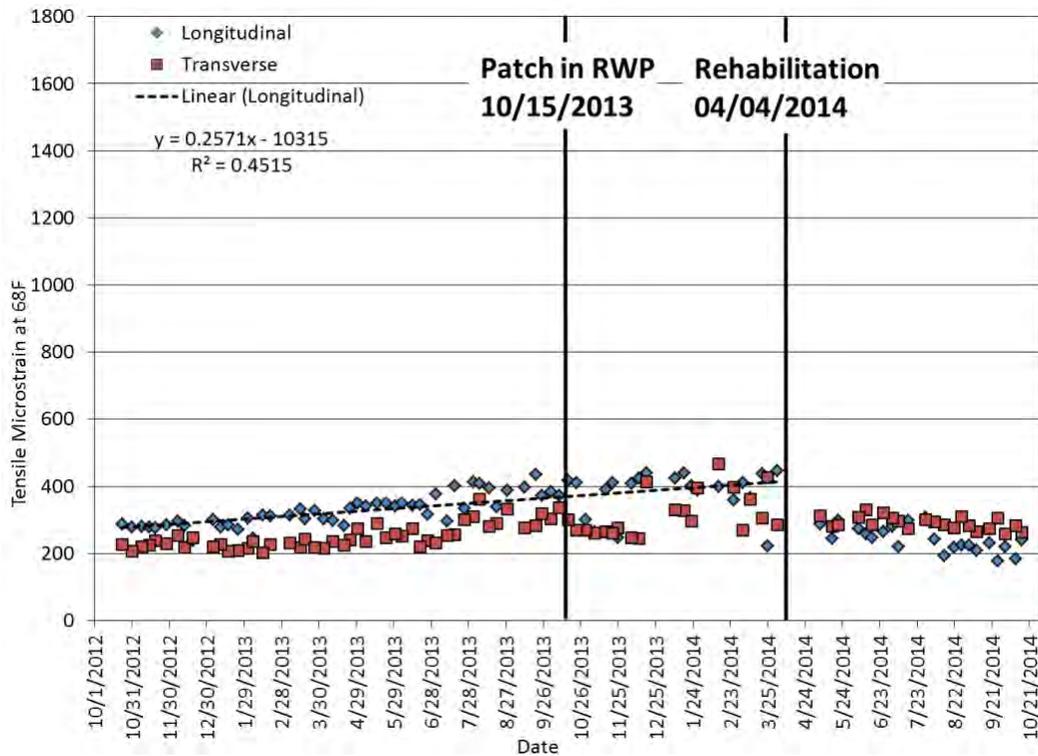
In Figure 29, the longitudinal and transverse strains both steadily increased prior to rehabilitation as illustrated by the trend line. Initially there was some separation between the strain levels for longitudinal and transverse gauges however as traffic continued and damage accrued in the section there were times when the longitudinal strain was less than the transverse. After rehabilitation, all of the longitudinal strains were less than the transverse strains. This is an indication that damage has occurred in the pavement because the section is behaving differently than it did in the initial, undamaged condition.

Figure 29 Section S6 (RAP/RAS) Horizontal Strain

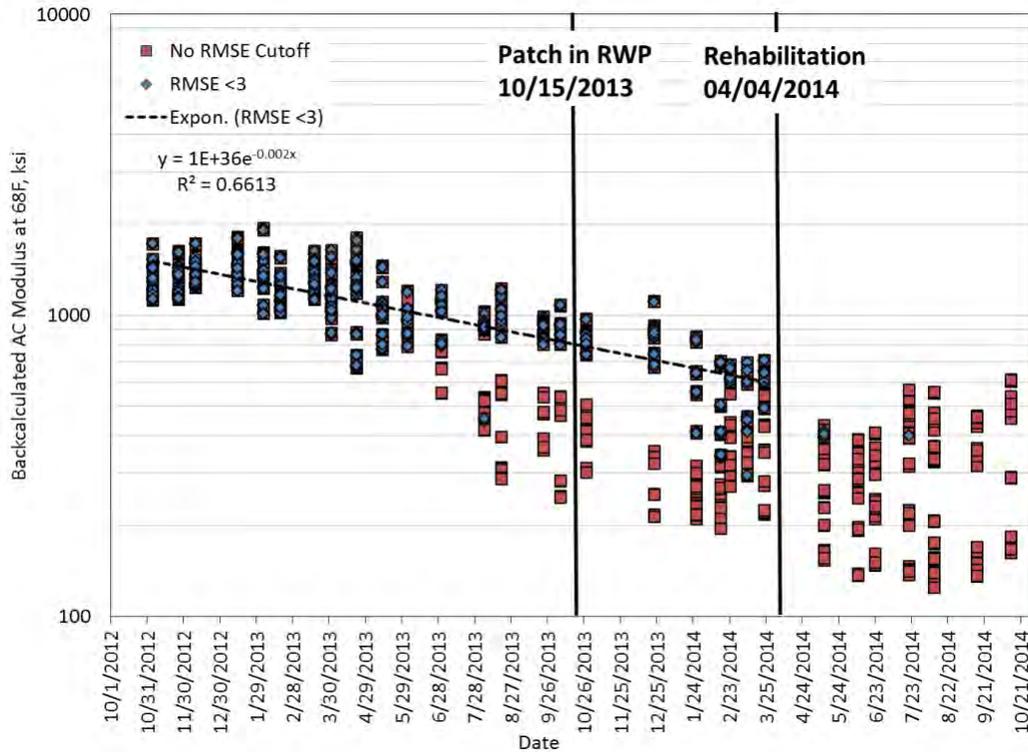
Backcalculated Moduli. It can be seen in the temperature-corrected backcalculated modulus plot (Figure 30) for Section S6 (RAP/RAS) that the moduli values were relatively stable until around the time the first crack was observed in June 2013. After June 2013, the number of data points with an RMSE above 3% increased. After rehabilitation on April 4, 2014, only two data points had an RMSE below 3%. Again, this is a strong indication that the rehabilitation did not fully improve the entire structure.

Figure 30 Section S6 (RAP/RAS) Backcalculated FWD Results

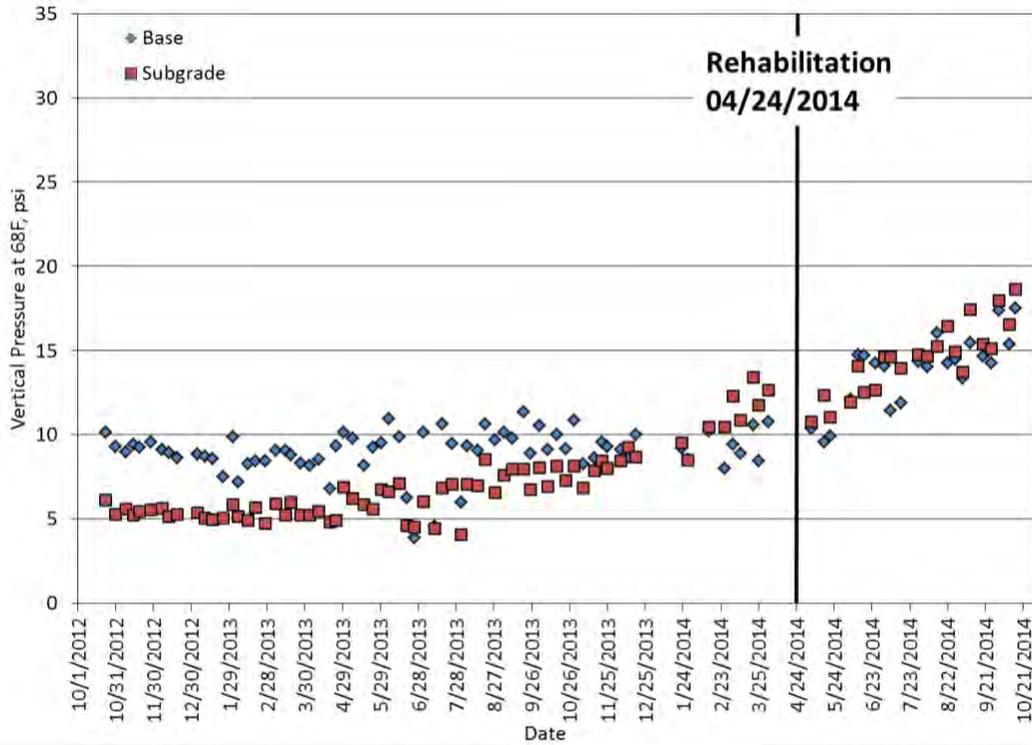
Strain/Pressure Measurements. It can be seen in Figure 37 that the temperature-corrected vertical pressures were fairly constant early in the research cycle. The subgrade pressure steadily increased beginning in summer 2013. By January 2014, the subgrade pressure was higher than the base pressure. After rehabilitation, the base and subgrade pressures both showed an increasing trend. These observations are consistent with the performance data presented above in that distress began to initially accrue and was not fully rectified by the rehabilitation.

Figure 37 Section S13 (GTR) Vertical Pressure

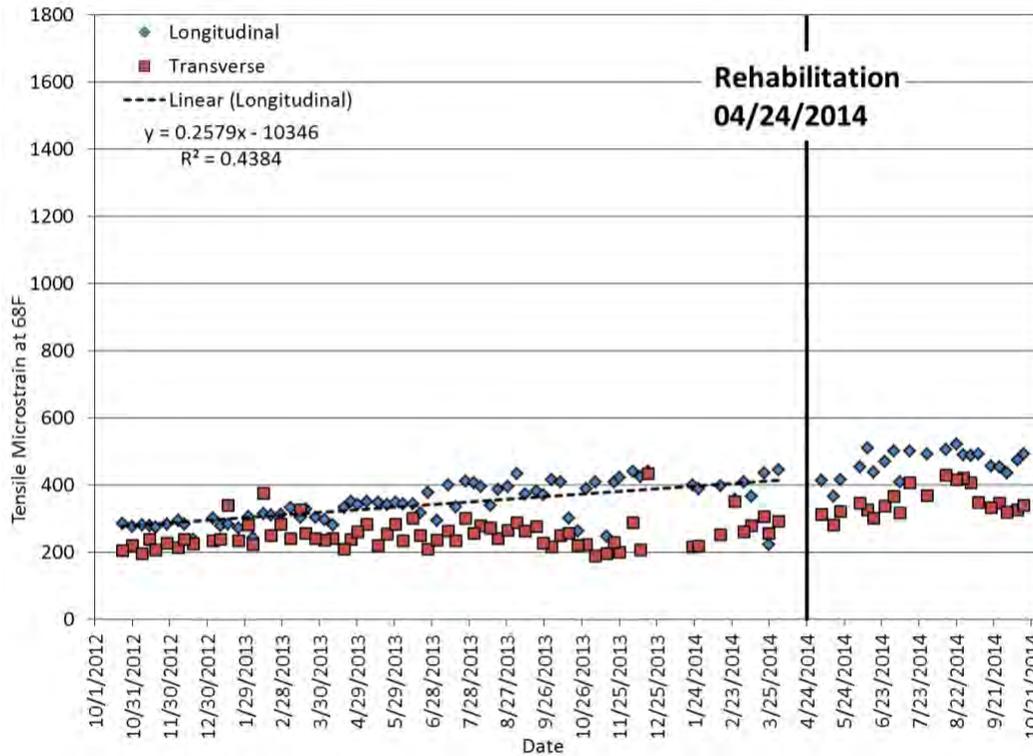
The transverse and longitudinal strains at a reference temperature of 68°F are provided in Figure 38. The longitudinal started below 300 $\mu\epsilon$ in October 2012 and steadily increased to almost 500 $\mu\epsilon$ by the end of the research cycle. The transverse strain followed a similar trend; it began the research cycle around 200 $\mu\epsilon$ and ended around 400 $\mu\epsilon$. The strain responses increased consistently throughout the research cycle despite the rehabilitation. Again, this is indicative of pavement damage development not fully being rectified by the 1.75-inch rehabilitation.

Figure 38 Section S13 (GTR) Horizontal Strain

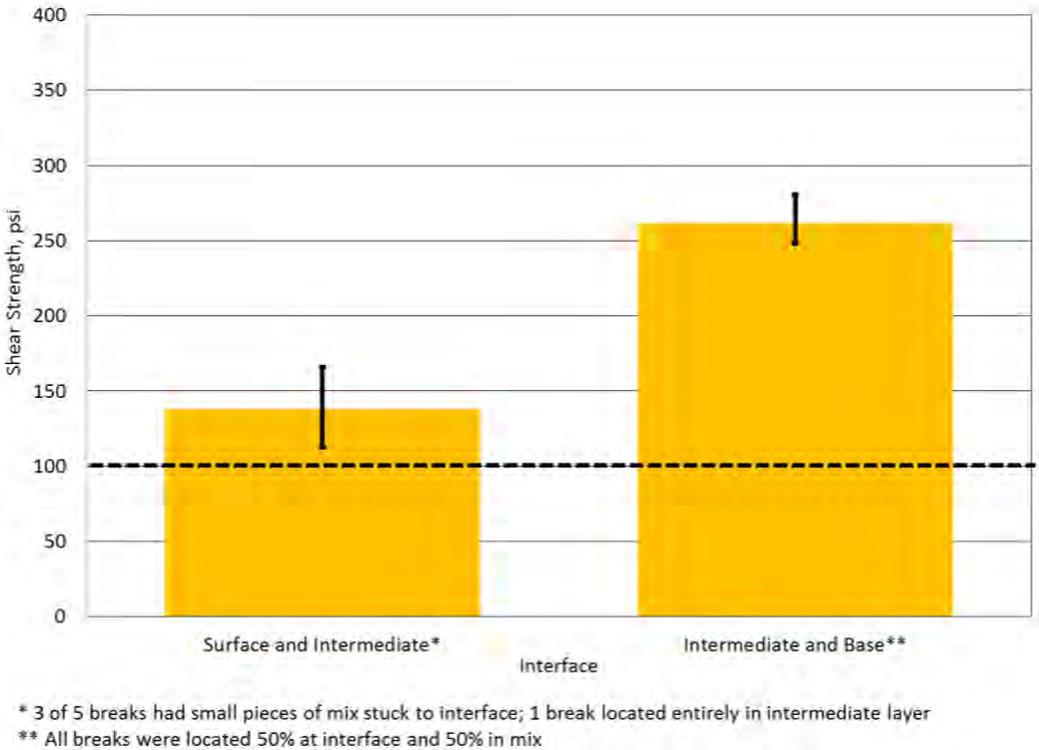
Figure 41 Bond Strength Testing Results for Section S13 (GTR)

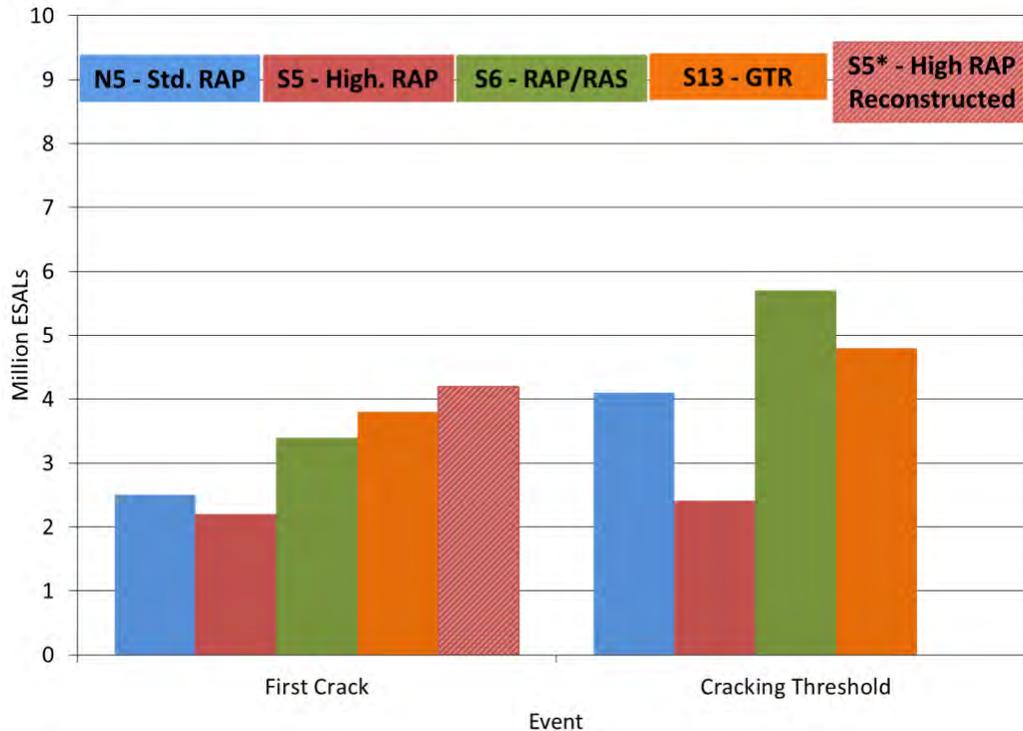
Figure 43 Green Group Cracking Comparison

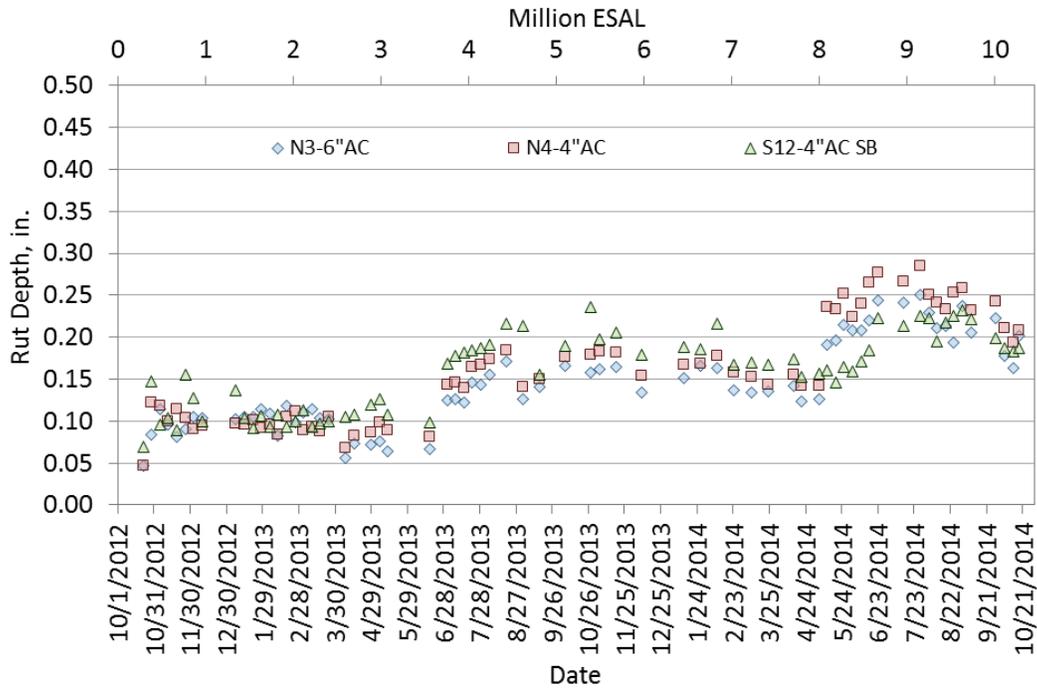
Figure 2 Rutting Performance

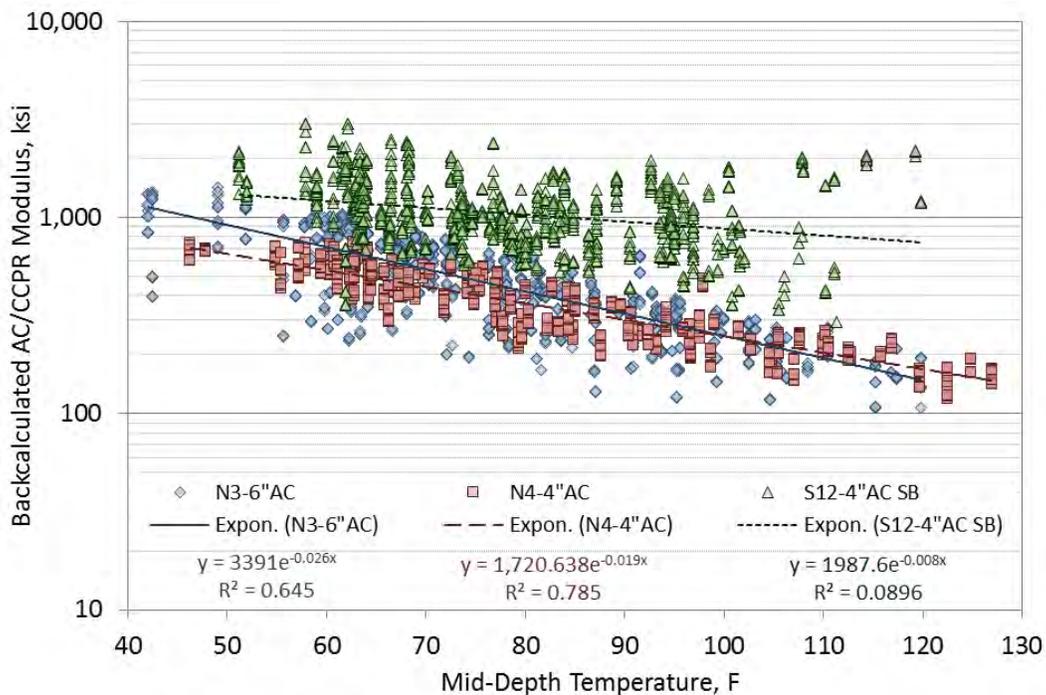
Figure 4 Backcalculated AC/CCPR Modulus vs. Temperature

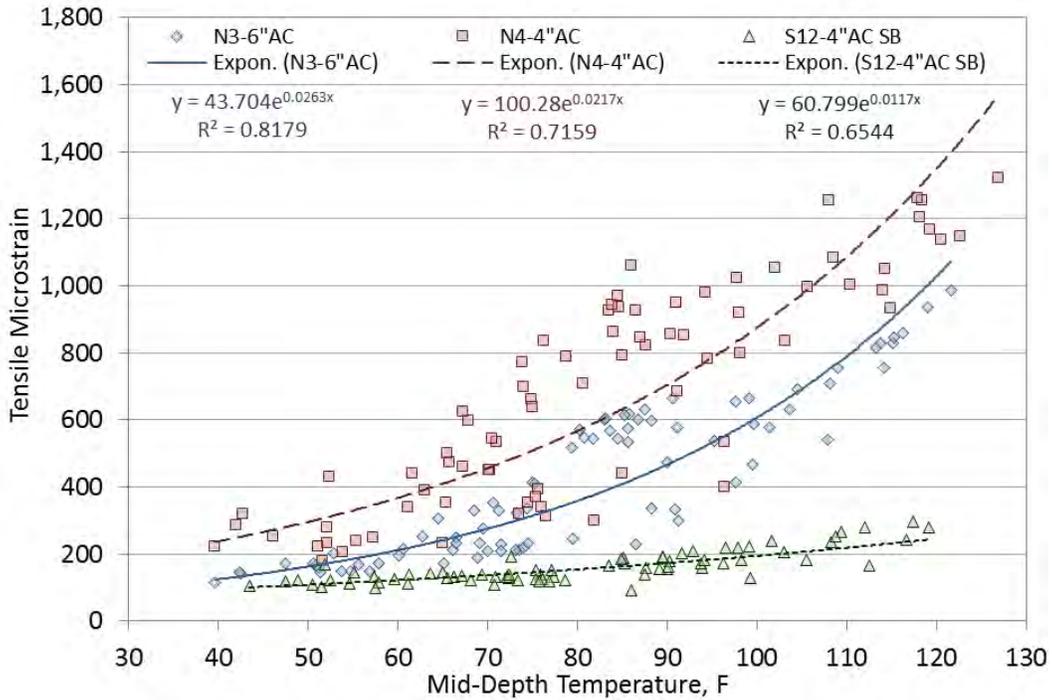
Figure 6 Tensile Strain at the Bottom of the CCPR Layer vs. Temperature

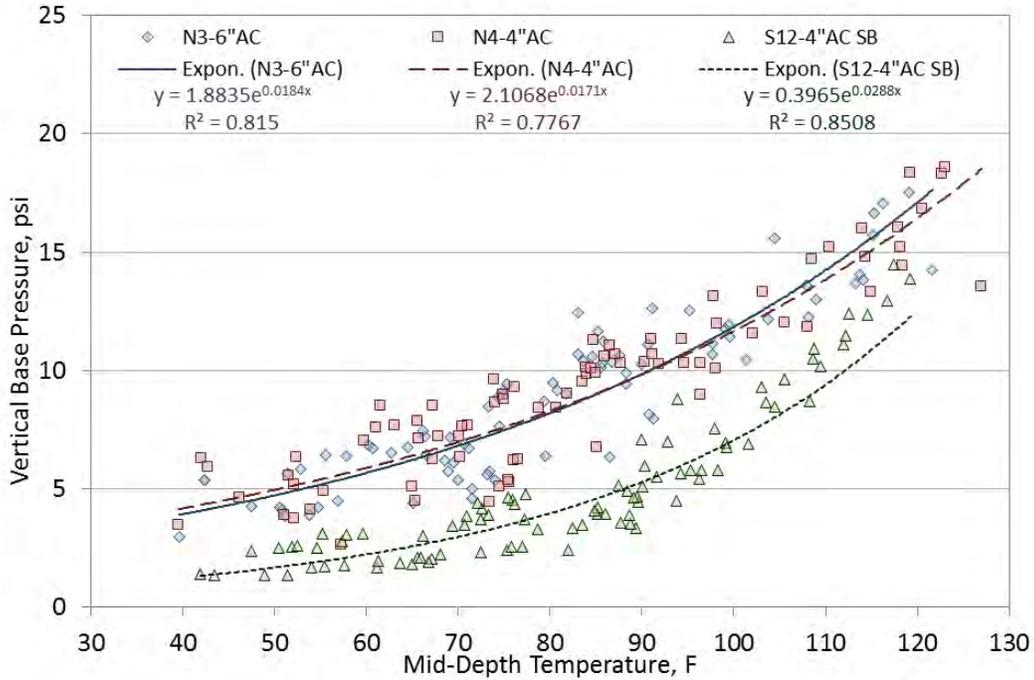
Figure 8 Base Pressure vs. Temperature

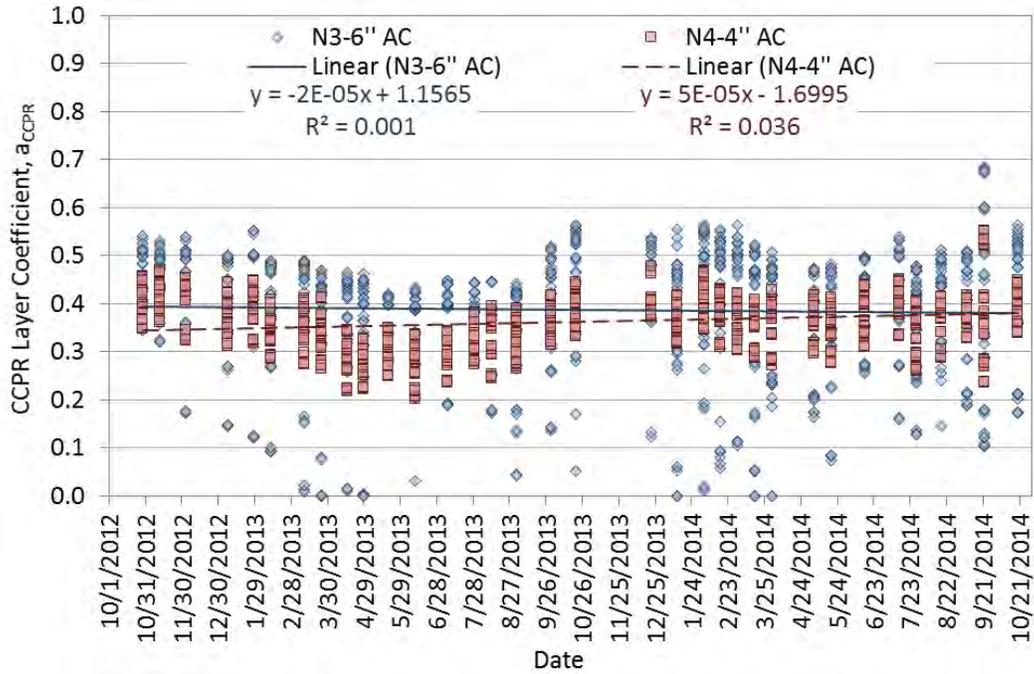
Figure 12 Structural Coefficient vs. Date/Traffic

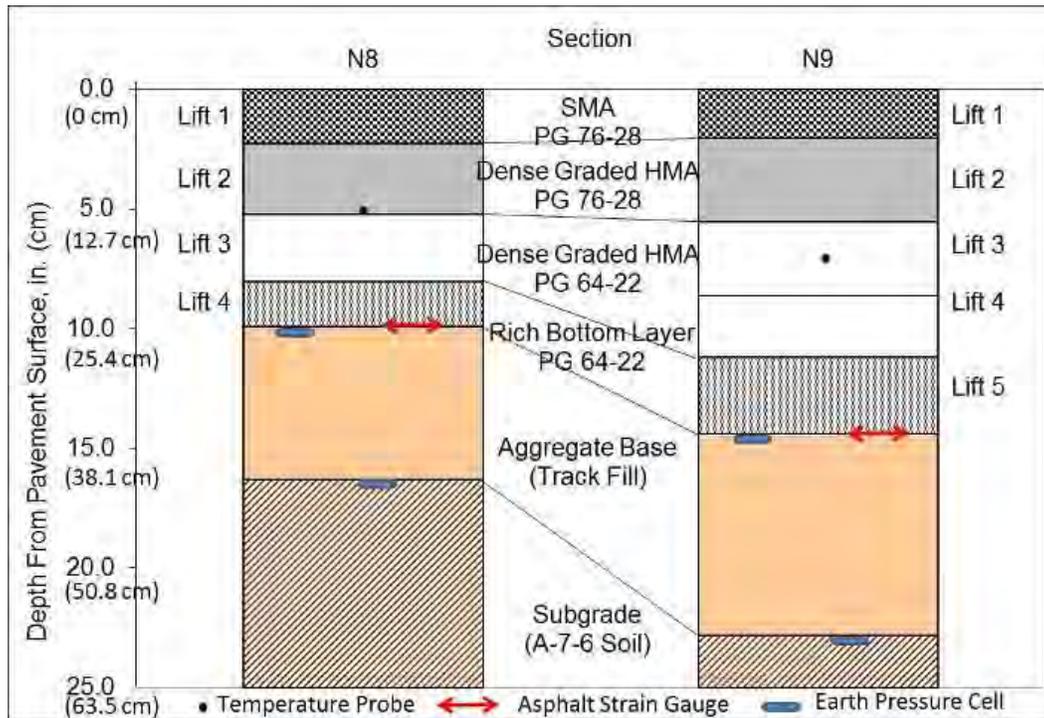
Figure 1 Structural Cross Sections and Instrumentation (1)

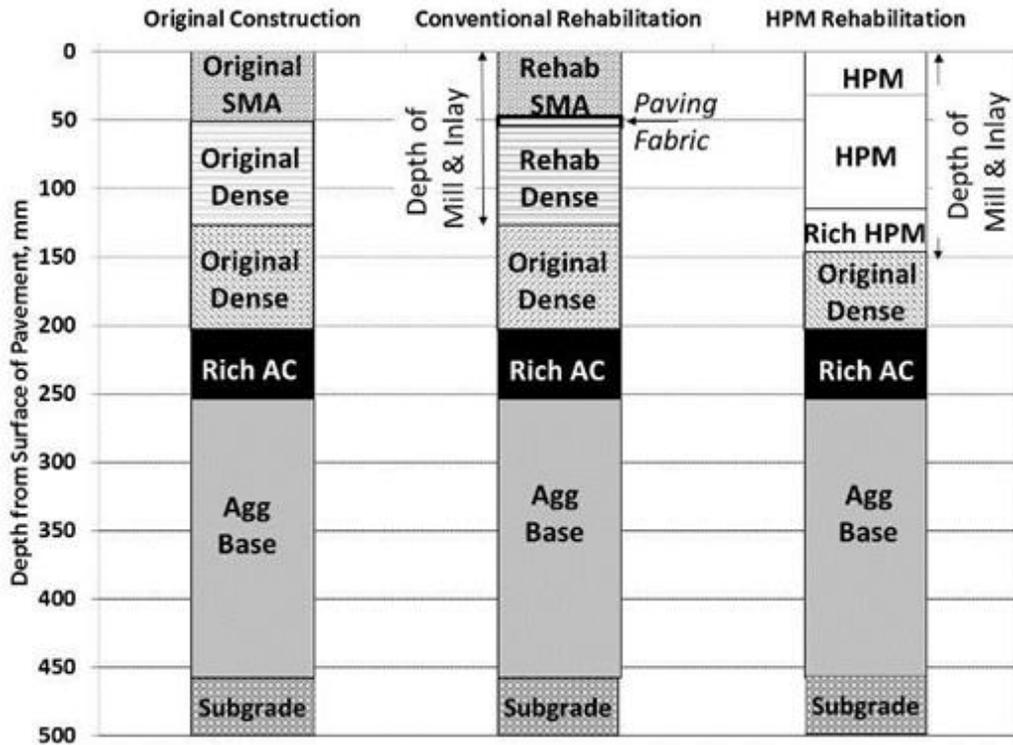
Figure 2 N8 Cross Section History (3)

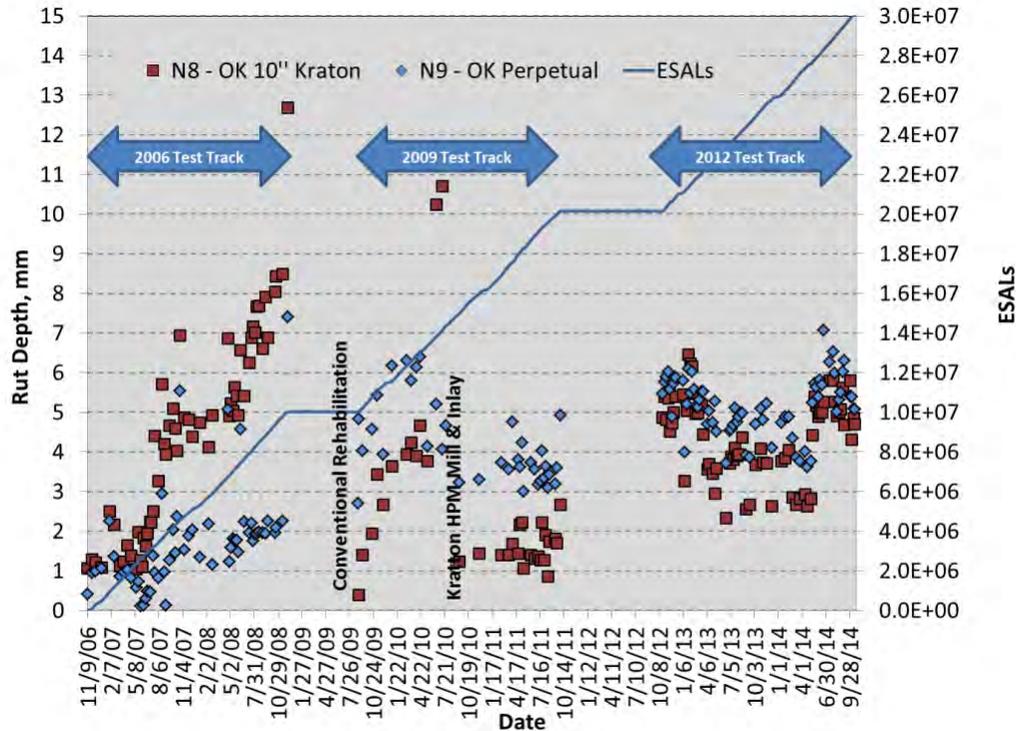
Figure 3 Rutting Progression Versus ESALs

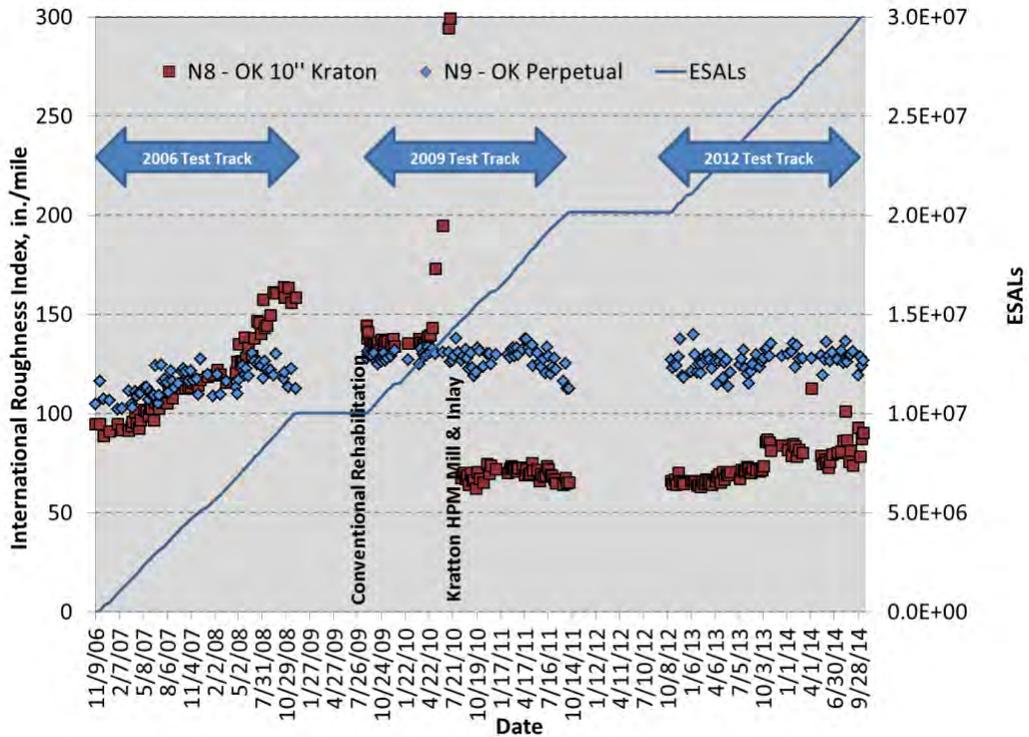
Figure 4 IRI Evaluation of Oklahoma Perpetual Pavement Sections

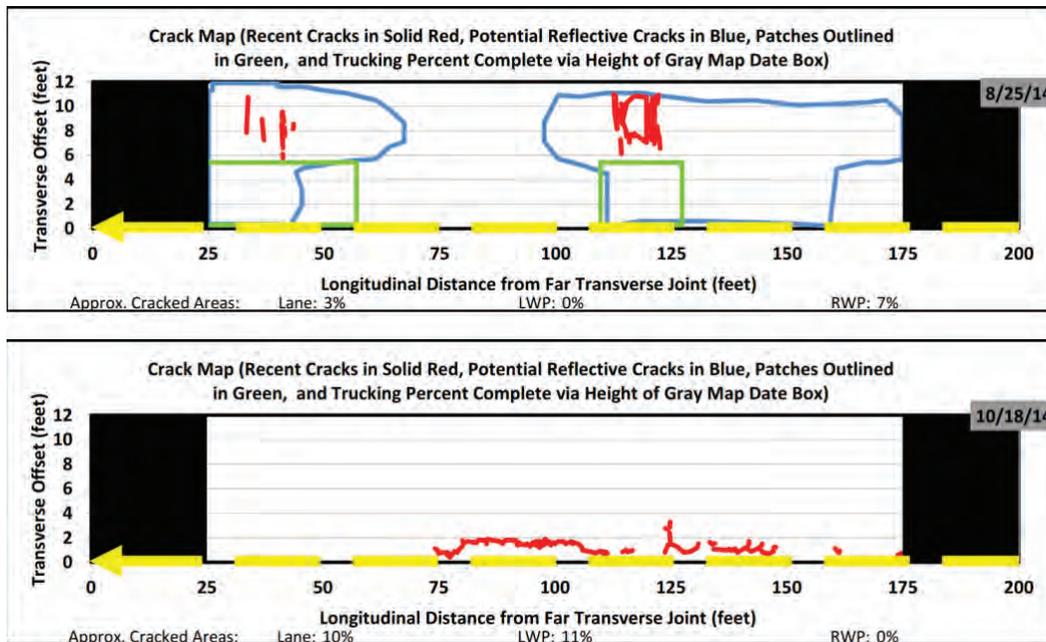
Figure 5 Cracking in Sections N8 (Top) and N9 (Bottom)

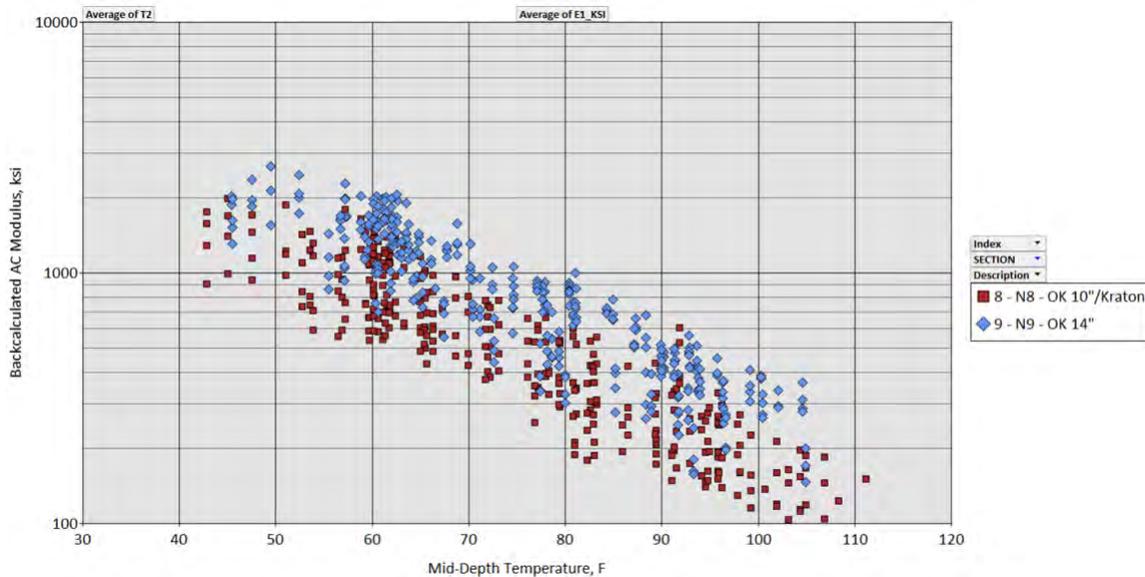
Figure 6 Backcalculated AC Modulus Versus Temperature
