NCAT Report 16-04

**PHASE V (2012-2014)
NCAT TEST TRACK FINDINGS**

**National Center for
Asphalt Technology**
NCAT
at AUBURN UNIVERSITY

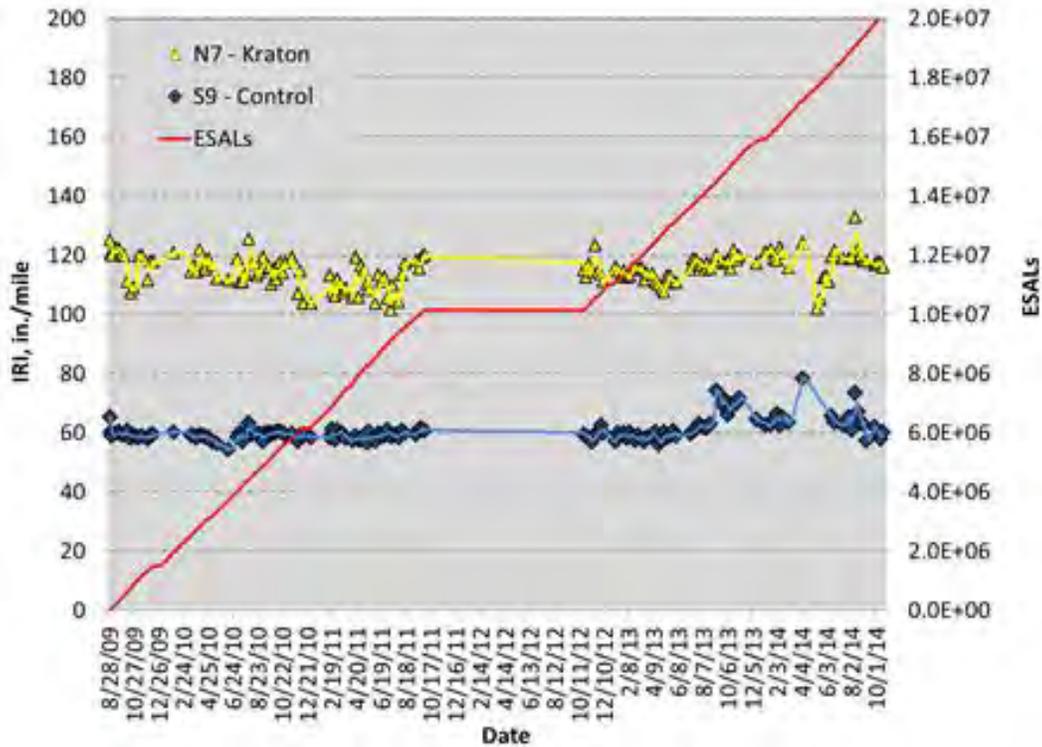
Figure 2 Kraton HPM Roughness Versus Time

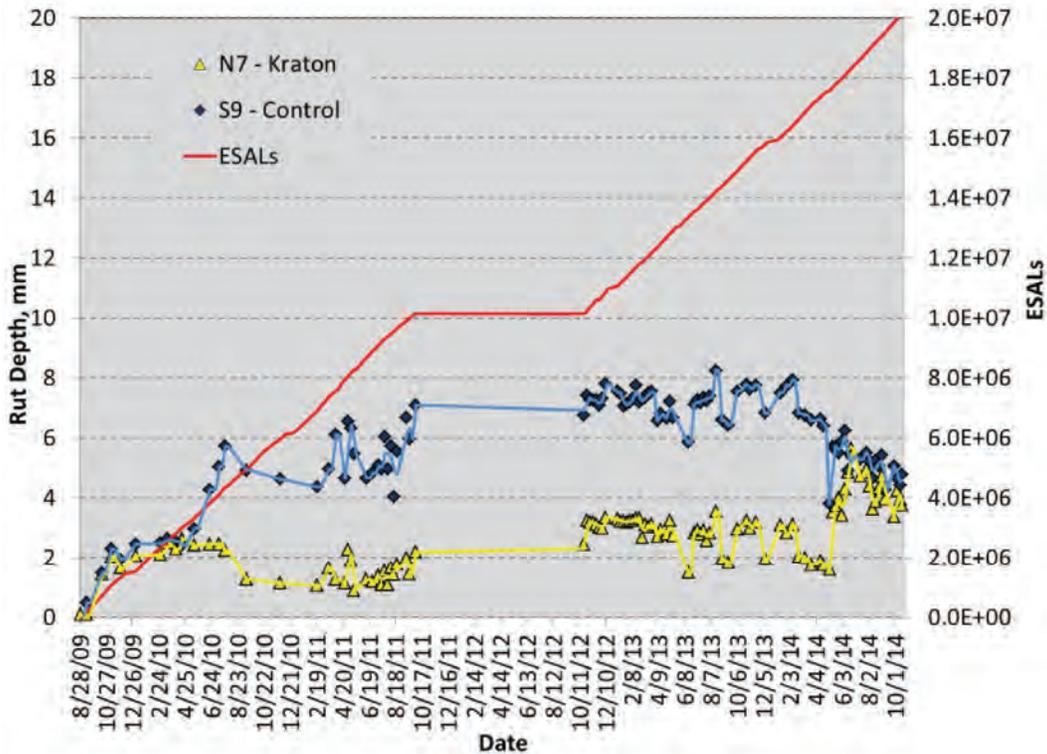
Figure 3 Kraton HPM Rutting Versus Time

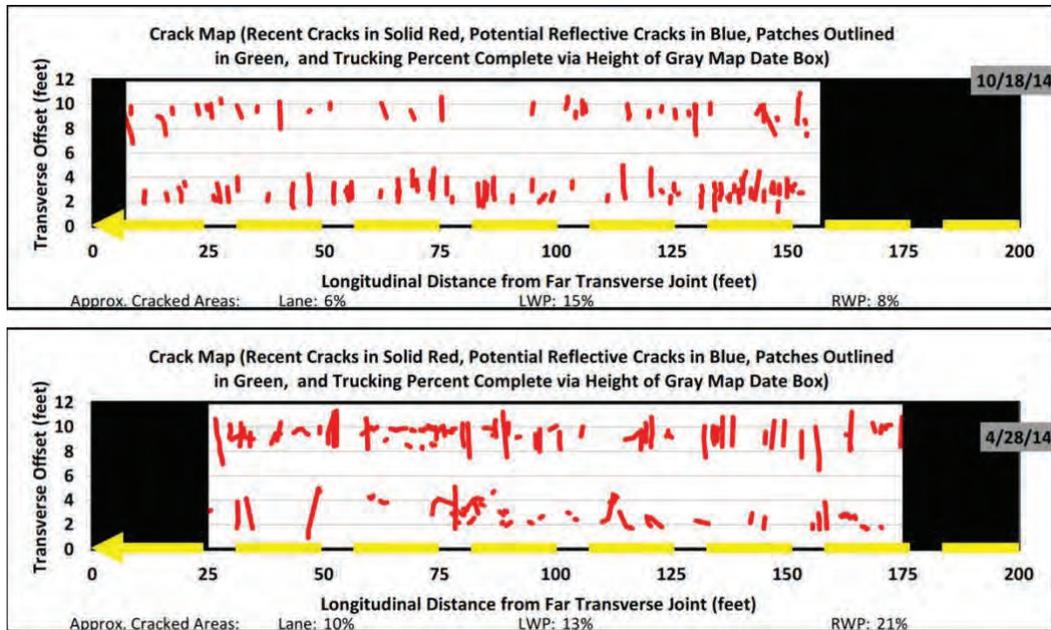
Figure 4 Crack Maps for HiMA in October 2014 (Top) and Control (Bottom) in April 2014

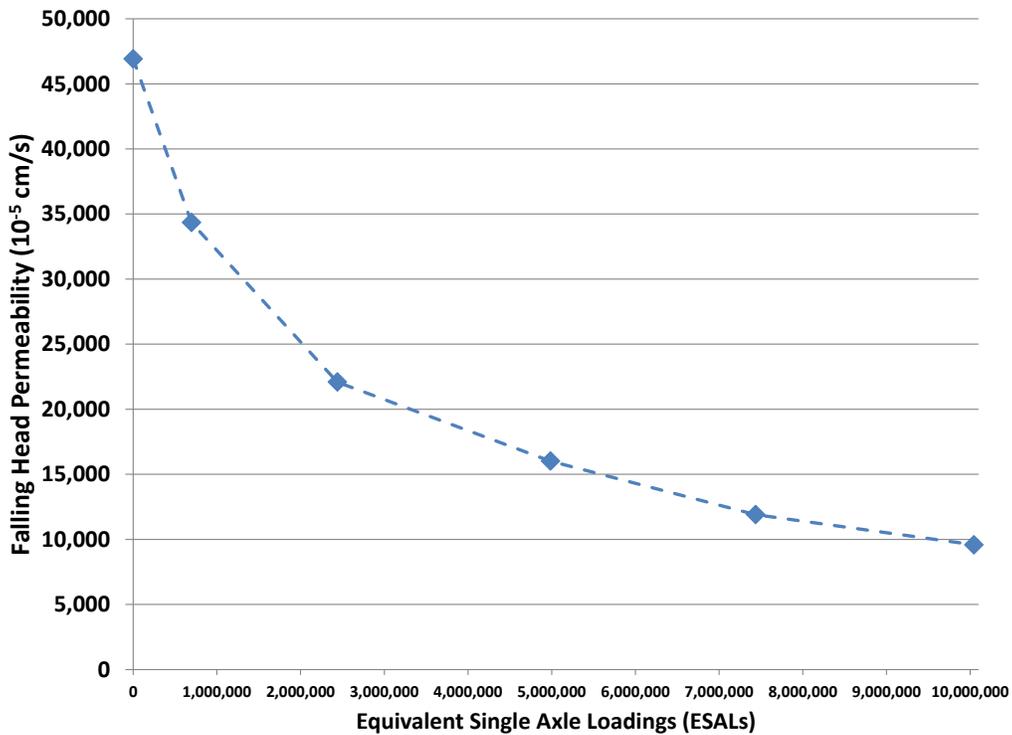
Figure 3 Reduction in Field Permeability Due to Time and Traffic

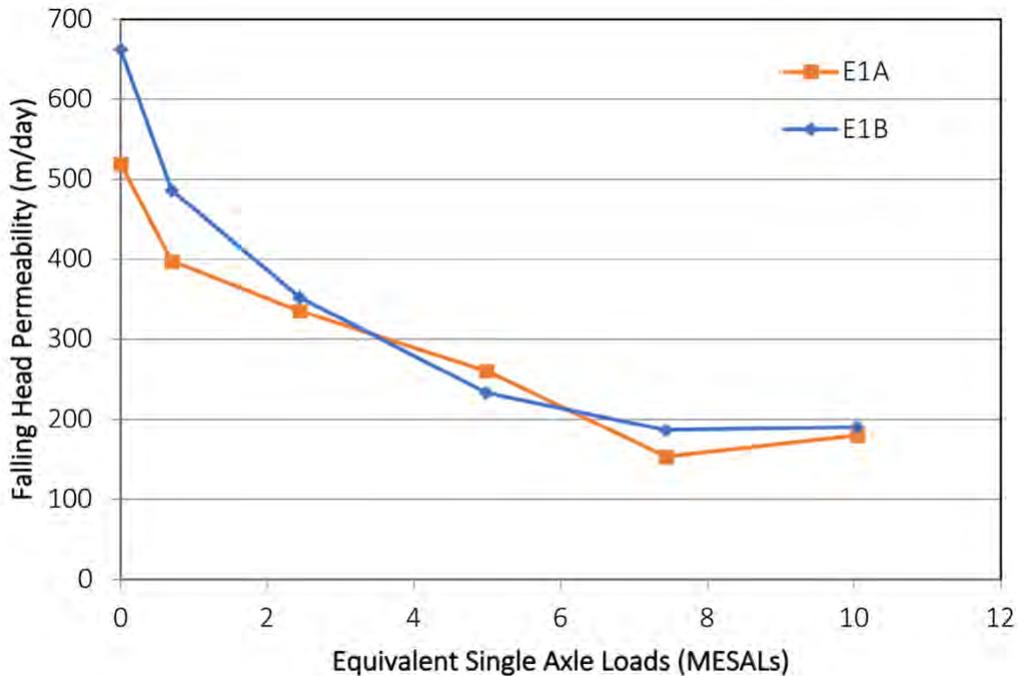
Figure 4 Field Permeability Measurements for Sections E1A and E1B

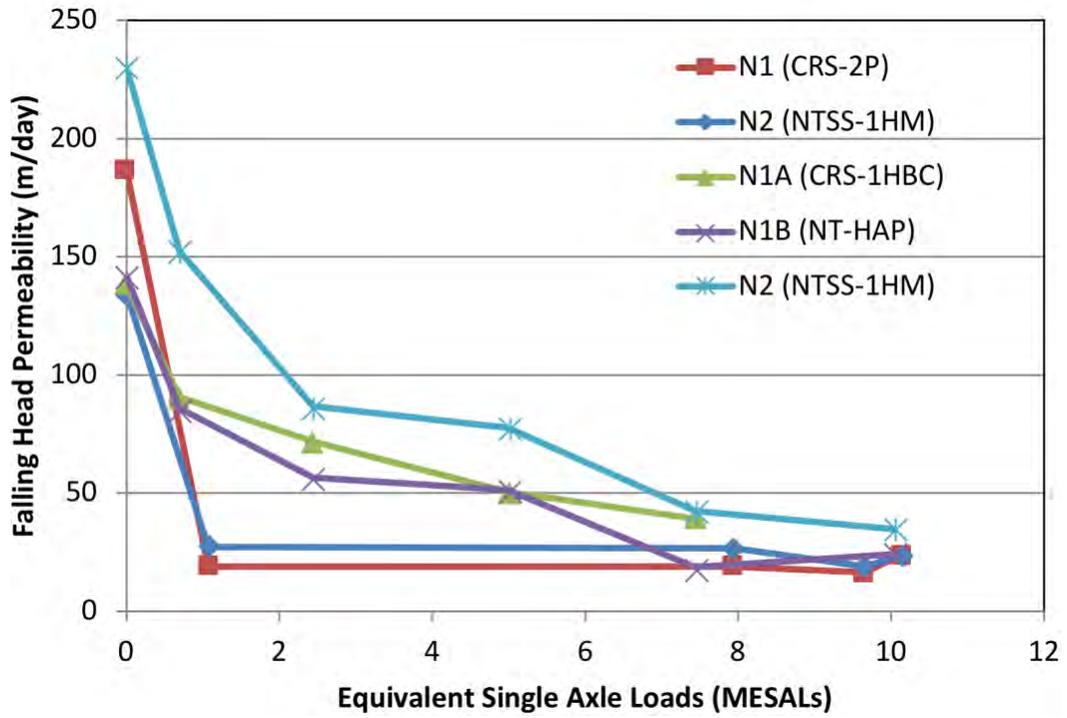
Figure 10 Field Permeability Testing Results

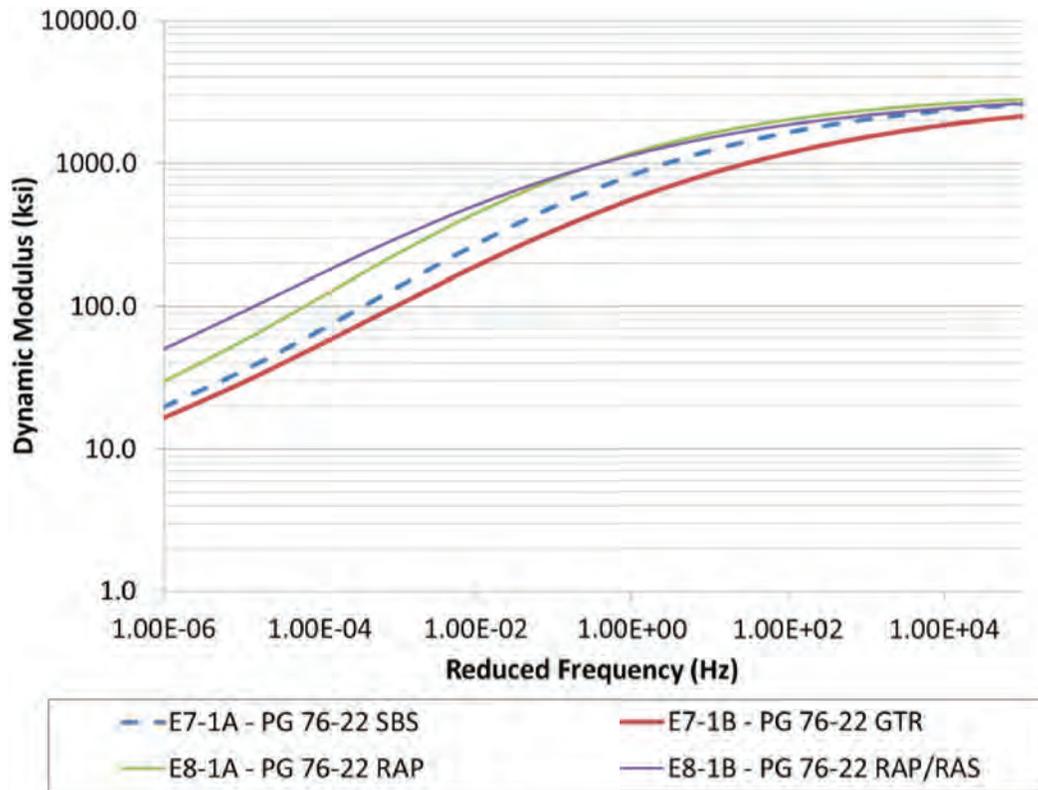
Figure 1 FDOT Cracking Study Master Curves

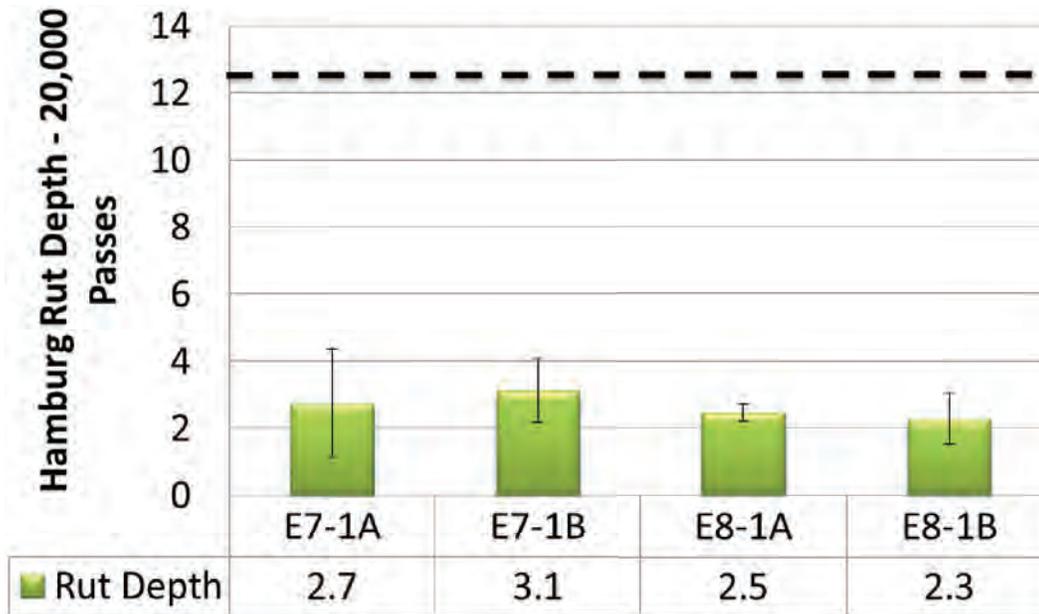
Figure 2 FDOT Cracking Study Hamburg Results

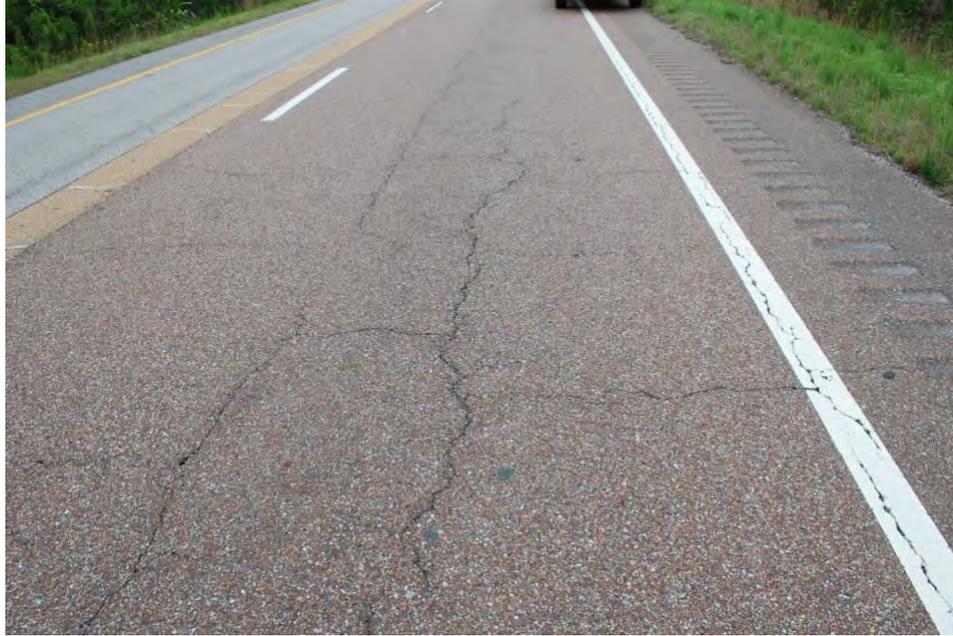
Figure 2 S2 45% RAP Mix After More Than 17 Million ESALs

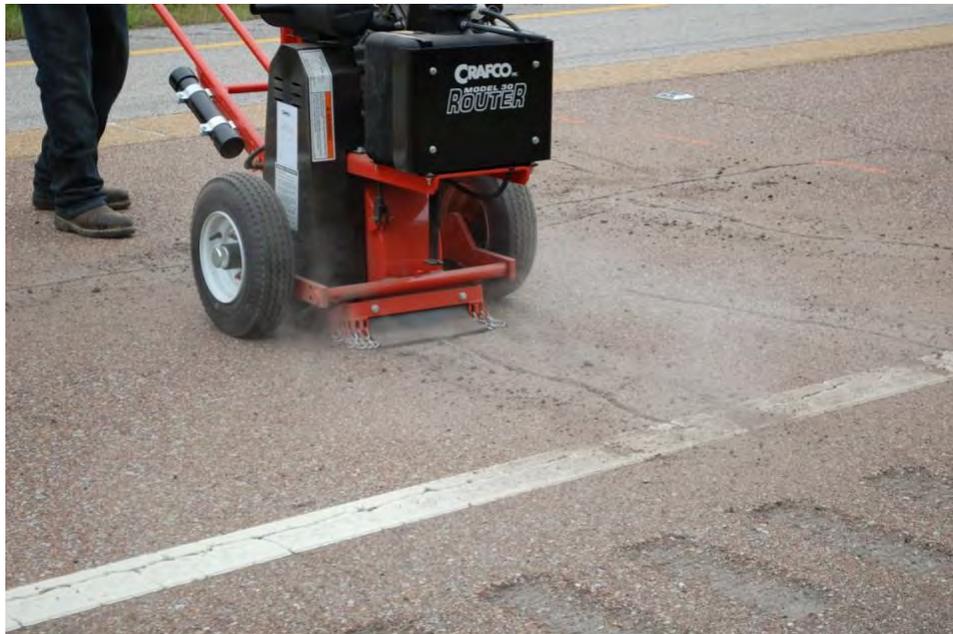
Figure 3 Routing Cracks in Section S2A

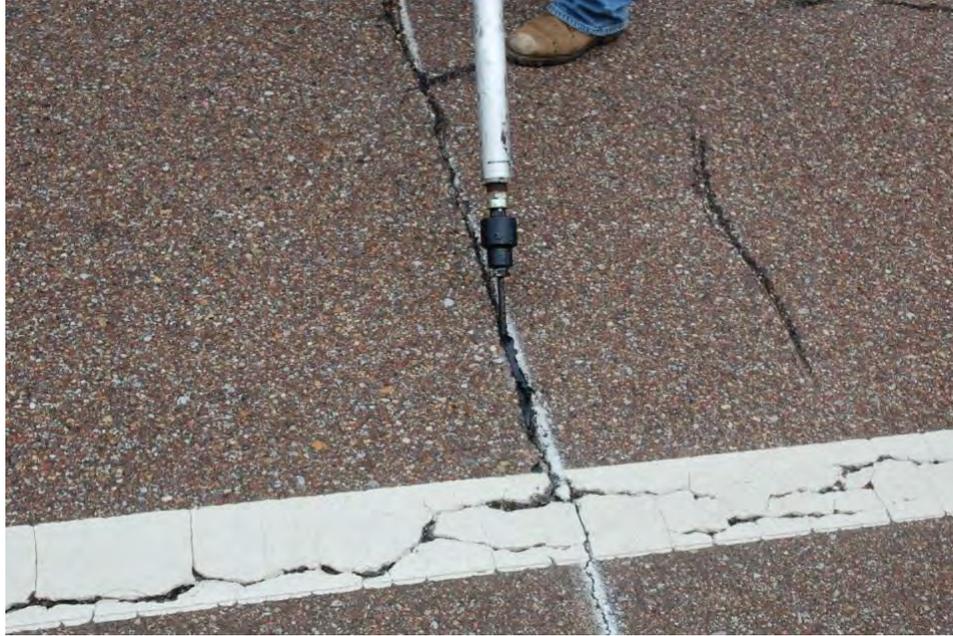
Figure 4 Filling Cracks in Section S2A

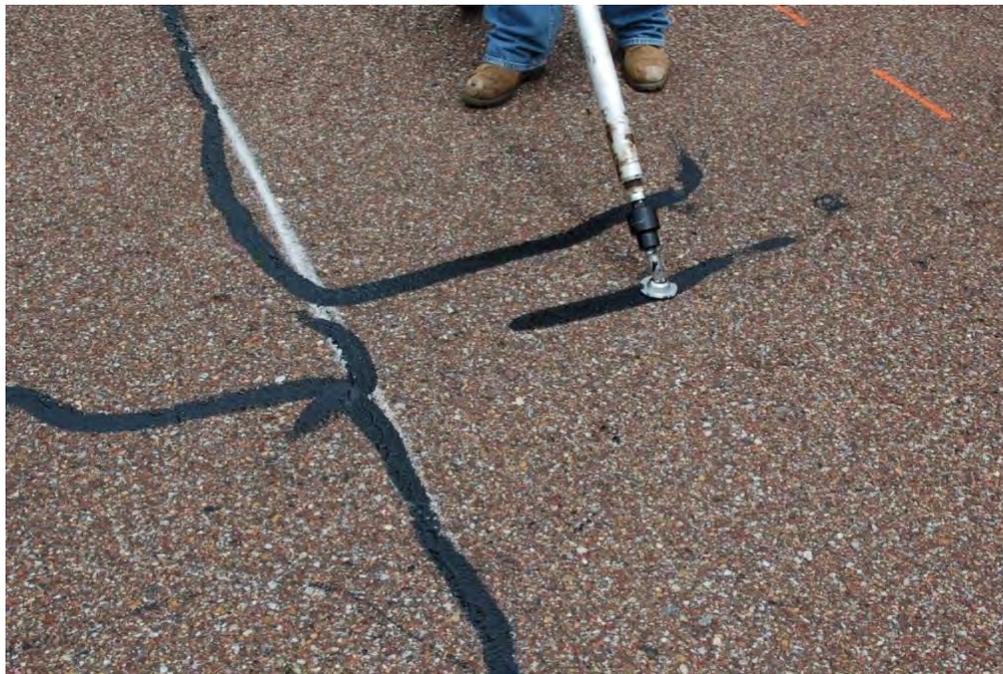
Figure 5 Blow/Band Crack Sealing in Section S2B

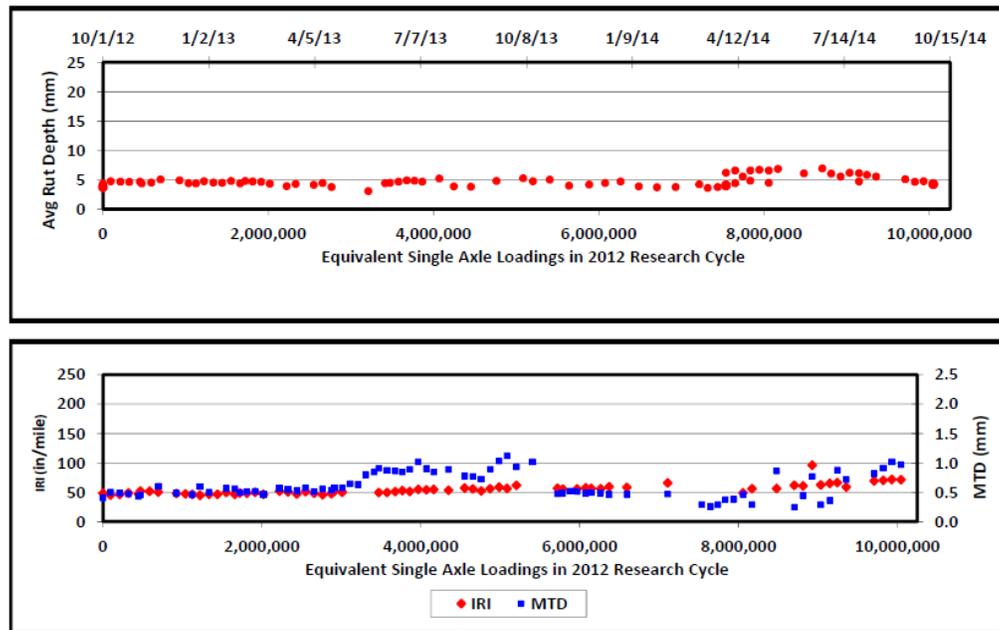
Figure 1 Section S7 Performance

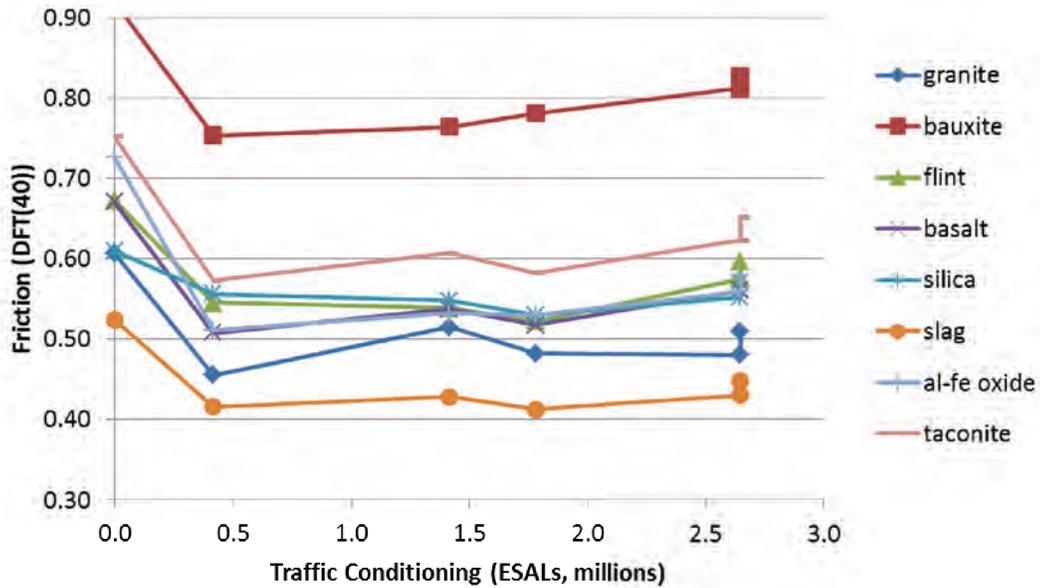
Figure 3. Left Wheel Path DFT(40) Fn Values After 2.6M ESALs
