Improving Density, State of Practice: Dielectric (Density) Profiling System

Kyle Hoegh, MnDOT

DPS for Continuous Asphalt Mixture Compaction Assessment

National Pooled Fund TPF-5(443)

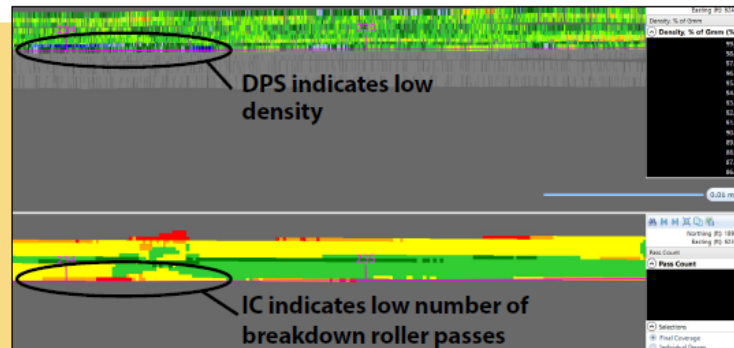
Use of Veta software to compare DPS measured density maps (top) with intelligent construction measured breakdown roller vibratory passes (bottom) to identify opportunities for construction process improvements.

Comparing the DPS data with information collected from other intelligent construction (IC) technologies, engineers verified the lower density locations were often caused by a reduced number of vibratory roller breakdown passes. MnDOT presented the findings to the contractor, who diagnosed potential causes and proposed plans for improving operations.

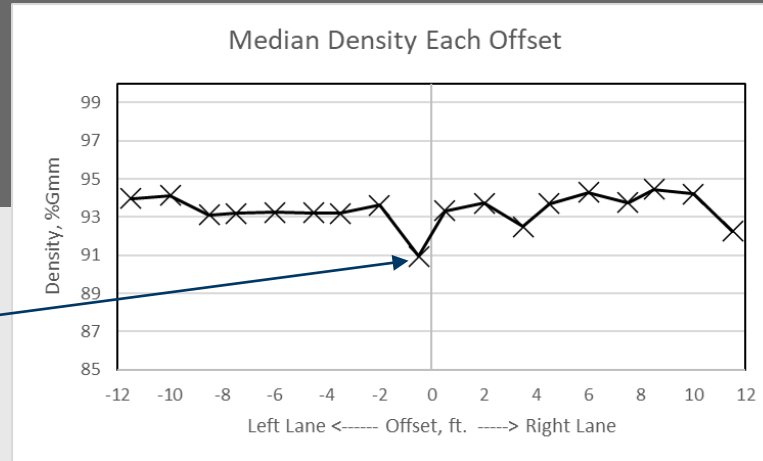
Occasional low density 6" Left of CL joint

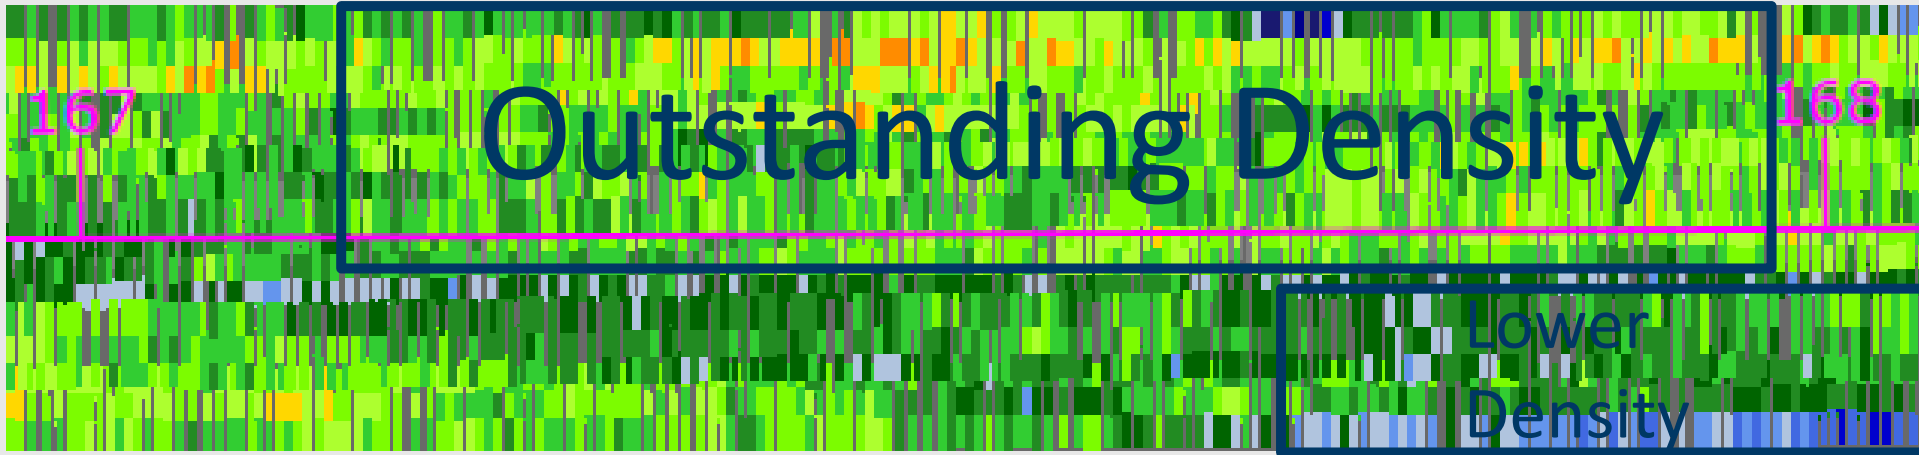
Primary Correlation with Consistent High Density: Breakdown Roller Pass Count

DPS Measured Density

IC Measured Breakdown Roller Pass Count

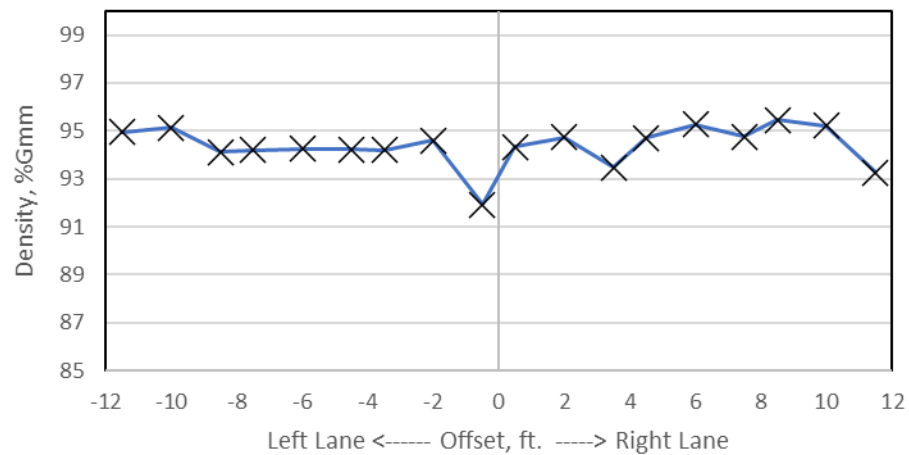
Median Density Each Offset

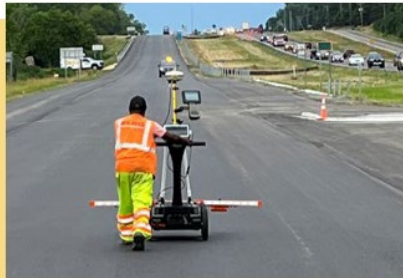
By rolling a DPS unit over the newly paved roadway, crews measured the pavement's density in real time.
