Alabama Department of Transportation  
Research Project 930-436

**Rapid Rehabilitation / Replacement  
of Bridge Decks – Phase II**

**Part IV – Documentation of the Rapid Replacement of Four GDOT  
Bridge Decks**

April 2006

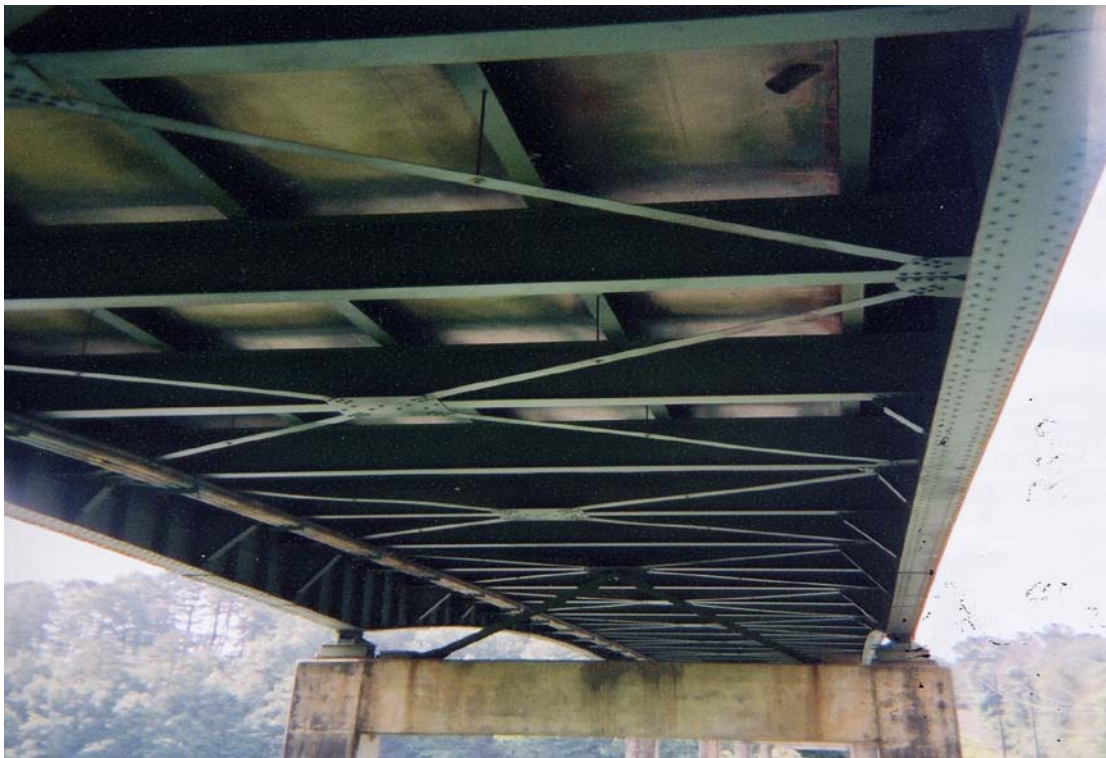
Fig. 2.5 Underneath Shot of Longstreet Bridge (2)

underneath view of the Longstreet Bridge. The superstructure consists of a concrete deck supported by five longitudinal stringers (WF 14 at approximately 6'-6" spacing) running the entire length of the bridge. The stringers are supported by cross-girders (WF 33 at approximately 13' spacing), and these are supported at each end by a haunched girder (varying in depth from 5'-9" to 10'-9") (2). It should be noted that the concrete deck and steel stringers were not connected for composite action. Figures 2.6 and 2.7 show the bridge deck from a topside overview and a close-up perspective. These figures show many transverse cracks and cracks previously repaired. Notice that the bridge is only two lanes wide with no shoulders, and has steel guard rails which remained in place during the deck replacement.

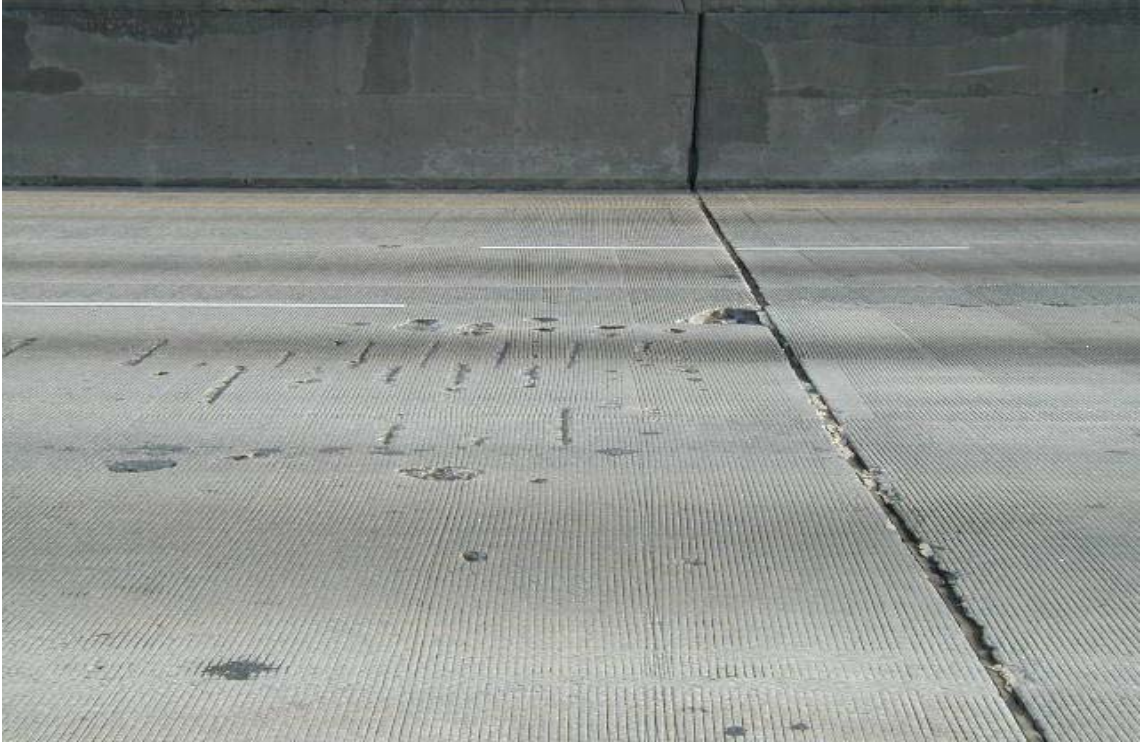
Fig. 2.23 Typical Spalling of Original Lanes (2)

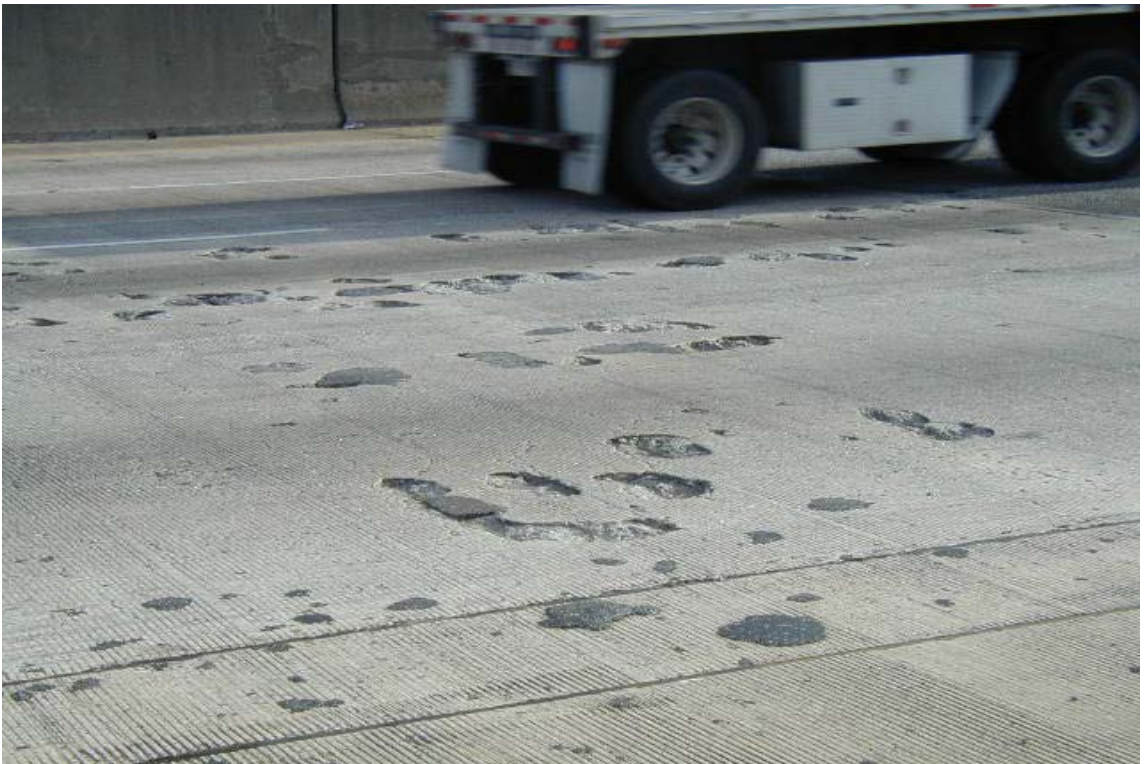
Fig. 2.24 Typical Deck Spalling of Lanes to be Replaced on Northbound Bridge (2)

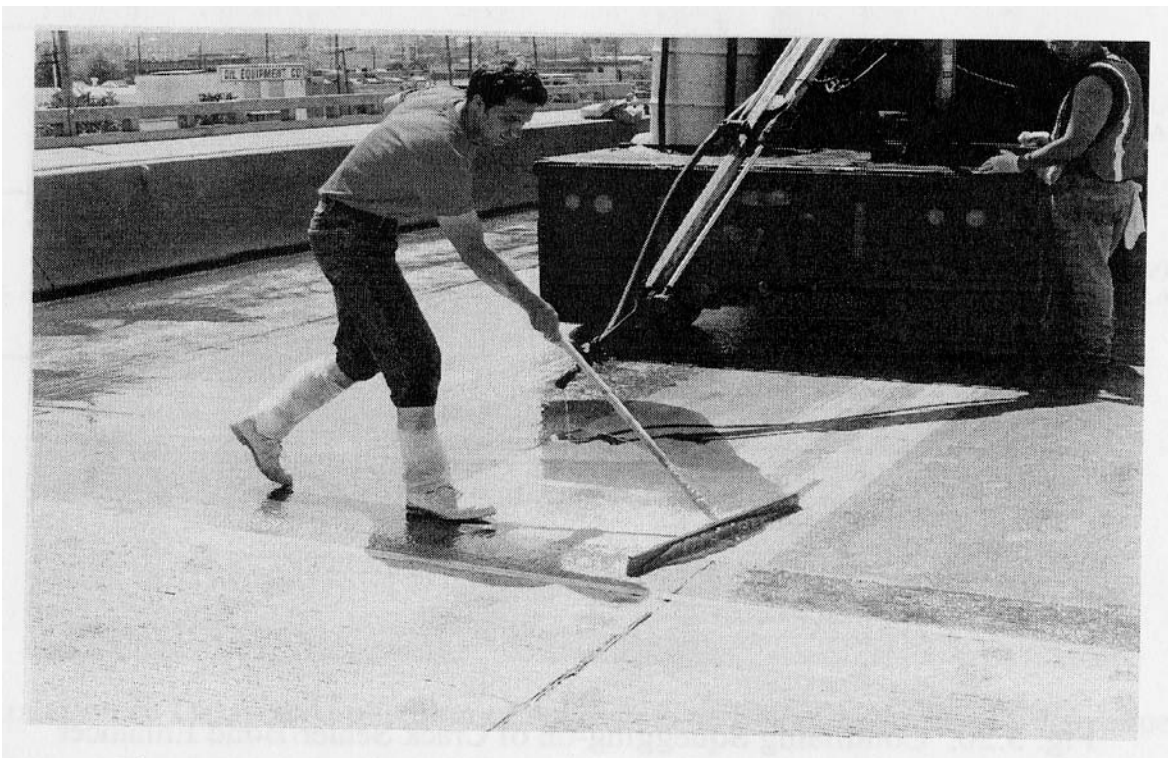
Fig. 2.26 Squeegeeing-on of Epoxy Based Copolymer Binder (4)

- Spalls on the existing deck were patched using a mixture of aggregate and polymer binder just before the first application of the polymer overlay.
- Began placement of the first application of the epoxy based copolymer binder. It consisted of placing a low viscosity epoxy crack sealer and bond enhancer prior to the first overlay application (Fig. 2.26).

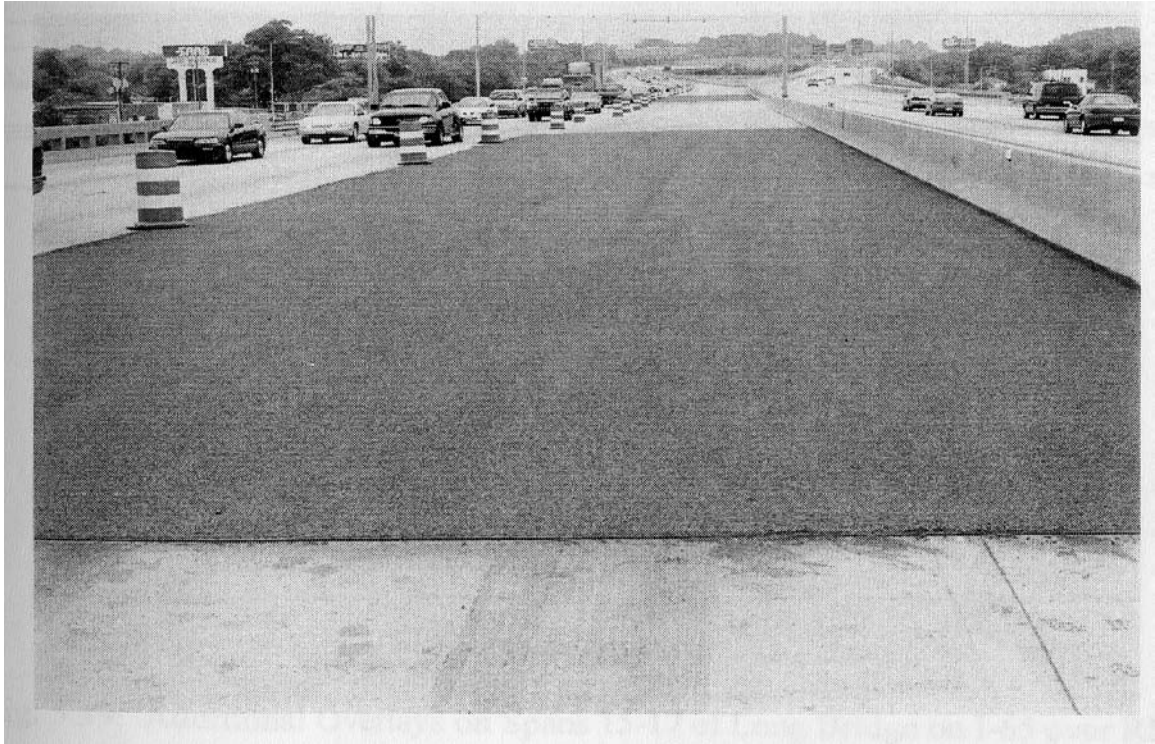
Fig. 2.29 Finished 3/8" Thick Polymer Concrete Overlay (4)

The overlay work on these eight Birmingham bridge decks was completed on schedule (Fig. 2.29). The eight bridge decks had suffered from significant cracking prior to deck replacement, but required very little spalling repair work in order to rehabilitate them properly. The Flexogrid overlays have performed very well since the rehabilitation, and it was shown that they could be placed rapidly with minimum traffic interference.

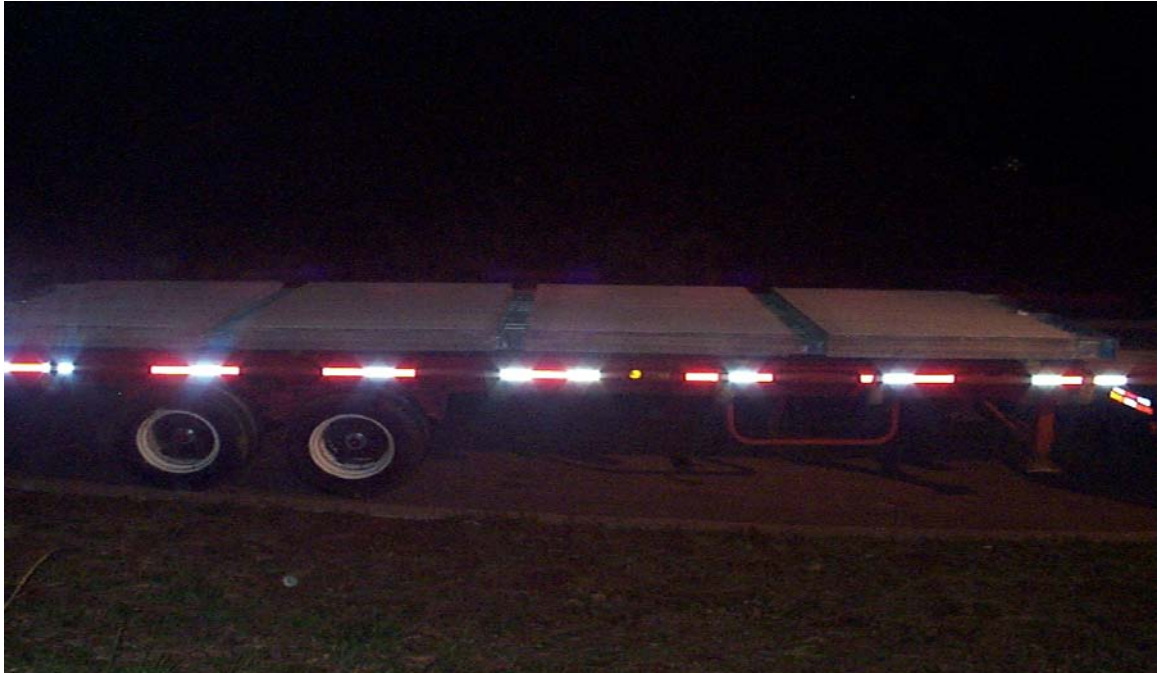
Fig. 3.1 Exodermic Panels in Off-Bridge Staging Area

A photographic display of a typical night's work that consisted of placing 2 new 8'-8" wide Exodermic deck panels is shown in Figs. 3.1-3.35. Figure 3.1 shows an 8'-8" x 26'-10" x 7½" precast Exodermic deck panel sitting on a low-boy truck in an off-bridge staging area. The low-boy delivered the panels from the opposite end from which deck replacement work began to permit transporting the panels to the crane more easily. Figure 3.2 shows the lift spreader being assembled to the Exodermic panel directly from the bed of the low-boy. Due to the limited staging area, Gilbert Southern had only the number of Exodermic panels needed during each night's construction delivered to the job site at a time. Delivery of the Exodermic panels typically consisted of 2 panels a night, but ranged from 1 – 3 panels a night.

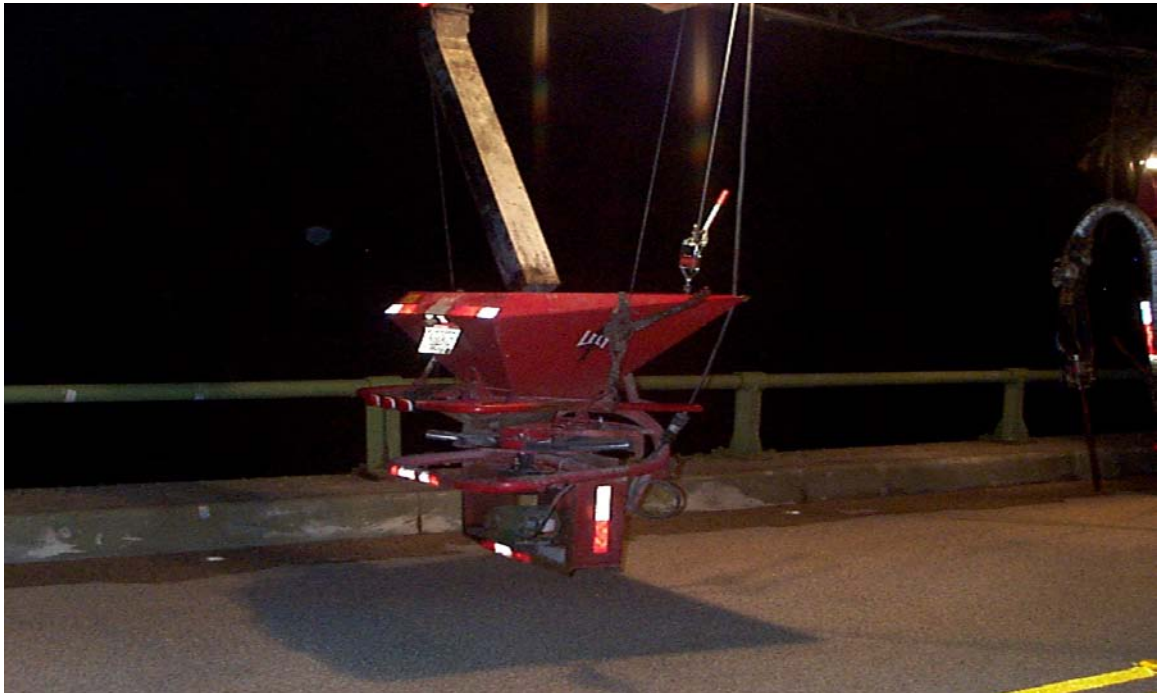
Fig. 3.48 Rotary Fine Aggregate Spreader

aggregate spreader used to broadcast the fine aggregate as it was conveyed from the Poly-Carb truck. Figure 3.49 shows a worker squeegeeing-on the epoxy as the Poly-Carb truck moves forward. Placement of the Flexogrid overlay consisted of a continuing process of application of the low viscosity crack sealer, squeegeeing of epoxy, and broadcasting of aggregate (see Figure 3.50). Note that the low viscosity crack sealer was applied in front of the Poly-Carb truck with a hand sprayer as it moved along the bridge. Figure 3.51 shows the finger joint located at midspan of the bridge with the first layer of overlay placed on one side. Note that the first layer of the overlay was placed on the other side of the finger joint on the night of the author's visit. A view of the first layer of the co-polymer overlay on approximately half of the bridge is shown in Figure 3.52. The finished 3/8" thick Flexogrid overlay is shown in Figure 3.53.

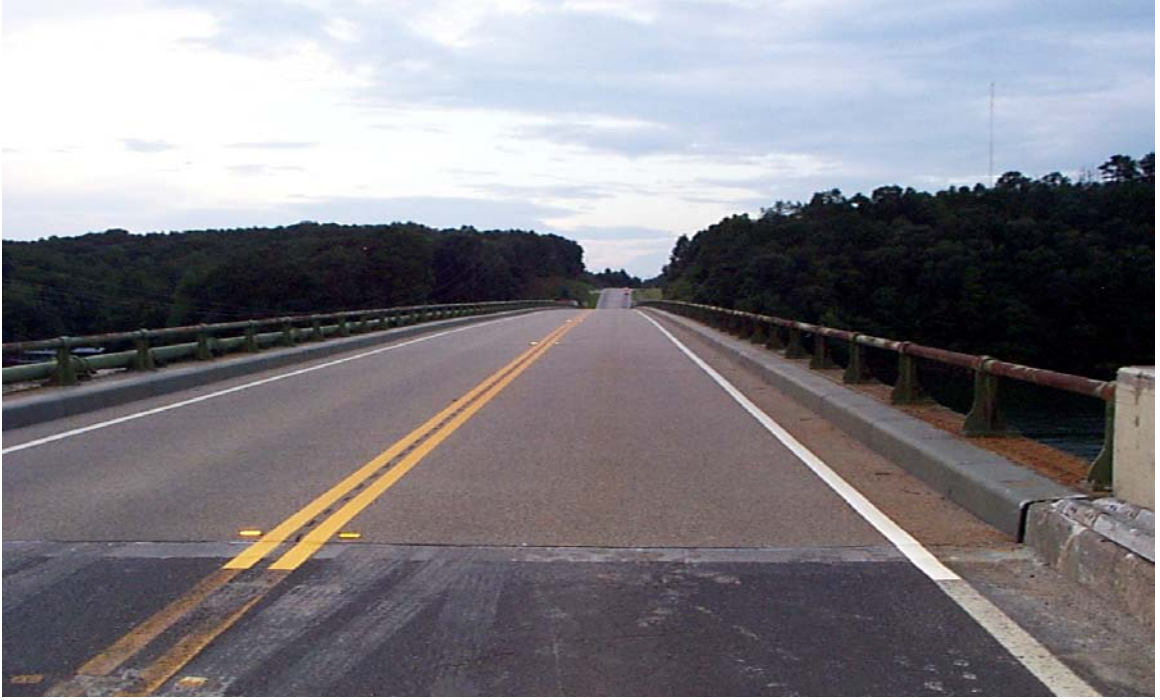
Fig. 3.53 Finished 3/8" Thick Flexogrid Overlay

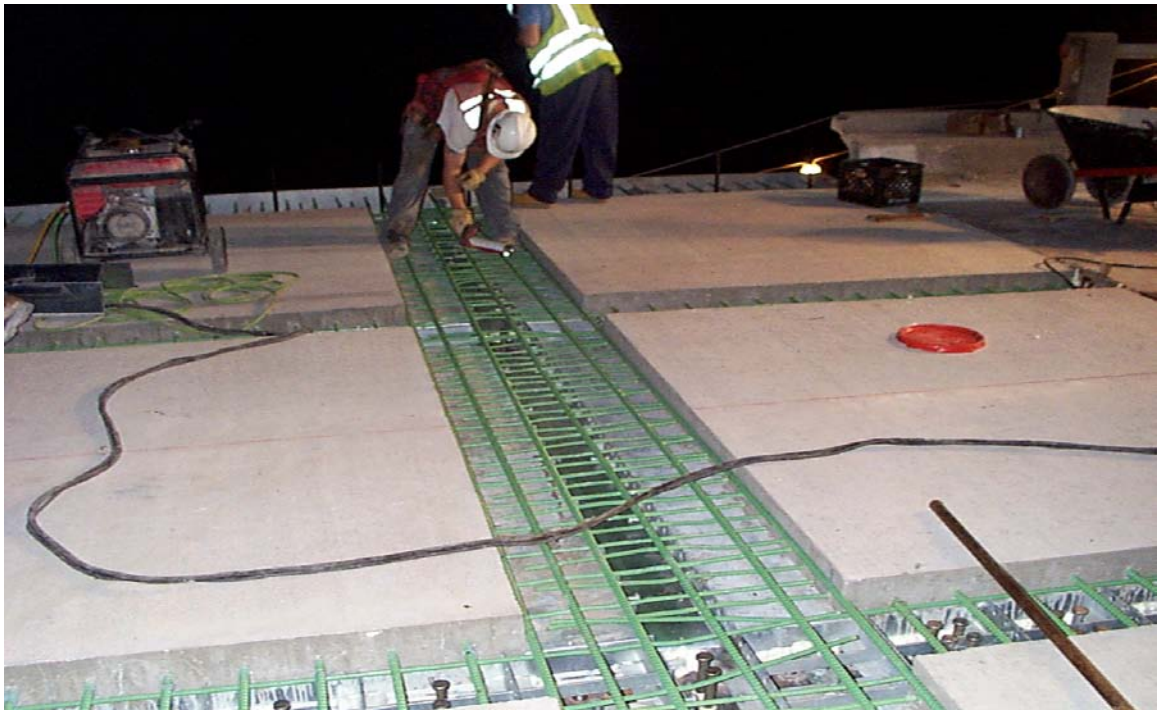
Fig. 4.15 Steel Reinforcement in the Negative Moment Regions

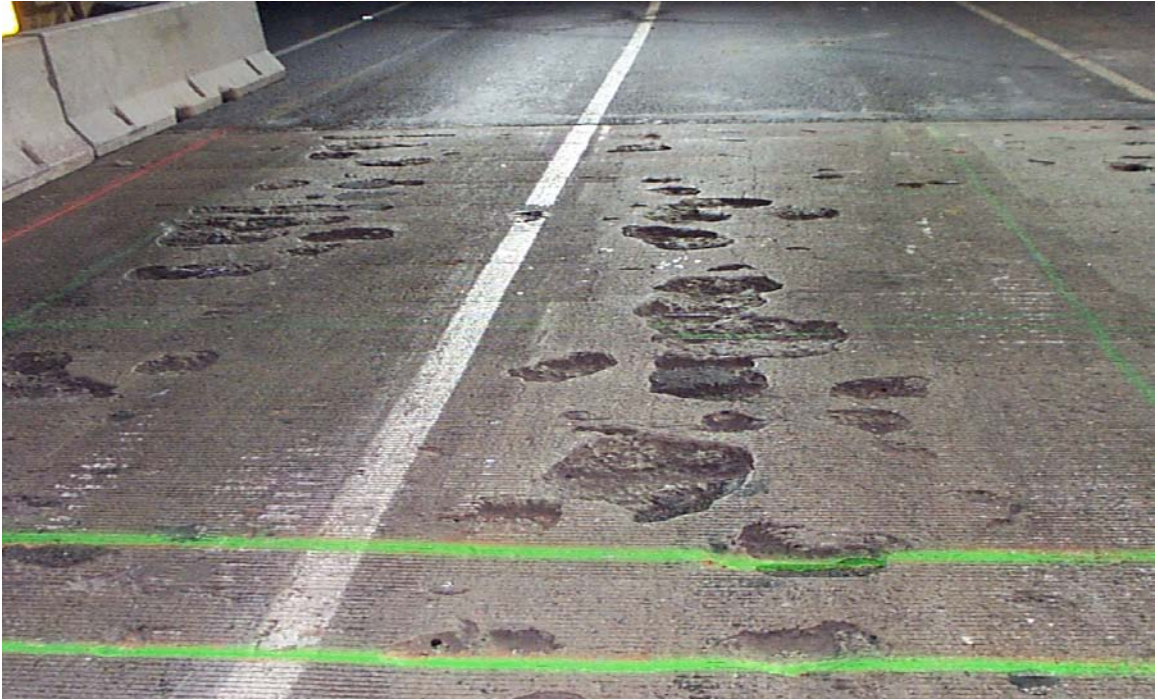
Fig. 5.2 Approach View of Typical Spalling of Original Travel Lanes

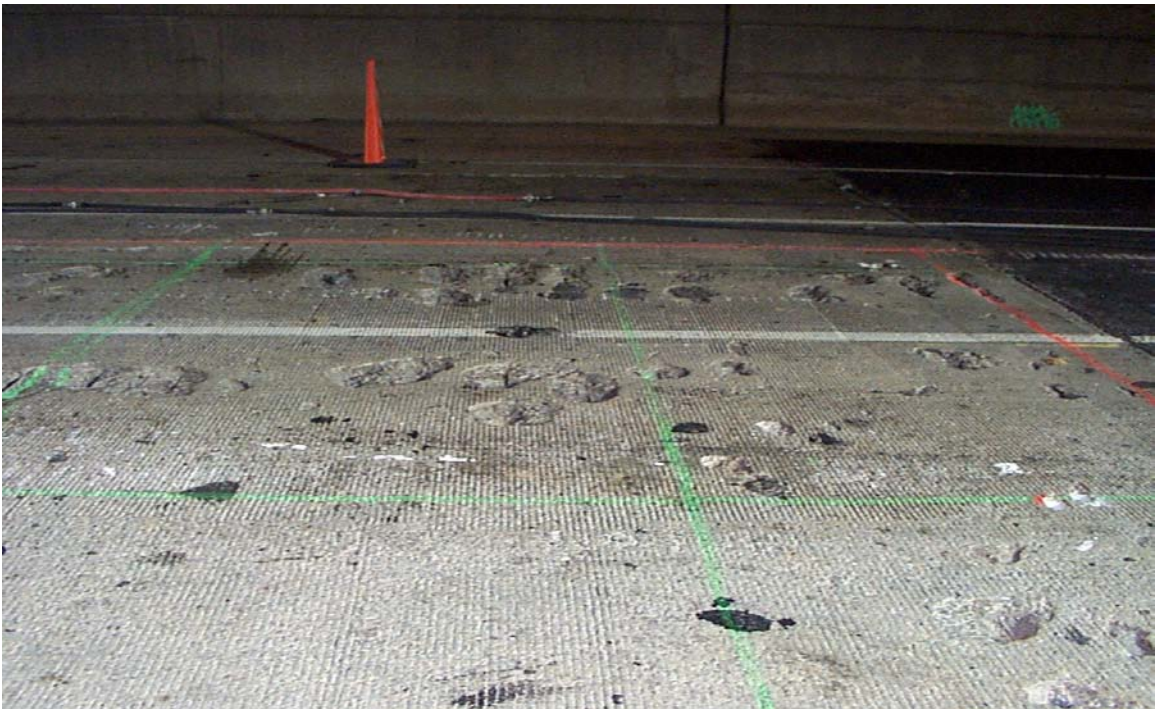
Fig. 5.3 Side View of Spalling of Original Travel Lanes

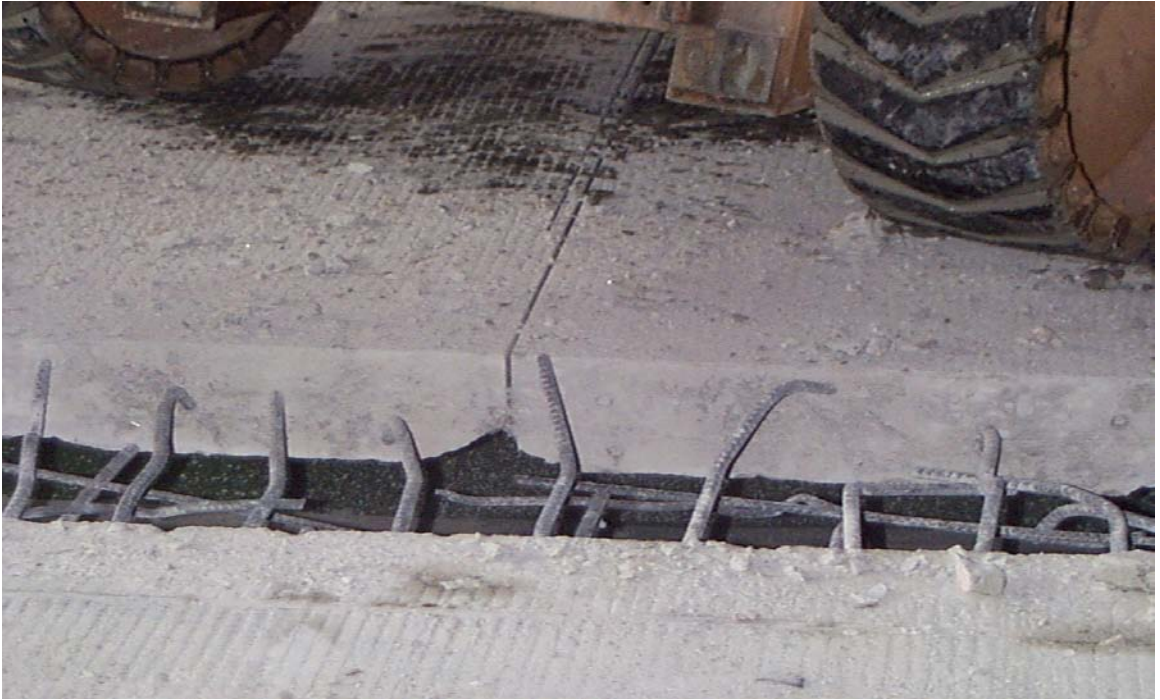
Fig. 5.8 Typical Depth of Transverse Saw Cuts

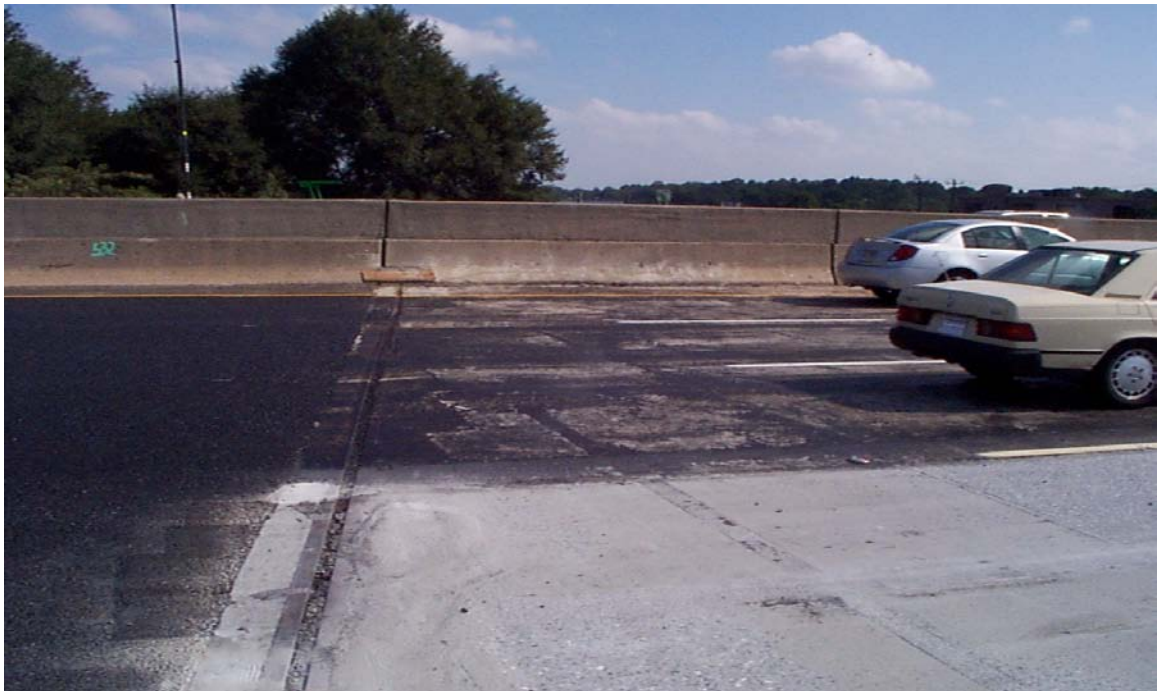
3. ***Problem:*** The newly placed asphalt wearing surface on I-285 was smeared onto the new bridge deck surface as seen in Figure 7.13. Removing this smeared asphalt to insure proper overlay bond increased the shot blasting and deck grinding time tremendously for the deck surface to meet the requirements of the copolymer overlay. The asphalt wearing surface was placed due to the lane shift implemented for deck replacement.

Fig. 7.13 Smearing of Newly Placed Asphalt Wearing Surface Onto New Deck Surface

***Proposal for Improvement:*** Selection and design of any wearing surface placed onto the roadway that approaches a bridge with a possible overlay should consider the effects of this smearing and the resulting clean-up problem.
