# **THE EFFECT OF MATERIAL TRANSFER DEVICES ON HMA MATERIAL UNIFORMITY AND RIDE QUALITY**

Final Report  
Project Number 930-471

National Center for Asphalt Technology  
Auburn University  
Auburn, Alabama

February 2004

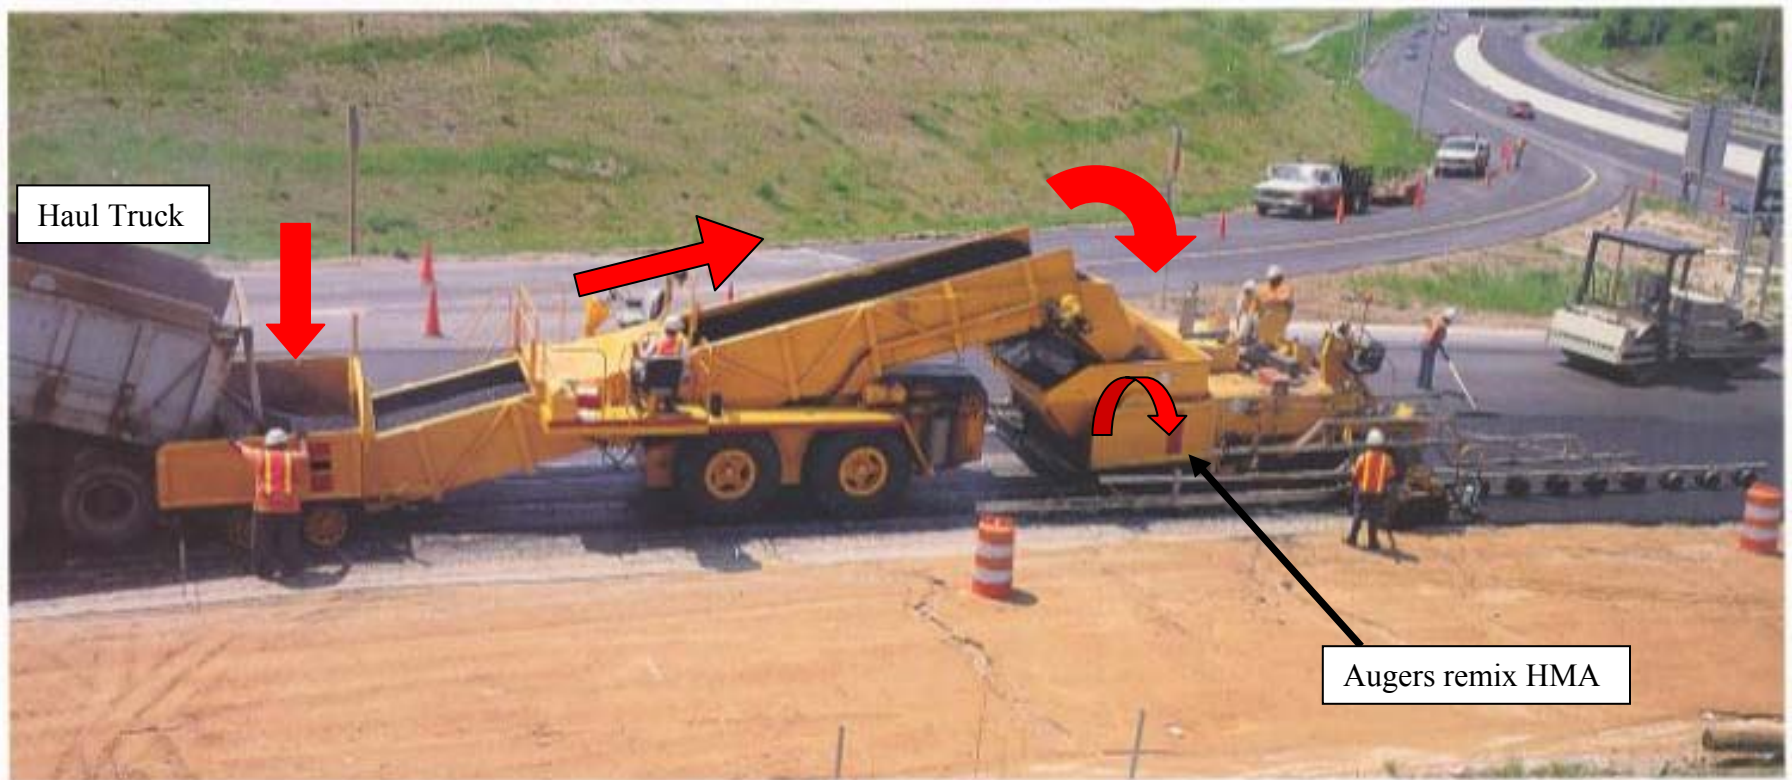
**Figure 2. Blaw-Knox MC-330. (The red arrows show the path that the mix follows).**

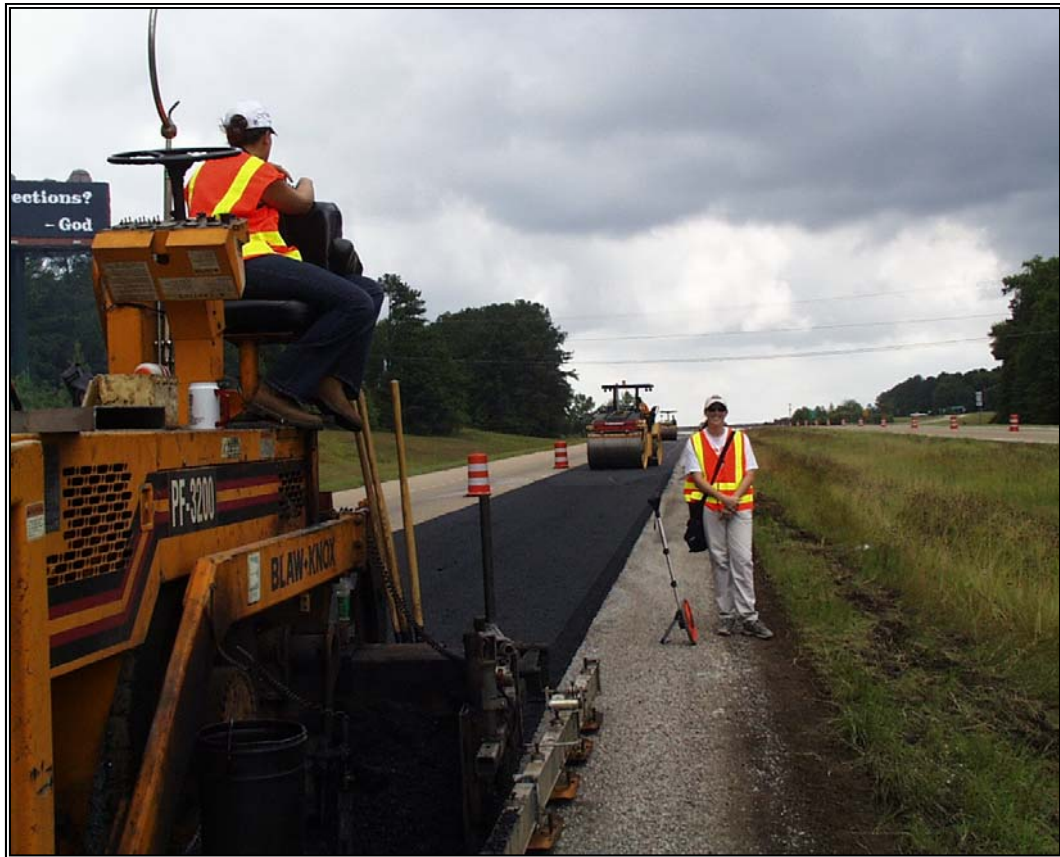
**Figure 11. Infrared Camera Operator and Manual Distance Meter Operator.**

The temperature differences, noted using an infrared camera, were differences in the mat just behind the paver of over 20°F. The operator of the infrared camera sat in the spare driver's seat on the paver (Figure 11) and faced the screed, or hot mat. When a temperature difference was seen, the operator took a picture of the anomaly with the camera, which logs the pictures with the time, and then signaled the manual distance meter operator. Figure 12 is an example that shows a temperature anomaly caused by a paver stop. The manual distance meter operator noted the distance measurement, from the start of paving, and the time the picture was taken. The time noted was used to correlate the distance marks to the infrared pictures. In sections without the MTD, it was common to see two cold spots, or one long cold spot, at the end of each truck of mix.
