**Research Report for ALDOT Project 930-645**

# **EVALUATION OF CRACKING OF THE US 331 BRIDGE DECK**

The Alabama Department of Transportation

**AUGUST 2010**

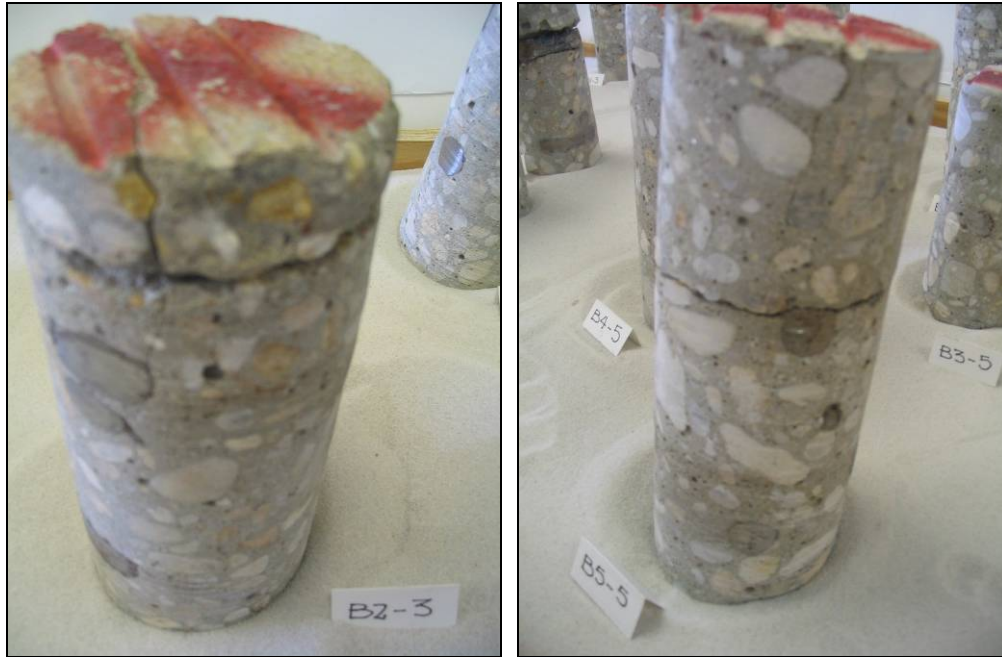
**Figure 1-4:** Cores from the US 331 deck with vertical and horizontal cracks

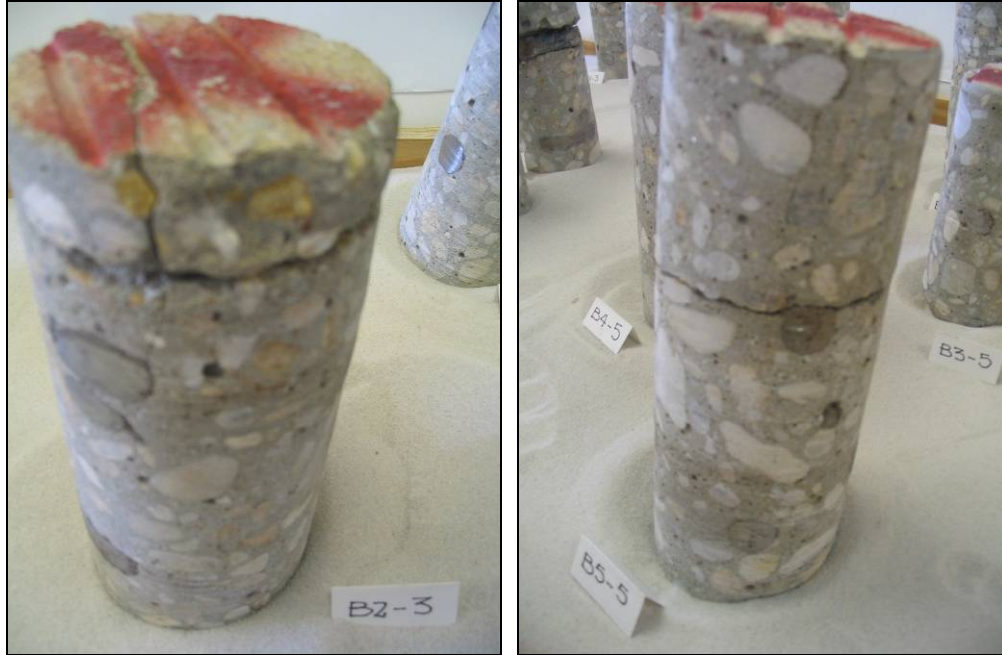
**Figure 3-6:** Cores from the US 331 deck with vertical and horizontal cracks

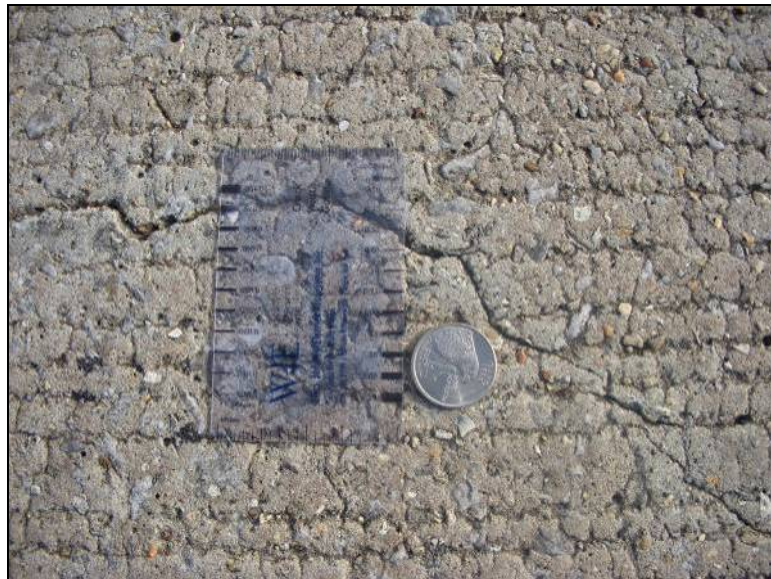
**Figure 3-22:** Picture of the wide surface cracks on the bridge deck on the Courtland Bypass

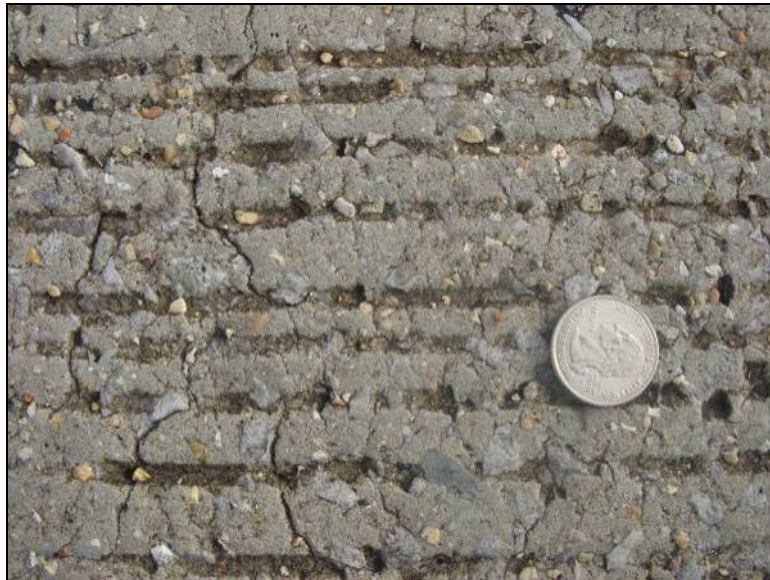
**Figure 3-25:** Picture of some surface cracks on the bridge deck on SR 216 over L&N RR

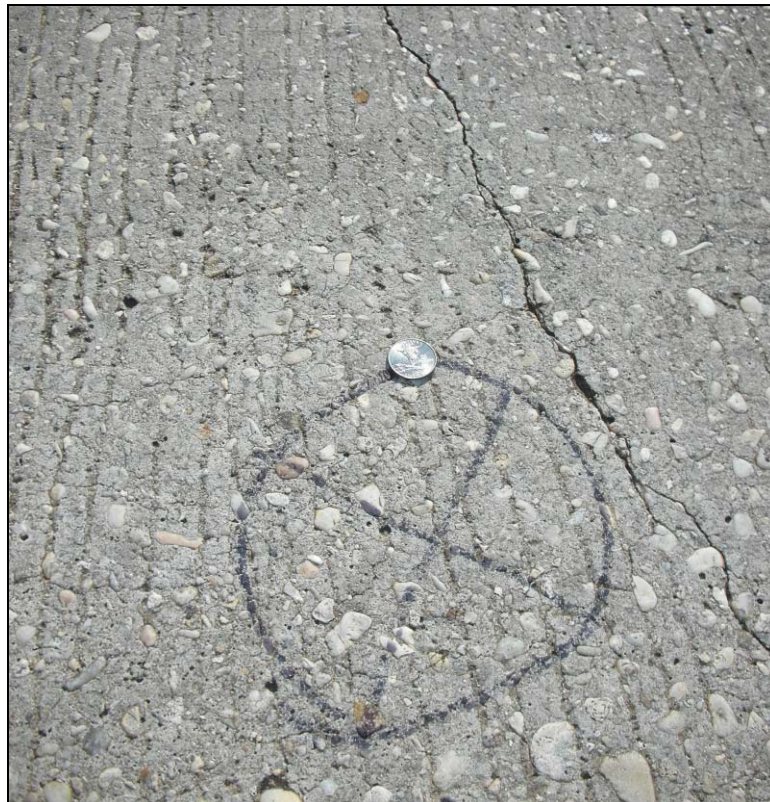
**Figure 3-27:** Picture of a wide surface crack on the SR 21 bridge deck at Tunnel Springs

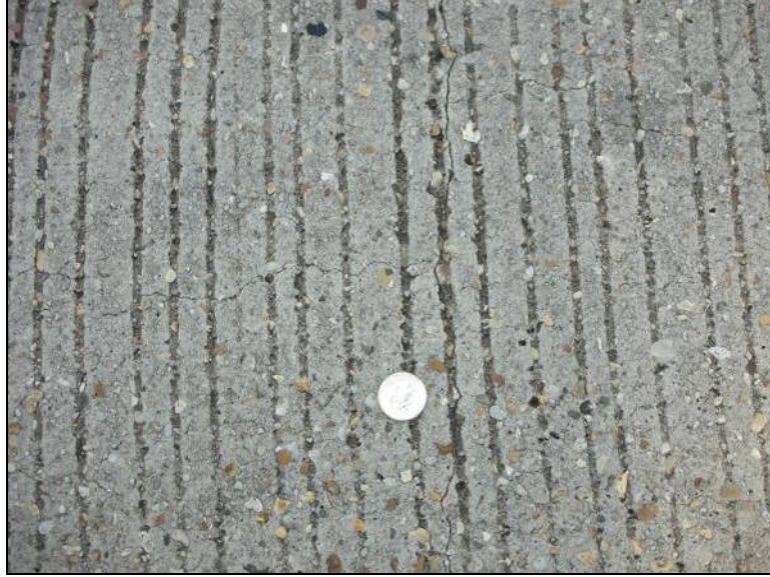
**Figure 3-30:** Picture of the surface cracking on the US 98 bridge deck
