Research Report for ALDOT Project 930-745S

FRP STRENGTHENING OF CONTINUOUS RC BRIDGE—LETOHATCHEE, ALABAMA

Research Report FHWA/ALDOT 930-745S

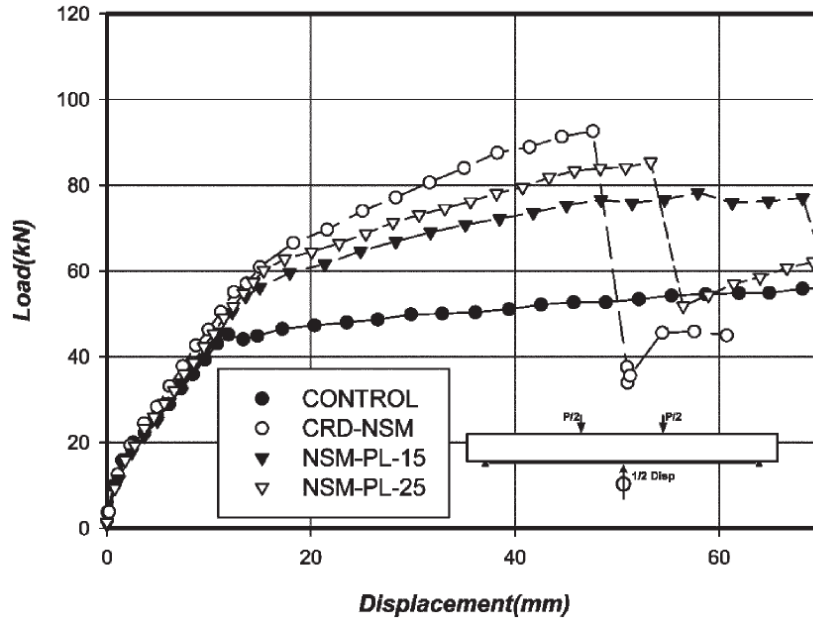
Beams that were strengthened with NSM FRP exhibited an increased ultimate load of 35–65%, when compared to the unstrengthened specimen. Figure 2.9 shows load-deflection results from the NSM FRP strengthened specimens.

Figure 2.9 Load-Displacement Plot of NSM FRP Specimens (Jung et al. 2005)

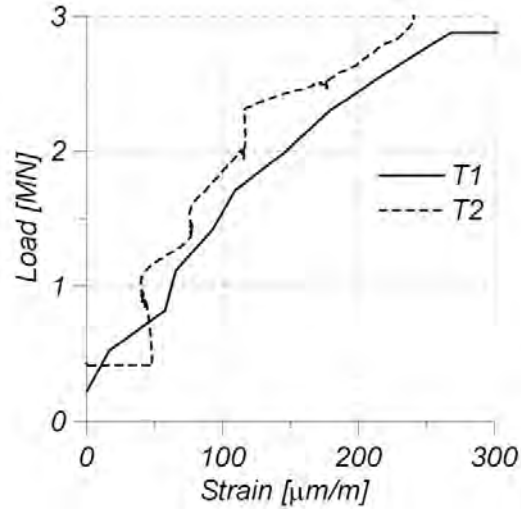
The bridge was tested by applying a load at midspan, and strains in the concrete, steel, and FRP were recorded during load testing of the bridge. Figure 2.19 shows that tensile steel strains measured at midspan resulted in a strain reduction of about 20% in the post-retrofit test (T2) compared to pre-retrofit test (T1).

Figure 2.19 Load versus Strain in the Concrete for Pre-Retrofit (T1) and Post-Retrofit (T2) Load Tests of the Örnköldsvik Bridge (Bergström, Täljsten, and Carolin 2009)

It was also observed that there was no failure in the FRP or in the epoxy bond between the concrete and FRP. The discrepancy in Figure 2.19 at low loads was attributed to development of shear deformation in the adhesive when the FRP strips begin to take some of the load. Figure 2.20 shows strains during the post-retrofit loading to failure.

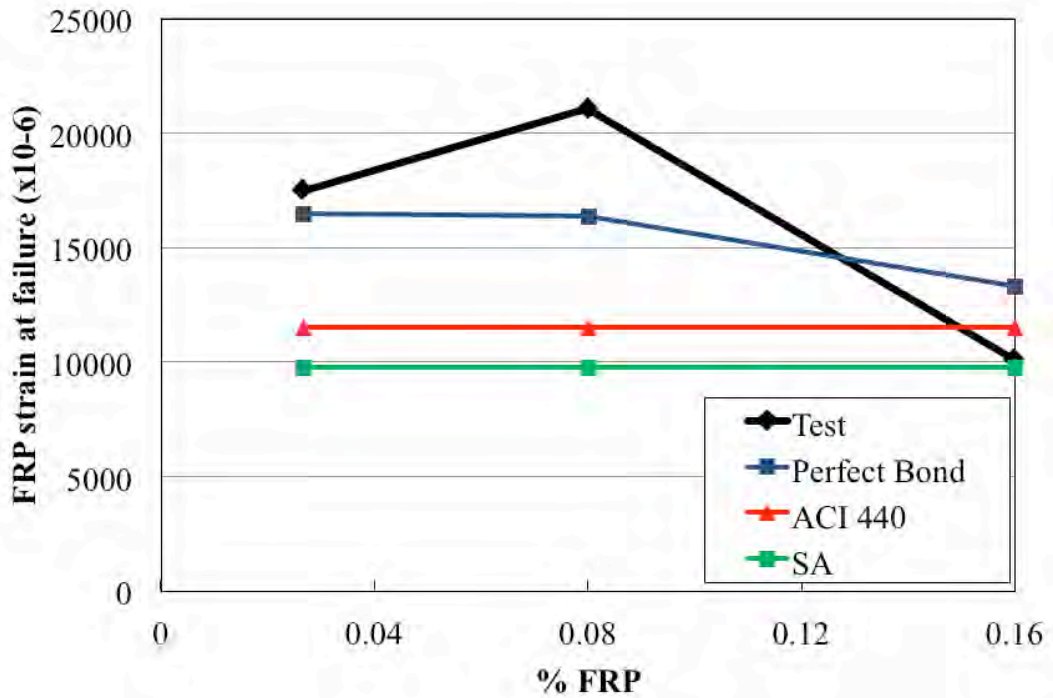
Figure 2.29 FRP Strain at Failure at FRP Reinforcement Ratios for $\rho_s=0.21\%$ (Bertolotti 2012)

The results indicated that there was no bond degradation during the laboratory testing program, as all FRP reinforcement performed close to expectations of the perfect bond condition. Therefore, there was no evidence of IC-debonding failure mechanisms. Failure occurred due to crushing of the concrete in the test specimens with 0.03% and 0.08% FRP reinforcement ratios. However, there was a discrepancy in the data at the FRP reinforcement ratio of 0.16%. This was due to a shear failure in the beam before a flexural failure could be achieved. Figure 2.30 shows this beam and the shear failure that occurred during laboratory testing.

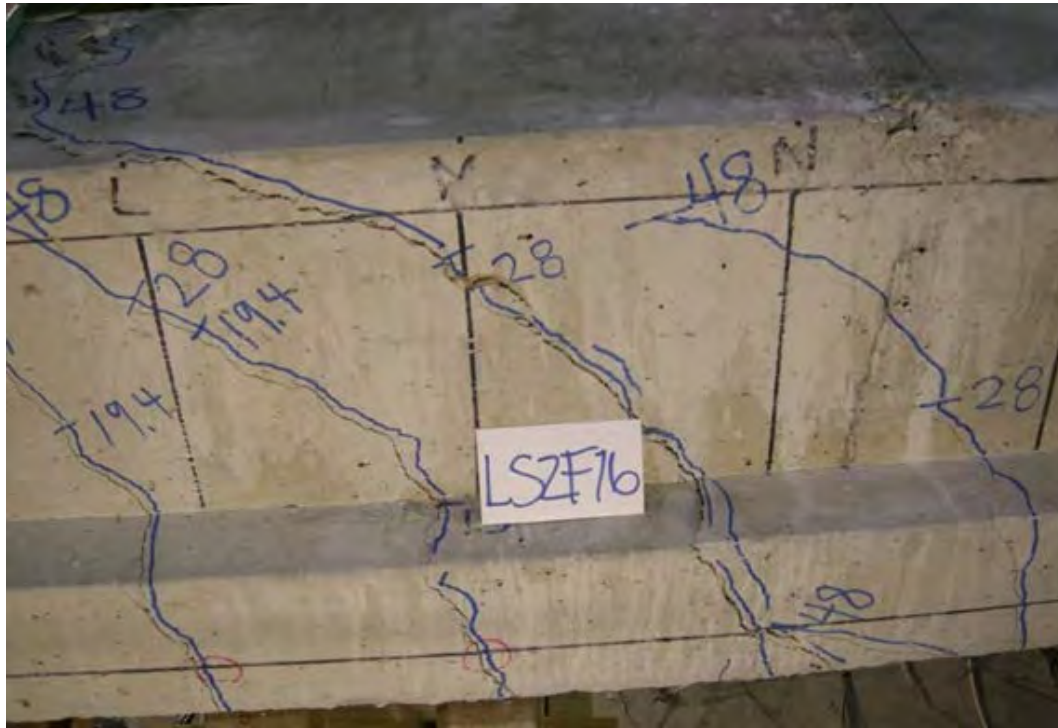
Figure 2.30 Shear Failure of Beam with 0.21% Steel and 0.16% FRP Reinforcement Ratios (Bertolotti 2012)

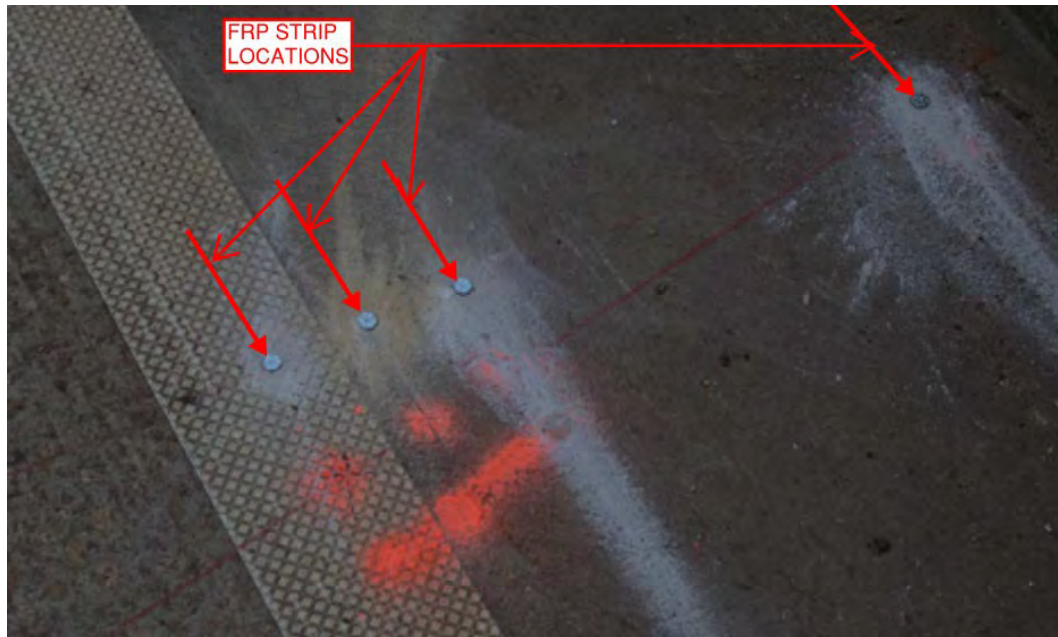
Figure 4.8 Mag Nails Marking FRP Strip Locations

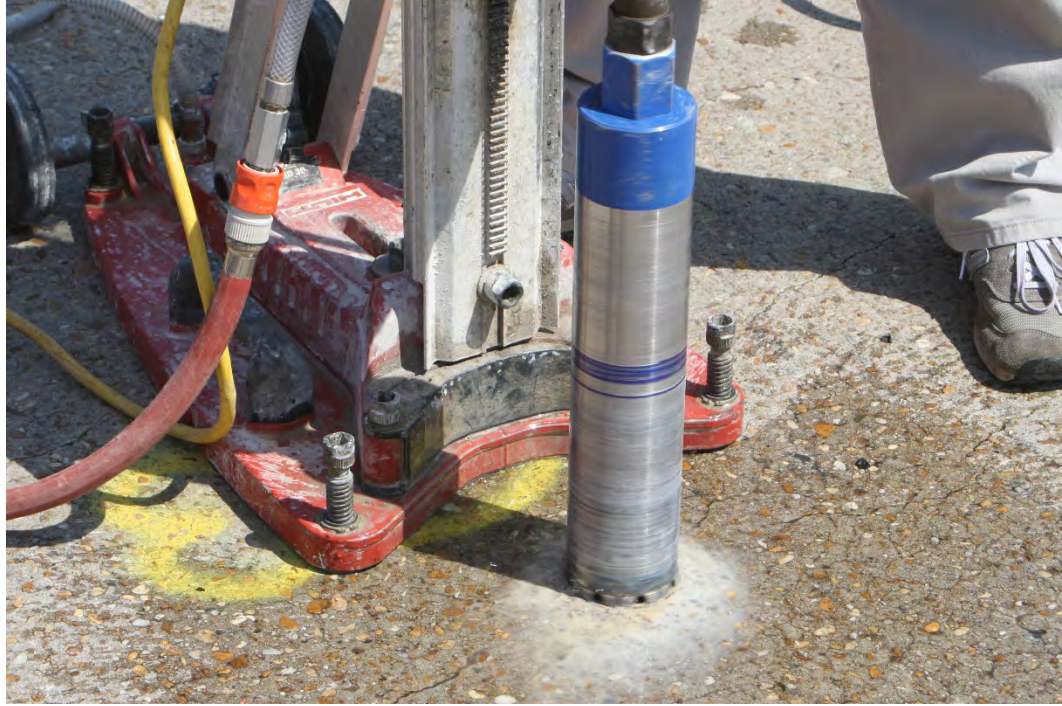
Figure 4.9 Coring of the Letohatchee Bridge

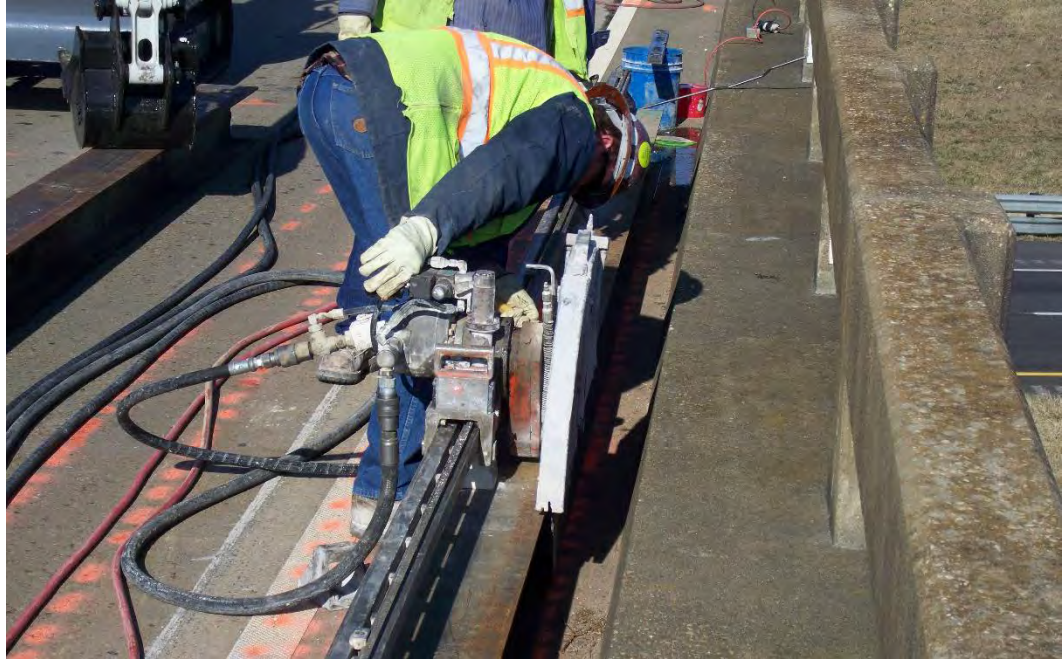
Figure 4.34 Attempted H-Pile Mounted Track Saw Setup

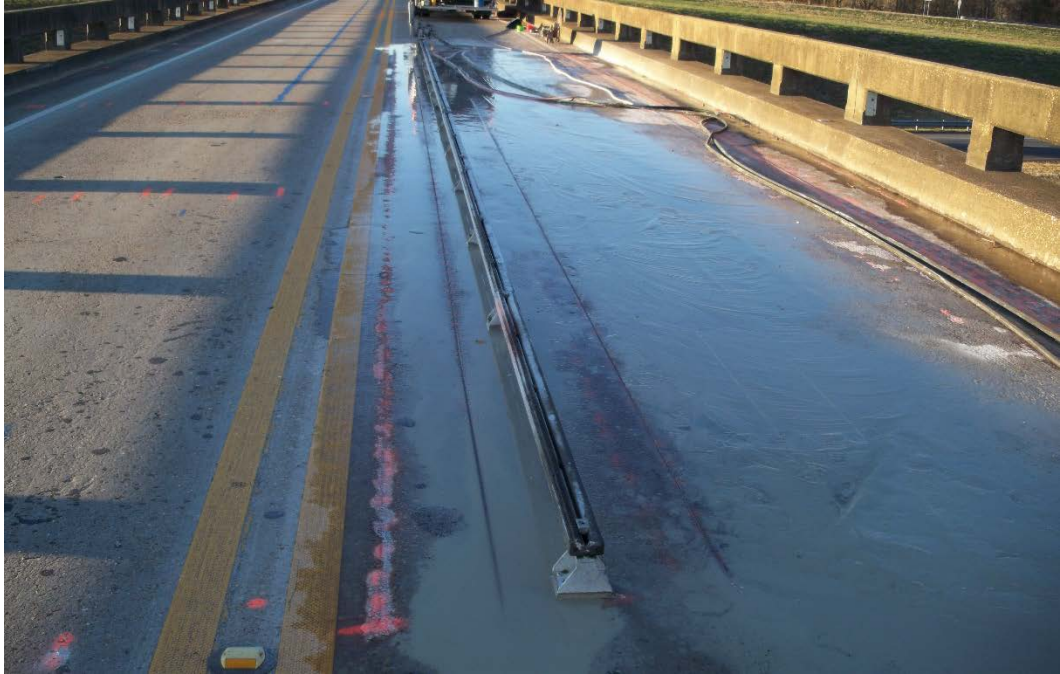
Figure 4.35 Slurry on Deck after One Day of Cutting

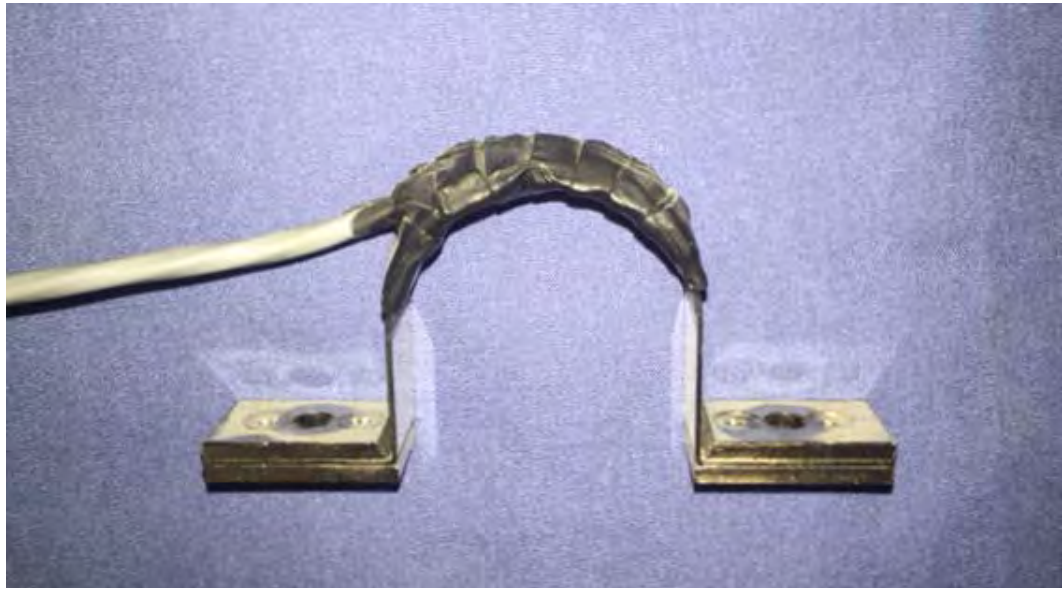
Figure 5.19 Crack Opening Displacement Transducer

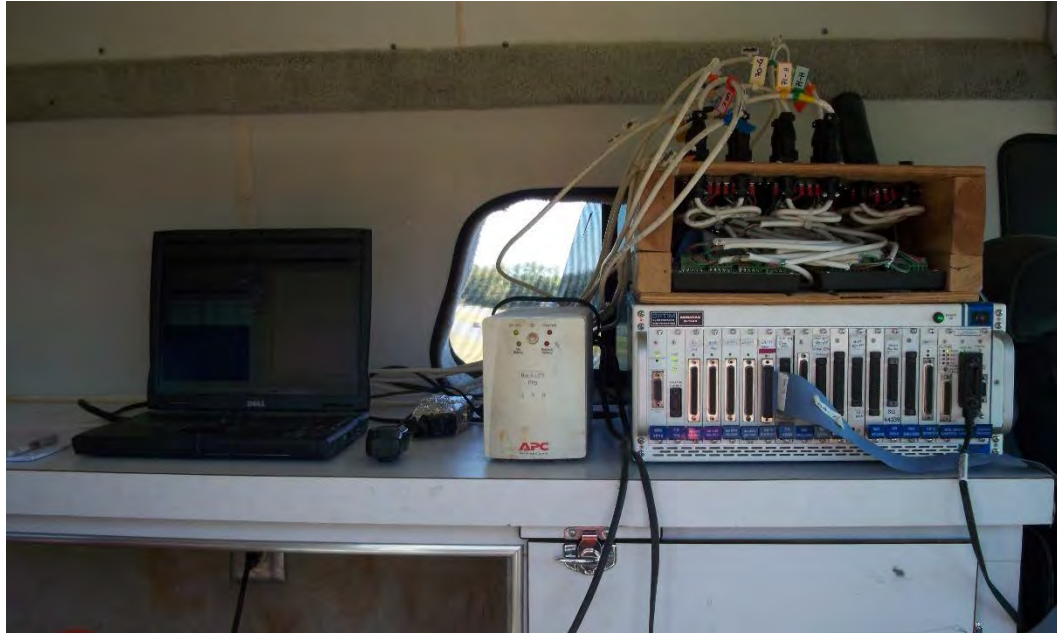
Figure 5.21 Optim Megadac® setup with TCS for Windows

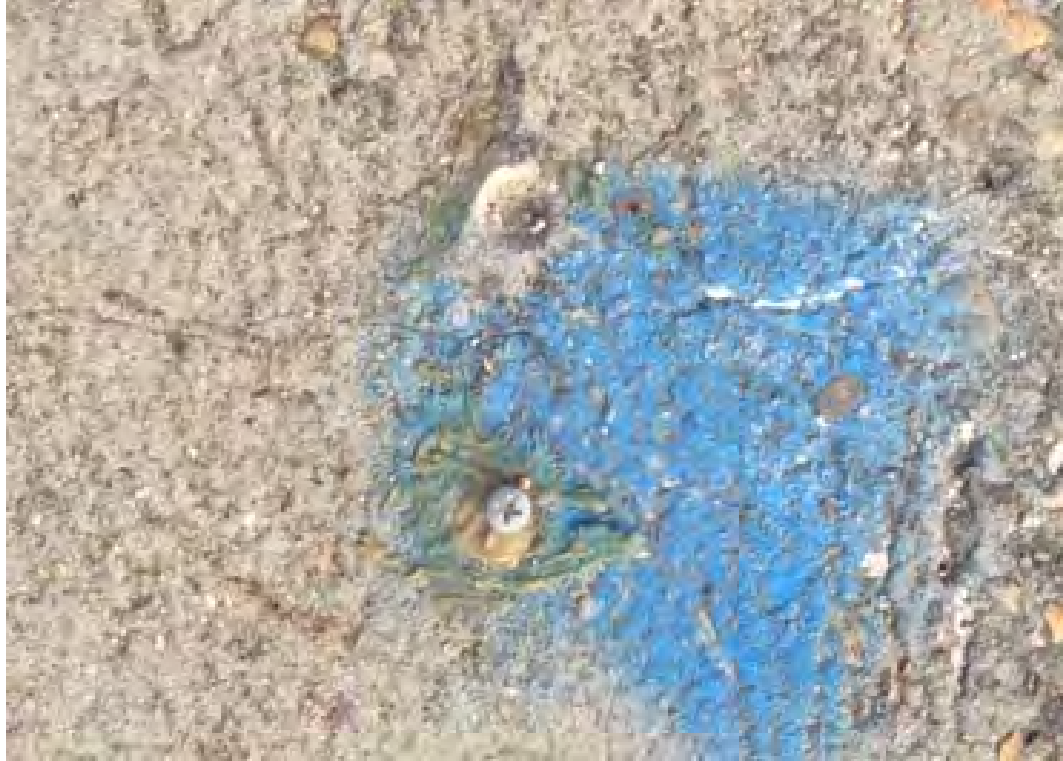
Figure 5.22 Transducer Mount Damaged by Traffic

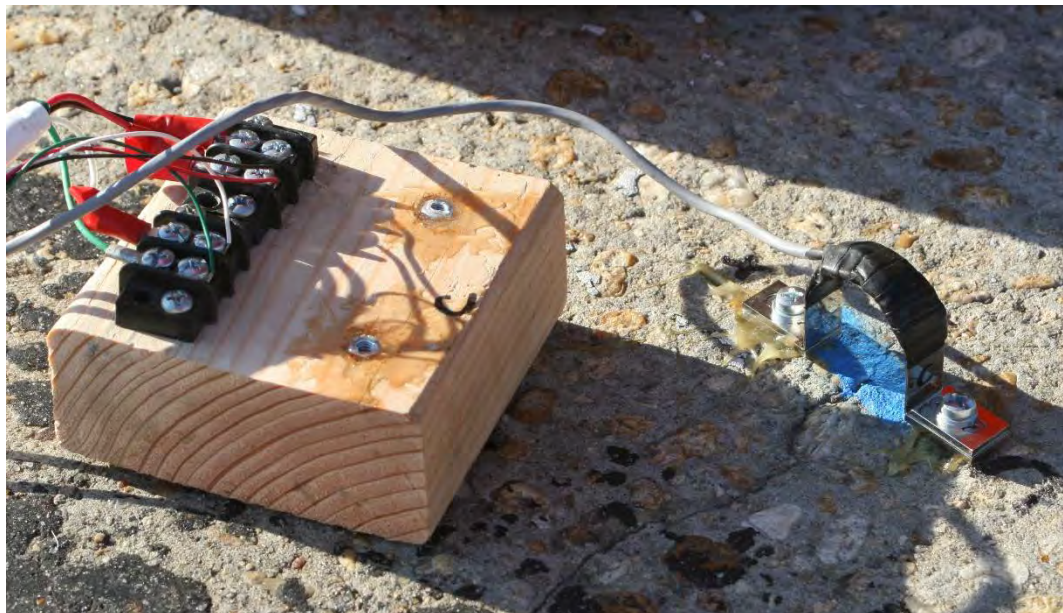
Figure 5.23 Installed Crack Opening Displacement Transducer

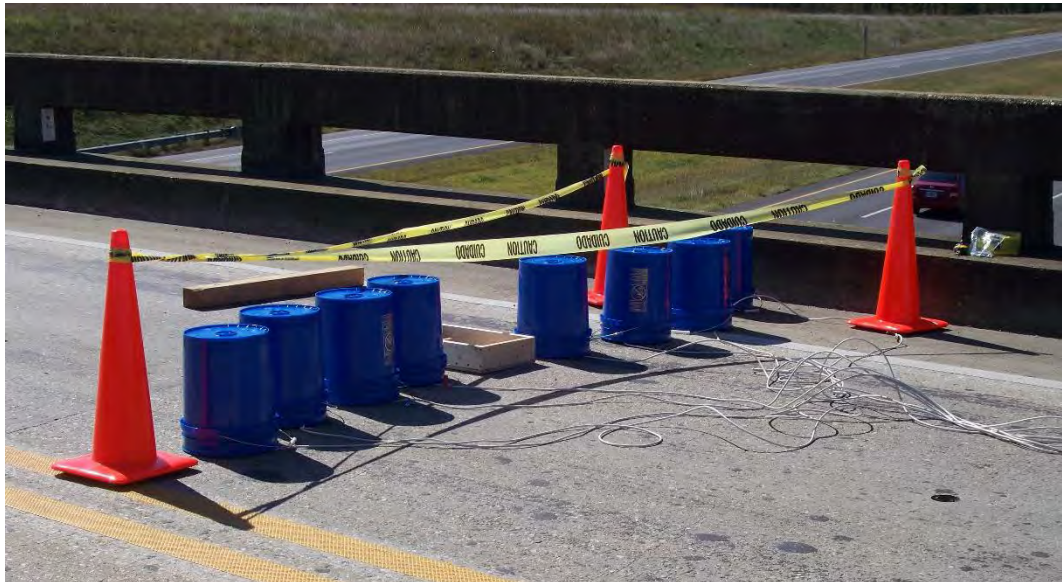
Figure 5.25 Instrumented Zone Ready for Load Test

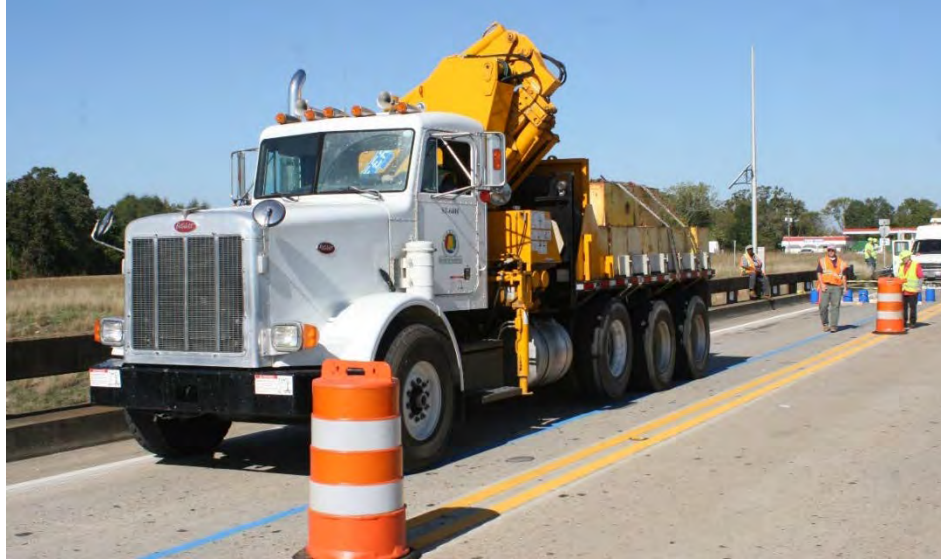
Figure 5.27 LC-4 Load Truck Backed into Position during Testing

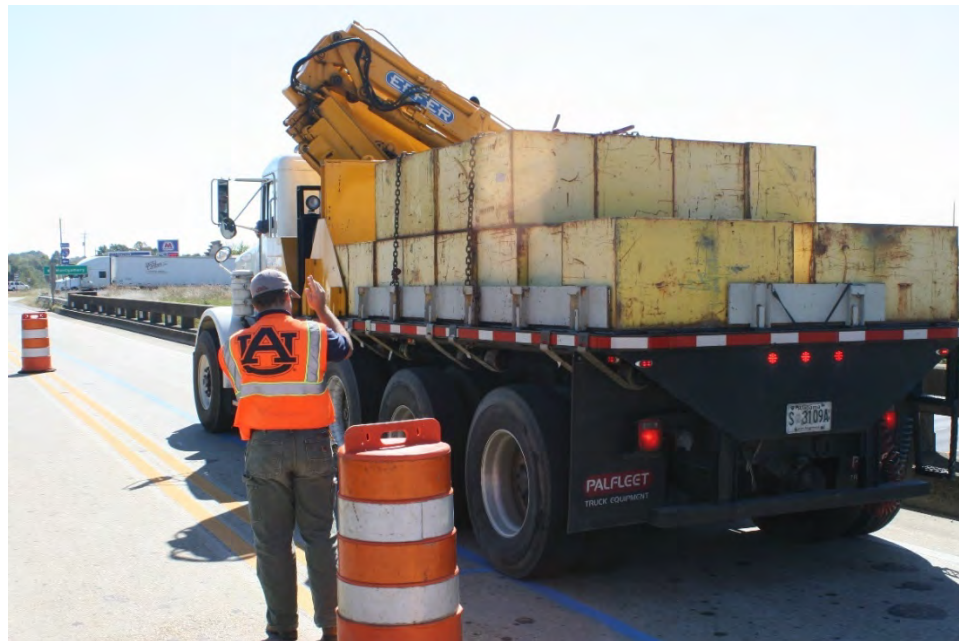
Figure 5.28 LC-5 Load Truck during Pre-Retrofit Load Test

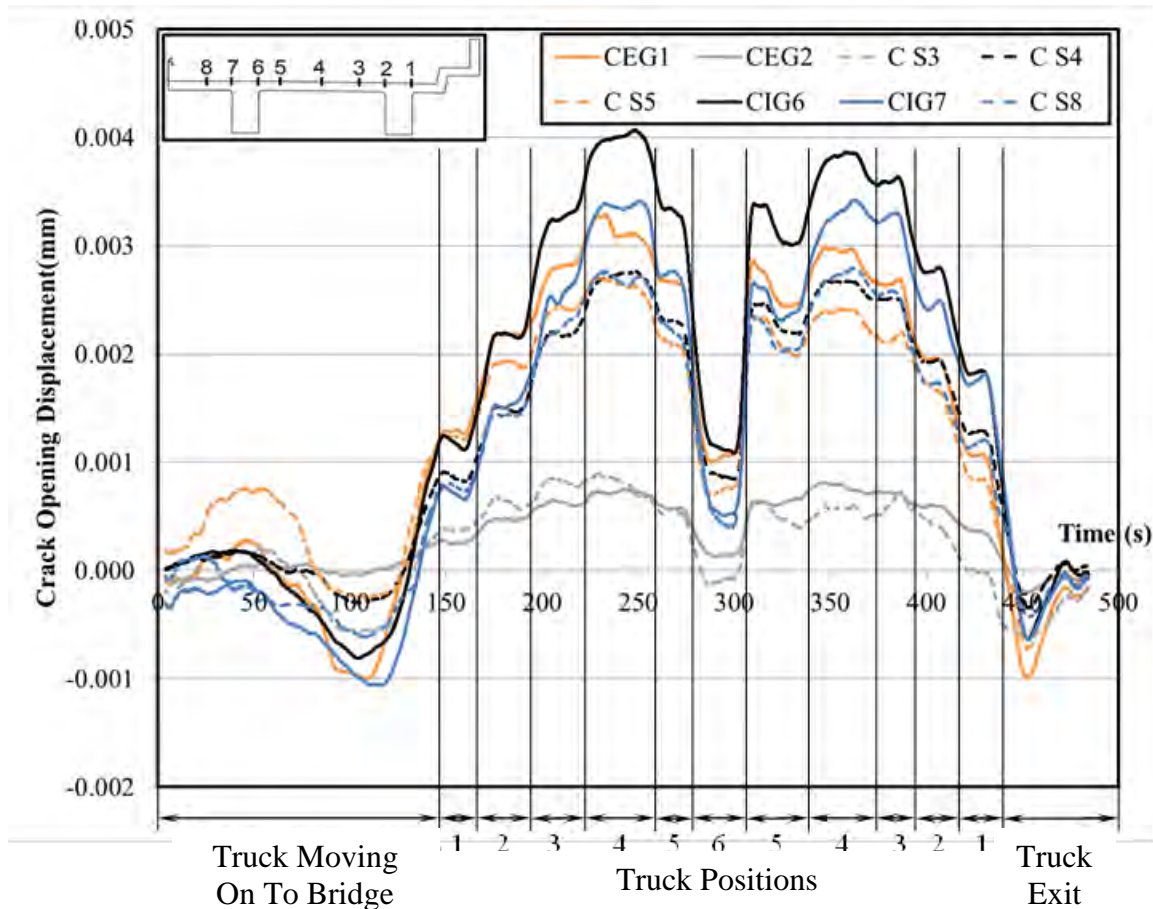
Figure 5.29 Data from the First Test Sequence with LC-5 Load Truck Configuration

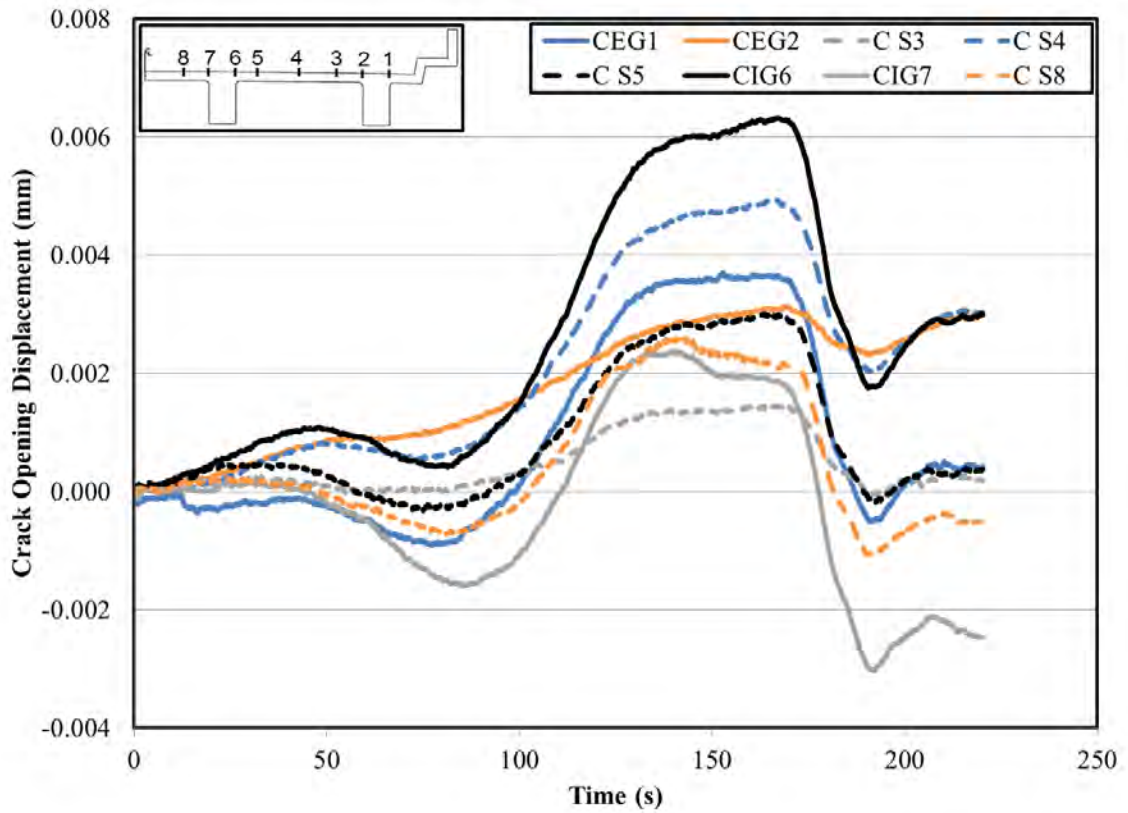
Figure 6.3 Raw Data for all Transducers for One Test Run

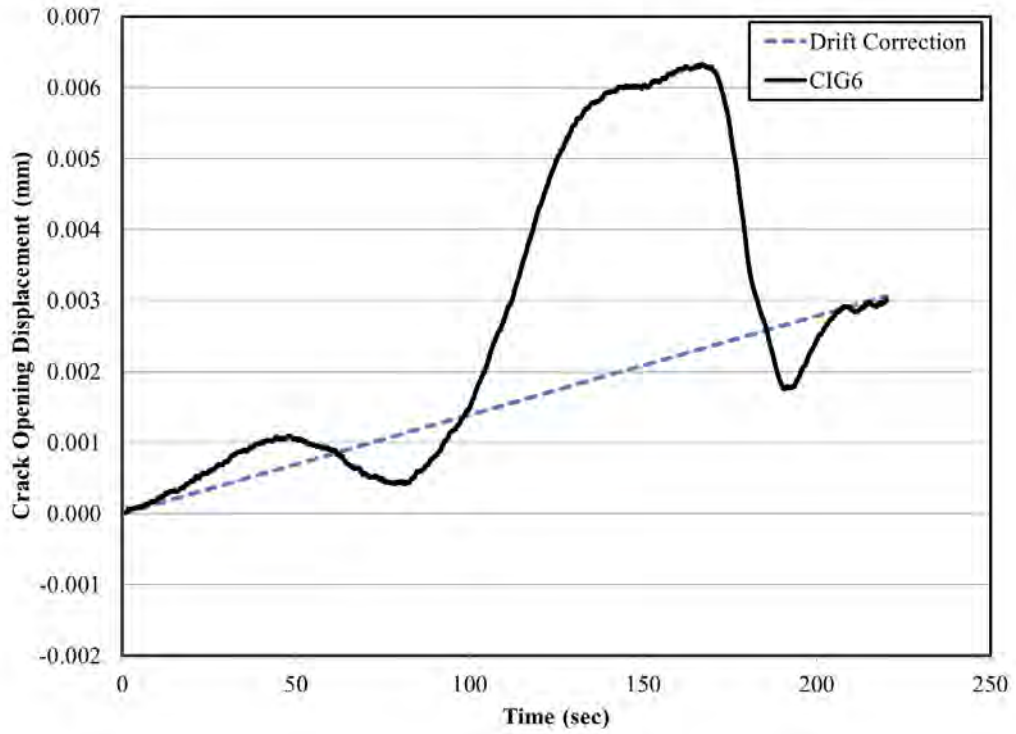
Figure 6.5 Transducer CIG6 Raw Data from Pre-Retrofit Load Test on Sunny Morning

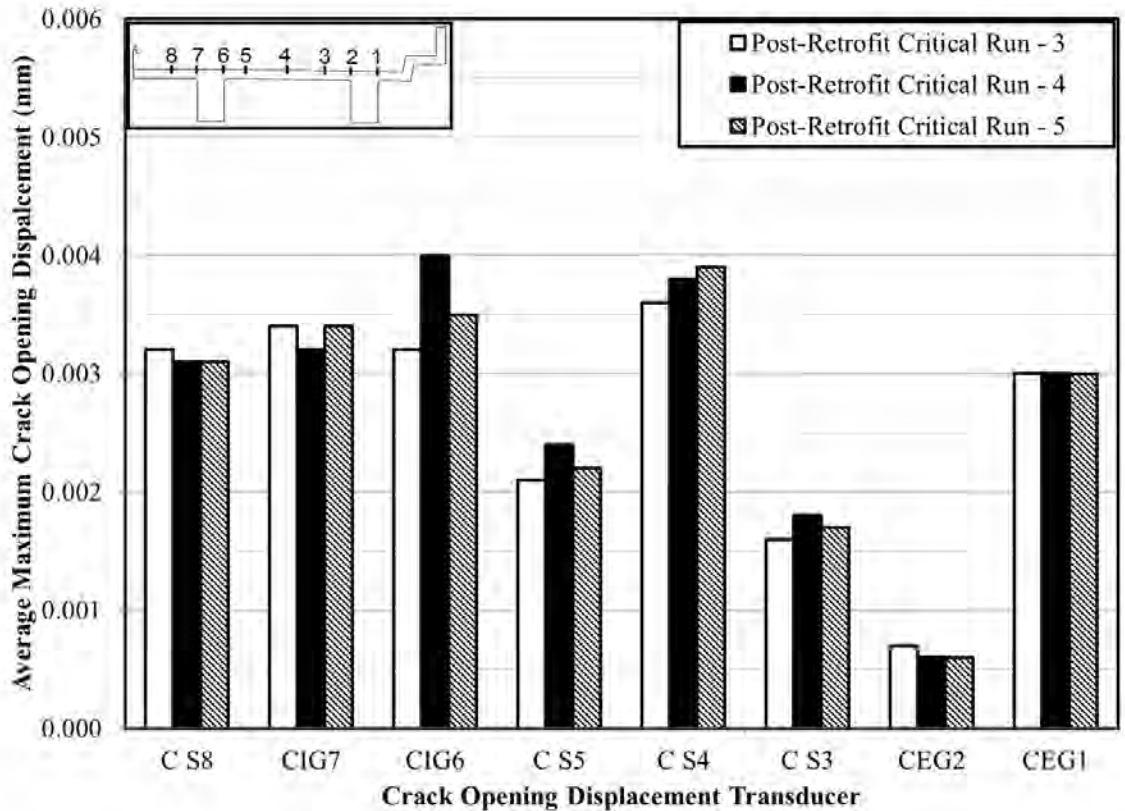
Figure 6.11 Post-Retrofit Maximum Average COD for Critical Runs with One Load Truck

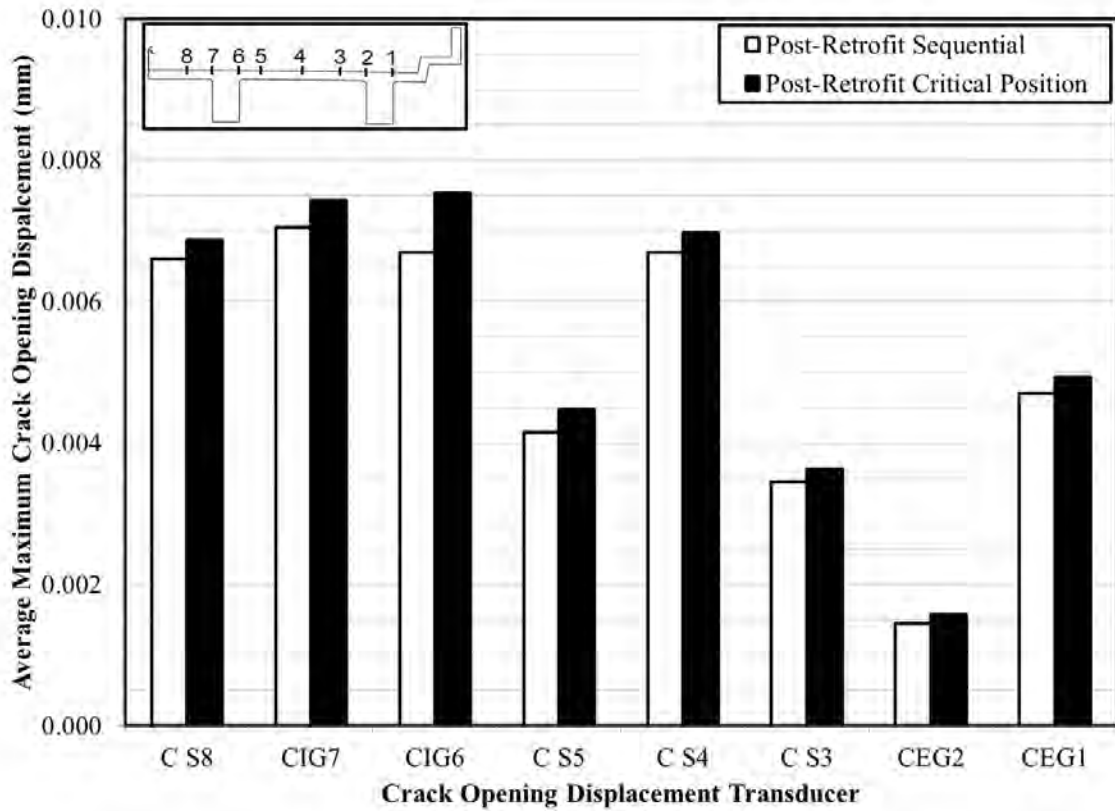
Figure 6.12 Post-Retrofit Maximum Average COD for Critical Runs with Two Load Trucks

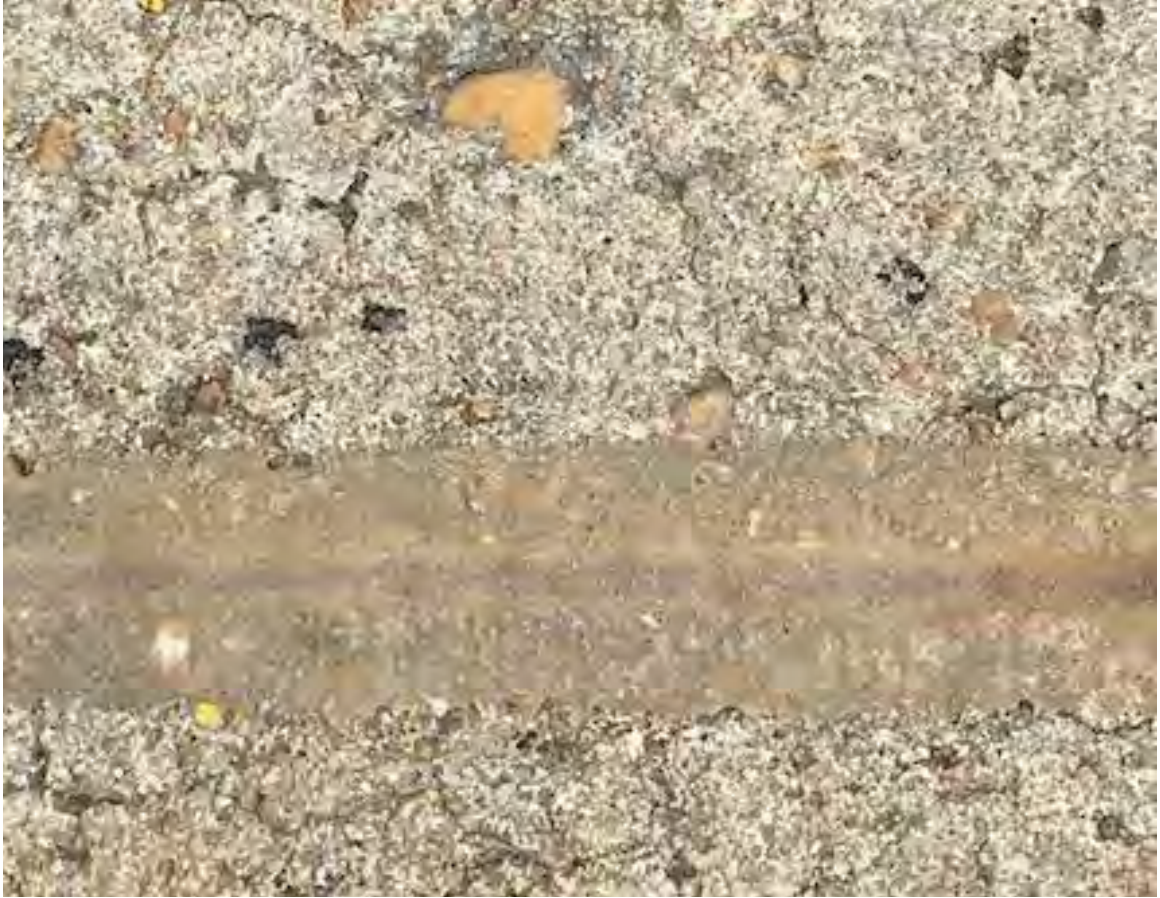
Figure 6.16 Epoxy Showing No Degradation One Year After Installation

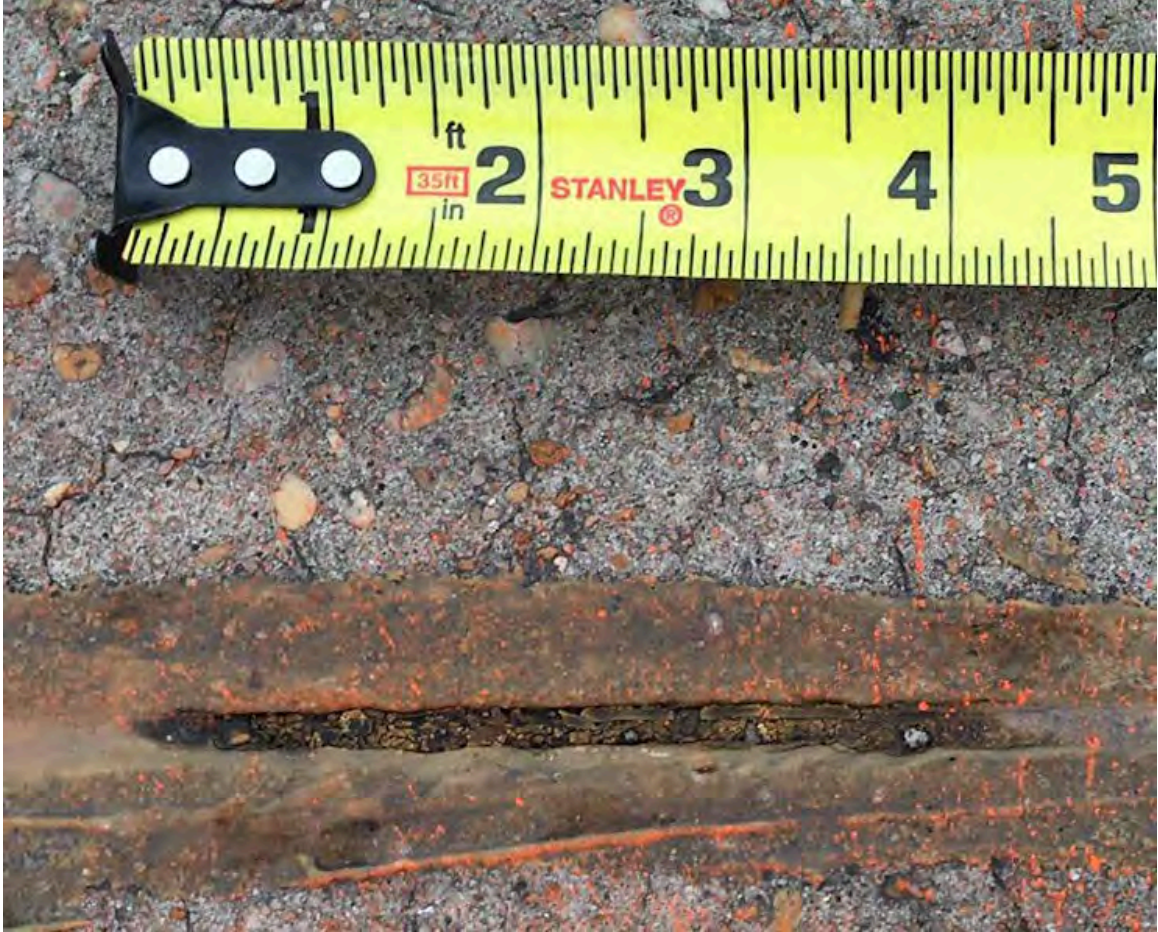
Figure 6.17 Typical Area of Epoxy Degradation

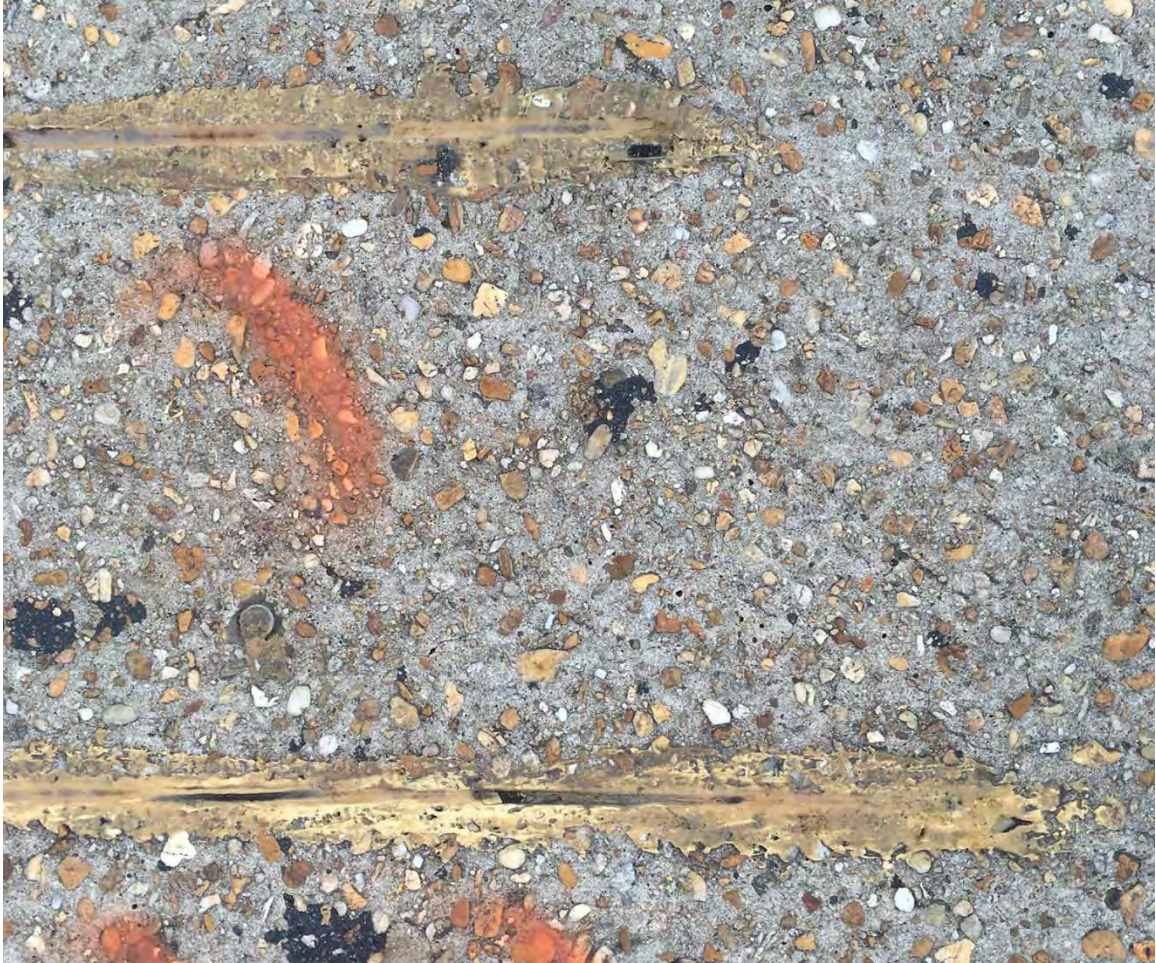
Figure 6.18 Degradation of Epoxy Near Ends of Strips
