Research Report No. 2 for ALDOT Project 930-762

**LABORATORY TESTING OF TRANSVERSE
JOINTS FOR PRECAST-PANEL BRIDGE-DECK
REPLACEMENT SYSTEMS**

AUGUST 2020

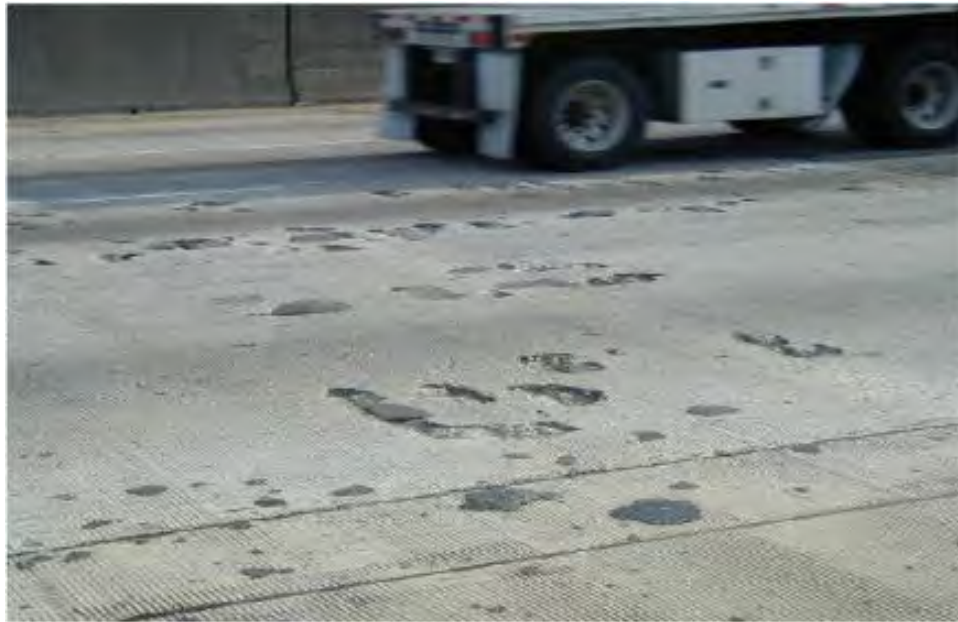
Out of the 16,098 bridges in Alabama, 1,229 are structurally deficient (FHWA 2016). The term structurally deficient means that a bridge has at least one structural defect which may indicate that a structural component does not satisfy current code requirements or that a structural component is damaged and thus has a reduction in structural capacity. In many instances this structural deficiency relates to the deck of the bridge. Deck degradation is very common in bridges over 25 years old (Biswas 1986). Many decks fail several years before the rest of the bridge superstructure and substructure reach the end of their useful life (Bettigole and Robison 1997). Figure 2.1 shows the deterioration of a typical bridge deck.

Figure 2.1 Typical Deck Deterioration (Umphrey 2006)

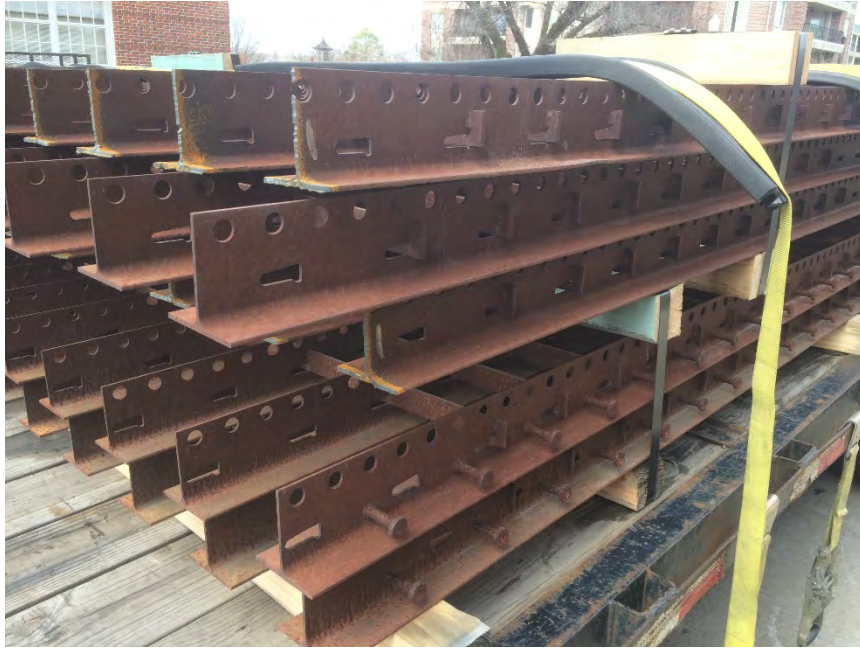
The grids were exposed to the weather on the D.S. Brown Company property for several years. Although light surface rusting had developed, the grids were still in adequate shape. Two of the five grids were designed for the unreinforced shear key joint decks while the other three grids were designed for the staggered hook reinforced joint decks. Figure 4.8 shows the difference between the steel grids. The two steel grids designed for the unreinforced shear key joint decks contained an additional attribute, specifically, $\frac{1}{2}$ in. x 2 in. welded studs at 6 in. on center.

Figure 4.8 Comparison of the Steel Grids

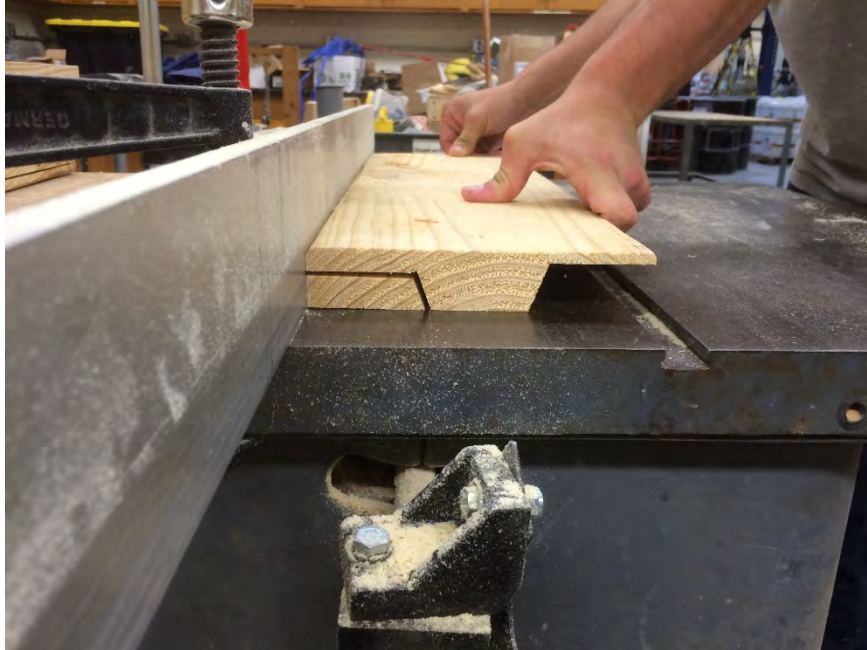
Figure 4.12 Unreinforced Shear Key Joint End Cap

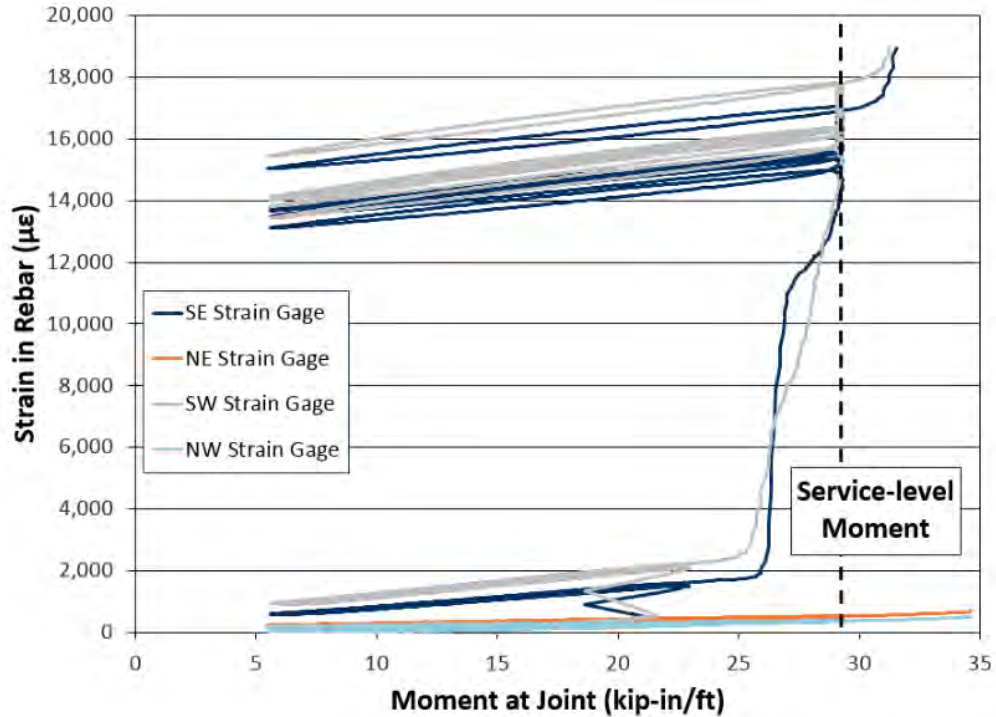
Figure 5.7 shows the behavior of the strain in reinforcing steel versus moment at joint. At each load step as the moment at the joint increases, more cracks form in the specimen and the strain in the reinforcement increases. Note that the SE and SW strain gages increased significantly between the third and fourth load step compared to the NE and NW strain gages. This shows that the south reinforcing steel yielded at 25.7 kip-in/ft. The strain gages reached their limit at approximately 19,000 $\mu\epsilon$.

Figure 5.7 Strain in Reinforcing Steel versus Moment at Joint (R-POS-Q)

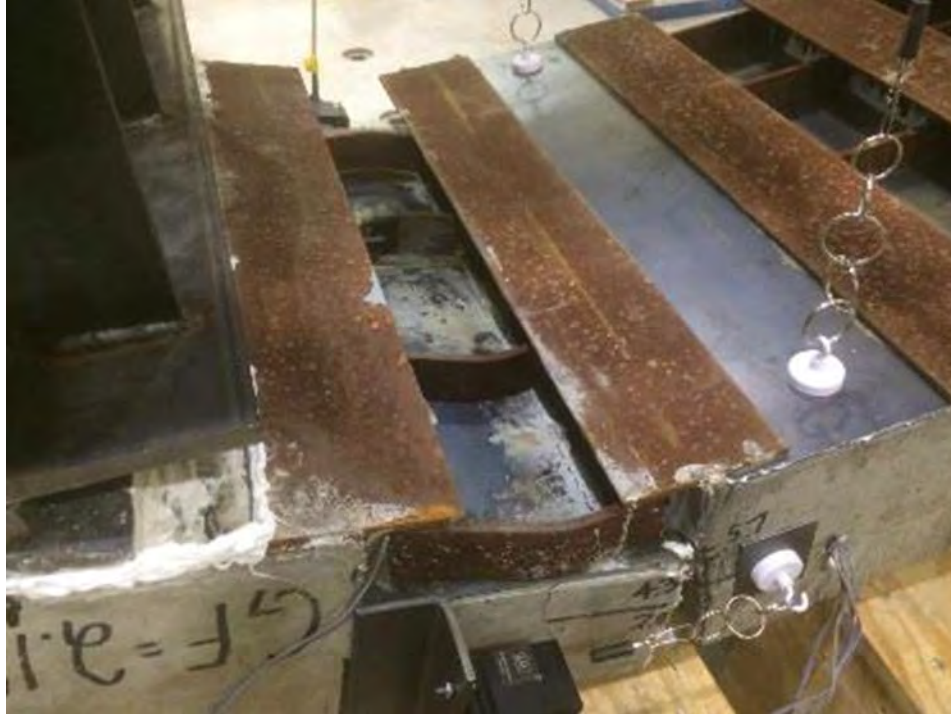
The distribution bars acted as part of the load-resisting mechanism of the specimen. These bars resisted compressive stresses and ultimately failed by buckling as shown in Figure 5.12.

Figure 5.12 R-NEG-Q Buckled Distribution Bars (Inverted Specimen)

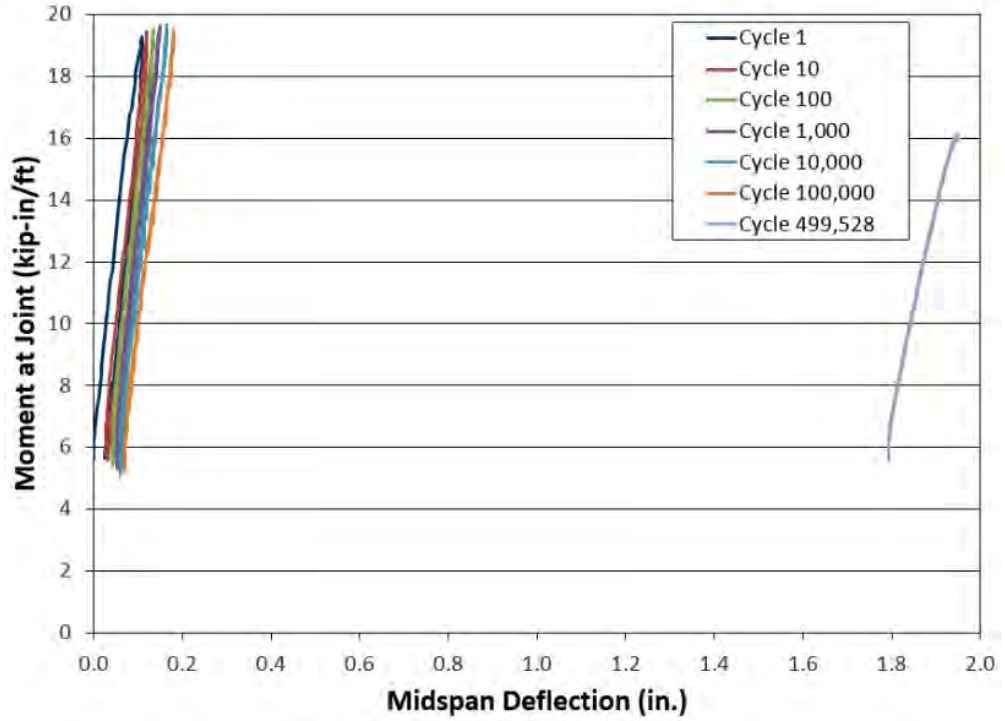
Figure 5.41 Moment at Joint versus Midspan Deflection (R-NEG-F)

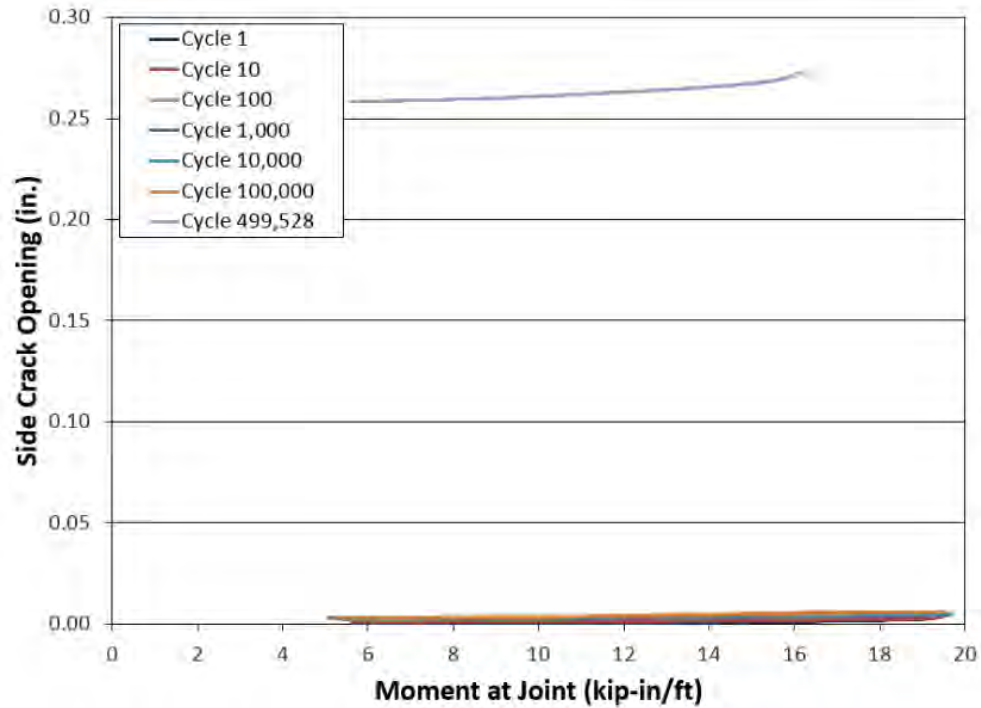
Figure 5.43 Side Crack Opening versus Moment at Joint (R-NEG-F)

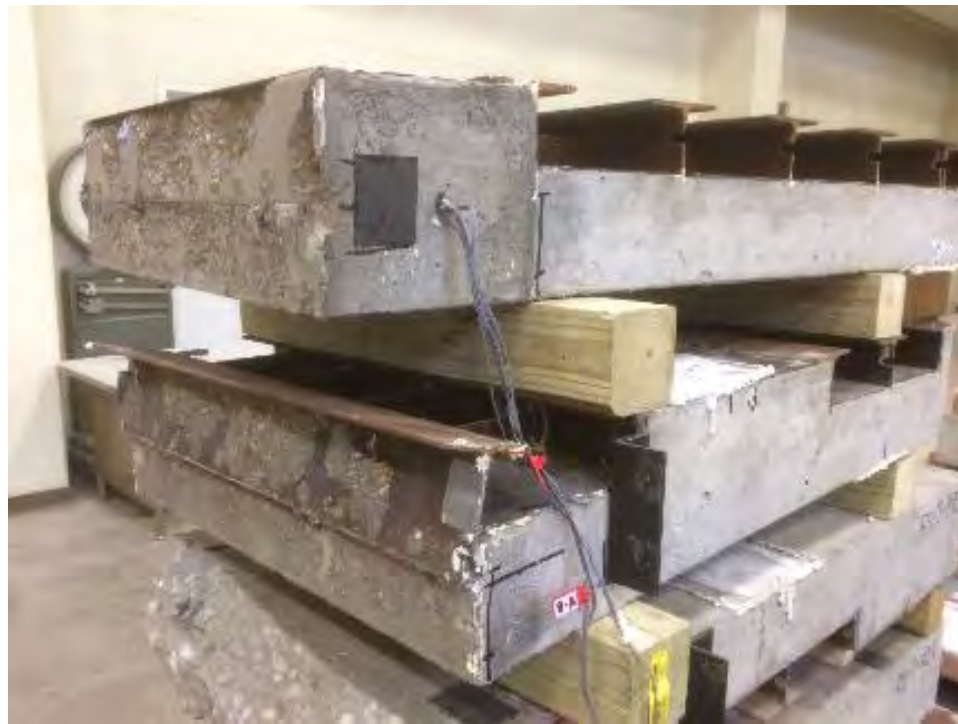
Figure 5.50 Separated (and Inverted) Deck Panels (R-NEG-F)
