EVALUATION OF LANDSLIDES ALONG ALABAMA HIGHWAYS

The Alabama Department of Transportation

AUGUST 2019

Highway Research Center

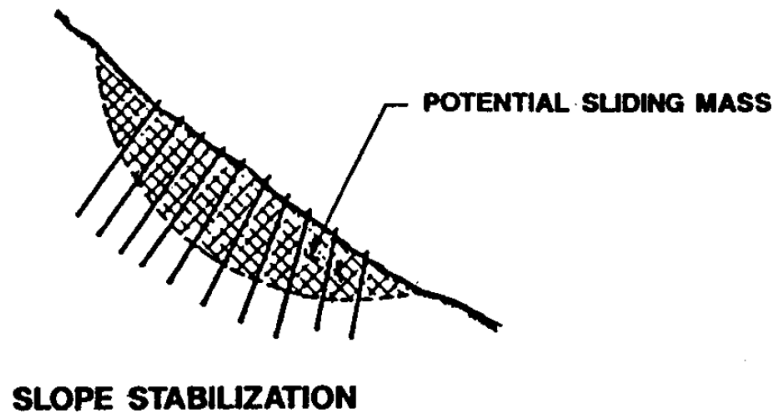
Figure 2-13. Main application of soil nailing (Abramson et al. 2002).

Soil nailing is performed by placing long slender bars through an unstable soil mass into the stable material behind or underneath it (Figure 2-13). The bars act as a passive reinforcing member and provide resistance as the soil attempts to move. Soil nailing is a very common slope stabilization technique and has been used successfully as both permanent and temporary

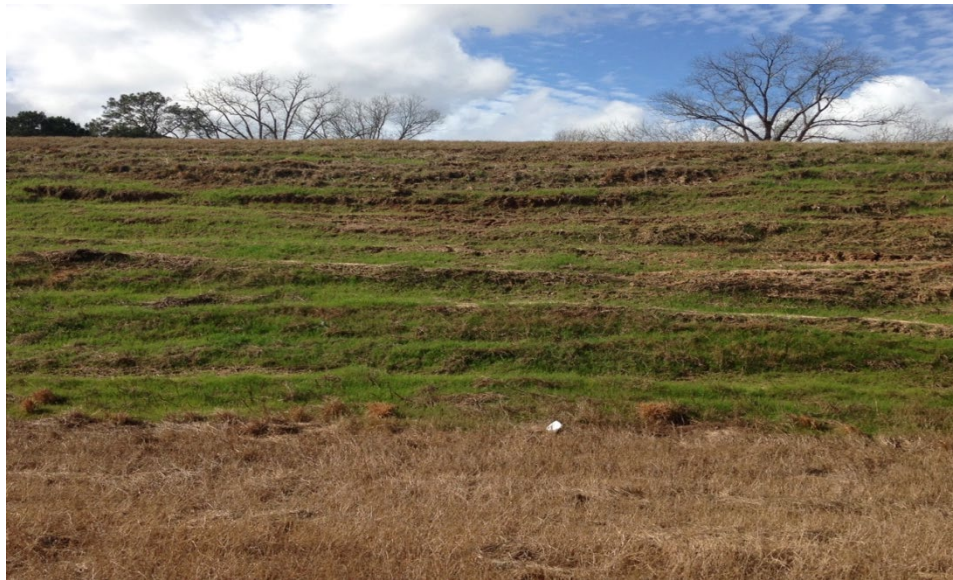
Figure 3-5. Rutting along the face of a slope due to mowing activities (photo provided by Jacob Hodnett, ALDOT).
