**EVALUATION OF SCOUR POTENTIAL  
OF COHESIVE SOILS**

FINAL REPORT  
PROJECT 930-644

Highway Research Center  
Auburn University, Alabama

August 2009

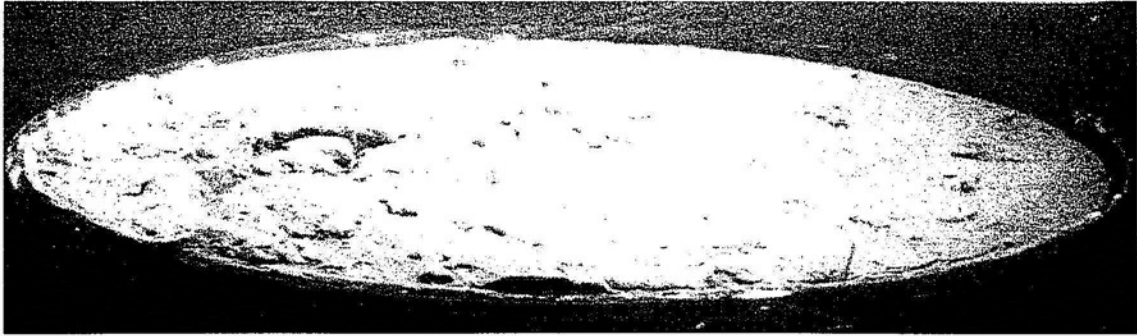
Test 316B was conducted for approximately 4.60 hours. Velocity was set to 0.65 m/s for the first 3.17 hours and 0.90 m/s for the final 1.43 hours. At 2.25 hours, a large spall suddenly flew out of the upstream 1/3 end, as shown in Figure 7. Along with the silty emission from the edges, this void grew larger at  $V = 0.90$  m/s for the final 1.43 hours. After testing, this sample was ejected 5 cm above the Shelby tube surface for examination (Figure 8). Around a pocket of small pebbles, erosion was obvious at the leading edge of the sample. In contrast, the downstream 2/3 of the sample surface showed very little erosion.

Test 316B, Test Start

$\Delta t = 2.25$  Hours,  $V = 0.65$  m/s

$\Delta t = 4$  Hours,  $v = 0.90$  m/s

**Figure 7: Talladega EFA Test 316B**

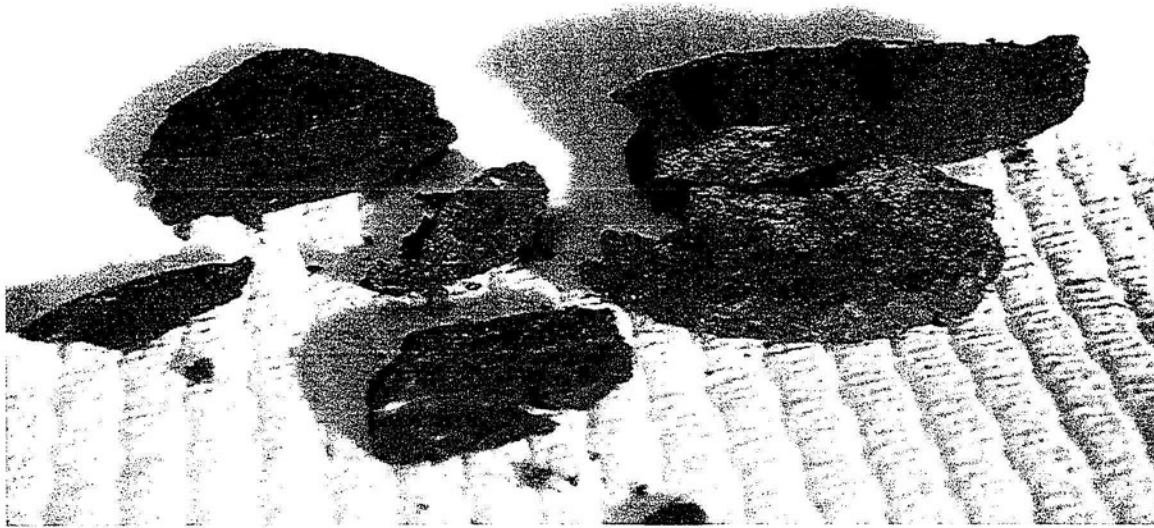
**Figure 9: Sumter County Sample Structure and Horizontal Layering**

Because of the layered structure of the silt (Figure 9) it was not possible to trim the cores to prepare a surface for testing without causing some disturbance. Figure 10 illustrates the difficulties encountered in preparing a uniform surface. In addition the layered structure of the hard silt resulted in very erratic sample erosion. Most of the soil

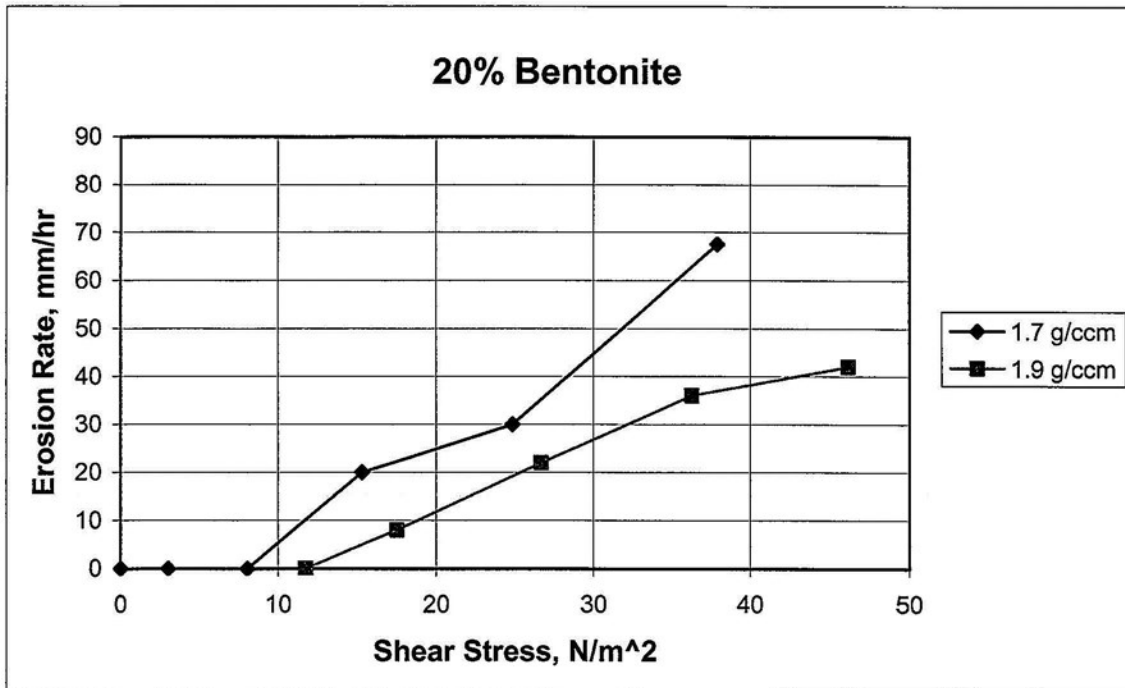
Figure 17: Comparison of Erosion Function Densities at 20% Bentonite

Figures 17 and 18 illustrate the significance of density on erosion rates. For soil that contained 25% clay and tested at 6.0 m/s ( $\tau = 45 \text{ N/m}^2$ ), the measured erosion rate for the  $1.70 \text{ g/cm}^3$  soil was 84 mm/hr, while the  $1.90 \text{ g/cm}^3$  soil eroded at a rate of only 34 mm/hr. An increase of  $0.2 \text{ g/cm}^3$  resulted in a 60% decrease in erosion rate. For soil composed of 20% clay, the higher density resulted in a reduction of about half the erosion rate.
