Final Report
Project Number 930-789

EVALUATION OF SCOUR POTENTIAL OF COHESIVE SOILS – PHASE 2

The Alabama Department of Transportation

JANUARY 2015

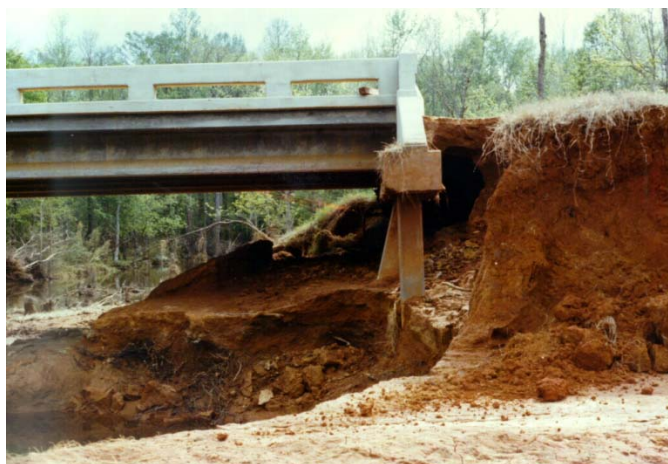
Figure 1-1. Example of Bridge Scour

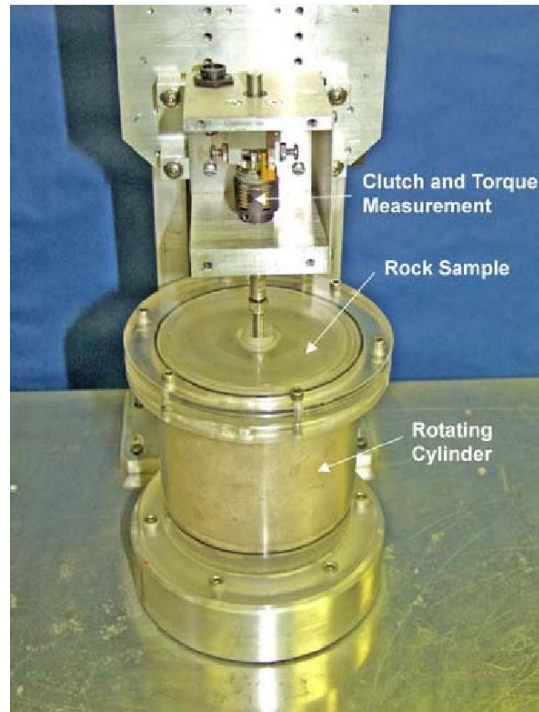
The Rotating Erosion Test Apparatus (RETA) was designed to determine the volume of erosion of stiff clay, sandstone, and limestone. A schematic of the RETA is shown in Figure A-4. The RETA performs an erosion test on a 102 mm long cylindrical soil sample with either a 61 mm inch or 102 mm diameter (Sheppard et al. 2005). A 6.4 mm diameter hole is drilled vertically through the sample and a support shaft that attaches to the RETA is inserted through the sample. The opposite end of the shaft is attached to a torque cell and clutch that is fixed to a surface (Sheppard et al. 2005). A larger diameter cylinder is placed over the sample, and water is added to fill the annulus between the sample and the outer cylinder. The outer cylinder is rotated using a motor and pulley system to create a shear stress on the surface of the sample. After a known duration of time the test is stopped and the test sample is measured radially and any eroded material is oven dried to determine the mass of the scoured soil. The shear stress is calculated by knowing the amount of torque applied to the sample along with the initial radius and length of the test specimen. The erosion rate is calculated using the change in radius, duration of the test, mass density of sample, and original sample geometry (Sheppard et al. 2005).

Figure A-4. Rotating Erosion Test Apparatus (RETA)

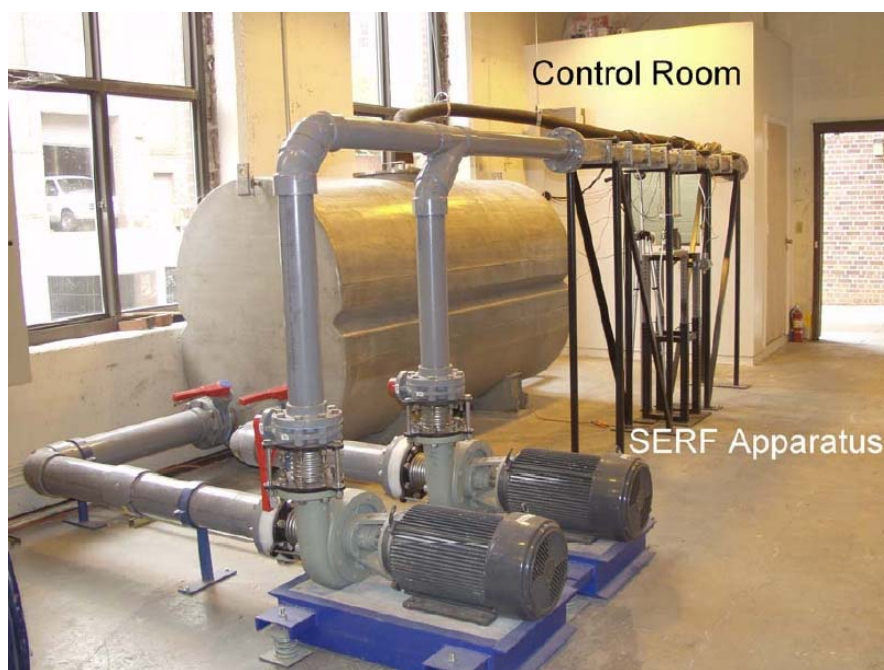
The Sediment Erosion Rate Flume (SERF) is the second apparatus created at the University of Florida for the purpose of measuring relationships between erosion rate and shear stress. The SERF functions similar to the EFA. Like the EFA, the SERF uses a flume with a rectangular cross section, a water pump, a reservoir, and a stepping motor. The SERF does have a larger water capacity than the EFA, as it utilized two pumps and has an 1100 gallon reservoir. The SERF is much more automated than the EFA, using multiple instruments and a Labview program. Images of the SERF are shown in Figure A-5 and Figure A-6.

Figure A-5. Sediment Erosion Rate Flume (SERF)

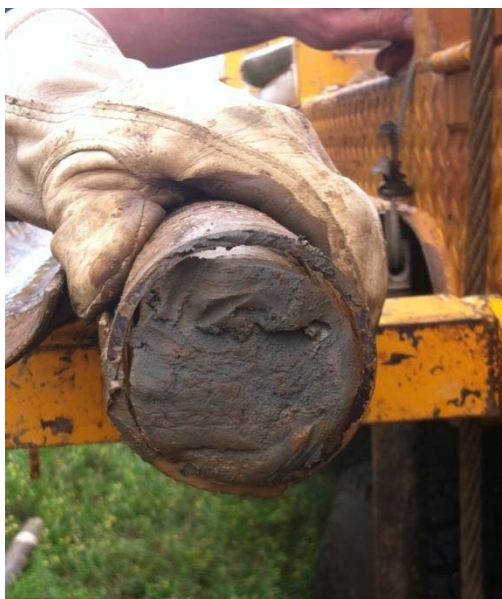
The continuous sample from 13.5 to 18.5 feet was determined to be unusable for EFA testing. The top of the sample was not usable as it had a plug missing from the Standard Penetration test taken above. The sample gathered from 13.5 to 18.5 feet meters was also smaller radially than the sample tube at the base of the sample as shown in Figure B-1.

Figure B-1. Bucatunna Clay Sample Smaller Radially than Sample Tube

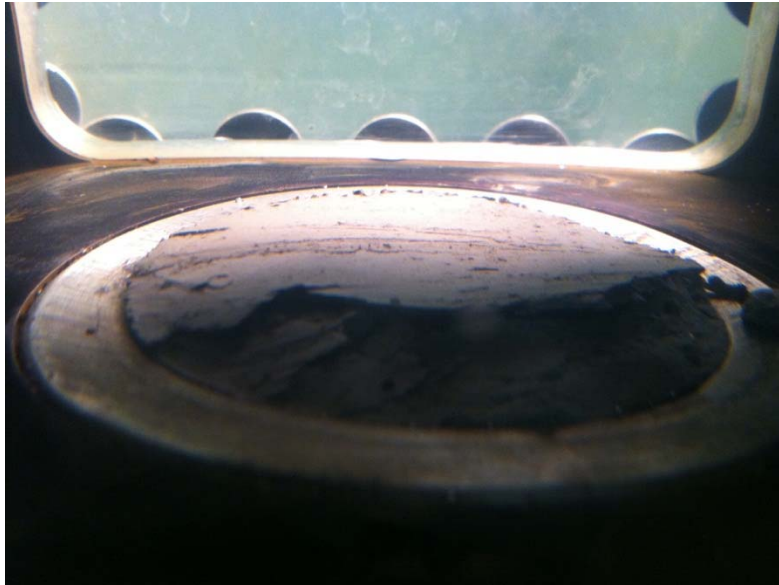
The first test performed on the Yazoo Clay formation was used to help determine the starting test velocity and was titled “Yazoo Clay 18.5_1”. The “Yazoo Clay 18.5_1” test started with a flow velocity of 0.3 m/s, and scour was not observed. After one hour the flow velocity was increased to 0.45 m/s and immediately a wedge of the sample scoured away. This wedge developed shortly after the test was started and grew in size throughout the test, and image of this wedge can be viewed in Figure B-5. However, since this method of failure had not yet been observed a second test titled “Yazoo Clay 18.5_2” was performed starting at a flow velocity of 0.45 m/s.

Figure B-5. Yazoo Clay 18.5_1 Test Failure Wedge

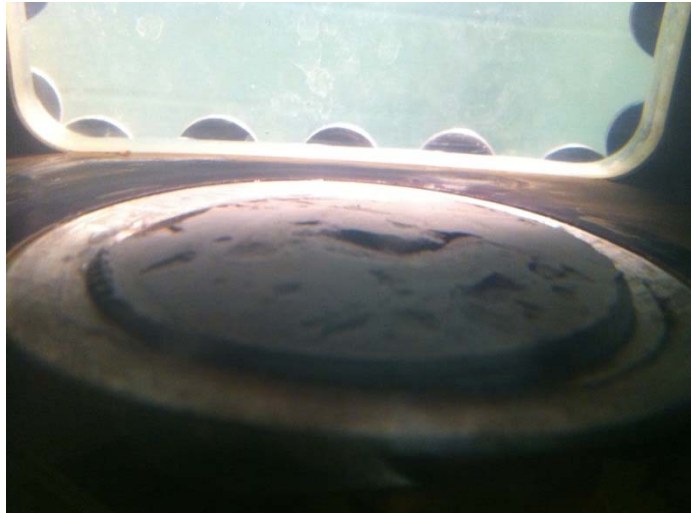
This was the first sample tested in this study that did not exhibit any scour behavior with the set testing regiment. If future testing of the Demopolis Chalk formation is necessary the remaining testable section of the formation was sealed and placed into a curing chamber to preserve field moisture conditions.

Figure B-12. DemopolisChalk19.0_5 After Testing

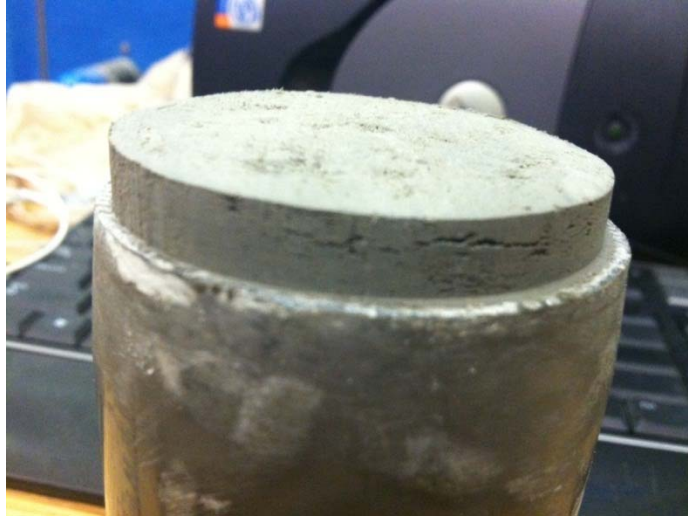
The first test on the Prairie Bluff Chalk formation started at a flow velocity of 1.0 m/s. The protrusion into the flume was calculated to be 1.51 millimeters or fifty percent higher than the height specified by Briaud. After fifty minutes a large mass chunk scoured away, the volume of the scoured section was approximately equal to five times the volume of the protrusion. It was noted during testing that the sample seemed dry and loose in some areas, and that the large scoured volume started from the loose areas of the sample. Another EFA test was performed at a flow velocity of 1.0 m/s, with a total protrusion of 1.85 millimeters. No scour was observed during this test, suggesting that the flow velocity should be increased for future tests. The idea that the test samples that had altered tubes and been manually advanced were exposed to differing stress states than initially intended during EFA testing was confirmed during testing of the Prairie Bluff Chalk formation. It was thought that these samples were exposed to shear or torsional forces during extruding. This idea was reinforced by cracking on the edges of the advanced sample as viewed in Figure B-16 and Figure B-17. These shear and torsional forces could have been developed through an eccentricity between the bowed sample tube and the extruder advancing the sample. It is unknown if these forces negatively influenced EFA testing. It was noted that these cracks that developed in the EFA sample created shear planes for scouring to occur that would not naturally exist in a stream bed.

Figure B-16. Prairie Bluff Chalk Formation Cracking Example 1

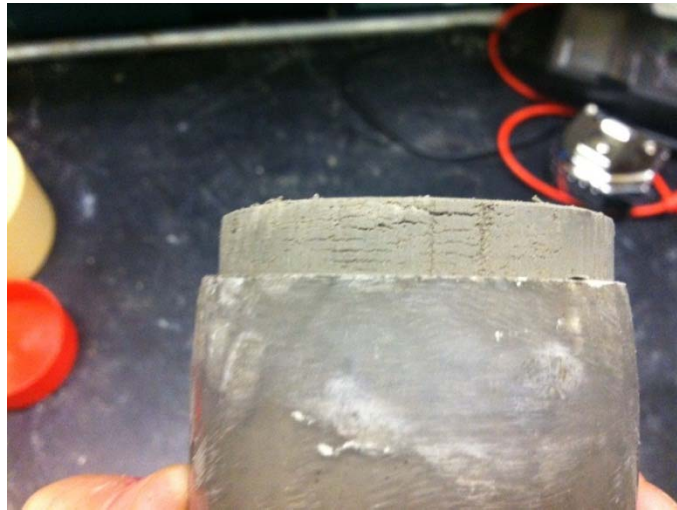
Figure B-17. Prairie Bluff Chalk Formation Cracking Example 2

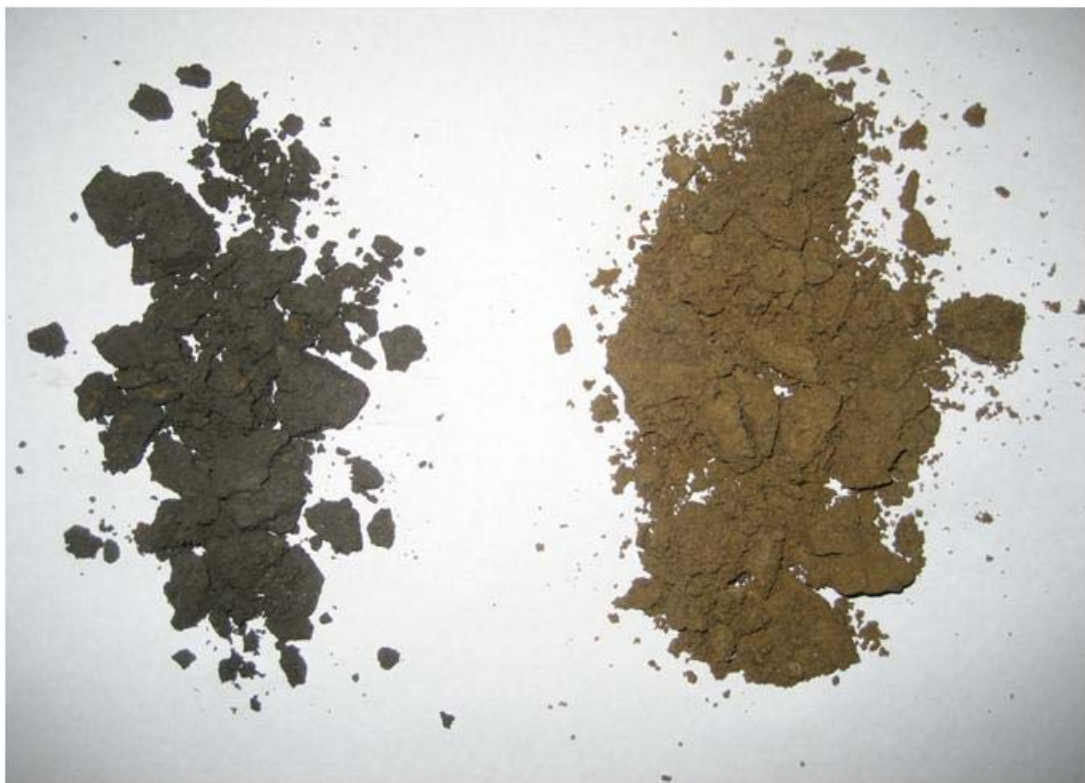
Figure C-5. Photograph of Naheola-Dark (left) and Naheola-Yellow (right) Formations.

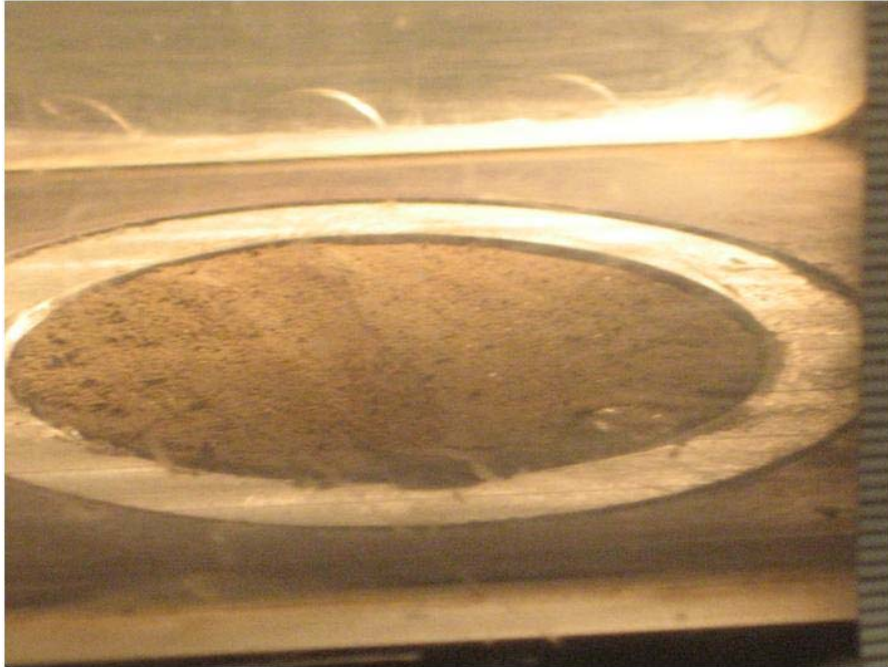
Figure C-6. Naheola Clay 17.2_1 Sample Prior to 2.0 m/s EFA Test.

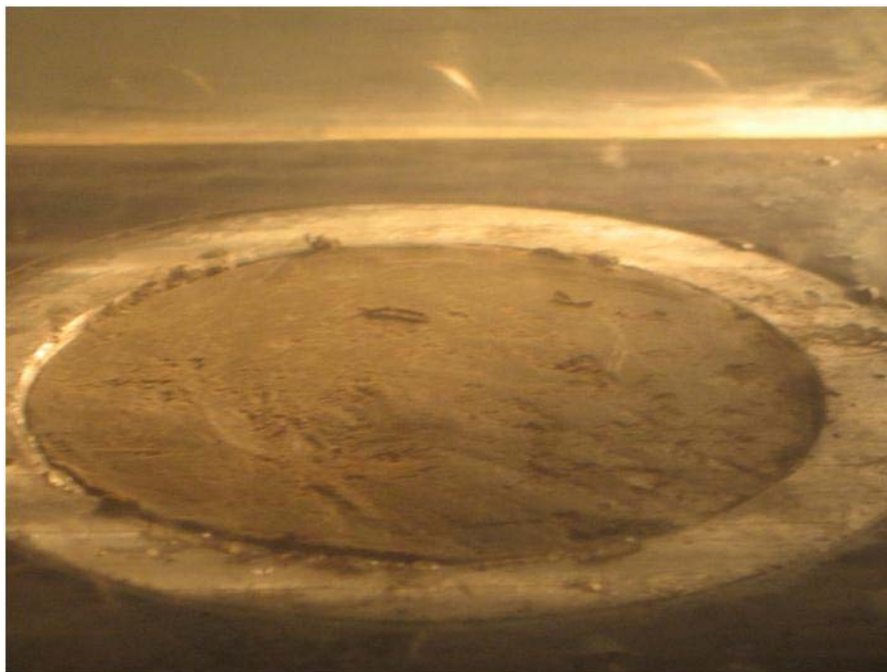
Figure C-23. Porter's Creek 24.0_4 Sample at Start of 0.3 m/s EFA Test.

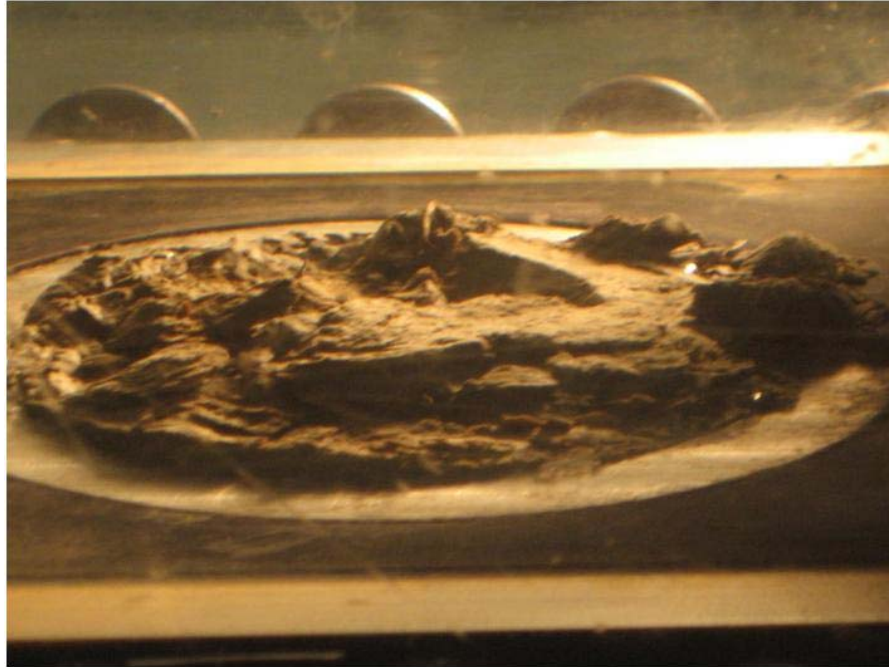
Figure C-24. Porter's Creek 24.0_4 Sample 15 minutes After Push.

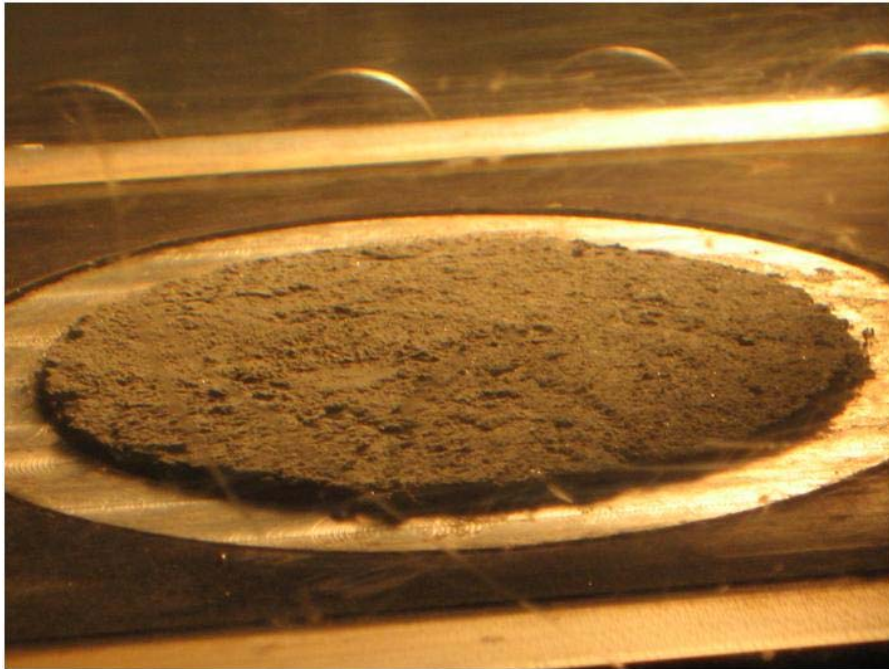
Figure C-26. Yazoo 21.0_4 Sample after Push.

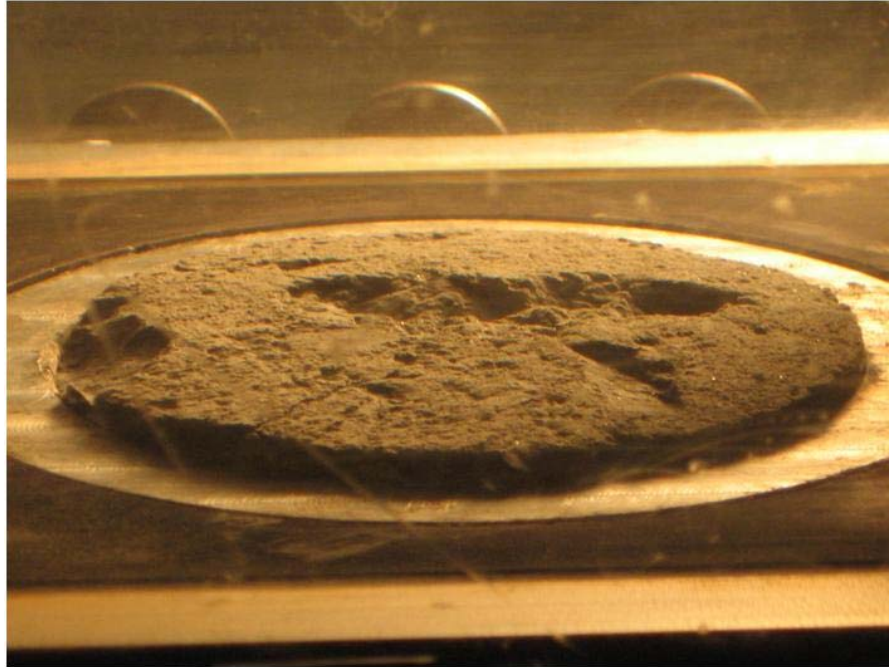
Figure C-27. Yazoo 21.0_4 Sample Approximately 57 Minutes after Push.
