# **Assessing and Enhancing the Durability/Longevity Performances of Highway Bridges**

**HRC Research Project  
2-13506  
Final Report**

**Prepared by  
George E. Ramey  
Randall Wright**

**September 1994**

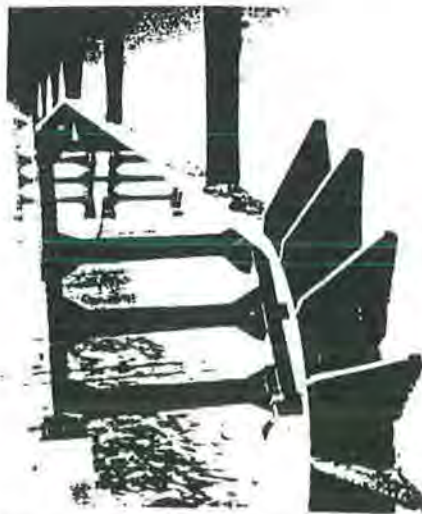
Figure 2.17 Water Trapping Stiffners.

3. Design Details. Avoid water- and debris-trapping details such as the one shown in Figure 2.17.

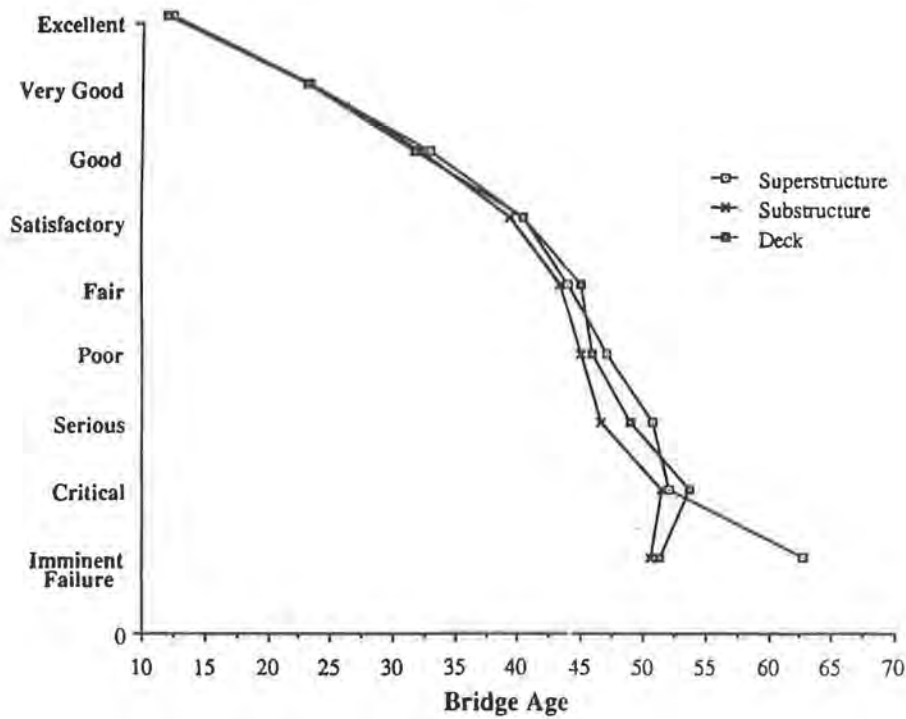
Figure 2.19 Average Ages of Alabama Bridges for Various Condition Categories [60].

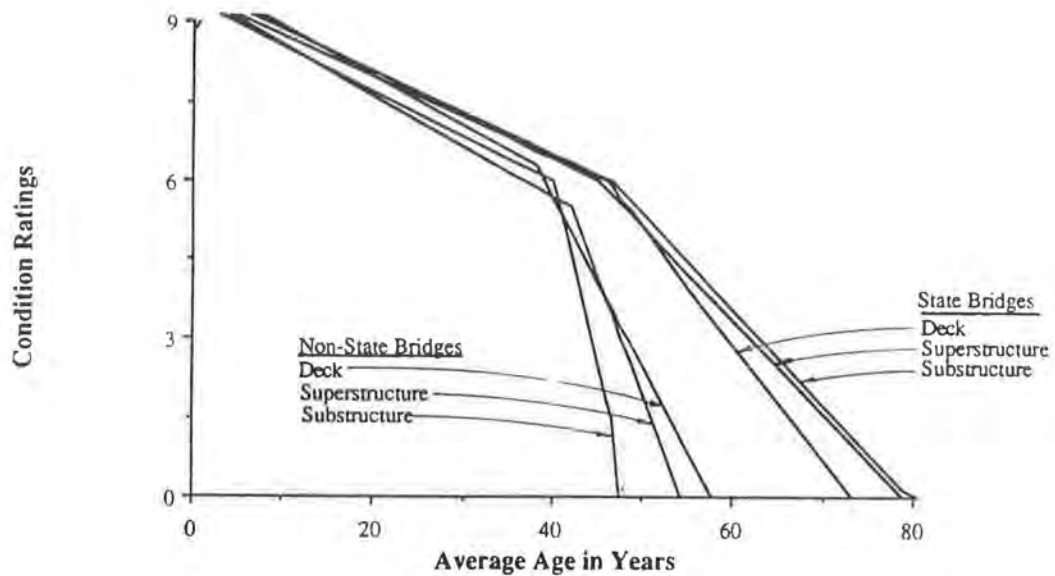
Figure 2.23 Recommended Deterioration Models [60].

The researchers decided to plot the data from the approximately 15,500 bridges and culverts in Alabama, separated in the categories indicated in the previous paragraph, in the manner of that shown in Figure 2.21 and to develop simple bilinear graphical models for each category. Their procedure is illustrated in Figure 2.22. They used findings from their earlier regression studies to make the Age vs Condition plots and then fit bilinear curves to the data. Their results employing this approach are shown in Table 2.5 and Figure 2.23.

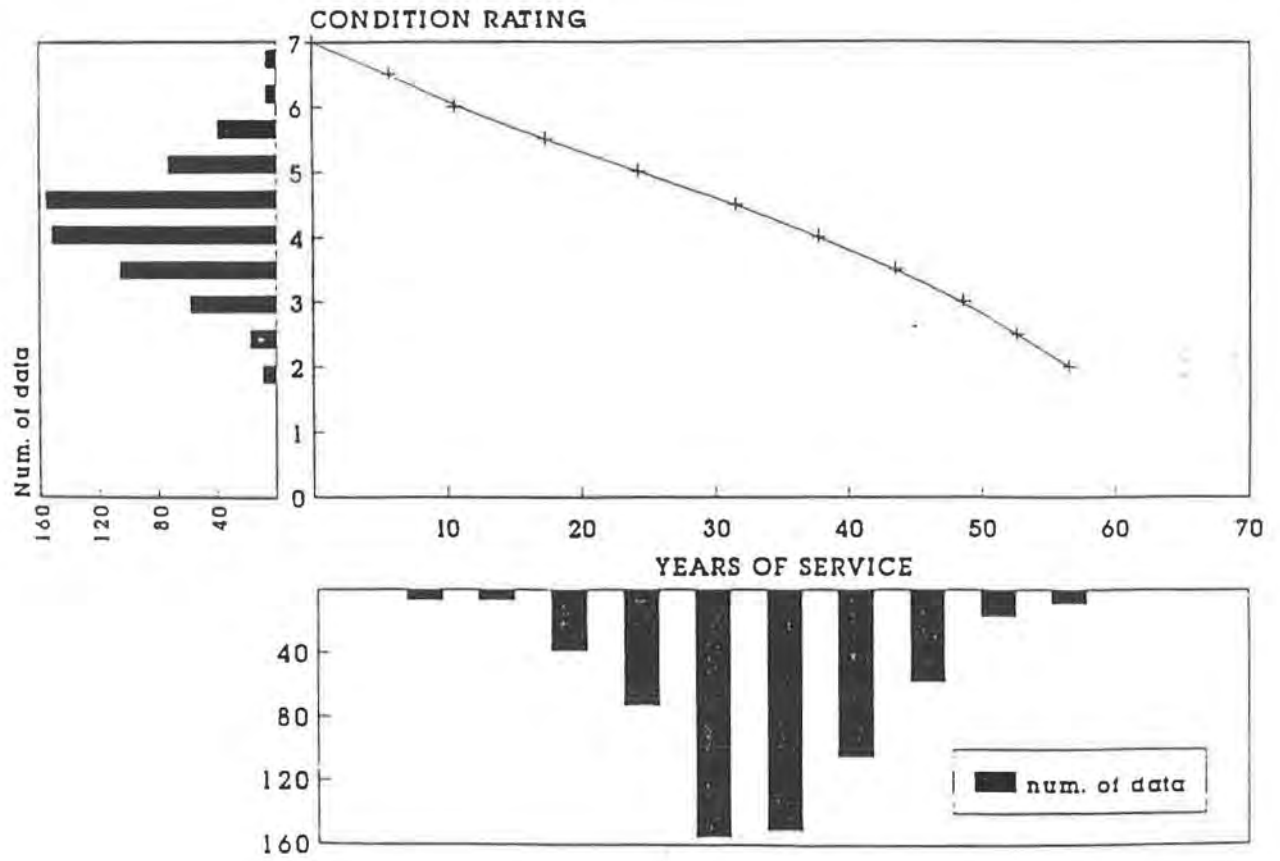
Figure 2.24 Bridge Condition Rating vs. Age and Distribution of Inspection Data from Bridges in NYC Without Major Rehab [62].

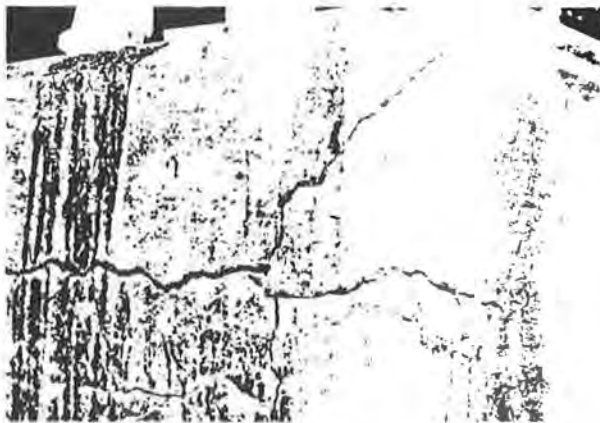
Figure 6.12 Concrete Cap with Horizontal Cracking.

Concrete cracking, rebar corrosion, and spalling is not a problem which is limited to decks. All components of all concrete bridges experience some degree of these deteriorations. Holding the degrees to a low level is critical to durability. It is a problem with prestressed concrete bridges as well. Many of the bridges visited had girder and bent cap cracks and spalls due to rebar corrosion as illustrated in Figures 6.10-6.12.

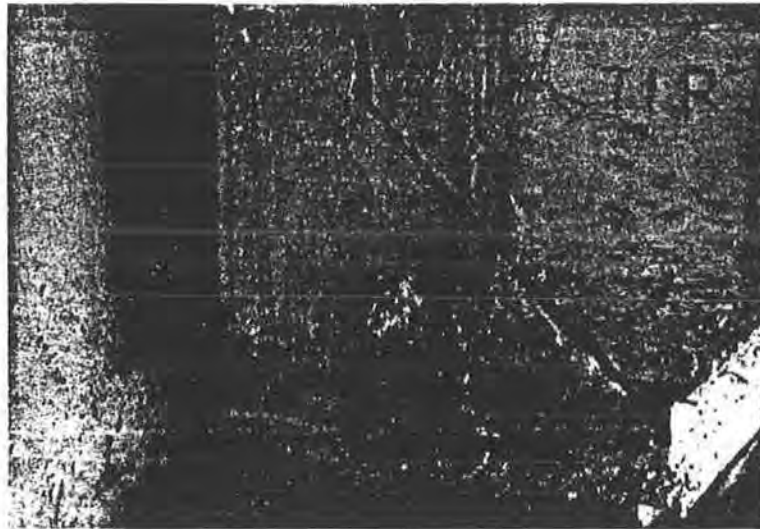
Figure 6.15 Diagonal Girder End Crack Due to Frozen Bearing [16].

Sheared girder ends and bent caps result from the freezing of bearings and/or the accumulation of debris in expansion joints. When bearings become frozen and expansion occurs, stresses begin to form at girder ends and bent caps. Likewise, if expansion is limited due to clogged joints, girders will try to expand at their fixed ends causing the formation of shear stresses. Both situations lead to cracking and loss of section and shear capacity as illustrated in Fig 6.14. Photos showing apparent frozen bearings and resulting sheared end girder and bent caps are presented in Figs. 6.15 and 6.16 respectively.

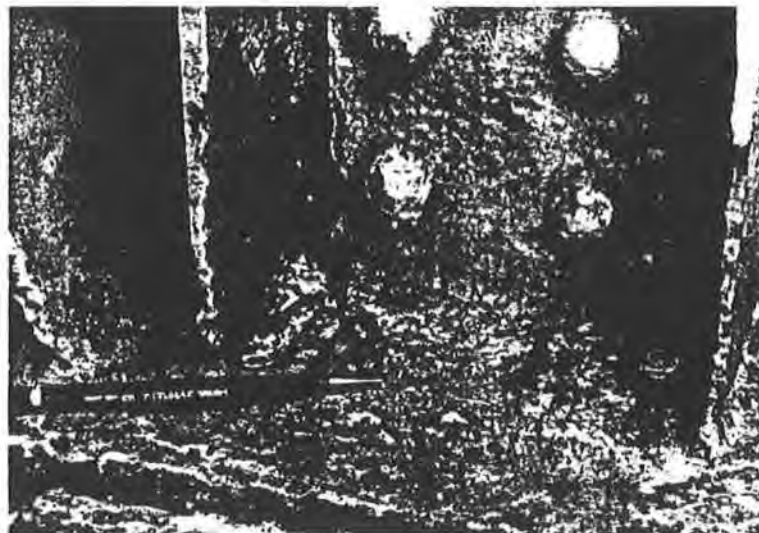
Figure 6.18 Severe Corrosion of Steel Column [16].

Rusting and corrosion of structural steel is one of the primary modes of deterioration for steel superstructure bridges. The northern state de-icing environment is quite severe in this regard. Even in Alabama, due to our humid conditions, relatively high annual rainfall, and salt water condition along the Gulf coast, the corrosion environment for steel can be rather severe. Figures 6.17 and 6.18 show examples of significant rusting on a steel stringer bridge, and severe corrosion at the base of a steel column respectively.
