Flexural Strengthening of Reinforced Concrete Beams with Externally Bonded CFRP Plates with Lap Splices

Nathan Matthew Porter
James Michael Stallings

Highway Research Center
Auburn University, AL

June 2001

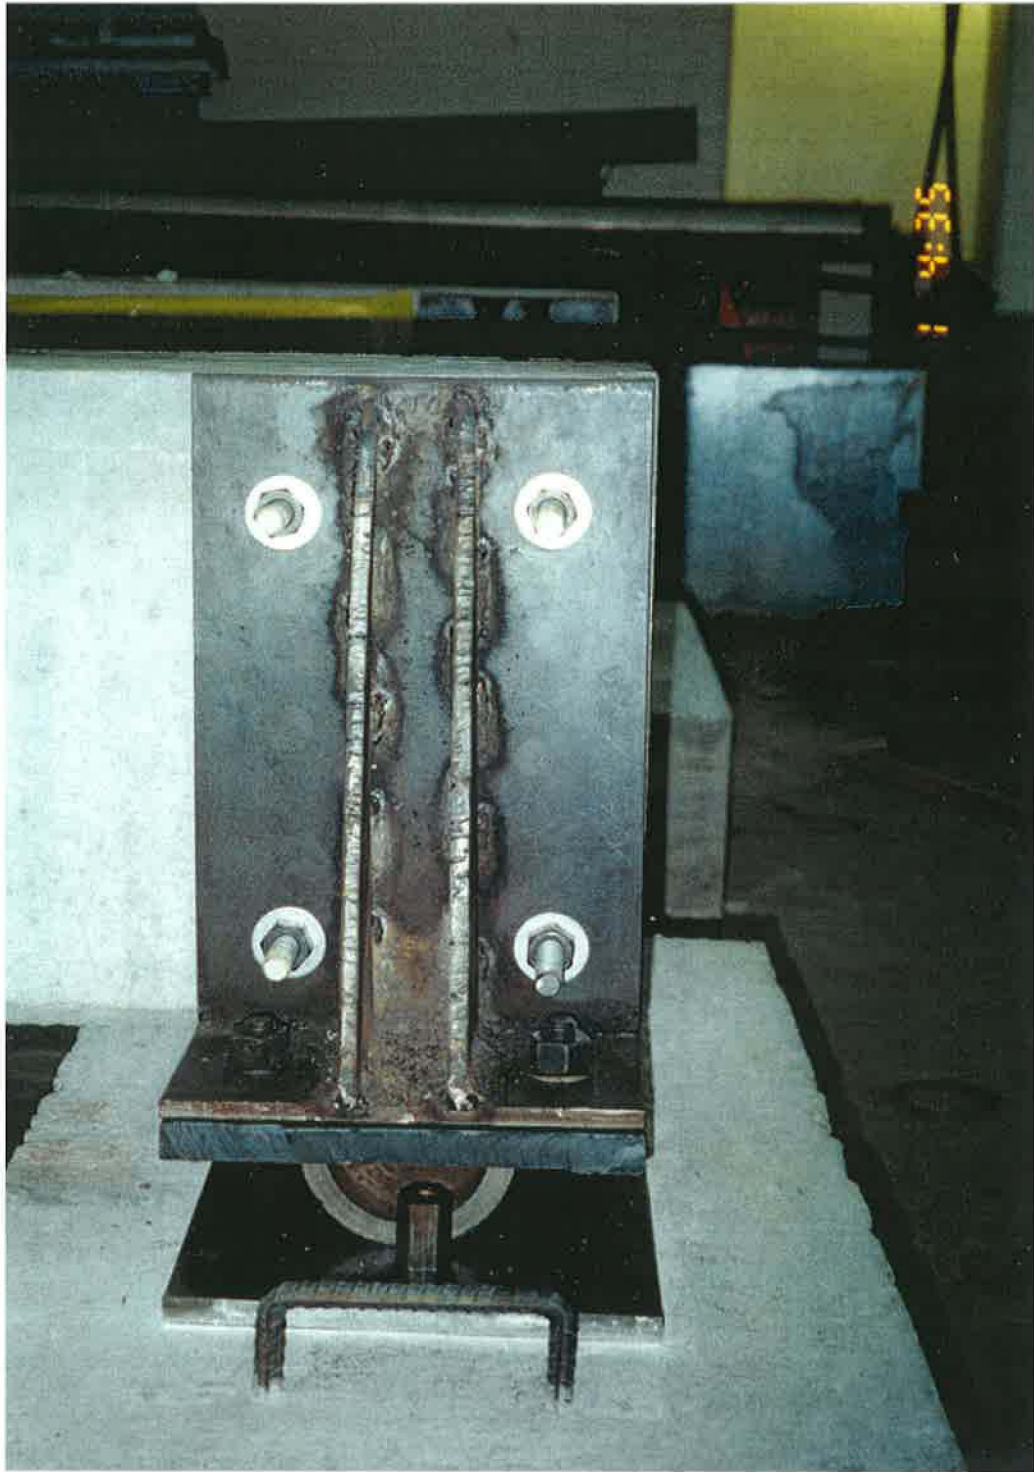
FIGURE 3.2. Beam Roller Bearing

Shear reinforcement consisting of #3 closed stirrups spaced along the beam was used (see Figure 3.1). The beams were designed for twice the anticipated shear to avoid brittle shear failure with the increased load capacity of the strengthened beams. Also, the ends of each beam were designed for a roller bearing. The bearing, bolted directly to the beam, provided lateral stability during testing and allowed the beam to rotate freely through large deflections (see Figure 3.2).

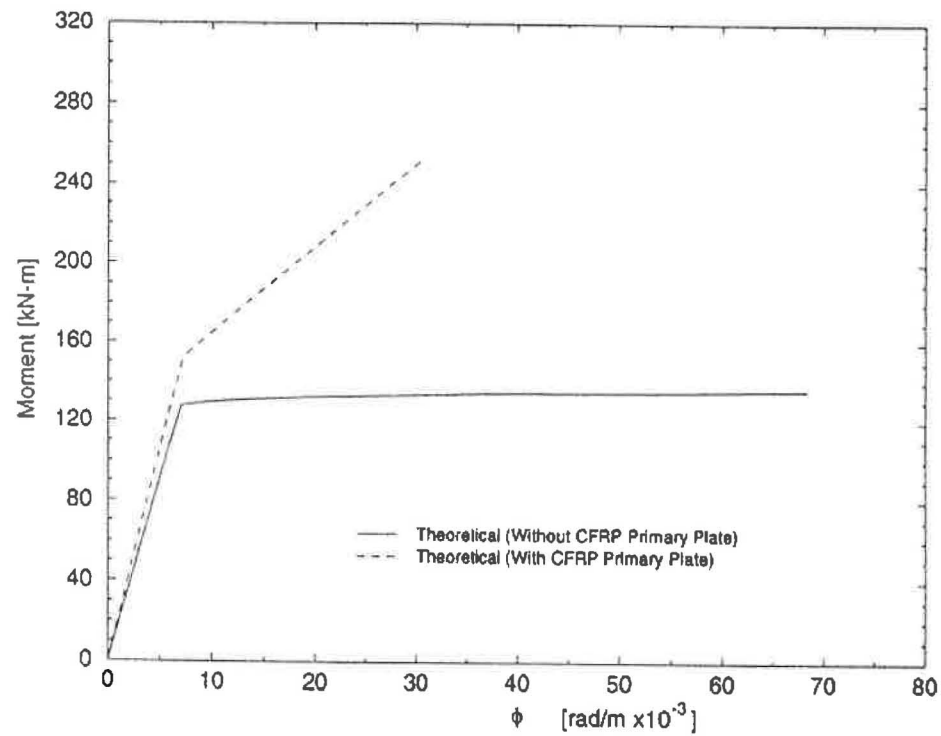
FIGURE 4.3. Typical Theoretical Moment-Curvature Relationships for Beams With and Without an Applied CFRP Primary Plate

Bending moment capacities at first yield of the steel tension reinforcement and at ultimate failure were calculated for the concrete strengths of each of the beam test specimens. These results are listed in Table 4.1. As shown in Table 4.2, application of the CFRP primary plate produces an increase in theoretical moment capacity of 87 percent and an increase in yield moment of 20 percent.

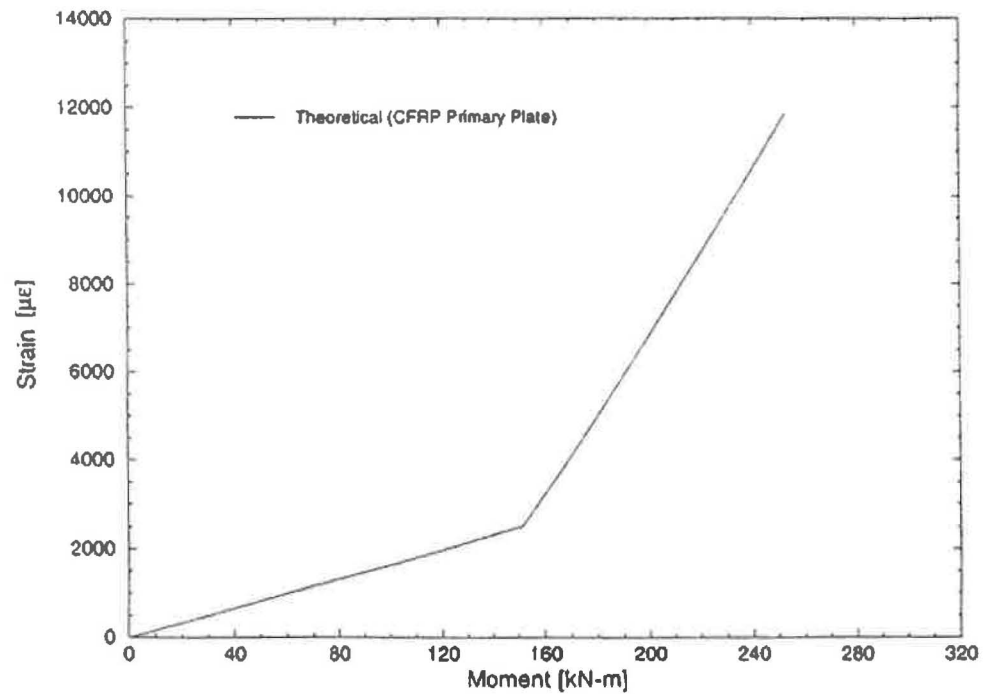
FIGURE 4.4. Typical Theoretical CFRP Primary Plate Strain-Moment Relationship

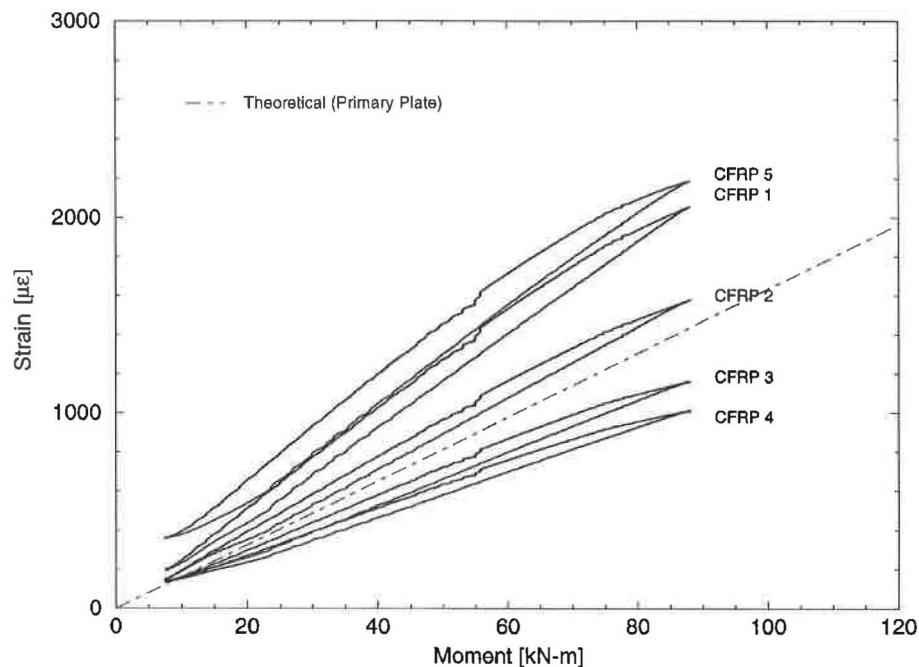
FIGURE 6.2. CFRP Strain-Moment Relationships at Gage Locations On and Off the Midspan Splice Plate, Beam 1 (FT)

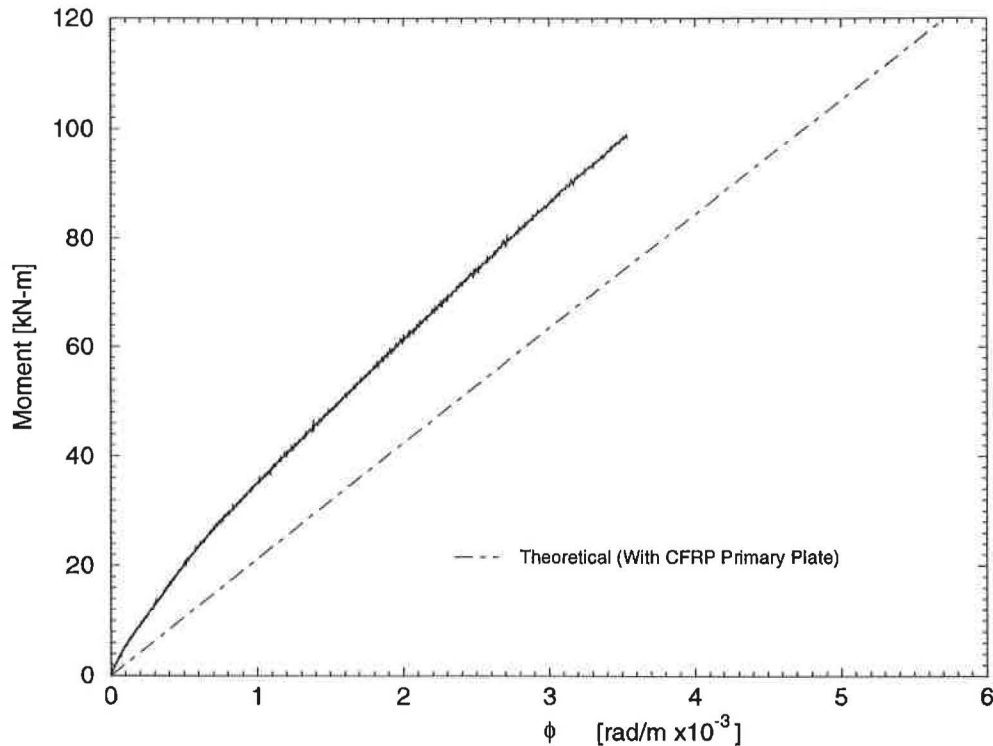
FIGURE 6.9. Moment-Curvature Relationships at Midspan, Beam 2 (FT)

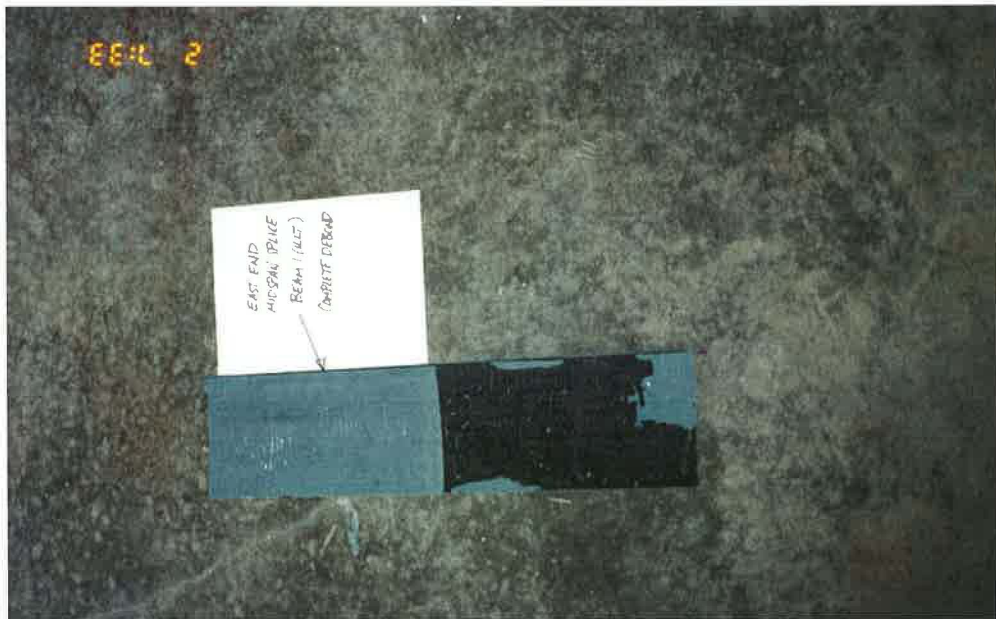
FIGURE 6.25. Splice Plate After Complete Debonding

It was determined after visual inspection of the splice plate that adhesive failure at the primary plate/adhesive interface controlled the failure mode of the splice. In Figure 6.25, a photo of the midspan splice plate of Beam 1 (ULT) removed after complete debonding is shown. The photo represents a typical completely debonded splice plate observed throughout testing. As can be seen in Figure 6.25, the adhesive remained with the splice plate after debonding as a result of adhesive failure occurring at the primary plate/adhesive interface.

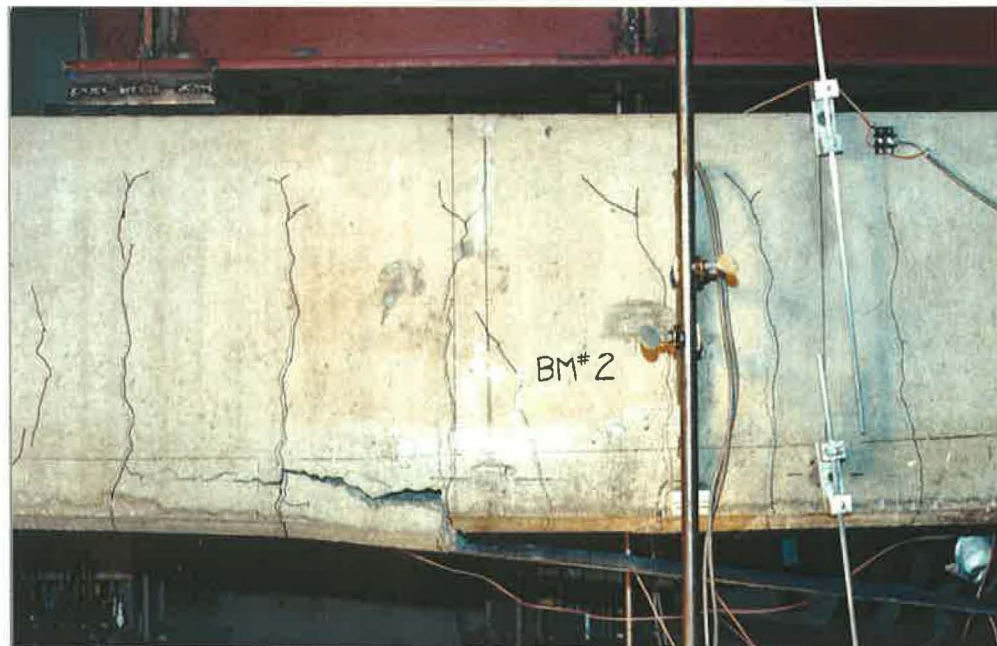
FIGURE 6.31. Typical Concrete Shear Failure Pattern After Complete Splice Debonding

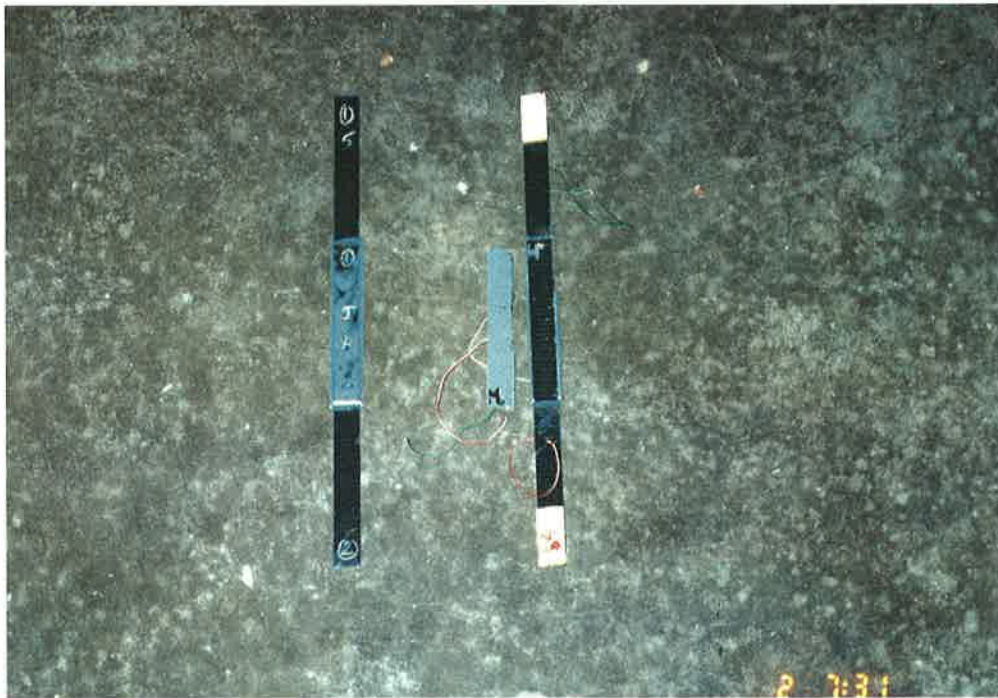
FIGURE 7.2. Typical Tension Test Specimen Before and After Testing
