IR-07-02

**Feasibility of Externally Bonded FRP Reinforcement for
Repair of Cracked Prestressed Concrete Girders, I-565,
Huntsville, Alabama**

Highway Research Center
Auburn University
Auburn University, Alabama

June 2007

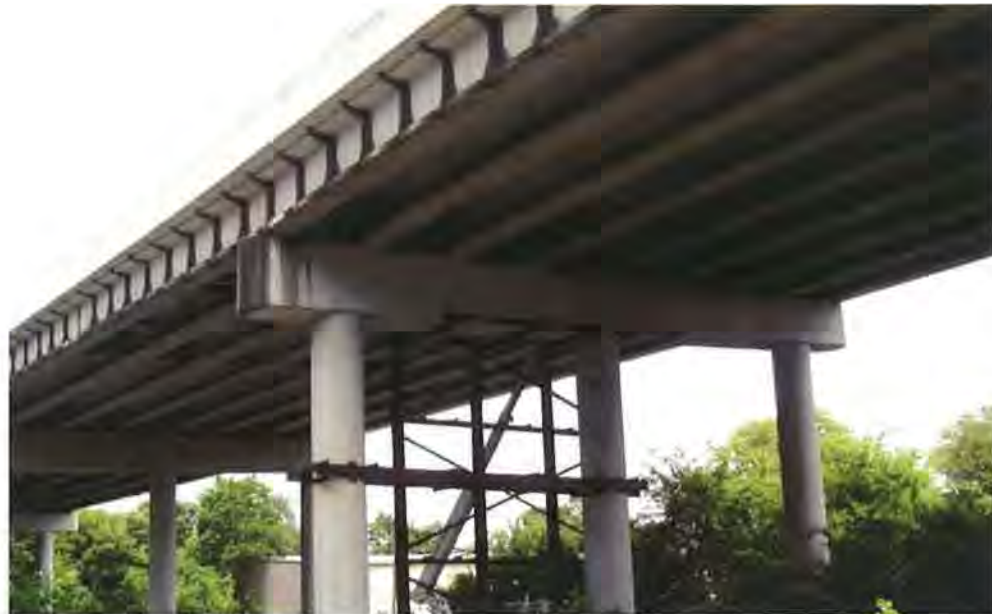
Figure 1.1 – Two-span Continuous Bridge Structure in Huntsville, Alabama

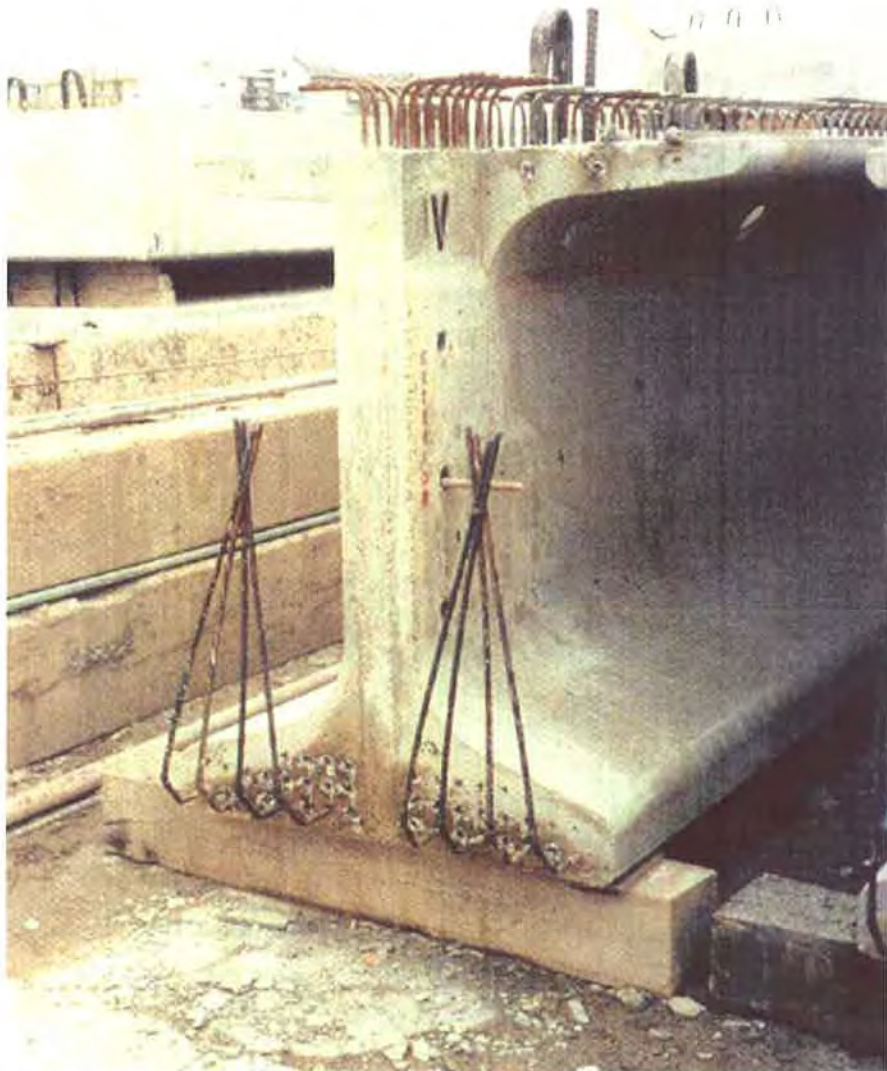
Figure 2.1 - Extended Bent Prestressing Tendons at the end of a Prestressed Concrete Girder (Noppakunwijai et al. 2002)

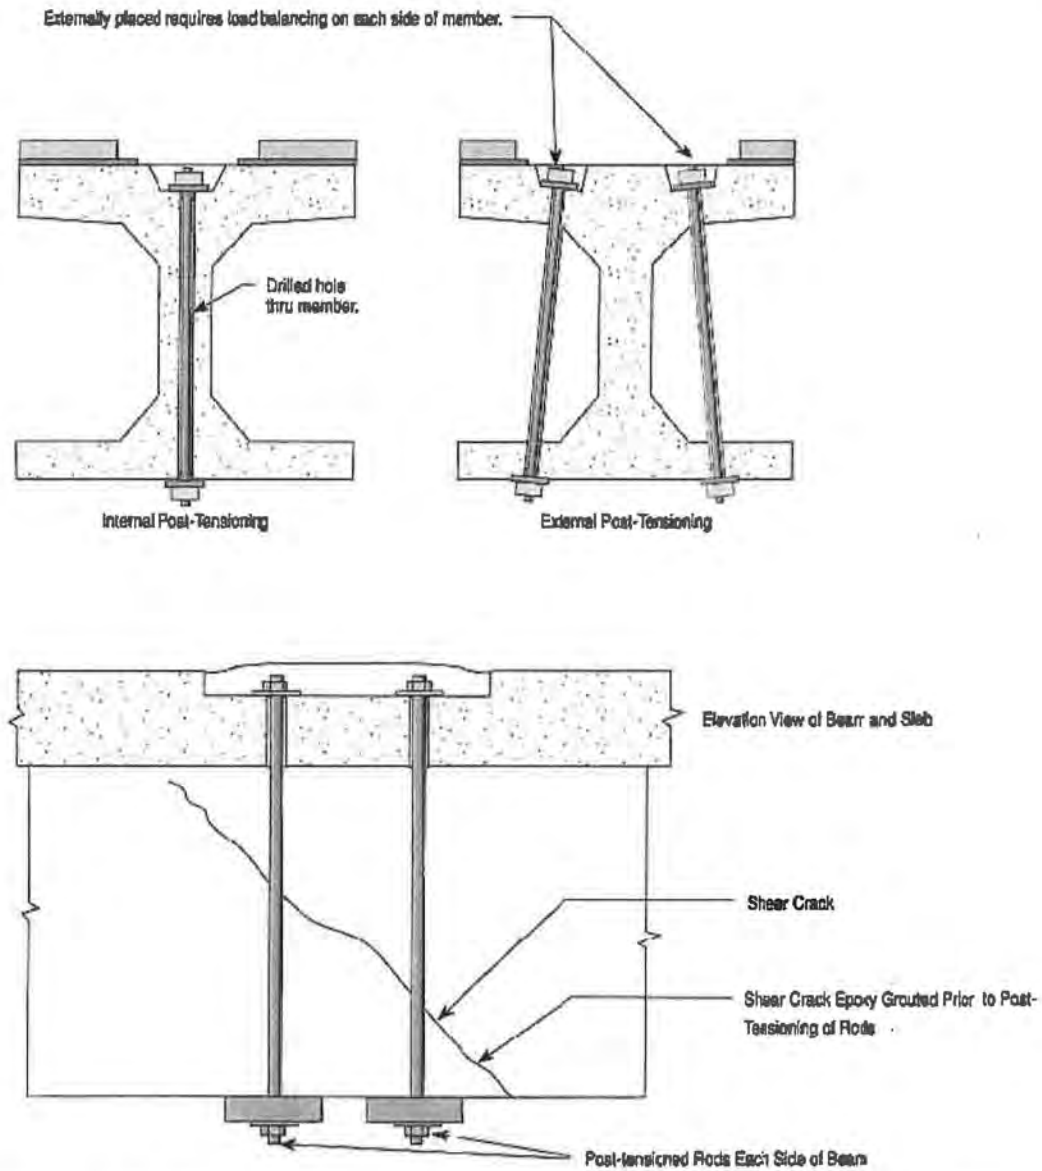
Figure 2.2 – Shear Strengthening with Post-tensioned Stirrups (Emmons 1993)

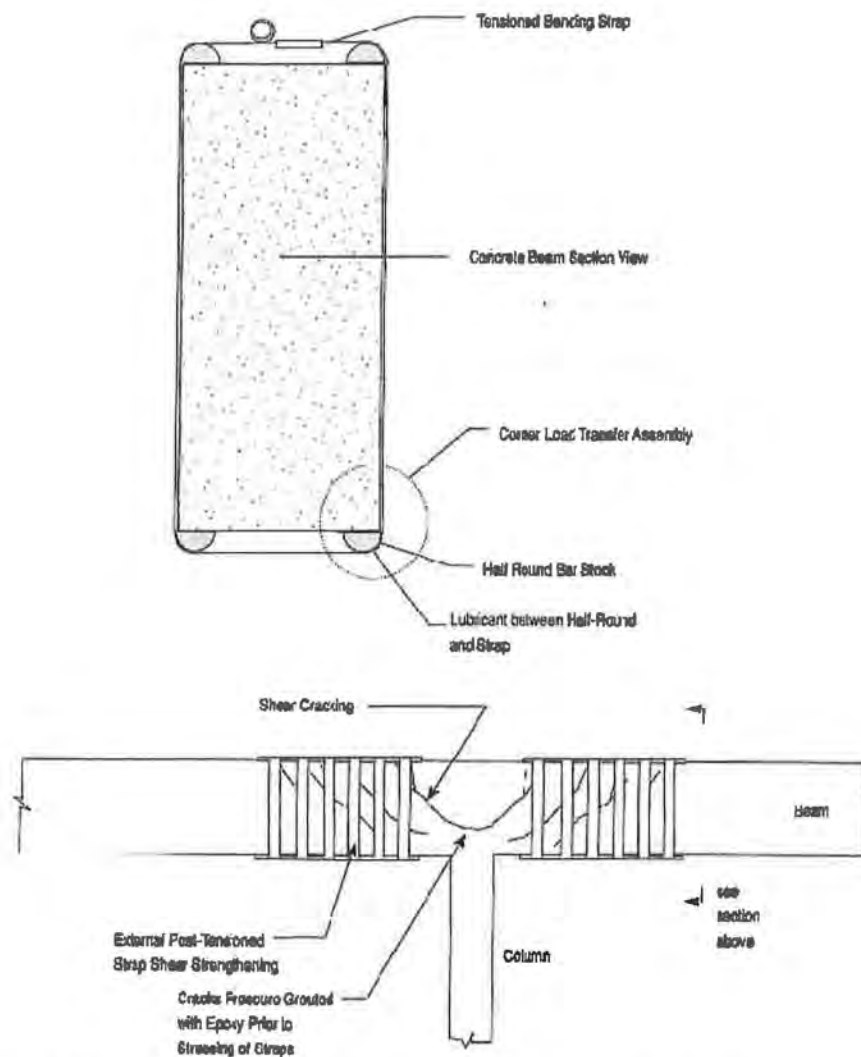
Figure 2.3 – External Post-tensioning with Composite Straps (Emmons 1993)

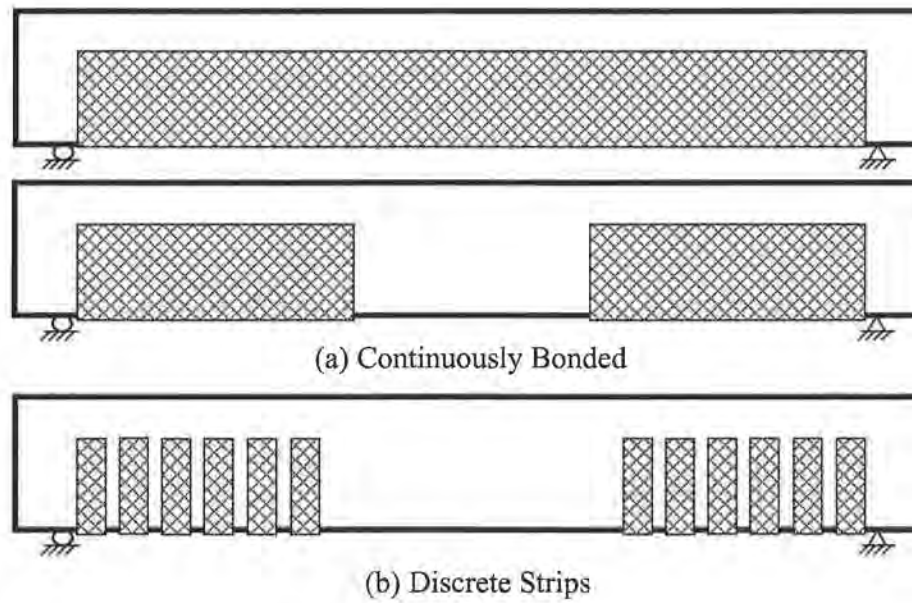
Figure 2.6 – Longitudinal Configurations for External FRP Shear Reinforcement

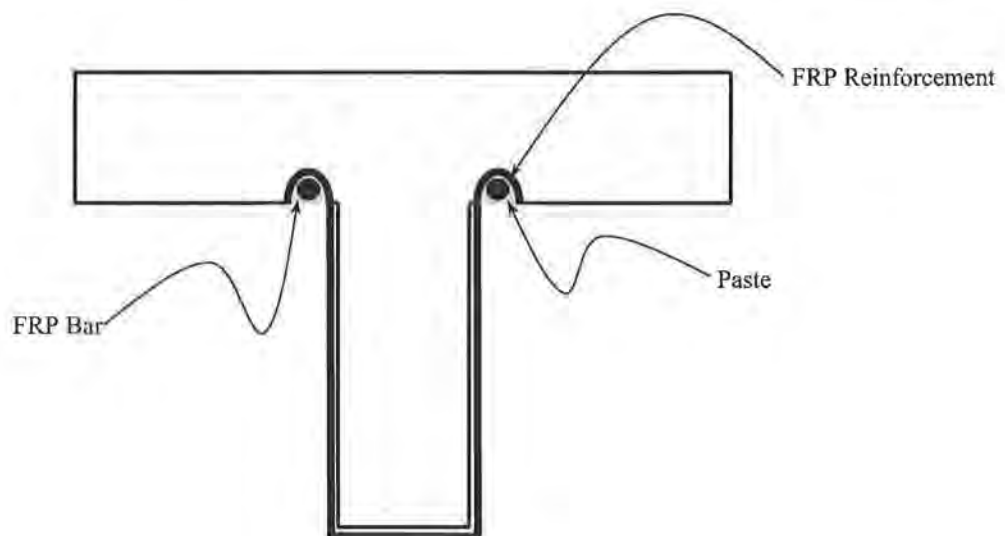
Figure 2.7 – FRP Bar End Anchor Detail

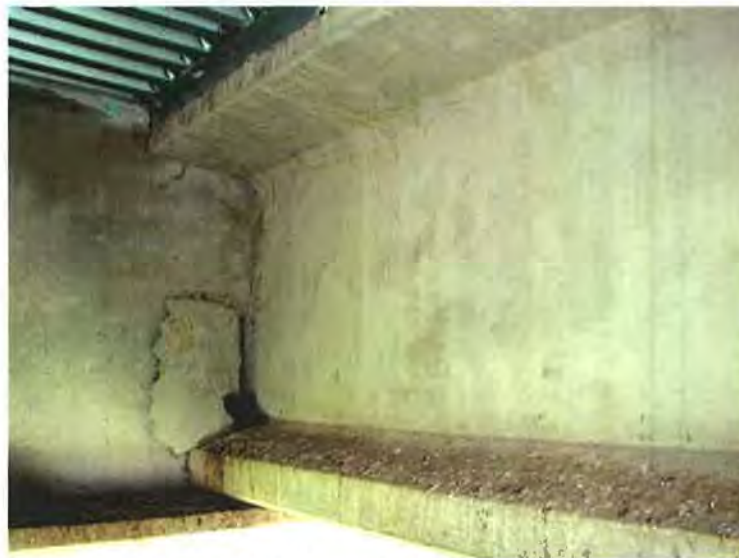
Figure 3.2 – Typical Pull-out Failure of a Prestressed Concrete Bulb-tee Girder

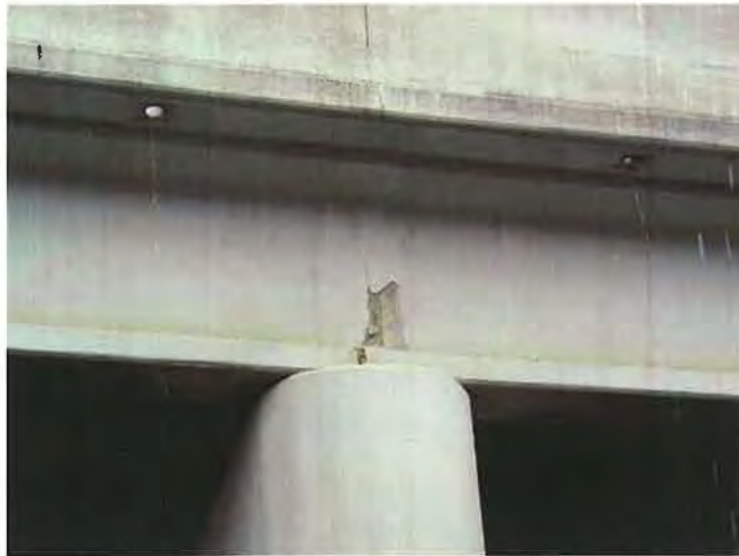
Figure 3.3 – Typical End Crack in a Continuity Diaphragm

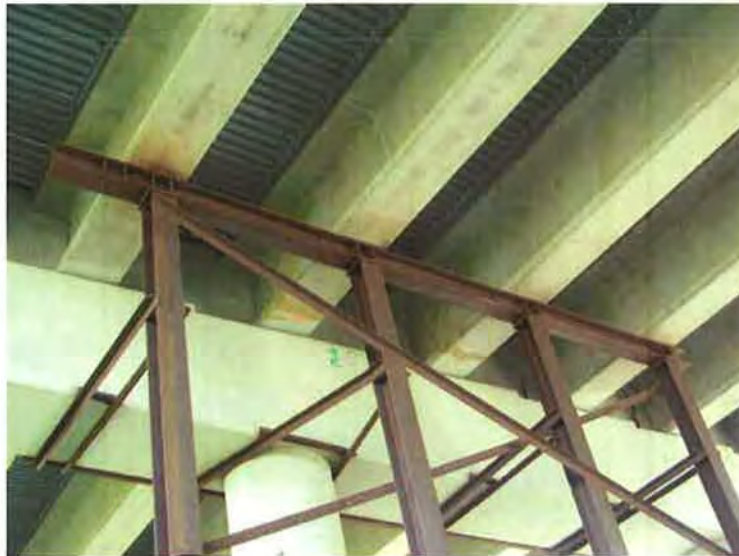
Figure 3.4 – Typical False Support

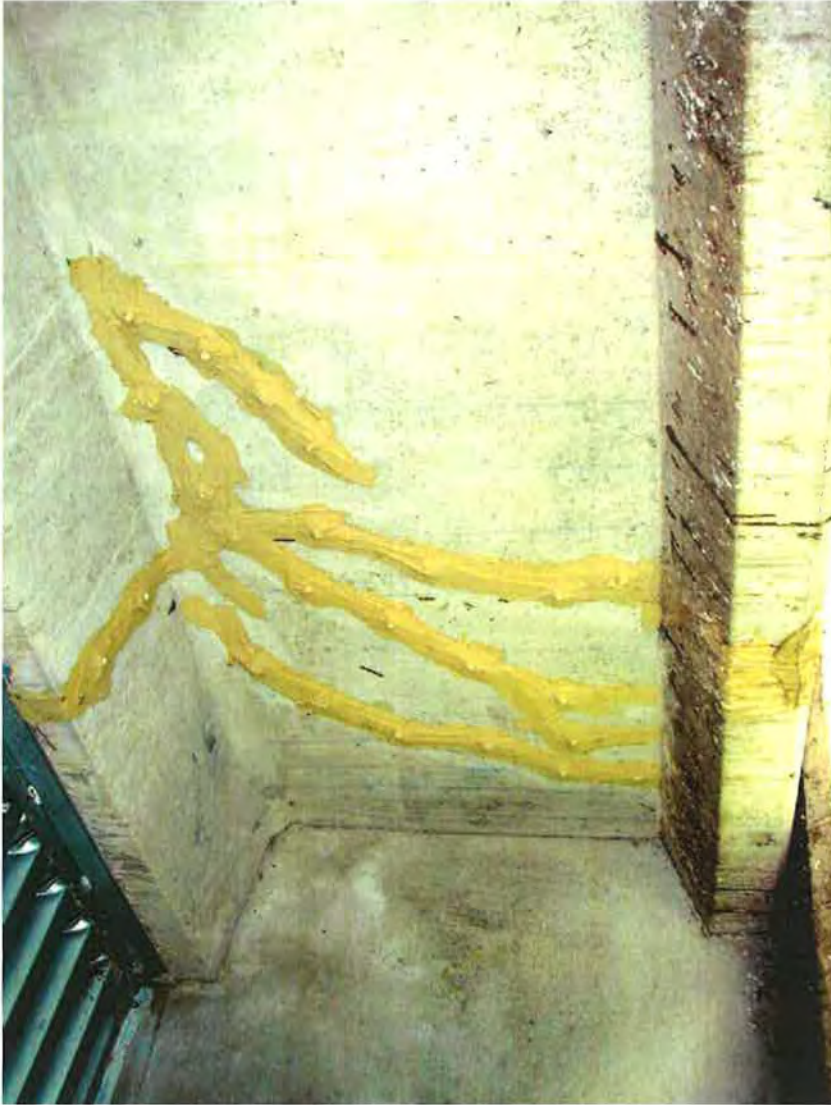
Figure 3.5 – Typical Girder with Epoxy-injected Cracks

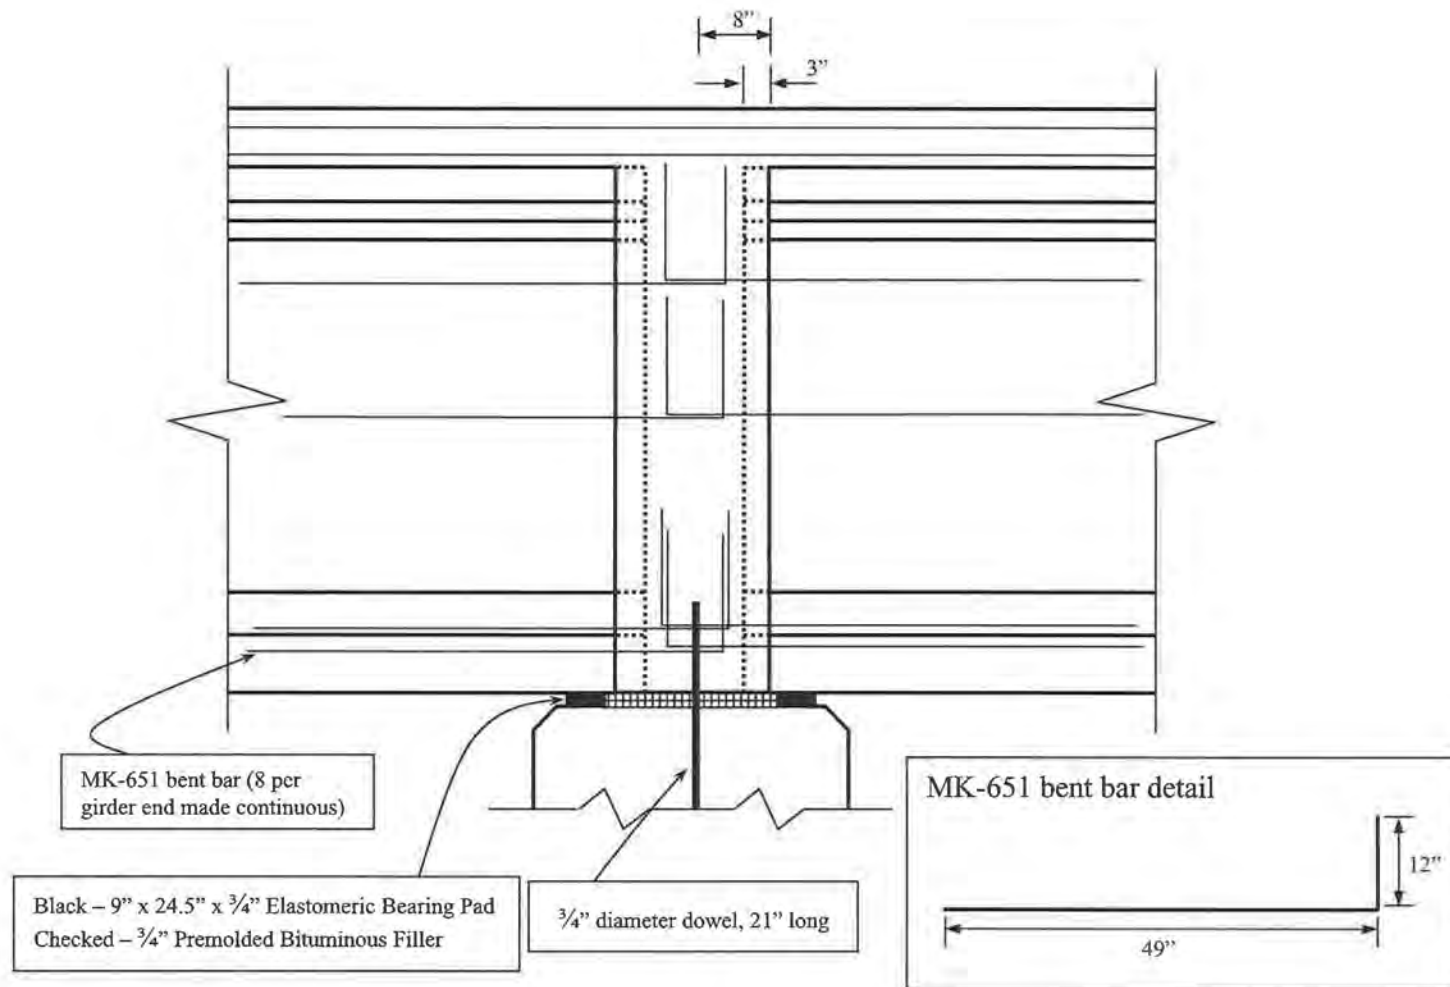
Figure 3.6 – Detail of Continuity Diaphragm at Interior Support

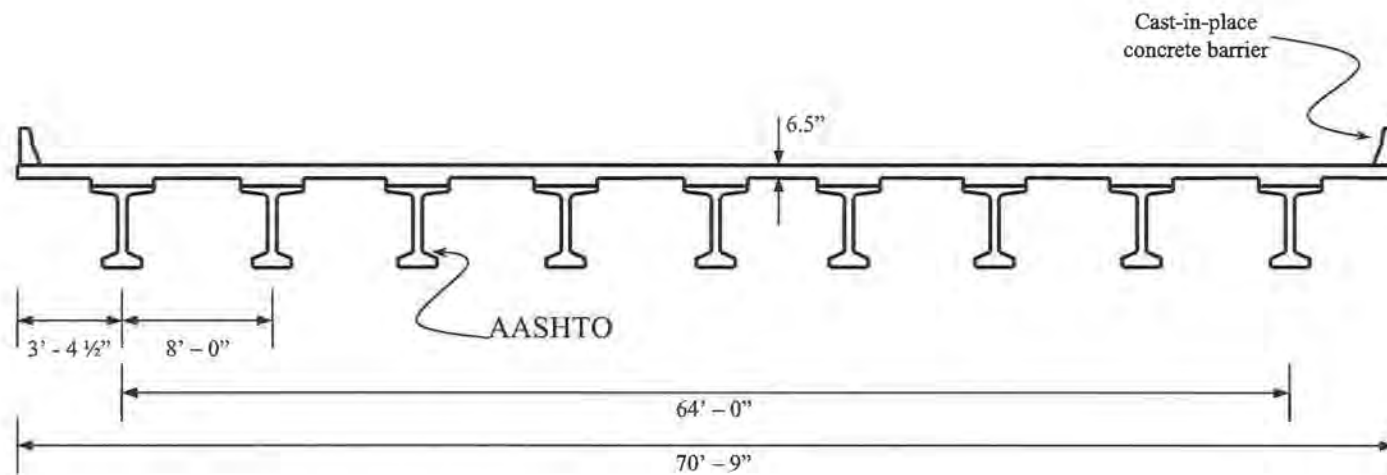
Figure 3.7 – Cross Section of a Typical Critical Span

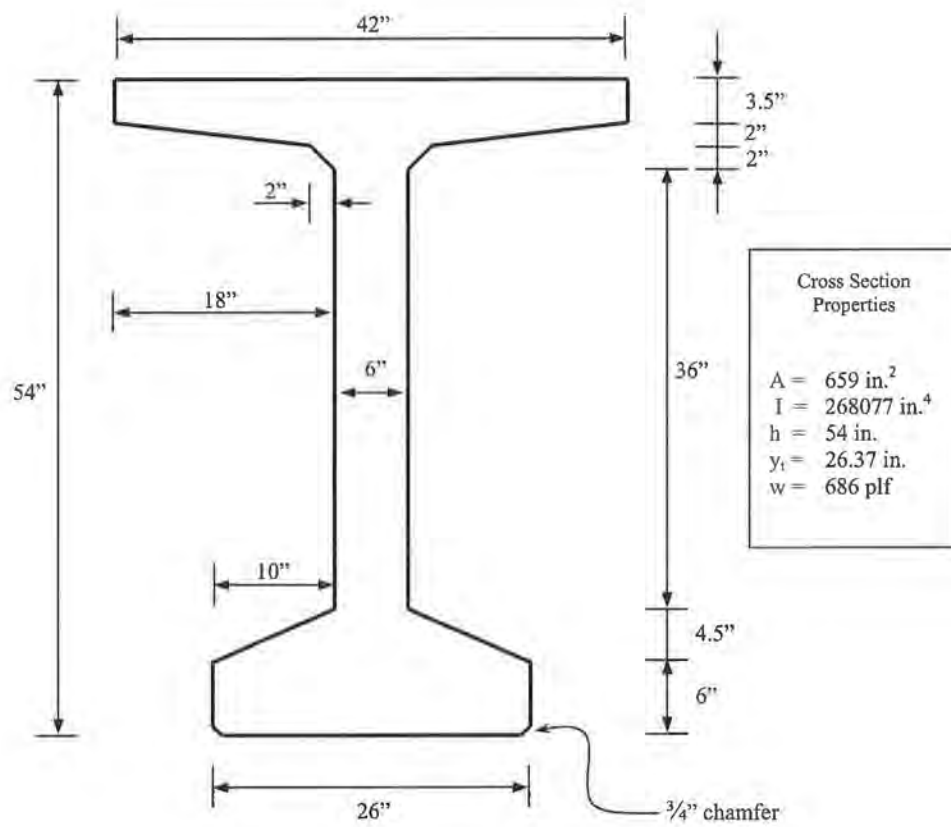
Figure 3.8 – Cross Section of a Typical BT54 Girder

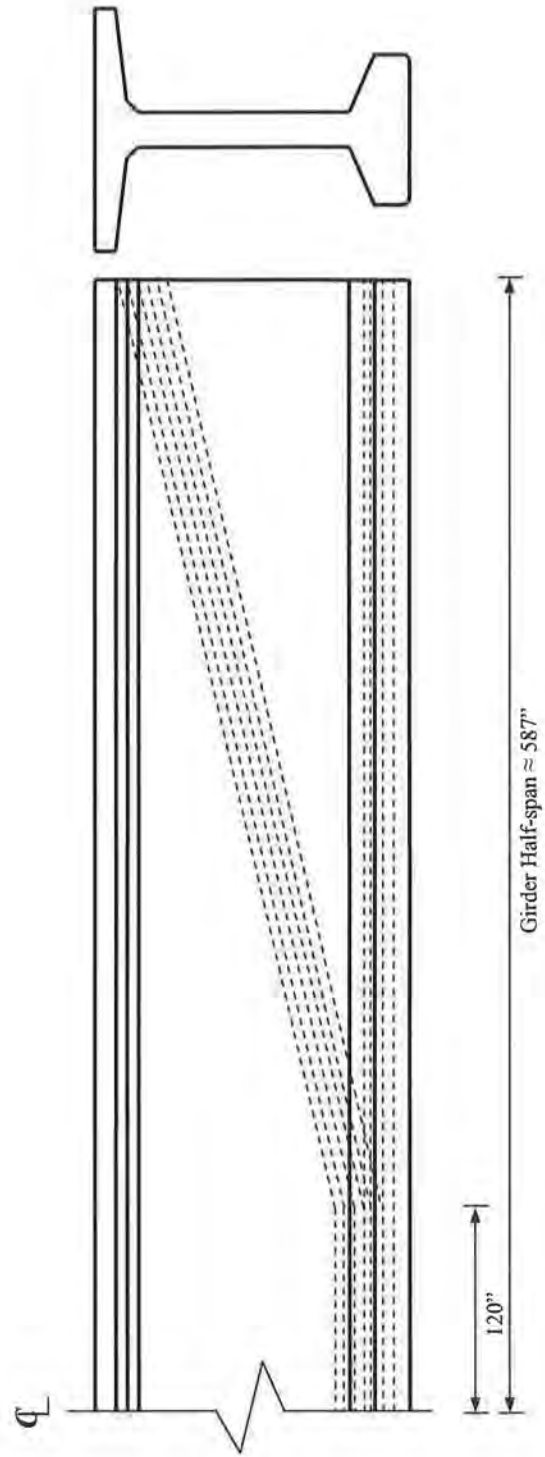
Figure 3.9 – Longitudinal Profile of Prestressing Tendons

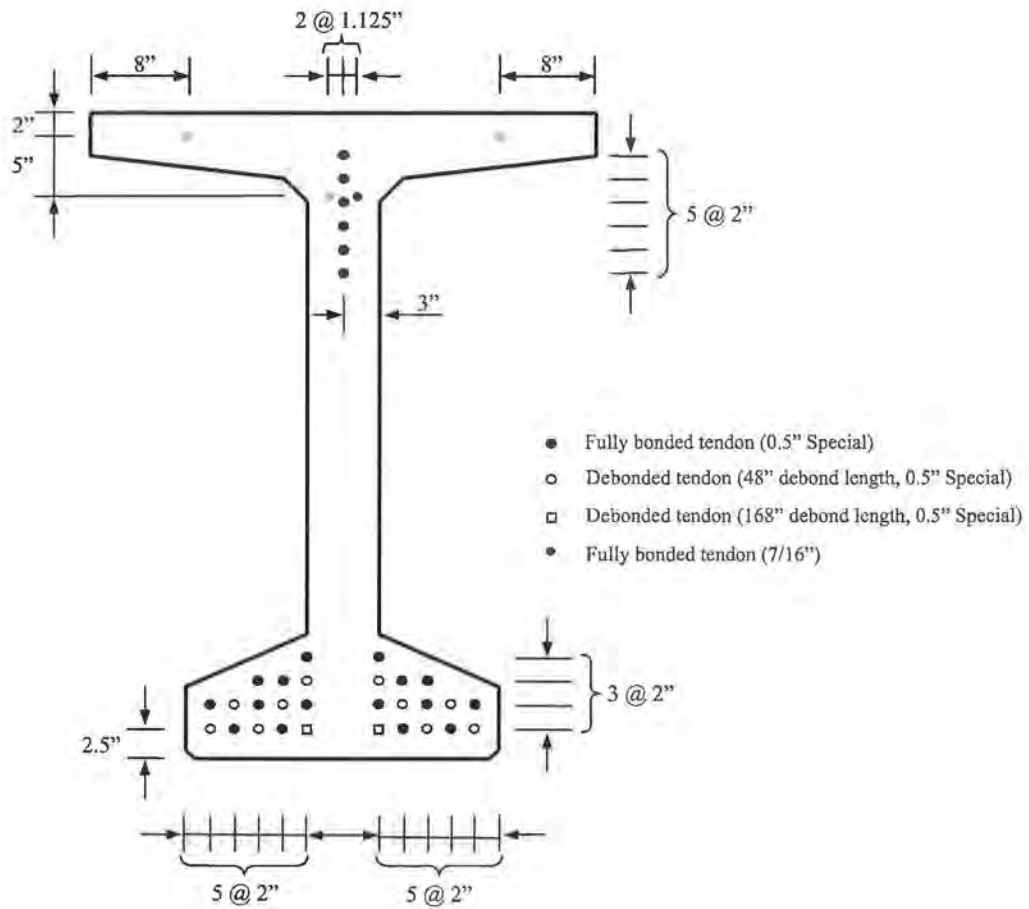
Figure 3.10 – Cross-sectional Prestressing Tendon Profile at Girder End

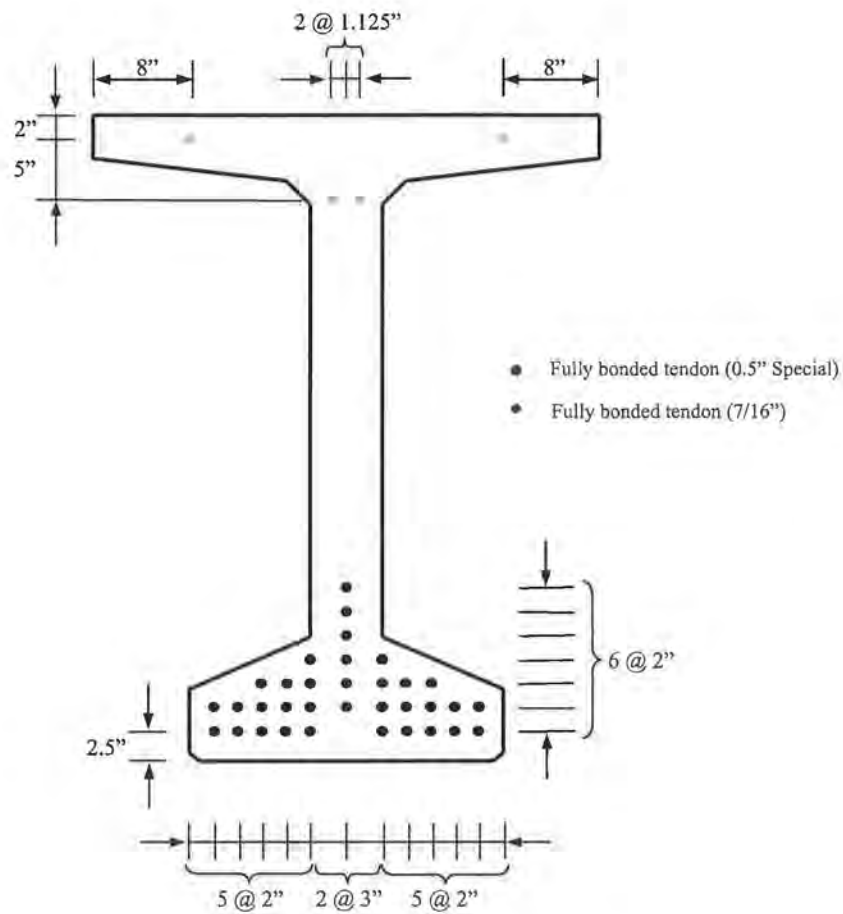
Figure 3.11 - Cross-sectional Prestressing Tendon Profile at Midspan

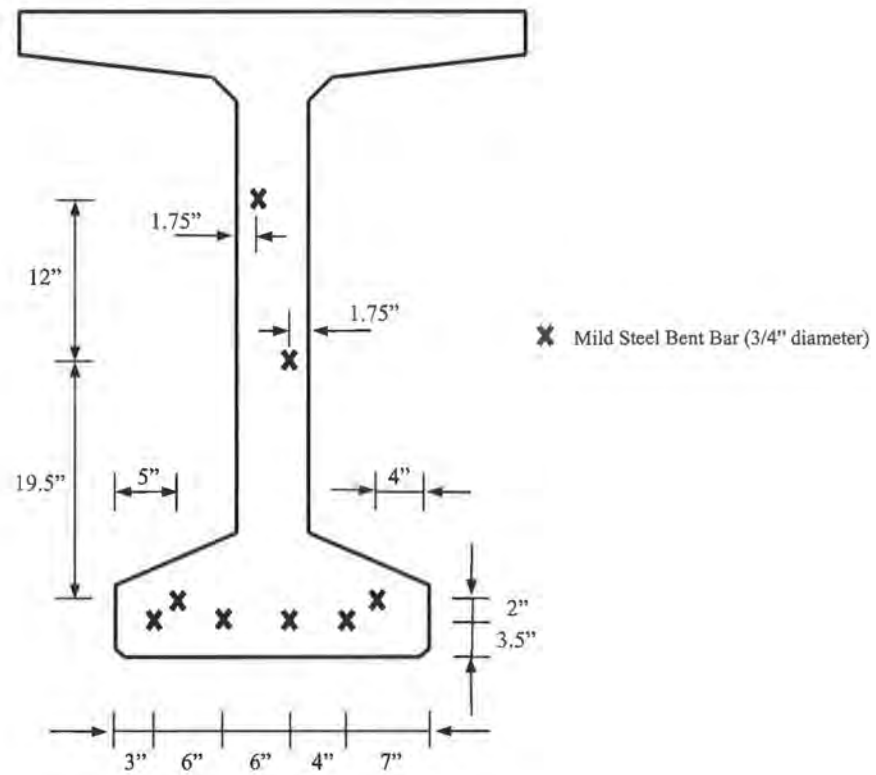
Figure 3.12 – Location of Mild Steel Bent Bars

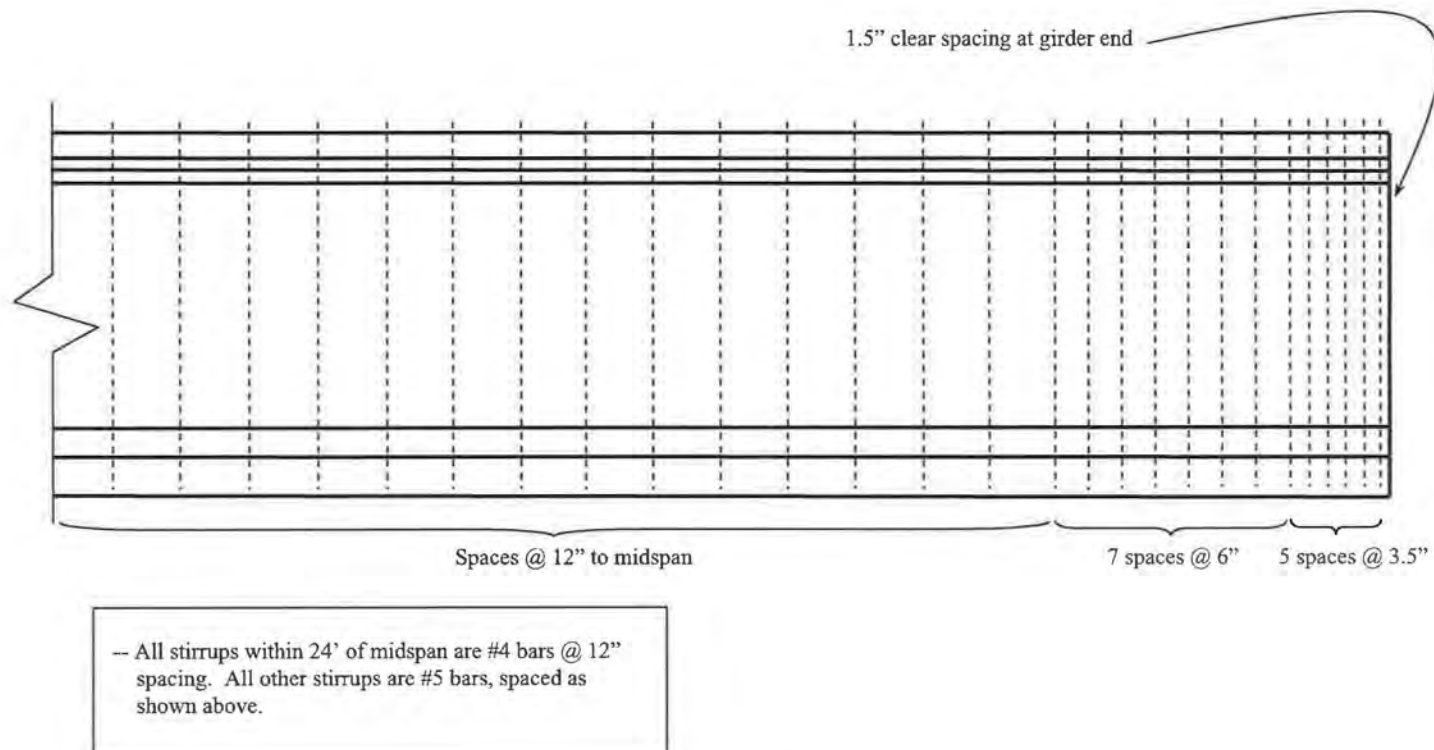
Figure 3.13 – Location of Vertical Shear Reinforcement in a Typical BT54 Girder

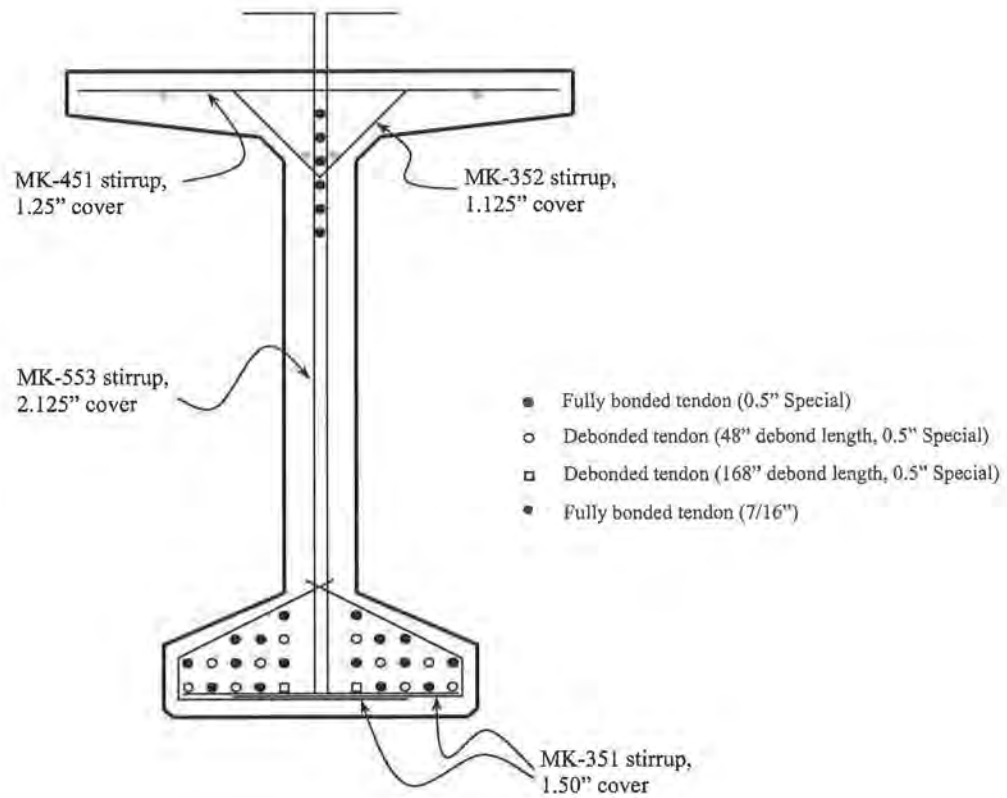
Figure 3.14 – Cross-sectional Configuration of the Vertical Shear Reinforcement at the Girder End

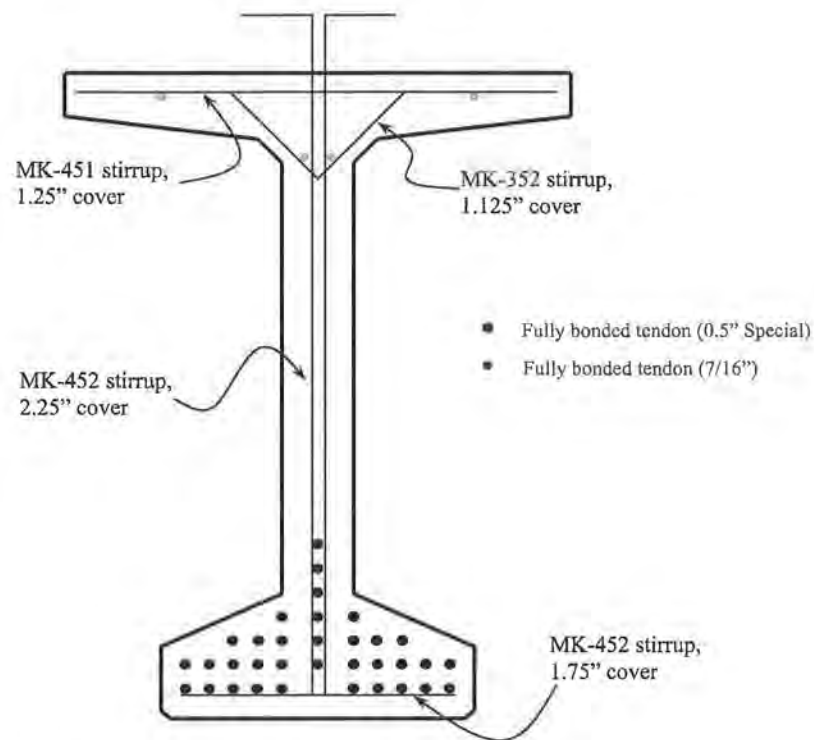
Figure 3.15 - Cross-sectional Configuration of the Vertical Shear Reinforcement at Midspan

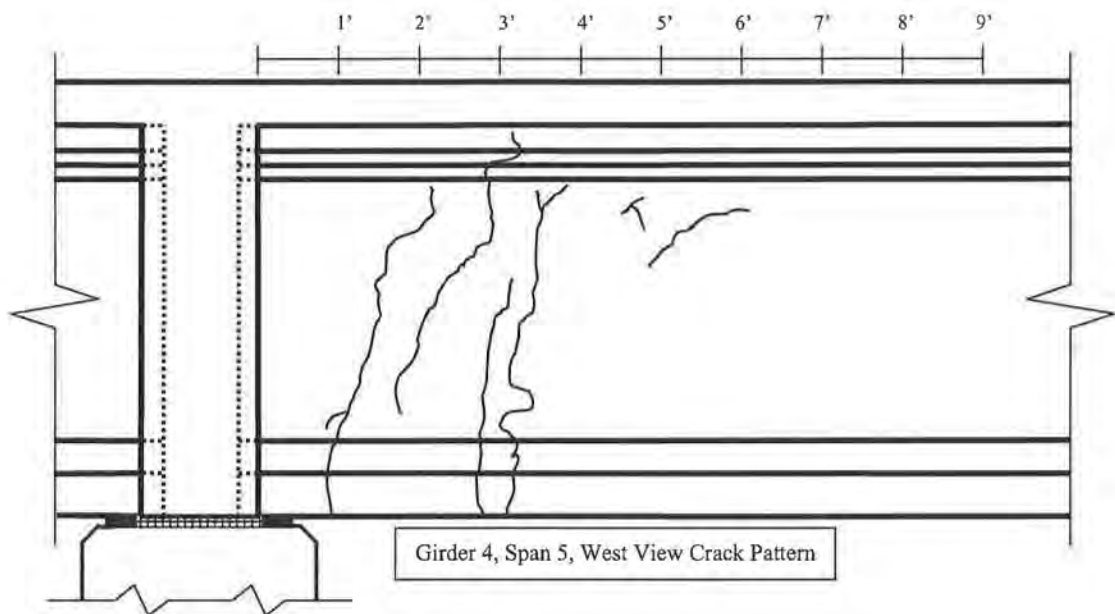
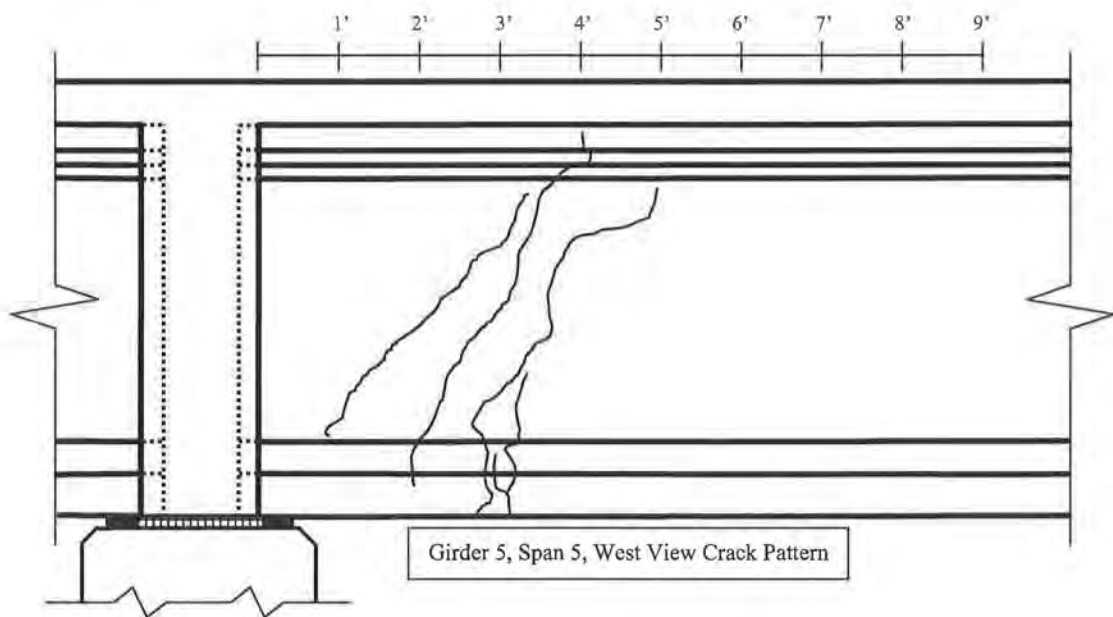
**Figure 3.19 – Cracking in Girders 4 and 5 of Northbound Span 5
(ALDOT 1994a)**

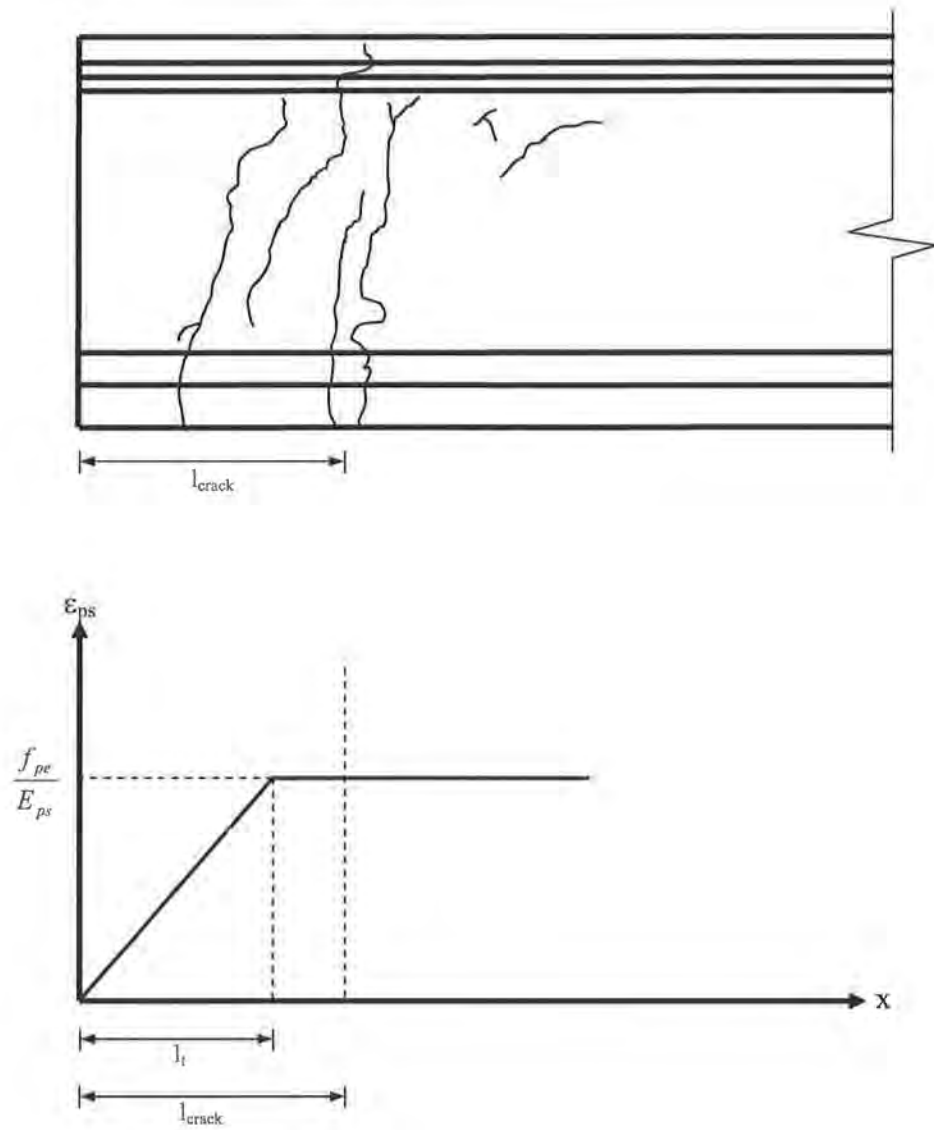
Figure 3.20 – Strain in a Single Prestressing Tendon in the End Region of a Cracked Bulb-tee Girder

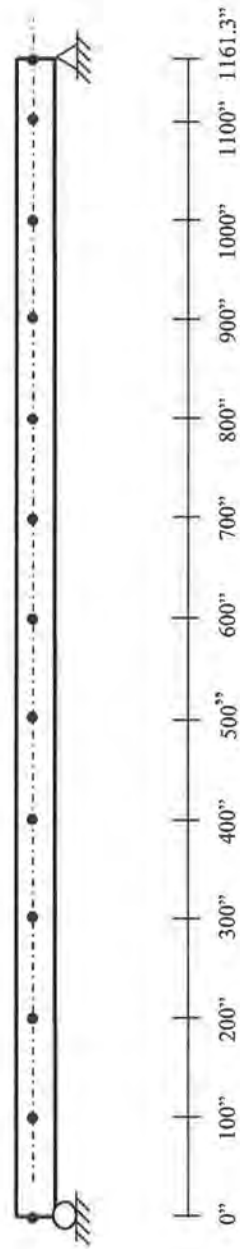
Figure 4.1 – Model #1 used in the Elastic Structural Analysis

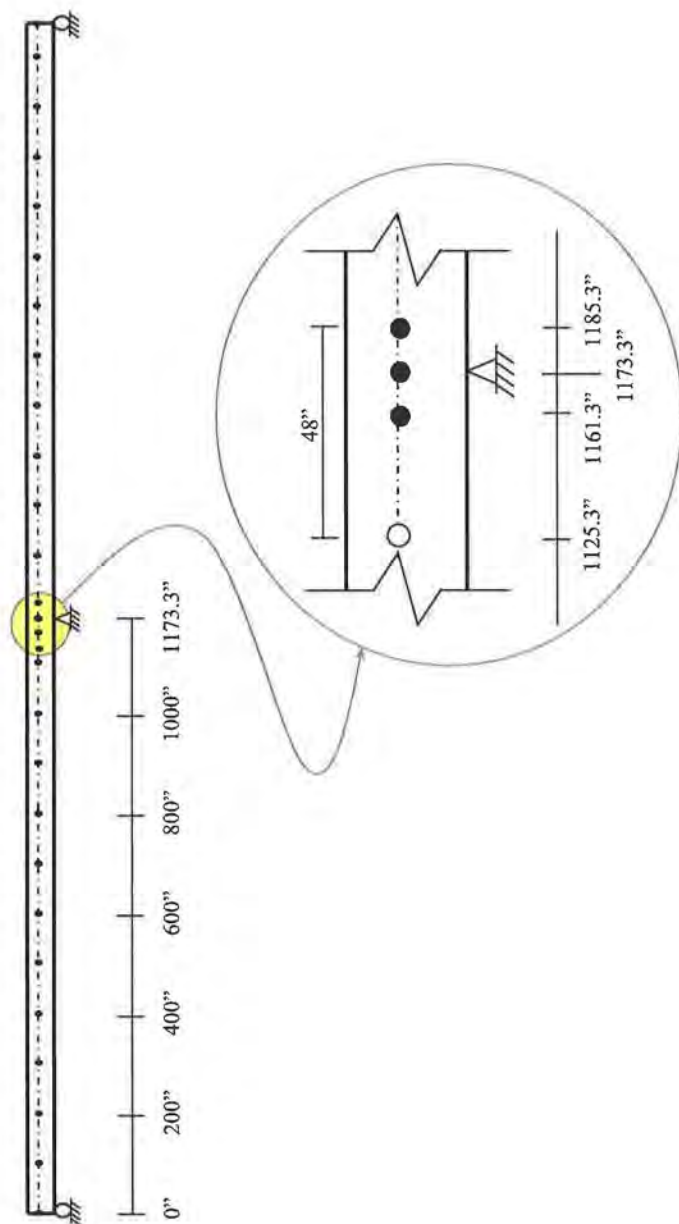
Figure 4.3 – Model #3 used in the Elastic Structural Analysis

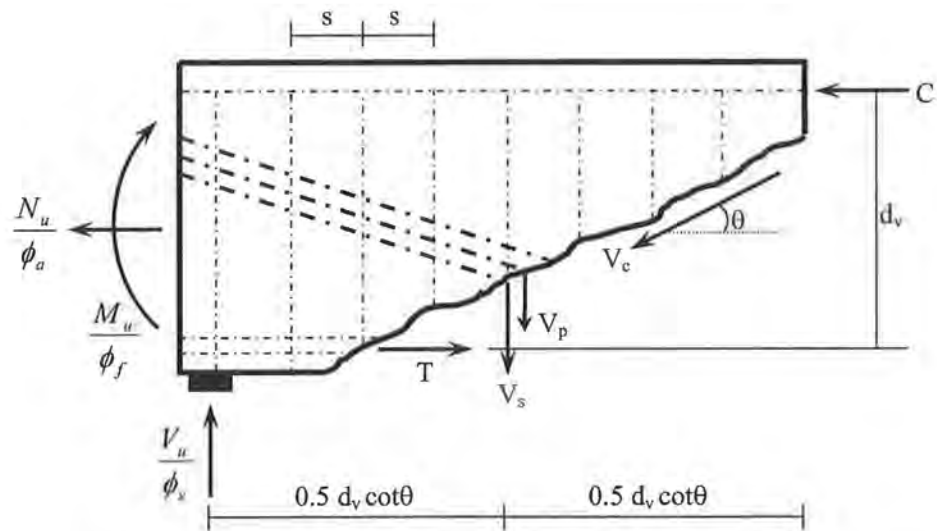
Figure 4.4 – Free-body Diagram of Girder End Region used to Formulate Equation 4.15a (AASHTO LRFD 2002)

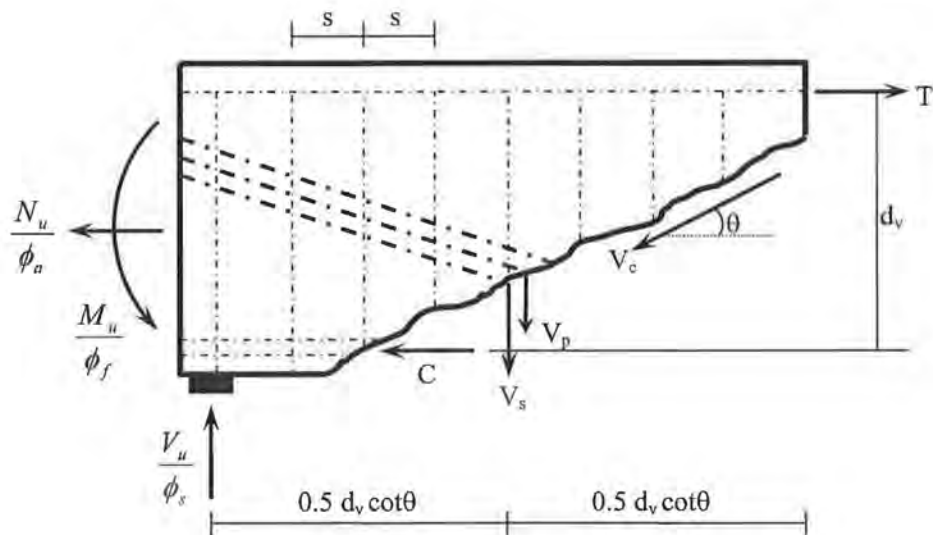
Figure 4.5 – Free-body Diagram of Girder End Region used to Formulate Equation 4.15b

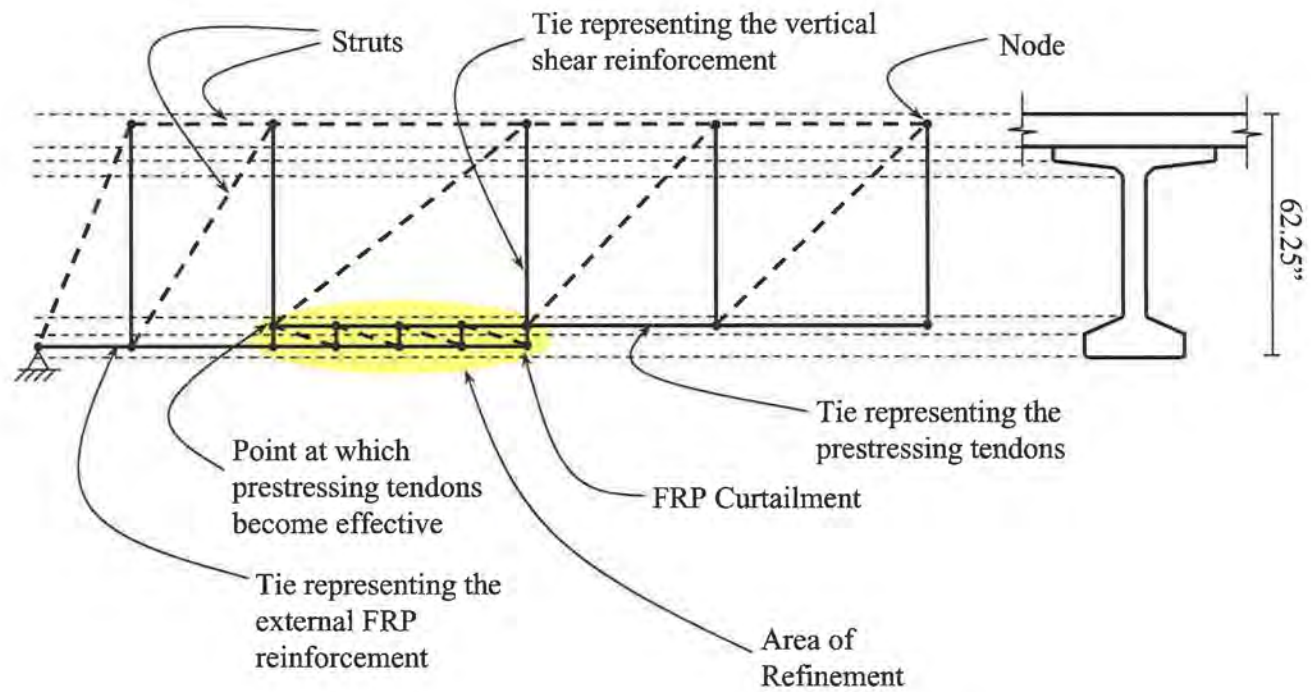
Figure 4.6 – Typical Strut-and-Tie Model

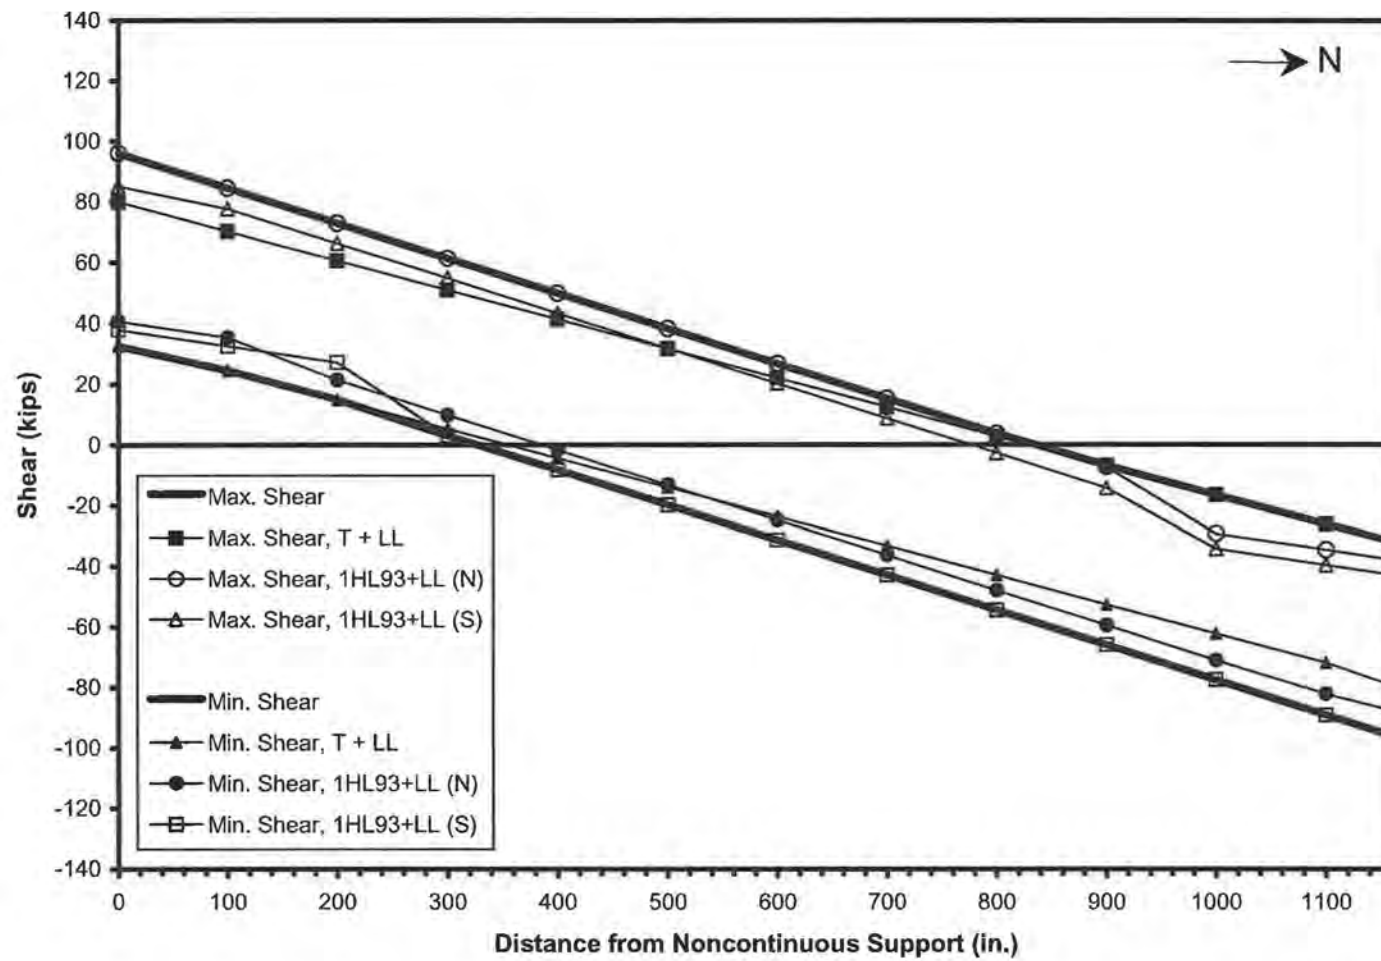
Figure 5.1– Unfactored Live Load Shears for Simply Supported Girder
