IR-07-02

**Feasibility of Externally Bonded FRP Reinforcement for
Repair of Cracked Prestressed Concrete Girders, I-565,
Huntsville, Alabama**

Highway Research Center
Auburn University
Auburn University, Alabama

June 2007

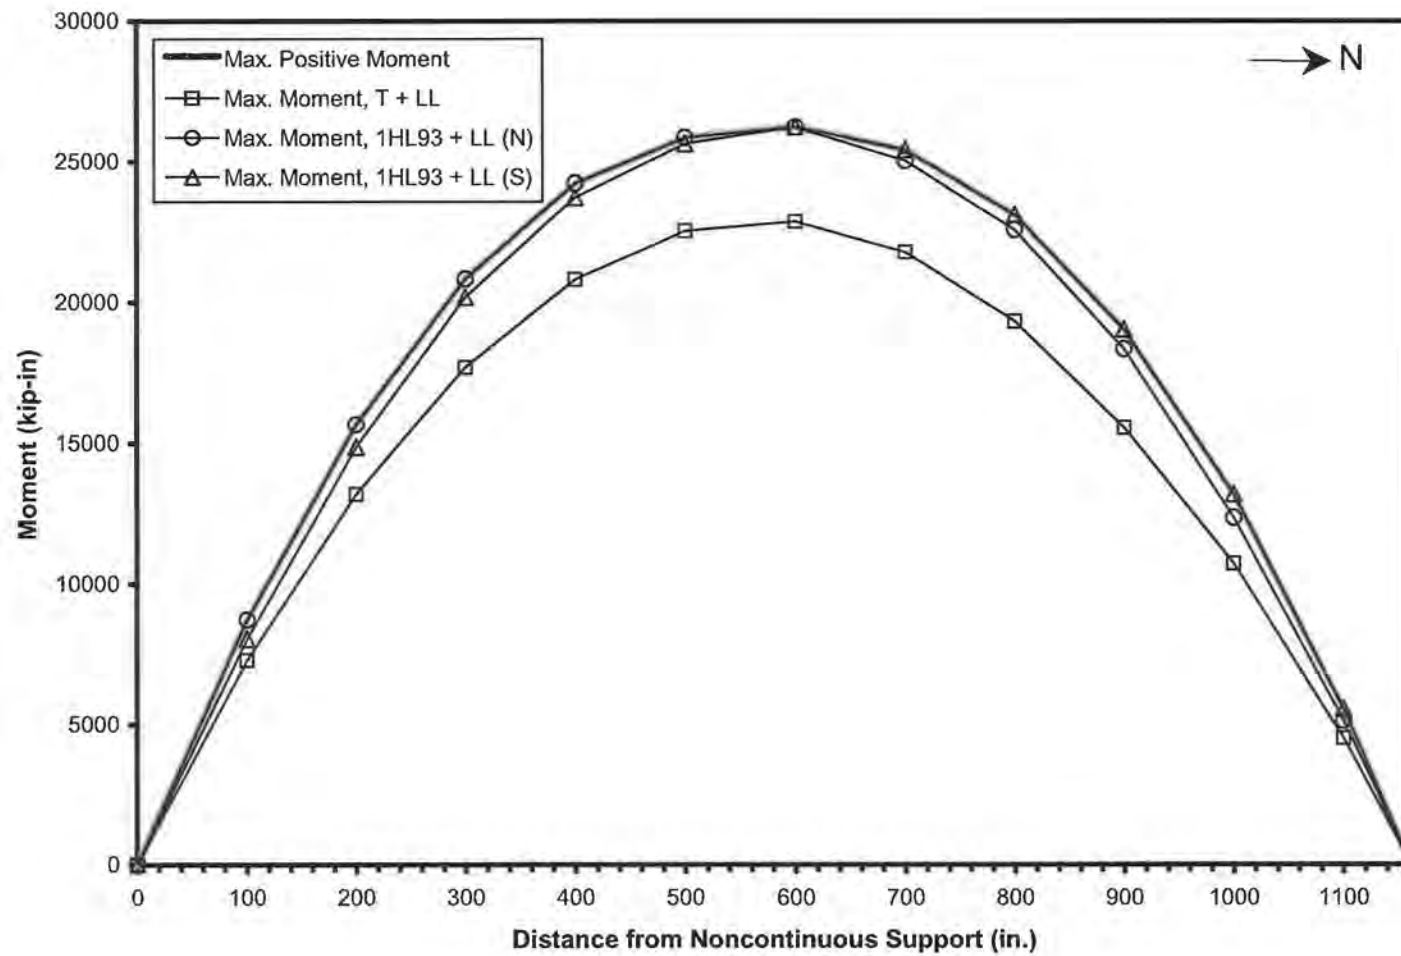
Figure 5.2– Unfactored Live Load Moments for Simply Supported Girder

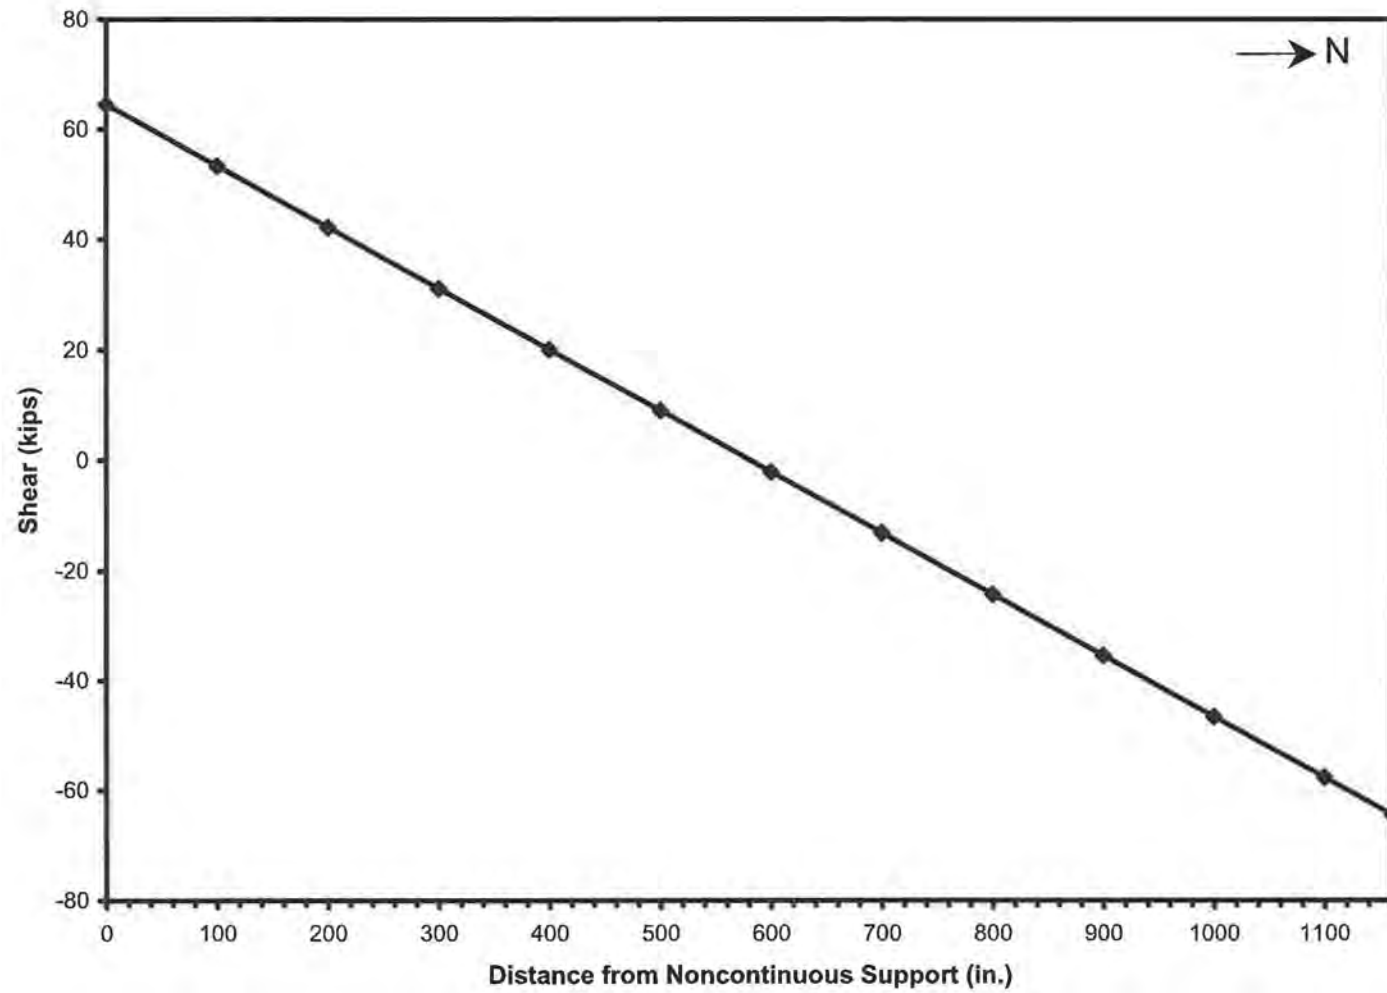
Figure 5.3– Unfactored Dead Load Shear Diagram

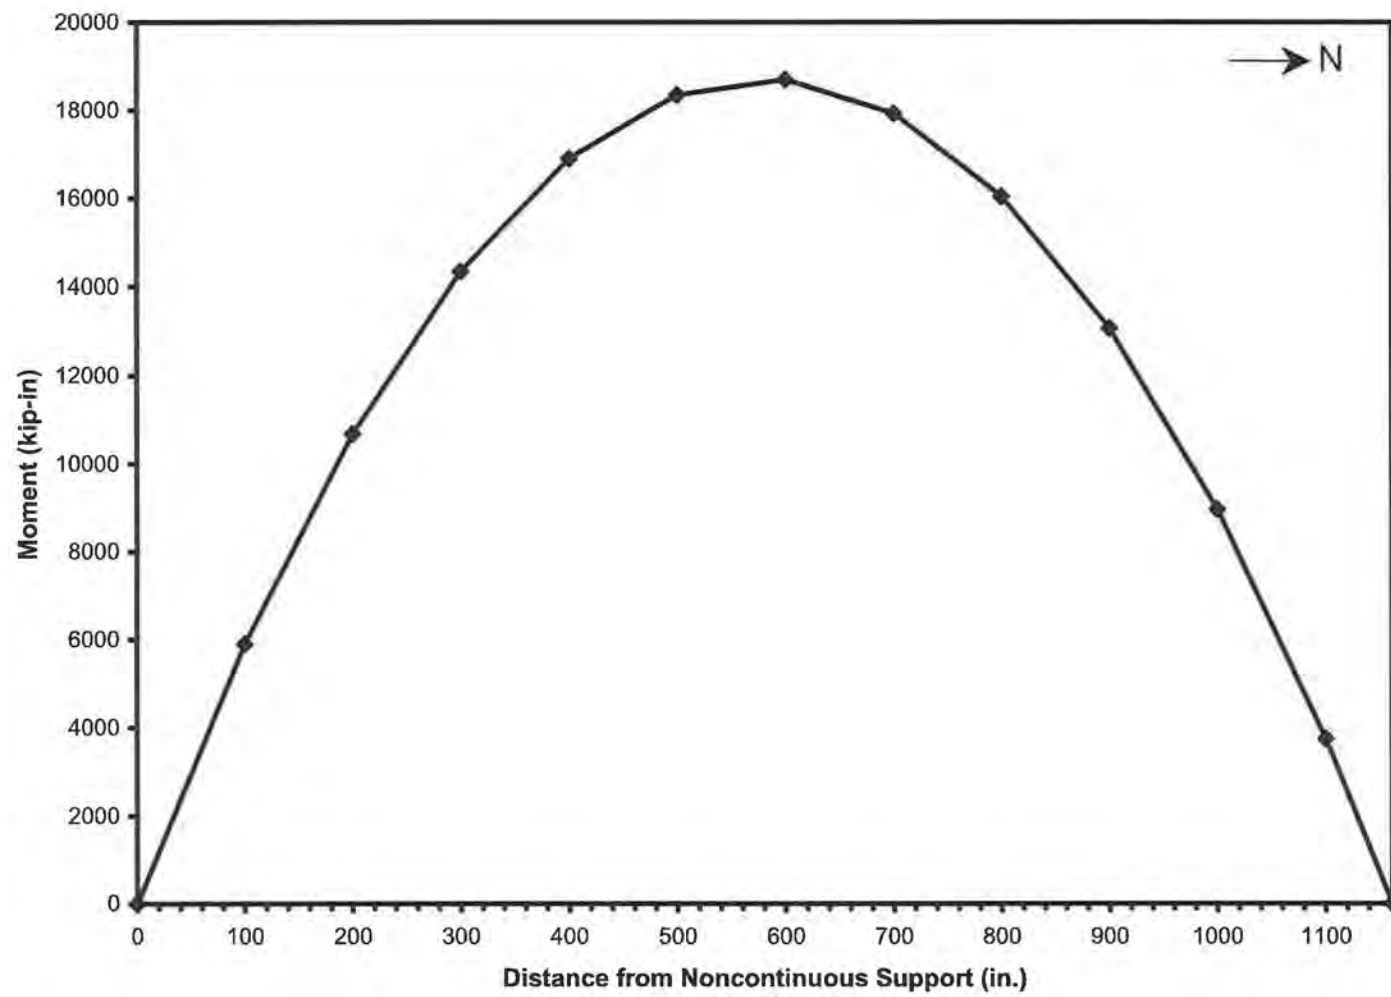
Figure 5.4– Unfactored Dead Load Moment Diagram

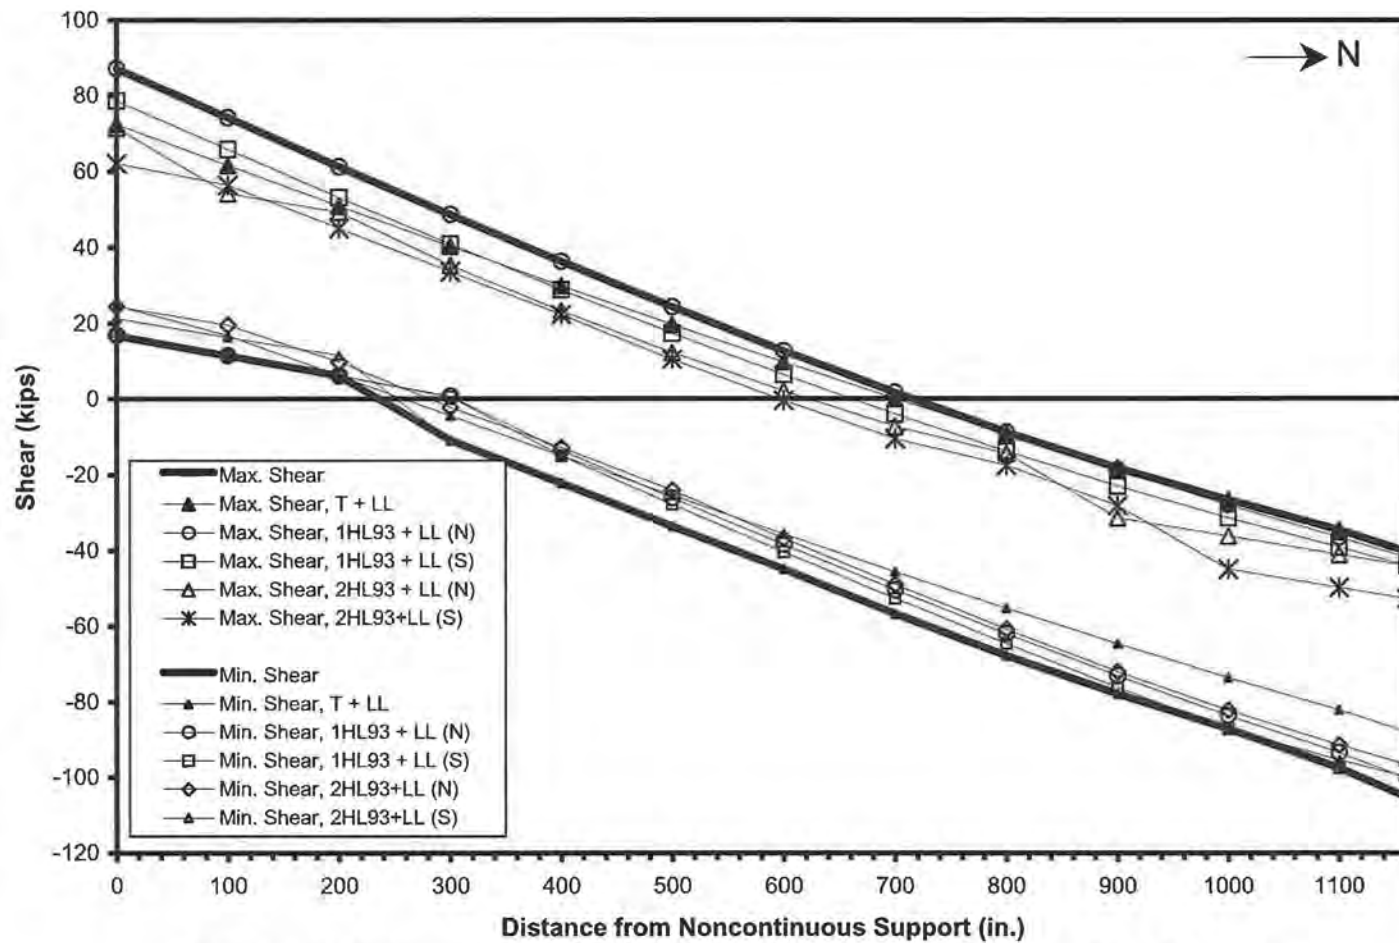
Figure 5.5– Unfactored Live Load Shears for Girder Made Continuous for Live Load

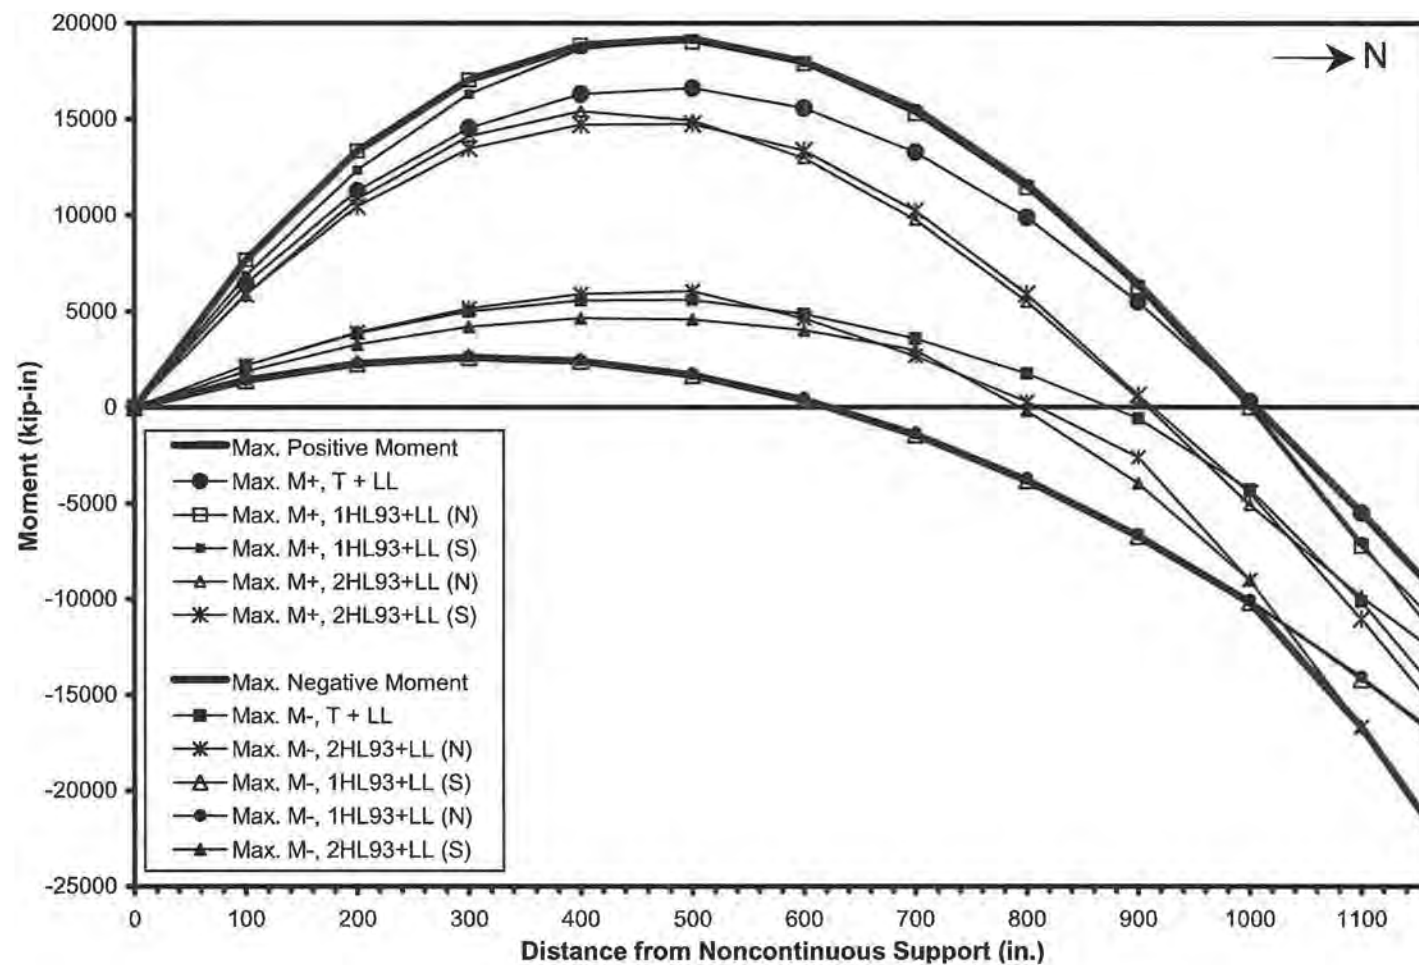
Figure 5.6— Unfactored Live Load Moments for Girder Made Continuous for Live Load

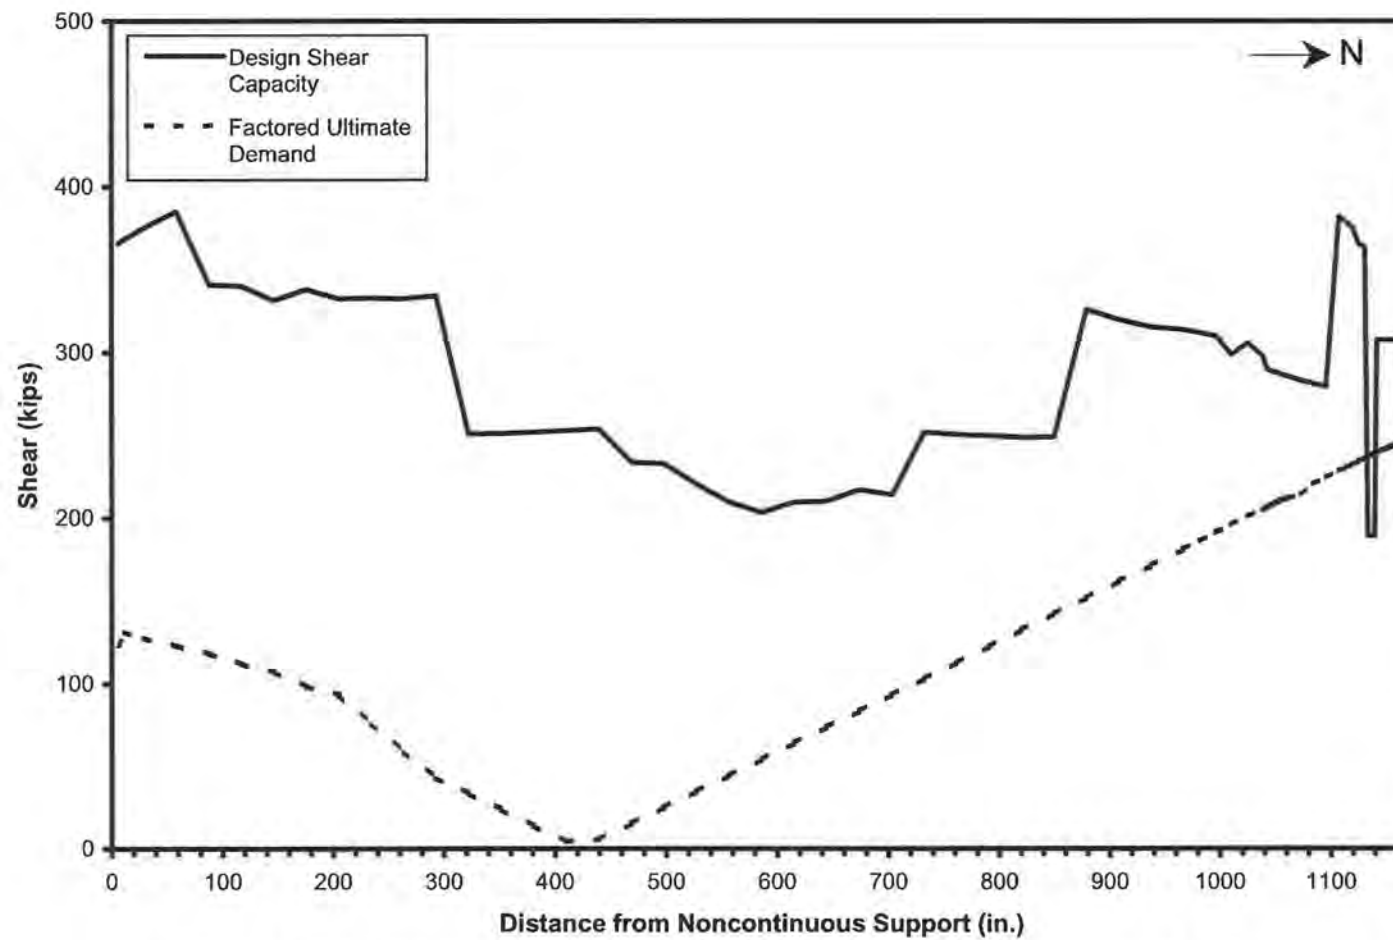
Figure 5.7– Design Shear Capacity vs. Factored Ultimate Demand for a Simply Supported Interior Girder (1 Design Truck, Southbound)

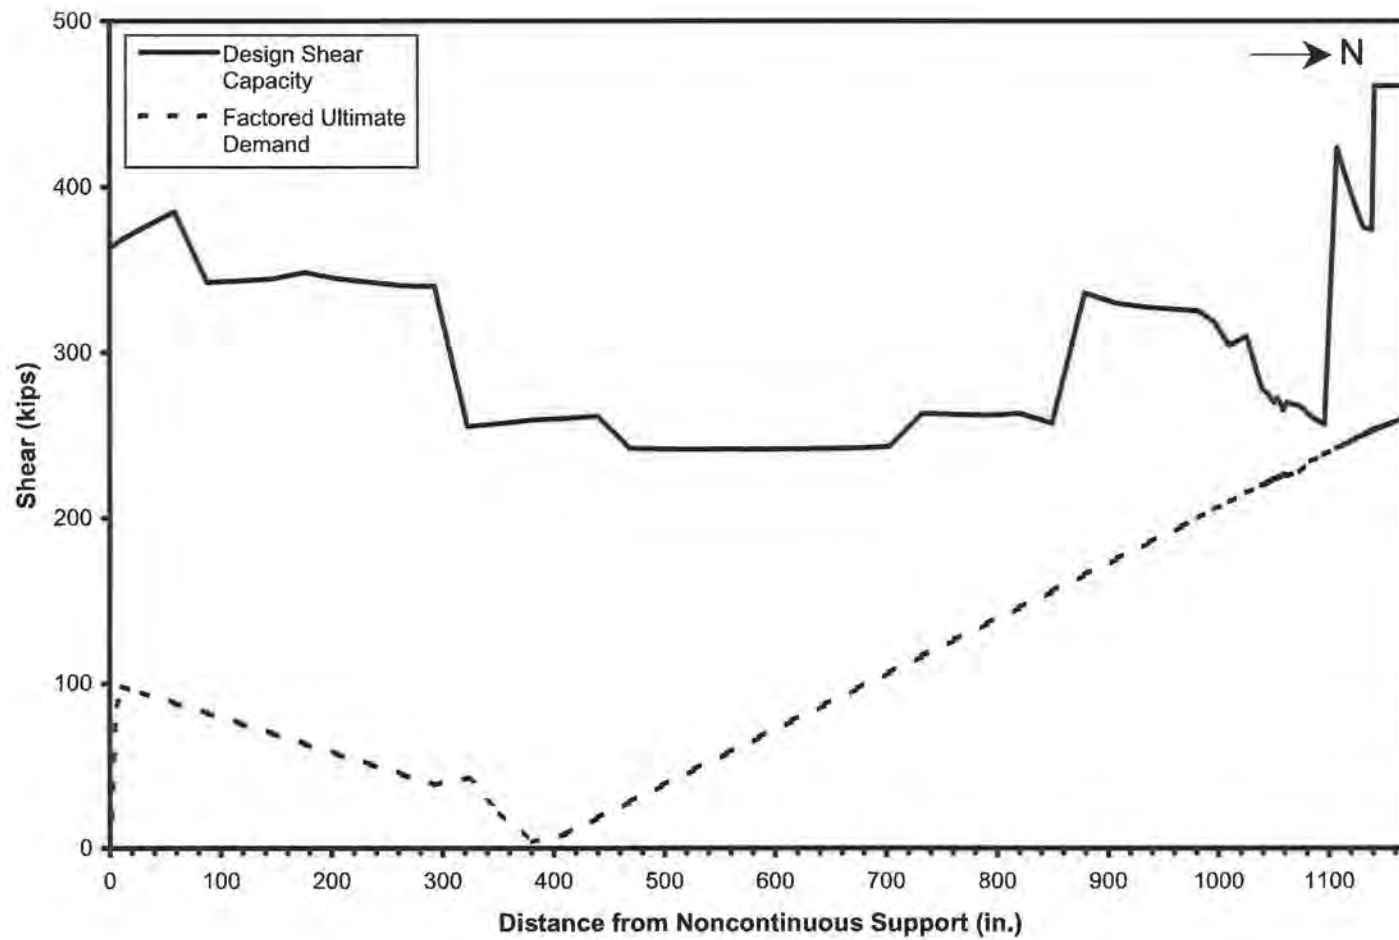
Figure 5.8— Design Shear Capacity vs. Factored Ultimate Demand for an Interior Girder Made Continuous for Live Load (1 Design Truck, Southbound)

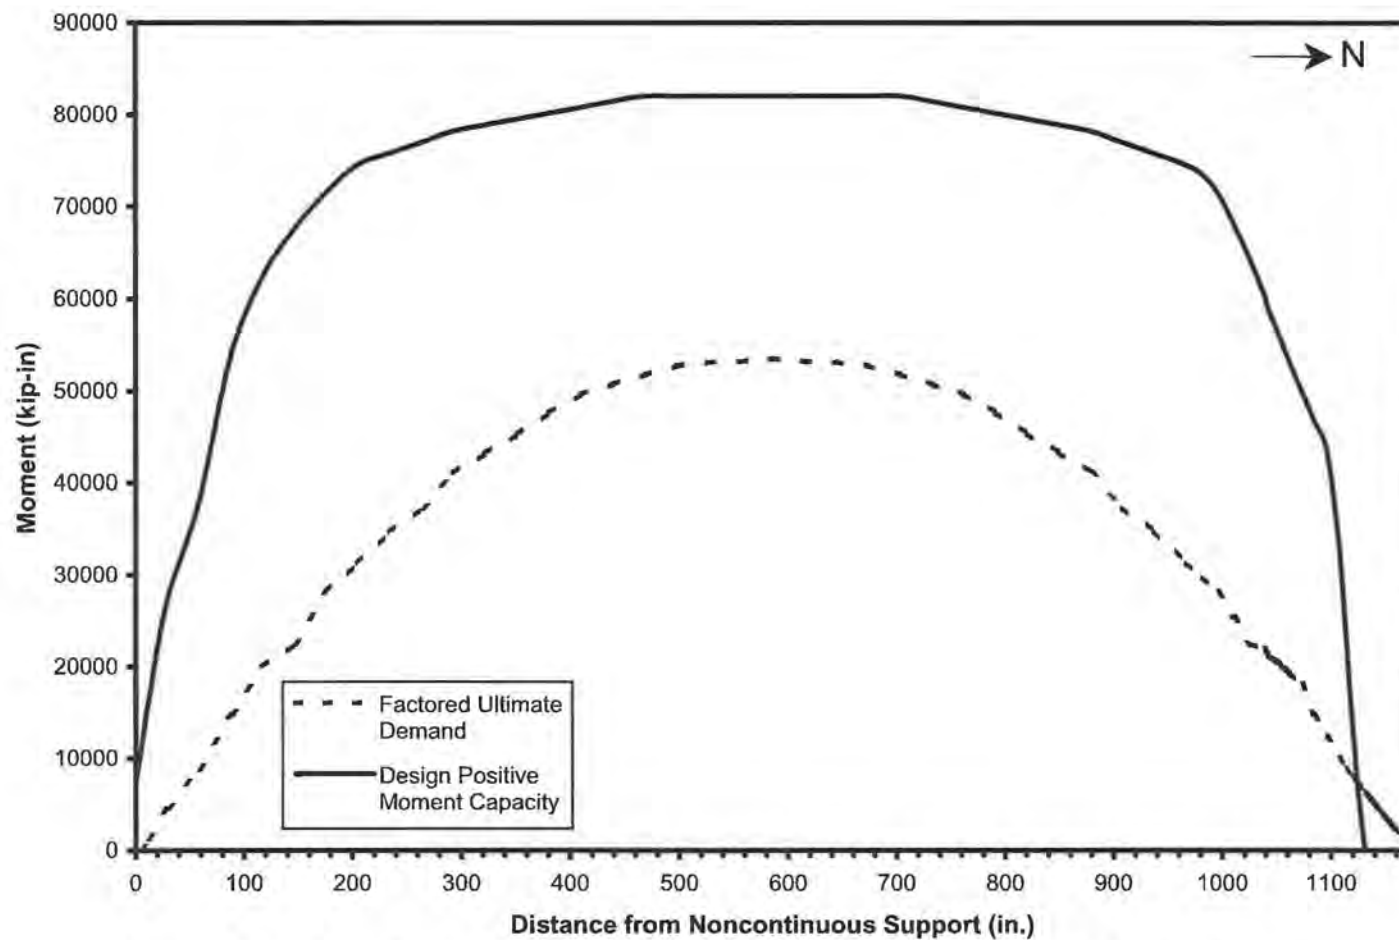
Figure 5.9– Design Positive Moment Capacity vs. Factored Ultimate Demand for a Simply Supported Interior Girder (1 Design Truck, Southbound)

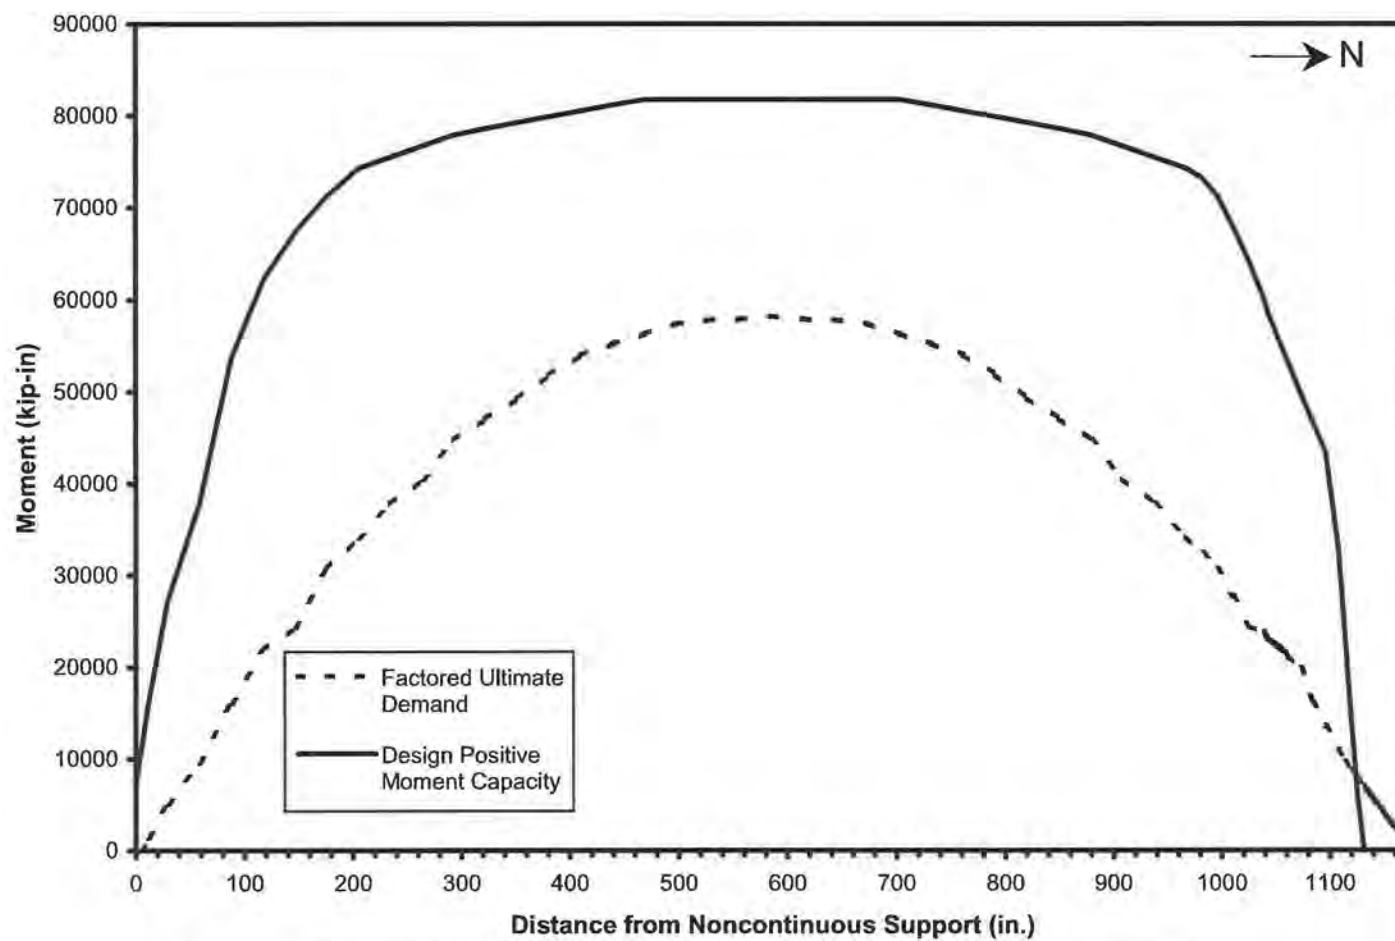
Figure 5.10— Design Positive Moment Capacity vs. Factored Ultimate Demand for a Simply Supported Exterior Girder (1 Design Truck, Northbound)

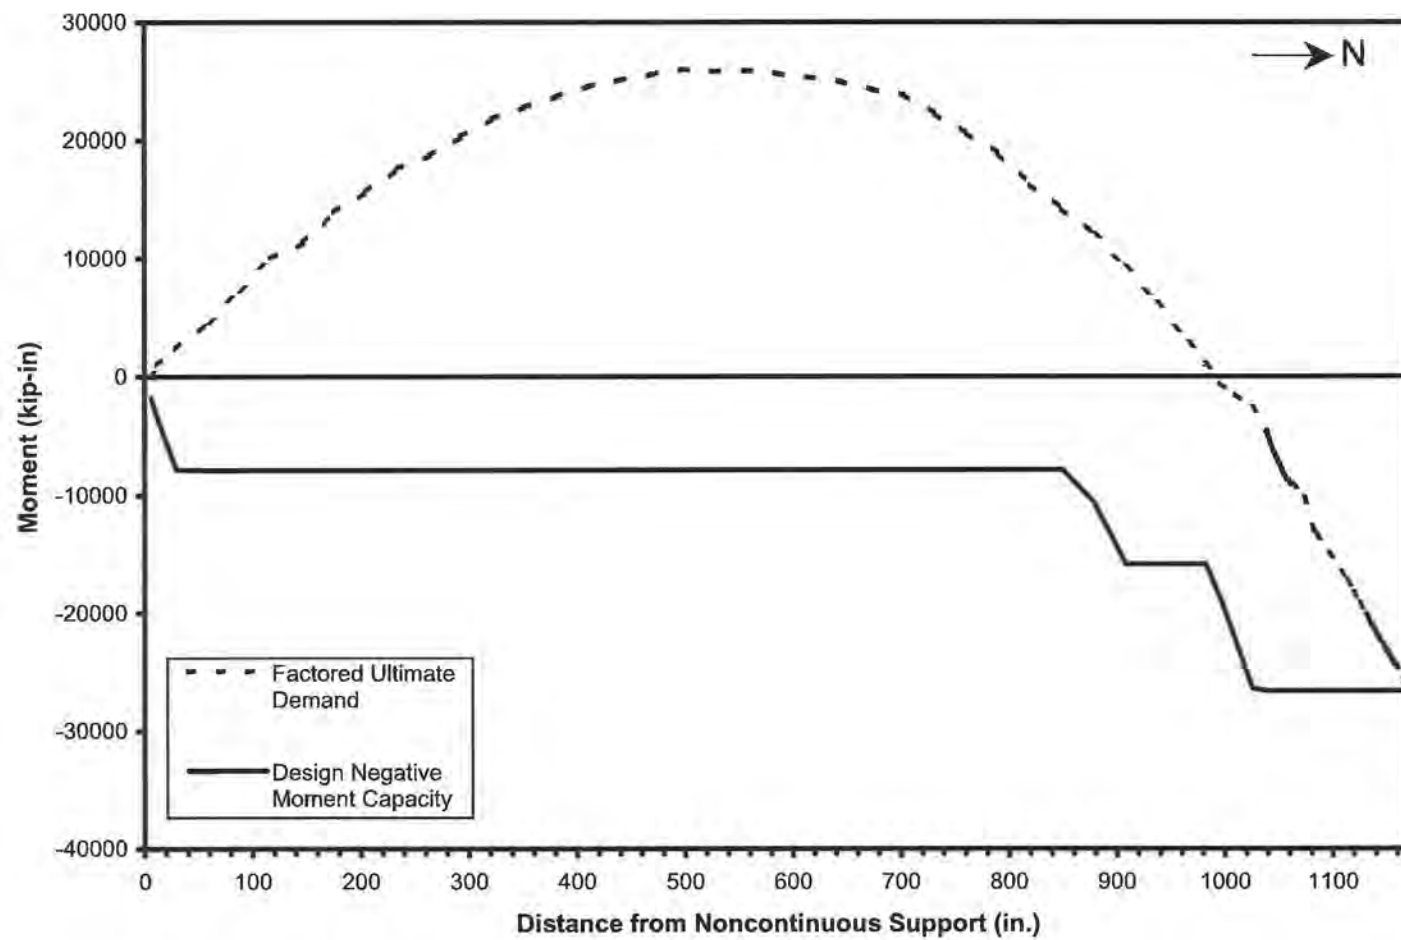
Figure 5.11– Design Negative Moment Capacity vs. Factored Ultimate Demand for an Interior Girder Made Continuous for Live Load ($\phi_f = 1.00$)

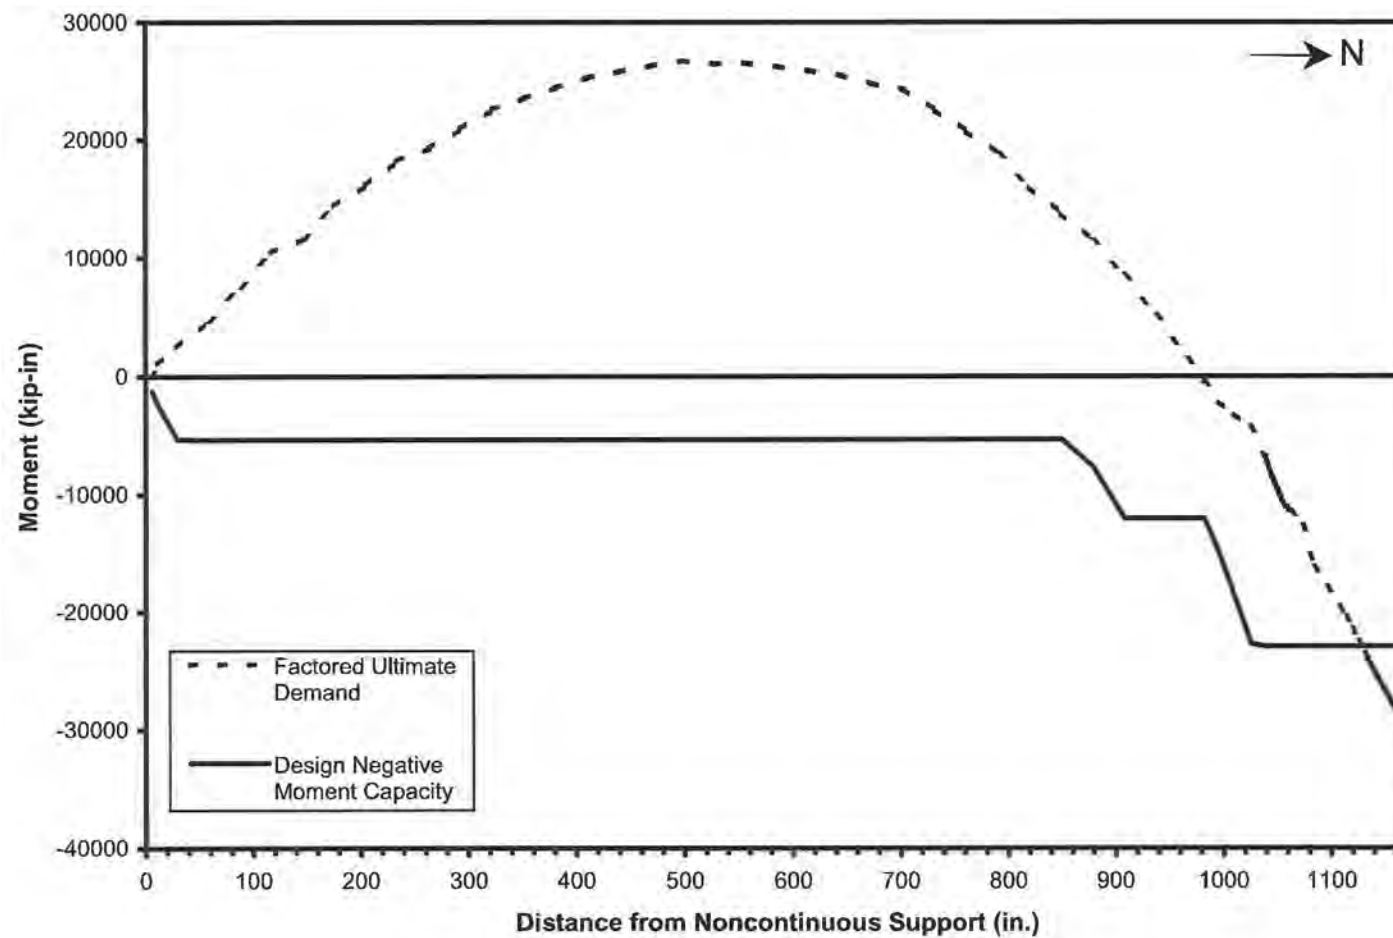
Figure 5.12– Design Negative Moment Capacity vs. Factored Ultimate Demand for an Exterior Girder Made Continuous for Live Load ($\phi_f = 1.00$)

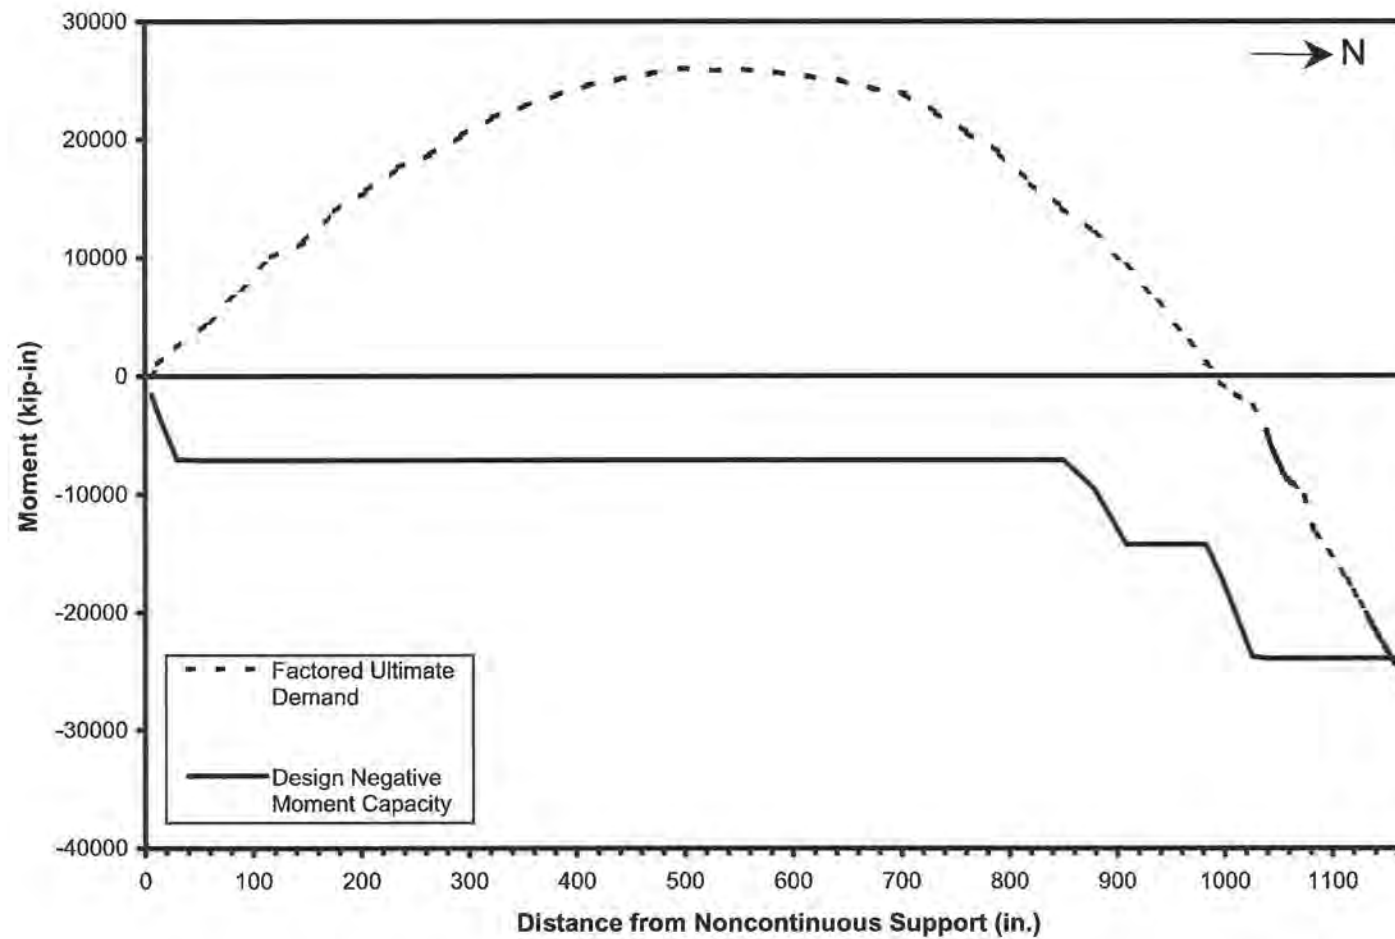
Figure 5.13– Design Negative Moment Capacity vs. Factored Ultimate Demand for an Interior Girder Made Continuous for Live Load ($\phi_f = 0.90$)

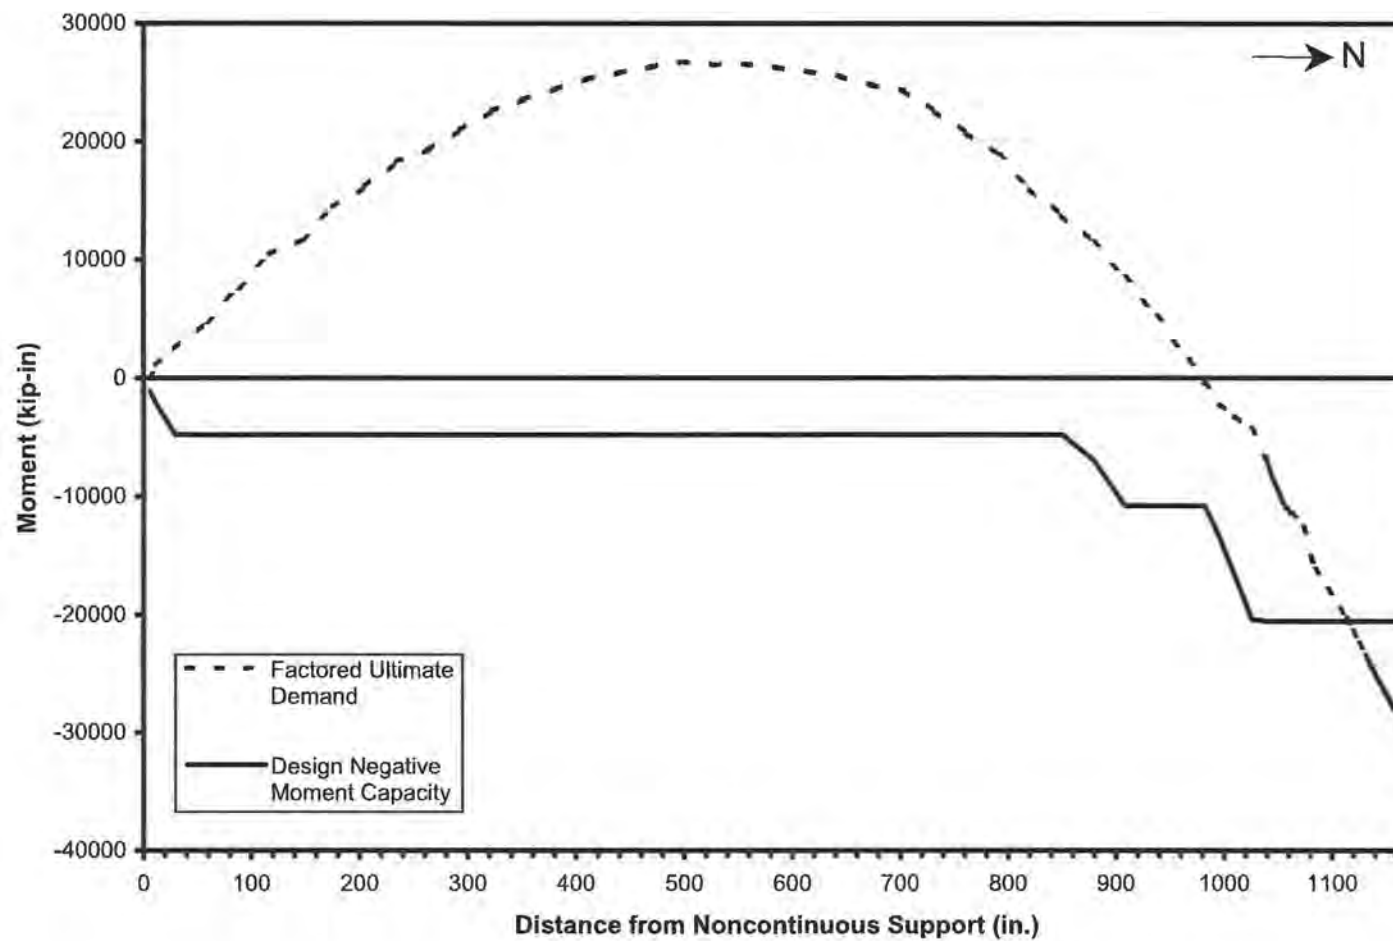
Figure 5.14– Design Negative Moment Capacity vs. Factored Ultimate Demand for an Exterior Girder Made Continuous for Live Load ($\phi_f = 0.90$)

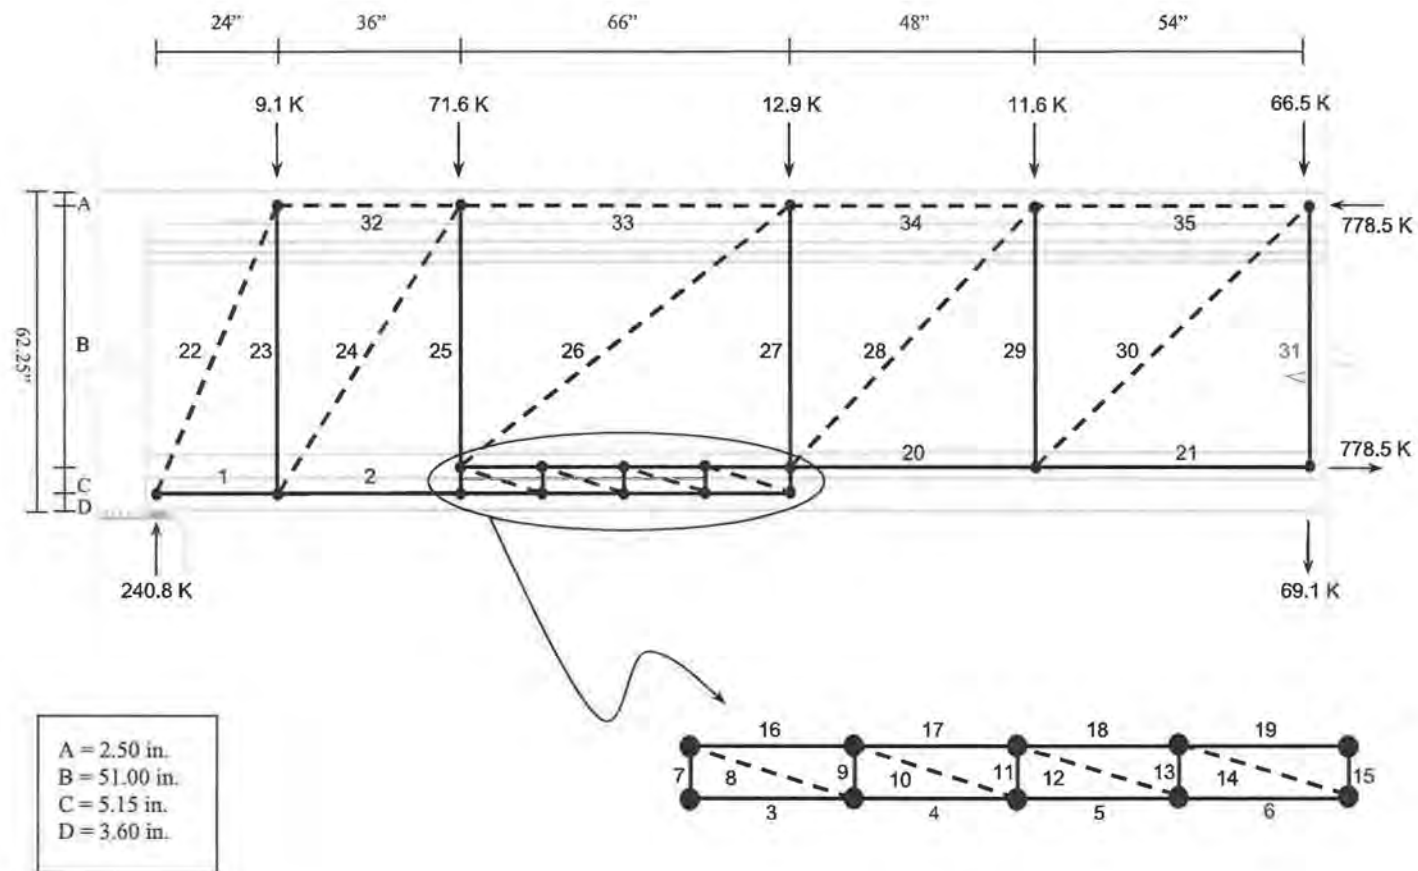
Figure 5.15 – Strut-and-Tie Model of Cracked End Region of a Simply Supported Girder (Model A)

Although a strut-and-tie model of the existing cracked girder was not made, some conclusions can be made about the behavior and strength of an unstrengthened cracked bridge girder. Examination of the strut-and-tie models reveals that applied loads cause tensile forces in the bottom flange if the behavior of the girders is not that of a continuous structure. Because the prestressing tendons have been assumed to be ineffective between the girder end and the crack location, they are not capable of resisting the tension forces present in the bottom flange ties. Without the external FRP reinforcement, the cracked prestressed concrete girders are not capable of transferring loads to the supports by the mechanism assumed in Model A and Model C.

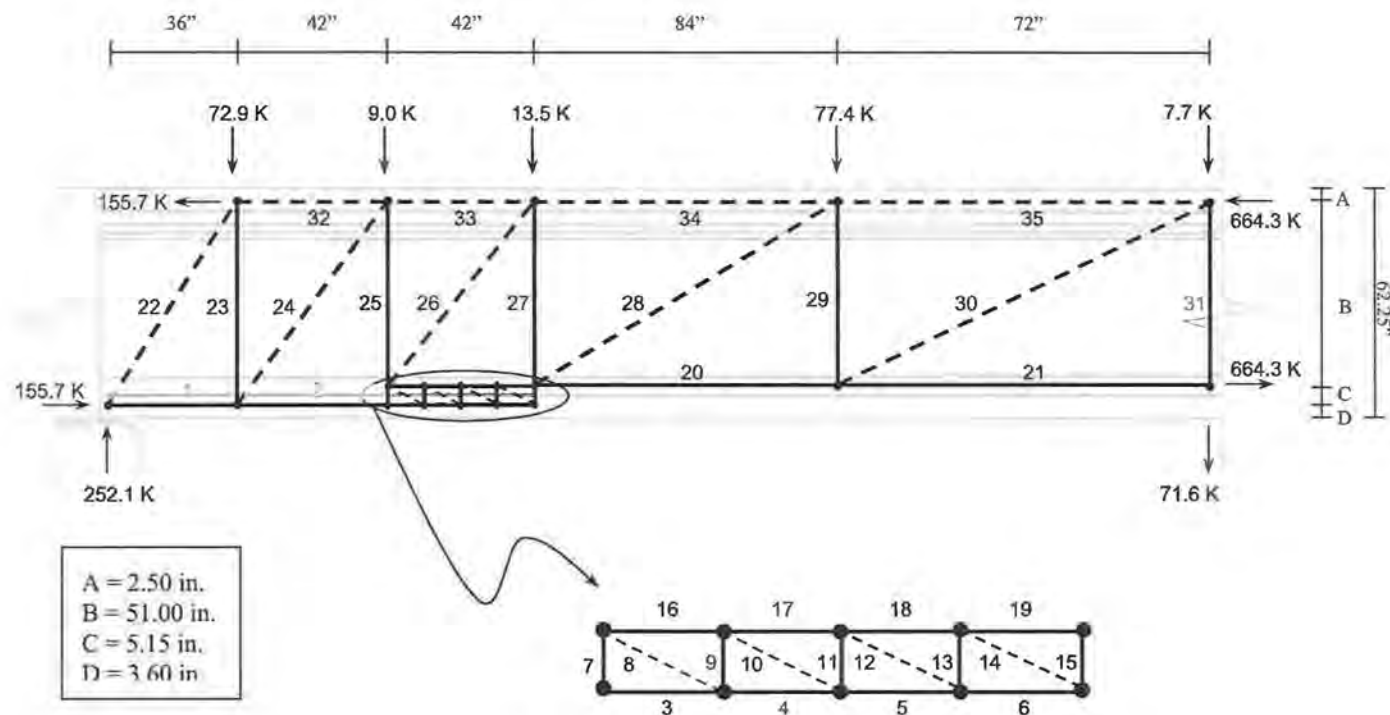
Figure 5.17 – Strut-and-Tie Model of Cracked End Region of a Girder Made Continuous for Live Load with an Internal Hinge at the Cracked Cross Section (Model C)

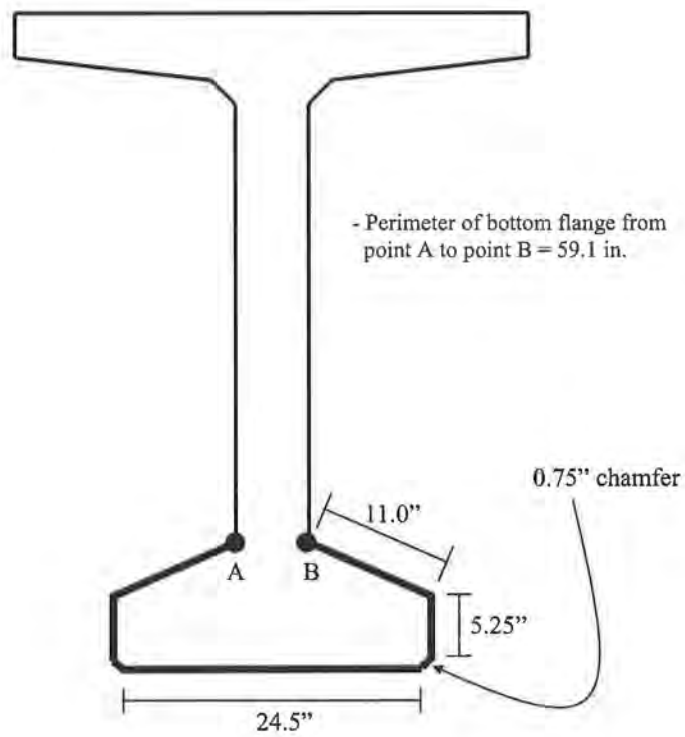
Figure 7.1 – Detail of Bottom Flange of BT54 Girder

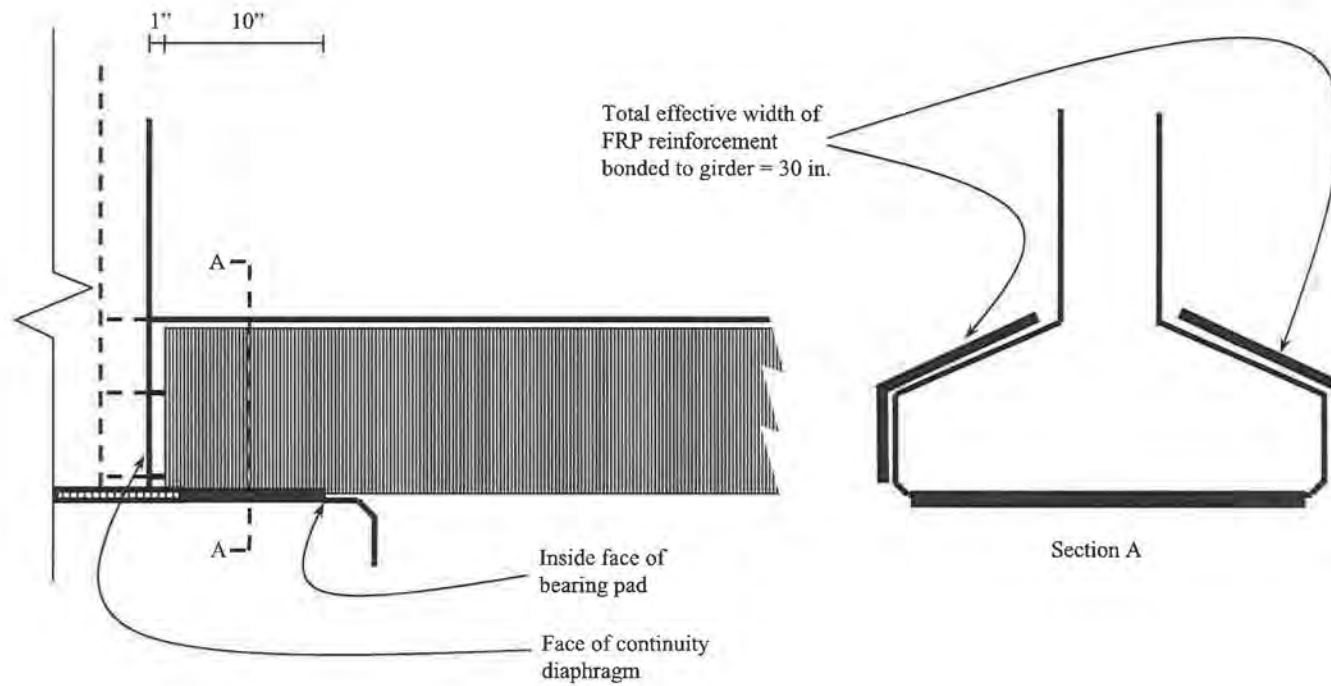
Figure 7.2 – Detail of Cross-sectional FRP Configuration for Cross Sections Over and Behind the Bearing Pad at the Continuous Support

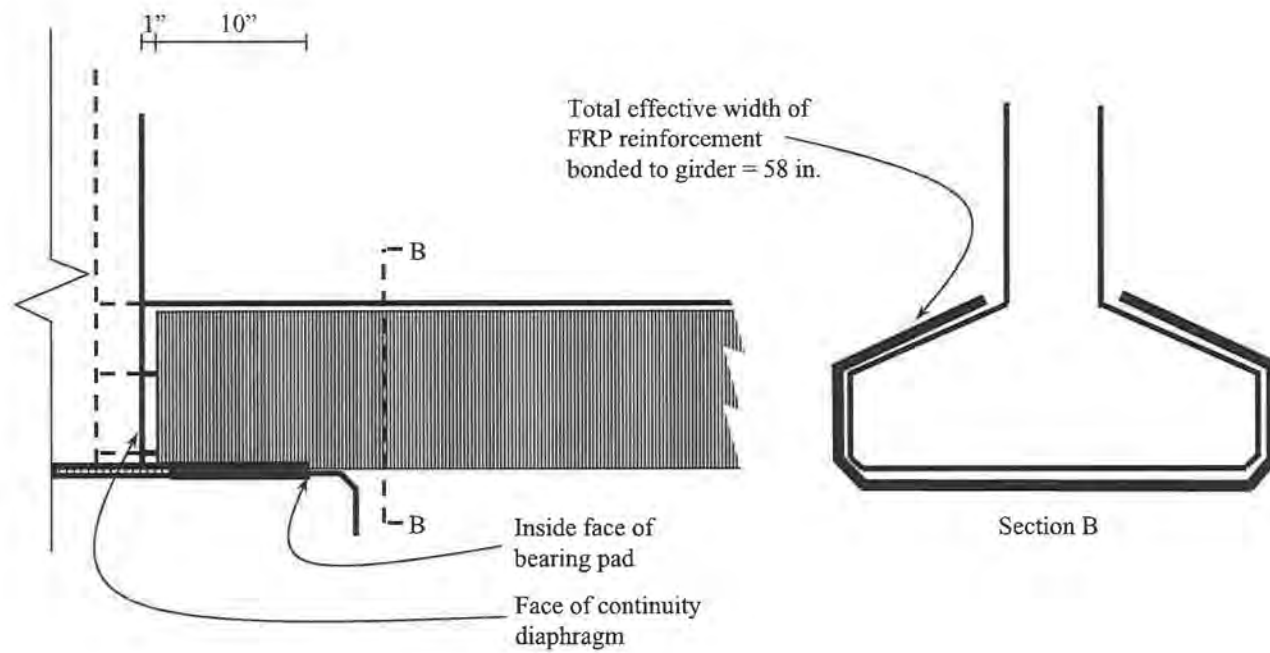
Figure 7.3 – Detail of Cross-sectional FRP Configuration for Cross Sections in the Clear Span of the Bulb-tee Girder
