IR-07-02

**Feasibility of Externally Bonded FRP Reinforcement for
Repair of Cracked Prestressed Concrete Girders, I-565,
Huntsville, Alabama**

Highway Research Center
Auburn University
Auburn University, Alabama

June 2007

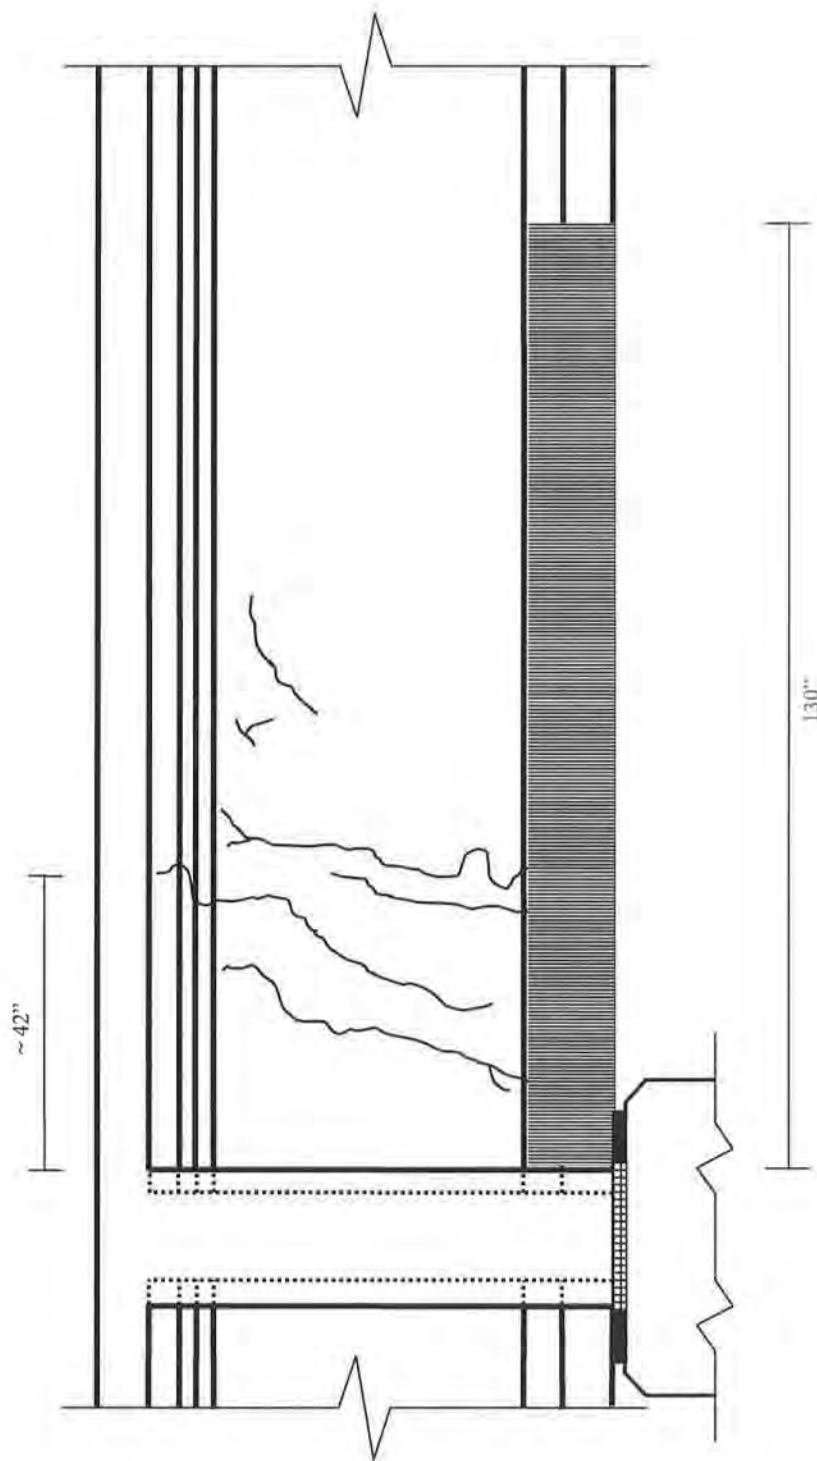
Figure 7.4 – Longitudinal Configuration of the 1-Ply FRP Strengthening System

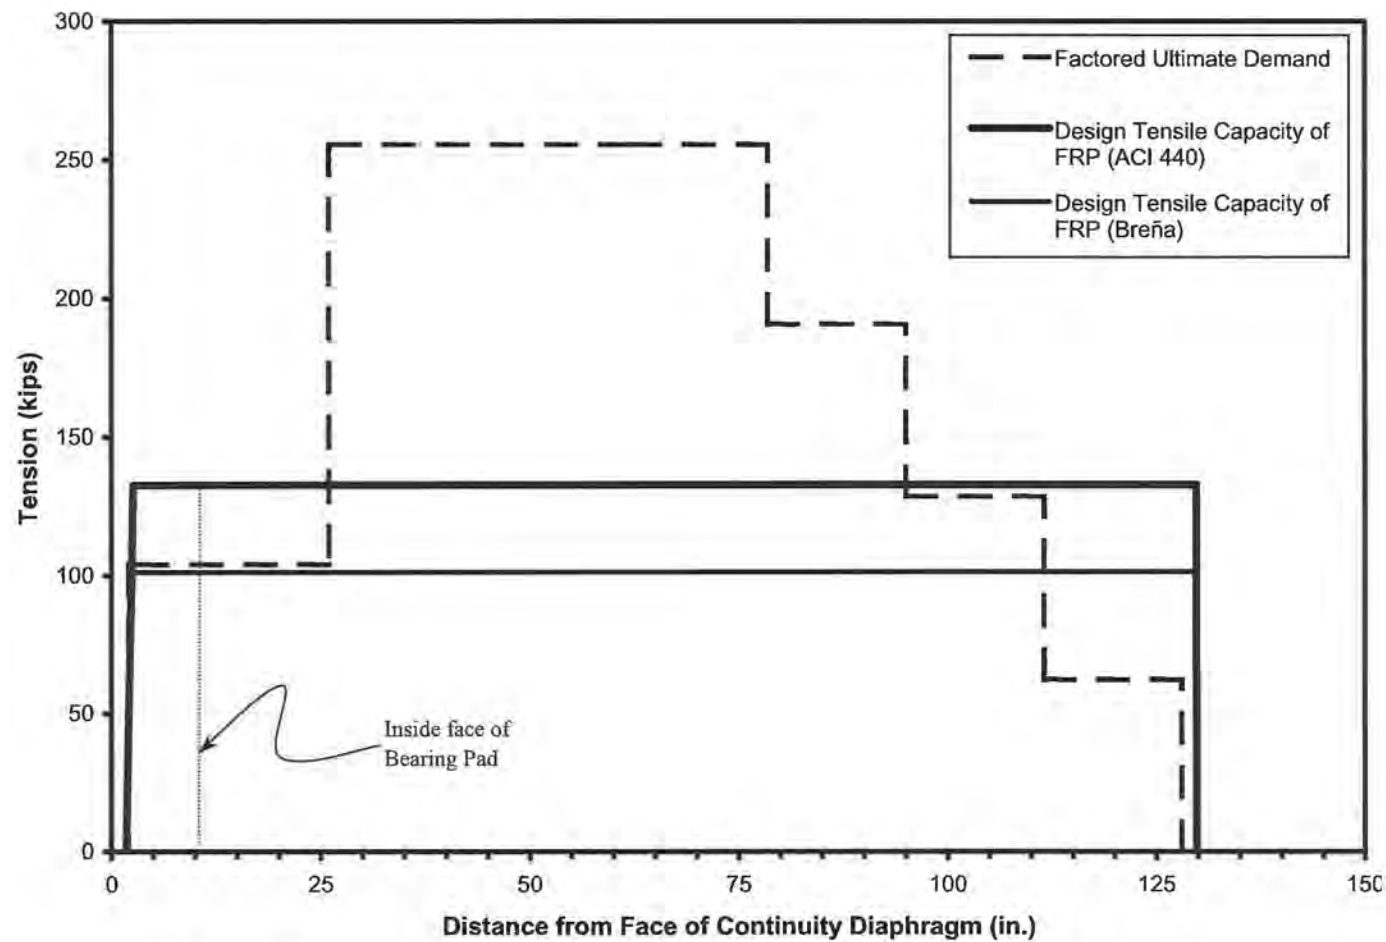
Figure 7.5 – Design Tensile Capacity vs. Factored Ultimate Demand for the 1-Ply FRP Strengthening System

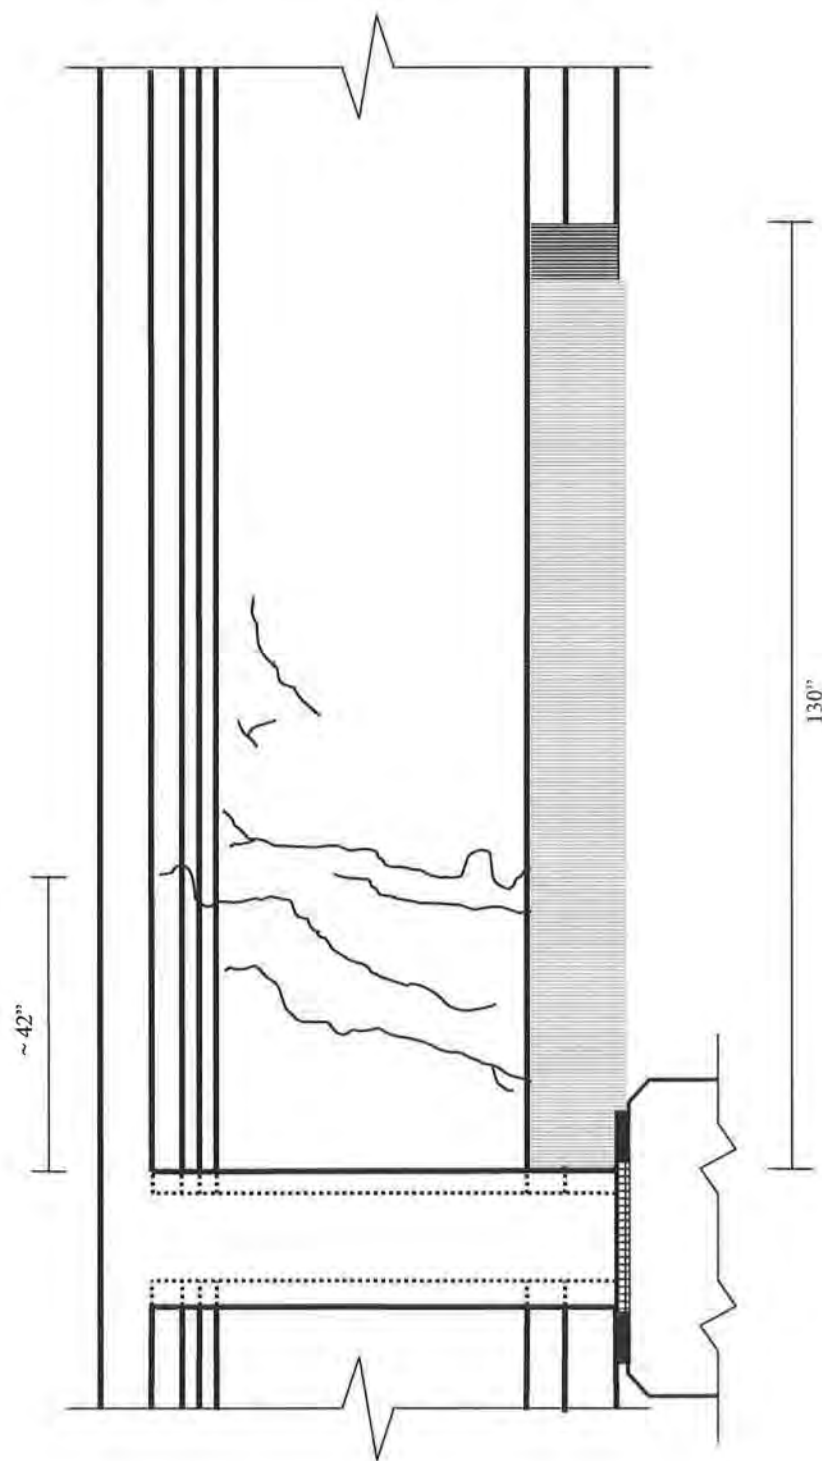
Figure 7.6 – Longitudinal Configuration of the 2-Ply FRP Strengthening System

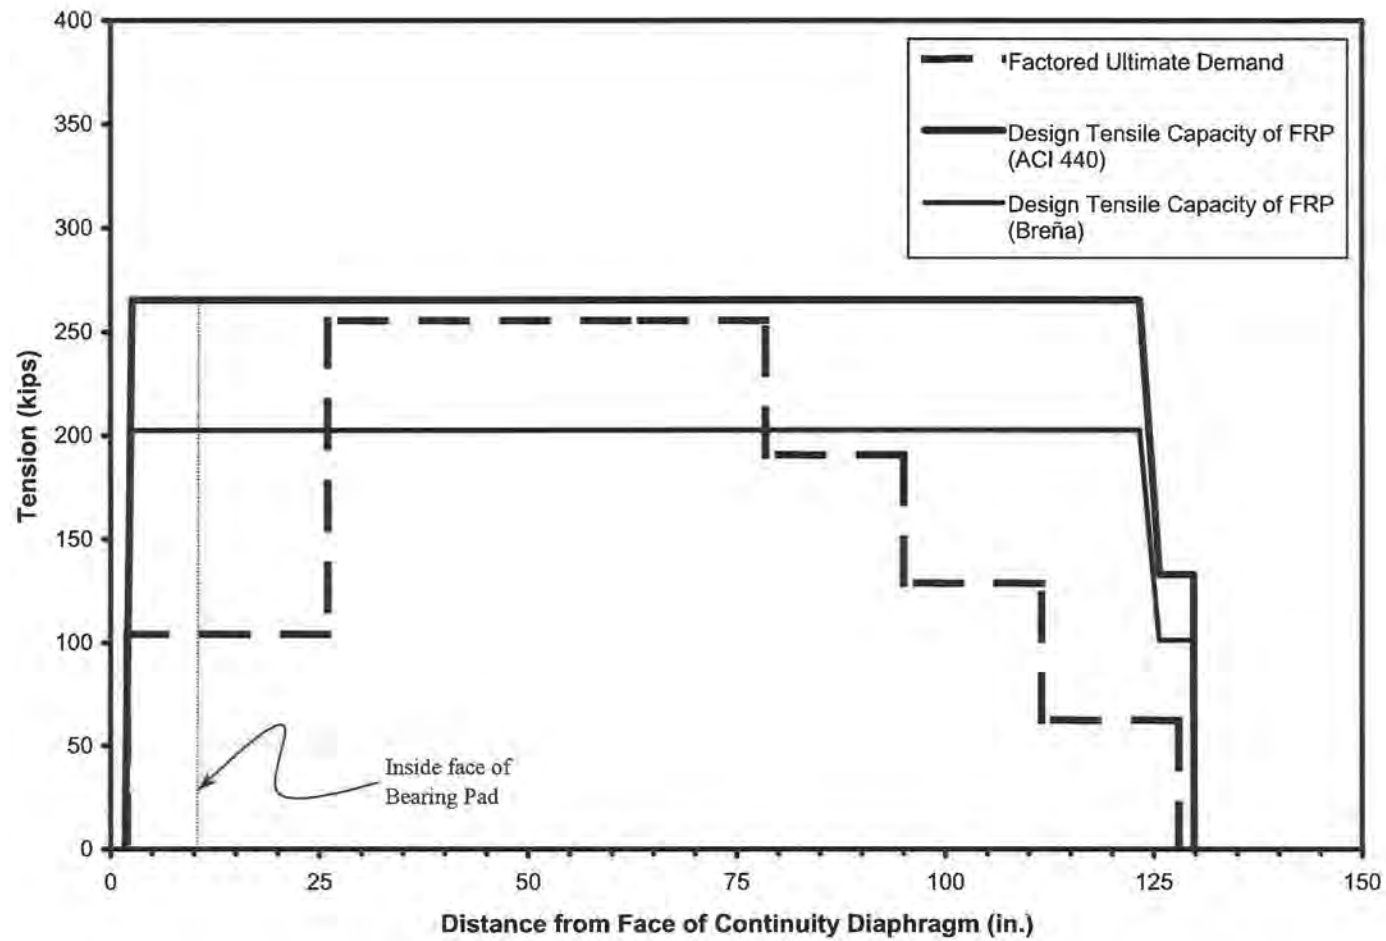
Figure 7.7 – Design Tensile Capacity vs. Factored Ultimate Demand for the 2-Ply FRP Strengthening System

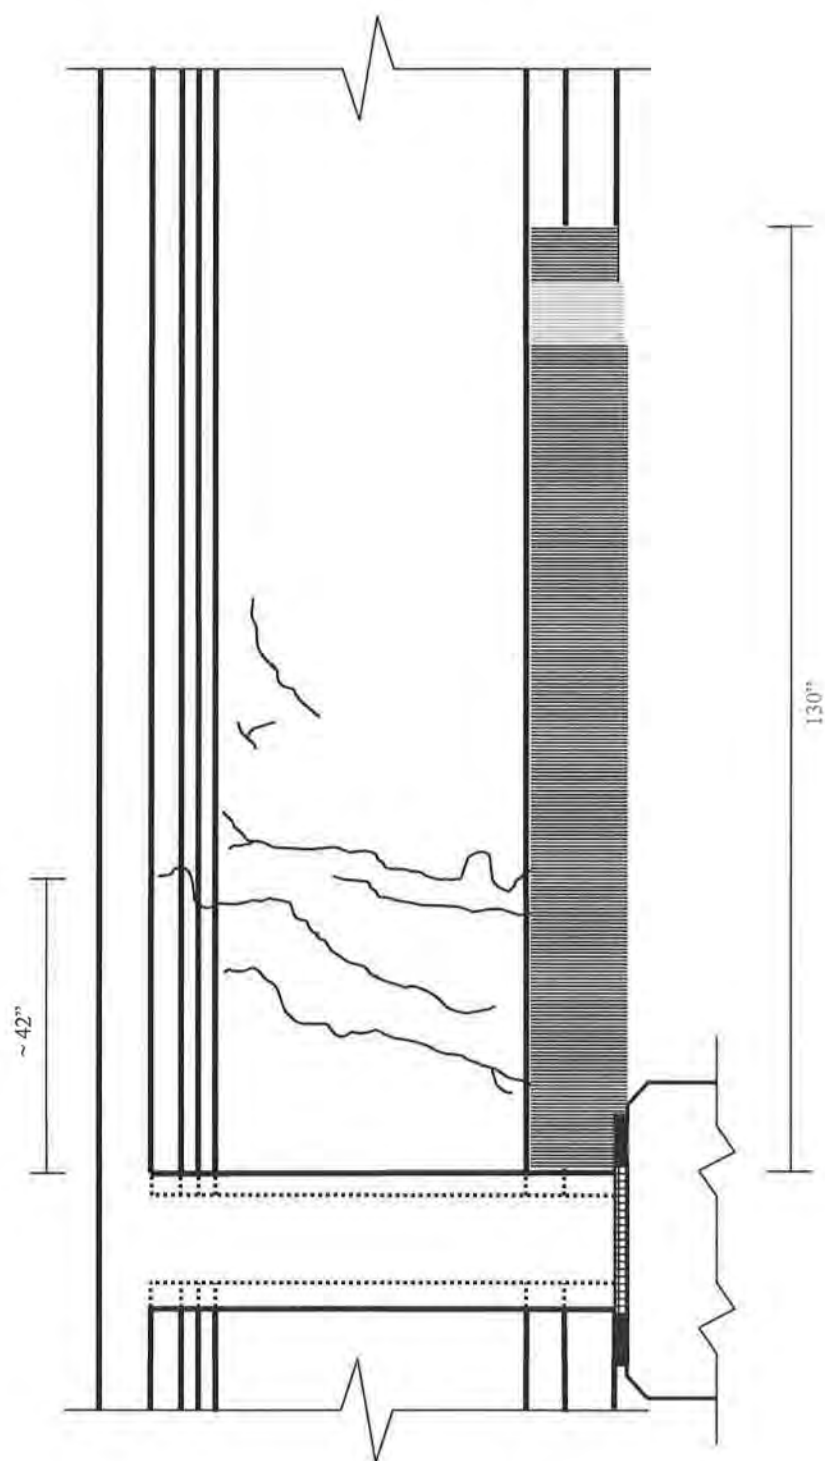
Figure 7.8 – Longitudinal Configuration of the 3-Ply FRP Strengthening System

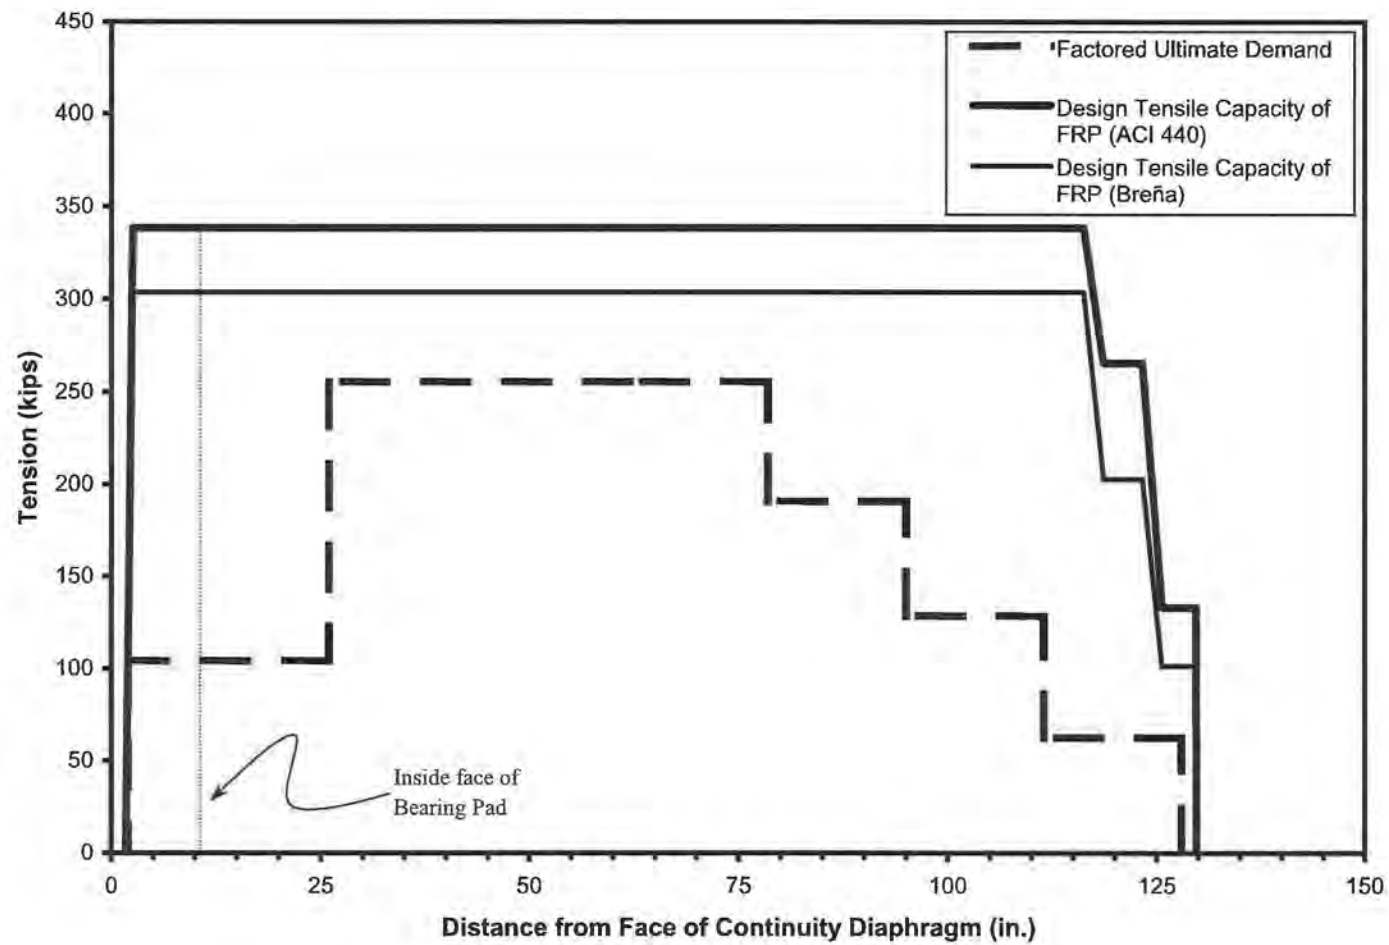
Figure 7.9 – Design Tensile Capacity vs. Factored Ultimate Demand for the 3-Ply FRP Strengthening System

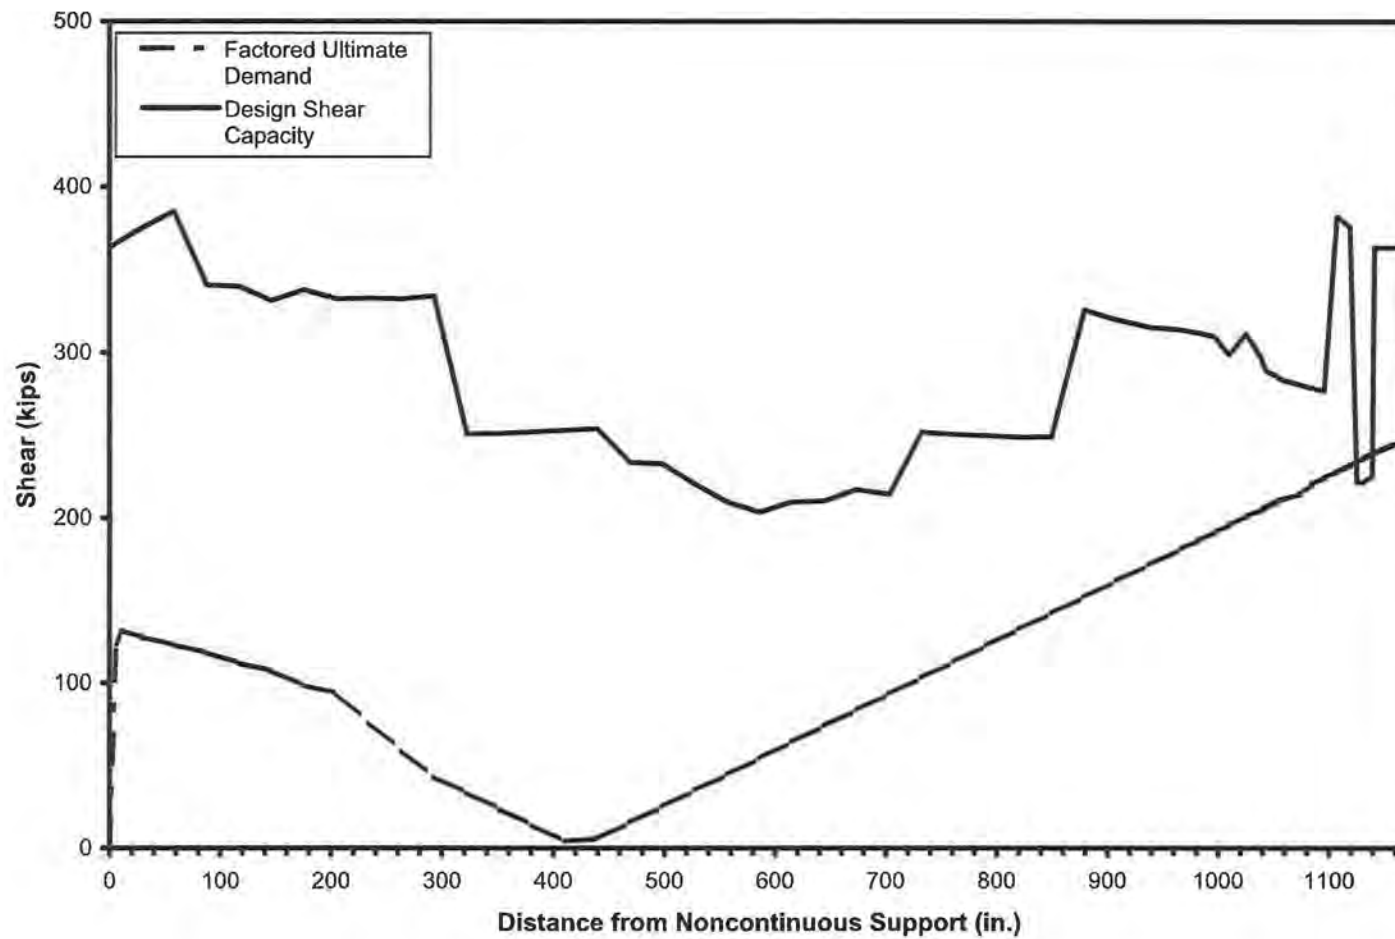
Figure 7.10 – Design Shear Capacity vs. Factored Ultimate Demand for the 3-Ply FRP Strengthening System on an Interior Girder

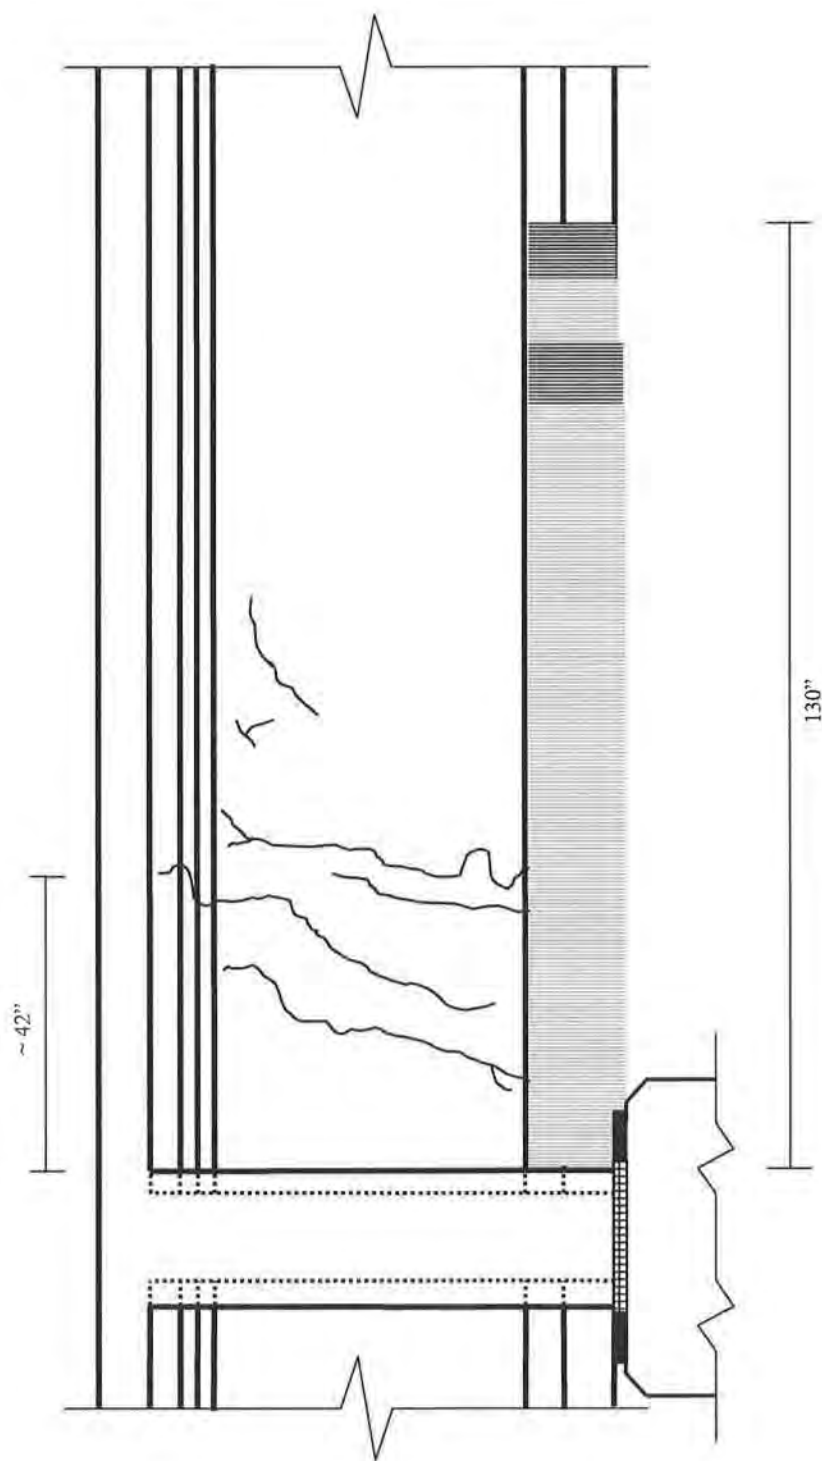
Figure 7.11 – Longitudinal Configuration of the 4-Ply FRP Strengthening System

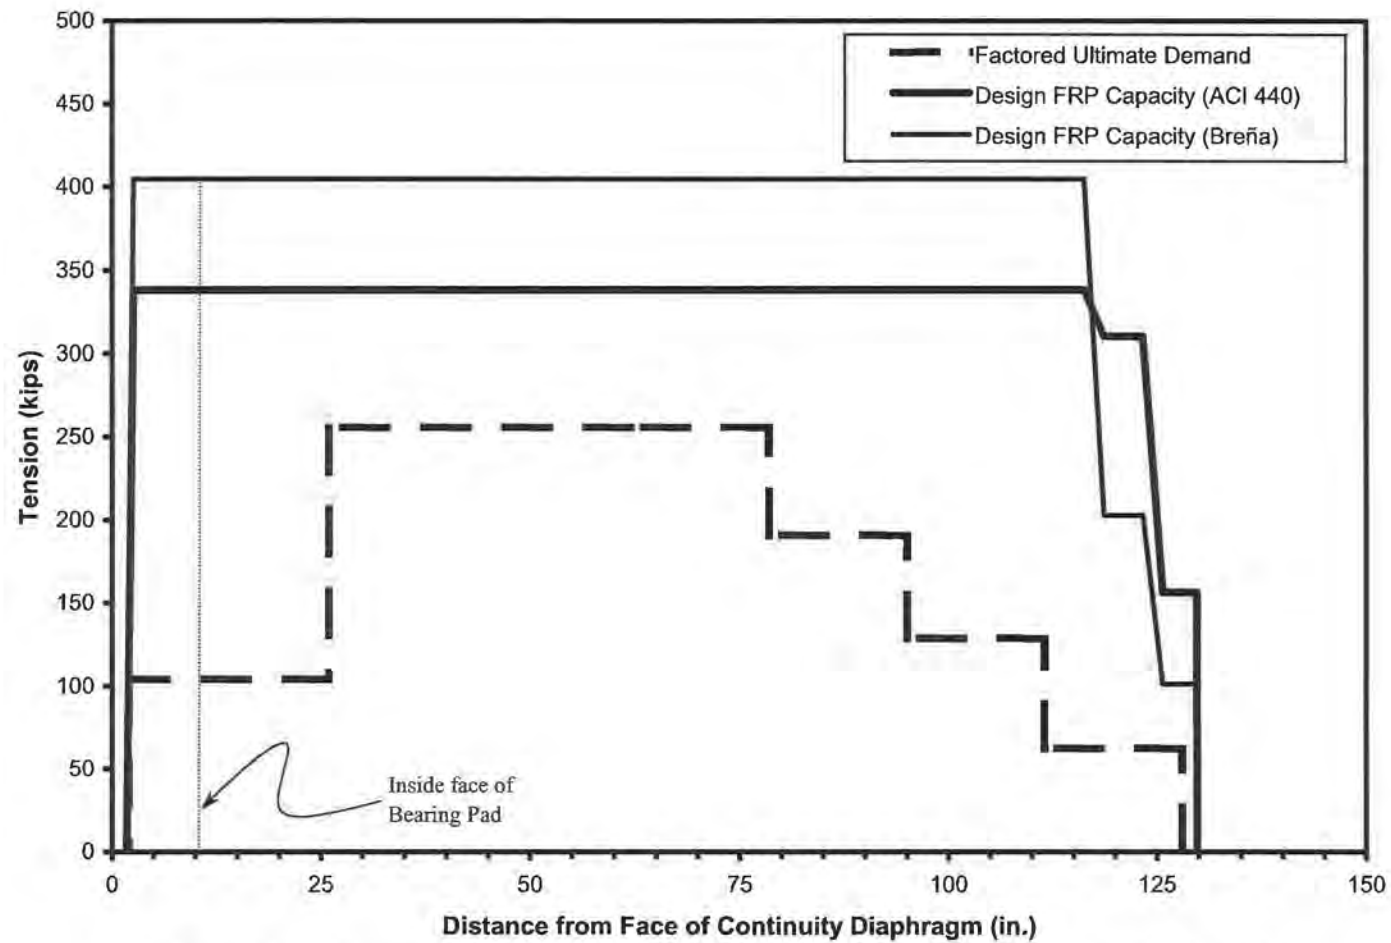
Figure 7.12 – Design Tensile Capacity vs. Factored Ultimate Demand for the 4-Ply FRP Strengthening System

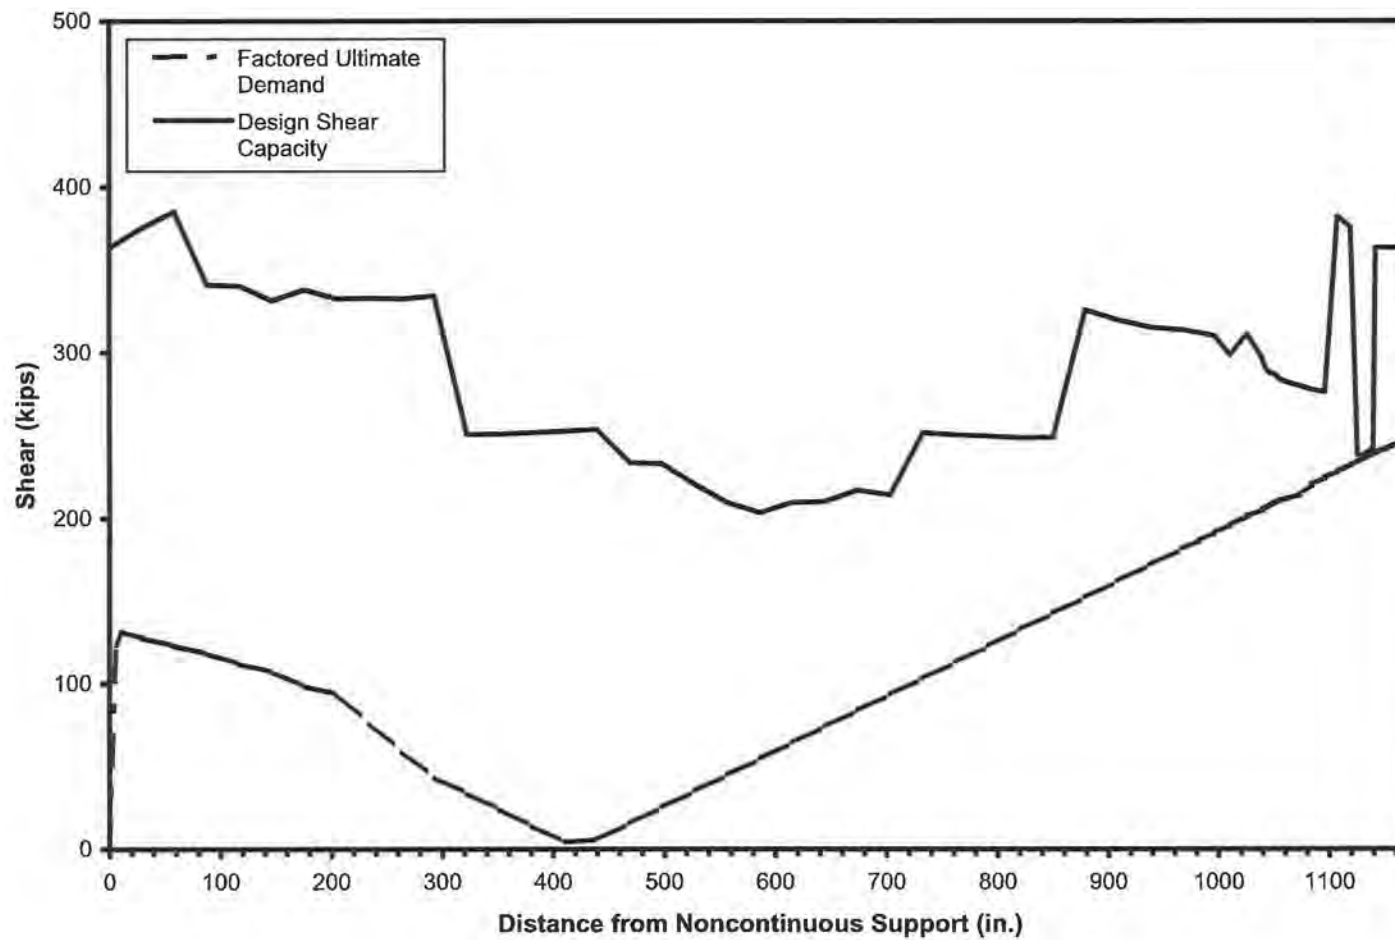
Figure 7.13 – Design Shear Capacity vs. Factored Ultimate Demand for the 4-Ply FRP Strengthening System on an Interior Girder

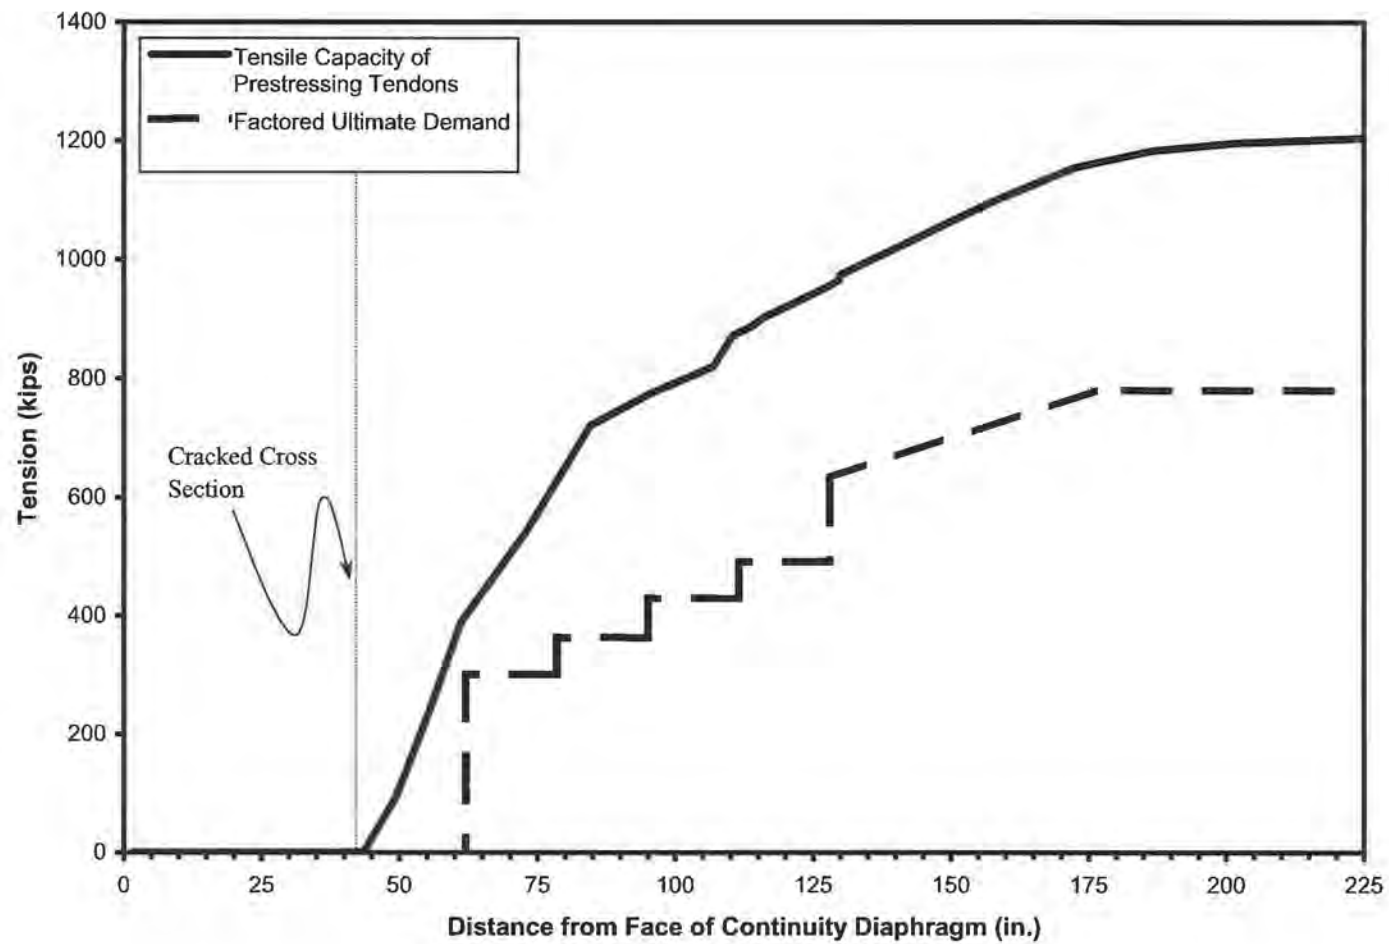
Figure 7.14 – Tensile Capacity vs. Factored Ultimate Demand for the Prestressing Tendons

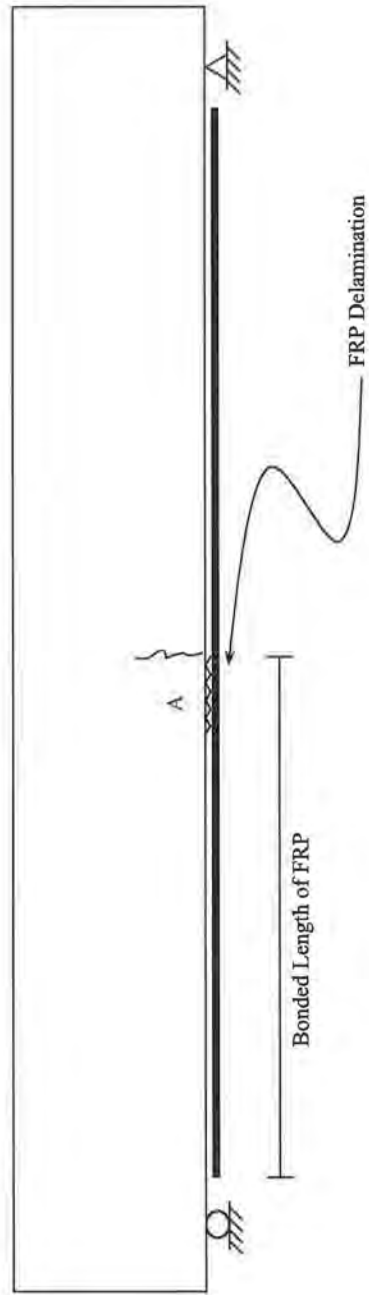
Figure 7.15 – FRP Delamination Type A

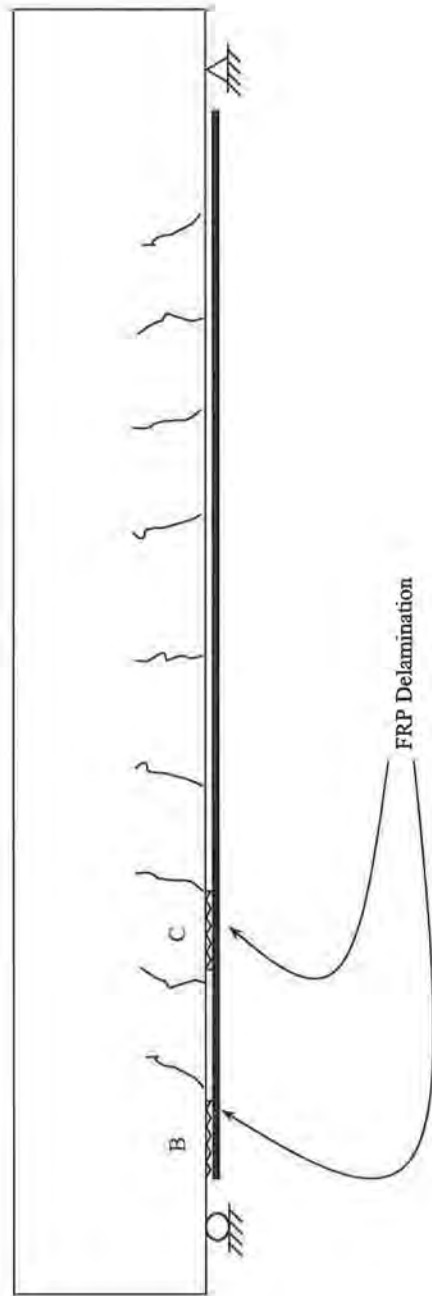
Figure 7.16 – FRP Delamination Types B and C

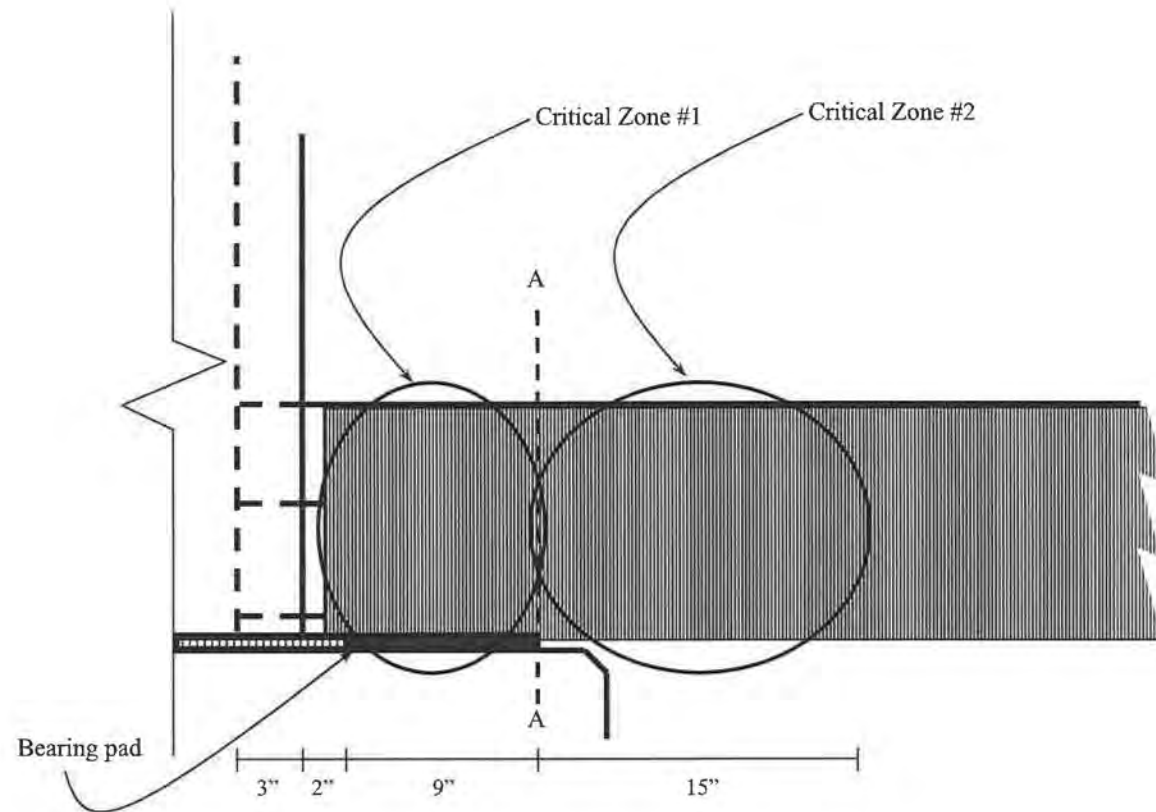
Figure 7.17 – Detailed of the Cracked End Region of a Strengthened Bulb-tee Girder

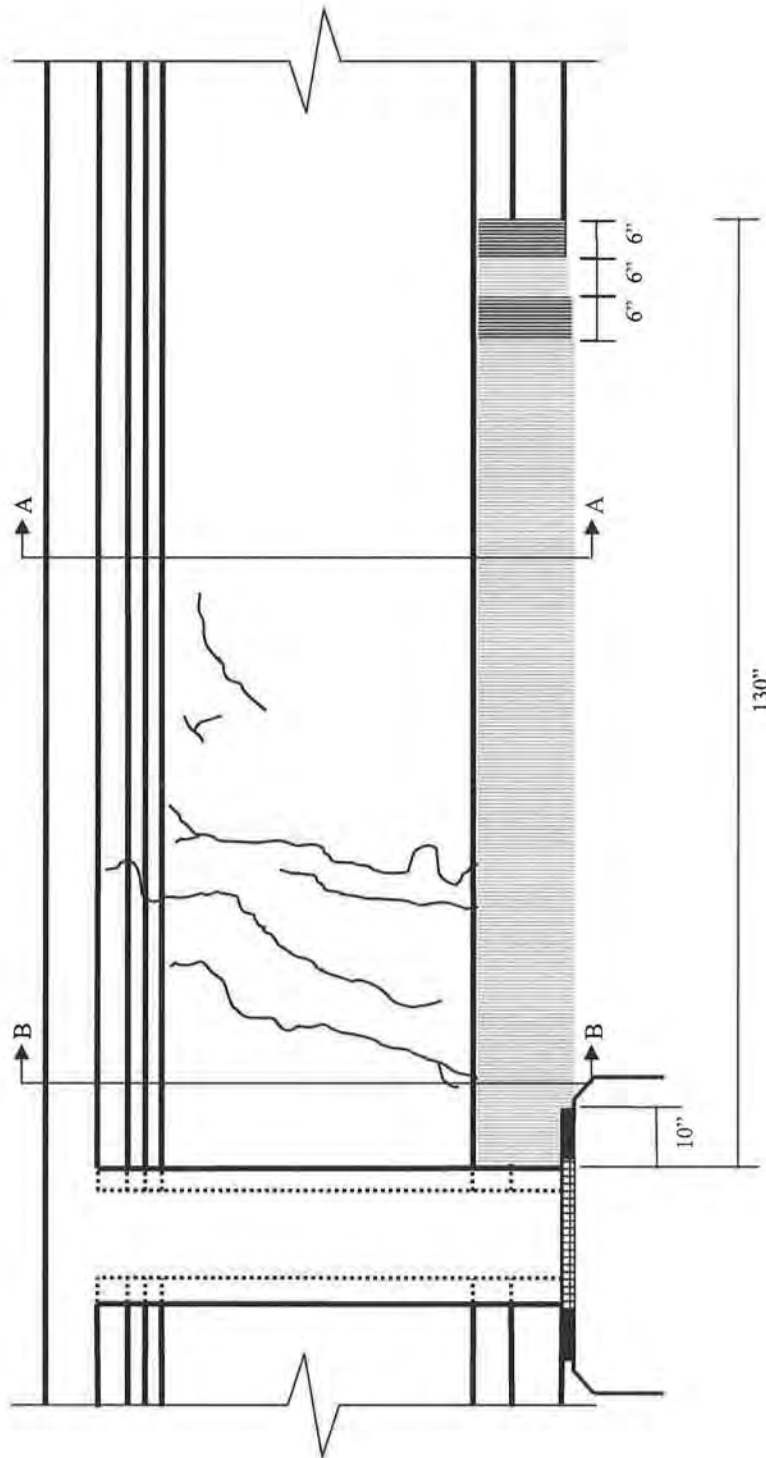
Figure 8.1 – Detail of the Longitudinal FRP Configuration

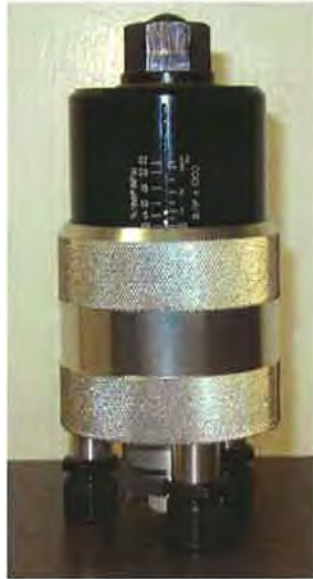
Figure A.1 - Elcometer 106 Fixed-alignment Portable Adhesion Tester

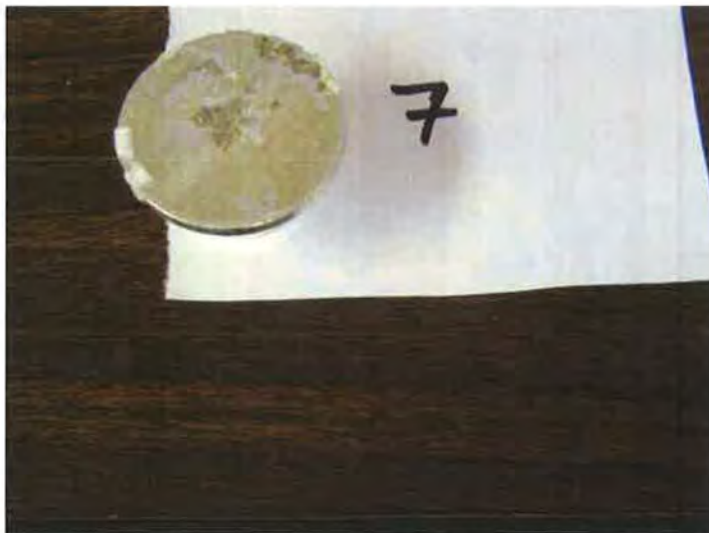
Figure A.8 – Bottom Surface of Test Dolly #7 after Failure

For the eight adhesion tests that resulted in a typical failure through the concrete and adhesive layer, similar stresses at failure were observed. Stresses at failure ranged from 397 psi (2.7 MPa) to 579 psi (4.0 MPa) and the mean stress at failure was 478 psi (3.3 MPa). Because the failure of the test dollies was controlled by a combined failure of the epoxy adhesive and the concrete paste, the mean stress at failure provides a lower bound value for the tensile strength of the concrete. Thus, a value of 480 psi (3.3 MPa) can be used as a conservative estimate of the tensile strength of the concrete.

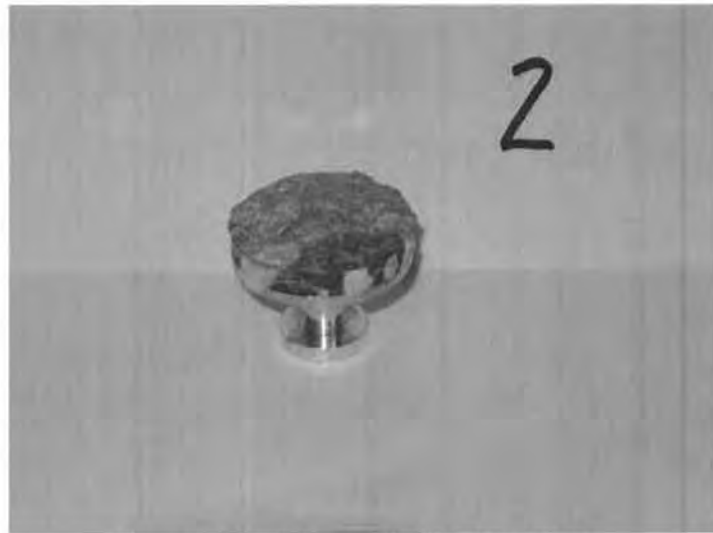
Figure A.9 – Test Dolly #2 after Failure
