Research Report for ALDOT Project 930-956

EVALUATION OF NONDESTRUCTIVE TEST METHODS TO ASSESS THE IN-PLACE CONDITION OF CONCRETE STRUCTURES

The Alabama Department of Transportation

JANUARY 2022

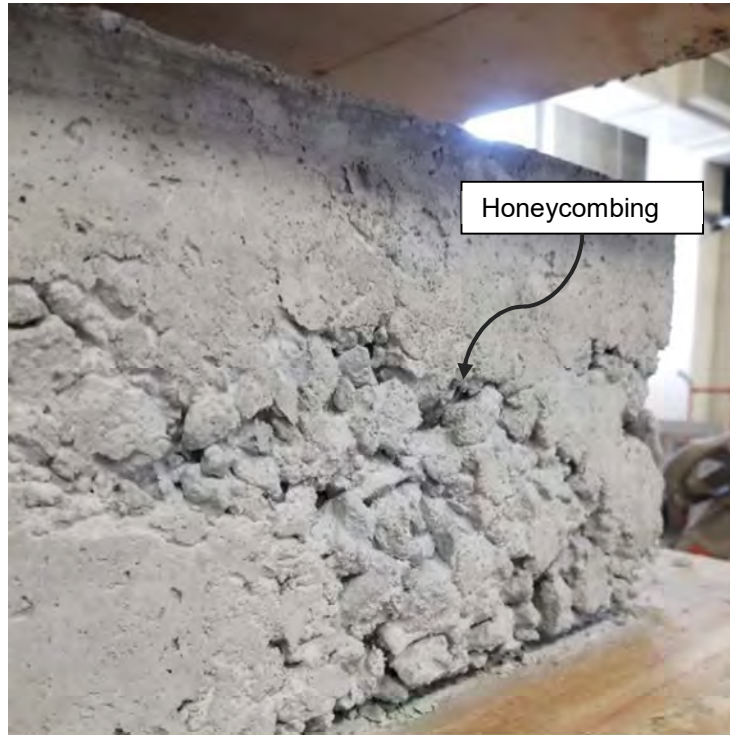
insufficient cover to formed surfaces, (4) improper consolidation of fresh concrete, (5) leaking at joints, and (6) segregation during placement (Emmons 1993). Honeycombing can be observed in the side of the concrete slab, shown in Figure 2-3.

Figure 2-3: Honeycombing in a Concrete Slab

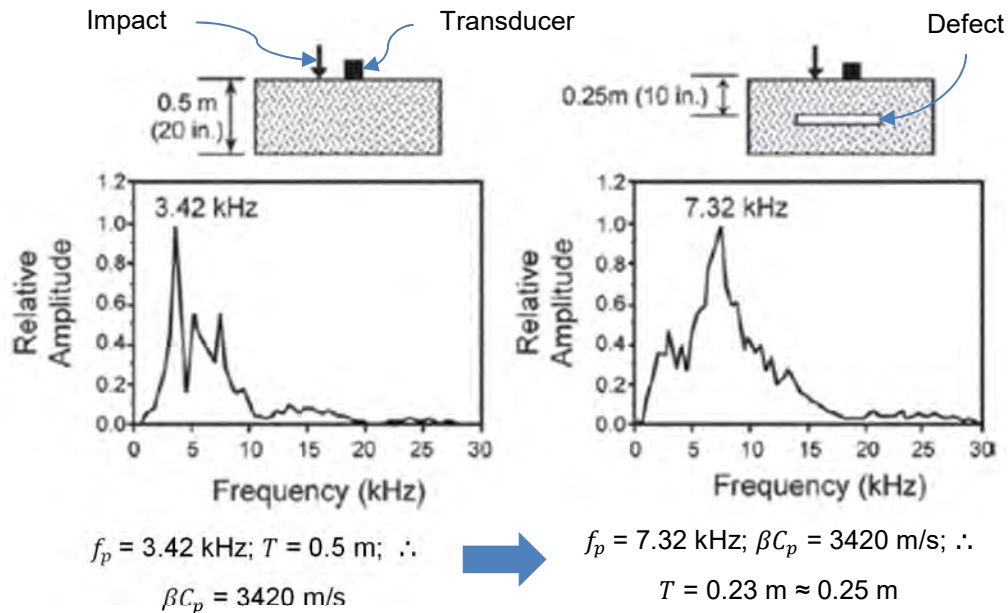
taken at any point on the slab, peak frequencies can be identified, and the depth to the peak reflections may be calculated using Equation 2.2. A schematic illustrating the IE method can be seen in Figure 2-6.

Figure 2-6: Validation of IE Method on Concrete Slabs (Adapted from ACI Committee 228 2013)

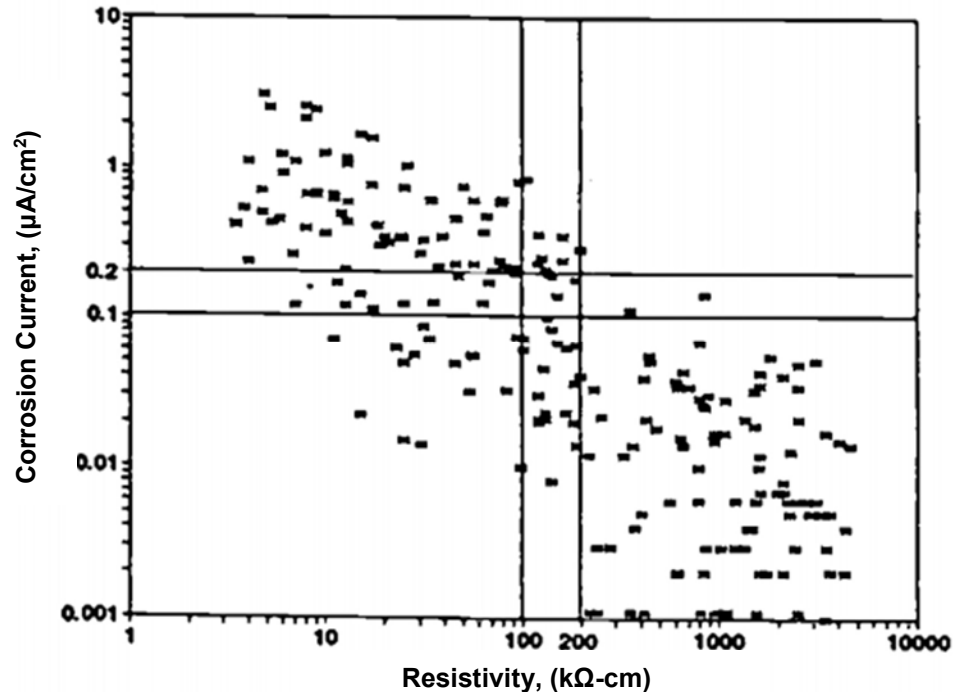
In part to assess the effectiveness of various NDT methods in measuring the in-situ rates of corrosion, Feliú et al. (1996) conducted testing on both laboratory specimens and in-service structures. A portable device using a galvanostatic pulse was implemented to measure the corrosion rates of the foregoing concrete elements. Furthermore, electrical resistivity of the same elements was measured, allowing for a comparison of corrosion current and resistivity. When the measured corrosion rate was plotted against the measured electrical resistivity, as provided in Figure 3-1, a clear correlation could be observed between the two parameters. Generally, it appeared that the corrosion current was a linear function of the electrical resistivity.

Figure 3-1: Correlation Between Corrosion Current and Electrical Resistivity (Adapted from Feliú et al. 1996)

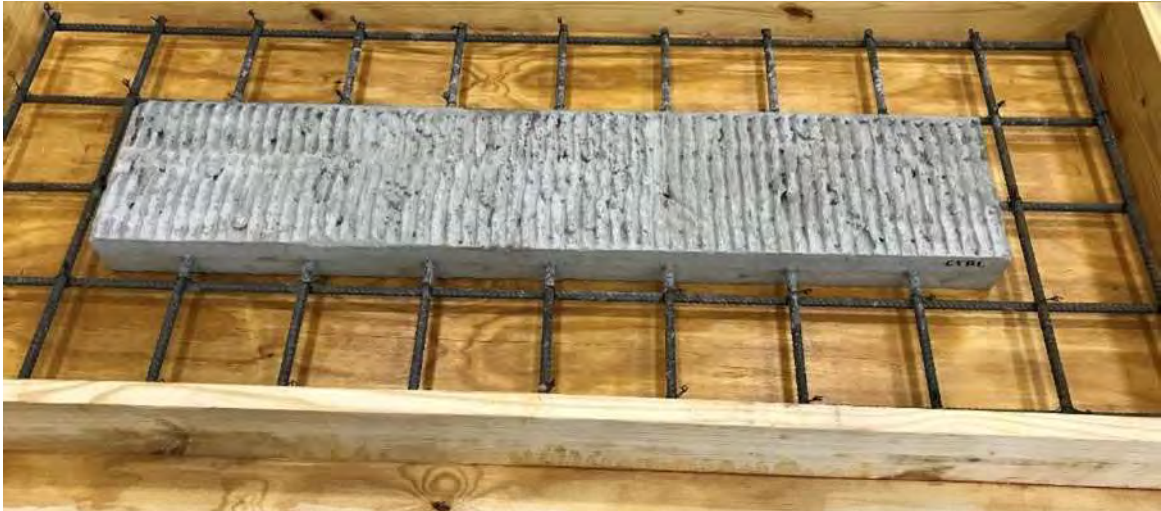
Unlike the DE specimens, Specimen CTRL was not deliberately fabricated with any defects. Nonetheless, this specimen was still built by casting concrete around a hardened 1 ft by 5 ft miniature slab. Rather, that miniature slab contained no simulated defects and was made using the same mixture proportions as the surrounding concrete. Accordingly, this specimen was built as a control to evaluate whether any given NDT method responded to the presence of the cold joint between the miniature slab and the surrounding concrete, rather than the defects simulated in the miniature slabs of the DE specimens. Thus, if an NDT method indicated that there was a defect at the location of the miniature slab in the control specimen, it would make it difficult to claim that the NDT method responded to a simulated defect in a DE specimen. As with all miniature slabs fabricated for this study, the surface of the miniature slab of the control specimen was intentionally roughened to allow for improved bond with the surrounding concrete to be placed, as can be seen in Figure 4-5.

Figure 4-5: Miniature Slab for Test Specimen CTRL

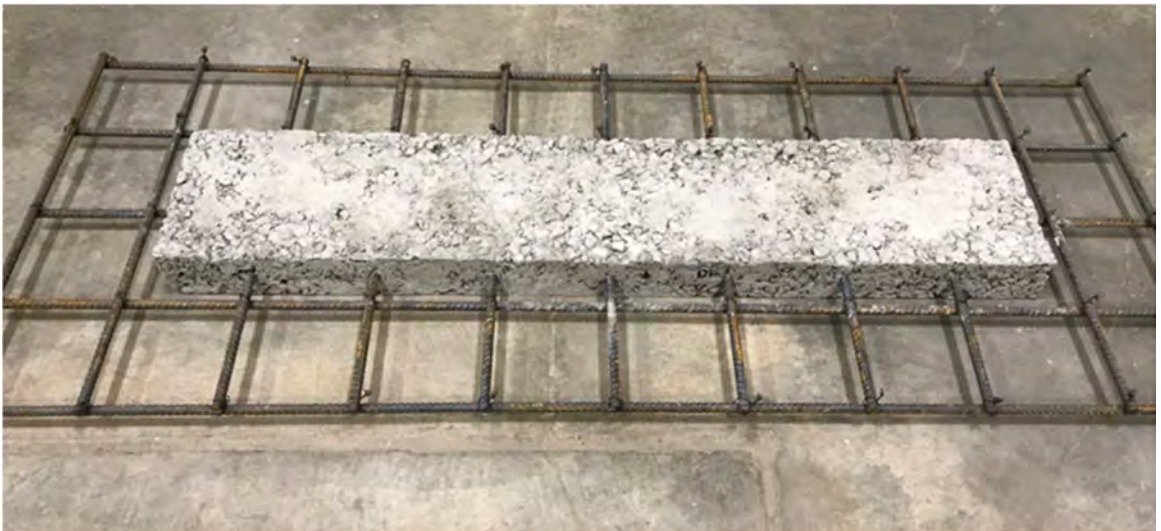
Several different approaches were implemented to simulate deterioration in Specimens DE2–5. Deterioration in Specimen DE2 was simulated by adding a high dosage of air-entraining admixture to the concrete in the miniature slab, increasing its air content. It was hypothesized that a high air content in the miniature slab relative to the surrounding sound concrete would mimic the increased porosity of concrete caused by progressive deterioration. To replicate a more severe state of concrete deterioration, the miniature slab of Specimen DE3 was constructed using concrete with a high degree of honeycombing, as can be observed in Figure 4-6.

Figure 4-6: Miniature Slab for Test Specimen DE3

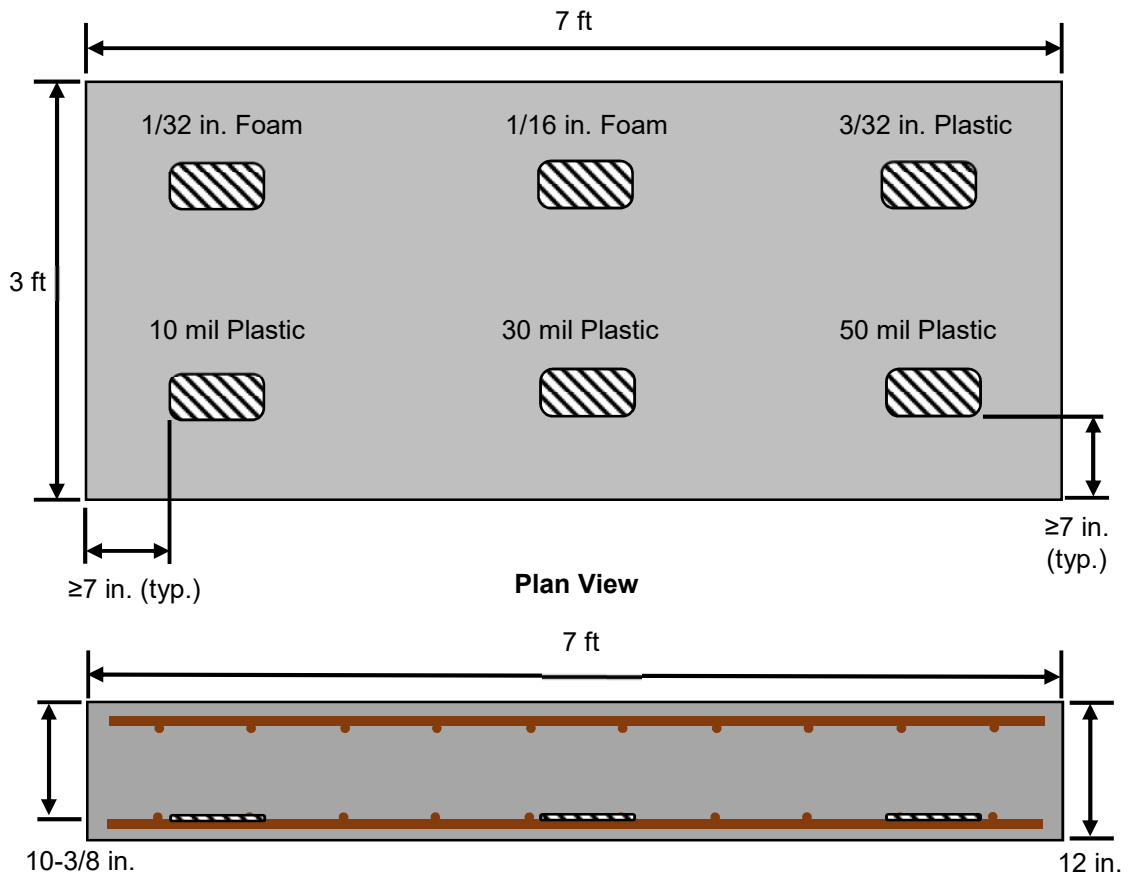
Delaminations placed in Specimen DL2, shown in Figure 4-9, were of the same in-plane dimensions and thicknesses as those from Specimen DL1. The two sets of delaminations differed only in depth; the deep delaminations in Specimen DL2 were placed 10-3/8 in. below the top surface rather than 2-5/8 in.

Figure 4-9: Conceptual Views of Specimen DL2

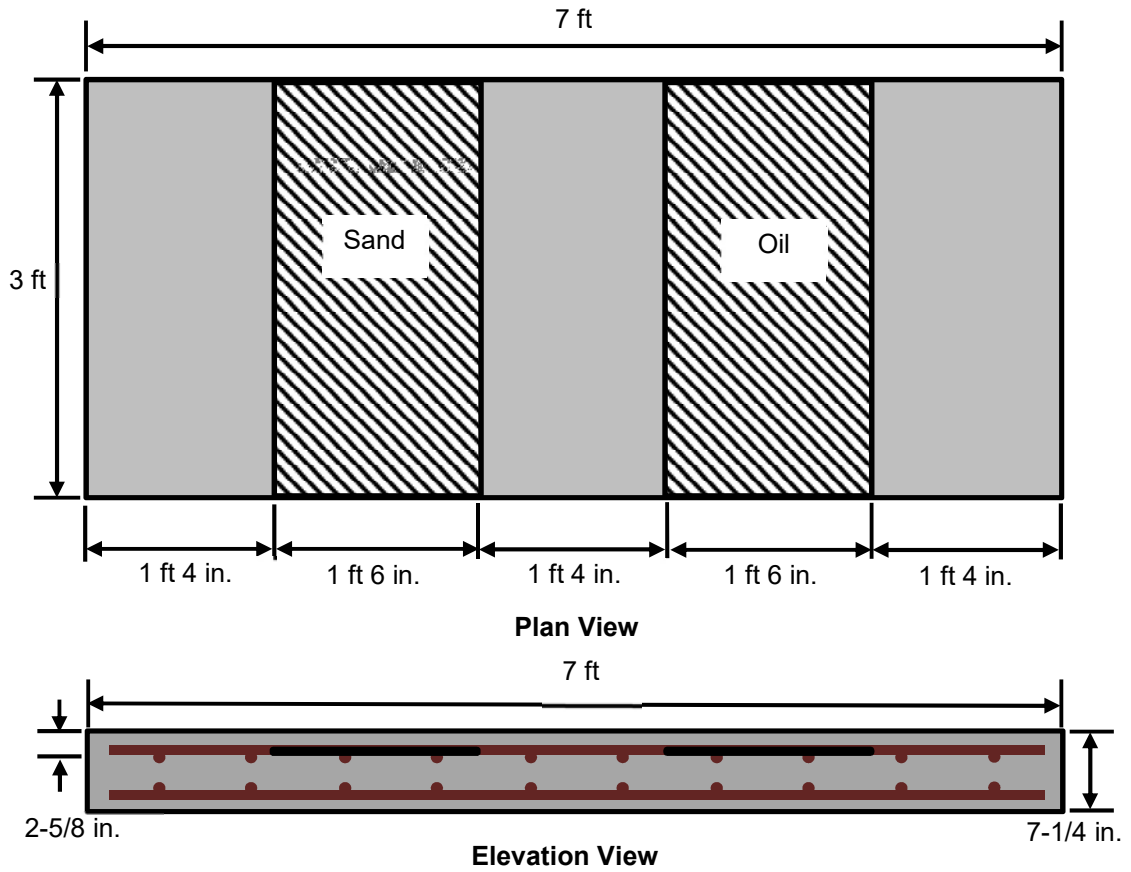
To investigate the capability of the NDT methods to detect real delaminations rather than gaps caused by inserted sheets, Specimens DL3–4 were fabricated. Sand and oil layers were placed within the specimens to cause real delaminations in a manner adapted from Lin and Sansalone (1996). As can be observed in conceptual views of Specimen DL3, shown in Figure 4-10, the sand and oil layers were placed distinctly from one another to allow for an investigation of which delaminating technique was more effective. For both specimens, the 1 ft 6 in. by 3 ft layers of sand and oil were placed at the level of the steel reinforcement to cause large delaminations. The two specimens were identical in all ways except that Specimen DL3 had shallow delaminations in a 7-1/4 in. thick slab while Specimen DL4 had deep delaminations in a 12 in. thick slab.

Figure 4-10: Conceptual Views of Specimen DL3

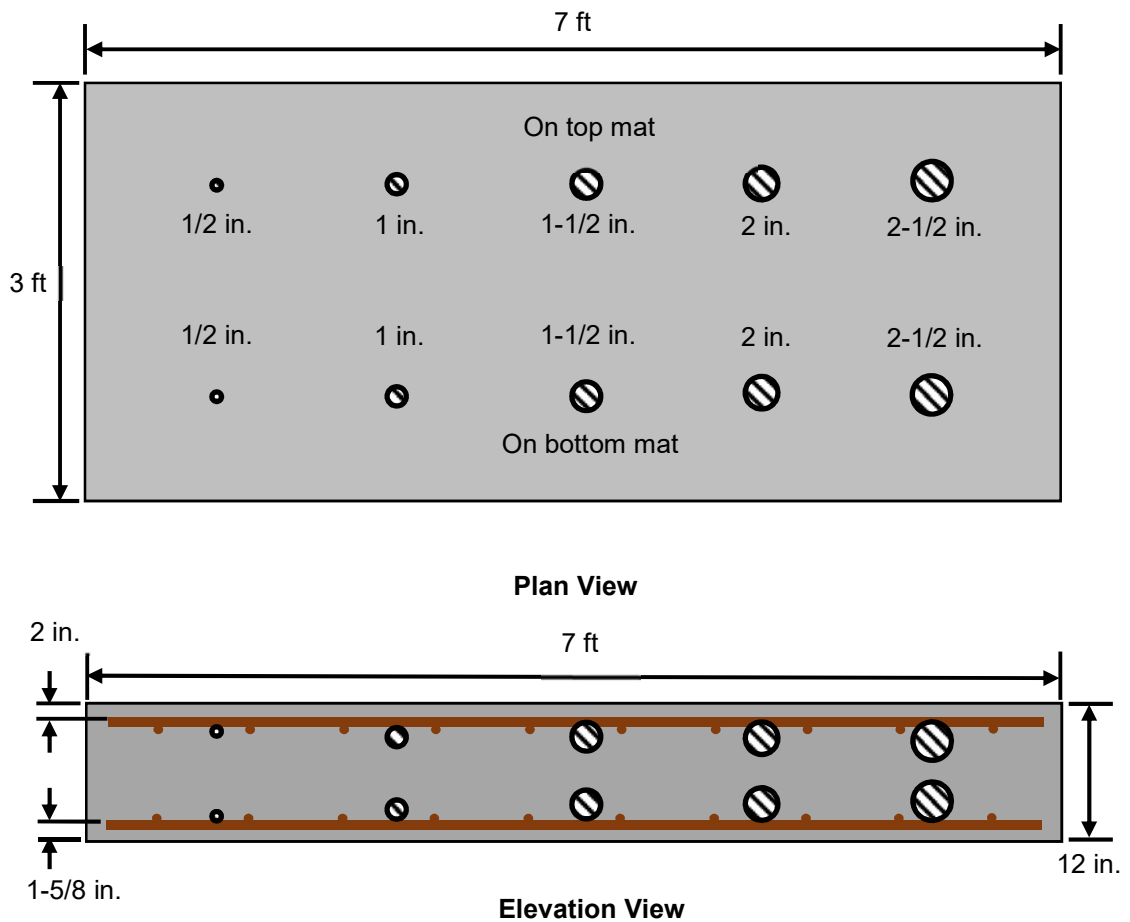
Test Specimens V1 and V2 were fabricated to evaluate the ability of NDT methods to identify voids of varying depth and size in concrete bridge decks, as can be observed in Figure 4-15. Such voids can be the result of poor-construction practices and may be filled with either water or air. Voids in concrete may also be the result of the use of unclean aggregates in concrete mixtures. During mixing, particulates on the aggregates are freed and agglomerate, forming balls of sediment. Such agglomerates can cause voids in concrete if placed in the bridge deck. Accordingly, the void specimens were built to be representative of these types of voids that may be found in a concrete bridge deck. Voids of diameters ranging between 1/2 in. to 2-1/2 in. were simulated in both Specimens V1 and V2, as can be observed in Figure 4-15. Furthermore, voids were placed on both the top and bottom reinforcement mats to explore the influence of depth on void detectability.

Figure 4-15: Conceptual Views of Void Specimens

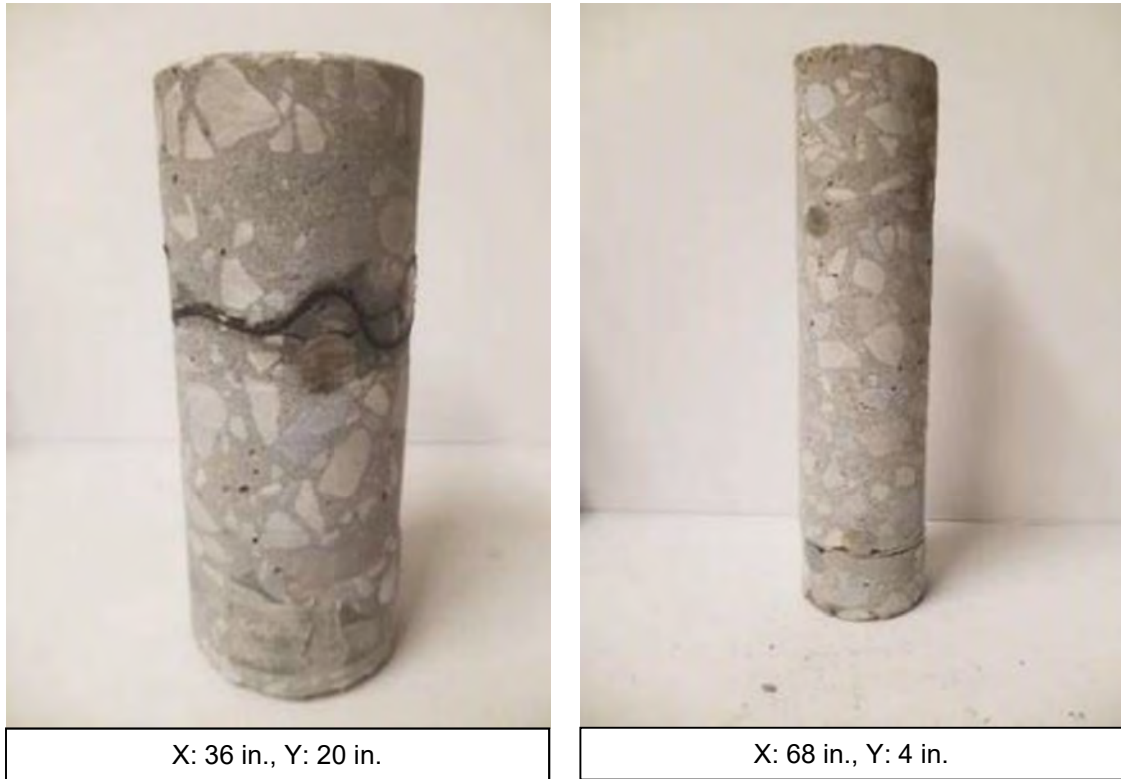
Cores were extracted from the delamination specimens to validate the presence and performance of simulated defects at their intended locations. In Specimens DL1 and DL2, plastic and foam inserts were successful in creating gaps in concrete simulating delaminations, as evidenced in cores from the two specimens shown in Figure 4-31. The shallow, foam insert in Specimen DL1 simulated a delamination while also causing a real delamination to open, spanning between the intersecting reinforcement in the core. Additionally, the deep, plastic insert in Specimen DL2 caused the concrete above and below the insert to split apart, as a real delamination would cause after core extraction.

Figure 4-31: Specimen DL1 Shallow Delamination (Left) and Specimen DL2 Deep Delamination (Right)

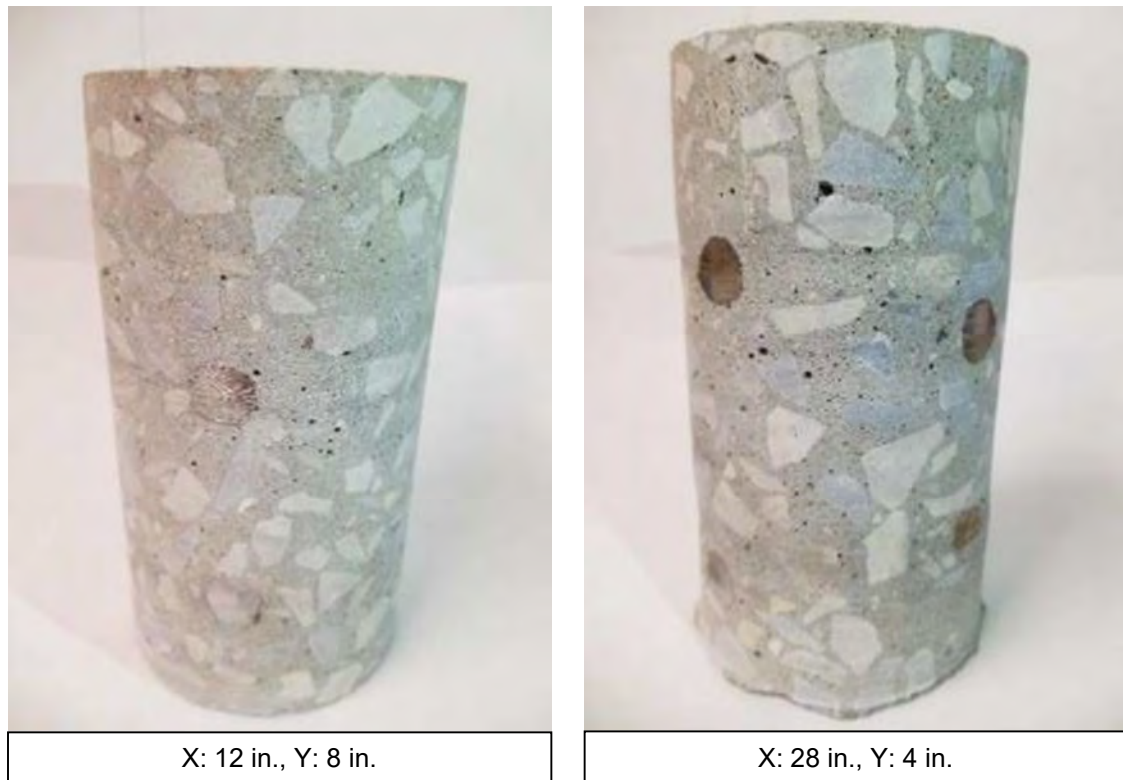
Figure 4-32: Poor Delamination Simulation using Sand Layer in Specimen DL3

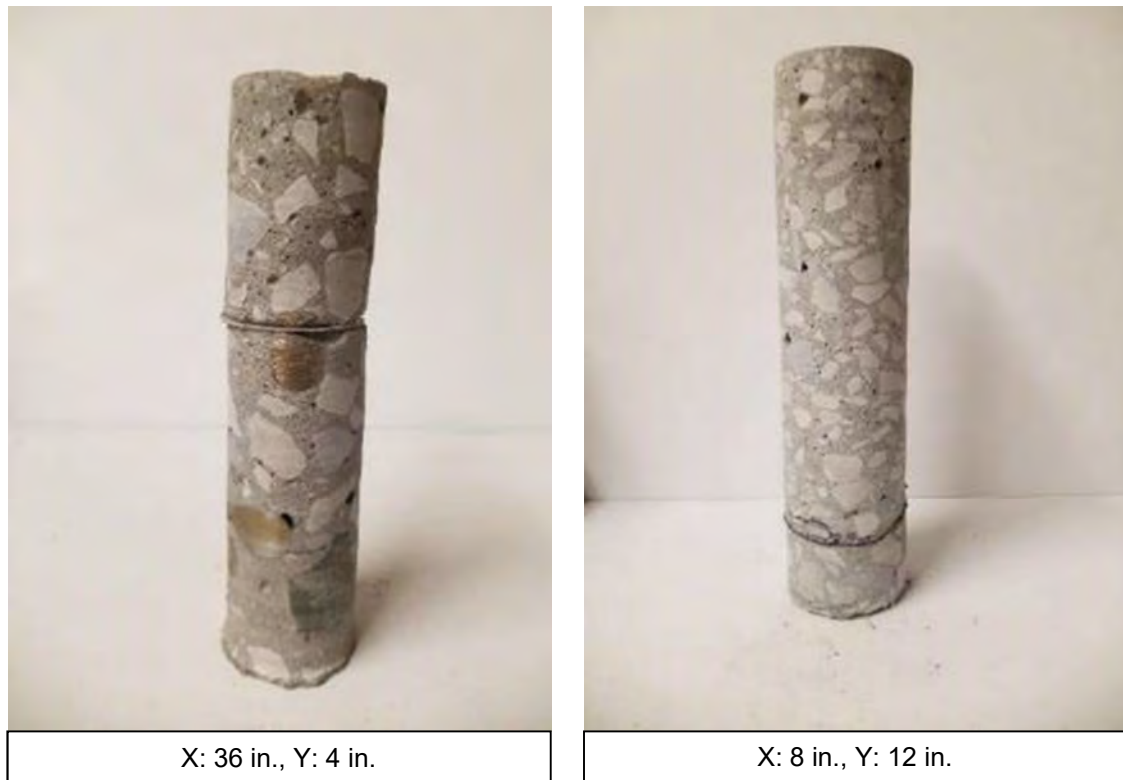
Figure 4-36: Specimen DL5 Shallow Delamination (Left) and Specimen DL6 (Deep Delamination (Right)

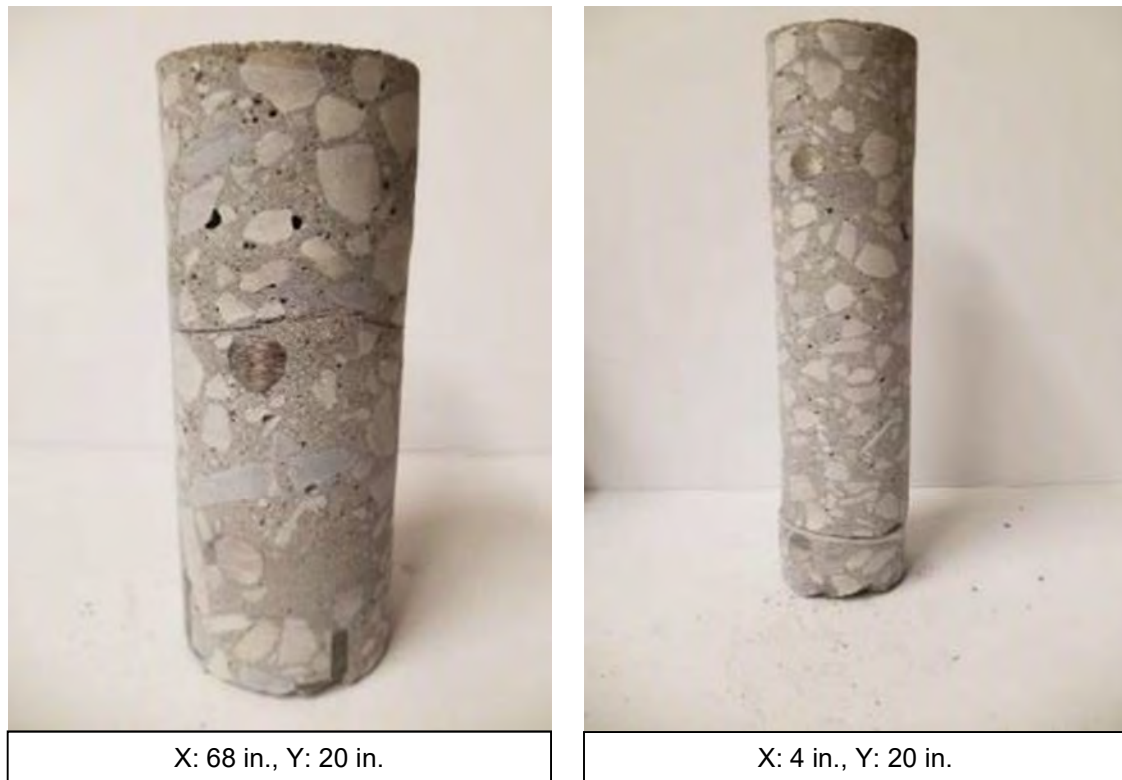
Figure 4-37: Partially bonded Delaminations in Specimens DL7 (Left) and DL8 (Right)

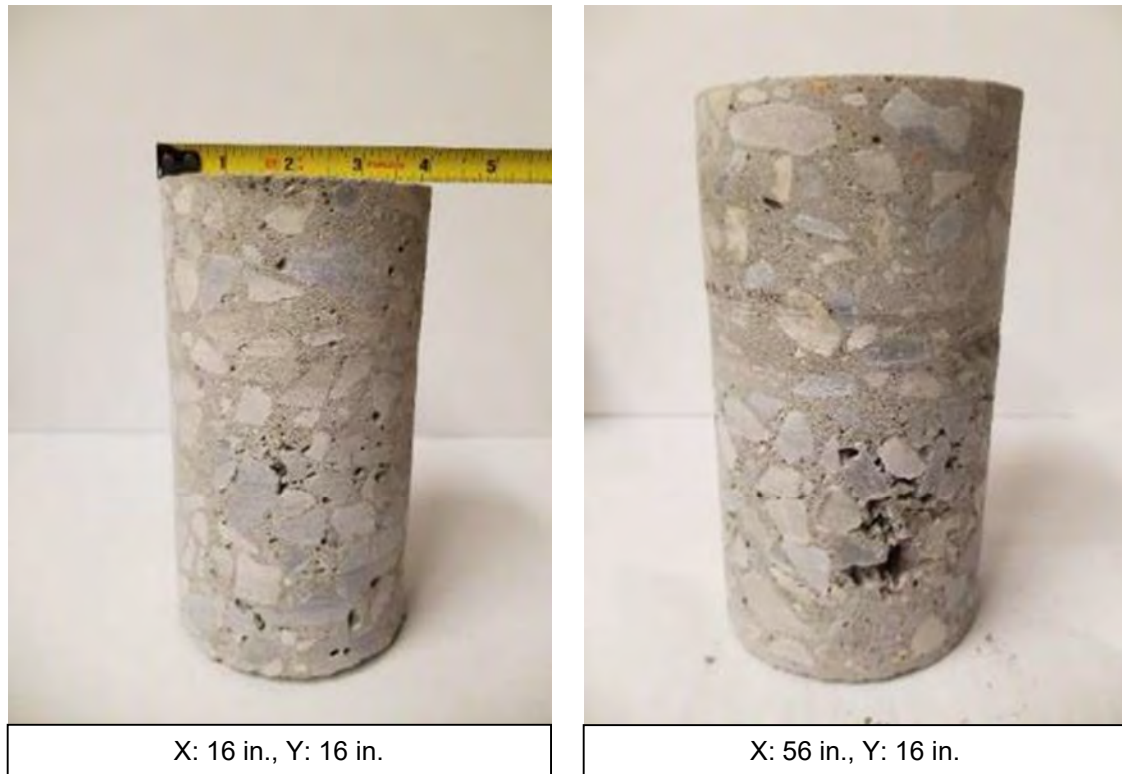
Figure 4-40: Honeycombing in Miniature Slab Concrete of Specimen DE3

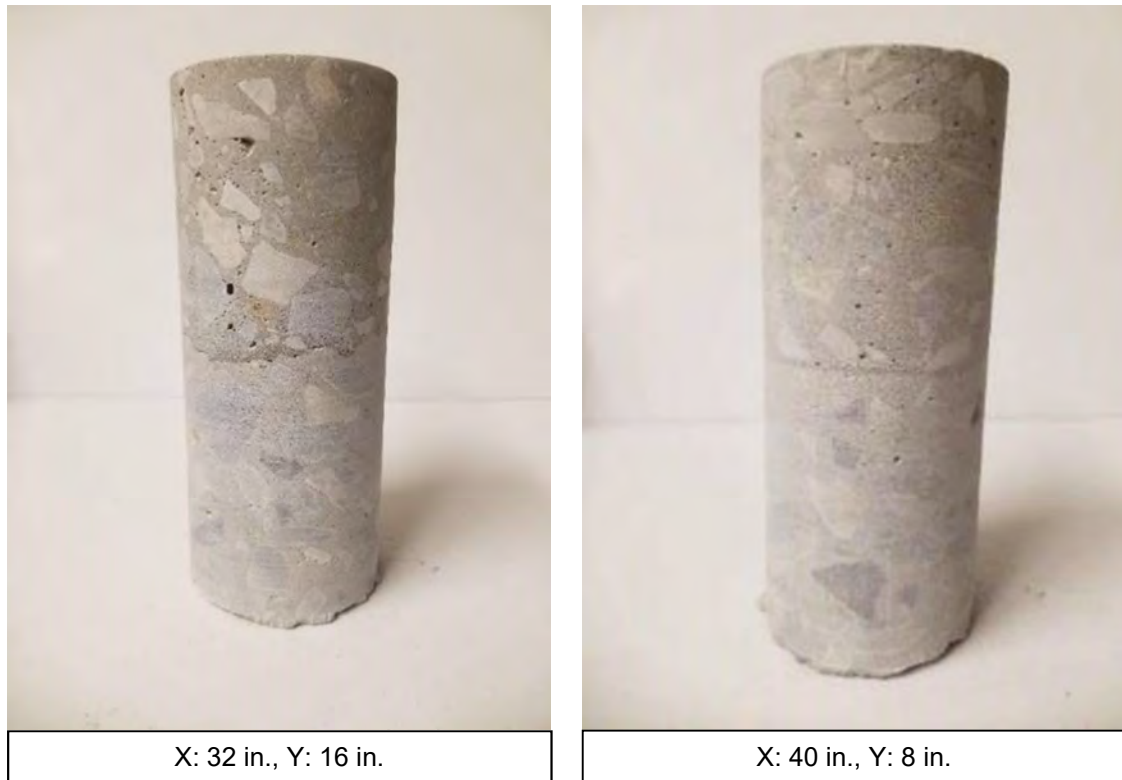
Figure 4-43: Well-Consolidated Cores from Specimen PC1

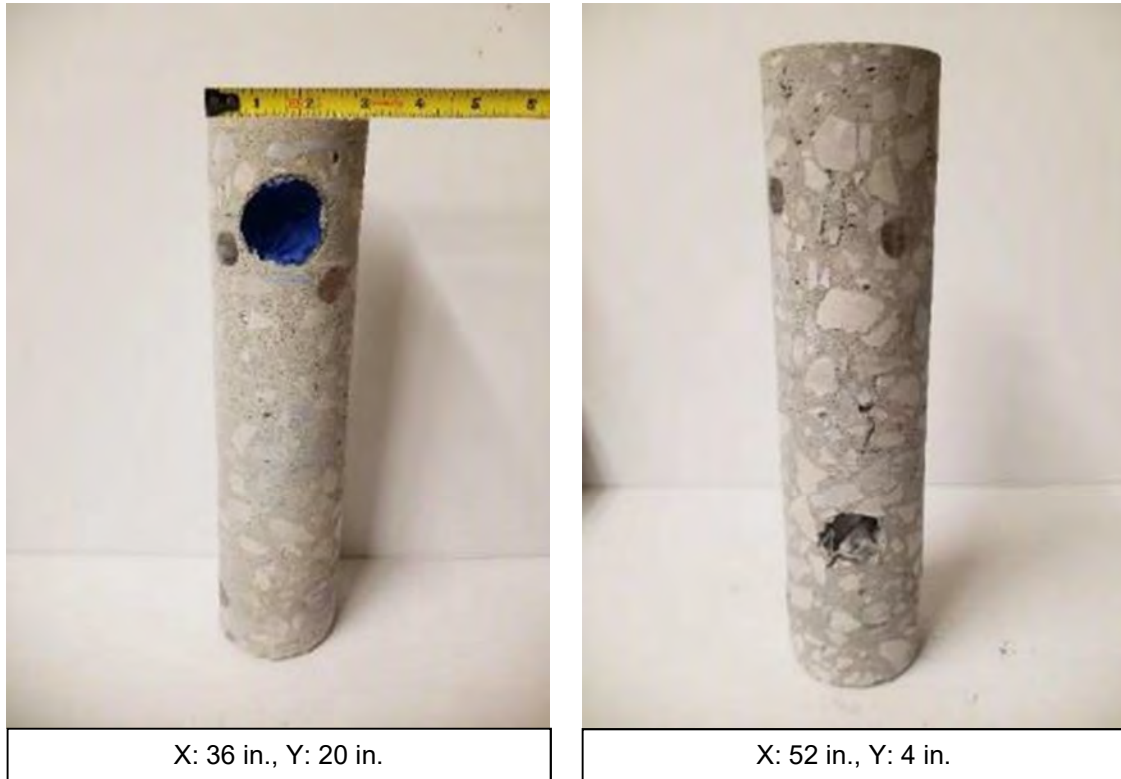
Figure 4-45: Floated Void in Specimen V1 (Left) and Deep Void in V2 (Right)

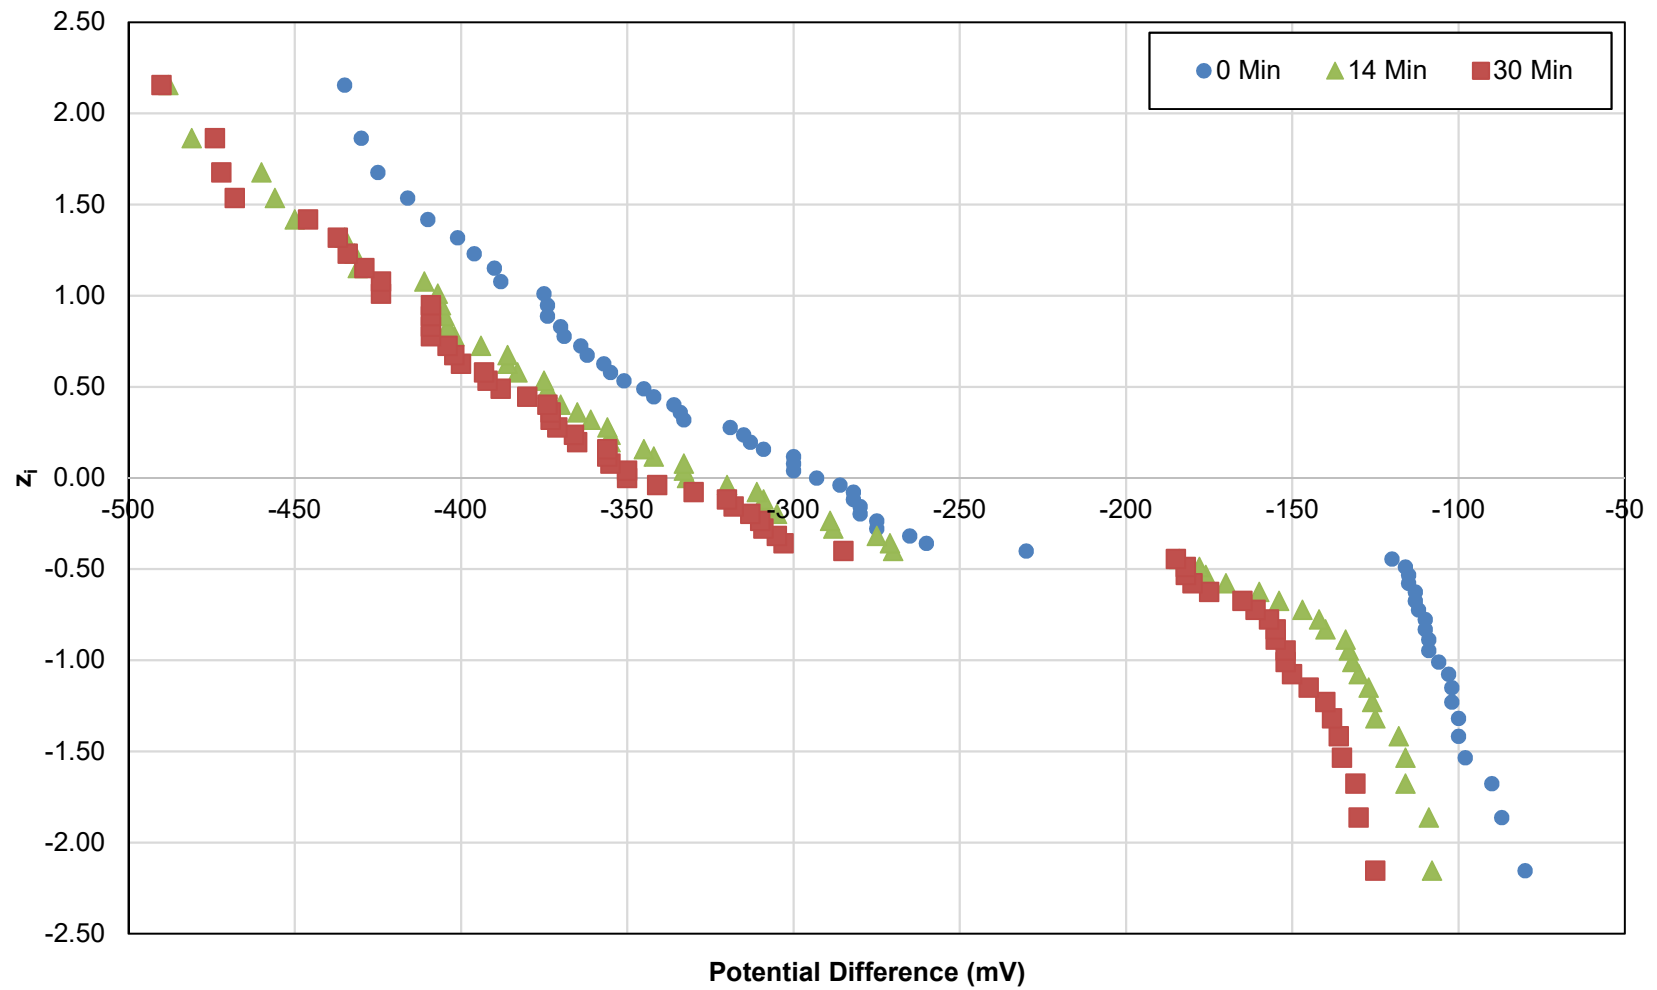
Figure 4-105: Air-dried HCP Measurements for Specimen C2 after Various Pre-moistening Durations

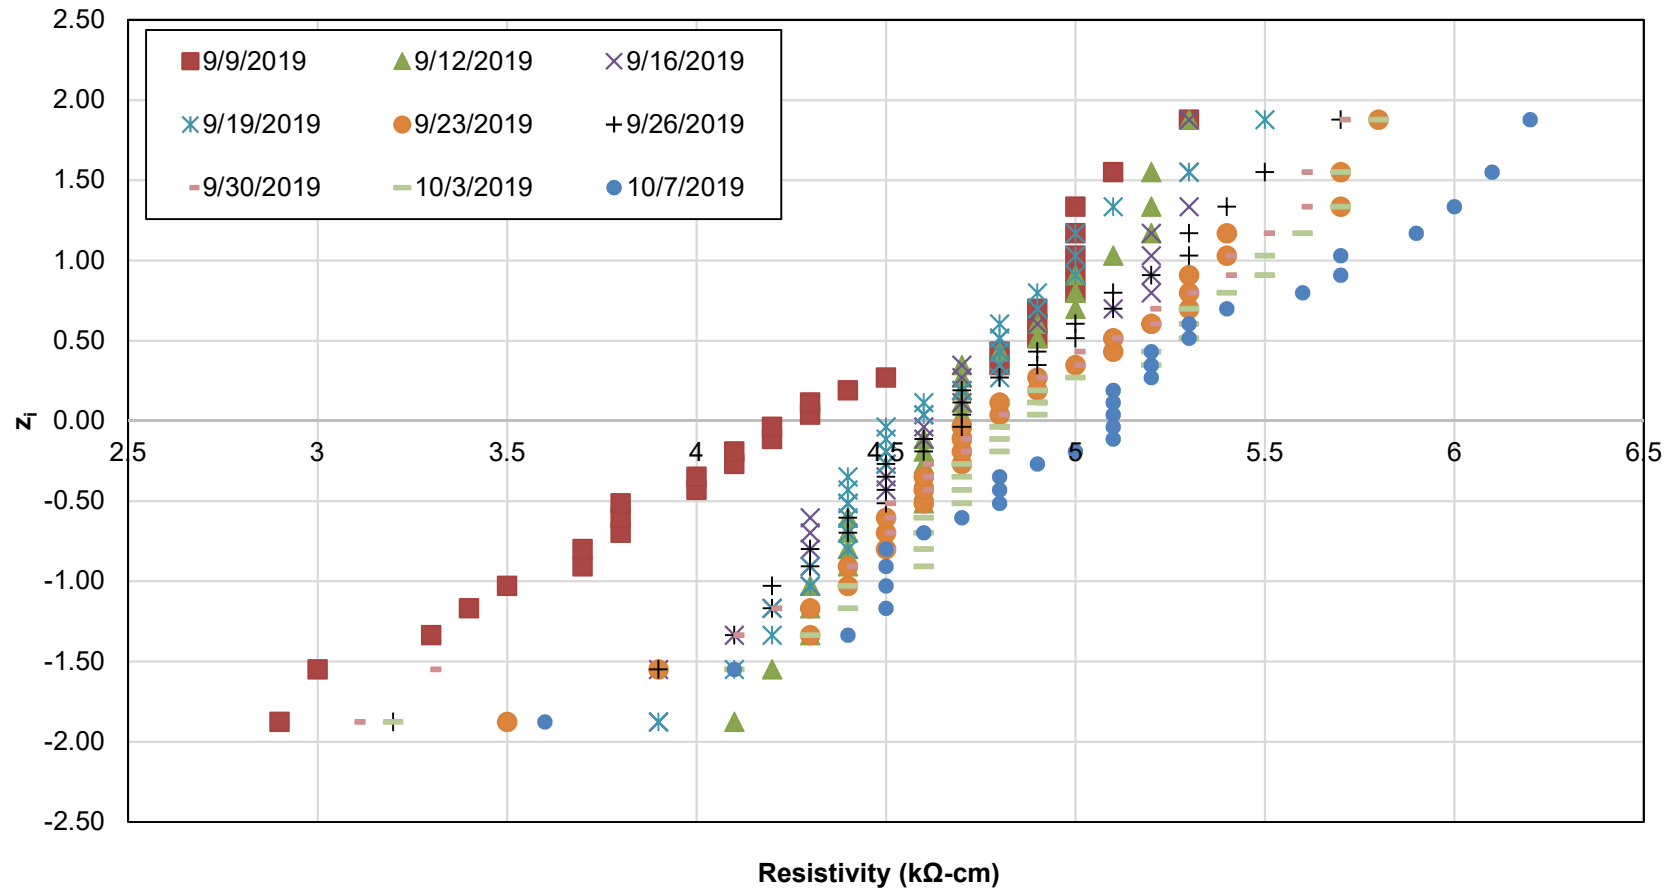
Figure 4-110: Transformed Cumulative Probability Distributions of Specimen C2 Resistivity Measurements during Accelerated Corrosion

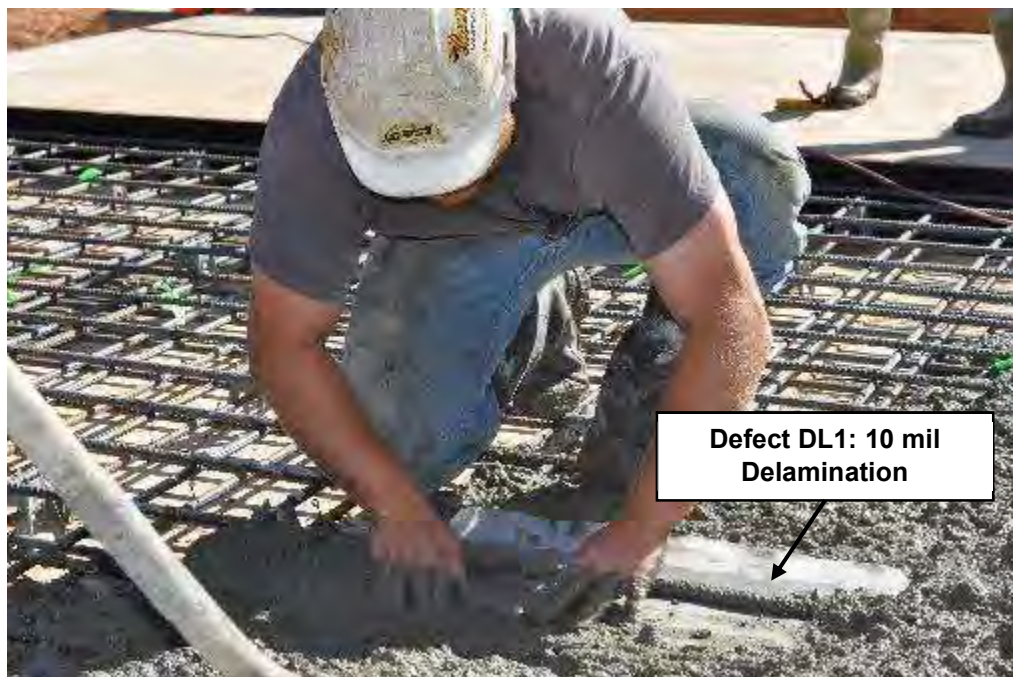
Figure 5-5: Plastic Sheetting Delamination Simulation in Test Bridge

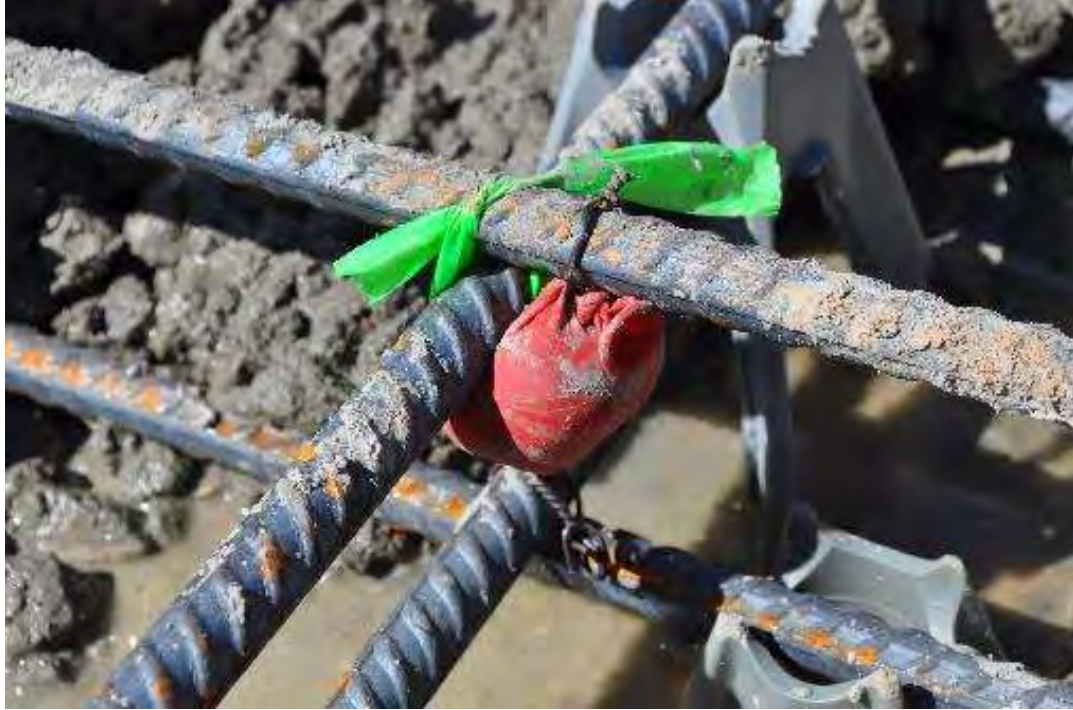
Figure 5-8: Shallow Void Simulation in Defect V1
