Research Report

**EXPERIMENTAL TESTING AND DESIGN
EVALUATION OF PRECAST THREE SIDED
ARCH BRIDGES**

Foley Products

JULY 2012

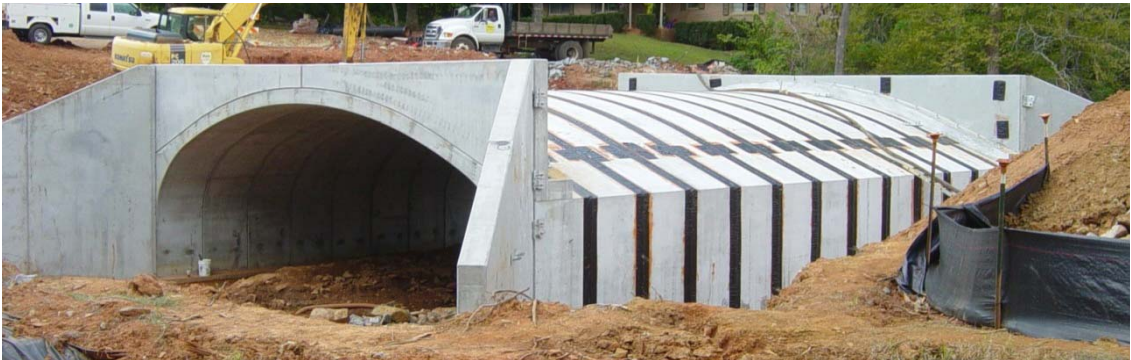
A 42 ft span bridge constructed in Midland, North Carolina was used for a field test of the Foley precast arch culvert bridge system. The bridge consisted of 13 units placed side-by-side, spanning over Wiley Branch Creek on Cabarrus Station Road. Each unit was 42 ft long clear span, four feet wide, and has a 14ft inside clear height at midspan. An image of the bridge structure prior to placement of backfill can be seen in Figure 2-1. Backfill was placed and compacted along the sides and top of the bridge up to a total of approximately two feet of cover over the midspan prior to live load testing. Figure 2-2 is an image of unit overall dimensions taken from the design drawings.

Figure 2-1 42 ft Bridge Structure

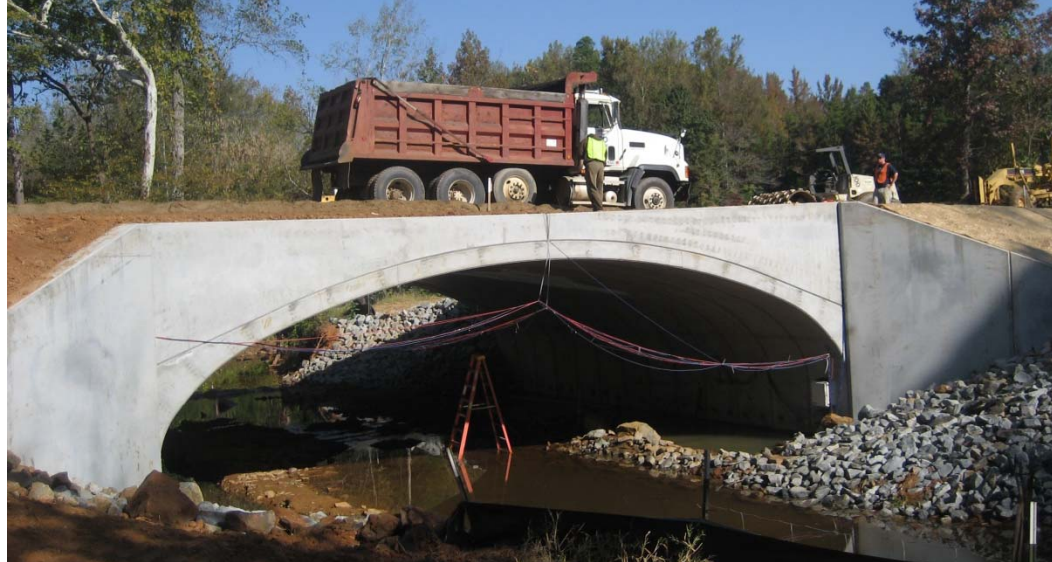
On September 19, 2010, a live load test using a full dump truck was performed. The strategy was to have the truck, which had a gross vehicle weight of 56,820 lbs, drive over the bridge, stopping at set intervals long enough for the data acquisition system to take several measurements, and then proceeding along the bridge. At each stop, the location of either the front axle or the centerline of the two rear axles was measured. The truck made a total of three passes over the bridge, two heading toward the northeastern side and one heading toward the southwestern side. For the first and third run, traveling toward the northeastern side, the truck was aligned along the roadway such that the outside wheels ran over the highly-instrumented unit. For the second run, traveling toward the southwestern side, the truck was aligned such that the outside wheels were four feet over from the highly-instrumented unit. Figure 2-6 shows an image of the live load testing.

Figure 2-6 Live Load Testing

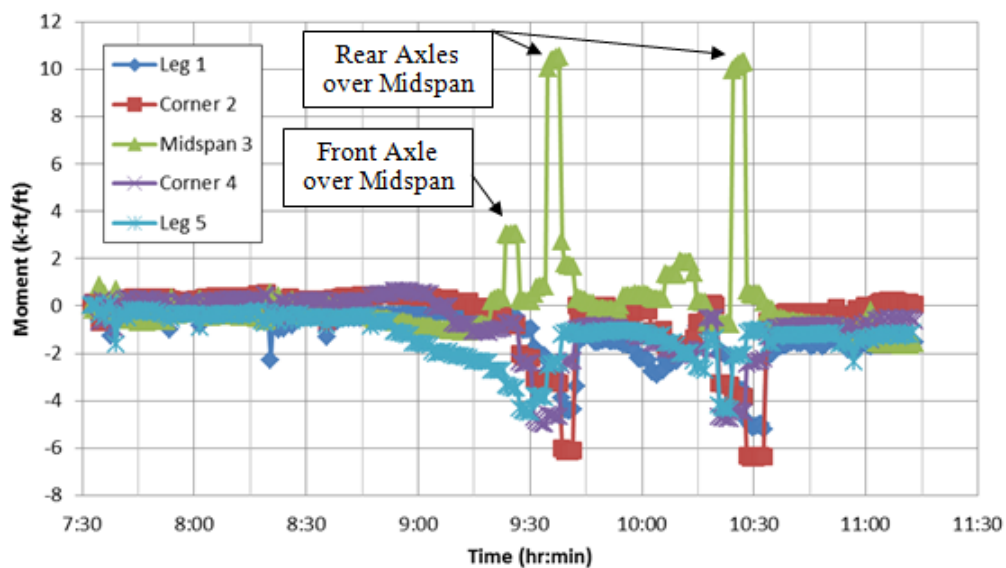
Figure 2-8 shows the development of moment versus time in the highly-instrumented unit, where the effect of the truck load was most pronounced. Figure 2-9 shows the development of moment versus the position of the centerline between the two rear axles for the first run.

Figure 2-8 Moments due to Live Load Only Versus Time

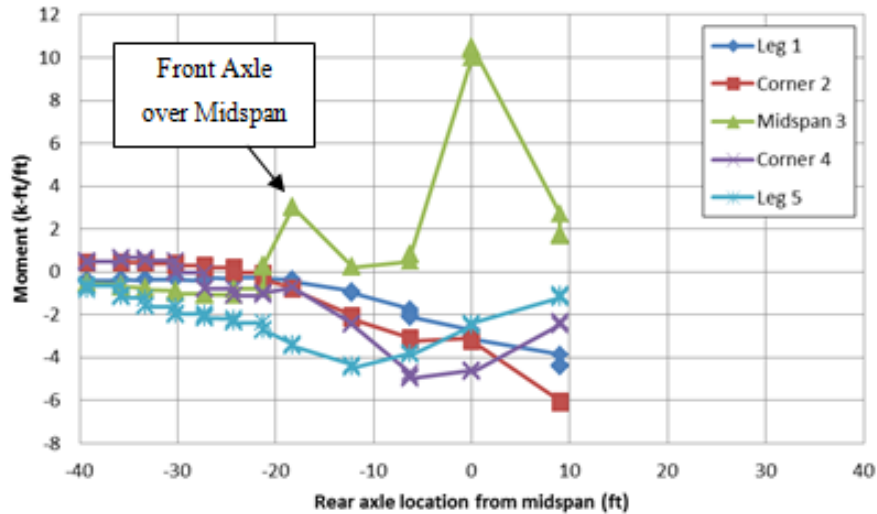
Figure 2-9 Live Load Moment Versus Rear Axle Location - Run 1

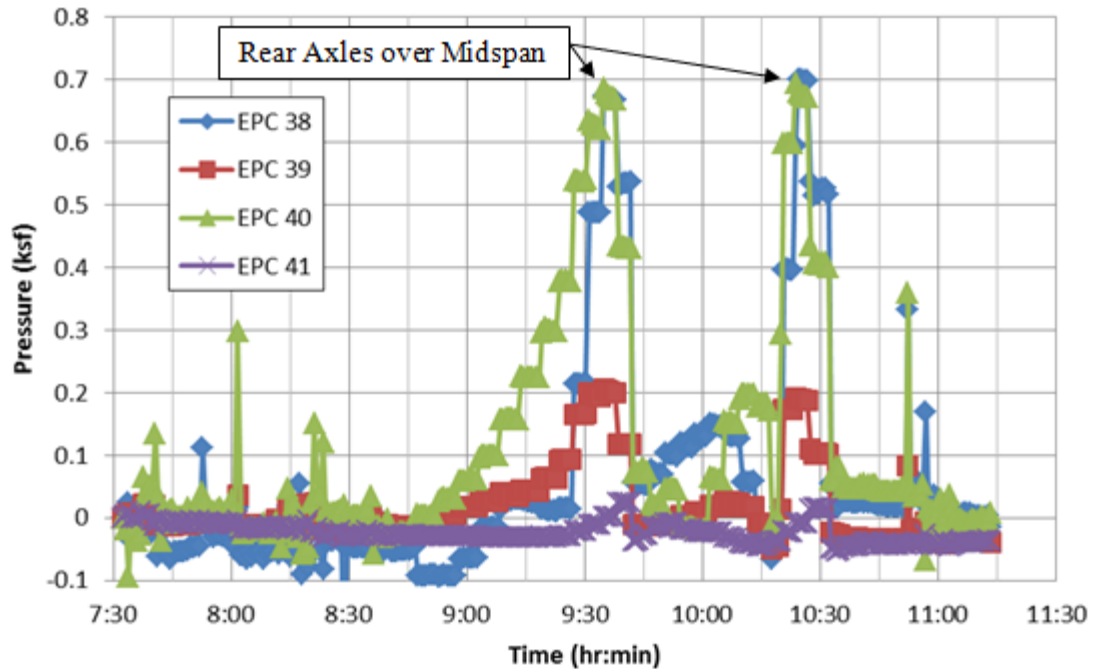
Lateral earth pressures on the external walls developed as anticipated when the truck load was applied to the bridge. As the truck load thrust the arch outward, larger lateral earth pressures were measured at the top of the wall, while very small pressures were measured at the bottom of the wall, indicating a “pinned” support condition, as opposed to a “roller” support condition. Figure 2-10 shows how the earth pressures developed versus time during the live load test in each EPC. Figure 2-11 shows the development of earth pressures versus the position of the centerline between the two rear axles for each of the three test runs. This graph provides a better illustration of the effect of the truck load as it passes over the bridge.

Figure 2-10 Lateral Earth Pressure due to Live Load Only Versus Time

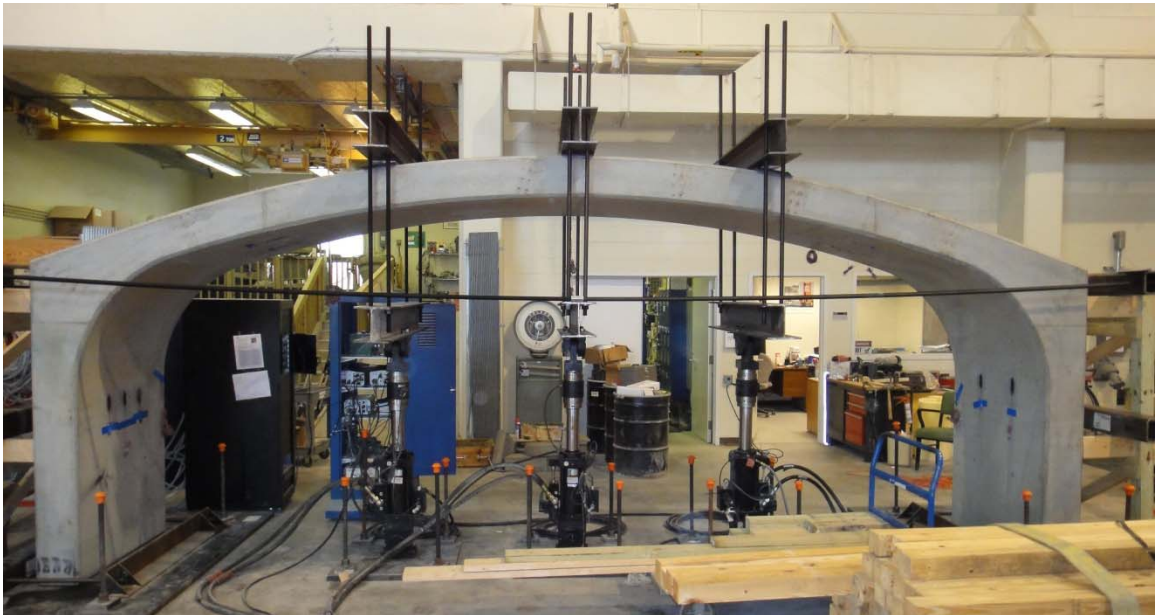
The load frame designed for this project consisted of three actuators pulling down on the bridge unit from underneath. The frames with the three actuators can be seen in Figure 3-4. The actuators were each tied to a beam which then framed up to another beam, which was bearing on the top of the bridge. Based on the layout of anchor points in the strong floor, the three actuators were spaced at four foot intervals, with the middle actuator located at midspan of the bridge unit.

Figure 3-4 Actuator Loading Frames

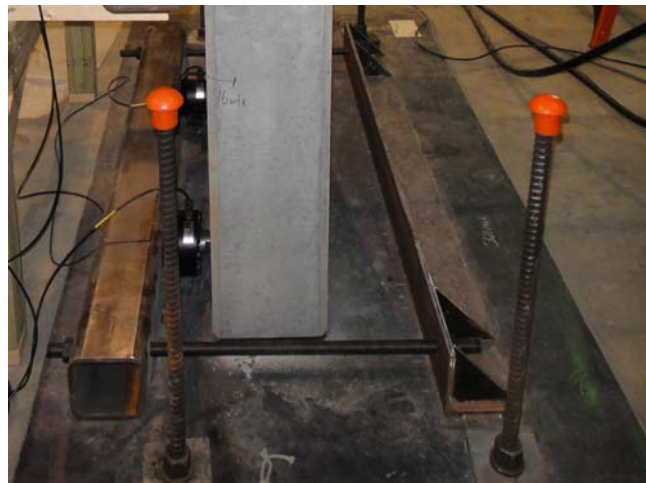
The base plates, seen in Figure 3-5, provided both the vertical and horizontal reaction forces. The horizontal restraint of the bottom of the leg was provided to simulate field conditions, in which the bridge units are placed into keyed footings.

Figure 3-5 Bridge Base Plate

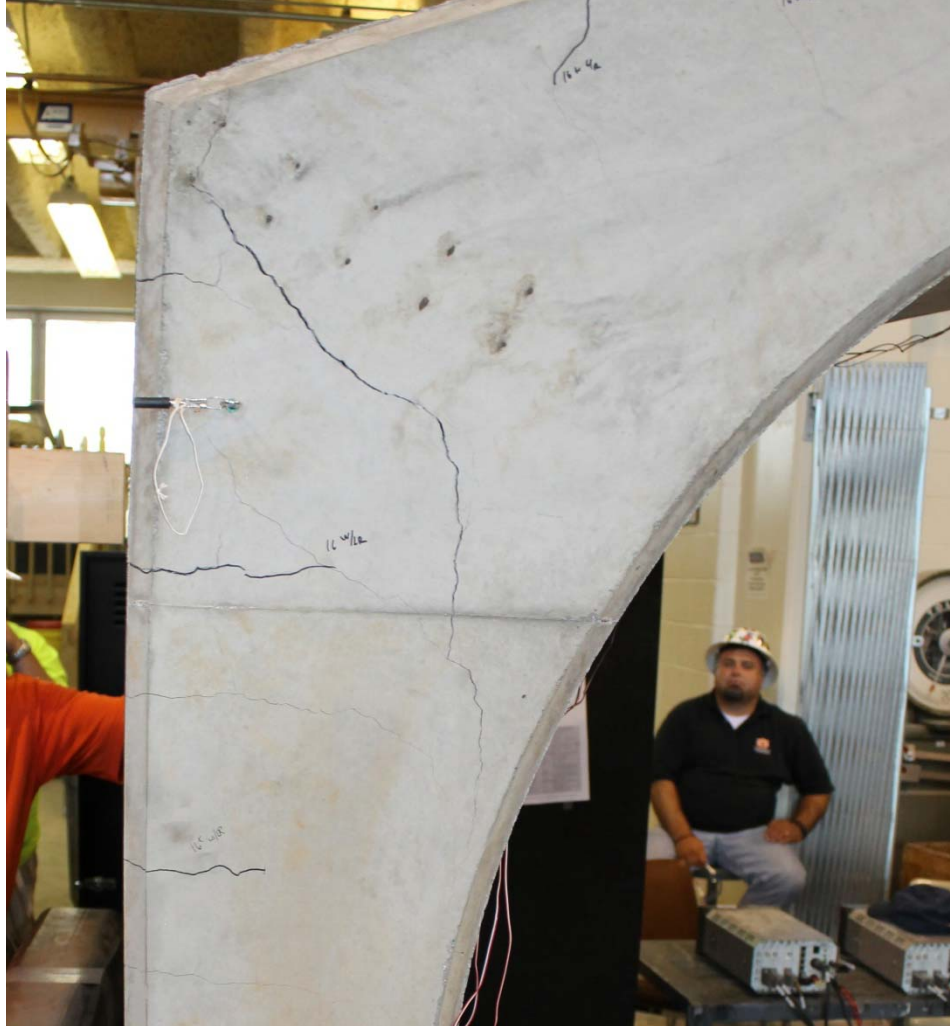
The first significant crack occurred at a total load of 120 kips. This crack ran straight through the corner of the bridge at its thickest point. The crack continued through the corner, beginning to run down the leg with the reinforcement. Figure 3-10 is an image of the crack propagating and widening at a total load of 156 kips. A similar crack opened up in the opposite corner as well.

Figure 3-10 Corner Crack at 156 kips Total Load

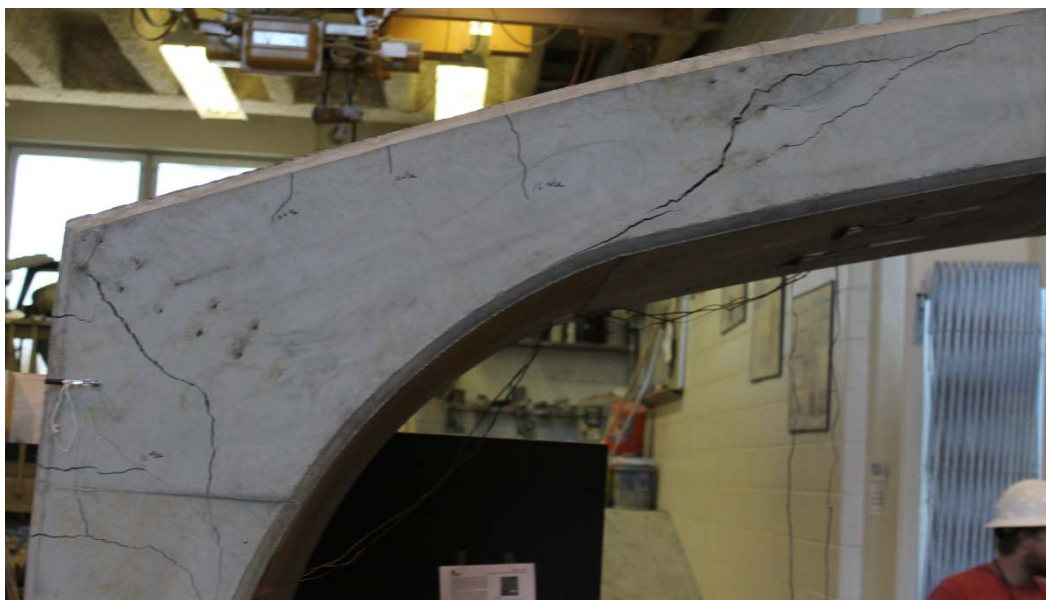
Figure 3-12 Corner Crack Immediately Prior to Failure

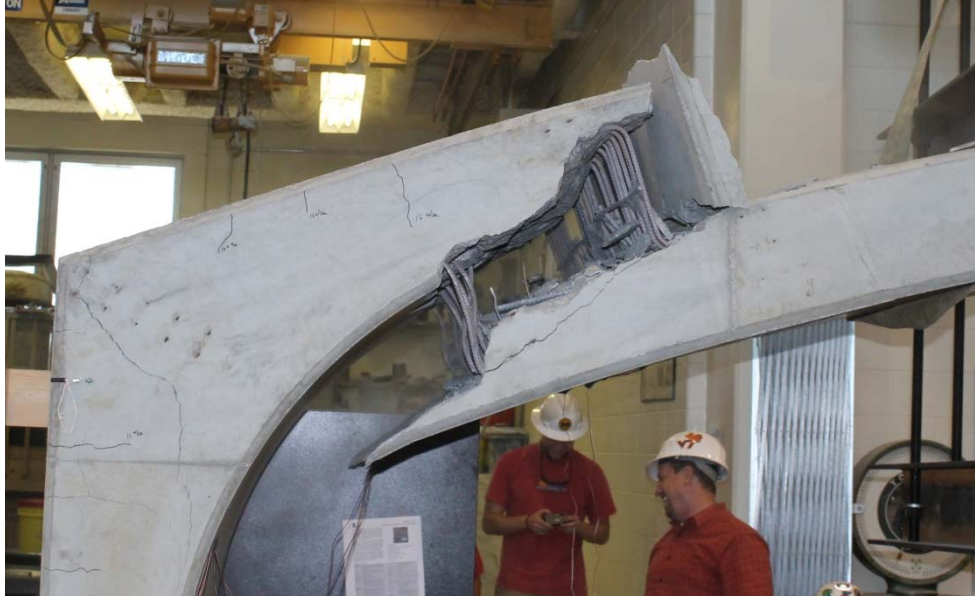
Figure 3-13 Failure Mechanism

The 20 ft span failed under a total applied load of 182.1 kips. The failure mechanism was a shear crack near the corner on the arch itself. The shear crack opened up on the side of the bridge containing cross sections four and five, wirepots three and five, and load cells three and four. The load configuration is shown in Figure 3-14. A picture of the failed structure is shown in Figure 3-15.

The shear failure mechanism of the bridge was unexpected. A general flexural failure caused by flexural hinges forming near the corners and at midspan was considered more likely. However, due to the stiffness of the concrete and large amounts of reinforcement steel, especially at midspan, steel did not significantly yield, causing a different failure mechanism.

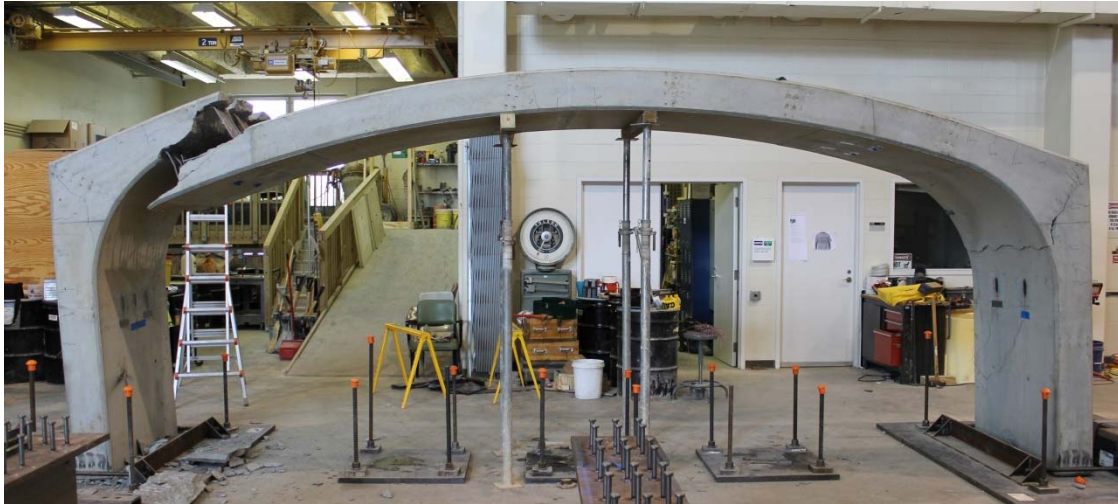
The failure mechanism was not ductile and developed quickly. The bridge failed rapidly and could not carry its own dead weight after failure. While flexural cracks did develop in the walls, corners, and midspan of the bridge, none of them opened up very much after forming, due to the bridge redistributing the load to stiffer sections. Overall, the flexural stiffness of this shorter span bridge forced the bridge to be controlled by shear strength of the concrete. The relatively thin section, containing no shear reinforcement, was not large enough to resist the large shear forces developed during the test.

Figure 3-15 Failed Bridge Section

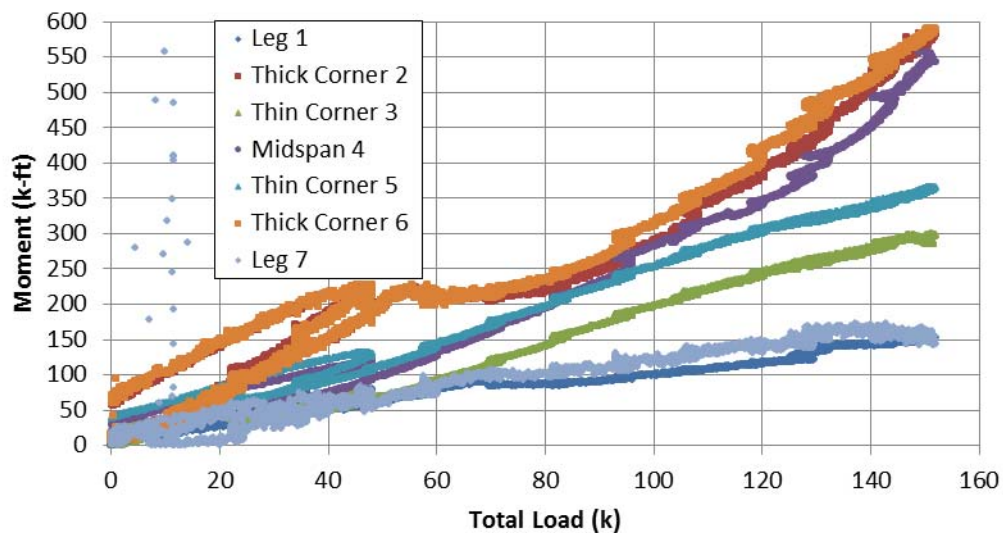
Moments in the seven cross sections during the ultimate load test are shown in Figure 4-6. Moments in cross sections two and six are the highest due to the thicker, stiffer cross section within the corner of the bridge. Note that the sign associated with the moment is relative to the position of the concrete and sister bar strain gages. Therefore a positive sign means that the moment is such that tension is in the sister bars and compression is in the concrete surface gages. Also note that, due to the preliminary loading portion of the test, there are loading, unloading, and reloading portions of the graph. The unloading curve for each cross section does not return to zero, indicating that there is permanent strain deformation, which is expected. After load is removed, the fictitious moment caused by the permanent strain is subtracted out before beginning the reloading portion of the graph.

Figure 4-6 Moment Versus Load

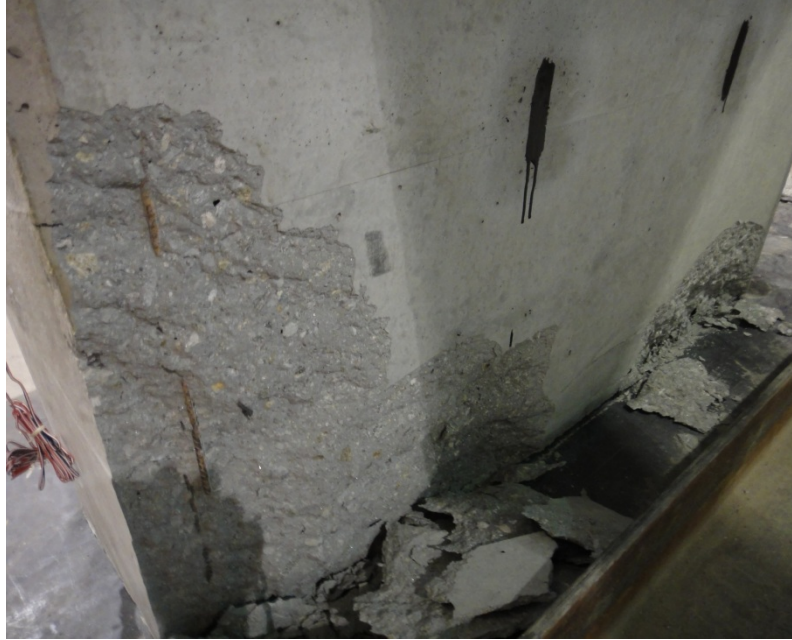
Due to issues shipping and handling the much larger and less stiff 36 ft span bridge unit, some cracking and spalling of the bridge occurred before testing. During the process of getting the bridge into the lab and onto the baseplates, initial flexural cracks formed at midspan and near the corners, but were still small prior to testing. More significantly, the bridge legs were placed on the baseplates such that they were not completely vertical, but slightly angled outward. This misalignment caused some spalling on the inside of the leg prior to testing, as can be seen in Figure 4-9. This misalignment also caused further spalling to occur during the test as more weight was placed on the bridge. The spalling and initial cracking did not affect the ultimate strength of the bridge, however.

Figure 4-9 Initial Spalling on Bridge Leg

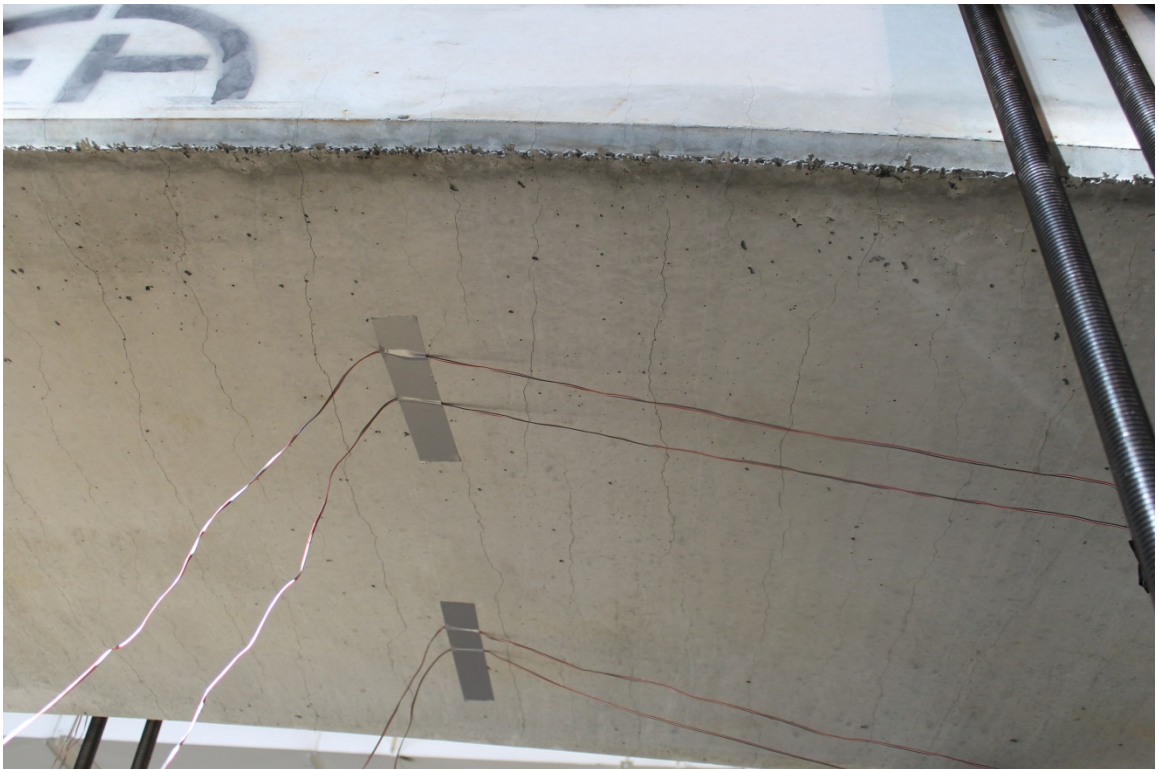
The first significant cracks occurred at midspan, followed by cracks developing near the corners. Several cracks formed near midspan, approximately spaced evenly at six inches. These cracks propagated up through the thickness of the bridge well past midheight before failure. An image illustrating the even spacing of the cracks near midspan is included as Figure 4-10. The cracks near the corners were also approximately evenly spaced at six inches. These cracks widened and extended until failure, indicating some yielding of the steel reinforcement.

Figure 4-10 Midspan Cracking – 120 kips Total Load

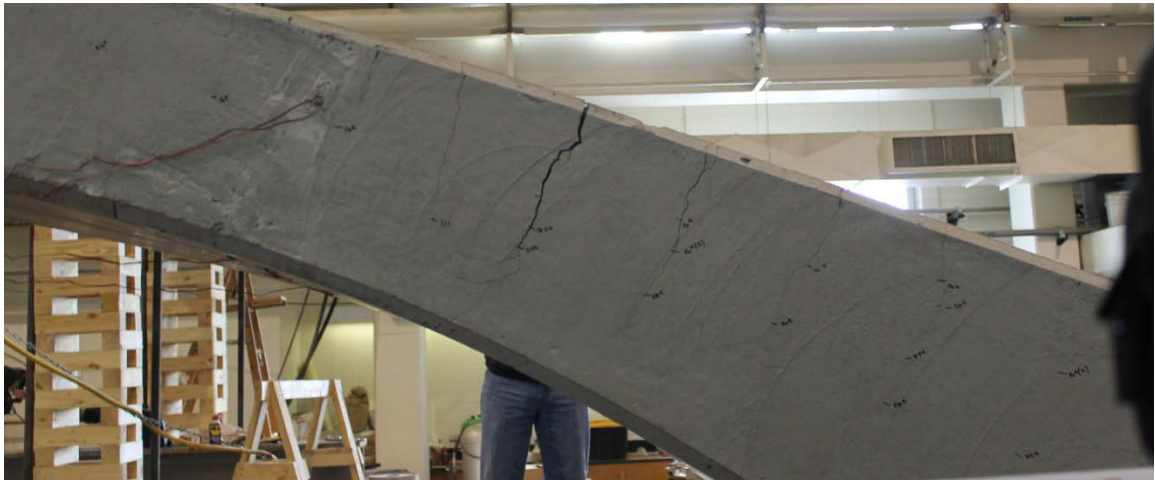
The 36 ft span failed under a total applied load of 151.9 kips. The failure mechanism was flexural in nature, with a crack near the corner of the arch widening until the tension steel

Figure 4-11 Bridge Cracking Immediately Prior to Failure

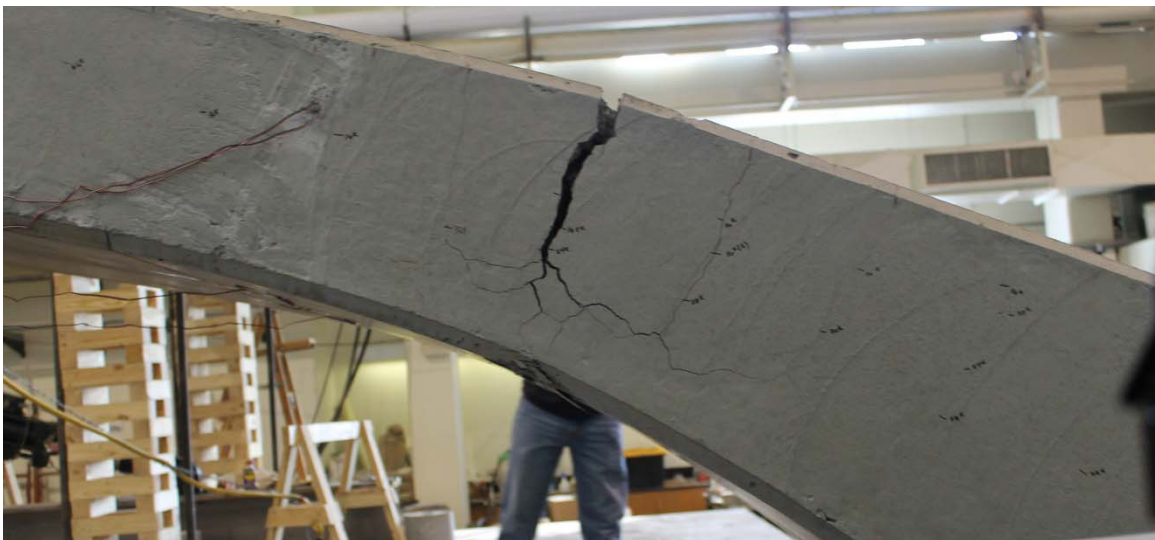
ruptured, which quickly caused the concrete to crush in compression. The remaining uncrushed concrete and compression steel allowed the bridge to continue carrying some load, but rupture of the tension steel meant that further loading of the bridge would be futile. An image of the failure mechanism immediately before and after failure can be seen in Figures 4-11 and 4-12, respectively. The failure occurs between cross sections five and six, on the side of the bridge with wirepot three and load cells three and four. The ultimate load configuration can be seen in Figure 4-13.

Figure 4-12 Bridge Section Immediately After Failure

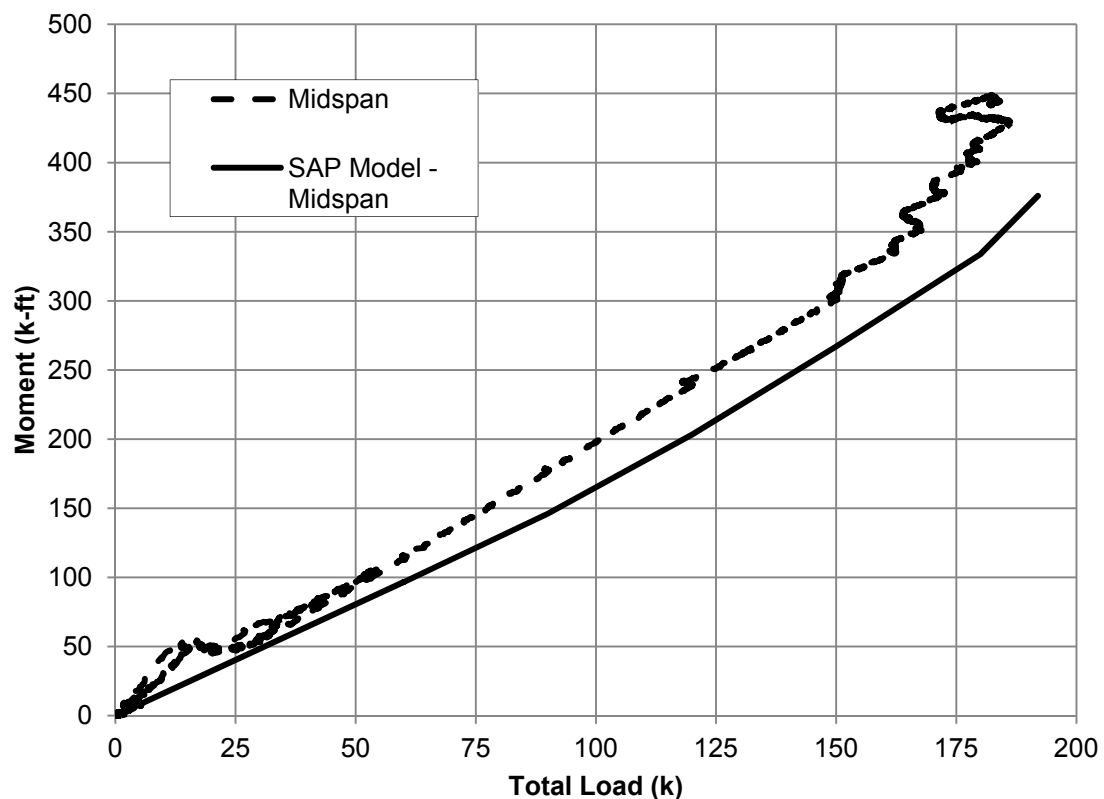
The midspan moment versus total load plot for the 20 ft clear span SAP2000 model has less than 20 percent difference than the laboratory throughout the range of loading. The SAP2000 model midspan moment was slightly lower than the 20 ft clear span laboratory test midspan moment throughout the range of testing.

Figure 5-5 Model Versus Laboratory Specimen – 20 ft Span Midspan Moment
