Project Report
For
Water Resources Research Institute Program
Under
Section 104, Water Resources Research Act of 1984
To the
Alabama Water Resources Research Institute

APPLICATION OF CELLULAR CONFINEMENT SYSTEMS TO MITIGATE SEDIMENT-
RELATED ISSUES IN STORMWATER SYSTEMS

August 30th, 2019

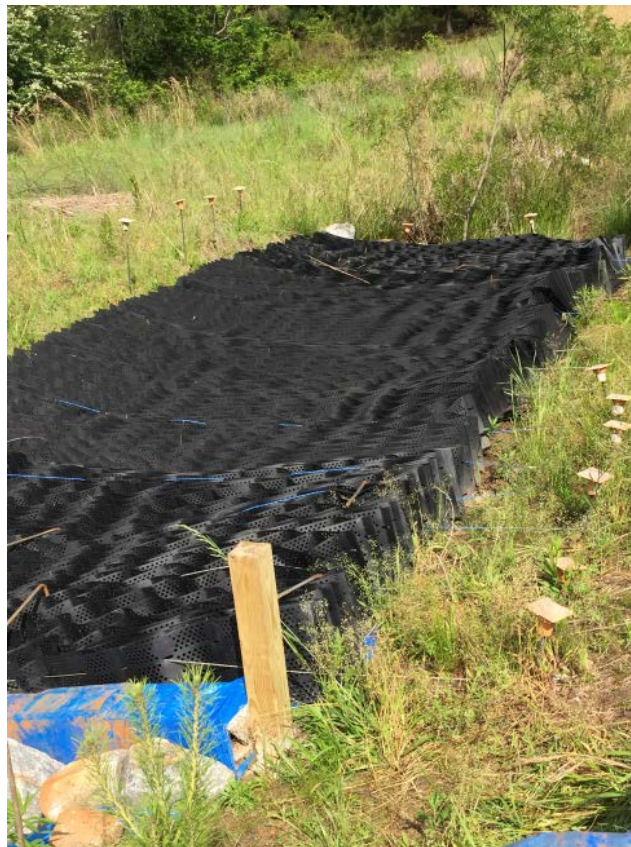
Figure 3 – Photograph of the experimental apparatus, looking toward the upstream end.

Over time, minor modifications were introduced in the apparatus to have it better attached to the surface of the ditch. The CCS cells are constructed with high density polyethylene (HDPE), which is slightly less dense than water (SG=0.93-0.97). Thus cables were used to anchor it across the width of the cells at various places and reinforcing bars were bent helped to anchor the CCS into the bottom of the ditch, as shown in Figure 3. These all ensured the stability of the CCS deployment.

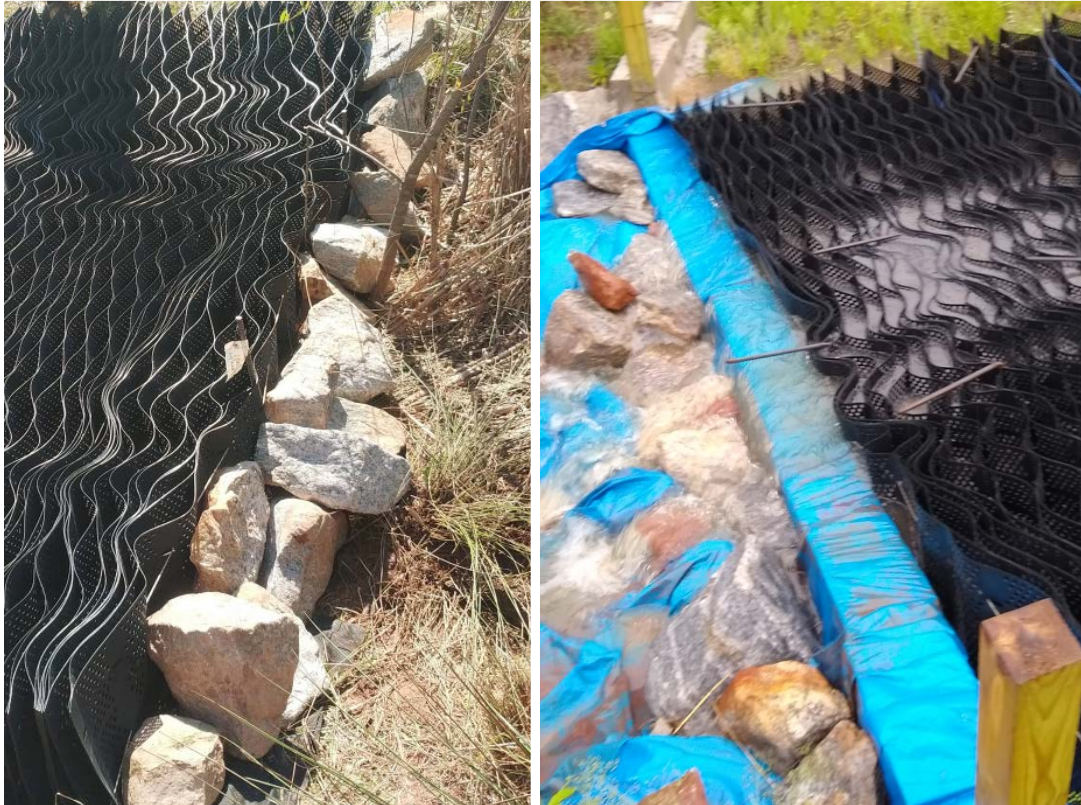
Figure 4 – Details of the upstream (Left) and downstream (Right) ends of the experimental apparatus, including the weir locations at the downstream end to gauge flow depth and calculate flow rates over the weir.

of debris to the cells, a line of rocks was placed immediately upstream from the cells, where there was the transition with the vegetated channel. At the downstream end, a line of cinder blocks was placed to create a broad-crested weir to enable calculation of the flows over the CCS. A tarp enclosed the cinder blocks to reduce flows between the blocks. These features are shown in Figure 4. Both these locations were used to collect the samples for water quality analysis.

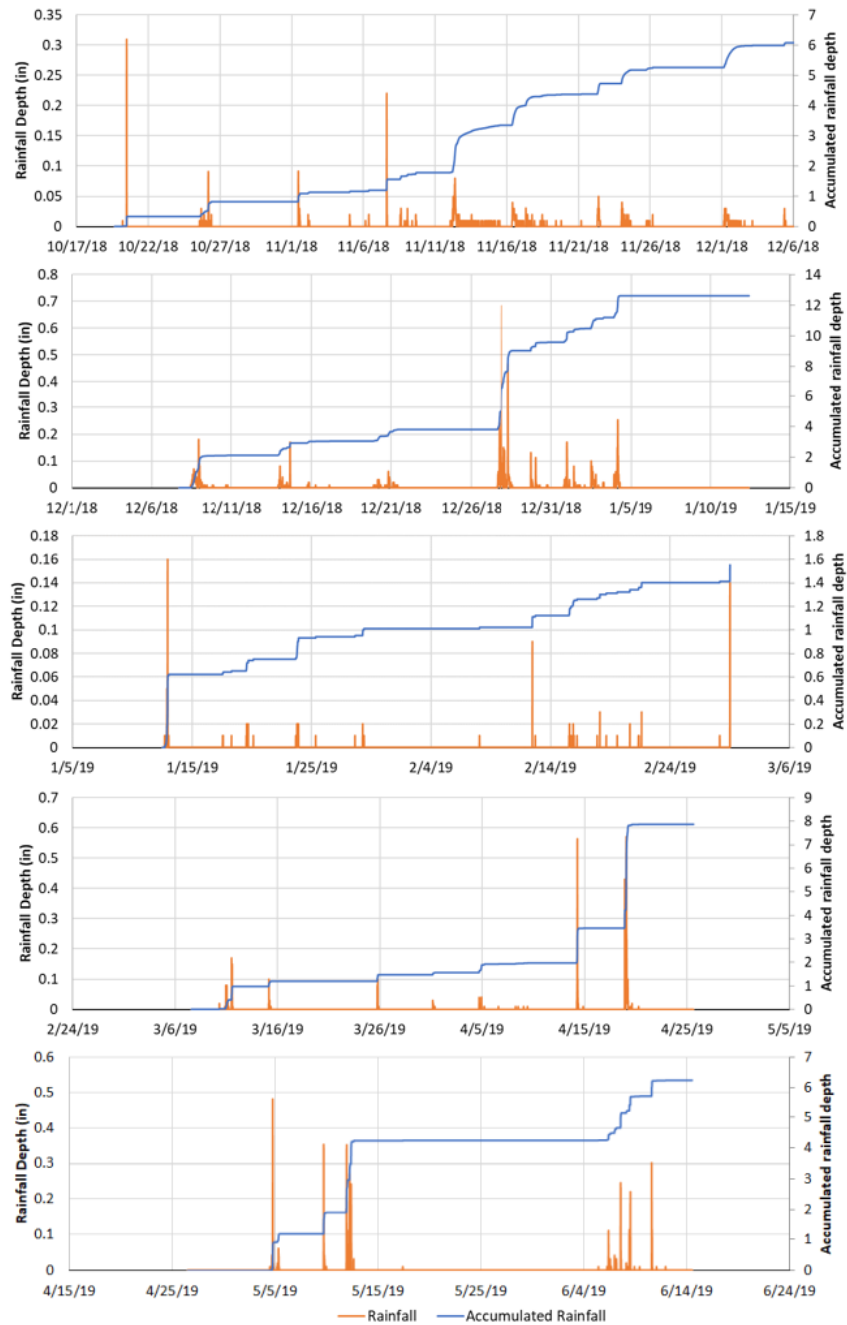
Figure 6 – Rainfall measurements performed in the research site from 10/17/18 to 6/17/2019

Following the installation of the CCS at the drainage channel in the south side of Cox Rd the monitoring process initiated with the collection of rainfall in the site. Results of the rainfall data, collected from Mid-October 2018 until the Mid-June, 2019 are shown in Figure 6, with a total accumulated rainfall depth exceeding 34 inches in the period.

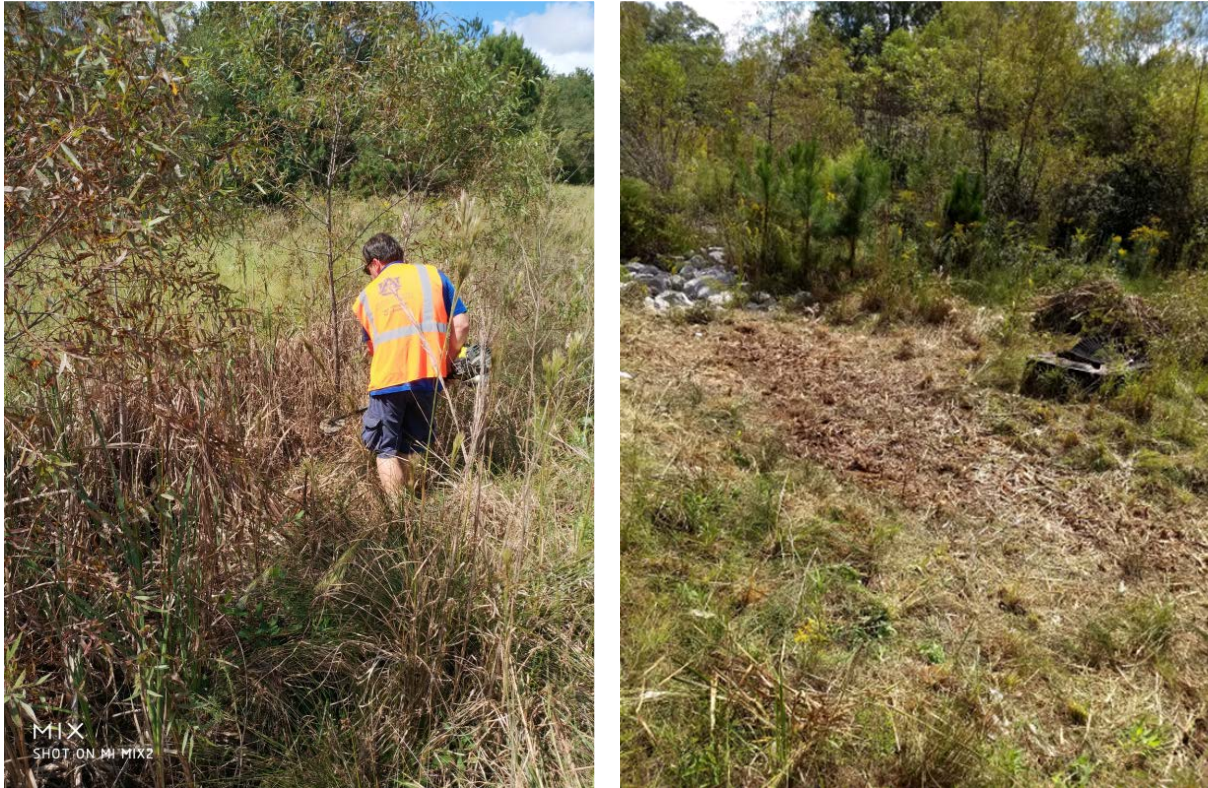
Figure 11 – Clearing of vegetated channel

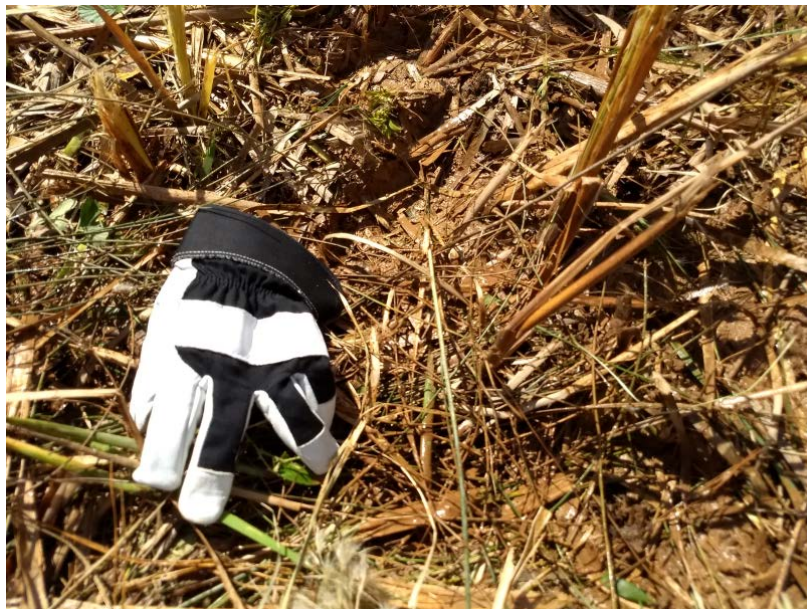
Figure 12 – Resulting bottom of the channel after clearing of channel vegetation. Soil was slightly covered with residual vegetation, and with high erosive potential

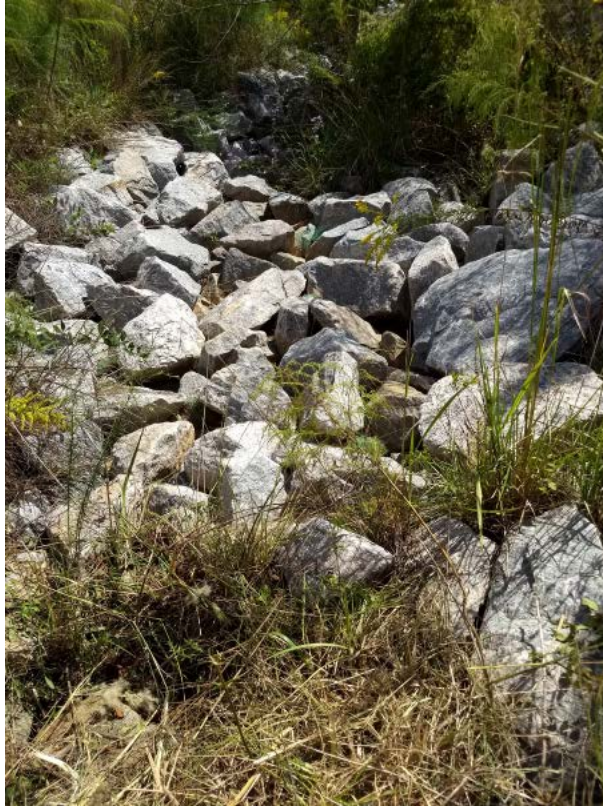
Figure 13 – Transition between the cleared channel and the beginning of the rip-rap lined channel.

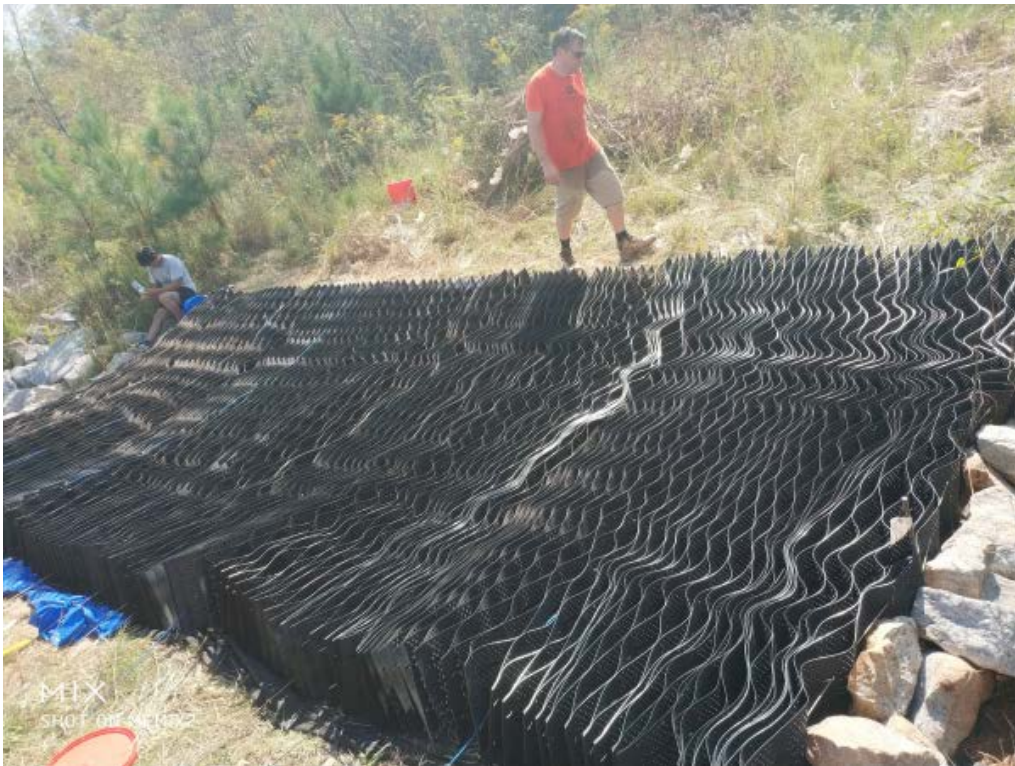
Figure 14 – Installation of the CCS in the region cleared from vegetation
