NCAT Report 24-01

May 2024

Phase VIII (2021-2024) NCAT Test Track Findings

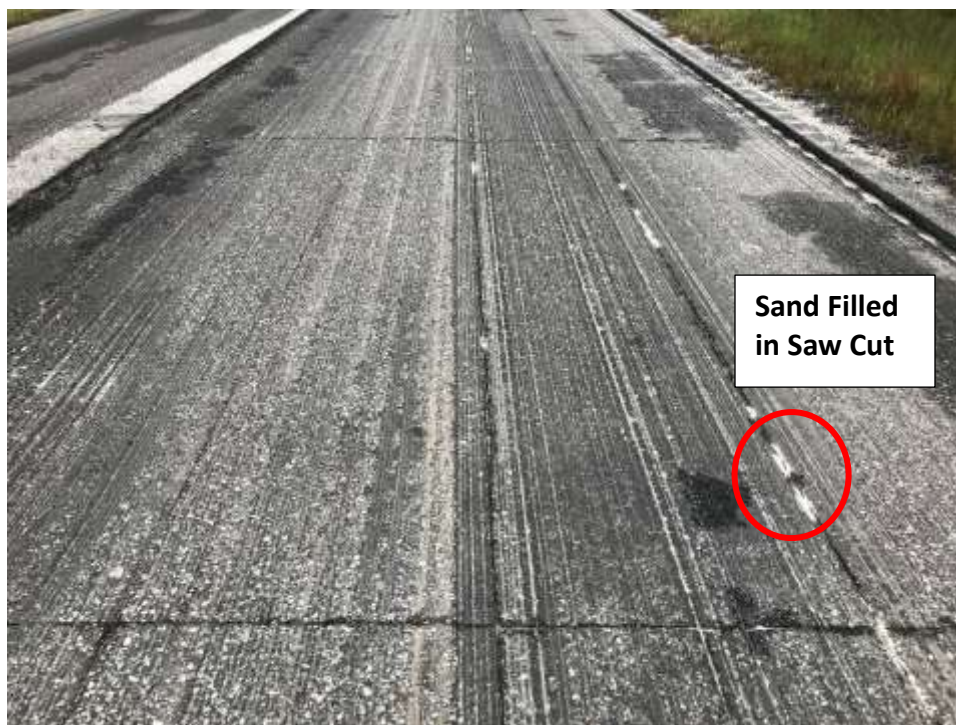
FIGURE 1 Deep saw cuts to simulate pavement cracks.

As depicted in Figure 1, these cuts were longitudinally aligned at intervals of 3 feet (0.91 meters) across the lane width and 15 feet (4.57 meters) in the transverse direction. The area impacted by the saw cuts accounted for roughly one-third of the test section's total surface area, assuming an influence zone of 1 foot (0.30 meters) on each side of the crack. The cuts were subsequently filled with sand to prevent the cracks from resealing during construction and warm weather conditions. The saw-cut pattern for this cycle replicated that of the previous research cycle.

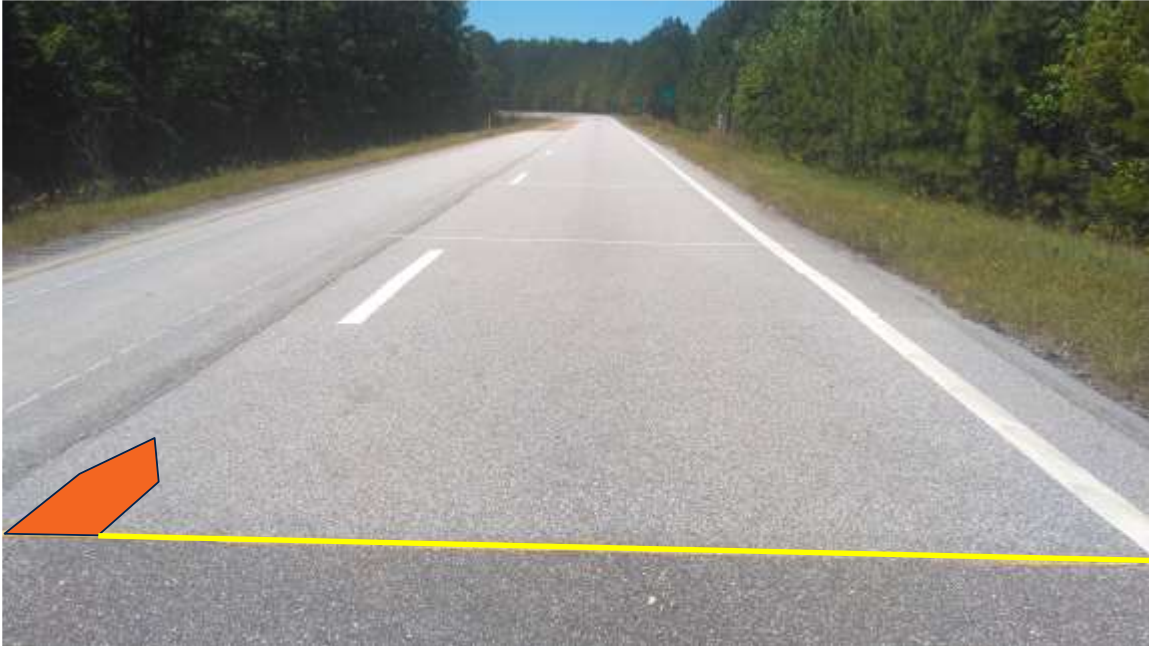
The final surface after loading for each section is shown in Figures 13 through 18. The yellow superimposed line marks the start of each subsection.

FIGURE 13 Subsection N12-A GlasGrid®, 0.24-inch rutting, no cracking (April 2024).

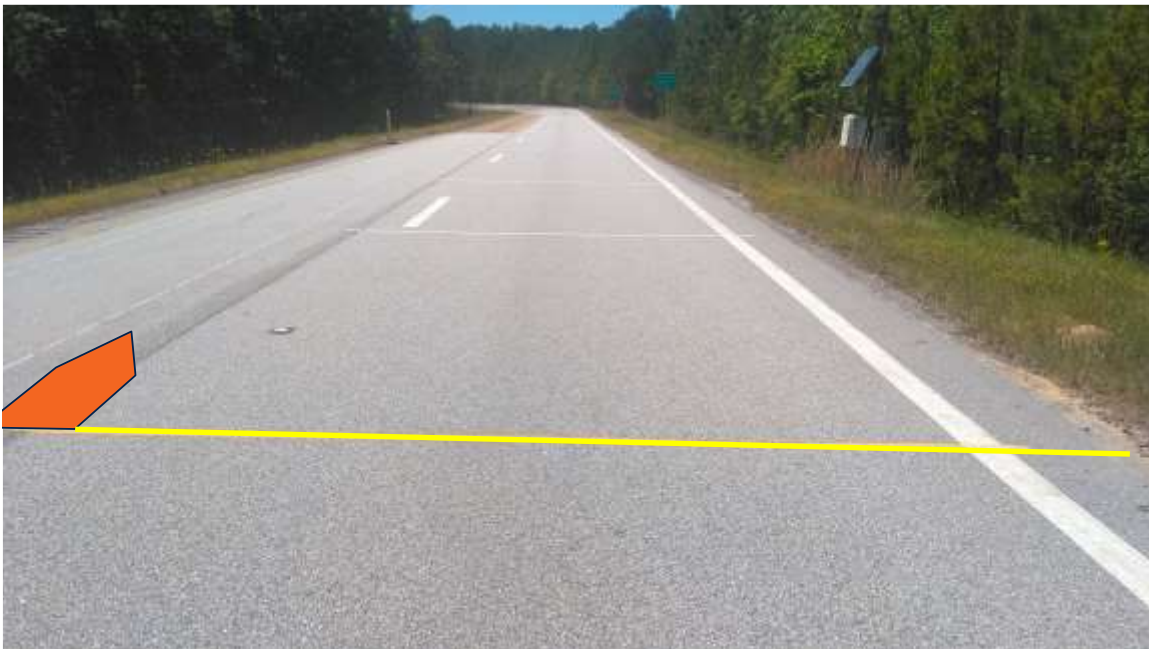
FIGURE 14 Subsection N12-B PETROMAT®, 0.27-inch rutting, no cracking (April 2024).

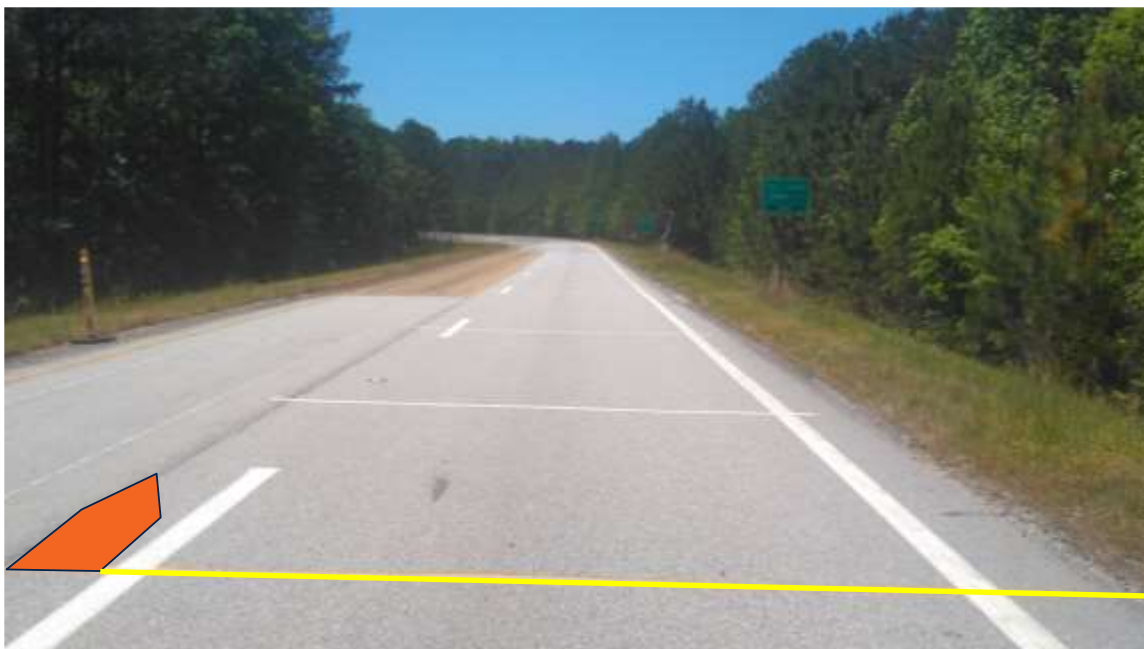
FIGURE 15 Subsection N12-C virgin chip seal, 0.21-inch rutting, no cracking (April 2024).

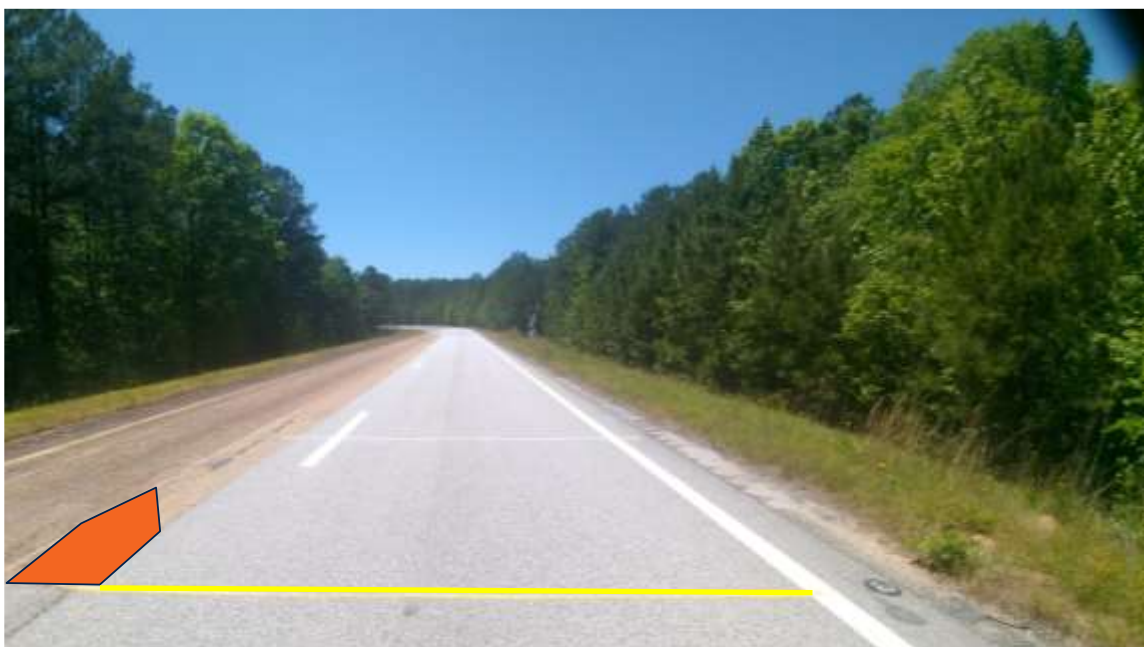
FIGURE 16 Subsection N13-A RAP chip seal, 0.41-inch rutting, 0.8% cracking (April 2024).

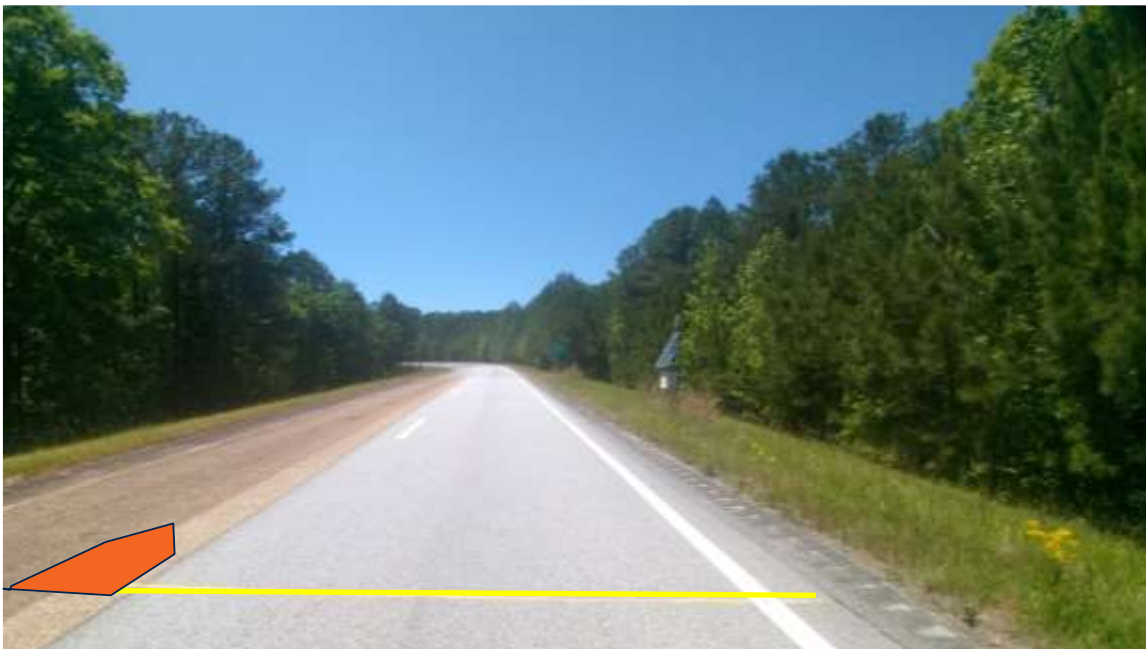
FIGURE 17 Subsection N13-B ARGG, 0.35-inch rutting, 3.1% cracking (April 2024).

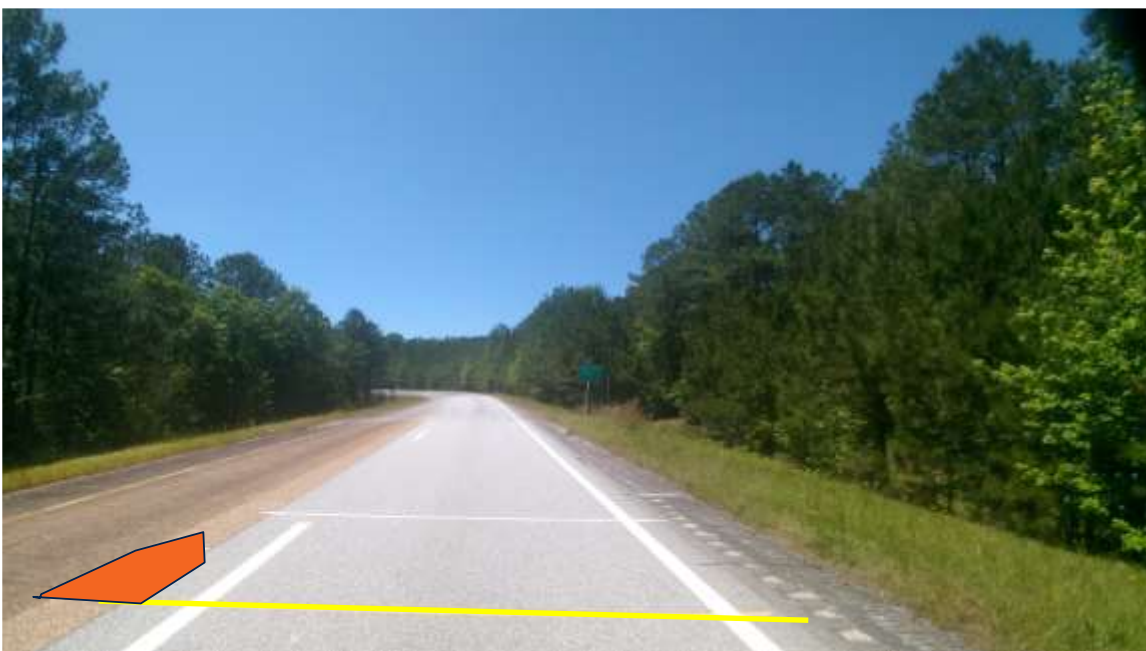
FIGURE 18 Subsection N13-B OGI, 0.19-inch rutting, 0.8% cracking (April 2024).

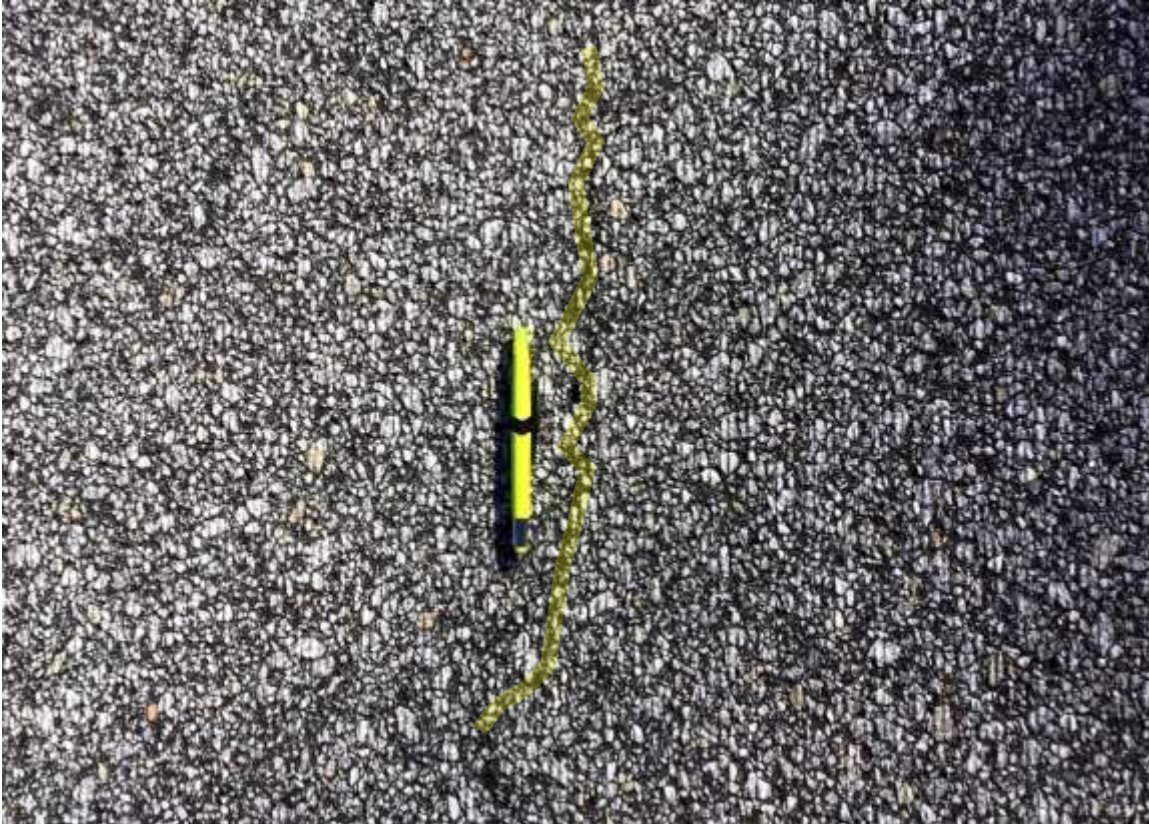
FIGURE 4 Longitudinal crack at edge of inside wheelpath in S9 at end of first test cycle.

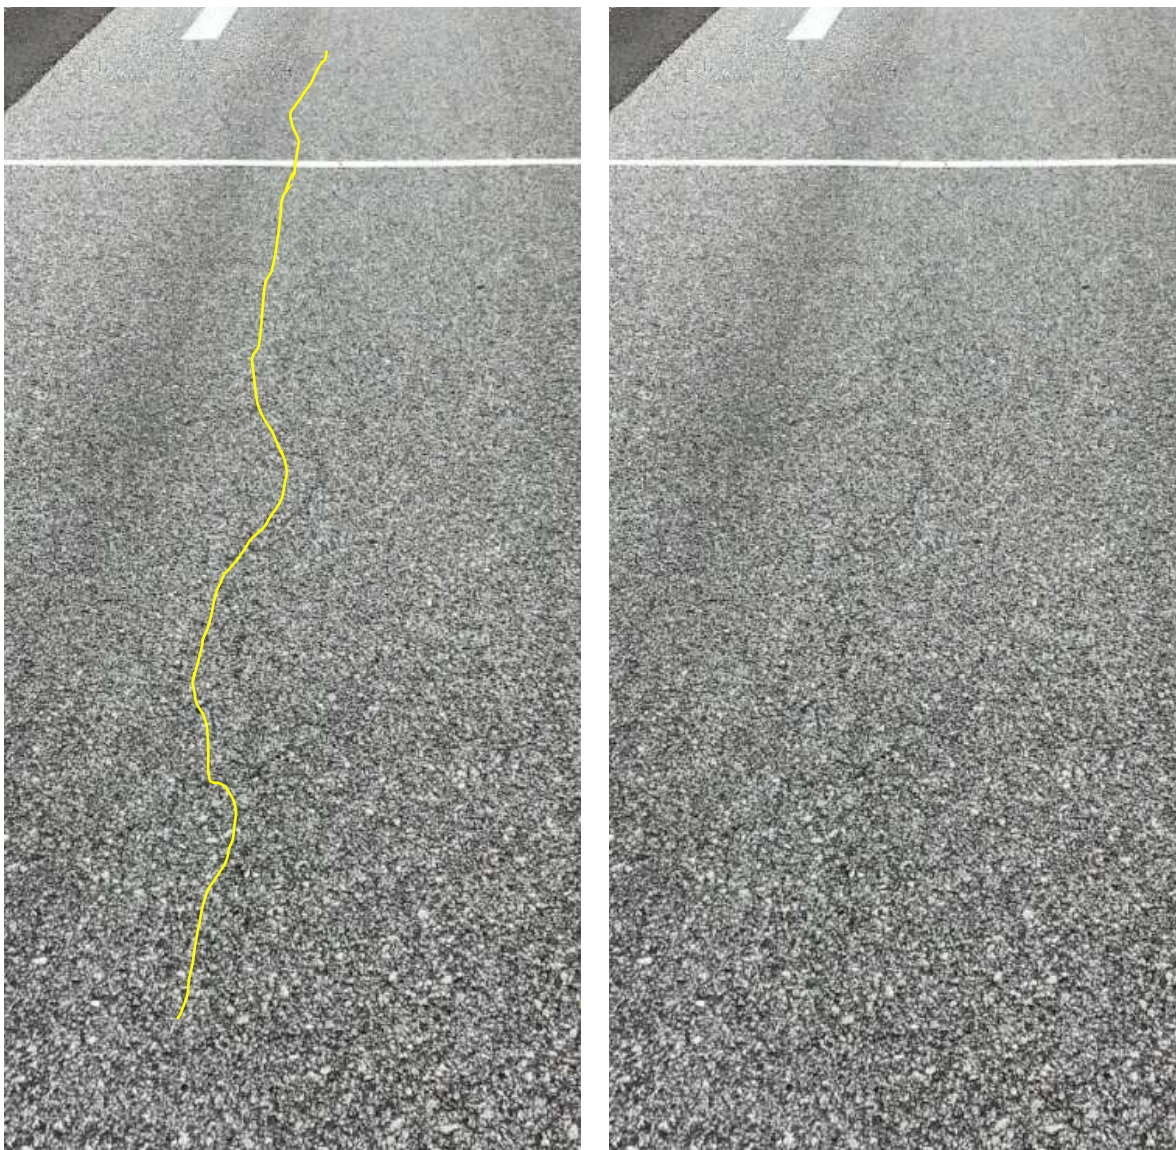
FIGURE 6 Longitudinal crack at edge of inside wheelpath in S9 at end of second test cycle (with and without highlighting).

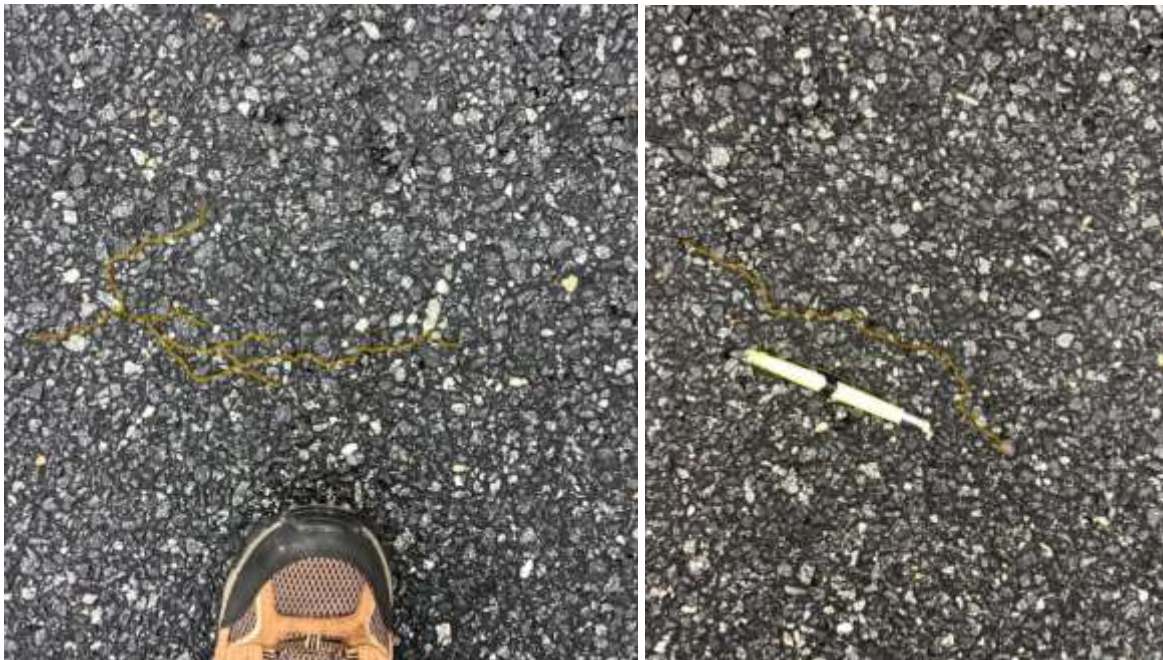
FIGURE 2 Sample cracking in N4 on 1/25/2021 (29.6 million ESALs).

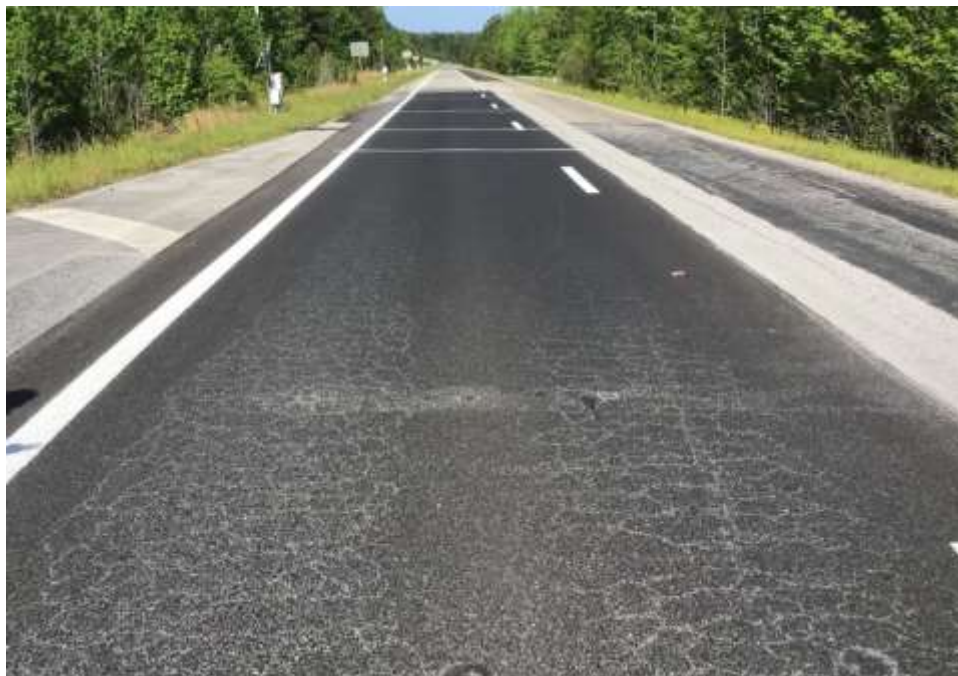
FIGURE 5 Cracking in Section S12 at approximately 1.3 million ESALs (April 2022).

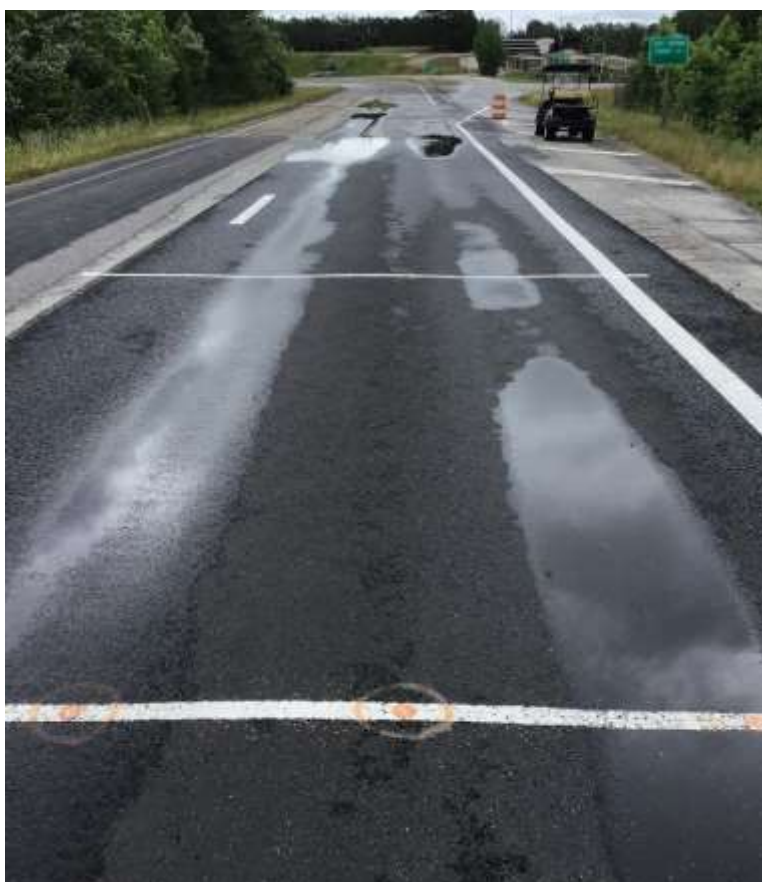
FIGURE 6 Rutting in Section S12 (April 2022).

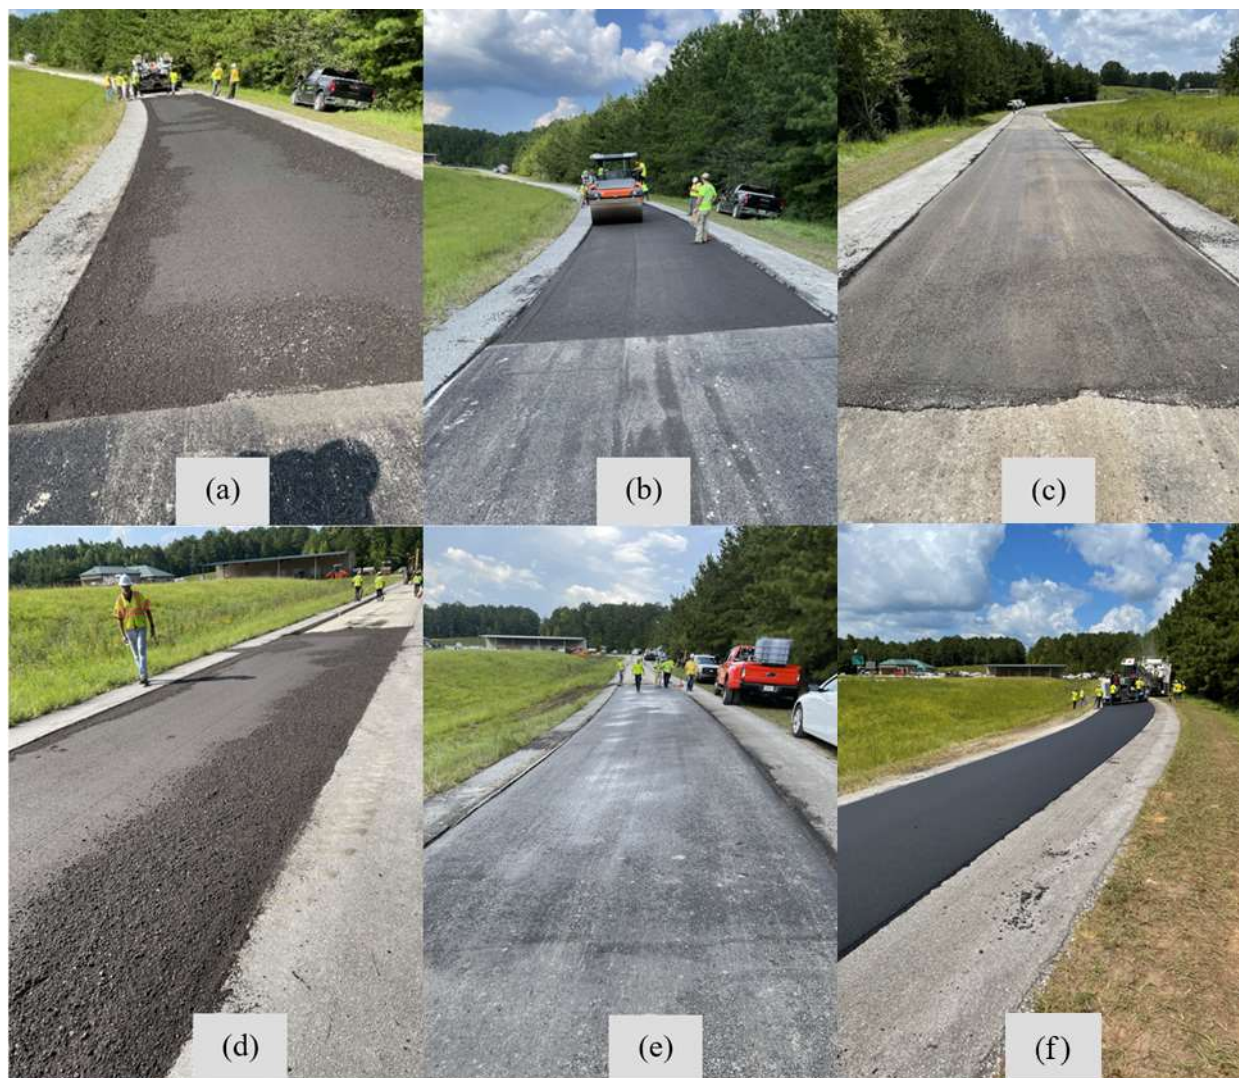
FIGURE 4 Paved CCPR Sections on off-ramp; (a) foamed asphalt with active filler, (b) engineered emulsion, (c) CR rejuvenator, (d) emulsified bio-based rejuvenator; (e) emulsified bio-based rejuvenator, and (f) HMA thinlay overlay.

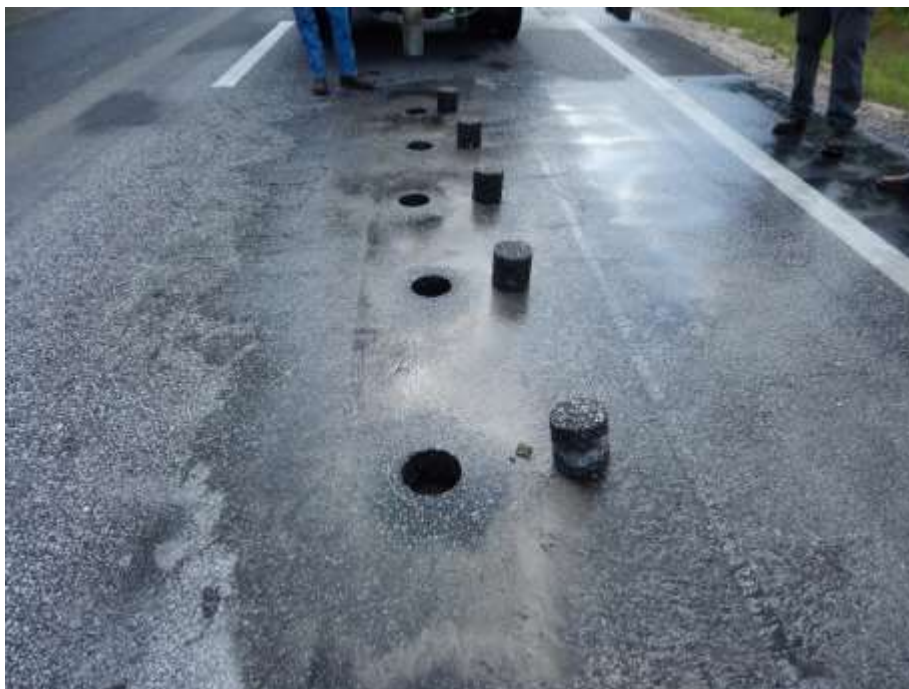
Figure 9. Cores Extracted in Section S8 in Distress Area (June 2022).
