**Airfield Asphalt Pavement Technology
Program Project 04-01:**

**Development of Guidelines for Rubblization
Final Report**

Mark Buncher, Ph.D., P.E., Asphalt Institute

May 23, 2008

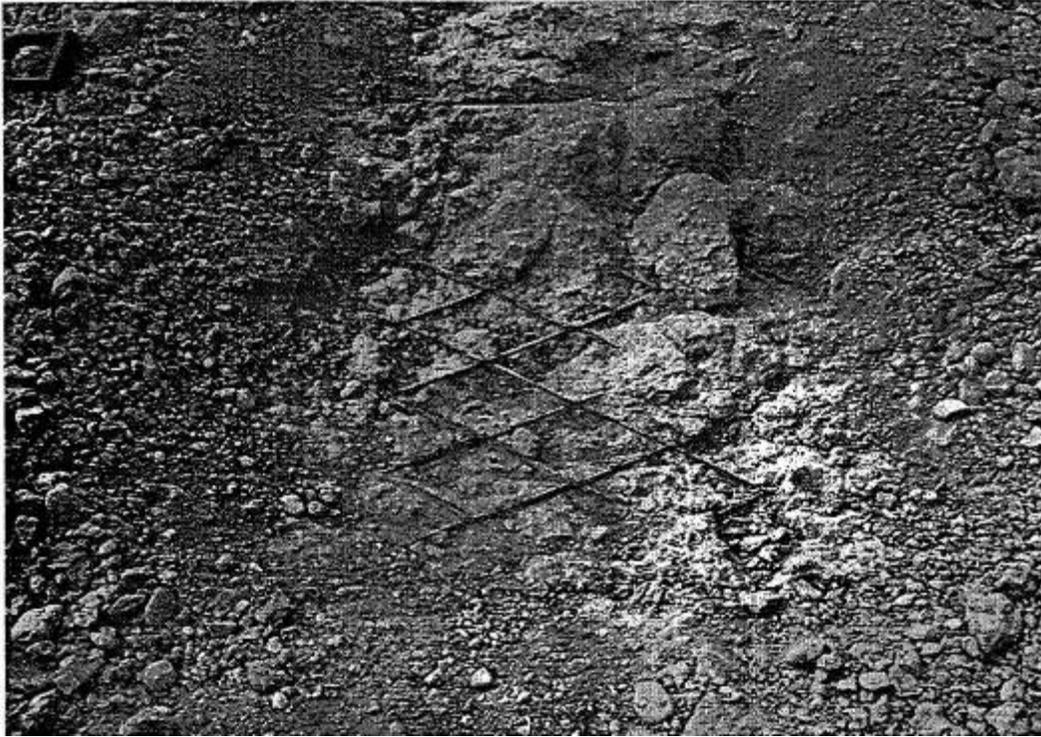
Figure 2.2, Photo Showing Partial Debonding of Temperature Steel [Baladi et al, 2002]

2. The RPB was successful in debonding the temperature steel from the PCC in most places, except where the steel overlapped and the two steel layers hindered the rubblization process by absorbing and/or deflecting part of the energy. The MHB was generally not successful, however, as only 15% of the temperature steel was

debonded from the PCC, as shown in Figure 2.2. Where the temperature steel overlapped, the MHB did not debond the steel.

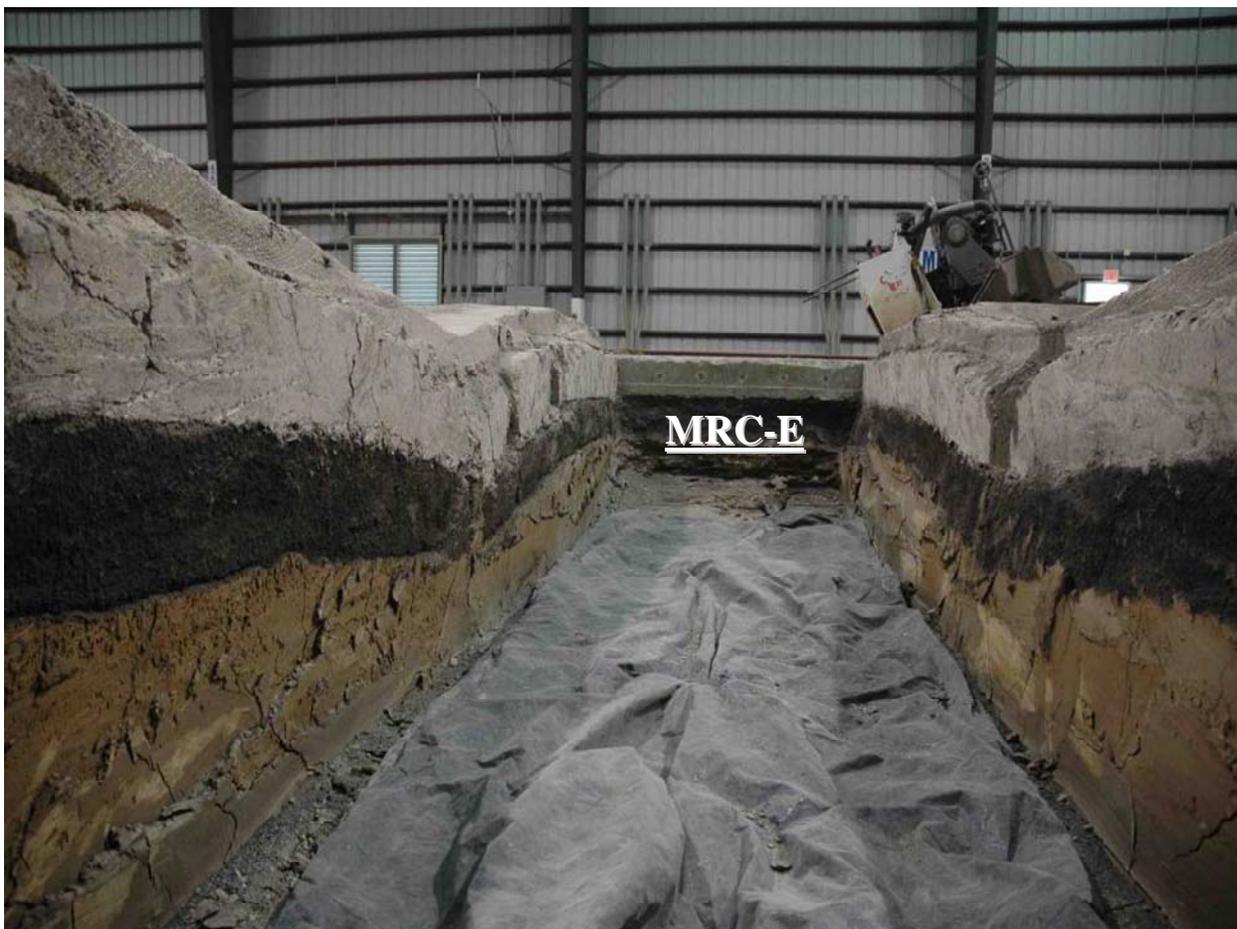
Figure 2.5, Trench in MRC Showing Subgrade Shear Failure [Garg, 2006]

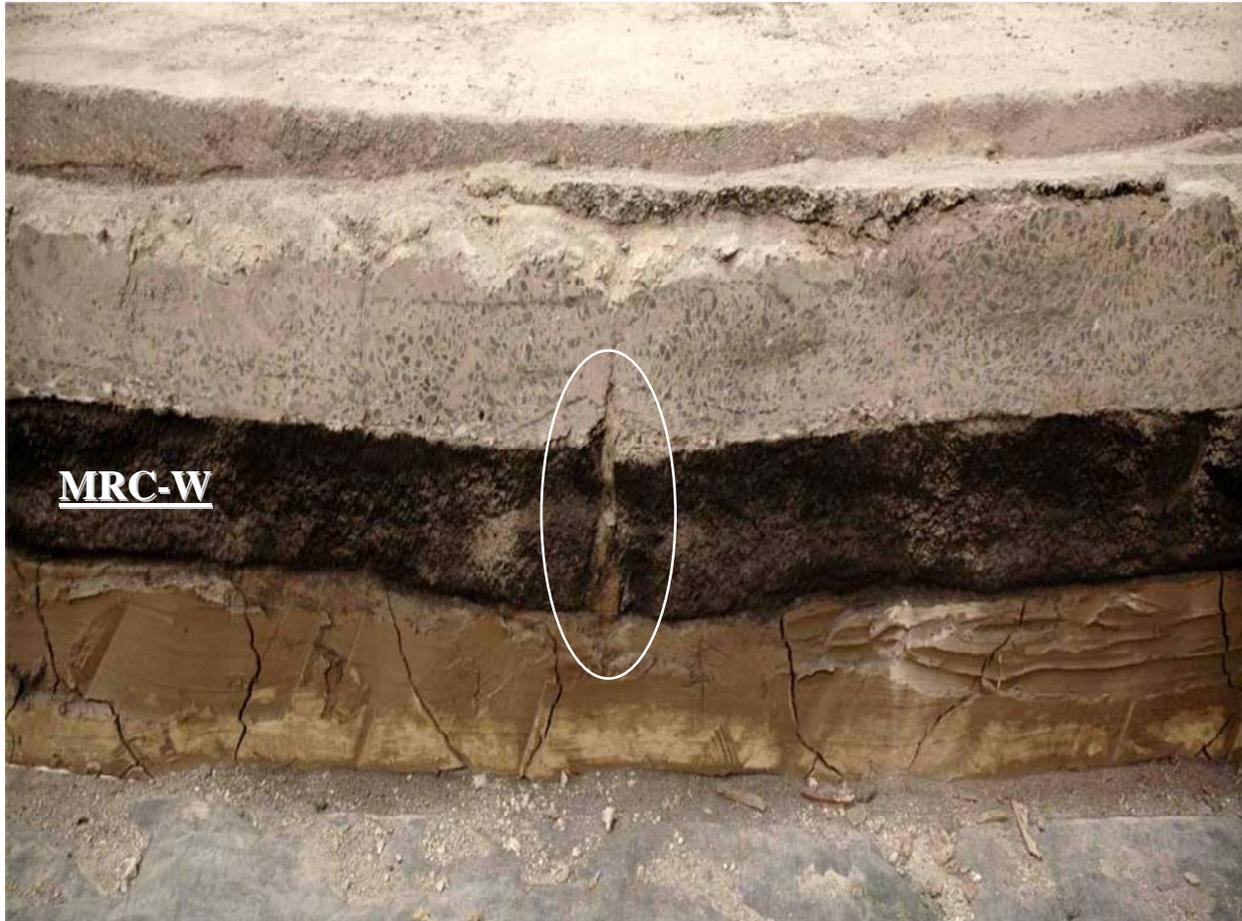
Figure 2.6, Close-up in MRC Trench Showing Subgrade Shear Failure (Garg, 2006)

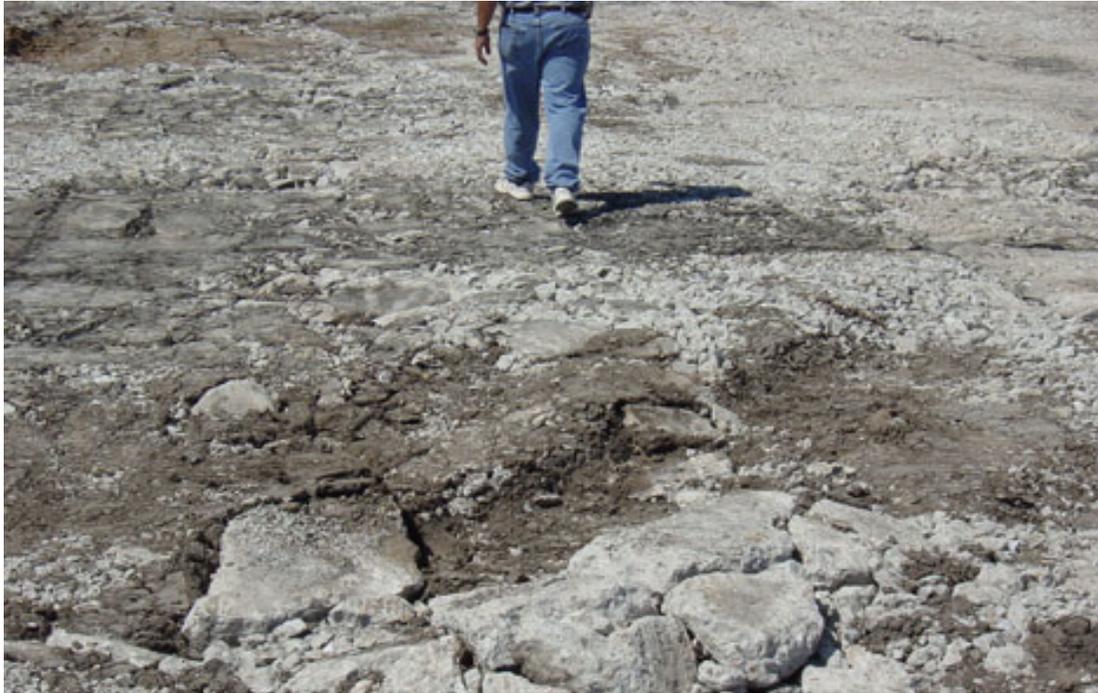
Figure 2.7, Ineffective Rubblization (Large PCC Pieces) at Pratt Due to Weak Support

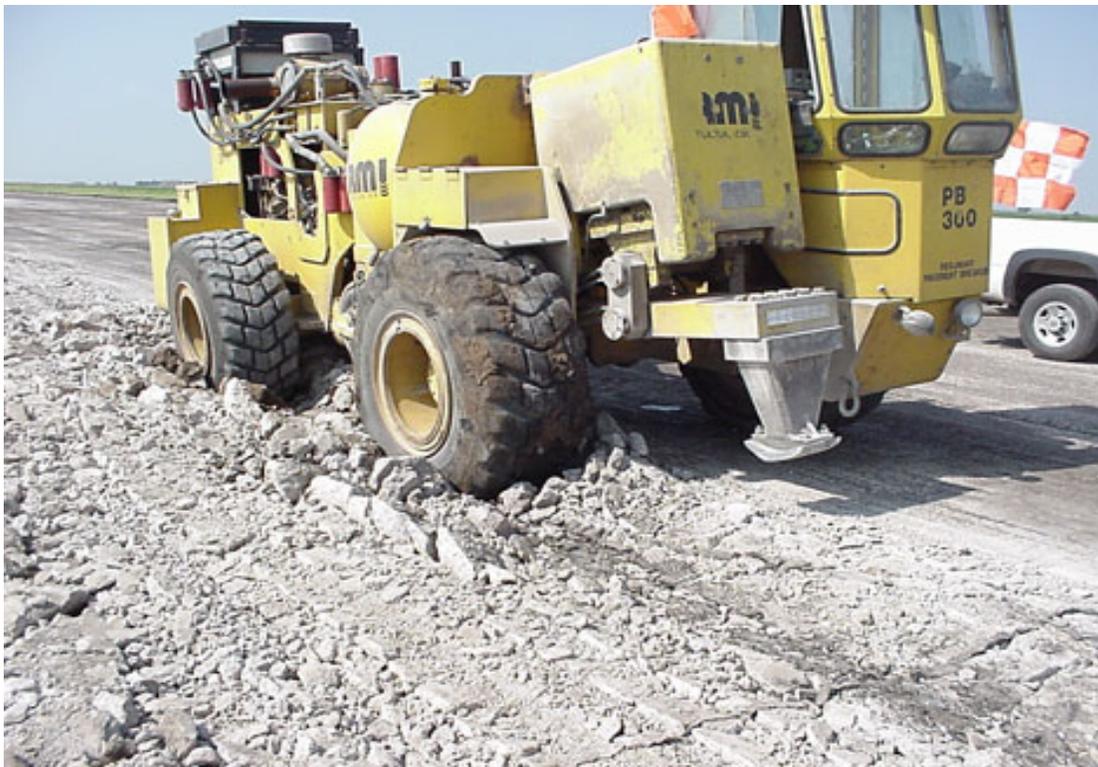
Figure 2.8, RPB with High Flotation Tires Stuck in Unstable Area at Pratt

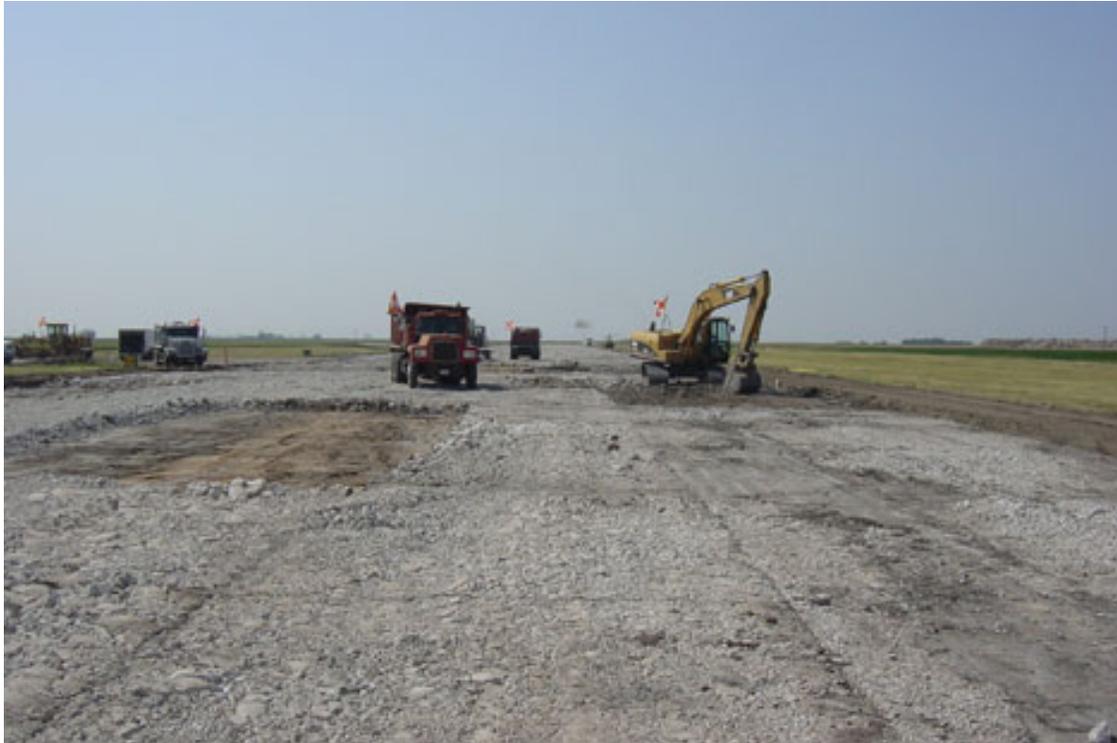
Figure 2.9, Excavation of Ineffective Rubblized Areas at Pratt for Full-depth Patch

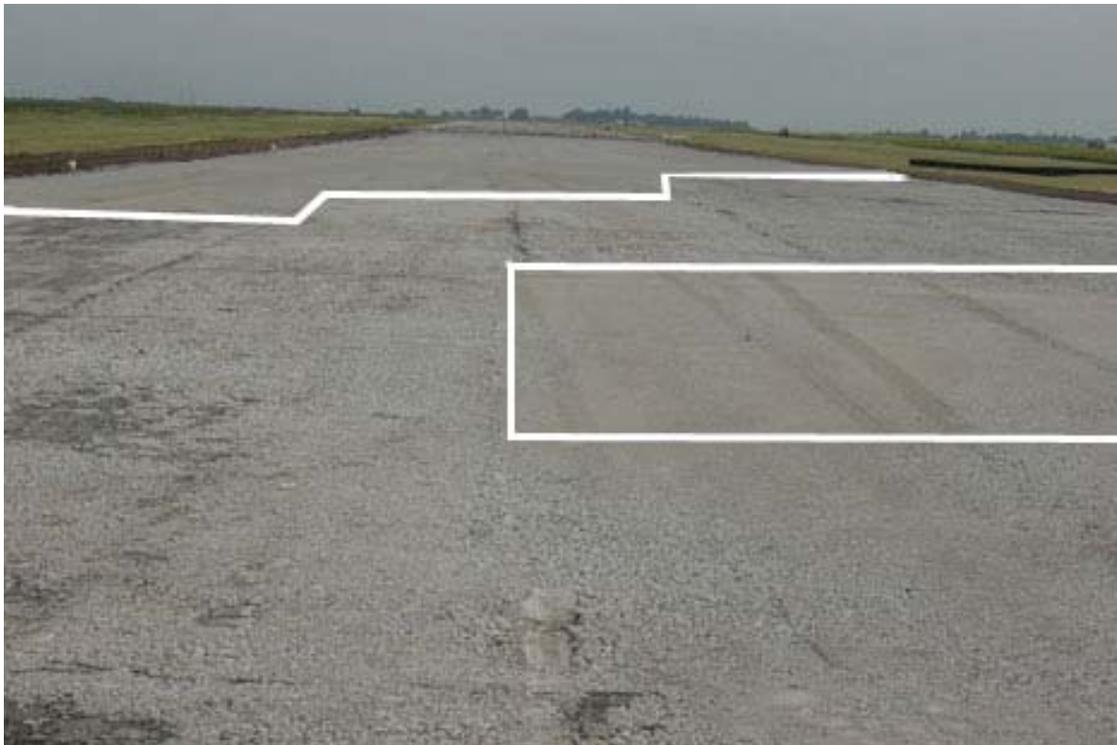
Figure 2.10, Finished Patched Areas Outlined in White at Pratt using Crusher Run

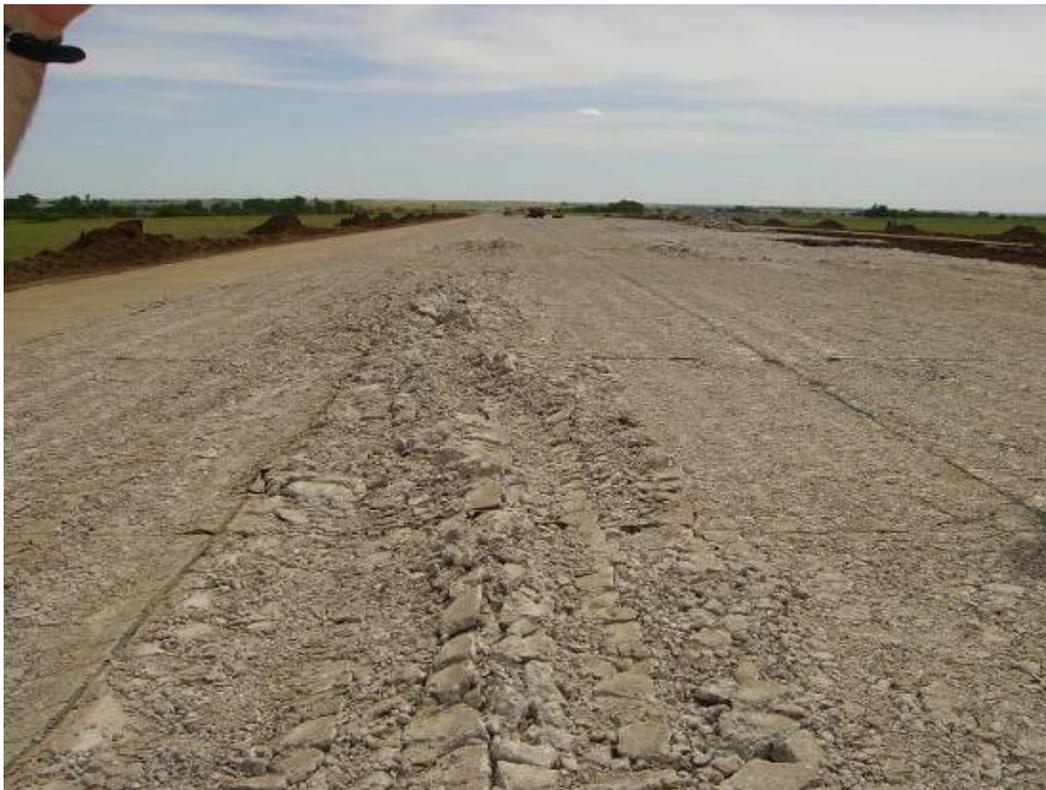
Figure 2.11, Rutting from RPB of Unstable Area at Kegelman that Requires Excavation

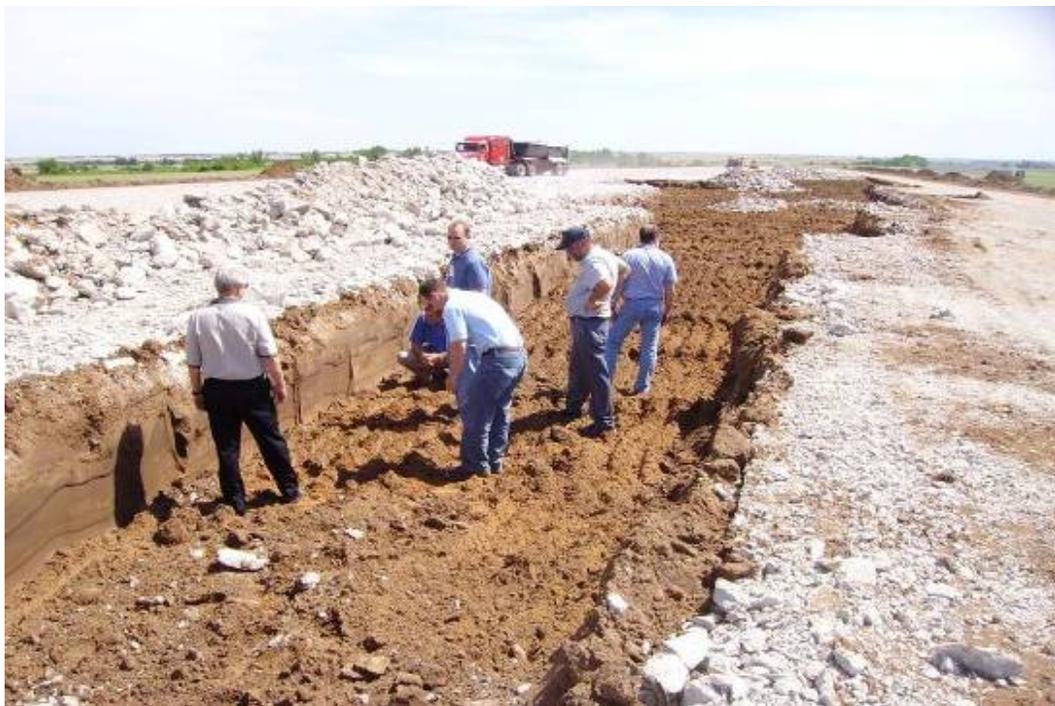
Figure 2.12, Full-depth Excavation Deep Into Subgrade of Patched Area at Kegelman

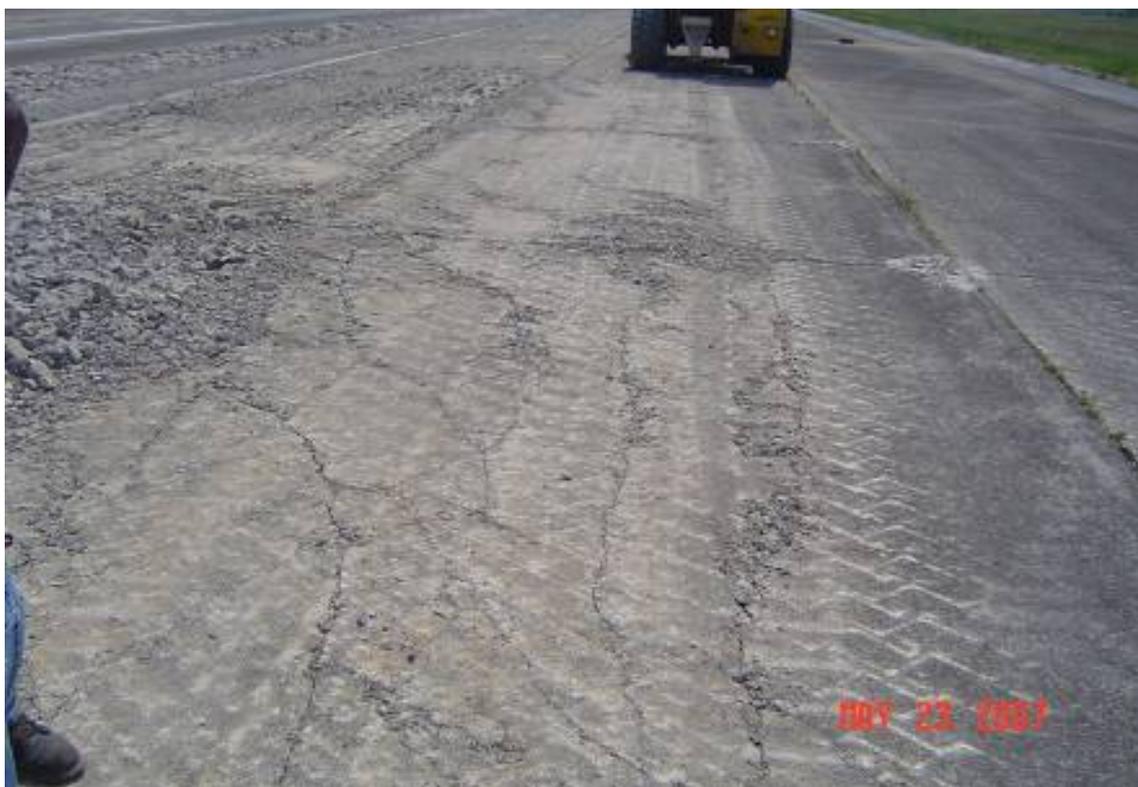
Figure 2.13, Fractured PCC by MHB with Low Drop Ht. and Wide Spacing at Tullahoma

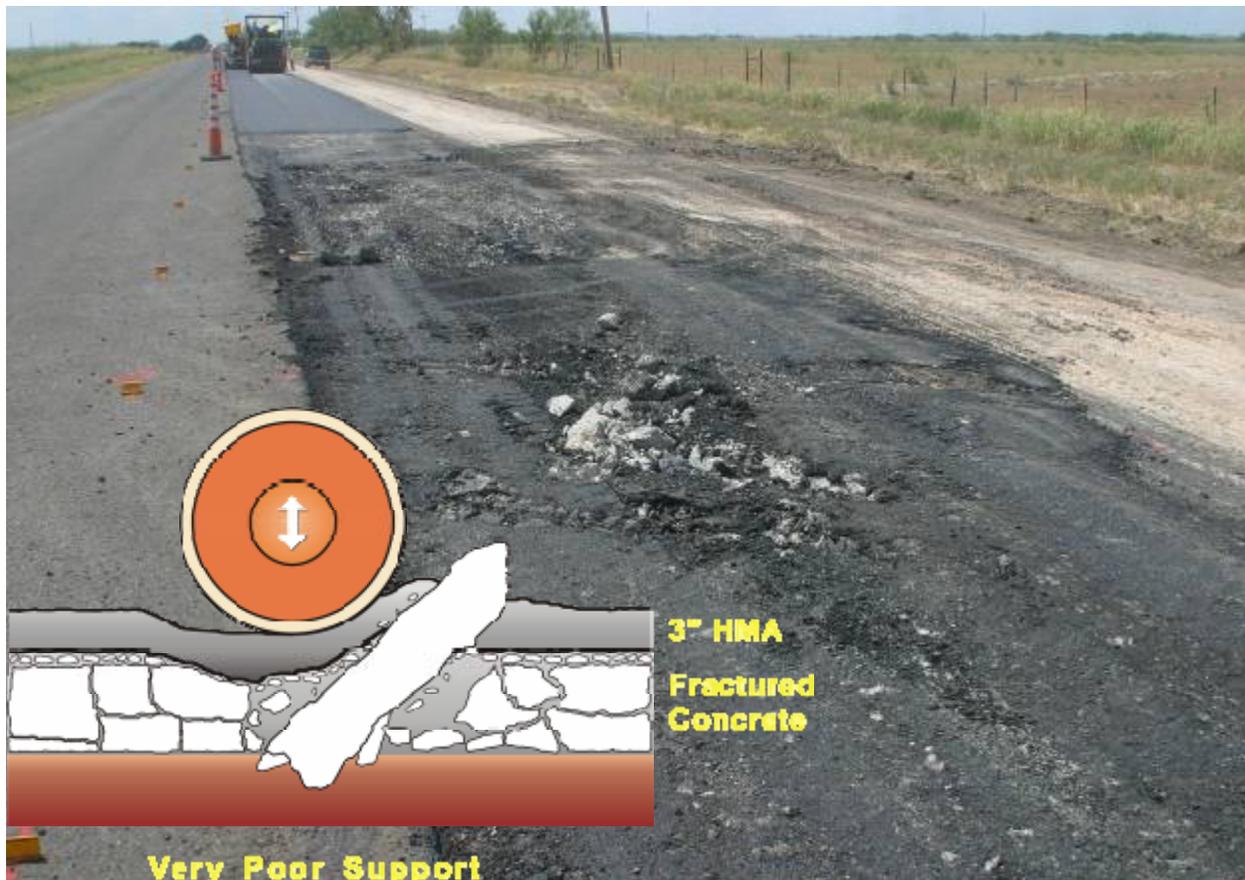
Figure 3.7, Shifting of Rubblized PCC from Paving Operations on Texas SH 70

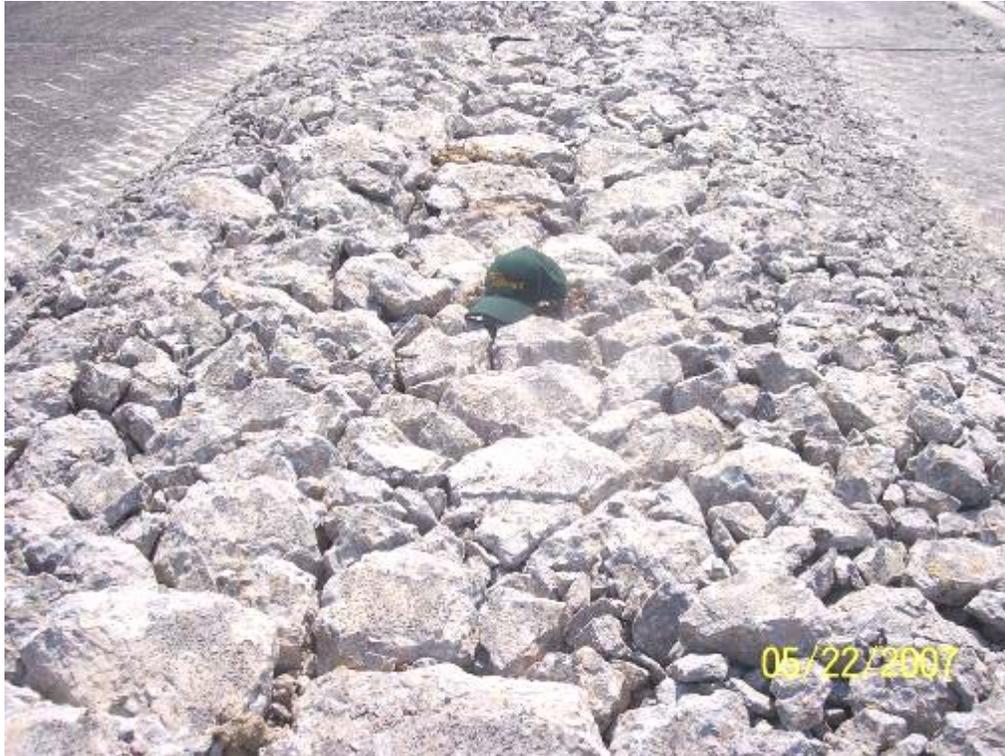
Figure 3.9, Unacceptable Rubblization from Start-up of MHB at Tullahoma

The feasibility trial at Tullahoma (section 2.4) illustrated this technique. Figure 3.9 shows the broken PCC at Tullahoma when the MHB first started rubblizing, with the normal 24-inch drop height and normal impact spacing. Since it was clearly apparent that these large PCC pieces were too disoriented to be able to be rolled into an acceptable surface for an HMA overlay, Antigo adjusted their MHB by lowering the drop height and increasing the impact spacing. Figure 3.10 shows the surface at Tullahoma after adjusting the MHB to a 16-inch drop height and 10-inch impact spacing, and after several passes of the Z-grid roller. Figure 3.11 shows the test pit from the same pavement in Figure 3.10, verifying full-depth fracture and revealing the particle sizing, which exceeded the specified criteria. As Figures 3.10 and 3.11 show, the resulting surface and fracture conditions of this “modified rubblization” technique appear to be suitable for an HMA overlay. The engineers on site at Tullahoma agreed.

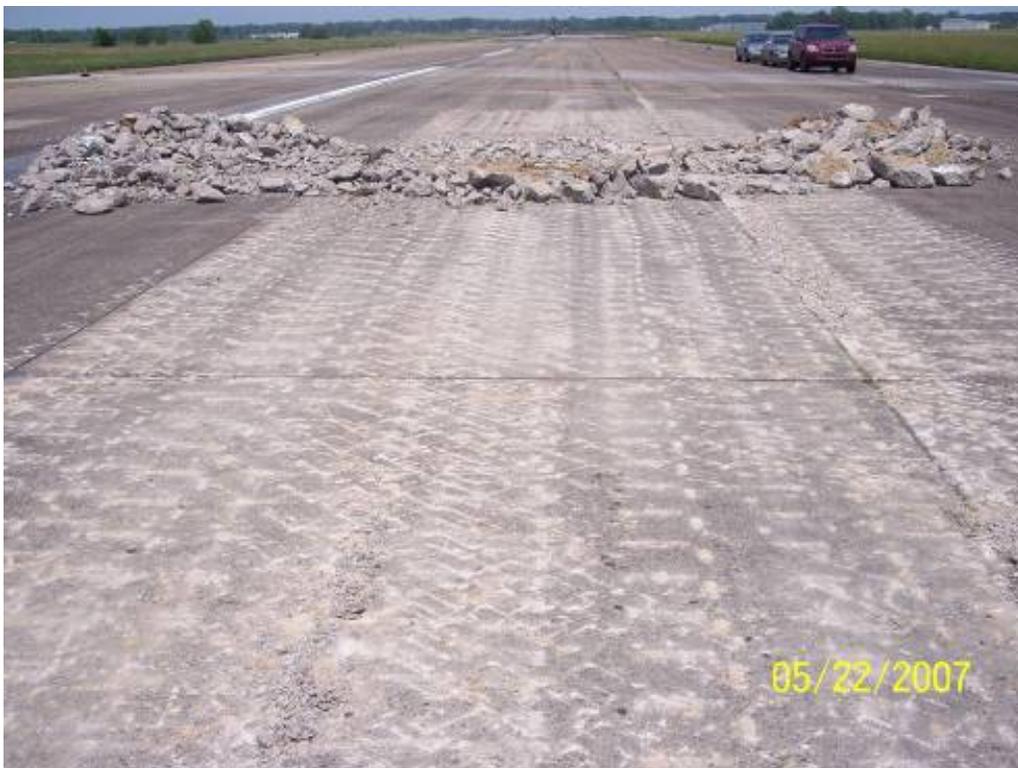
Figure 3.10, Result of “Modified Rubblization” Process after Z-grid at Tullahoma

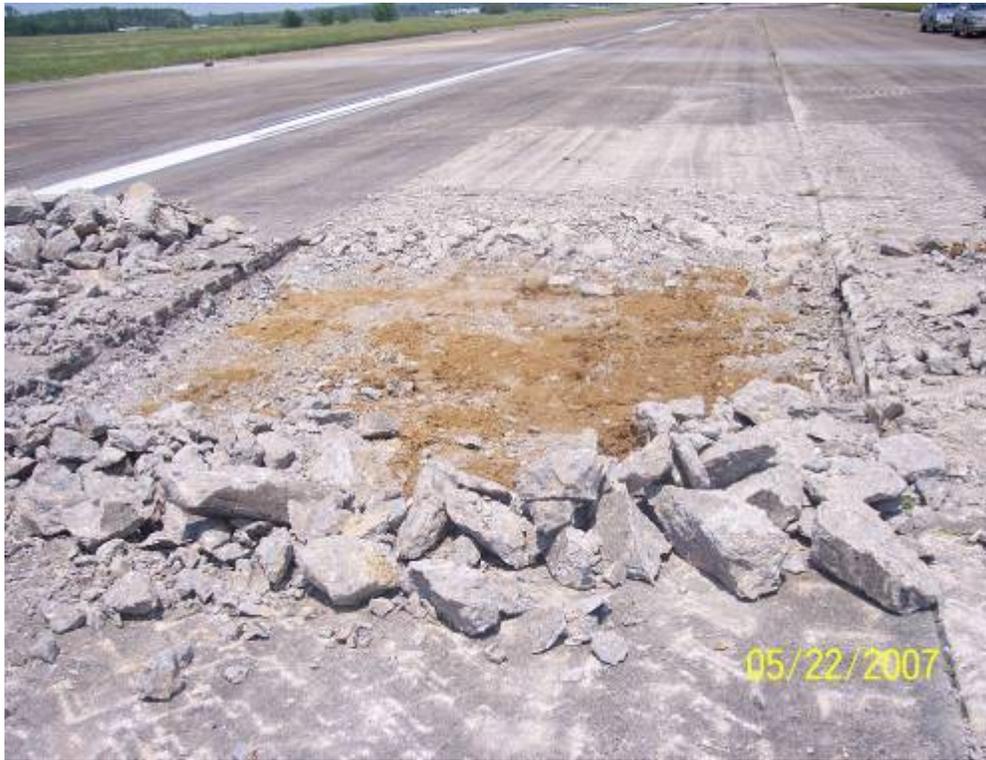
Figure 3.11, Test Pits from “Modified Rubblization” at Tullahoma

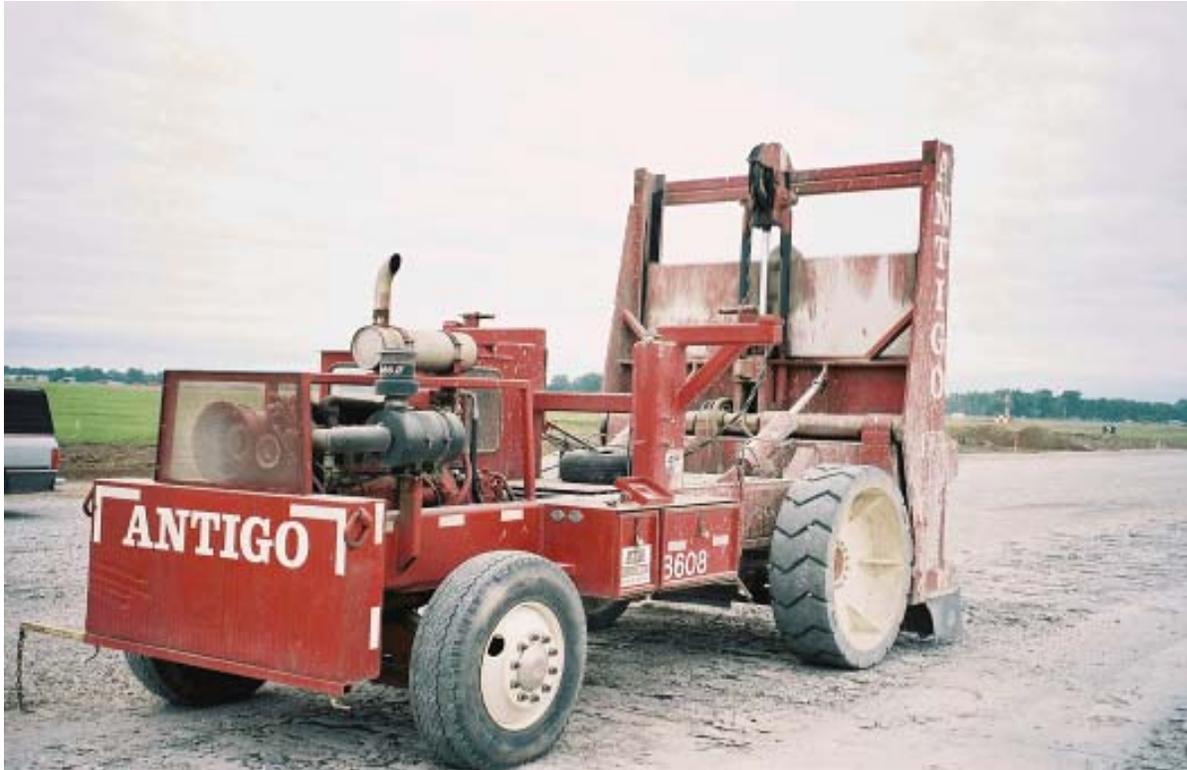
Figure 3.12, Guillotine Hammer Used with Traditional Crack and Seat Method

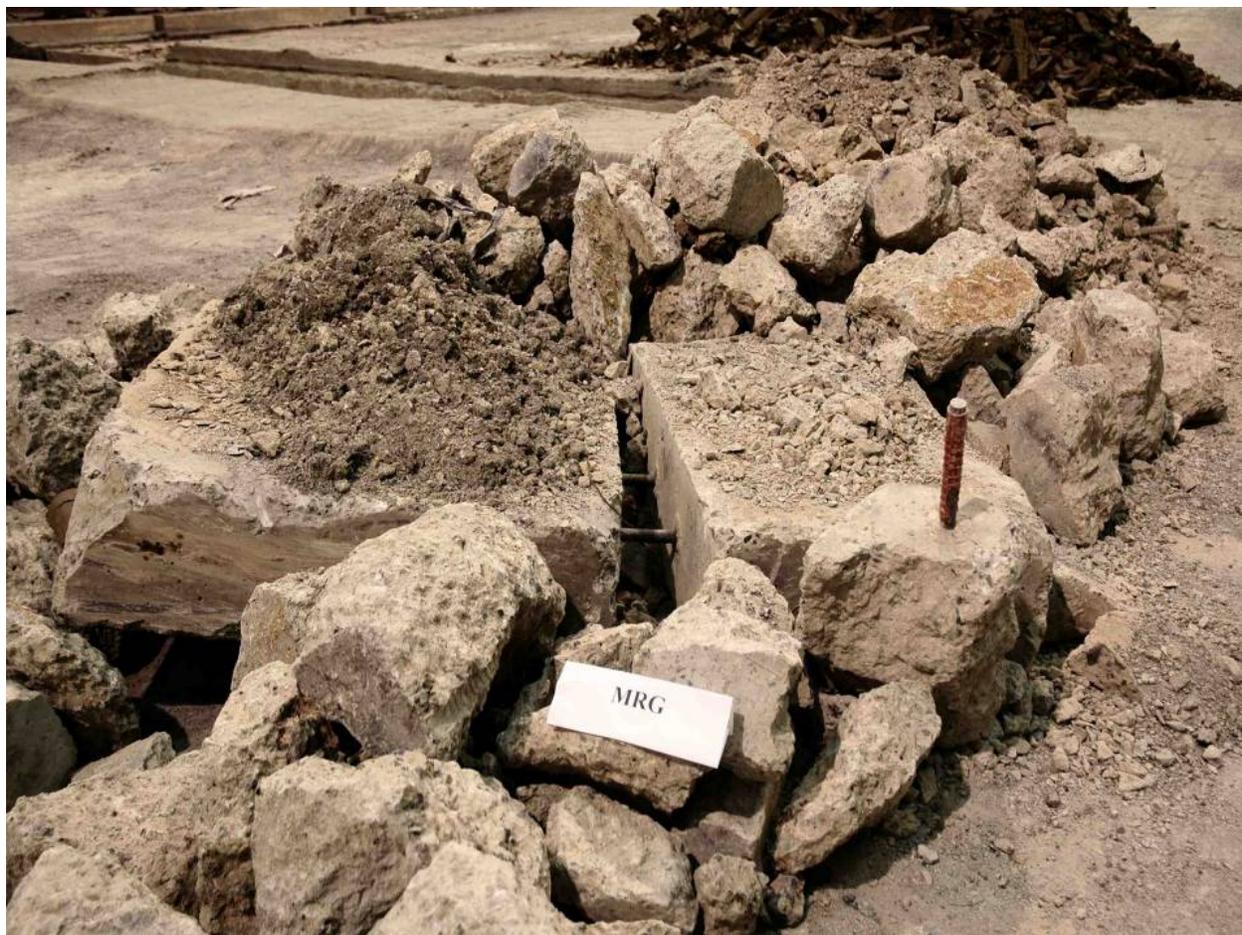
Figure 4.4, Excavated Rubblized PCC in MRG Section at NAPTF [Garg ppt, 2006]

These average rubblized moduli are relatively high at NAPTF compared to those reported elsewhere. This may be explained by examining the rubble excavated from the test trenches (see Figure 4.4). It is apparent that the slabs were fractured full depth but not to the gradation limits typically required in rubblization specifications. The fractures were hairline with a high degree of particle interlock below the top 3 inches of "crushed" material. Personnel on-site estimated that about 80% of the steel dowels examined from the test pits remained bonded to the concrete.

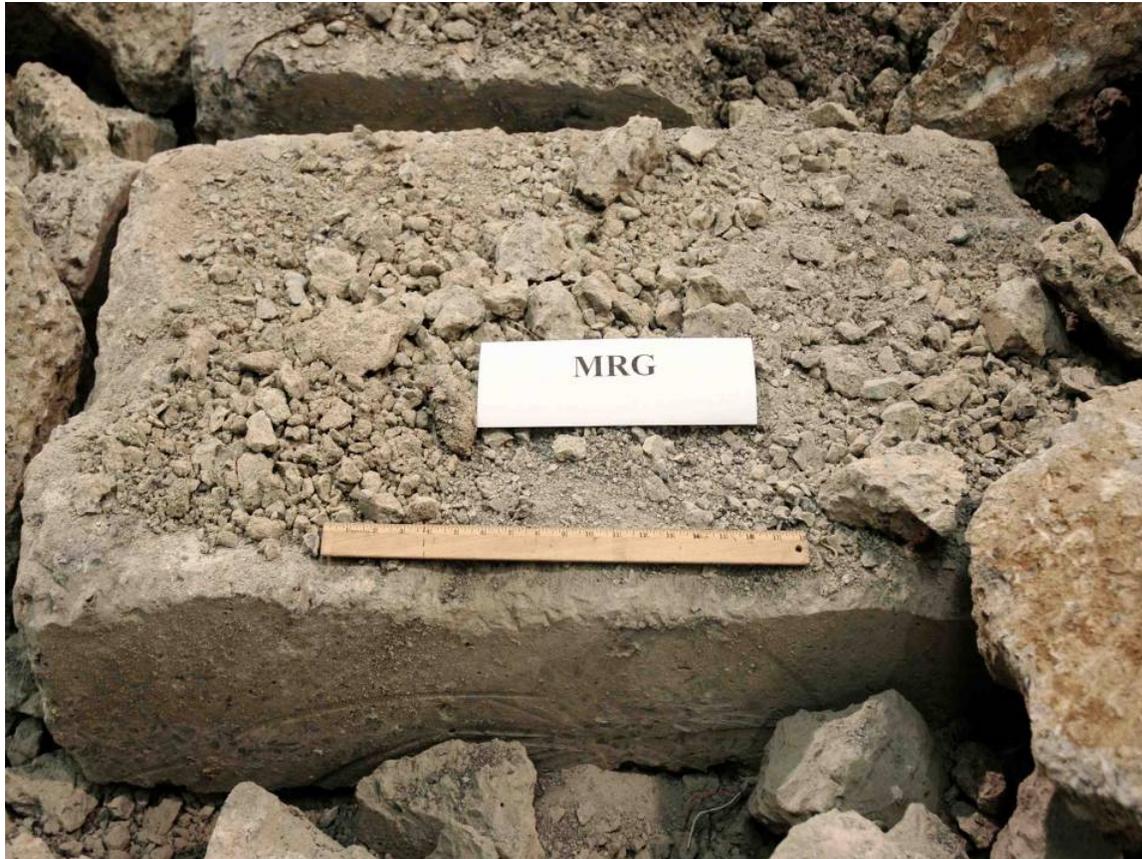
Figure 4.7, Photo of Large Concrete Piece from MRG at NAPTF

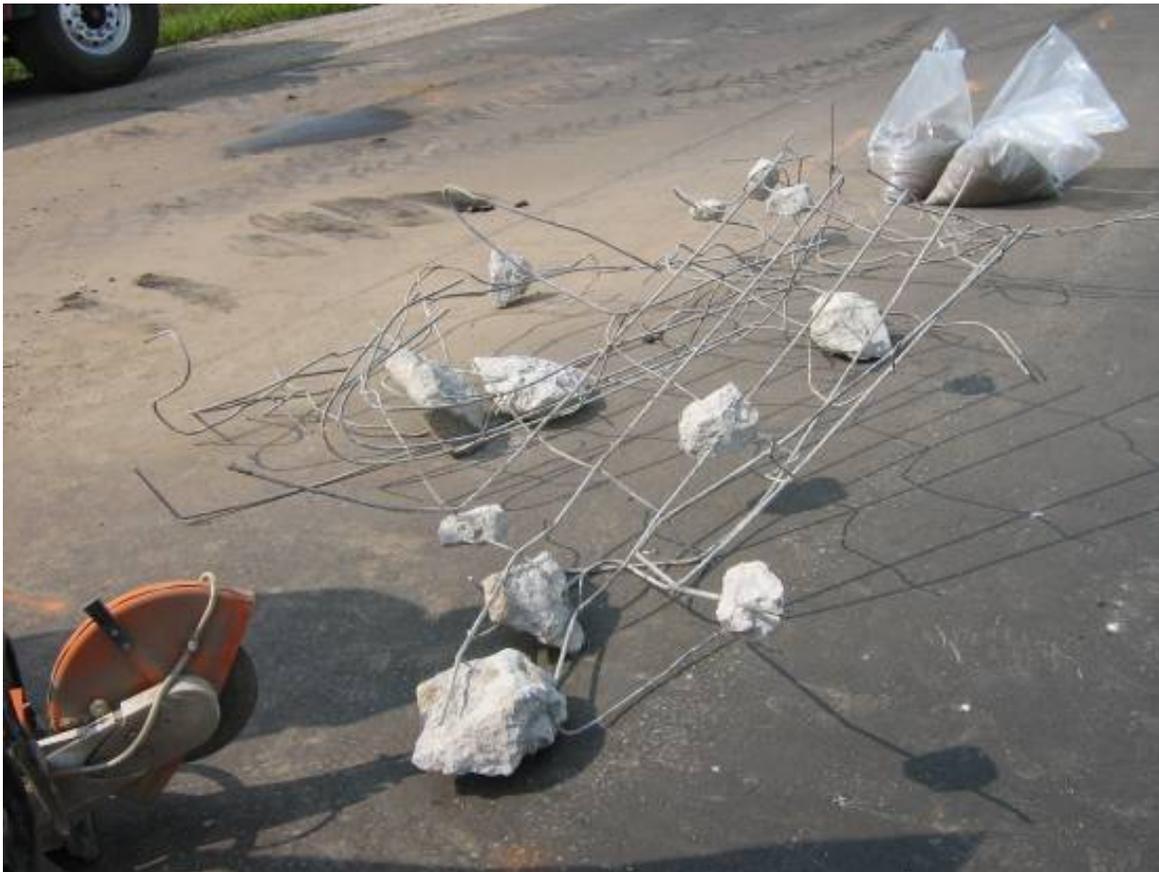
Figure 5.1, Substantial Debonding of the Steel Rebar

An issue regarding test pit acceptance criteria is whether the specification and enforcement should require “complete” steel debonding or some lesser degree. On one extreme is the strict Michigan enforcement of complete debonding, while most other states accept a lesser degree. Depending on the type of steel present and the conditions, 100% debonding is usually difficult to achieve. Repeated passes of the rubblizing equipment may help achieve additional debonding, but may also produce a less desirable effect of reduced in-place modulus. This was discussed in Section 4.3.2 of this report. It is always important to remember that the objective of rubblization is to eliminate slab action while retaining a strong support layer for an overlay. We believe it is appropriate to use the term “substantially debonded” in a rubblization specification and let engineering judgment prevail when examining test pit conditions to determine if slab action is eliminated. A minimal amount of PCC bonded to the steel should not cause reflective cracking as long as slab action is eliminated. The finer rubblized material above the steel may also serve as a crack relief “interlayer.” Figures 5.1 and 5.2 below show a steel rebar mat that we consider “substantially” debonded from the PCC. On the other extreme, Figures 2.2 and 2.3 from Chapter 2 show test pits in Michigan where the temperature steel remained substantially bonded to the concrete and could potentially cause a reflective cracking problem. In the case of dowels bars, the contractor should be allowed to sawcut along the joints prior to rubblization to sever the dowels if these cannot be “substantially” debonding. Figure 4.4 illustrates such a condition in one of the NAPTF test pits where sawcutting along the joint would have been recommended.

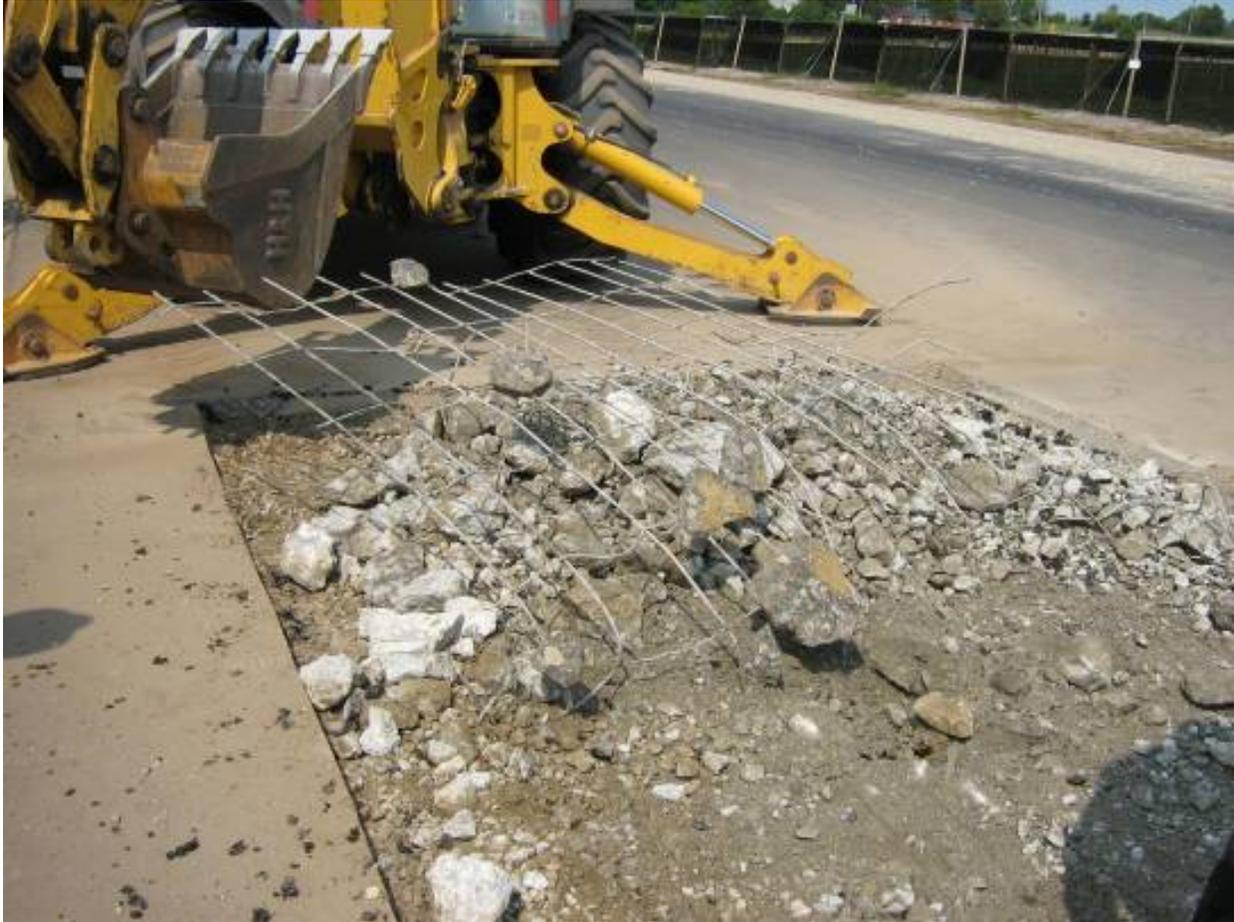
Figure 5.2, Test Pit with Rebar Mat Substantially Debonded
