# **EVALUATION OF EIGHT LONGITUDINAL JOINT CONSTRUCTION TECHNIQUES FOR ASPHALT PAVEMENTS IN PENNSYLVANIA**

NCAT Report 02-03

February 2002

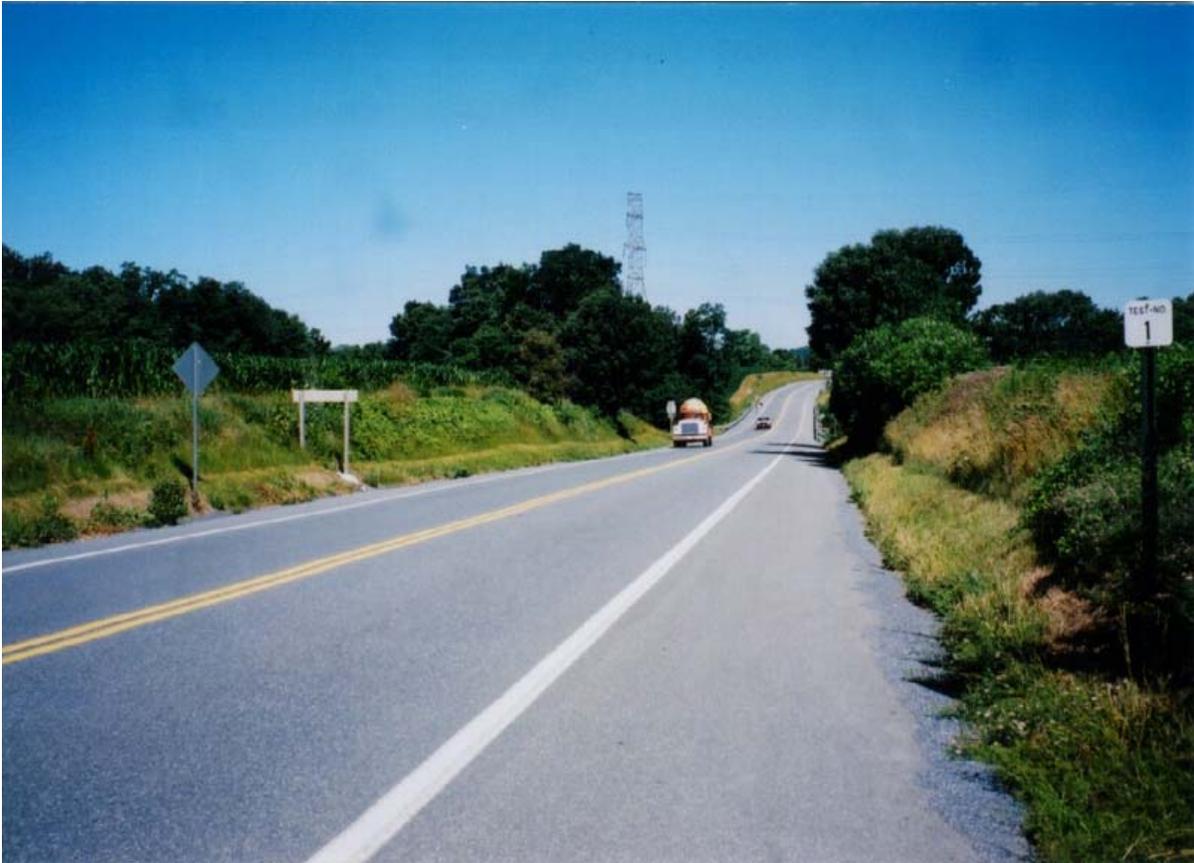
**Figure 1. General View of State Route 441 (Lancaster County)**

All test sections were constructed on September 11-12, 1995. Work began at Station 171+00 (intersection with SR 0241). The northbound lane of this two-lane highway (Figure 1) was paved first. Each test section was 152 m (500 feet) long. The joints were constructed in the ID-2 wearing course, 38 mm (1.5 inch) thick, placed on ID-2 binder course 50 mm (2 inches) thick. The gradation of the wearing course mix was as follows: 100% passing 12.5 mm, 98% passing 9.5 mm, 68% passing 4.75 mm, 45% passing 2.36 mm, 25% passing 1.18 mm, 15% passing 0.6 mm, 11% passing 0.3 mm, 8% passing 0.15 mm, and 5.0% passing 0.075 mm sieve. The asphalt content was 6.0 percent. An AC-20 asphalt cement tack coat was used on the vertical edge of the first paved lane in all sections except No. 7 which used a rubberized asphalt tack coat instead. The ambient temperature during paving ranged from 9°C to 22°C (48°F to 72°F). HMA in the adjacent (hot) lane was placed such that the end gate of the paver extended over the top of the first (cold) lane by about 25-50 mm (1-2 inches). Luting was done with a view to provide extra material to be compacted by the roller in the hot lane near the joint in order to achieve high density. However, instead of just bumping the mix back to the hot lane (which is desirable), it was pushed approximately 150 to 450 mm (½ to 1½ feet) over the hot lane. Breakdown rolling was accomplished with a vibratory roller.

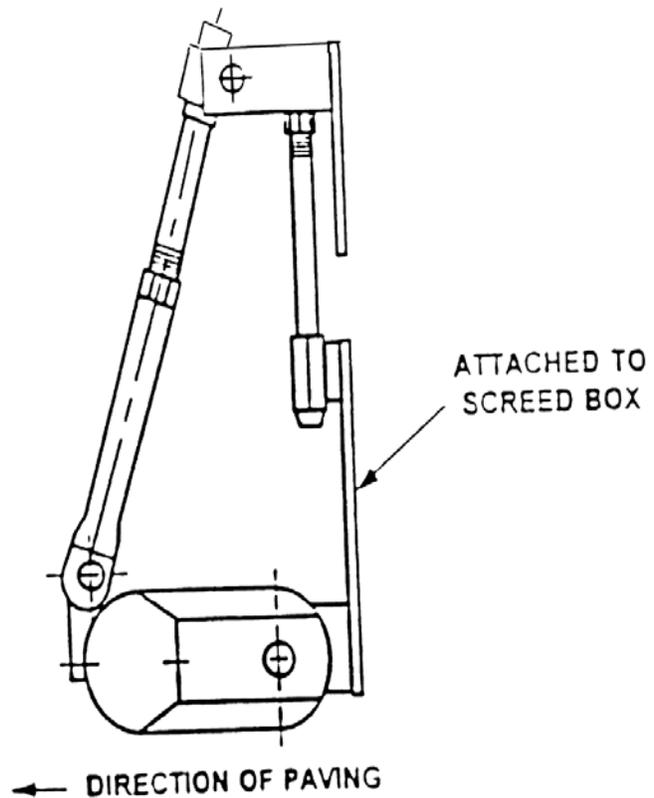
Figure 2. Joint Maker

This is an automated joint construction technique, and a recent innovation in joint making technology. It consisted of a boot-like device about 75 mm wide (Figure 2) which is attached to the side of the screed at the corner during construction. The device forces extra material at the joint through an extrusion process prior to the screed. A kicker plate is also furnished which is attached to the side of the paver to lute back the overlapped HMA mix without the help of a lute man. It is claimed that proper use of the joint maker ensures high density and better interlocking of aggregates at the joint. Prior to the use of the joint maker in the test section, the supplier adjusted the height and angle of attack of this device mounted on both sides of the paver. The first lane was placed in the morning and the adjacent lane was placed in the afternoon. The kicker plate worked well on this project. Rolling of the joint was done from the hot side with 152 mm (6 inches) overlap on cold side.

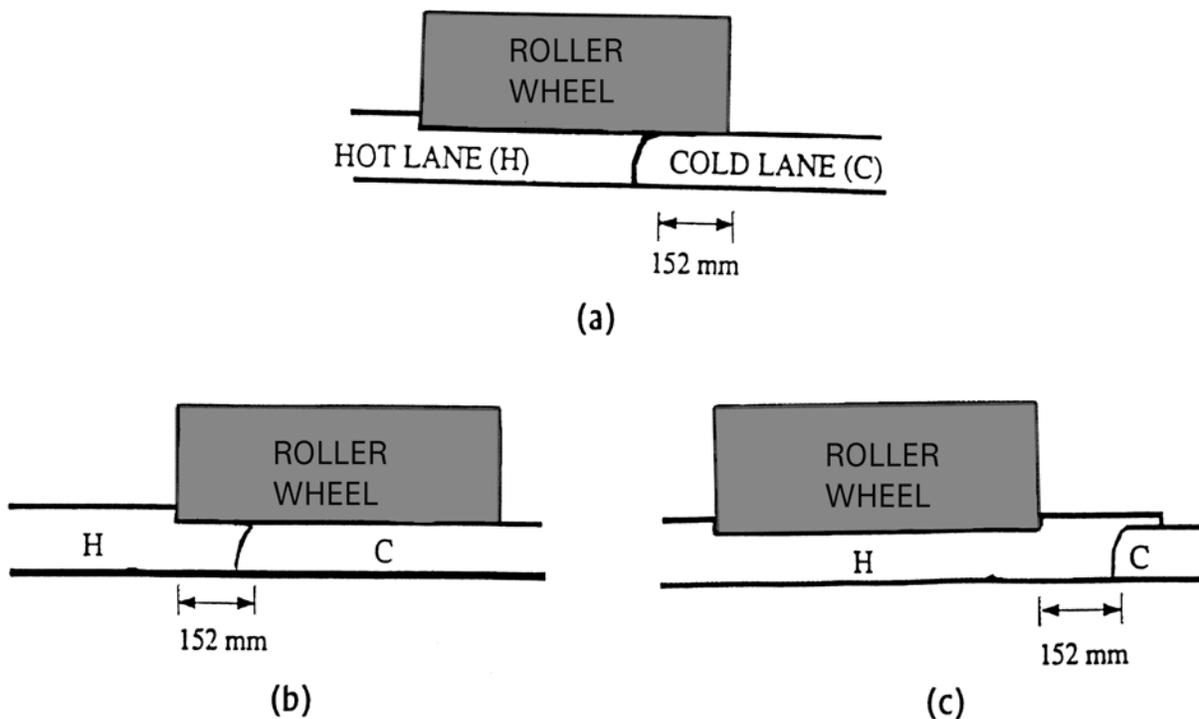
Figure 3. (a) Rolling From Hot Side, (b) Rolling From Cold Side, and (c) Rolling From Hot Side 152 mm Away From Joint

Different techniques for rolling longitudinal joints have been attempted in the past. In this test section, compaction at the joint was done from the hot side of the lane being constructed wherein a major portion of the roller wheel remained on the hot side with about 152 mm (6 inches) overlap on the cold lane (Figure 3a). The first lane was placed in the morning and the adjacent lane was placed in the afternoon. The breakdown roller made two passes (forward and backward)

Rolling in the first pass was done in the static mode with a major portion of the roller wheel on the cold side with about 152 mm (6 inches) of the roller wheel on the hot side of the joint (Figure 3b). This technique is believed to produce a “pinching” effect on the joint. The second backward pass was made in the vibratory mode with roller on the hot side with about 152 mm (6 inch) overlap on the cold side. However, timing in this type of rolling is critical. When the roller is operated on the cold side, the hot side undergoes cooling which can make it difficult to achieve the desired compaction level.

Compaction in this method was started with the edge of the roller about 152 mm (6 inches) from the joint on the hot side (Figure 3c) during the first pass in

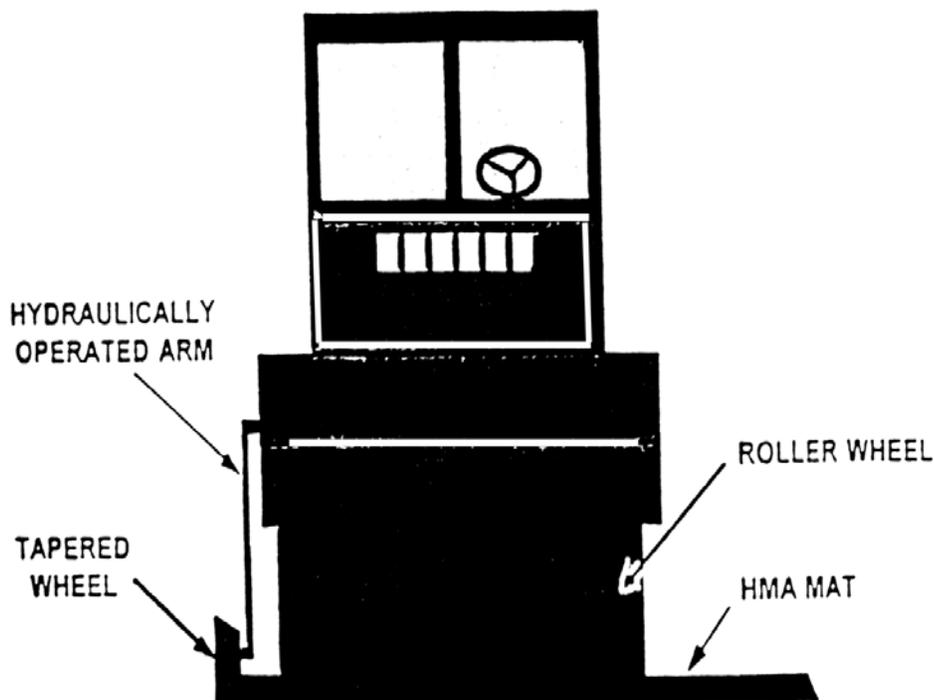
Figure 4. Edge Restraining Device

The restrained edge compaction technique utilizes an edge-compacting device which provides restraint at the edge of the first lane constructed. The restraining device consists of a hydraulically powered wheel which rolls alongside the compactors drum, simultaneously pinching the unconfined edge of the first lane towards the drum providing lateral resistance (Figure 4). The edge restraining wheel is approximately 75 mm (3 inches) wide and has a bevel

of about 45 degrees. This technique is believed to increase the density of the unconfined edge. When the edge restraining device was lowered, the edge of the steel wheel roller was about 152 mm (6 inches) away from the edge. Two passes were made by the roller in static mode with the device lowered. Approximately 75 to 125 mm (3 to 5 inches) of the longitudinal edge of the first lane was restrained with the wheel attachment. Once completed, the longitudinal joint face of the first lane (cold side) had an approximate 45 degree compacted slope. The original breakdown roller then finished the rest of the lane in vibratory mode including the 152 mm (6 inches) which were not rolled when the edge restraining device was lowered. The adjacent lane was placed in the afternoon and compacted from hot side.

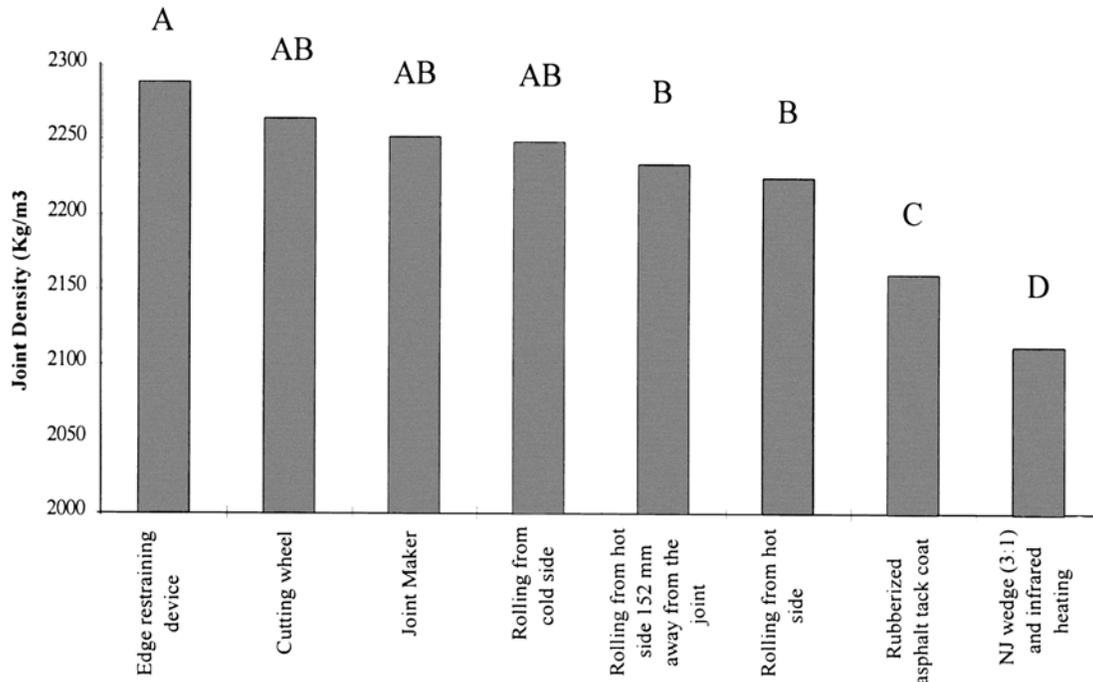
**Figure 5. Joint Density Obtained With Different Techniques Showing DMRT Groups**

The joint density values were used to group the different joint construction techniques. The rankings were done by Duncan’s Multiple Range Test. The air voids values would have provided the same ranking because the same TMD was used to calculate the air voids from the density values. Figure 5 shows the results. Letters such as A, AB, B, and C indicate different groups within which the core densities do not differ significantly at significance level (p) of 0.05. The

edge restraining device (Group A) produced the highest density followed by cutting wheel, joint maker, and rolling from cold side techniques, all of which (Group AB) produced similar densities. Rolling from hot side 152 mm (6 inches) away from joint and rolling from hot side produced the next lower densities, followed by the rubberized asphalt material tack coat and NJ wedge (3:1) techniques. It should be noted that rolling from the hot side generally gave higher density compared to rolling from cold side in NCAT longitudinal joint projects in other states.

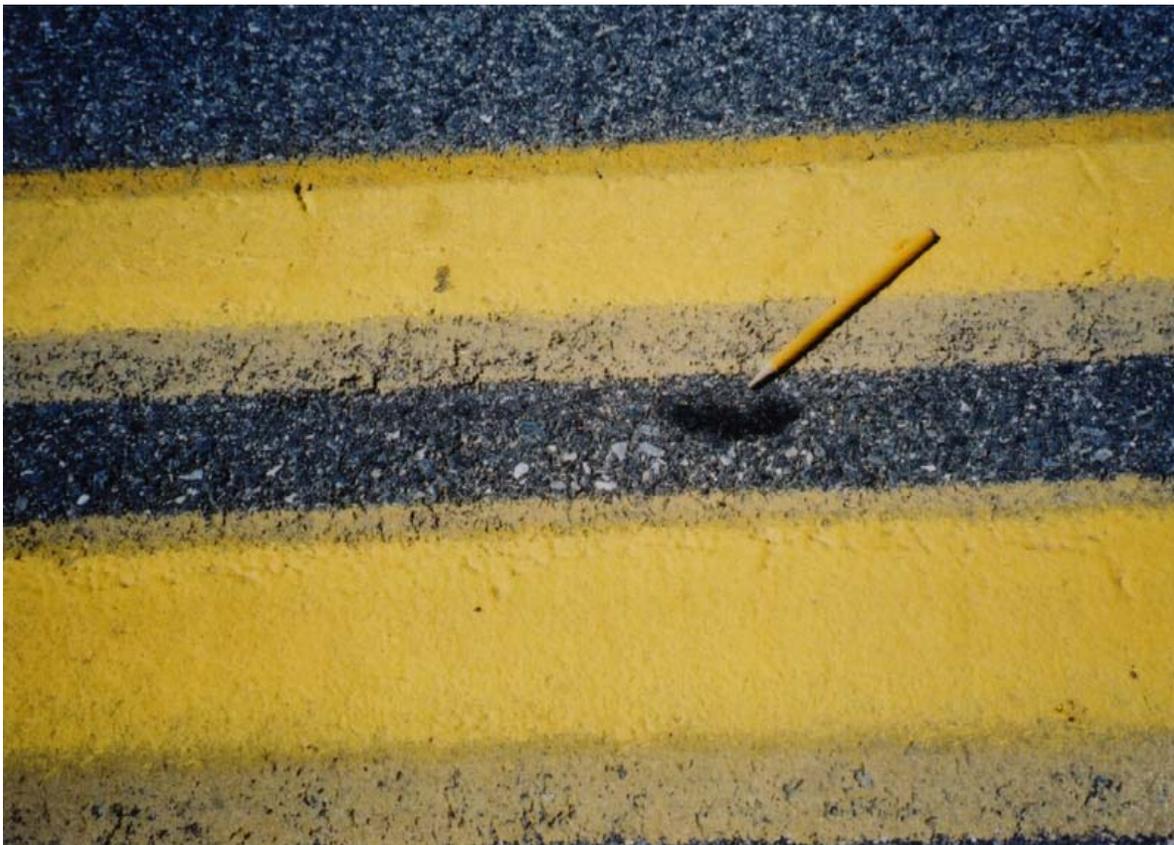
**Figure 6. Closeup of Joint with Rubberized Asphalt Tack Coat, Joint Between Yellow Stripes Is Hardly Visible, Pencil Pointing to Excess Tack Coat on the Surface in a Few Spots Helped Locate the Joint**

As shown in Table 2, the test section with rubberized joint material (Figure 6) has performed the best after six years, closely followed by the test section with cutting wheel (Figure 7). Both sections have not developed any significant cracking. The use of rubberized joint material involves normal paving procedures except that this material is applied as a tack coat on the vertical edge of the first paved lane in lieu of AC-20 asphalt cement. It is surmised that this material keeps the joint sealed and does not allow any cracking to occur because it can stretch when pavement lanes contract transversely during cold weather. This probably keeps water from entering at the longitudinal joint. The rubberized joint material also showed the best performance in seven test sections constructed on I-25 in Colorado in 1994 (5, 6), and evaluated after five years in December 1999.

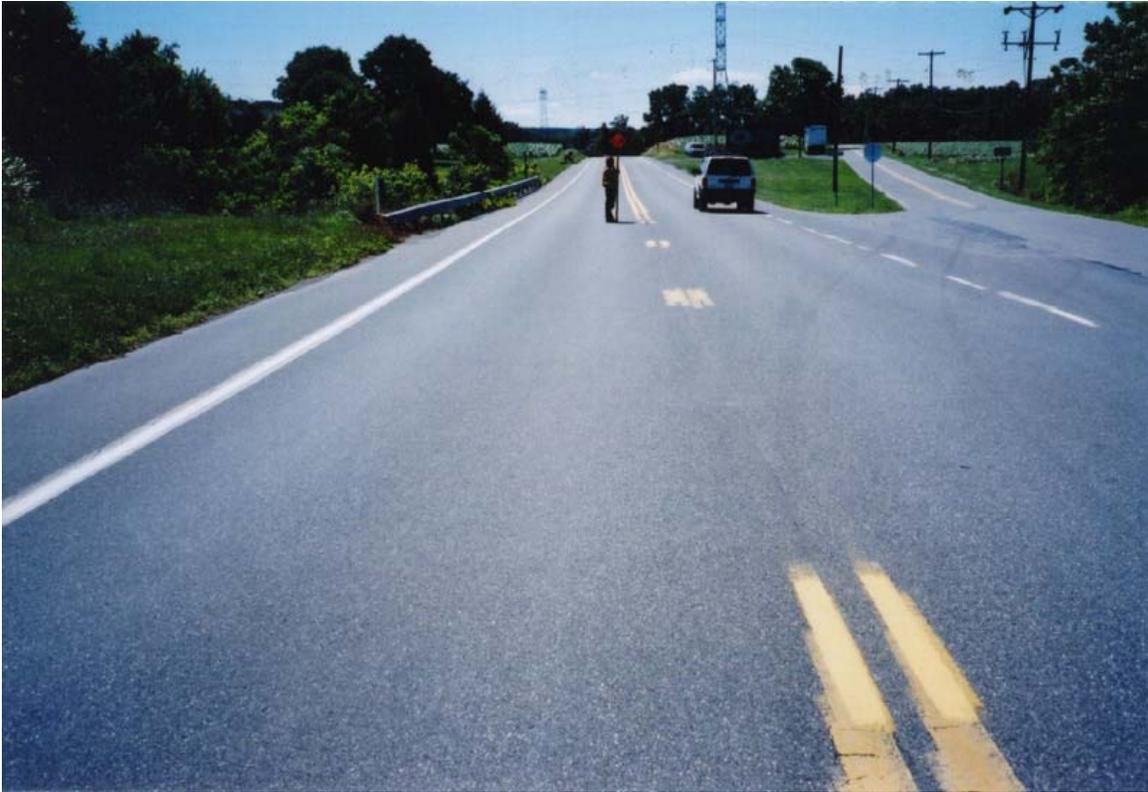
**Figure 7. General View of Section Where Cutting Wheel Used, No Significant Cracking Can Be Seen, Joint Not Visible in Most of the Section**

Cutting wheel has been used widely by HMA contractors in construction of longitudinal joints for airport runway pavements because the Federal Aviation Administration usually specifies a minimum density at the longitudinal joints. However, the quality of longitudinal joints using cutting wheel is dependent upon the skill of the operator in making a straight cut and the skill of the paver operator in matching the cut if it is not straight.

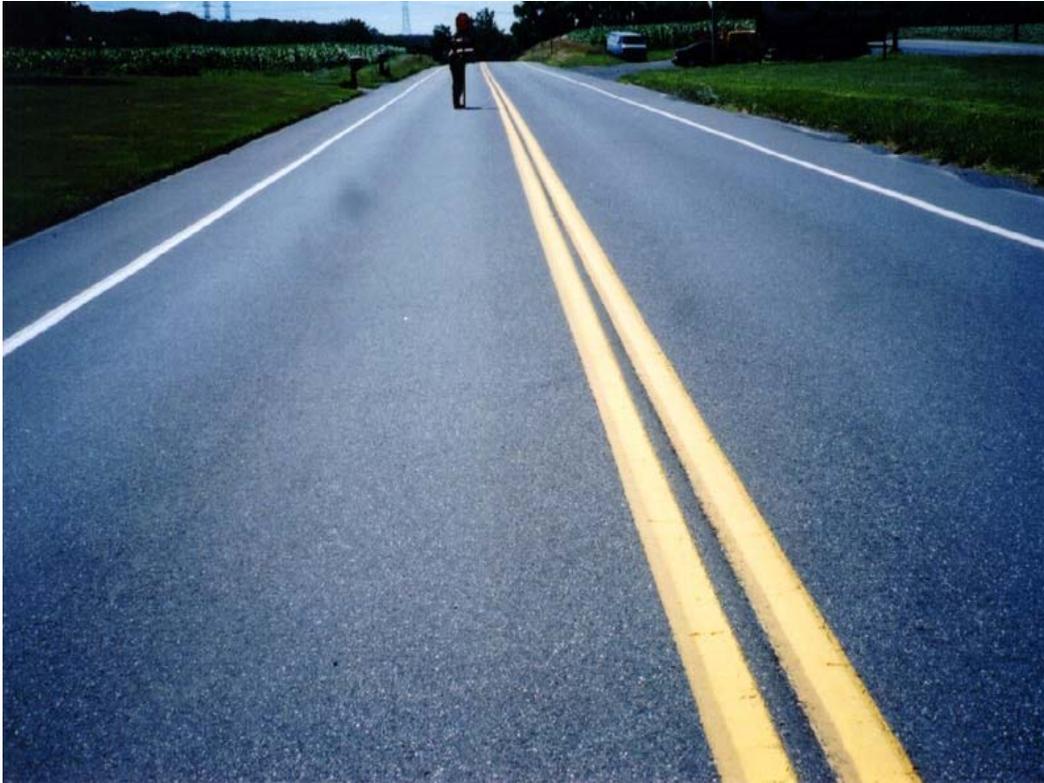
**Figure 8. General View of Section Where Rolling Was Done from Hot Side 152 Mm Away from the Joint, No Significant Cracking Can Be Seen, Joint Visible in Most of the Section**

Test sections using rolling from hot side 152 mm away (Figure 8) and the New Jersey wedge also performed reasonably well after six-year service with no significant cracking. The joint is hardly visible in the former section except where intermittent cracking is seen. Although hardly any cracking can be observed, the New Jersey wedge without any notch developed raveling in a width of 50 to 75 mm at the joint as mentioned earlier. A vertical notch similar to Michigan joint would have prevented the raveling by accommodating the mix aggregate particles of the hot mat in the notch and also achieving relatively higher compaction level as was observed on Michigan test project (6).

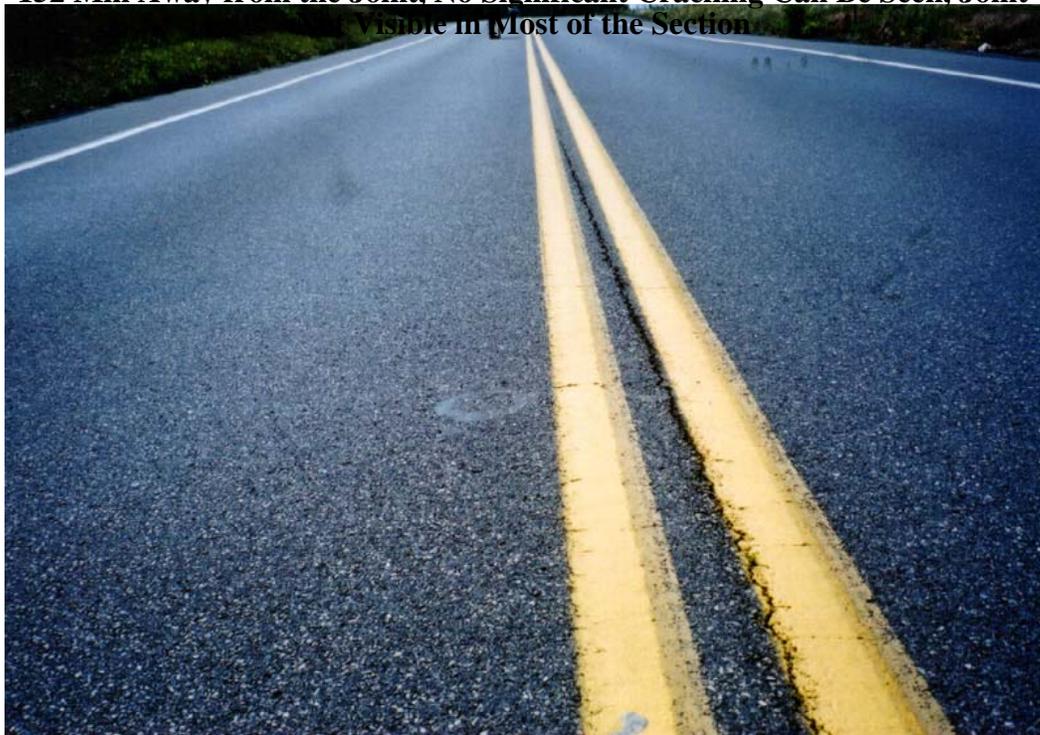
**Figure 9. Section Where Joint Maker Used, an Almost Straight Crack with an Average Width of 9.5 Mm Can Be Seen Between the Yellow Stripes**

Sections using edge restraining device and joint maker (Figure 9) developed cracking in about 35 and 85 percent of the length of the 152-m (500-foot) test sections, respectively. Edge restraining device was able to achieve better compaction at the joint (7.7% air voids) compared to the joint maker which achieved 9.2% air voids (Table 1). The average width of crack in section using edge restraining device is 4.75 mm (3/16 inches) as compared to average width of 9.5 mm (3/8 inches) in section using joint maker. However, similar to cutting wheel, the quality of longitudinal joint made with the edge restraining device depends on the skill of the roller operator who has to do the hard task of keeping the device right at the edge of the loose mat. This is indicated by intermittent cracks in this section (Table 2).

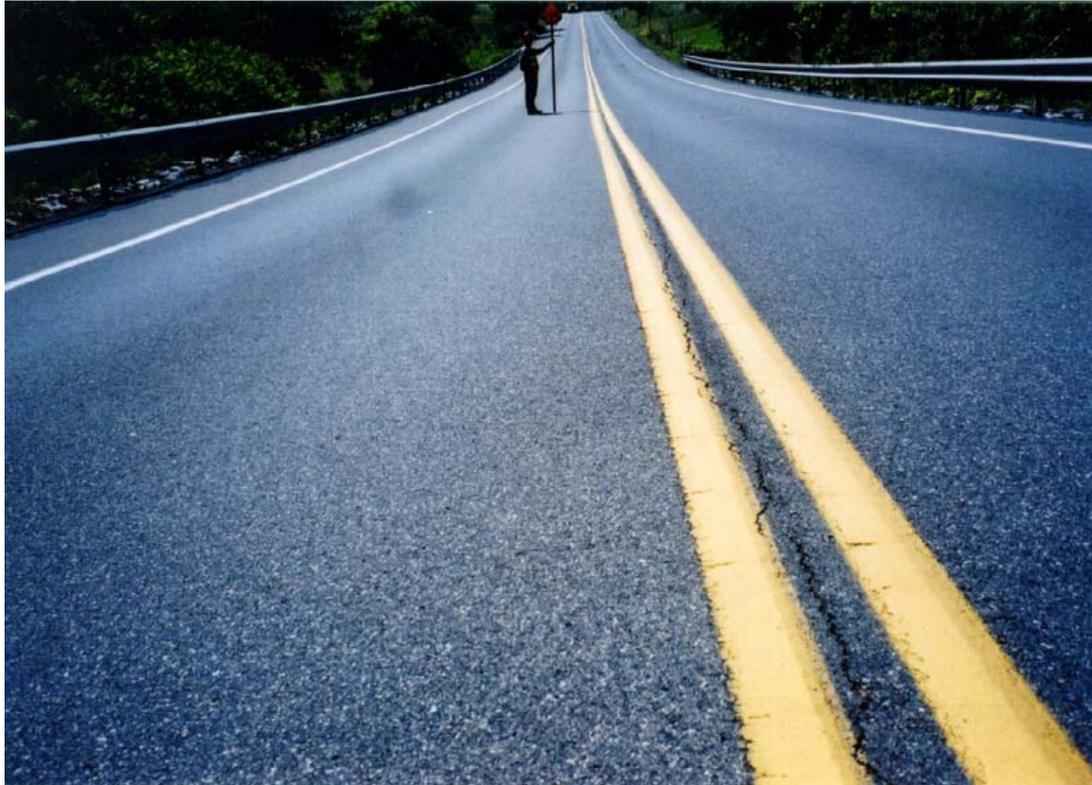
**Figure 10. Section Where Rolling Was Done from Hot Side with 152 Mm Overlap on Cold Side, a Jagged Crack Can Be Seen Between the Yellow Stripes**

Rolling from hot side (Figure 10) and rolling from cold side (Figure 11) finished last with cracking in 99 and 88 percent of length, respectively, of the test section. However, rolling from cold side resulted in a wider and deeper crack compared to rolling from hot side. It should be noted all test sections except nos. 3 and 4 were rolled from hot side with an overlap of about 152 mm on cold side. This was done based on NCAT's experience in other states where rolling from hot side generally gave higher density than rolling from cold side because a vibratory roller can be used effectively in the first pass.

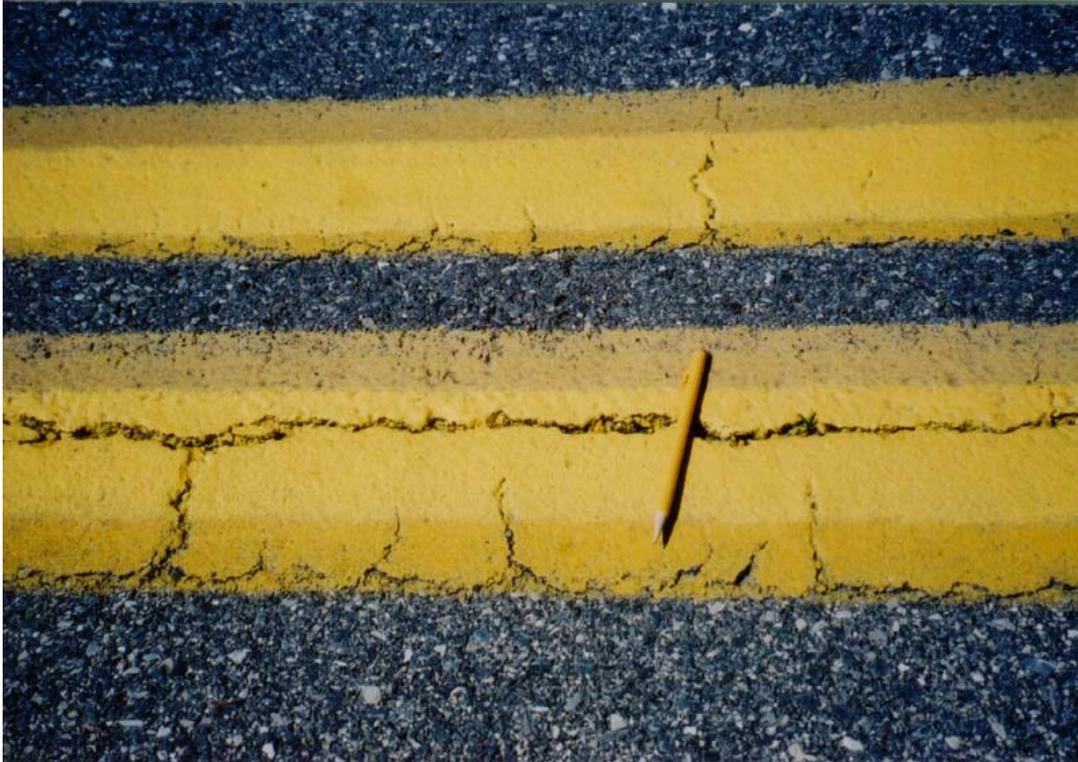
**Figure 11. Closeup of Jagged Cracking in the Section Rolled from Cold Side, the Crack Is Generally Wider and Deeper than That in Section Rolled from Hot Side**
