**NCAT Report 20-03**

**BENEFITS OF  
REHABILITATING CONCRETE  
PAVEMENTS WITH SLAB  
FRACTURING AND ASPHALT  
OVERLAYS**

**By  
Randy West  
Fan Gu  
Benjamin F. Bowers**

**May 2020**

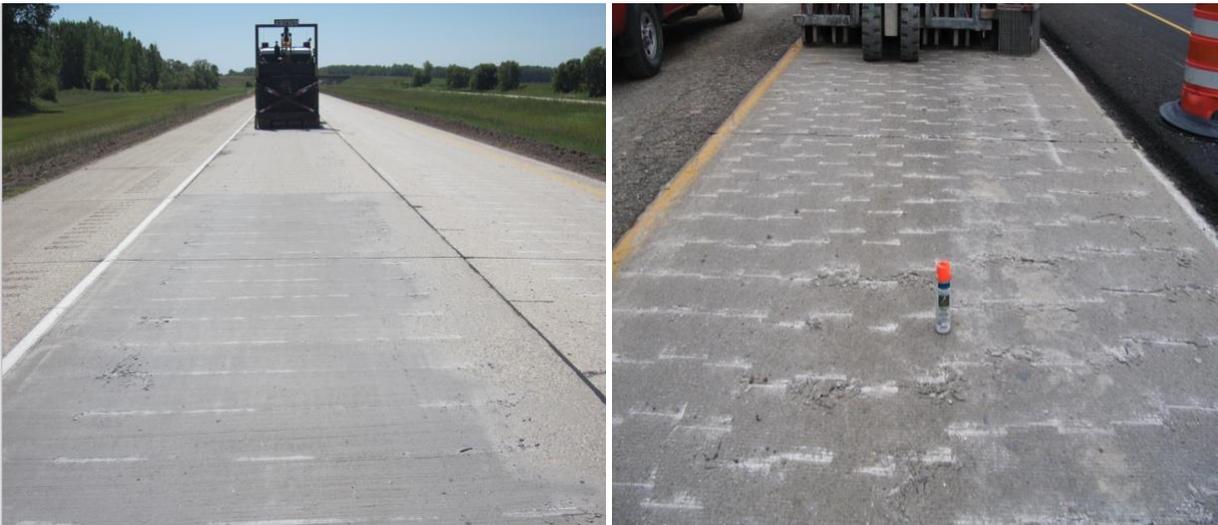
**Figure 1. Typical Fractured PCC using C&S (left) and B&S (right) Methods (Antigo, 2019)**

C&S and B&S minimize the movement of concrete slabs by reducing the effective slab length and seating the broken slab pieces (Freeman, 2002). Both techniques utilize pile drivers, guillotine hammers, whip hammers, or impact hammers to crack the concrete slabs followed by a heavy pneumatic roller to seat the cracked or broken pieces onto the base. Walker (2019) suggested that a test section should be used to establish the fracturing effort of the equipment with a test pit to verify effectiveness. Two roller passes should be required for seating. Excessive rolling might reduce interlock of the slab pieces. The only distinction between B&S and C&S is that C&S is used on jointed plain concrete pavement (JPCP) and B&S is applied to jointed reinforced concrete pavement (JRCP). Figure 1 shows typical fractured PCC slabs using C&S and B&S methods.

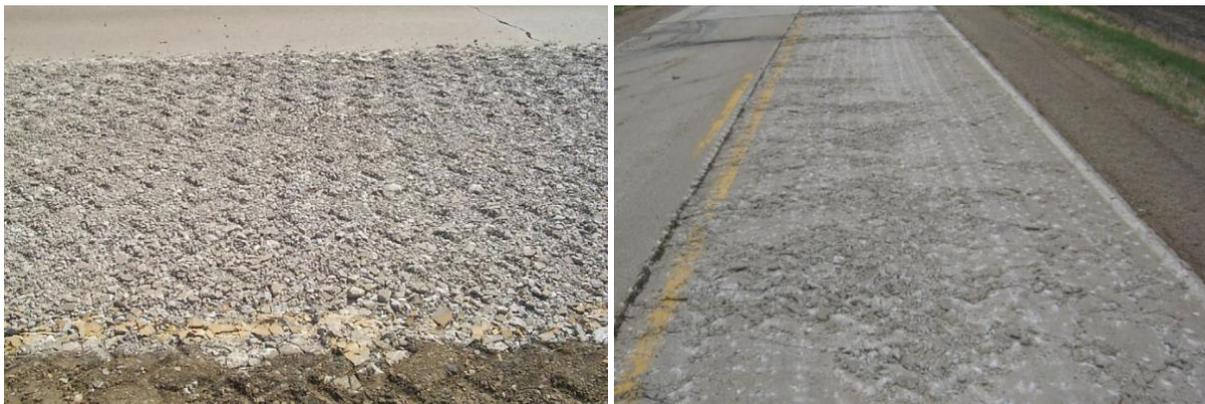
a. Rubblization

b. Modified Rubblization

Regarding the degree of slab fracturing, NAPA IS-117 recommends that the maximum crack spacing (or resulting fragment size) be less than 30 inches for C&S projects and less than 12 to 18 inches for B&S projects and that the nominal maximum fragment size be limited to 8 to 12 inches for rubblization projects. In general, rubblization can meet the specified fragment size only when the base and subgrade provide adequate support. If the underlying support is poor, rubblization will yield inadequate support for the asphalt overlay (Antigo, 2014). In the 2000s, Antigo developed a modified rubblization technique that employs less fracture energy to produce a stiffer rubblized concrete layer to support construction operations and asphalt overlays while still effectively eliminating reflective cracking (Buncher et al., 2008). They specified that the maximum particle size should be less than 12 inches at the surface and less than 15 inches at the bottom of the slab, which differs from the recommended maximum size of 12 inches in IS-117 (Antigo, 2015). Figure 2 shows typical fractured PCC slabs using rubblization and modified rubblization methods.

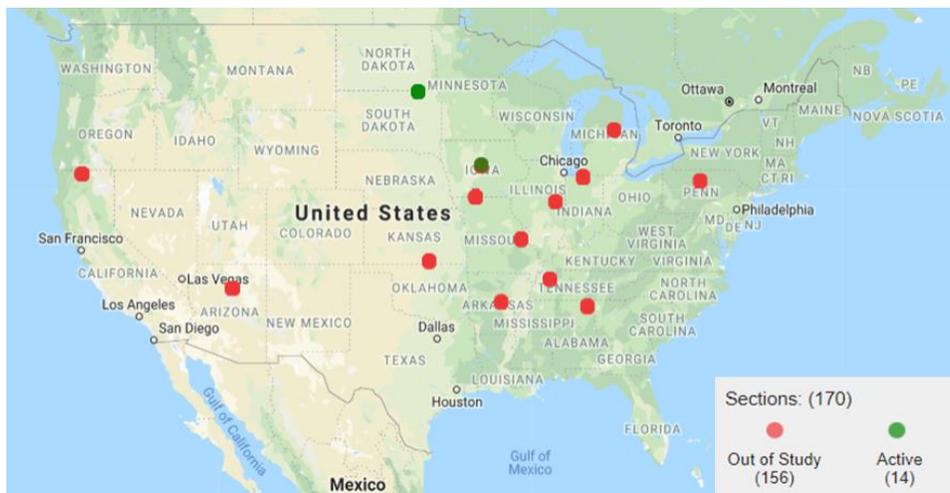
**Figure 3. Map of LTPP SPS-6 Sections**

wet-no freeze [WNF], and dry-freeze [DF]). Figure 3 shows a map of LTPP SPS-6 projects. The sections with green indicate that they are still under evaluation by LTPP, but those with red are no longer monitored. Hall et al. (2002, 2003) conducted an LTPP data analysis of the experiment to quantify the effectiveness of rehabilitation treatments based on changes in performance (international roughness index [IRI], rut depth, and percent cracking area) before and after treatments. In that study, the percent cracking area was calculated by combining the percent area of alligator cracking and block cracking of all severities, but it did not include transverse cracking. Excluding transverse cracking, presumed to be largely associated with reflection cracking, is considered to be a significant oversight of those studies since minimizing reflection cracking is the primary objective of slab fracturing methods. Ambroz and Darter (2005) further investigated the SPS-6 experiment and found that the data availability and completeness were good overall. They suggested performing site-by-site analyses to determine the effects of design factors and treatment methods on the long-term performance of rehabilitated pavements.

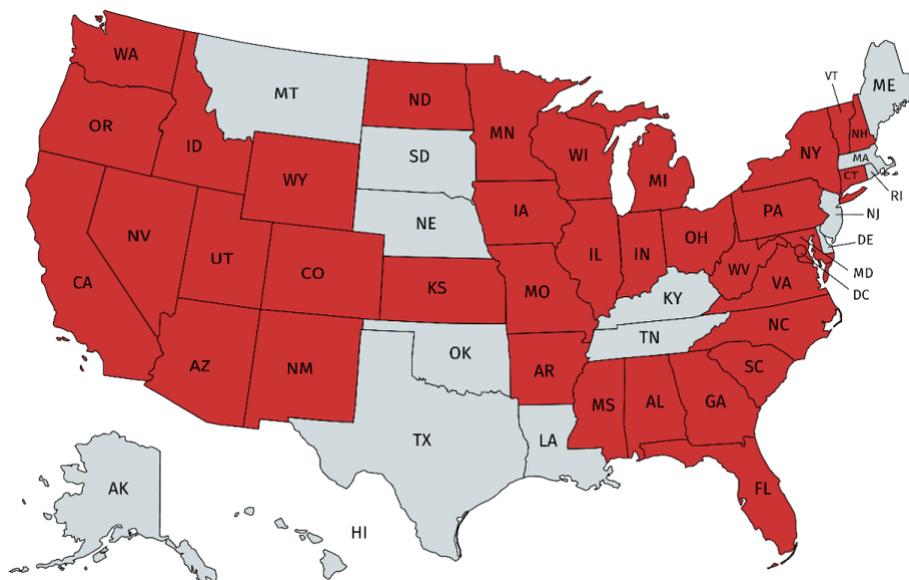
Figure 4. Geographical Distribution of Respondents' Organizations

The survey was distributed to state asphalt pavement associations (SAPAs), state and local agency representatives, slab-fracturing equipment manufacturers, and consulting pavement design engineers. A total of 58 quality responses were received. Figure 4 shows the geographical distribution of respondents' organizations. As illustrated, the survey covered the majority of states that had concrete rehabilitation projects in the past 10 years. Several states (i.e., Kentucky, Louisiana, and Texas) with considerable quantity of concrete rehabilitation projects were unfortunately not represented in this study.

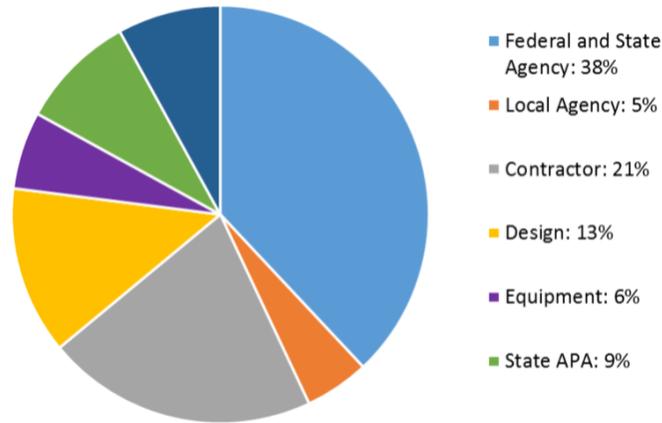
**Figure 5. Overview of Respondents' Organizations**

Figure 5 shows the categories of the respondents' organizations. Majority of respondents were from federal and state agencies, contractors, and design firms. Figure 6 illustrates the years of work experience of the respondents related to concrete rehabilitation. More than 65% of respondents had at least five years of relevant experience.

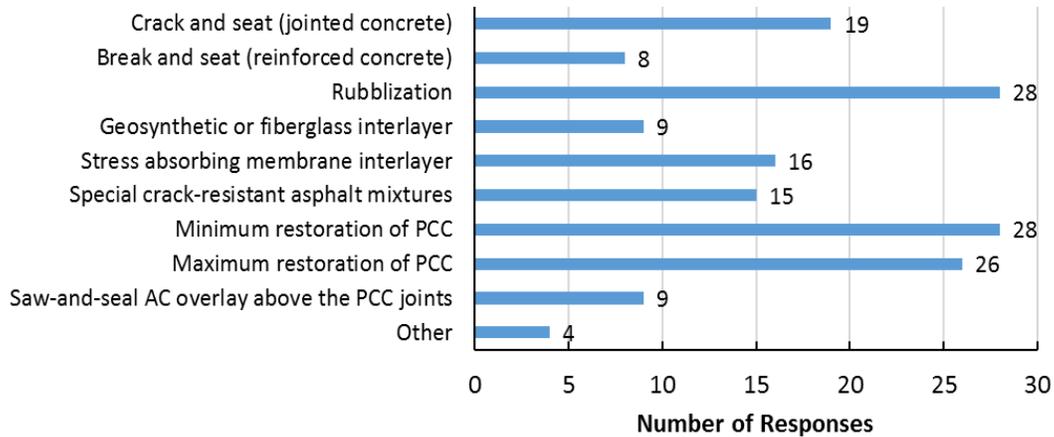
**Figure 7. PCC Rehabilitation Techniques Used by Respondents' Organizations in Past 10 Years**

Figure 7 shows the popularity of PCC rehabilitation techniques used by respondents' organizations in the past decade. The most popular PCC rehabilitation options were minimum and maximum restoration of PCC and rubblization. Minimum restoration includes sealing of joints, surface diamond grinding, etc., and maximum restoration includes full or partial repair of broken slabs and deteriorated joints, retrofit of dowel bar, etc. C&S, stress-absorbing membrane interlayer, and special crack-resistant asphalt mixtures including stone-matrix asphalt, open-graded asphalt, and gap-graded asphalt-rubber mixtures were also frequently used for PCC rehabilitation to retard reflective cracking. Compared to rubblization and C&S, B&S was much less frequently used for PCC rehabilitation.

Figures 8-10 summarize the number of C&S, B&S, and rubblization projects that were conducted by respondents' organizations in the past 10 years. These results were consistent with the finding from Figure 7 that C&S and rubblization were more popular than B&S for PCC rehabilitation.

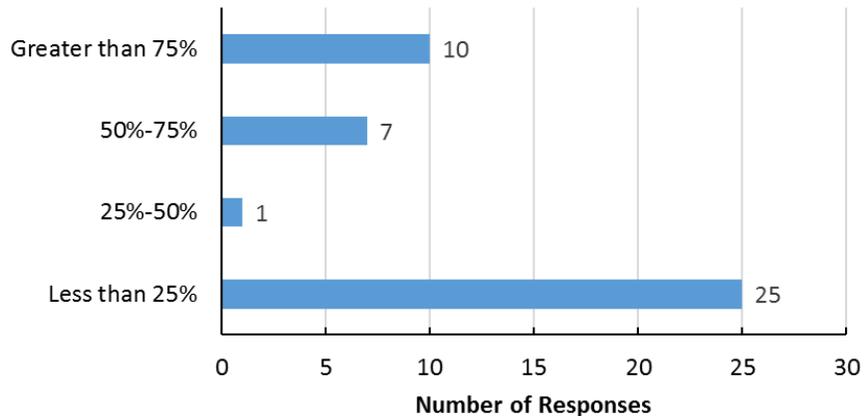
**Figure 11. Percent of PCC Rehabilitation Projects Utilizing Edge Drain Systems**

Figure 11 shows the percentage of PCC rehabilitation projects that included an edge drain system. Note that the installation of edge drain is effective in reducing the moisture damage of rehabilitated pavements. However, the survey results indicate that edge drain systems were not often used in PCC fracturing projects. This contradicted the finding from Ksaibati et al. (1999) stating that the majority of states added edge drain to rubblized pavements.

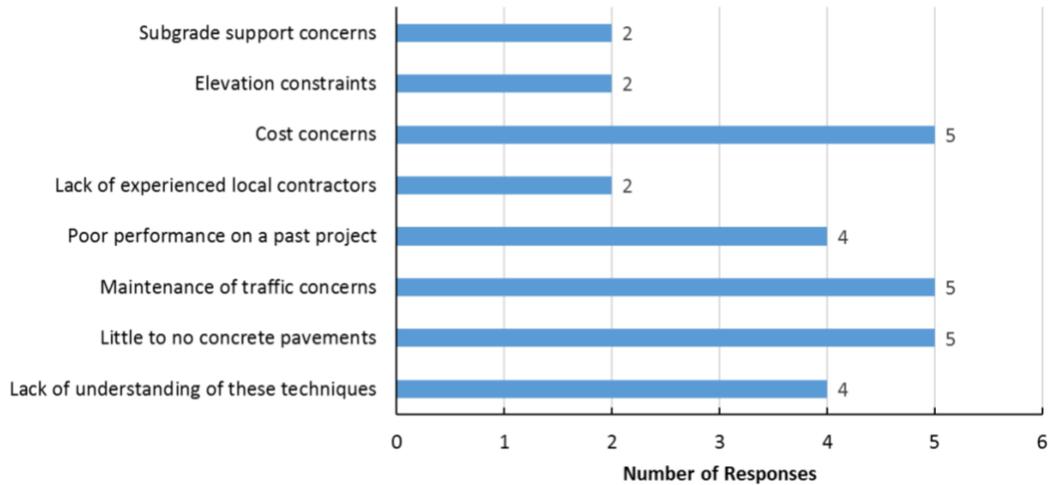
**Figure 12. Reasons Preventing Respondents' Organizations from Using Slab-Fracturing Methods**

Figure 12 shows concerns that prevented respondents' organizations from using slab-fracturing methods to rehabilitate PCC pavements. As shown, the primary reasons were cost concerns, poor performance on a past project, maintenance of traffic concerns, and lack of understanding of slab-fracturing techniques.

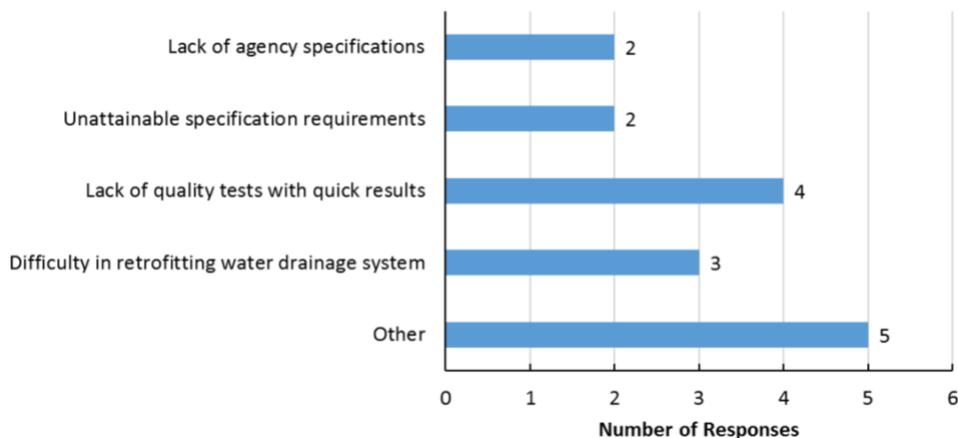
**Figure 13. Challenges in Performing Slab-Fracturing Methods**

Figure 13 shows the identified challenges faced in performing slab-fracturing methods, including lack of agency specifications, unattainable specification requirements, lack of quality tests with quick results, and difficulty in retrofitting water drainage systems. Some respondents indicated other challenges such as lack of agency experience or specified projects with slab-fracturing techniques.

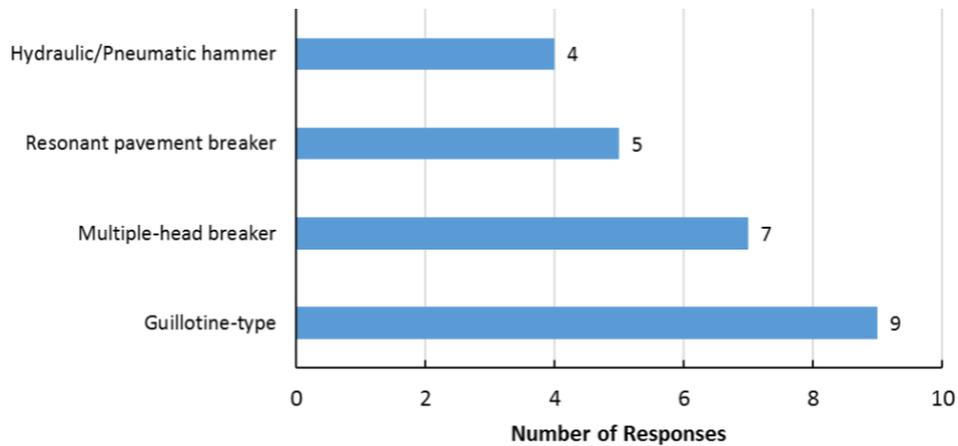
**Figure 14. Types of Equipment Used for Breaking PCC Slabs in Past 10 Years**

Figure 14 summarizes the types of equipment used for breaking PCC slabs in the past 10 years. As indicated, guillotine-type equipment, multiple-head breaker, resonant pavement breaker, and hydraulic or pneumatic hammer were the most popular types of equipment used. Figure 15 demonstrates the types of equipment used for seating fractured PCC slabs in the past 10 years. Heavy pneumatic rollers, steel vibratory rollers, and a combination of vibratory and pneumatic rollers were mainly used for seating. One respondent indicated other equipment for seating but did not specify the equipment type.

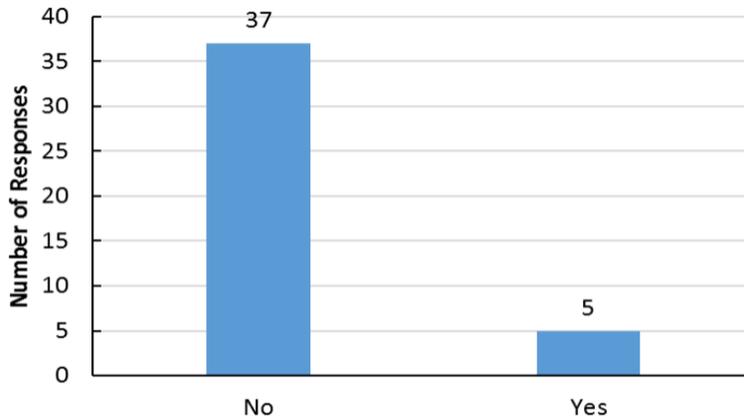
**Figure 16. Respondents' Organization Requirement or Supply of Specific Mixture for Use on Fractured PCC**

This survey investigated the asphalt overlay mix design, which was used to determine the optimum mixture component materials, including aggregate, asphalt binder, and additives. As shown in Figure 16, only five organizations required or supplied specific mixture for use on fractured PCC pavements. The mixtures used to mitigate reflective cracking were utilized standard dense-graded mixture, modified dense-graded mixture with lower air voids and higher asphalt content, standard open- or gap-graded mixture, and modified gap-graded asphalt-rubber mixture, as presented in Figure 17.

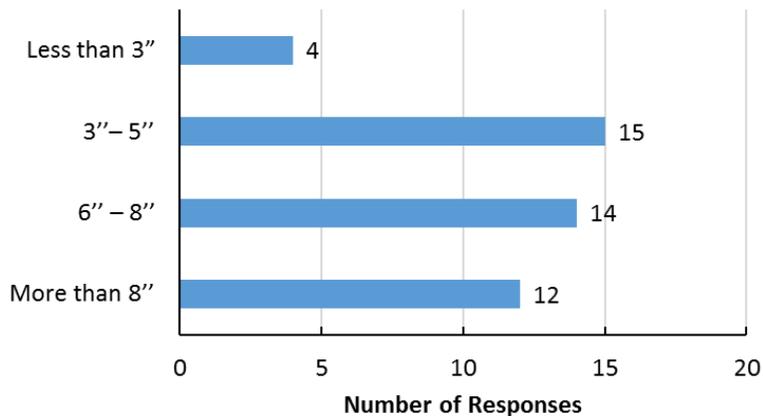
**Figure 18. Thickness Range of Asphalt Overlays for Existing Projects Using PCC Fracturing Techniques**

Figure 18 summarizes the thickness ranges of asphalt overlays for existing projects that used PCC fracturing techniques. As shown, most asphalt overlays had layer thicknesses greater than 3 inches, and about 27% of asphalt overlays had layer thicknesses greater than 8 inches.

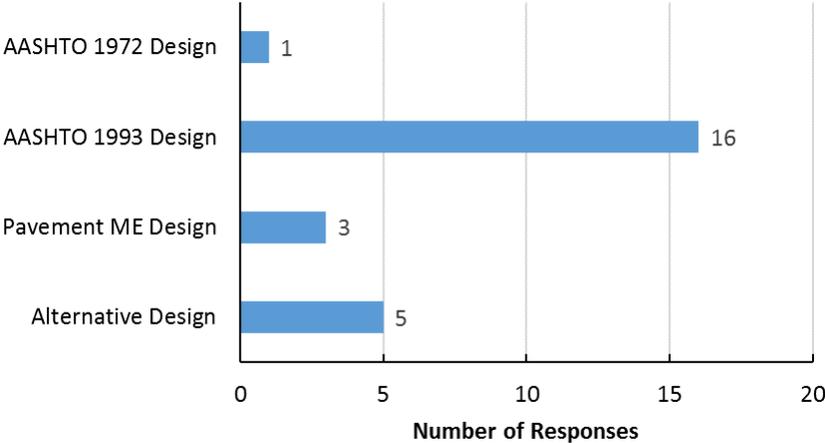
**Figure 19. Structural Design Method Used for Asphalt Overlays on Fractured PCC**

This survey also investigated the structural design methods for asphalt overlay, which were used to determine the layer thickness required to accommodate a given loading regime. Figure 19 presents the structural design methods used for asphalt overlays on fractured PCC. The majority of states used the AASHTO 1993 method. It is worth mentioning that Wisconsin used the AASHTO 1972 method; Indiana, Missouri, and Wyoming used Pavement ME design; and California, New York, and Illinois used their own mechanistic-empirical design methods.

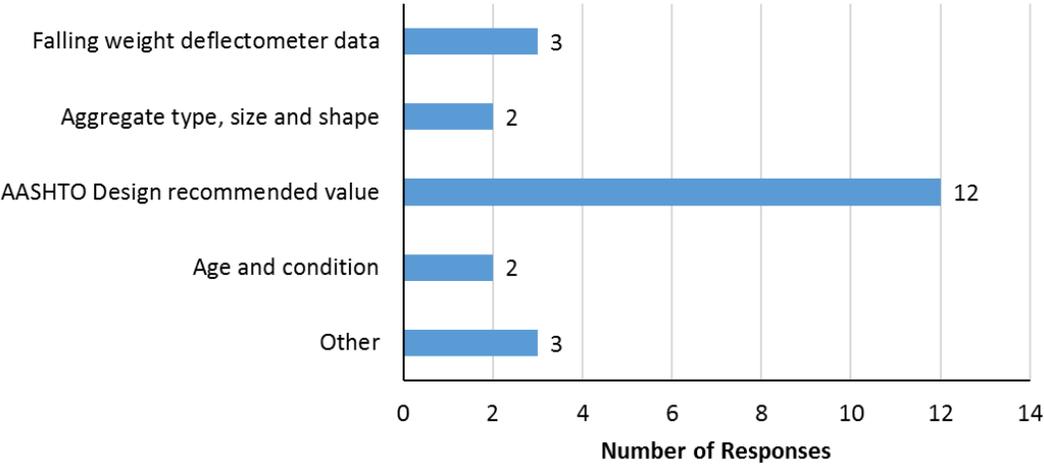
**Figure 20. Approaches for Determining Layer Coefficients of Fractured PCC Layers**

For those states that used the AASHTO 1993 method, Figure 20 shows the approaches they employed for determining layer coefficients of fractured PCC layers. As demonstrated, most of the states used AASHTO recommended values, which are shown in Table 2. Maryland, Iowa, and Oregon used FWD data; Colorado and South Carolina used aggregate type, size and shape; and South Carolina and Nevada used age and condition to determine the layer coefficients of fractured PCC layers.

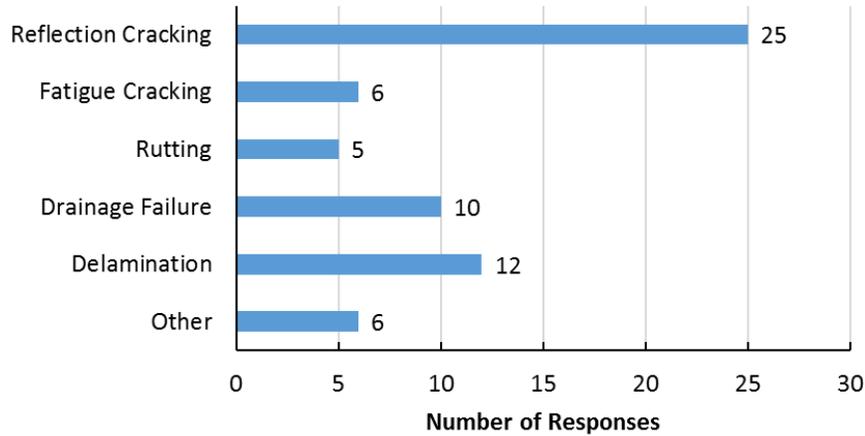
**Figure 21. Typical Distresses Observed for Rehabilitated PCC with Asphalt Overlay**

Figure 21 presents the typical distresses observed for rehabilitated PCC pavements with asphalt overlay. As shown, the predominant distress is reflection cracking, followed by drainage failure and delamination or debonding of the overlay. Other distresses were identified by respondents, including thermal cracking, top-down cracking, and longitudinal joint cracking.

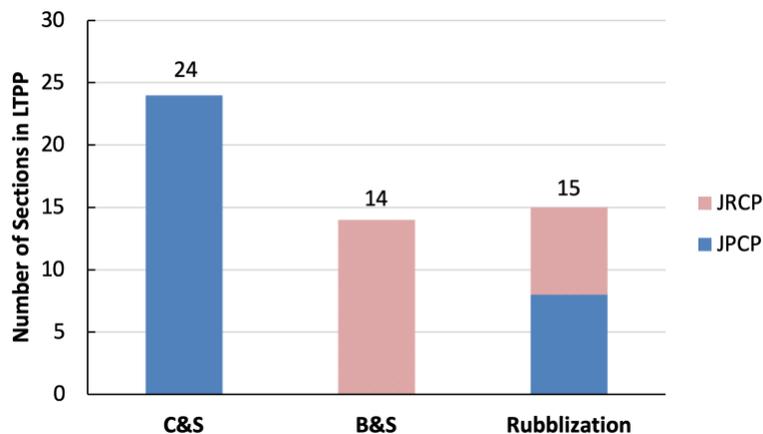
**Figure 22. Identified Pavement Sections Using Slab Fracturing Techniques**

Figure 22 shows the number of pavement sections using various slab-fracturing techniques from the LTPP SPS-6 experiment. As presented, there are 24 C&S sections, 14 B&S sections, and 15 rubblization sections. Among them, some C&S and B&S sections have asphalt overlay thicknesses other than 4-inch and 8-inch, which were not included in the data assembly. Figure 22 also demonstrates that C&S was used for JPCP, B&S was applied to JRCP, and rubblization was suitable for both JPCP and JRCP.

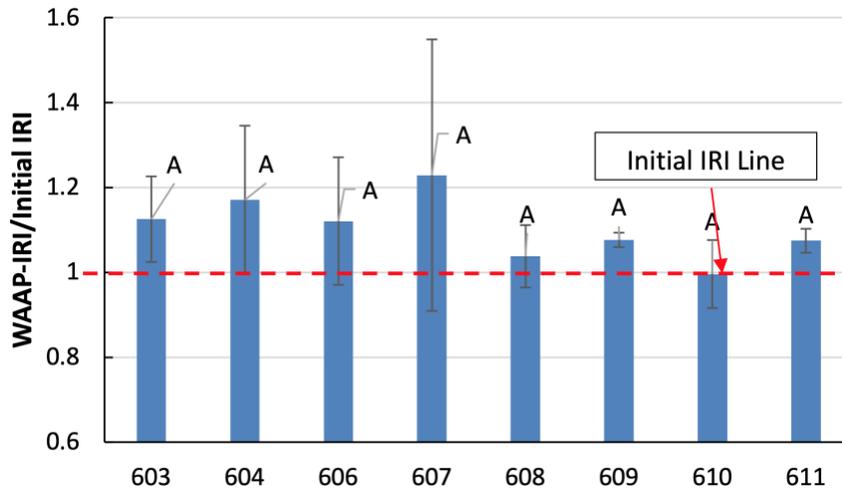
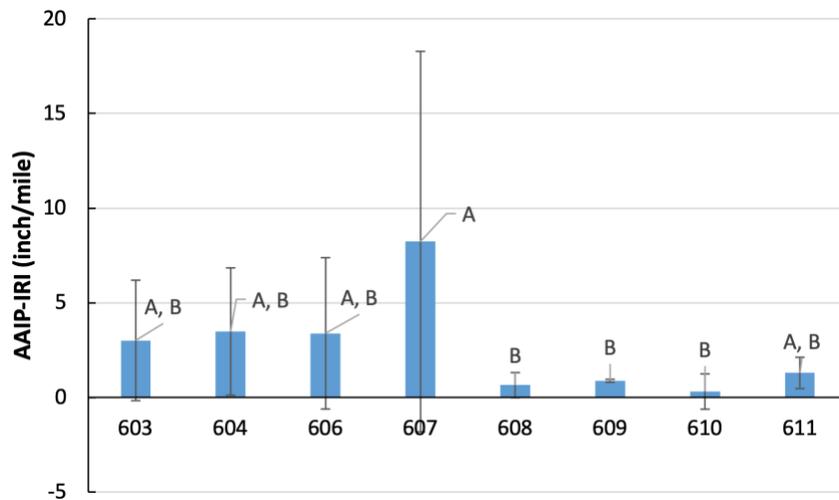
a. Effects of PCC Treatments on WAAP-IRI Divided by Initial IRI

b. Effects of PCC Treatments on AAIP-IRI

**Figure 23. Effects of PCC Treatments on International Roughness Index**

An Analysis of Variance (ANOVA) with Tukey’s honestly significant difference (HSD) test was conducted to statistically rank these results, as shown in Figure 23a. The confidence level was assigned as 95% ( $\alpha=0.05$ ). Label A represents the group of sections that had the highest value, label B represents the group of sections having statistically lower value, whereas label A/B represents the group of sections that had the measured value between Group A and Group B. As presented in Figure 23a, all of the PCC treatments were ranked the same in terms of WAAP/Initial IRI. This indicates that there was no statistical difference among these treatments for improving the weighted annual average IRI. Figure 23b shows AAIP-IRI for the different PCC

treatments, indicating the average change in IRI per year. As presented, the pavement sections using C&S or B&S with 4-inch asphalt overlays (section code 607) had the highest annual change in IRI, while C&S or B&S with 8-inch asphalt overlays (section code 608) and rubblization with various overlay thicknesses (section codes 609, 610, and 611) yielded much lower annual changes in IRI. Tukey's HSD test was also conducted to rank these results. The ranking results show that pavement sections using C&S or B&S with 8-inch asphalt overlays or rubblization with various overlay thicknesses had statistically lower annual changes in IRI than the other PCC treatments, including minimum and maximum restoration, overlay saw and seal, and C&S or B&S with 4-inch asphalt overlays.

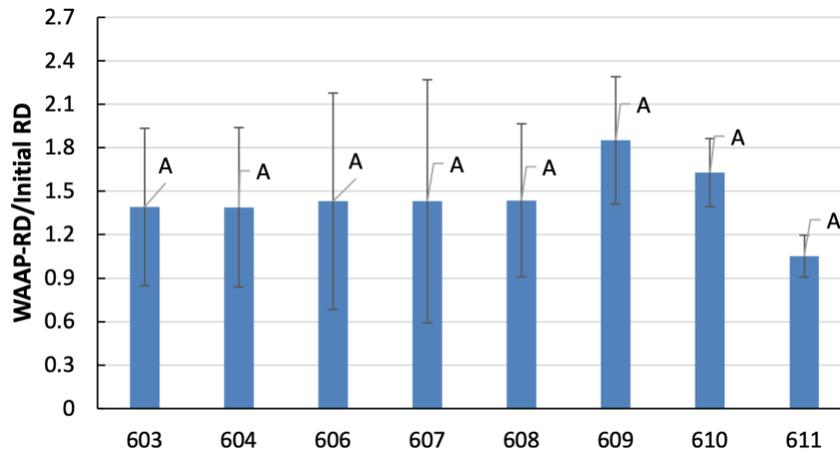
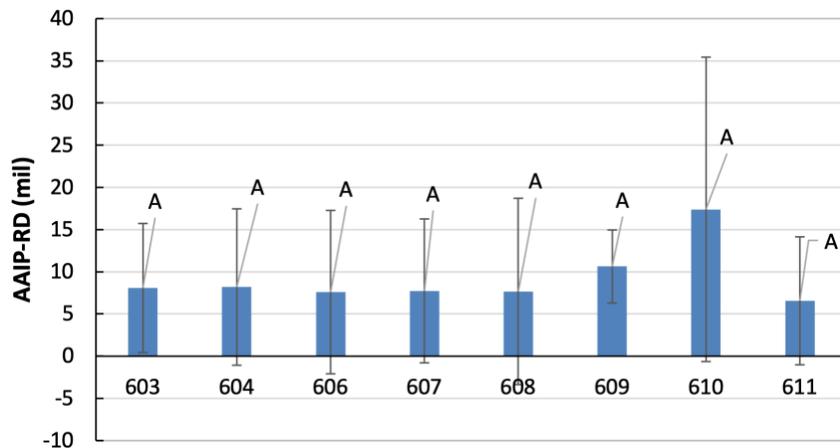
a. Effects of PCC Treatments on WAAP-RD Divided by Initial RD

b. Effects of PCC Treatments on AAIP-RD

**Figure 24. Effects of PCC Treatments on Rut Depth**

Figures 24a and 24b present the influence of PCC treatments on rutting performance. As shown in Figure 24a, rubblization with a 6-inch or less asphalt overlay (section code 609) and with more than an 8-inch asphalt overlay (section code 611) provided the highest and lowest weighted rut depths, respectively. Similarly, the pavement sections using these two PCC

treatments had the highest and lowest annual change in rut depth, as shown in Figure 24b. The Tukey's HSD test results shown in Figures 24a and 24b indicate that these PCC treatments were not statistically different with respect to long-term rutting performance.

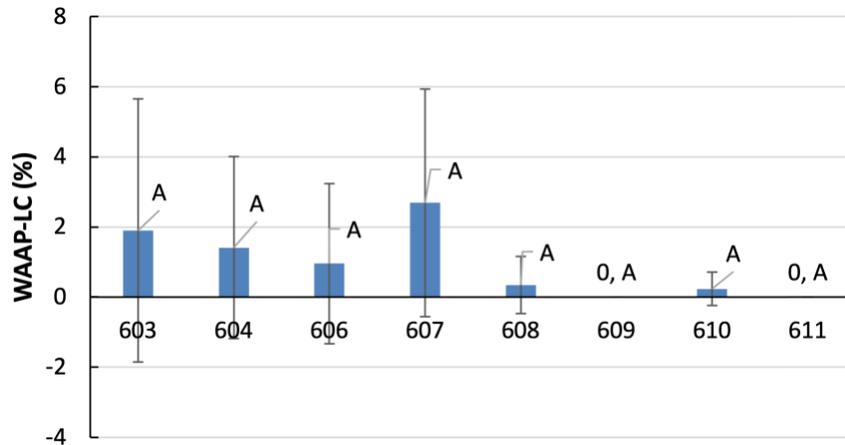
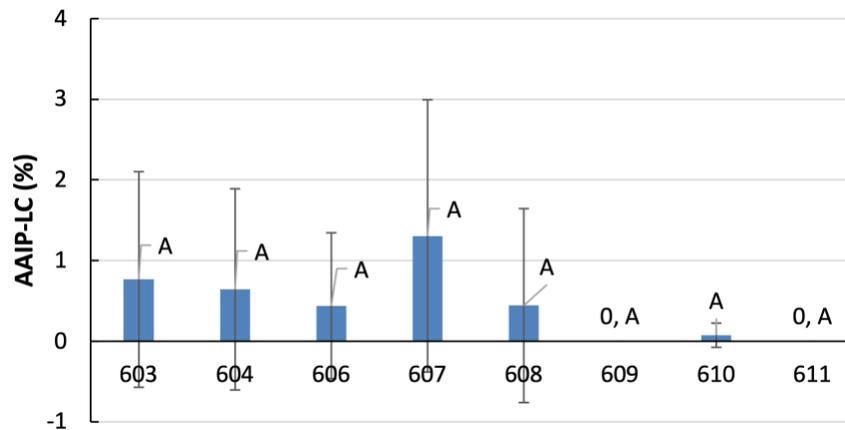
a. Effects of PCC Treatments on WAAP-LC

b. Effects of PCC Treatments on AAIP-LC

**Figure 25. Effects of PCC Treatments on Longitudinal Cracking**

Figures 25a and 25b demonstrate the impacts of PCC treatments on longitudinal cracking performance. Since as-constructed asphalt overlays can be assumed to have no cracking distress, the weighted cracking performance does not require normalization for comparisons. As presented in Figures 25a and 25b, all of the sections had relatively low weighted longitudinal cracking and relatively low annual change. Compared to other pavement sections, the pavement sections with C&S or B&S with 4-inch asphalt overlays (section codes 607) had the greatest amount of longitudinal cracking and the highest annual change in longitudinal cracking, while those using rubblization with an asphalt overlay thicker than 6 inches exhibited no longitudinal cracking through seven years of service. The Tukey's HSD results show that the differences in longitudinal cracking performance among these pavement sections were not statistically significant.

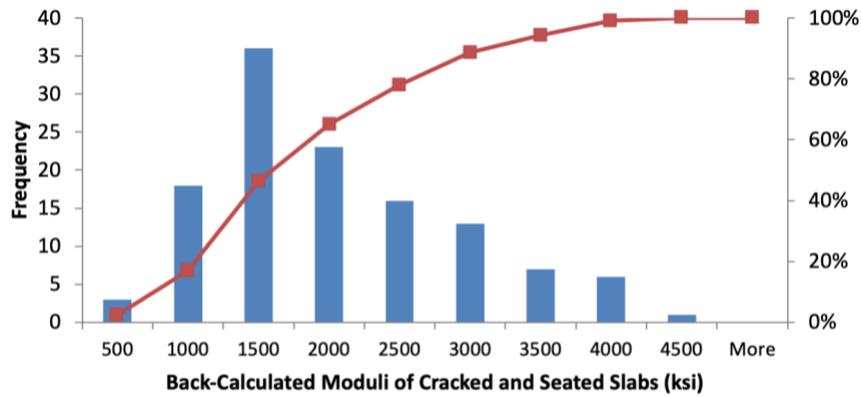
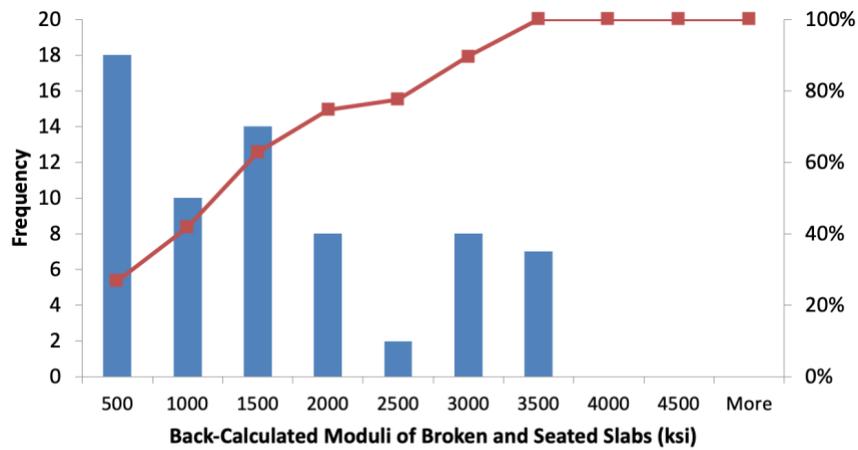
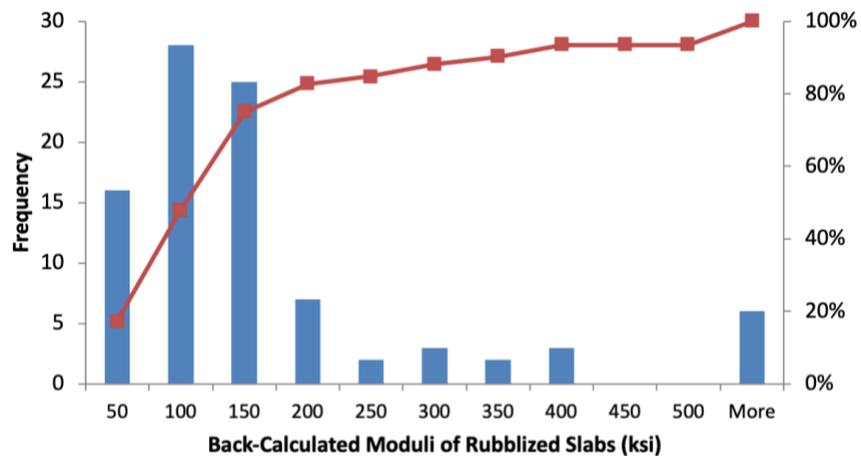
a. Cracked and Seated Slabs

b. Broken and Seated Slabs

c. Rubblized Slabs

**Figure 26. Distribution of Back-Calculated Moduli of Fractured Slabs**

Figure 26 shows the moduli distributions of these fractured slabs. As shown, the majority of C&S and B&S sections had slab moduli ranging from 507 ksi to 3,553 ksi, and most of them exceeded the threshold level ( $E_{PCC} = 1,000$  ksi) suggested by PCS (1994). As described previously, these sections showed satisfactory reflective cracking performance in general. This demonstrated that the existing threshold level of  $E_{PCC}$  was not suitable for recent slab-fracturing projects. It is also shown that the broken and seated slabs had slightly lower  $E_{PCC}$  than the cracked and seated slabs. This was because B&S usually requires greater fracturing effort, which results in a higher degree of fracturing and debonding. As can be seen from Figure 26c, most of the rubblization sections had slab moduli ranging from 51 ksi to 203 ksi, which were much lower than the C&S and B&S slabs but greater than conventional unbound aggregates (Gu et al., 2015). It is typically considered that rubblization of PCC with thick asphalt overlay could be a candidate for perpetual pavement.

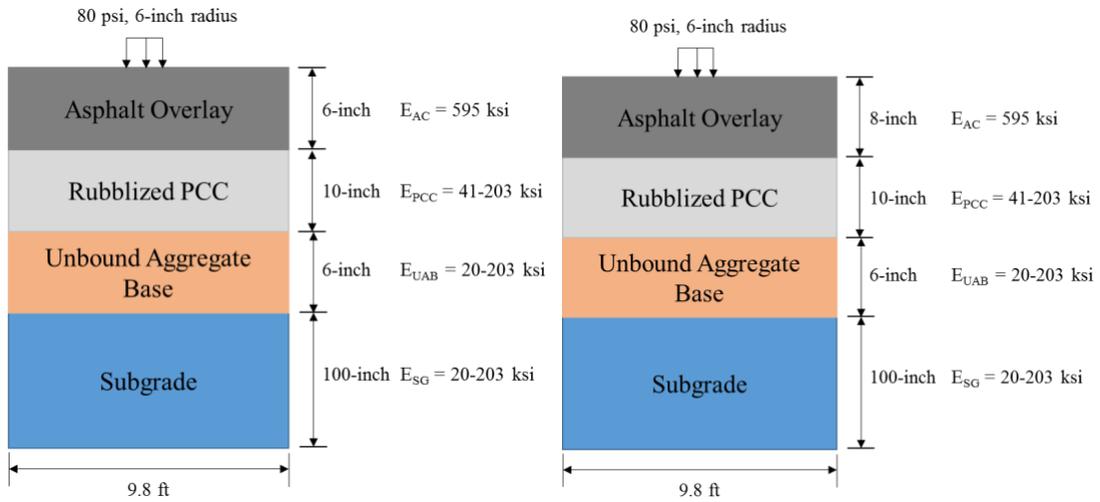
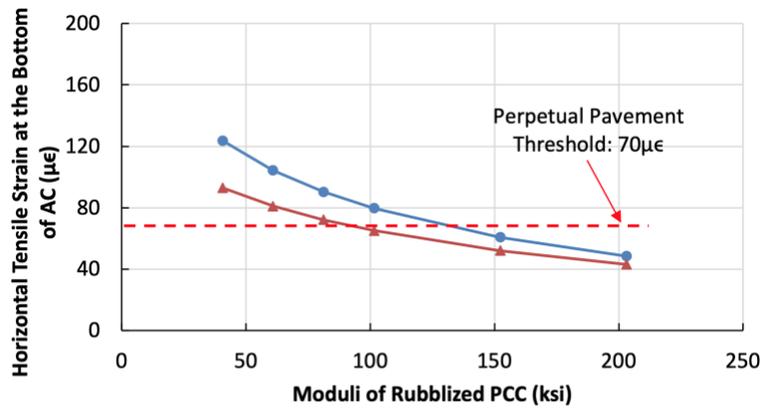
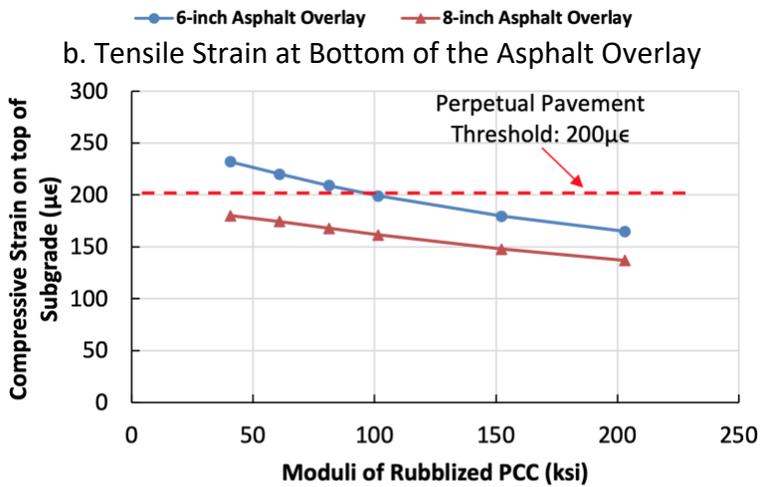
a. Two Rehabilitated Pavement Structures with Rubblized PCC

c. Compressive Strain on Top of the Subgrade

Figure 27. Structural Analysis of Rehabilitated Pavements with Rubblized PCC

According to perpetual pavement design criteria, horizontal tensile strain at the bottom of the asphalt concrete should be less than  $70 \mu\epsilon$  to achieve satisfactory fatigue cracking performance, and compressive strain on the top of the subgrade should be lower than  $200 \mu\epsilon$  to eliminate rutting problems. As can be seen from Figures 27b and 27c, the pavement with an 8-inch asphalt overlay could be perpetual when the modulus of the rubblized slab is greater than 81 ksi, and the pavement with a 6-inch asphalt overlay could achieve perpetual status when the slab modulus is higher than 122 ksi. Increasing the moduli of the rubblized slabs was effective in prolonging the fatigue life of composite pavements and reducing their rut depth. However, if slab moduli are too high, it might indicate an insufficient rubblization process, which will result in transverse cracking problems. Therefore, pavement designers should be cautious about balancing the degree of rubblization to achieve satisfactory overall performance.

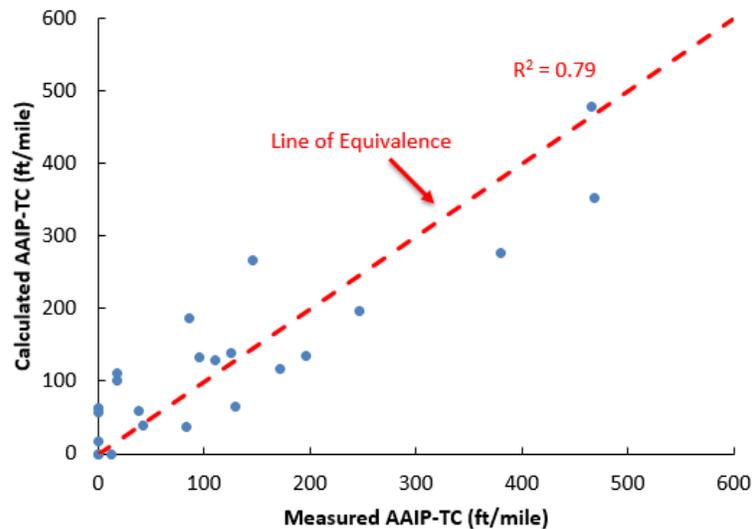
Figure 28. Comparison of Model Calculated AAIP-TC against Field Measured AAIP-TC

where AAIP-TC is the average annual incremental transverse cracking length (unit: ft/mile),  $T_{AC}$  is the thickness of asphalt overlay (unit: inch),  $T_{PCC}$  is the thickness of existing PCC (unit: inch),  $E_{PCC}$  is the elastic modulus of the fractured PCC slab (unit: ksi),  $E_{AC}$  is the elastic modulus of the asphalt overlay (unit: ksi), and  $FI$  is the freezing index (unit: °C degree-days). If the calculated AAIP-TC value is less than 0, then return 0. As can be seen from Figure 28, the calculated AAIP-TC values were in good agreement with those measured from the field, which demonstrated that the developed model had a high prediction accuracy.

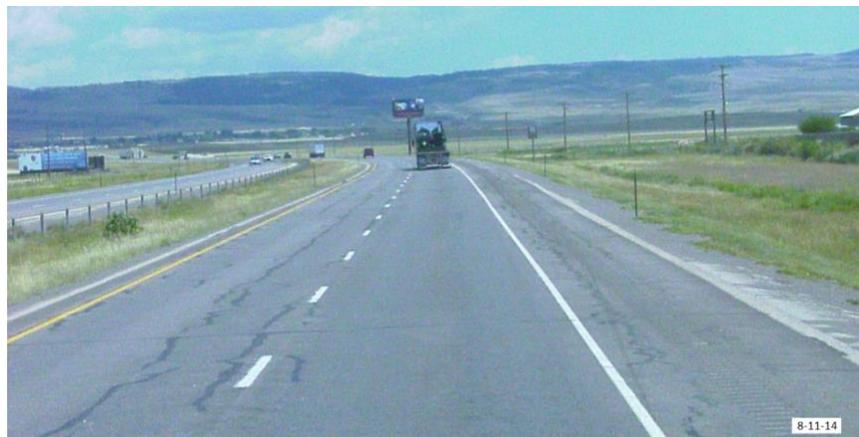
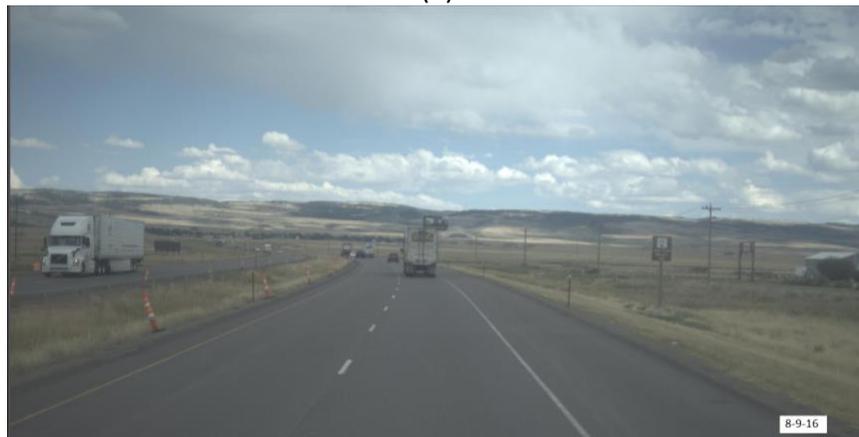
**Figure 29. Laramie Marginal (a) before and (b) after asphalt rehabilitation in 2016 (Photos courtesy of Bob Rothwell, Wyoming DOT)**

The Laramie project was originally built in 1963, and in 1997 it was time to either rehabilitate or reconstruct the pavement. The C&S approach was originally designed to serve as a 10-year design, but the pavement performed for 19 and 20 years for Laramie and Cheyenne, respectively. The project in Cheyenne was originally constructed in 1978 and was rehabilitated using crack-and-seat in 1997 (EB) and 1998 (WB). Figure 29 illustrates the pavement condition of the Laramie project before and after rehabilitation in 2016.
