NCAT Report 20-05
LIFE CYCLE COST ANALYSIS –
END OF LIFE CONSIDERATIONS

Life Cycle Cost Analysis – End of Life Considerations

National Center for Asphalt Technology

Sponsored by
National Asphalt Pavement Association

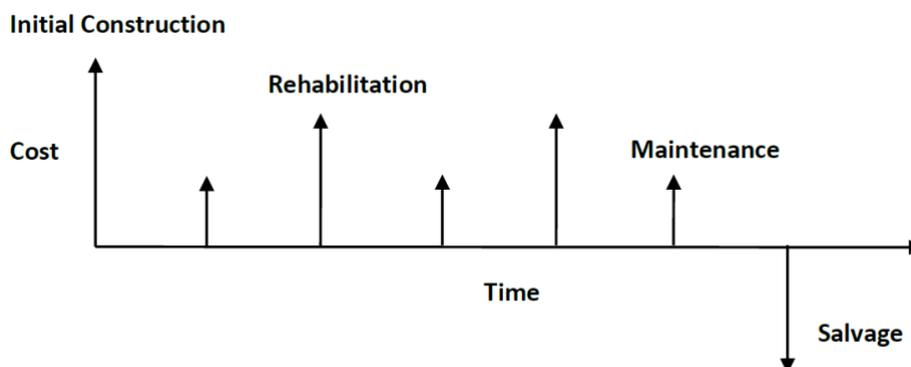
Figure 1. Stream of Expenditures for a Paving Project

Life Cycle Cost Analysis (LCCA) is a technique used by many state highway agencies (SHAs) to evaluate the overall expected costs of competing pavement alternatives, primarily between asphalt and concrete designs. Whereas the majority of design-bid-build projects primarily focus on a project's initial construction costs, an LCCA considers expected costs over the life of each pavement alternative and is a process for identifying the best long-term value among pavement alternatives. In addition to the initial construction costs, future anticipated costs such as maintenance, and rehabilitation costs, as well as user costs, are discounted back to the present time to account for the time value of money. Any of the pavement value remaining at the end of the analysis period (i.e. salvage value) can be discounted back to its present value. A typical expenditure stream diagram for a project is shown in Figure 1.

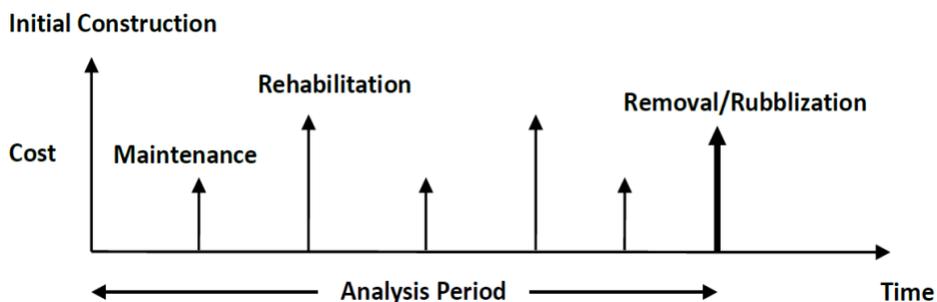
Figure 2. Stream of Potential Expenditures for Concrete Pavement (West et al., 2013)

In 2013, West et al. defined salvage value as the expected worth of the investment at the end of the analysis period, which should reflect the residual value of the last rehabilitation and the remaining pavement structure at the end of the analysis period. A further recommendation of that study (in this case, Alabama) was that the analysis period should be long enough to consider the reconstruction of pavements that have reached their terminal serviceability. Many of the PCC pavements in Alabama had been rubblized or broken and seated, while asphalt pavements that were built during the same time period were still in service with only periodic resurfacings to maintain a high level of serviceability. A typical expenditure stream diagram for the concept of removing or rubblizing a pavement is shown in Figure 2. West et al. further recommended that a monetary salvage value should be credited to asphalt pavement alternatives at the end of the analysis period because much of the original asphalt structure will continue to be a primary element of the pavement for an indefinite period of time. In addition, if the asphalt pavement is resurfaced near the end of the analysis period, that portion of the overlay's remaining service life beyond the analysis period should also be recouped in the LCCA.

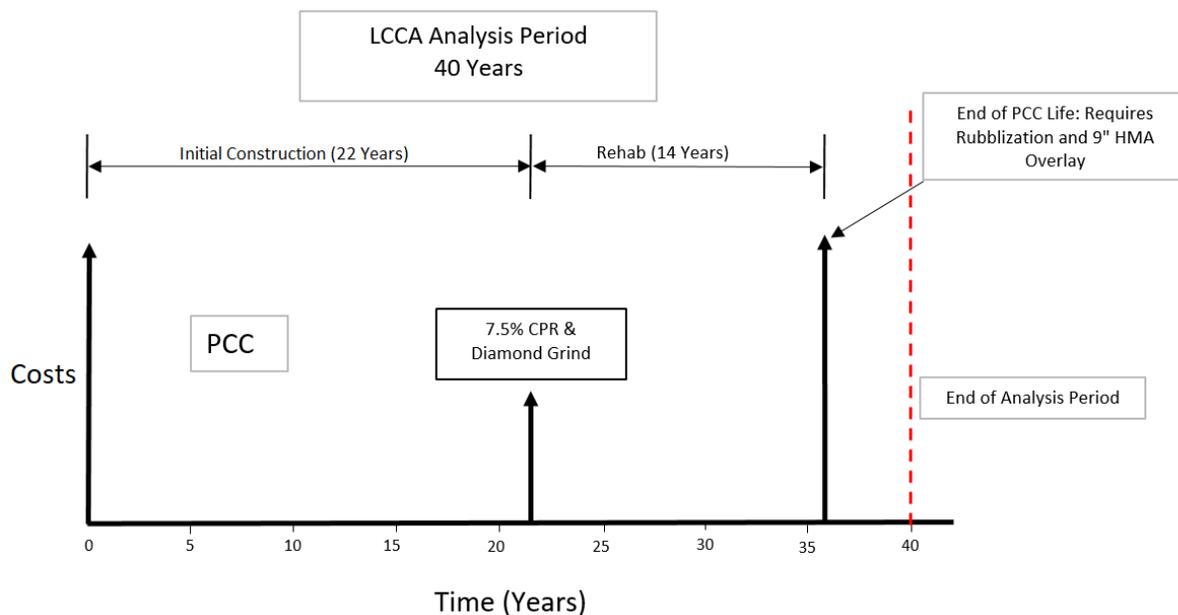
Figure 3. Expenditure Stream with Analysis Period Beyond PCC Life

West et al. (2013) proposed several concepts related to accurately establishing terminal values during an LCCA. The first concept was that the LCCA analysis period should be long enough to ensure that the concrete pavement alternative reaches its terminal serviceability, and that the cost of the concrete remediation (rubblization, removal and replacement, crack and seating, break and seating, etc.) be accounted for as a future cost during the analysis. An expenditure stream diagram for this concept is shown in Figure 3.

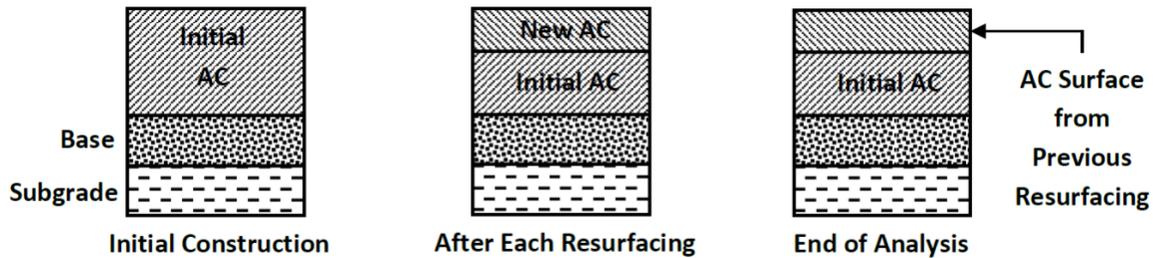
Figure 4. Changes in Asphalt Structure (West et al., 2013)

structure will continue to function indefinitely as designed in the pavement. The changes in the asphalt structure through the analysis period are shown in Figure 4.

As shown in Figure 4, with respect to an asphalt pavement alternative, the terminal value consists of two components: the RSL value of the last resurfacing; and the RSL value of the lower asphalt layers remaining from the initial construction. In situations where the underlying base and subgrade of the pavement structure are different than the concrete alternative, the RSL value of those layers should also be determined as described for the second scenario above.

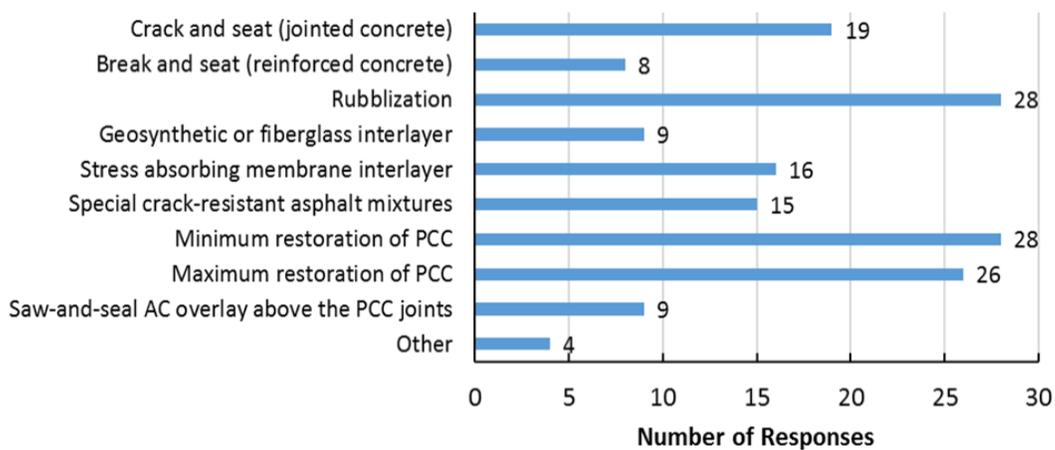
Figure 5. PCC Rehabilitation Techniques Used by Participants' Organizations in the Past 10 Years (West et al., 2020)

As part of a NAPA project on the Benefits of Rehabilitating Concrete Pavements with Asphalt Overlay, West et al. (2020) conducted a survey to gather information on methods used to rehabilitate concrete pavements with asphalt overlays in the United States. State asphalt pavement associations (SAPAs), state and local agency representatives, slab fracturing equipment manufacturers, and consulting pavement design engineers were surveyed. As shown in Figure 5, the three most common methods of PCC rehabilitation were rubblization, minimum restoration of PCC, and maximum restoration of PCC. Minimum restoration of PCC (as defined in this survey) only includes the sealing of joints, surface diamond grinding, etc., and is not considered a major rehabilitation. Maximum restoration of PCC includes the full or partial repair of broken slabs and deteriorated joints, retrofit of dowel bars, installation of edge drains, etc. Crack and seating, stress absorbing membrane interlayers, and special crack-resistant asphalt mixtures were also frequently used for PCC rehabilitation to retard reflective cracking.

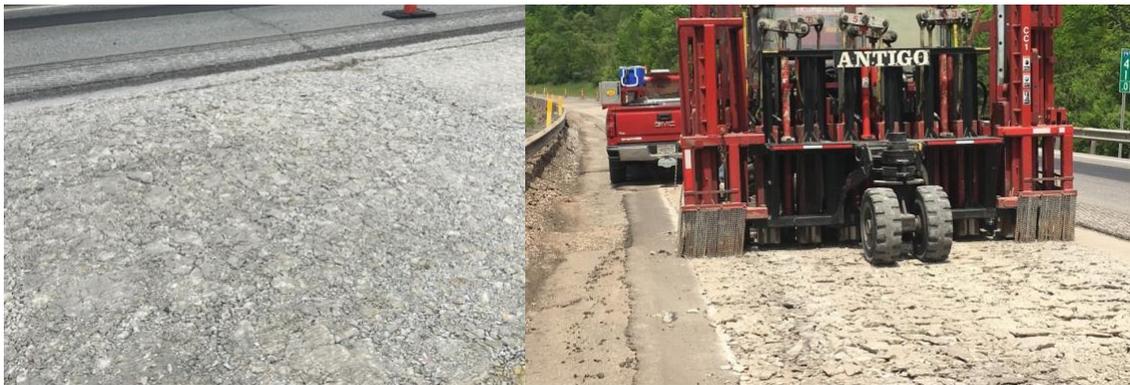
Figure 6. Rubblized PCC Pavement Surface, I-79 West Virginia

- Construction costs. As shown in Tables 4 and 5, slab fracturing alternatives are significantly greater than costs associated with traditional milling and resurfacing operations on an asphalt pavement.
- Maintenance of traffic during construction. In general, traffic is not allowed on a fractured PCC pavement until it is overlaid. As an example, a rubblized PCC surface is shown in Figure 6. Consequently, this results in longer-term lane closures and traffic delays, or it requires the construction of temporary pavement lanes to handle the traffic. This leads to greater user costs, as well as increased construction costs.

The West Virginia Department of Highways (WVDOH) began routinely using rubblization as a means of addressing deteriorated jointed plain concrete pavements (JPCP) in 2017. Their reasons for choosing rubblization included the following factors:

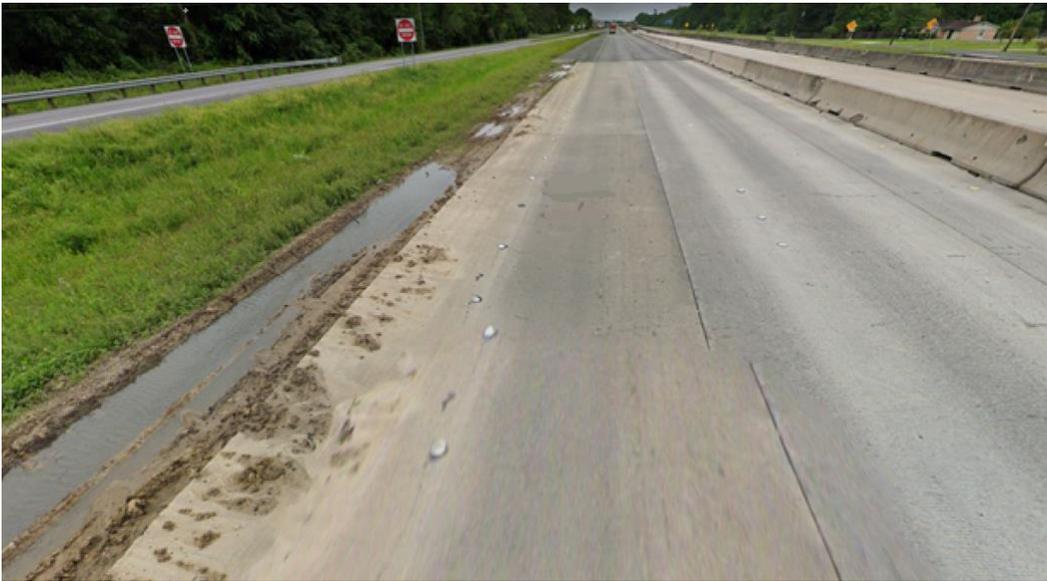
Figure 7. Excessive Drop-Off, I-10 Texas

- Excessive drop-offs at shoulders/edges of pavement (Figure 7). Drop-offs at the edge of pavement or shoulder create serious safety concerns and typically result in the use of fill material on the shoulders to raise the grade. This construction activity can be very costly and results in increased construction time on the project, which then results in a greater impact on the traveling public, freight movements, and increased user costs.

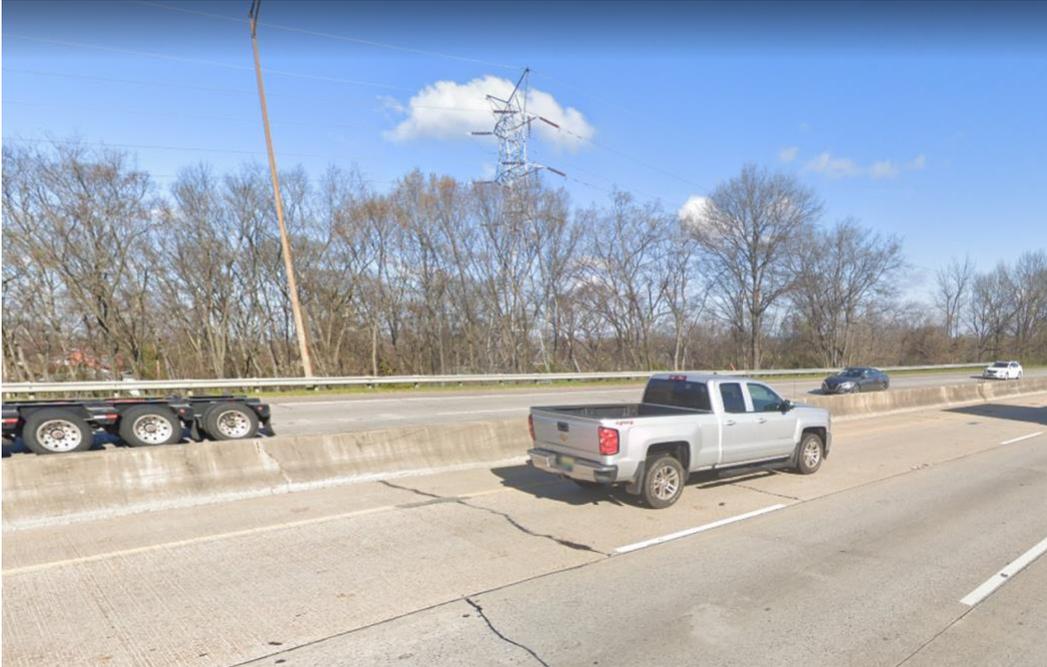
Figure 8. Inadequate Barrier Wall Height, I-85 Georgia

- Guardrail/barrier wall heights (Figure 8). The increased thickness of the pavement surface results in the height of the guardrail or barrier wall being too low in many instances, which violates safety standards, necessitating its costly and time-consuming replacement.

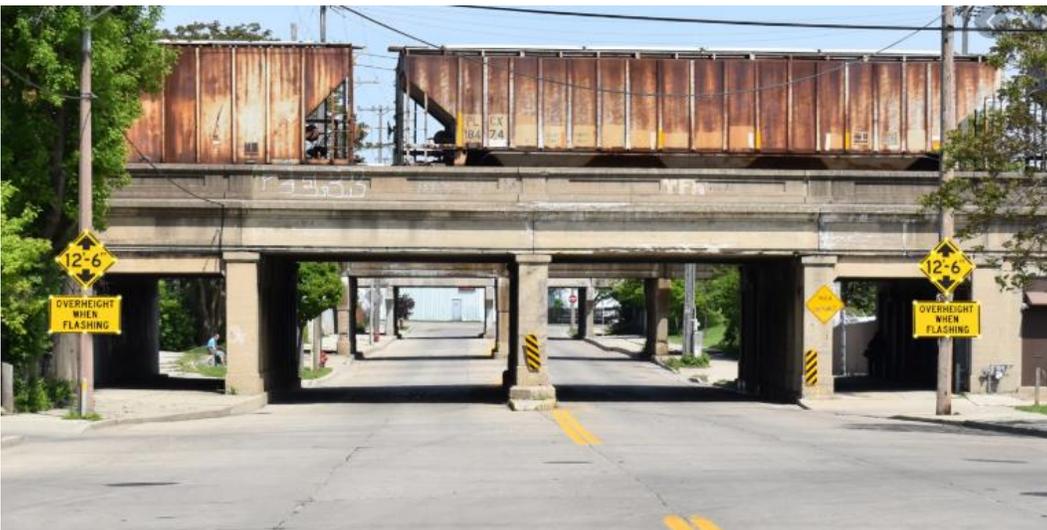
Figure 9. Inadequate Bridge Clearance, Location Unknown

- Clearances under bridges and overpasses (Figure 9). In many locations, raising the elevation of the pavement surface results in inadequate clearances. This results in the need to either completely remove and replace the pavement underneath the structure or to equip it with sensing devices to alert motorists of the low clearance.

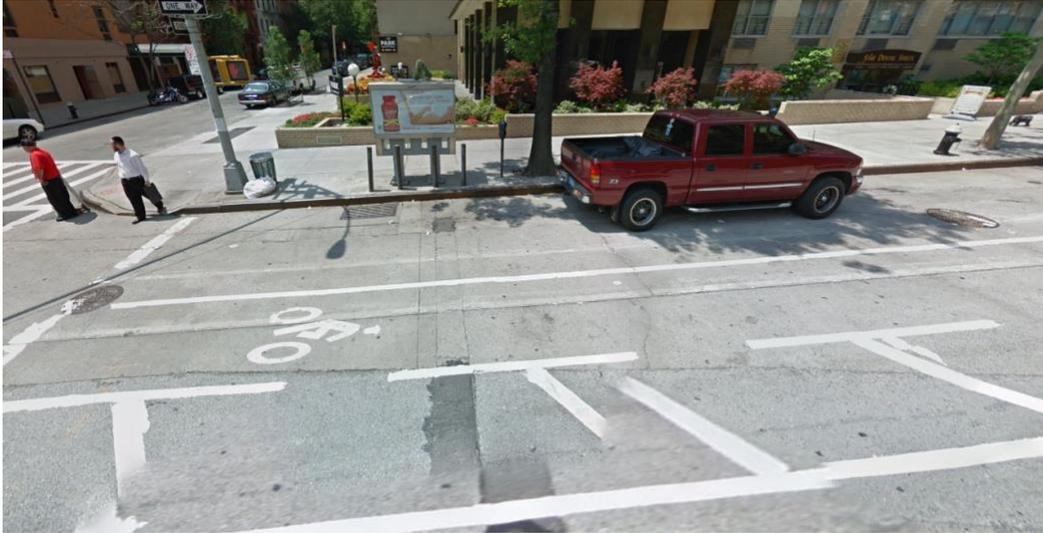
Figure 10. Tie-ins to Curb and Gutter and Drainage Inlets, 1st Avenue, New York City

- Other impacts (Figure 10). Changes in the elevation of the pavement also creates problems with the surface being at the proper height to tie-in to bridges, drainage structures, curbs, and gutters.

In 2013, the New York City Transportation Department rehabilitated 1st Avenue in New York City with a high performance thin overlay. The existing pavement was an 18-inch reinforced concrete pavement that had significantly deteriorated. Potential damage to underground utilities made slab fracturing not feasible, and budget limitations excluded removal and replacement of the PCC. In addition, there were also major concerns with user delays, which limited lane closures. Ultimately, NYCDOT opted to micromill the existing PCC pavement, and then patch and crack seal the more distressed areas as required. They used a PG 76-22 tack coat followed by a fabric interlayer and then placed a 1.5-inch-thick high performing thin overlay mix with a highly modified asphalt binder. The project was completed in September 2013 (Corun, 2015).
