# NCAT Report 21-03

## Phase VII (2018-2021) NCAT Test Track Findings

NCAT Report 21-03  
Phase VII (2018-2021) NCAT Test Track Findings

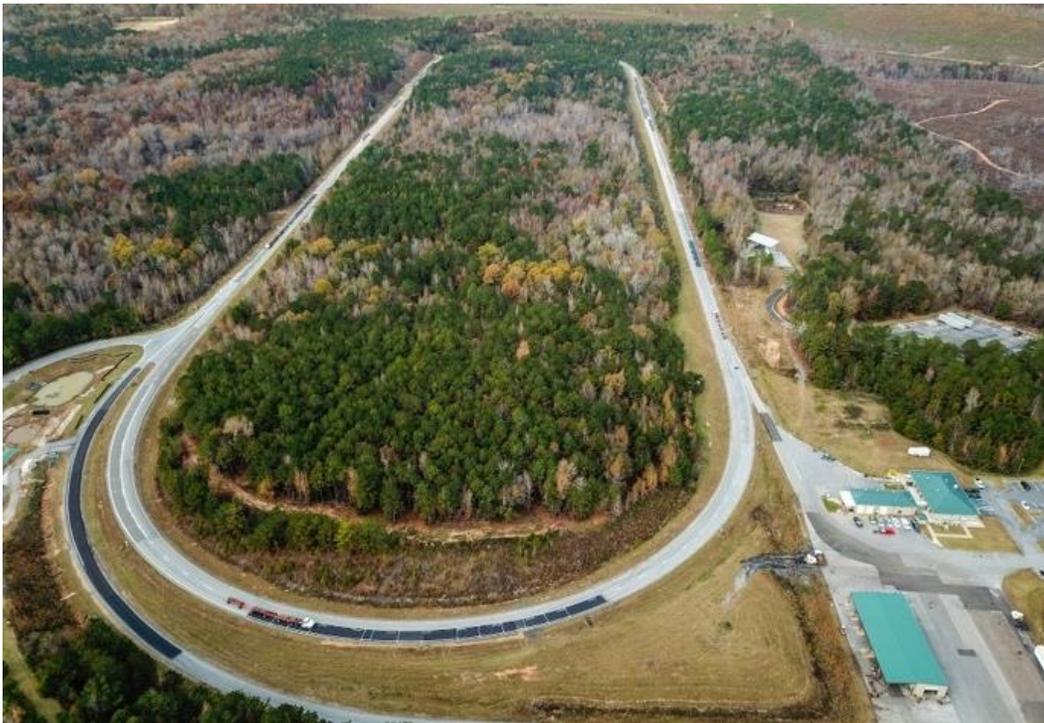
**Figure 1. Aerial Photograph of the NCAT Test Track**

The National Center for Asphalt Technology (NCAT) Test Track is a successful pavement proving ground originally constructed in 2000. The 1.7-mile oval track is a unique accelerated pavement testing facility combining full-scale test section construction with heavy trafficking at highway speeds to evaluate pavement response and performance in a drastically shortened time frame. The Test Track allows sponsors to realistically evaluate innovative asphalt technologies, allowing rapid implementation of materials and design methods that advance safe, durable, and sustainable asphalt pavements.

The Test Track has 46 main test sections, each nominally 200 ft. in length. Some are divided into subsections depending on the objective of the experiment. Twenty-six sections are located on the straight segments and the remaining 20 sections are equally divided between the two curves.

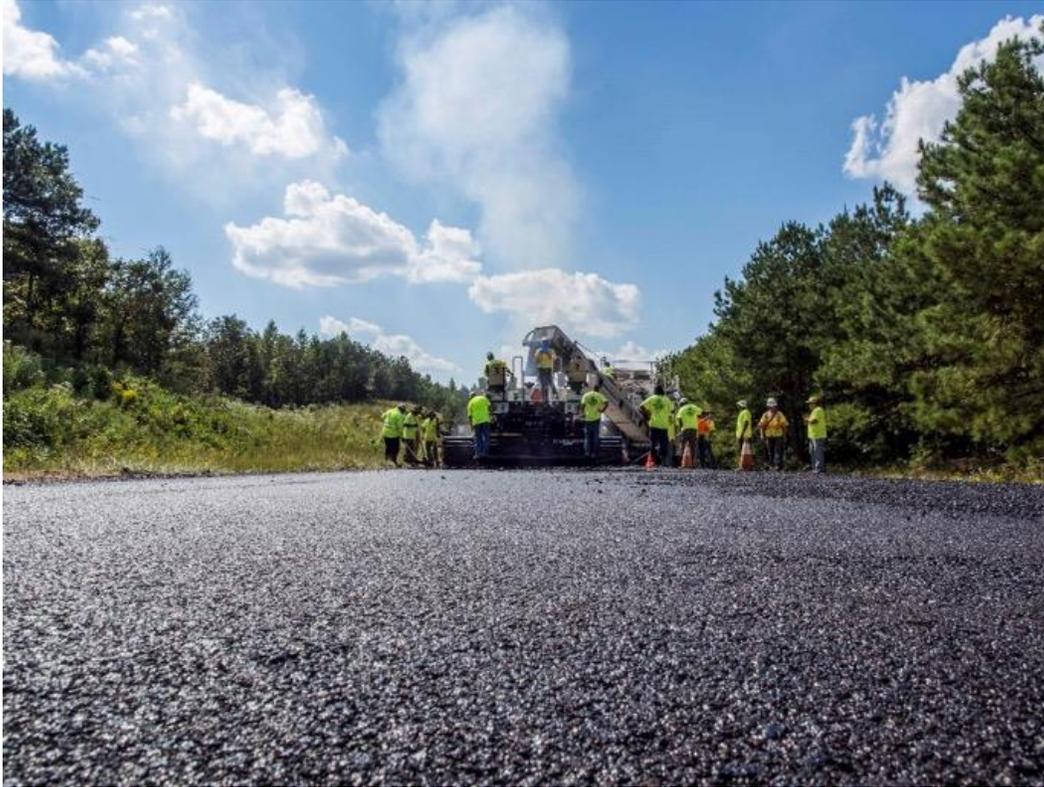
**Figure 2. Paving a Test Section for the 2018-2021 Research Cycle**

Mix produced for placement on the test sections followed the same production sequence described above. Mix production continued until a sufficient quantity of material was available for placement. The contractor was responsible for hauling mixes to the track, and the paving equipment and crew were staged at the track.

Before placing mixes on the test sections, the contractor tacked the underlying asphalt pavement with a PG 67-22 binder, NTSS-1HM emulsion, or other tack material depending on the sponsor's preference. Target application rates were generally between 0.04 to 0.07 gallons per square yard (residual for emulsion) unless otherwise directed.

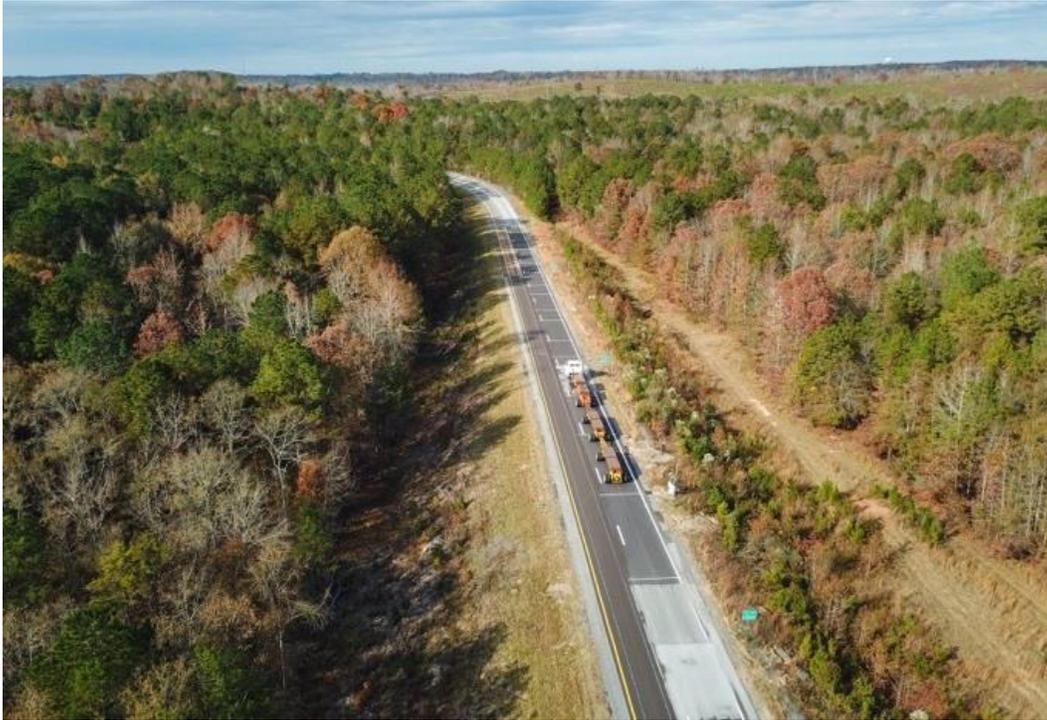
**Figure 3. Heavily Loaded Triple-Trailer used for Accelerated Loading on the Test Track**

Trafficking for the 2018 Test Track was applied in the same manner as with previous cycles. Two shifts of professional drivers operated five trucks pulling triple flatbed trailers (Figure 3) and one truck pulling a triple box trailer from 5 a.m. until approximately 10:40 p.m. Tuesday

through Saturday. Trafficking began on November 26, 2018, and ended February 27, 2021. The total traffic applied to the test sections during this cycle was 10,023,907 ESALs.

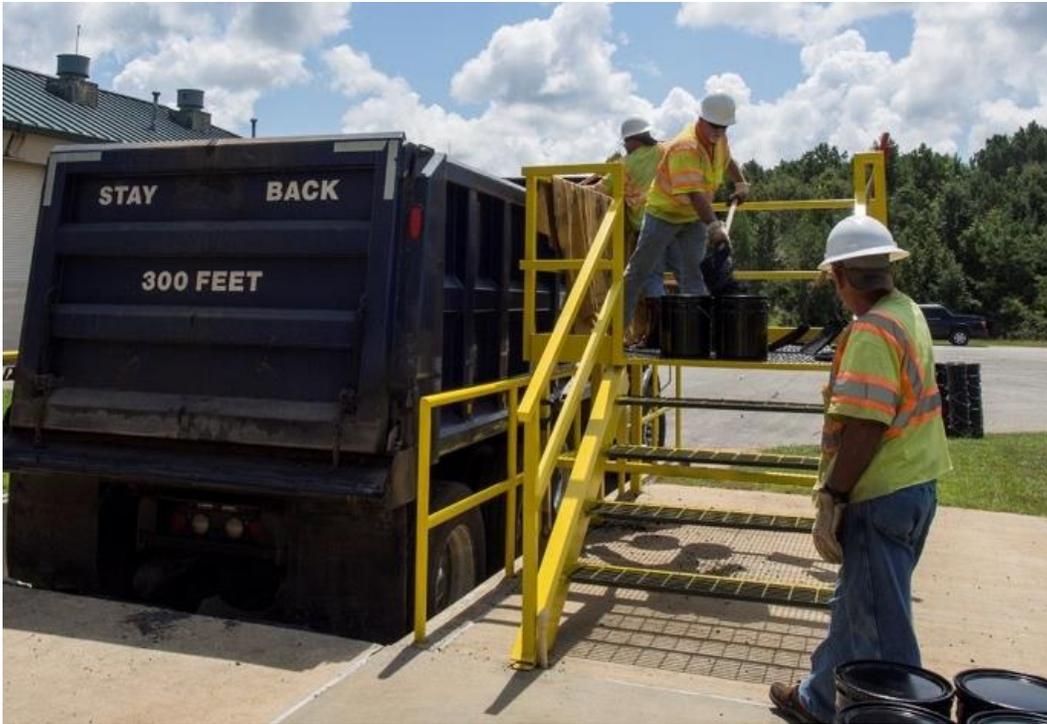
**Figure 4. Sampling Plant-Produced Mix for Quality Assurance Testing**

NCAT staff obtained large representative samples of each experimental mix placed on the Test Track for additional testing. Mix was diverted from the conveyor of the material transfer vehicle (MTV) ahead of the paver into a flatbed truck. The truck then hauled the mix to the rear of the track's laboratory where the mix was shoveled into five-gallon buckets and labeled. A total of 1,283 buckets of mix were sampled for additional testing to accomplish the research objectives of the experiment. Asphalt binder samples were also obtained at the plant for characterization.

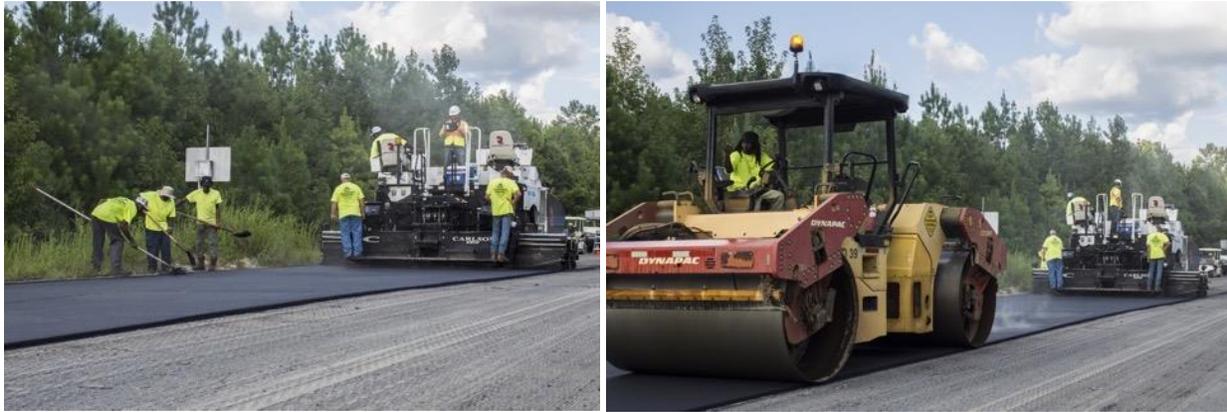
**Figure 5. N10 Mix Placement and Compaction**

Section N10 was constructed on August 29, 2018. The mix was produced at 340°F and had an average in-place density of 93.8%. The as-built lift thickness was 20.3 mm. Figure 5 shows the mix placement and compaction of Section N10. Section N11 was constructed on August 27,

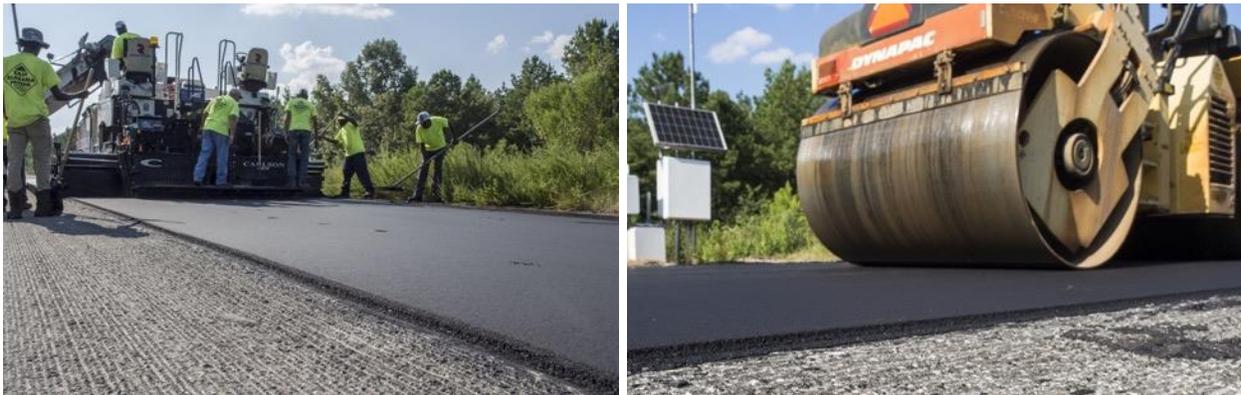
**Figure 6. N11 Mix Placement and Compaction**

2018. The N11 mix was produced at 325°F and had an average in-place density of 91.5%. The as-built lift thickness was 12.7 mm. Figure 6 shows mix placement and compaction activities on Section N11. The planned thickness/rate of both N10 and N11 were designated by ALDOT, noting that Section N10 was thicker for higher performance preservation and Section N11 was thinner for a treatment with lower cost. Figures 1 and 2 show the milled surface of the inside lane. The outside lane is the research lane, and no changes were made to the base layer prior to placement of the thinlays.

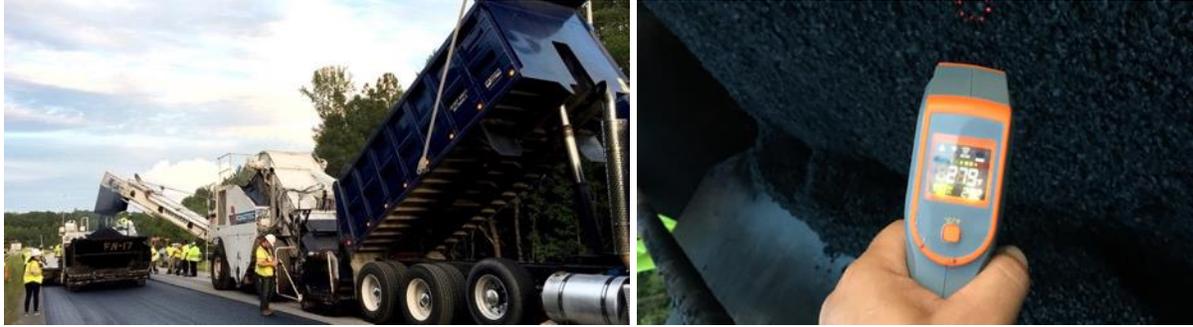
Figure 10. Paving of Section N3A and N3B

The control mixture was placed in Section N3A (100 feet long). The paver was then hot-stopped to clean out the mix from the hopper. After that, the paving continued to place the experimental mixture in Section N3B (100 feet long), as shown in Figure 2.

The temperature measured behind the paver for the control mixture was 290°F, and the in-place density was 96.2% of  $G_{mm}$  of as-produced mix. Due to an incident at the Test Track, the temperature measured behind the paver for the experimental mixture was lower at 279°F. However, since the rejuvenator was also designed for use as a warm-mix additive, the experimental mixture still compacted well, and the in-place density was 96.8% of  $G_{mm}$  of as-produced mix. Table 4 summarizes the design and construction data for the two test sections.

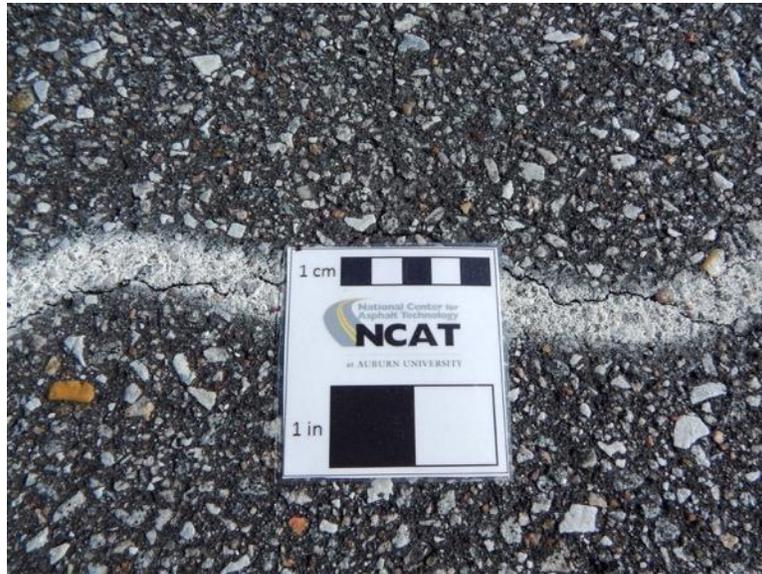
**Figure 4. Close-up of Hairline Cracks in Sections N7 and N1**

cracking observed in the surface mixture of Section N7 was higher than that of the surface mixture in Section N1, but the cracks were very tight (less than 1 mm opening) near-surface cracks, as shown in Figure 4. Both sections were kept in place for continued traffic in the 2018 research cycle (2018-2021) to allow for a thorough field performance evaluation.

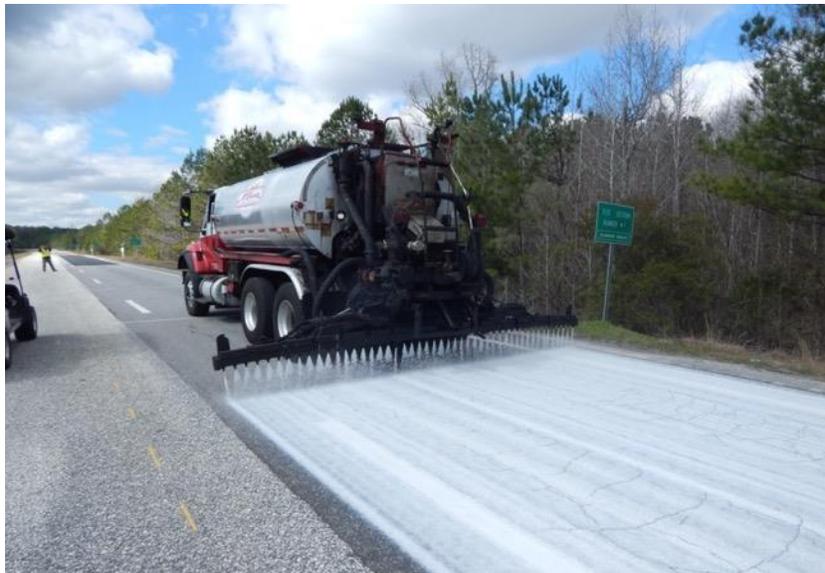
**Figure 6. Delta Mist Application on Section N7 in February 2020**

After consulting with the sponsor, Delta Mist spray-on rejuvenator was applied to the distressed surface of Section N7 at a 0.08 GSY rate on February 21, 2020 (Figure 6) to evaluate if the spray-on rejuvenator could help extend the life of asphalt pavements with bottom-up fatigue cracking. Cracking progressed significantly the week after Delta Mist was applied in late February of 2020. Cracking in Section N7 increased from 33.1% right before the Delta Mist application (13.3 million ESALs) to 53.4% in April of 2020 after 14.2 million ESALs. The addition of Delta Mist presumably softened the distressed asphalt structure and accelerated the rate of failure in which the surface layer was then milled and inlaid.

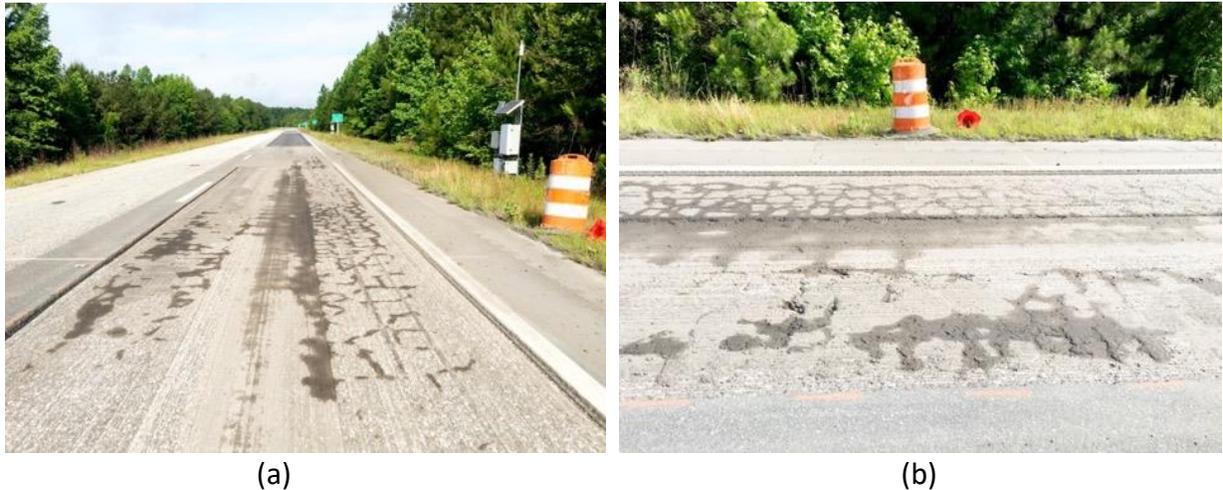
**Figure 7. Section N7 Milled and Inlaid in May of 2020 (a) Milled Surface Showing Bottom-Up Cracking (b) Area of Severe Bottom-Up Cracks**

The two surface mixtures in Sections N1 and N7 (before the bottom-up cracking failure) showed good ride quality and rutting performance. The bottom-up cracking failure in Section N7 can be observed in rutting and IRI measurements around 14 million ESALs in Figures 3b and 3c. The areas of bottom-up cracking failures (Figure 7) in Section N7 were milled and replaced in May of 2020.

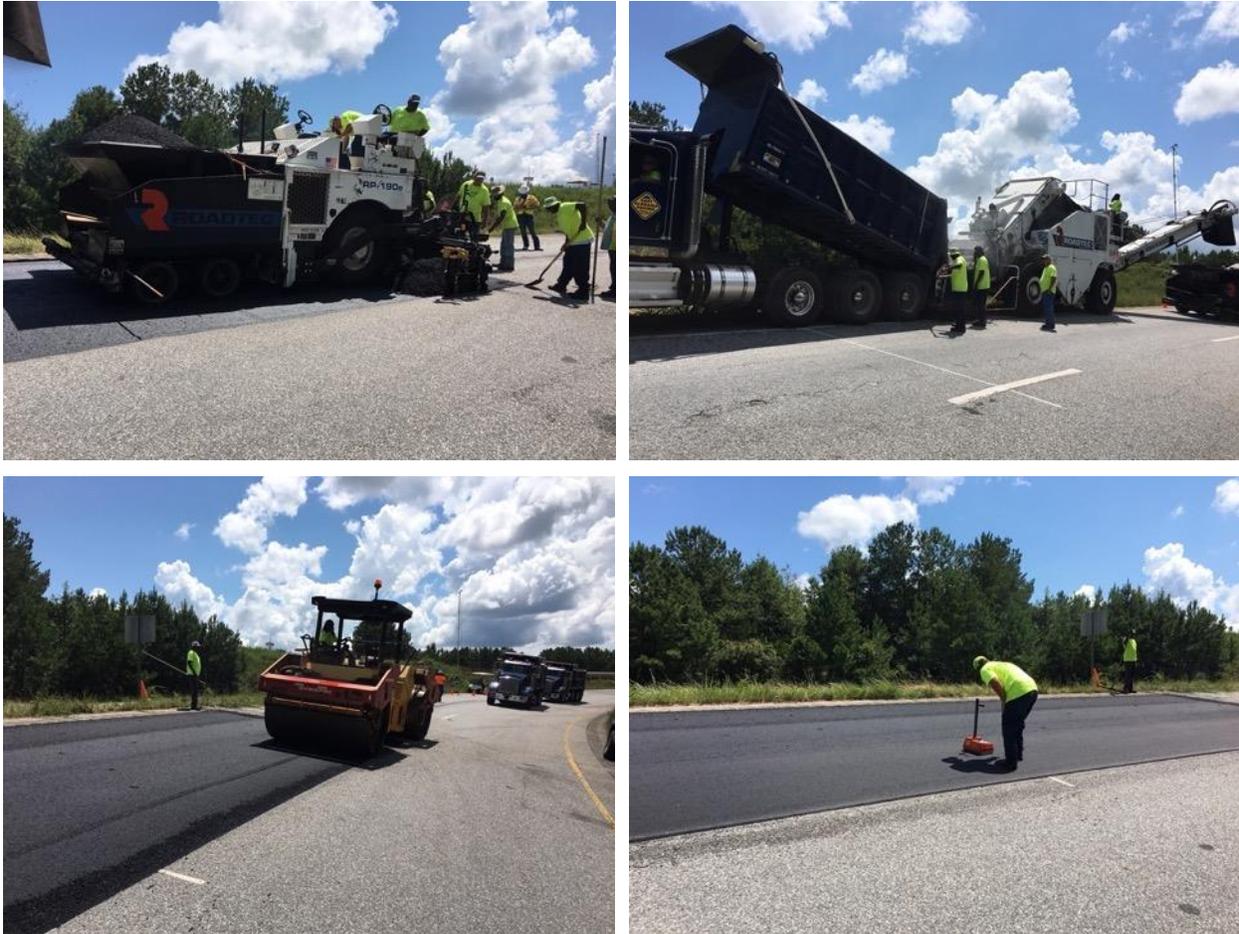
**Figure 5. Equipment Utilized During Construction**

Section E5-1A received the most compactive energy with four vibratory passes and three static passes. This pattern was adjusted on the remaining sections by reducing the number of vibratory passes per section. Densities of the sections were monitored by the contractor with a nuclear density gauge, and 6-inch diameter core samples were taken for acceptance and tested by NCAT personnel.

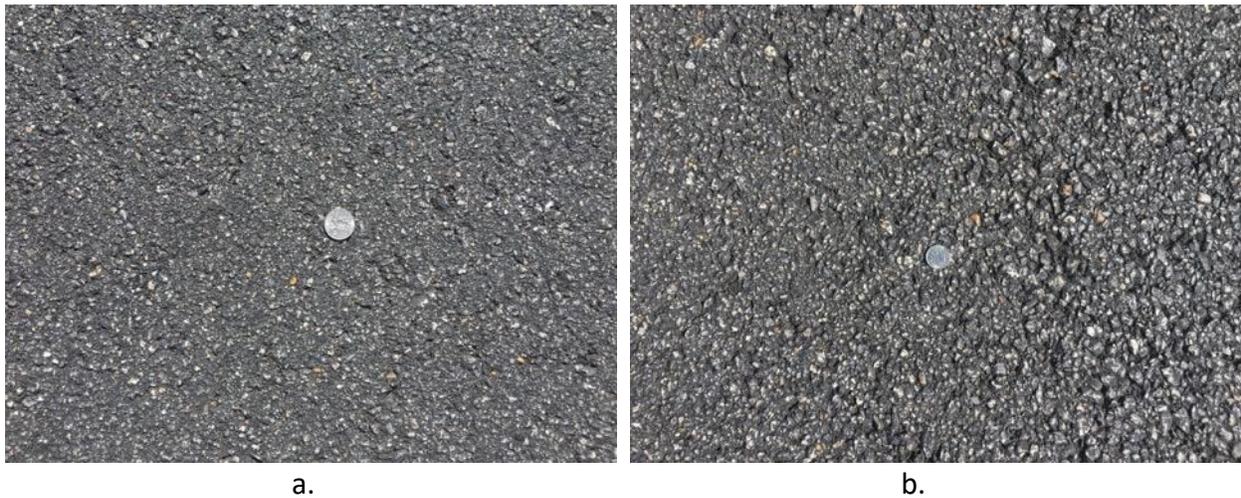
**Figure 18. Difference in Surface Texture of (a) Section E5A (93.6%) and (b) Section E6A (87.9%)**

Figure 18 shows the physical difference in texture between sections E5A and E6A. These are the high and low density levels from the study, and the effect of density is reflected on the surface texture. Despite the low density and potential high permeability of Section E6A, no evidence of moisture damage such as weathering and raveling have been found after 10 million ESALs of trafficking and 2.5 years in place.

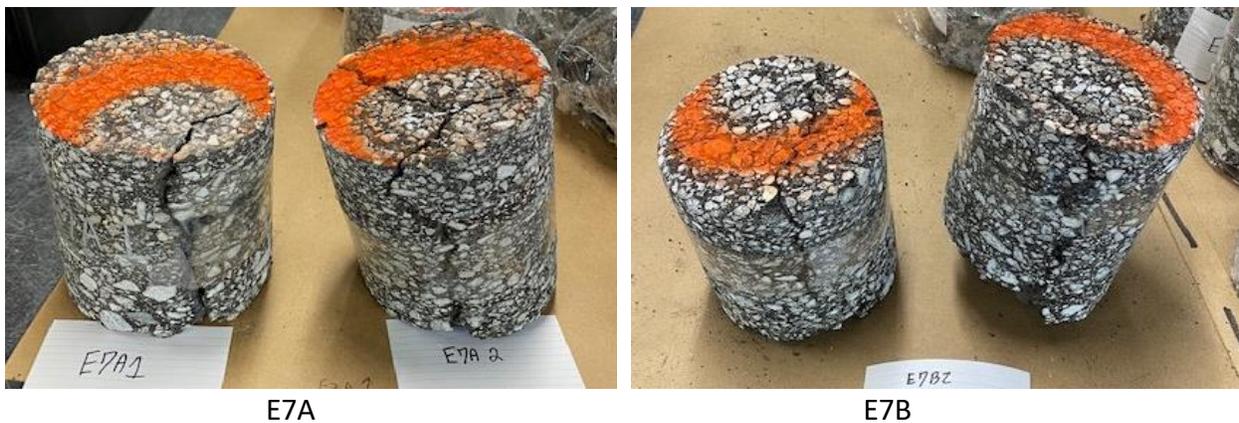
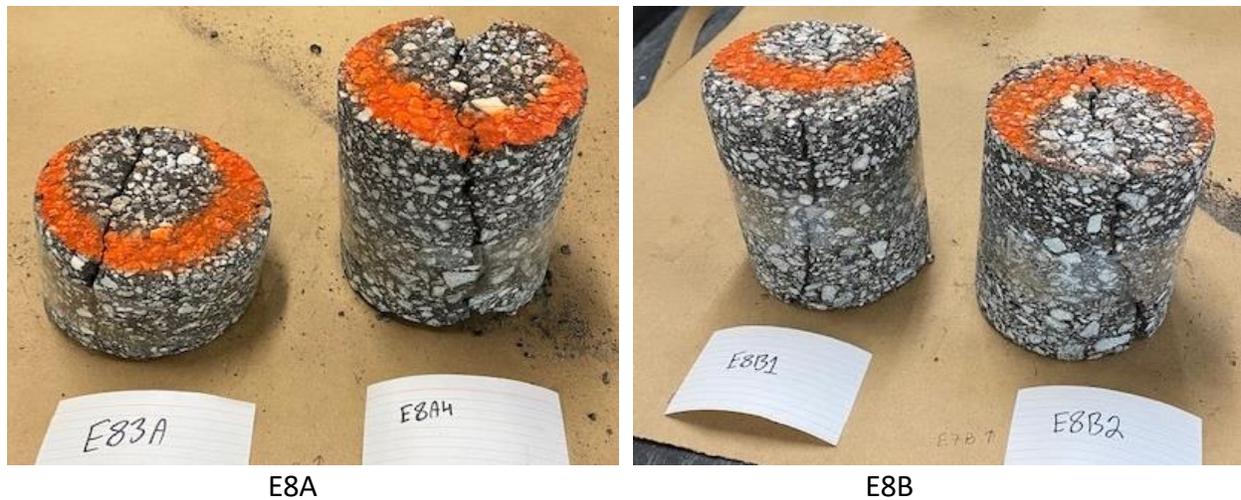
**Figure 11. Extracted Samples for Cracking Origin Evaluation**

Since there was still uncertainty on the origin or type of cracking observed in these sections, four cores were taken on different locations with cracks. Figure 11 shows pictures of representative cores from each section. The same cracking pattern was observed on all the cores, where the cracks were found throughout the entire thickness of the core which includes the 1.5 in lift built for this experiment and about 8 to 10 inches from the previous cycles. At this point, the most likely cause of these cracks was new bottom-up and reflective cracking. However, top-down cracking can still be a possibility for the observed samples since these sections were in place for 20 million ESALS and over five years such that the top lifts could have cracked first due to high amounts of RAP used in this study (stiffer and more susceptible to cracking mixes).

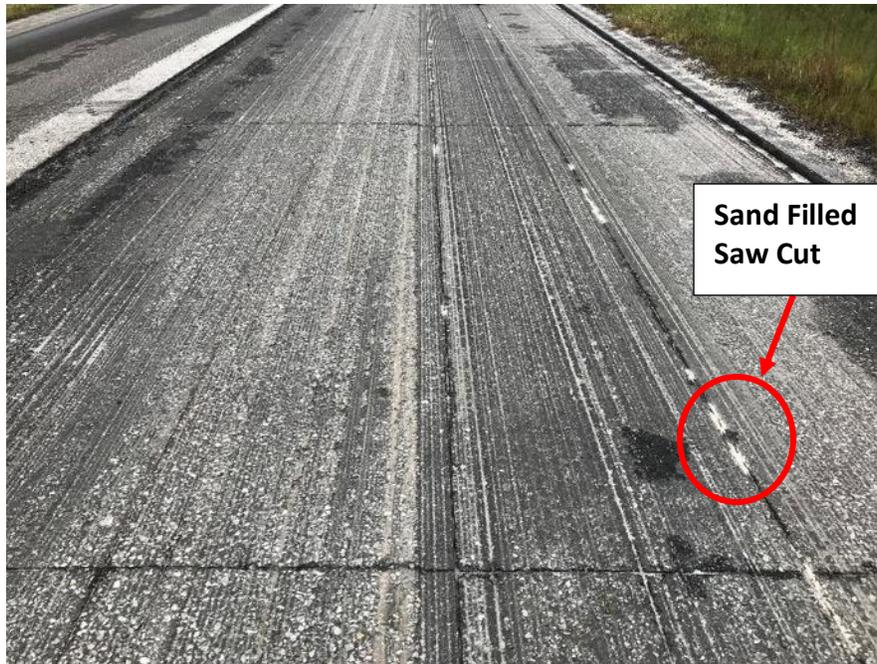
**Figure 1. Deep Saw Cuts to Simulate Pavement Cracks**

In this research cycle, 1/8-inch wide deep saw cuts were made in the existing pavement for the full depth of the structural layer to simulate cracking in the pavement structure. As shown in Figure 1, the saw cuts were made in a longitudinal direction at 3-foot intervals across the width of the lane and at 15-foot intervals in a transverse direction. Therefore, the saw cut area represented about one-third of the total test section surface area when using 6 inches on each side of the crack as the potential area of influence. The cuts were then filled with sand to keep the cracks from healing back together during warm weather. Note that the saw cut pattern and the sand filling approach in this cycle are the same as those made in the last research cycle.

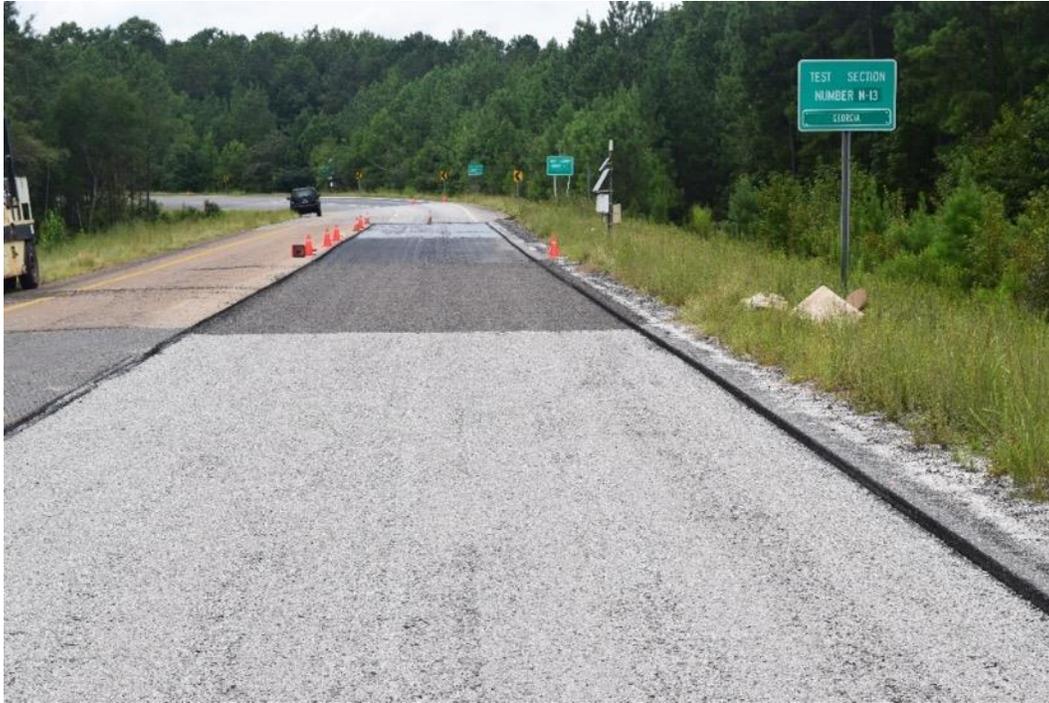
**Figure 4. Chip Seal with No. 7 Stone (12C) and Reclaimed Asphalt Pavement (13A)**

Section N13 was also divided into three subsections for different treatment methods, which included N13A (chip seal with 100% fractionated coarse reclaimed asphalt pavement) (Figure

4), N13B (rubber modified asphalt interlayer), and N13C (OGI). Based on the GDOT specification for bituminous tack coat, CRS-2h emulsion tack was applied onto the existing pavement of N13A with a residue rate of 0.23 gallons/sq. yard. To compare with the NTSS-1HM used in the 2012 research cycle, the UltraFuse trackless tack was used for N13B and N13C with an application rate of 0.25 gallons/sq. yard. The thickness of chip seal with reclaimed asphalt pavement was 0.6 inches, and the rubber modified asphalt interlayer and OGI were approximately 1.1 inches thick. The NMAS 9.5 mm Superpave mix was used as the surface layer with a thickness of 1.5 inches for subsections N13A, N13B, and N13C. Note that no leveling mix was used in subsections N13B and N13C, and 0.5-inch leveling mix was placed on subsection N13A.

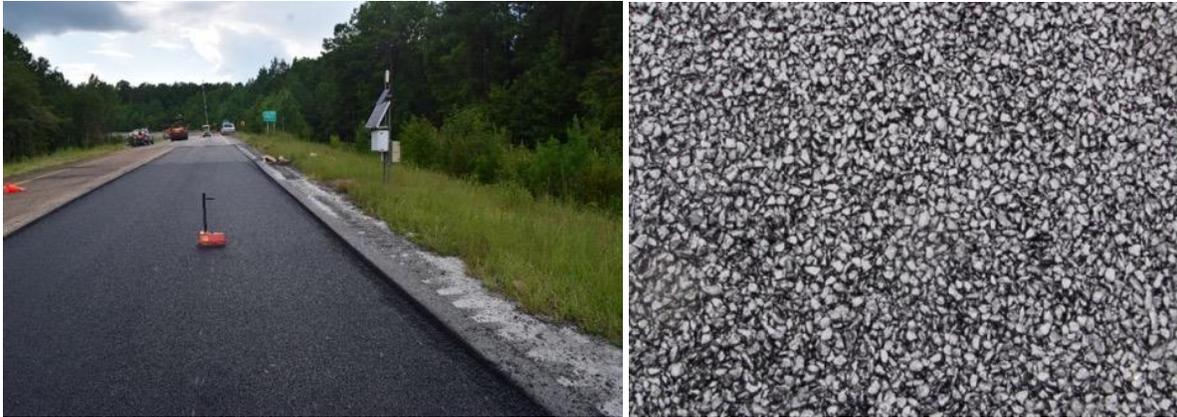
The rubber modified asphalt interlayer, shown in Figure 5a, was a 1/2-inch NMAAS gap-graded interlayer with granite aggregate and 7.4% PG 76-22 binder modified with ground tire rubber. The OGI mix, shown in Figure 5b, was a 1/2-inch NMAAS porous friction course (PFC) mixture that was designed with a lower asphalt content than a typical PFC surface mix and used PG 64-22 binder grade. It also omitted fiber stabilizer for economic reasons, and instead used a reduced mix temperature of  $250^{\circ}\text{F} \pm 20^{\circ}\text{F}$  to resist drain-down. The purpose of these two mixes is to provide a discontinuity between the existing surface and overlay (to relieve stresses from loading and thermal forces) so stresses are dissipated and cracks are not as easily reflected.

a. Rubber Modified Asphalt Interlayer

b. Open Graded Interlayer

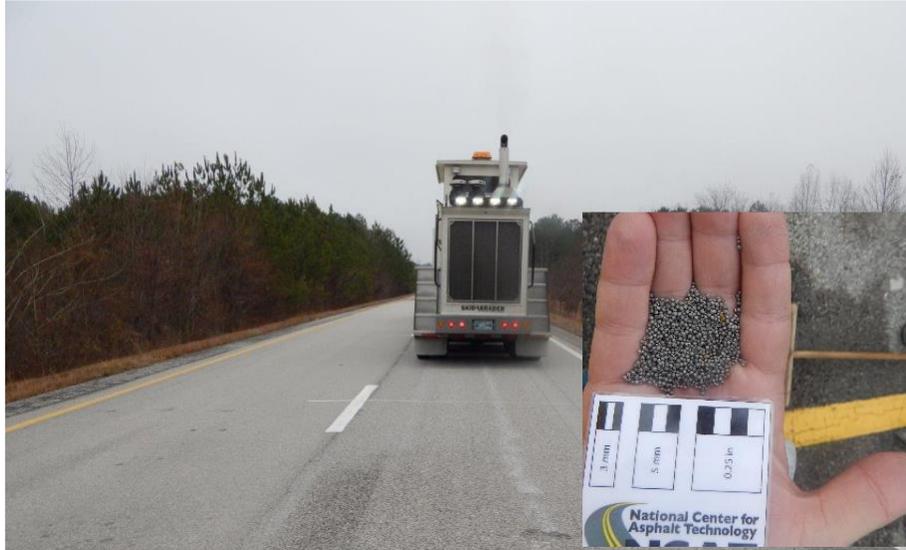
**Figure 29. Application of Shotblasting Treatment to S7A and S7B and Close up of Steel Shots**

The low friction numbers shown for Sections S7A and S7B urged the decision to apply a friction treatment to improve the friction characteristics of the sections. In consultation with the KYTC, a shotblasting treatment was selected and applied to the test sections after approximately 15.3 million ESALs of trafficking. Figure 2 illustrates the shotblasting treatment being applied to the sections and a close up of the steel shots used to abrade the sections.

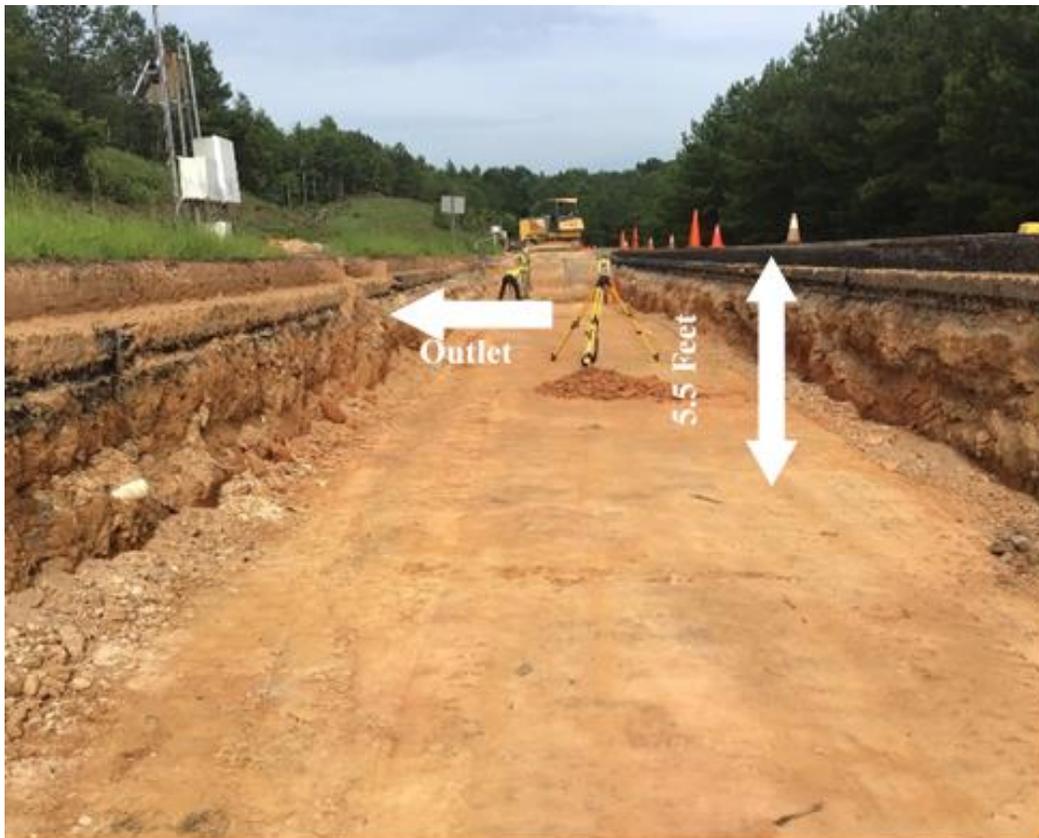
**Figure 3. Section S2 Excavation**

Preparing Section S2 for the stabilized foundation pavement required substantial removal of existing materials to facilitate installation of foundation layers from Mississippi. This process began on April 30, 2018, with milling and excavation of the existing pavement and soil to a depth of almost 6 feet as shown in Figure 3. This depth was similar to that excavated for another section built in 2006 for the Oklahoma DOT where soil was imported to the Test Track which demonstrated the depth was sufficient to replicate their local soil conditions. The remaining soil foundation was native to the Test Track, originally placed as part of the construction of the 2000 Test Track and was classified as an AASHTO A-4(0) soil. Soil from Mississippi was hauled to the Test Track and was placed and compacted in eight lifts to a depth of approximately 56 inches. This was done in accordance with provisions described in the 2017 Mississippi Standard Specifications for Road and Bridge Construction. The soil was classified as an AASHTO A6 (20) with 93% passing the #200 sieve (See Table 1). The optimum unit weight was determined to be 107.8 pcf for the soil with 98% of optimum required for layers in the top 36 inches and 95% of optimum for the deeper layers. Table 2 shows the in-place unit weight and moisture contents of all eight soil layers.

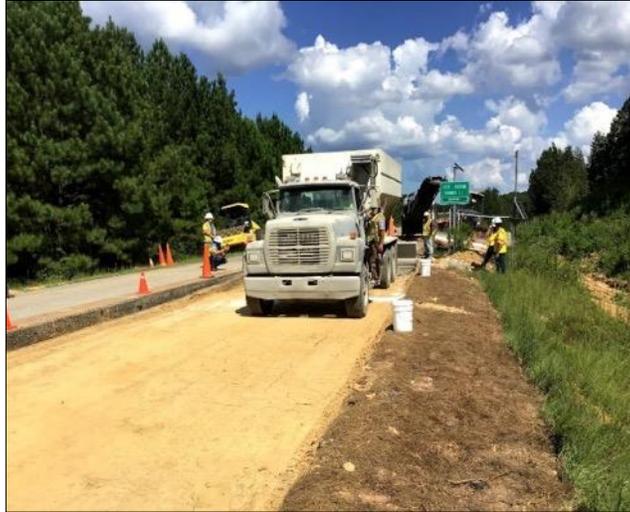
a) Mississippi Soil Ready for Lime Treatment

Once the soil was placed and compacted (Figure 4a), lime treatment to a target depth of 6 inches began on September 7, 2018. Dry hydrated lime, applied with a drop-spreader (Figure 4b) at 4% by dry weight of the soil, was mixed to depth using a milling machine with the conveyor system turned off (Figure 4c). The lime treated soil (LTS) was designed to obtain a soaked California Bearing Ratio (CBR) of 20% after seven days of protected curing.

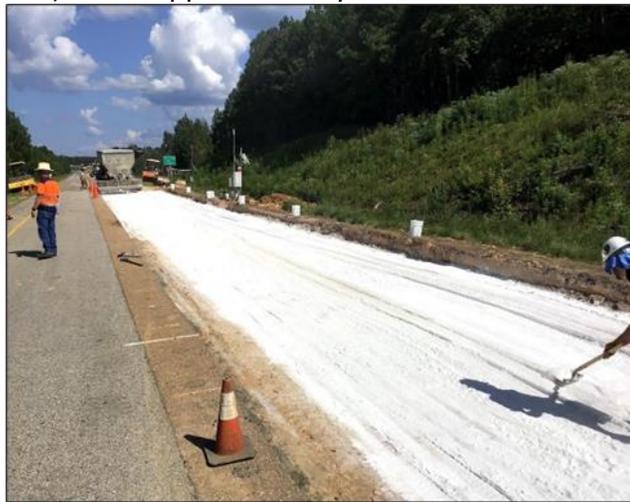
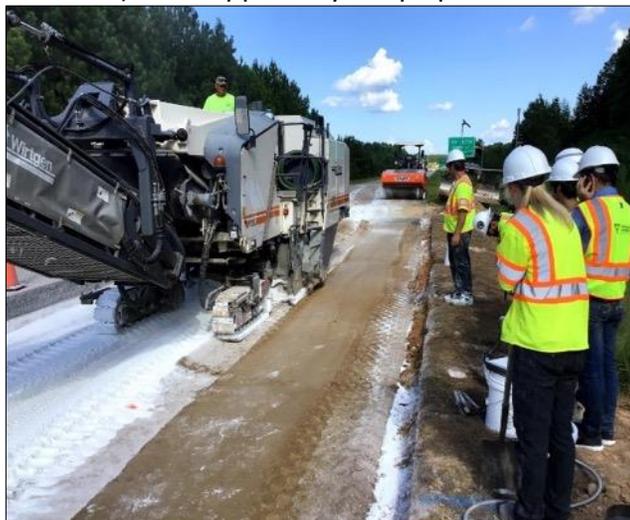
b) Lime Applied by Drop Spreader

c) Lime Mixing with Milling Machine

**Figure 4. Lime Treatment of Section S2**

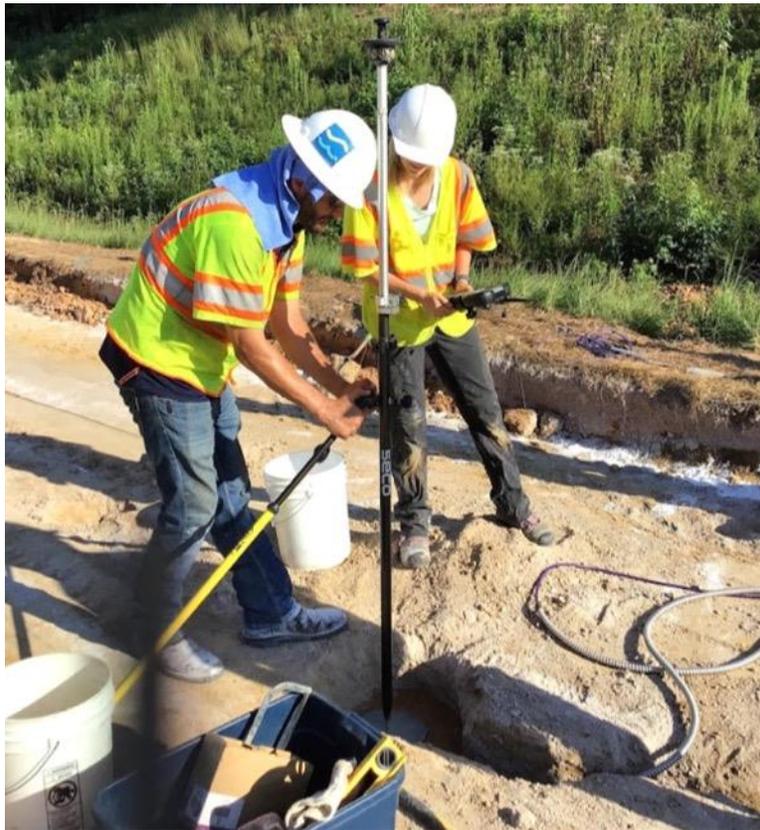
**Figure 5. Installation of First EPC Below Lime Treated Soil in Section S2**

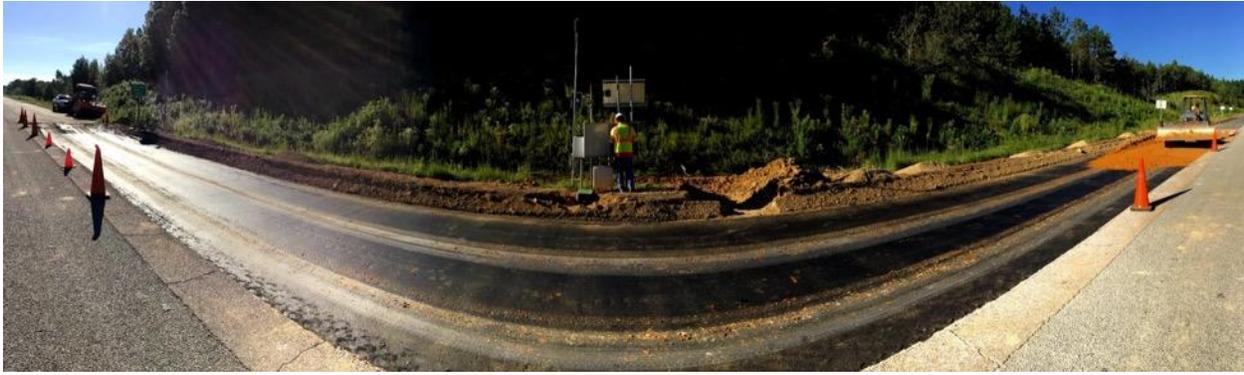
After the sensor was installed, the LTS was compacted with a steel-wheel roller and brought to grade and cross-slope with a motor grader. After density (100.1 pcf) and moisture content (15.8%) were achieved, a prime coat (NTSS-1HM anionic asphalt emulsion) sealed the layer to prevent possible loss of moisture. The prime coat was sprayed at the rate of 0.2 gal/sy. The LTS was given a 10-day mellowing period after which placement of the silty-sand base began on September 17, 2018 (Figure 6). Note that the panorama image in Figure 6 gives the appearance of curvature, but the section is straight, located on the south tangent of the Test Track.

**Figure 6. Placement of Silty-Sand Base on Prime Coated LTS in Section S2 (Panorama Image)**

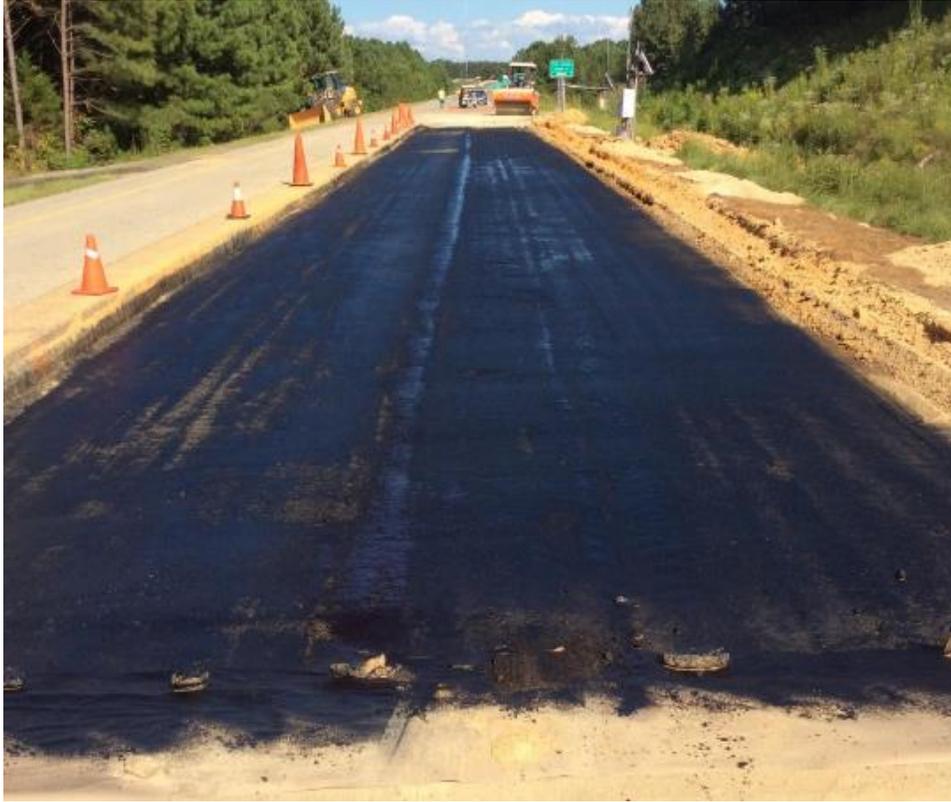
**Figure 7. Completed CTB in Section S2 Shortly After Tack Coat Application**

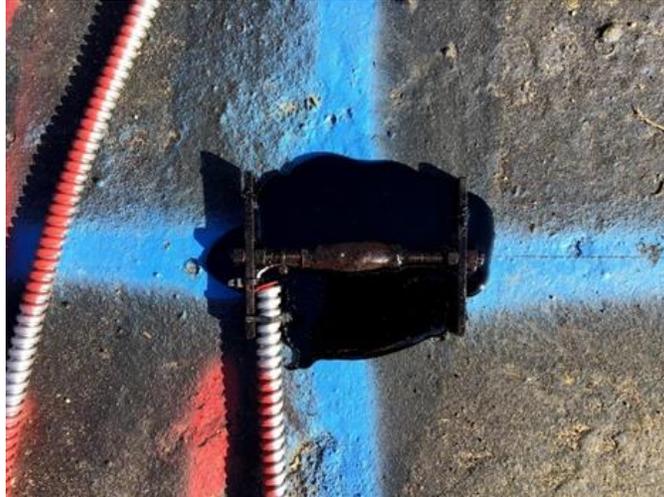
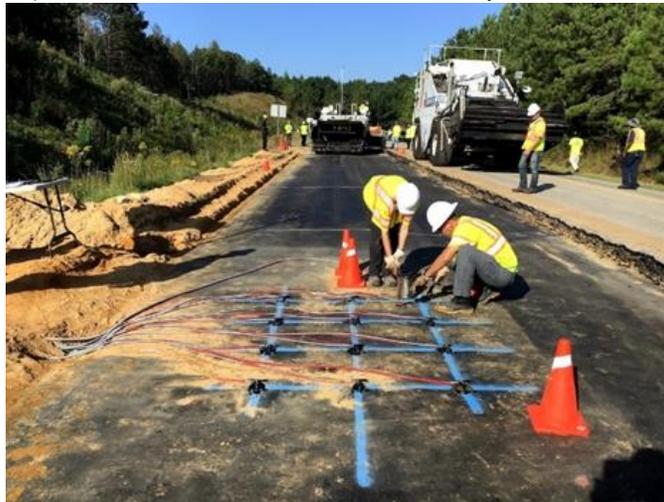
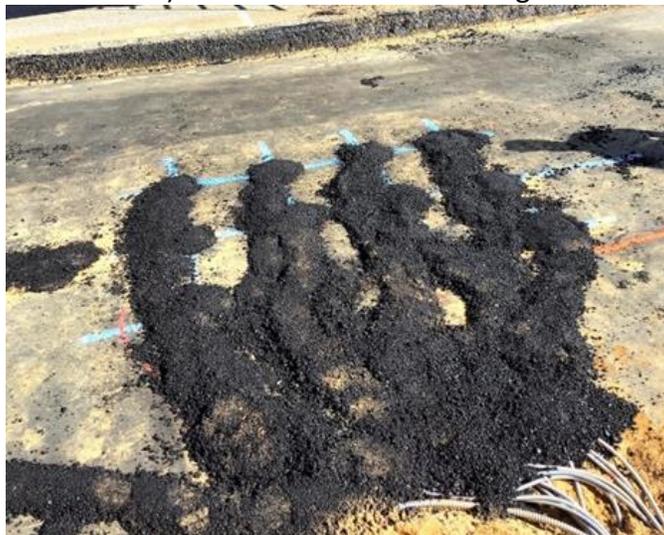
Other than placing the gauges and cables on top of the CTB, the process of preparing the gauges for paving followed well-established Test Track procedures (1). Figure 8a shows an ASG tacked in place while Figure 8b shows the array of 12 ASGs laid out prior to paving. As shown in Figure 8c, all the gauges were covered with mix sieved through a #4 screen and hand compacted to provide minimal protection during the paving and compaction process. Paving operations over the gauge array were identical to elsewhere in the section except that rollers were not allowed to stop or change direction over the gauge array. All three pressure plates survived the paving process while 11 of 12 ASGs were functional after paving. The loss of the ASG was deemed non-critical since redundancy had been built into the system (i.e., three other ASGs were position in the same relative offset as the lost gauge to make the same measurement.

a) ASG Tacked in Place with Sand/Asphalt Mixture

b) ASGs Positioned for Paving

c) ASGs covered with Sieved Mix Prior to Paving

**Figure 8. Placement of ASGs in Section S2**

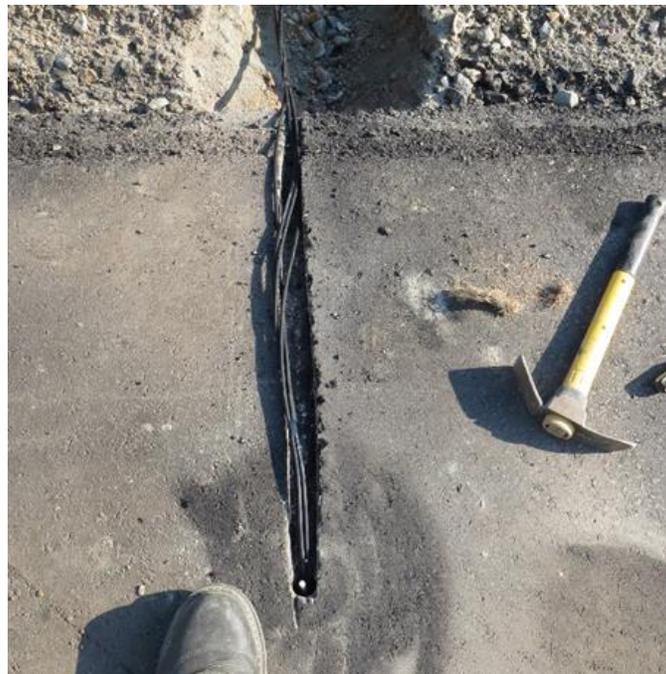
The final sensor installation occurred after paving was completed. To monitor in situ temperatures, a bundle of four thermocouples were installed to measure temperatures at the top, middle, and bottom of the AC and 3 inches into the CTB. A vertical hole was drilled into the pavement just outside the edge stripe that was deep and wide enough to accommodate the four thermocouples with the top one flush to the pavement surface. Figure 10 shows the installation with a slotted trench containing the thermocouple cables running to the shoulder before everything was covered and sealed with roofing asphalt (Figure 11).

**Figure 10. Installed Thermocouple Bundle Prior to Covering with Roofing Asphalt**

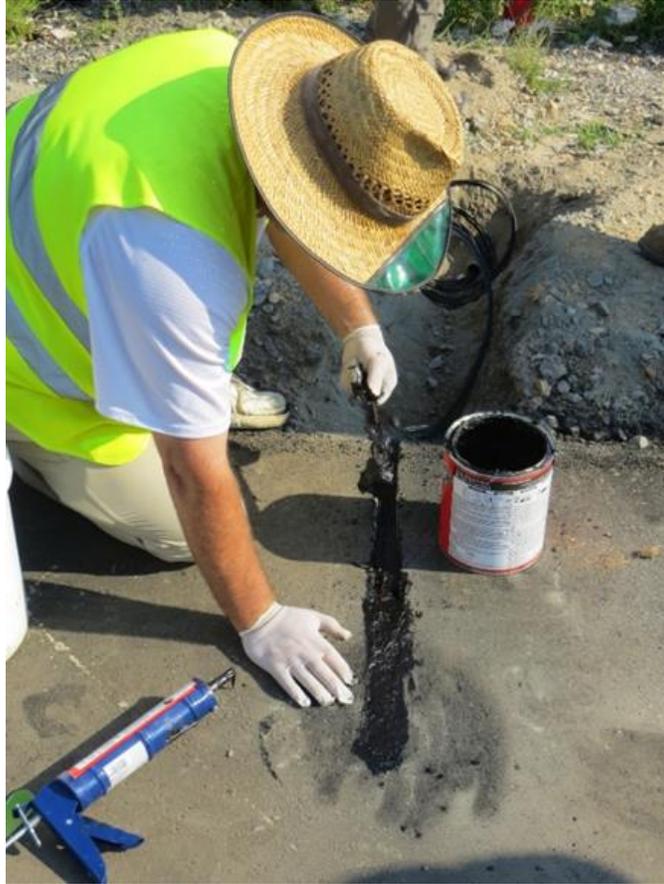
**Figure 11. Covering Thermocouple Bundle with Roofing Asphalt**

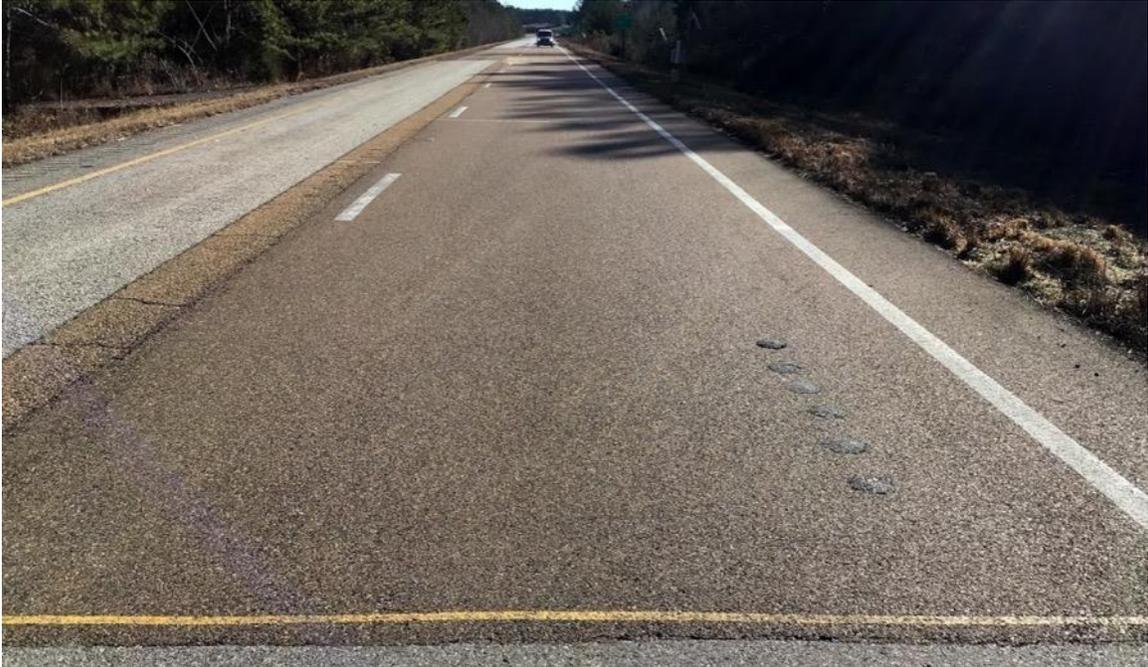
As with all the other Test Track sections, this section was measured frequently for rutting and roughness and was inspected for cracking during the research cycle. Figure 12 shows the section on February 8, 2021 near the end of the two-year trafficking cycle. The following sections document the field performance in terms of both time and traffic application expressed as equivalent single axle loads (ESALs).

**Figure 12. Section S2 Near the End of Trafficking**
