# NCAT Report 21-03

## Phase VII (2018-2021) NCAT Test Track Findings

NCAT Report 21-03  
Phase VII (2018-2021) NCAT Test Track Findings

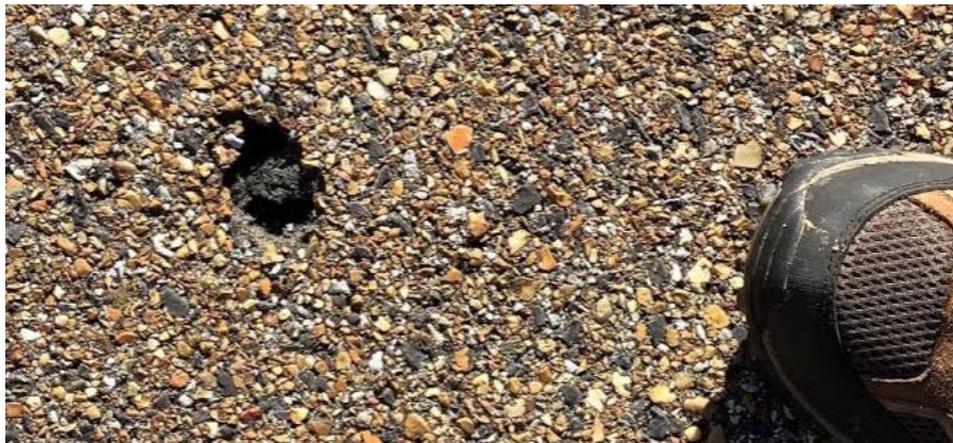
No cracking was observed anywhere in the section after the full two years and 10 million ESALs. There were, however, a few pop outs randomly located in the section. Figure 14 shows one of the largest. Exactly when this pop out occurred is not known but it was not deemed detrimental to the structural integrity of the section.

**Figure 14. Pop Out in Section S2**

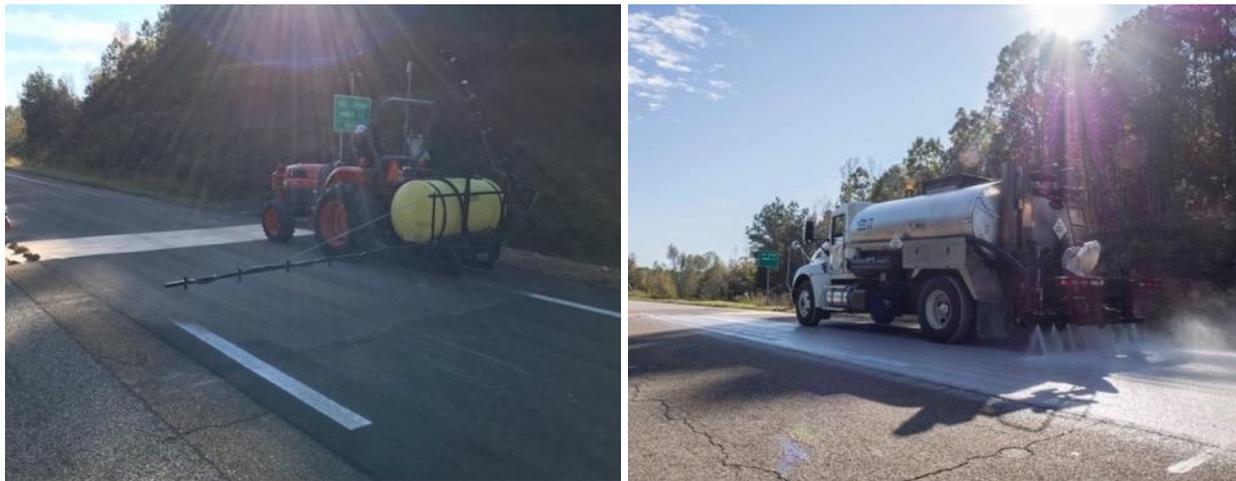
For Section S3, two spray-on rejuvenator products were applied over the surface of a 1.5” mill/inlay asphalt pavement section constructed in 2012 after the section experienced around 20 million ESALs of traffic without presenting rutting and cracking distresses (Figure 1). The hot mix asphalt (HMA) of Section S3 was a dense-graded mix with sand and gravel containing 25% reclaimed asphalt pavement (RAP) and an asphalt content of 6.8%. The asphalt binder used in the design was a neat binder with performance grade (PG) 67-22.

**Figure 35. S3-A and S3-B Application of Spray-on Rejuvenators**

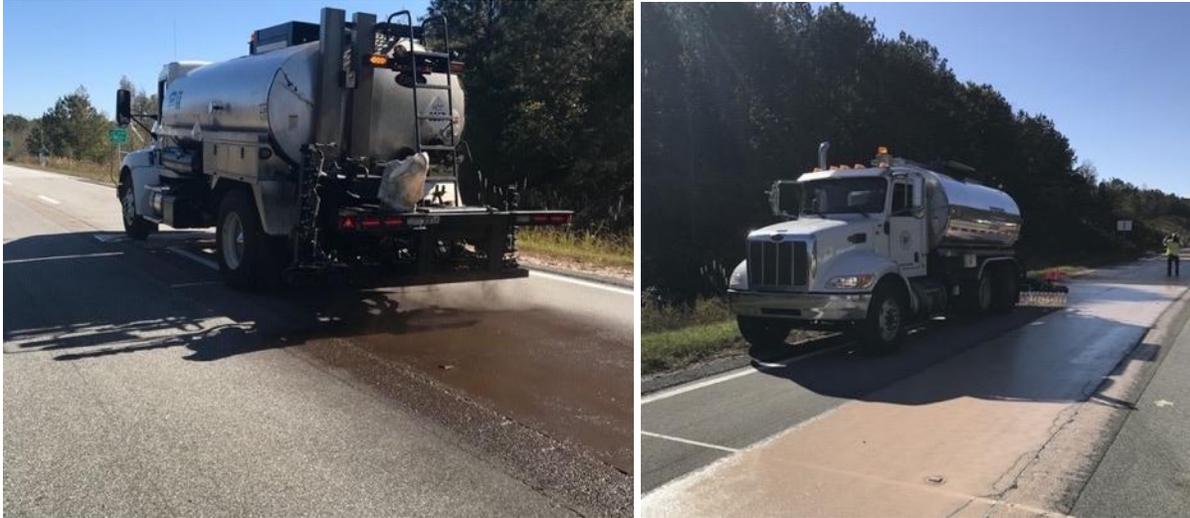
For Section S4, two spray-on rejuvenator products were applied over the surface of a 1.5” mill/inlay asphalt pavement section constructed in 2015 after the section experienced around 10 million ESALs of traffic without presenting rutting and cracking distresses (Figure 2). The HMA was a dense-graded mix with sand and limestone containing 15% fine RAP (F-RAP) and with an asphalt content of 6.2%. The asphalt binder used in the design was a neat binder with PG 67-22.

**Figure 36. S4-A and S4-B Application of Spray-on Rejuvenators**

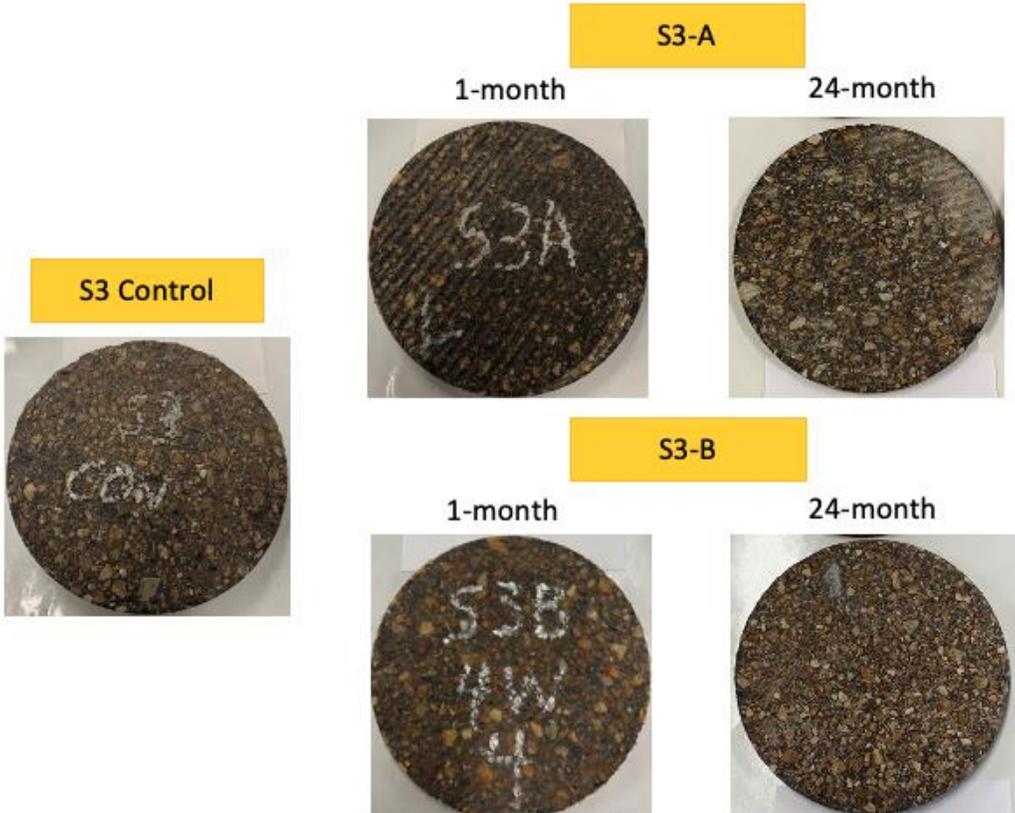
Figure 4 shows the pavement surfaces of Section S3, including control and treated sections after 1 month and 24 months of application of the spray-on rejuvenator products. For section S3-A, the cores were collected from the diamond ground portion of the section that existed prior to this study. Figure 5 shows the pavement surfaces of Section S4, including control and treated sections after 1 month and 24 months of application of the spray-on rejuvenator products.

**Figure 4. Section S3 Pavement Surfaces Before and After 1 Month and 24 Months of Treatment Application**

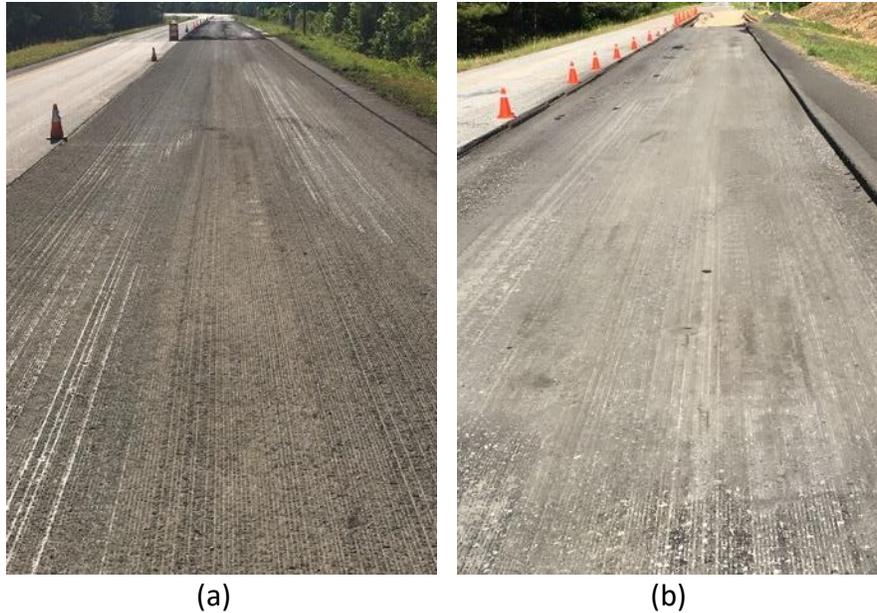
In the 2015 research cycle, Section N9 was converted to an open-graded friction course (OGFC) study for ODOT to evaluate the friction performance of OGFC mixes using locally available aggregates. The section was divided into two sub-subsections, which were milled and inlaid with 0.75 inches of sandstone OGFC mixes with two tack coat rates. In May 2018, the top 1.5 inches of the OGFC and underlying mixes were milled off for the preparation of the 2018 research cycle, as shown in Figure 3(a).

**Figure 3. Existing Pavements after Milling in (a) Section N9 and (b) Section S1**

The existing pavement of Section S1 has supported numerous surface layer experiments since the original Test Track construction. The overall thickness of the section includes 24 inches of asphalt mixes. In May 2018, the top 5.0 inches were milled off for the preparation of the 2018 research cycle, as shown in Figure 3(b).

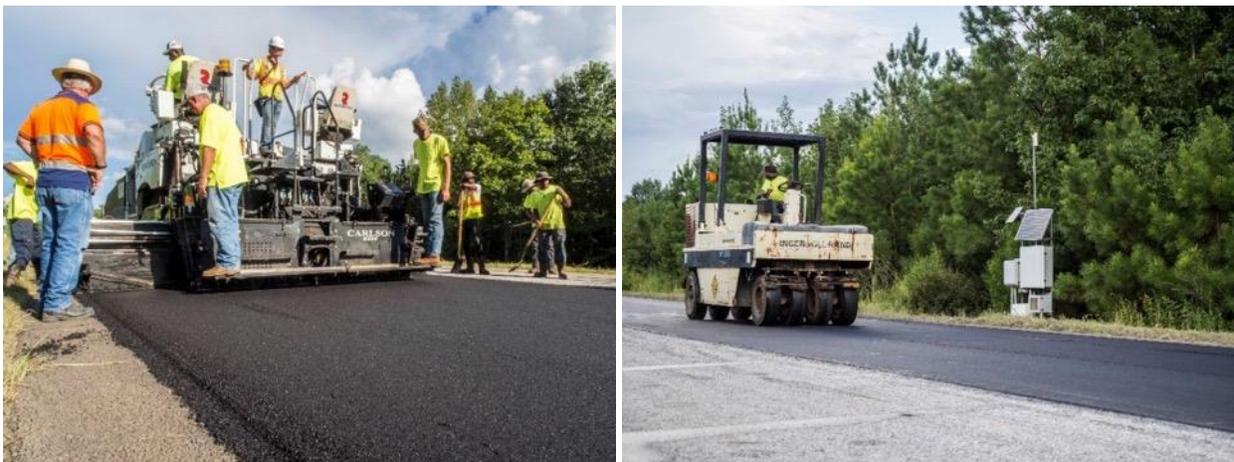
Section N9 was built as a 1.5-inch mill-and-inlay on a 14-inch asphalt pavement. The mix was produced and placed on September 10, 2018 with a 24-hour high temperature of 84°F, a low temperature of 73°F, and less than 0.1 inch of 24-hour rainfall. With ODOT's approval, the mix was produced with a virgin binder at the same PG grade but from a different source than what was used by the contractor in Oklahoma for the mix design. The aggregates and RAP used for production were the same as mix design. As shown in Table 1, quality control testing of the production mix hit the target total binder content and gradation from the JMF. However, the production mix had 2.1% air voids and 14.0% VMA. Although these changes were outside ODOT's production tolerance, the performance test results of the production mix (which will be discussed later) indicated good rutting and cracking resistance. Given that the mix was designed using a BMD approach, ODOT agreed to relax the volumetric requirements for production and leave the mix in-place for performance evaluation on the Test Track. The mix had an average production temperature of approximately 325°F and in-place density of 96.4%. Figure 5 shows the mix laydown and compaction for Section N9.

Figure 5. Construction of Section N9

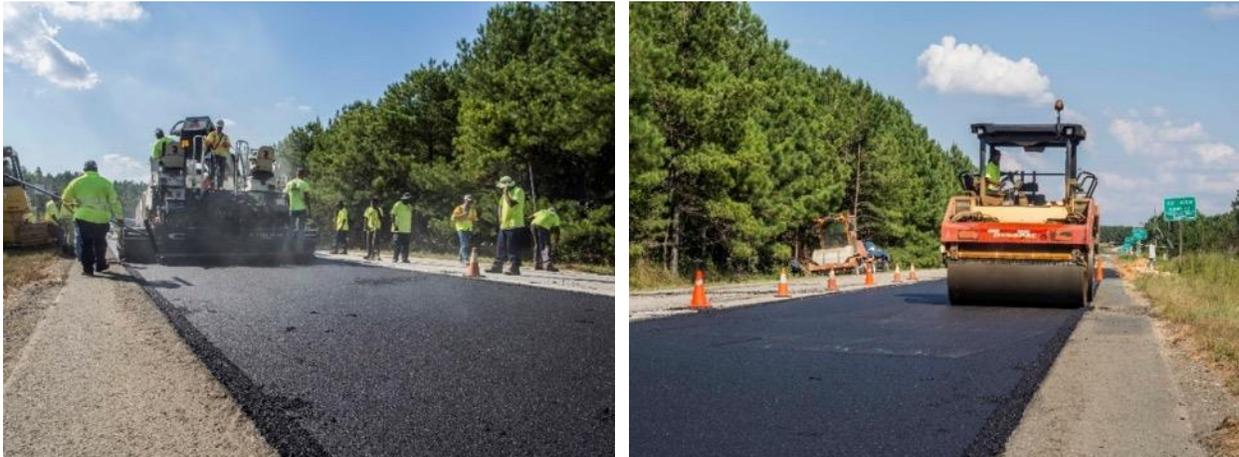
As shown in Table 1, QC testing of the S1 base mix indicated a slight reduction in the total binder content from 5.2% in mix design to 5.1% at production but no significant changes in the combined aggregate gradation from the JMF. Although the mix had a reduction in air voids from 3.4% in mix design to 2.7% at production and a reduction in VMA from 14.0% to 13.1%, these differences were within ODOT's production tolerance. The S1 base mix had an average production temperature of approximately 305°F and in-place density of 94.6%. Figure 6 shows the laydown and compaction of the base mix for Section S1.

**Figure 6. Construction of the Base Layer of Section S1**

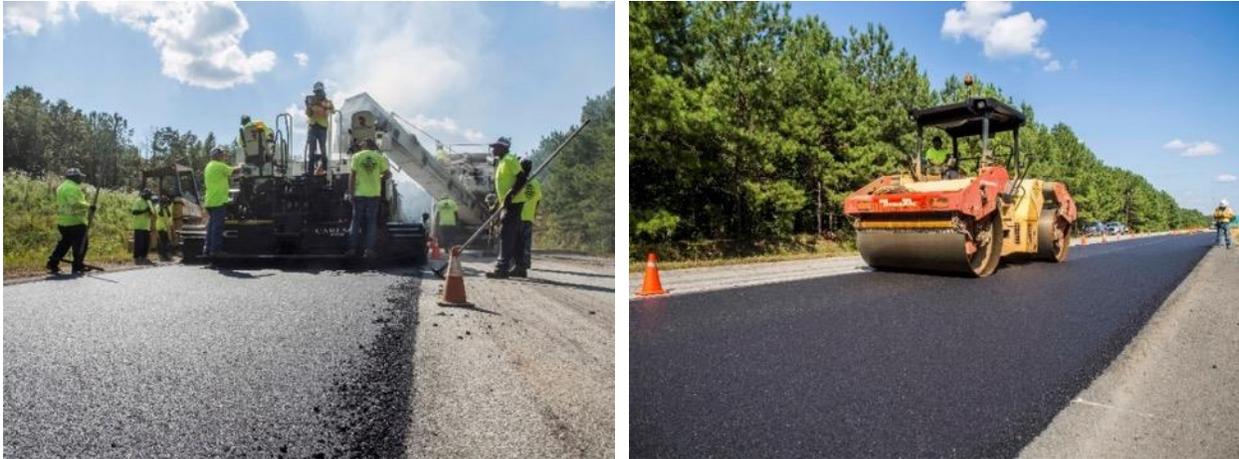
QC testing of the S1 surface mix showed a reduction in the total binder content from 5.8% in mix design to 5.5% at production but no significant changes in the combined aggregate gradation from JMF. Furthermore, the mix had a notable reduction in air voids from 3.4% in mix design to 2.3% at production and a reduction in VMA from 16.2% to 14.7%, but these changes were within ODOT's production tolerance. The S1 surface mix had an average production temperature of approximately 325°F and in-place density of 96.1%. Figure 7 shows the laydown and compaction of the surface mix for Section S1.

**Figure 7. Construction of the Surface Layer of Section S1**

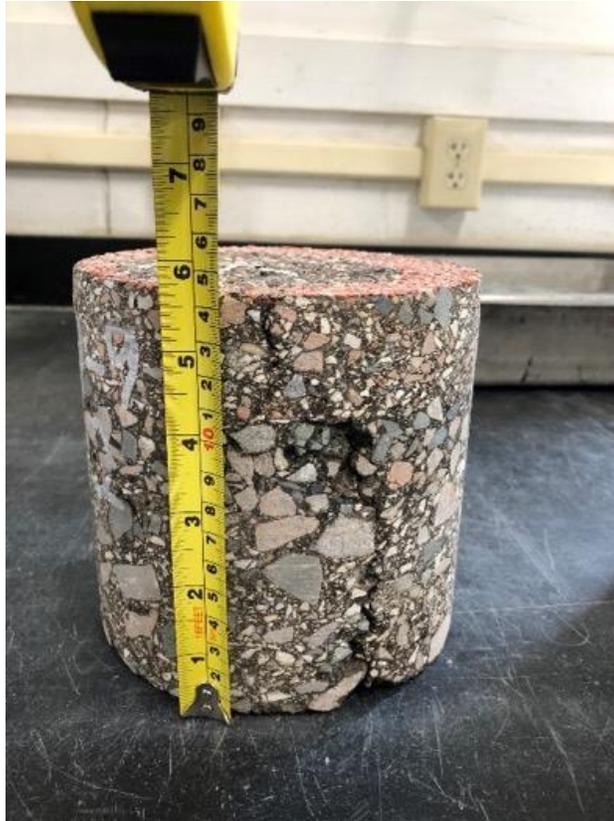
Figure 20. Field Core from Cracked Area in Section N9

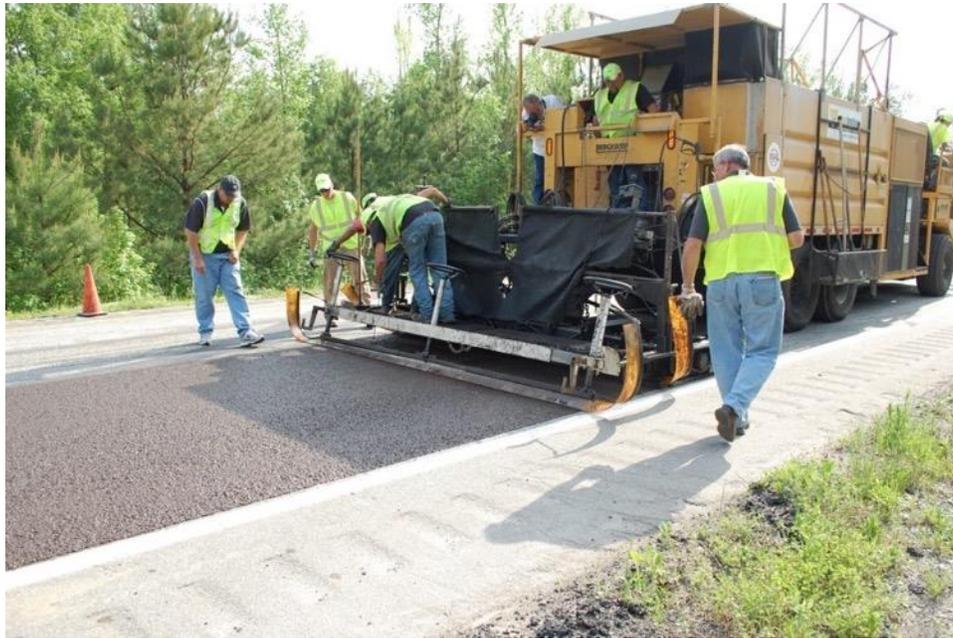
A plastic strip was placed at the stopping point to ensure a sharp, uniform edge. The treatment was applied to the clean pavement surface with a variable width spreader box equipped with augers and a secondary strike off at a rate of 24 lbs/yd<sup>2</sup>. Due to various maintenance activities being conducted at the Track during that time, fleet operations were suspended from April 26 to May 2, 2014. Cones were placed around the section as a precaution to protect it from light traffic and construction equipment until it had properly cured. However, vehicles were unlikely

**Figure 1. Micro Surfacing Application on Section N6A**

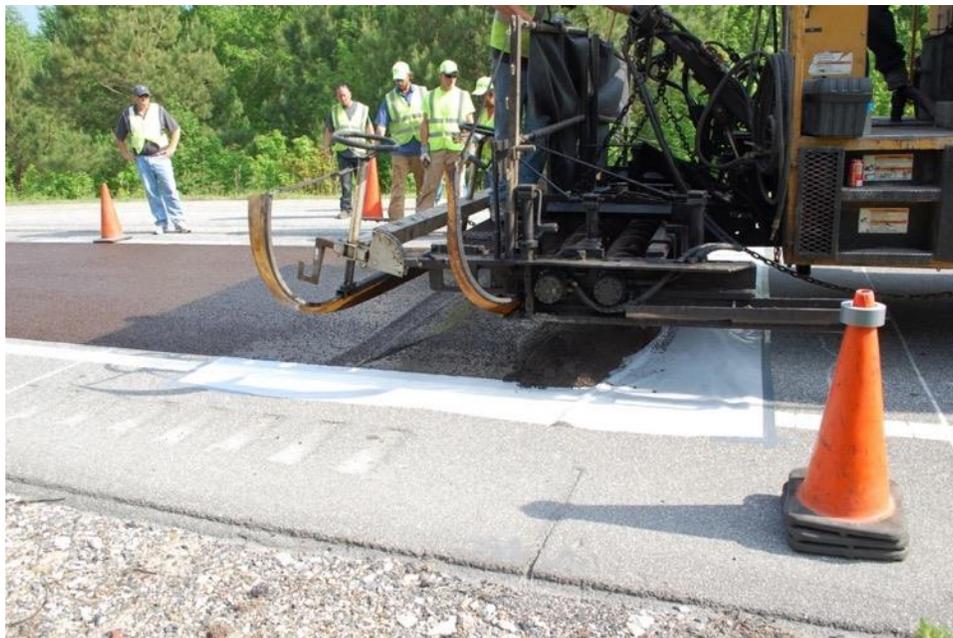
**Figure 2. Plastic Strip at Stopping Point**

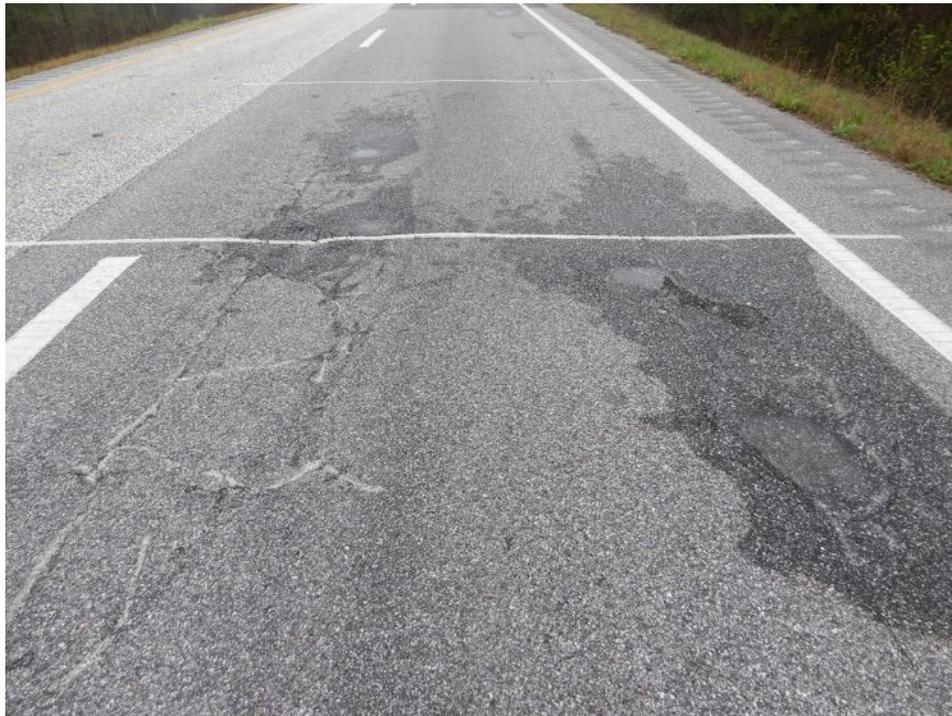
It should be noted that the type of cracking observed was mostly low severity fatigue cracking, manifested as longitudinal cracking with a few interconnected cracks along the wheel paths and widths under 10 mm. However, in the control section, some cracking areas were also accompanied by pumping and depressions (Figure 5), which accelerated the deterioration of the pavement compared to the micro surfaced section.

**Figure 5. Cracking and Depressions in Untreated Section**

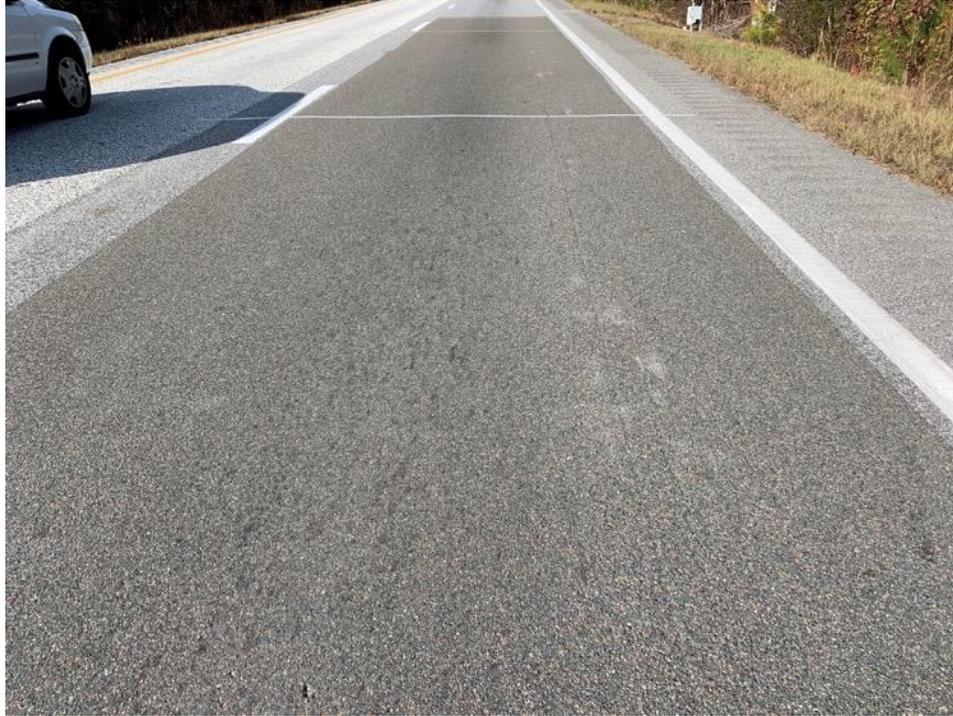
Figure 11 shows a general view of the treated section. Micro surfacing application was effective in restoring the pavement surface and correcting rutting while maintaining safe frictional characteristics. The treatment was able to withstand heavy traffic loading without wearing off, contributing to extending the life of the existing pavement. These observations agree with NCAT’s research findings from full-scale test sections that are located in open roadways and subjected to live traffic. Long-term monitoring of these off-track sections has shown that micro surfacing is capable of improving cracking performance over time, correcting minor rutting and maintaining ride quality and pavement integrity (13, 14).

**Figure 11. Overview of Micro Surfacing Test Section**

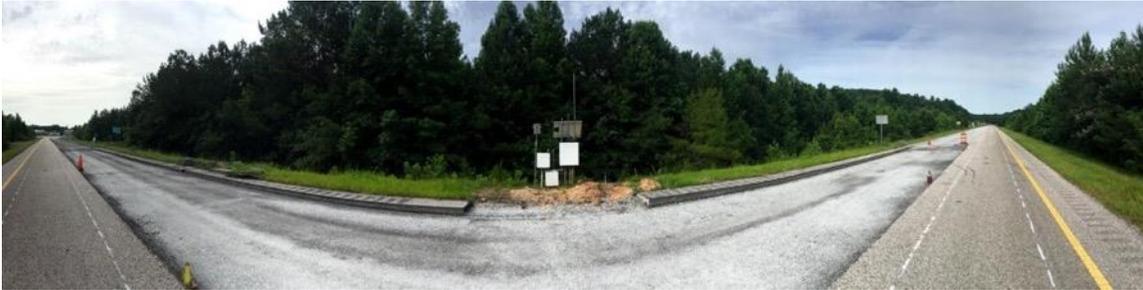
Preparation of Section S9 for paving included removal of the old AC through milling. The remaining substructure consisted of approximately 6 inches of crushed granite aggregate base over the native Test Track A-4 (0) soil. Figure 1 shows the prepared surface prior to placing the AC.

**Figure 1. Section S9 Prior to Paving**

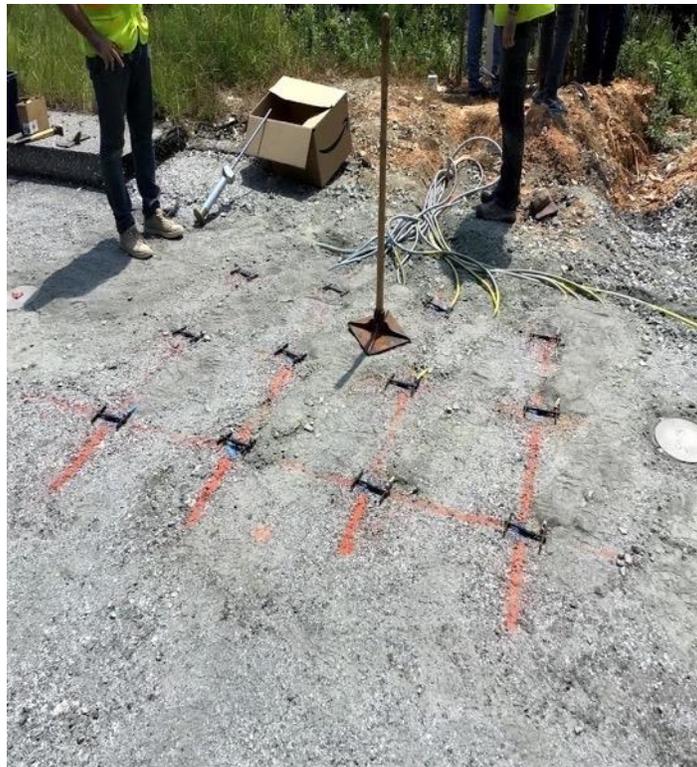
a) Pre-Placement of Instrumentation

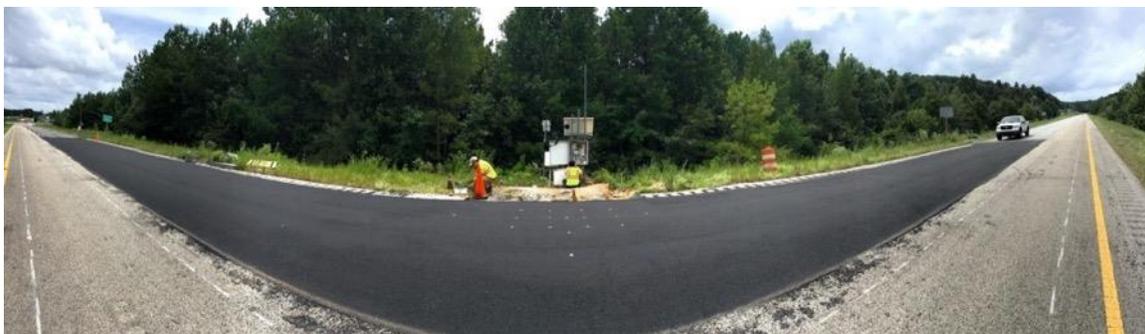
**Figure 5. Section S9 After Paving**

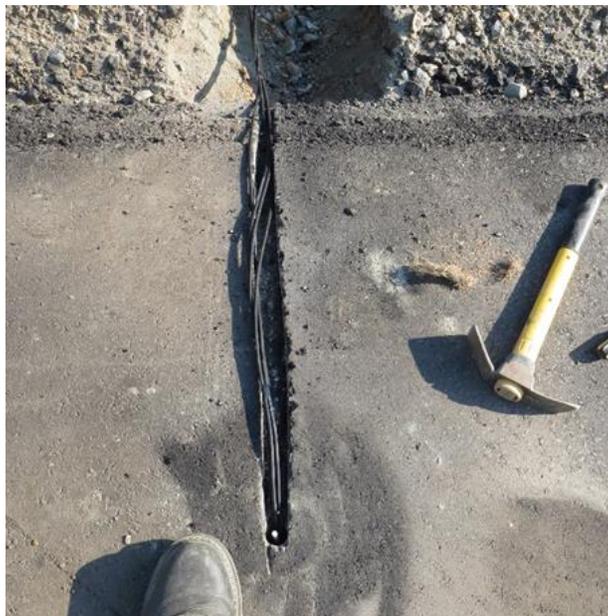
**Figure 7. Installed Thermocouple Bundle Prior to Covering with Roofing Asphalt**

The final sensor installation occurred after grinding to achieve smoothness. To monitor in situ temperatures, a bundle of four thermocouples was installed to measure temperatures at the top, middle, and bottom of the AC layer, and 3 inches into the aggregate base. A vertical hole was drilled into the pavement just outside the edge stripe that was deep and wide enough to accommodate the four thermocouples, with the top one flush to the pavement surface. Figure 7 shows the installation, with a slotted trench containing the thermocouple cables running to the shoulder before everything was covered and sealed with roofing asphalt (Figure 8).

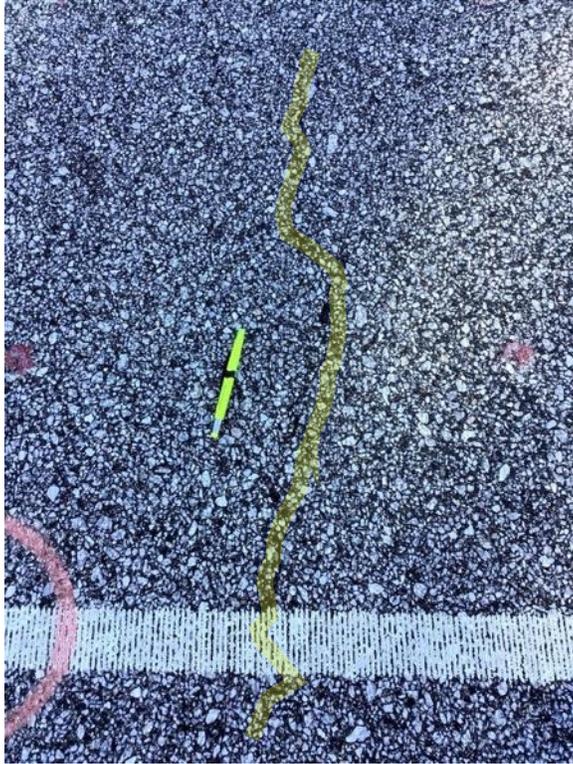
A small amount of cracking was observed in the section, first observed in mid-December 2020 after approximately 9.4 million ESALS. The hairline cracks were aligned in the direction of travel and were at the edges of the wheelpath. At the end of trafficking, the cracking represented a total of 0.7% of the lane area or 1.1% of the wheelpath area. One crack was located at the edge of the outside wheelpath near the gauge array, while another crack was further along the section at the edge of the outside wheelpath. Figures 10 and 11 show the two cracks lightly highlighted for easier identification, and traffic moves in the vertical direction in each photo.

**Figure 10. Section S9 Longitudinal Crack at Edge of Outside Wheelpath**

At this time, given the magnitude, amount, and orientation of the cracking, it seems that it is likely top-down. As will be presented in the structural characterization section, the stress, strain, and backcalculated modulus data also support this assertion. Future destructive forensic coring and/or trenches will be done to check this hypothesis.

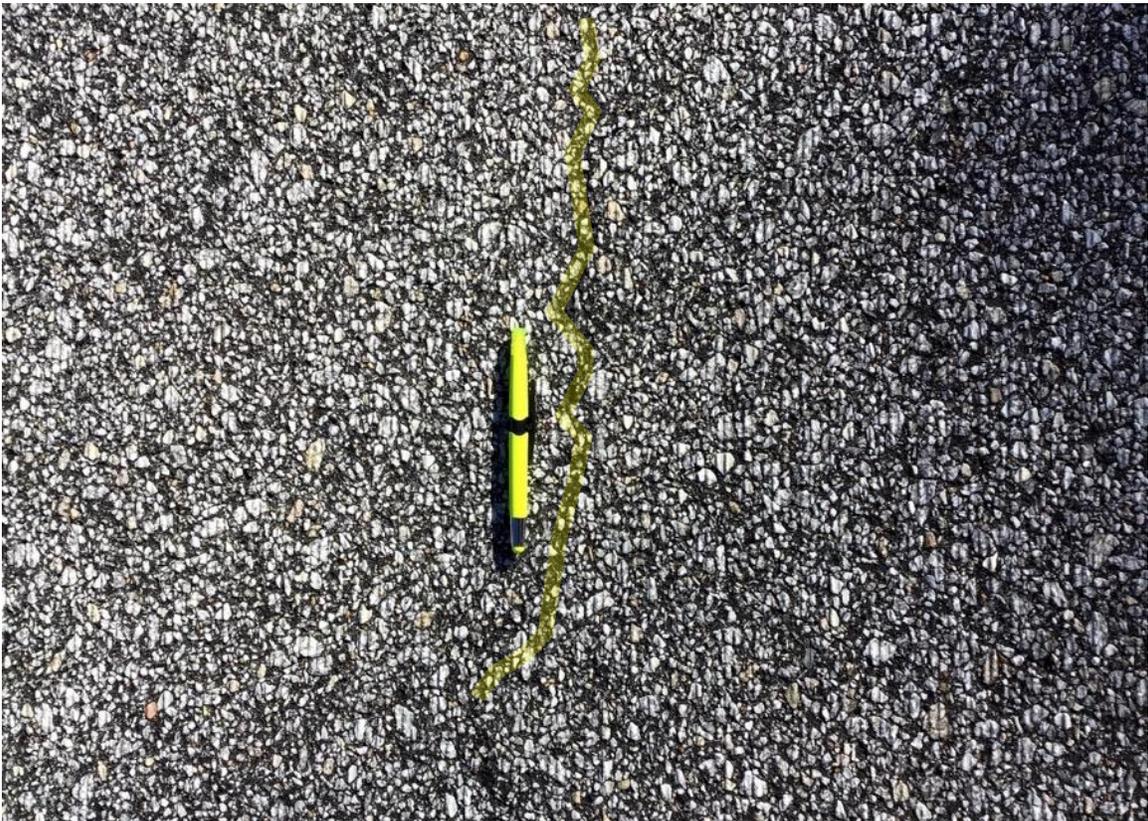
**Figure 11. Section S9 Longitudinal Crack at Edge of Inside Wheelpath**

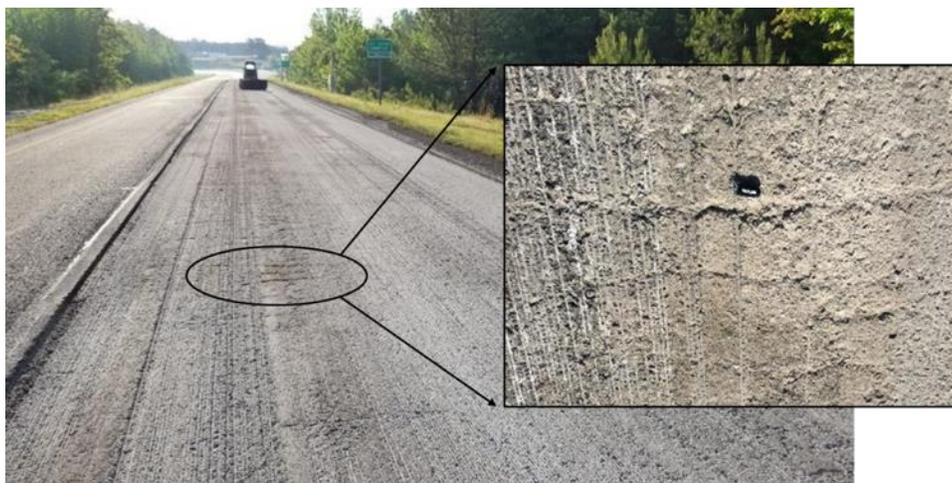
The existing pavements of Sections S10 and S11 were constructed in 2009 as part of the Green Group Experiment. Both sections were constructed with 7 inches of asphalt mix over 6 inches of graded aggregate base and a stiff subgrade (approximately 30 ksi). The sections had approximately 15 to 20% of the lane area cracked after being trafficked for 14 million equivalent single axle loads (ESALs) through April 2014, when at that point, they were converted to the Pavement Preservation Experiment. Section S10 was divided into two sub-sections and treated with scrub cape and scrub seal, respectively. Section S11 was also divided into two sub-sections, with one treated with chip seal and the other left untreated as a control section. In May 2018, the top 2.5 inches of both sections were milled off for the preparation of the 2018 Test Track research cycle. Figure 2 shows the fatigue cracking in the underlying pavement of sections S10 and S11 after milling. These two sections allowed TxDOT and NCAT to determine if a BMD mix would still outperform a volumetric mix in terms of cracking resistance with a challenging underlying pavement condition.

**Figure 2. Fatigue Cracking in Underlying Pavement of Sections 10 and S11 after Milling**

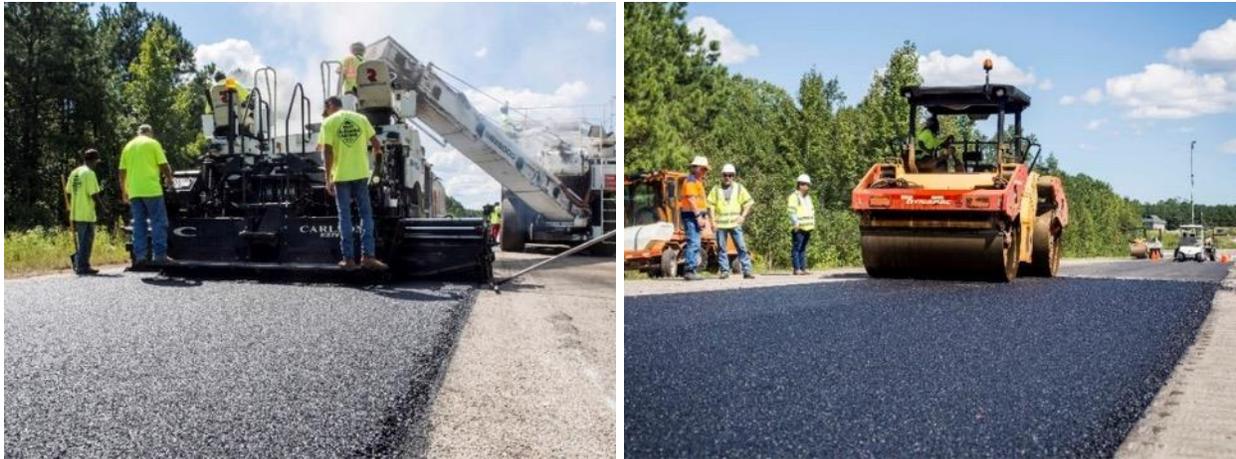
The S10 BMD mix was produced and placed on September 18, 2018, with a high temperature of 91°F, a low temperature of 73°F, and no rainfall. As shown in Table 1, quality control (QC) testing of the plant mix showed a reduction in the total binder content from 5.5% in mix design to 5.3% at production, as well as slight changes in the 3/8", #4, #8, and #50 fractions. The production mix had 2.4% lab-molded air voids and 14.8% VMA ( $G_{se}$ ) at 50 gyrations ( $N_{design}$ ), and 4.0% lab-molded air voids and 16.2% VMA ( $G_{se}$ ) at a reduced  $N_{design}$  of 35 gyrations. The production mix met TxDOT's specific specification for *Superpave Mixtures – Balanced Mix Design*, except that the %passing on the #8 sieve size was 1% lower than the allowed master gradation limits. The extracted binder of the mix was graded to be PG 82-16. The mix had an average production temperature of approximately 305°F and in-place density of 95.9%. Figure 4 shows the laydown and compaction of the BMD surface mix for Section S10.

**Figure 4. Construction of Section S10 with a BMD Mix**

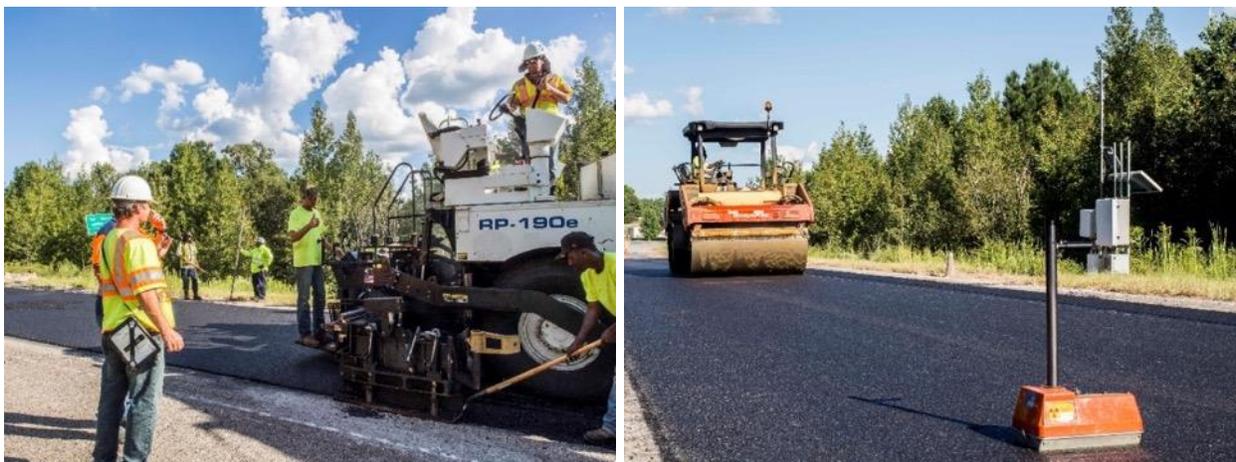
The S11 volumetric mix was produced and placed on September 18, 2018, with a high temperature of 93°F, a low temperature of 72°F, and no rainfall. As shown in Table 1, QC testing of the plant mix showed a reduction of asphalt content from 4.7% in mix design to 4.4% at production and slight changes in the 1/2", 3/8", #16, and minus #200 fractions. The plant mix had 3.6% lab-molded air voids and 14.0% VMA ( $G_{se}$ ) at 50 gyrations ( $N_{design}$ ), which met TxDOT's specification for Item 341, *Dense-Graded Hot-Mix Asphalt*. The extracted binder of the mix was graded to be PG 82-16, which was the same as that of the S10 BMD mix. The S11 mix had an average production temperature of approximately 300°F and had in-place density of 95.4%. Figure 5 shows the laydown and compaction of the volumetric mix for Section S11.

**Figure 5. Construction of Section S11 with a Volumetric Mix**

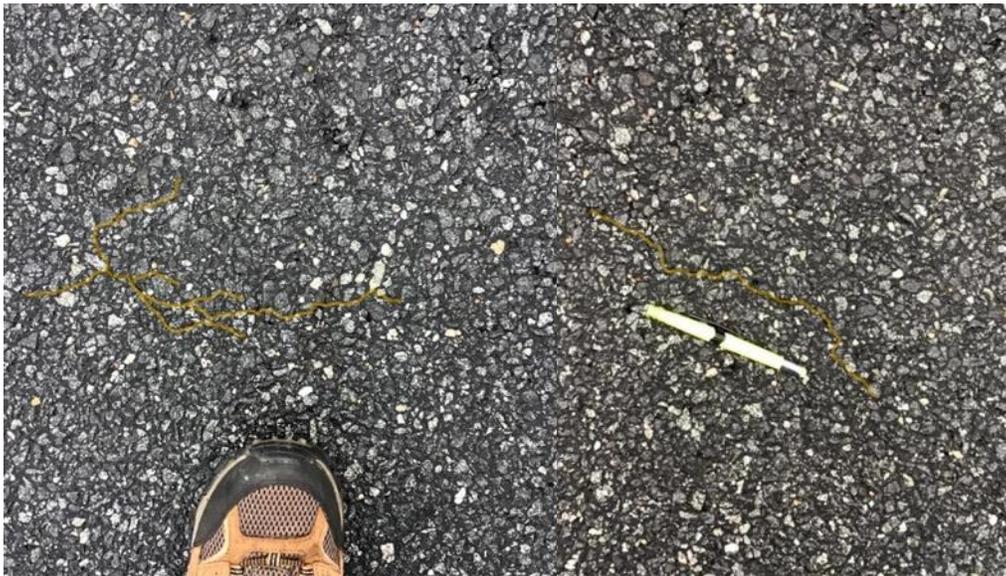
**Figure 2. Sample Cracking in N4-4"AC on 1/25/2021 (29.6 Million ESALs)**

cracking rather than bottom-up. Future forensic investigations will reveal the nature of the cracking, but at this point it is recommended to leave N4-4" AC in place to better capture cracking progression with the application of more traffic in the next test cycle.

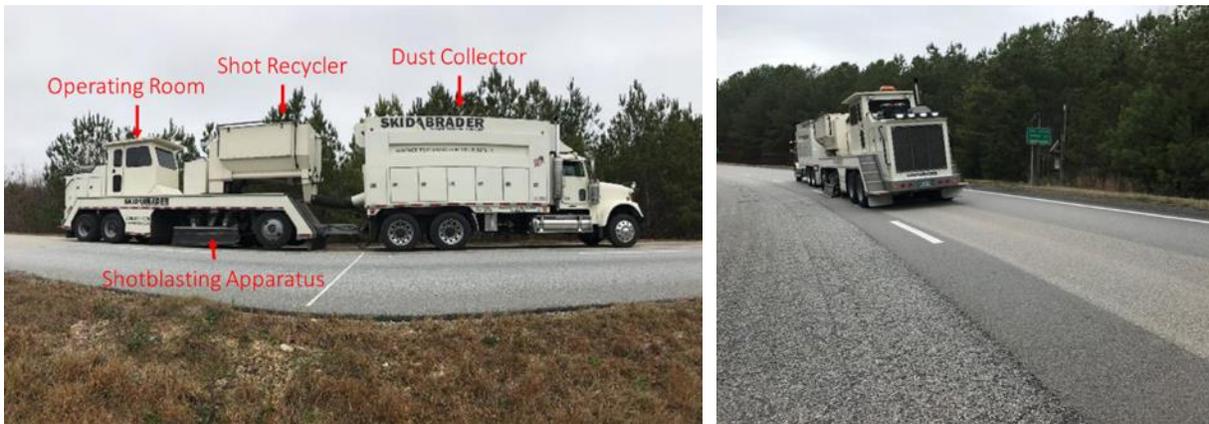
5.3 million ESALs of accumulated traffic. The details of shotblasting treatment can be found in Sarkar et al. (2). Figure 8a illustrates a typical shotblasting system, including an operating room, a shotblasting apparatus, a shot recycler, and a dust collector. The shotblasting apparatus is an essential unit that consists of a shot propeller, vacuum system, magnetic separator, brush, and broom. Figure 8b shows the shotblasting treatment at the NCAT Pavement Test Track. The shotblasting train ran at a speed of 28.3 m/min (92.8 ft/min) with a treatment width of 1.8 m (5.9 ft).

(a) Shotblasting System

(b) Treatment at Test Track

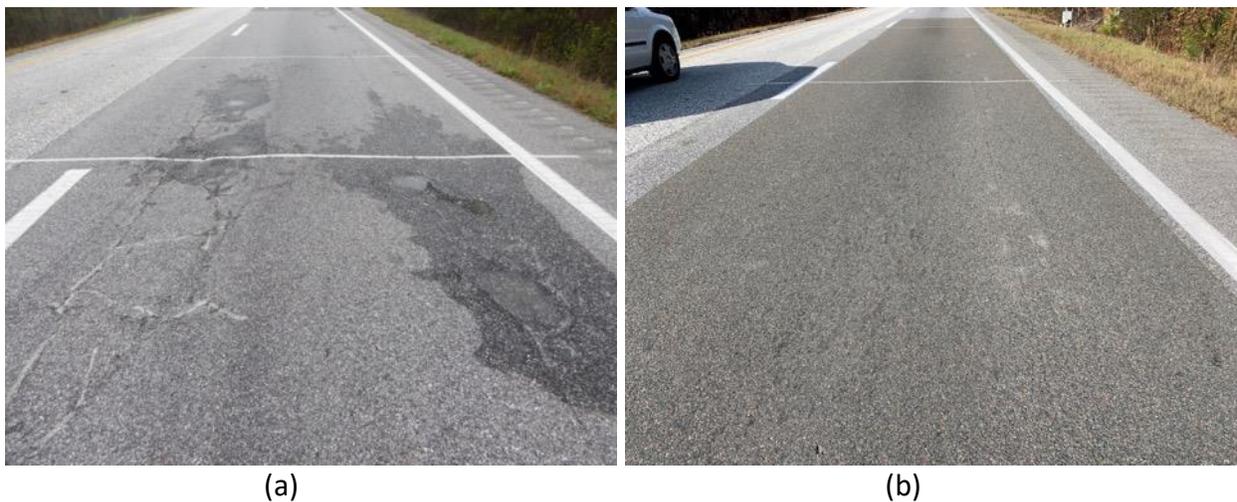
**Figure 1. Overview of a) Control and b) Micro Surfacing Test Sections**

Micro surfacing application was effective in restoring the pavement surface and correcting rutting while maintaining safe frictional characteristics. The treatment was able to withstand heavy traffic loading without wearing off, contributing to extending the life of the existing pavement. These observations agree with NCAT’s research findings from full-scale test sections that are located in open roadways and subjected to live traffic. Long-term monitoring of these off-track sections has shown that micro surfacing is capable of improving cracking performance over time, correcting minor rutting and maintaining ride quality and pavement integrity.
