NCAT REPORT 24-01

JULY 2024

# Findings from the Pavement Preservation Group (PG) Study

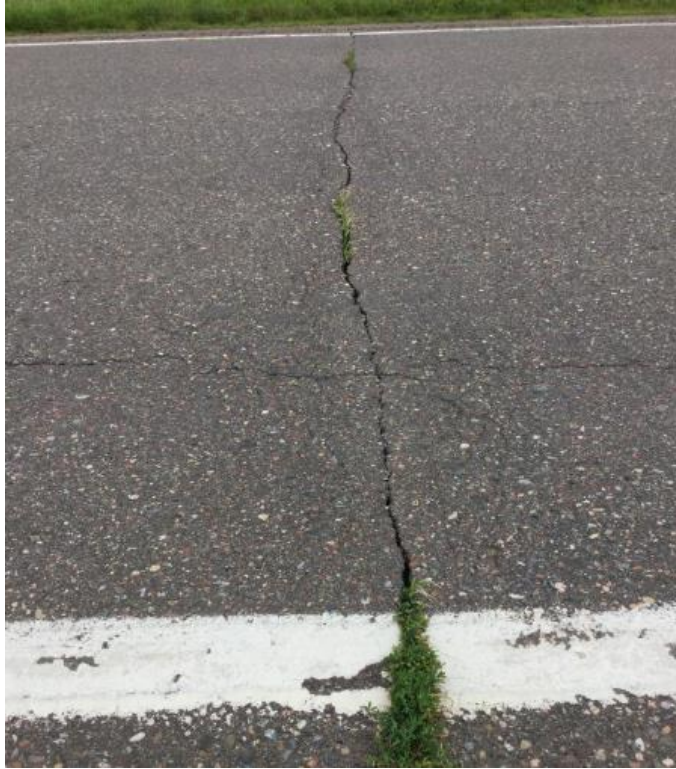
**Figure 3. Thermal cracking in CSAH-8.**

CSAH-8 is a two-lane county road near Pease, Minnesota, with an estimated AADT of 510 vehicles per day. Traffic is comprised of approximately 7% heavy vehicles, many of which are heavy implements of husbandry traveling to and from corn fields and dairy farms. The predominant distress at the time of treatment was thermal cracking (Figure 3). Each section had five to seven thermal cracks with varying levels of severity, which also affected pre-treatment ride quality.

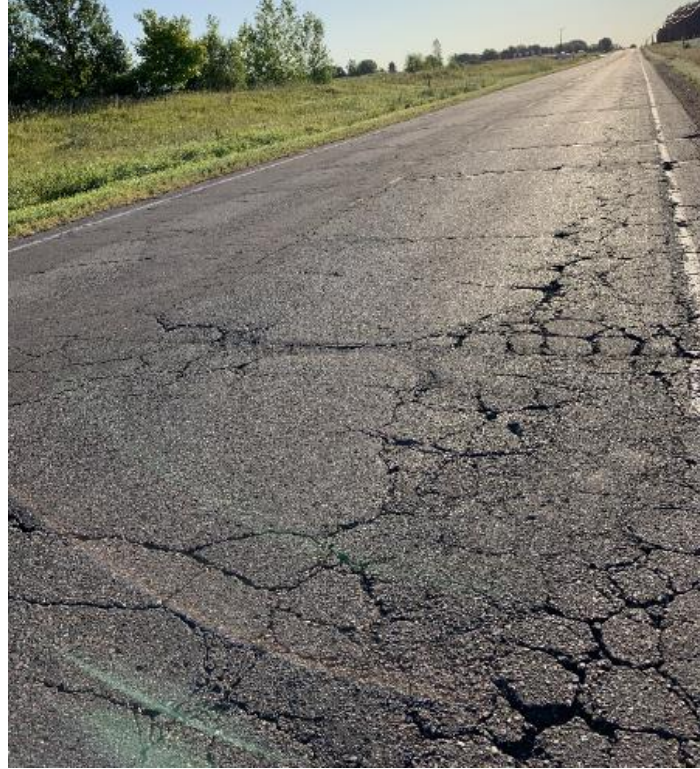
**Figure 5. Overall pavement condition of 70<sup>th</sup> Street.**

70<sup>th</sup> Street is a two-lane road with an estimated AADT of 2,300 vehicles per day. The roadway is located near the MnROAD facility and is owned by the cities of Albertville (eastbound lane) and Otsego (westbound lane). The existing pavement structure consisted of 4 inches of asphalt over 6 inches of aggregate base. It was heavily distressed at the time of treatment in 2019, which made it a candidate for evaluating various cold recycling and full-depth reclamation treatments. A 1-mile stretch was divided into 16 sections, each 500-ft long. Treatments were applied on both lanes, including traditional mill and fill sections and thin overlays for comparison. Due to the shared ownership of the road, there were differences in the maintenance activities performed before treatment. The westbound lane, which services more residents, exhibited a greater amount of patching and crack sealing. The general condition of the pavement was poor, with extensive environmental and load-related cracking, as shown in Figure 5.

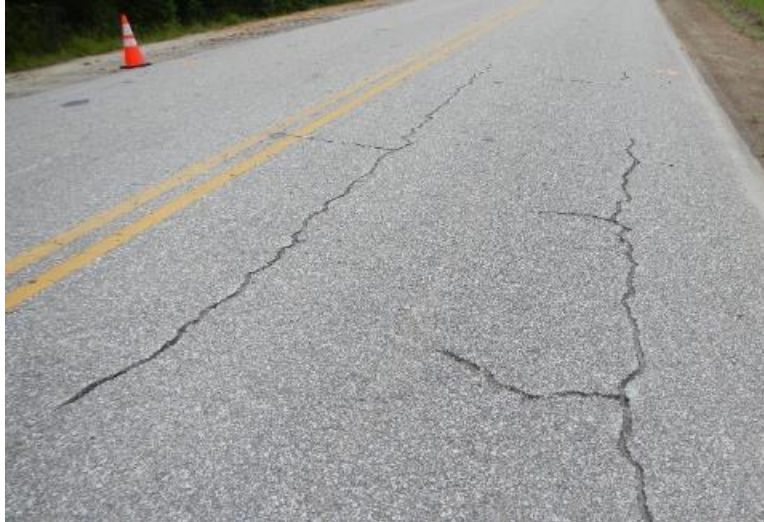
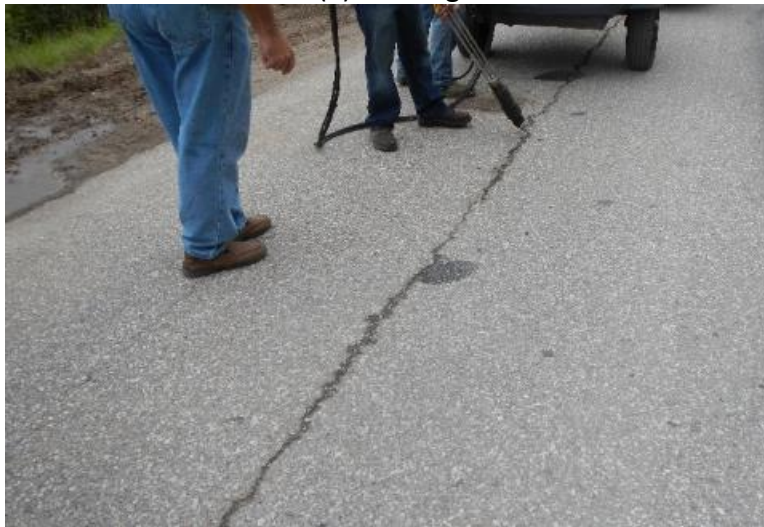
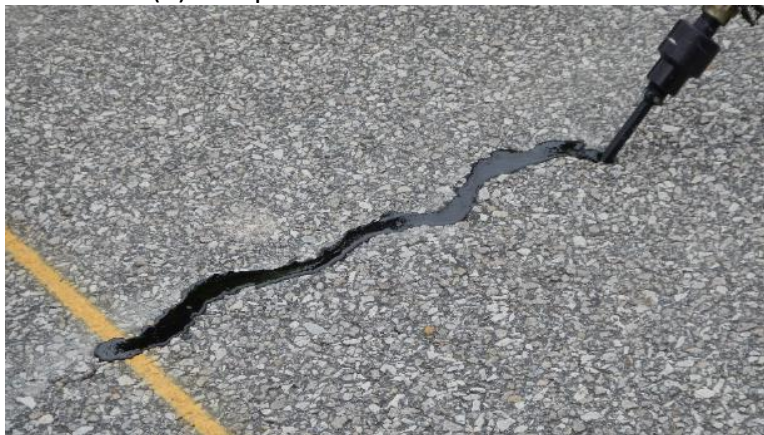
(a) Routing

(b) Compressed air with a heat lance

(c) Crack sealing

**Figure 6. Rout and seal procedure.**

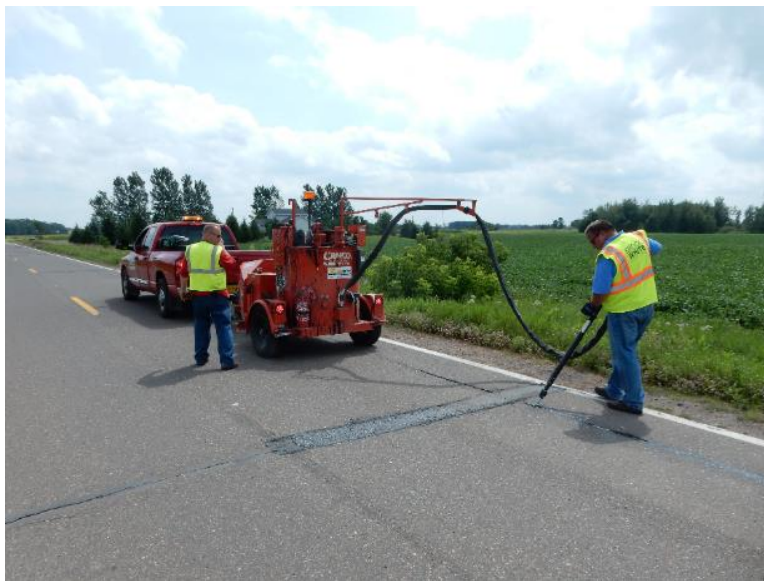
**Figure 8. Crack sealing and mastic treatments in CSAH-8 test section.**

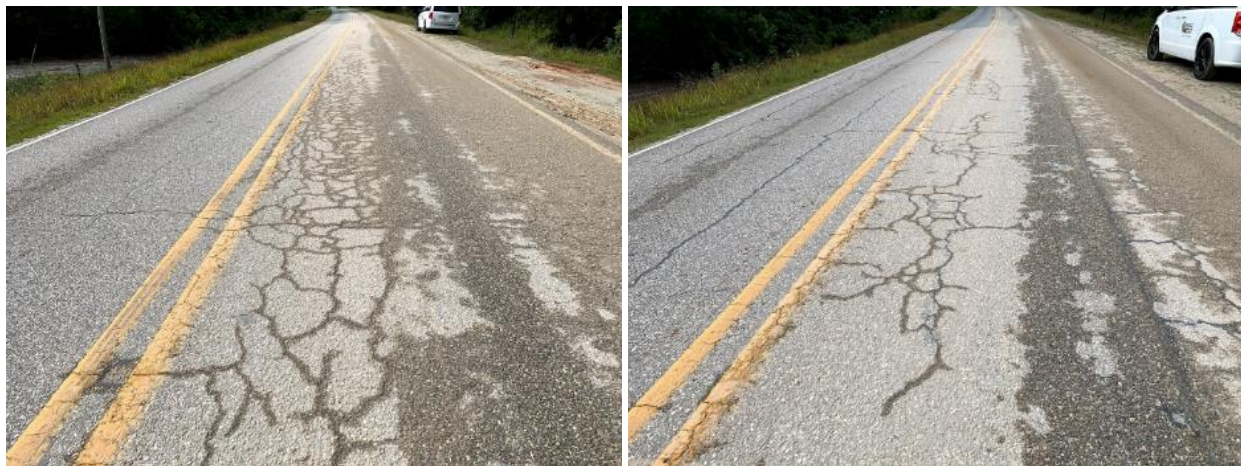
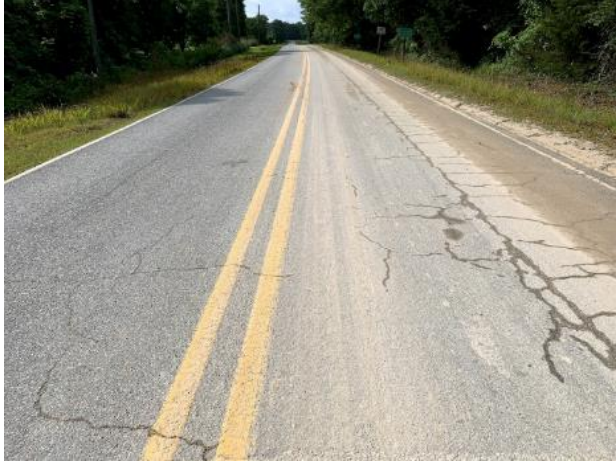
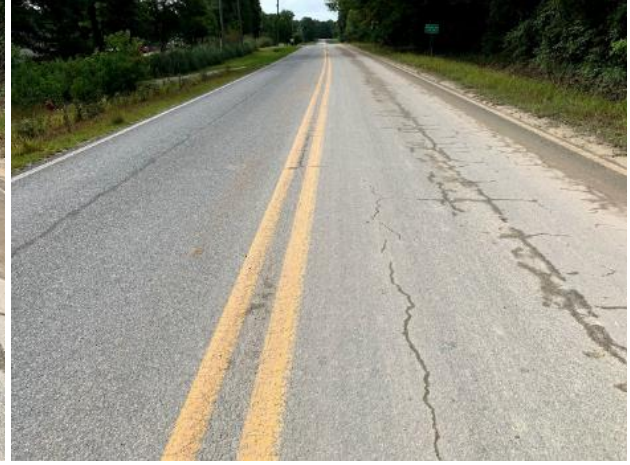
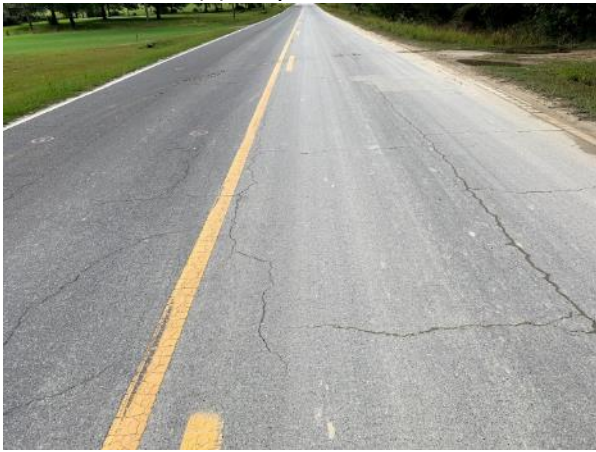
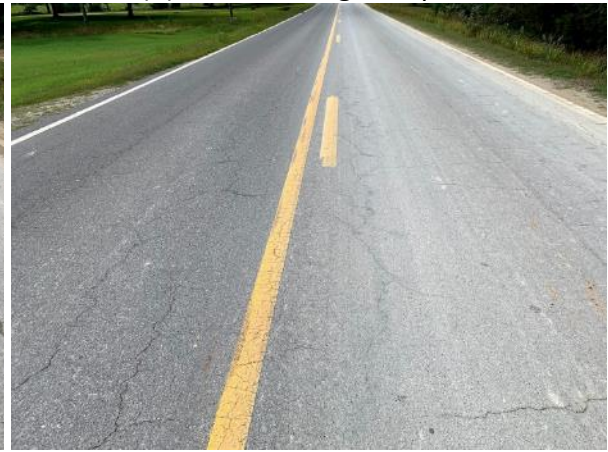
(a) Unsealed (control)

(b) Standalone crack sealing

(c) Chip seal

(d) Crack sealing + chip seal

(e) Micro surfacing

(f) Crack sealing + micro surfacing

**Figure 9. Unsealed vs. sealed section comparison.**

Notably, differences in performance were observed based on the sealing technique applied. When rout & seal was performed with the 5/8-inch bit followed by a surface treatment, slight compression of the sealing material occurred from traffic, resulting in reflected cracking along the sides of the routed crack (shown in Figure 10). Nonetheless, these cracks were less than 1/4” in width and prevented water intrusion without compromising the integrity or functionality of the surface treatments. Switching to a smaller bit eliminated this concern, and no sealant failures were observed throughout the study.

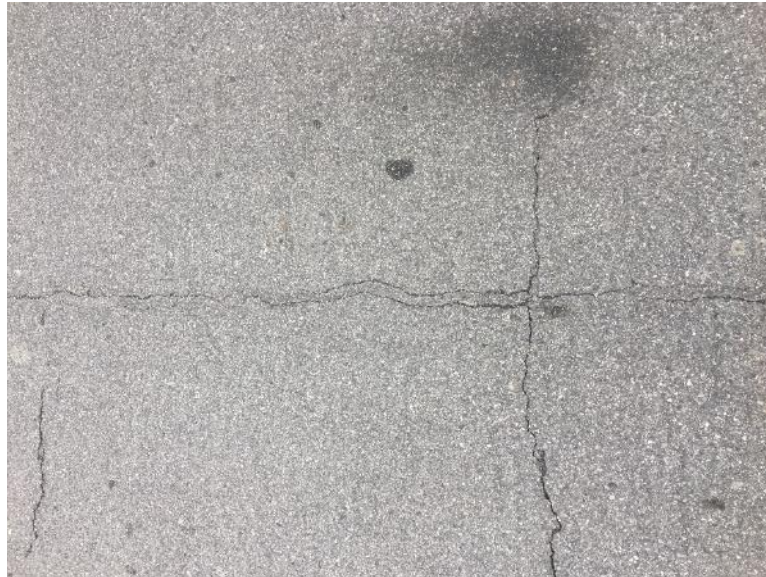
**Figure 10. Cracking along routed and sealed cracks under micro surfacing.**

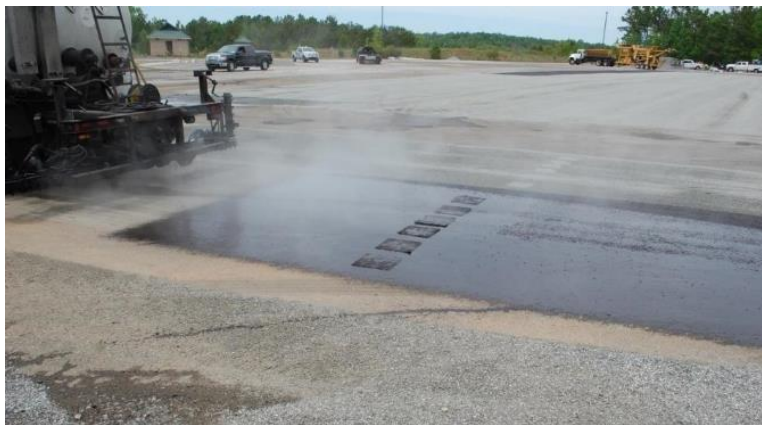
**Figure 12. Bar rate calibration.**

All conventional fog seals consisted of a CSS-1H emulsion, and all rejuvenating fog seals consisted of a CMS-1P(QB) emulsion. Equipment calibration was performed in each location to ensure accurate application rates. The procedure involved placing pre-weighed pads on the road surface and driving the asphalt distributor over the pads while spraying the emulsion (Figure 12). The pads were then removed and re-weighed to obtain the emulsion weight by subtraction, facilitating the application rate calculation.

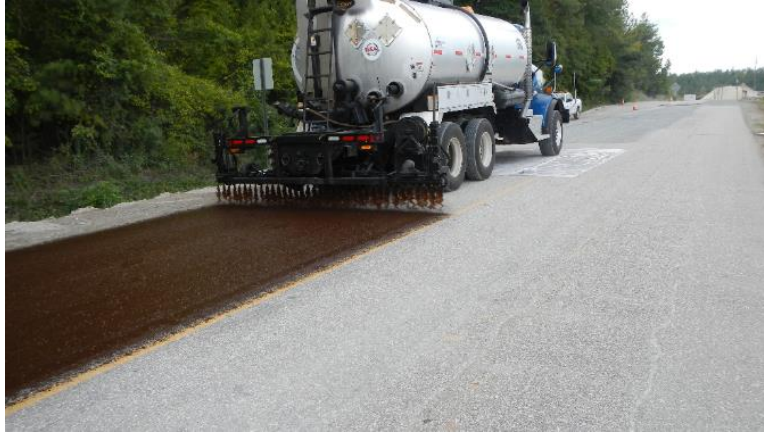
**Figure 13. Fog seal application.**

The pavement was swept as part of surface preparation to remove dust and loose materials. Plastic sheeting was affixed at the beginning and end of each section to protect adjacent test sections from contamination and ensure clean edges, as shown in Figure 13. The fog seals were then applied to the clean surface with a distributor truck at the diluted application rates shown in Table 5 and Table 6. Moreover, in the cold climate sections (CSAH-8 and US-169), a coal slag abrasive product known as Black Beauty sand was applied to ensure friction numbers remained above an acceptable level.

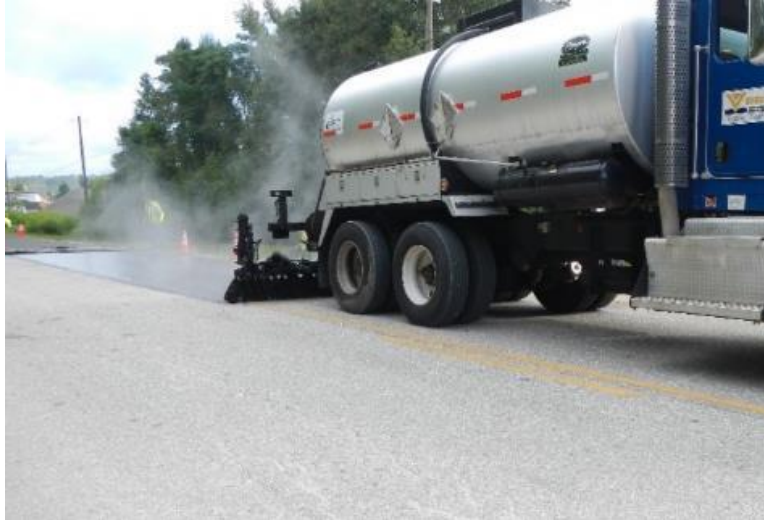
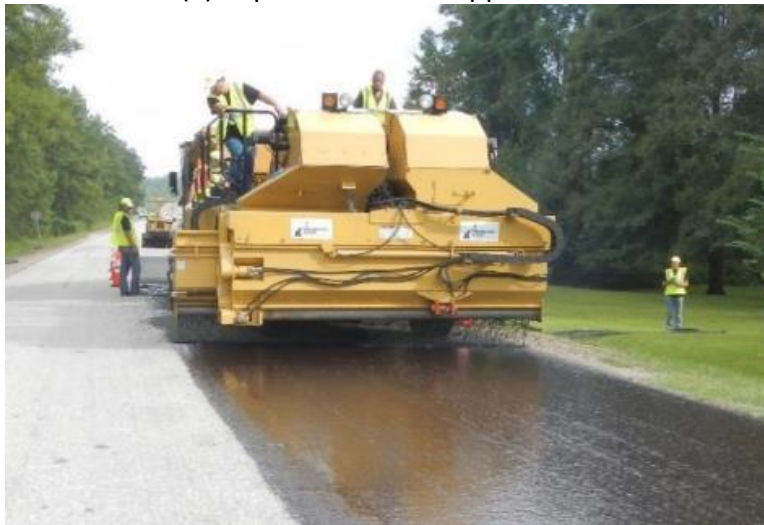
(a) Asphalt emulsion application

(b) Aggregate application

The existing surface was swept prior to construction to remove any loose material before applying the emulsion. The spray distributor and chip spreader were calibrated to ensure accurate emulsion and aggregate rates were applied. Once calibration was complete, the distributor applied the asphalt emulsion, which was immediately followed by aggregate application. The aggregate was then rolled with three passes of a pneumatic roller to embed it into the binder. After curing, the excess aggregate was removed using a broom before the road was opened to traffic. Figure 16 illustrates the procedure for chip seal application.

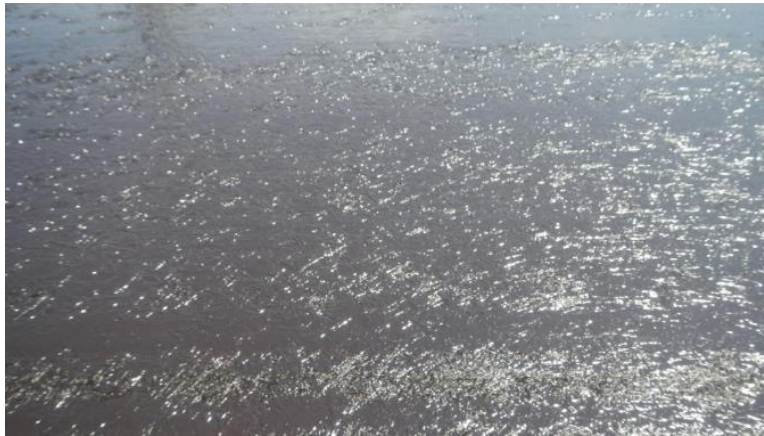
**Figure 18. Fibermat® membrane.**

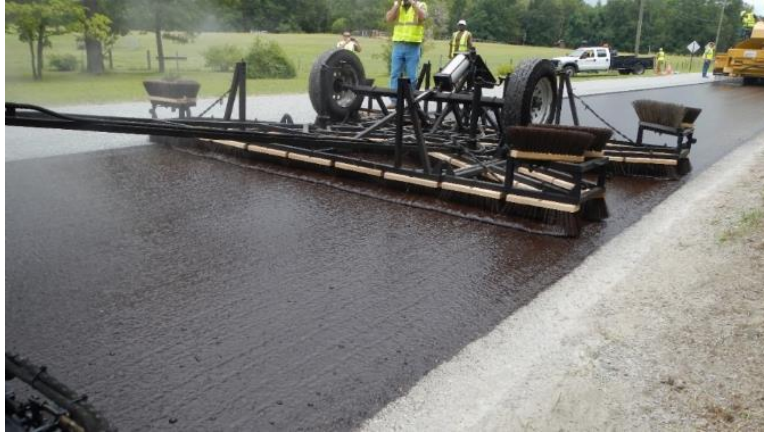
**Figure 19. Scrub seal application.**

The scrub seal application process is very similar to that of a standard chip seal. The differences between the two are the use of a rejuvenating polymer-modified emulsion and a scrub broom pulled by the distributor to force the emulsion into the cracks prior to aggregate application (Figure 19).

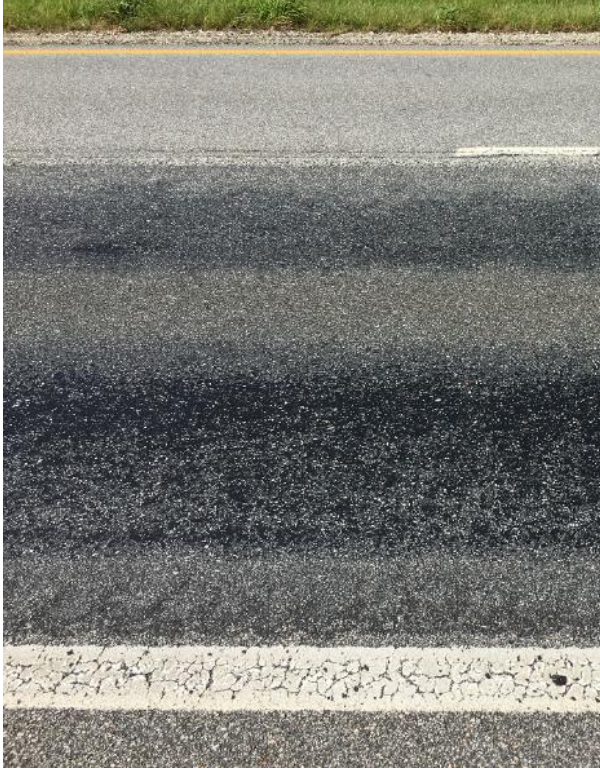
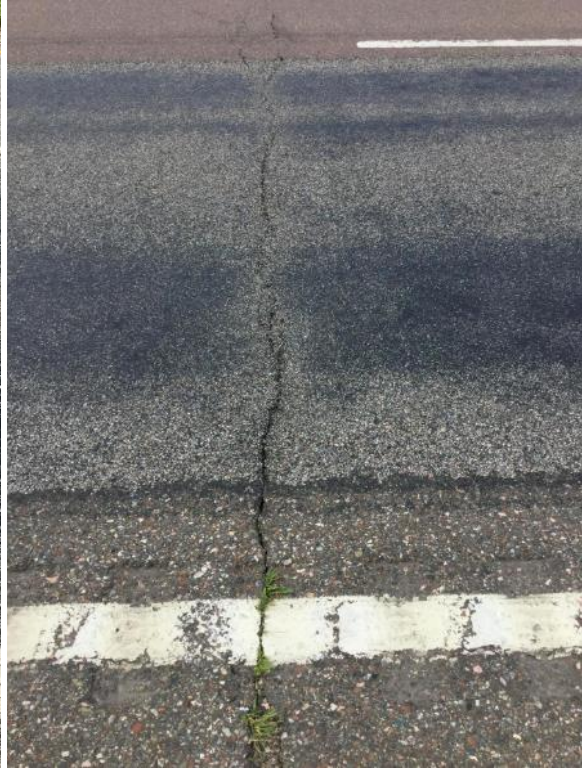
(a) US-280

(b) US-169

**Figure 20. Flushing in high traffic triple chip seal sections.**

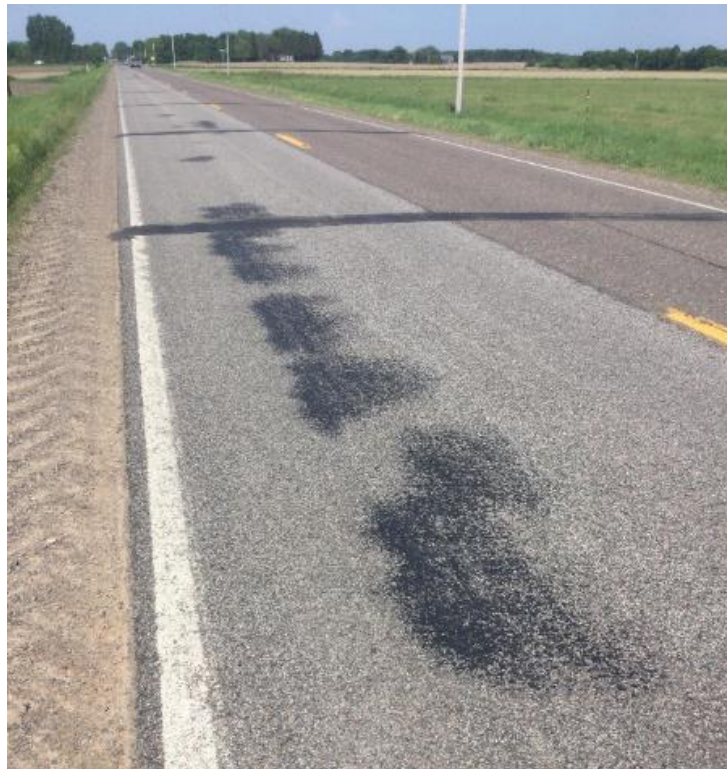
**Figure 21. Isolated flushing in CSAH-8 at year 6.**

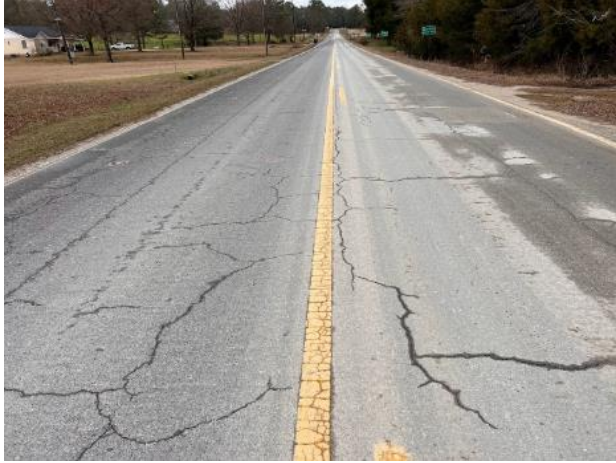
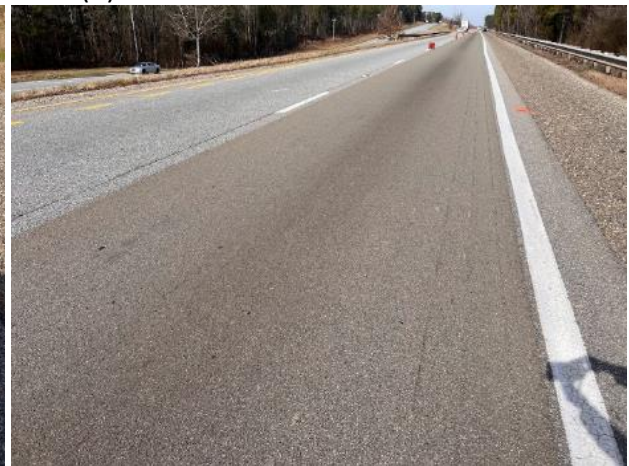
(a) Single micro surface LR-159

(c) Single micro surface US-280

(d) Double micro surface US-280

**Figure 27. Single vs. double layer micro surfacing condition in warm climate sections after 7 (US-280) and 11 (LR-159) years.**

The micro surfacing test sections effectively restored minor rutting and roughness and provided a skid-resistant pavement surface. Although micro surfacing is not intended as a crack treatment, the test sections exhibited improved cracking performance compared to the controls. Variations from the typical single layer application, such as the use of double layer micro surfacing, enhanced performance, as shown in the side-by-side images in Figures 27 and 28. In addition, the use of fibers had a moderate improvement in cracking performance compared to a traditional micro surface, while the use of high polymer-modified emulsion yielded better results, maintaining cracking under 20% ("poor" condition threshold).

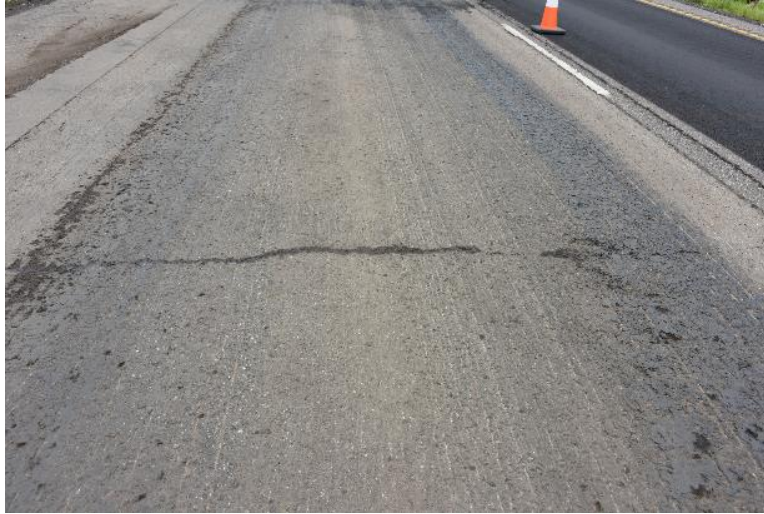
**Figure 30. Milled surface of US-169 prior to thinlay application.**

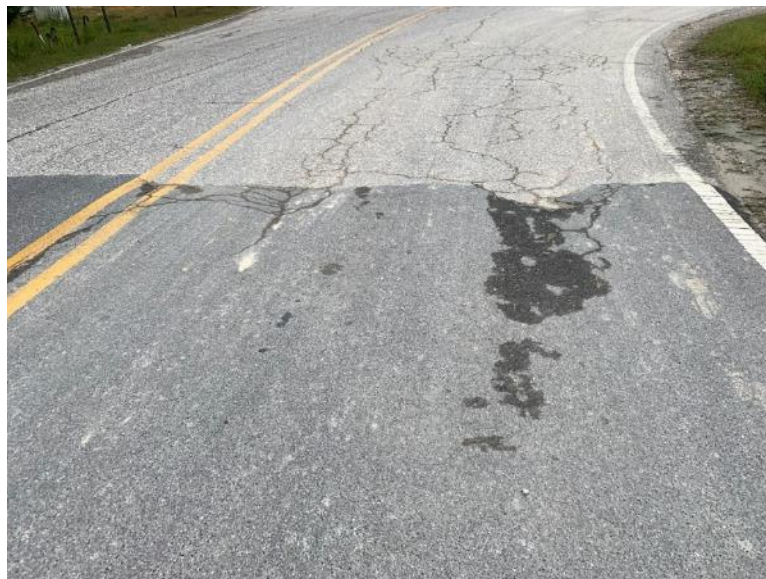
**Figure 33. LR-159 HiMA thinlay after 11 years.**

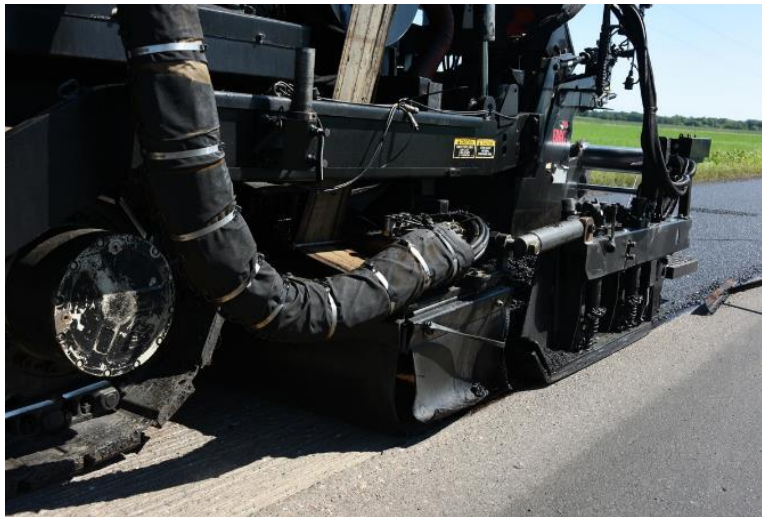
**Figure 34. UTBWC application with spray paver (27).**

The UTBWC mixes were designed with all virgin aggregates (granite from local sources) and placed at a thickness of  $\frac{3}{4}$ -inch. With the exception of US-280, the mixes were placed using a spray paver, a specialty paver that incorporates a heated tank for the tack material and a spray bar located immediately in front of the paver augers and screed (25). This allows for the mix to be delivered within seconds of the tack coat application. The heat from the hot mix causes the emulsion to break quickly and “wick” upward into the bottom portion of the hot mix lift, filling voids in the aggregate and creating an interlayer of high cohesion (26, 27). Figure 34 shows application using a spray paver.

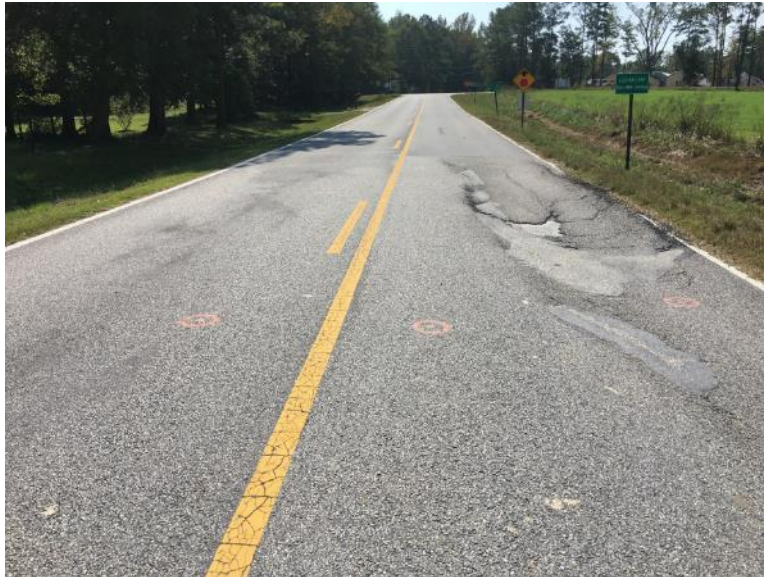
**Figure 36. UTBWC in LR-159 five years after construction.**

The exception was the LR-159 section, where site-specific conditions contributed to a slippage failure in the outbound lane (Figure 36). Poor drainage and a significant rain event after approximately three years of service caused flooding and the moisture in the pavement structure, combined with the heavy truck loads, created slippage cracking near the areas with high density cracking prior to treatment application. The outbound half of the section was milled and replaced with an ABR thinlay in 2018 to avoid compromising the integrity of the adjacent section. The inbound portion remained in place for the entirety of the study. This type of issue was not repeated in any of the other locations, nor in the inbound lane of LR-159.

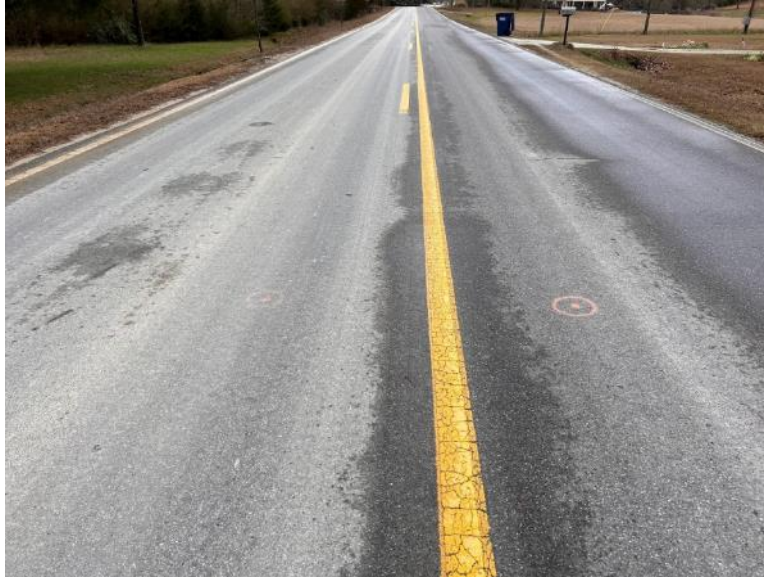
**Figure 40. Scrub cape seal on LR-159 after 11 years of service.**

Combination treatments have proven to be very effective options, especially for pavements subjected to low traffic volumes, as shown in the example in Figure 40. The performance indicators mostly remained in the “good” and “fair” condition categories. Only cracking in certain high-traffic sections exceeded 20% by the end of Phase II, some of which were already in the “fair” condition range prior to treatment application.

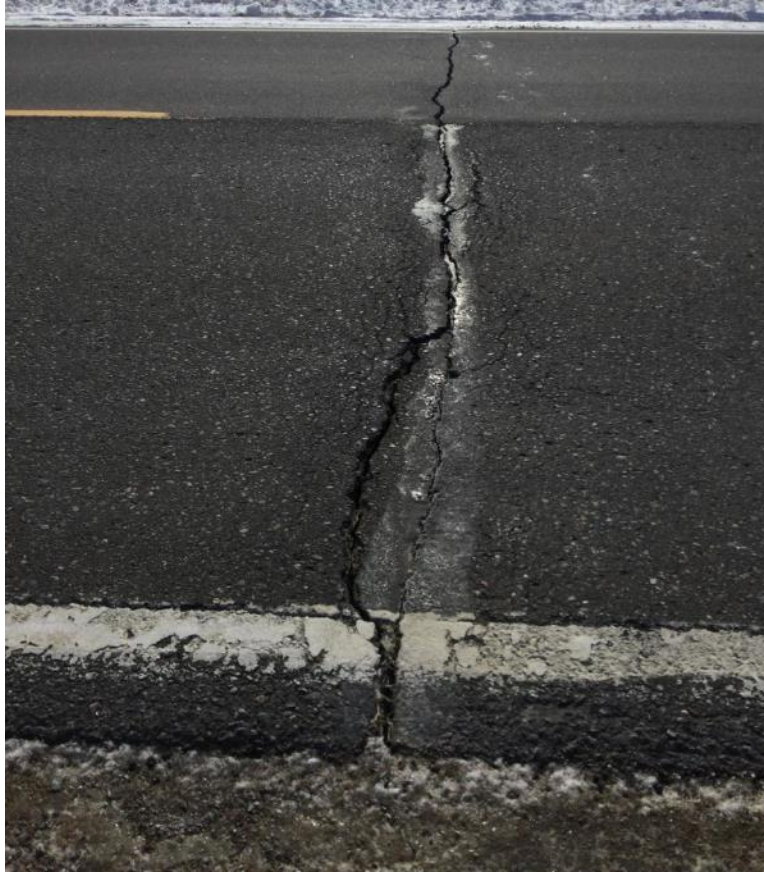
**Figure 41. Severity of transverse cracking in treated and untreated sections.**

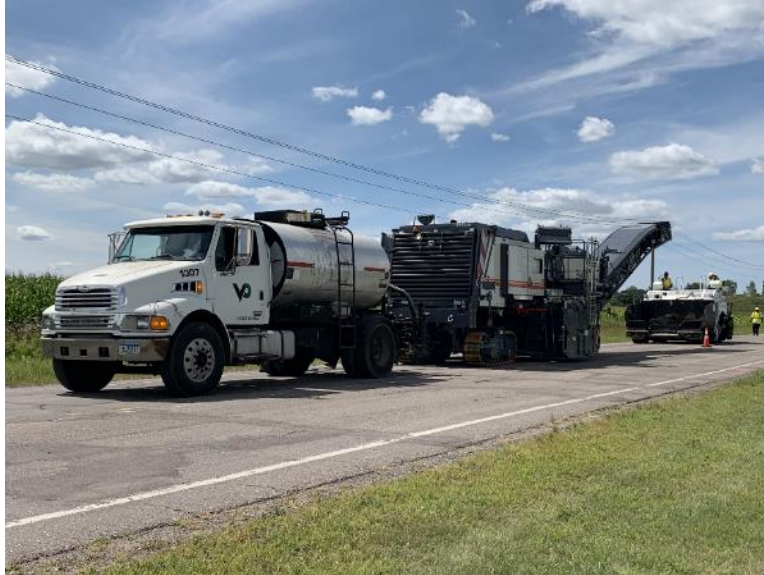
**Figure 46. 70<sup>th</sup> Street CIR equipment train.**

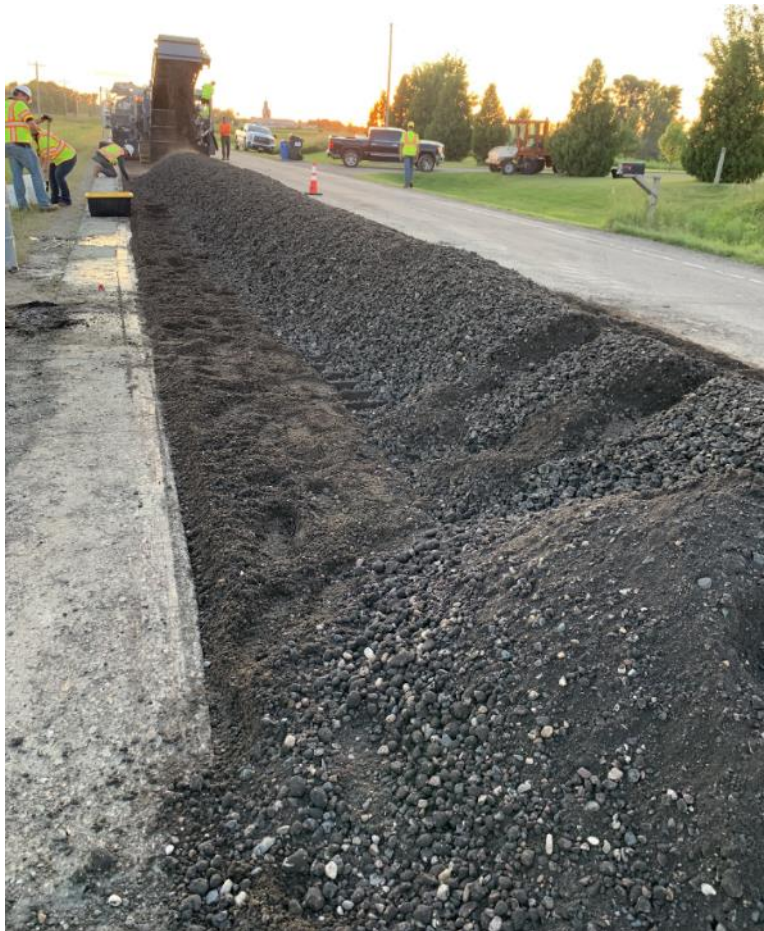
**Figure 47. Reclaimed material in FDR section.**

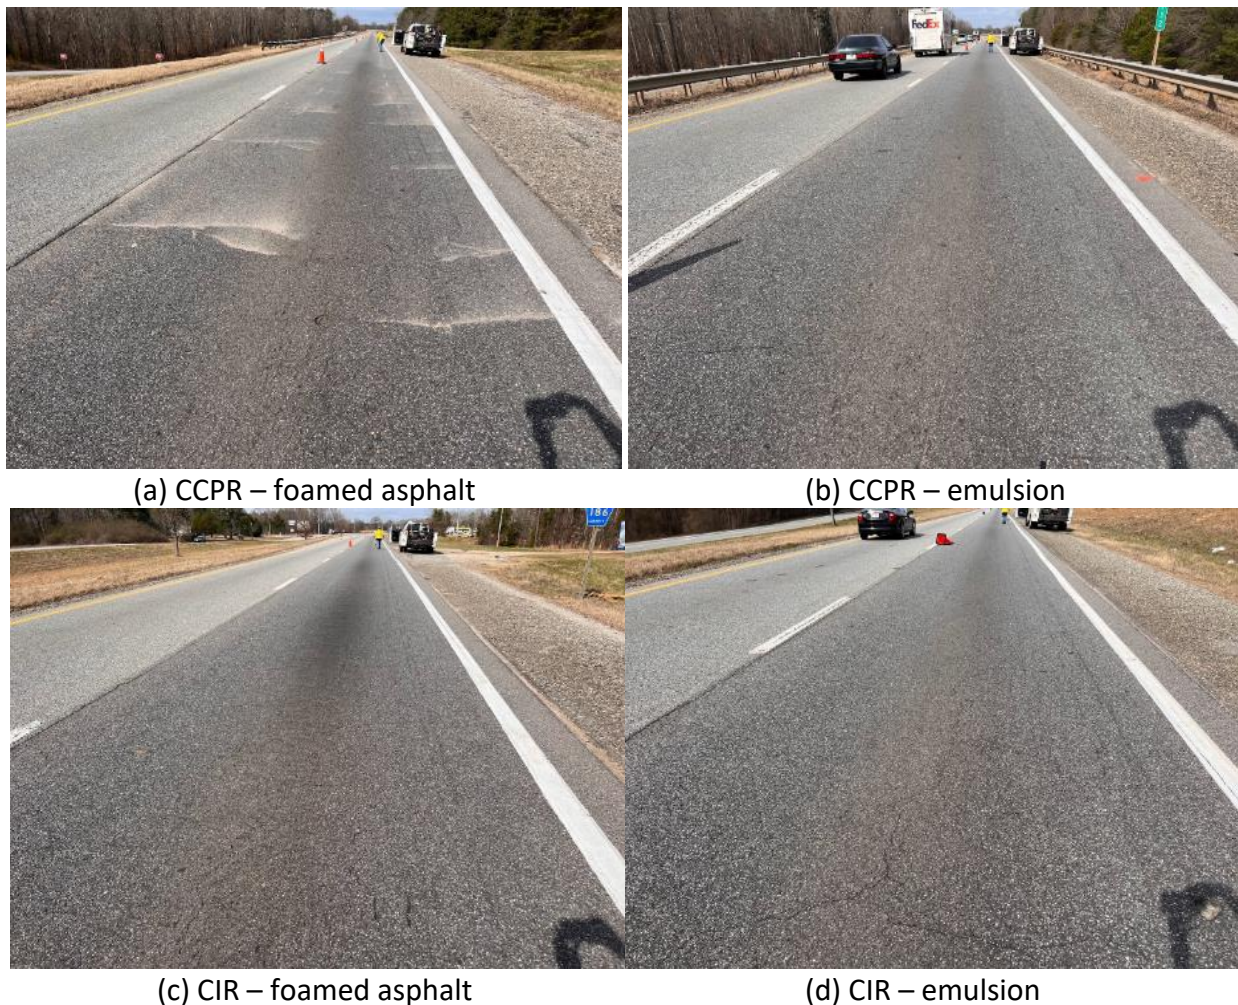
**Figure 48. Overall condition of US-280 cold recycled sections after 7 years.**

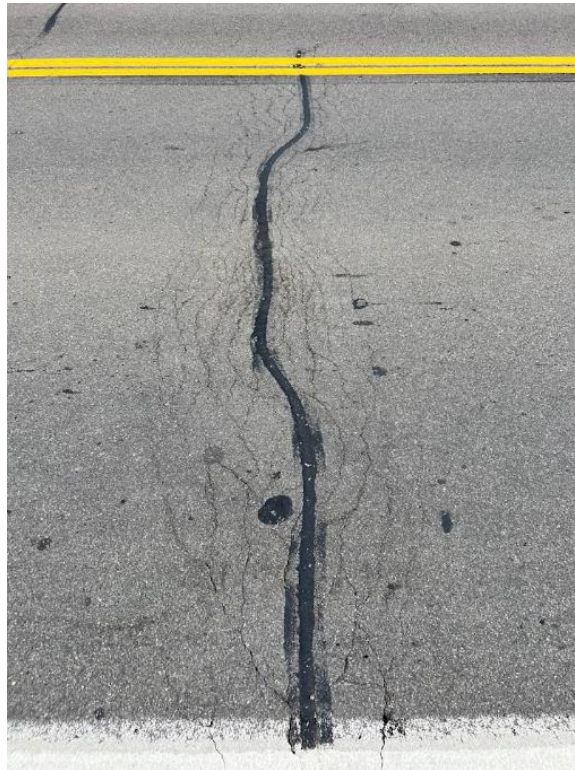
**Figure 50. Transverse cracking in 70<sup>th</sup> Street test section.**

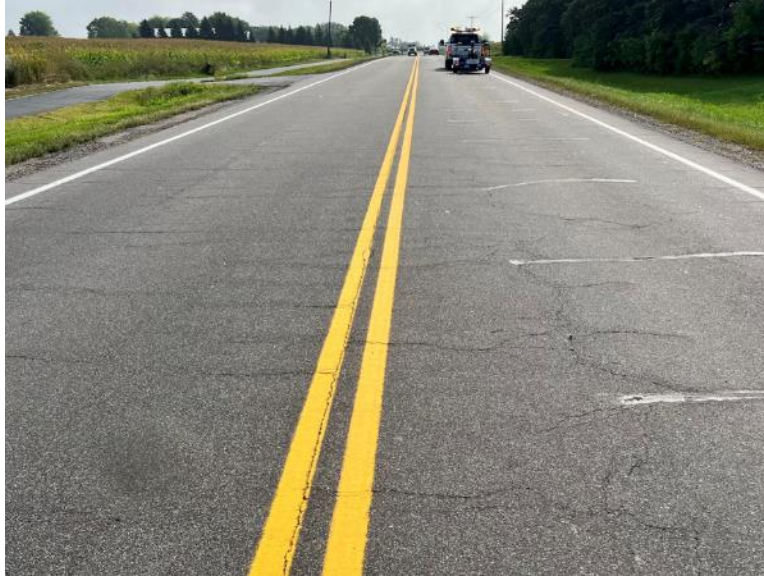
**Figure 51. Overall condition of 70<sup>th</sup> Street control section (thinlay only) after 4 years.**

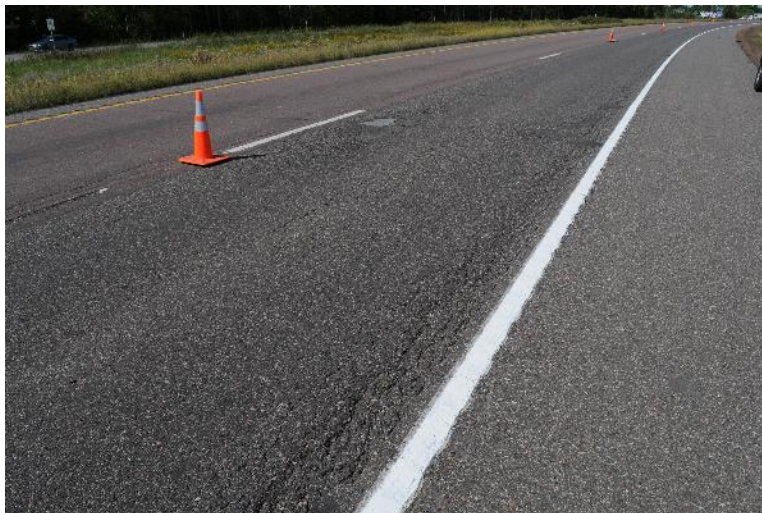
**Figure 52. US-169 control section condition before resurfacing.**
