NCAT REPORT 24-02

Findings from the Pavement Preservation Group (PG) Study

Adriana Vargas-Nordcbeck, Jerry Geib, Benjamin Worel,
Buzz Powell, Joel Uling

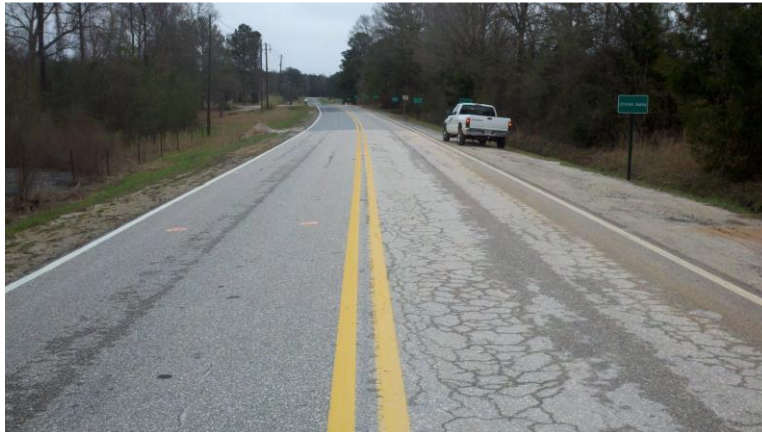
Figure 1. Variation in surface condition by lane in untreated pavement.

One unique characteristic of Lee Road 159 is that although both lanes are subjected to the same traffic volume, loads vary significantly as trucks travel unloaded inbound (to the quarry and asphalt plant) and exit loaded in the outbound direction. This difference in equivalent single axle loads (ESALs) between the two lanes resulted in different pavement conditions at the time of treatment, as shown in Figure 1.

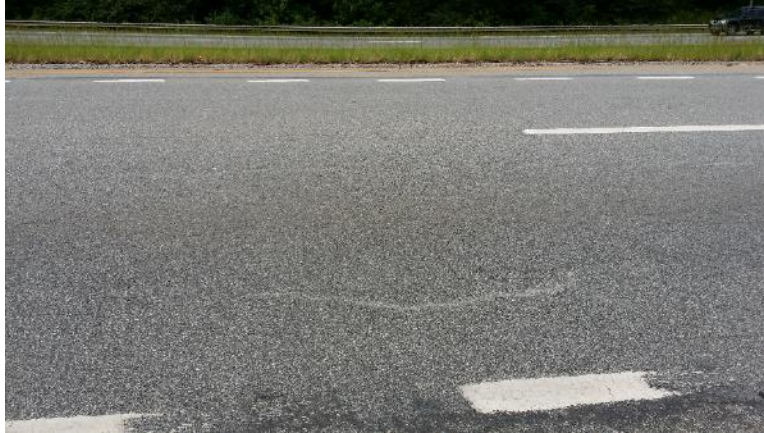
Figure 2. Cracking in US-280 sections.

At the time of treatment in 2015, the existing pavement surface was nine years old and showed varying levels of deterioration, with weathering and cracking as primary distresses. Cracking severity was low with signs of pumping and was mainly located along the wheel paths, as shown in Figure 2. Overall, the pavement was in better condition than LR-159.

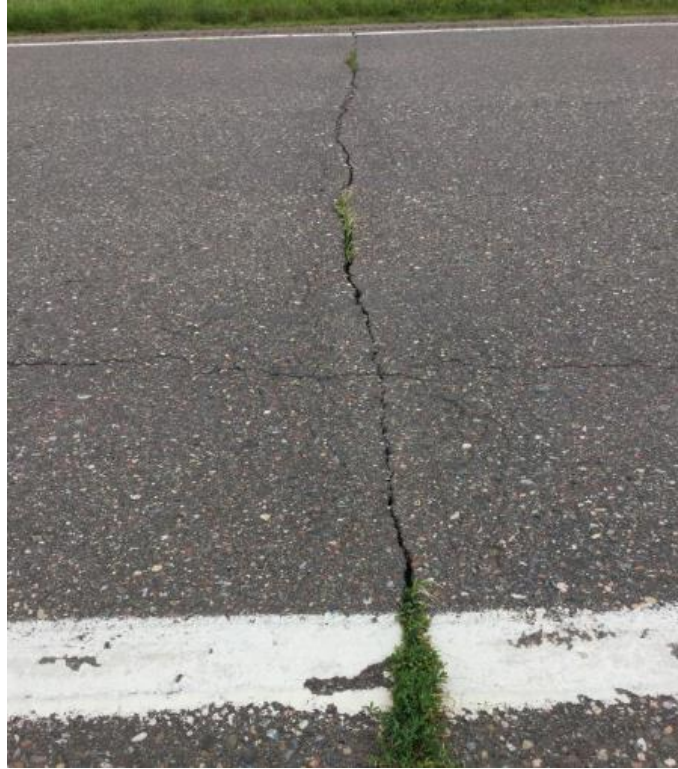
Figure 3. Thermal cracking in CSAH-8.

CSAH-8 is a two-lane county road near Pease, Minnesota, with an estimated AADT of 510 vehicles per day. Traffic is comprised of approximately 7% heavy vehicles, many of which are heavy implements of husbandry traveling to and from corn fields and dairy farms. The predominant distress at the time of treatment was thermal cracking (Figure 3). Each section had five to seven thermal cracks with varying levels of severity, which also affected pre-treatment ride quality.

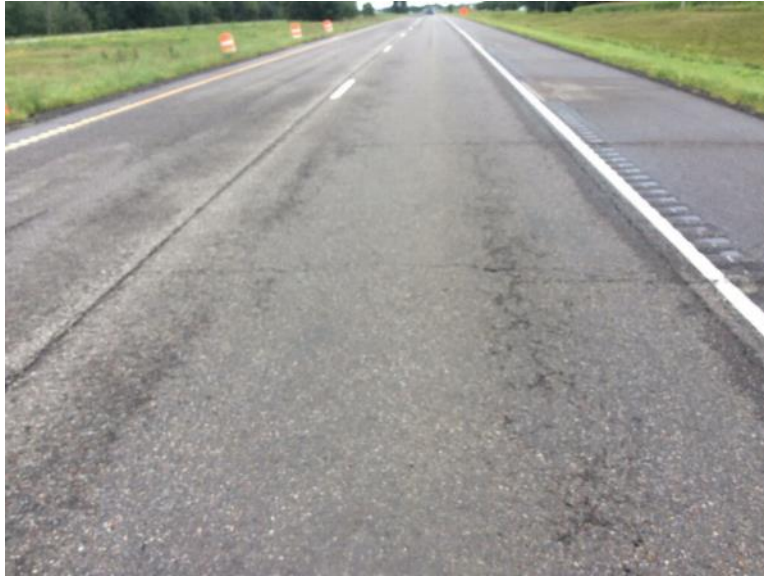
Figure 4. Overall pavement condition of US-169.

At the time of treatment in 2016, the existing pavement surface was seven years old with signs of environmental and load-related distresses. As shown in Figure 4, there was minor loss of fines and cracking along the wheel paths as well as thermal cracking. The longitudinal joints were in fair condition. The pavement structure consisted of 6.5 inches of asphalt over a 17-inch granular base.

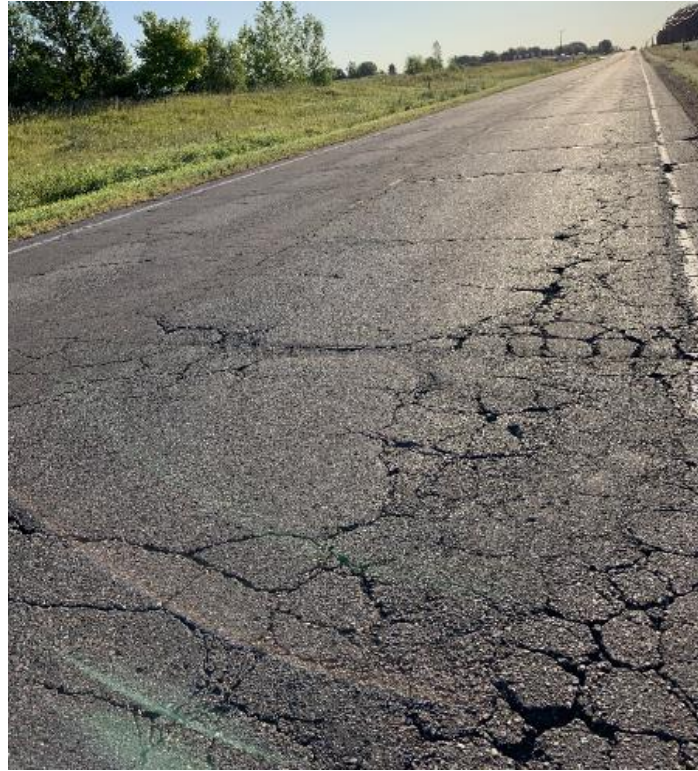
Figure 5. Overall pavement condition of 70th Street.

70th Street is a two-lane road with an estimated AADT of 2,300 vehicles per day. The roadway is located near the MnROAD facility and is owned by the cities of Albertville (eastbound lane) and Otsego (westbound lane). The existing pavement structure consisted of 4 inches of asphalt over 6 inches of aggregate base. It was heavily distressed at the time of treatment in 2019, which made it a candidate for evaluating various cold recycling and full-depth reclamation treatments. A 1-mile stretch was divided into 16 sections, each 500-ft long. Treatments were applied on both lanes, including traditional mill and fill sections and thin overlays for comparison. Due to the shared ownership of the road, there were differences in the maintenance activities performed before treatment. The westbound lane, which services more residents, exhibited a greater amount of patching and crack sealing. The general condition of the pavement was poor, with extensive environmental and load-related cracking, as shown in Figure 5.

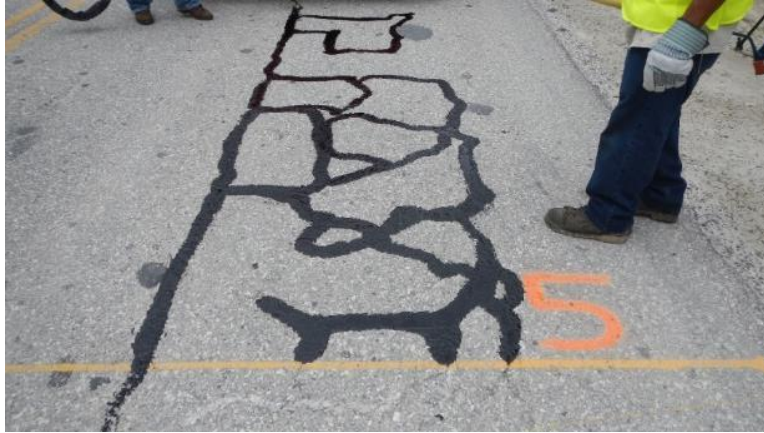
Figure 7. Crack sealing with overband configuration.

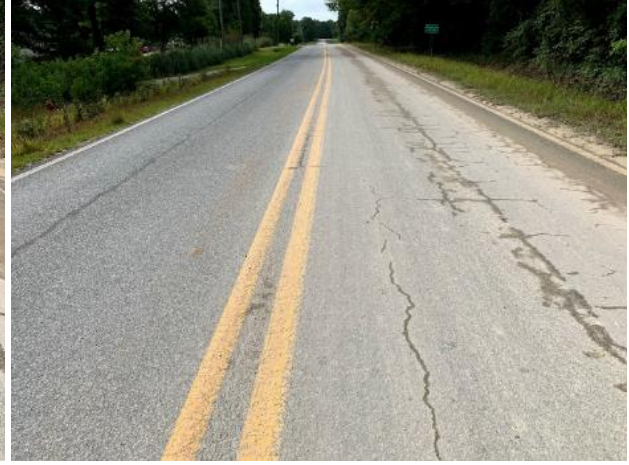
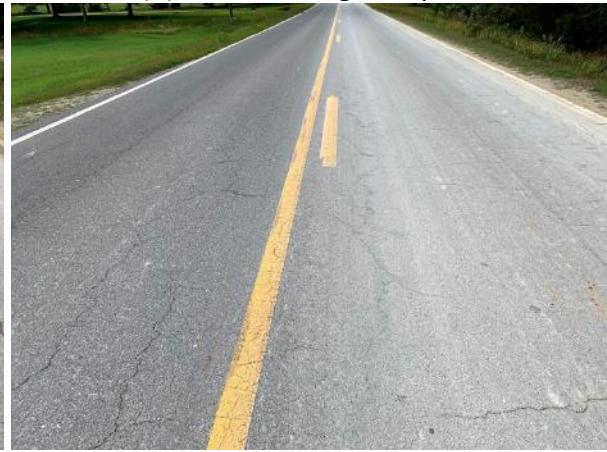
(a) Unsealed (control)

(b) Standalone crack sealing

(c) Chip seal

(d) Crack sealing + chip seal

(e) Micro surfacing

(f) Crack sealing + micro surfacing

Figure 9. Unsealed vs. sealed section comparison.

Notably, differences in performance were observed based on the sealing technique applied. When rout & seal was performed with the 5/8-inch bit followed by a surface treatment, slight compression of the sealing material occurred from traffic, resulting in reflected cracking along the sides of the routed crack (shown in Figure 10). Nonetheless, these cracks were less than 1/4” in width and prevented water intrusion without compromising the integrity or functionality of the surface treatments. Switching to a smaller bit eliminated this concern, and no sealant failures were observed throughout the study.

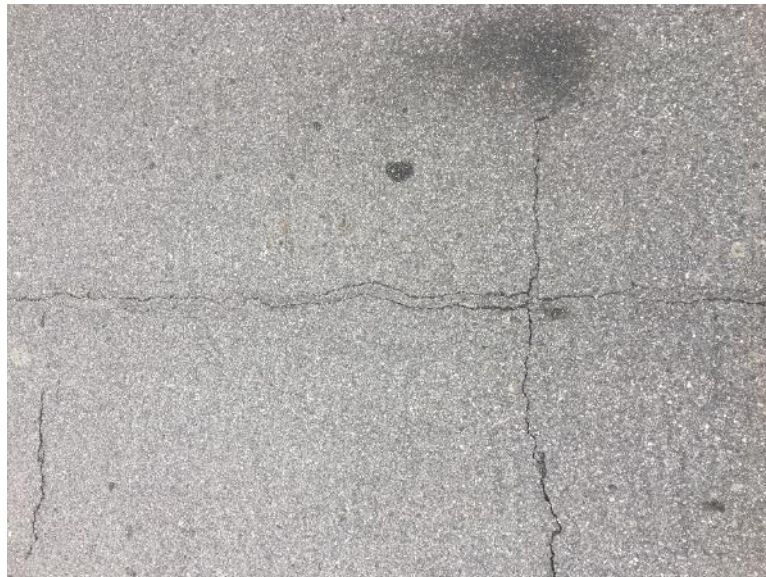
Figure 10. Cracking along routed and sealed cracks under micro surfacing.

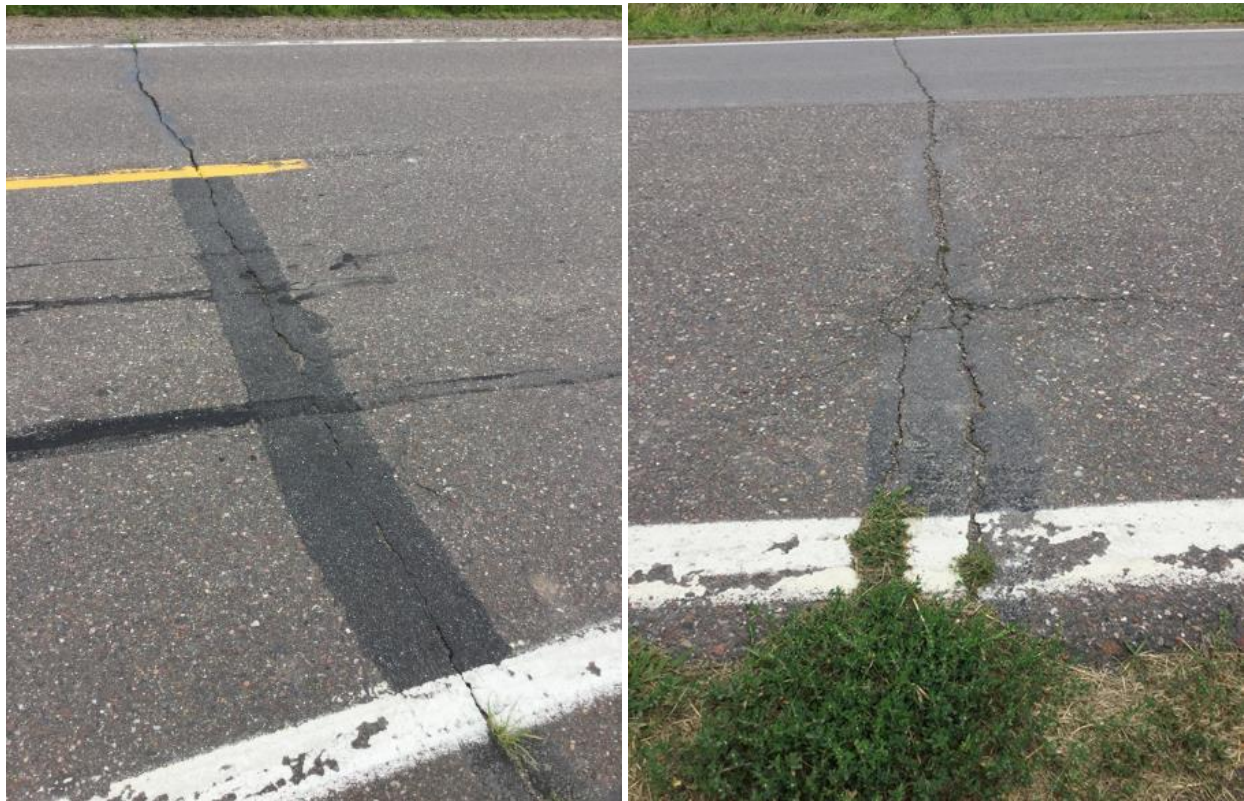
(a) Transverse mastic

Figure 11. Crack condition comparison of sections with and without transverse mastic.

To improve ride quality, transverse mastic was applied to all sections of CSAH-8 in fall 2022, including previously sealed sections. This proactive maintenance measure resulted in average IRI reduction of 21 in/mi, with the degree of improvement varying depending on the existing treatment. Rougher sections obtained the greatest benefit (as high as 60 in/mi IRI reduction), while sections already in good condition saw minimal change in roughness, as there was little room for improvement.

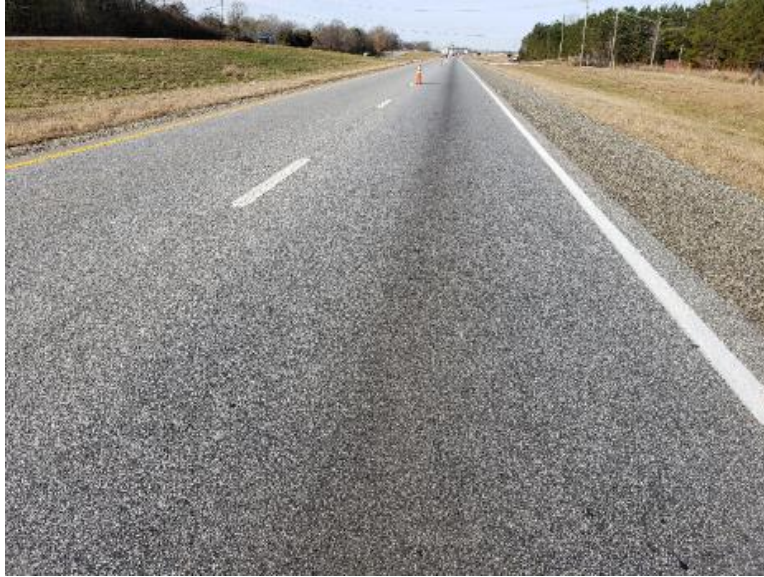
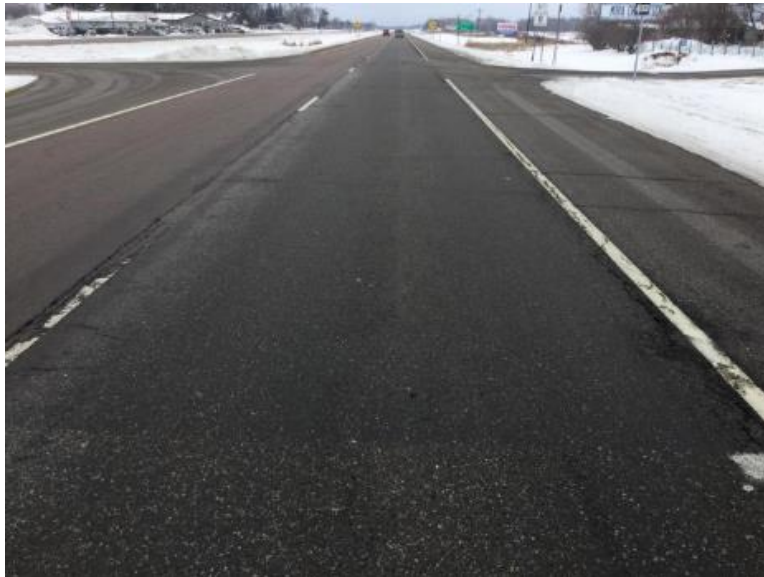
(a) US-280

(b) US-169

Figure 14. Condition of fog sealed sections in warm and cold climate.

Although fog seals are typically applied to newer pavements, this study found they can also improve the cracking performance of older pavements. While these treatments have a lower durability compared to other preservation options, they were effective in maintaining a sealed pavement surface and delaying the appearance of distresses such as cracking and weathering. In fact, only three of seven test sections fell in the “poor” condition category by the conclusion of Phase II. Figure 14 shows examples of conventional fog seal sections subjected to high traffic after six years of service. In both cases, the initial cracking condition was “fair” with a cracking rate of 5-20%. The treatments helped to maintain this condition throughout the study, with cracking reaching approximately 11% in both sections. There was no significant difference in performance between the climatic regions other than the cracking types observed, which were predominantly longitudinal cracking along the wheel paths for the warm climate location and transverse cracking in the cold climate.

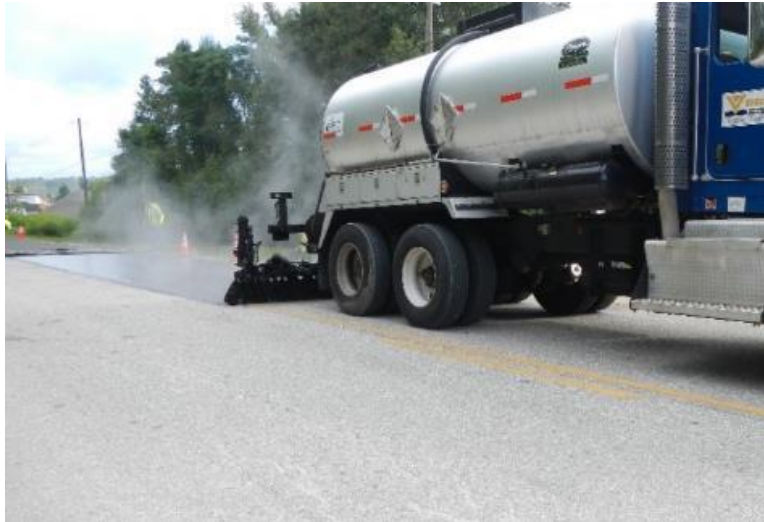
(a) Asphalt emulsion application

(b) Aggregate application

The existing surface was swept prior to construction to remove any loose material before applying the emulsion. The spray distributor and chip spreader were calibrated to ensure accurate emulsion and aggregate rates were applied. Once calibration was complete, the distributor applied the asphalt emulsion, which was immediately followed by aggregate application. The aggregate was then rolled with three passes of a pneumatic roller to embed it into the binder. After curing, the excess aggregate was removed using a broom before the road was opened to traffic. Figure 16 illustrates the procedure for chip seal application.

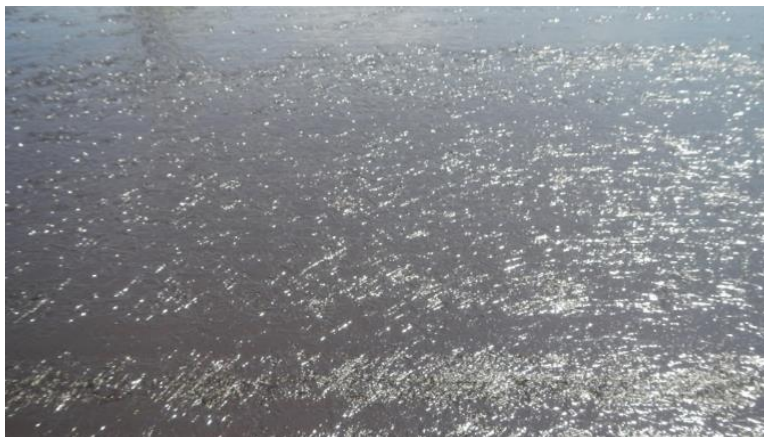
Figure 18. Fibermat® membrane.

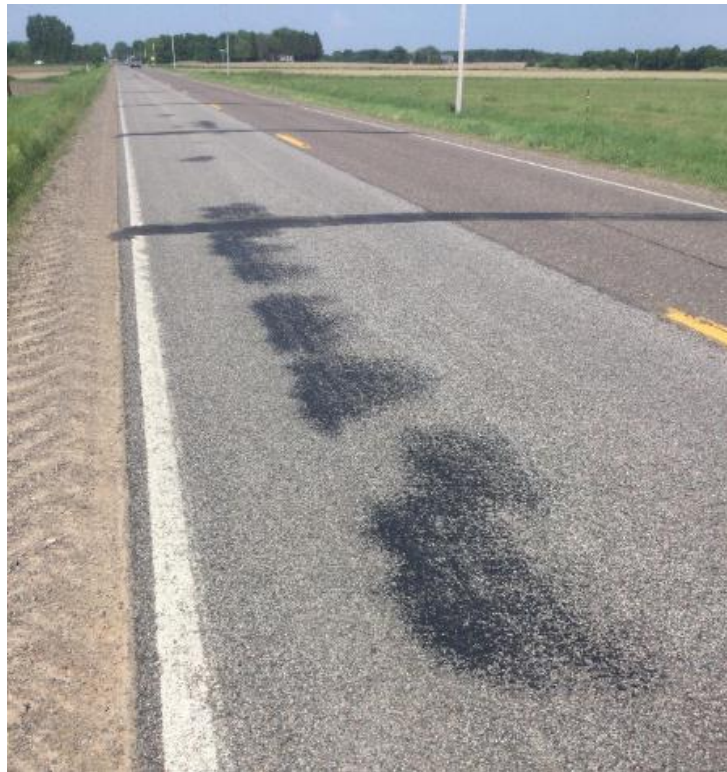
Figure 21. Isolated flushing in CSAH-8 at year 6.

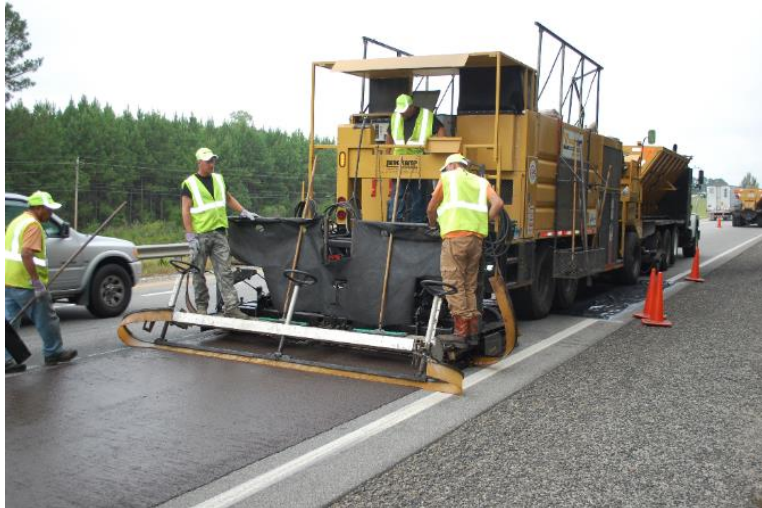
Figure 24. Micro surfacing application.

Strips of plastic sheeting were placed at the stopping points to ensure a sharp, uniform edge and to protect adjacent cells from application of other treatments. The treatments were applied to the clean pavement surface with a variable width spreader box equipped with augers and a secondary strike-off at a target of 18 to 20 lbs/yd² and allowed to cure before returning to traffic.

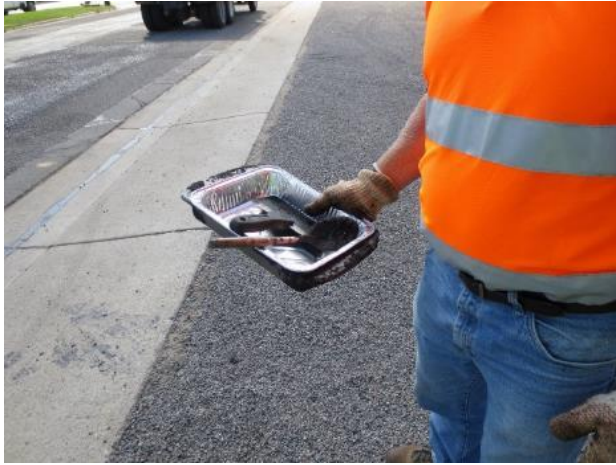
(a) Pan assembly and mixing tools

The sample collecting procedure used a disposable aluminum pan approximately 13 by 9 by 2 inches deep, placed inside a reusable pan of similar dimensions. Material was collected directly from the machine by passing the pan assembly in front of the material flow as it came out of the chute until the pan was approximately $\frac{3}{4}$ full. Samples were then stirred with a metal spoon until an emulsion break occurred, stiffening the mix. At this point, the metal spoon was replaced with a stainless-steel drywall taping knife, which was used to evenly divide the sample into four smaller quarter samples. As the mix continued to stiffen significantly after the initial break, the sample had to be cleanly split throughout its depth before reaching the point where it could no longer be easily manipulated. Figure 25 illustrates the field sampling procedure.

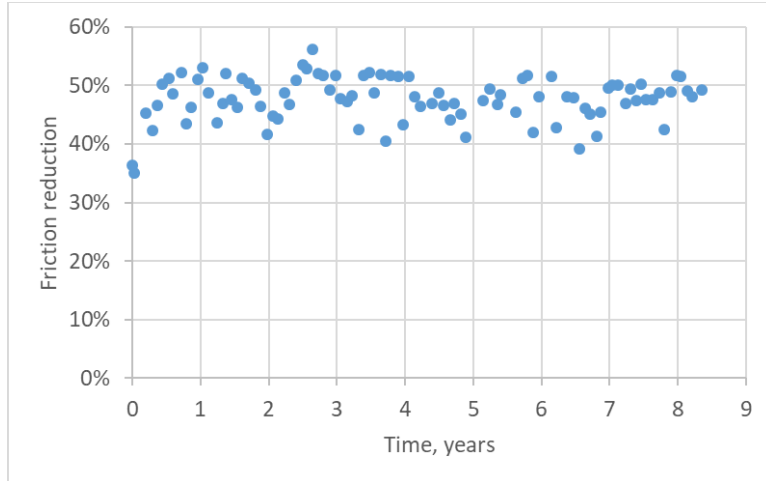
Figure 29. Friction reduction in limestone micro surface compared to sandstone micro surface.

Although micro surfacing provides a smooth, skid-resistant surface, material selection can affect friction performance. This is evident by comparing the friction numbers in the sections containing different aggregate sources (sandstone and limestone) in US-280. Figure 29 shows friction in the limestone section expressed as a percent reduction from the average of the sandstone sections. It can be seen that the limestone micro surface had approximately 40 to 55% lower friction numbers compared to the sandstone mixes. This difference is also due to the use of various gradations, shown previously in Table 16. Although friction numbers were lower when using limestone, they were still considered safe and did not pose a safety risk.

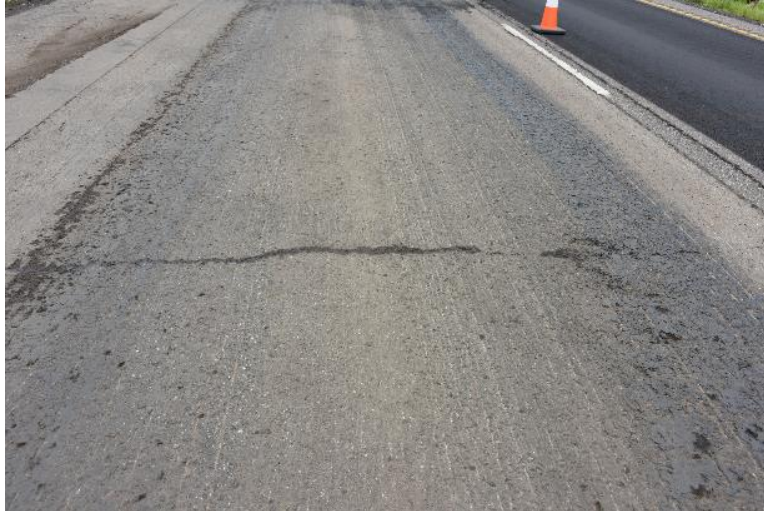
Figure 30. Milled surface of US-169 prior to thinlay application.

All mixtures had a nominal maximum aggregate size (NMAS) of 4.75 mm and were designed using local materials that met the climate requirements of each region. The design thickness of the overlays was $\frac{3}{4}$ -inches. For the LR-159 sections, the surface was swept to remove dust and loose materials, and a tack coat was applied to the existing surface using a NTSS-1HM emulsion (trackless tack). The surface was milled in the remaining locations prior to treatment placement to maintain grade. This milling operation removed distresses in the pavement surface such as top-down cracking and minor rutting, further enhancing treatment performance. In addition, milling improved ride quality, especially in the cold climate sections. While transverse cracking was not completely eliminated (Figure 30), milling improved the condition around these cracks, resulting in lower IRI values after treatment.

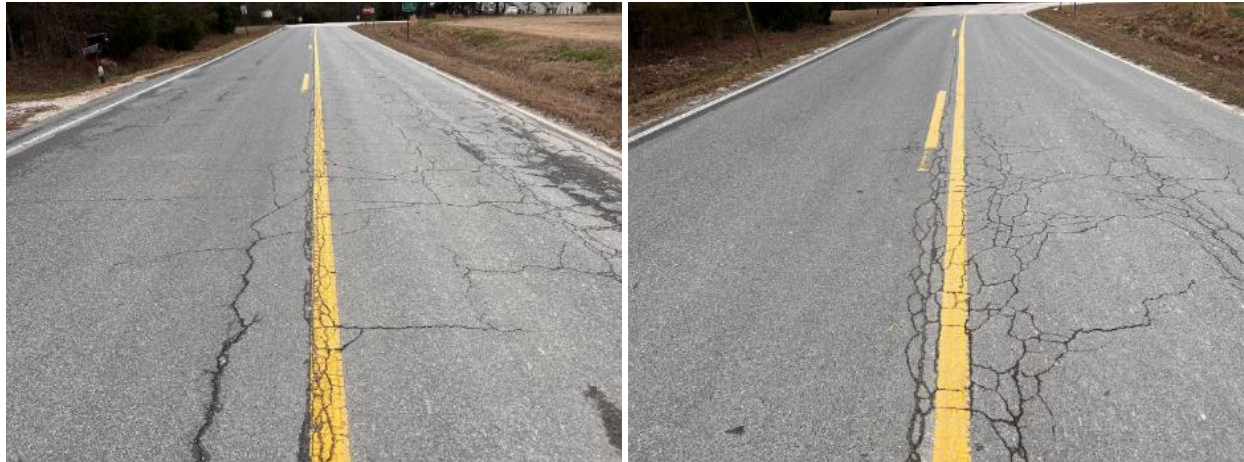
(a) 50% RAP thinlay (b) 5% RAS thinlay
Figure 31. LR-159 high recycled content thinlay sections after 11 years.

As expected, the use of virgin materials resulted in the most crack resistant mixtures. The inclusion of recycled materials like RAP and RAS showed they can still provide durable treatments, but they must be properly evaluated during mixture design. For instance, during the construction of the first test sections in LR-159, high RAP and high RAS thinlays were included as alternatives to the virgin mixture design. These mixes were designed using a volumetric approach without additional modifications to adjust the binder grade. Although they met the design criteria, their cracking performance was reduced due to the increased stiffness of the mix (Figure 31). These sections reached the “poor” condition category after approximately seven years, which is in the lower range for the expected service life of thinlays.

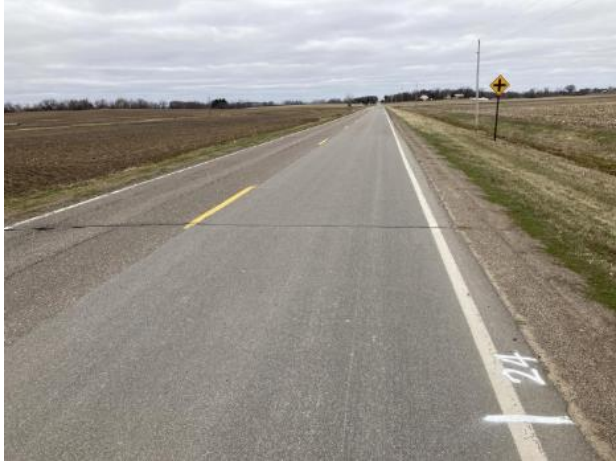
(a) CSAH-8 ABR thinlay

Figure 32. ABR Thinlay sections in cold climate locations after 6 years.

Polymer-modified binders did not provide notable benefits in terms of cracking performance during Phases I and II. However, all thinlay sections, including mixtures produced with a neat binder, showed good rutting performance. Furthermore, high polymer modification was effective in maintaining low levels of rutting, even under high-stress situations. In LR-159, the HiMA thinlay test section was placed strategically near the intersection where loaded trucks traveling from the quarry and asphalt plant brake and turn. These movements induce high stresses on the pavement, resulting in rutting and cracking. Figure 33 shows the transition from the HiMA thinlay to the untreated pavement at the intersection. Although the transition started to exhibit distress towards the end of Phase II, the surface condition was greatly improved as a result of the treatment.

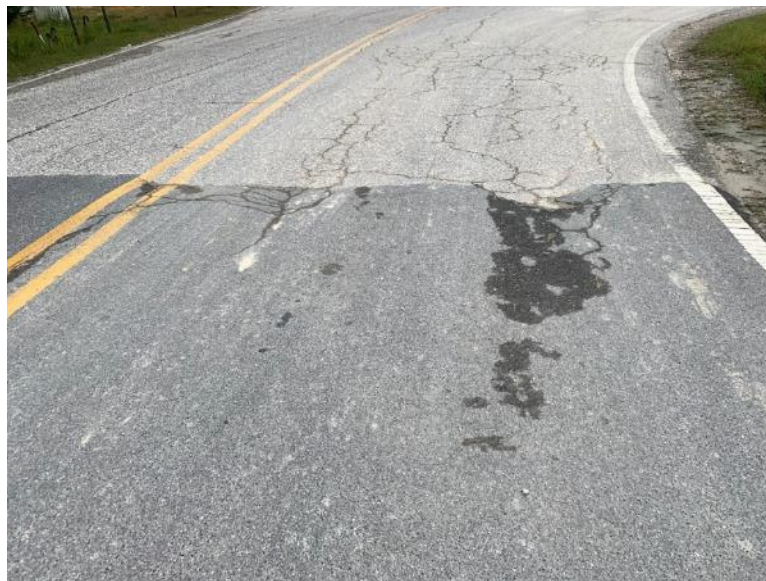
Figure 33. LR-159 HiMA thinlay after 11 years.

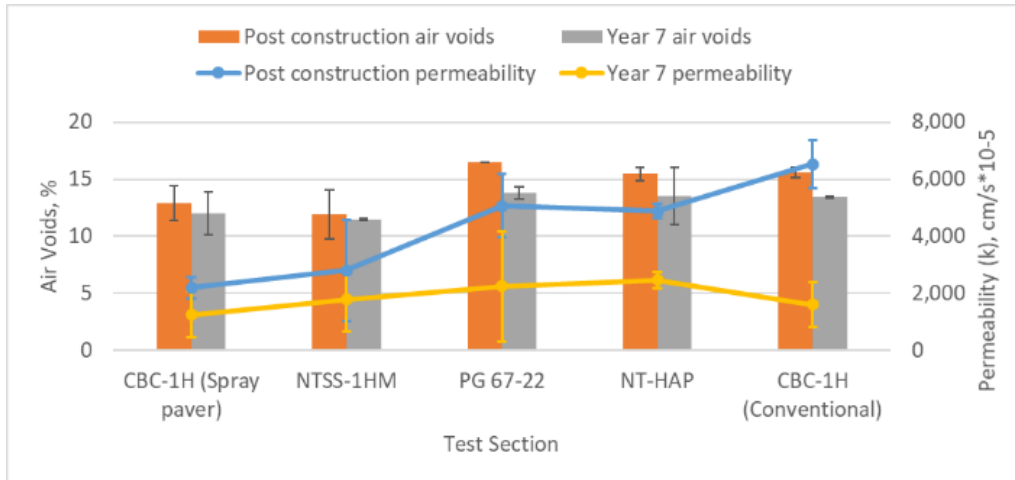
Figure 37. Air void content and permeability results for US-280 test sections.

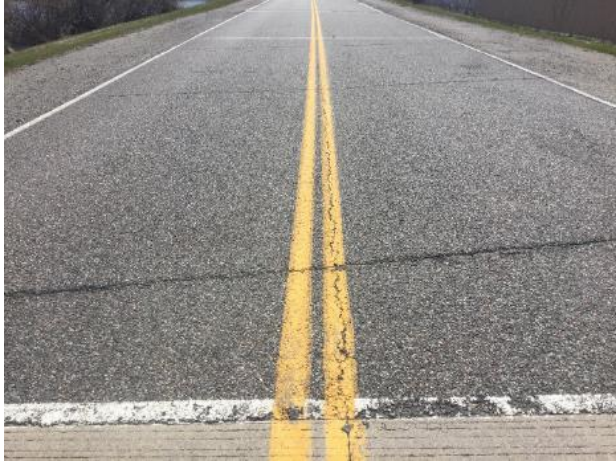
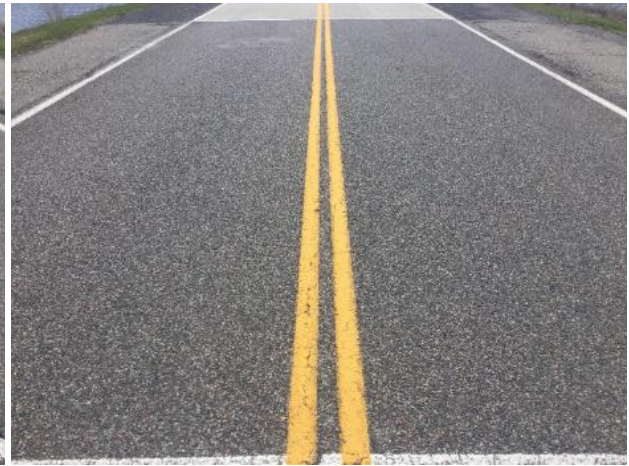
(a) OGFC over PCC (regular tack)

(c) OGFC over AC (regular tack)

(d) OGFC over AC (trackless tack)

In the cold climate location, the main concern was the durability of the OGFC thinlays. Compared to dense-graded mixes, OGFCs are more sensitive to temperature variations due to interconnected air voids, and therefore are more susceptible to freeze-thaw cycles. These can cause swelling stresses resulting in raveling, cracking, and delamination (31-33). The MnROAD sections exhibited reflective cracking from the underlying PCC pavement and from the transverse cracks in the asphalt pavement, but overall withstood the cold climate conditions without major issues. Some raveling developed by the end of Phase II after seven years of service. Field permeability measurements were obtained in June 2017, and follow-up measurements were taken in 2018, 2019, 2021, and 2023. Similar trends were observed with permeability declining drastically over time, reaching values ranging between 112×10^{-5} and 518×10^{-5} cm/s by 2021, similar to a dense-graded asphalt surface. Interestingly, the results from 2023 showed a significant increase in field permeability, yielding the greatest values since construction. Raveling near the testing locations may have influenced the results.

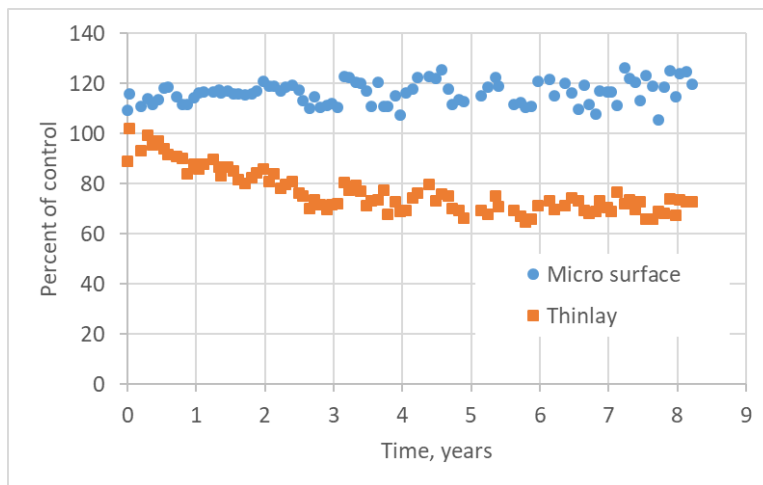
Figure 42. Friction performance in US-280 sections compared to untreated.

The micro surface over thinlay combination used in US-280 was selected to address friction concerns due to the fineness and low macrotexture of the thinlay mix. To improve the skid resistance of the pavement, a micro surface was added as the final wearing surface. Figure 42 shows friction number results of the micro surfacing over thinlay section and the average of the thinlay combination sections as a percentage of the control sections. The micro surfacing over thinlay section consistently had friction numbers around 20% higher than the untreated sections. Conversely, the combination treatment sections where the thinlays were the wearing surface initially had friction numbers comparable to the control sections but decreased in time until reaching a reduction of approximately 30%. Although friction levels are considered safe in all of these sections, if a particular project considers the fine thinlay mix a safety risk, adding a micro surfacing layer can improve skid resistance while preserving the existing pavement.

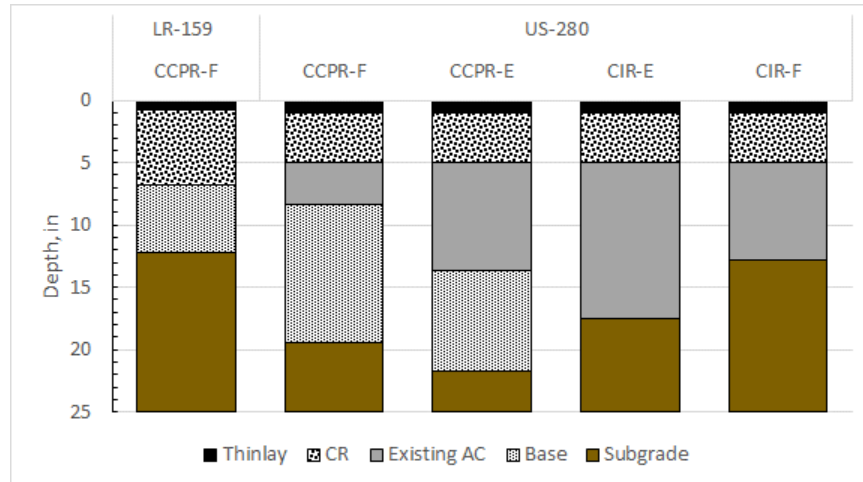
Figure 43. Pavement cross-sections in warm climate locations.

The pavement structure varied among the sections, as shown in Figure 43 and Figure 44. For LR-159, all bituminous material was removed and replaced with the foamed CCPR mix and then surfaced with a ¾-inch virgin thinlay. In US-280 sections, the existing structure varied, as shown in Figure 43. In all cases, the thickness of the cold recycled layer was 4 inches, but the thickness of the remaining asphalt concrete layer ranged from 3.4 to 12.5 inches. It should also be noted that the CIR sections did not have a base layer. Due to the increased traffic level on US-280, the thinlay used for the wearing surface was increased to a thickness of 1-inch and consisted of an ABR mix.

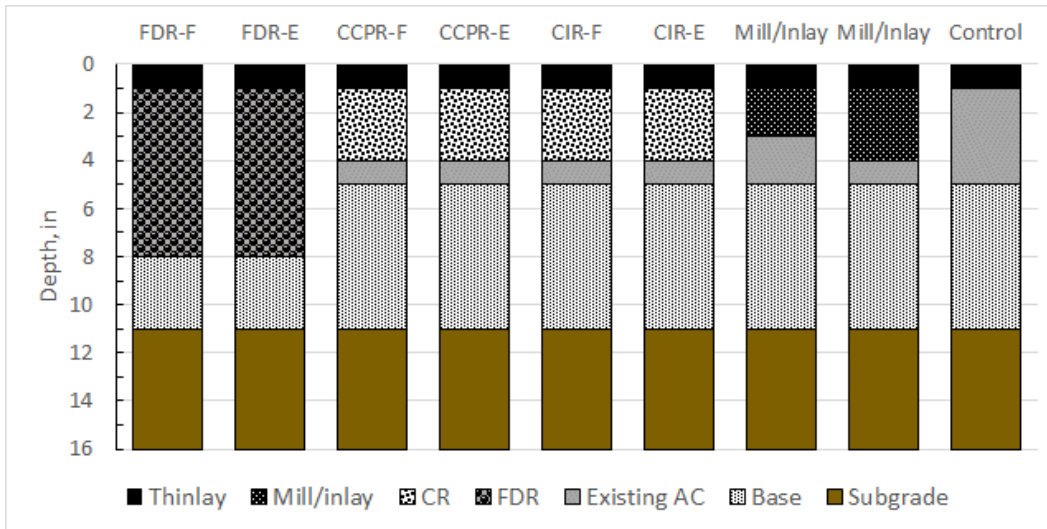
Figure 44. 70th Street pavement cross-sections.

The existing pavement in the 70th Street location consisted of a 4-inch layer of asphalt concrete over 6 inches of granular base on top of a clay subgrade. The CIR and CCPR layers were 3 inches deep, leaving 1 inch of the existing pavement in place. The FDR sections were constructed at 7 inches deep, replacing all of the existing asphalt material and leaving 3 inches of the aggregate base in place. Additionally, mill and inlay rehabilitation options were used in two sections to represent a more traditional approach; one was 2 inches deep, and the other was 3 inches deep. All sections were surfaced with a 1-inch ABR thinlay, including seven sections where the thinlay was placed directly on the existing, heavily distressed pavement. These were designated as “control” sections and are representative of the stopgap measures agencies often apply to maintain pavements serviceable over short-term periods. Figure 45 shows a schematic of the test section layout for 70th Street. Due to time and logistic constraints, the focus of the project was on the eastbound lane. However, some rehabilitation options were also placed on the westbound lane.

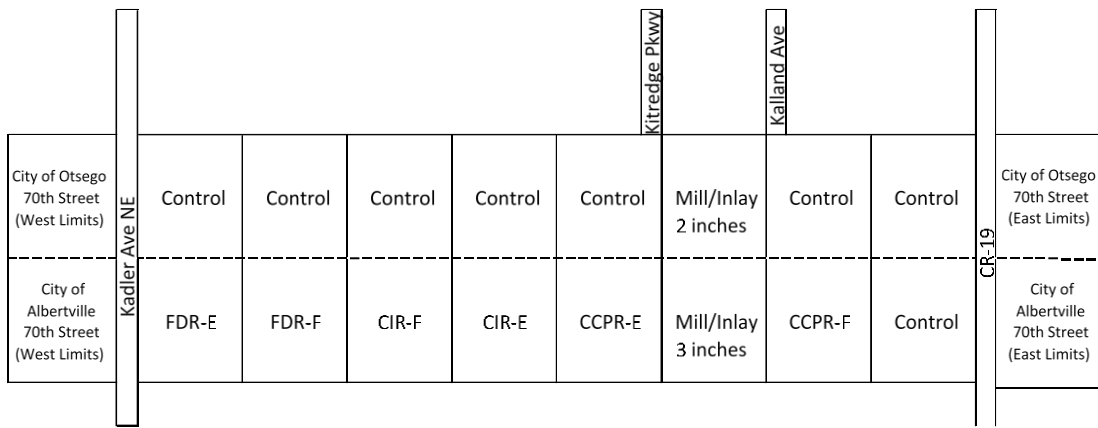
Figure 45. 70th Street test section layout (wearing surface is a 1-inch ABR thinlay).

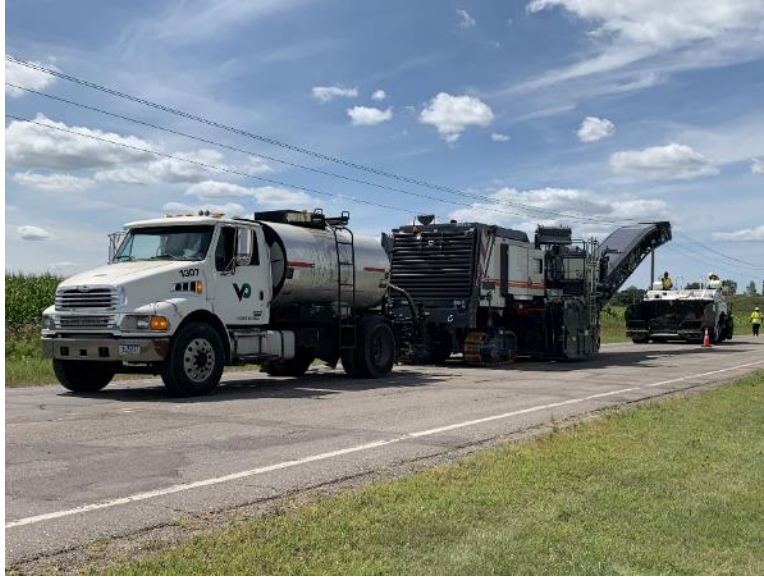
Figure 46. 70th Street CIR equipment train.

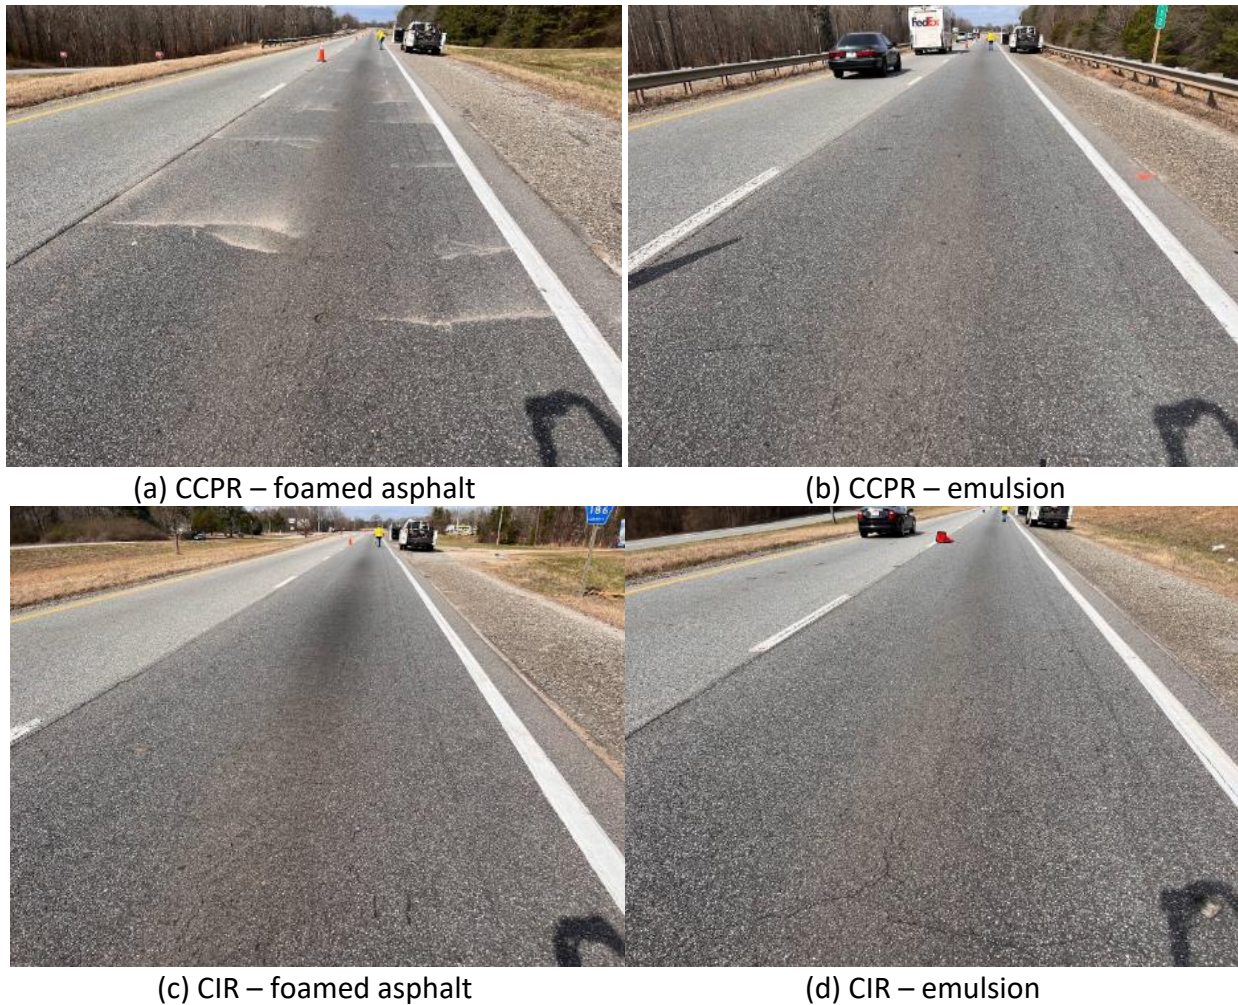
Figure 48. Overall condition of US-280 cold recycled sections after 7 years.

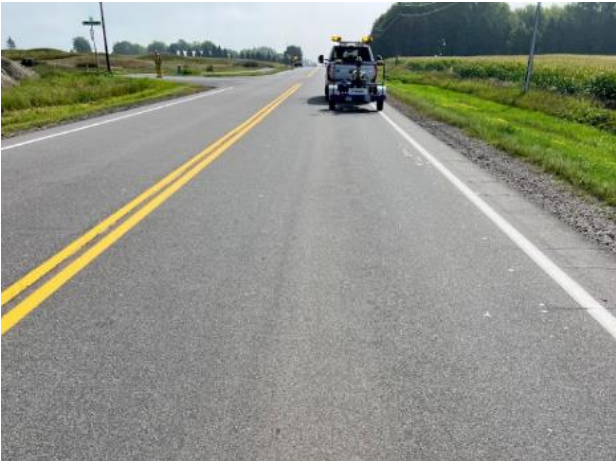
(a) CCPR – foamed asphalt

(e) FDR – foamed asphalt

(f) FDR – emulsion

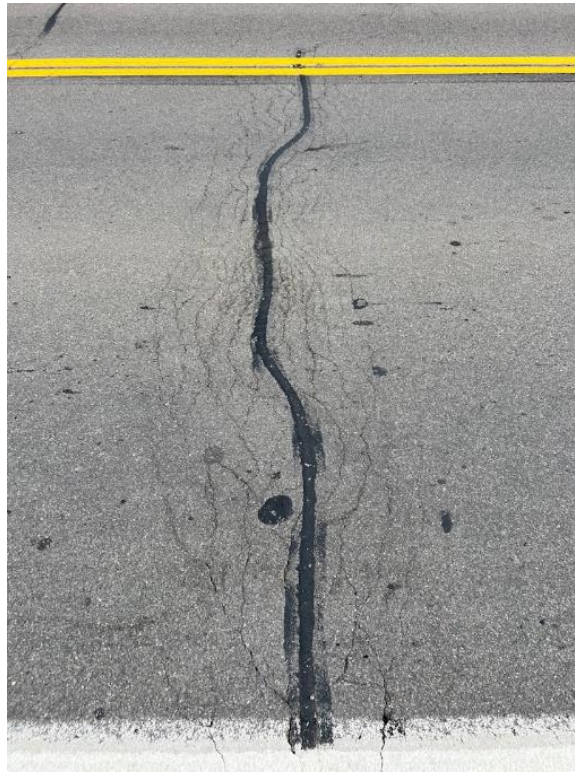
Figure 50. Transverse cracking in 70th Street test section.

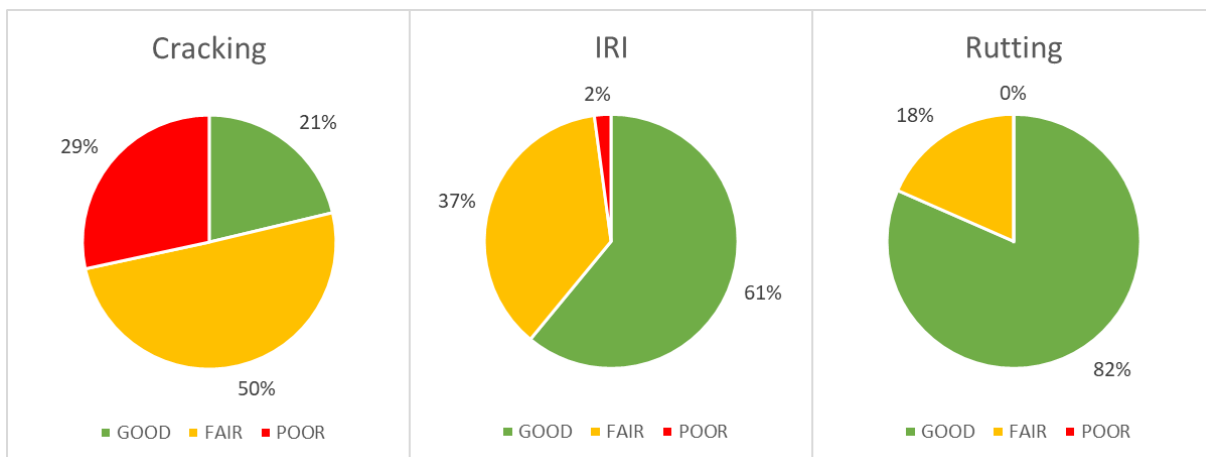
Figure 53. Percentage of sections in each condition category by performance measure.

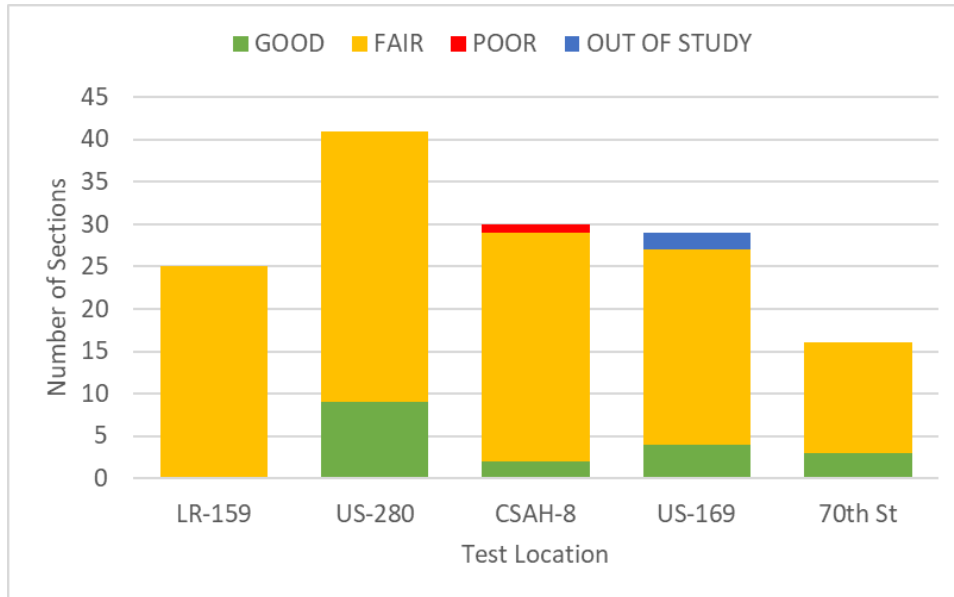
Figure 54. Overall pavement condition of the test sections by the end of Phase II.

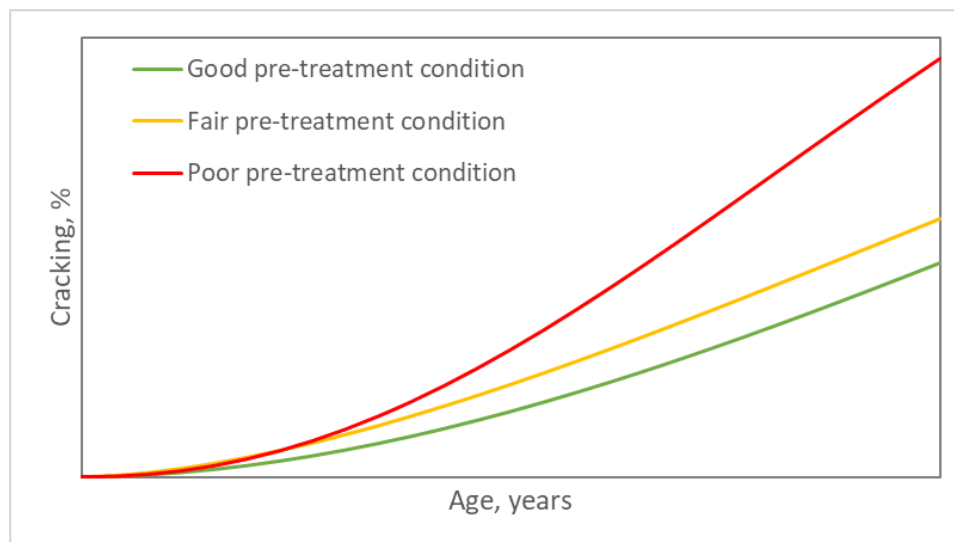
Figure 55. Example of deterioration curves based on pre-treatment condition.

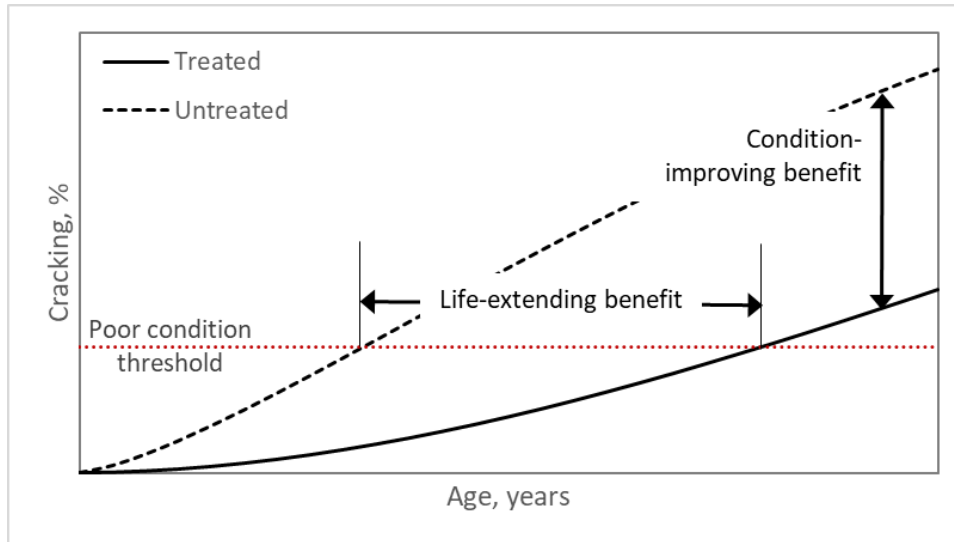
Figure 56. Schematic of benefit calculation based on cracking performance.

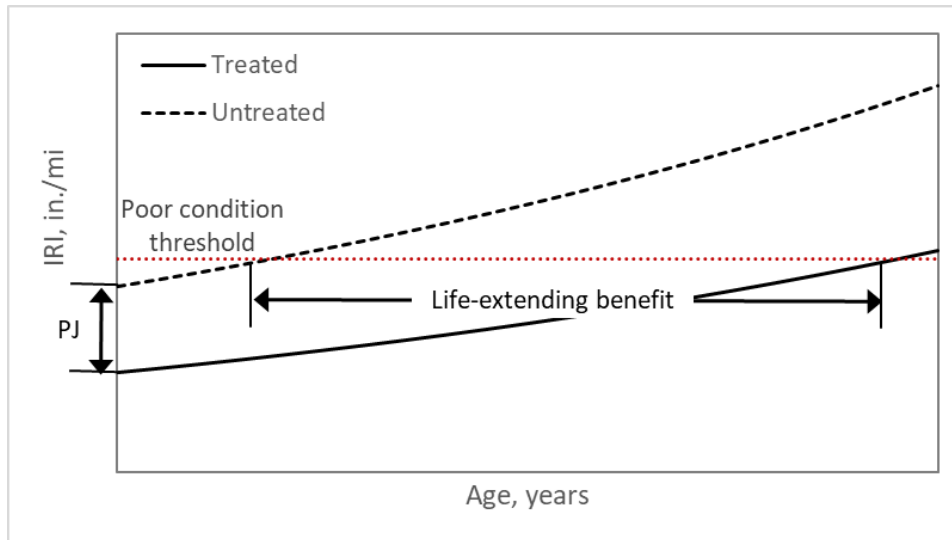
Figure 57. Schematic of benefit calculation based on roughness performance.
