# NCAT Draft Report 24-01

## Phase VIII (2021-2024) NCAT Test Track Findings

NCAT Draft Report 24-01  
Phase VIII (2021-2024) NCAT Test Track Findings

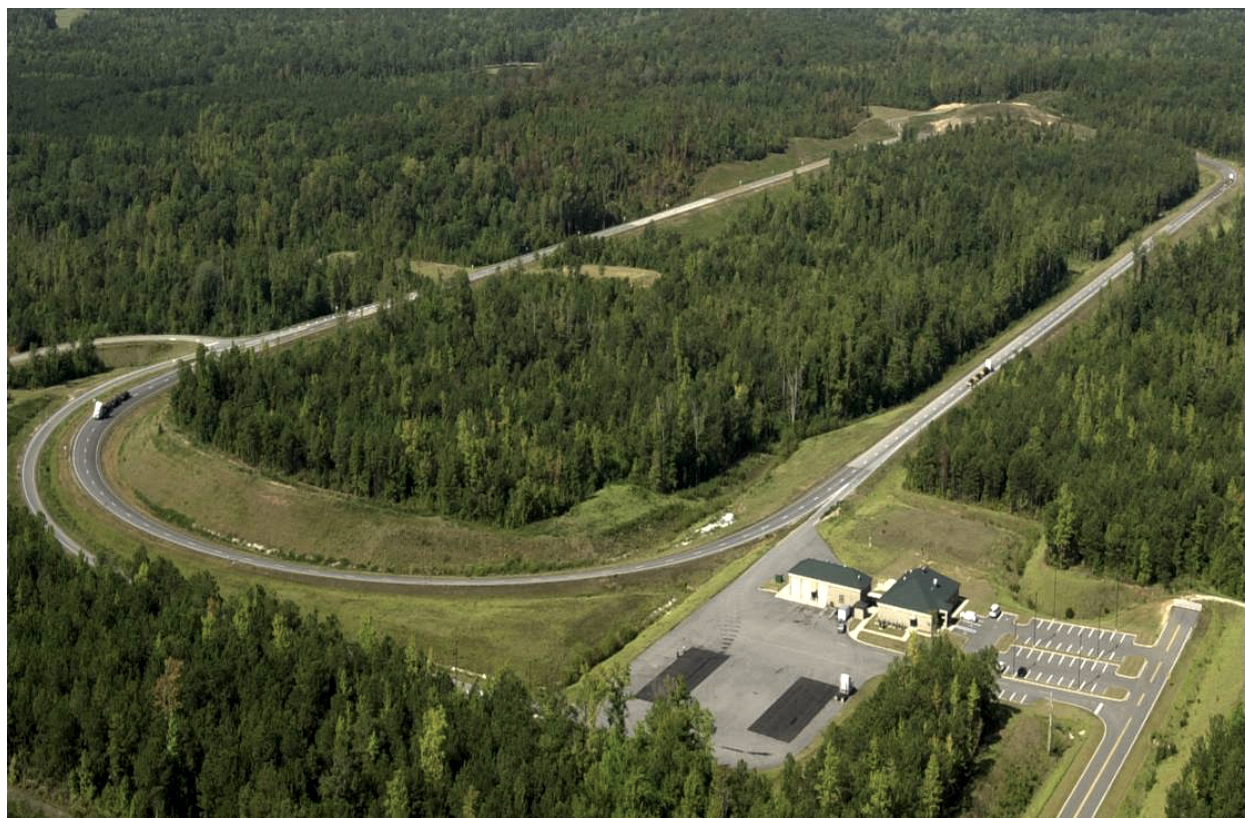
**FIGURE 1 Aerial photograph of the NCAT Test Track.**

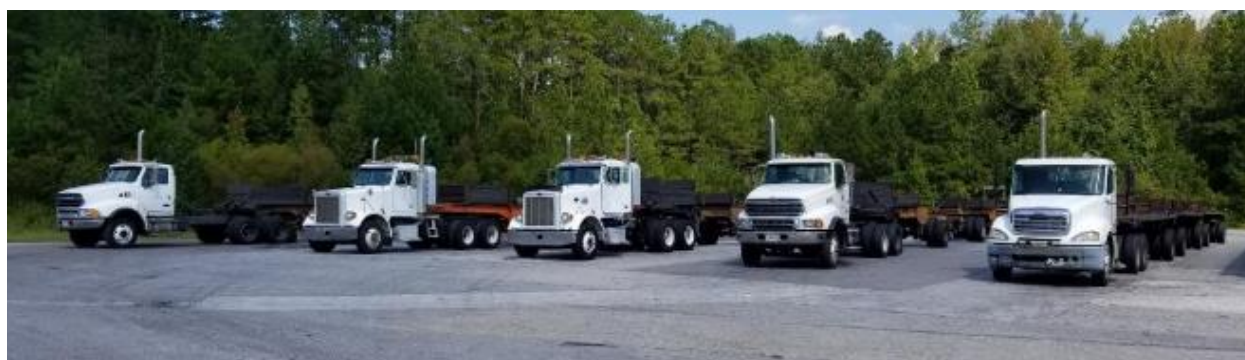
**FIGURE 2 The five tractor-trailers of the NCAT Test Track.**

Trafficking for the 2021 Test Track was applied in the same manner as with previous phases. Two shifts of professional drivers operated four trucks pulling triple flatbed trailers (Figure 7) and one truck pulling a triple box trailer from 5 a.m. until approximately 10:40 p.m. Tuesday through Saturday. Trafficking began on November 10, 2021, and ended in April 5, 2024. The total traffic applied to the test sections during this phase was 10,052,142 ESALs.

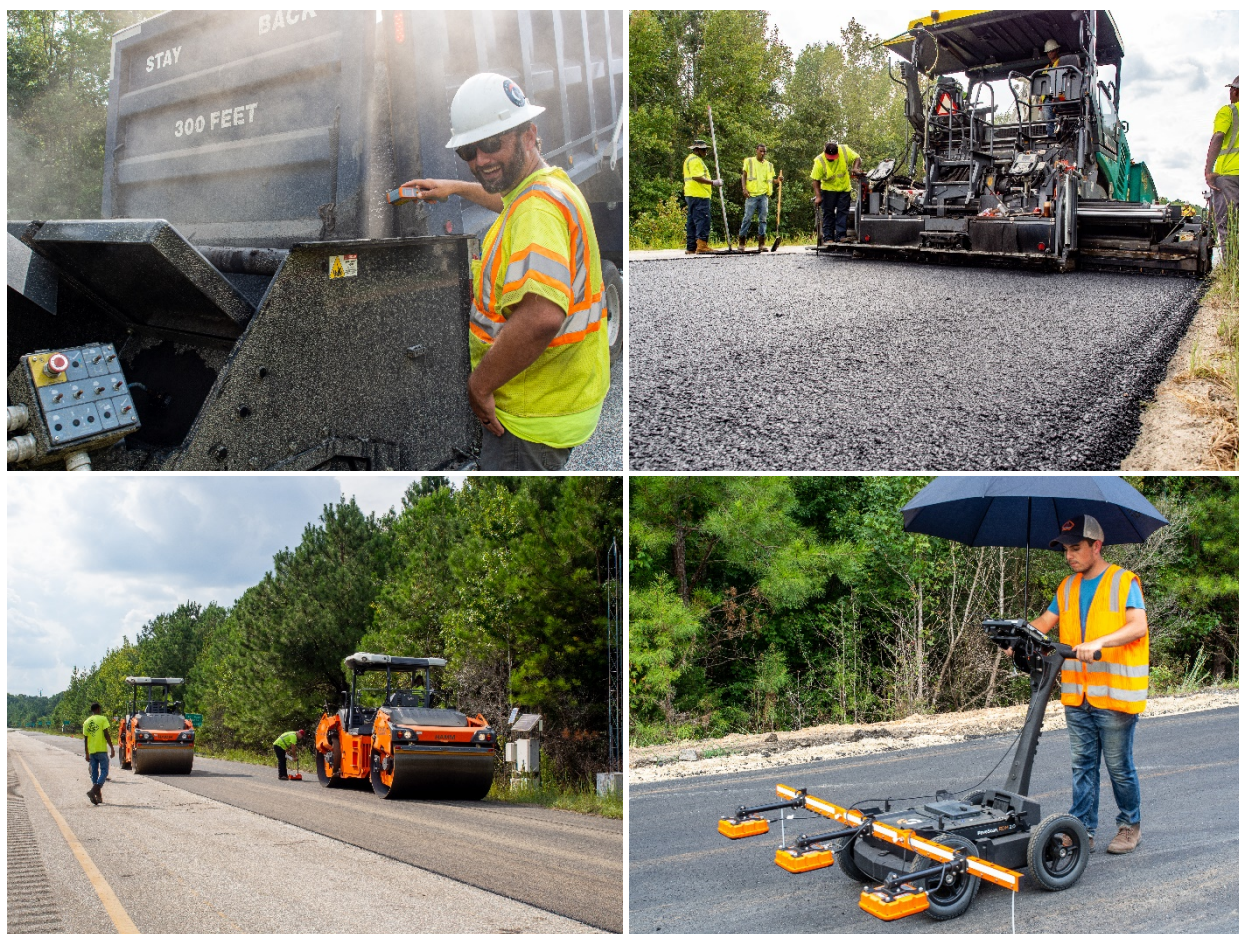
**FIGURE 6 Paving test section N6 for the 2021-2024 research phase.**

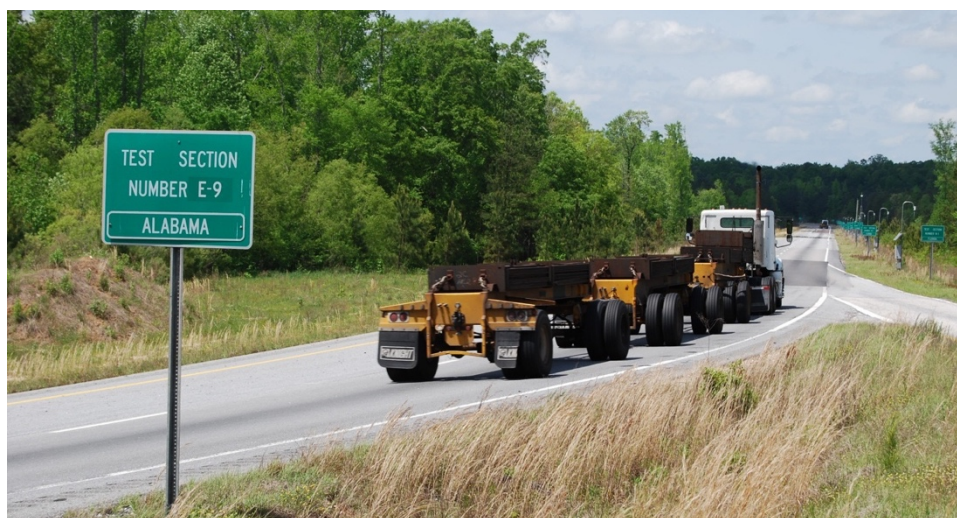
**FIGURE 7 Heavily loaded triple-trailer used for accelerated loading on the Test Track.**

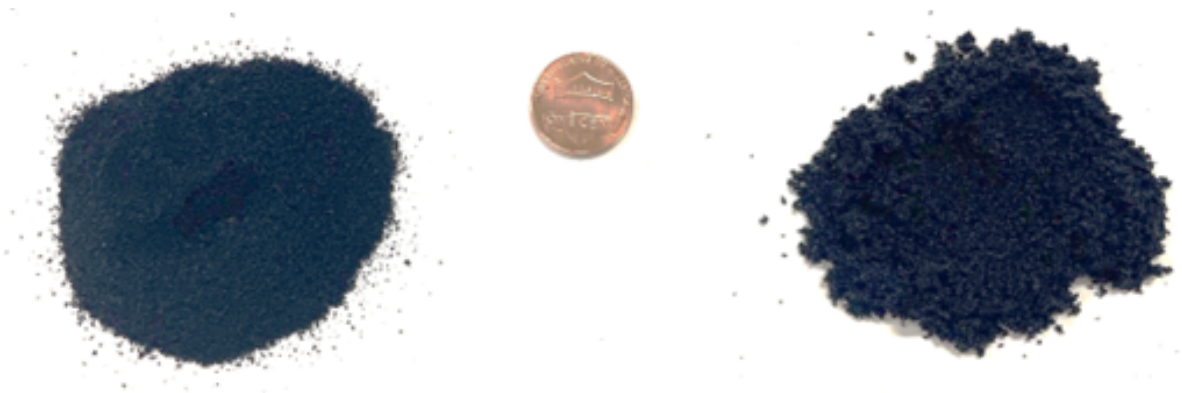
**FIGURE 1 Entech (left) and SmartMIX (right) ground tire rubber.**

This experiment used both wet and dry processes to incorporate rubber into the asphalt mixtures. The wet process involved a terminal blended rubber-modified binder that used a PG 64-22 virgin binder modified with 10% (by weight of binder) of a -30 mesh RTR supplied by Entech, Inc. The dosage of the rubber was selected to match the Superpave performance grade (PG) of the PG 76-22 SBS binder. The dry process used a pre-reacted rubber provided by Liberty Tire Recycling, marketed under the name SmartMIX. This process entailed combining a fine-grind rubber with extender oil and heating to approximately 275°F for 30 minutes. After heating, swelling, and saturation, the reacted rubber was moved into a cooling system and mixed with a flow agent to prevent particle sticking. SmartMIX was added to the mix alongside a PG 67-22 binder using a separate feed system to proportion the rubber at a rate of 12% by weight of the total binder. Figure 1 shows the two types of rubber technologies used in the AG experiment.

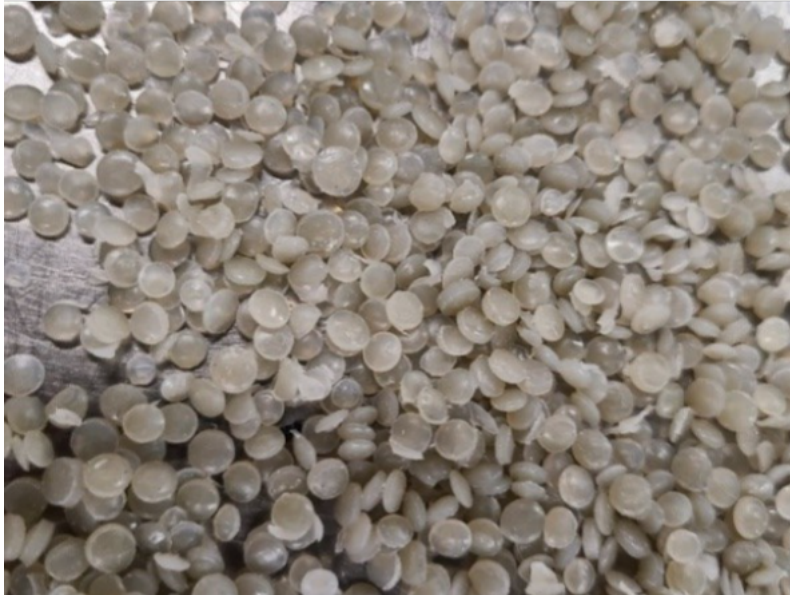
**FIGURE 3 Post-consumer recycled (PCR) plastic additive.**

The plastic additive used was post-consumer recycled (PCR). As shown in Figure 3, the additive was in pellet form, with 97% passing the 3/8-inch sieve and 3% passing the No. 4 sieve. It contained approximately 95% linear low-density polyethylene (LLDPE), had a specific gravity of 0.91 to 0.92, a melt flow rate of 1.8 to 2.8 g/10 min., and contained less than 1.0% ash. The plastic additive was evaluated for asphalt modification using both the wet process and the dry process. For the wet process, a PG 67-22 virgin binder was modified with 1.0% plastic pellets, 1.5% reactive elastomeric terpolymer (RET) to stabilize the plastic, and 0.32% polyphosphoric acid (PPA) to act as a co-reactant to the RET. The dosages of the plastic, RET, and PPA

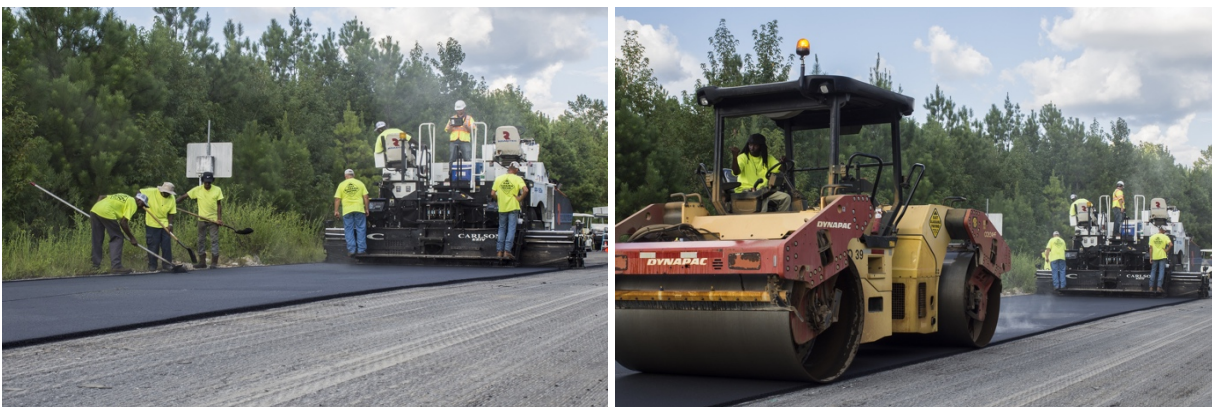
**FIGURE 1 N10 mix placement and compaction.**

Section N10 was constructed on August 29, 2018. The mix was produced at 340°F (163°C) with an average in-place density of 93.8%. The as-built lift thickness was 0.80 inches (19.1 mm). Figure 1 shows the mix placement and compaction of Section N10.

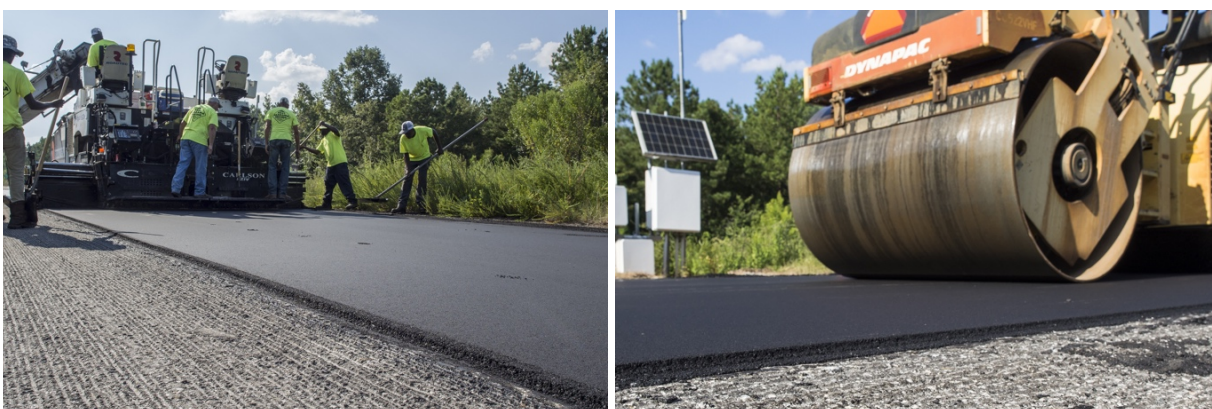
**FIGURE 2 N11 mix placement and compaction.**

Section N11 was constructed on August 27, 2018. The N11 mix was produced at 325°F (171°C) with an average in-place density of 91.5%. The as-built lift thickness was 0.50 inches (12.7 mm). Figure 2 shows the mix placement and compaction activities on Section N11. The planned thickness/rate of both N10 and N11 were designated by ALDOT, highlighting that Section N10 was thicker for higher performance preservation and Section N11 was thinner for lower cost preservation.

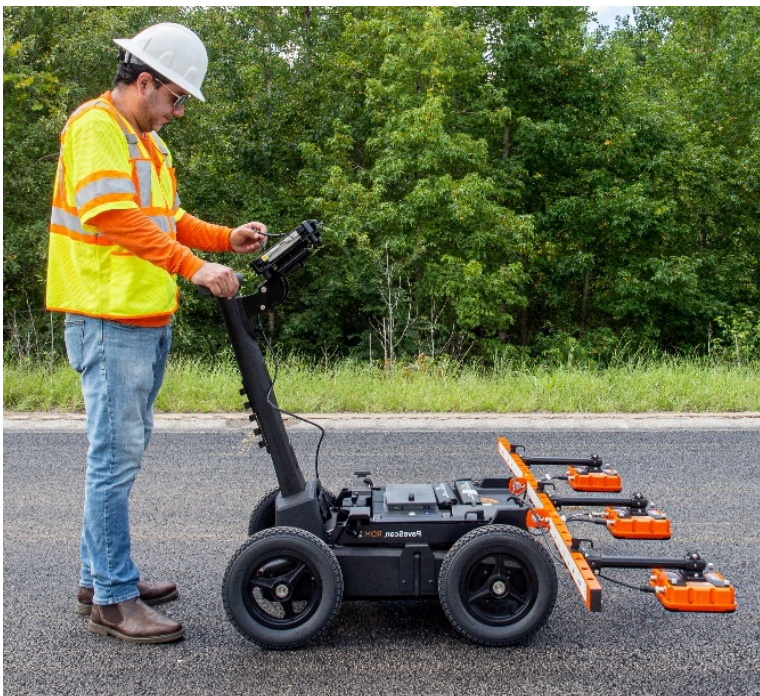
**FIGURE 1 DPS operated by Dr. Fabricio Leiva on the NCAT Test Track.**

Approximately three years after the density experiment subsections were built and after they had accumulated 10 million ESALs of trafficking, additional testing was conducted using a density profiling system (DPS), shown in Figure 1. Using air-coupled ground penetrating radar technology, the DPS provides essentially continuous density data in the path that the device travels without the need for pavement coring (4).

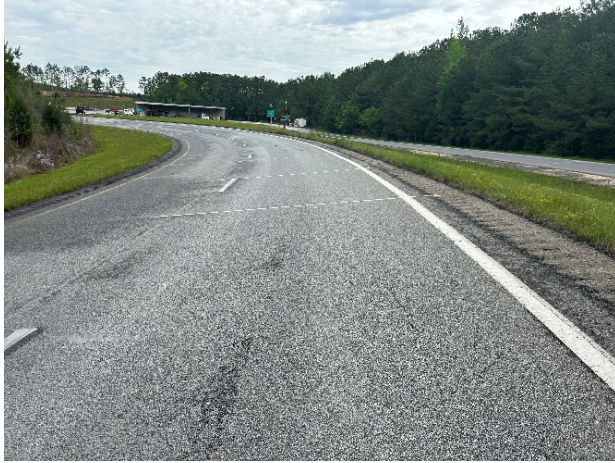
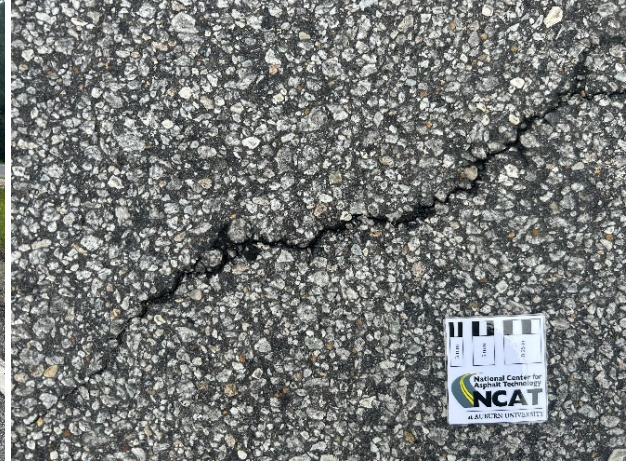
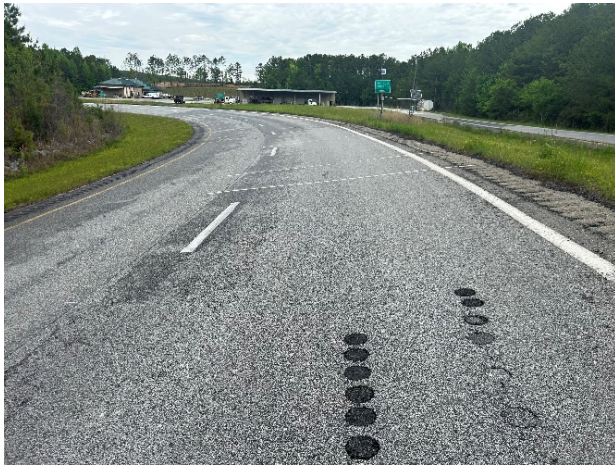
**E5A (93.6% of  $G_{mm}$ ) overview**

**E5A (93.6% of  $G_{mm}$ ) representative cracking**

**E5B (92.0% of  $G_{mm}$ ) overview**

**FIGURE 6 Subsection overviews and representative cracking severity in April 2024.**

Figures 6 and 7 provide representative photographs of the subsections. Overall, the subsections are performing well. Most cracks are categorized as minor severity ( $\leq 5$  mm) and are barely discernable during the warmer months. Some cracks in E6A and E6B are more easily visible with some spalling beginning to occur.

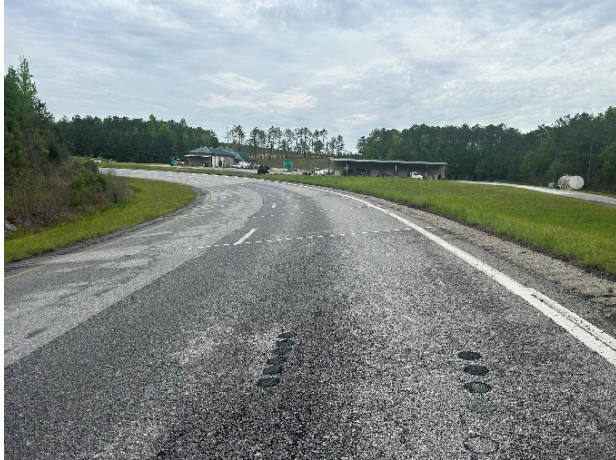
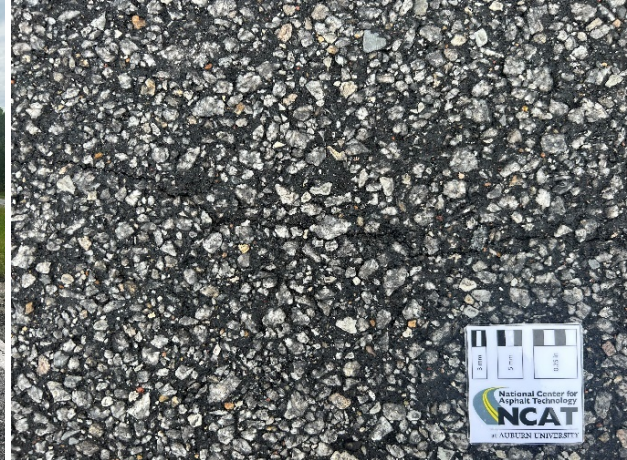
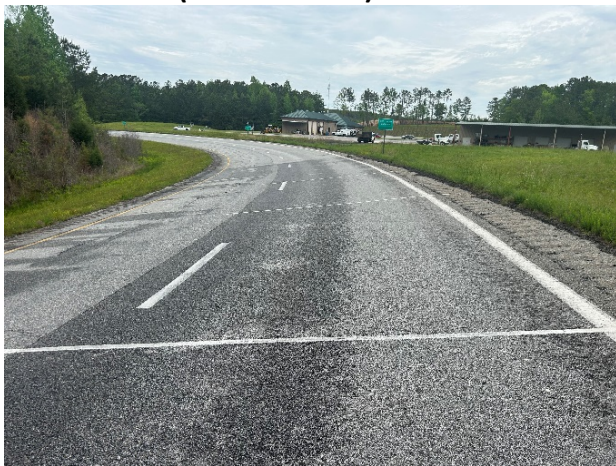
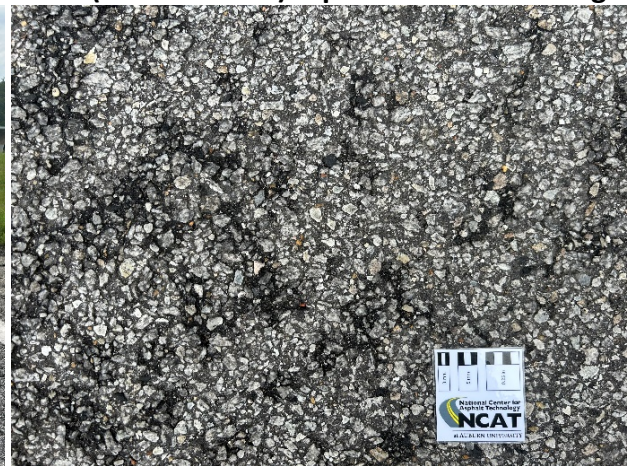
**E6A (87.8% of  $G_{mm}$ ) overview**

**E6A (87.8% of  $G_{mm}$ ) representative cracking**

**E6B (89.7% of  $G_{mm}$ ) overview**

**E6B (89.7% of  $G_{mm}$ ) representative cracking**

**FIGURE 7 Subsection overviews and representative cracking severity in April 2024.**

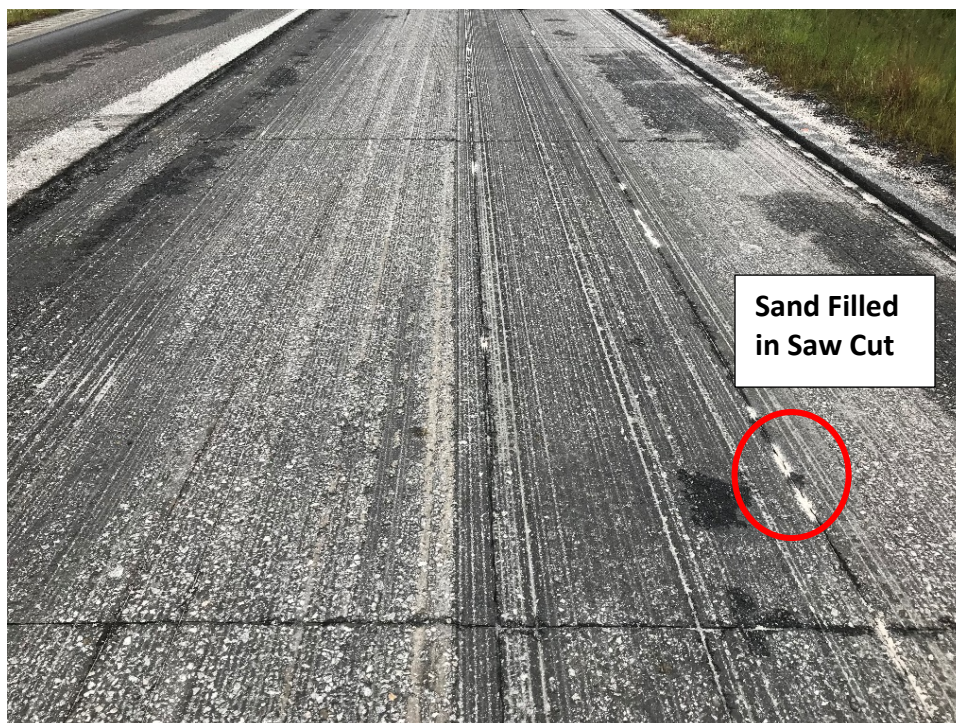
**FIGURE 1 Deep saw cuts to simulate pavement cracks.**

As depicted in Figure 1, these cuts were longitudinally aligned at intervals of 3 feet (0.91 meters) across the lane width and 15 feet (4.57 meters) in the transverse direction. The area impacted by the saw cuts accounted for roughly one-third of the test section's total surface area, assuming an influence zone of 1 foot (0.30 meters) on each side of the crack. The cuts were subsequently filled with sand to prevent the cracks from resealing during construction and warm weather conditions. The saw-cut pattern for this cycle replicated that of the previous research cycle.

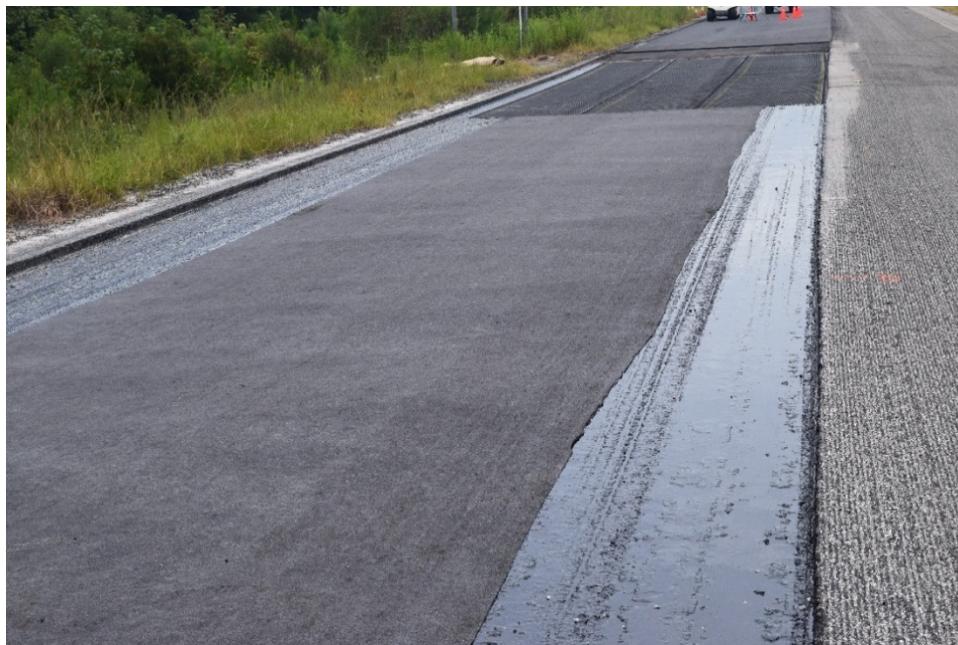
**FIGURE 2 Section N12-B geosynthetic PETROMAT® (foreground) and N12-A GlasGrid® (background) interlayers.**

Section N12 was segmented into three subsections to evaluate different treatment methods: N12-A with GlasGrid<sup>®</sup>, N12-B with PETROMAT<sup>®</sup> fabric (Figure 2), and N12-C with a No. 7 stone, virgin chip seal (Figure 3, foreground). For subsections N12-A and N12-B, a PG 64-22 asphalt binder was applied as a tack coat at 0.30 and 0.27 gallons per square yard, respectively. Per the manufacturer, GlasGrid<sup>®</sup> CG100 can be installed on a milled surface or leveling course with a tack coat application ranging from 0.20 to 0.30, and PETROMAT<sup>®</sup> recommends a PG 70-XX

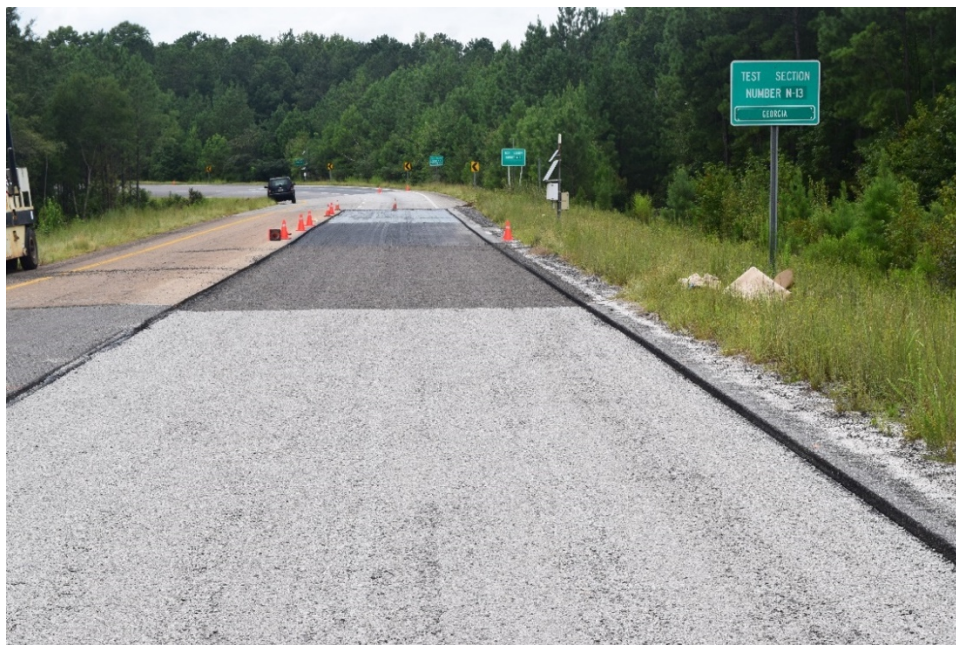
**FIGURE 3 Section N12-C chip seal with No. 7 stone (foreground) and N13-A chip seal with RAP (background).**

Section N13 was divided into three subsections for various treatment methods: N13-A with an RAP chip seal RAP, (Figure 3), N13-B with an ARGG, and N13-C with an OGI. The existing pavement of N13-A received a CRS-2h emulsion tack with a residue application rate of 0.23 gallons per square yard. This is the same application rate as section N12-C. In hindsight, this rate should have been adjusted down to account for the precoated RAP aggregates. Blacklidge UltraFuse® trackless tack was employed for N13-B and N13-C subsections at 0.25 gallons per square yard.

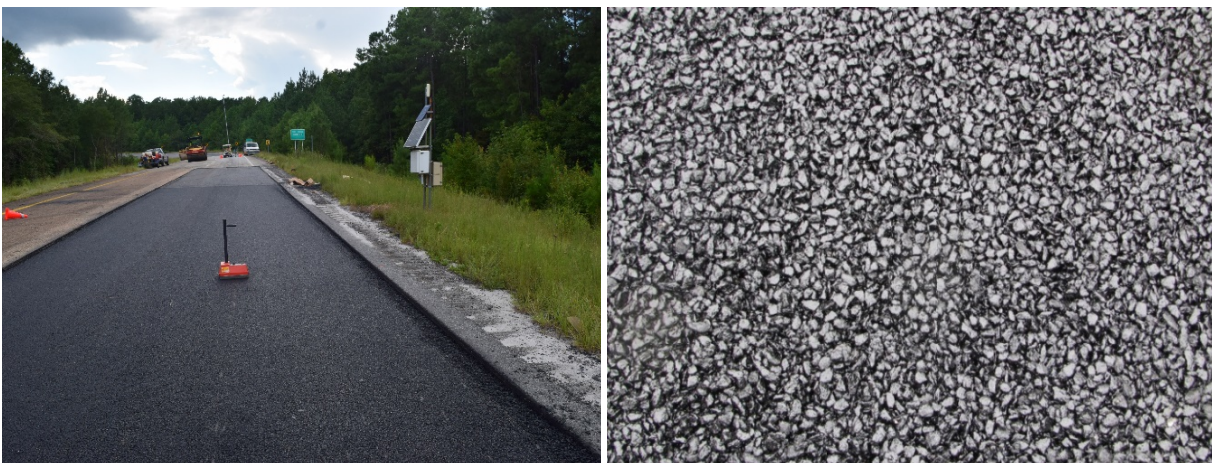
a. ARGG interlayer

b. Open-graded interlayer

The asphalt rubber gap-graded interlayer, shown in Figure 4a, featured a 1/2-inch (12.5 mm) NMA S gap-graded mix with granite aggregate and 7.4% ARB20 – asphalt rubber binder modified with 20% ground tire rubber (GTR). The OGI, depicted in Figure 4b, was a 1/2-inch NMA S porous friction course (PFC) with a PG 64-22 binder grade, designed according to GDOT special provision section 415, which targets an OBC between 4.50 to 5.25%. This mix omitted fiber stabilizer for cost considerations and utilized a reduced mix temperature of 250°F ± 20°F (121°C ± 11°C) to prevent drain-down. These mixes aimed to provide a discontinuity between the existing surface and overlay, thereby diminishing crack reflection.

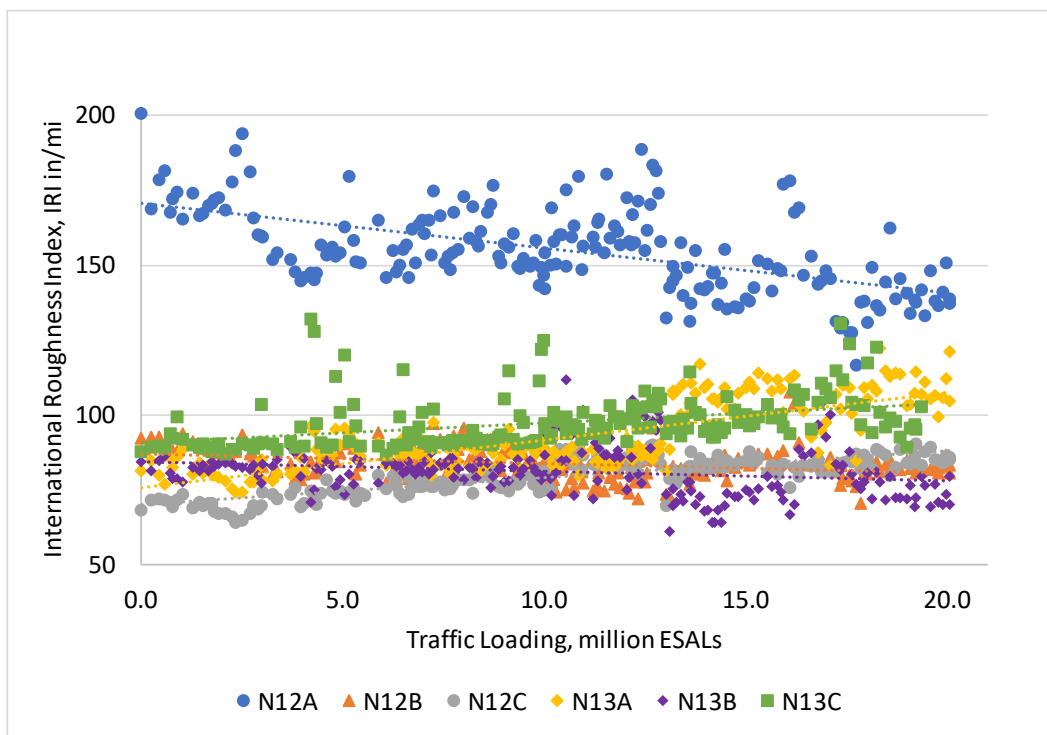
**FIGURE 5 International Roughness Index measurements of N12 and N13.**

Figure 5 illustrates initial International Roughness Index (IRI) readings, highlighting that subsection N12-A started with a notably higher IRI than other subsections (200 in./mile). This discrepancy is attributed to interference from the adjacent Section N11, which boasts an IRI exceeding 150 inches per mile (93.2 inches/km), and the impact of the transverse joint. Across the board, none of the six subsections exhibited significant increases in IRI. Overall smoothness improved slightly for half of the subsections, as shown in Figure 6.

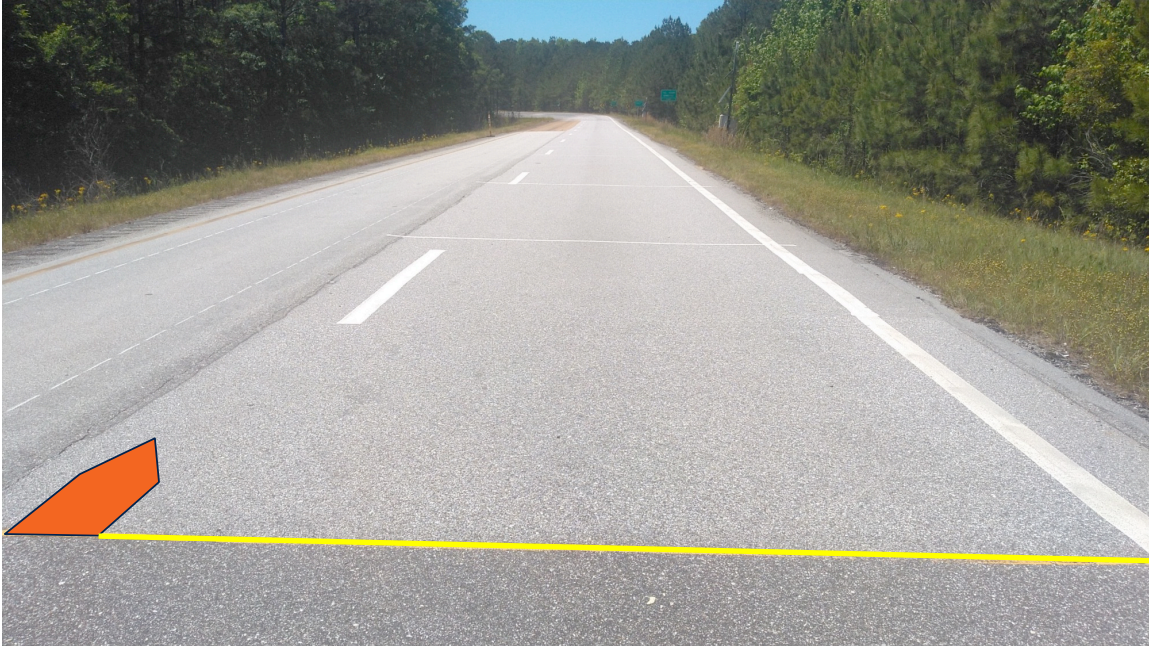
**FIGURE 13 Subsection N12-A GlasGrid<sup>®</sup>, 0.24-inch rutting, no cracking (April 2024).**

The final surface after loading for each section is shown in Figures 13 through 18. The yellow superimposed line marks the start of each subsection.

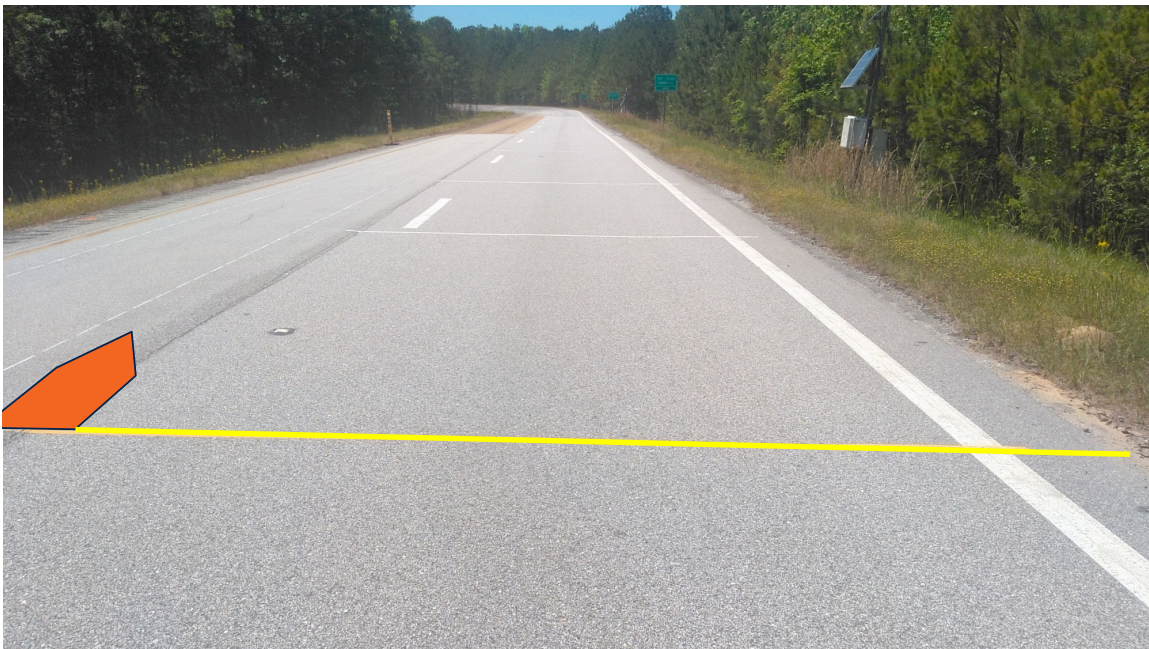
**FIGURE 14 Subsection N12-B PETROMAT<sup>®</sup>, 0.27-inch rutting, no cracking (April 2024).**

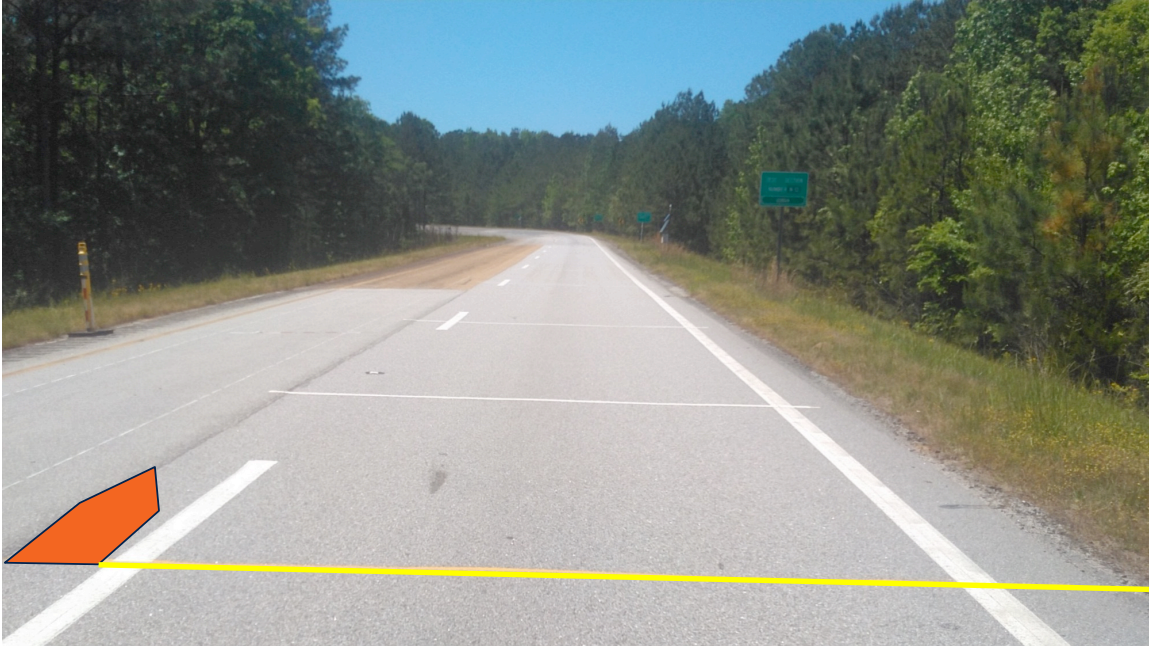
**FIGURE 15** Subsection N12-C virgin chip seal, 0.21-inch rutting, no cracking (April 2024).

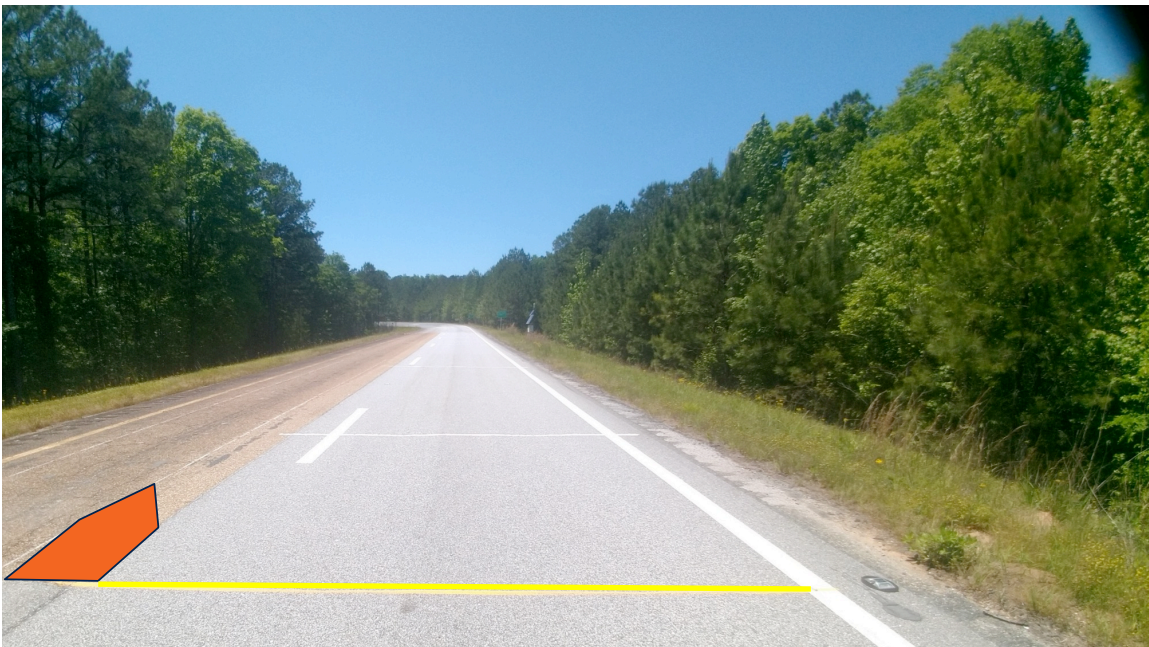
**FIGURE 16** Subsection N13-A RAP chip seal, 0.41-inch rutting, 0.8% cracking (April 2024).

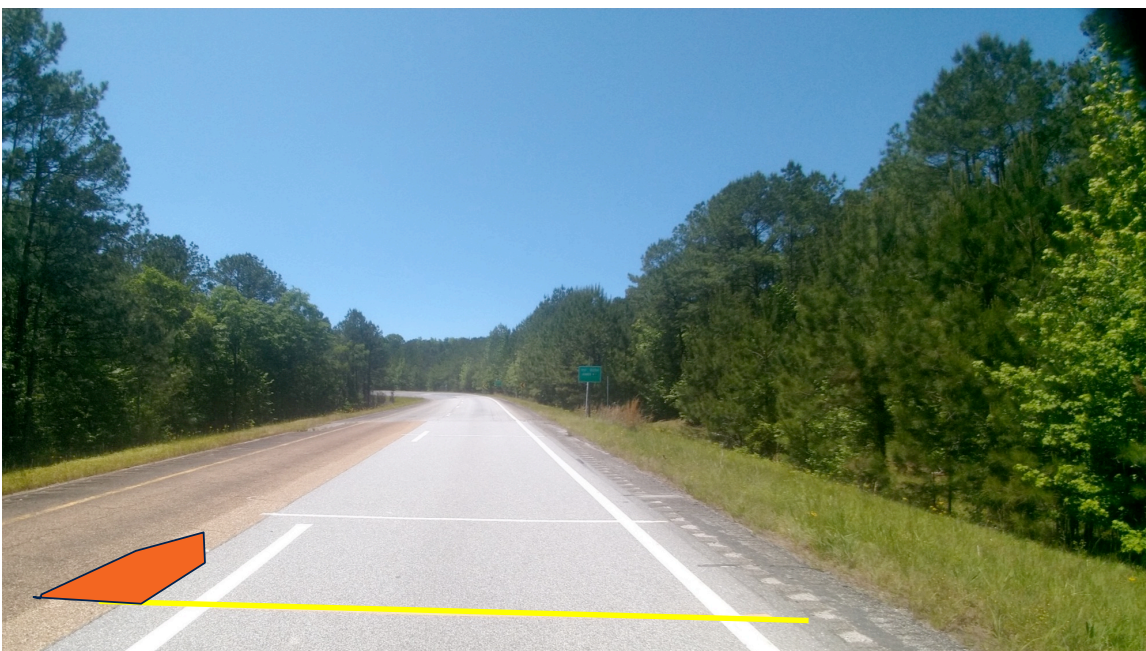
**FIGURE 18 Subsection N13-B OGI, 0.19-inch rutting, 0.8% cracking (April 2024).**

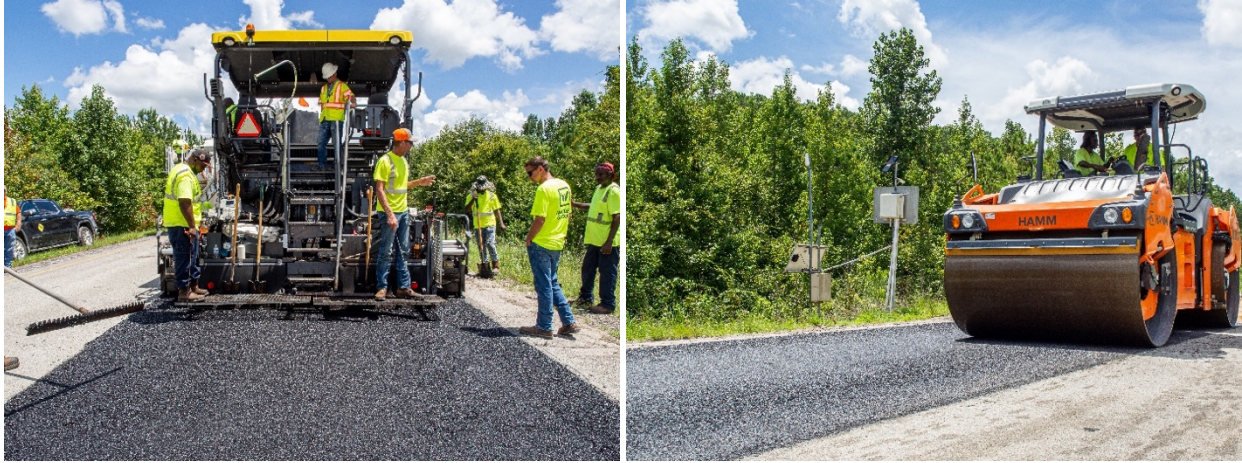
**FIGURE 5 Construction of Section S7A.**

The S7A “medium” friction mix was produced and placed August 19, 2021, with a high temperature of 92°F, a low temperature of 75°F, and no 24-hr rainfall. The mix had an average production temperature of 325°F and in-place density of 92.9%. Figure 5 shows laydown and compaction of Section S7A.

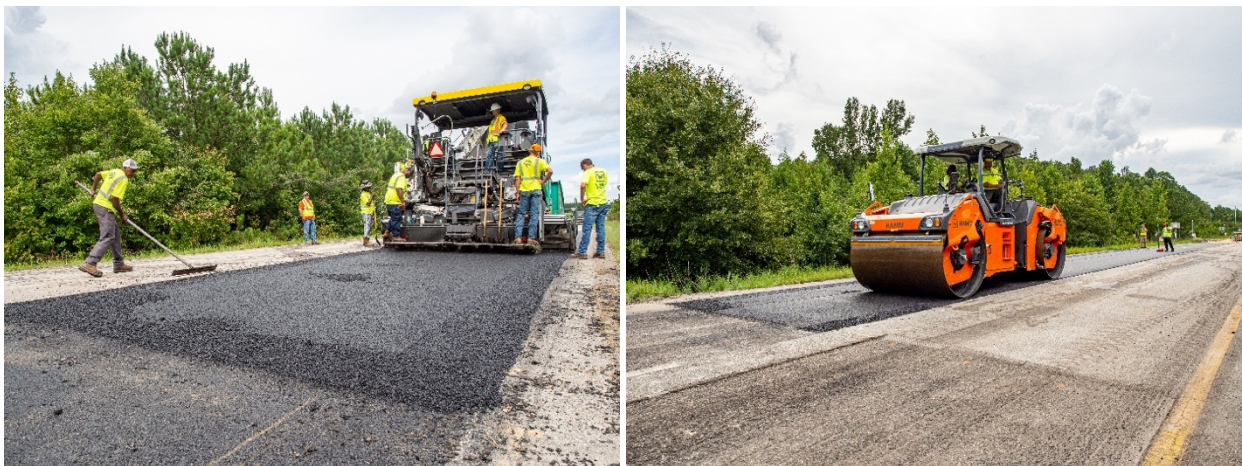
**FIGURE 6 Construction of Section S7B.**

The S7B “high” friction mix was also produced and placed August 19, 2021, with a high temperature of 92°F, a low temperature of 75°F, and no 24-hr rainfall. The mix had an average production temperature of 325°F and in-place density of 92.9%, which matched Section S7A. Figure 6 shows the laydown and compaction of S7B. Figure 7 shows the transition line between the two sections after six months of traffic, with S7A (with quartzite coarse aggregate) on the left and S7B (with sandstone coarse aggregate) on the right.

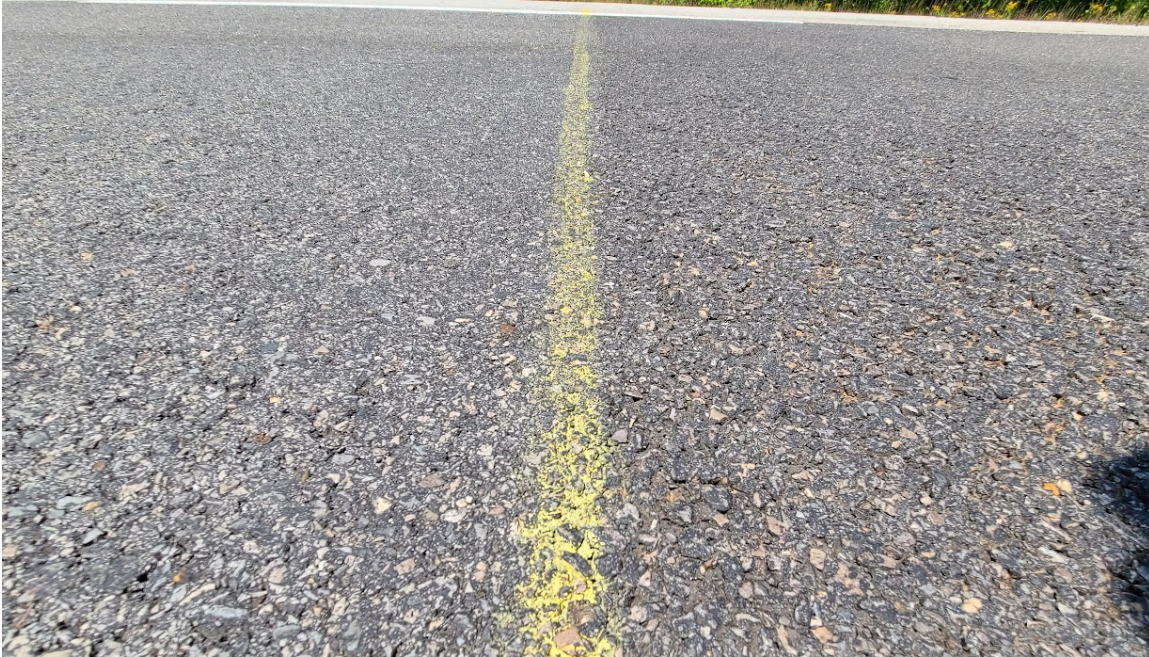
**FIGURE 7 Transition from S7A (left) to S7B (right).**

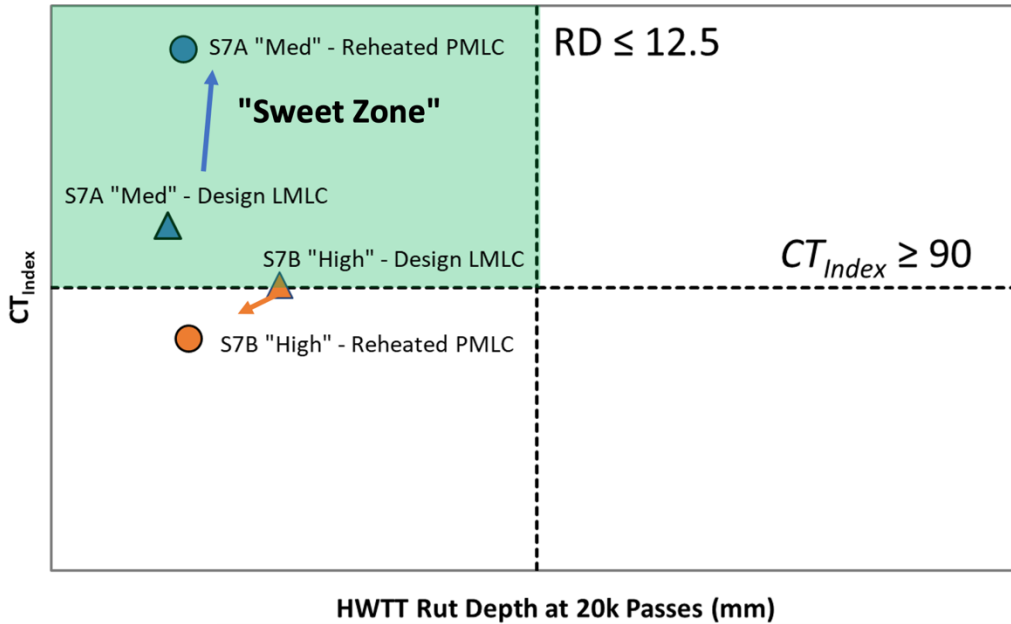
**FIGURE 9 BMD performance diagram from S7A and S7B reheated mix testing.**

A production sample was taken from each mix during construction and transported to the NCAT laboratory for future testing. The mix was later reheated in metal buckets to the compaction temperature to produce plant-mixed, lab-compacted (PMLC) performance testing results to compare to the lab-mixed, lab-compacted (LMLC) results from mix design. HWTT and IDEAL-CT were conducted to evaluate rutting and cracking resistance, respectively, of the mixes in Sections S7A and S7B. Figure 9 shows the results of these tests plotted in the same performance space diagram as in Figure 4. Arrows indicate the changes from design to reheated PMLC results. The reheated S7A PMLC mix remained in the “sweet zone,” passing both HWTT and IDEAL-CT criteria. The S7B reheated PMLC mix dipped below the  $CT_{Index}$  threshold to 74 but remained well below the HWTT threshold. Field evaluation was necessary to determine the quality of the S7B mix and the validity of the IDEAL-CT threshold of 90 as a performance threshold for the KYTC mixes.

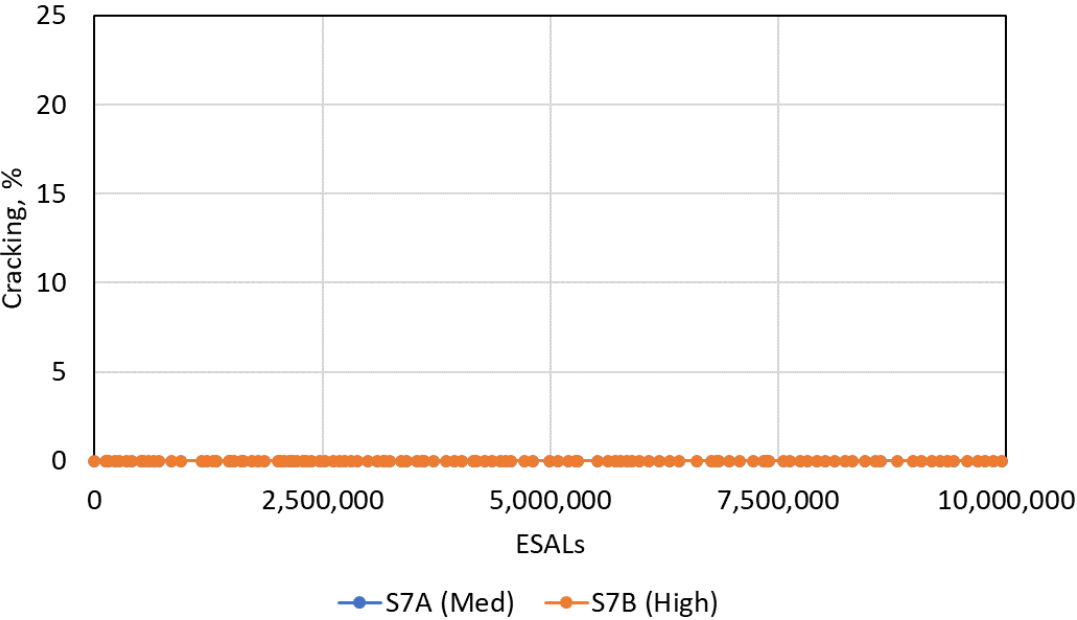
**FIGURE 13 Cracking performance for Sections S7A and S7B.**

Figures 13-15 show the cracking, rutting, and rideability of the two sections. Figure 13 highlights the lack of cracking in either section after 10 million ESALs. Figure 14 shows the rutting performance of Sections S7A and S7B. At 10 million ESALs, neither section had rut depths more than 0.2 inches, well below the failure threshold of 0.5 inches used at the track. Therefore, the BMD tests accurately identified both mixes as resistant to cracking and rutting up to 10 million ESALs on the NCAT Test Track.

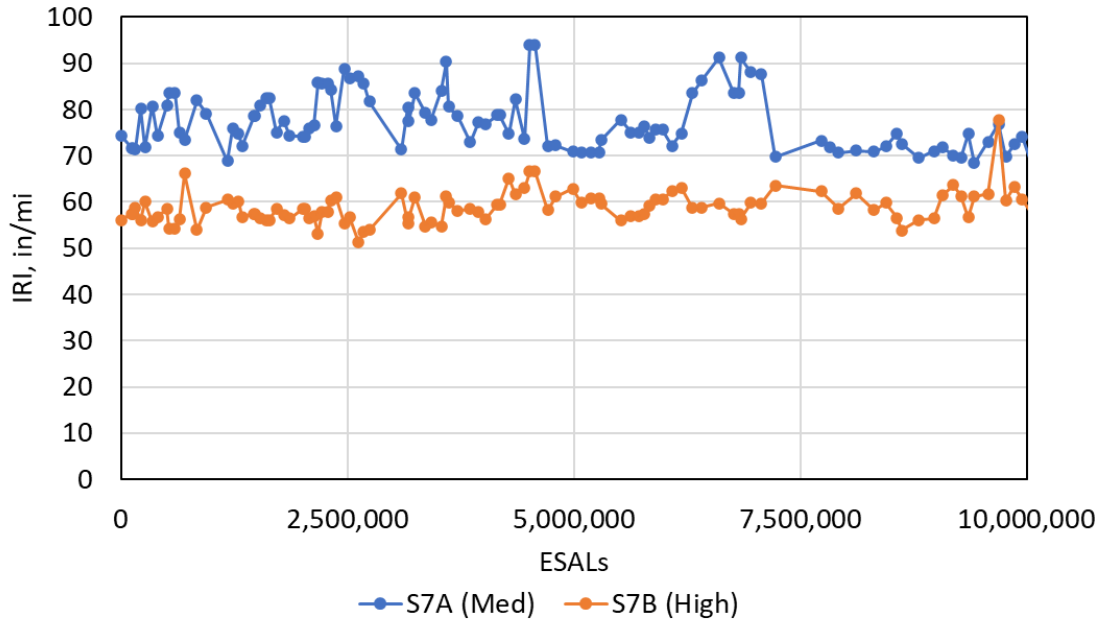
**FIGURE 15 IRI performance of Sections S7A and S7B.**

Figure 15 displays rideability, expressed as IRI as in/mile. In both cases, ride performance was good. S7A had relatively consistent ride quality, except for the noise in the data from approximately 6 to 7 million ESALs. An adjacent section was repaved during this time which caused the temporary bump in the overall IRI measurements due to the short section length. Discounting this event, the ride in Section S7 remained between 70 and 80 in/mile until the end of the experiment. The ride in S7B was even smoother, hovering consistently between 55 and 65 in/mile.

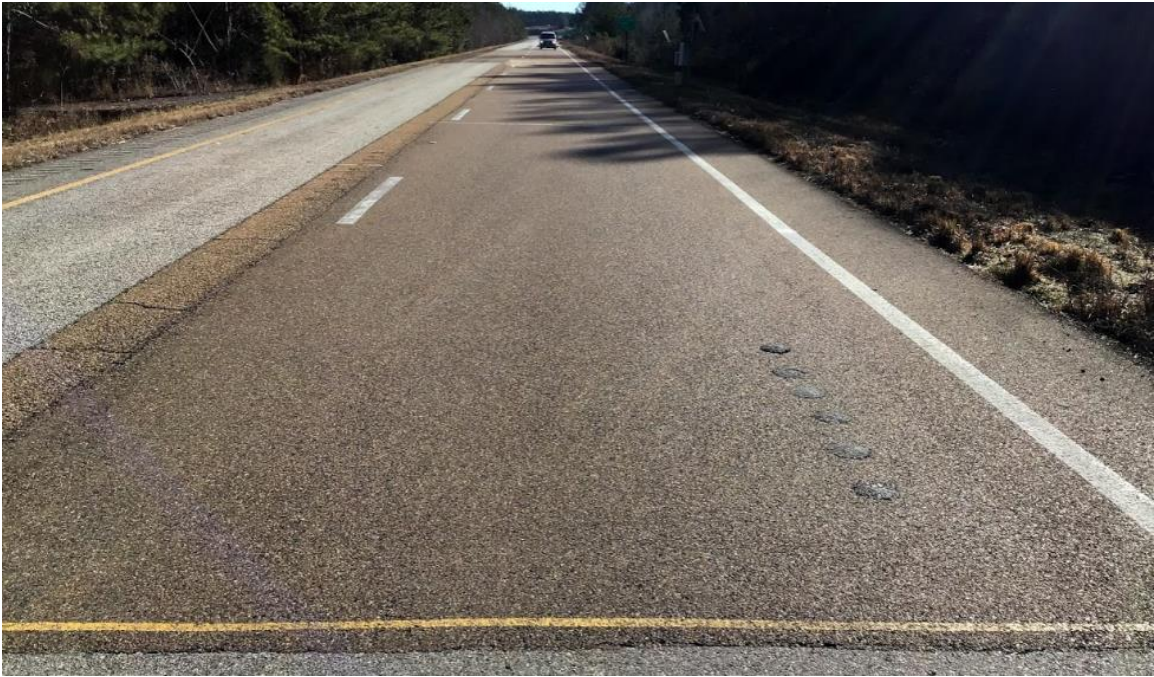
**FIGURE 2. Test Section S2 near the end of first trafficking cycle.**

As with all other Test Track sections, Section S2 was measured frequently for rutting and roughness during the two research cycles and was inspected for cracking on a regular basis. Figure 2 shows the section on February 8, 2021, near the end of the first two-year trafficking cycle. Figure 3 shows the section after trafficking was completed in April, 2024. The following
