# NCAT Draft Report 24-01

## Phase VIII (2021-2024) NCAT Test Track Findings

NCAT Draft Report 24-01  
Phase VIII (2021-2024) NCAT Test Track Findings

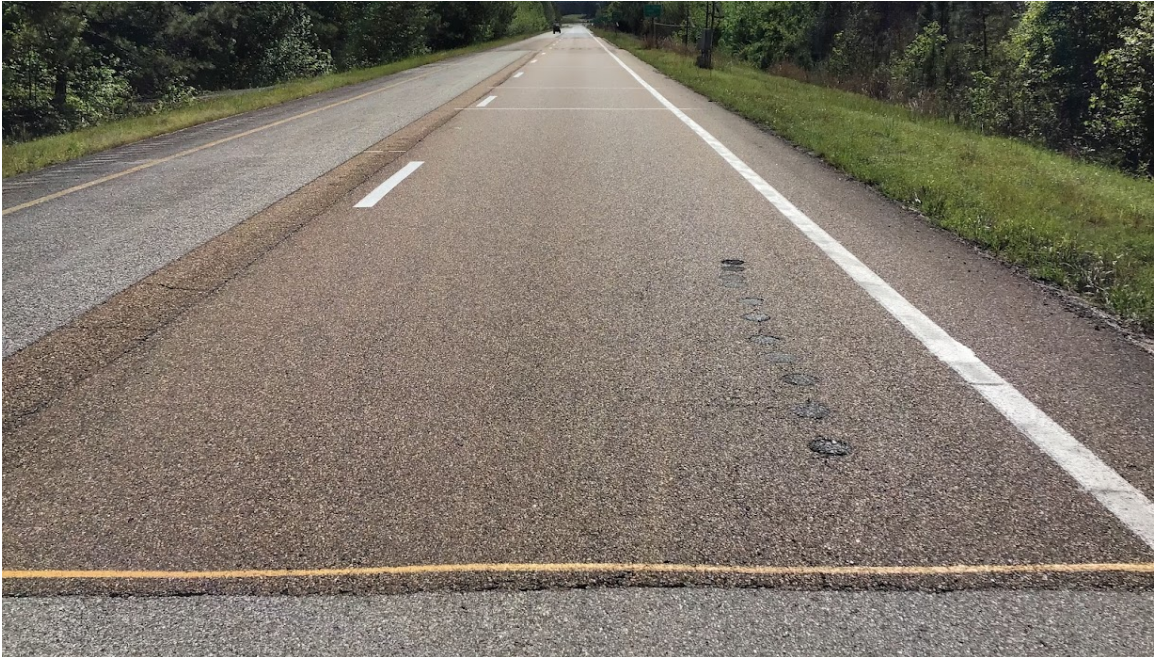
**FIGURE 3. Test Section S2 after completion of second trafficking cycle.**

As with all other Test Track sections, Section S2 was measured frequently for rutting and roughness during the two research cycles and was inspected for cracking on a regular basis. Figure 2 shows the section on February 8, 2021, near the end of the first two-year trafficking cycle. Figure 3 shows the section after trafficking was completed in April, 2024. The following

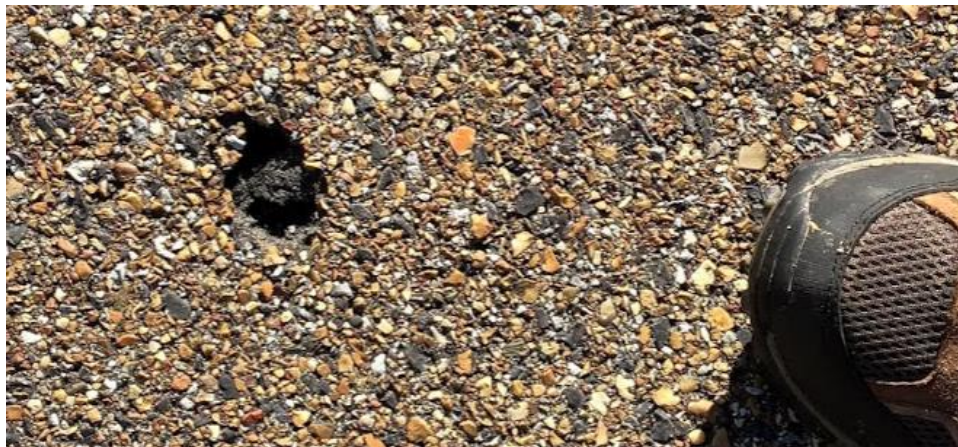
No cracking was observed in the section after the first 2 years and 10 million ESALs. There were, however, a few randomly located pop-outs. Figure 5 shows one of the largest pop-outs. The time this pop-out occurred is unknown, and it was not deemed detrimental to the section's structural integrity.

**FIGURE 5 Pop-out in Section S2.**

Minor longitudinal between-wheelpath cracking developed during the second test cycle. The cracking was first observed April 24, 2023 at 15.3 million ESALs. Figure 5 shows one of the larger cracks. In subsequent months, the cracking would literally disappear depending on the time of year. This was especially evident during warmer months, and it was assumed the asphalt was able to flow back together, or self heal, at elevated temperatures. This also supported the notion that the cracking was top-down, though no forensics were performed on the cracks. At the conclusion of the test cycle, this cracking represented 1% of the lane area and was not considered detrimental to the section's structural integrity.

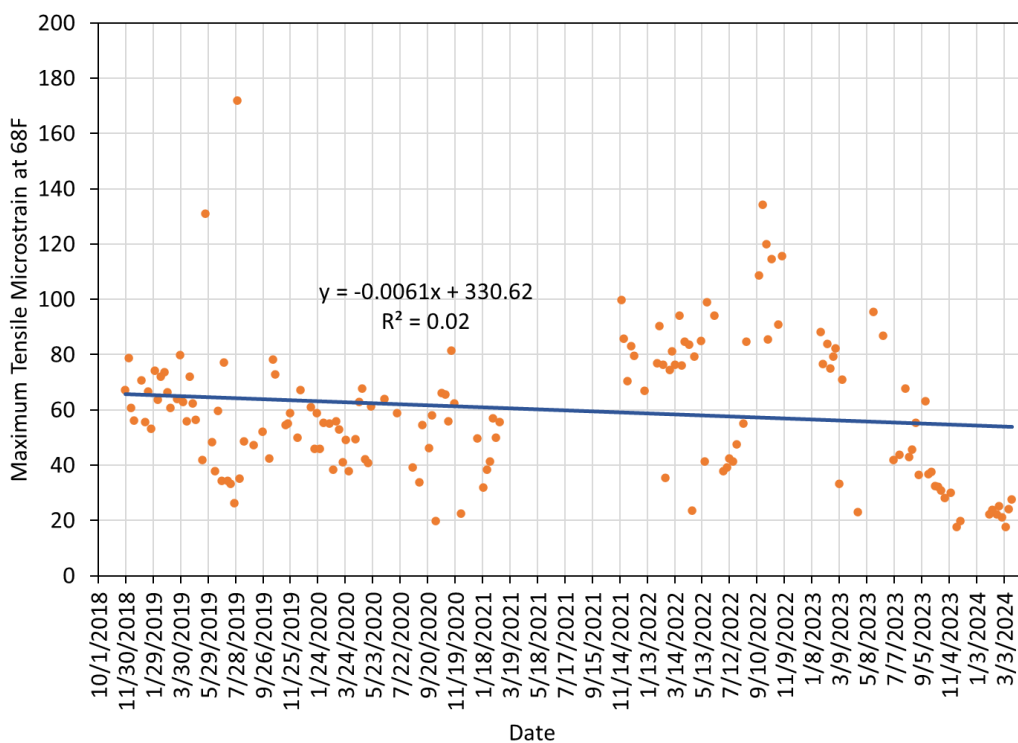
**FIGURE 9 Section S2 maximum tensile strain at 68°F versus date.**

than a 10 microstrain decrease since the start of the experiment. This will be monitored into the next test cycle, but to date, these strain levels indicate a structurally healthy test section.

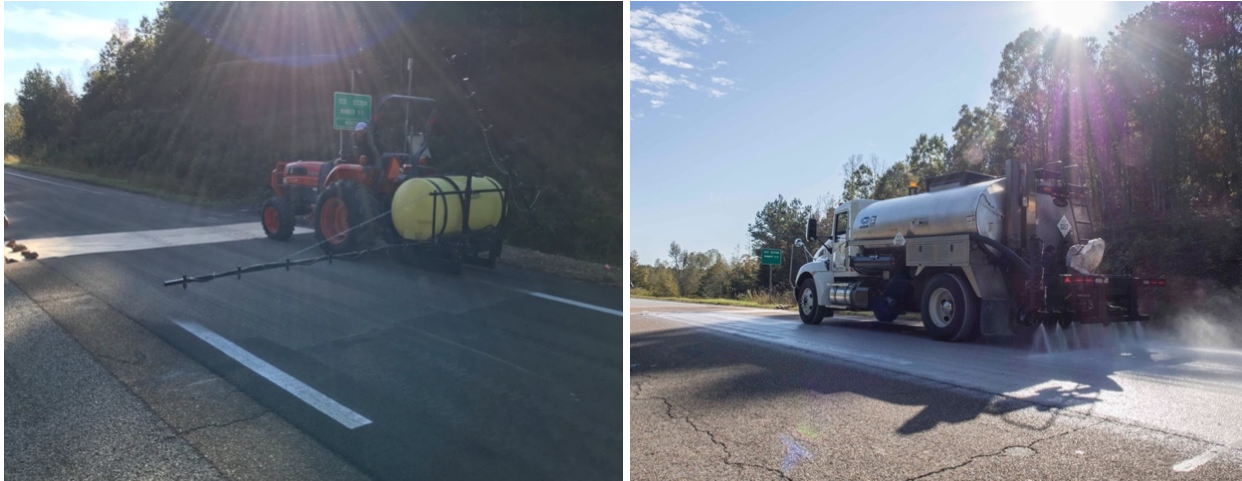
**FIGURE 1 S3-A and S3-B application of spray-on rejuvenators.**

Two spray-on rejuvenator products were applied over the surface of Section S3, a 1.5” mill/inlay asphalt pavement section constructed in 2012, after the section experienced around 20 million equivalent single axle loads (ESALs) of traffic without presenting rutting or cracking distresses (Figure 1). The hot mix asphalt (HMA) of Section S3 was a dense-graded mix with sand and gravel containing 25% reclaimed asphalt pavement (RAP) and an asphalt content of 6.8%. The asphalt binder used in the design was a neat binder with a performance grade (PG) 67-22.

The spray-on rejuvenator products utilized in this study were ReGenX<sup>®</sup> and Delta Mist<sup>™</sup>, listed in this report as S3-A and S3-B, respectively. The application rate, water dilution rate, and residual application rate of the products were determined following manufacturer recommendations, and this information is described in Table 1.

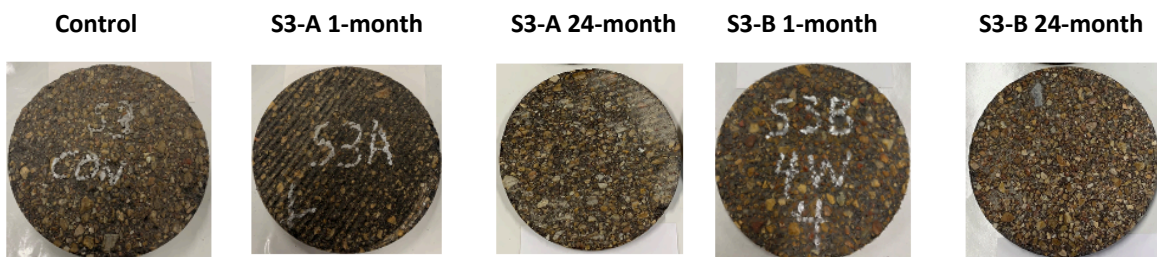
**FIGURE 3 Section S3 pavement surfaces 1 month and 24 months after treatment application.**

Figure 3 shows the pavement surfaces of Section S3, including control, 1 month post-application, and 24 months post-application of the spray-on rejuvenator products. For section S3-A, the cores were collected from the diamond ground portion of the section that existed before the application of spray-on products for this study.

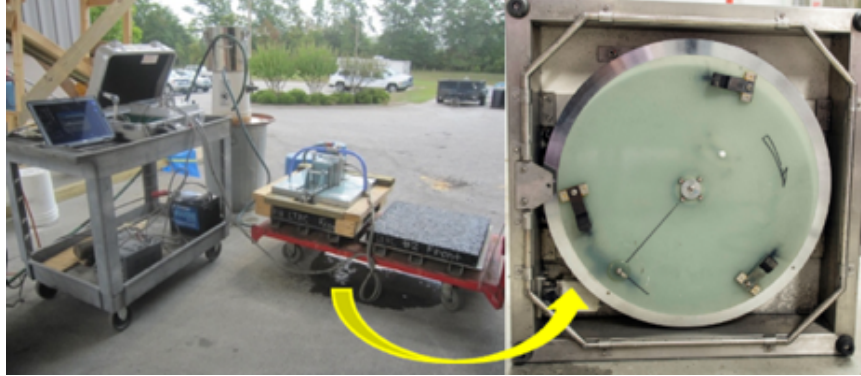
**FIGURE 17 Dynamic friction tester.**

Pavement surface frictional properties of Section S3 as a function of speed were measured using the Dynamic Friction Tester (DFT). The DFT consists of a horizontal spinning disk fixed with three spring-loaded rubber sliders that contact the pavement surface (Figure 17). A water spray system is used to simulate wet conditions. When the disk is lowered onto the test surface, the DFT measures the torque generated by the sliders' resistive force to calculate the friction coefficient of the asphalt pavement surface. Velocity is also measured to indicate the relationship between the coefficient of friction and speed. Each DFT test includes three replicate measurements as described in ASTM E 1911. This study selected speeds of 20, 40, and 60 km/h for measuring friction properties of the pavement surface of Sections S3-A and S3-B. Heitzman and Moore indicated that 40 km/h DFT speed produces the most repeatable measure (12). Therefore, this speed was used for detailed analysis.

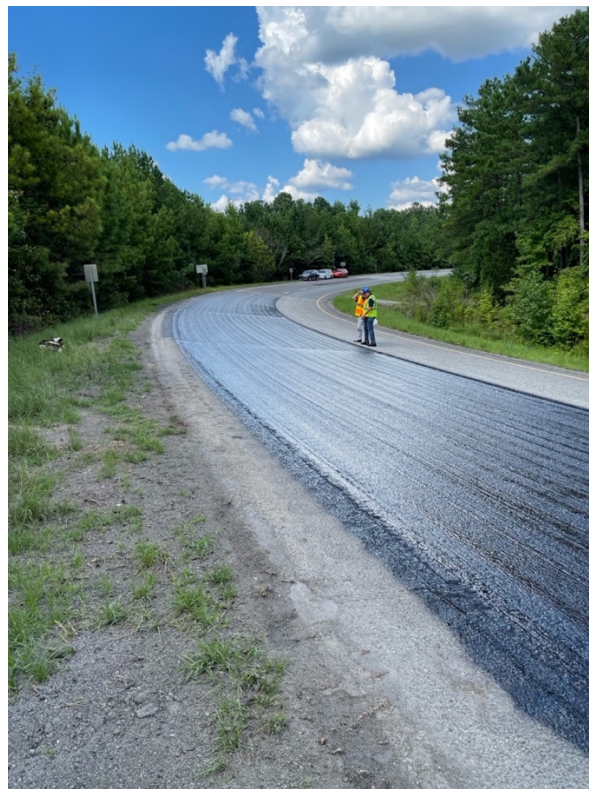
**FIGURE 2** Section W4 for the 2021-2024 research cycle.

As part of the 2021-2024 Test Track research cycle at the National Center for Asphalt Technology (NCAT), the North Carolina Department of Transportation (NCDOT) sponsored a tack coat experiment in Section W4 (the 4<sup>th</sup> section in the west curve) (Figure 2). The study aimed to assess 1) the effect of tack coat type and rate on initial and long-term interface shear bond strength under the influence of aging and traffic loading, and 2) whether NCDOT's mixture specifications are sufficient to ensure the stability of high recycled content mixes under realistic, high shear stress conditions.

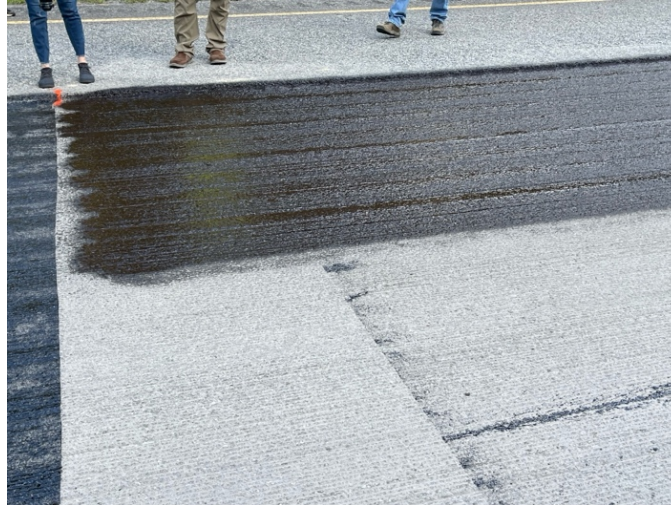
**FIGURE 3 Tack coat application after milling in Section W4.**

Two tack coat products, a PG 67-22 binder and CRS-1h (a cationic rapid-set emulsion with a relatively low asphalt emulsion viscosity made with hard base asphalt), were applied over the surface of Section W4, a 1.5" milled asphalt pavement section (Figure 3). Section W4 was constructed in 2018 and experienced around 10 million ESALs of traffic without presenting rutting and cracking distresses before milling in 2021.

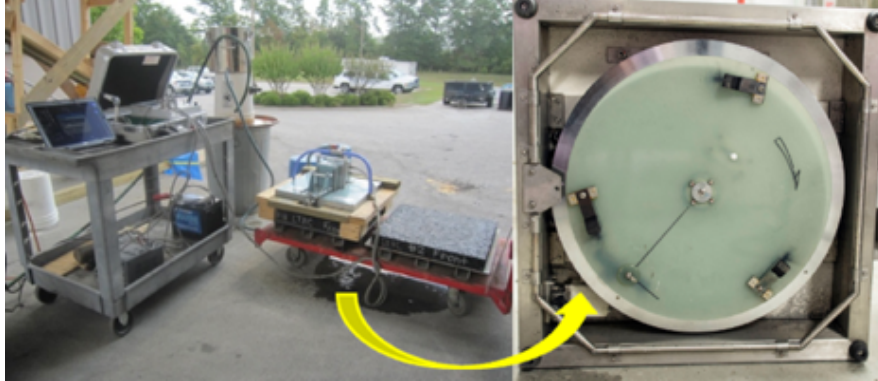
**FIGURE 9 Dynamic friction tester (DFT).**

Pavement surface frictional properties of Section W4 as a function of speed were measured using the DFT after 3 and 18 months of construction (Figure 9). The DFT consists of a horizontal spinning disk fixed with three spring-loaded rubber sliders that contact the pavement surface. A water spray system is used to simulate wet conditions. When the disk is lowered onto the test surface, the DFT measures the torque generated by the sliders' resistive force to calculate the friction coefficient of the asphalt pavement surface. Velocity is also measured to indicate the relationship between the coefficient of friction and speed. Each DFT test includes three replicate measurements as described in ASTM E 1911. This study selected speeds of 20, 40, and 60 km/h for measuring friction properties of the pavement surface of Sections W4-A, W4-B, and W4-C. Heitzman and Moore indicated that 40 km/h DFT speed produces the most repeatable measure (8). Therefore, this speed was used for detailed analysis.

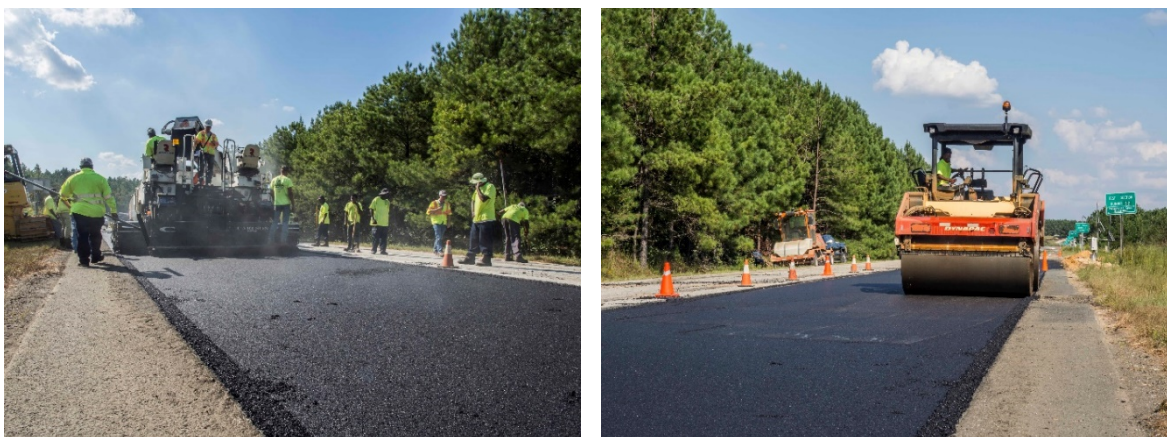
**FIGURE 3 Laydown and compaction of S1 base mix.**

As shown in Table 1, QC testing of the base mix indicated a slight reduction in the total binder content from 5.2% in mix design to 5.1% at production, but there were no significant changes in the combined aggregate gradation. Although the mix had a reduction in air voids from 3.4% in mix design to 2.7% at production and a reduction in VMA from 14.0% to 13.1%, these differences were within ODOT's production tolerance. The base mix was produced at approximately 305°F and had an in-place density averaging 94.6%. Figure 3 shows the laydown and compaction of the base mix.

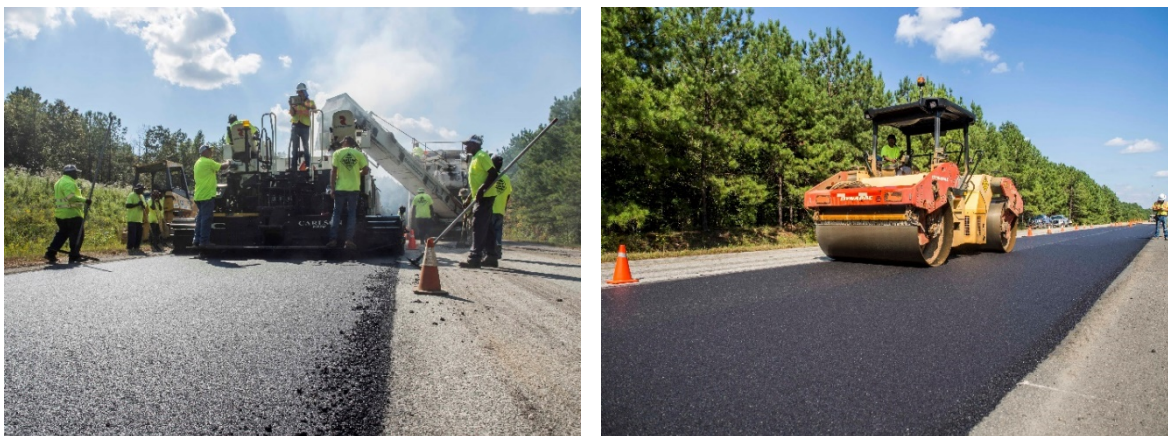
**FIGURE 4 Laydown and compaction of S1 surface mix.**

QC testing of the surface mix showed a reduction in total binder content from 5.8% in mix design to 5.5% at production but no significant changes in combined aggregate gradation. The mix had a notable reduction in air voids from 3.4% in mix design to 2.3% at production and a reduction in VMA from 16.2% to 14.7%, but these changes were within ODOT's production tolerance. The surface mix was produced at approximately 325°F and had an in-place density averaging 96.1%. Figure 4 shows the laydown and compaction of the surface mix.

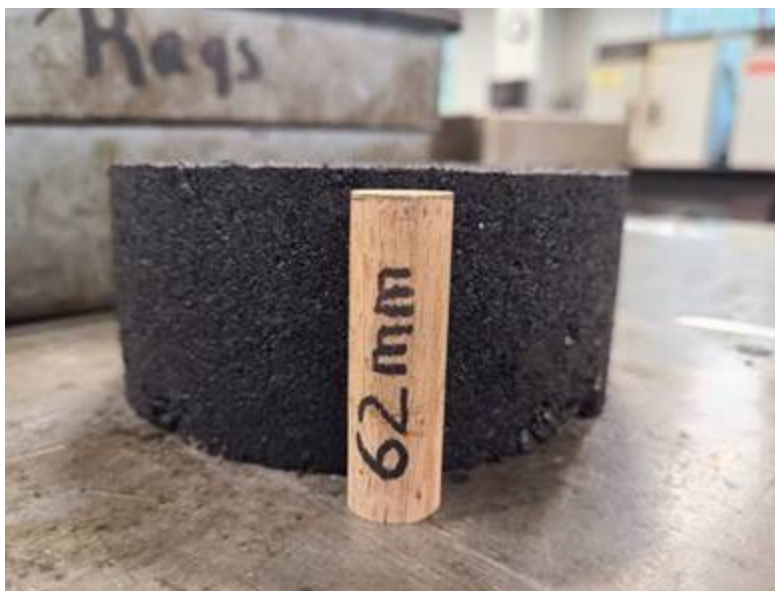
**FIGURE 15** Typical expansion with RTR specimens.

Issues with specimen expansion were encountered when working with the mix modified with dry rubber additive. Specimen expansion is typical for mixes incorporating certain rubber or plastic additives, where the gyratory specimens expand above the target height after immediately extruding them from the mold, as illustrated in Figure 15. To mitigate this issue, specimens must cool under a fan in the gyratory molds while the specimen is still under pressure from the gyratory ram for at least 15 to 30 minutes after compaction. States that use rubber mixtures regularly recommend similar protocols to account for specimen expansion (Caltrans, 2023).

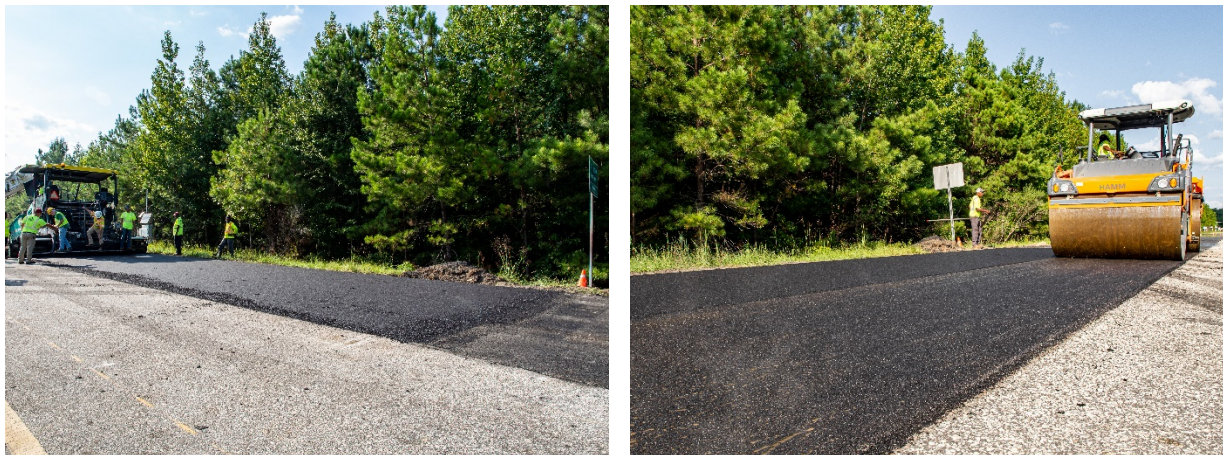
**FIGURE 16 Laydown and compaction of N9 surface mix.**

Section N9 was built as a 1.5-inch mill-and-inlay on a 14-inch asphalt pavement. The mix was produced and placed on September 10, 2021, with a 24-hour high temperature of 85°F, a low temperature of 64°F, and no rainfall over 24 hours. As shown in Table 3, quality control testing of the production mix closely matched JMF gradation, while the asphalt content was 0.1% lower than the target. Other volumetric requirements, such as VMA, were very close to the target. However, the production mix had 2.5% air voids while the JMF results indicated 3.3% air voids. The mix had an average production temperature of approximately 335°F and in-place density of 95.7%. Figure 16 shows the mix laydown and compaction for Section N9.

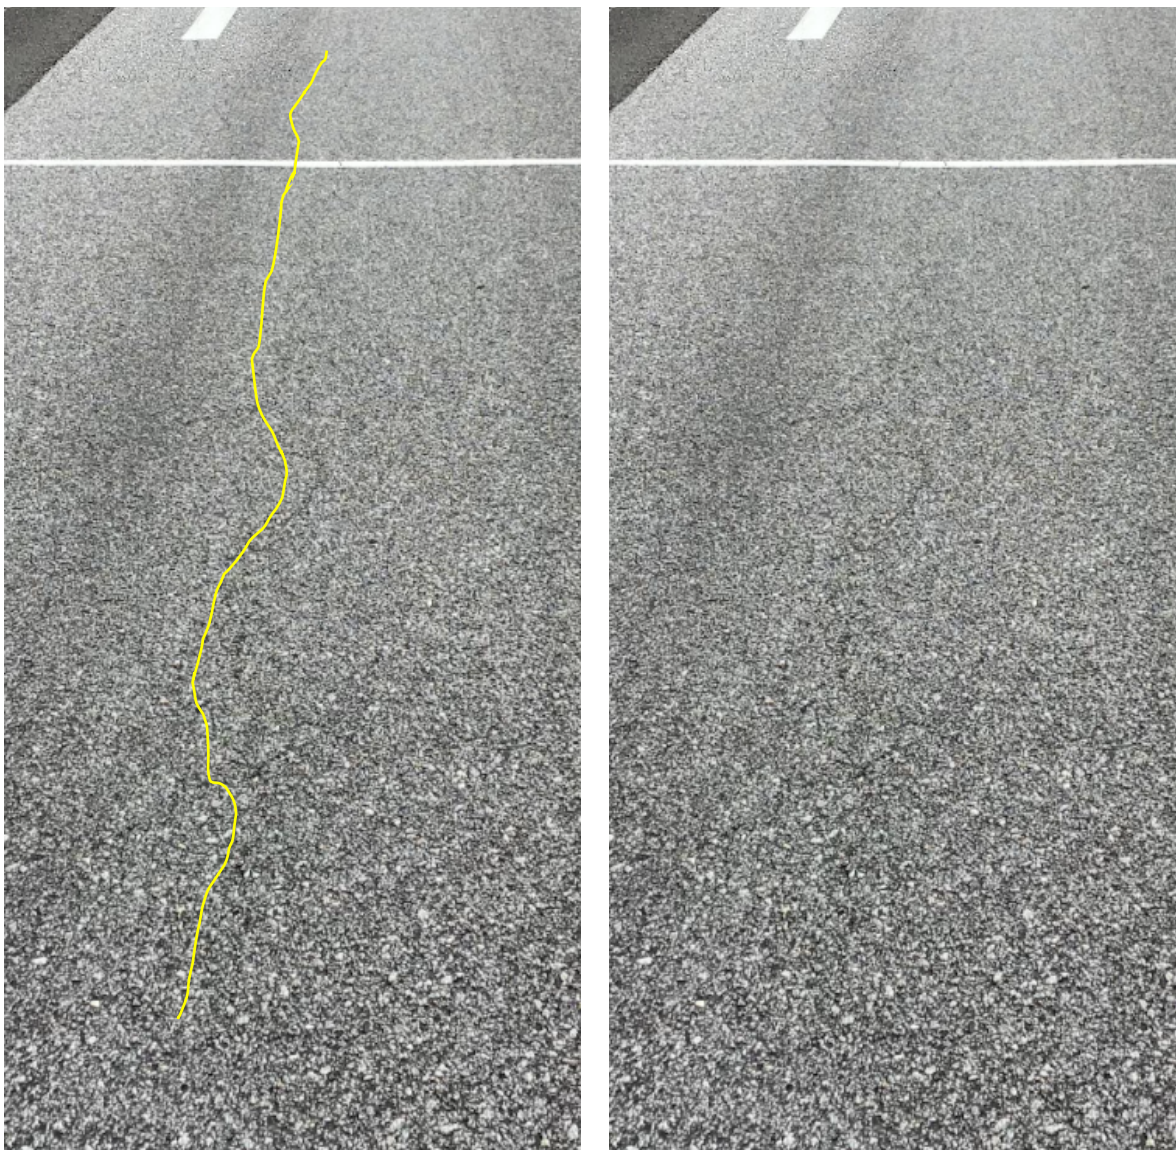
**FIGURE 6 Longitudinal crack at edge of inside wheelpath in S9 at end of second test cycle (with and without highlighting).**

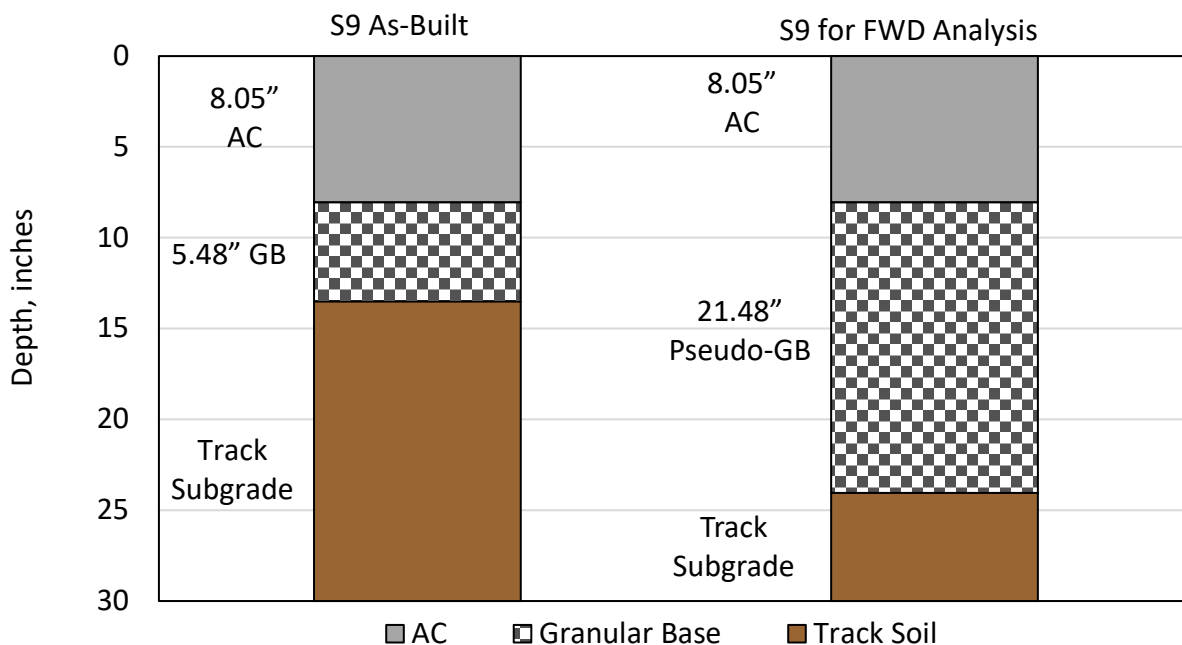
**FIGURE 14 Section S9 thick-lift as-built and backcalculation cross-sections (West et al., 2021).**

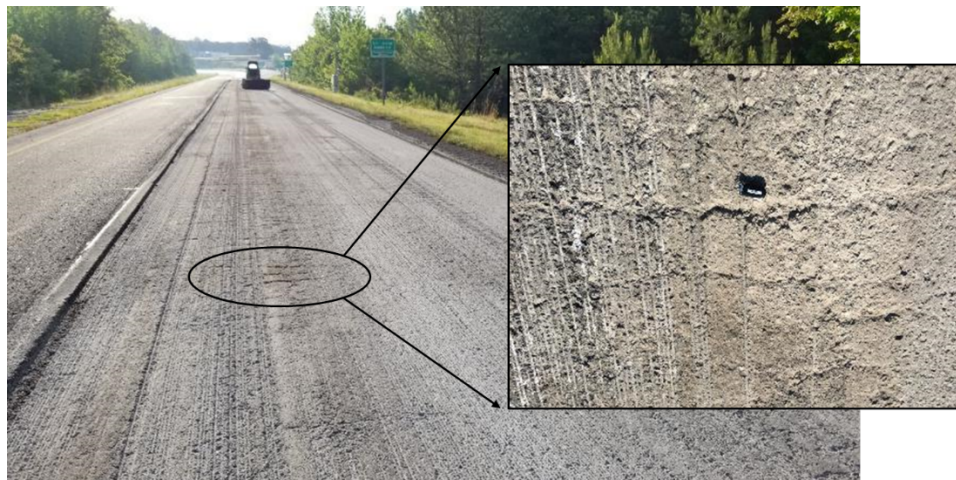
**FIGURE 2. Fatigue cracking in underlying pavement of Sections 10 and S11 after milling.**

Sections S10 and S11 were constructed in 2009 as part of the first Group Experiment at the NCAT Test Track. Their existing pavements had 7 inches of asphalt mix over 6 inches of graded aggregate base and a stiff subgrade (approximately 30 ksi). Both sections had approximately 15 to 20% of the lane area cracked after 14 million equivalent single axle loads (ESALs) of trafficking through April 2014. At that point, they were converted to the Pavement Preservation Experiment. Section S10 was divided into two sub-sections and treated with scrub cape and scrub seal, respectively. Section S11 was also divided into two sub-sections, with one treated with chip seal and the other remaining untreated as a control section. In May 2018, the top 2.5 inches of both sections were milled for the preparation of the 2021 research cycle. Figure 2 shows the fatigue cracking in the underlying pavement after milling. These two sections allow TxDOT to determine if a BMD mix would still outperform a volumetric mix in terms of cracking resistance with a challenging underlying pavement condition.

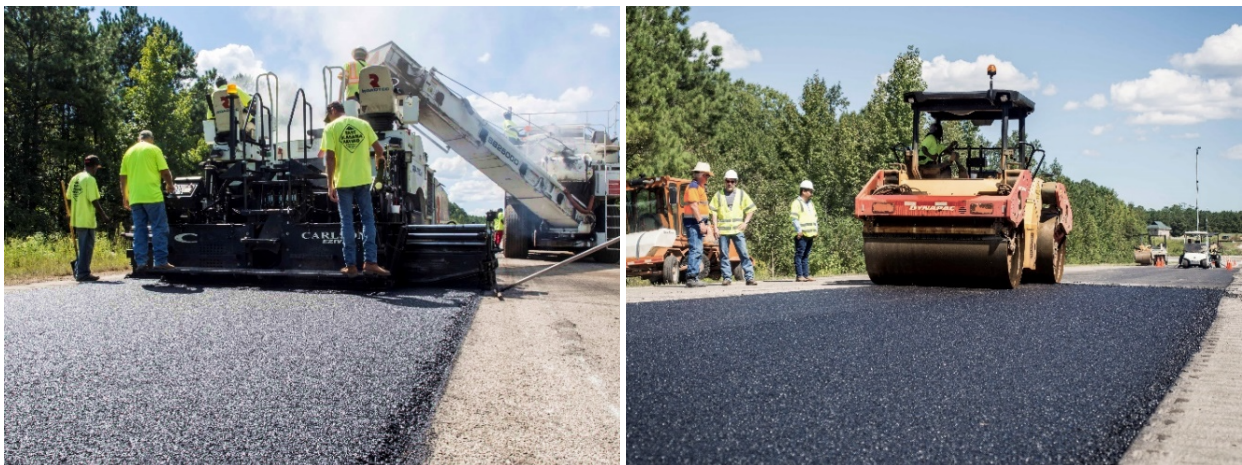
FIGURE 4. Constructing Section S10 with a BMD mix.

The BMD mix for Section S10 was produced and placed on September 18, 2018, with a high temperature of 91°F, a low of 73°F, and no rainfall. As shown in Table 1, QC testing of the plant mix showed a reduction in the total binder content from 5.5% in mix design to 5.3% at production, as well as moderate changes in the 3/8", #4, and #8 fractions. The production mix had 2.4% lab-molded air voids and 14.8% VMA ( $G_{se}$ ) at 50 gyrations ( $N_{design}$ ), and 4.0% lab-molded air voids and 16.2% VMA ( $G_{se}$ ) at a reduced  $N_{design}$  of 35 gyrations. The production mix met TxDOT's special specification for *Superpave Mixtures – Balanced Mix Design*, except that the percent passing on the #8 sieve size was 1% lower than the allowed master gradation limits. The extracted binder of the plant mix was graded at PG 82-16. The mix was produced at approximately 305°F and had an in-place density averaging 95.9%. Figure 4 shows the laydown and compaction of the BMD mix for Section S10.

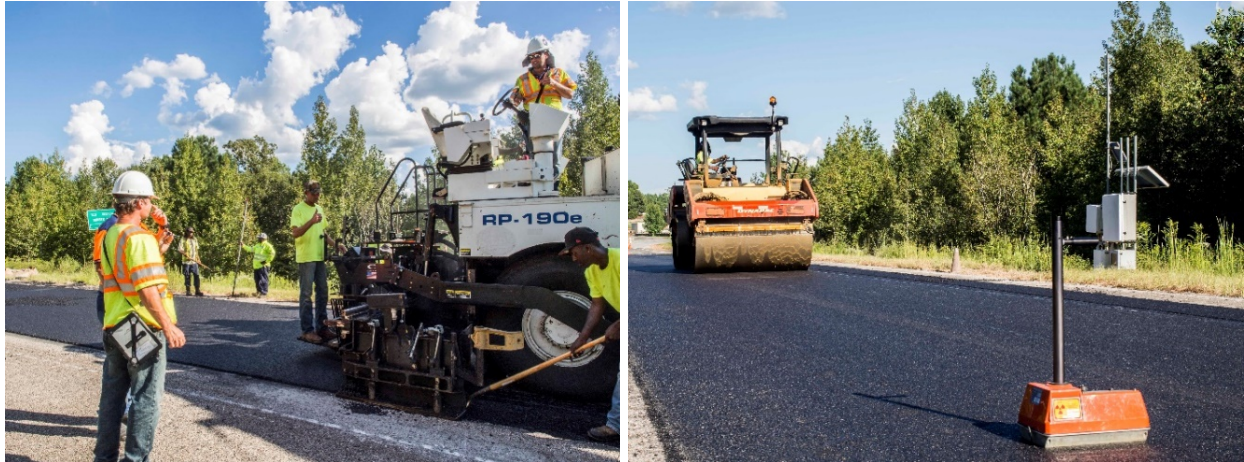
**FIGURE 5. Constructing Section S11 with a volumetric mix.**

changes in the 1/2", 3/8", #16, and minus #200 fractions. The plant mix had 3.6% lab-molded air voids and 14.0% VMA ( $G_{se}$ ) at 50 gyrations ( $N_{design}$ ), which met TxDOT's specification for Item 341, *Dense-Graded Hot-Mix Asphalt*. The extracted binder of the plant mix was graded at PG 82-16, which was the same as that of the S10 BMD mix. The S11 mix was produced at approximately 300°F and had an in-place density averaging 95.4%. Figure 5 shows the laydown and compaction of the volumetric mix for Section S11.

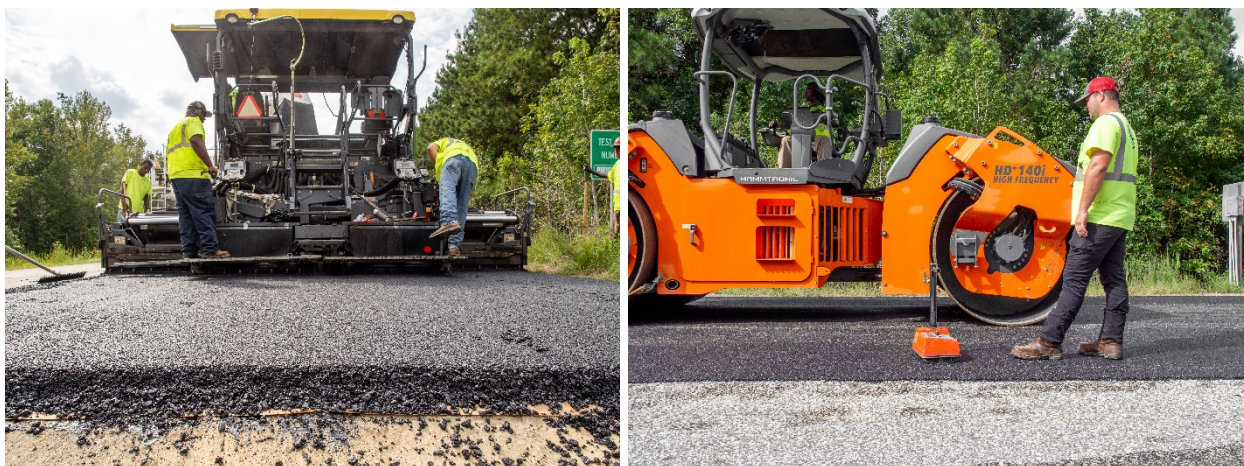
**FIGURE 6. Constructing Section N6 with a BMD mix.**

The BMD mix in Section N6 was produced and placed on September 13, 2021, with a high temperature of 89°F, a low of 67°F, and no rainfall within the previous 24 hours. As shown in Table 1, there were no major differences between the JMF and the QC results. The asphalt content was deliberately targeted to run slightly lower than the JMF to slightly push the OT CPR result from 0.43 closer to the 0.45 threshold. This resulted in an asphalt content of 0.1% less than the JMF at QC testing. The gradation was essentially the same for the QC sample compared to the JMF, except the percent passing the 3/8" sieve was 5% finer. The volumetrics from QC testing were also similar to the JMF, within typical production tolerances. The mix was produced at approximately 320°F and had an in-place density averaging 93.3%. Figure 6 shows the laydown and compaction of the BMD mix for Section N6.

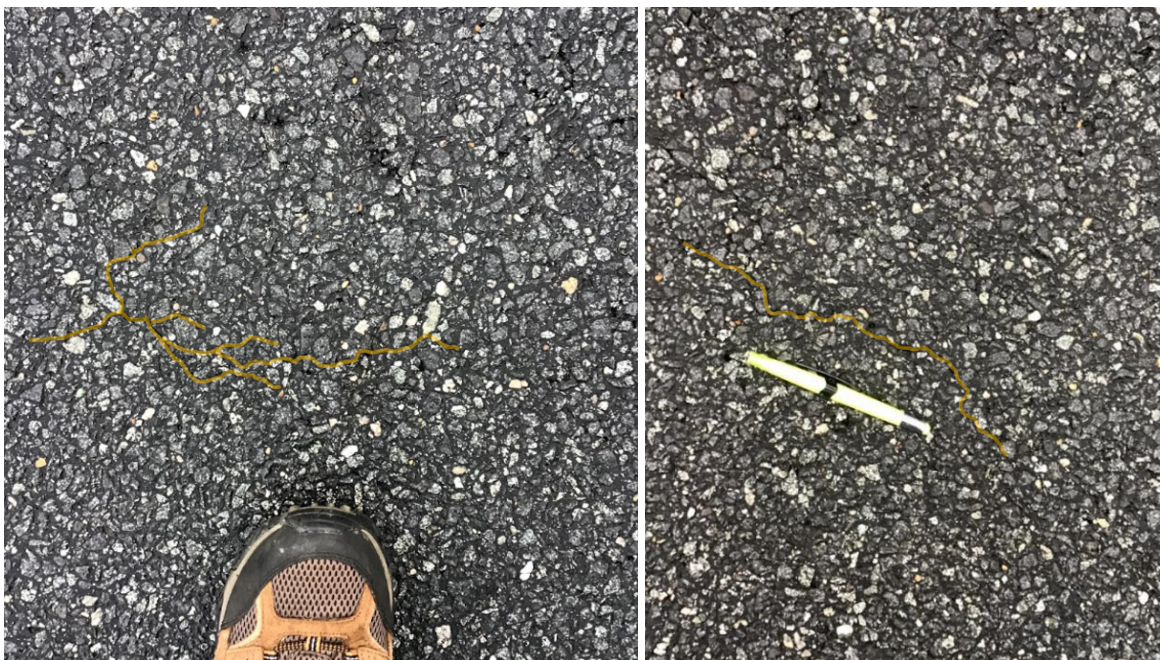
**FIGURE 2 Sample cracking in N4 on 1/25/2021 (29.6 million ESALs).**

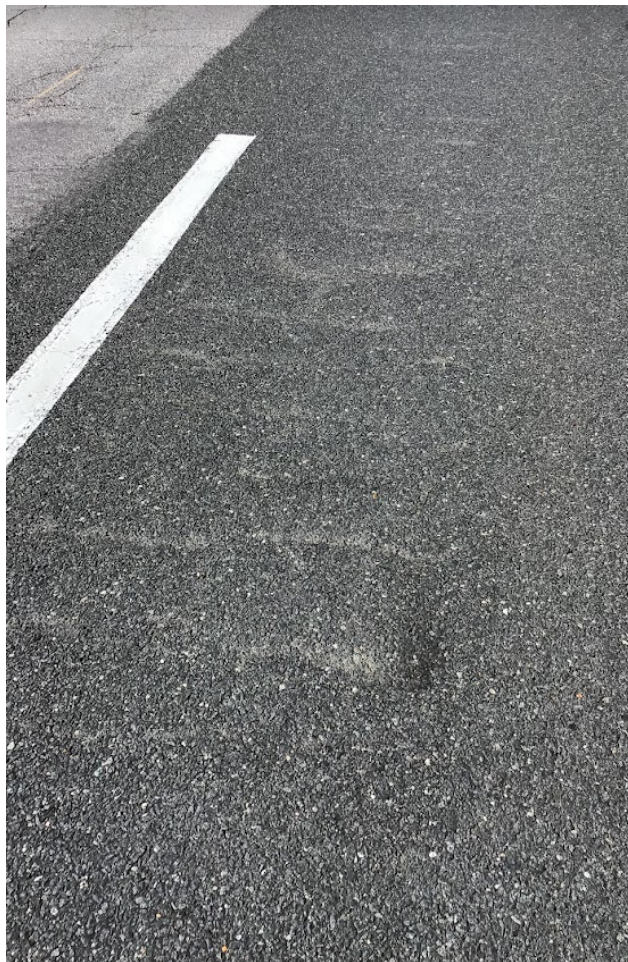
**FIGURE 3 Wheelpath fatigue cracking in N4 on 1/22/2024 (39.1 million ESALs).**

Subsequent inspections on later dates revealed much less cracking, which did not appear to progress or worsen during the last 400,000 ESAL applications of the third test cycle. As of February 15, 2021 (29.9 million ESALs), 0.5% of the lane area and 0.1% of the wheelpath area cracked, as determined from inspection of high-resolution crack mapping images. Both values were considered quite low and did not indicate a pavement experiencing cracking failure. The lane area had more reported cracking than the wheelpath, which indicates more cracking outside the wheelpaths than within. This may be indicative of top-down cracking rather than bottom-up. The forensic investigation presented later in this chapter reveals the nature of the cracking, but after the third test cycle, VDOT elected to keep the section in place for another 10 million ESALs during the 2021 research cycle. During this time, lane area cracking grew to 3.4% and wheelpath cracking increased to 2.8%. Cracking severity also increased, particularly in the inside wheelpath. For example, Figure 3 shows clear wheelpath fatigue cracking with dust at the surface, that could be indicative of fines pumping from below, or aggregates grinding against each other under traffic, at approximately 39.1 million ESALs on January 22, 2024. This will be fully investigated in future forensic investigation of the section.

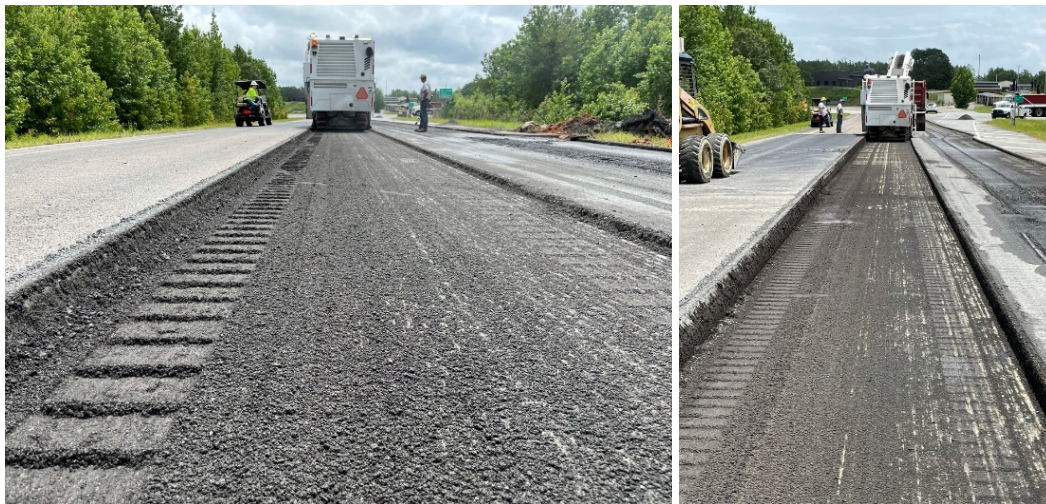
**FIGURE 2 SMA and dense graded asphalt layer milling (left) and CCPR layer milling (right).**

In order to perform the mix design for the re-recycled CCPR layer, the existing asphalt layers from Section S12-2012 was milled so that the milling unit barely touched the top of the CCPR layer. Next, the CCPR layer was milled, and the reclaimed CCPR material was stockpiled. The reclaimed CCPR material was sampled from the stockpile for mix design. Figure 2 shows the milling process, and Figure 3 shows the reclaimed CCPR millings (stockpiled). The existing stabilized layer from Section S12-2012 beneath the CCPR was removed and replaced with the typical test track subgrade and six inches of aggregate base material to closely match the condition and thickness of the unbound layers of Section N4-2012.

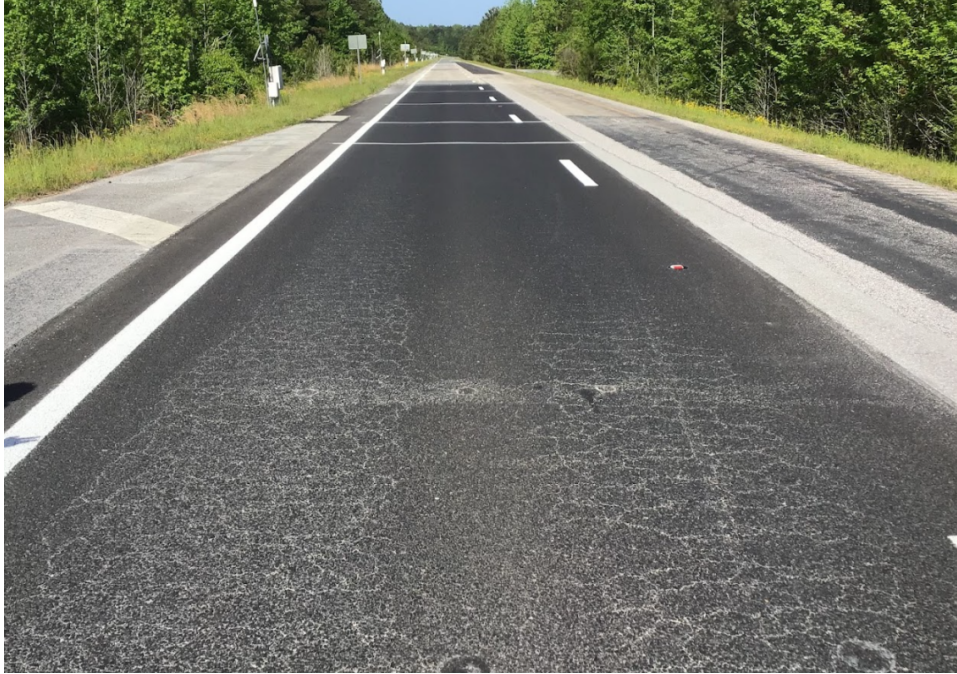
**FIGURE 5 Cracking in Section S12 at approximately 1.3 million ESALs (April 2022).**

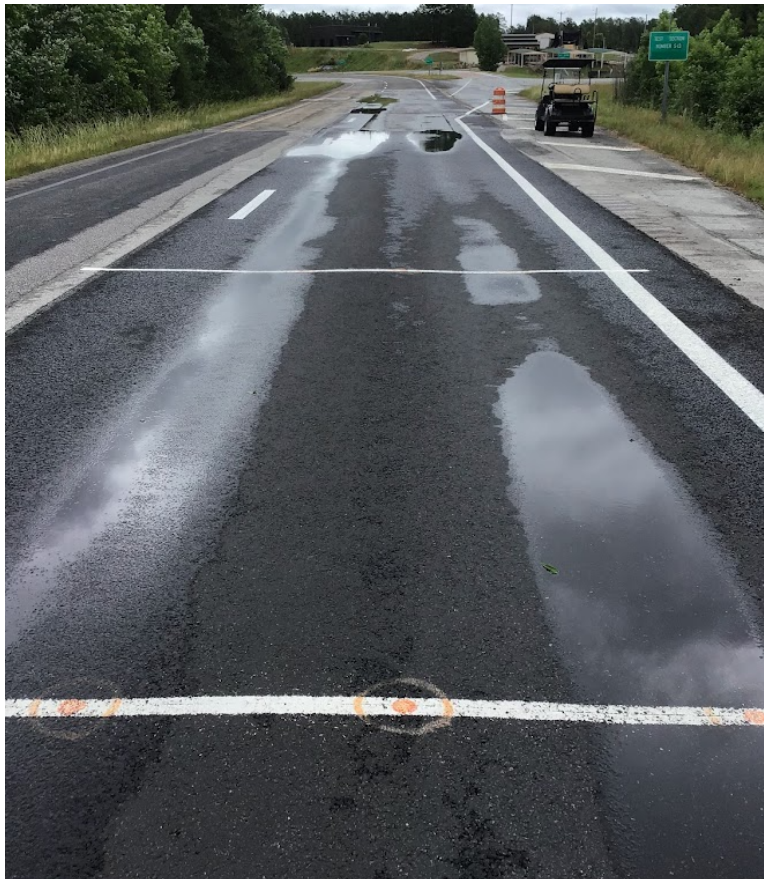
**FIGURE 6 Rutting in Section S12 (April 2022).**

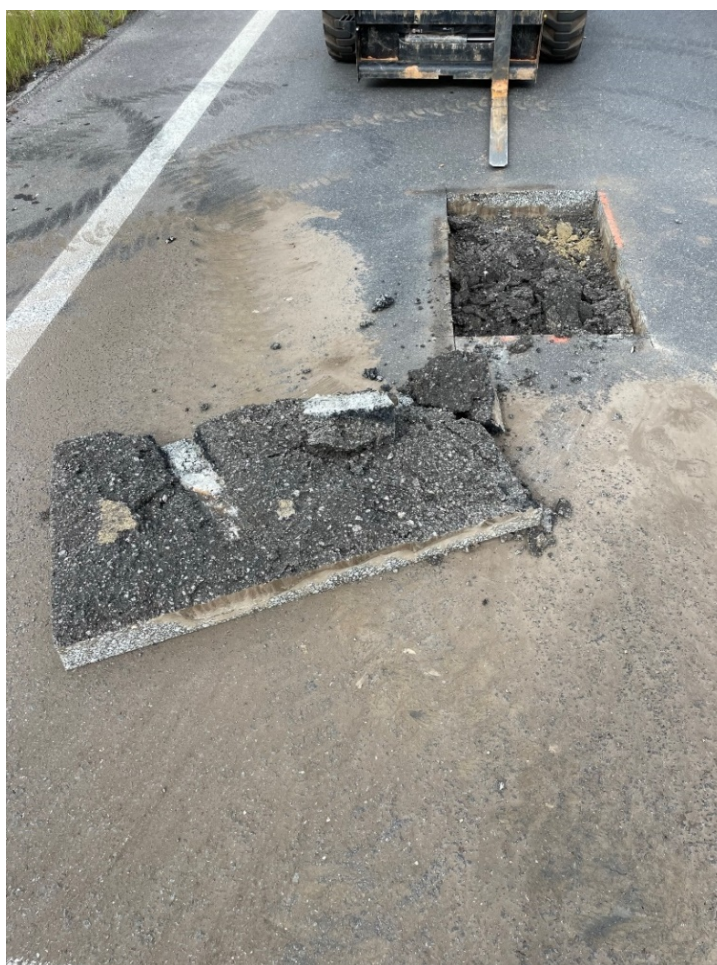
**FIGURE 7** Material collection for mix design of 3<sup>rd</sup> generation re-recycled CCPR.

Maintenance or rehabilitation was deemed required due to the level of cracking and rutting that had occurred. It has been hypothesized that the 2<sup>nd</sup> generation re-recycled CCPR mix did not cure prior to traffic loading, and the lack of stiffness beneath the SMA overlay caused the rutting and fatigue to occur. This was further confirmed when the surface was saw cut and removed to collect CCPR materials for mix design of a 3<sup>rd</sup> generation re-recycled CCPR. By the time the surface was removed, the CCPR layer appeared to have cured (Figure 7).

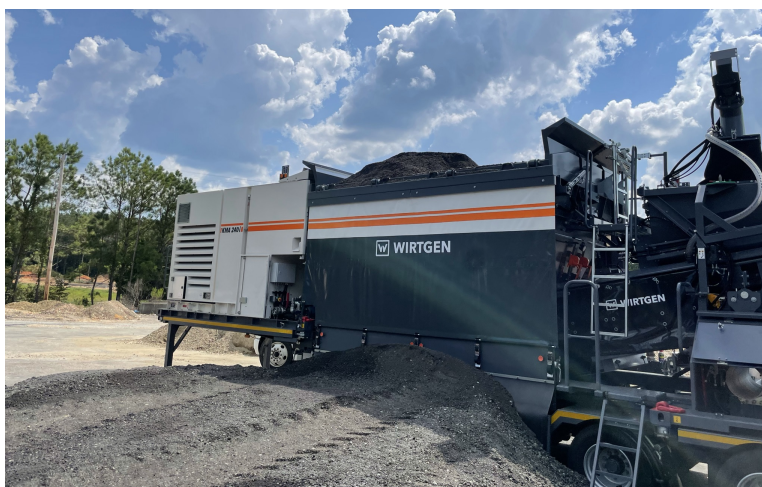
**FIGURE 2 Wirtgen KMA 240i.**

The CCPR mixtures were produced on the NCAT Test Track property using one of two portable plants. The foamed asphalt and engineered emulsion mixtures were produced in a Wirtgen KMA 240i (Figure 2), and the anionic emulsion with bio-based rejuvenator, CR rejuvenator, and emulsified bio-based rejuvenator mixtures were produced in a Pugmill Systems Portable Pugmill (Figure 3). The production equipment selection was made by the research sponsors. Once produced, the mixtures were then immediately loaded into a dump truck, hauled to the off-ramp, and placed using a conventional paver, then compacted using a series of vibratory steel drum, oscillatory, static steel drum, and rubber tire rollers. All rollers were provided by Hamm and were models HD 140i, HP 180i, and HD 90i PH (oscillatory).

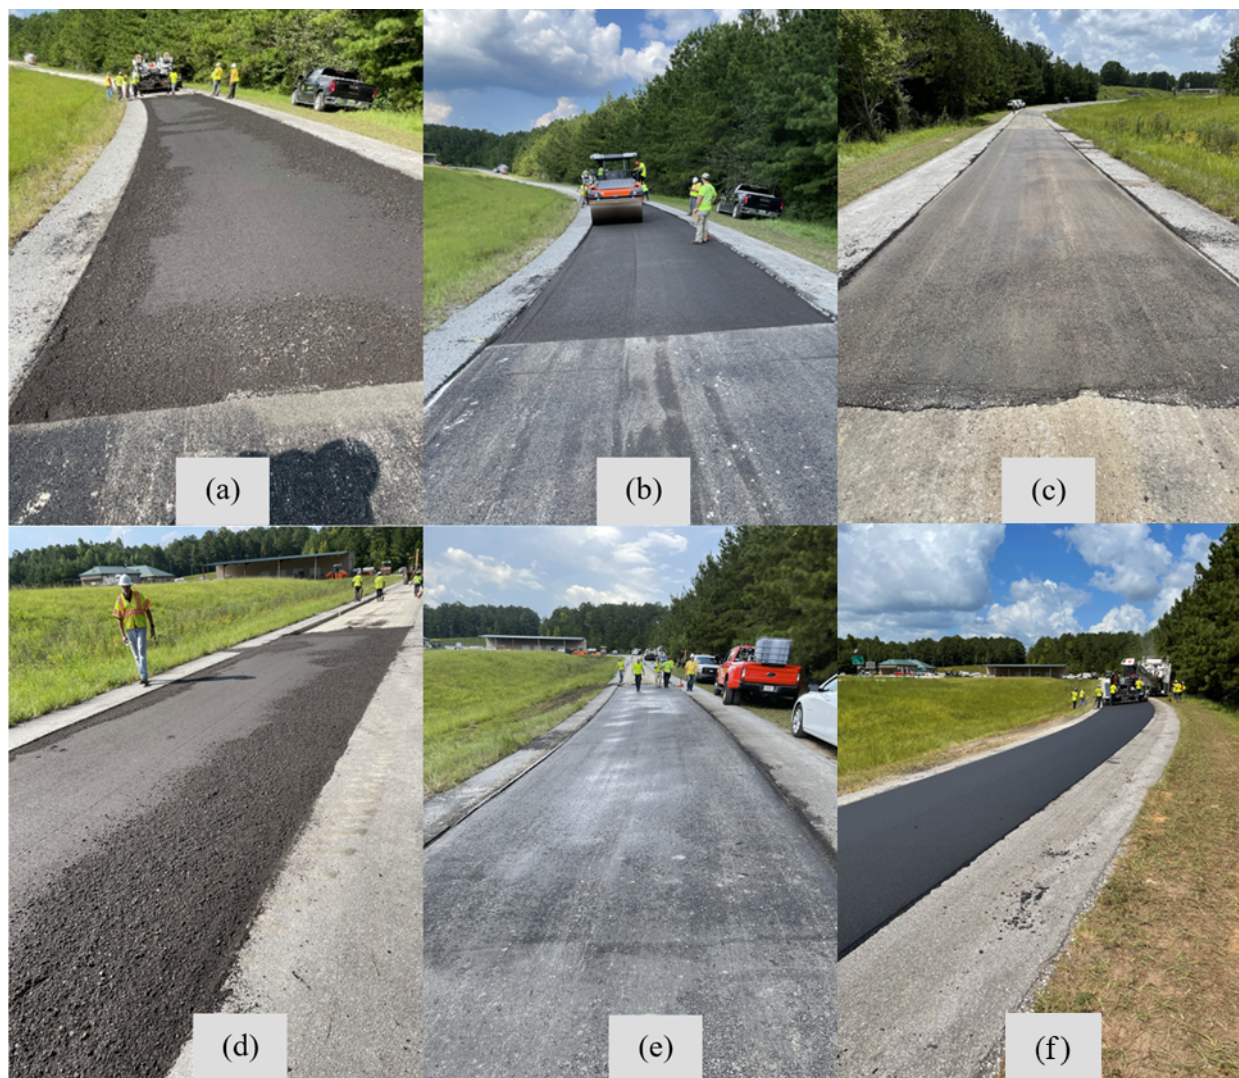
**FIGURE 4 Paved CCPR Sections on off-ramp; (a) foamed asphalt with active filler, (b) engineered emulsion, (c) CR rejuvenator, (d) emulsified bio-based rejuvenator; (e) emulsified bio-based rejuvenator, and (f) HMA thinlay overlay.**

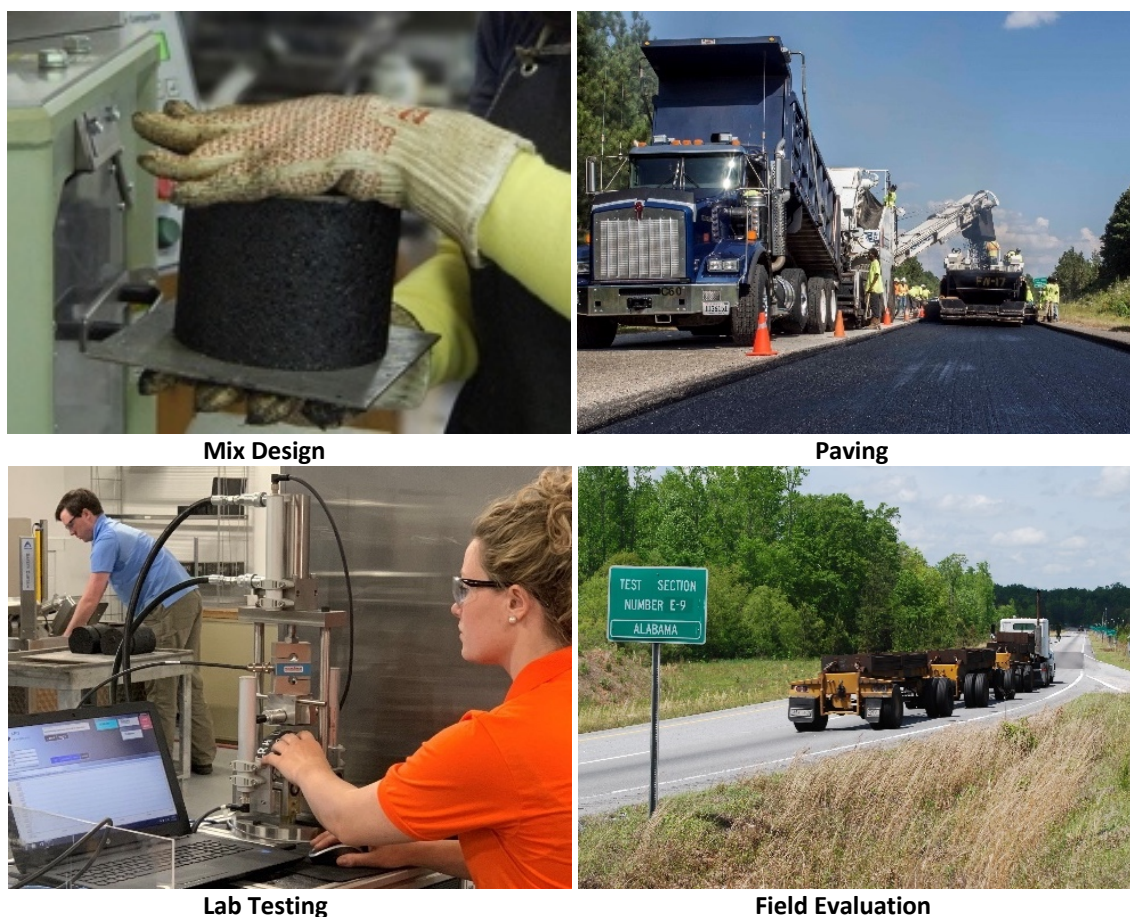
**FIGURE 1 Experimental plan.**

This study was divided into four main tasks, illustrated in Figure 1: (1) mix design, (2) mix production and paving, (3) laboratory performance testing, and (4) field performance evaluation.

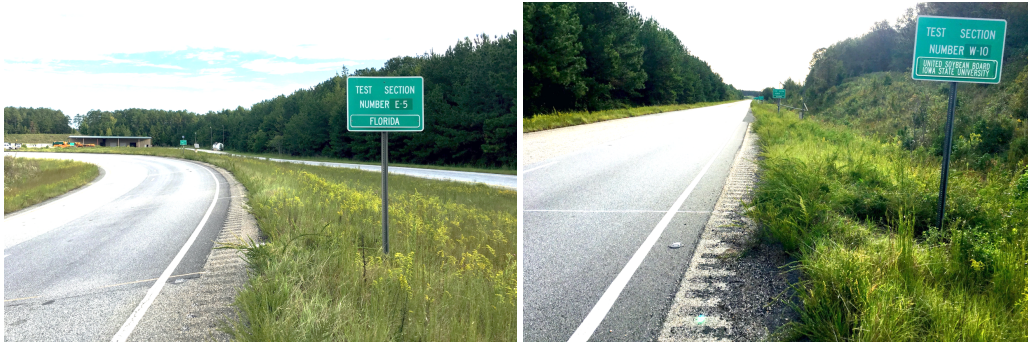
FIGURE 2 Paving of Sections E5A and W10.

The control surface mixture for Section E5A was produced and placed on August 29, 2018, based on the volumetric mix design. The control mixture was made using an SBS-modified asphalt binder PG 76-22. On November 16, 2018, the experimental mixture was produced and paved based on the same mix design, except a biopolymer-modified binder PG 70-16 was used. In both mixtures, a liquid antistripping agent was used at a dosage of 0.5% by weight of the total binder. The target lift thickness for both mixtures was 1.5 inches, and the target mix temperature was 320°F. In-place density was comparable for both sections, with 93.2% of  $G_{mm}$  of the as-produced mix for Section E5A and 93.3% of  $G_{mm}$  for Section W10. Figure 2 shows the two test sections after construction. Table 3 summarizes the design and construction data for both test sections.
