Final Report 930-965

**Field Implementation and Evaluation of Low-Cost Countermeasures for  
Wrong-Way Driving Crashes in Alabama**

Alabama Department of Transportation  
Montgomery, Alabama

**December 2020**

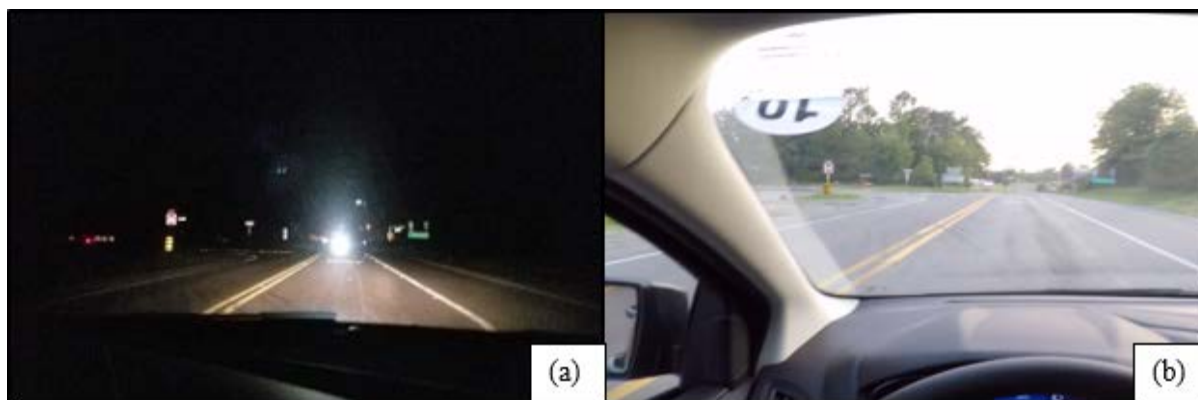
Another important observation is that more drivers relied on the pavement markings to identify the on-ramps during the nighttime. Figures 3.a and 3.b showed the view of left-turning drivers from the crossroad during nighttime and daytime, respectively. As shown in Figure 3, the pavement markings illuminated by the headlights comprise the major portion of a driver's view during the night and help them to make a decision. This finding also supports the results in Table 6 that the implementation of newly painted pavement markings can be more effective in preventing WWD incidents during nighttime. Therefore, it is very important to maintain highly visible pavement markings to reduce the possibility of nighttime WWD incidents, especially at locations with no street lighting.

**Figure 3. Driver's View of I-65 Exit 284 SB Ramp during (a) Nighttime and (b) Daytime**

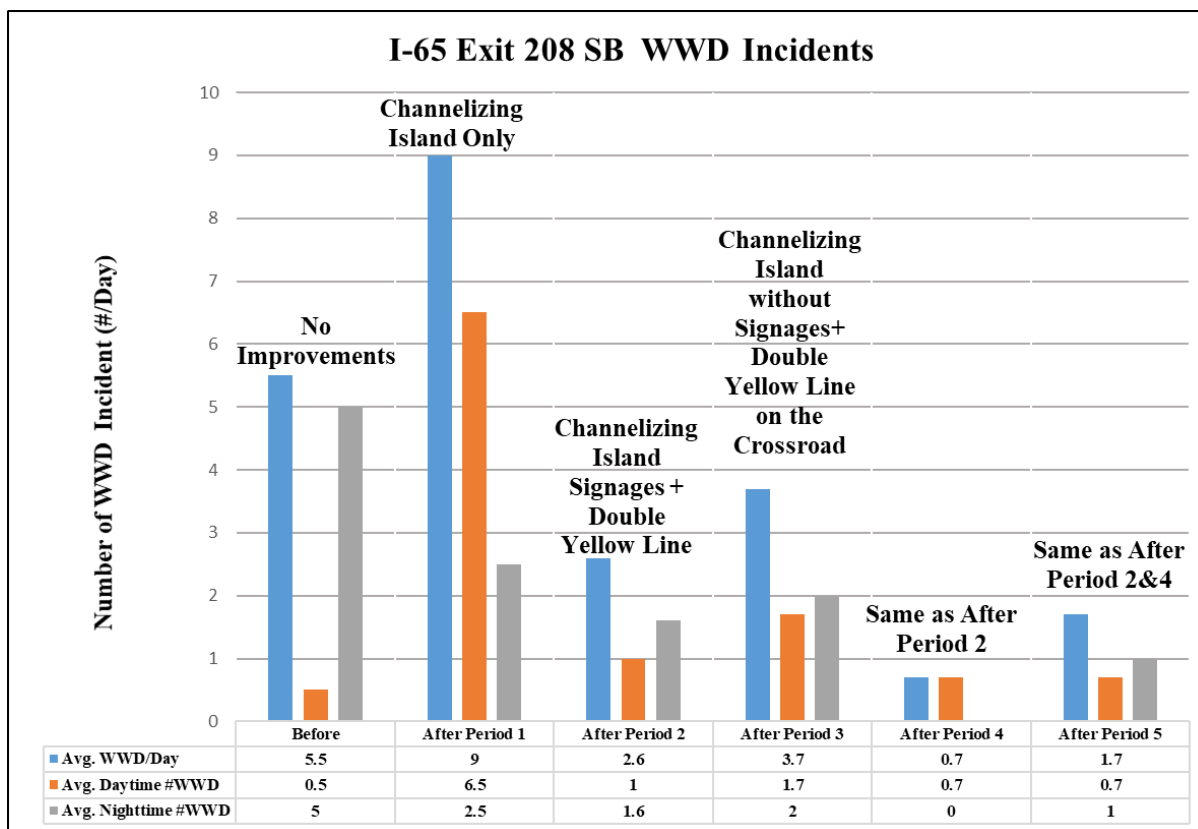
**Figure 5. Impact of Different Countermeasures Applied at I-65 Exit 208**

The average number of WWD incidents was reduced during the fourth and fifth after periods after the new DNE/One-Way signs were installed on the channelized island again. The results suggested that the non-traversable channelizing island without any signage might cause driver's confusion and result in more WWD incidents during the daytime. The implementation of the additional signs is essential to reduce driver's confusion. Furthermore, the repainted double yellow line on the crossroad and the repainted stop bar can also help guiding the drivers to the right way. Overall, the number of WWD incidents was reduced from 5.5 per day in the before period to an average of 1.7 per day during the after periods 2, 4 and 5 when all the low-cost countermeasures were in place.

A total of 11 WWD incidents was observed in one 48-hour before period. Additionally, 49 WWD incidents were recorded in the five after periods for a total of 384 hours, including three Property Damage Only (PDO) crashes. Table 8 listed the total number of WWD incidents in each study period, average number of WWD incident per day, and the distributions during daytime and nighttime. Figure 5 shows the average number of WWD incidents for each of the six periods.

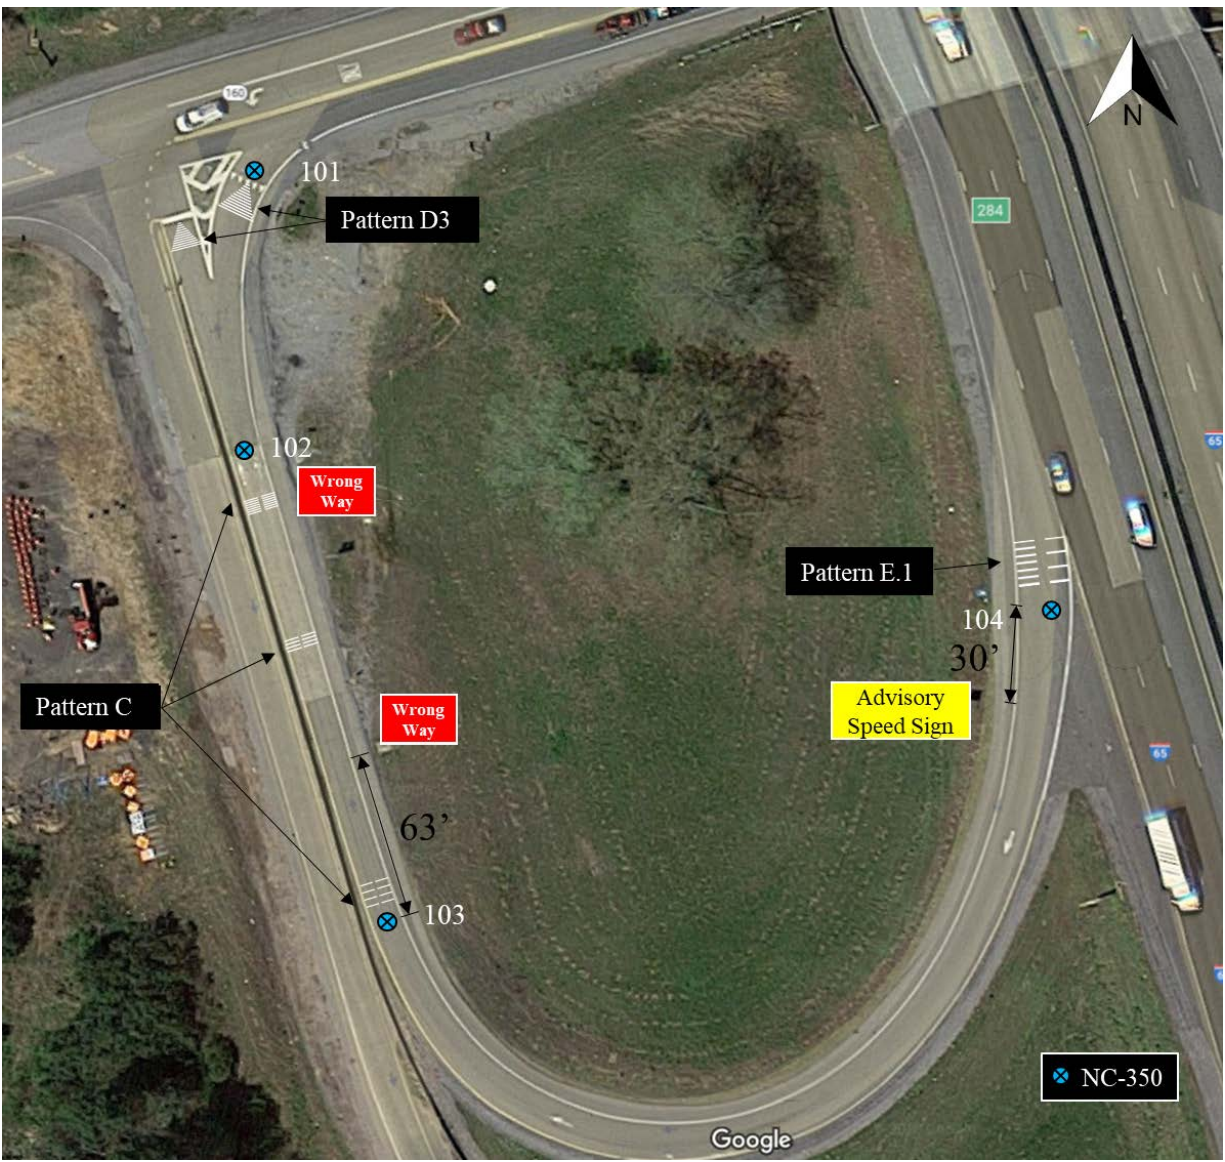
Figure 8 shows the existing TCDs, and proposed locations for DRS and magnetic sensors for collecting traffic volumes and speed data on SB off-ramps at Exits 208 (Figure 8.a) and 284 (Figure 8.b) on I-65 in Alabama. Three DRS patterns were installed by a contractor in December 2018. Figure 9 illustrates field photos of DRS. Pattern D3 was positioned 1 foot after the stop bars or yield lines on the off-ramps at two study sites. It also acts as an enhanced lane-use arrow due to the triangle shape. To not overlap with the existing WW arrows, Pattern C was placed 3 ft behind the dual WW arrows at both sites. A 2-ft center gap was left in the middle of Pattern C to allow motorcycles and emergency vehicles to bypass the strips. Pattern E.1 was designed to have double strips on the driver side in the WW direction. Pattern E.1 was installed 30 ft ahead of the advisory ramp speed sign. Similar to Pattern C, a 2-ft center gap was also left in the middle of the strips to serve motorcycles and emergency vehicles.

**Figure 8. Existing TCDs and Magnetic Sensors Deployments on Off-Ramps: (a) Exit 208 and (b) Exit 284 on I-65**

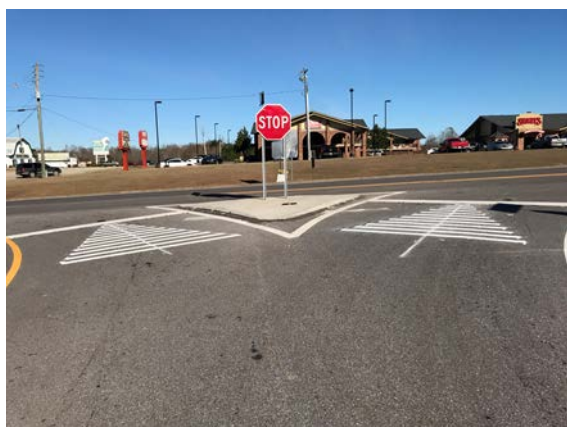
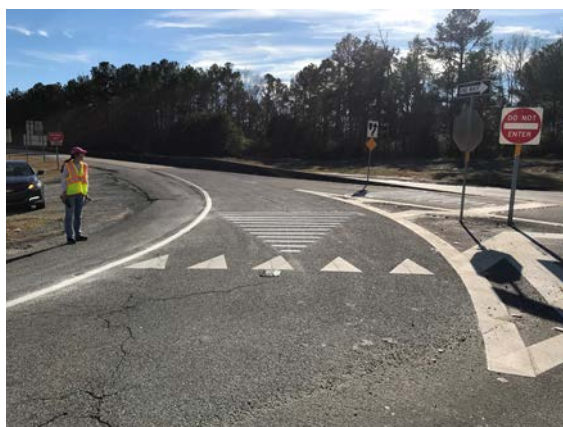
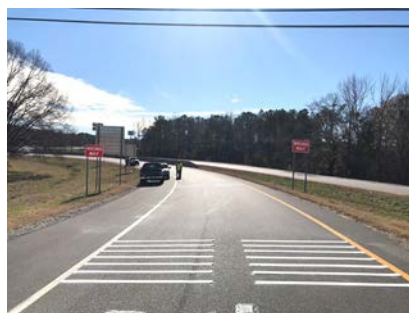
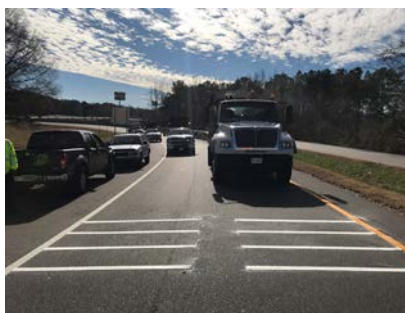
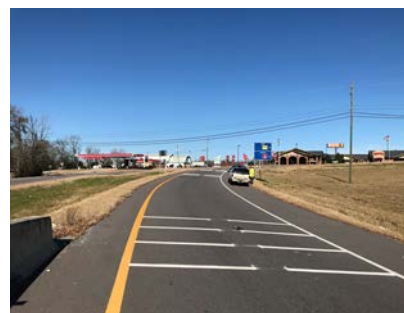
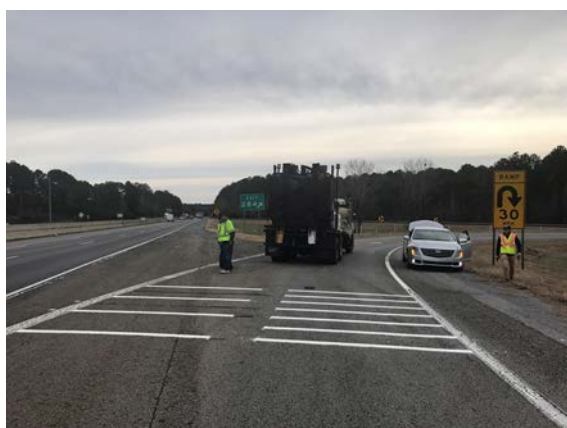
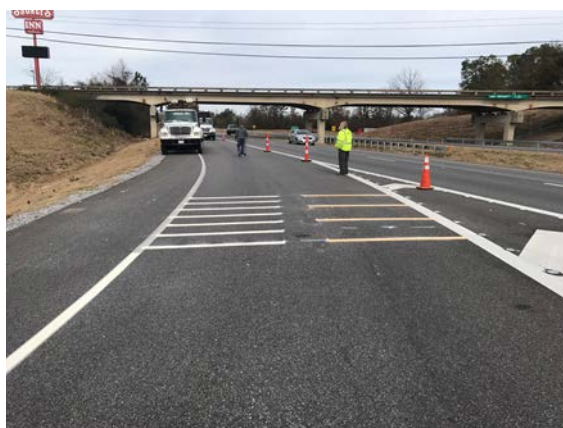
(a) Pattern D3 (right way)

(b) Pattern D3 (wrong way)

(c) Pattern C (1-ft spacing)

(d) Pattern C (2-ft spacing)

(e) Pattern C (5-ft spacing)

(f) Pattern E.1 (right way)

(g) Pattern E.1 (wrong way)

**Figure 9. Field Photos of DRS**

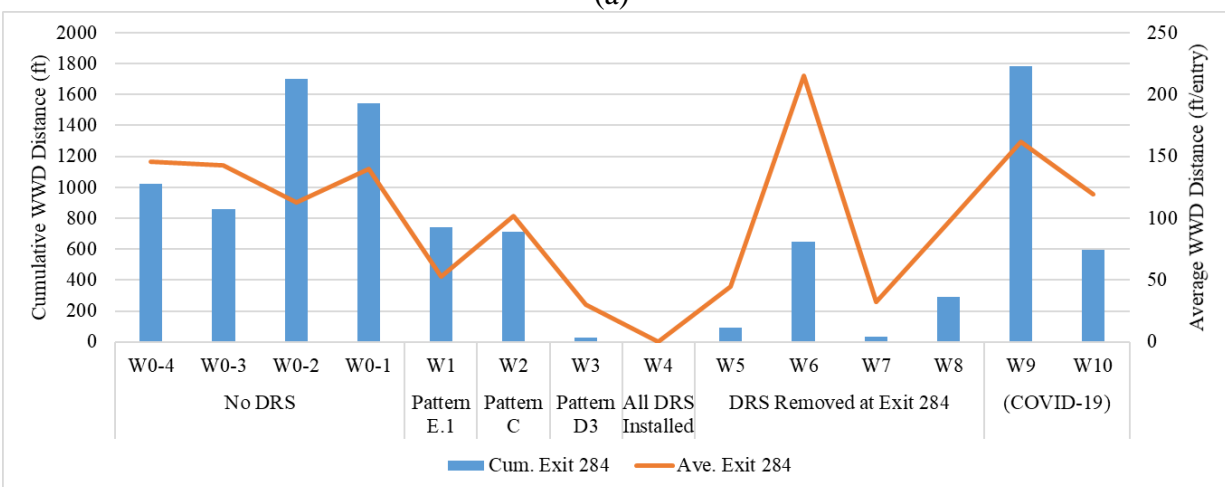
Figure 11 presents the changes in WWD distances before and after DRS installation. The cumulative and average WWD distance shows a decreasing trend after DRS installation at both locations. Additionally, an increasing trend was observed at Exit 284 after DRS were removed. For WWD incidents occurring at Exit 208 (Figure 11.a), the average WWD distance was more than 50 ft per entry before DRS installation. All WW drivers stopped and self-corrected after going the WW in less than 20 ft after all the DRS installation. The average WWD distance slightly

increased due to the low volume during the COVID-19 pandemic period. At Exit 284 (Figure 11.b), the average WWD distance was roughly more than 100 ft per entry. It was reduced to below 30 ft per entry with the installation of DRS. According to video data, the WW drivers quickly stopped and self-corrected after driving over DRS Pattern D3. After DRS were removed, average WWD distances were found to be close to the before condition.

**Figure 11. Changes in WWD Distances before and after DRS Installation: (a) Exit 208 and (b) Exit 284**

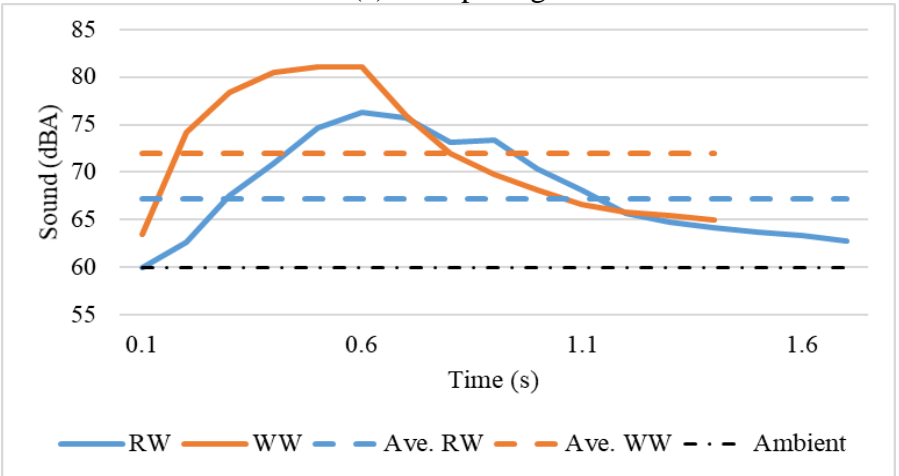
Figure 14 shows the RW and WW sound level on Pattern C when the average RW speed was 30 mph and average WWD speed was 35 mph. As shown in Figure 14.a, RW drivers perceived a maximum of 10 dBA louder sound than in ambient conditions, while WW drivers perceived 17 dBA louder sound when driving on the strips of 5-ft spacings. Moreover, average sounds for the RW drivers and WW drivers are 65 dBA and 69 dBA, respectively. A  $p$ -value of 0.03 implied that a significant difference existed between the average RW and WW sound levels.

Figure 14.b presents the RW and WW sound generated by the strips of 2-ft spacing. The average RW speed was 25 mph and WWD 30 mph. Compared with the ambient condition, the strips of 2-ft spacing produced a maximum 15 dBA louder sound for RW drivers and 17 dBA for WW drivers. The average sound level (72 dBA) for WW drivers is 5 dBA more than average sound (67 dBA) for RW drivers. The  $t$ -test results revealed that the average WW sound level was significantly different from the RW with a  $p$ -value of 0.03.

Figure 14.c shows the RW and WW sound produced by 1-ft spacing strips of Pattern C. The speed sensors recorded an average speed of 20 mph for RW drivers travelling on these strips, while WWD were 35 mph. In comparison with the ambient status, a maximum of 17 dBA louder sound was caused by strips for RW drivers and 20 dBA for WW drivers. Average sound level (71 dBA) for WW drivers is 5-dBA more than the sound level (66 dBA) perceived by RW drivers.

A *p*-value of 0.02 manifested the significant difference between the average RW and WW sound levels.

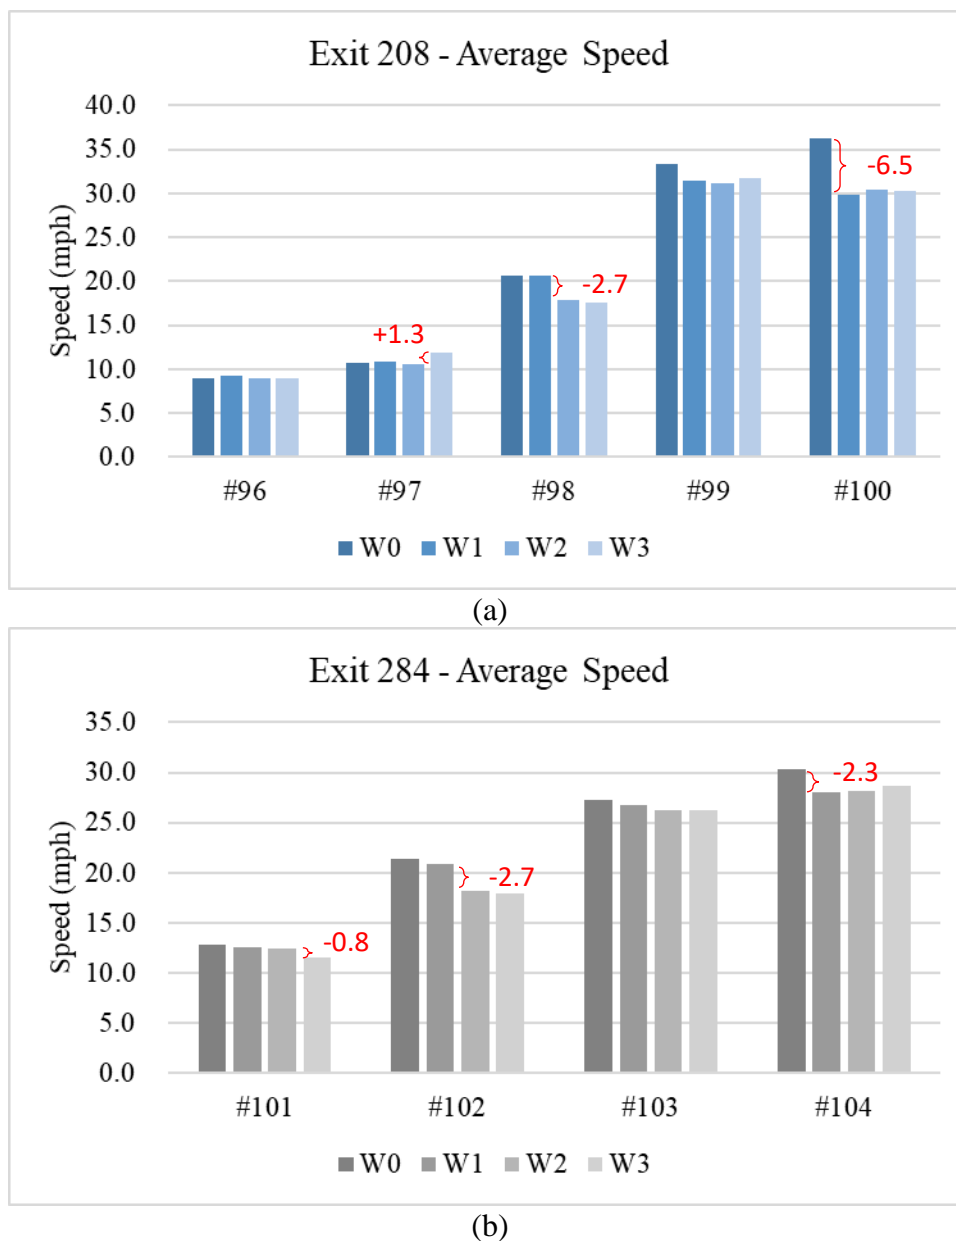
Significant changes can be observed in average speeds collected from sensors #98 and #102 immediately after Pattern C at Exits 208 and 284. The same average speed reduction of 2.7 mph was estimated for both locations, as shown in Figure 19. The average speeds collected by sensors # 99 and #103 before the Pattern C were also reduced after Pattern E.1 was implemented in W1.

**Figure 19. Average Speeds on SB Off-Ramps at Exits (a) 208 and (b) 284 on I-65**

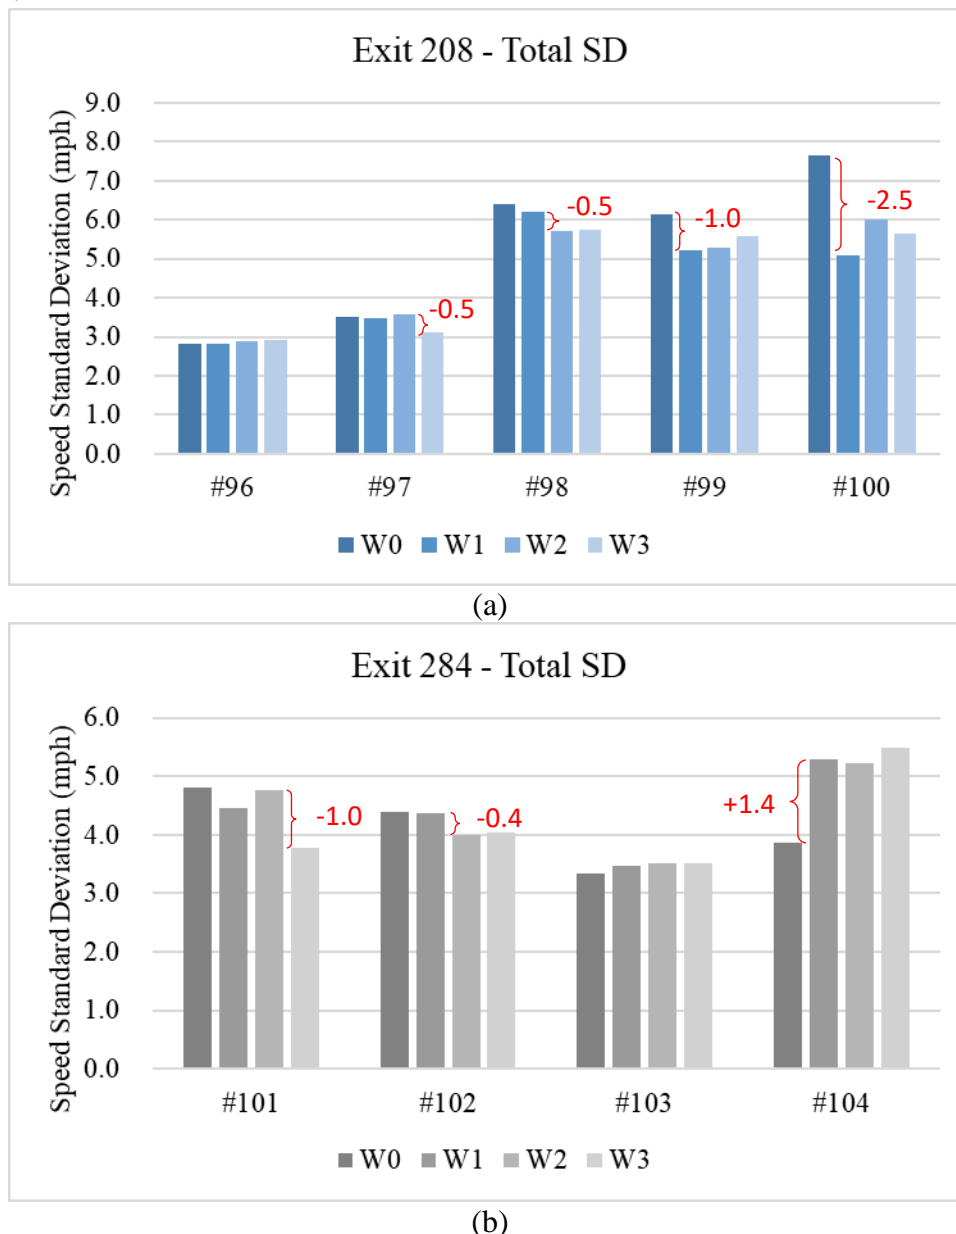
after implementing DRS. In the W1 period after implementing Pattern E.1, SDs of speed from sensors #100 and #99 significantly decreased by 2.5 and 1.0 mph, respectively. From W1 to W2, the SDs of speed from sensor #98 was significantly reduced by 0.5 mph after installation of Pattern C. Further, Pattern D3 led to a decrease of 0.5 mph in SDs for right-turn speed at the stop bar (sensor #97). There was no significant change in SDs for the left-turning speed at the stop bar (sensor #96).

**Figure 20. Speed Standard Deviations on SB Off-Ramps at Exits (a) 208 and (b) 284 on I-65**

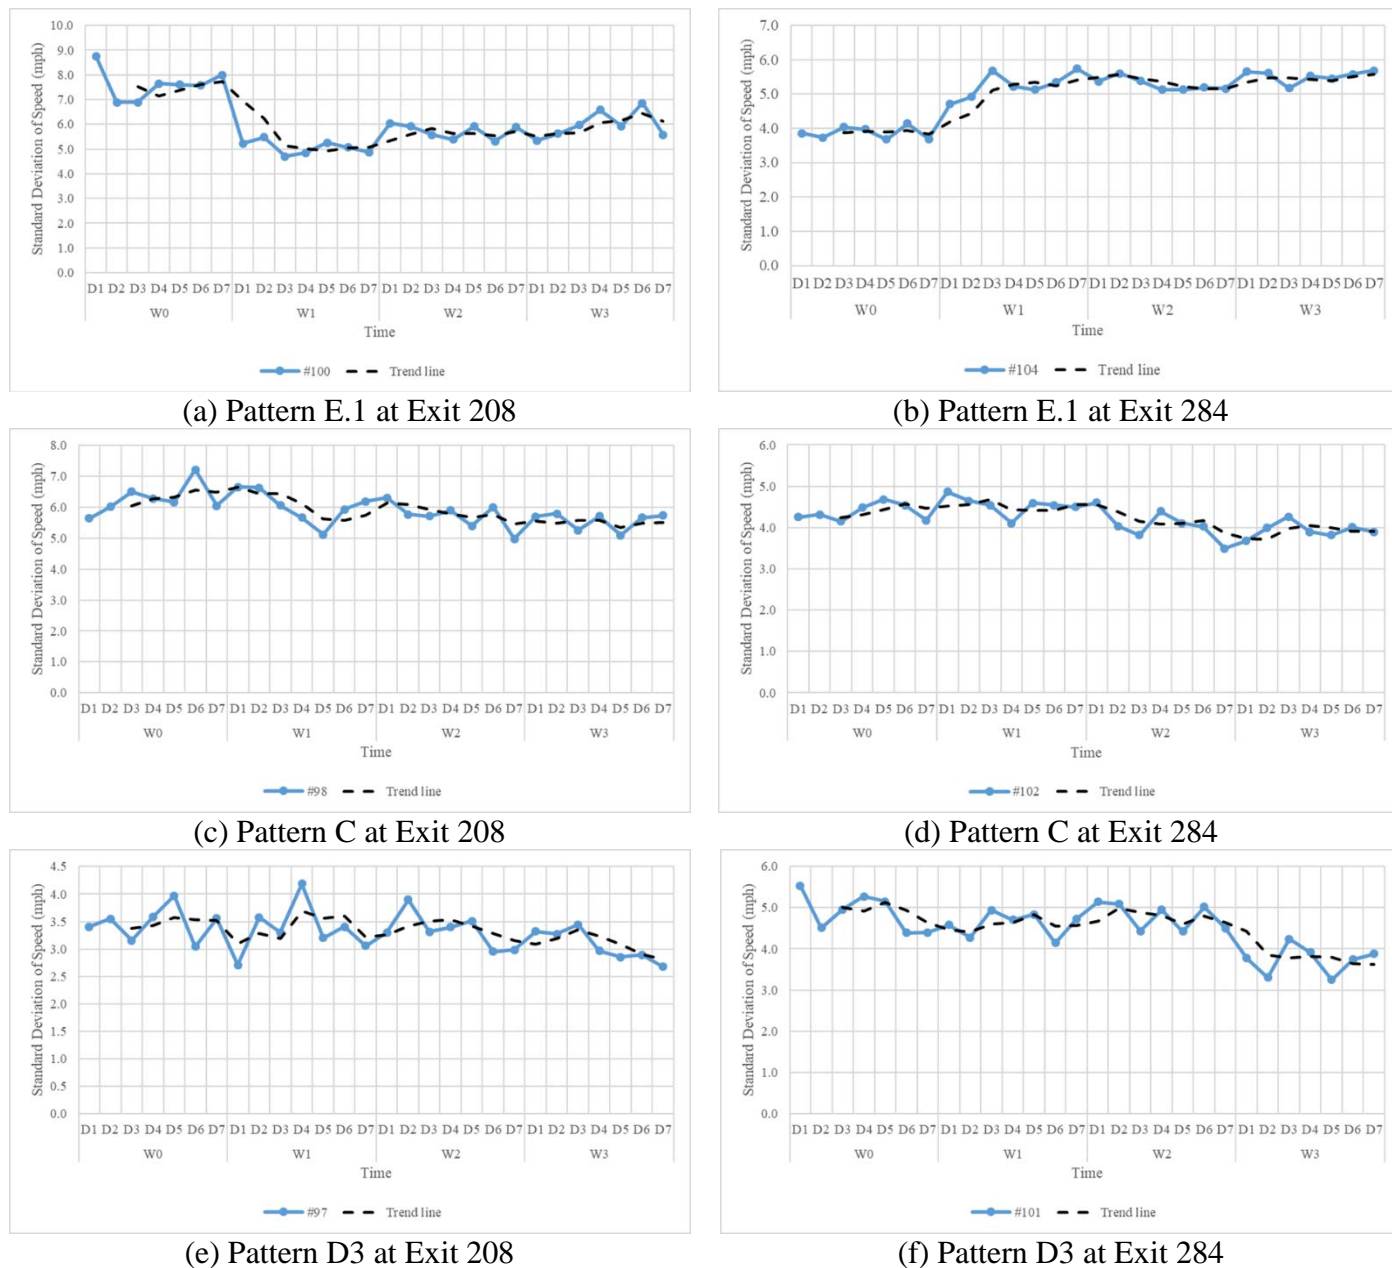
In this study, the trends of daily changes in speed SDs were used to evaluate the driver adoption of a certain DRS pattern. Figure 21 presents the trends of the driver adoption process.

Note: Solid line = recorded speed SD; Dashed line = 2-day moving average

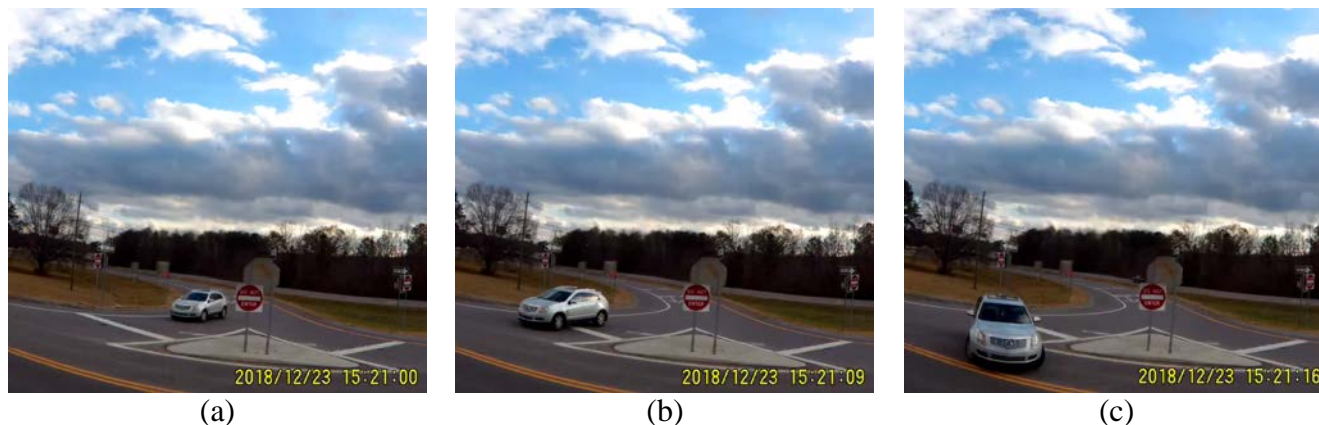
The video camera captured that the new channelization island confused some left-turn drivers at the off-ramp terminal at Exit 208 on I-65. As shown in Figure 22, a driver entered a right-turn lane to turn left. The driver may mistakenly consider the new island as a right-in/right-out channelization design. Thus, there was a concern that some drivers did not fully understand the purpose of the channelized island at the off-ramp terminal.

**Figure 22. Left-Turn Confusion Captured at Exit 208 on I-65**

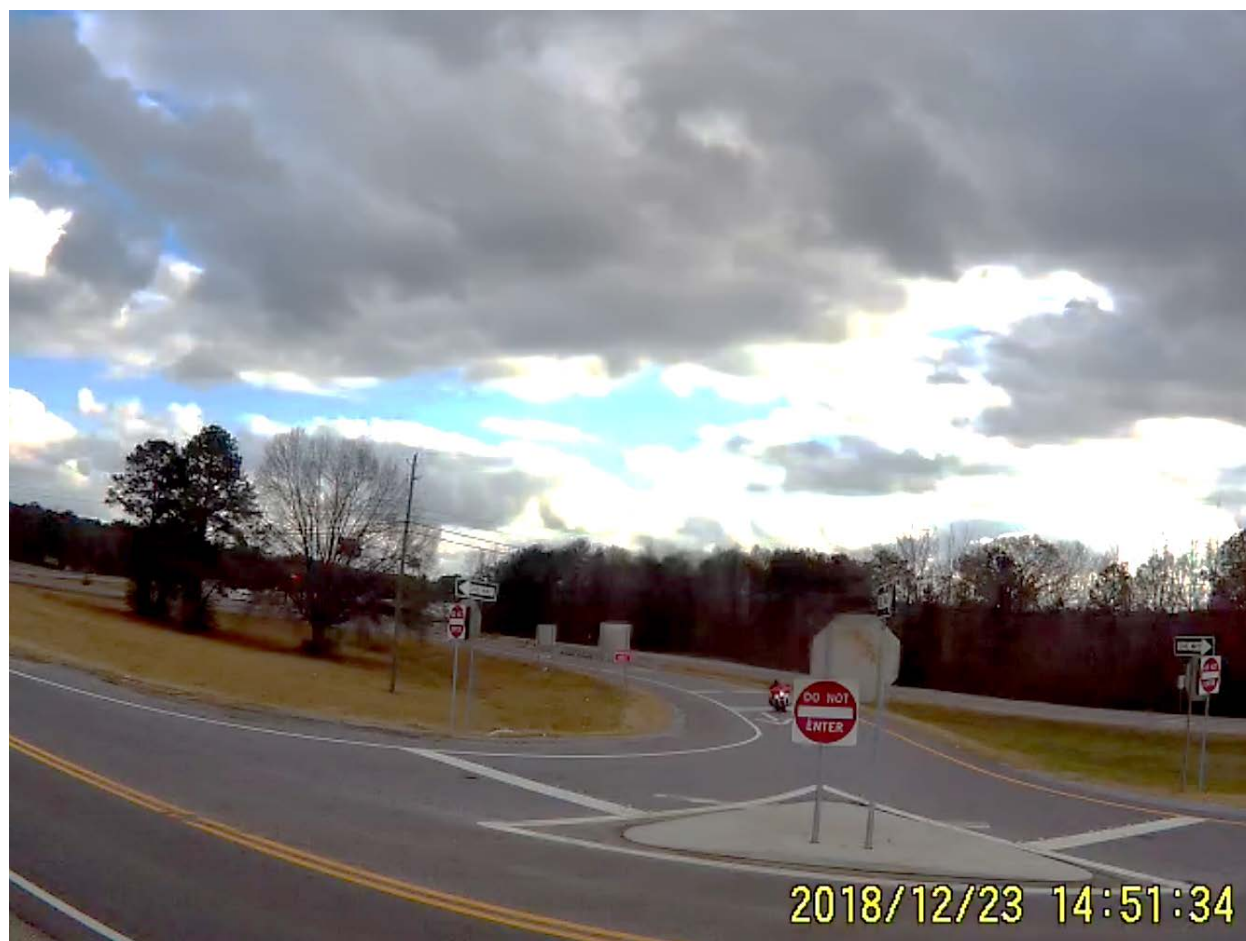
Considering the complaints from motorcyclists on TRS based on past studies, a 2-ft gap in the middle of Patterns E.1 and C was designed to allow motorcyclists to pass the strips without hitting them. As observed in the videos (Figure 23), motorcyclists utilized the center gap to pass Patterns E.1 and C.

**Figure 23. Motorcycle Using the Center Gaps to Pass DRS Pattern C**

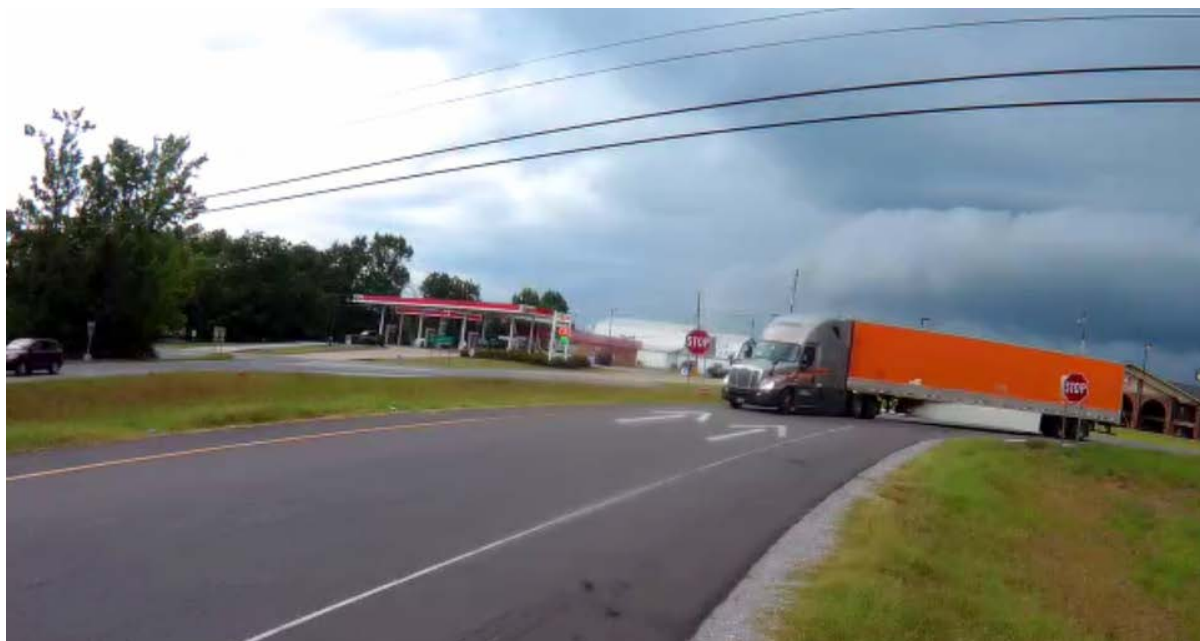
Compared with passenger vehicles, trucks typically cause more severe results when driving the WW due to their large size and limited space of off-ramps for self-correction. Alarming, based on 504 hours of the video data collected from the SB off-ramp terminal at I-65 Exit 208 in Alabama, 25 out of 69 WW drivers were truck drivers. In other words, approximately 36% of WWD incidents involved truck drivers entering off-ramps from the crossroad at this interchange terminal, where a truck station is located less than 1,000 ft away. Figure 25 shows a semi-truck making a left turn from the crossroad and entering the off-ramp at the I-65 Exit 208.

**Figure 25. A WWD Incident by a Truck at I-65 Exit 208, Alabama**

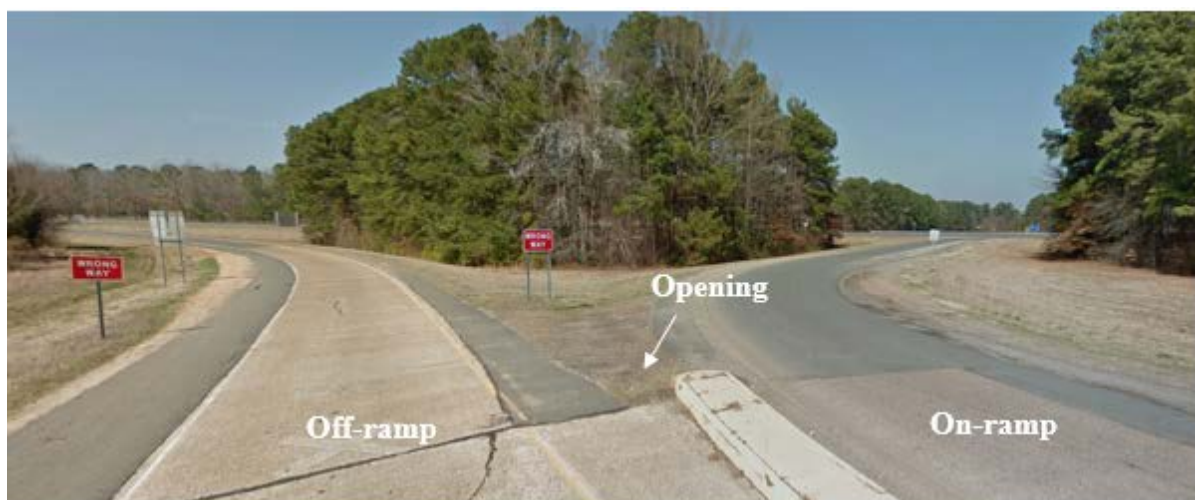
As an alternative to the turn-around area on an off-ramp, some state DOTs provide an opening before the fork areas for two-way ramp segments, as shown in Figure 30. This gives drivers the chance to correct their way in the last minute without making a U-turn on the off-ramp. Illinois DOT designs an accident investigation site on the off-ramp (Figure 31) which can be used as a turn-around area for WW drivers.

**Figure 30. Example of Median Opening Before the Fork Area (I-30 Exit 63, AR) (Source: Google Maps)**

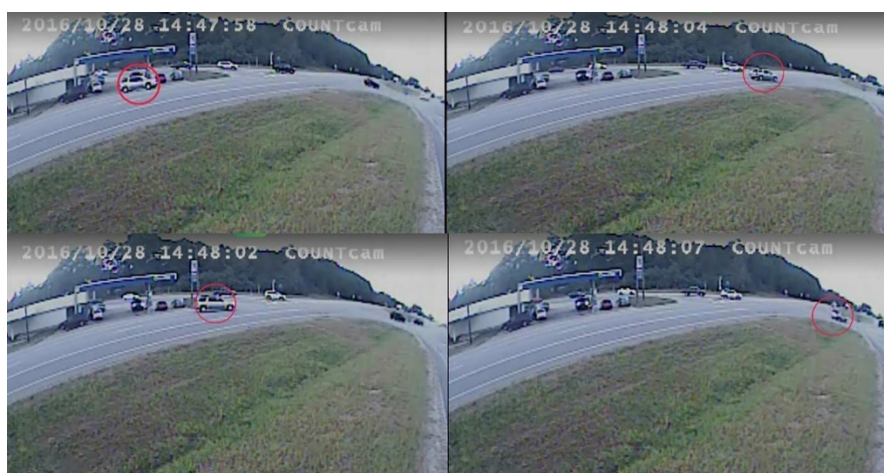
It was found that all the WW drivers tried to make a WW left turn as a shortcut to the NB of the U.S. 280 because of the lack of a nearby downstream U-turn median opening. They intentionally made the WW left turns and drove WW for a shortcut to an upstream median opening. A field review of site design features and existing TCDs was conducted. Some possible factors for the deliberate WW movements were identified, including: (1) lack of channelized island and TCDs to make the driveway as right-in and right-out only; (2) the distance for downstream U-turns at this location is too far; and (3) traffic volume on side street (N College St.) is very high at peak hours and often block the gas station's other exit to the side street.

**Figure 34. Screenshots of a WW Movement Track by Time Series at Location**

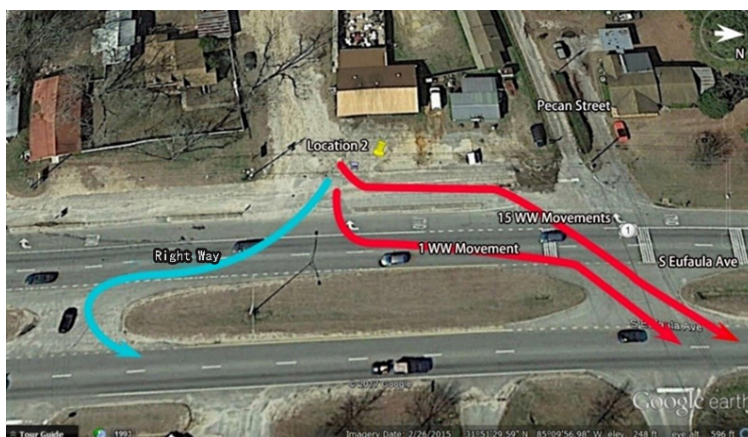
**Figure 36. An Aerial Photo of the Study Location 2 (Source: Google Earth)**

The second WW entry point of this study is a parking lot in front of a lounge located at 2842 S Eufaula Ave, Eufaula, AL, which was recorded as an entry point of a WWD crash that occurred in the year of 2011. Figure 36 shows a Google aerial photo of study location 2. Field data were collected by video cameras from 5:00 p.m. February 17, 2017 (Friday) to 5:00 p.m. February 19, 2017 (Sunday).

The business property is located on the SB side of S Eufaula Ave, which is a four-lane divided highway with a 30-ft wide median. There is an unsignalized intersection at S Eufaula Ave and Pecan St upstream of the access point to the business and there are no access control or traffic

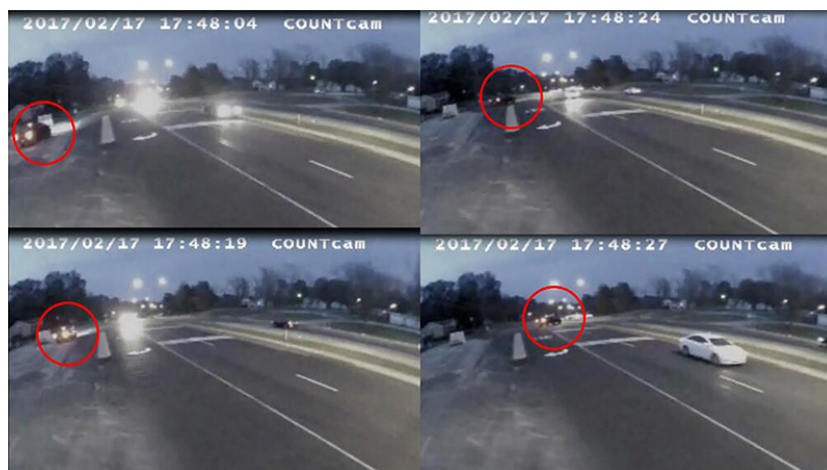
In the 48-hour video data from this location, a total of sixteen WW left-turn movements were observed. An average of eight WW movements made here per day. Of the sixteen observed WWD incidents, fifteen drove along the frontage road as a shortcut to turn left to S Eufaula Ave, and more than half of them (eight) performed this WW movement at night (with the headlights on). One WW driver made a left turn to travel north in the SB lanes of S Eufaula Ave before crossing the upstream median opening at around 12:30 a.m. after leaving the parking lot. Figure 37 shows the screenshots from a video recording of an example of a WW movement track. The red circle shows the WWD vehicle.

**Figure 37. Screenshots of a WW Movement Track by Time Series at Location 2**

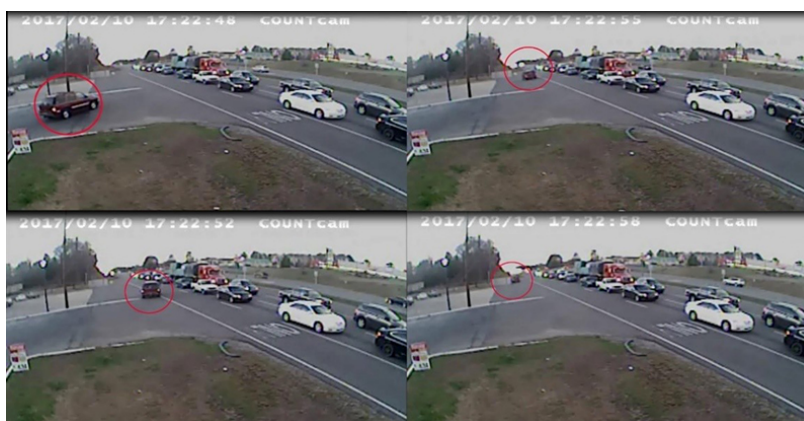
**Figure 39. Screenshots of a WW Movement Track by Time Series at Location 3**

On watching the 48 hours of video data of this location, a total of fifteen intentional WW movements were observed. Six WWD incidents happened at night (with headlights on) and nine happened in the daytime. Among the fifteen WW drivers, thirteen of them drove WW along the frontage road to make the shortcut to the residential area, and the remaining two made a left turn to enter the median opening. Meanwhile, there is one vehicle trying to make a left turn to go to NB in the SB lane, but due to the continuous coming traffic, he/she gave up and made a U-turn back. Based on an average of 7.5 WW movements per day, approximately 2,738 WW movements could be made at this location for one year. Figure 39 shows the screenshots of an example of WW movement track by time series from the video recording.

There are two reasons for making the intentional WW movements at this location. One is that during peak hours the queue of the downstream intersection is too long that indirect left turn drivers cannot merge into the left-side lane to make a U-turn downstream; another is a lack of connection road between this business area and the nearby residential areas.

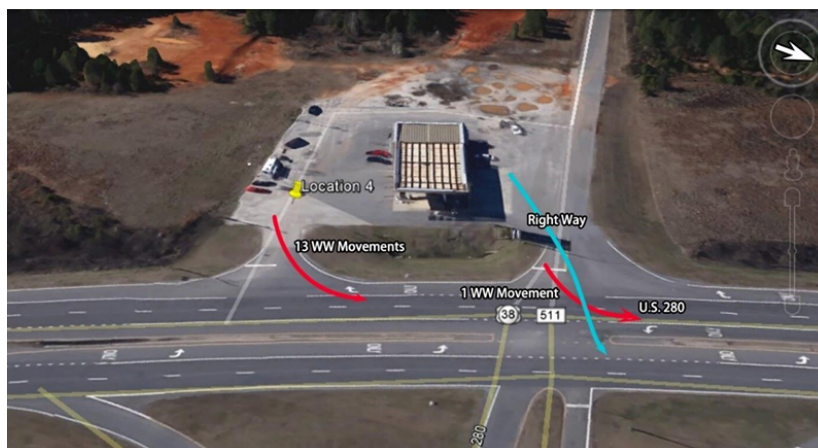
**Figure 40. Image of Study Location 4 (Source: Google Earth)**

The fourth study location is a driveway for a Shell gas station, which is close to an upstream unsignalized intersection of the U.S.280 and Bloise Zeigler Boulevard in Sylacauga, AL. Figure 39 shows a Google aerial photo of the study location. The driveway to the gas station connects the SB of U.S.280, which has one separate left turn lane, two through lanes, and one separate right turn lane. The raised curb median is narrow (around 6 ft). The speed limit on U.S.280 is high (65 mph). There is another median opening for making a right-turn followed by a U-turn movement located more than 2,000 feet downstream. Notably, the grade increases 7% from the gas station parking lot onto U.S. 280, which may contribute to a short sight distance problem.

As a result of a large upgrade, drivers exiting the gas stations may not be able to see median closure for this driveway. It was observed that many drivers backed to the gas station when they found no median openings to make a left turn to US 280. These drivers either made a WW left turns or turned back to use the exit to the side street. The field data were collected by video cameras from 6:00 p.m. on April 7, 2017 (Friday) to 6:00 p.m. on April 9, 2017 (Sunday).

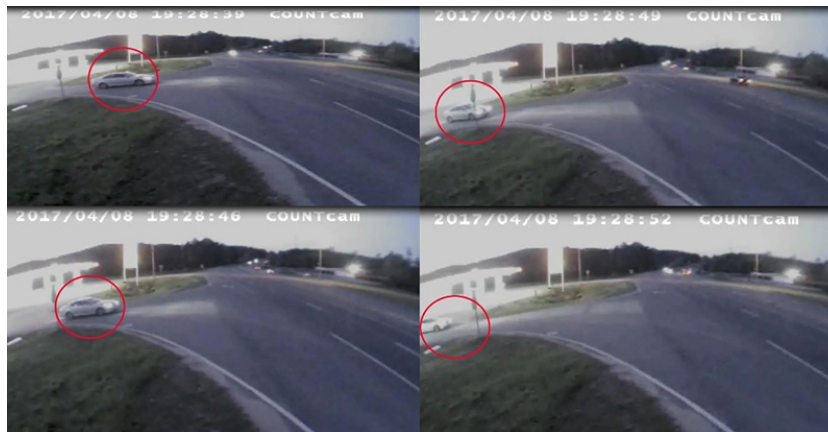
**Figure 41. Screenshots of a WW Movement Track by Time Series at Location 4**

did not know that it was a right turn only exit until they climbed the hill. There was one truck coming from the minor road of the intersection during the night that made a WW left turn onto U.S. 280, and immediately realized that it was the WW and then backed up to turn around to the right direction.

It was found that limited sight distance because of the grade change contributed to all fourteen WWD movements. Figure 40 shows the screenshots of an example of the backup movement track by time series from the video recording.

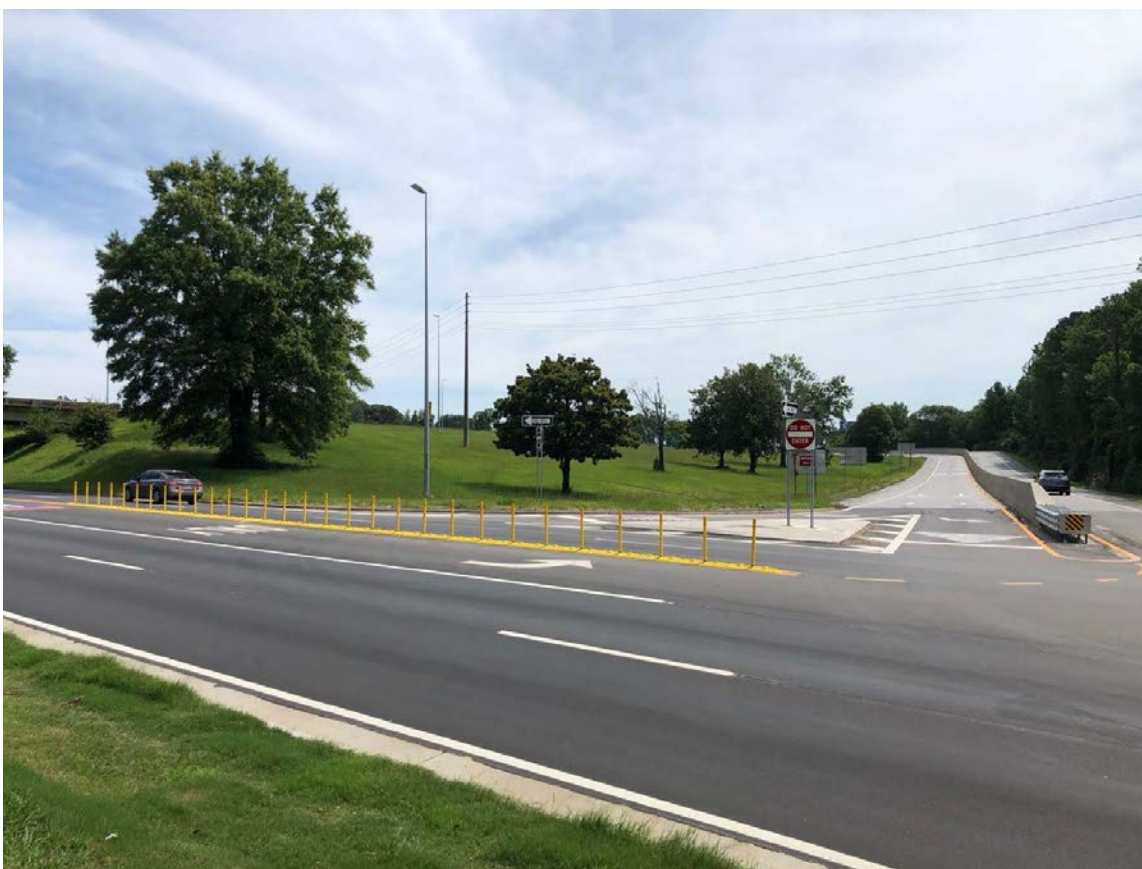
**Figure 42. Quick Kurb Installed on the Crossroad near an Off-Ramp Terminal**

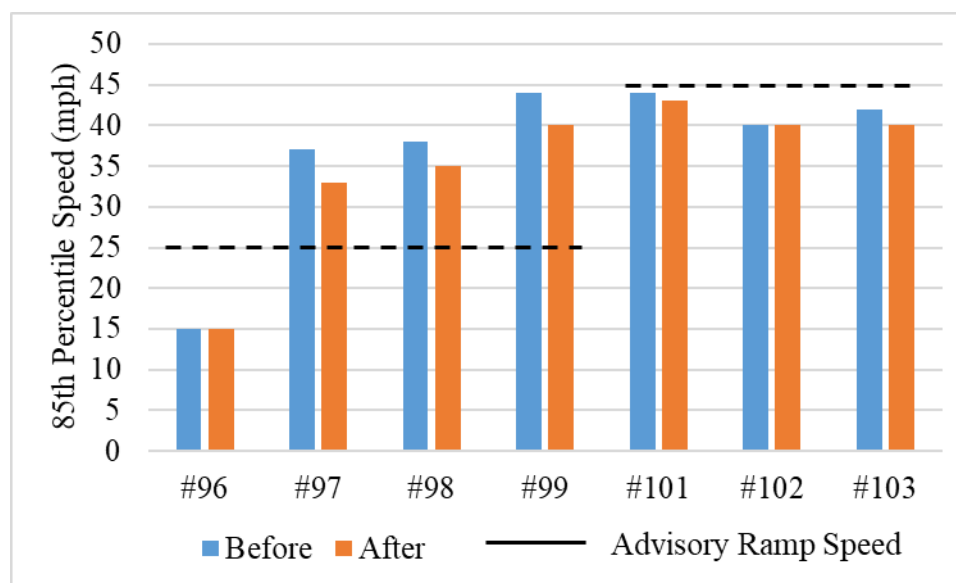
**Figure A-5. 85<sup>th</sup> Percentile Speed Before and After DRS Implementation**
