## Reliability and life study of hydraulic solenoid valve. Part 2: Experimental study

This work studies the reliability of a solenoid valve (SV) used in automobile transmissions through a joint theoretical and experimental approach. The goal of this work is to use accelerated tests to characterize SV failure and correlate the results to new comprehensive finite element models (Part 1).

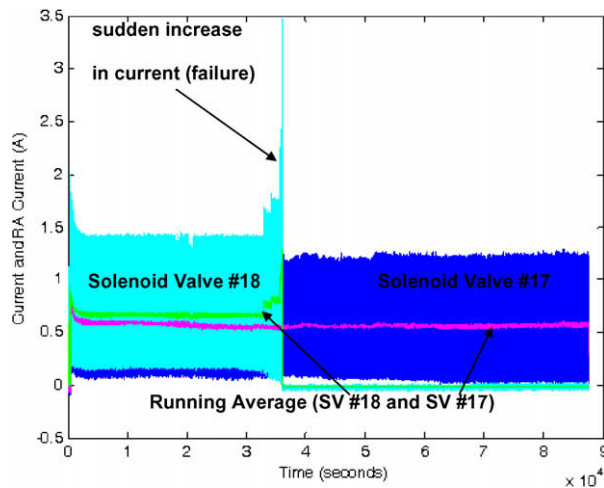
Fig. 8. Variation of applied current and running average for current as a function of time and also showing one completely failed solenoid and one solenoid that did not fail.

Although a total of 22 solenoid valves are tested, Figs. 7–10 show the current, the calculated running average of the current, and the measured temperature as a function of time for 4 of the solenoid valves. Figs. 7 and 9 show peak current and maximum temperature values at which complete failure has occurred for 2 valves, whereas Figs. 8 and 10 show the current, running average and temperature data for a completely failed valve and for a valve where no failure has occurred. It is clearly evident that solenoid failure is marked by a sudden increase in temperature and current. Once failure occurs the solenoid valve ceases to actuate and the protective fuse blows causing the applied current and voltage to reduce to zero. These clear failure points are used to extract the time to failure for each solenoid valve. A detailed set of the extracted results and observations on all solenoid valves tested in this work is included in the following sections (see Table 2).

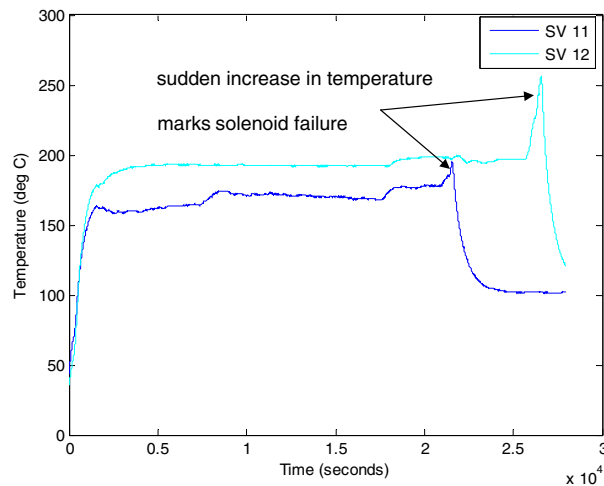
Fig. 9. Variation of temperature with time for two completely failed solenoid valves.

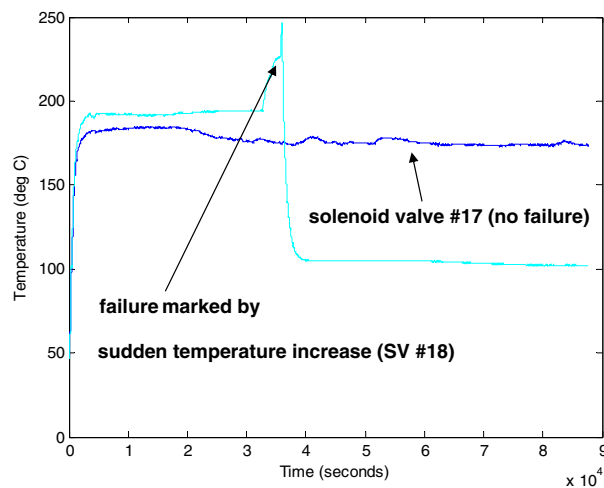
Fig. 10. Variation of temperature with time for one completely failed solenoid and one solenoid that did not fail.

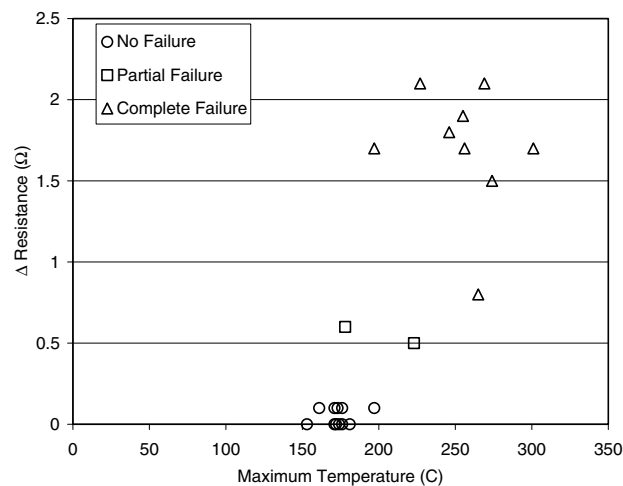
Fig. 13. Variation of change in resistance in relation to the maximum temperature for the tested solenoid valves.

Fig. 13 shows a clear change in the electrical resistance of the solenoid valves with respect to the maximum temperature reached during each test. The resistance of each new SV measured before testing is 3.4  $\Omega$  and indicates that each wire is insulated from all nearby wires by a thin polyamide-imide insulation. The melting point of the insulation material (polyamide-imide) used in the solenoid coil is approximately 200 °C [20]. Therefore it is believed that if the temperature and stresses in the coil are high enough, then the solenoid insulation will fail. The drop in resistance means that the solenoid valve coil wire has shorted so that the current can bypass significant portions of the coiled wire. For most of the valves that belong to the (c) case (complete failure), the change in resistance is high (there is a drop in resistance from the original 3.4 or 3.5  $\Omega$  for a new solenoid valve to a very low value varying in the range 1.2–2.5  $\Omega$ ).

It is observed from Figs. 13 and 15 that for the reasonable ambient temperatures of 100 °C and applied electrical loads that these valves are subjected to high temperatures (in the range 200–300 °C) which is well above the melting point of the coil insulation. Fig. 15 also presents perhaps the best correlation of data and the clearest indicator of failure. The peak current of the completely failed solenoid valves are all above a value of approximately 2.8 A and there also appears to be a separation of the data at approximately 200 °C. Initially for each of the valves when it begins to operate, the applied peak current is approximately 1.3–1.4 A, but this applied peak current increases in gradual steps until a point of complete failure occurs due to a corresponding gradual drop in the resistance of the SV to a very low value (Table 2). The valves have then been exposed to extreme temperatures that eventually cause complete failure as the coil insulation starts to melt (see Fig. 26) which causes shorting of the solenoid coil copper wires due to a lack of insulation between them. At complete failure, there is also considerable thermal expansion and deflection in the coil region or wire cross-section (see Figs. 23, 25 and 26). In fact, the coil wire can be bulged out, melting out of the insulation, and show the presence of pores or vacant spots in and around the core region (see Section 3.4). The wire cross-section of the (a) case solenoid valves (non-failure) shows none of the observations noted for the (c) case. Instead, these samples exhibit in an expected manner, a neatly arranged close packed helical wound coil structure [21] of a SV with a thin layer of polymer insulation clearly seen between all the copper wires. This is typical of any solenoid valve that has not shown any signs of failure.

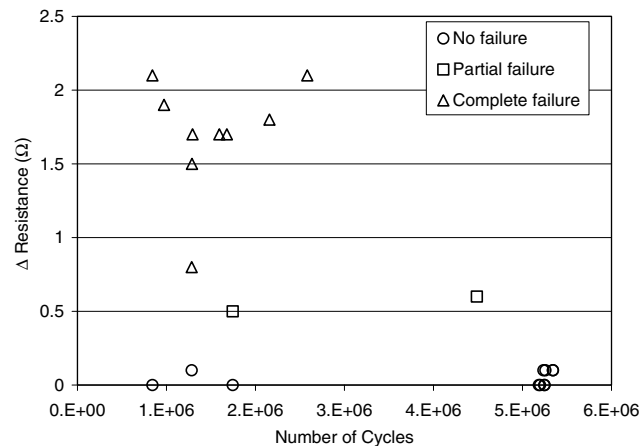
Fig. 14. Variation of change in resistance Vs number of cycles for the tested SVs.

The change in resistance is also shown as a function of the number of cycles in Fig. 14. The results show that for the failed solenoid valves almost a million cycles or more were still required for failure to occur. This suggests that the failure may also be a cyclic process as the wire insulation is slowly degraded over many cycles of operation. However, it also appears that many solenoid valves survive for many millions of cycles without reaching failure. Surprisingly, in this work for all the valves tested for more than 5 million cycles ((a) case valves), there were no signs of failure which is validated by extremely small changes in resistance of the order of 0–0.2  $\Omega$ , even after the valves were cycled for 24 h. It could be that there are differences in the manufacturing tolerances of the solenoid valves that allow some valves to operate for longer before failure. The performance of (a) type of valves clearly proves the well established fact that many SVs run for very long durations to the order of many years without failure when operated at the rated operating conditions. In contrast, the current tested SVs are subjected to more severe operating conditions (16.8 V average peak voltage, 100 °C, 50% DC, etc.) and are made to run in these conditions for at least a period of 24 h (that is, approximately 5 million cycles). Despite this, many of them run well even after 5 million cycles while being exposed to these operating conditions (the accelerated test conditions). The problem is some of them do fail, and it appears to be significant portion.

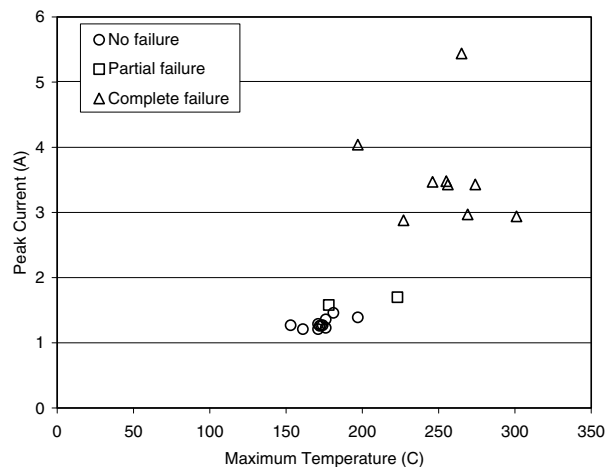
Fig. 15. Variation of peak current as a function of maximum temperature for the tested SVs.

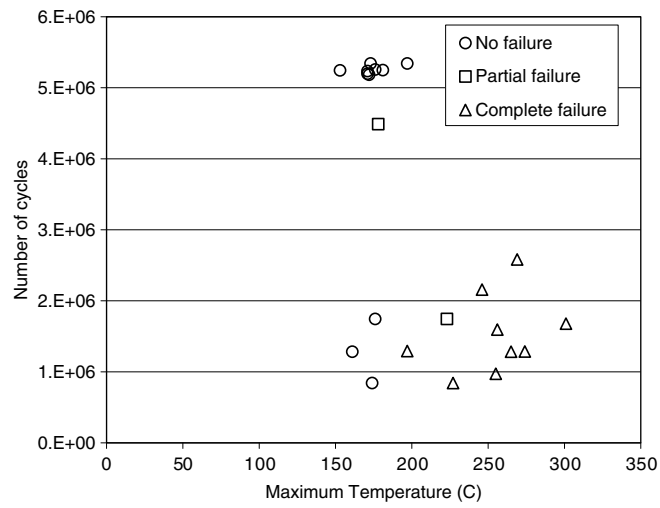
**Fig. 16.** Variation of number of cycles as a function of the maximum temperature for the tested solenoid valves.

Fig. 16 shows the variation of the number of test cycles as a function of the maximum temperature reached during each test for all SVs. From this it shows that the higher maximum temperatures reached by the solenoid valve might be due to high peak currents. Then these high peak currents are in turn probably a result of the large drop in resistance of the solenoid valve from 3.4 to 3.5  $\Omega$  to the range of 1.2–2.5  $\Omega$ . Since these lower resistances are caused by high temperatures, there does seem to be a viscous cycle that the solenoid valve may enter once the threshold of failure is reached. Alternatively, the solenoid valves subjected to moderately high temperatures in the range 150–185  $^{\circ}\text{C}$  run extremely well for at least 5 million cycles (that is, approx. 24 h) with no signs of failure, therefore these tests belong to the (a) category.

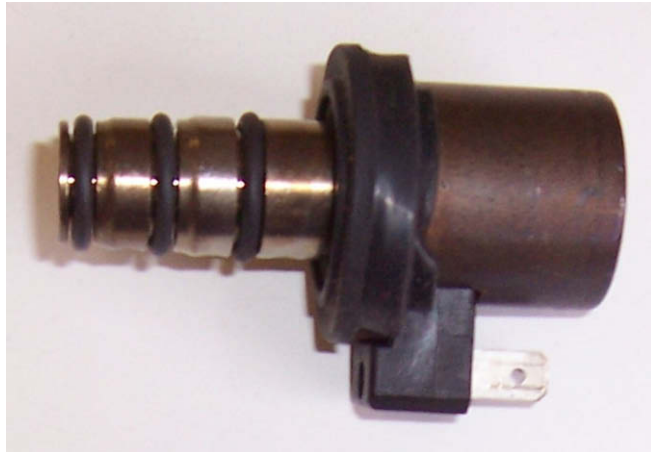
**Fig. 17.** A macroscale photograph of a SV belonging to (a) case (the solenoid valve was run for 24 h without failure).

For the (a) and (b) cases (see Figs. 17 and 18), where both are run for 24 h and about 5 million cycles, the outer structural appearances of the valves are similar. The presence of a brownish color is observed over most of the outer region of the valves since the outer casing of the valves is made of iron (due to iron oxidation and exposure to extreme temperatures in the range 150–200 °C) unlike the silver color of the valves seen prior to testing. In addition, some bluish discoloration of the surfaces can also be seen due to the high temperatures that are encountered. In contrast, for the (c) case valves (see Figs. 19 and 20), along with the discoloration in the outer structure, plastic material is seen oozing or coming out of valve due to exposure to very high temperatures in the range of 200–250 °C. The color of the type (c) failed solenoid valve is also a deeper blue than the other samples, indicating the occurrence of higher temperatures. Again, the existence of extreme temperatures in the valves is due to the applied current and the build up of Joule heat in addition to the heat in the ambient air of the thermal chamber.

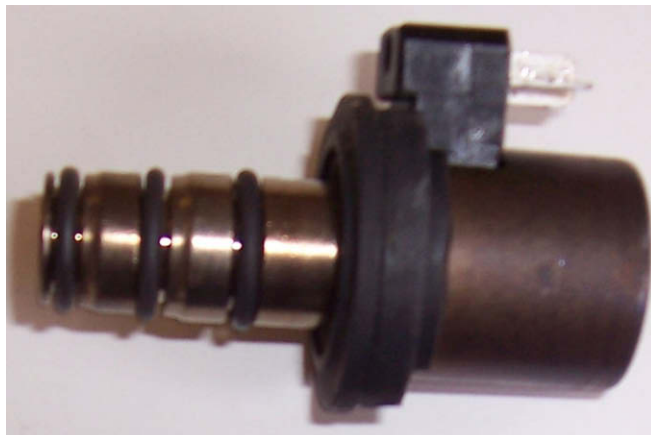
**Fig. 18.** A macroscale photograph of a solenoid valve belonging to (b) case (partially failed but still run for 24 h).
