Executive Summary
RP 930-307

FATIGUE OF DIAPHRAGM-GIRDER CONNECTIONS

**The Alabama Department of Transportation
Montgomery, Alabama**

April 1996

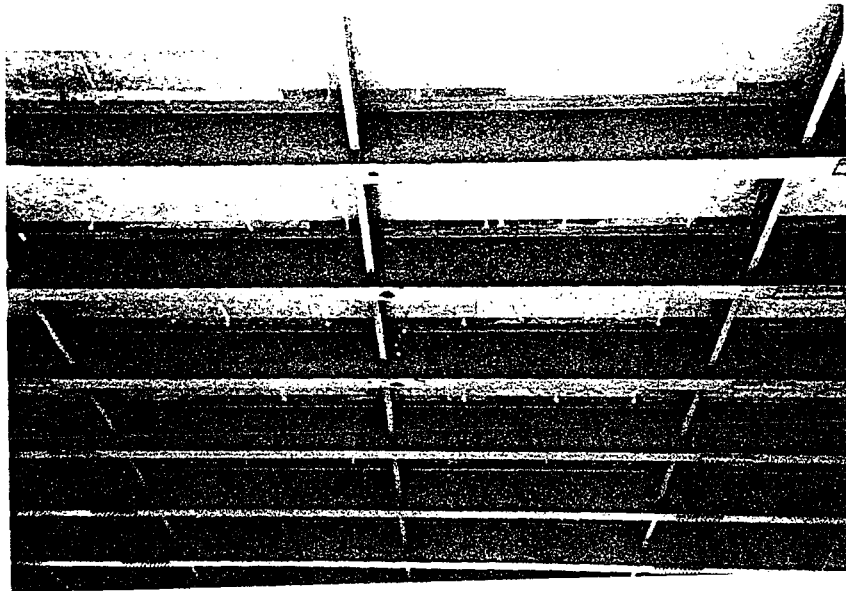
Construction of the interstate highway system through downtown Birmingham began in the late 1960's, and multi-girder steel bridges were used extensively. Primarily rolled W-shapes were used for girders and rolled channels for the diaphragms as shown in Figure 1.1. The diaphragm-girder connection in the original construction typically consisted of a plate field welded to the channel diaphragm and shop welded to the girder web. A typical connection is shown in Figure 1.2. Some connections were made using an angle welded to the girder web instead of a flat plate. The diaphragm connection plates were not attached to the girder flanges because welding to a tension flange was discouraged in common design guides at that time.

Figure 1.1. Typical Lines of Channel Diaphragms

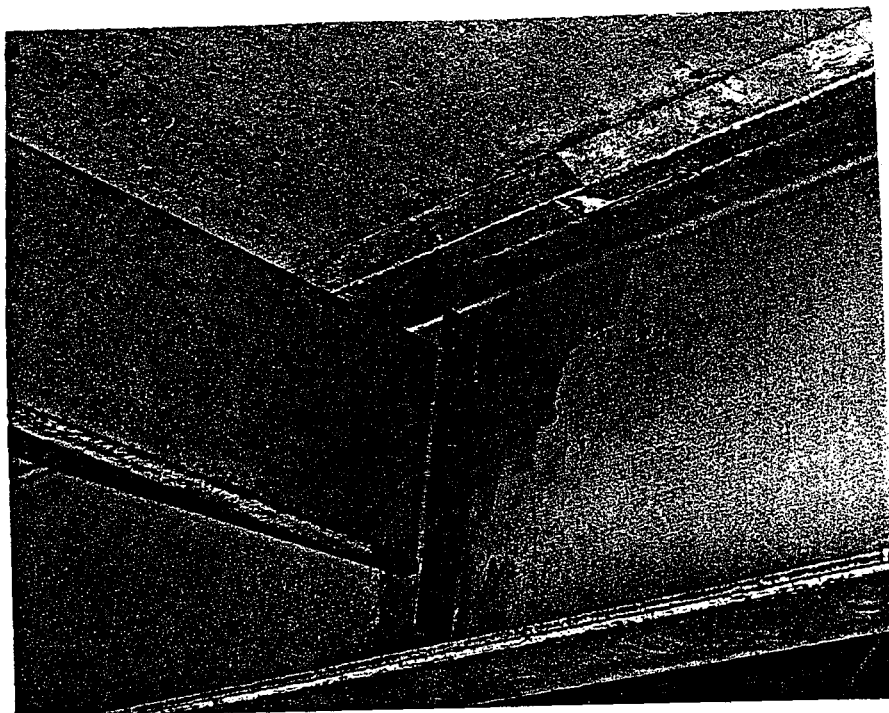
Over the last six years bridge inspectors have discovered fatigue cracking in the welds and base metal in many of the welded diaphragm-girder connections. Cracks have been discovered in the welds connecting the diaphragm to the connection plate,

Figure 1.2. Welded Plate Diaphragm-Girder Connection

in the welds connecting the connection plate to the girder web and in the girder web. Cracking in the girder web, as illustrated in Figure 1.3, poses the greatest threat to the longevity of the bridges. Fatigue cracks develop at diaphragm-girder connections due to secondary live load forces created by differential deflections between the girders. These secondary live load forces cause out-of-plane distortion of the girder web which leads to distortion-induced stresses in the web and in the welds of the connection.

In the past the Alabama Department of Transportation (ALDOT) used three basic techniques to repair fatigue cracking at diaphragm-girder connections. Short cracks in welds were removed by grinding. More extensive weld cracks and cracked connection plates were repaired by removing the original welded connection and installing an angle bolted to the diaphragm and girder web as shown in Figure 1.4. Subsequent bridge inspections revealed cracking in many of these angles, as illustrated in Figure 1.5, due to bending of the angle leg bolted to the girder web. Distortion-induced cracks in the girder web were repaired by drilling a 19 mm to 25 mm diameter hole to remove the crack tips. This was ineffective at some locations as illustrated in Figure 1.6 by the fatigue cracks which have extended beyond the holes. Connections with significant weld cracks and web cracking were repaired by a combination of drilling holes in the web at crack tips and replacing the connection with a bolted angle connection.

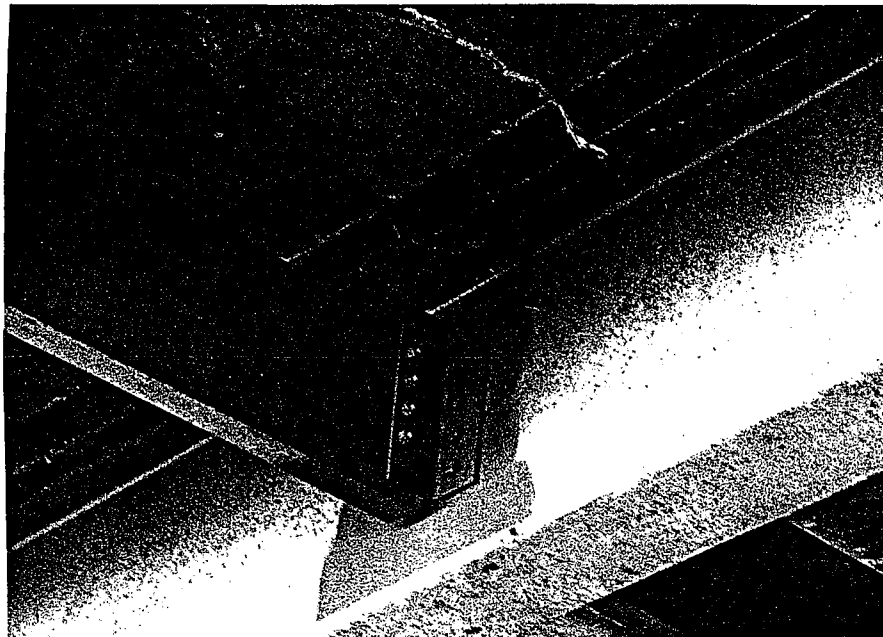
Figure 1.4. Bolted Angle Connection
