Research Report No. 2F for ALDOT Project 930-601

**REPAIR OF CRACKED PRESTRESSED
CONCRETE GIRDERS, I-565,
HUNTSVILLE, ALABAMA**

The Alabama Department of Transportation

JULY 2011

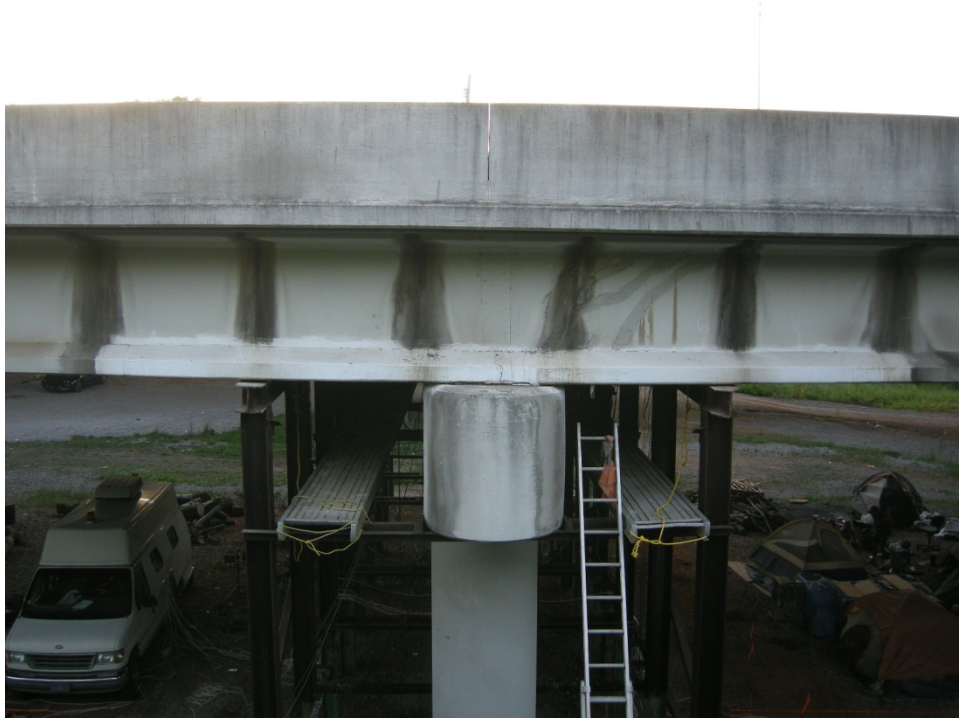
Figure 1.4: Girder 9 of Northbound Spans 10 and 11—repaired

desirable to develop a repair solution for these conditions that would require minimal traffic disruption or delay during repair. The proposed FRP reinforcement system, which was installed on Northbound Spans 10 and 11 of I-565 in Huntsville in December of 2007, provides an unobtrusive repair solution, but this solution required verification through testing before further implementation could confidently be recommended. Girders repaired with FRP reinforcement are shown in Figures 1.4 and 1.5.

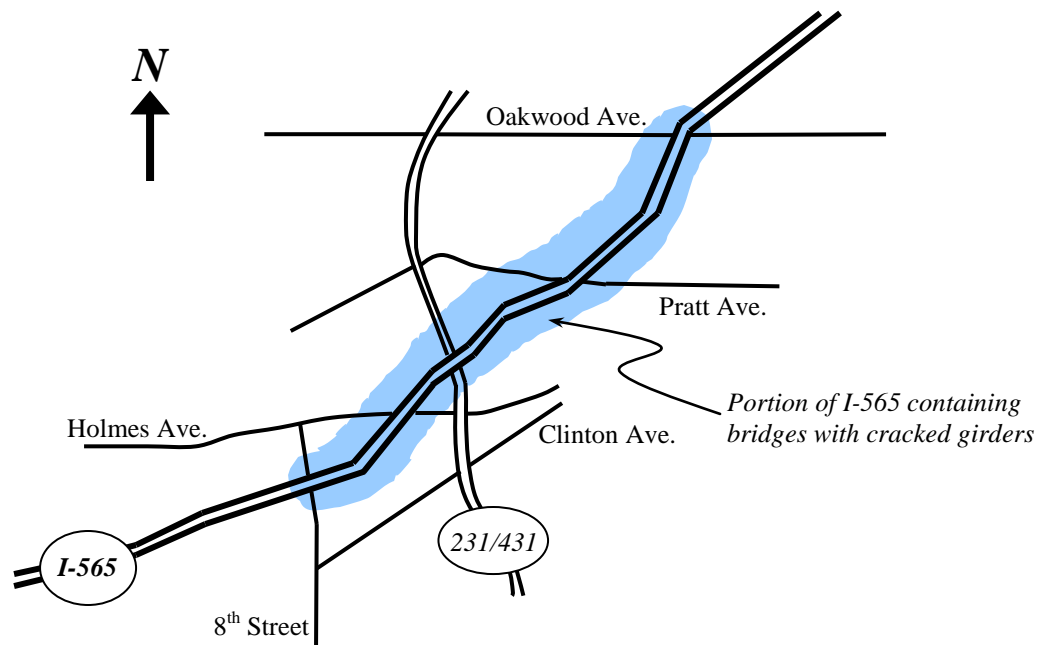
Cracked girders were found at ten different sites between Eighth Street and Oakwood Avenue (ALDOT 1994). The portion of I-565 containing cracked bridge girders is illustrated in Figure 2.15. The pattern of cracking found in one BT-54 girder of Span 5 is illustrated in Figure 2.16. The inclined web cracks were limited to approximately 0.06 in. (1.5 mm) due to the transverse reinforcement that the cracks intersected. The vertical bottom-flange cracks only crossed the longitudinal prestressed strands and crack widths were not controlled by transverse reinforcement. Some of the larger bottom-flange cracks with widths up to 0.25 in. (6 mm) were visible from the ground in 1994, as shown in Figure 1.3.

Figure 2.15: Portion of I-565 containing cracked bridge girders (Swenson 2003)

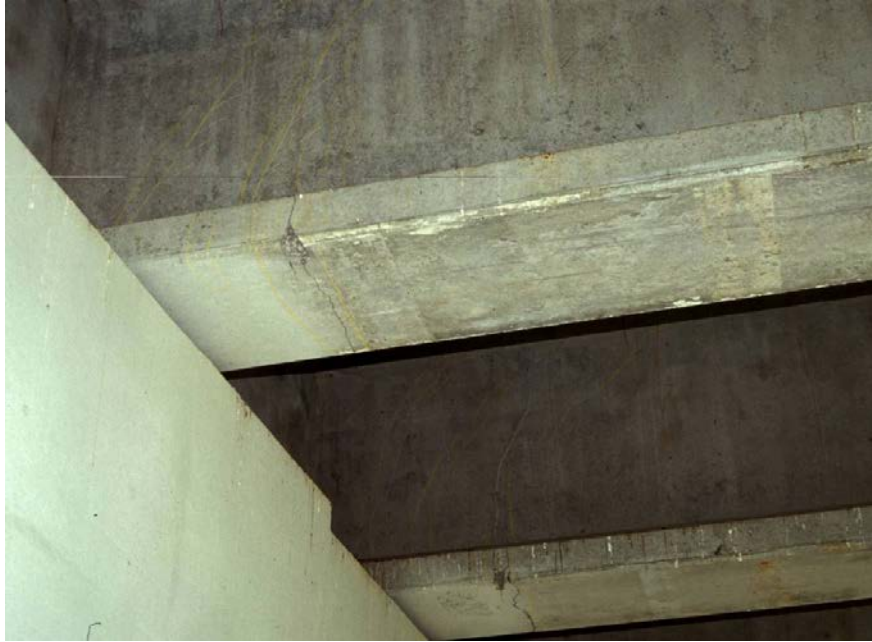
Figure 2.17: Cracked pre-tensioned bulb-tee girders (Barnes et al. 2006)

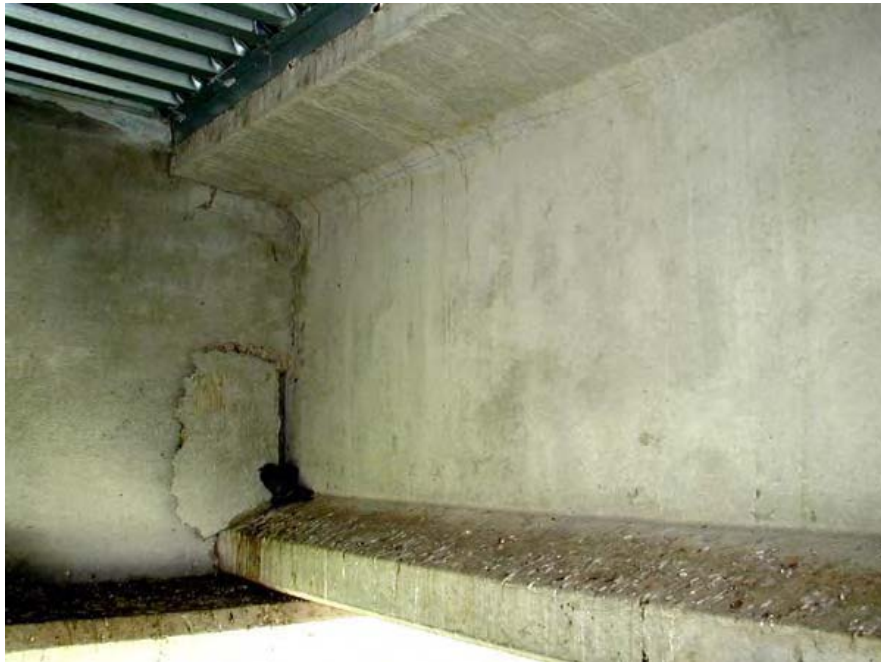
The 1994 investigation also resulted in the discovery of continuity diaphragm cracking. The two types of cracks present in some of the continuity diaphragms were face cracks and end cracks. An example of a typical continuity diaphragm face crack can be seen in Figure 2.18, and an example of a typical diaphragm end crack can be seen in Figure 2.19. Approximately 57 percent of bents supporting bulb-tee girders contain diaphragm face cracks, and roughly 85 percent of bent contain diaphragm end cracks. All interior bents in two-span continuous structures constructed with BT-54 girders exhibit diaphragm end cracks (ALDOT 1994).

Figure 2.18: Typical diaphragm face crack (Swenson 2003)

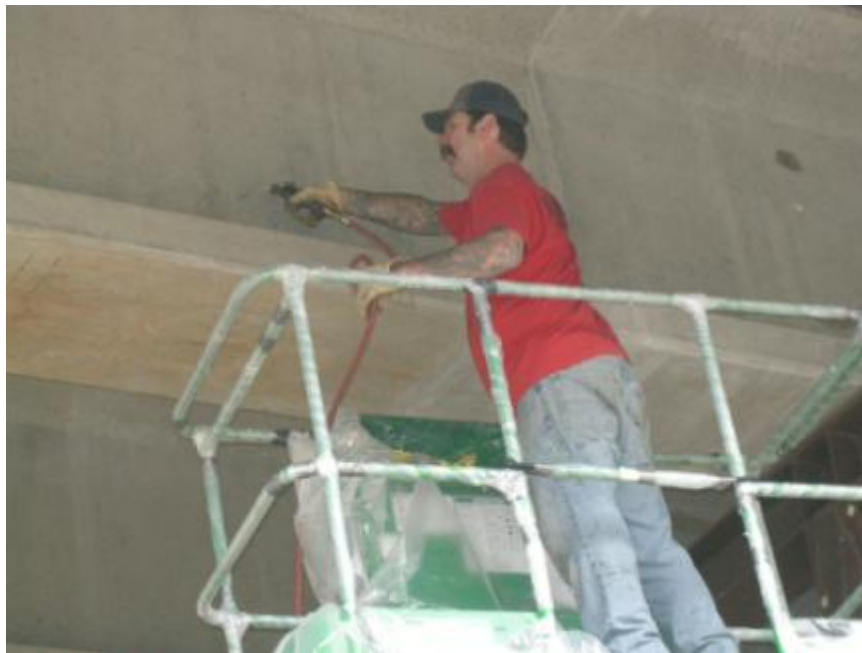
Figure 2.29: Surface cleaning—final removal of dust and debris

Prior to FRP fabric installation, the contractor was required to prepare the surface to ensure adequate contact between the FRP and concrete. Surface preparation procedures were conducted in accordance with the ALDOT Special Provision regarding the use of fiber-reinforced polymer reinforcement for girder repair. Surface preparation techniques included surface grinding of irregularities such as excess crack-injected epoxy, surface patching of unacceptable voids and depressions, light surface roughening for improved bond quality, and final surface cleaning to remove dust and all other bond-inhibiting material. The use of compressed air for final cleaning is shown in Figure 2.29.

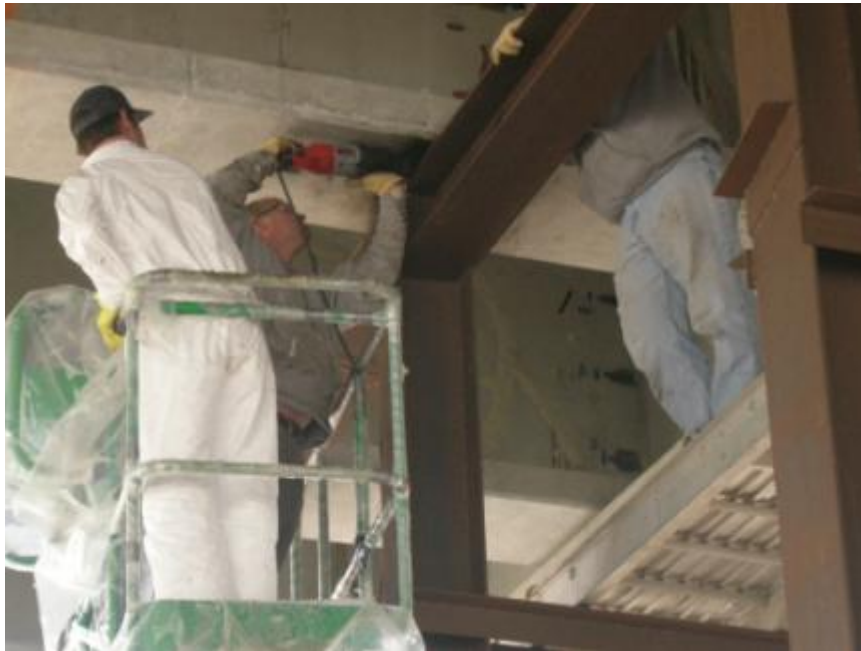
Figure 2.30: Use of saw for bearing pad removal

bearing pads under Span 11 were, in general, more difficult to remove than the bearing pads under Span 10. Initially, the contractor attempted to remove each bearing pad by punching it out of place using a chisel and hammer. When a bearing pad was under enough pressure to prevent removal, the contractor then used a reciprocating saw on the pad to alleviate some of that pressure, as shown in Figure 2.30. In some cases, saw cutting alone was not effective at alleviating enough pressure for successful bearing pad removal. In these cases, a propane torch was used to soften the rubber and allow for a more effective sawing process, which is shown in Figure 2.31. After successful pressure alleviation, the bearing pad was removed using the initial chisel-and-hammer removal method, as shown in Figure 2.32. An example of a bearing pad that required extensive removal efforts is shown in Figure 2.33.

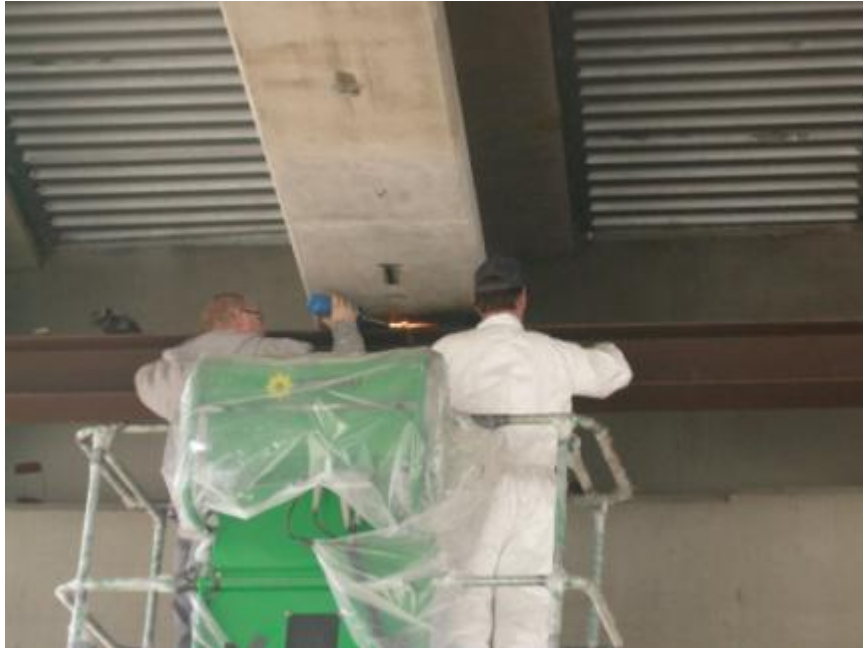
Figure 2.31: Use of torch for bearing pad removal

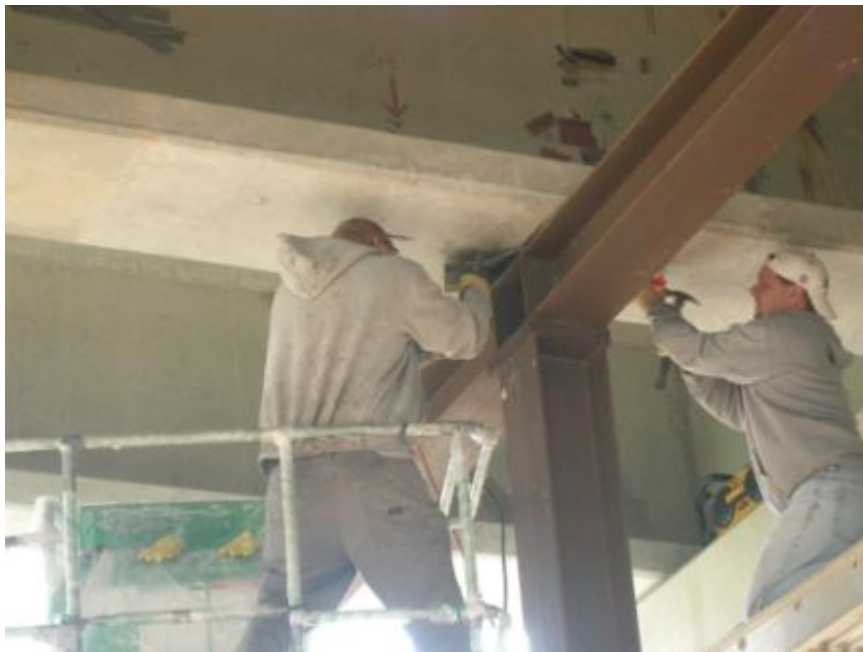
Figure 2.32: Successful removal of bearing pad

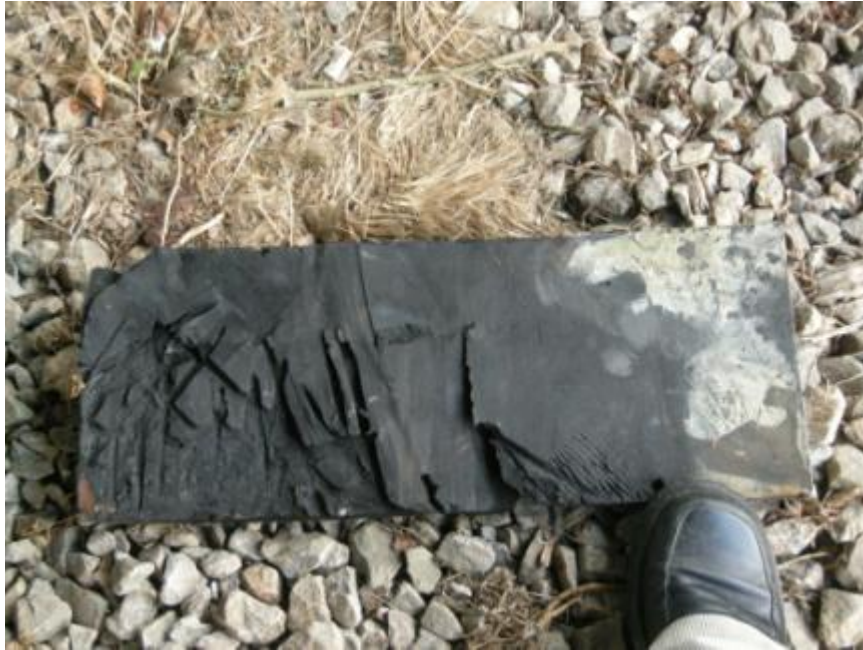
Figure 2.33: Bearing pad after forceful removal

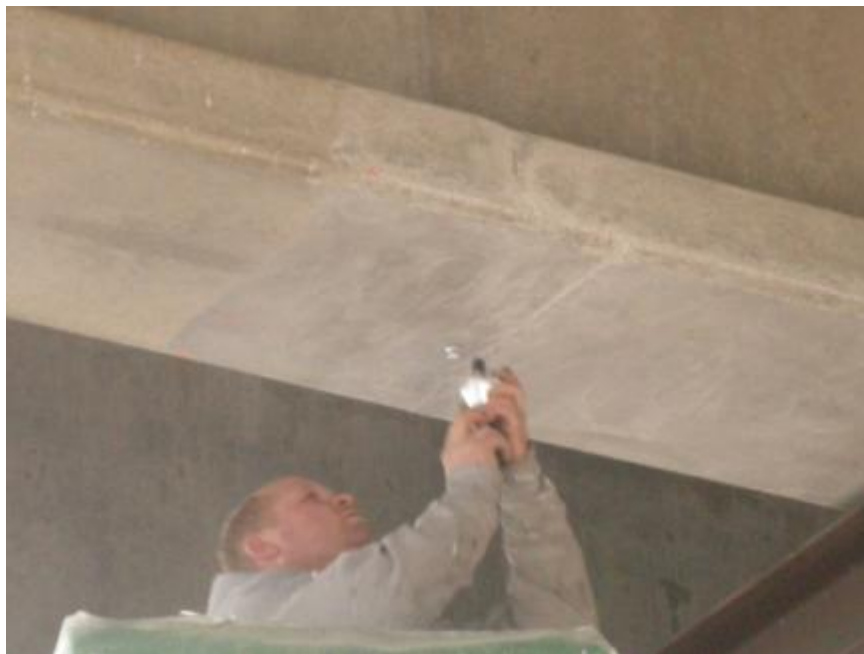
Figure 2.35: Performance of on-site adhesion test

Tyfo S saturant epoxy manufactured by Fyfe Co. was used throughout the FRP installation. Adhesion testing of the Tyfo S epoxy on the concrete surface was required to ensure that the bond strength of the epoxy exceeded the tensile strength of the concrete. The adhesion tests were conducted in accordance with the requirements given in ASTM D4541. Detailed description of the ASTM D4541 adhesion testing procedure has been reported by Swenson (2007). A minimum of three tests were required for each day in which FRP reinforcement was installed, and a minimum of one test was required per 500 square feet of installed FRP reinforcement. Adhesion testing equipment is shown in a laboratory setting in Figure 2.34. On-site adhesion testing is shown in Figure 2.35.

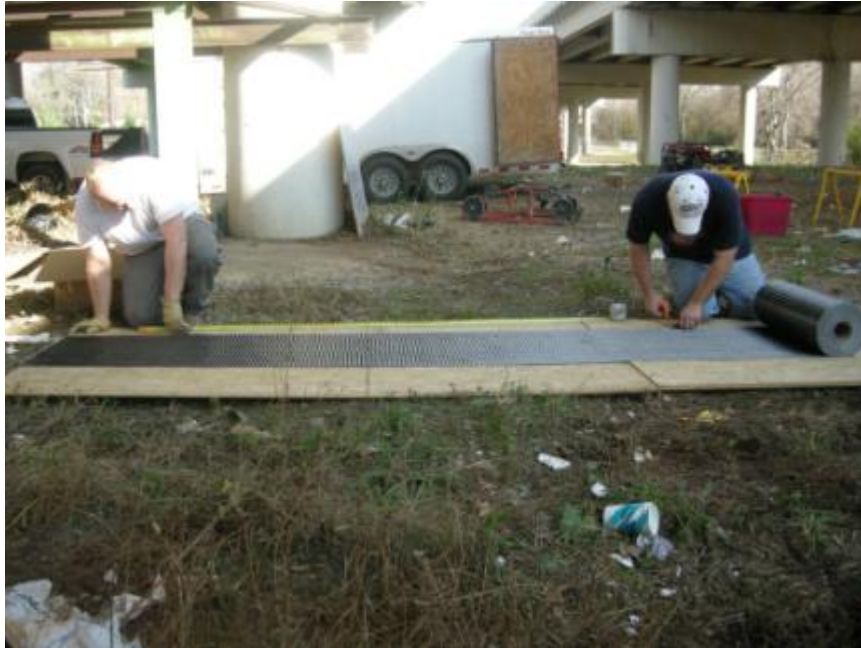
Figure 2.38: Cutting strips of FRP fabric

Each sheet of FRP fabric was cut to size and then saturated with epoxy. The typical fabric cutting and epoxy saturation procedures are shown in Figures 2.38 and 2.39. Epoxy was also applied to the surface of the girders prior to application of the first layer of FRP fabric, as shown in Figure 2.40. The first layer of FRP fabric was then installed as shown in Figure 2.41. Successive layers of FRP and epoxy were then applied, and an example of a typical four-layer installation is shown in Figure 2.42.

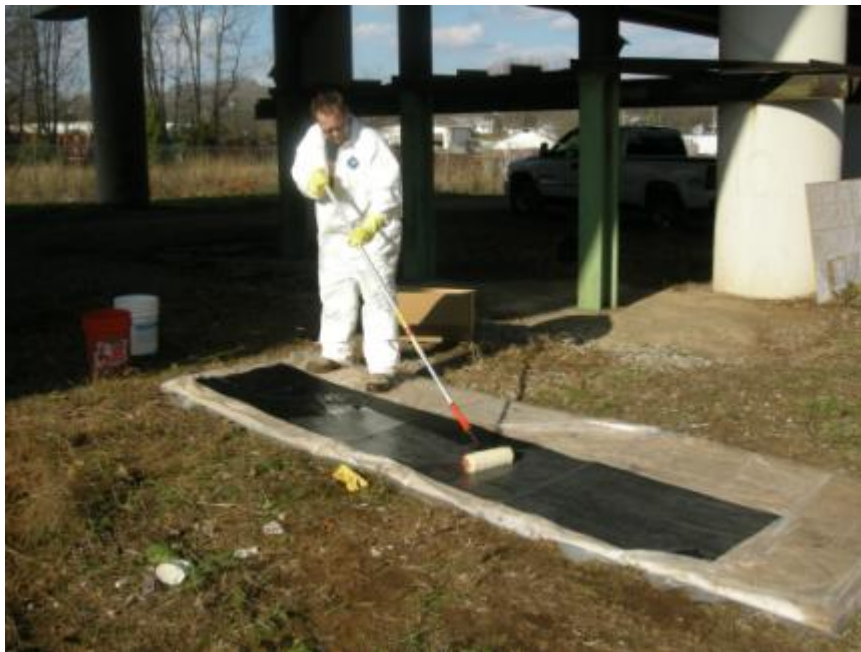
Figure 2.39: Epoxy saturation of FRP fabric

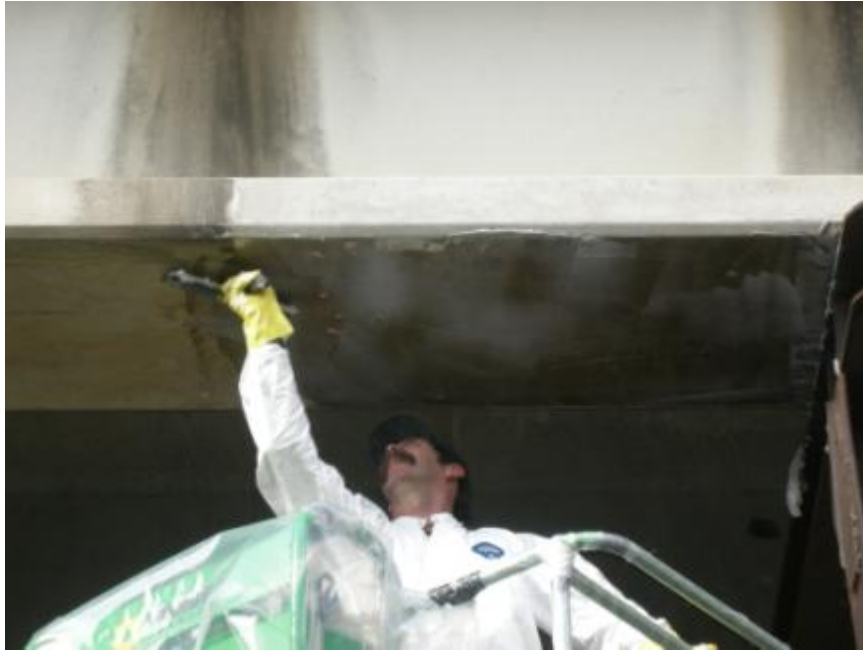
Figure 2.40: Applying epoxy to girder surface before FRP fabric installation

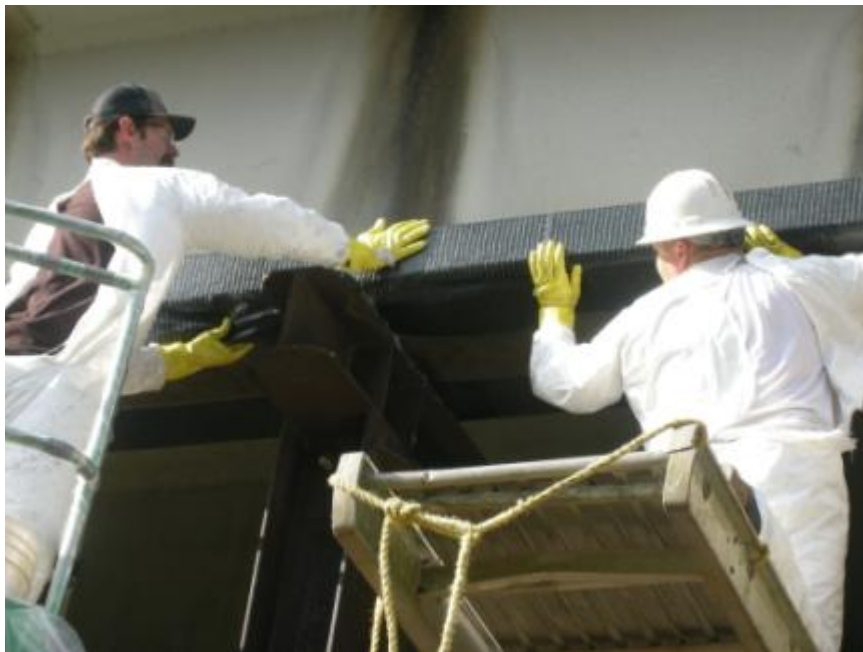
Figure 2.41: Installation of first layer of FRP fabric

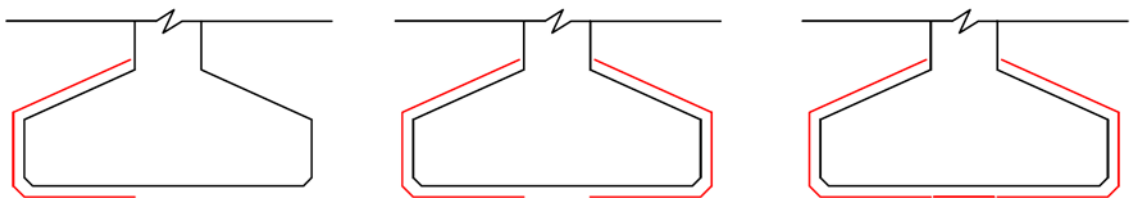
Figure 2.43: FRP installation sequence—first layer

The installation sequence for the first layer of FRP fabric is illustrated in Figure 2.43. The two wider strips were installed beginning at the joint of the web and top of bottom flange on their respective faces of the girder and wrapped around to extend partially along the bottom of the bottom flange. The narrower strip was applied along the centerline of the bottom of the bottom flange of the girder to fill the gap between the termination points of the two wider FRP fabric sheets.

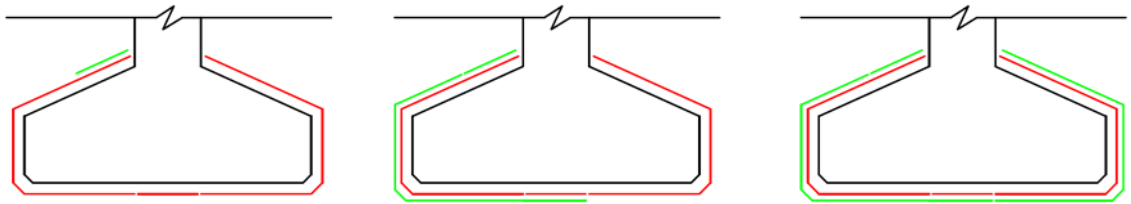
Figure 2.44: FRP installation sequence—second layer

The installation sequence for the second layer of FRP fabric is illustrated in Figure 2.44. The narrow sheet was applied at the joint of the web and top of bottom flange on one face of the girder. One of the wide sheets was applied beginning at the edge of the narrow sheet and

overlapped the centerline of the girder on the bottom flange. The remaining wide sheet began at the termination of the first wide sheet and wrapped around the bottom flange to terminate at the joint of the web and top of the bottom flange.

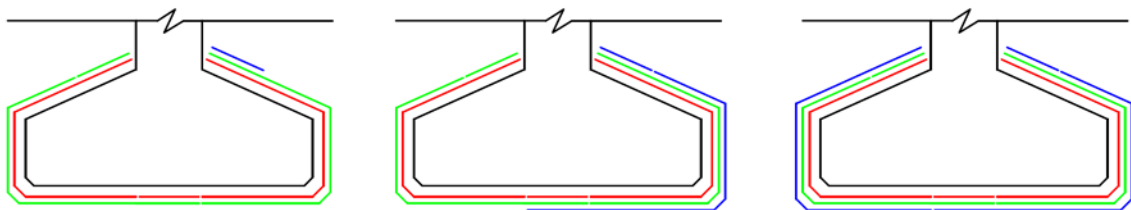
Figure 2.45: FRP installation sequence—third layer

The third layer was similar to the second layer, but the installation began with the narrow sheet being applied to the face of the girder opposite of the narrow sheet in the second layer. The sheets were arranged in this opposing pattern so that fabric of the third layer overlapped the seams in the second layer. The installation sequence for the third layer of FRP fabric is presented in Figure 2.45.

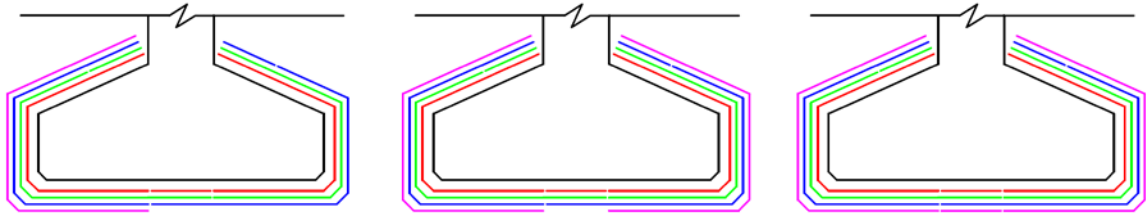
Figure 2.46: FRP installation sequence—fourth layer

The fourth layer pattern was identical to the symmetric first layer pattern. The installation sequence for the fourth layer of FRP fabric is presented in Figure 2.46.

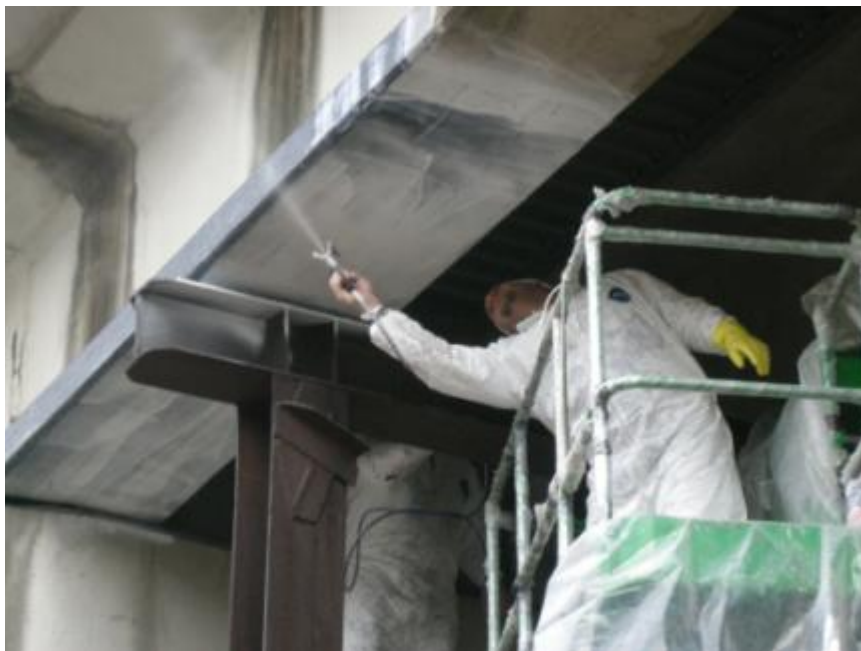
Figure 2.47: Painting of FRP reinforcement

After the epoxy of the FRP reinforcement sufficiently cured, the FRP surface was painted using Masonry, Stucco, and Brick Paint manufactured by Behr. This white acrylic latex paint was used to further protect the reinforcement from ultraviolet rays and weather-related distress over time. The paint was sprayed onto the FRP surface as shown in Figure 2.47, and the finished girders of Span 10 are shown in Figure 2.48.

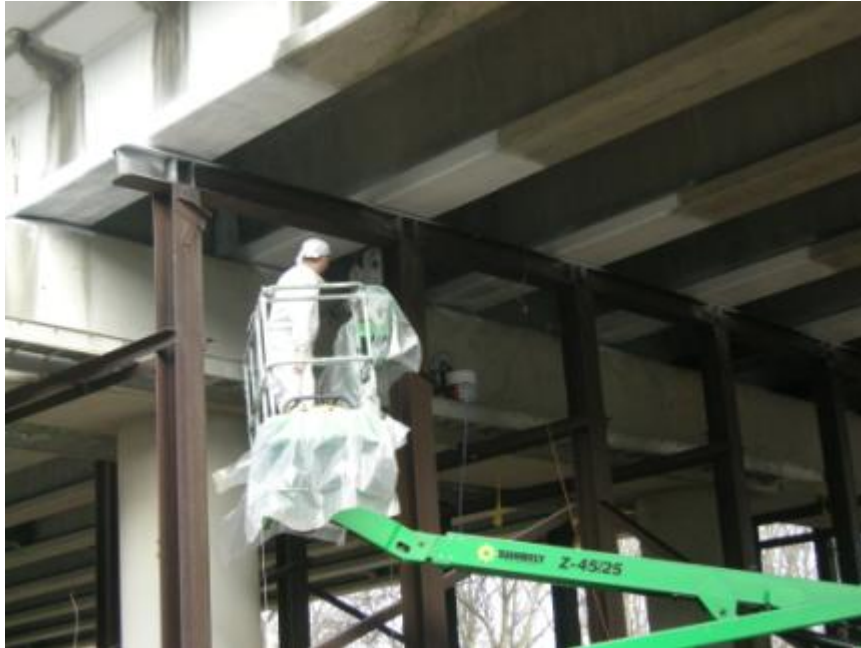
Figure 2.48: Painted FRP reinforcement of Span 10

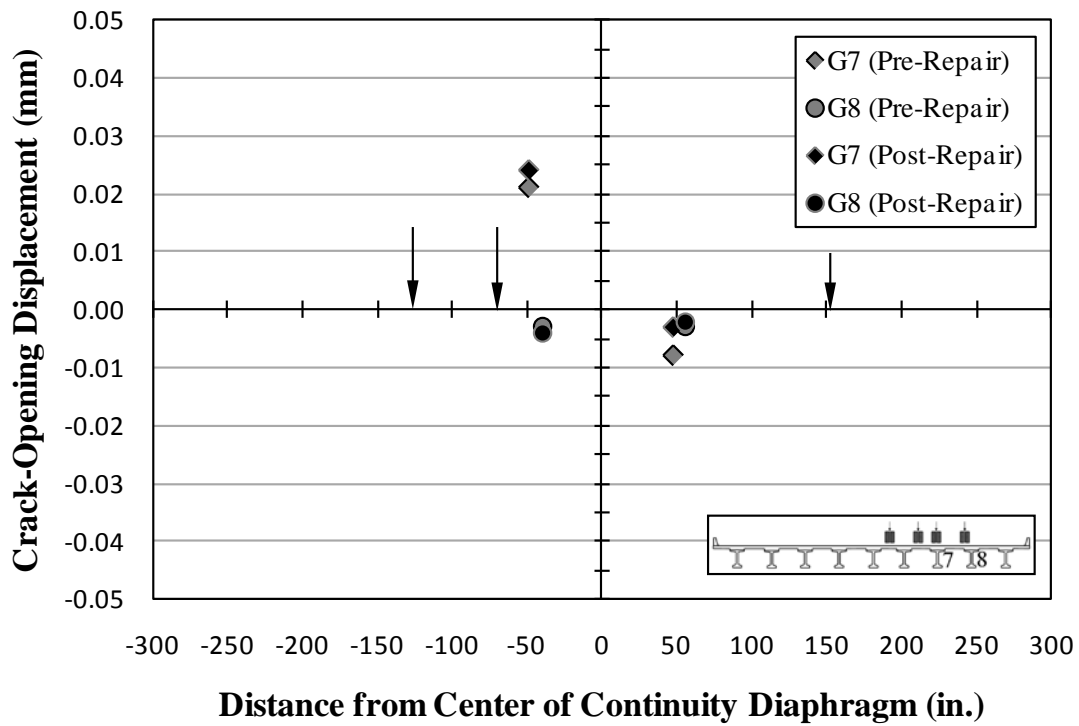
Figure 5.1: Crack-opening displacements—pre- and post-repair—A4

The comparison of crack-opening displacements from the pre- and post-repair tests in response to the same truck positions is one behavior that indicates that the bearing pads had a significant effect on the pre-repair measurements. Stop positions that resulted in crack openings were analyzed. Stop position locations are described in Section 4.4 of this report. During both the pre- and post-repair tests, Stop Position 4 had the greatest effect on the Span 10 crack

openings, and Stop Position 7 had the greatest effect on the Span 11 crack openings. The pre- and post-repair crack-opening displacement measurements for Stop Positions A4, A7, C4, and C7 are presented in Figures 5.1–5.4 and Table 5.1. The arrows in the figures represent the position of the wheel loads on the bridge.

The crack-opening displacements measured in Span 10 were similar for both pre- and post-repair testing, but the crack-opening displacements measured in Span 11 in response to the Stop Position 7 load condition of the post-repair test increased in comparison to the crack-opening displacements measured in response to the same load condition during pre-repair testing. This behavior corresponds with the Span 10 bearing pads being partially removed prior to pre-repair testing, and the Span 11 bearing pads being under enough pressure to prevent any removal prior to pre-repair testing. It is apparent that girder contact with the false support bearing pads under Span 11 resulted in additional support conditions that affected pre-repair measurements. This conclusion is further supported by the other comparisons that are located in Appendix K.

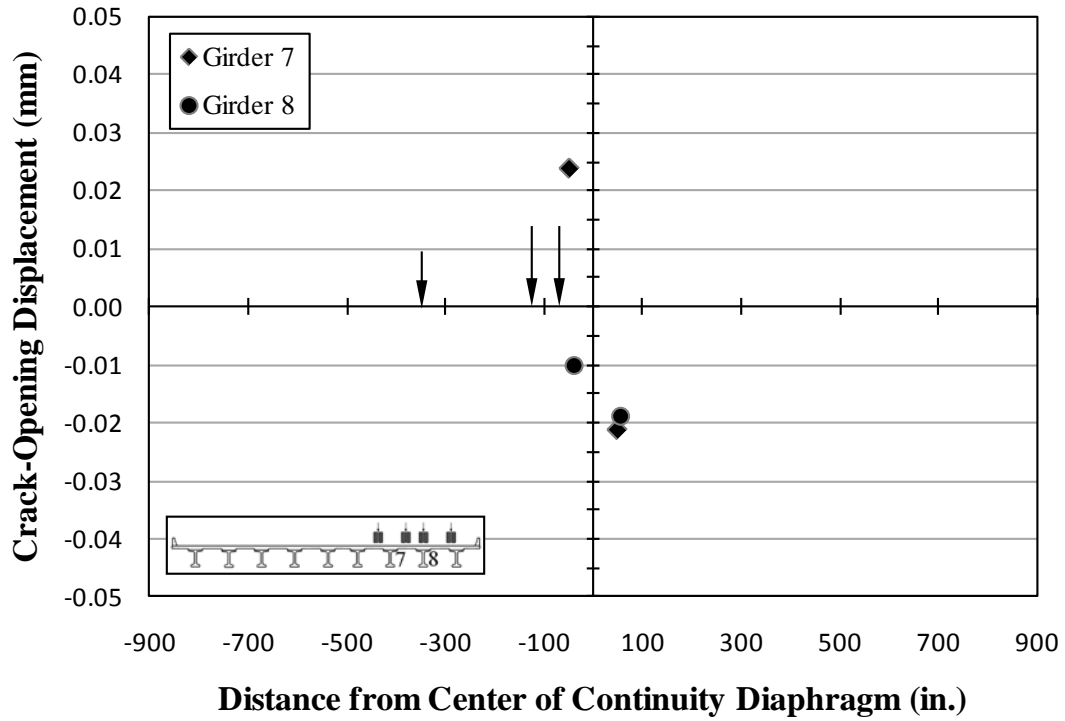
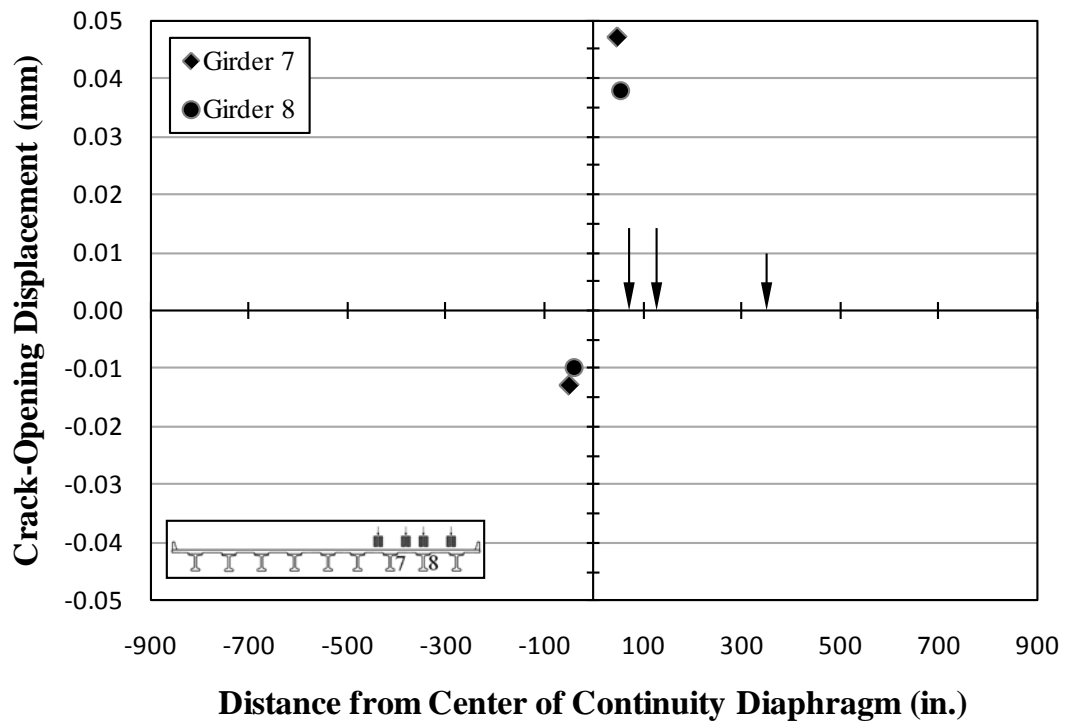
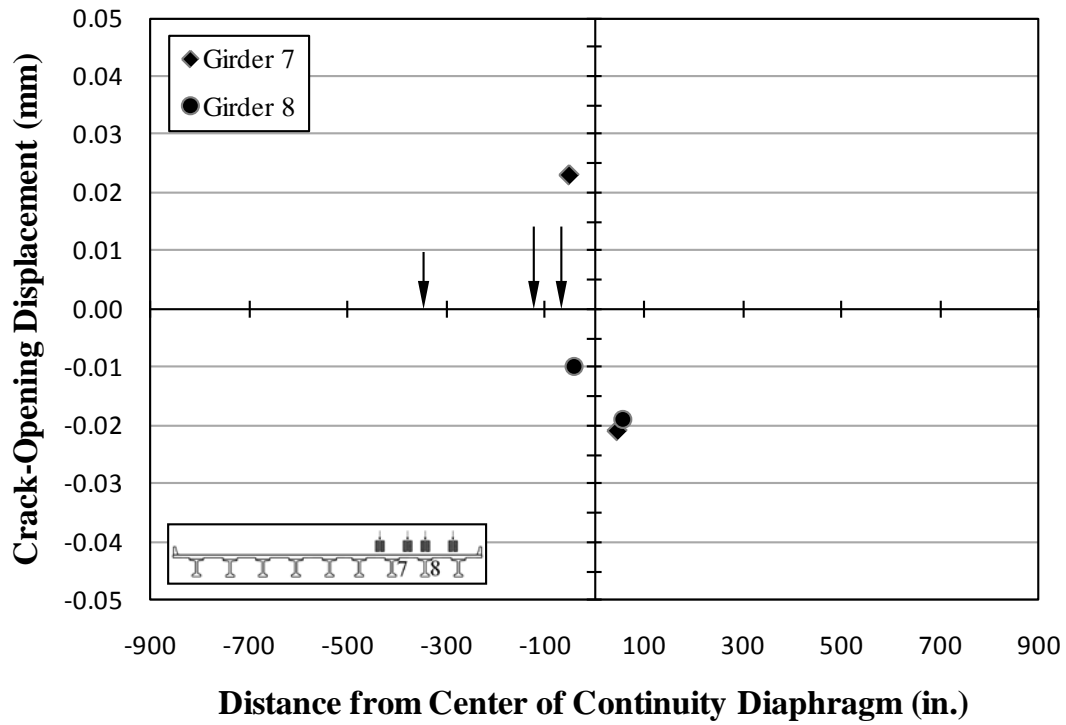
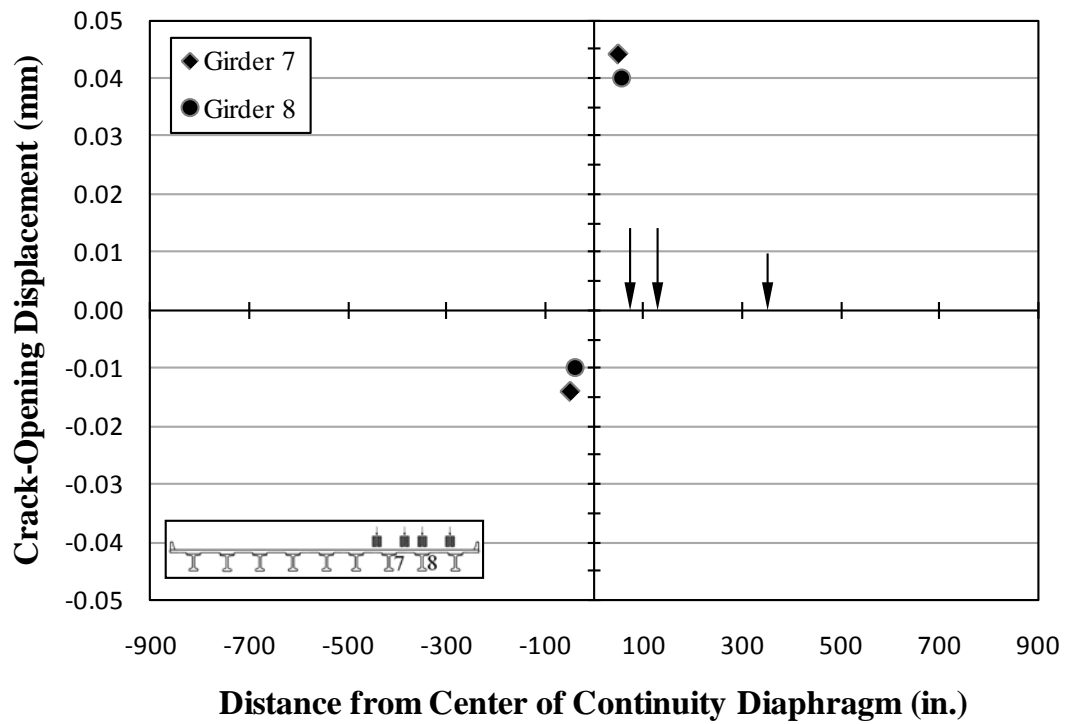
Figure 5.11: AE Span 10 truck position—crack-opening displacements—LC-6.5

Figure 5.12: AE Span 11 truck position—crack-opening displacements—LC-6.5

Figure 5.13: AE Span 10 truck position—crack-opening displacements—LC-6

Figure 5.14: AE Span 11 truck position—crack-opening displacements—LC-6

A maximum crack opening of 0.047 mm (1.83×10^{-3} in.) was measured by the COD gage on the east face of Girder 7 in Span 11 in response to the AE Span 11 static position. A maximum crack closure of 0.021 mm (0.84×10^{-3} in.) was measured by the same COD gage on the east face of Girder 7 in Span 11 but in response to the Span 10 static position. The COD gage on the west face of Girder 8 in Span 10 did not measure a crack opening due to any of the AE static positions.

The crack openings measured on the instrumented girders of Span 11 due to the Span 11 static position were of greater magnitude than the Span 10 crack openings due to the Span 10 static position. Similarly, the crack closures measured on the instrumented girders of Span 11 due to the Span 10 static position were of greater magnitude than the Span 10 crack closures due to the Span 11 static position. In response to trucks with consistent load-block configurations, the maximum range of crack-opening displacements on an instrumented Span 11 crack was 0.068 mm (2.67×10^{-3} in.) measured by the COD gage on Girder 7 of Span 11. The maximum range of crack-opening displacements on an instrumented Span 10 crack was 0.037 mm (1.47×10^{-3} in.) measured by the COD gage on Girder 7 of Span 10.

The crack-opening displacements measured for the instrumented crack on Girder 8 of Span 10 exhibited behavior that was inconsistent with the other three instrumented cracks.

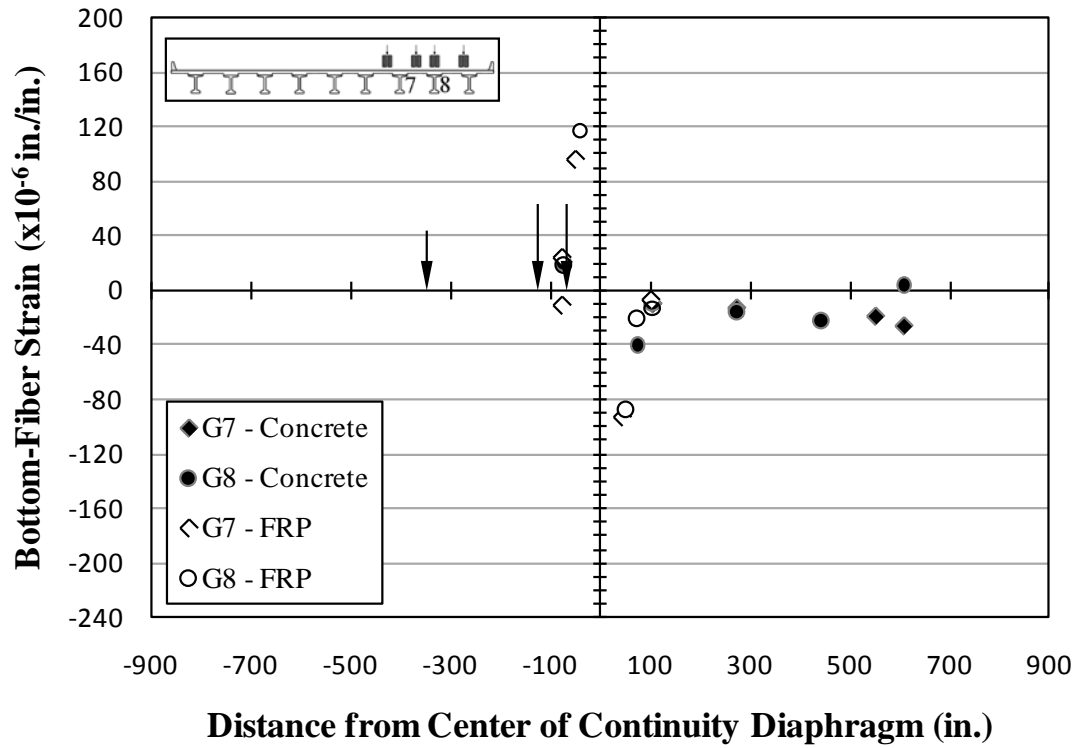
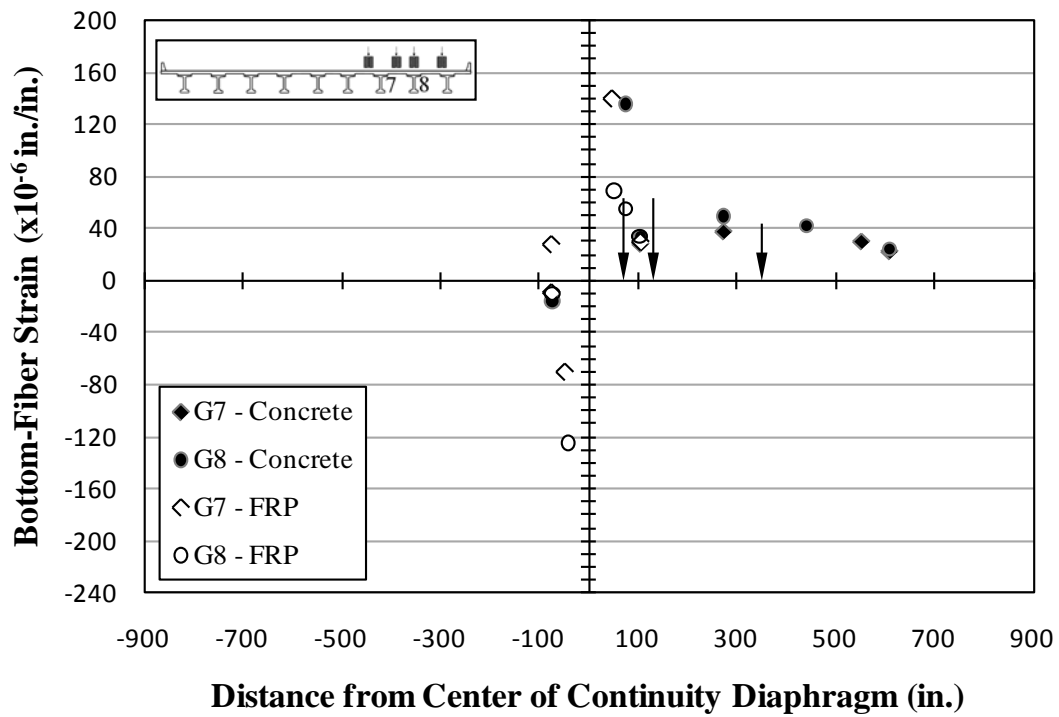
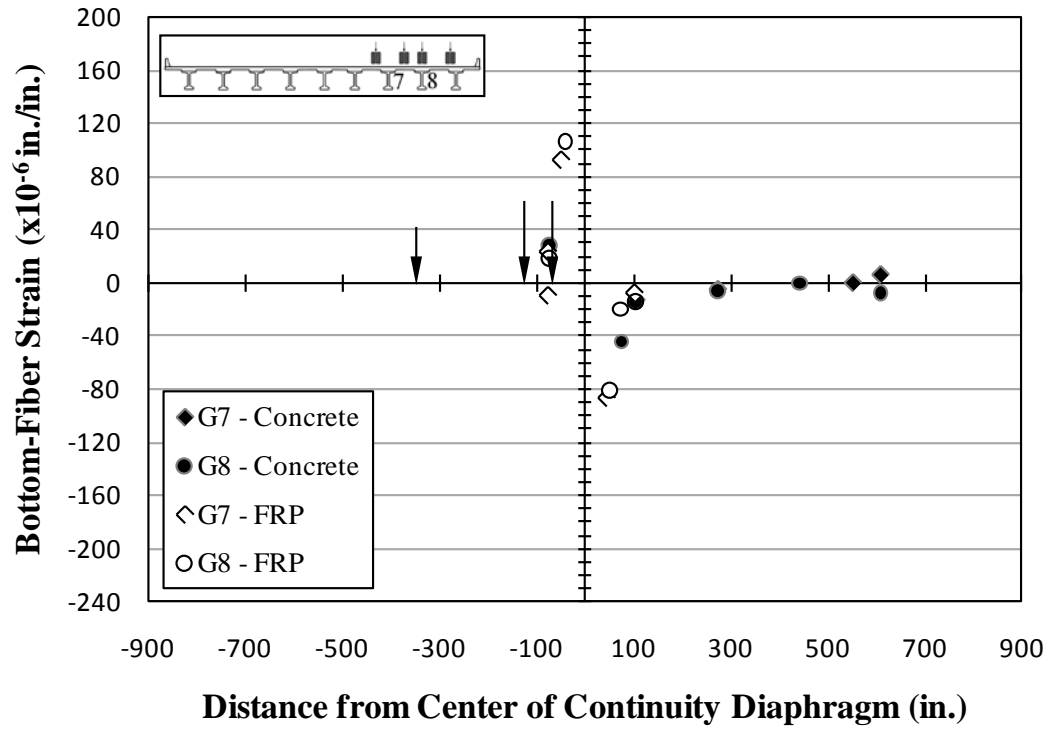
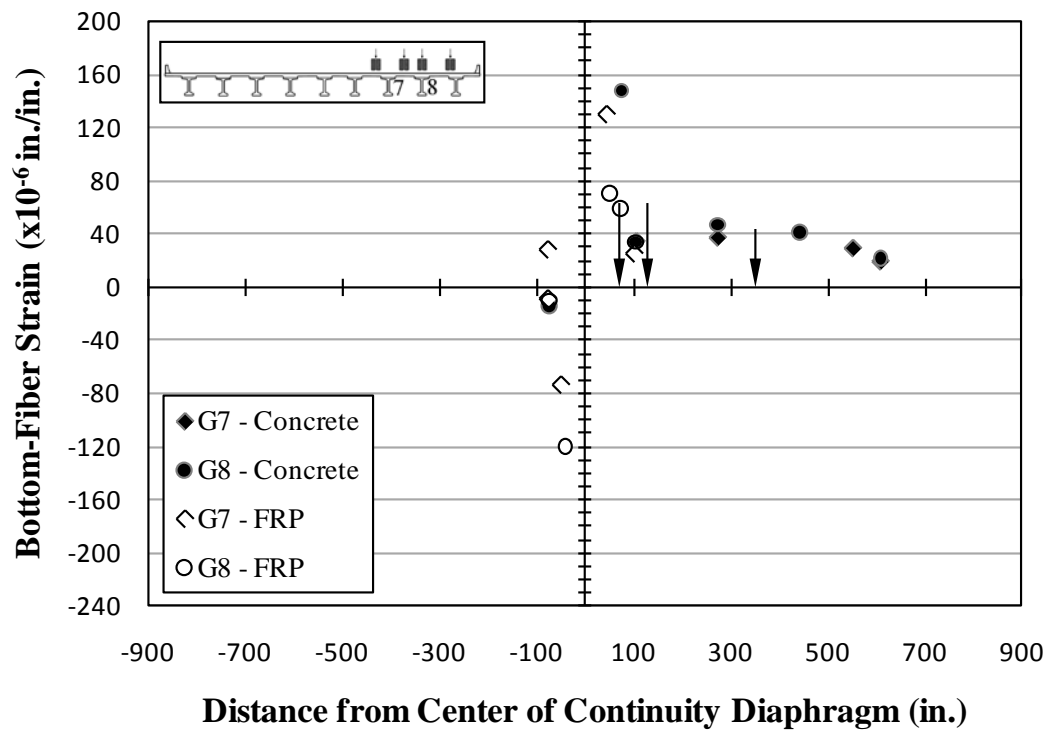
Figure 5.15: AE Span 10 truck position—bottom-fiber strains—LC-6.5

Figure 5.16: AE Span 11 truck position—bottom-fiber strains—LC-6.5

Figure 5.17: AE Span 10 truck position—bottom-fiber strains—LC-6

Figure 5.18: AE Span 11 truck position—bottom-fiber strains—LC-6

A maximum bottom-fiber near-crack FRP reinforcement tensile strain of 140×10^{-6} in./in. was measured 47 in. from the center of the continuity diaphragm at the crack on Girder 7 of Span 11 in response to the Span 11 static position. A maximum bottom-fiber near-crack FRP reinforcement compressive strain of 125×10^{-6} in./in. was measured 41 in. from the center of the continuity diaphragm at the crack on Girder 8 of Span 10 in response to the Span 11 static position.

In response to the AE static positions, the FRP strain gage installed at the crack location of Girder 7 in Span 11 measured tensile and compressive strains of greater magnitude than the strains measured at the gage installed at the crack location of Girder 7 in Span 10. The FRP strain gage installed at the crack location of Girder 8 in Span 10 measured strains of greater magnitude than the strains measured at the gage installed at the crack location of Girder 8 in Span 11. The magnitudes of strain measured at the FRP gage corresponding with the crack location on Girder 8 of Span 11 were not consistent with the magnitudes of strain measured at the crack locations of the other girders. Also, the concrete strain gage on Girder 8 of Span 11 located 75 in. from the continuity diaphragm measured tensile strains similar to the tensile strains measured at the FRP corresponding with the crack locations of the other girders.
