Research Report No. 2F for ALDOT Project 930-601

**REPAIR OF CRACKED PRESTRESSED
CONCRETE GIRDERS, I-565,
HUNTSVILLE, ALABAMA**

The Alabama Department of Transportation

JULY 2011

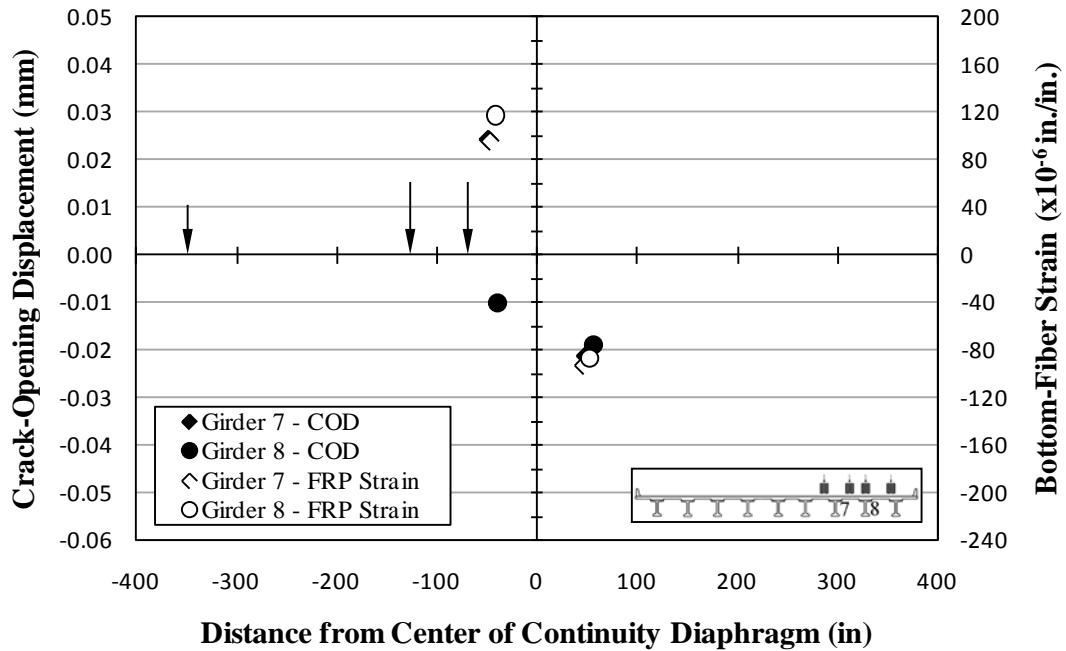
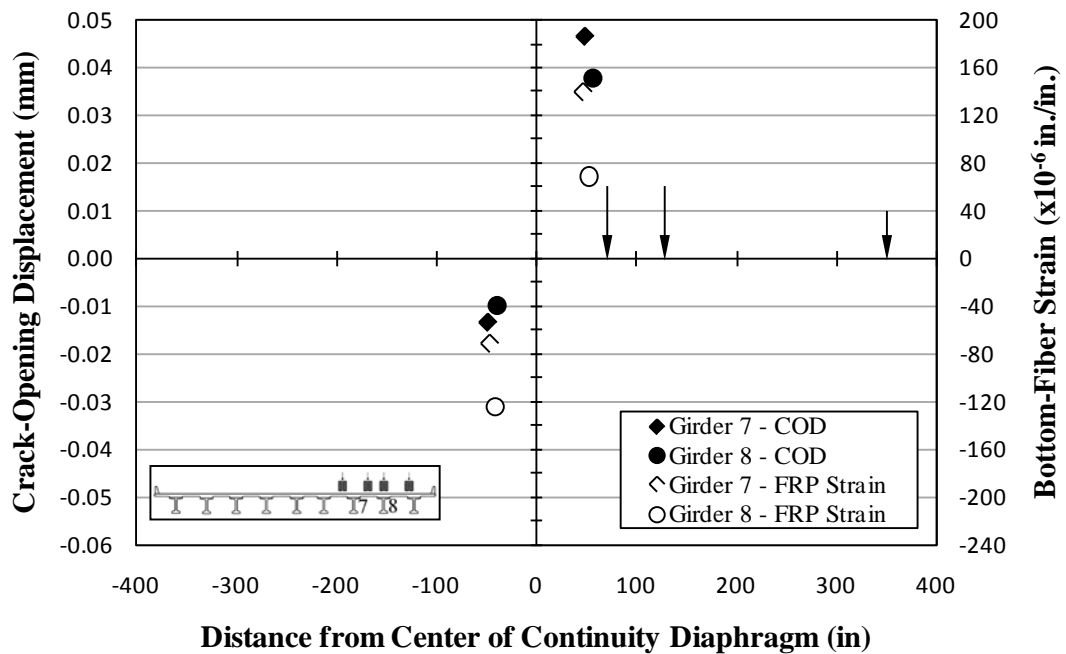
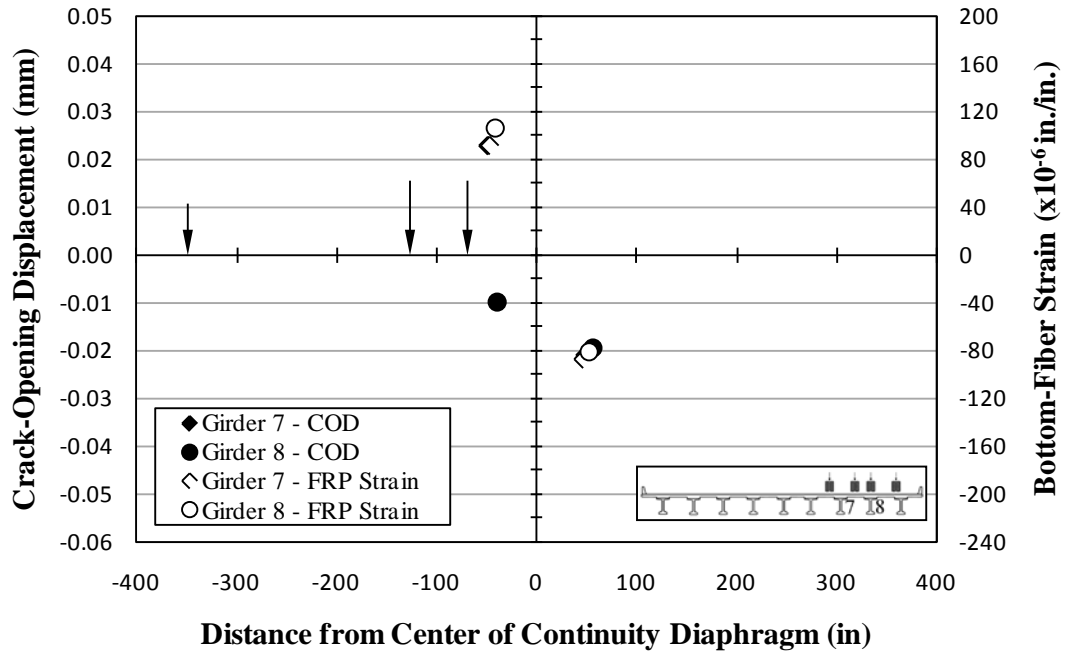
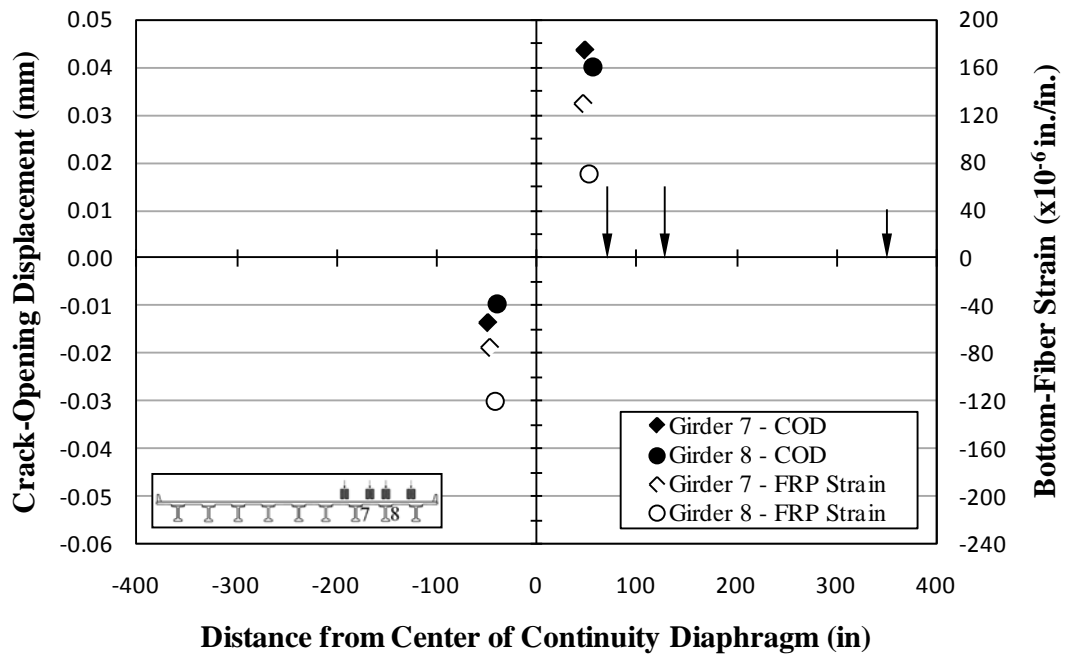
Figure 5.19: COD and bottom-fiber strain comparisons—LC-6.5—AE Span 10

Figure 5.20: COD and bottom-fiber strain comparisons—LC-6.5—AE Span 11

Figure 5.21: COD and bottom-fiber strain comparisons—LC-6—AE Span 10

Figure 5.22: COD and bottom-fiber strain comparisons—LC-6—AE Span 11

The COD and near-crack bottom-fiber strain measurements of Girder 8 in Span 10 exhibited contradicting behavior. Crack closure was measured in response to the Span 10 load condition while a near-crack bottom-fiber tensile strain was measured. The tensile strain measured at the Girder 8-Span 10 near-crack strain gage location was similar to the tensile strain

The crack-opening displacement behavior of Girder 8 in Span 11 was similar to the bottom-fiber strain behavior at the crack location of the same girder. Tensile strains were measured when crack-openings were observed, and compressive strains were measured when crack closures were observed. However, the relationship between the bottom-fiber strain and crack-opening displacement for Girder 8-Span 11 was not similar to the relationships observed in Girder 7-Span 11 and Girder 7-Span 10. The bottom-fiber strain gage on Girder 8 of Span 11 measured less tensile strain relative to a respective crack opening when compared to the other two girders. In response to the load conditions resulting in the maximum crack openings for each COD gage, the ratio of crack opening to the near-crack bottom-fiber FRP strain was 250 mm (10 in.) for Girder 7-Span 10, 330 mm (13 in.) for Girder 7-Span 11, and 570 mm (22 in.) for Girder 8-Span 11. These three ratios are an indication that the relationship between crack opening and bottom-fiber tensile strain varies for each damaged region.

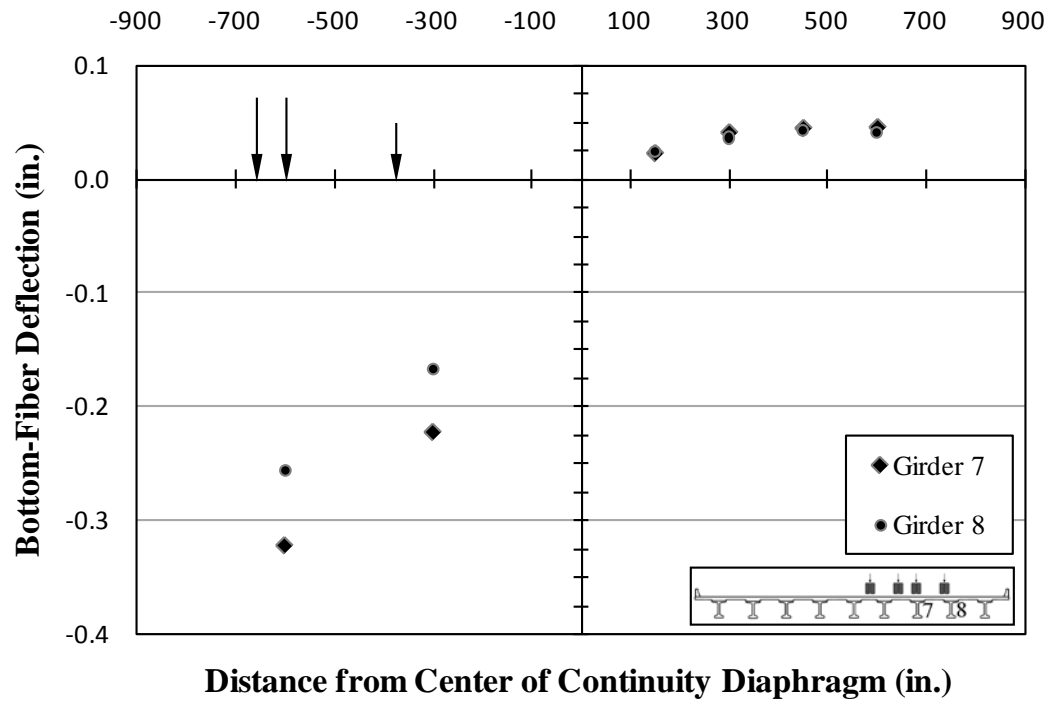
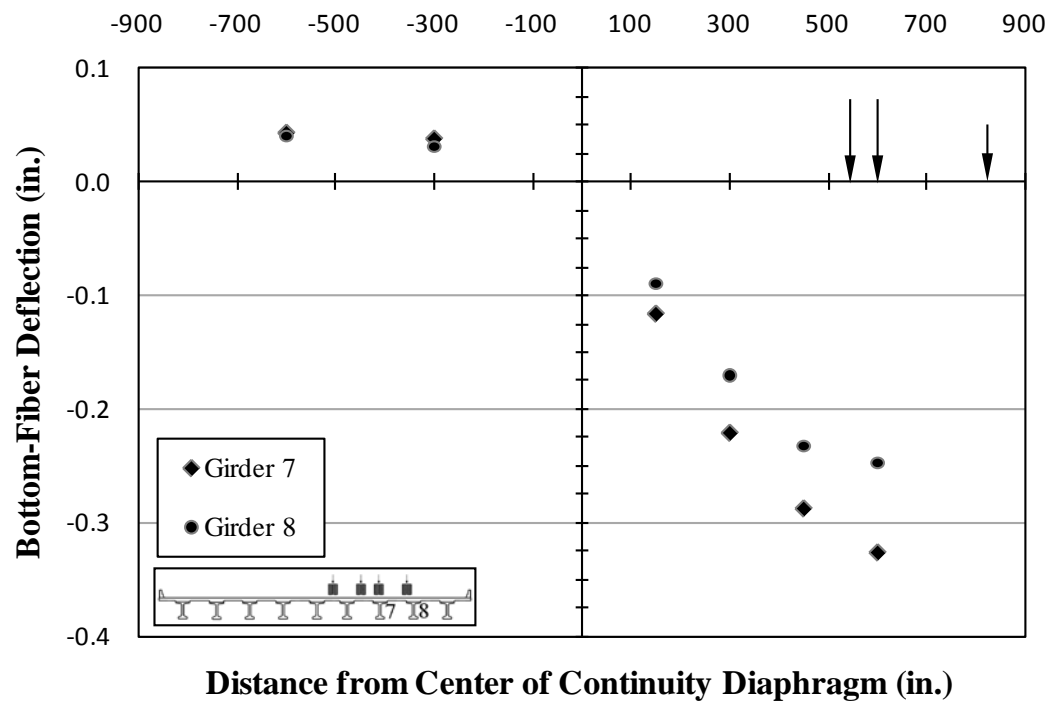
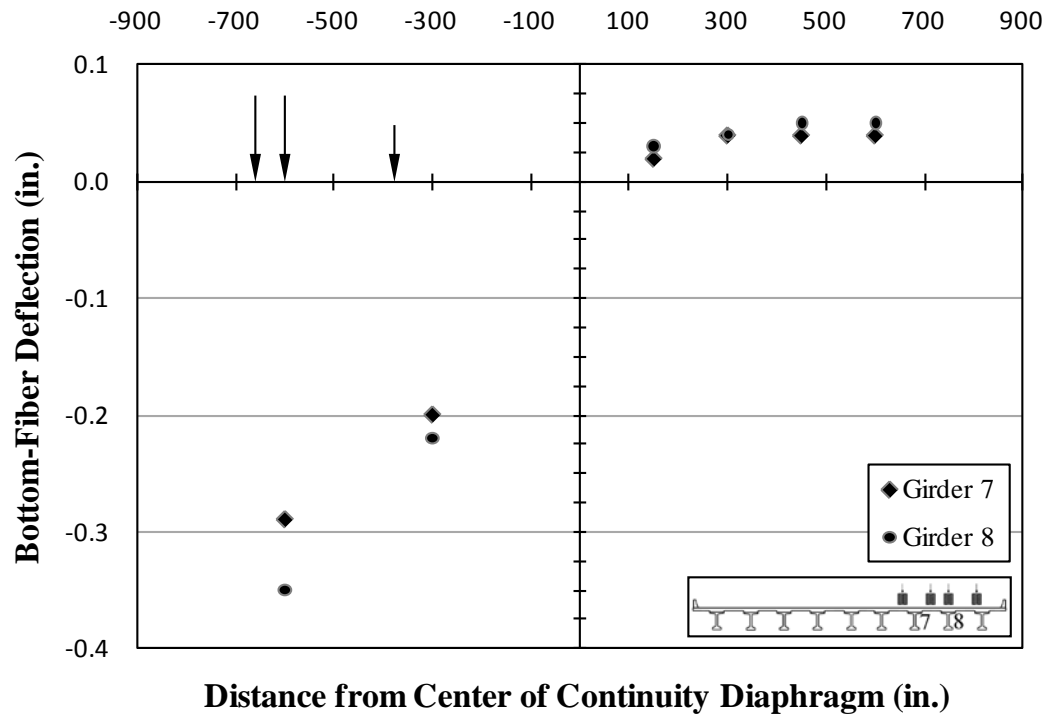
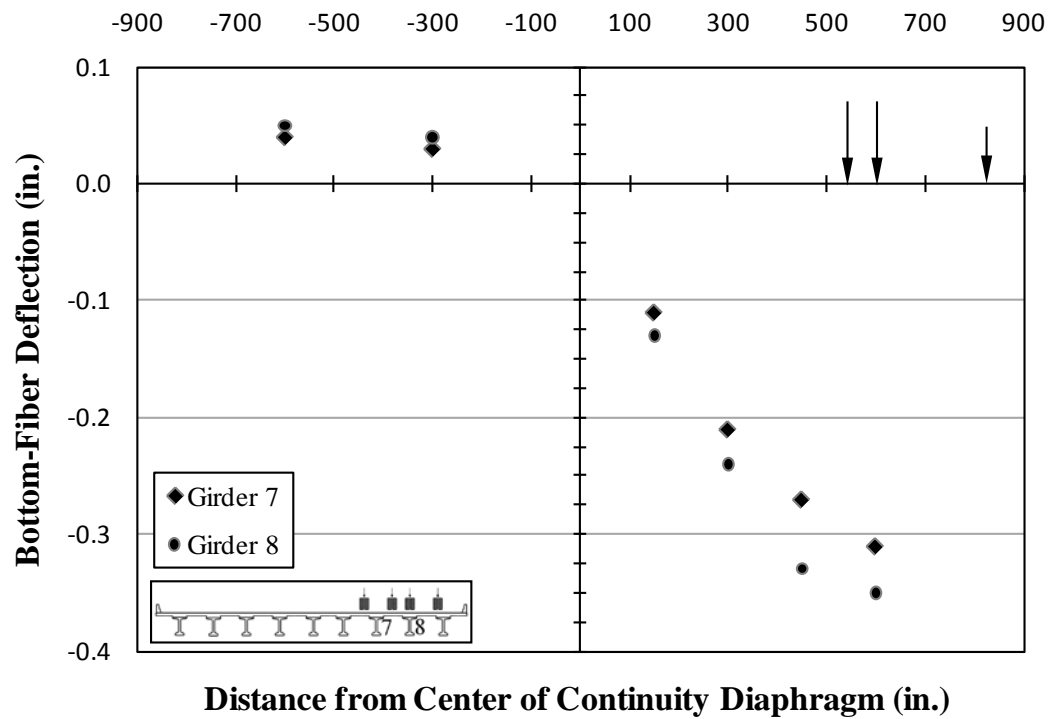
Figure 5.23: Deflections—A1

Figure 5.24: Deflections—A9

Figure 5.25: Deflections—C1

Figure 5.26: Deflections—C9

A maximum downward deflection of 0.35 in. was measured at the midspan location of Span 11 due to the Span 11 midspan load condition. A maximum upward deflection of 0.05 in. was measured at three different locations due to separate load conditions. The upward deflections due to live loads are an indicator that partial continuity has been preserved.

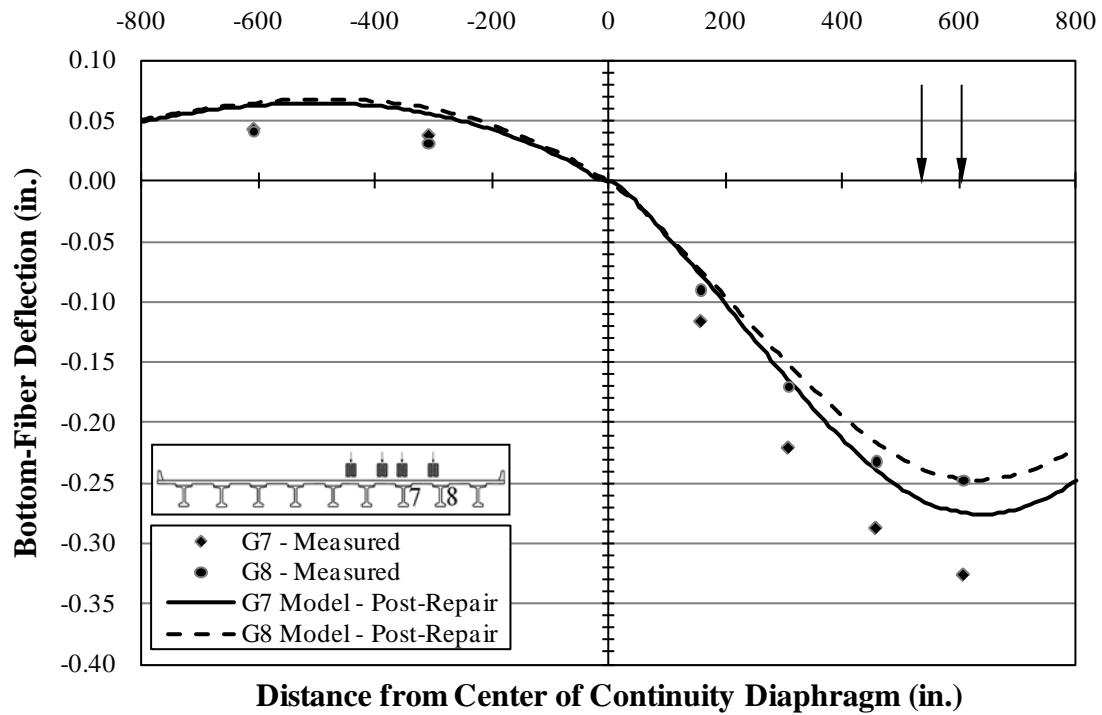
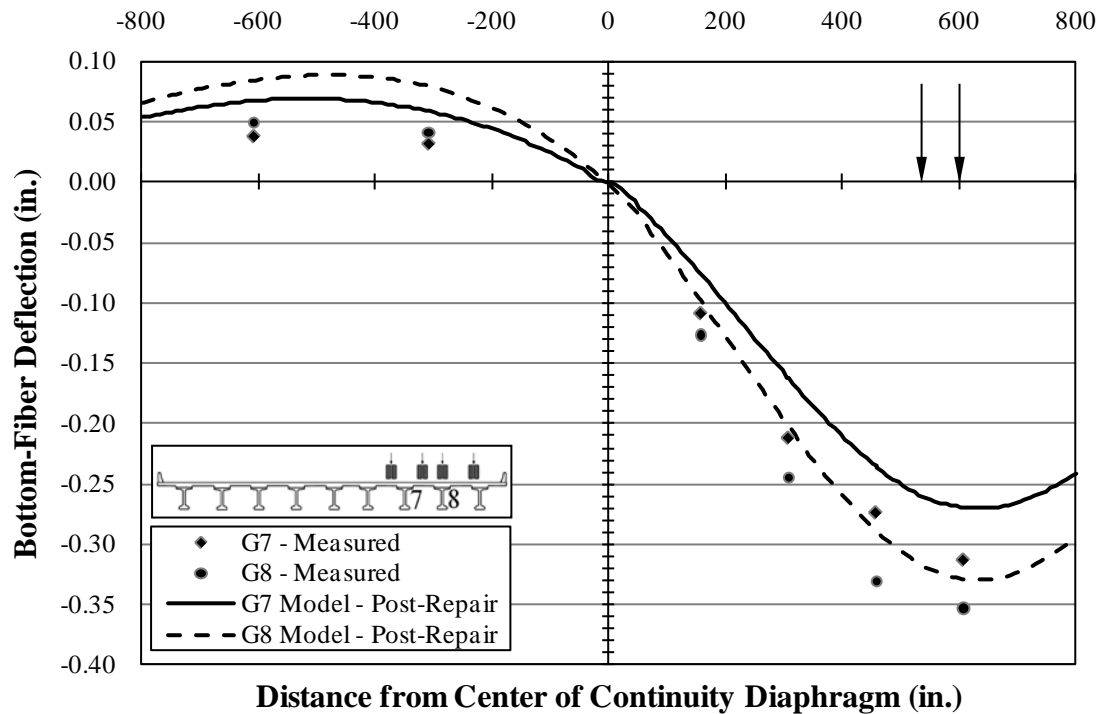
Figure 5.27: Deflections—post-repair—measurements and predictions—A9

Figure 5.28: Deflections—post-repair—measurements and predictions—C9

Post-repair deflection measurements are an indication that the *modeled* post-repair structure exhibits more apparent stiffness and continuity than the *actual* post-repair structure. The downward deflections measured in the loaded span were greater than the downward deflections predicted. The upward deflections measured in the non-loaded span were less than the upward deflections predicted.

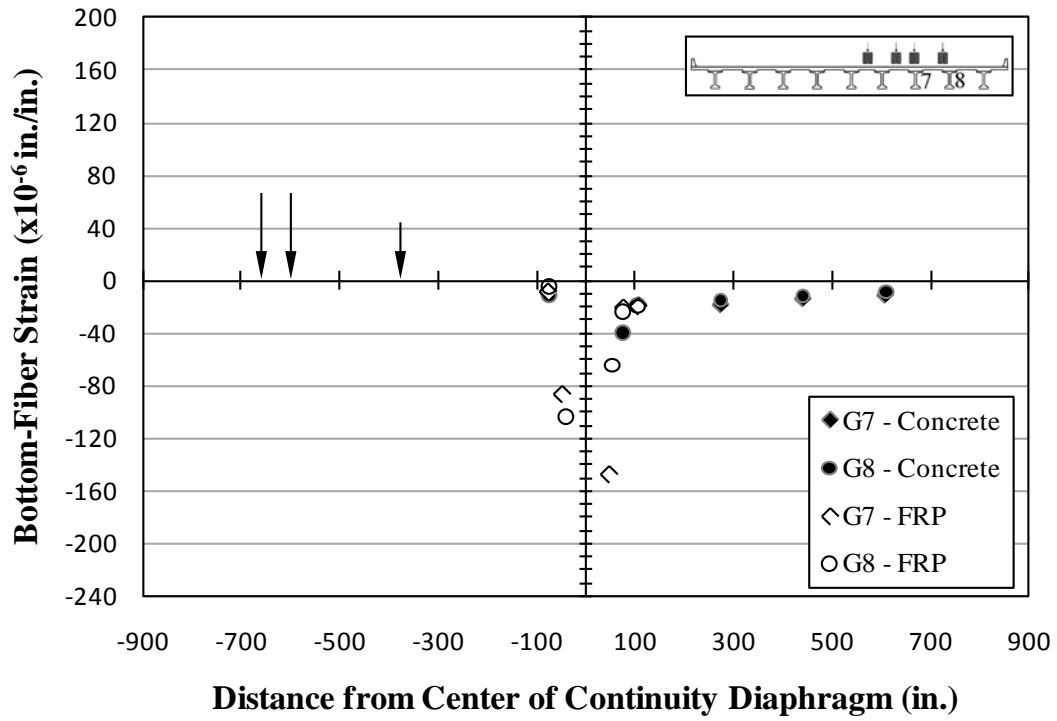
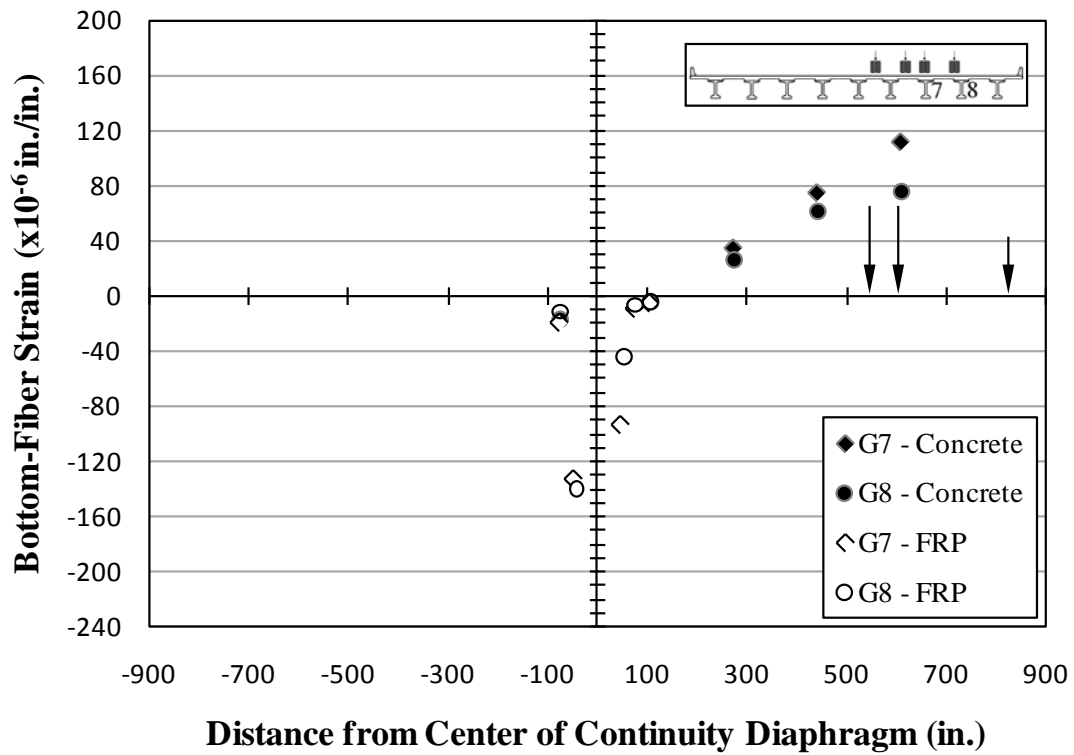
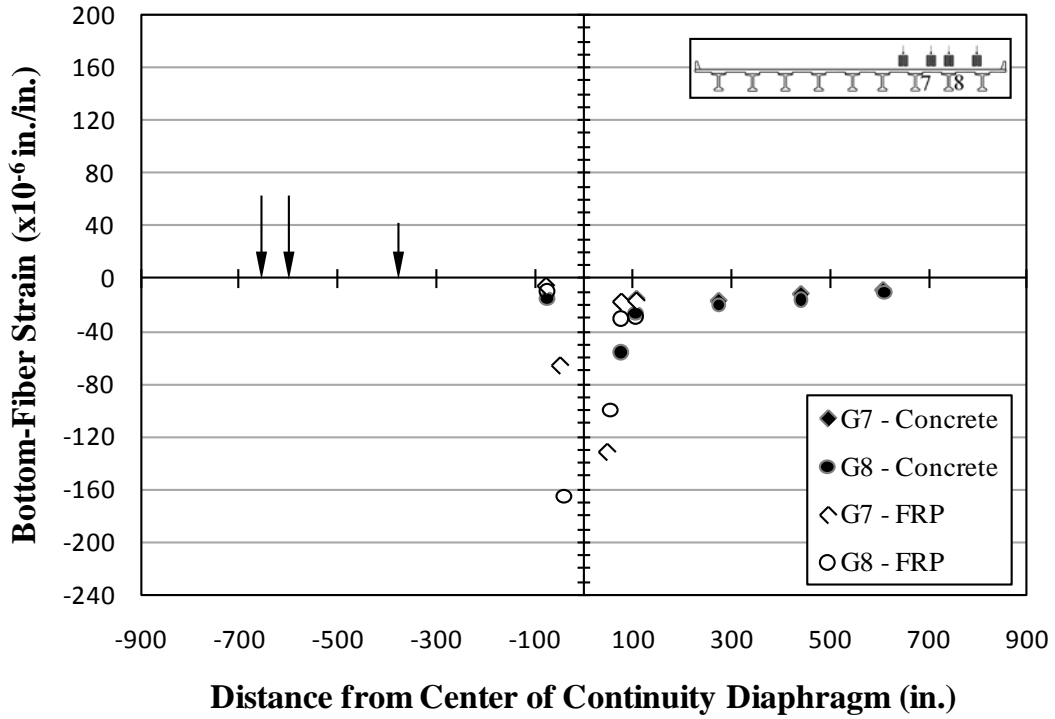
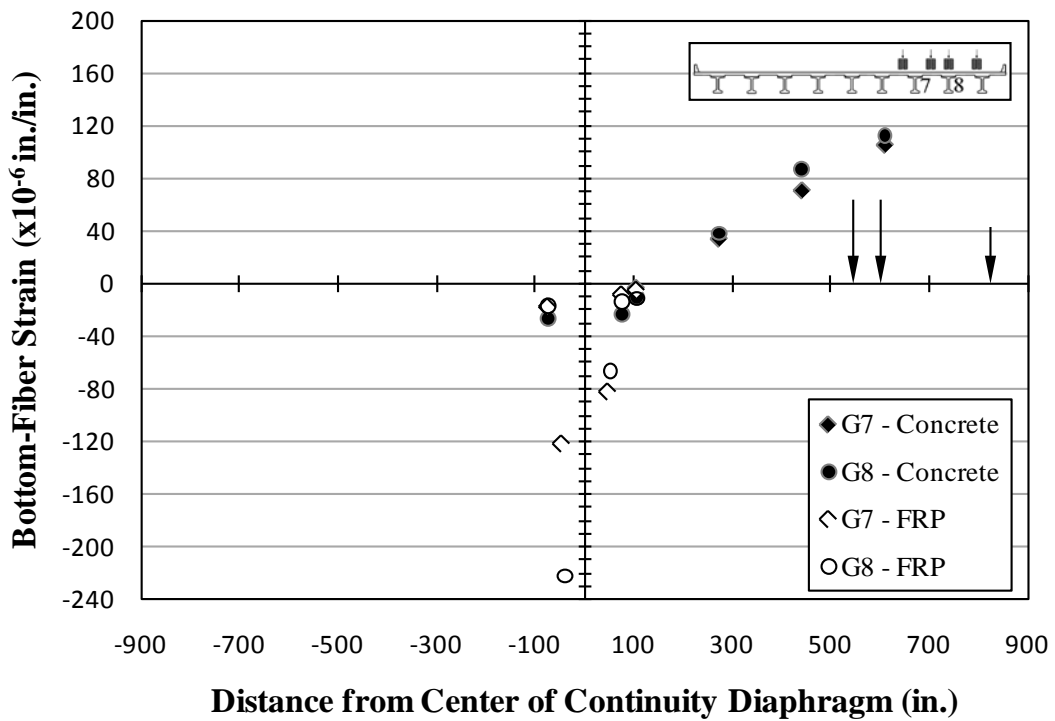
Figure 5.29: Bottom-fiber strain—A1

Figure 5.30: Bottom-fiber strain—A9

Figure 5.31: Bottom-fiber strain—C1

Figure 5.32: Bottom-fiber strain—C9

The maximum bottom-fiber compressive strain measured during the post-repair static load test was 222×10^{-6} in./in. at the FRP reinforcement near the crack location of Girder 8 in Span 10 due to the Lane C midspan static position of Span 11. This bottom-fiber compressive response in the non-loaded span is a sign of continuous behavior.

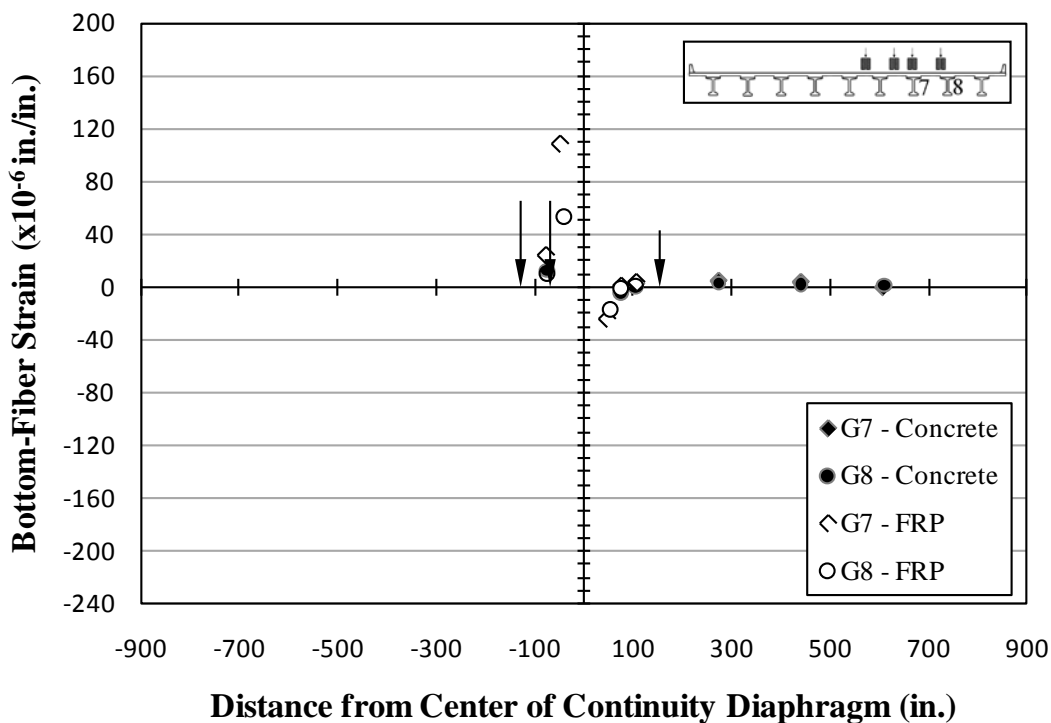
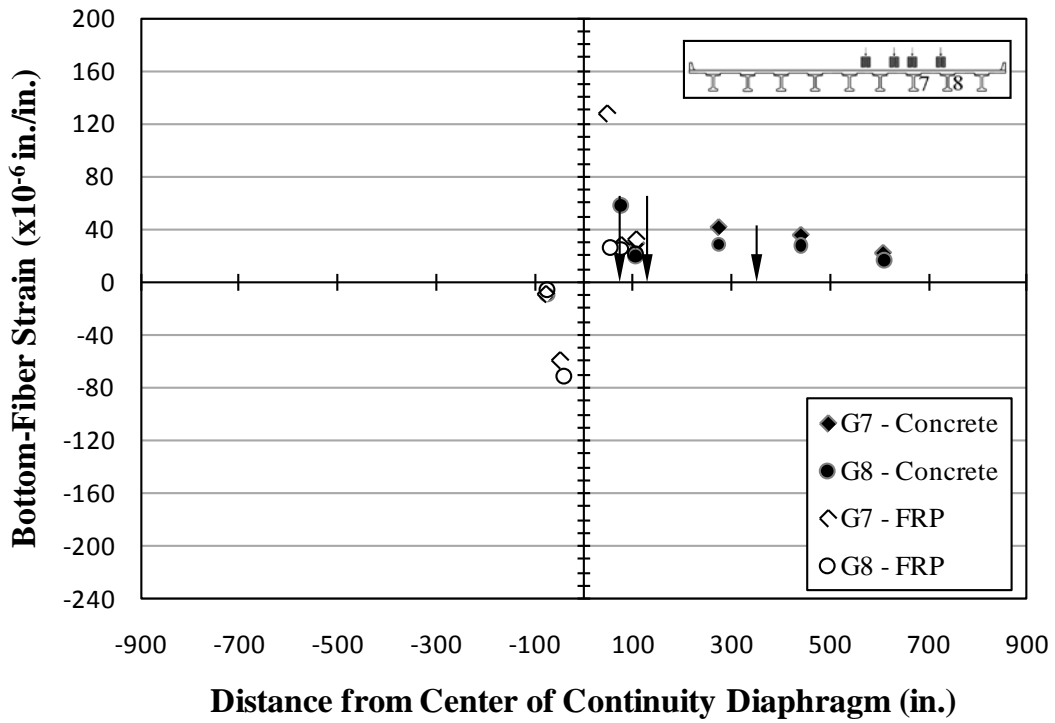
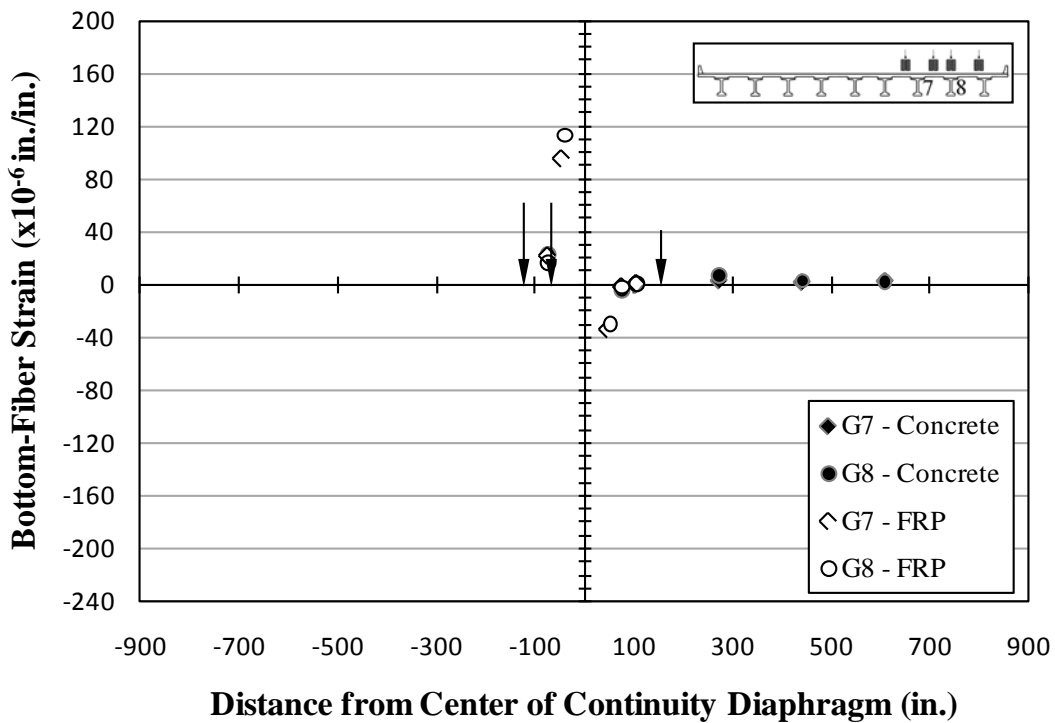
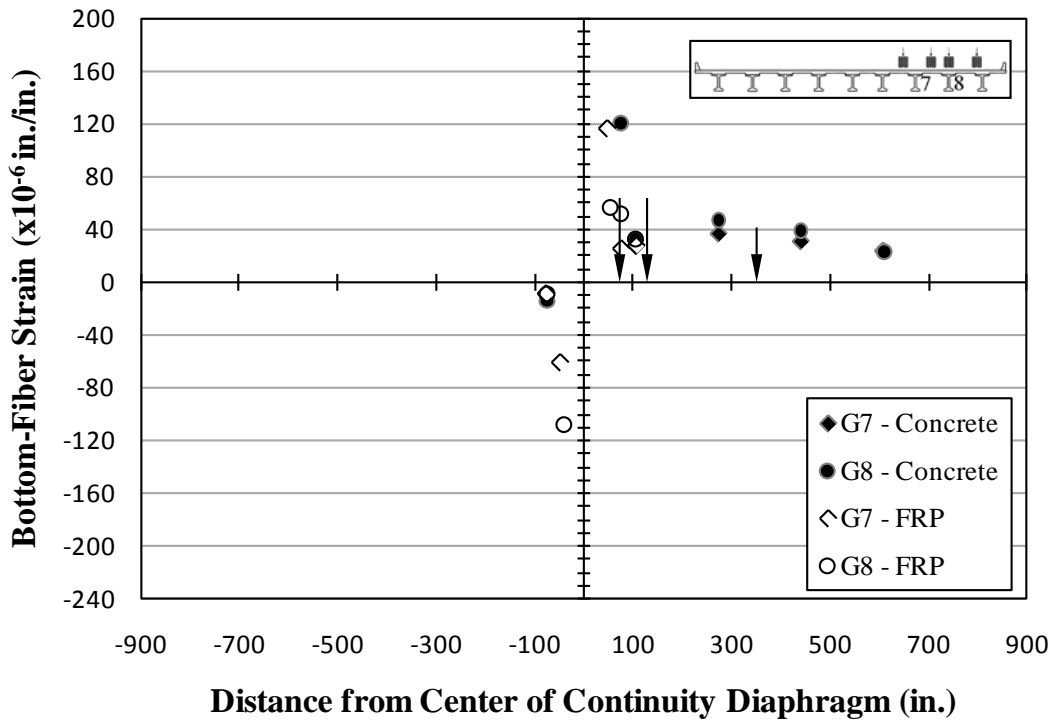
Figure 5.33: Bottom-fiber strain—A4

Figure 5.34: Bottom-fiber strain—A7

Figure 5.35: Bottom-fiber strain—C4

Figure 5.36: Bottom-fiber strain—C7

The maximum bottom-fiber tensile strain measured in response to the eighteen post-repair traversing-load-test truck positions was 128×10^{-6} in./in. near the crack location 47 in. from the continuity diaphragm along Girder 7 of Span 11 in response to trucks aligned with Lane A and positioned near the damaged section (A7). A bottom-fiber tensile strain of 28×10^{-6} in./in. was measured 74 in. from the continuity diaphragm along the same girder and in response to the same load condition. This bottom-fiber tensile response near the continuity diaphragm is a sign of local behavior that decreases the overall continuity of the bridge structure.

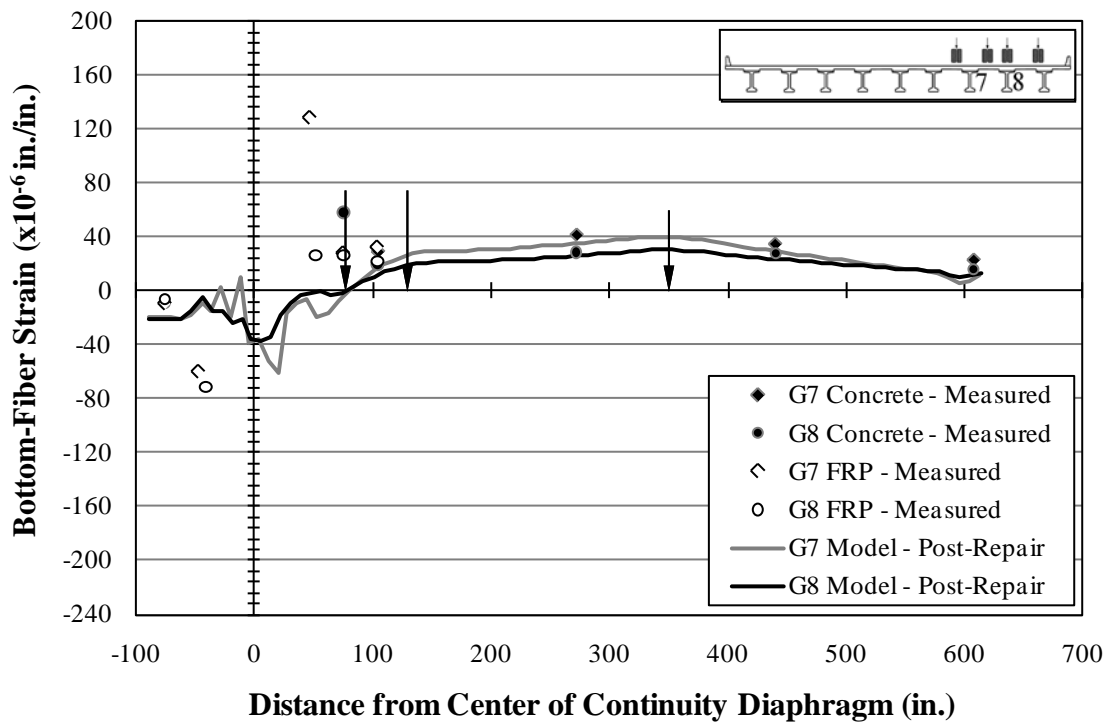
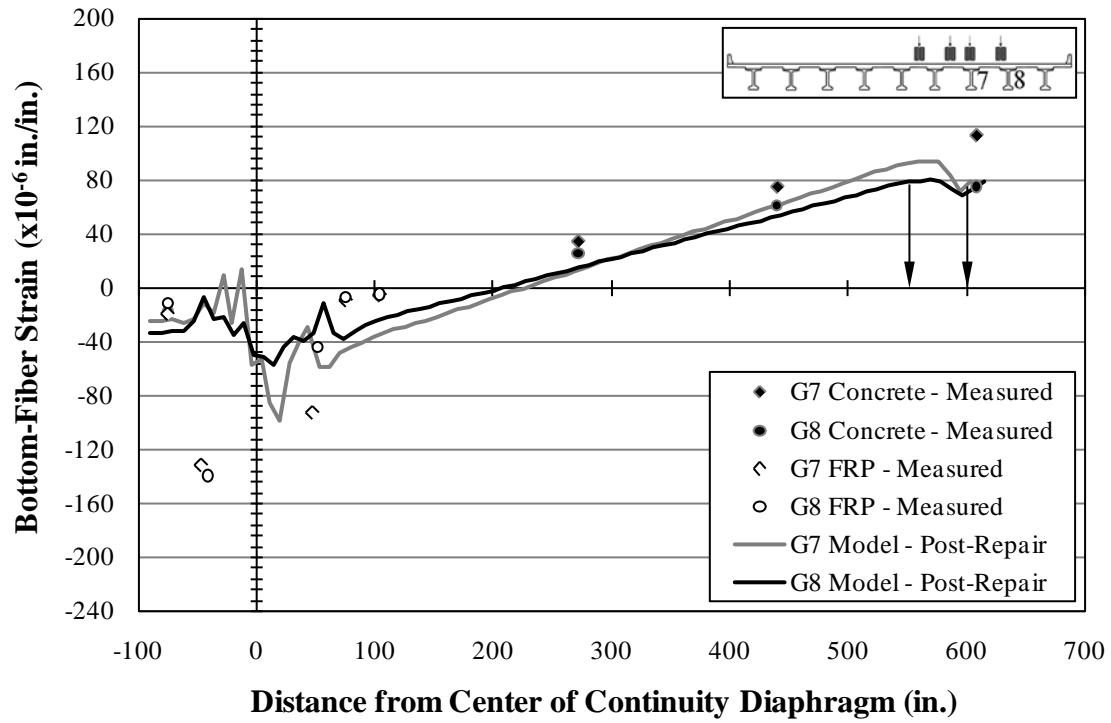
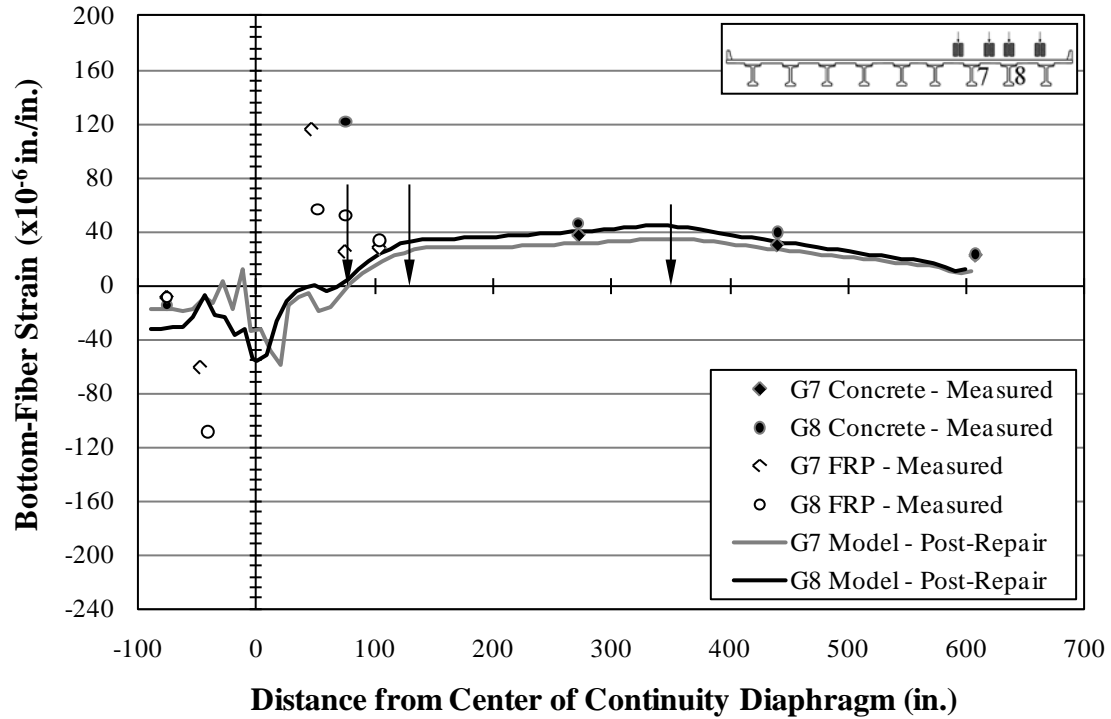
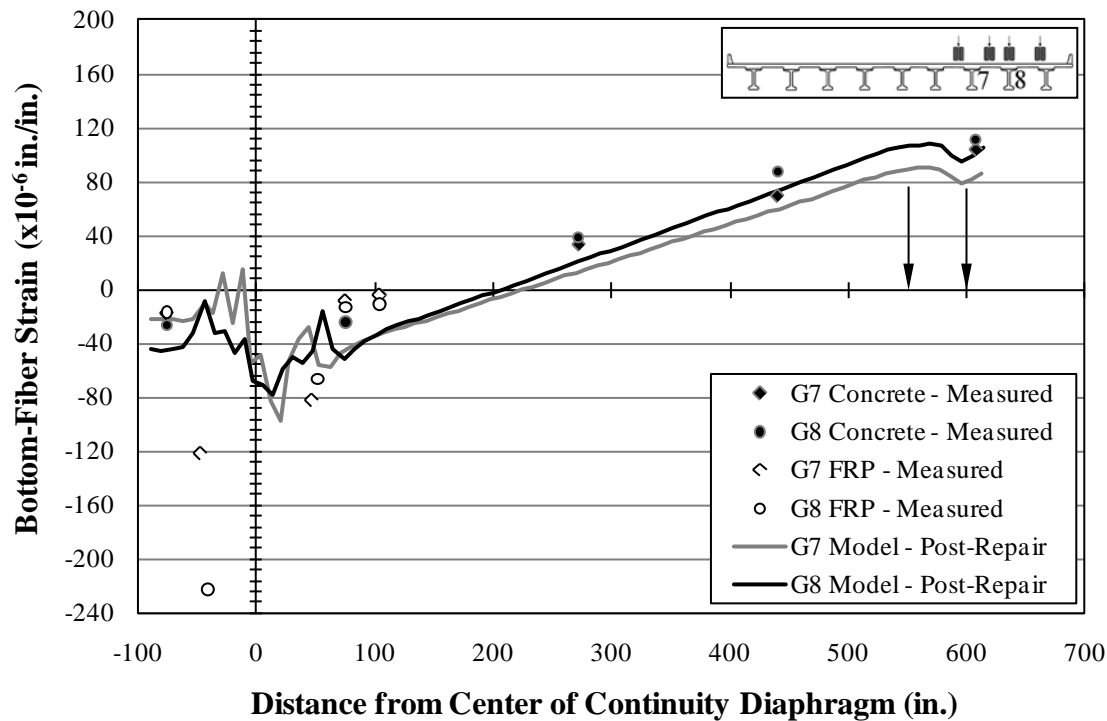
Figure 5.37: Bottom-fiber strain—post-repair—measurements and predictions—A7

Figure 5.38: Bottom-fiber strain—post-repair—measurements and predictions—A9

Figure 5.39: Bottom-fiber strain—post-repair—measurements and predictions—C7

Figure 5.40: Bottom-fiber strain—post-repair—measurements and predictions—C9

Bottom-fiber strains measured beyond the damaged regions were similar to the predicted strains, but they were slightly more tensile. This is an indicator that the bridge structure is behaving continuously, but with slightly less apparent stiffness than modeled. The measured bottom-fiber strains near the damaged region were not similar to the predicted strains. When the trucks were positioned near the damaged regions of Span 11, the bottom-fiber strains measured near the crack locations of Span 11 were more tensile than predicted. When the trucks were positioned near midspan of Span 11, the bottom-fiber strains measured near the crack locations of Span 10 were more compressive than predicted.

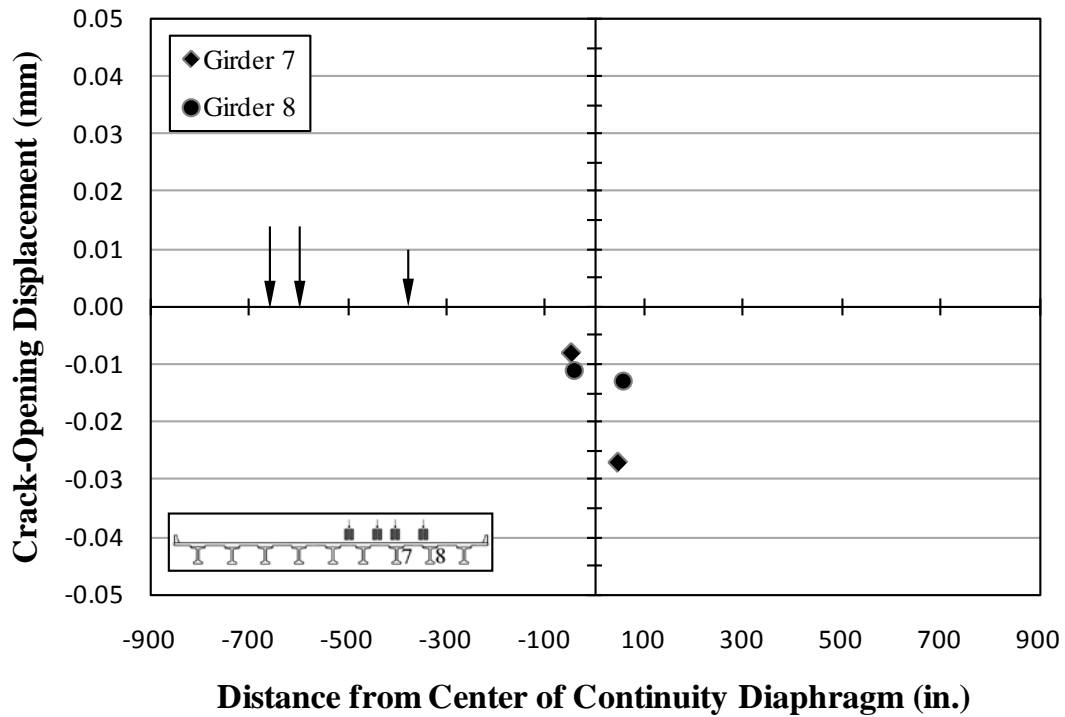
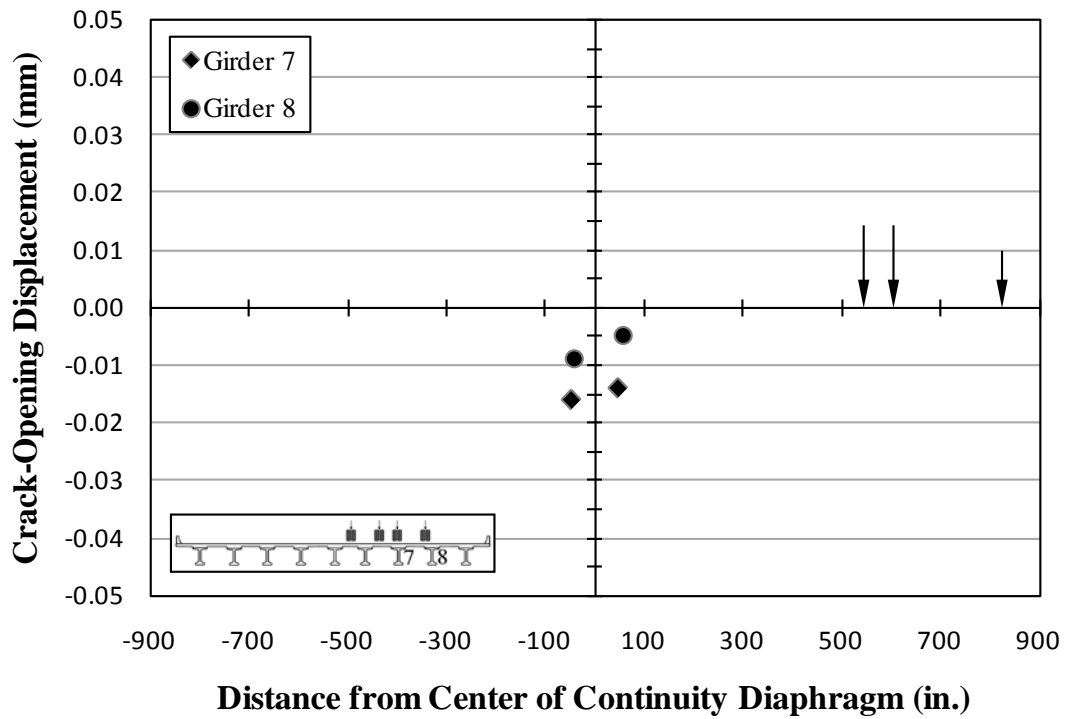
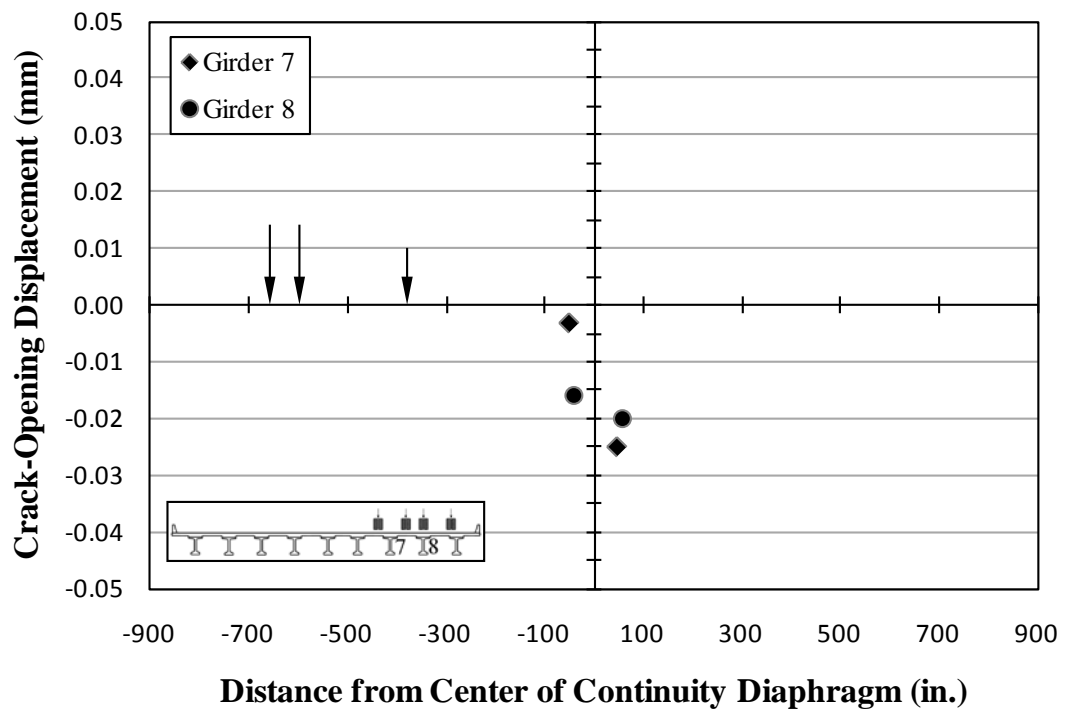
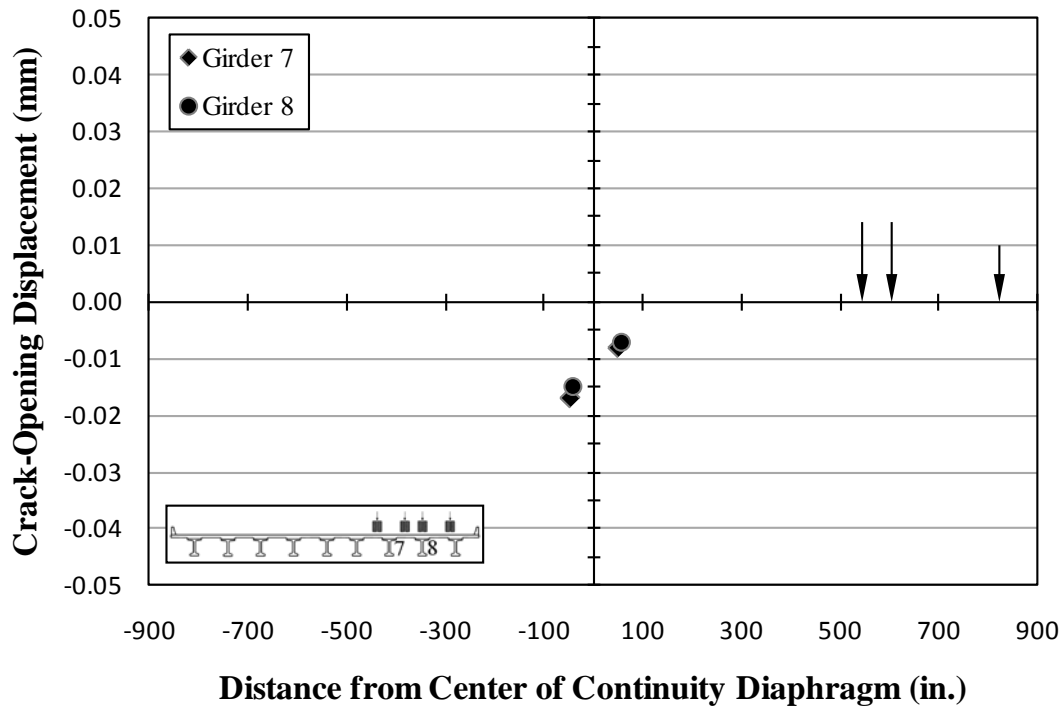
Figure 5.41: Midspan truck positions—crack-opening displacements—A1

Figure 5.42: Midspan truck positions—crack-opening displacements—A9

Figure 5.43: Midspan truck positions—crack-opening displacements—C1

Figure 5.44: Midspan truck positions—crack-opening displacements—C9

location of Girder 7 in response to the Lane C midspan load condition of Span 11 (C9). Crack closures measured at damaged regions of both spans in response to midspan truck positions are signs of continuous behavior being partially preserved as well as decreased local apparent stiffness.
