Research Report No. 2F for ALDOT Project 930-601

**REPAIR OF CRACKED PRESTRESSED
CONCRETE GIRDERS, I-565,
HUNTSVILLE, ALABAMA**

The Alabama Department of Transportation

JULY 2011

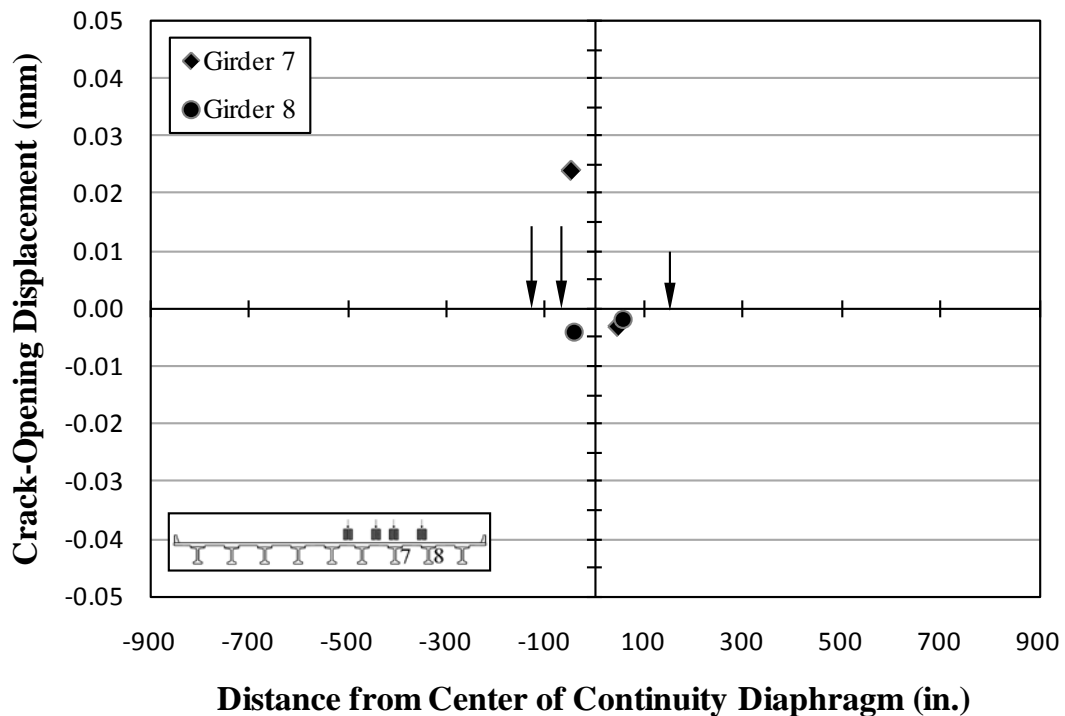
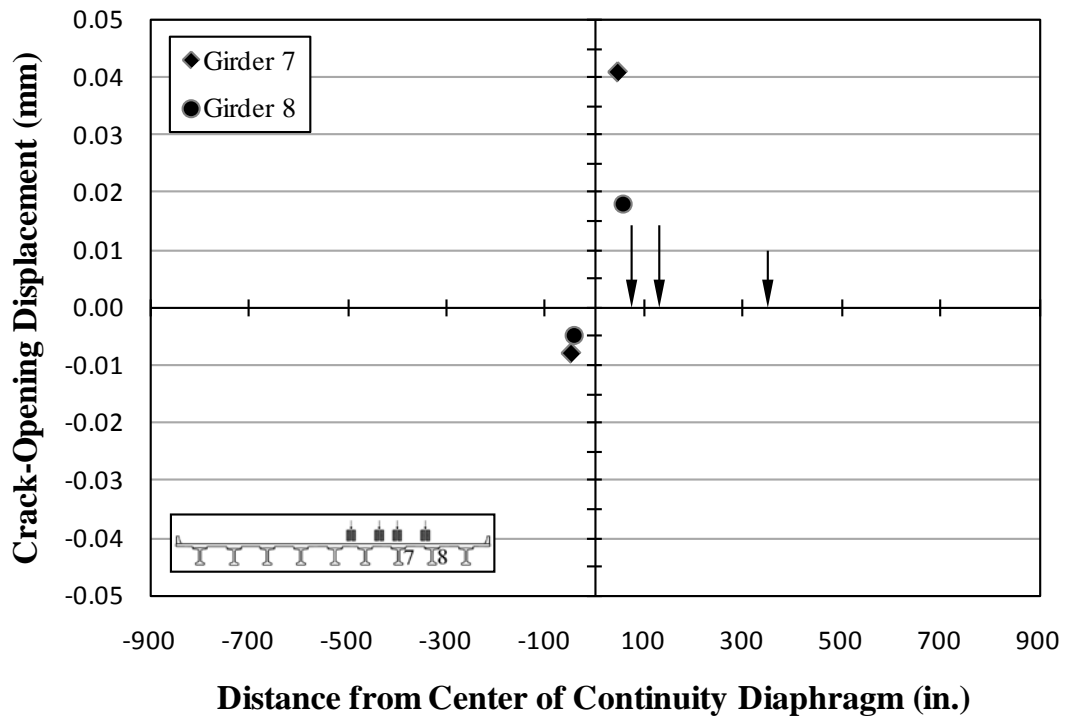
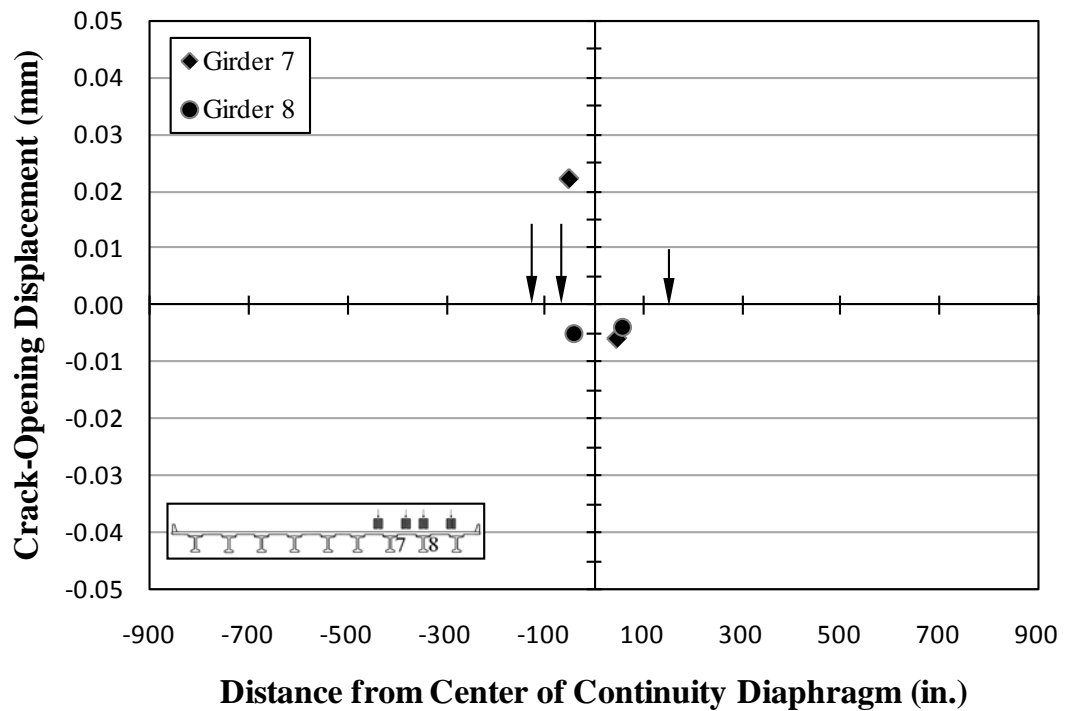
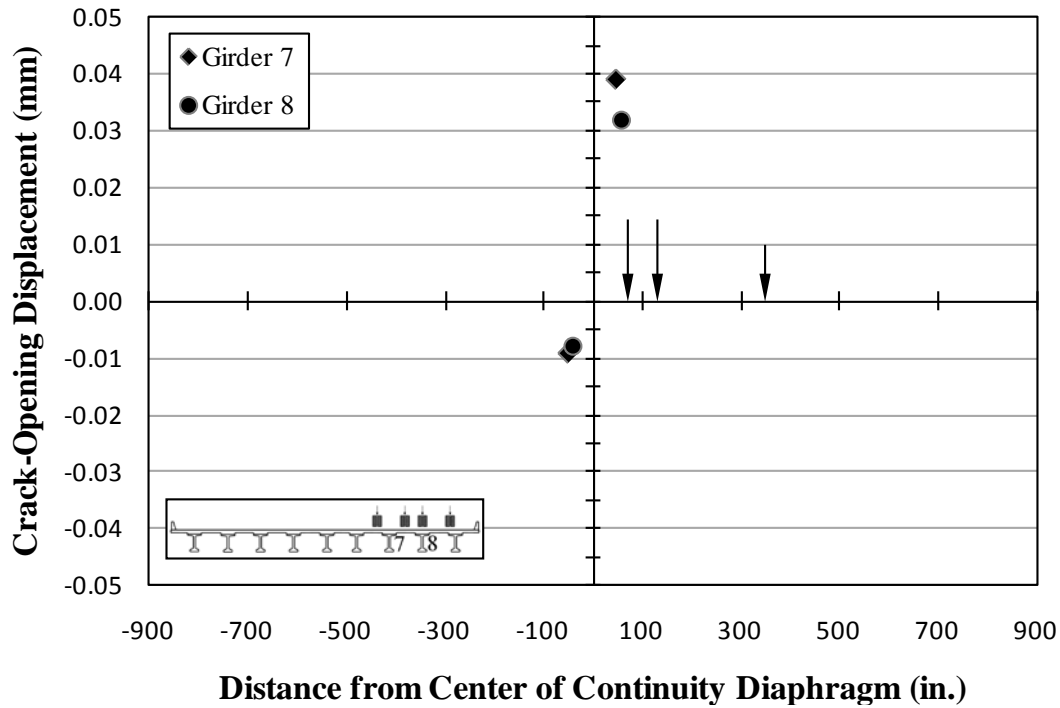
Midspan load conditions were the only load conditions of the post-repair static load test that did not result in the measurement of at least one crack opening. Maximum crack openings were measured in response to truck positions near gaged crack locations, which are the truck positions that cause the greatest shear demand within the damaged region. Crack-opening displacements measured in response to load trucks positioned near gaged damaged regions are presented graphically in Figures 5.45–5.48. The summary of crack-opening displacements measured in response to load trucks positioned near gaged damaged regions is presented in Table 5.12.

Figure 5.45: Damaged region truck positions—crack-opening displacements—A4

Figure 5.46: Damaged region truck positions—crack-opening displacements—A7

Figure 5.47: Damaged section truck positions—crack-opening displacements—C4

Figure 5.48: Damaged region truck positions—crack-opening displacements—C7

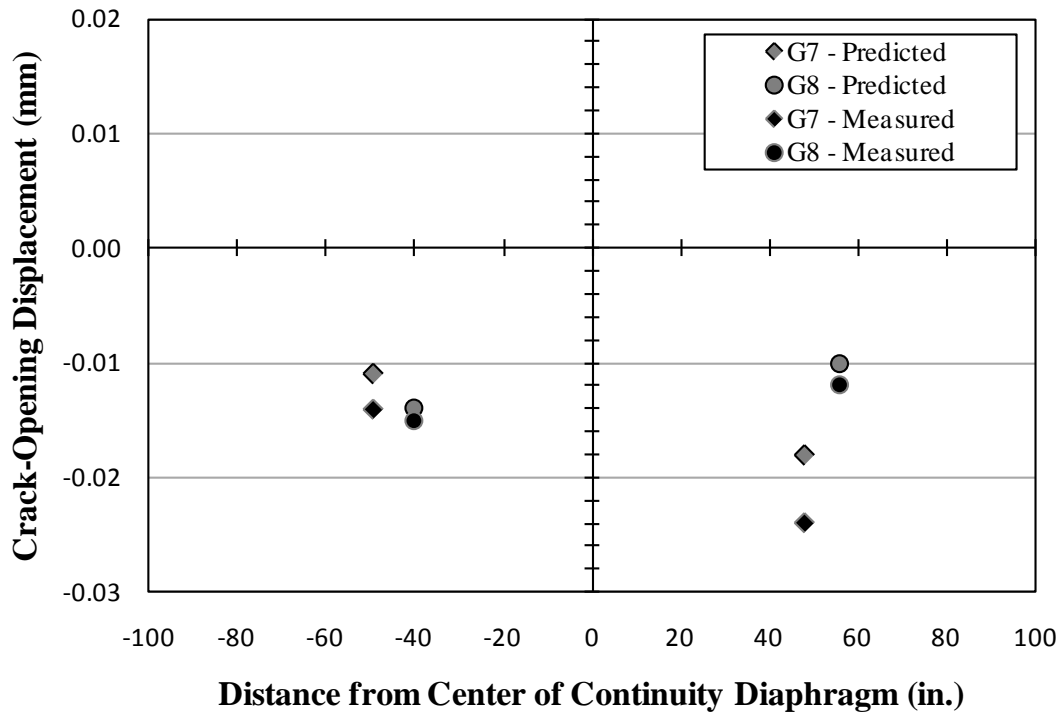
Figure 5.50: Superposition—crack-opening displacements—predicted and measured

Each instrumented crack experienced closure due to all of the superposition-test load conditions. The crack closures measured in response to the combined load condition (A1 and A9) were greater in magnitude than the crack closures predicted by superposition (A1 + A9). The maximum difference between the measured and predicted superposition crack closures was 0.006 mm (0.27×10^{-3} in.) at the crack on the east face of Girder 7 in Span 11. This difference

The magnitudes of the differences and percentage differences between measured and predicted crack closures during the post-repair superposition test indicate that the principle of superposition is not valid in the cracked regions. Therefore, crack locations are exhibiting nonlinear behavior. As previously noted, the location of the COD gage on Girder 8-Span 10 likely had an effect on the crack-opening displacement measurements making this gage less reliable for comparison. The damaged region of Girder 7 in Span 11 exhibited the apparent least linear behavior. The damaged region of Girder 8 in Span 10 exhibited the most apparent linear behavior. These varying degrees of linear behavior can be related to varying degrees of damage within each girder.

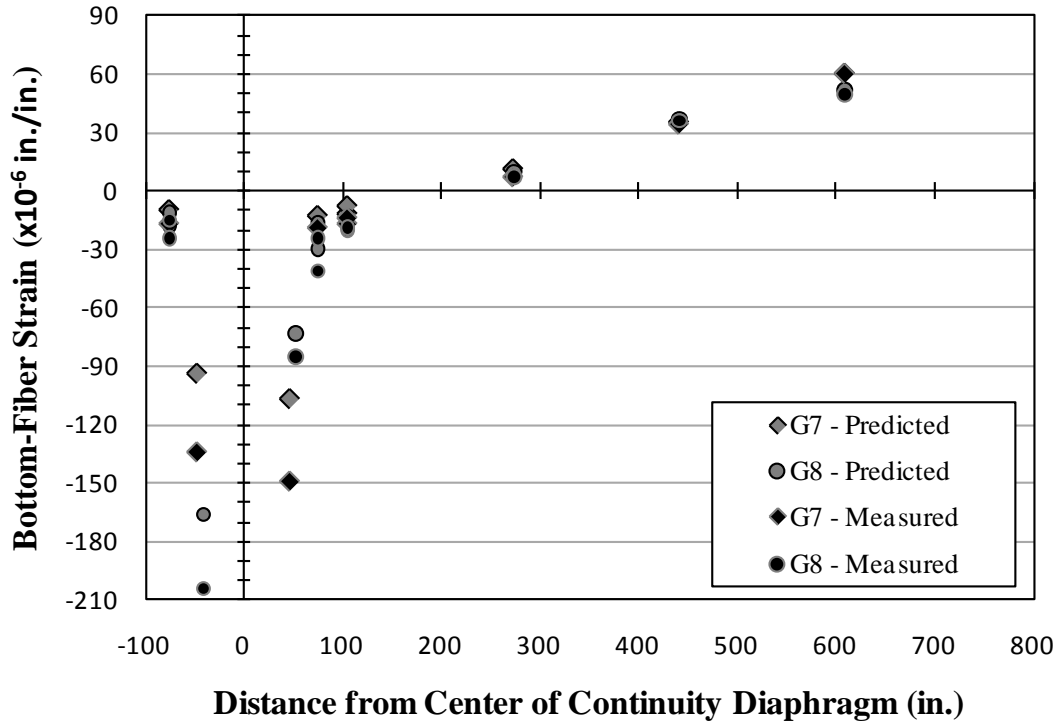
Figure 5.51: Superposition—bottom-fiber strains—predicted and measured

The differences between predicted and measured superposition strains were observed to be of greater magnitude at the FRP near the primary crack locations. A maximum difference of 42×10^{-6} in./in. was observed at the FRP strain gage installed near the crack location on Girder 7 of Span 11. From this difference, it is evident that the damaged region of Girder 7 in Span 11 exhibits the least apparent linear behavior of the four instrumented damaged regions.

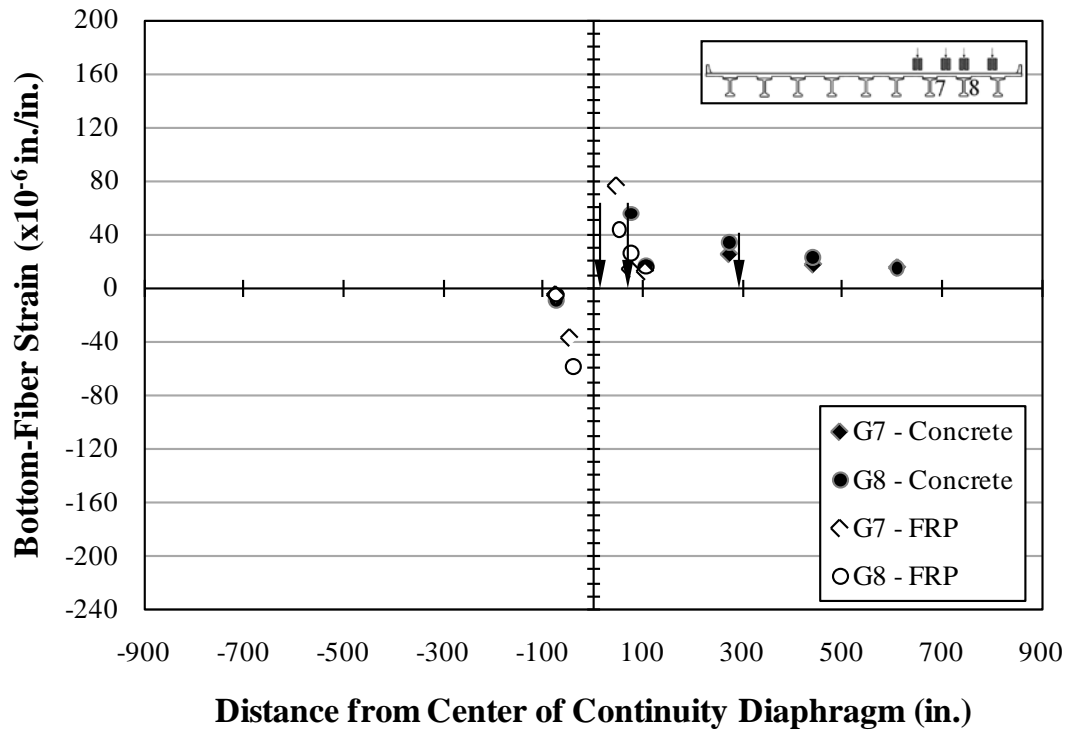
Figure 5.55: Bottom-fiber strains—C6

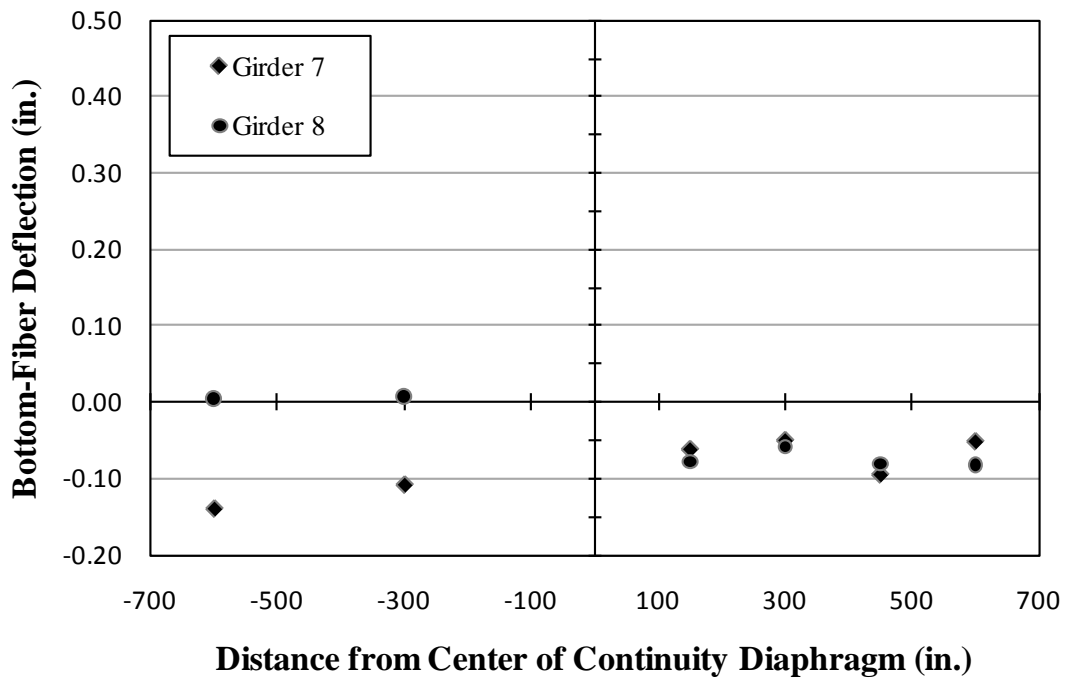
Figure 5.75: Deflections—2:30 a.m.

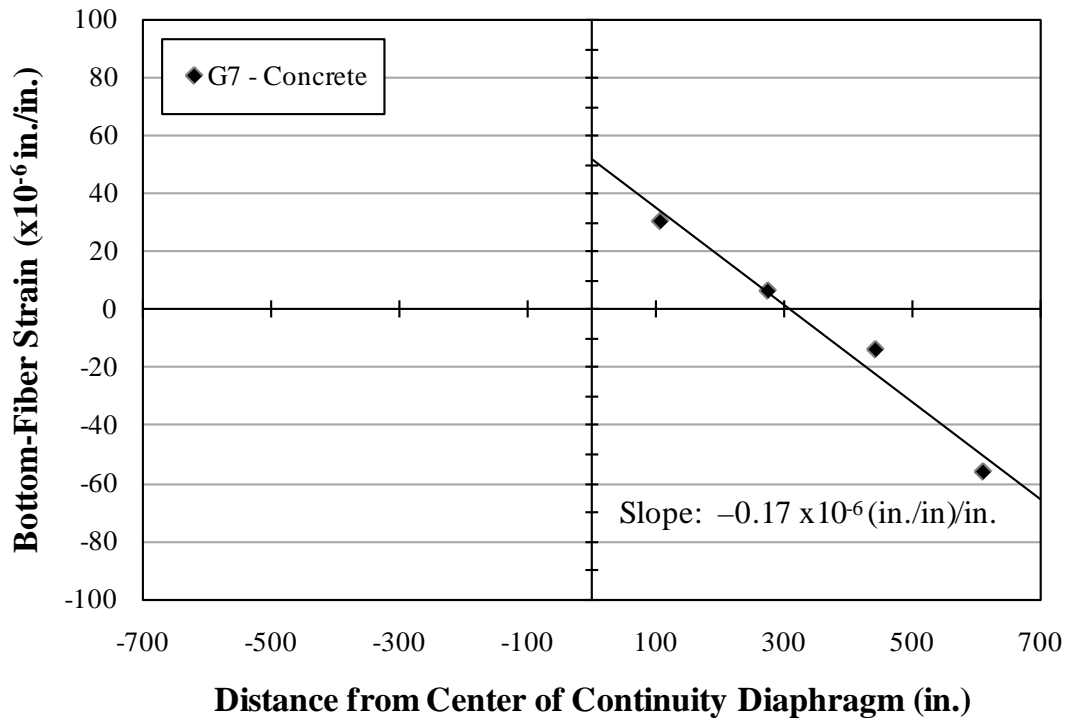
Figure 5.85: Bottom-fiber strains—concrete—Girder 7—4:30 p.m.

The slope of the bottom-fiber strain profile expected due to these conditions is $-0.24 \times 10^{-6} (\text{in./in.})/\text{in.}$, which is similar to the $-0.17 \times 10^{-6} (\text{in./in.})/\text{in.}$ slope of the measured strain profile for Girder 7 in Span 11 at 4:30 p.m. as presented in Figure 5.85. The slope of the measured strain profile is less steep than the slope of the theoretical strain profile, which could be an indication that the girder is not exhibiting fully continuous behavior as theoretically assumed, or that the actual temperature gradient was less than the estimated value. This decrease in continuity exhibited by the slope of the measured strain profile is likely due to the local behavior of the damaged region.

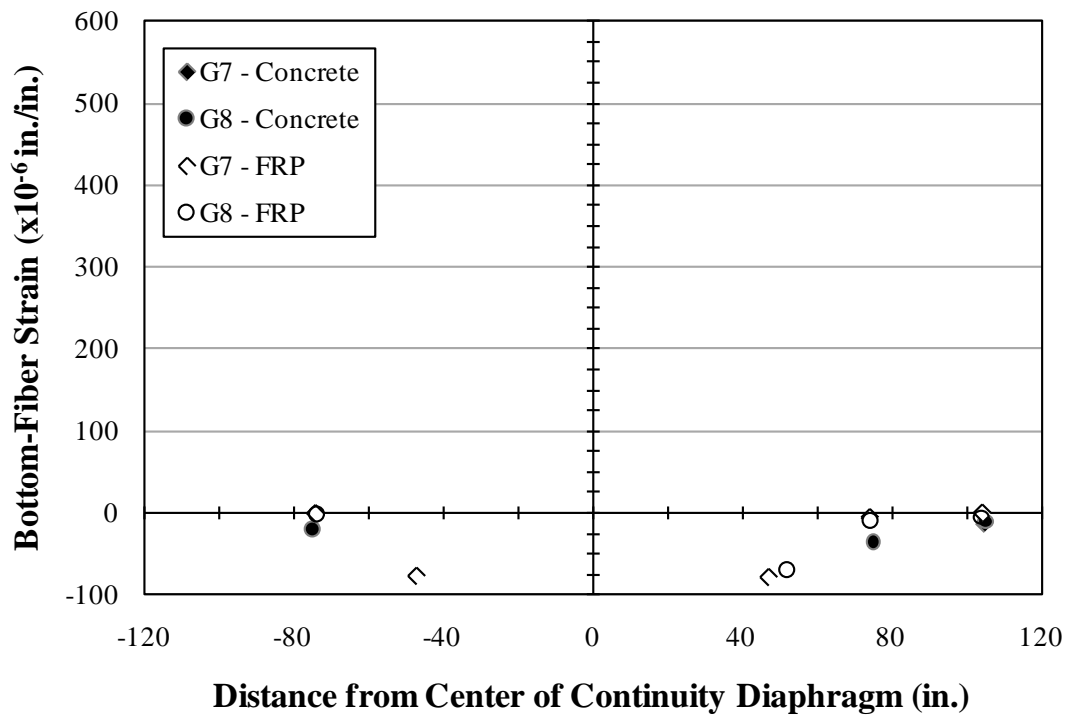
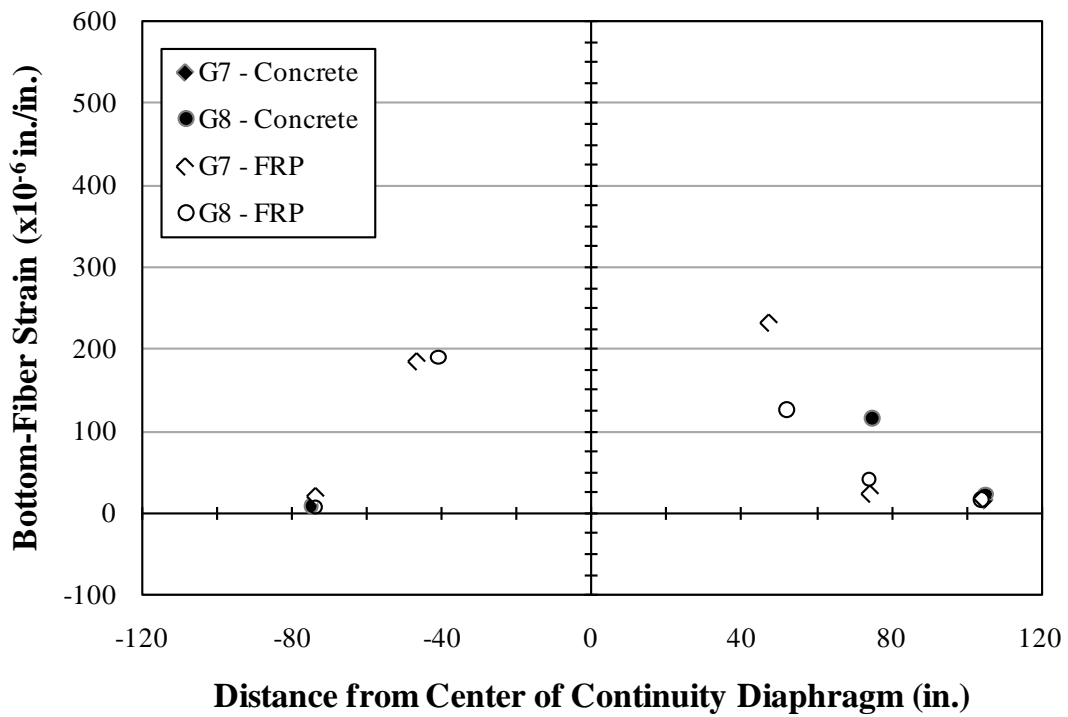
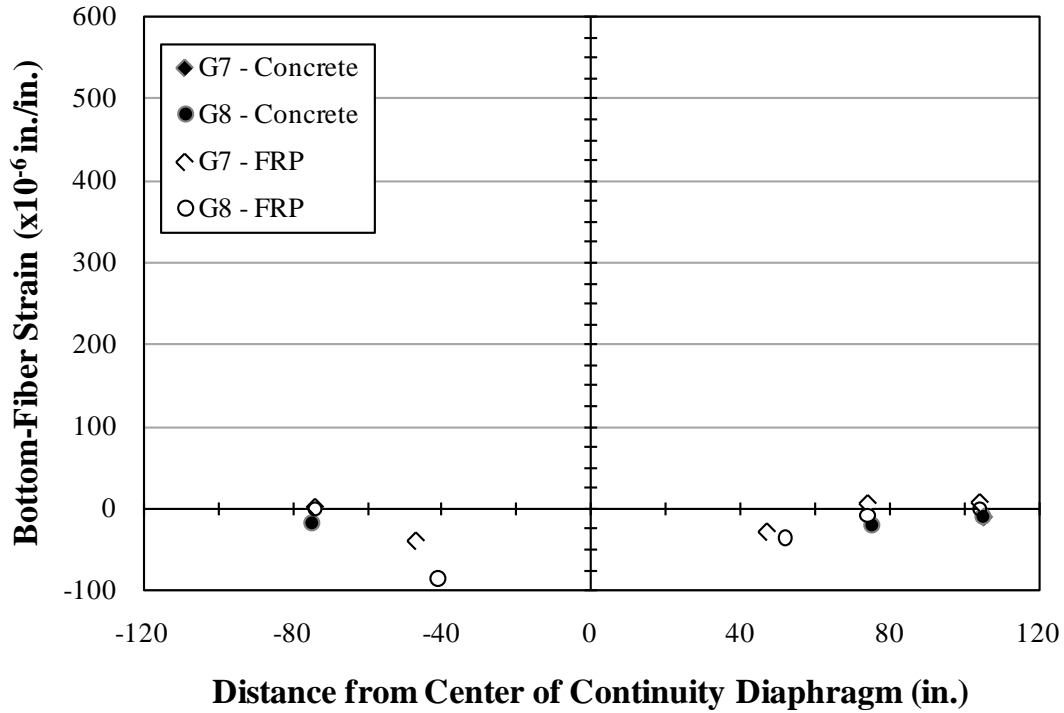
The bottom-fiber strains near the damaged region are shown to be greater than the strains projected by trend lines associated with concrete strains beyond the damaged region. These near damage zone bottom-fiber strains are presented in Figures 5.92–5.95. The

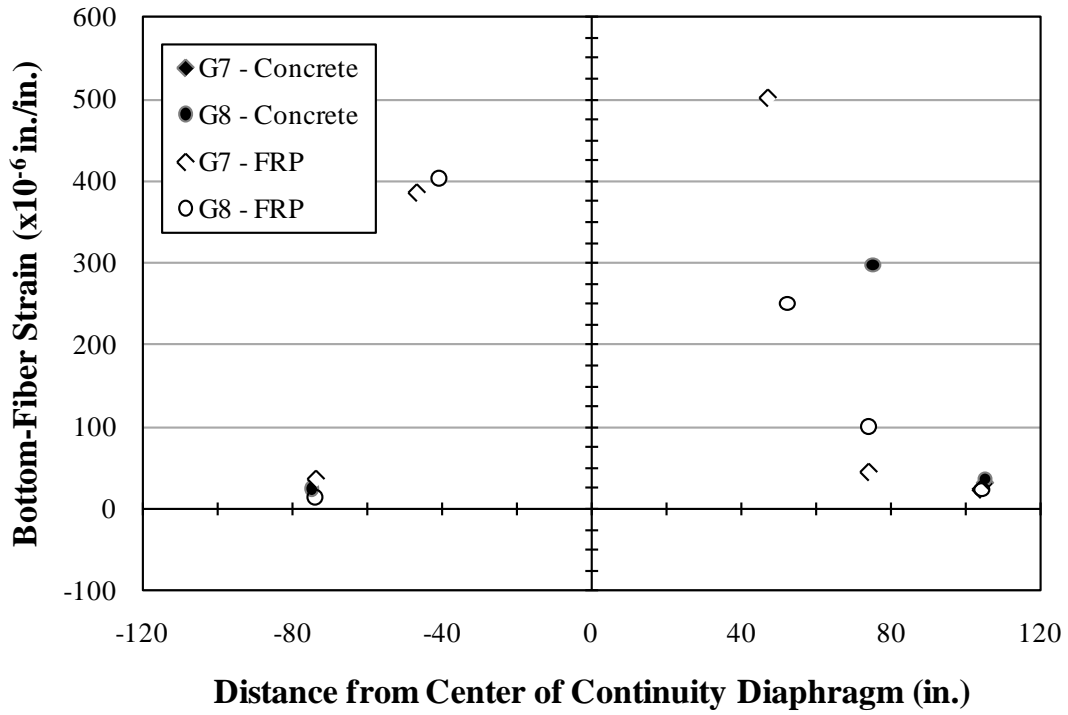
Figure 5.93: Bottom-fiber strains—damaged region—4:30 p.m.

magnitudes of the bottom-fiber tensile strains measured within the damaged region at 4:30 p.m. as shown in Figure 5.93 are an indication that the ambient thermal conditions have a significant effect on the damaged regions.

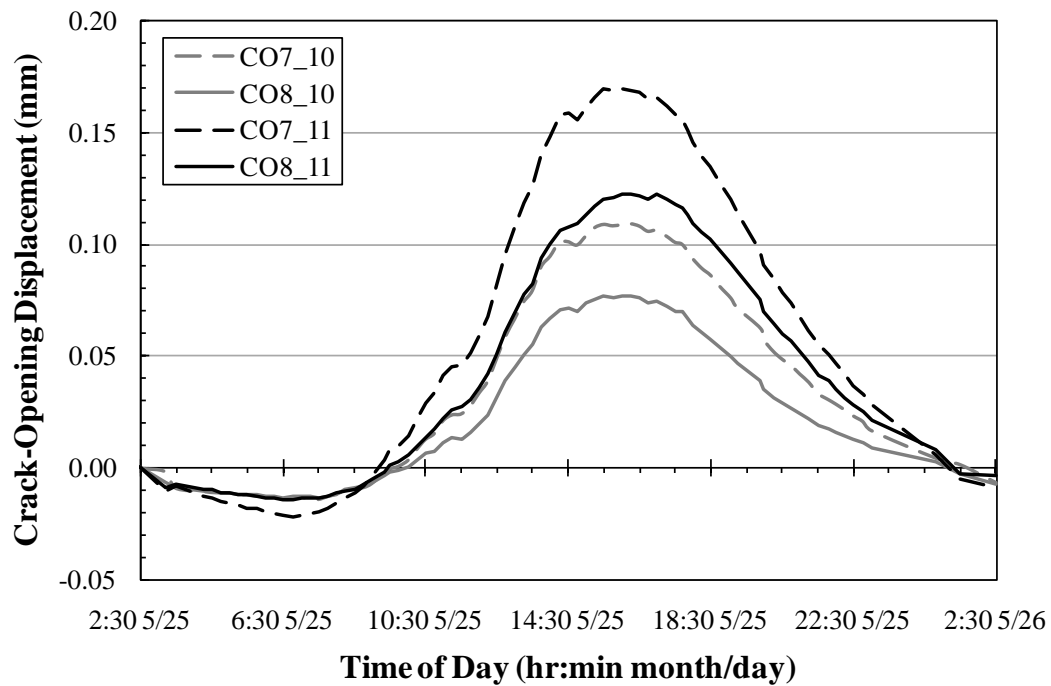
Figure 5.96: Crack-opening displacements—normal traffic—twenty-four hours

The maximum crack openings measured in response to thermal conditions were observed around the time of day when the thermal gradient would be expected to peak. A maximum crack opening of 0.169 mm (6.66×10^{-3} in.) was measured at roughly 3:30 p.m. by the COD gage on the east face of Girder 7 in Span 11. The maximum crack opening measured in response to any load truck position during post-repair bridge testing was 0.047 mm (1.83×10^{-3} in.) at the same COD gage location on Girder 7 of Span 11 in response to the AE Span 11 static position. All of the COD gages measured crack openings of greater magnitude in response to thermal conditions compared to crack openings due to truck loads.

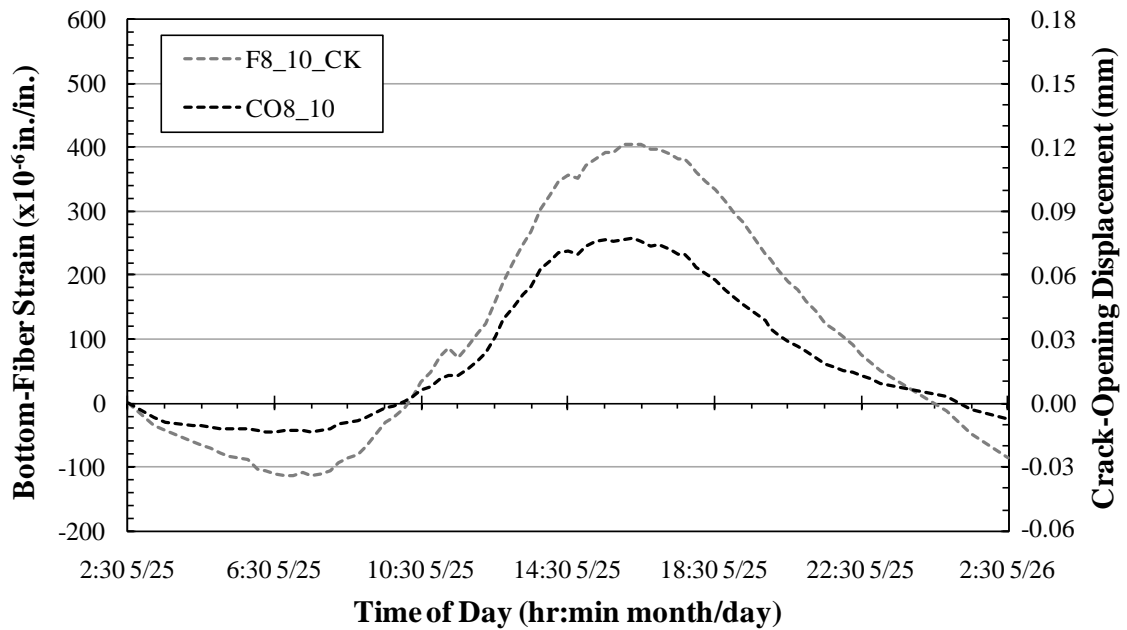
Figure 5.99: Bottom-fiber strain and COD—thermal conditions—Girder 8—Span 10

As previously discussed, the Girder 8-Span 10 COD gage measured crack openings in response to ambient thermal conditions but not in response to truck loads. Although the measured behavior at this gage location is more similar to the other gages in response to ambient temperature than it was in response to truck loads, the COD and FRP strain relationship is not similar to the relationships observed at the Girder 7 crack locations of both instrumented spans. The FRP strain measurements for Girder 8 of Span 10 were similar to the FRP strain measurements for Girder 7 of Span 10, but the COD measurements for the two girders were not similar under the same conditions. The smaller magnitude of the Girder 8-Span 10 COD measurements can be associated with the fact that cracks within the girder web are only present on the west face. The relationship observed in Figure 5.99 supports the previous conclusions that the performance of the COD gage on Girder 8 of Span 10 has been affected by the presence of cracks only on the west face of the girder web resulting in different cross sectional behavior compared to the other instrumented damaged regions and also requiring that the COD gage be installed on an opposite girder face compared to the other COD gages.

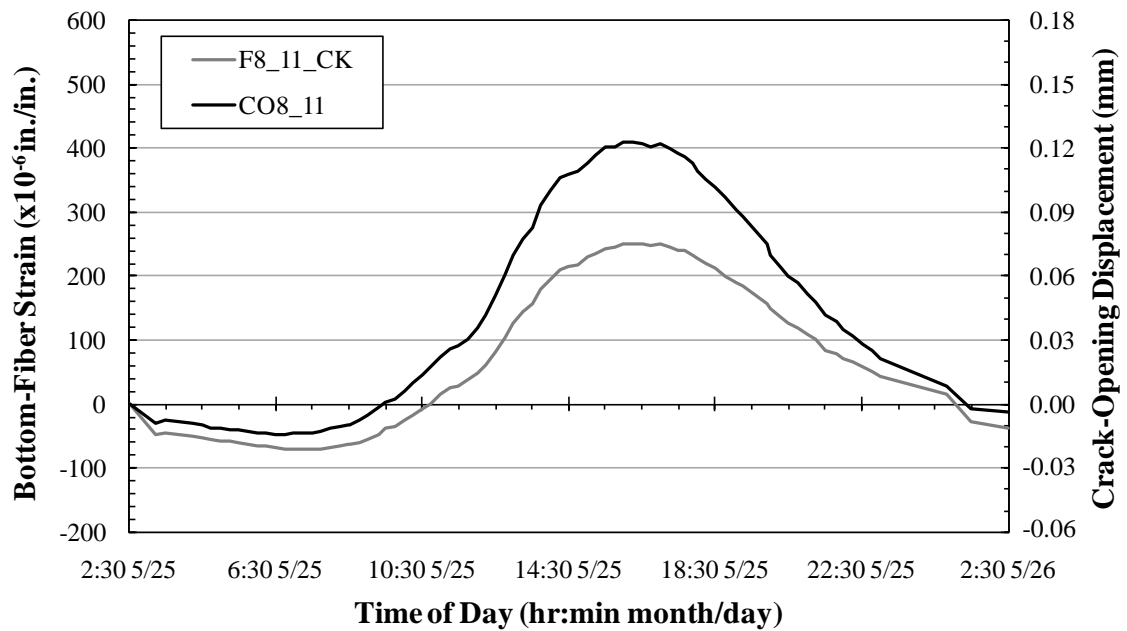
Figure 5.100: Bottom-fiber strain and COD—thermal conditions—Girder 8—Span 11

The FRP strains measured at the crack location of Girder 8 in Span 11 were consistently the least tensile of the four instrumented girders. This behavior is not consistent with the crack-opening displacements measured by the COD gage on the same girder. The relationship shown in Figure 5.100 between the COD measurements and the bottom-fiber FRP strain measurements at the crack location of Girder 8-Span 11 supports the previous conclusion that the bottom-fiber FRP strain gage assigned to that crack location was not accurately installed as close to the actual underlying crack location as the other FRP strain gages assigned to their respective crack locations.

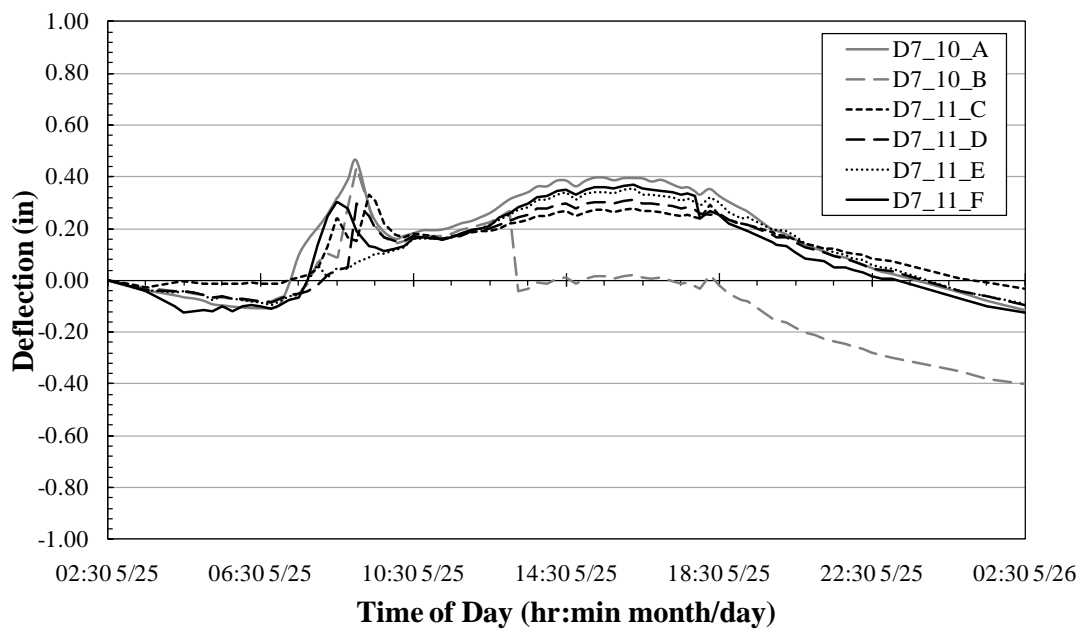
Figure F.1: Original deflection results—Girder 7

The deflectometers seemed to be sensitive to temporary direct sunlight on the aluminum bar during the sunrise hours. An example of this type of sensitivity is evident during the morning hours plotted in Figure F.1. Unexpected physical movement of a deflectometer could also have an effect relative to the original baseline and cause a permanent data shift. Electrical noise or interference could have also caused a momentary or permanent movement relative to the original baseline. Instruments not returning to a similar measurement at the end of the test, in relation to either the initial measurement of that sensor or the concluding measurements of other comparable sensors, were the primary reason for deciding to adjust certain results. An example of this type of offset can be readily observed in the response of Sensor D7_10_B in the early afternoon in Figure F.1. Measurements that seemed to be inconsistent with the expected result were inspected and adjustments were proposed and implemented when deemed appropriate.

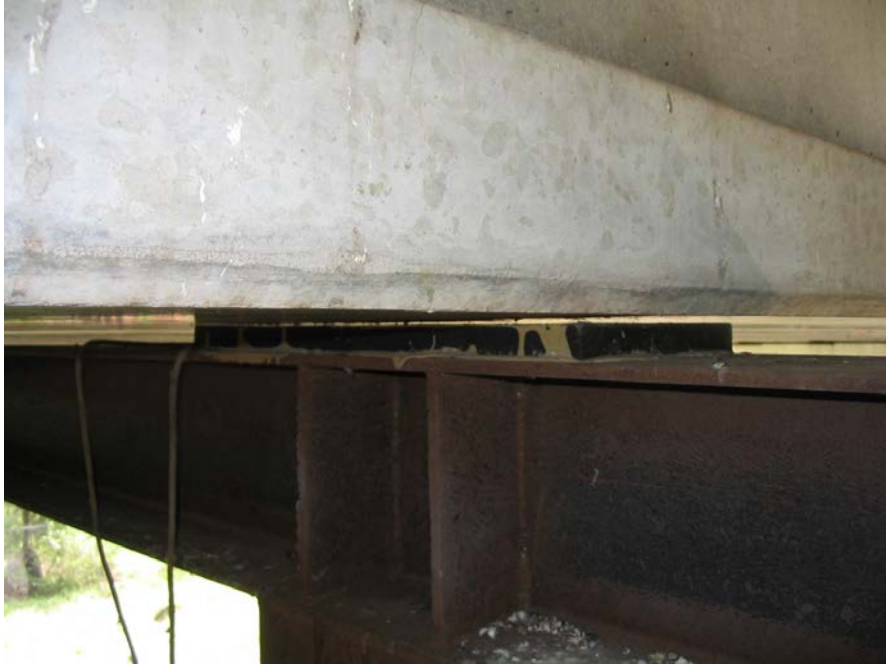
Figure K.3: Bearing pad location *with* space between the bearing pad and girder

A small gap between the bearing pad and girder bottom remained after false support installation. Bearing pads were installed to prevent catastrophic collapse in case of further deterioration of the bridge girders, but it was undesirable for bearing pads to remain in contact with bridge girders during load testing. An installed bearing pad with space remaining between the pad and girder is shown in Figure K.3. A bearing pad that is in contact with a girder and likely transferring loads through the false support is shown in Figure K.4.

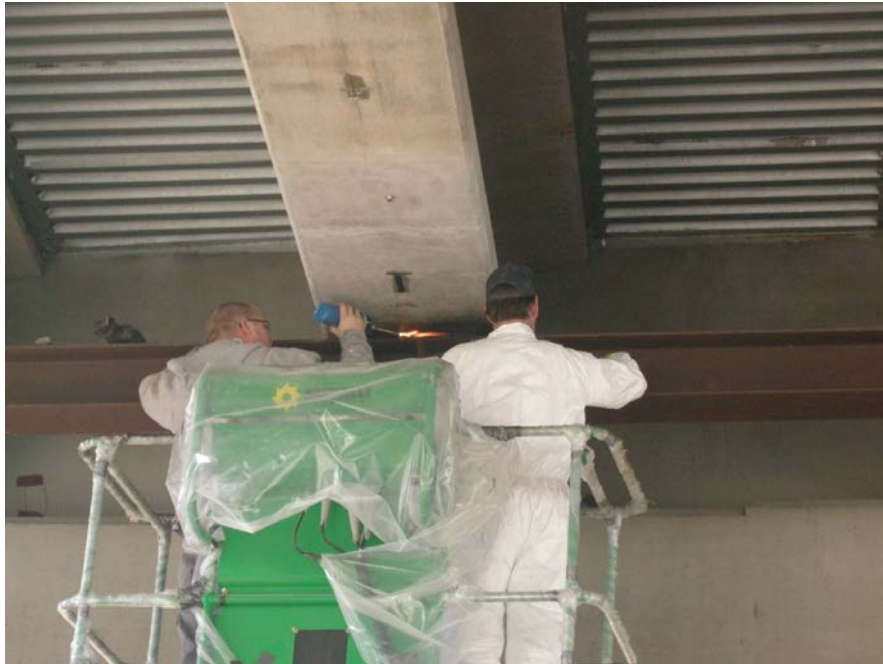
In some cases, saw cutting alone was not effective at alleviating enough pressure for successful bearing pad removal. In these cases, a propane torch was used to soften the rubber, as shown in Figure K.7, which then allowed for a more effective sawing process.

Figure K.7: Use of propane torch during bearing pad removal

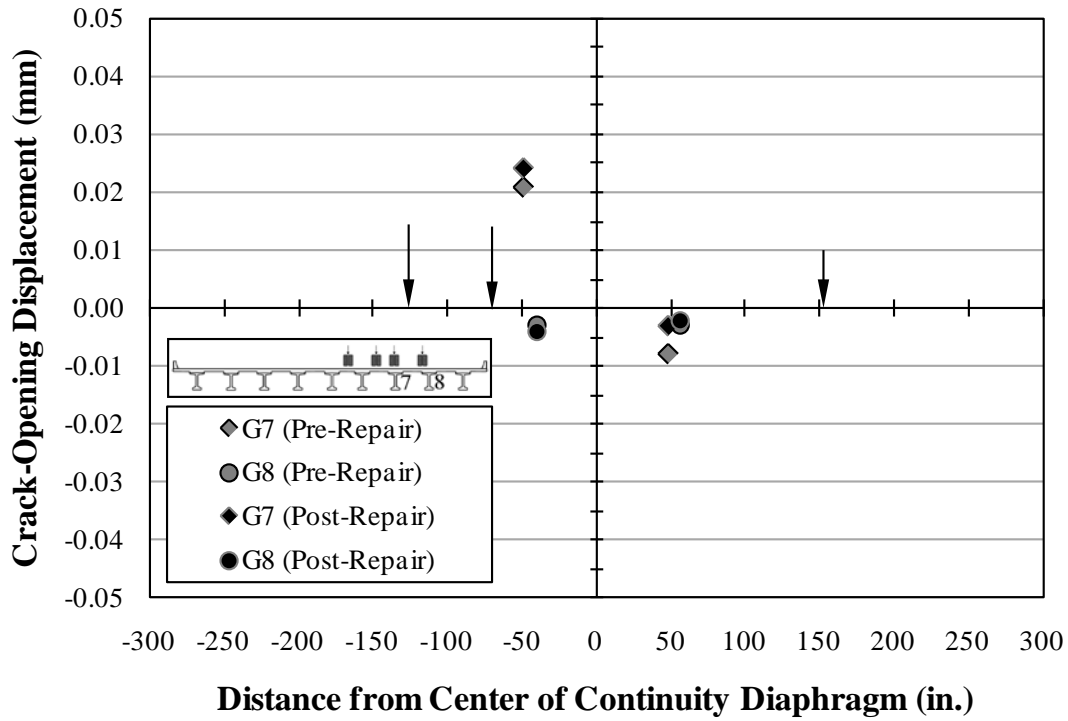
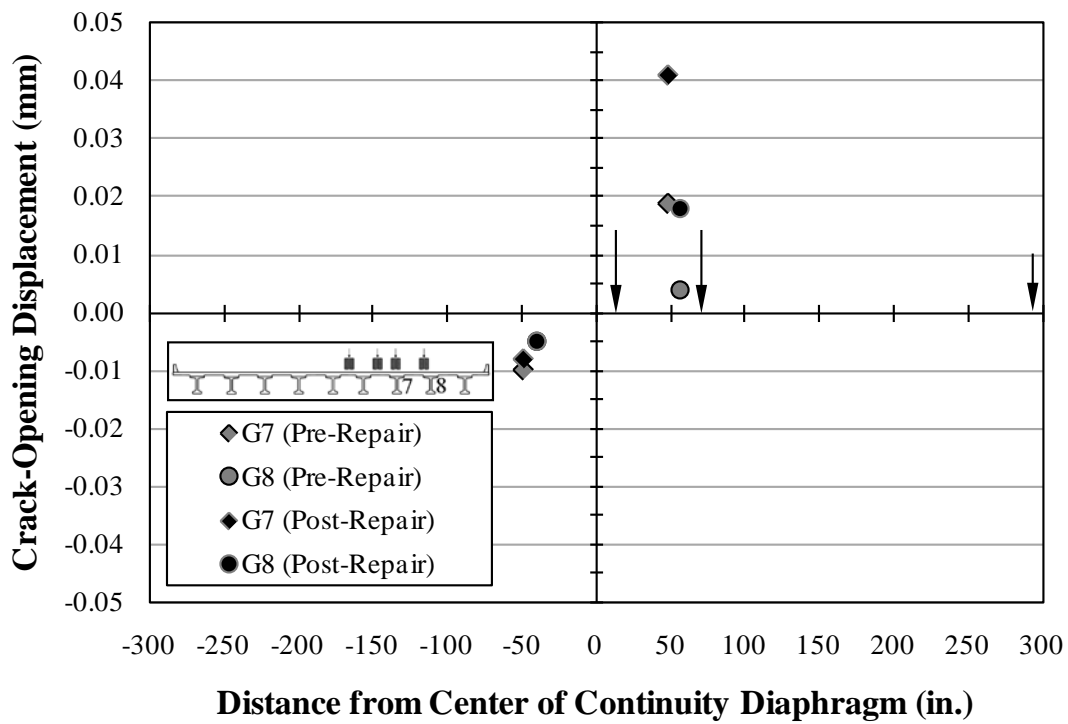
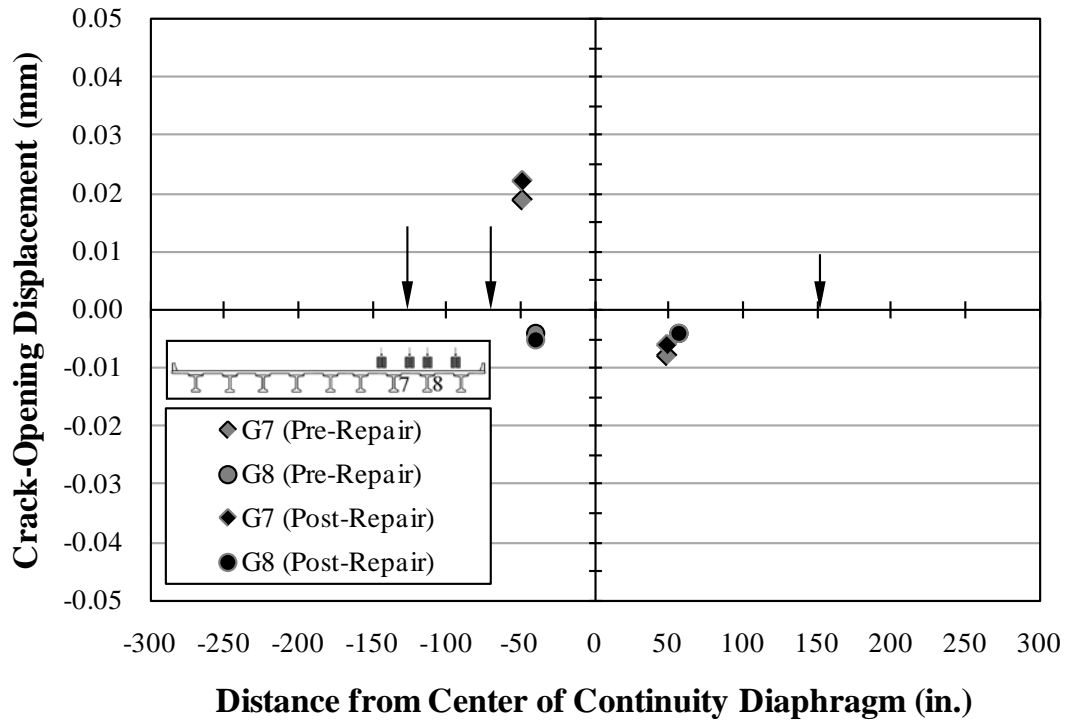
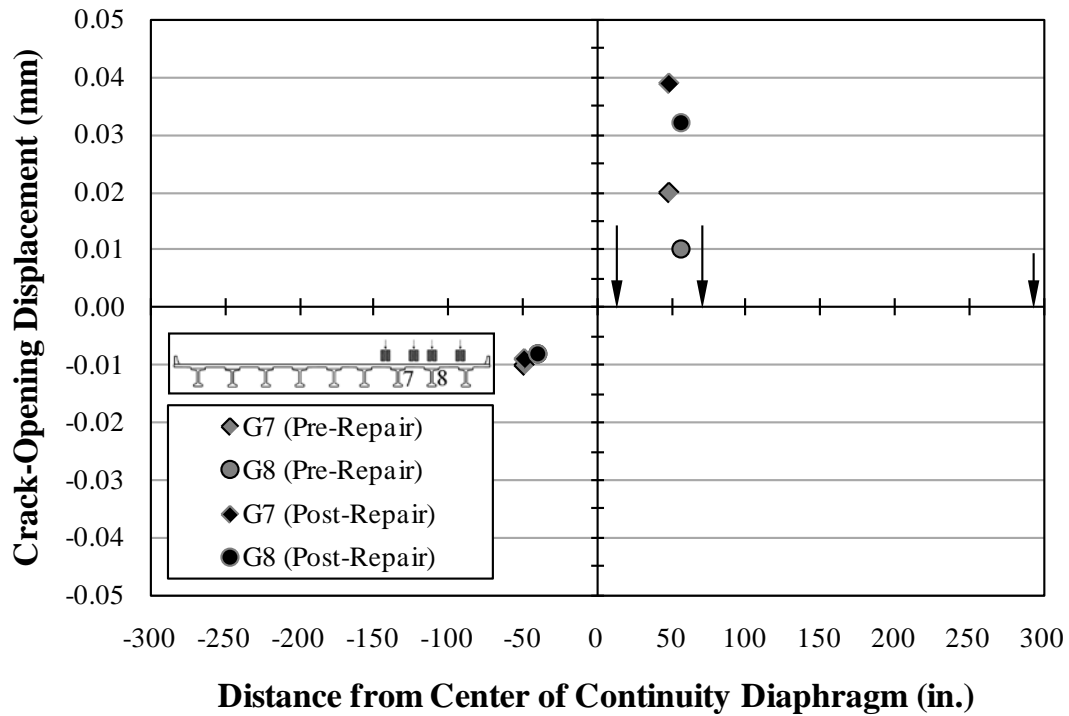
Figure K.14: Crack-opening displacements—pre- and post-repair—A4

Figure K.15: Crack-opening displacements—pre- and post-repair—A7

Figure K.16: Crack-opening displacements—pre- and post-repair—C4

Figure K.17: Crack-opening displacements—pre- and post-repair—C7

The crack-opening displacements measured in Span 10 were similar for both pre- and post-repair testing, but the crack-opening displacements measured in Span 11 in response to the Stop Position 7 load condition of the post-repair test increased in comparison to the crack-opening displacements measured in response to the same load condition during pre-repair testing. This behavior corresponds with the Span 10 bearing pads being partially removed prior to pre-repair testing, and the Span 11 bearing pads being under enough pressure to prevent any removal prior to pre-repair testing. It is apparent that girder contact with the false support bearing pads under Span 11 resulted in additional support conditions that affected pre-repair measurements.

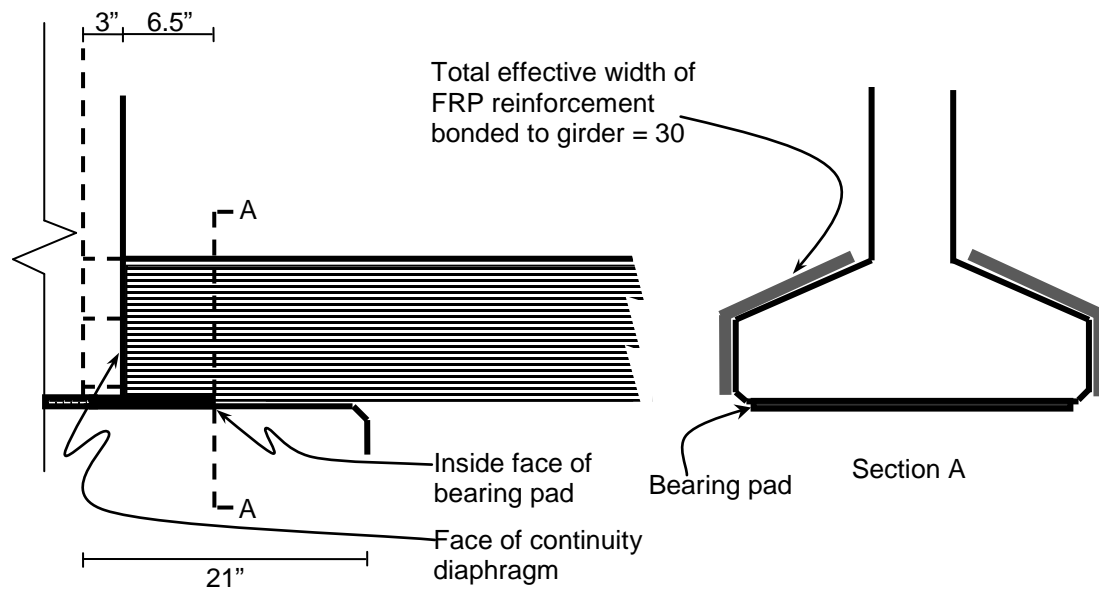
The end regions of continuous sheets of reinforcement must be cut appropriately to account for support conditions. At the interior face of the bearing pad, FRP reinforcement cannot be installed along the bottom face of the girder, as shown in Figure N.3. At the termination of the continuity reinforcement, the FRP reinforcement can be installed to wrap around the entire perimeter of the tension flange, as shown in Figure N.4.

Figure N.3: Cross-sectional configuration of FRP—near diaphragm (Swenson 2003)

The cross section at the interior face of the bearing pad at the continuity diaphragm is located roughly 6.5 in. from the face of the diaphragm. This location is considered critical because it is a support condition and the bearing pad obstructs the ability to install FRP reinforcement around the entire tension flange, which also represents a reinforcement transition location. This is also the point of maximum shear force influence on the bottom flange of the girder.

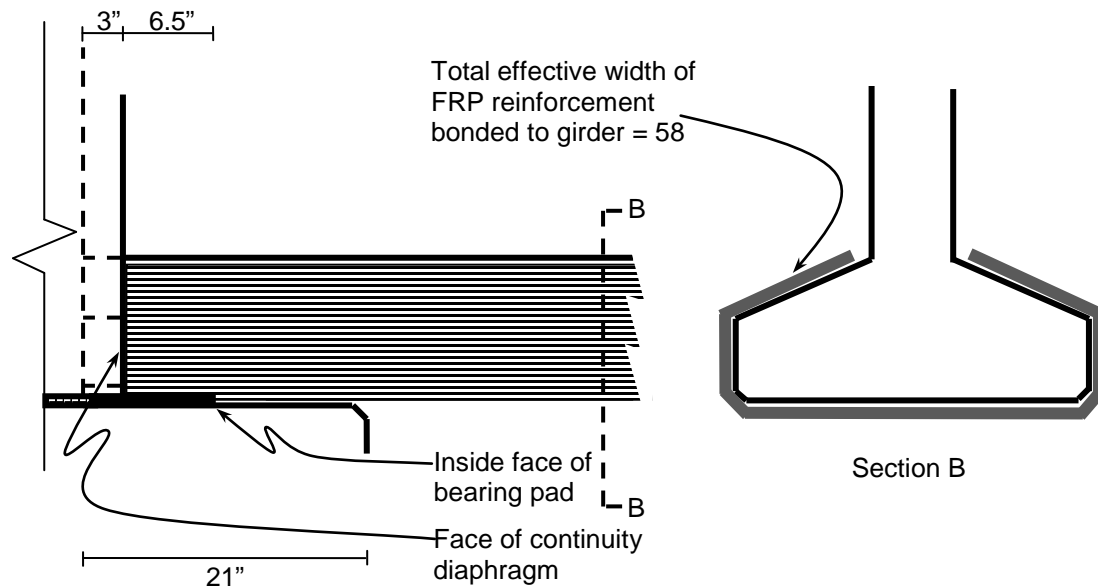
Figure N.4: Cross-sectional configuration of FRP—typical (Swenson 2003)

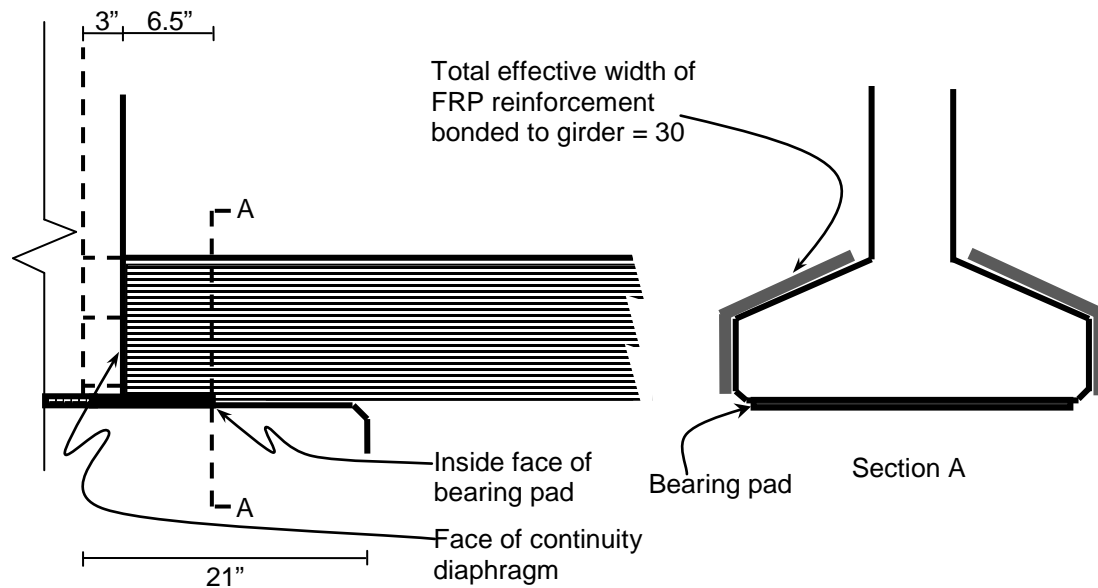
Figure N.9: Cross-sectional configuration of FRP—near diaphragm (Swenson 2003)

The FRP reinforcement configuration at the interior face of the bearing pad has an available effective width (b_f) of 30 in., and the typical configuration that wraps the perimeter of the tension flange has an effective width of 58 in. The centroid of FRP reinforcement (y_f) at the interior face of the bearing pad is roughly 6.5 in. from the bottom face of the girder, which equates to a reinforcement depth (d_f) of 57.5 in. The bonded length (L_b) from the FRP termination at the

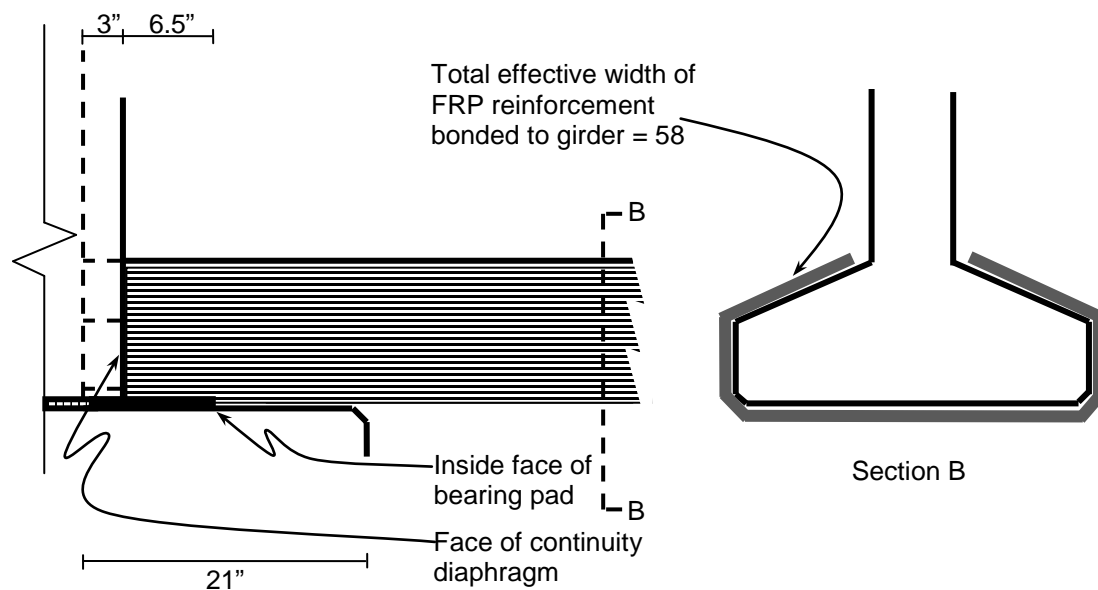
Figure N.10: Cross-sectional configuration of FRP—typical (Swenson 2003)
