# PREMATURE FAILURE OF ASPHALT OVERLAYS FROM STRIPPING: CASE HISTORIES

**Prithvi S. Kandhal**  
**Ian J. Rickards**

NCAT Report 01-01

April 2001

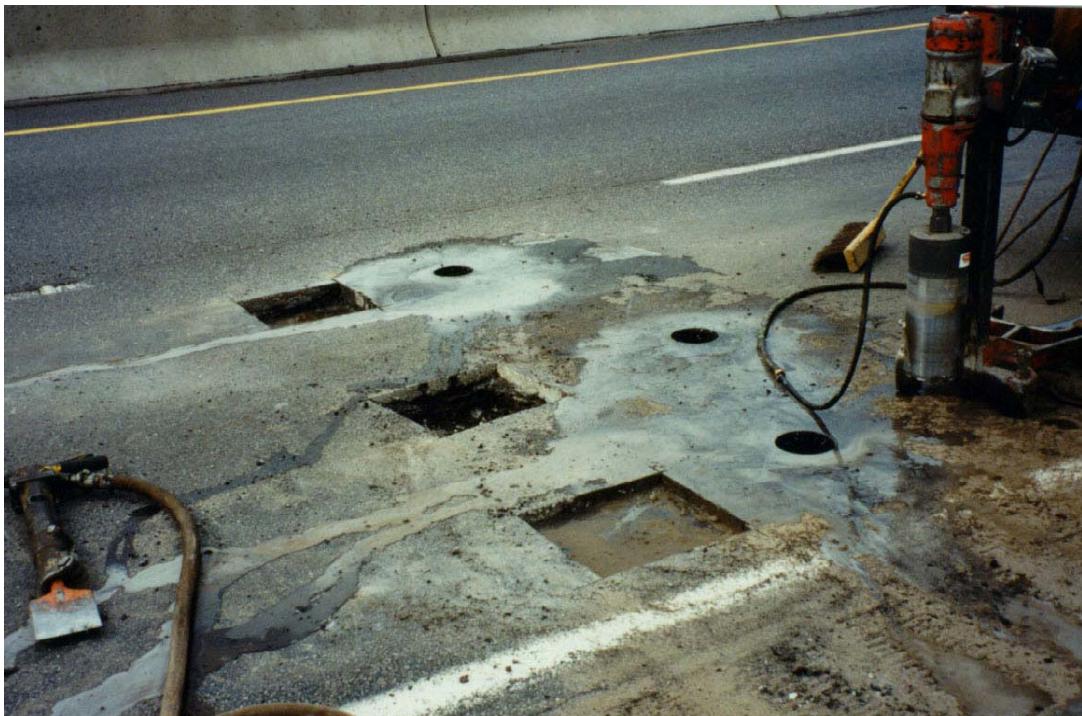
**Figure 8. Cores Taken Adjacent to Square Holes at MP 217.65**

Full depth pavement cores (150-mm diameter) were also obtained adjacent to the square holes to observe the pavement layers and to determine the thickness, bulk specific gravity, and air void content of each layer (Figure 8).

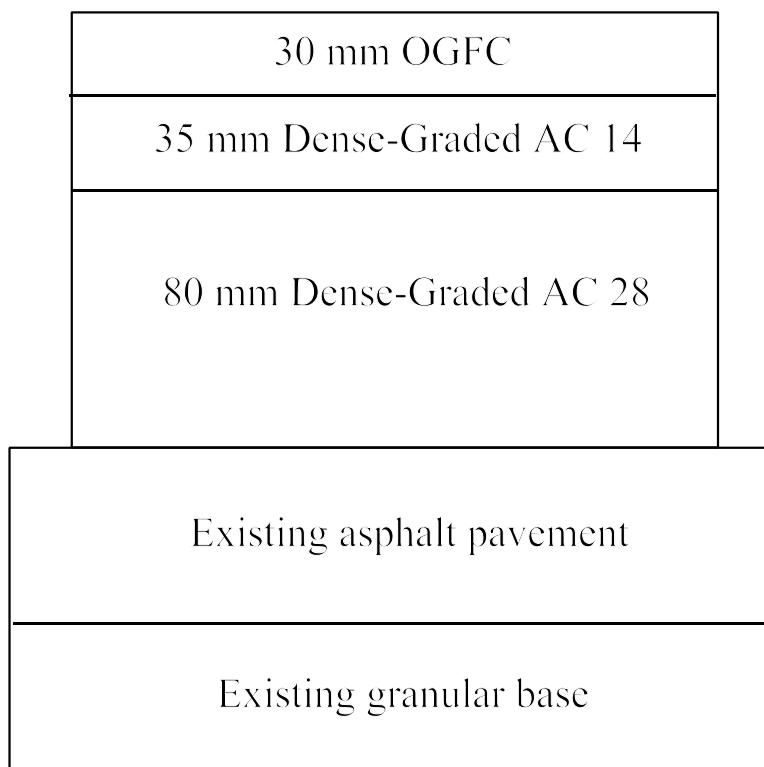
**Figure 23. Courses Used in New Asphalt Overlay on Hume Highway**

An existing asphalt section of the 4-lane Hume Highway south of Sydney in New South Wales was overlaid in May/June (winter in Australia) 1993. As shown in Figure 23, the asphalt overlay consisted of the following:

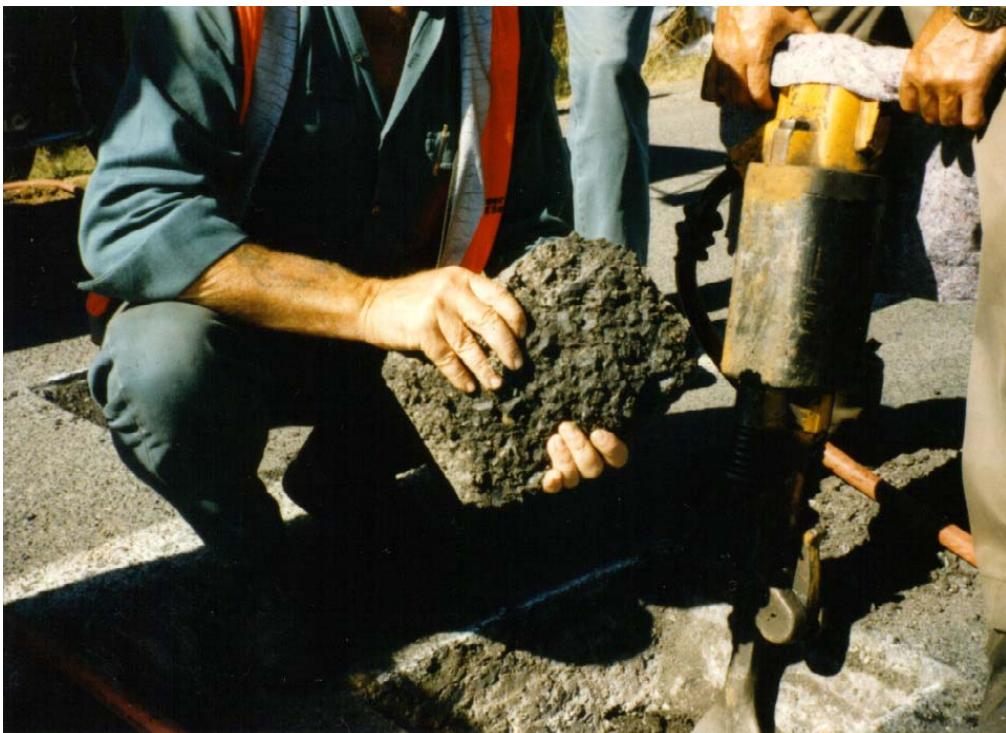
**Figure 27. Excavation of Each Asphalt Layer With a Jack Hammer**

In March 1995, test holes (approximately 400 mm square) were excavated in the asphalt pavement with a jack hammer (Figure 27), and the excavated material collected for testing. Samples were collected from each asphalt layer (OGFC, AC 14, and AC 28) and stored in sealed plastic bags prior to moisture determination and visual evaluation to determine the extent of stripping. Dry excavation methods were used to facilitate moisture content determination. Test holes were excavated both at sites exhibiting failure and about 15 m away at sites that had no visible sign of failure. A limited number of test holes were also excavated in the 3-m wide shoulder to obtain the moisture profile within that undamaged portion of the pavement.

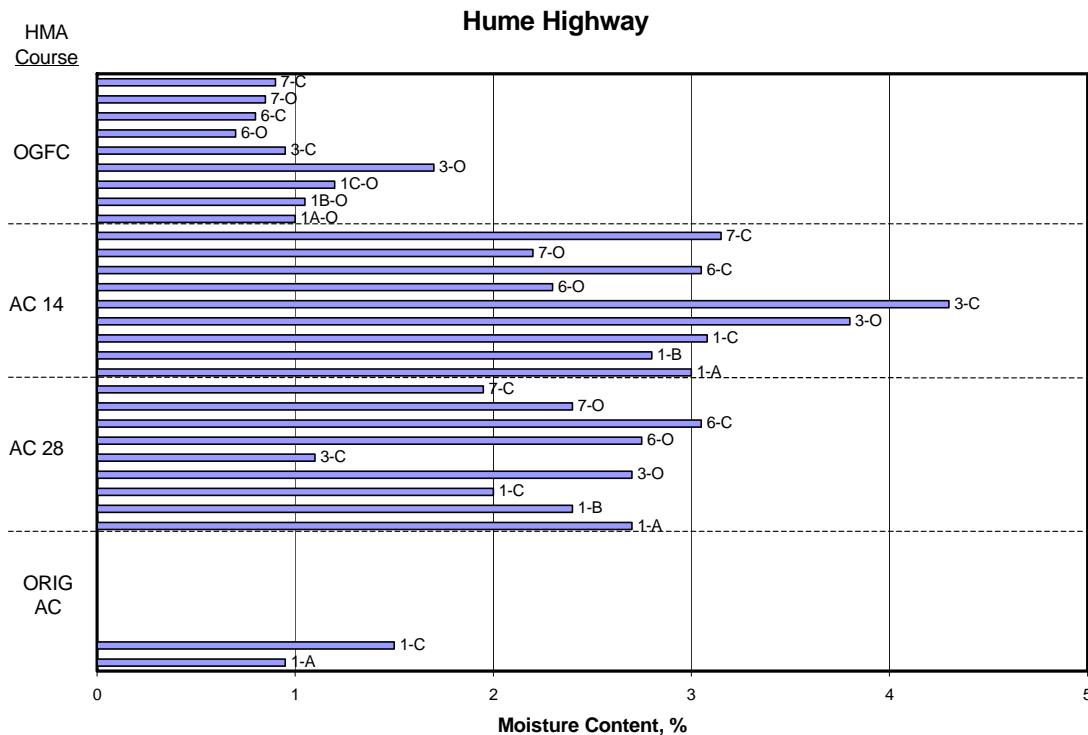
**Figure 28. Moisture Content Profile at Site 1, 3, 6, and 7**

Figure 28 shows typical moisture contents in OGFC, AC 14, AC 28, and existing asphalt course at four locations. Designation C such as Site 7-C stands for test hole in the center of the lane (between the wheel paths). Designation O such as Site 7-O stands for test hole on the wheel path. There was no significant difference in moisture content of the materials extracted from test holes at the failed and adjoining non-failed sites, indicating the water ingress preceded, and was not as a consequence of, the failure.

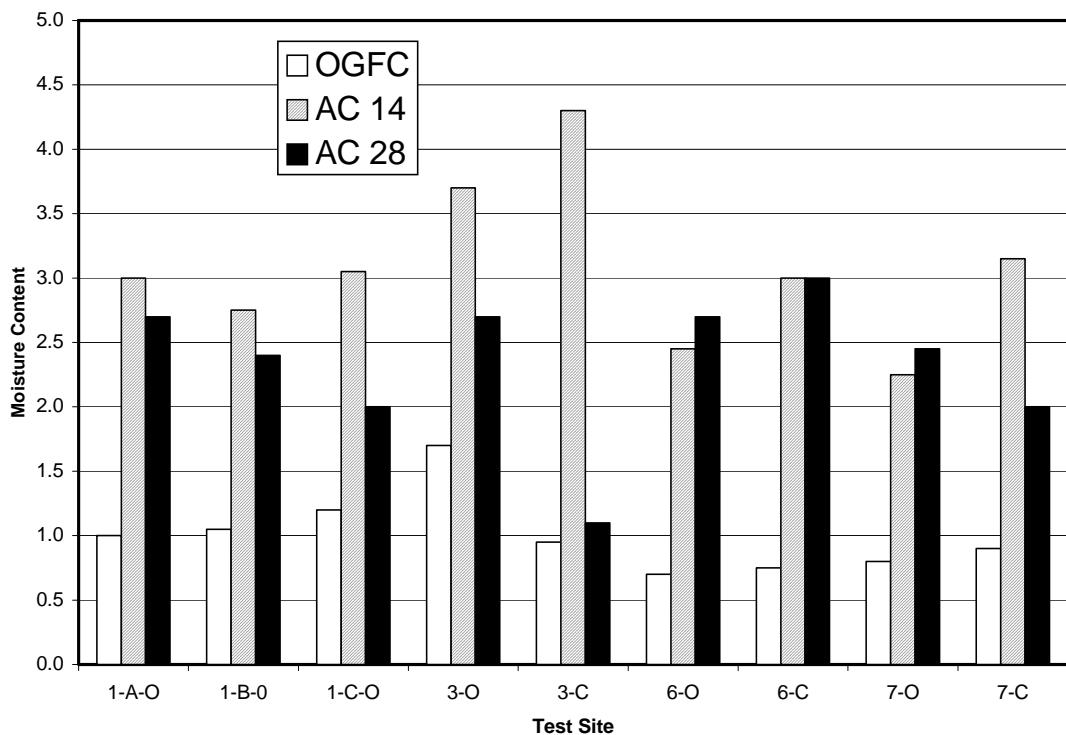
**Figure 29. Comparative Moisture Contents at Sites 1, 3, 6, and 7**

Figure 29 shows the relative comparison of moisture contents in OGFC, AC 14 and AC 28 courses obtained in nine test pits. The following observations can be made.

1. The moisture profile shows decreasing moisture contents from surface downwards. However, the air voids in both AC 14 and AC 28 are almost completely saturated with moisture.
2. The existing asphalt course was not significantly stripped. Only AC 28 and AC 14 and bottom 1/3 of the OGFC were stripped in the slow traffic lane. Figure 27 shows a piece of badly stripped AC 28.
3. Both AC 14 and AC 28 courses did not strip in the shoulder obviously due to reduced saturation and lack of traffic loading.

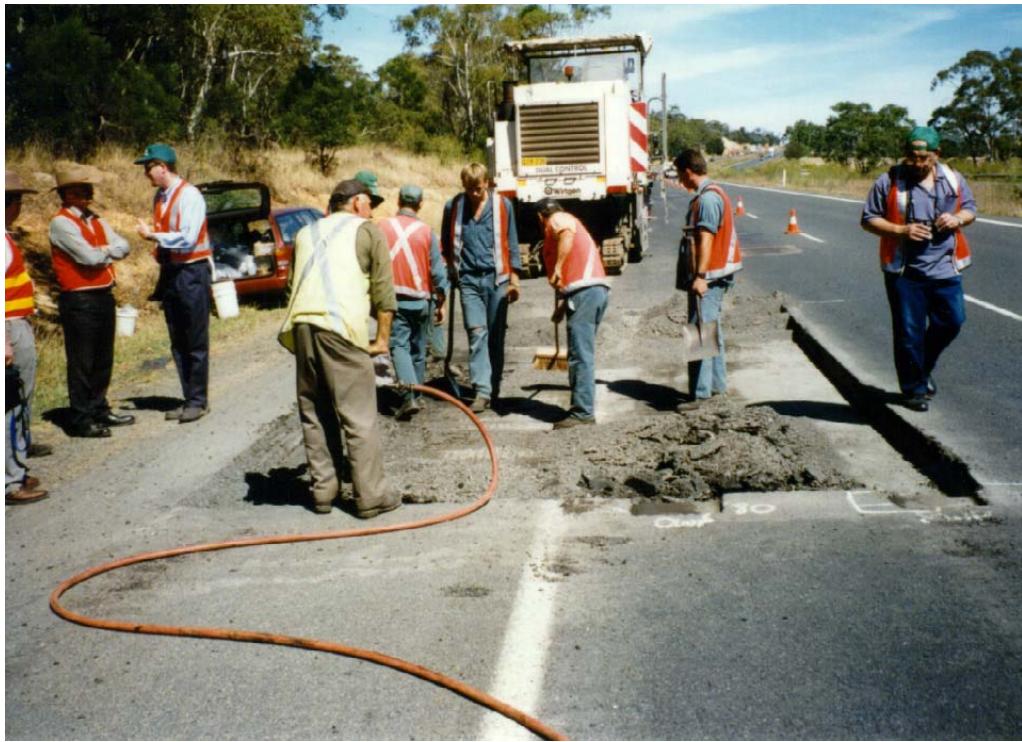
**Figure 31. Cold Milling in the Slow Lane and Shoulder Area to Evaluate the Condition of Asphalt Layers**

Both authors investigated the project in March 1996. More test holes were excavated with a jack hammer in the slow lane and shoulder of the distressed southbound lanes. A milling machine was also brought (Figure 31) to mill off the asphalt overlays so that all courses could be evaluated visually. The test data and observations were similar to those in March 1995. Free moisture was visible in AC 14 just below the OGFC at the edge of the milled trench (Figure 32). Both AC 14 and AC 28 mixes were badly stripped (Figure 33).

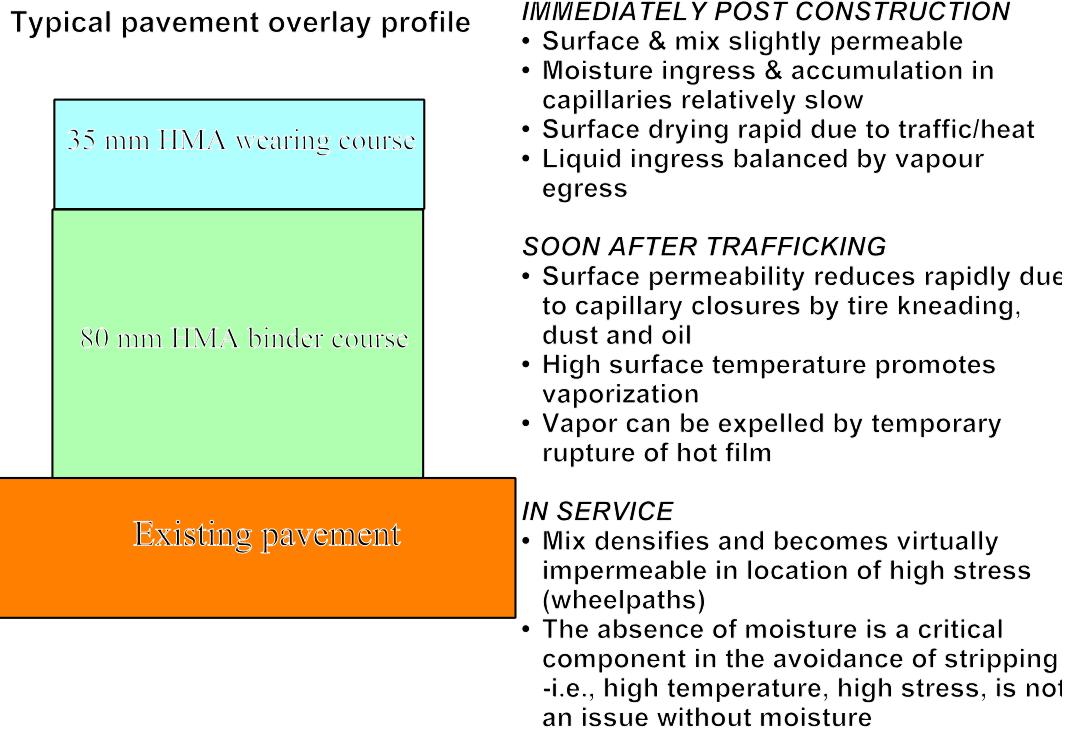
**Figure 34. Typical Time/Moisture Profile in Asphalt Overlay Without OGFC (After Rickards, 4)**

The preceding hypothesis is explained further in Figures 34 through 37. Figures 34 and 35 depict typical time/moisture profiles in dense-graded HMA courses without and with OGFC, respectively. Figures 36 and 37 show schematic representation of moisture movement in dense-graded HMA courses due to thermal pumping without and with OGFC, respectively.

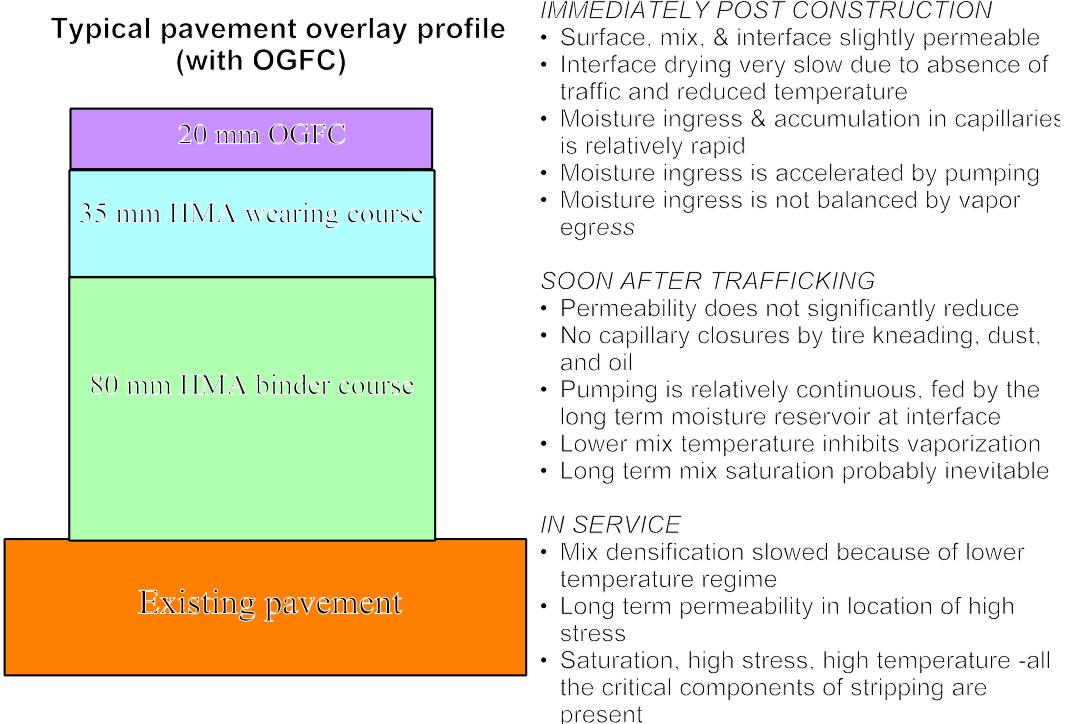
**Figure 35. Typical Time/Moisture Profile in Asphalt Overlay With OGFC (After Rickards, 4)**

The conditions that occur when a fresh dense-graded HMA course is overlaid by an OGFC are illustrated in Figures 35 and 37 (after Rickards, 4). In such conditions the permeability of the dense graded HMA course is not significantly reduced with time due to the absence of kneading action of traffic and densification. Compaction by traffic is diminished because (a) tire load stress is dissipated by the OGFC, and (b) the temperature of the dense-graded HMA course is generally 5-10°C lower.
